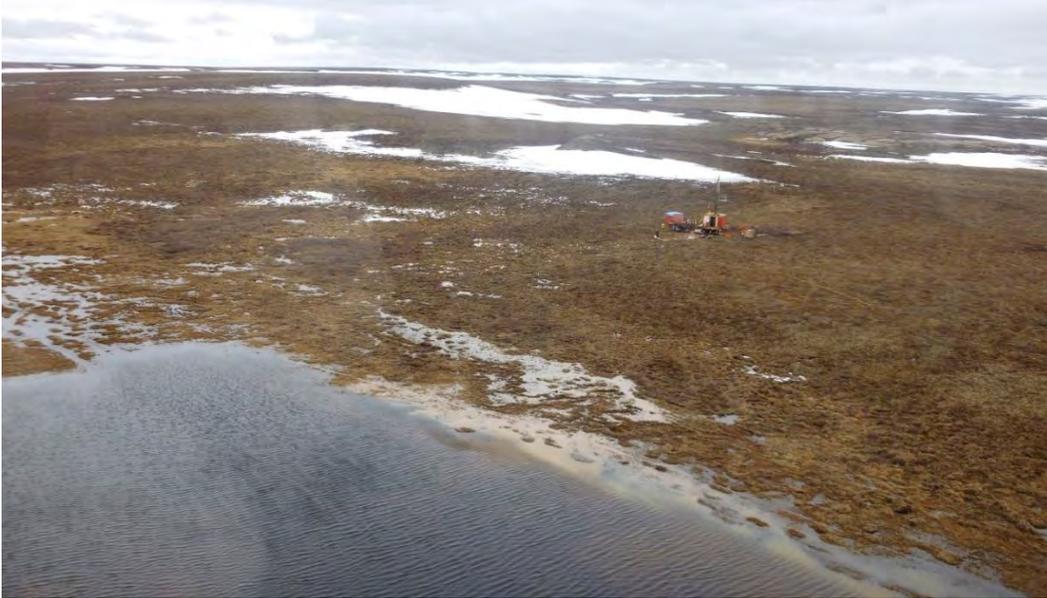
While drilling in the 85W area on June 17, 2015, drill cuttings mobilized into a water body located at 64°25'12.32" N, 97°48'17.27" W (14W 557578 7144369). The spill was detected during a routine drill inspection by the Safety, Health, Environment, and Quality Supervisor and Project Geologist (Photograph 3.4-2). Reporting was completed in accordance with the NWB licence Part H item five and the AANDC Land Use Permit N2014C0001 item 32. In addition to immediate notification to the NT-NU Spill Report Line, the thirty day report summarizing the incident and corrective actions was distributed to regulators. The impacted spill area was estimated to be approximately 2,000 m² (Photograph 3.4-3).

Photograph 3.4-2: Unauthorized Cuttings Discharge near 85W-009 on June 17, 2015

Various corrective and preventative measures were implemented following the spill identification. To limit the spatial extent of the spill, the pump discharging clean water was stopped and the hose was relocated and extended away from the affected area. All drill crews on site were subsequently instructed not to place their excess clean water hoses in places that could create a potential uncontrolled runoff into a water body and to alert AREVA staff if discharge fluids are accumulating around the drill. A sump pump and wood chip sock berm were placed at the bottleneck of the spill to further reduce the transport of sediments towards the small water body (Photograph 3.4-6).

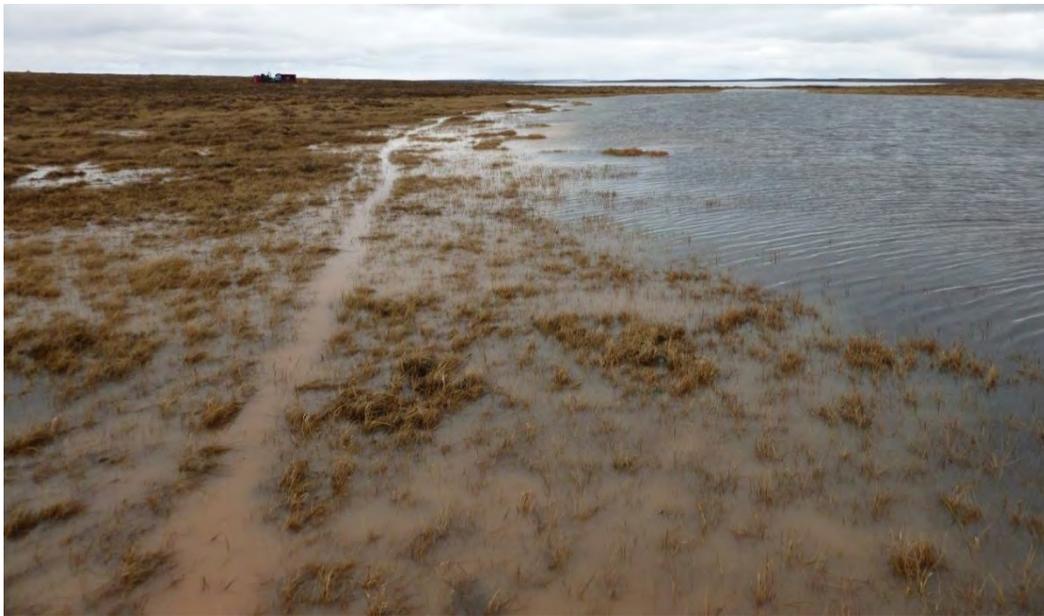
Photograph 3.4-3: Unauthorized Cuttings Discharge to Unnamed Lake June 17, 2015

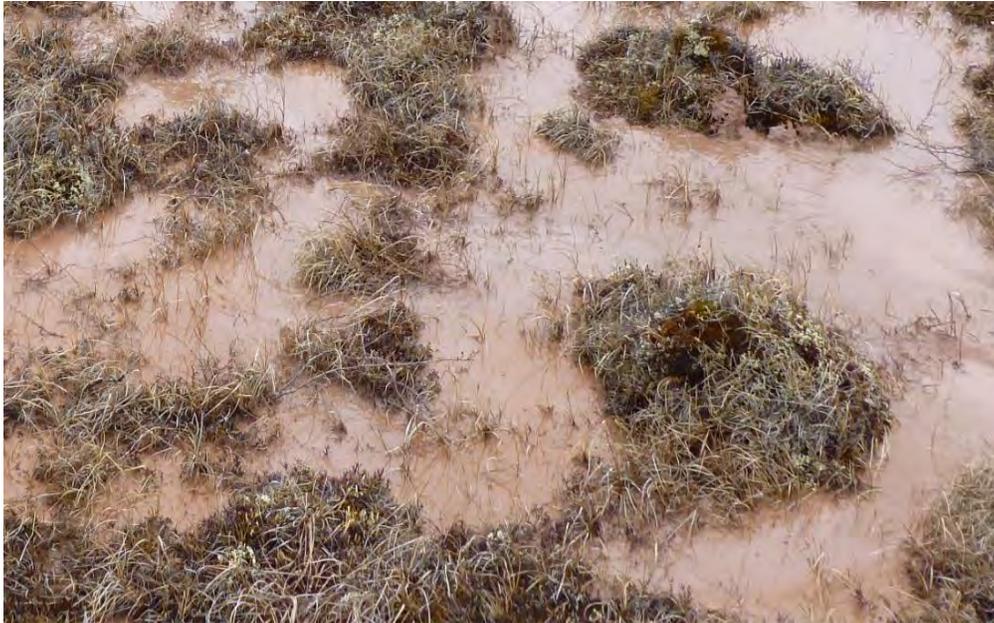
Non-mineralized drill cuttings located at 64°25'17.91" N, 97°48'17.18" W (14W 557576 7144542) were washed downhill away from the drilling rig due to the presence of runoff in the area. The excess clean water line further facilitated the downhill migration of the cuttings into a water body approximately 120 m to the west. A ground survey of the area was immediately

conducted and indicated that the spill was a combination of runoff water, drill return water, and cuttings from the installation of the casing (Photograph 3.4-4 and Photograph 3.4-5).

Photograph 3.4-4: Spill Water Mixture June 17, 2015

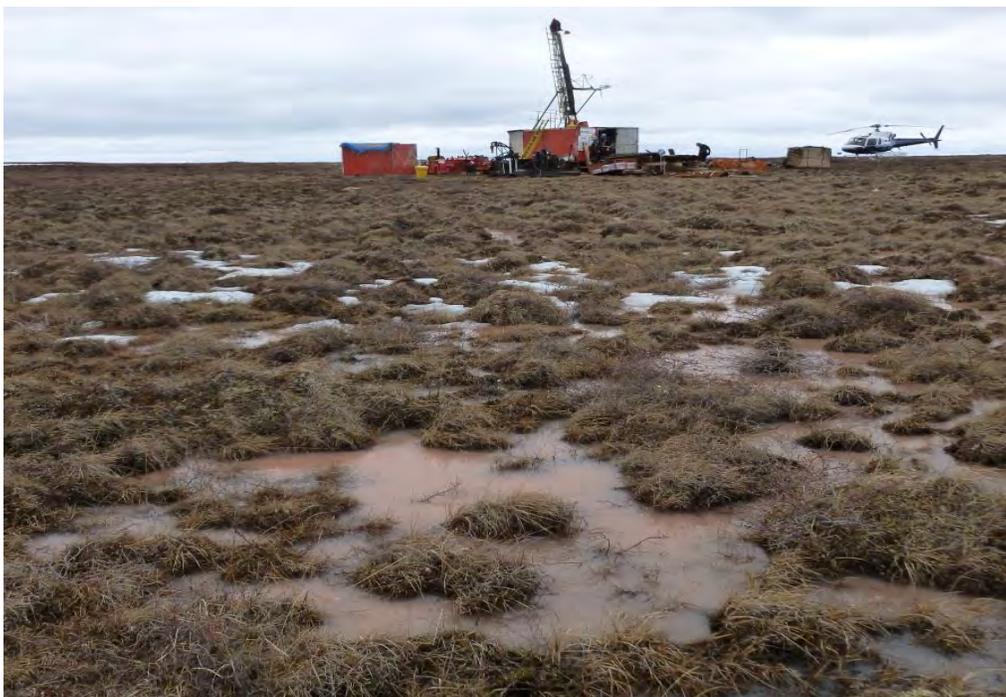
Photograph 3.4-5: Runoff Water Mixed with Drill Cuttings June 17, 2015

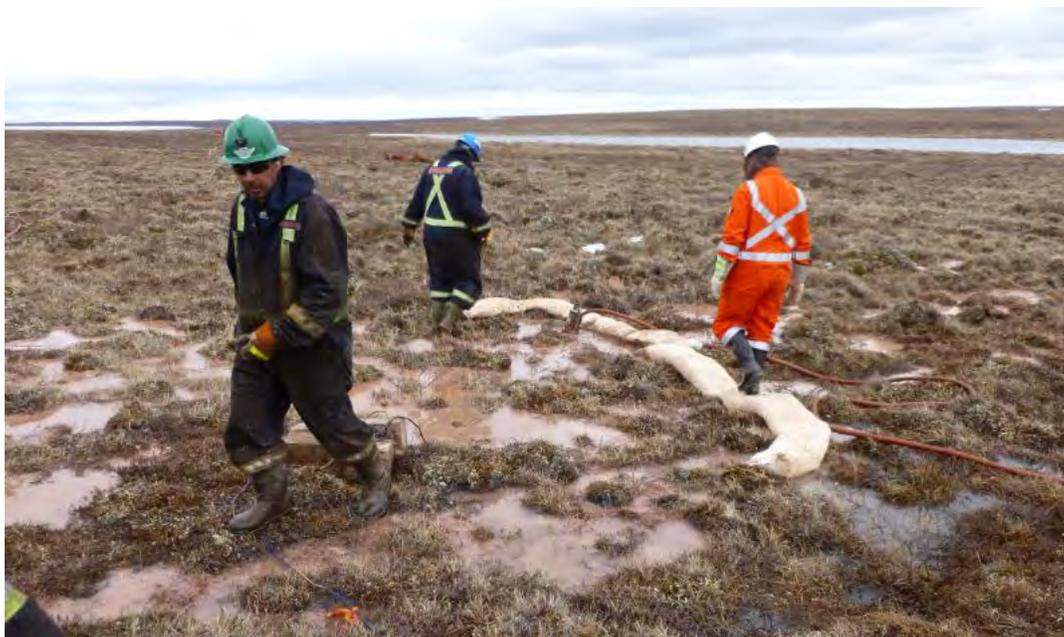
Photograph 3.4-6: Installation of Filter Socks and Sump Pump June 17, 2015

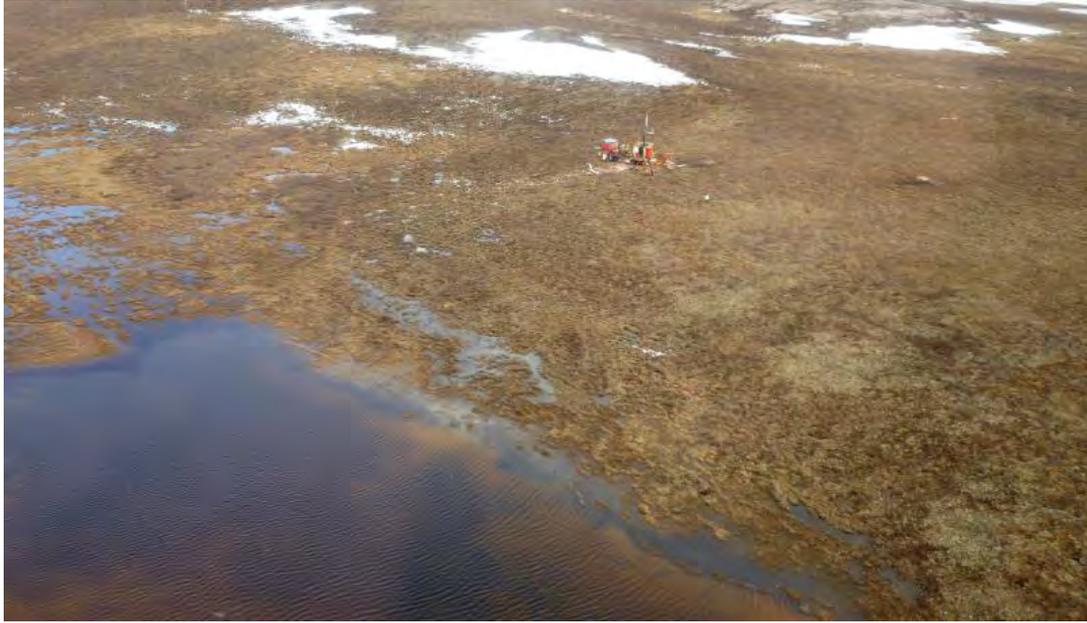
An Automess 6150 AD radiation detection device was used to scan the spill area immediately following the spill with an additional survey the following day. The surveys indicated no radioactive contamination in the area as a result of the spill. The site was monitored over the days following the spill and by June 18 the white discoloration of the water was no longer visible (Photograph 3.4-7).

Photograph 3.4-7: Aerial Survey of Spill Area on June 18, 2015

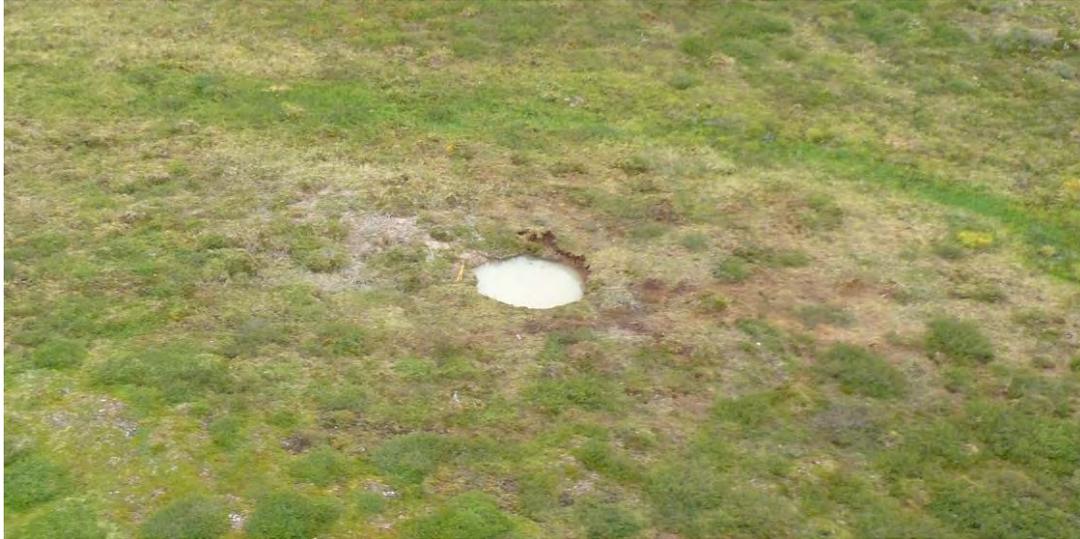
During a 2014 AANDC annual inspection, a sink hole was discovered at $64^{\circ}20'42.21''$ N, $97^{\circ}50'24.37''$ W (14W 556030 7135977) in the End East grid that was approximately two meters in diameter (Photograph 3.7-3). It is believed that the sink hole was created due to drilling activities in the area during the 2014 drilling program.

Photograph 3.7-3: Sink Hole Discovered at EE-05

The area was identified during a 2014 inspection and reclamation work was completed during the 2015 season. Throughout the 2015 season non-mineralized drill cuttings were deposited in the sink hole from various locations. Additionally, 30 cubic meters of gravel was obtained from Baker Lake and shipped to site during the 2015 winter haul for use as additional fill. Approximately 15 bags of cuttings and 15 bags (one cubic meter bags) of gravel were used to completely fill the sink hole (Photograph 3.7-4 and Photograph 3.7-5).

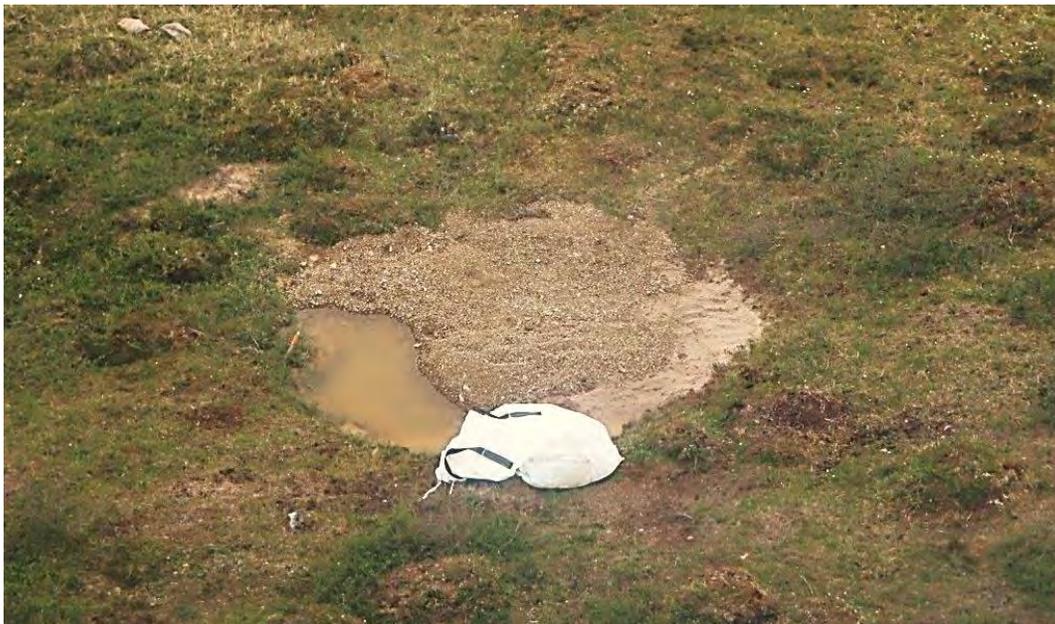
Photograph 3.7-4: Filling Sink Hole at EE-05

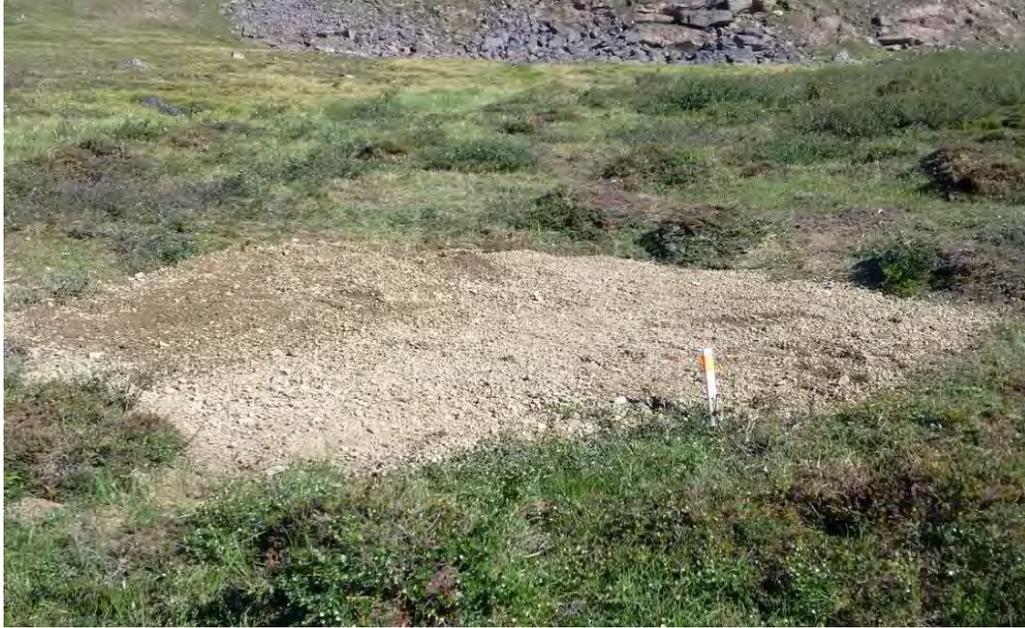
Photograph 3.7-5: Completed Work at EE-05

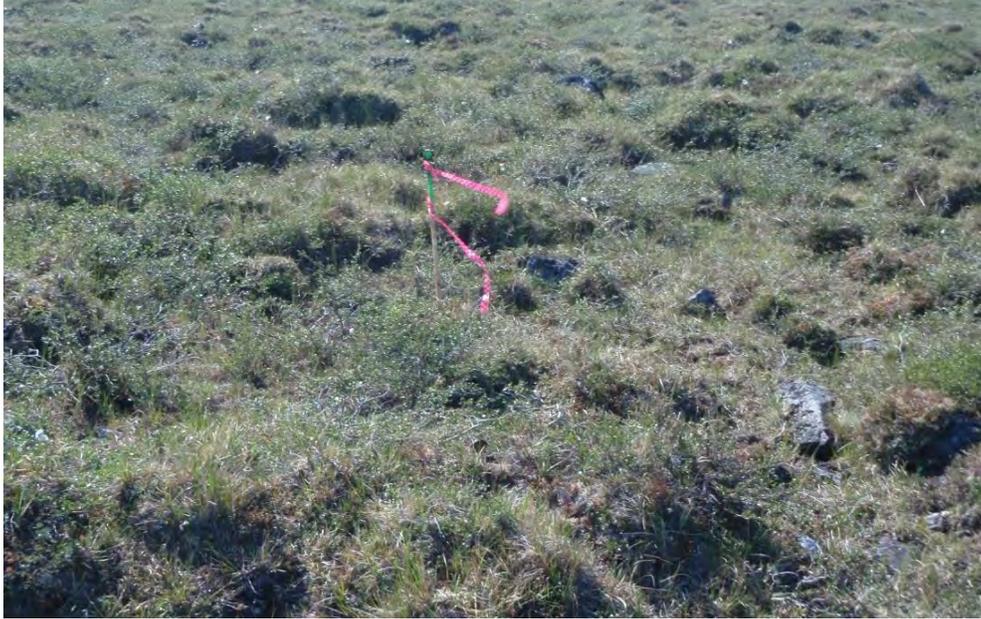
Photograph 3.7-6: CONT-027 Pre Drill Inspection August 5, 2015

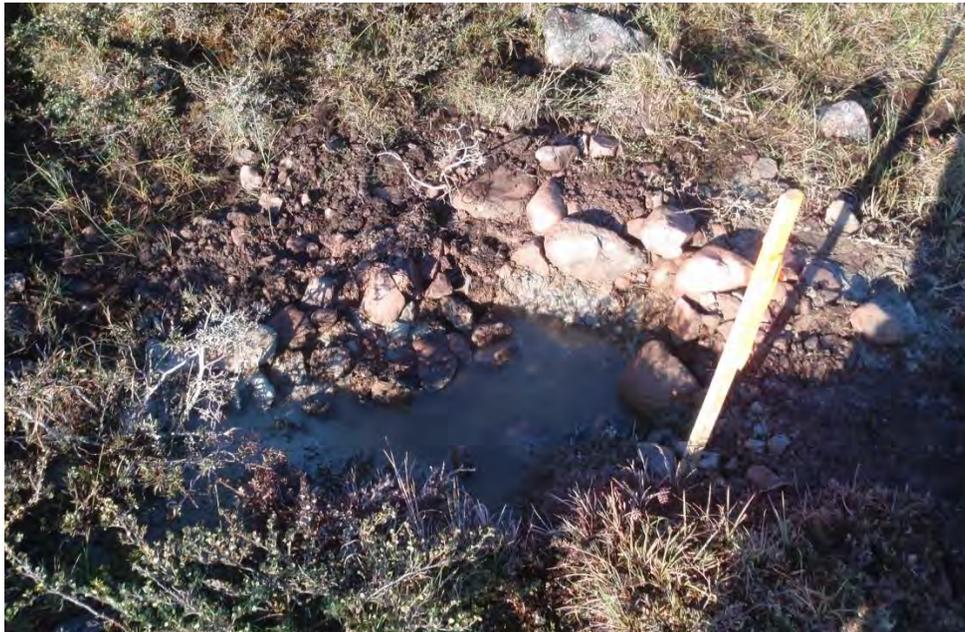
Upon finalizing a post drilling inspection in the Contact area, a slight depression from drilling activities was discovered near the CONT-027 drill hole (Photograph 3.7-6 and Photograph 3.7-7). Non-mineralized drill cuttings collected from that drill hole were used to level out the depression and restore physical stability in the area (Photograph 3.7-8).

Photograph 3.7-7: CONT-027 Post Drill Inspection August 12, 2015
