WATER LICENCE INSPECTION FORM

Licensee		Licensee Representative	
Raytheon Canada Ltd/DND		Don Beattie	
Licence No. / Expiry		Representative's Title	
3BC-CAM0919		Environmental Officer	
Land / Other Authorizations		Land / Other Authorizations	
3 associated Spill Files: 15-385, 16-129 & 17-196			
Date of Inspection		Inspector	
July 5, 2017		Baba Pedersen	
Activities Inspected			
<input type="checkbox"/> Camp	<input type="checkbox"/> Drilling	<input type="checkbox"/> Mining	<input type="checkbox"/> Construction
<input type="checkbox"/> Roads/Hauling	<input checked="" type="checkbox"/> Other: Fuel Spills		<input checked="" type="checkbox"/> Reclamation
			<input checked="" type="checkbox"/> Fuel Storage
			<input checked="" type="checkbox"/> Other: Operational NWS Site

PHOTO LOG

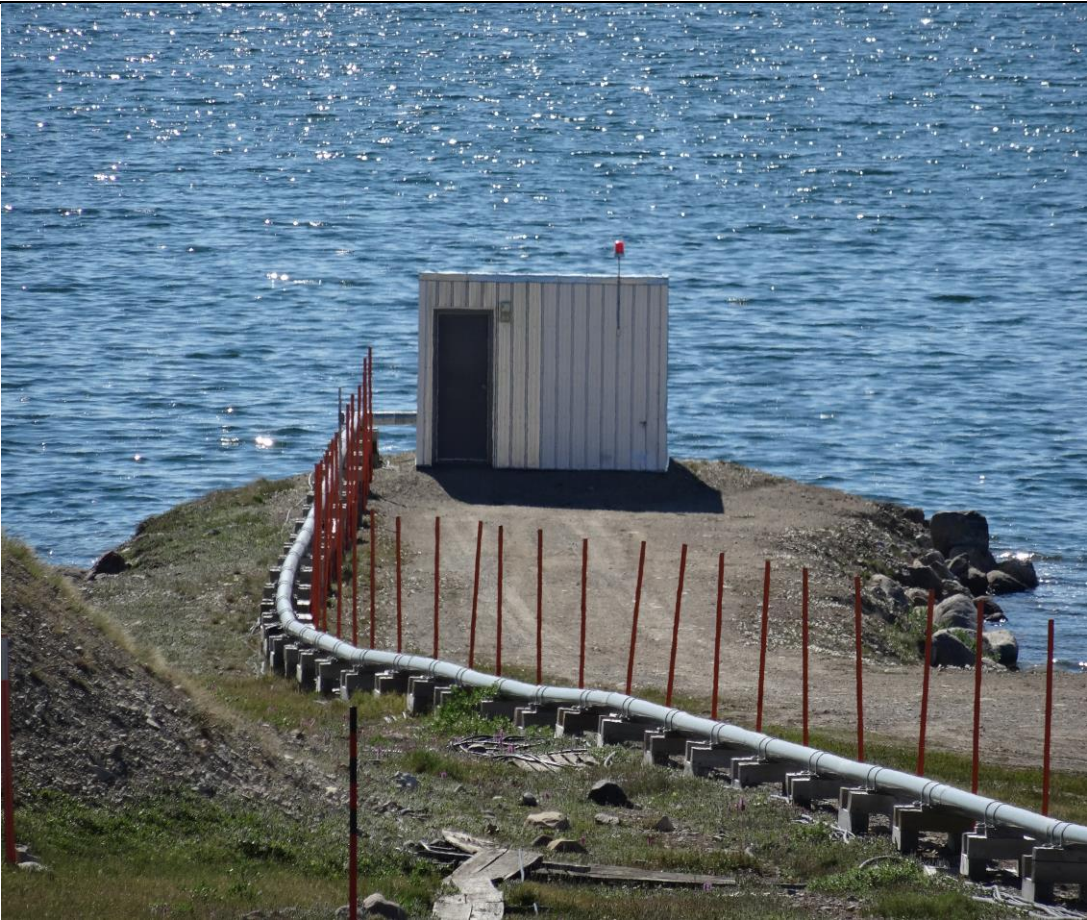
Photo 1

1. There was no Signage to indicate where Sample Station CDL-1 (Photo 1) at the Water Lake Intake (N69°06'51.3" W105°07'21.9") and the CDL-2 (Photo 2) Final Discharge Monitoring Station (N69°07'03.1" W105°07'11.7") where. 2. Total consumption of Water Use was hard to determine as not all usage (ie: Domestic, Roads, Fire & Washing of Vehicles) is metered. 3. There were no accurate records of Actual Discharge at the CDL-2 Monitoring Station. 4. 2 Fuel Line Valves just outside the Beach Tanks Berm (Photo 3) were not secured. 5. The above ground Fuel Pipeline directly behind the Hanger (Photos 4 & 5) is a major concern for a possible Fuel Spill entering the Ocean near the West Arm as it is a mere few feet away from the edge of the hill. 6. Spill #17-196 (Photos 6 to 10) has all been excavated with no signs of any further fuel on the ground. Excavated materials consisted of 47 drums of Fuel/Water mix, 122 Mega Bags of impacted Soils, 42 salvage drums of impacted Soils and 4 salvage Drums of Absorbent Pads & Booms currently being safely stored on site. 7. Spill #15-385 (3 Ltrs Glycol)(Photo 11) and Spill #16-129 (96 Ltrs Glycol/Water mixture)(Photo 12) have both been Cleaned Up satisfactorily and all waste shipped off site.

Description: No Signage at Sample Station CDL-1, Raw Water Intake

1. Appropriate Signage must be installed at Sample Stations CDL-1 & CDL-2 prior to July 2018. 2. All water consumption must be metered and recorded so volumes are readily available when requested by the Inspector. 3. An accurate measuring system must be installed at Sample Station CDL-2 to allow for actual discharge volume data to be provided to the Inspector on request. 4. Padlocks need to be installed on the 2 Pipeline Valves just outside the Beach Tanks Berm. 5. It is strongly suggested that the Fuel Pipeline behind the Hanger be relocated as to not pose a direct threat of a spill entering the ocean. 6. Spill #17-196 needs to be backfilled after Test Results are confirmed positive and all stored materials need to be either treated or sent off site for treatment. Confirmation of this must be provided to the Inspector when completed. Spill #17-196 will be inspected again during the next Site Visit. 7. I recommend Closure of both Spill #15-385 and Spill #16-129.

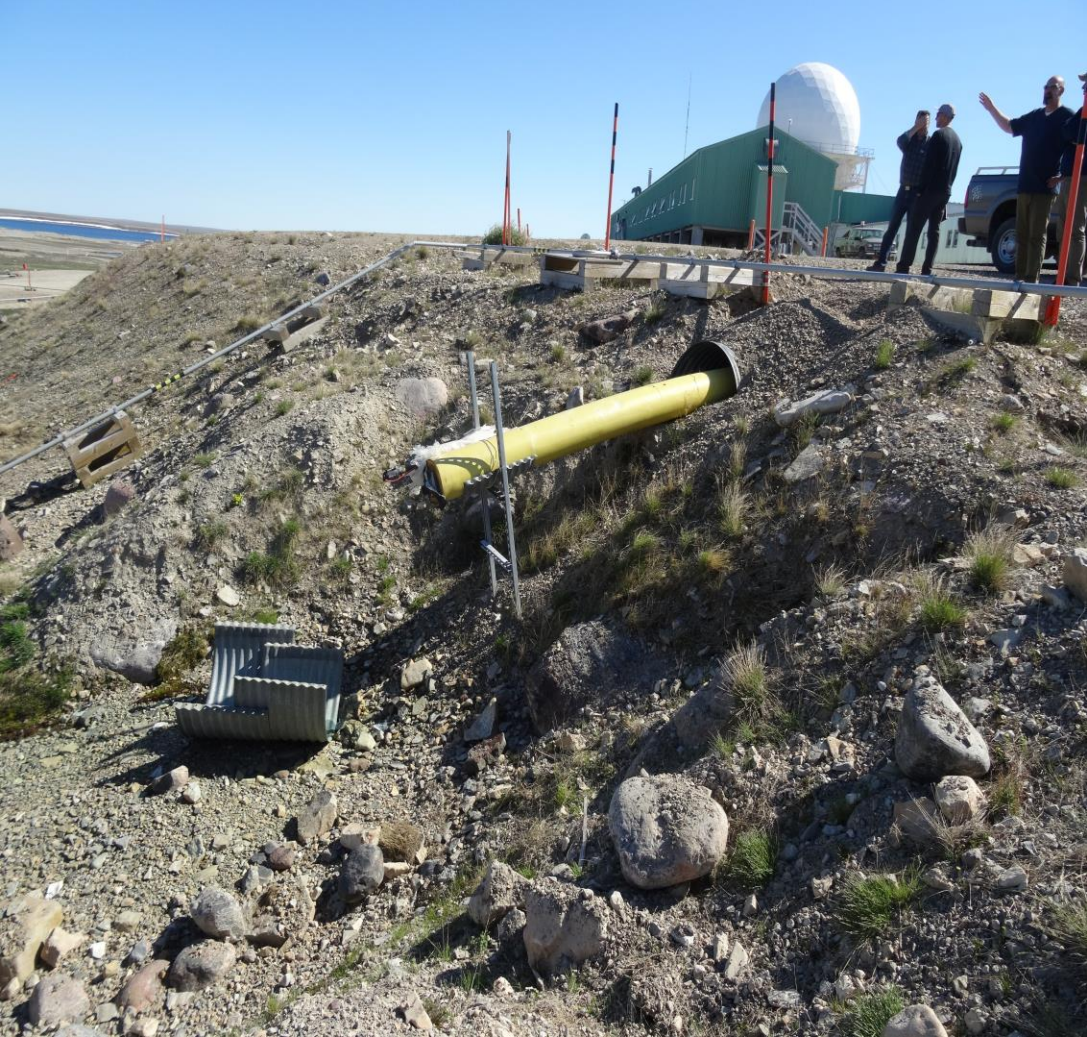
Photo 2

Description: No Signage at Sample Station CDL-2, End of Pipe Final Discharge

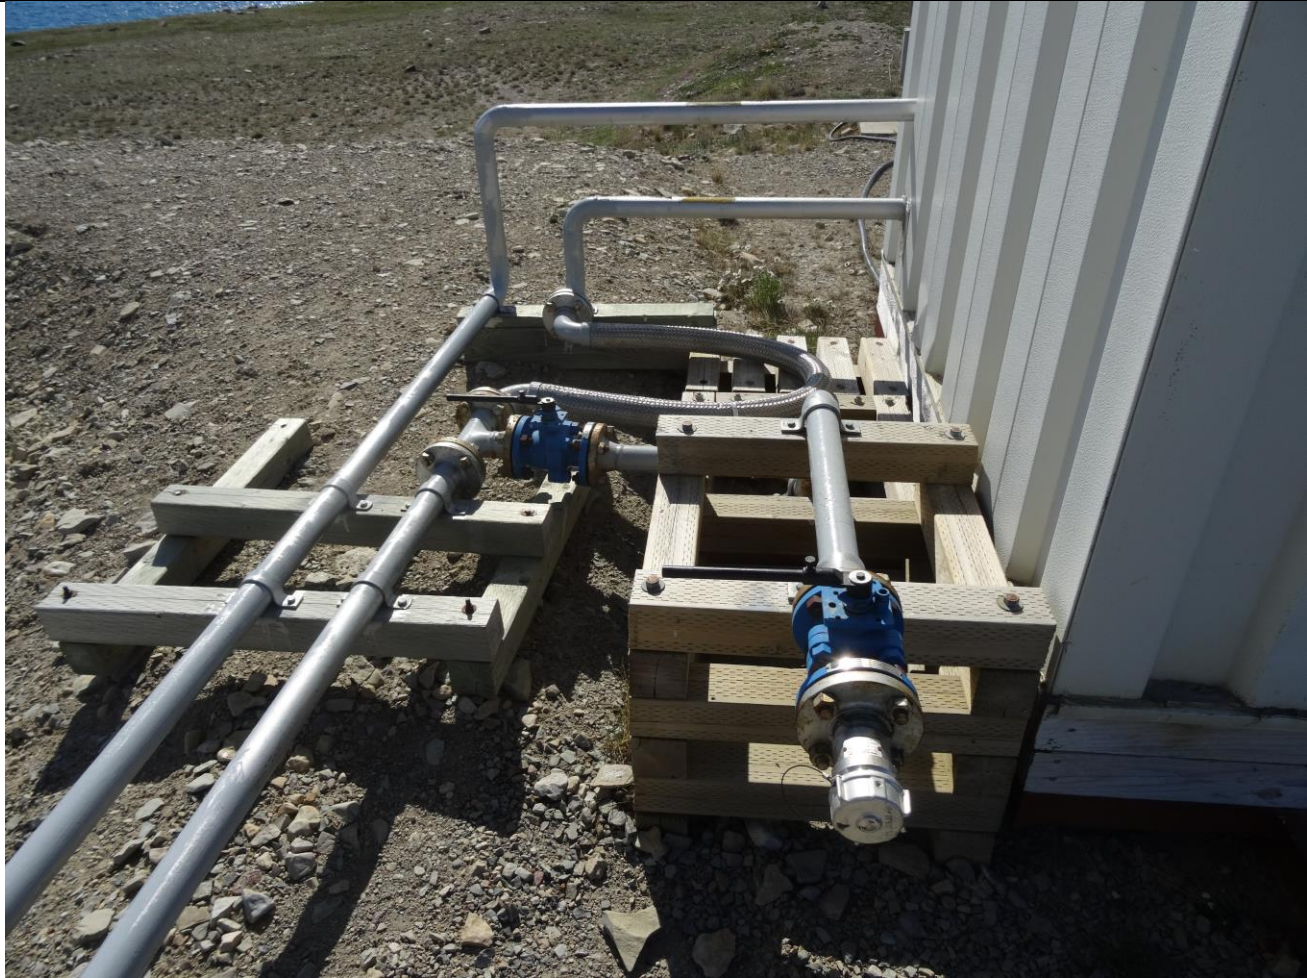
Photo 3

Description: 2 Unsecured Pipeline Valves beside Beach Tanks Pump House

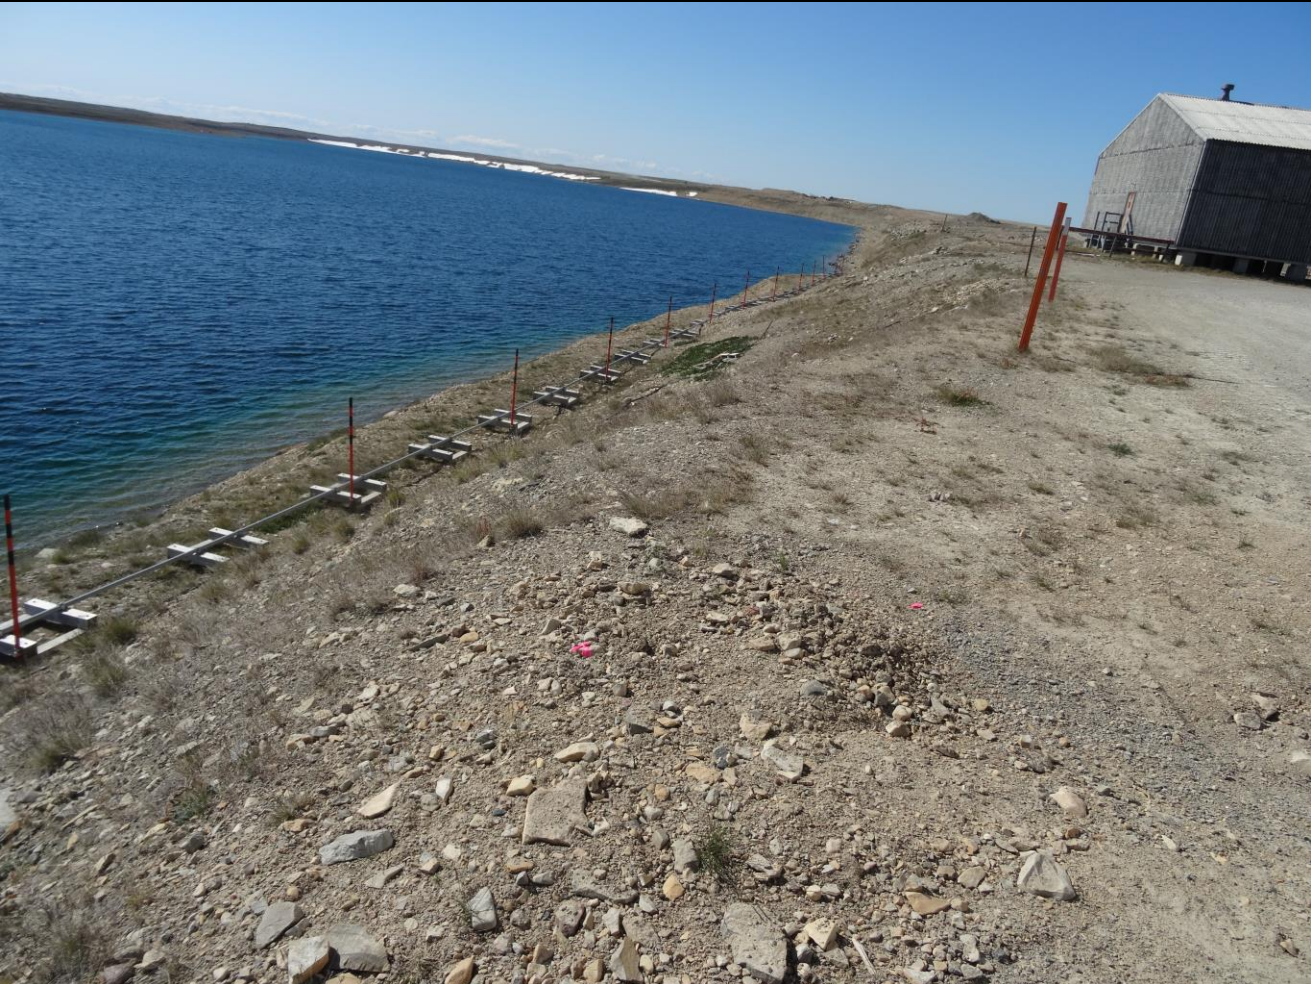
Photo 4

Description: Fuel Pipeline behind Hanger Building a few feet away from edge of hill going down to the ocean

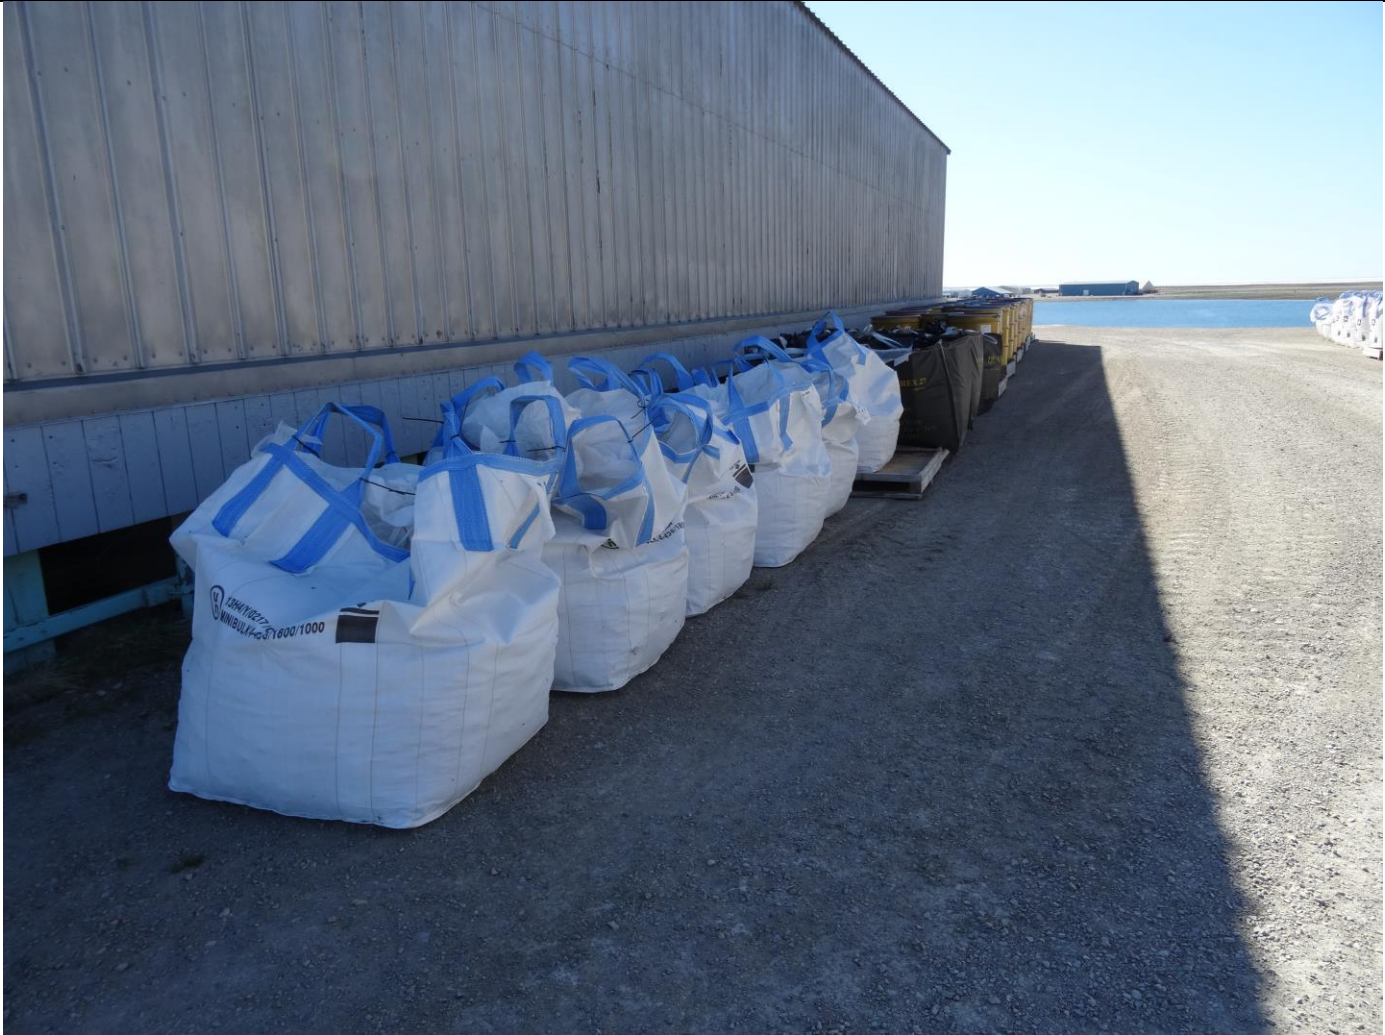
Photo 7

Description: Spill #17-196 some of the Mega Bags and Waste Drums in Storage area

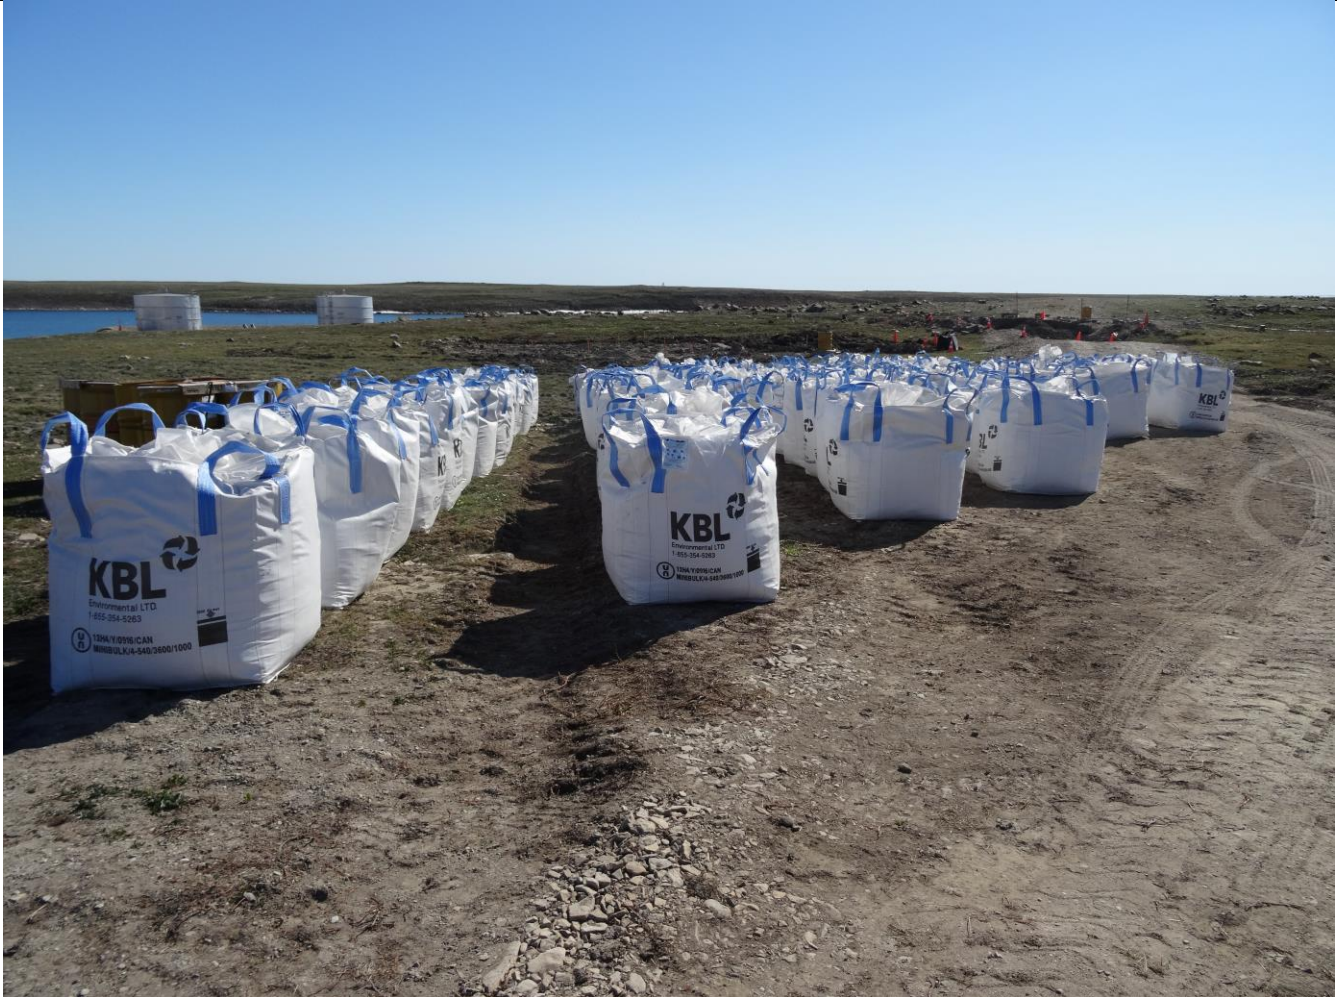
Photo 8

Description: Spill #17-196 Mega Bags waiting to be moved to temporary storage area from Spill Site

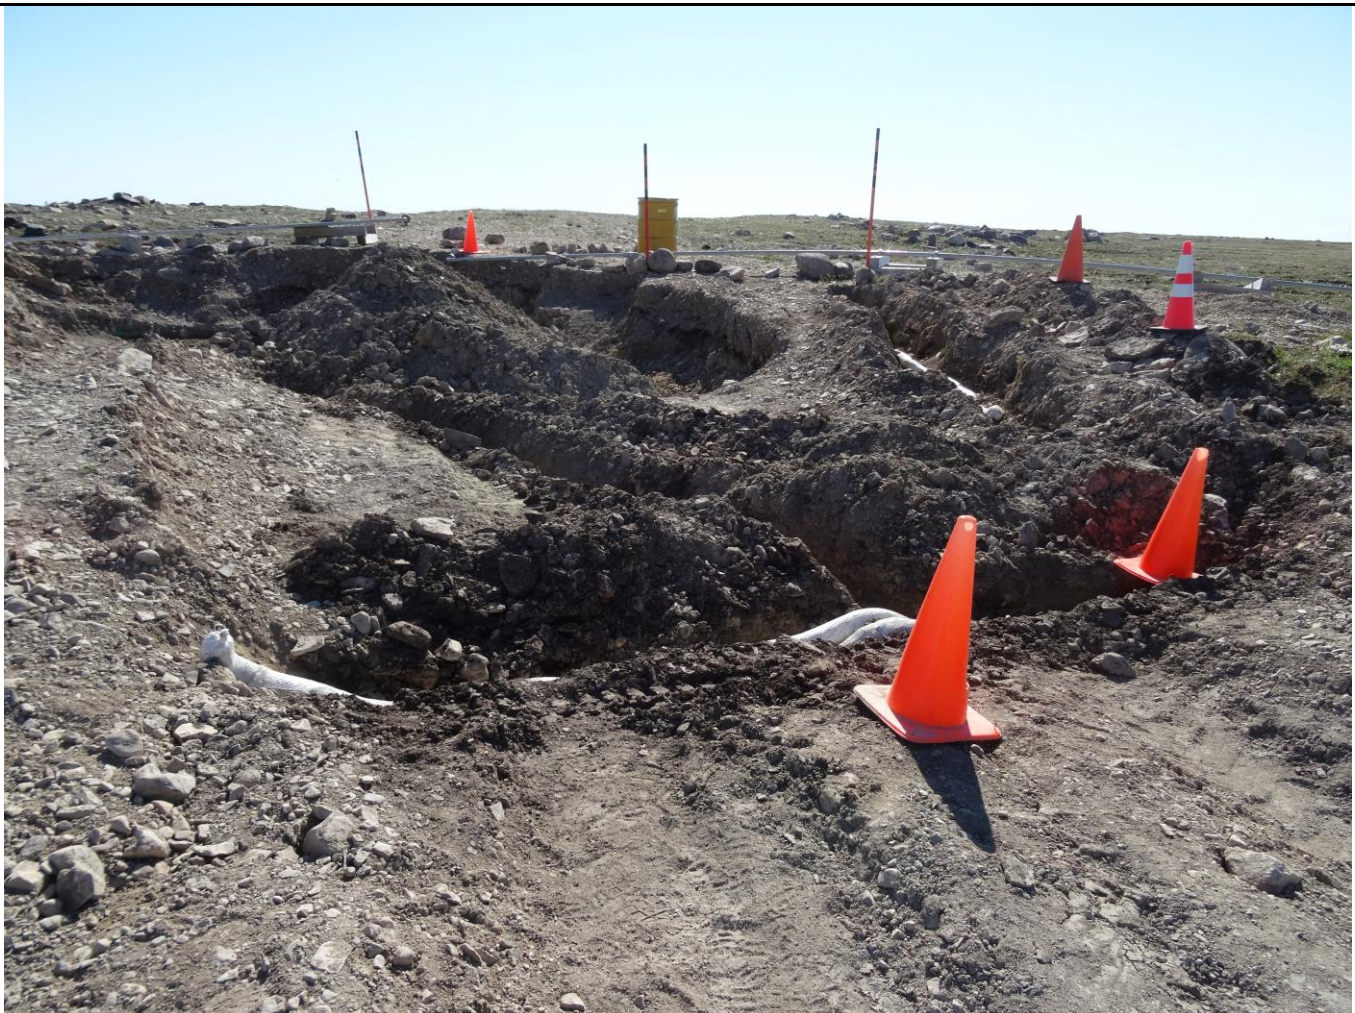
Photo 9

Description: Spill #17-196 effected Spill area near Beach Tanks area

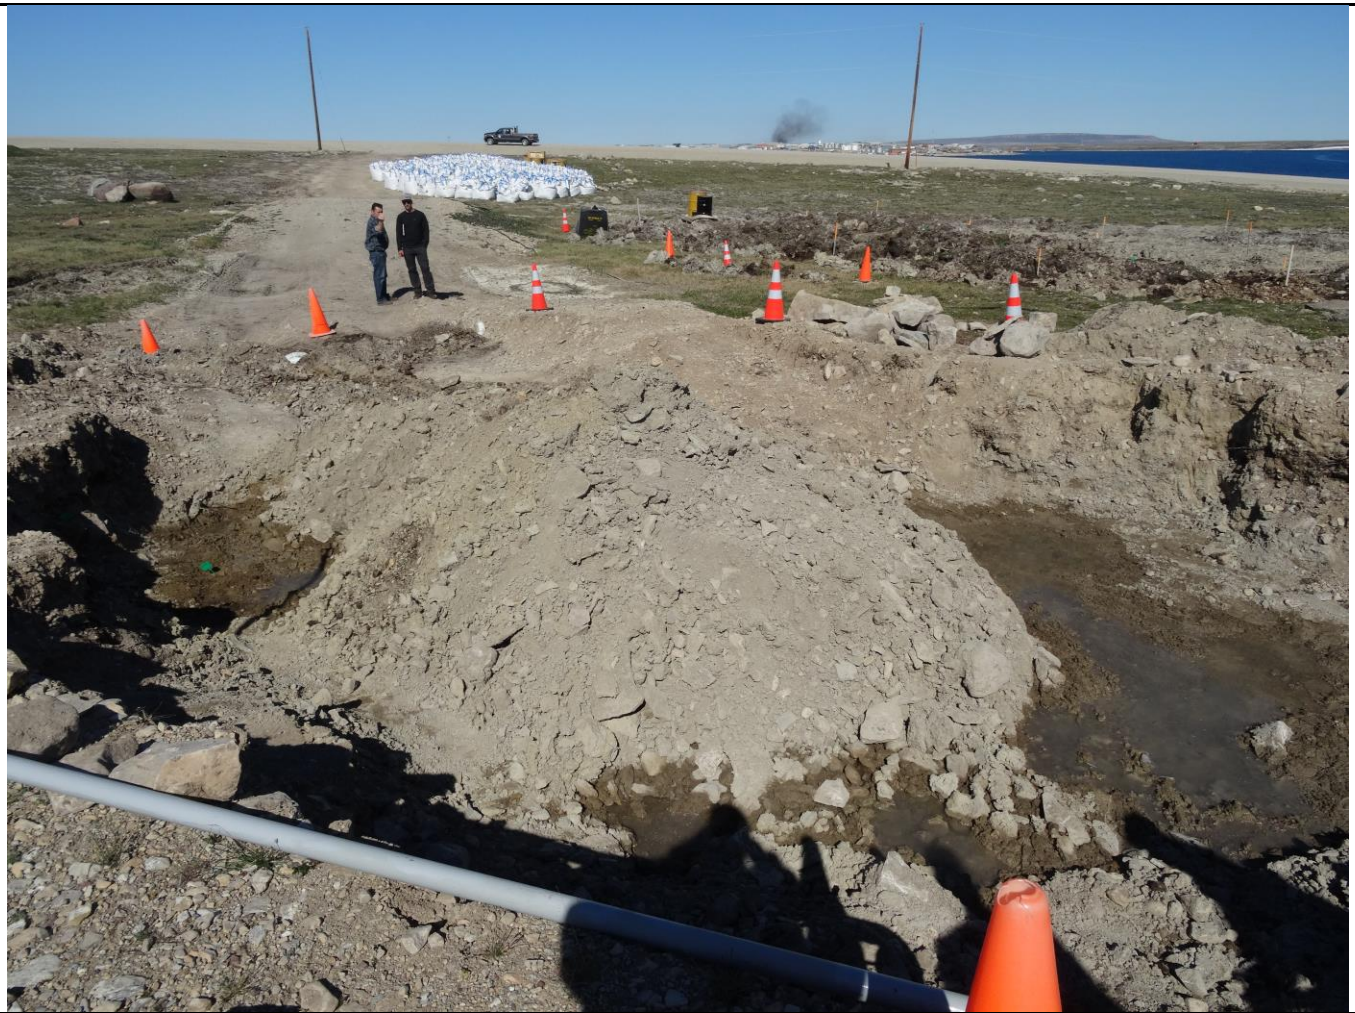
Photo 10

Description: Spill #17-196 effected Spill area near Beach Tanks area

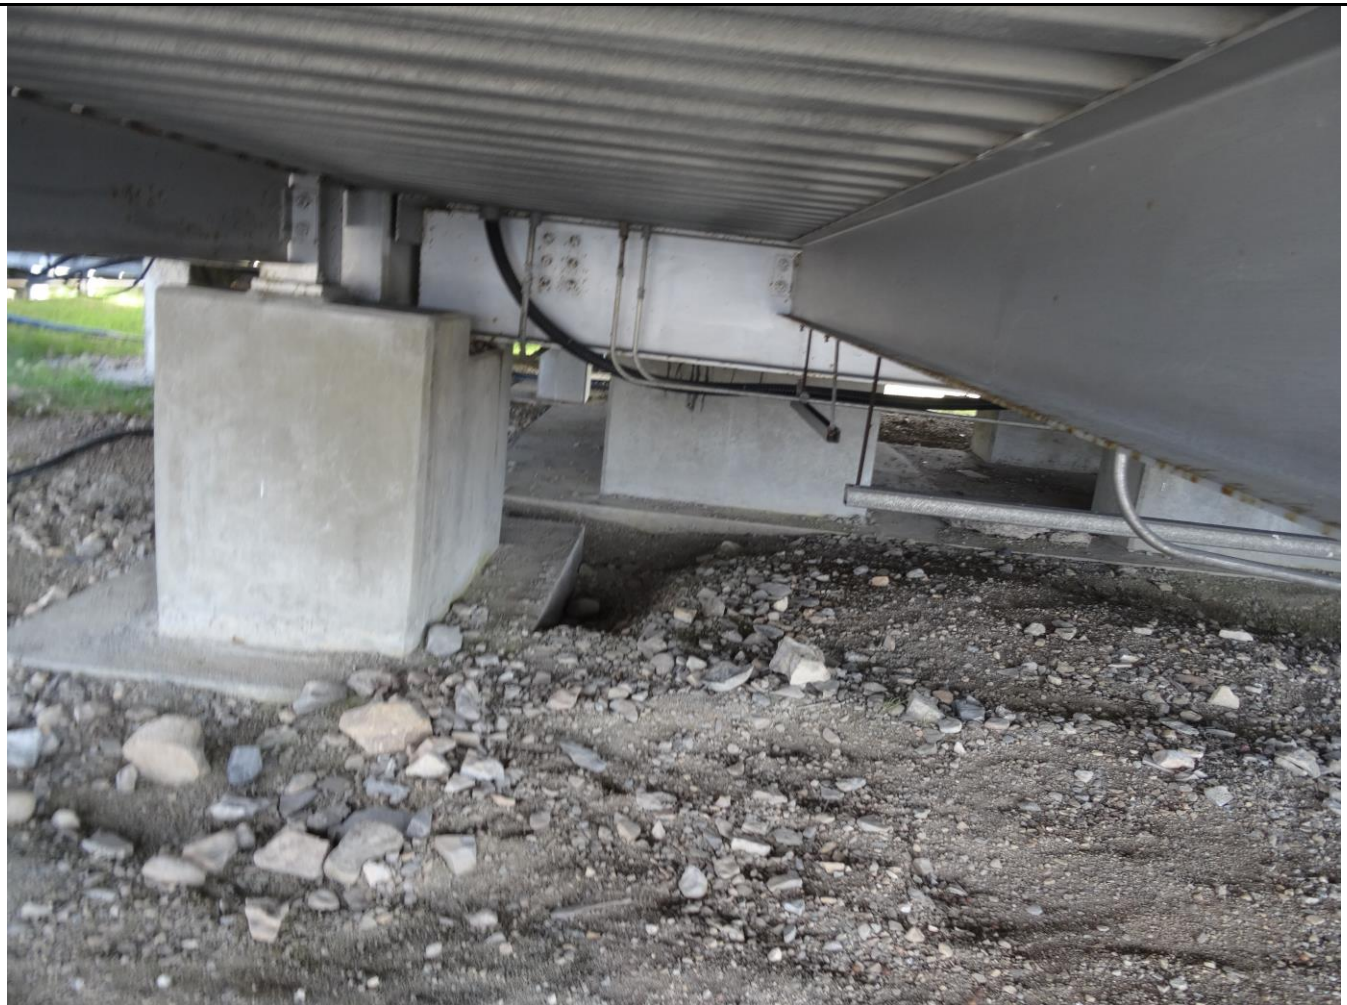
Photo 11

Description: Spill #15-385 cleaned up and excavated area underneath Power Plant Building on CAM-M NWS Site

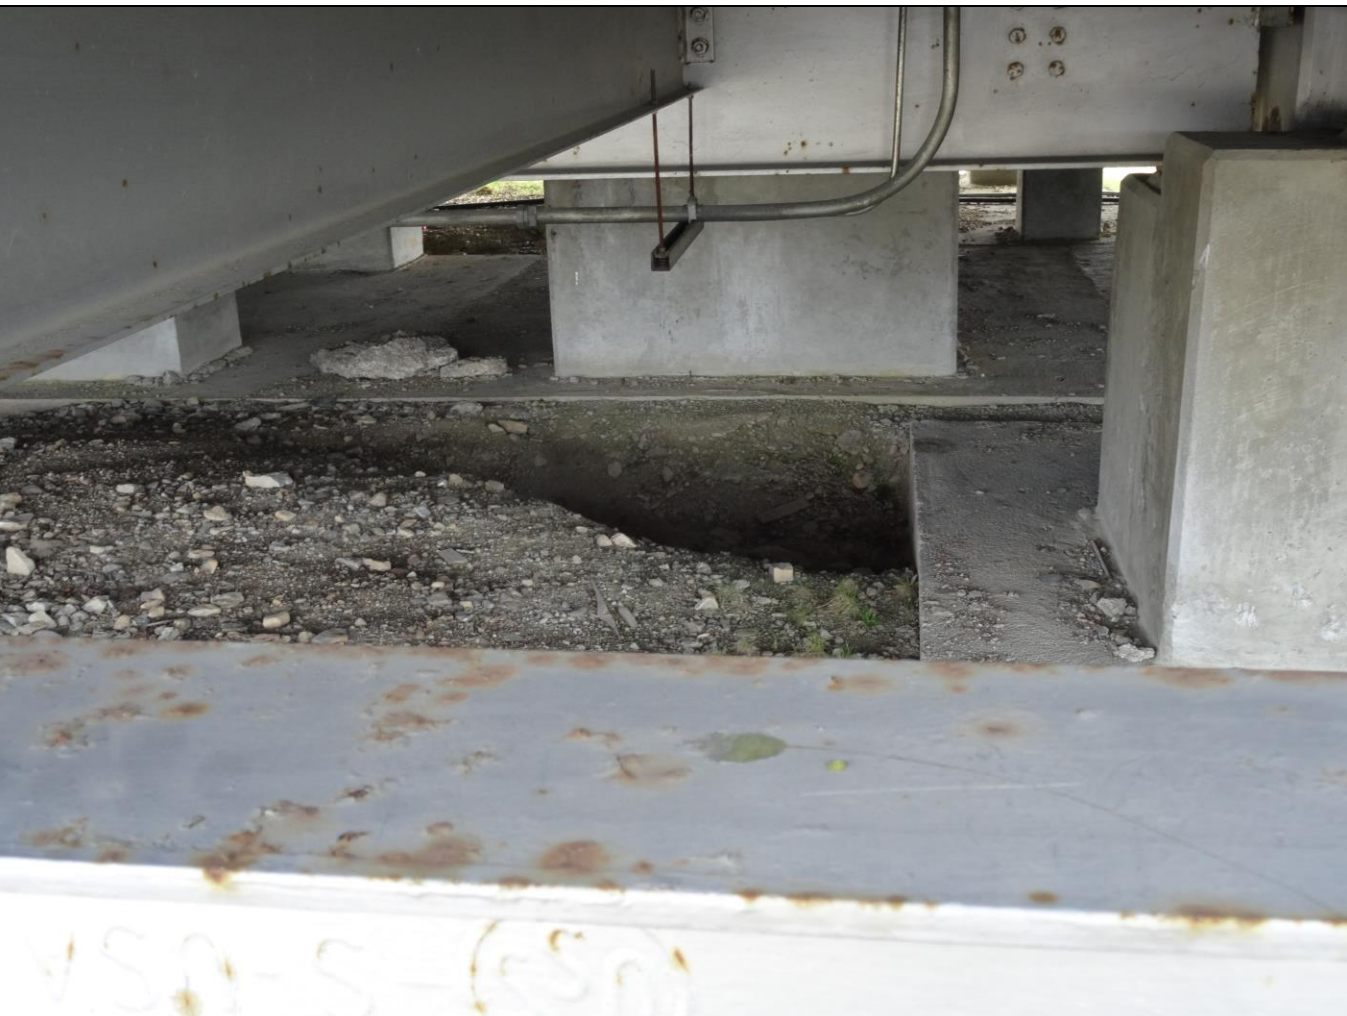
Photo 12

Description: Spill #16-129 cleaned up and excavated area underneath Power Plant Building on CAM-M NWS Site
