Meadowbank 2018 Annual Review of Portage and Goose Pit Slope Performance

2018 ANNUAL PIT SLOPE PERFORMANCE REVIEW

MEADOWBANK MINE, NUNAVUT

ISSUED FOR USE
704-ENG. ROCK03053-02

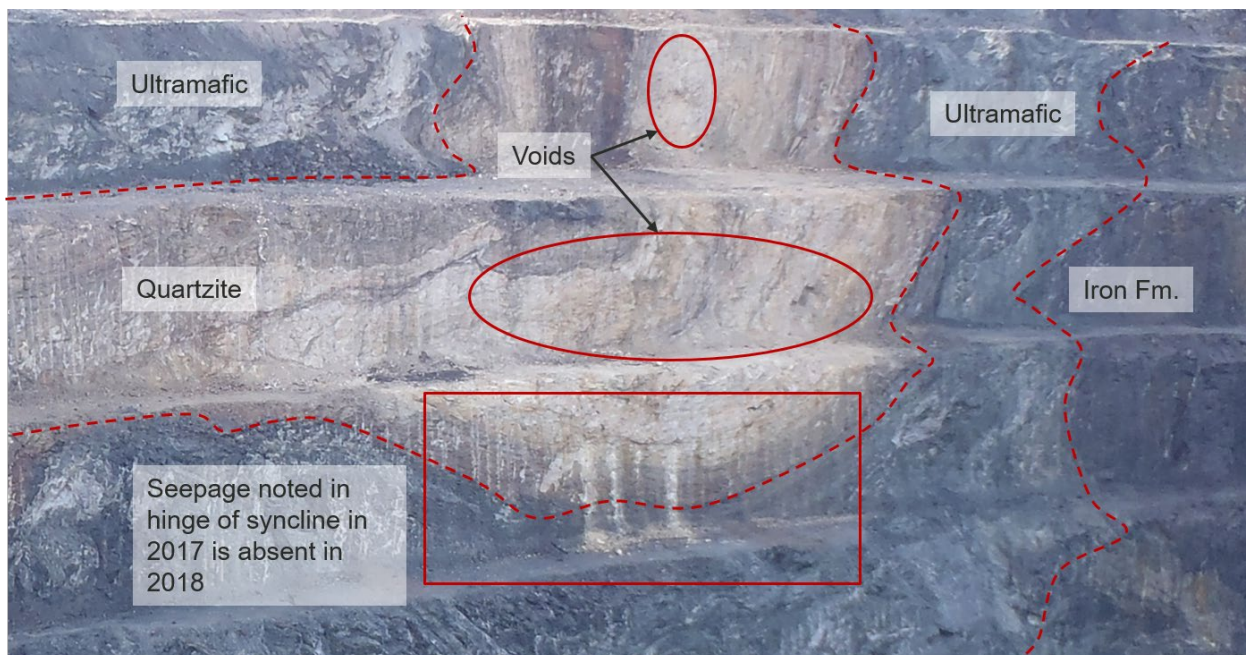
Photograph 4-6: Voids in quartzite above Pit A west ramp (2018)

The quartzite stratigraphy observed in the Pit A west wall contains several large voids identified during previous inspections. There has been no significant accumulation of material on the benches since the 2017 inspection. Seepage that was noted along the synform axis of the quartzite in 2017 is absent in 2018.

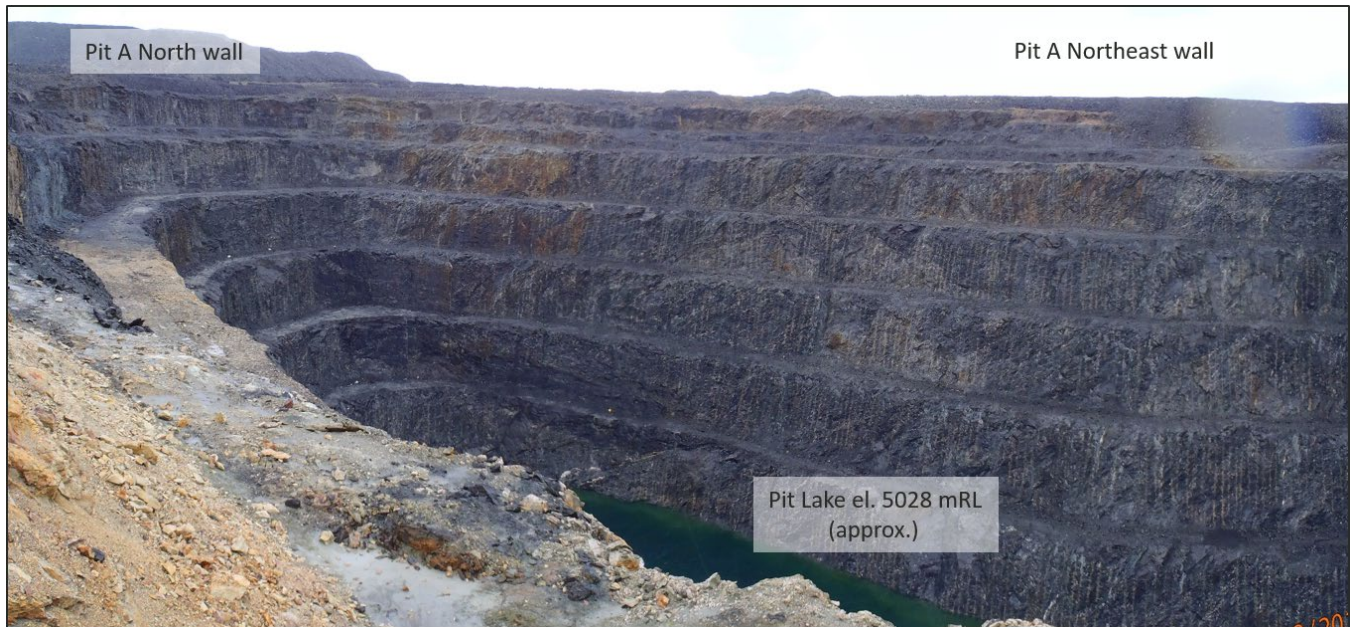
Photograph 4-8: Pit A north to northeast wall (2018)

The north through northeast walls of Pit A continue to perform adequately. There are no noticeable changes from 2017 to 2018. Very little accumulation of loose or raveling material on the catch benches was noted during the site visit.

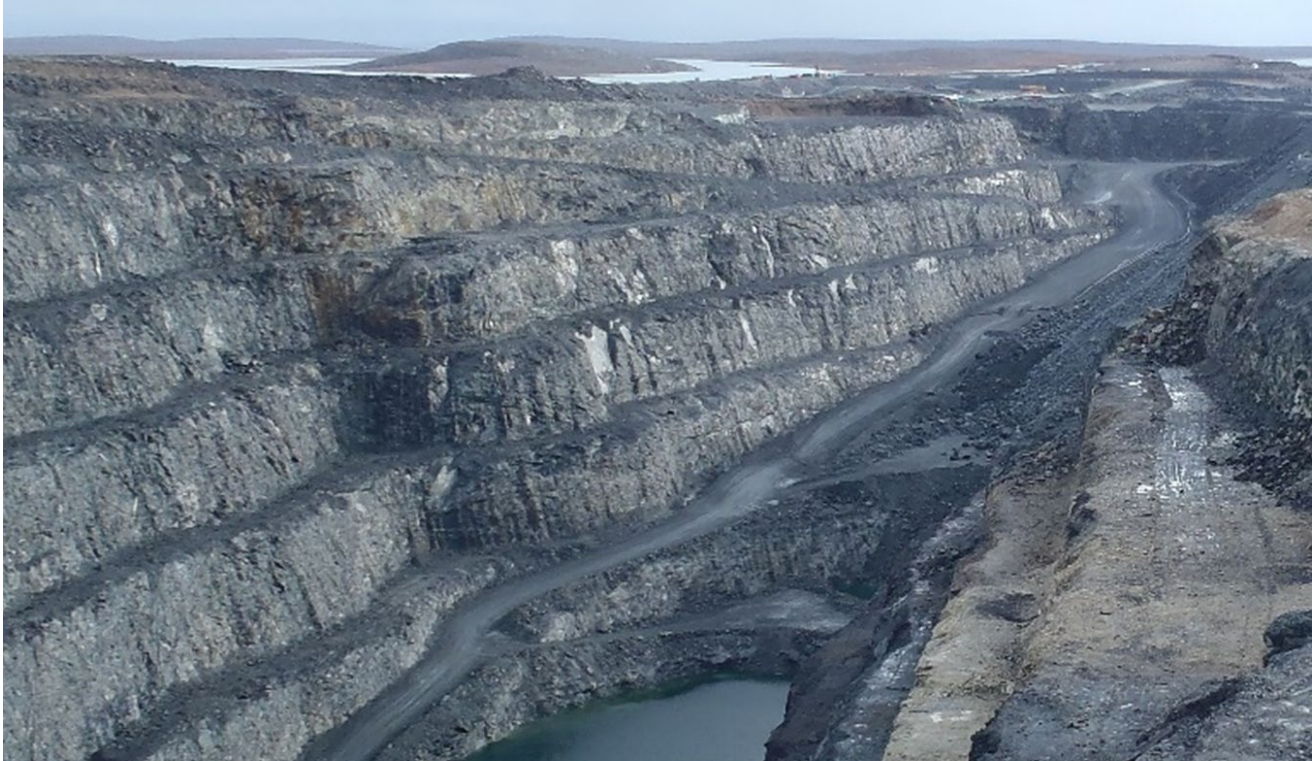
Photograph 4-12: Pit B east wall, looking south (2018)

The east wall of Pit B was inspected from several viewpoints as well as from within the pit. The wall continues to perform satisfactorily. Benches are generally clean with little accumulation of material.

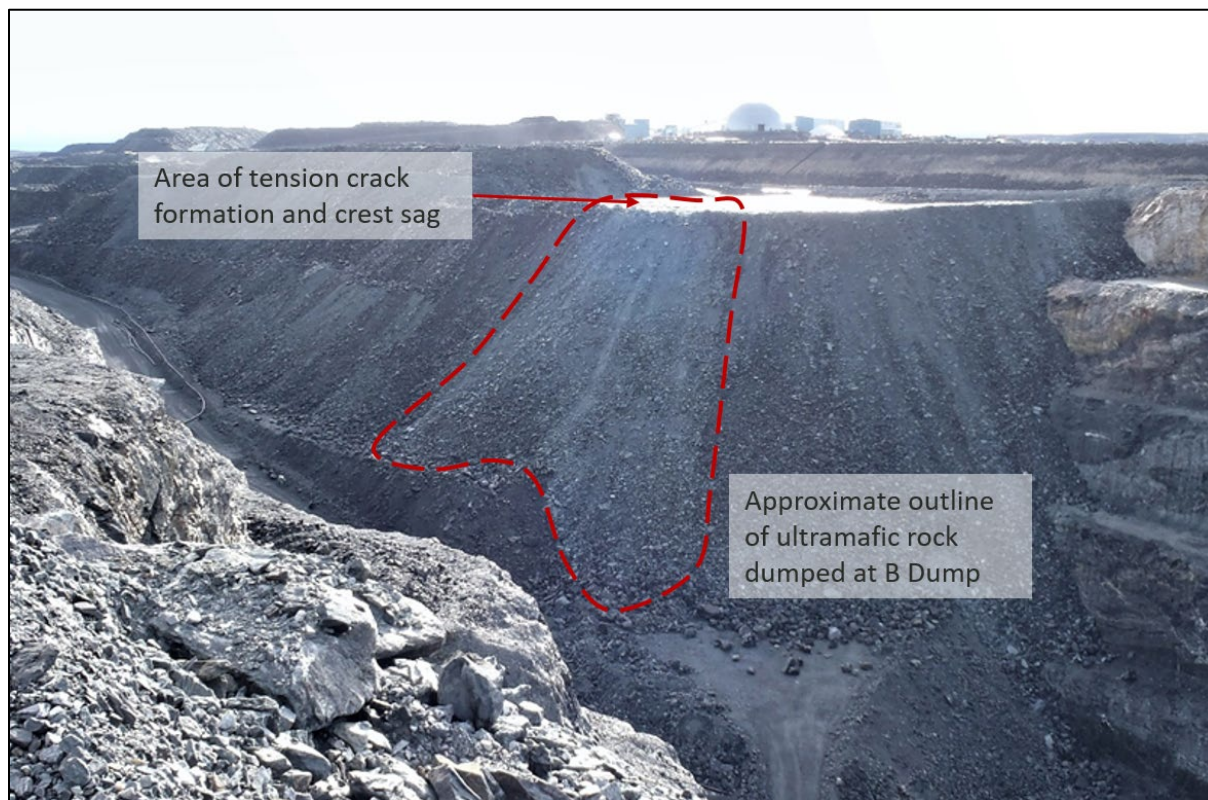
Photograph 4-13: B Dump looking southwest and outline of approximate ultramafic rock

The general Pit B (B Dump) geometry remains unchanged from the 2017 site inspection, however some tension cracks and crest sag were noted during dump use in 2018. This relates to dumping of ultramafic rock inadvertently in a local area of the dump. Since the ultramafic rock is weak, of generally poor quality, and often with associated talc mineralization, sagging and slumping of a local area of the dump face has occurred. Tension cracks were noted and AEM established a simple wireline extensometer to monitor. Measured displacements did not exceed trigger response levels and the movement is limited in extent.

The tension cracks and associated sagging of the platform at the dump crest is shown in Photographs 4-13 and 4-14.

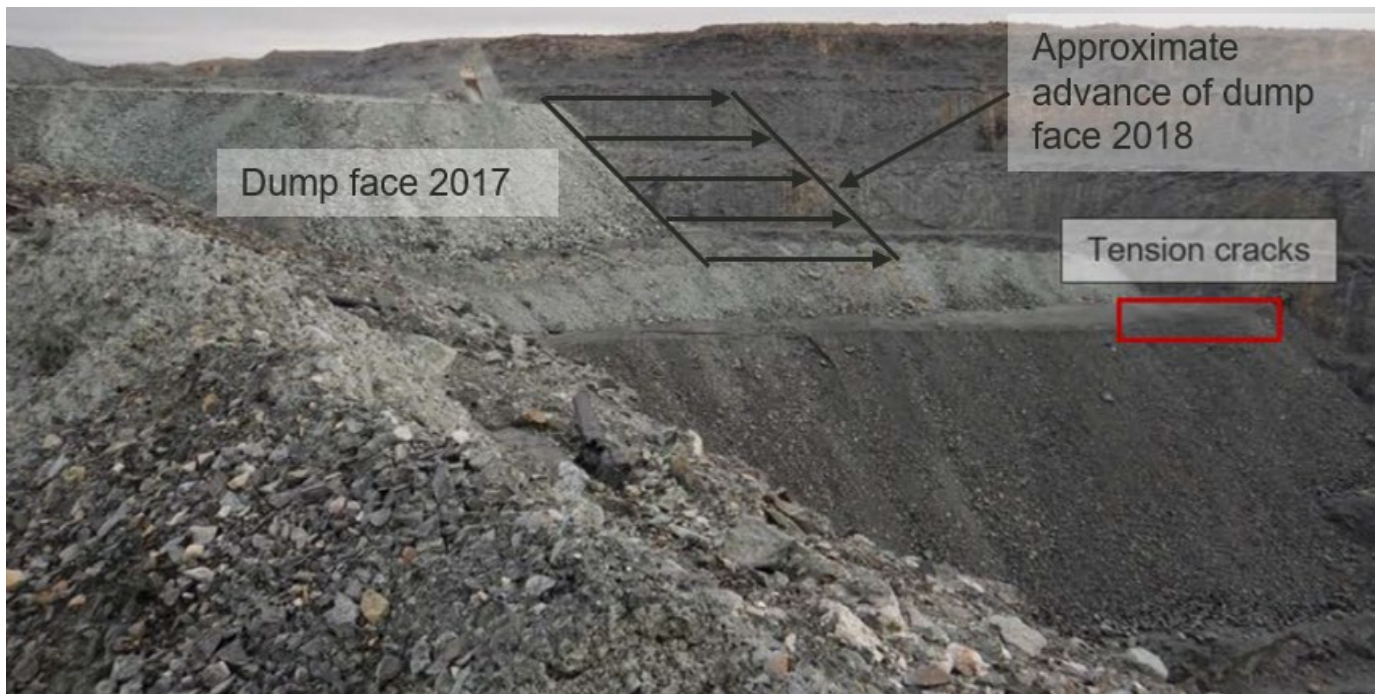
Photograph 5-2: Pit D dump showing 2017 dump face and approximate advance 2018 dump face location

An area of tension cracks that was observed on the D Dump platforms during the 2016 and 2017 inspections has increased, and this may be a result of the advancement of the 5126 platform southward over the 5088 platform. Both radial (perpendicular to dump crest) and transverse (parallel to dump crest) were observed. These are shown in the following photograph.

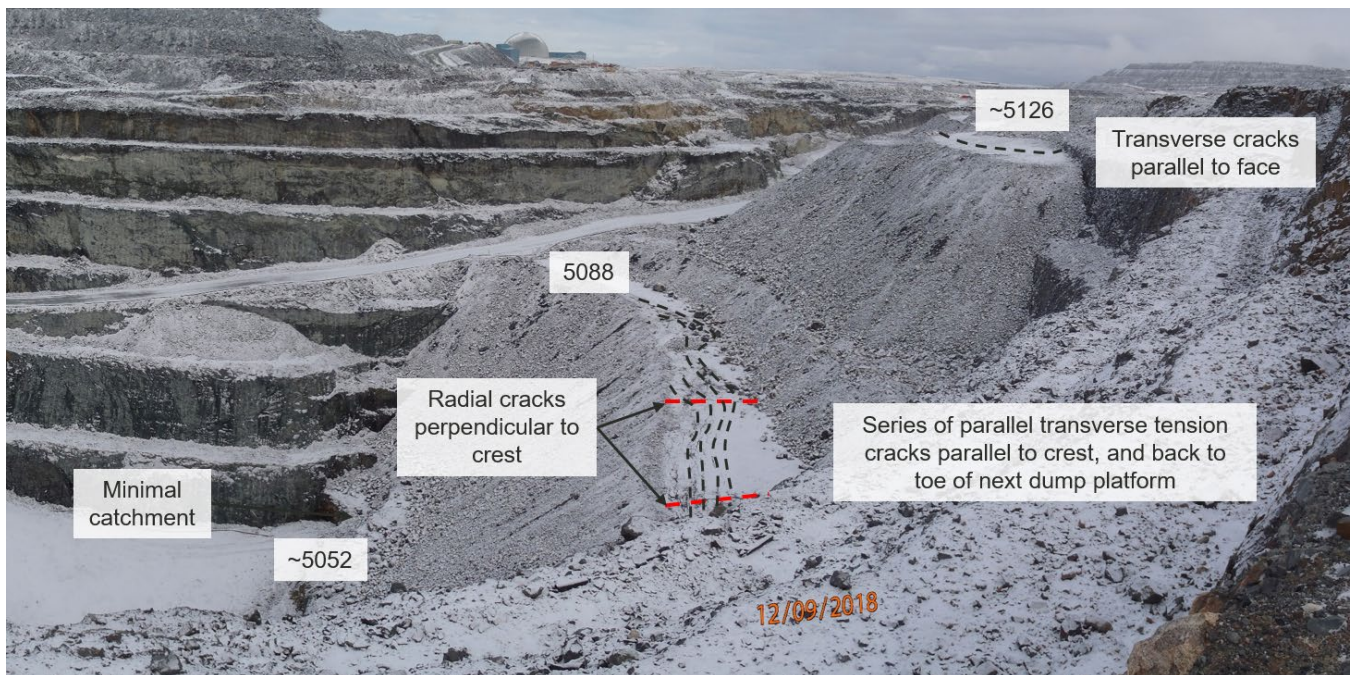
Photograph 5-3: Pit D dump viewed from east pit crest showing area of transverse and radial cracks on the 5088 mRL platform

An area of tension cracks that was observed on the D Dump platforms during the 2016 and 2017 inspections has increased, and this may be a result of the advancement of the 5126 platform southward over the 5088 platform. Both radial (perpendicular to dump crest) and transverse (parallel to dump crest) were observed. Recommendations include continued visual monitoring of the dump, and prior to mining the final Pit E below the dump area, a dump inspection and review should be completed. Other recommendations include surveying the current platforms, including locations of tension crack, proper management of water in the crest areas, and the installation of simple extensometers prior to freshet to establish a baseline for any movement.

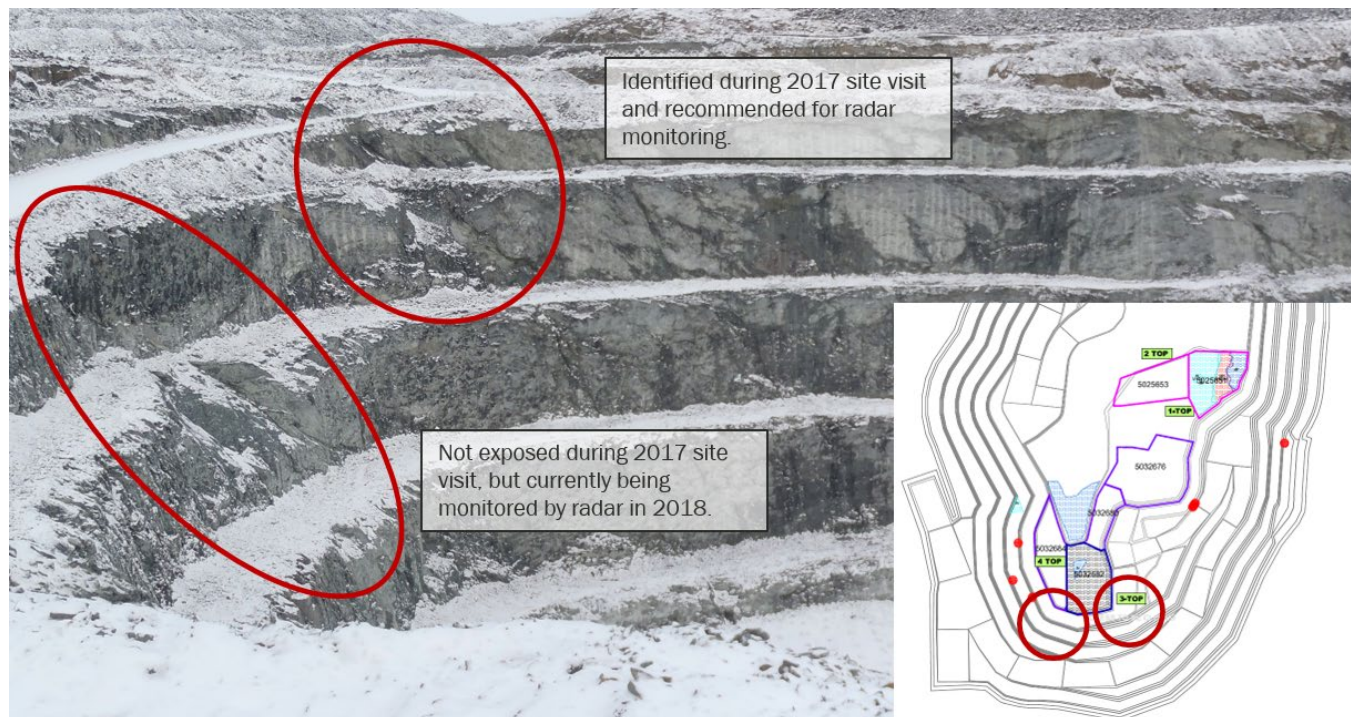
Photograph 6-5: North to northwest dipping shear planes contributing to wedge and planar instability in south wall

Many of the rock fall events that occurred along the south wall of Pit E5 beginning in June are associated with wedge and planar instability along relatively smooth, discrete, and continuous, but widely spaced shear planes that strike obliquely to the south wall, and are inclined to the north to northwest.

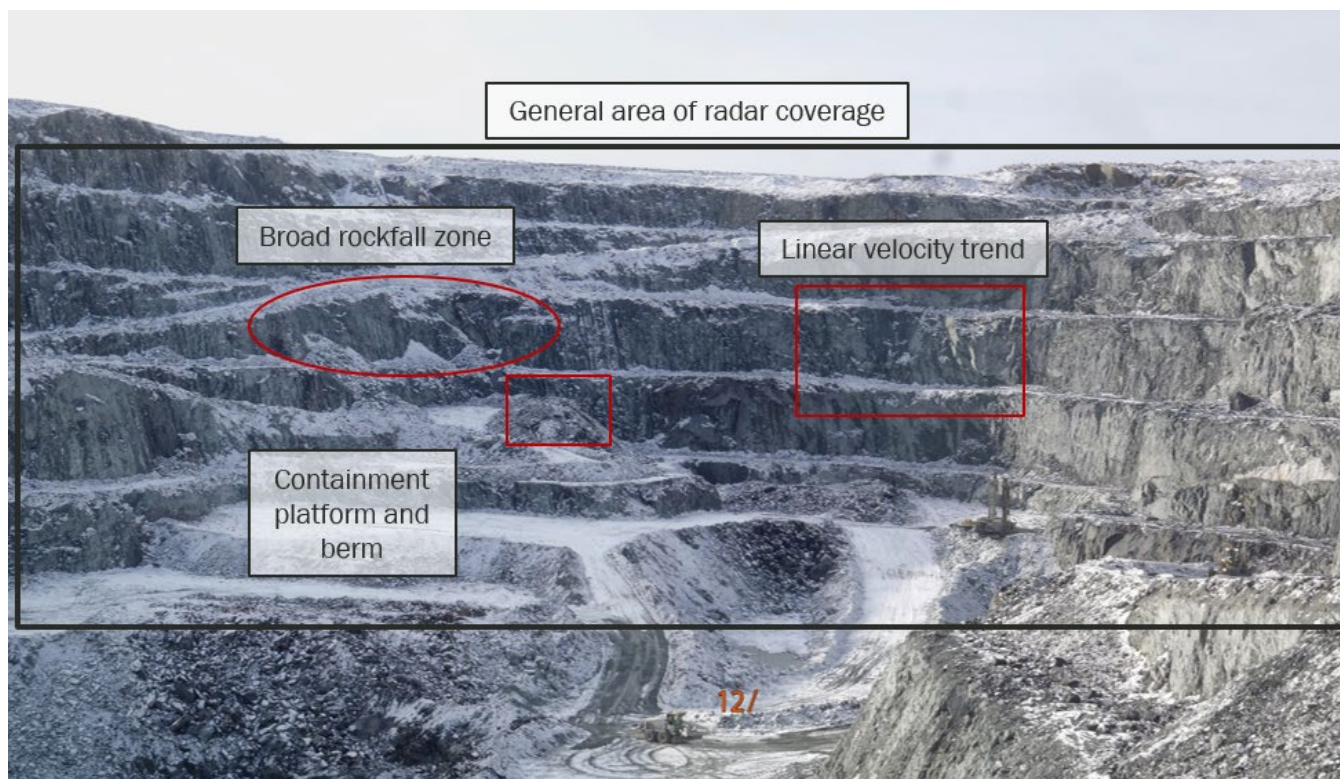
Photograph 6-6: General radar coverage of south wall Pit E5

The south wall of the pit is currently monitored using radar in addition to instrumentation. The following photograph shows the approximate coverage by radar of the south wall of Pit E5. The wedge and planar instability that have occurred have in many cases been predicted by the radar. AEM have taken proactive steps to buttress areas of instability, to restrict access to others, and to develop a containment platform and berm beneath the broader rockfall zone below the south wall ramp. An area of linear velocity trend on the western side of the south wall has been identified on the radar, and is monitored using radar.

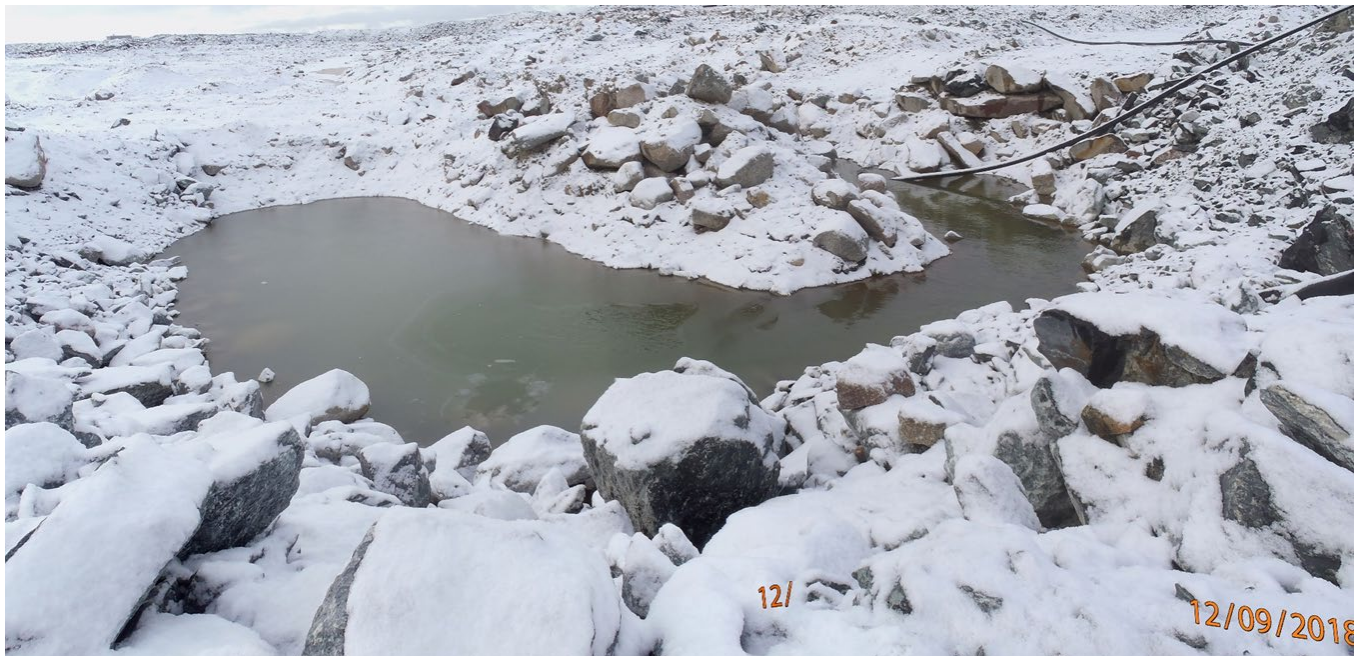
Photograph 6-7: Sump at crest of Pit E south wall

During inspection of the crest area of the south wall of Pit E it was noted that a sump was located near the crest area above the ramp. The sump was filled with water, and directly above an area of the wall above the ramp which experienced instability. Water should not be allowed to collect at the crest area, and sumps should be pumped down regularly to prevent water from contributing to instability.

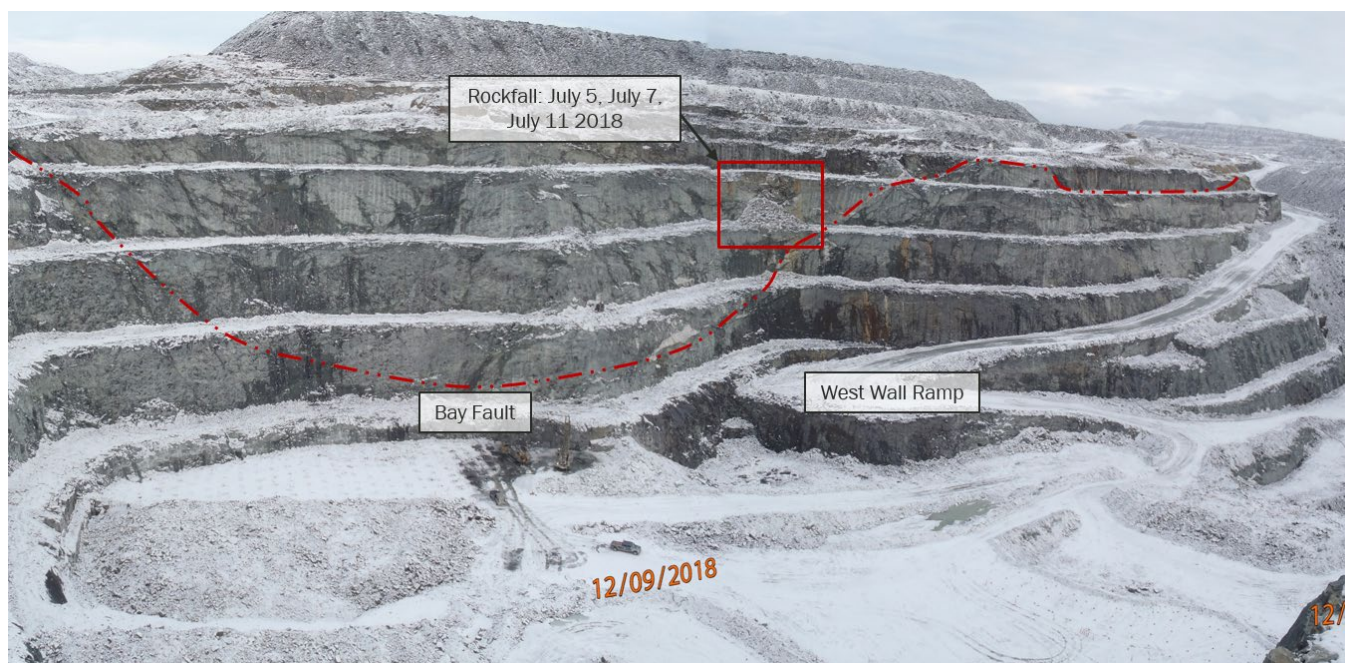
Photograph 6-11: Pit E west wall showing seepage and Bay Fault (2018)

At the south end of the west wall, the contact of the ultramafic rock and overlying intermediate volcanic rock is inclined into the wall, which is beneficial for overall slope stability, but results in bench-scale instability of the underlying ultramafic rock. Local rock falls creating small overhangs have occurred as the ultramafic rock separates from the overlying volcanic contact, followed by sliding along a steeply east dipping orthogonal joint set. This potential instability is contributed to by the presence of the Bay Fault and parallel shear planes within the ultramafic rock, which are also inclined steeply into the west wall. Photograph 6-11 shows the west wall at the time of the 2018 site visit. An area of rockfall events on July 5, 7, and 11 2018, directly above seepage faces and associated with the steeply west dipping Bay Fault and associated shear planes.

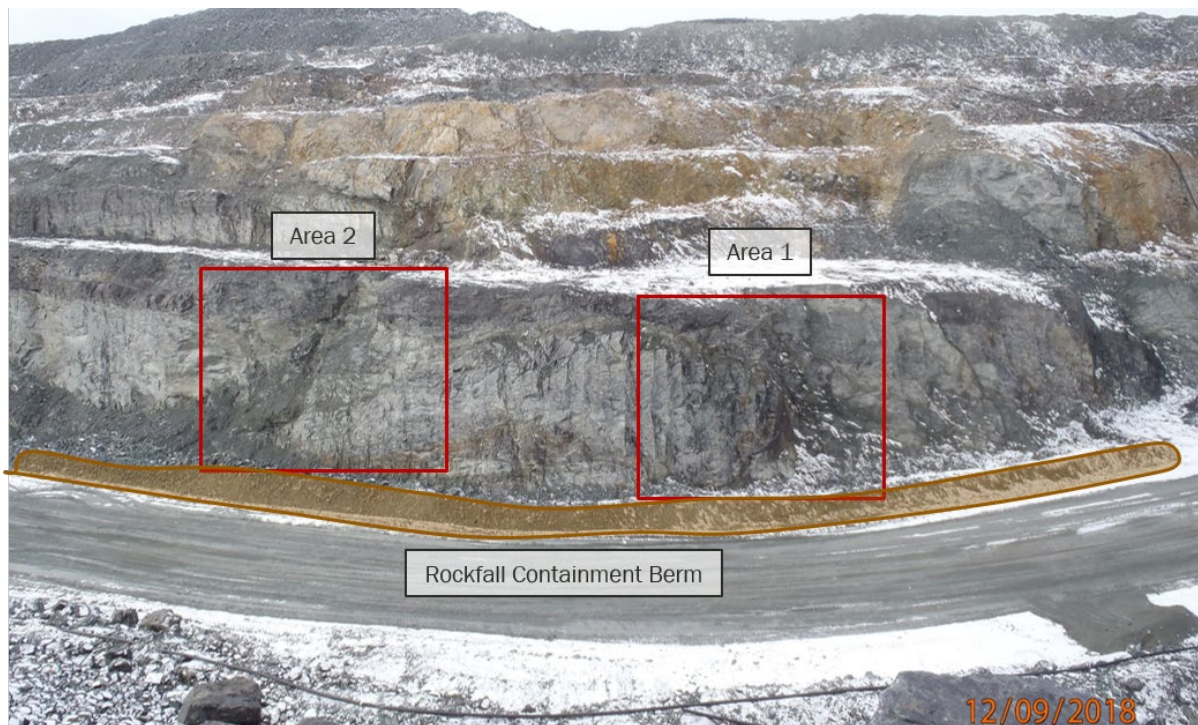
Photograph 6-14: Pit E west wall ramp hazard identification (2018)

Seven areas of potential instability observed immediately adjacent to the West Wall Ramp continue to be monitored. In addition to these known areas, an unexpected rock fall occurred along the west wall ramp, identified as Zone E35. The material fell on to the safety berm and spilled on to the ramp. A review of the area noted an apparent reduction in the height of the rockfall containment berm along the inside ramp. It is possible the berm height has decreased over time by natural settlement. It was recommended that the containment berm be re-established, and the height be increased to the maximum possible height while still respecting the single lane requirement width. AEM have installed a crack meter in Zone E31 which coincides Tetra Tech's Area 4 geotechnical hazard area. The crack meter does not show any movement at this time.

The Pit E ramp descends southward into the pit along the west wall. Seven areas of geotechnical hazards identified during previous inspections continue to be monitored, and are discussed below.

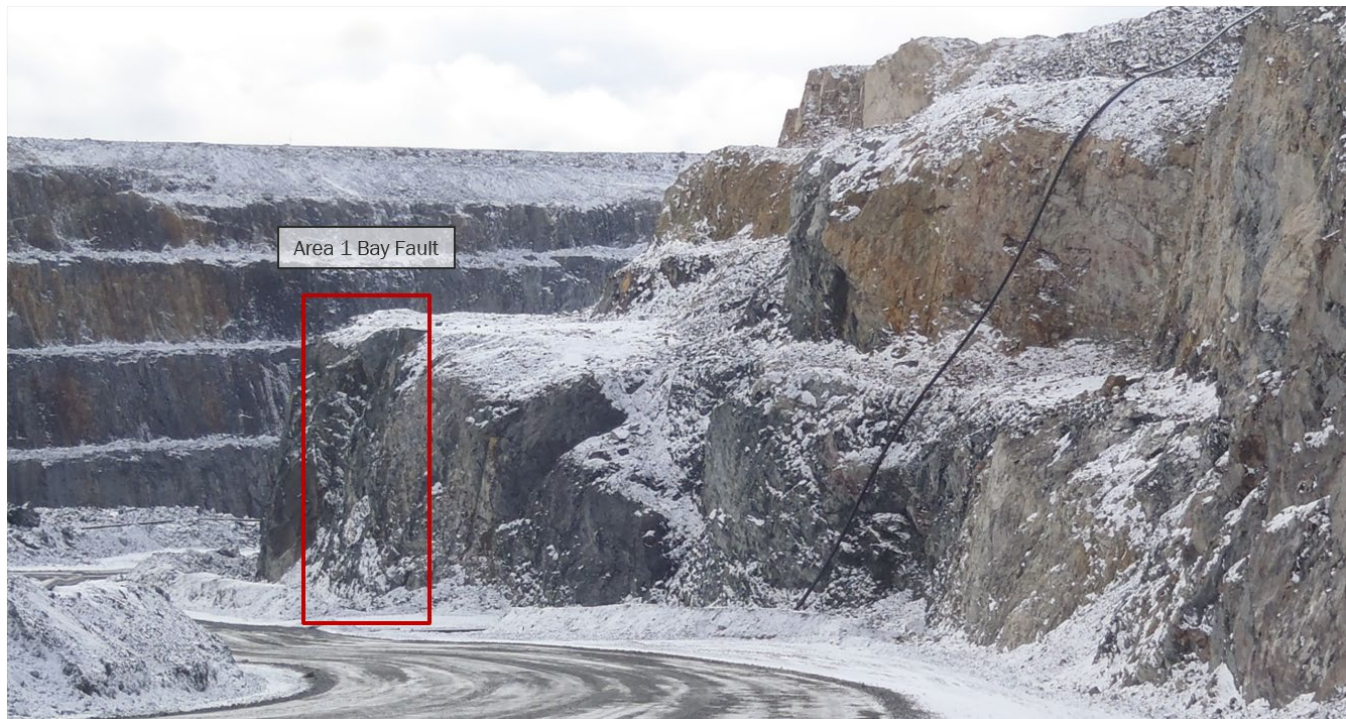
Photograph 6-16: Pit E Ramp Area 1 above ramp - Bay Fault or splay (2018)

The West Wall Ramp enters the Portage Pit along the west side of the pit, and ramps down to the south towards Pit E3/E5. The ramp passes beneath an area of wall that was experienced several rock falls in 2014 (Area 1 and Area 2). The area of wall is associated with a fault zone – the Bay Fault or a splay off that fault trend - trending along the west wall of the pit. This fault, or shear, is several metres wide, and steeply inclined to the west. No changes to the performance of the wall above the ramp in this area were noted.

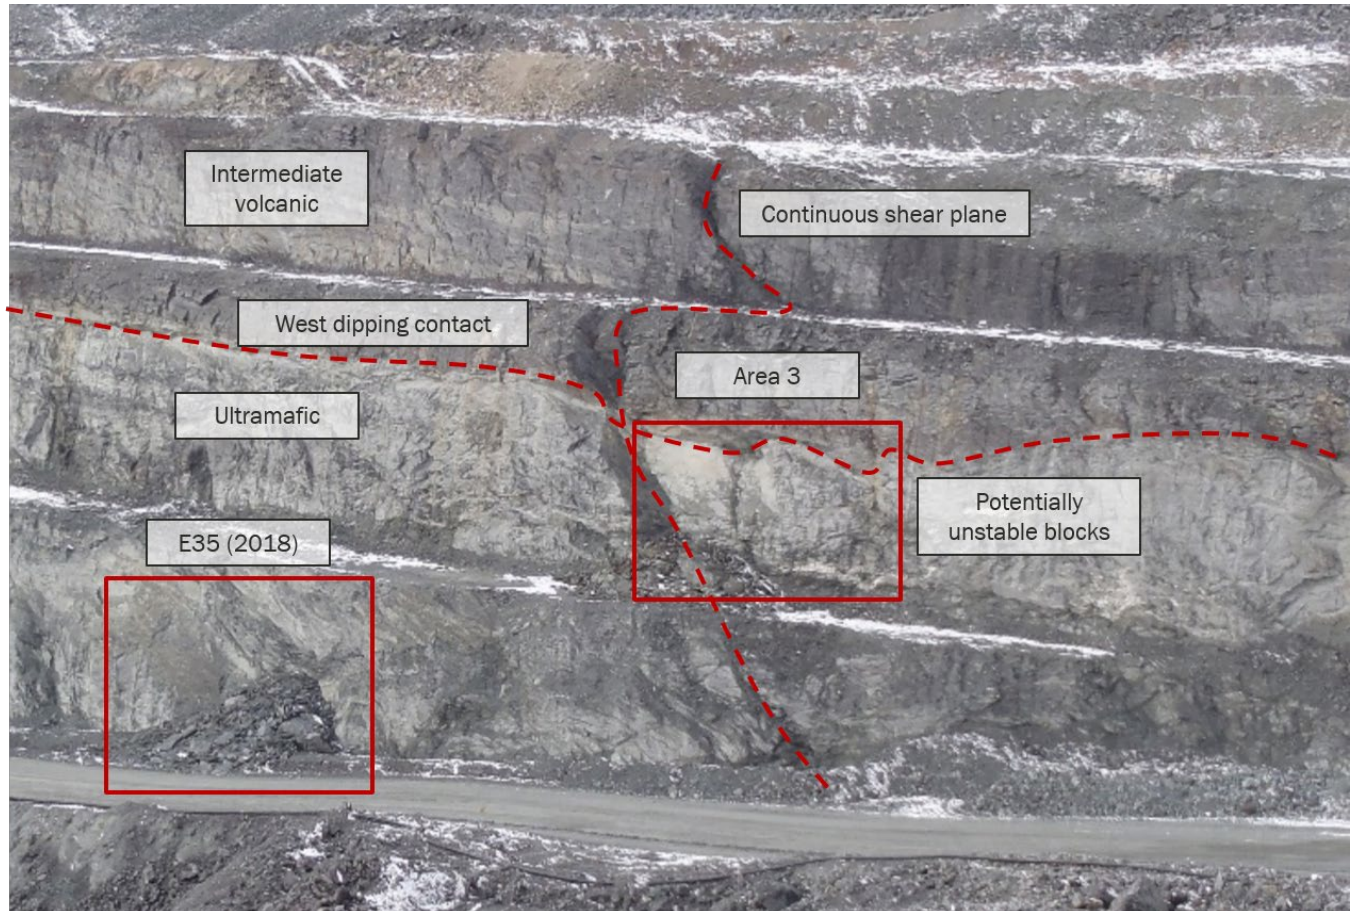
Photograph 6-18: Pit E Ramp Area 3 (2018)

No increase in the material accumulating at the toe of Area 3 was noted during the 2018 inspection.

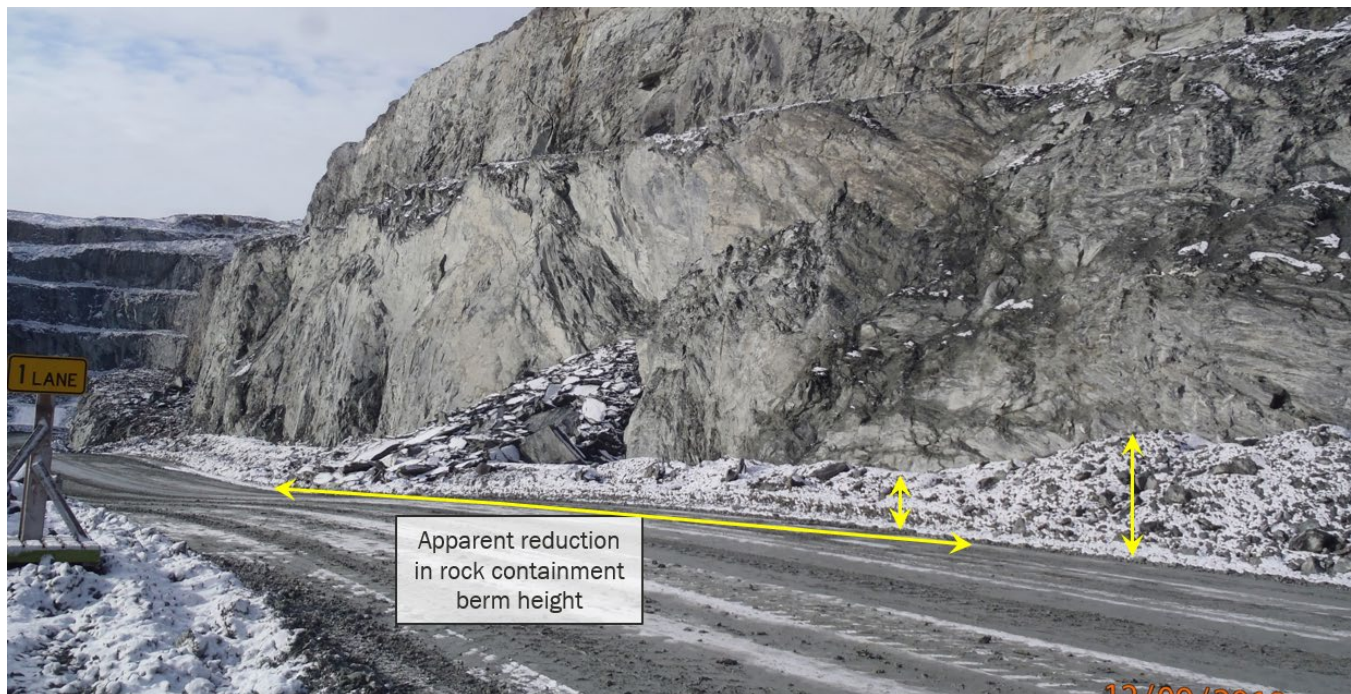
Photograph 6-19: Zone E35 rock fall

A review of the area during the site inspection noted an apparent reduction in the height of the rockfall containment berm along the inside ramp. This might result from long term natural settlement of the tabular rockfill material used to construct the berm. This is shown in Photograph 6-19.

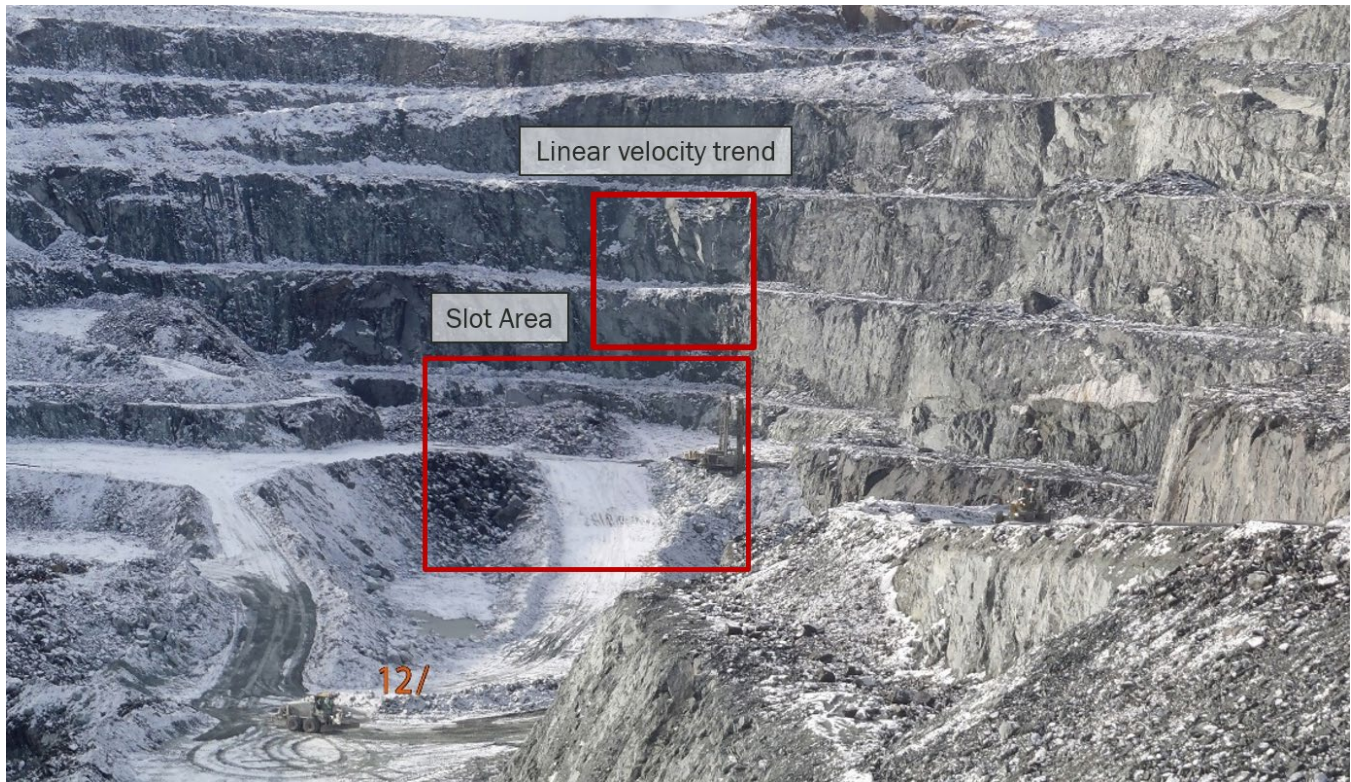
Photograph 6-24: Pit E slot south and east wall

Mining of Pit E is scheduled to be completed in Q3 2019, with a final floor elevation of 4976 mRL. The final geometry of the slot that will be mined at the south end of Pit E will result in a very narrow configuration with steep east, west, and south walls. The south wall is currently being monitored by radar. Several bench-scale rock falls have occurred on the south wall during 2018.

- Mine this area during winter months while ground is frozen.
- Continue monitoring the south wall with the GroundProbe radar, and specifically areas of the south wall above the slot which have demonstrated linear velocity trends, but not acceleration.
- Continue the use of controlled pre-shear blasting methods to minimize damage to the final walls.
- Remind equipment operators to remain within dig-lines, and not to over-excavate or undercut benches.
- Continue careful scaling and bench cleaning as the pushback is deepened.
- Continue visual monitoring and recording observations as part of regular site geotechnical inspections.

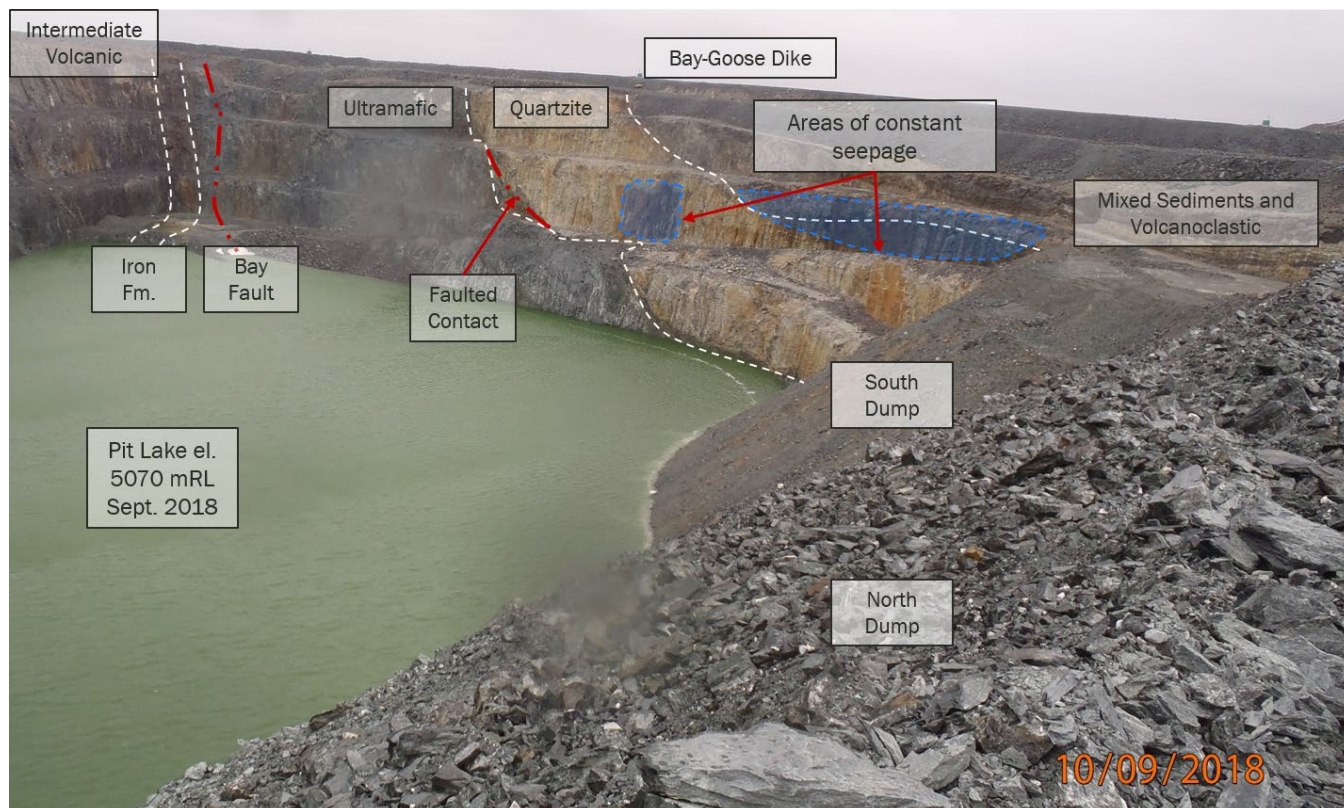
Photograph 7-2: Goose Pit south wall (2018)

During the 2018 inspection, a fault was identified at the contact between the ultramafic and quartzite, and it was noted that the fault gouge associated with the fault is being eroded, resulting in a widening gap. The risk of failure is very low. It is recommended that the faulted contact be added to the geotechnical risk register developed as part of the assessment to store tailings in Goose Pit.

During the 2018 inspection, a fault was identified at the contact between the ultramafic and quartzite, and it was noted that the fault gouge associated with the fault was being eroded, resulting in a widening gap.

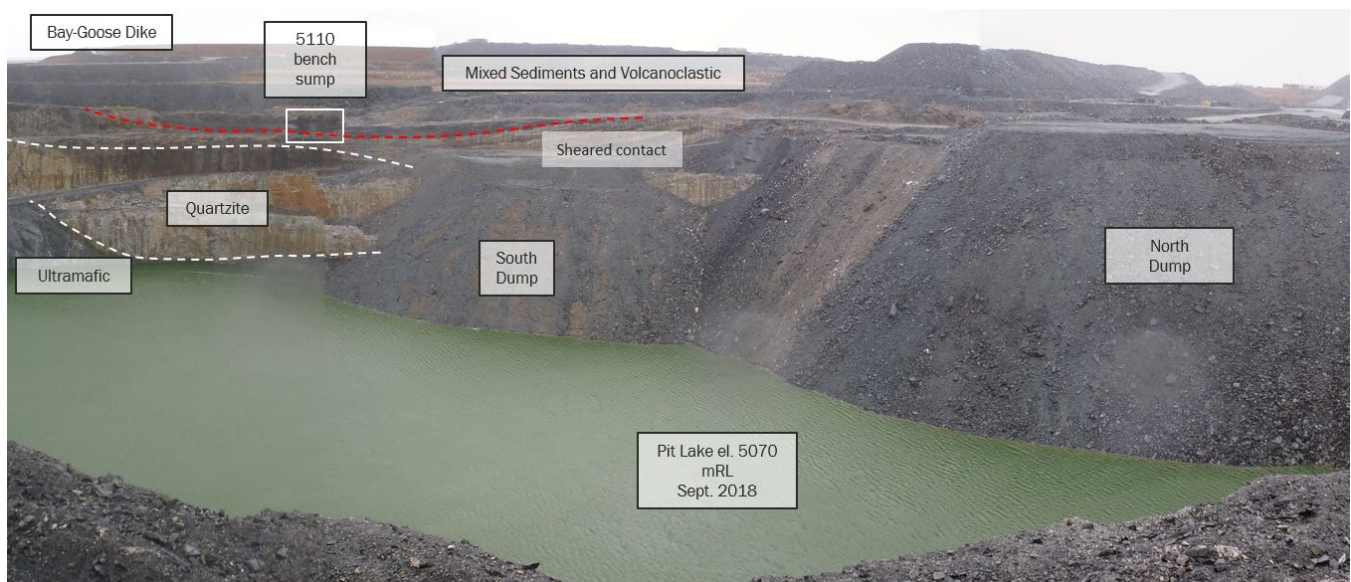
Photograph 7-5: Goose Pit west wall (2018)

There are no observable changes to the hydrogeological regime. The volcanoclastic and quartzite rock immediately below the sheared contact remains saturated, and water continues to seep from the face above the ramp, as well as from the bench faces below the ramp.

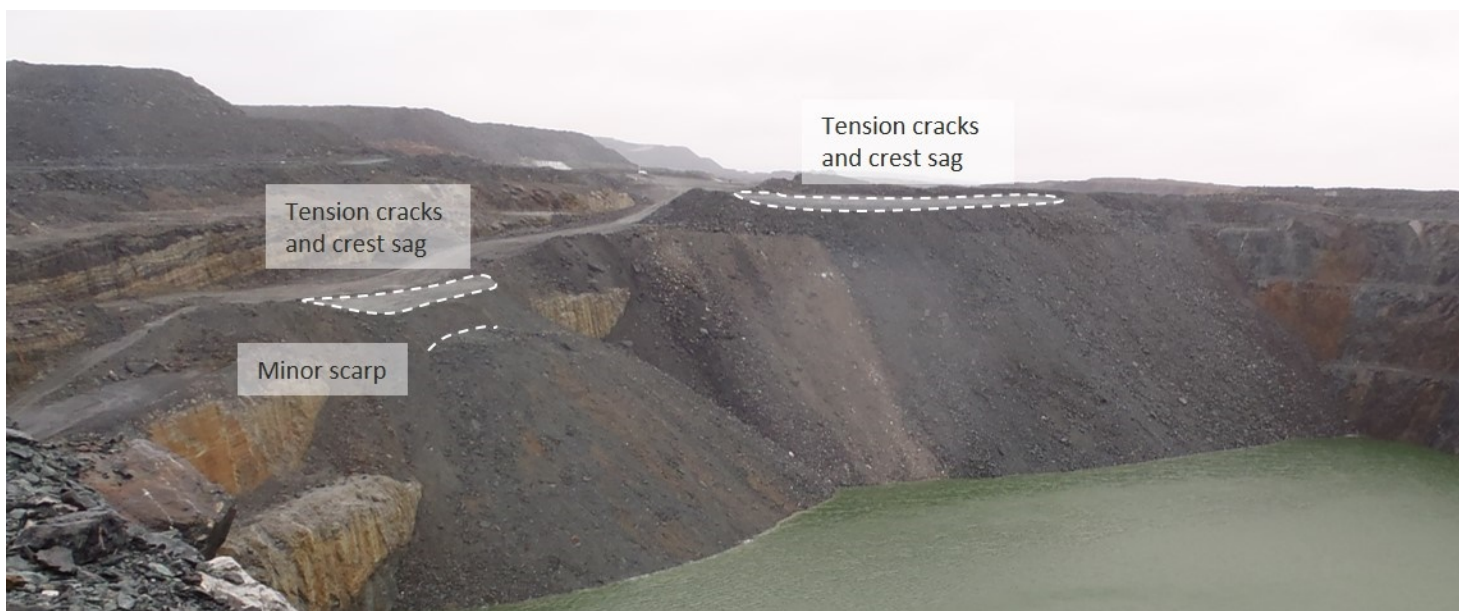
Photograph 7-6: Goose Pit waste rock dumps (2018)

Tension cracks on the North Dump platform were first noted during the 2015 inspection, and these have been monitored regularly since. During the 2017 inspection, tension cracks were also noted on the South Dump platform. During the 2018 inspection additional shallow slumping of the South Dump face was noted, along with significant crest sag. AEM has been monitoring by observation as part of the regular geotechnical inspections. AEM monitoring the dump platform previously using simple wireline extensometers installed across the tension cracks, and established a set of procedures to implement based on relative movement magnitude.

Prior to commencing of active dumping a dump inspection should be carried out, and an action plan developed that might include frequent inspections of the crest area, and the installation of additional instrumentation as required.

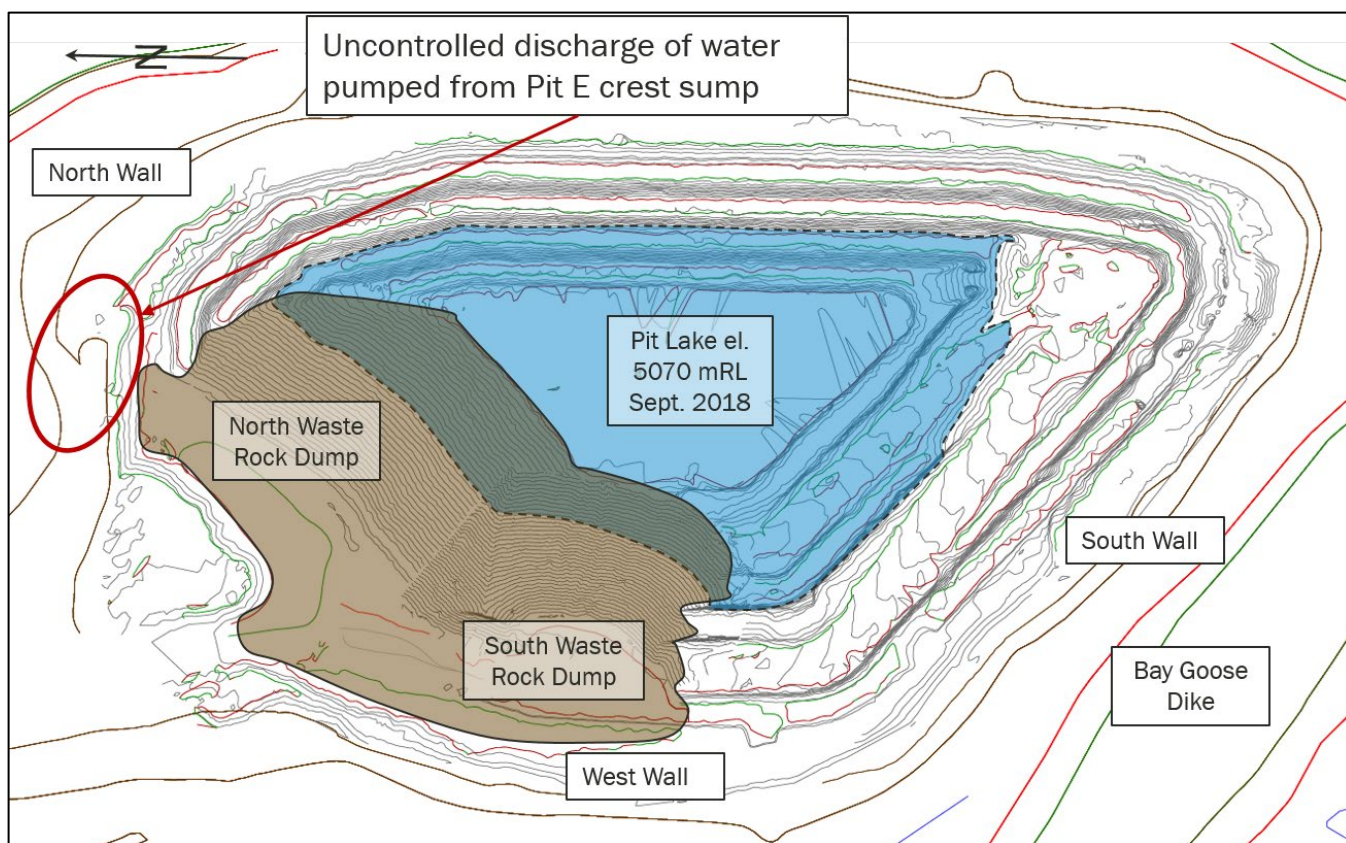
Figure 7-3: Location of uncontrolled water discharge at north pit crest of Goose Pit

During the inspection, it was noted that water was being discharged on to the ring road and thermal cap at the north pit crest in an uncontrolled manner. The water was being pumped from a sump at the crest of Pit E. This was a temporary occurrence; however uncontrolled water discharge should be avoided. This was discussed with AEM during the site visit. It was also noted that an existing water discharge line over the edge of the pit at the north end is underlain by kinematically unstable rock blocks in the bench face. When the discharge line is to be moved, equipment and personnel should stay back from the crest in this area.

During the site inspection, it was noted that water was being discharged on to the ring road and thermal cap at the north pit crest, and flowing through the rockfill before spilling on to the rock face. Water was also flowing along the ring road to spill over the edge of the pit. The water was being pumped from a sump at the crest of Pit E. It is understood this was only a temporary discharge; however this could still affect the integrity of the ring road and should be avoided. Any water discharge should be directed on to the pit wall face, and not through the rockfill materials at the crest. During the site visit this process was stopped. The location of the water release is shown on the following figure.

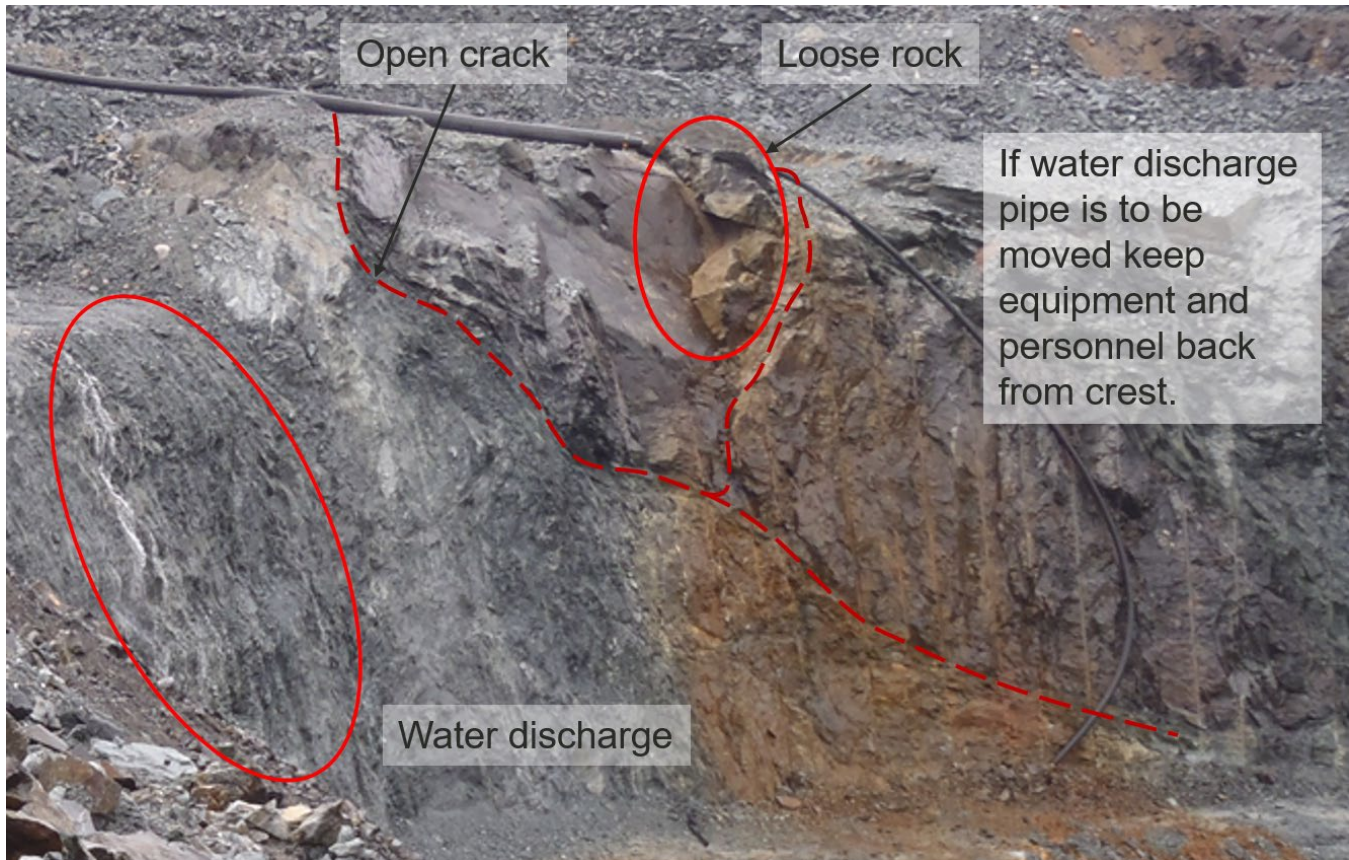
Photograph 7-12: Unstable rock beneath water discharge pipe at north end of Goose Pit

During the review of this area it was also noted that an existing water discharge line to the east is situated on some loose rock material at the pit crest. This was noted to AEM so that if and when this water line is moved, care be taken to keep equipment and personnel back from the crest in this area.
