Meadowbank 2018 Annual Review of Portage and Goose Pit Slope Performance

2018 ANNUAL PIT SLOPE PERFORMANCE REVIEW

MEADOWBANK MINE, NUNAVUT

ISSUED FOR USE
704-ENG. ROCK03053-02

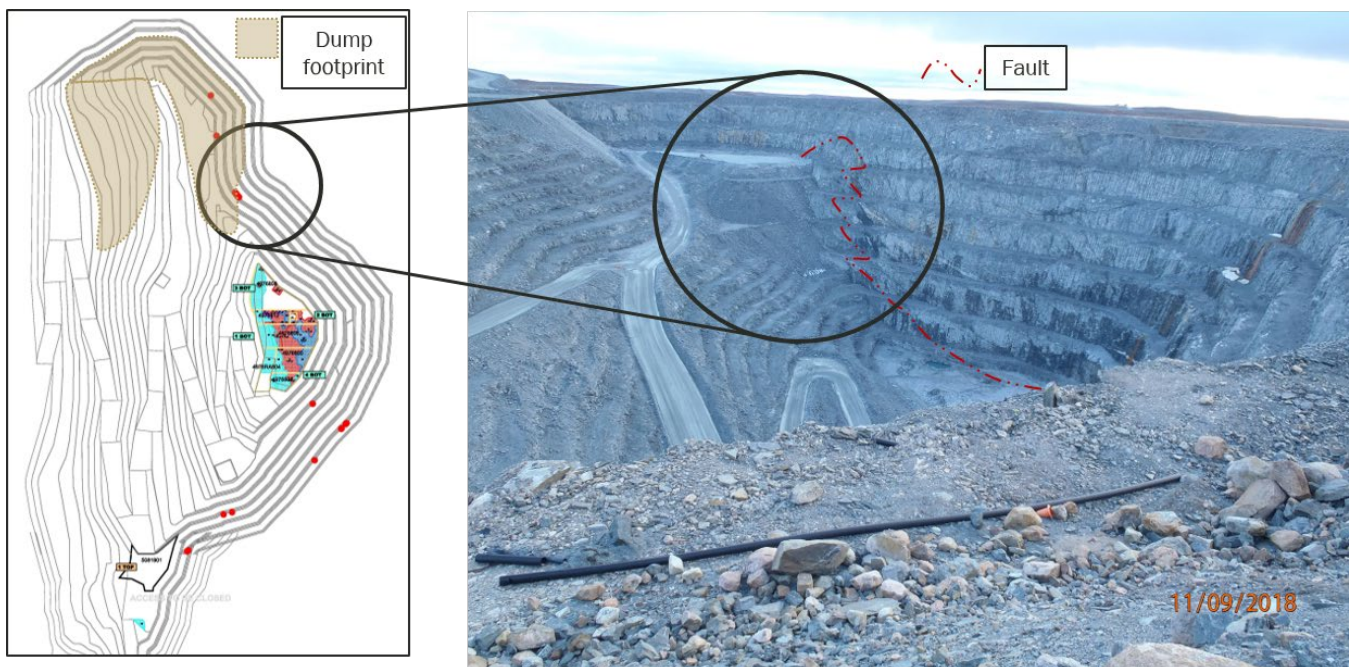
Photograph 8-10: Vault Pit east highwall nose and fault (2018)

A series of widely spaced faults and open continuous joints dip into the nose area at steep angles. This area continued to be monitored during mining, but now is being backfilled as a waste rock dump, effectively buttressing this area and eliminating the risk.

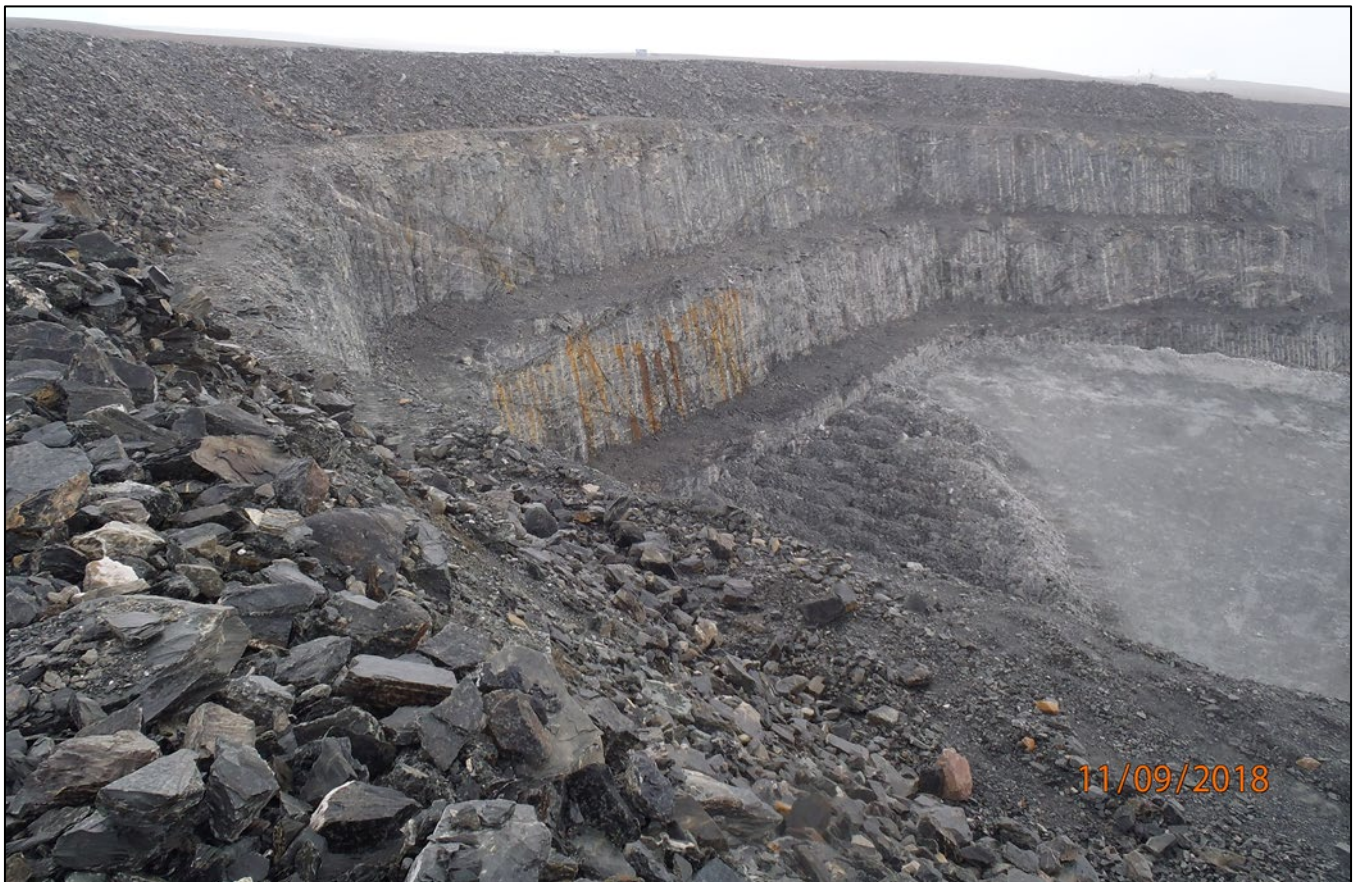
Photograph 8-11: Vault Pit northeast wall bench performance (2018) and dump platform

The north through northeast area of the Vault Pit is being backfilled with waste rock material. Waste rock has been backfilled to approximately the 5088 mRL elevation through the north and northeast, and near to ground surface through the northwest. Consequently, many of the geotechnical hazards identified during previous inspections no longer exist.

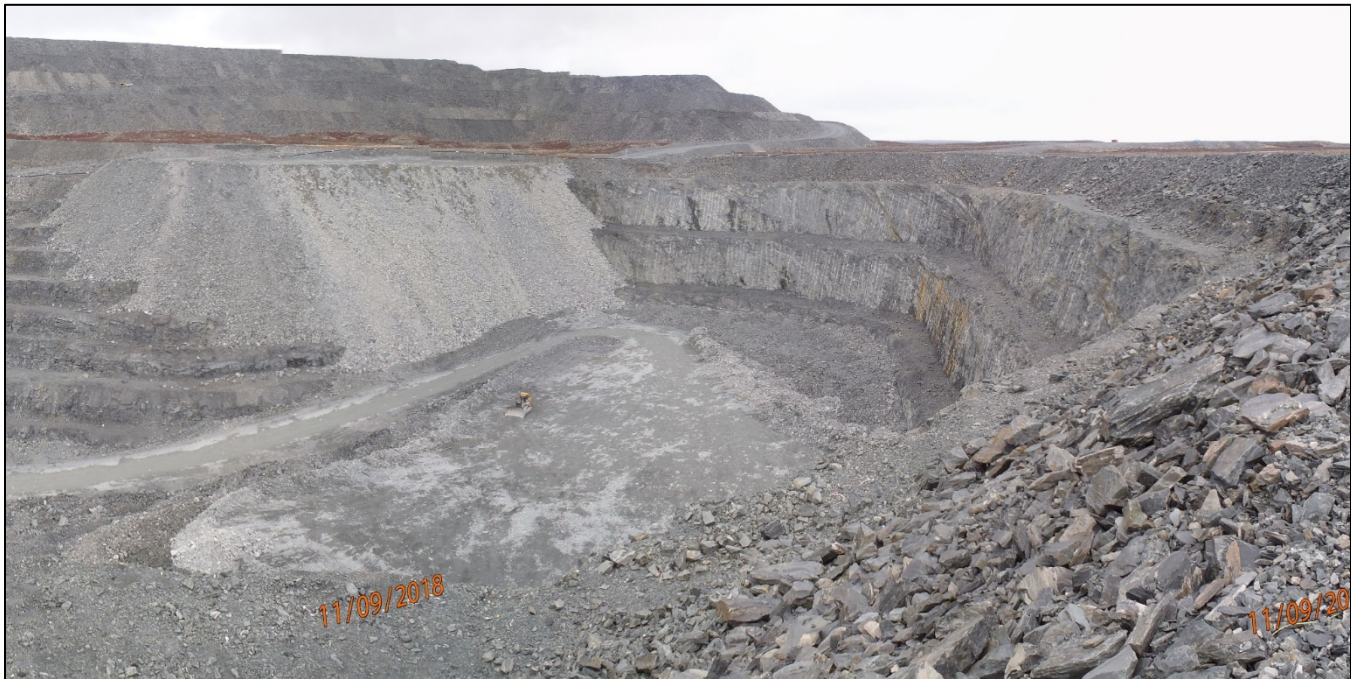
Photograph 8-12: Northeast through north transition wall (2018) and dump platforms at 5088 mRL and 5130 mRL

- A series of shear planes, parallel to stratigraphy, in the lower north transition wall. Overhangs identified in the lower northeast wall.
- A potential bench scale wedge was noted at the north end of the east wall, where it intersects the north wall at a right angle.

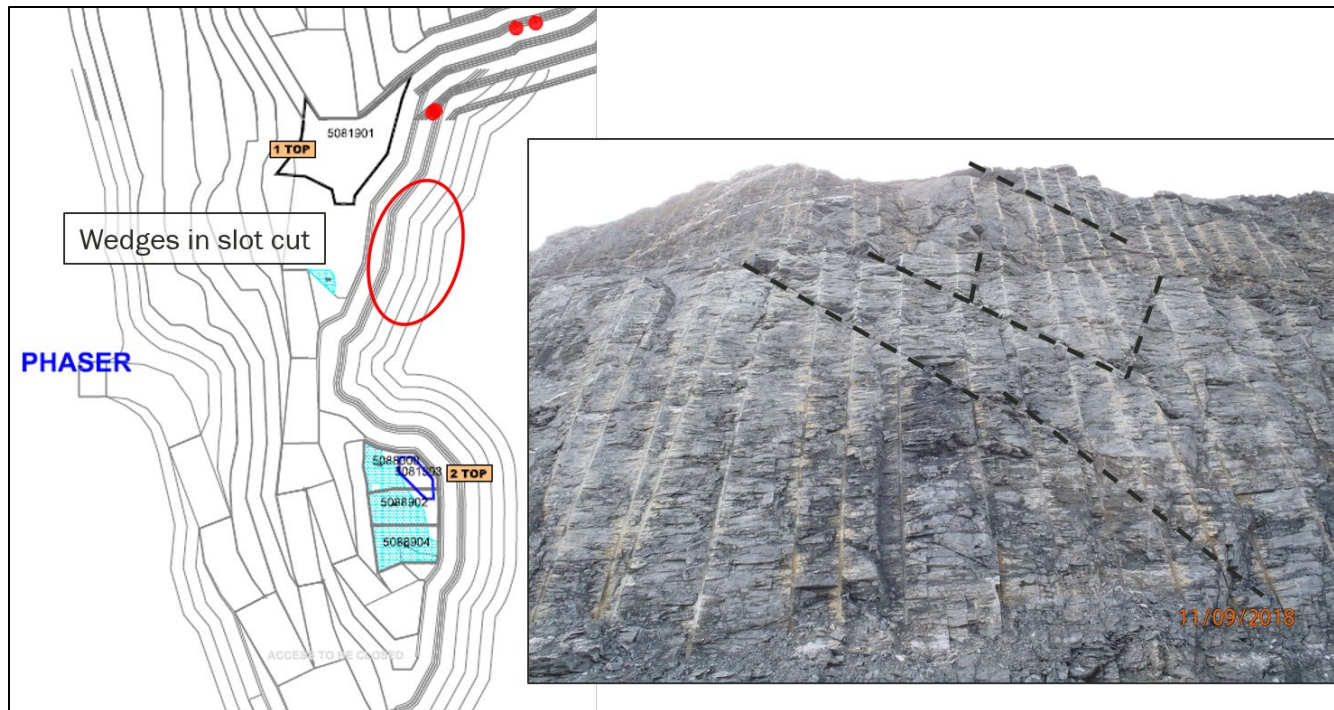
Photograph 8-13: Wedges in east-southeast bench face of slot cut to Phaser Pit

The transition slot cut connecting the south end of Vault Pit to Phaser Pit was reviewed. The highwall of the cut is performing well with half-barrels from pre-shear blastholes visible. Some wedge-forming jointing was noted in the wall, and this was discussed with AEM. It was recommended that as a temporary measure a row of candles be placed to prevent personnel or equipment from accessing this area.
