for the NIRB's Monitoring of
Baffinland Iron Mines Corp.'s Mary River Project

Nunavut Impact Review Board

April 2018

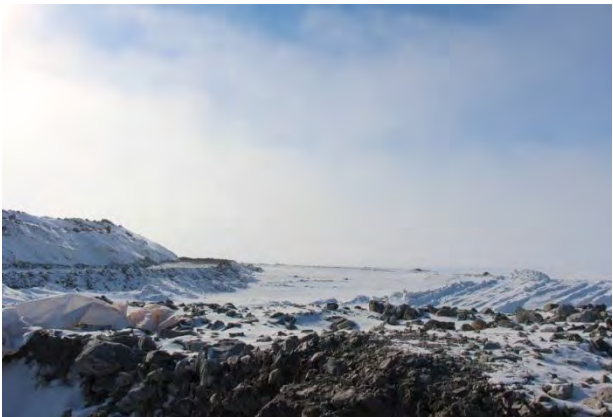
The waste rock facility is an area designated for the disposal of potentially acid generating (PAG) rocks. During the site visit, it was noted that the waste rock facility (WRF) area was snow covered and frozen and there was no observations of any signs of runoff or uncontrolled seepage of potentially contaminated contact water from the piles of PAG waste rocks into the adjacent tundra. Baffinland staff indicated that during 2017, exceedances of the applicable water quality discharge criteria during controlled discharges from the WRF pond consisted of two (2) minor exceedances for total suspended solids (TSS) limit in early July followed by multiple exceedances of the applicable pH and TSS limits in August and September respectively. Baffinland staff also noted that during on-site inspections by Indigenous and Northern Affairs Canada (INAC) and Environment and Climate Change Canada (ECCC) staff in late August, there were observations and concerns regarding the uncontrolled seepages of runoff from the toe of the pond's berm.¹ During the site visit, NIRB staff generally observed that Baffinland has taken key actions to address these environmental concerns by undertaking repairs of the WRF pond to address overflow issues as well as the planned installation of a waste water treatment plant to manage all the effluent discharges from the waste rock facility pond prior to discharge into the receiving environment. The Monitoring Officer also noted site preparation works were being undertaken in preparation for the installation of a new water treatment plant near the WRF to be completed by May 2018 (Photo 3 and Photo 4).

Photo 3: Waste Rock Storage Area Pond

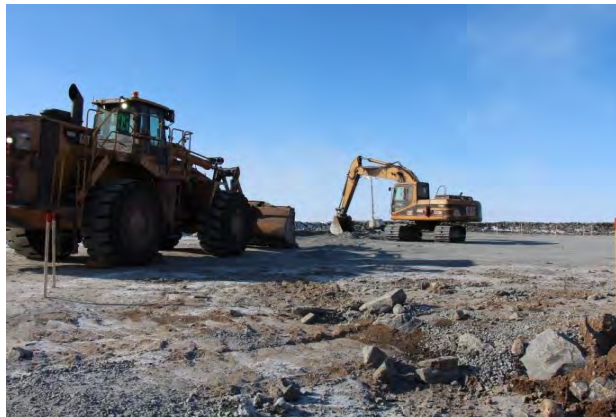
Photo 4: Waste Water Treatment Plant Pad

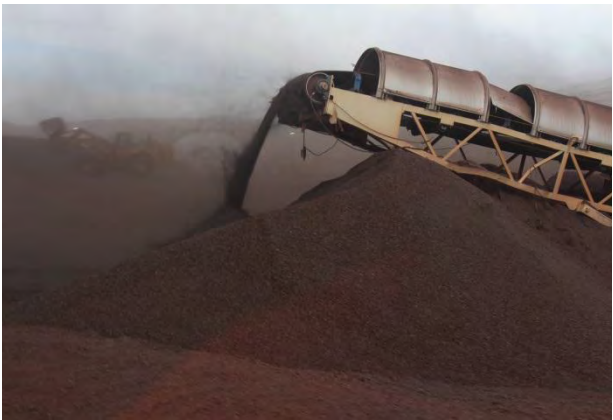
At the time of the current site visit, the Monitoring Officer noted there are no effective dust control measures at the crusher and screening plant in order to prevent dust dispersion to the surrounding environment, as such dust management continues to be an issue from the crusher plant.

Photo 12: Missing cover from end of conveyor

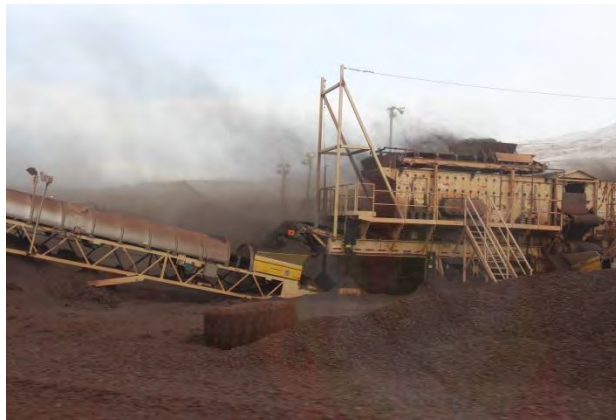
NIRB staff also took a tour around the crusher area and while at the facility observed dust emissions including large visible dust plumes from the crusher plant due to ongoing ore crushing, stacking, and loading activities (Photo 9, Photo 10). Although shrouds had been installed (Photo 11) which improved dust emissions from the plant slightly, there is still large amounts of visible dust at the transfer points along the belts. The Monitoring Officer noted that the crusher plant was generally still lacking proper dust containment controls along the conveyor belt and end of the feeder (Photo 12). In addition, dust plumes were also observed when the haul trucks dump the iron ore into the crusher plant. Overall, the dust emissions observed from the crusher plant during the current site visit do not appear to have significantly improved compared to previous site visit observations. Dust accumulation was also noted in the surface soils and snow cover adjacent to the facility and up to a minimum of one (1) km away. Baffinland staff indicated that there are plans to come up with better engineering solutions, such as ensuring the covers are re-installed along the conveyor belt and at the end of the ore feed to reduce dust emissions. However, Baffinland staff also indicated that there are no current solutions for the shaker in the crusher facility as the movement of the equipment would not support a cover and may require increased maintenance on the screens (Photo 13).

Photo 13: Dust from shaker and transfer points

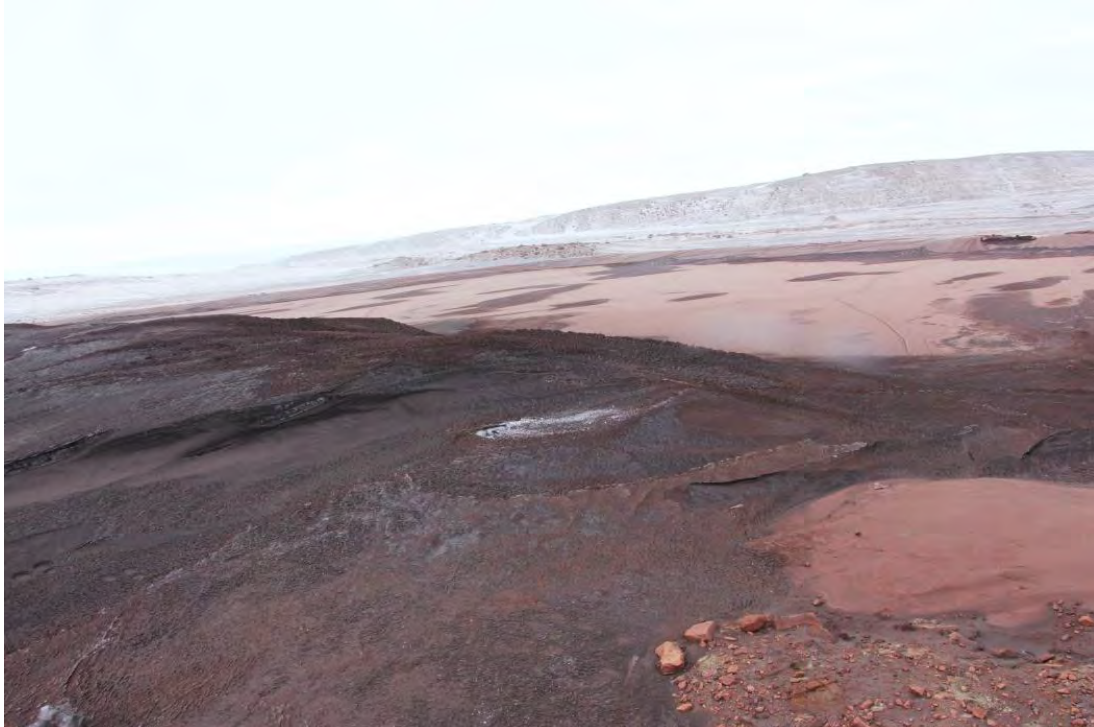
NIRB staff observed that the trenches constructed around the crusher pad to direct snowmelt and water runoff from the crusher pad to the sedimentation pond (Photo 14) were filled with snow, although Baffinland indicated that some improvements were made to the trenches to ensure that deposition of material carried off from the crusher pad due to erosion activities has been cleaned out and are hoping the issue will not re-occur this year. Additional trenching around the crusher

pad is expected to be completed prior to freshet. Baffinland staff indicated that the sedimentation pond is designed for a 1-10 year flood event and that there are plans to raise the level of the sedimentation pond a further 18 inches but that engineering designs would have to be completed prior to undertaking such activity. This will be confirmed with the NIRB's summer site visit.

Photo 14: Sedimentation Pond at crusher pad

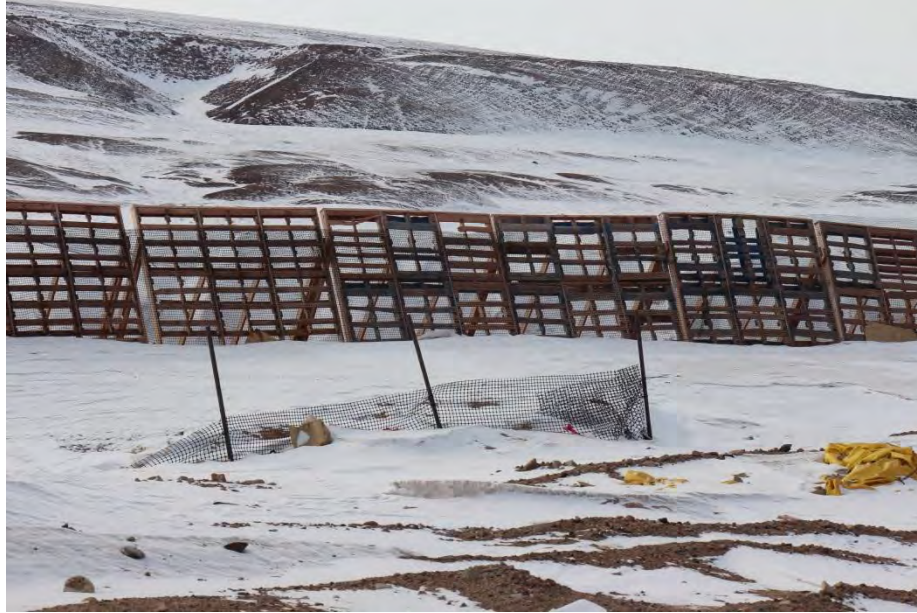
NIRB staff also visited the landfill site in order to follow-up on the NIRB's previous observations that most of the protective mesh around the landfill footprint was completely removed from the supporting poles and that the fencing issue has still not been fully rectified. Although wooden fences (Photo 15) are being utilized for fencing at the site, the Monitoring Officer noted that the current fencing does not fully enclose the landfill footprint and increase the risk for offsite waste dispersion. Baffinland has stated that they will be installing a wire mesh fence around the landfill using waste tires to support the posts this summer. This will be confirmed with the NIRB's summer site visit.

Photo 15: Fencing at landfill

During the NIRB's current site visit, the Monitoring Officer observed that solid waste materials were properly contained within the landfill, although incomplete fencing of the landfill footprint continues to be a recurring issue. The Monitoring Officer noted that the condition of the landfill fencing has not improved compared to previous year's observations, as Baffinland has yet to fully install a more durable fencing material to prevent offsite dispersal of waste materials to the adjacent tundra. Baffinland is requested to develop a long-term solution for addressing the recurring fencing issue of the landfill.

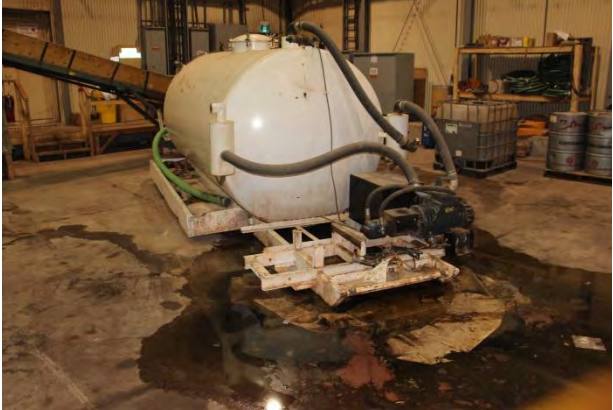
The Monitoring Officer noted that the incinerator in use at the Mary River mine site continue to remain well maintained except for presence of oily water from a tank on the floor drainage system (Photo 16). Within the incineration building, NIRB staff noted that waste materials are segregated into labelled bins for incineration (i.e., food and paper waste) or disposal off site (i.e., batteries, paint, oily rags, kitchen grease etc.) (Photo 17). NIRB staff however, observed that some of the bags containing items for incineration contained recyclable waste such as aluminum cans, aerosols, and plastics (Photo 18) and recommended that Baffinland make improvements to its waste management and waste segregation practices site wide. NIRB staff also noted that throughout the site and especially within the accommodations complex there are few bins with poor labeling to enable proper segregation of wastes, and that all staff and visitors should be provided training during their orientation on how to segregate waste, including personal waste into the appropriate bins. During this site visit, the Monitoring Officer observed the ongoing effort of Baffinland staff in relocating most of the historical tires and other used items into sea cans which were properly stacked and prepared for offsite disposal (Photo 19). Baffinland staff also noted that used tires from the maintenance shops are now automatically being put into sea cans for disposal.

Photo 16: Tank with oil at Incinerator Building

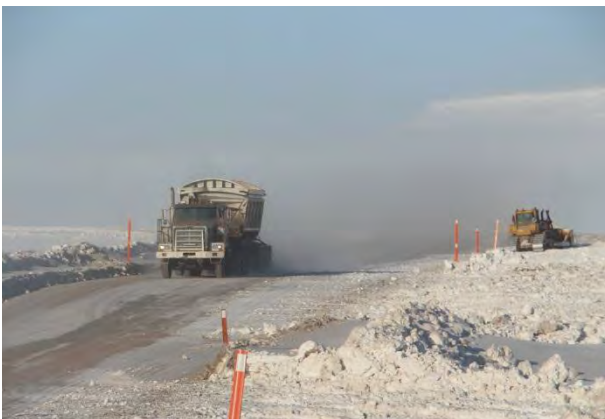
Photo 22: Dust from B-Trains

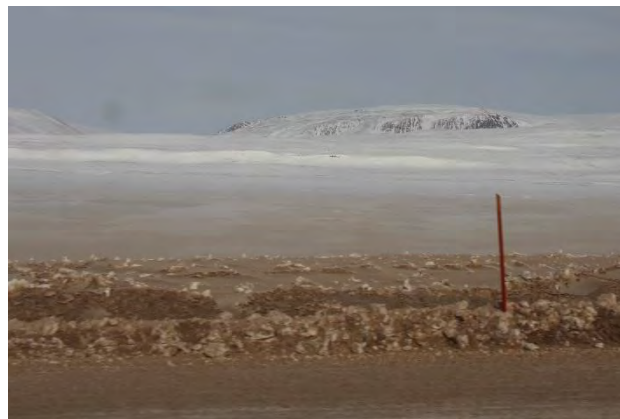
Photo 23: Dust on Snow along haul road

During the drive along the Tote Road, the Monitoring Officer observed the increased generation of dust plumes and widespread discolouration of snow areas adjacent to the road (Photo 22 and Photo 23). Managing dust in winter is difficult as freezing conditions after application of a dust suppressant may create associated safety concerns. NIRB staff inquired about any research being done into winter dust control. None are currently being considered. Dust fall stations were observed along the Tote Road, which can be noted as being in compliance to part c of Condition 10 (Photo 40).

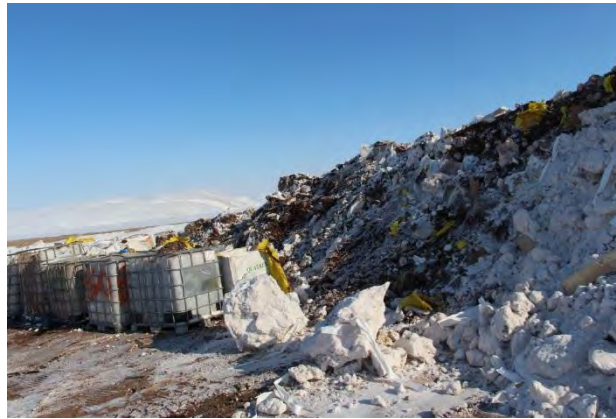
The Monitoring Officer visited the landfarm facility and followed up on progress of the facility with respect to management of contaminated snow, synthetic liners, and used tires. While the Monitoring Officer generally indicated there has been an overall improvement in the operations of the facility, there were still outstanding concerns regarding presence of several waste material items such as plastics and wood materials (Photo 24 and Photo 25). The Monitoring Officer also noted that the laydown area near the landfarm area used for salt storage had not been addressed as previously recommended during NIRB's 2017 summer site visit as many salt bags were still there and deteriorating which could increase the risk of localized salt contamination into the environment. An addition to the landfarm area was a designated area for excess snow removed from around site. Excess snow was trucked and placed on the hillside to allow for meltwater to move slowly down the hillside and remove any sediment through natural filtration before reaching Milne Inlet, or any surrounding waterbodies.

Photo 25: Plastics at landfarm area

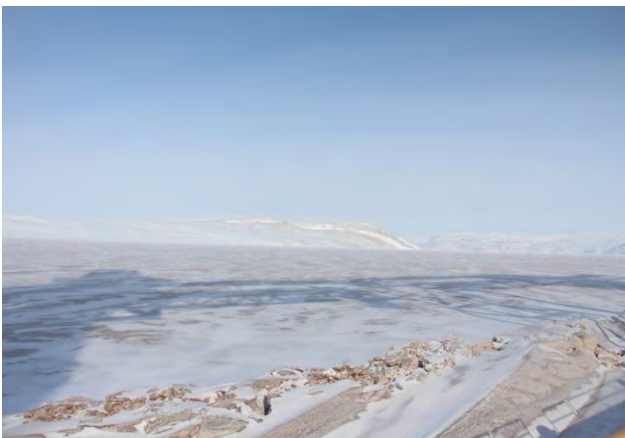
Photo 30: Iron ore dust on Milne Inlet

While at Milne Inlet, the Monitoring Officer followed up the community concerns regarding dust accumulation on sea ice and the potential effects to the aquatic environment. During the current site visit, there was clear evidence of dust deposition and accumulation on sea ice around Milne Inlet due to blowing dust from the ore stock pile (Photo 30 and Photo 31). Recommendations were made to Baffinland staff about adding additional snow and sediment studies to their monitoring program.

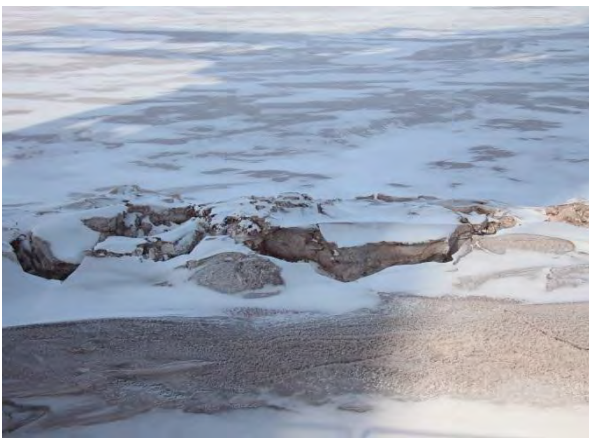
NIRB staff also took a tour to the Milne Inlet stockpile area and the ore dock and did not observe any major activities with the exception of ore stockpiling activities (Photo 28 and Photo 29). The Monitoring Officer observed that during ore stockpiling the ore transfer heights were minimized and there was minimal dust blowing from the stockpile, however, ore dust was observed on the snow and ice in Milne Inlet originating from the stockpile (Photo 30 and Photo 31). As dust fall and its potential impacts to the aquatic environment in Milne Inlet continues to be a key community concern, NIRB staff undertook discussions with Baffinland environmental staff and recommended adding additional snow and sediment studies to their monitoring program.

Photo 31: Dustfall on snow at Milne Inlet

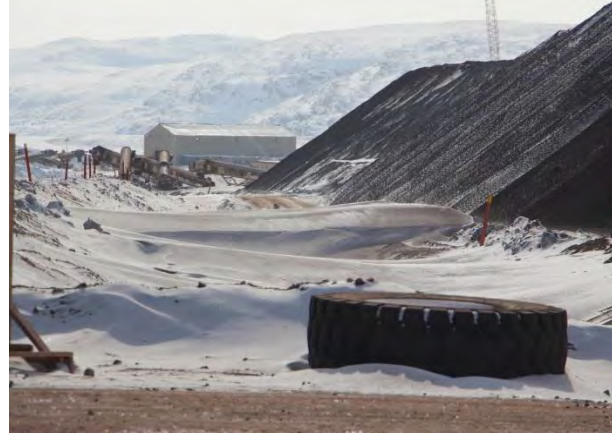
The Monitoring Officer observed that the two (2) sedimentation ponds on the east and west side of the ore stockpile pad were completed (Photo 32). The trenches to these ponds along the ore pad were filled with snow (Photo 33) which was to be removed prior to spring freshet.

Photo 33: Trenches along ore pad Milne Inlet

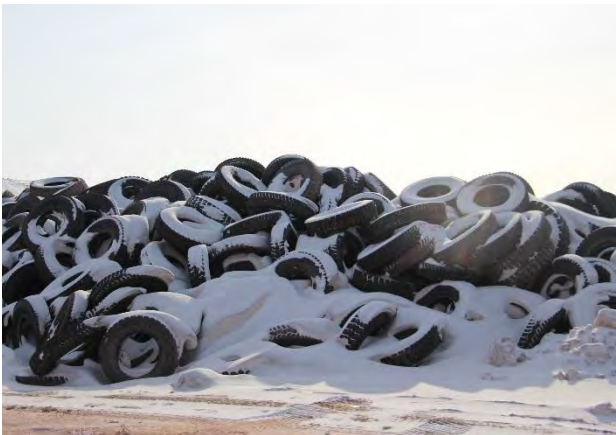
The Monitoring Officer noted that many of the designated laydown areas around Milne port contained tires piles and various scrap materials and affect the aesthetics of the area. Baffinland staff informed the Monitoring Officer that the tire stockpiles would be removed to sealift containers and that the entire clean-up of the area will be completed prior to summer sealift season (Photo 34 and Photo 35).

Photo 34: Tires stockpiled at Milne Inlet

Used tires continue to be a significant waste stream generated across the Project sites and continue to be an issue around the Mile Port. As the amended Project Certificate does not have any specific terms and conditions to address this particular waste stream, the Monitoring Officer recommended that Baffinland staff continue to develop a consistent approach for managing unused tires onsite. Baffinland is implementing the procedures outlined within its tire management plan, by placing them in sealift containers however more work is still required to be able to fully repurpose or dispose of the tires.

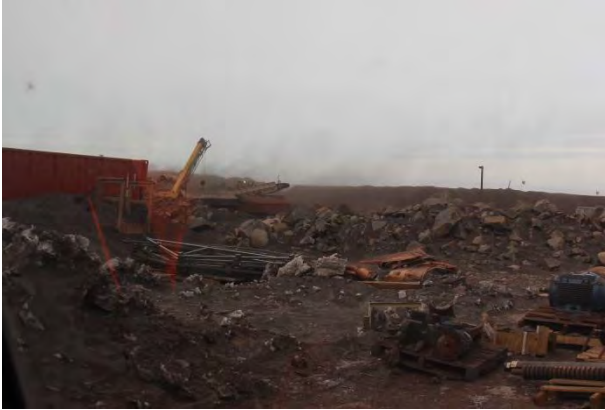
The Monitoring Officer observed that while there have been significant improvements, many areas within and surrounding the PDA, including the Mine site and Milne Inlet, require additional waste management actions of scrap materials and unused items such as tires. (Photo 36, Photo 37, and Photo 38). Baffinland has indicated it will do a site wide clean-up during and after freshet. This will be confirmed with the NIRB's summer site visit. The NIRB staff also observed that generally there was a lack of signage though out the site to indicate specific use of designated areas; however, Baffinland staff noted that there were plans to install more signage across the site to provide direction to personnel.

Photo 36: Scrap materials at crusher pad Mary River

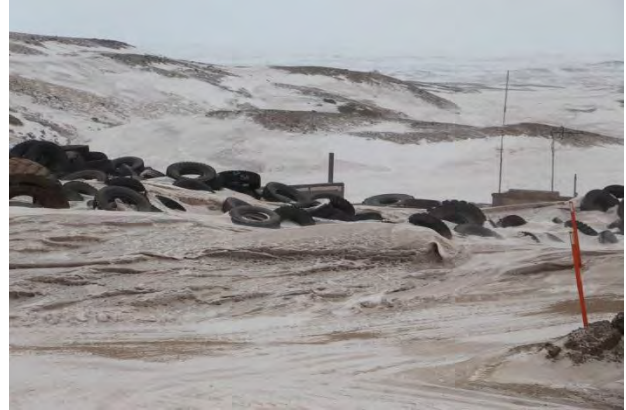
Photo 37: Waste tires at Mary River

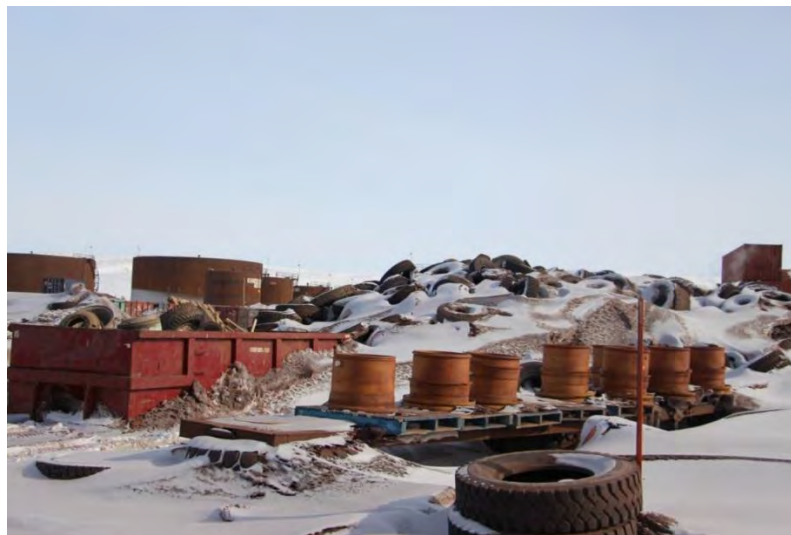
Photo 38: Pile of waste tires around ore stockpiles in Milne Inlet

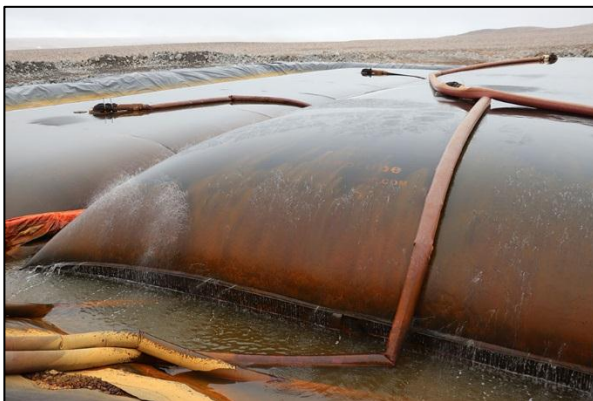
Picture 5: MS-08 Geotubes

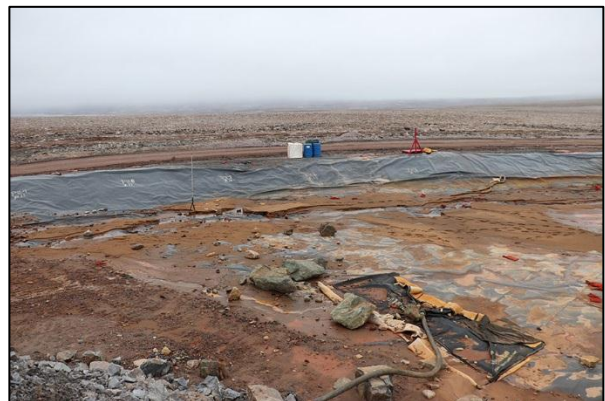
The water in the sedimentation pond MS-08 was removed during the summer ([Picture 6](#)) in preparation for locating and repairing the tear in the liner. Baffinland noted the engineering consultants contracted to repair the liner would be arriving to work on the repairs.

Picture 6: MS-08 Pond

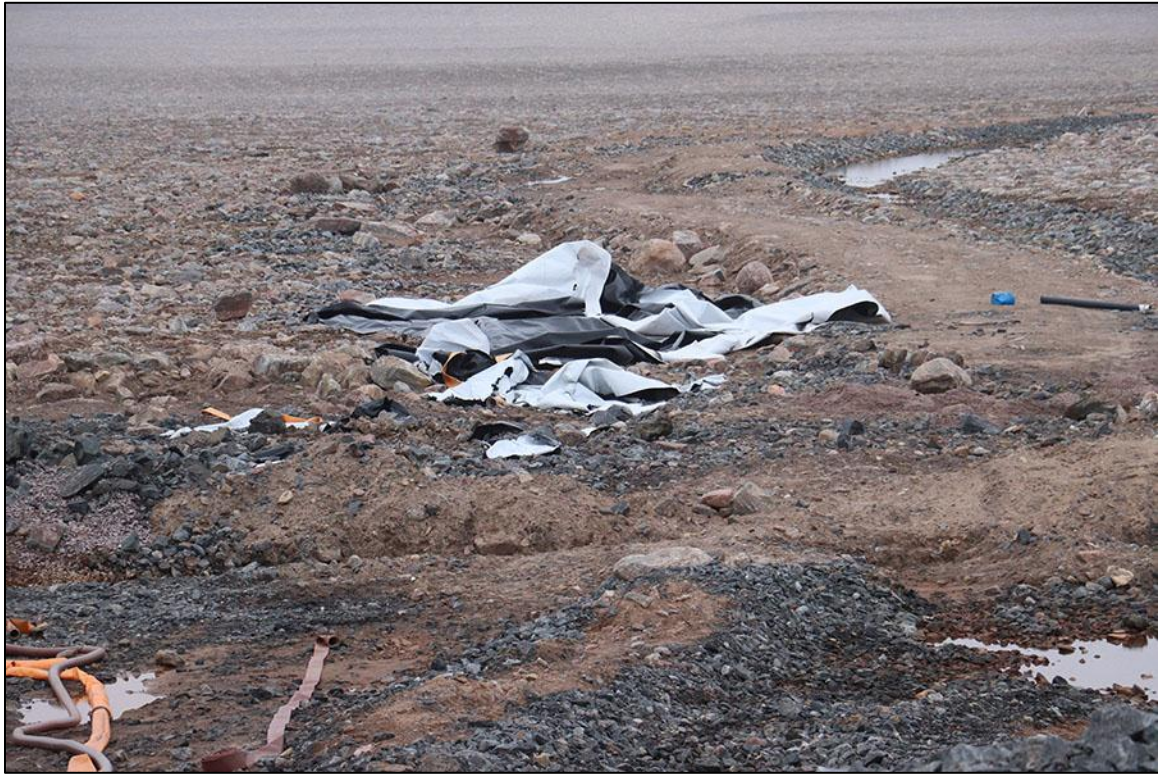
Viewing the area around MS-08 area, the Technical Advisor observed liners on the tundra that had been used in the emergency ditches and sumps constructed in 2017 ([Picture 7](#)) that were no longer needed due to the new water treatment system. In discussions with Baffinland staff on site, debris would be removed and disposed of in appropriate facilities.

Picture 7: MS-08 Debris

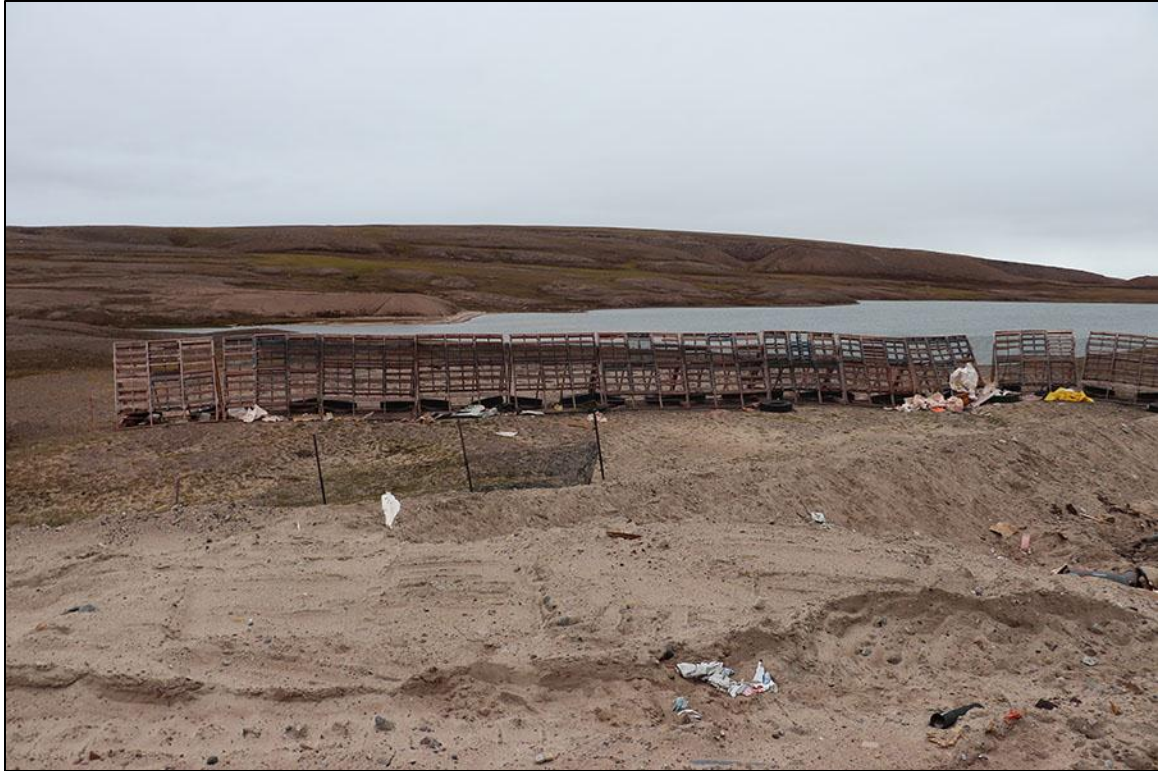
In previous visits, the landfill site ([Picture 11](#)) has had issues pertaining to the fencing around the landfill. During the 2016 and March 2017 site visits, it was noted that fencing mesh was removed from the supporting poles and that Baffinland had not replaced and maintained the fencing surrounding the landfill to retain wind-blown debris. Since 2017, the landfill was lacking fencing with only a small section of wooden fencing providing any means of containing wind-blown debris ([Picture 12](#)). No improvement in the fencing in comparison to the April 2018 site visit was observed, but Baffinland indicated mesh fencing was due on sealift and would be installed once it was on site; however, Baffinland staff indicated the fencing would be limited to the north and west sides of the landfill.

Picture 12: Landfill Fence

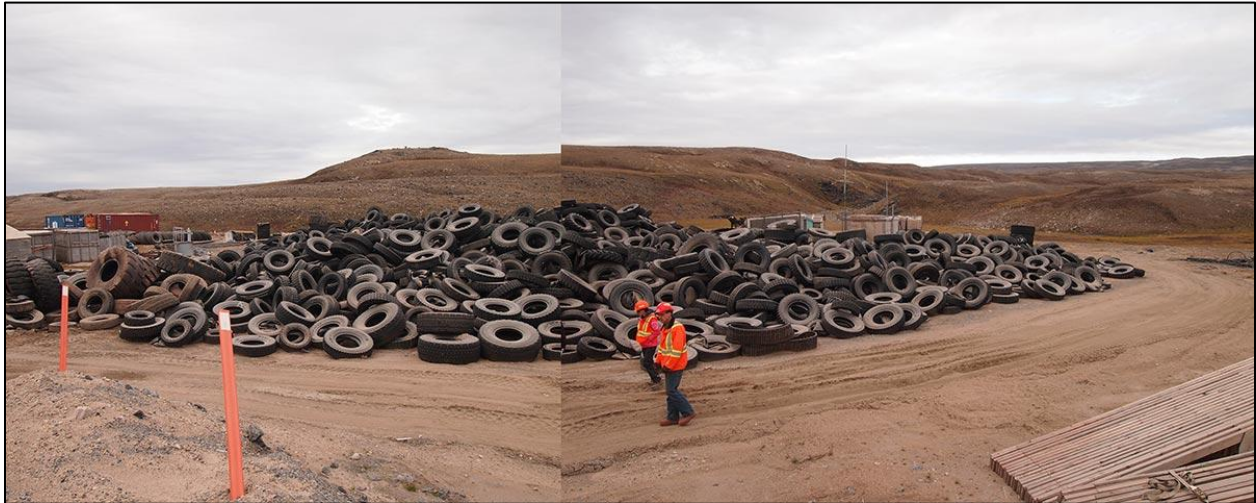
During the August 2017 visit, it was noted that while the area around the incinerator showed improvement in the cleanup of scrap and synthetic materials, the large pile of scrap tires remained next to the incinerator. (Picture 15). During the August 2018 visit it was observed that the number of tires had been significantly reduced (Picture 16) and Baffinland indicated it continued its plan to place scrap tires in seacans for shipment south whenever personnel were available (e.g., such as the truck drivers during road closures)

Picture 15: Scrap tire pile at Mary River Incinerator (composite image), 2017

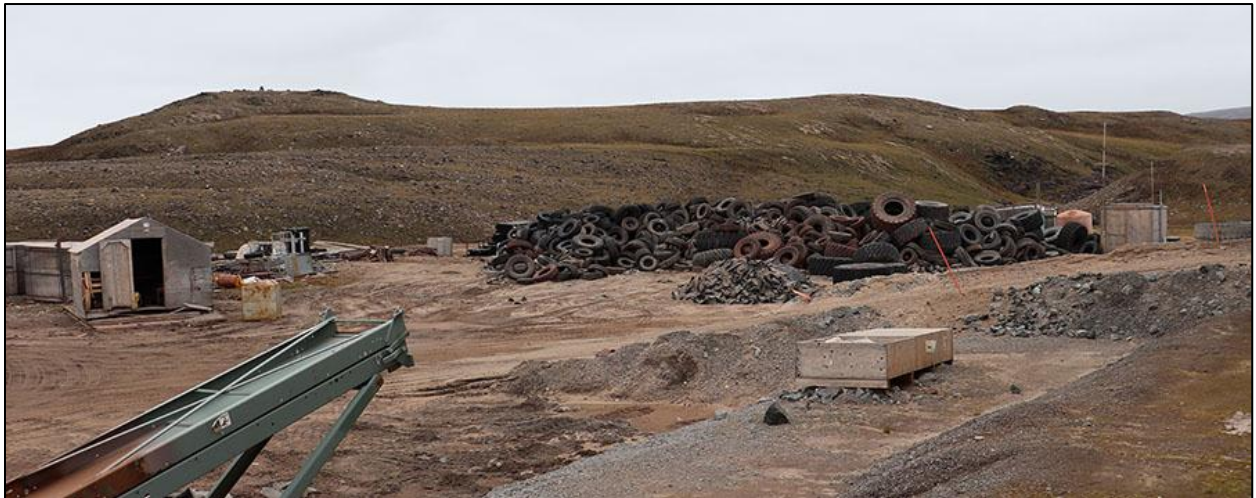
Picture 16: Scrap tire pile, August 2018

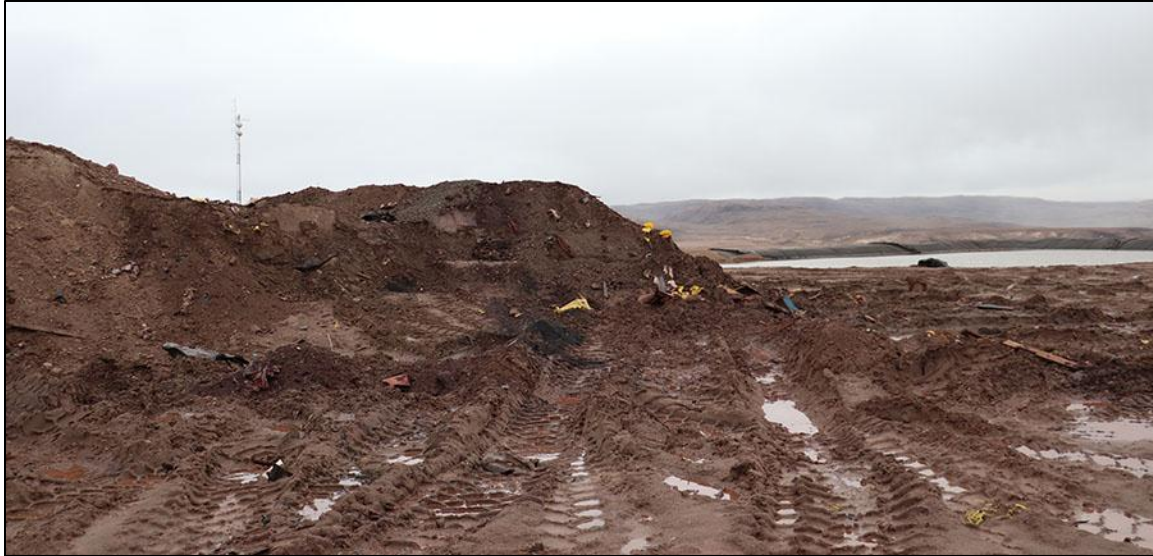
Since 2014, site visit reports had reported on the deteriorating condition of the landfarm facility and raised concerns about the disposal of synthetic liners and that contaminated snow and soils had not been managed following industry best practices. At the time of this visit the landfarm showed significant improvement compared to the August 2017 visit with most debris removed. Although scraps of liner material and some debris remained ([Picture 19](#)), Baffinland staff indicated that workers would be removing scraps as they moved the soil within the landfarm to prepare for tilling the material.

Picture 19: Debris in Landfarm

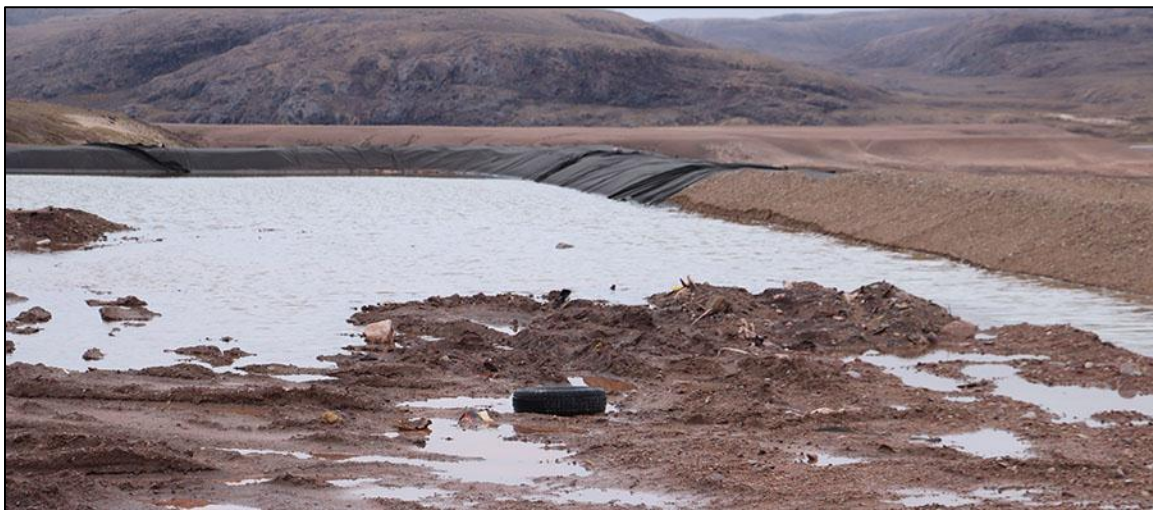
At the time of the August 2018 visit, water from recent rain had pooled within the landfarm berm ([Picture 20](#)). Baffinland staff indicated that the water was being tested to decide if it needed treatment before being released into the environment. Once the determination was made, the water was to be removed from the landfarm and preparations for tilling the soil would begin.

Picture 20: Ponded Water in landfarm

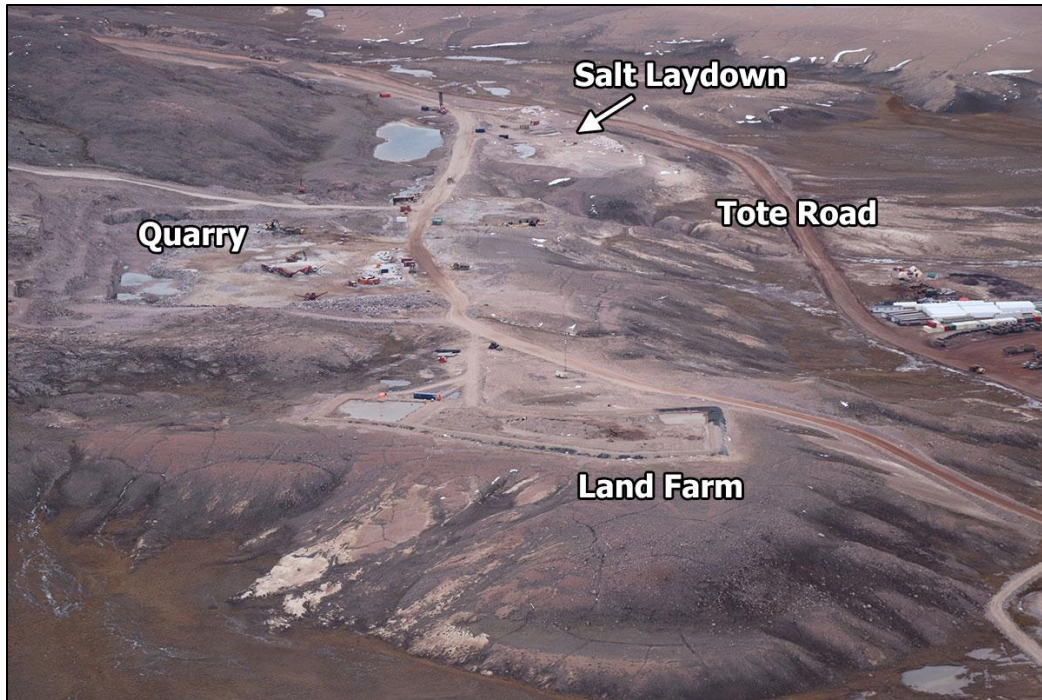
In the August 2017 and April 2018 site visit, the laydown area at Milne Inlet used for storage of salt used as a dust suppressant ([Picture 21](#)) was noted as having poor organization and a generally untidy appearance.

Picture 21: Salt Laydown location

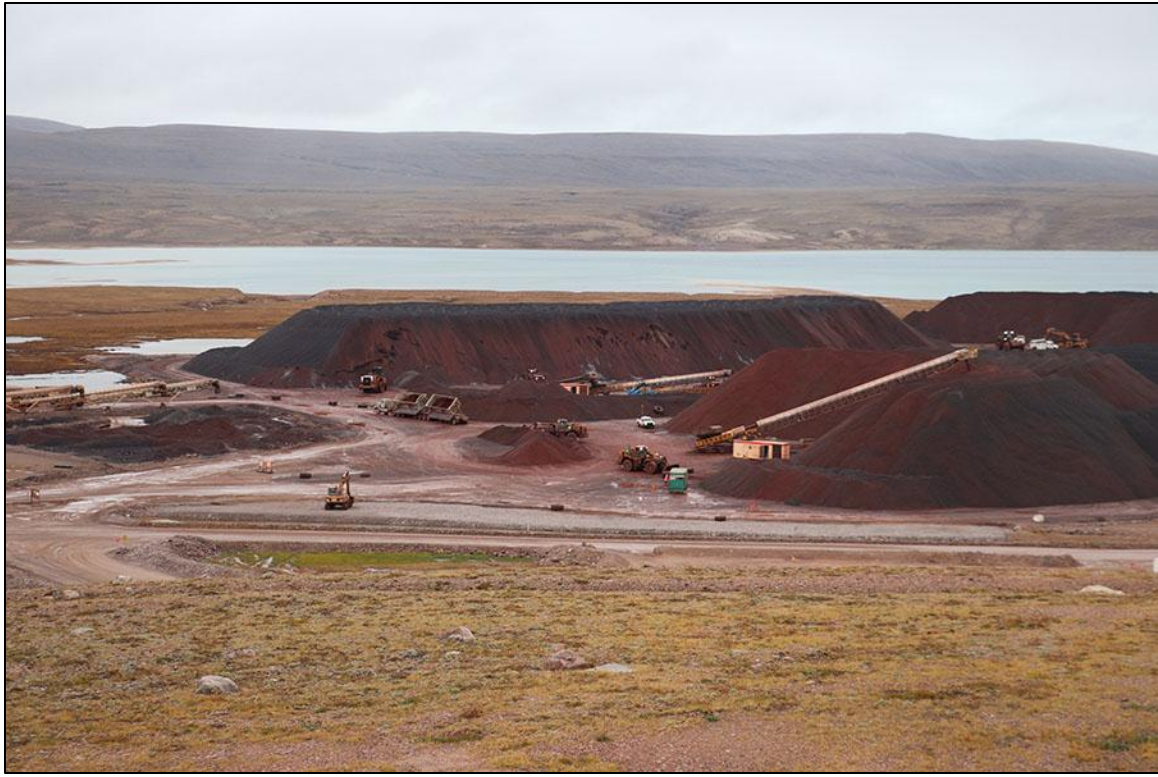
There was no dust observed by the Technical Advisor at site; however, several puddles/wet conditions were noted at the ore stockpile ([Picture 23](#)).

Picture 23: Ore Stockpile
