Site Visit Report

Meadowbank Gold Project (NIRB File No. 03MN107) and ***Whale Tail Pit Project*** (NIRB File No. 16MN056)

Agnico Eagle Mines Ltd.

October 2019

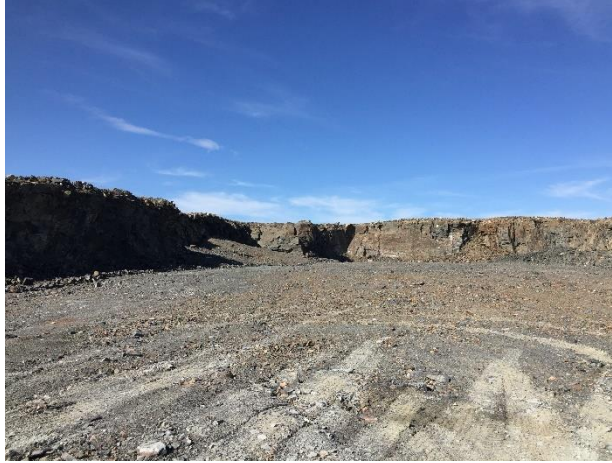
- d) As in previous years, remediation has been ongoing at Quarry 22 following storage of contaminated hydrocarbon soil in previous years with the soil/gravel still testing positive for hydrocarbons (see [Photo 10](#)). No remediation work was conducted in 2018 and 2019 due to active Peregrine Falcon nests at this quarry, but plans were in place to continue the remediation work in September 2019.

Photo 10: Quarry 22 along the AWAR

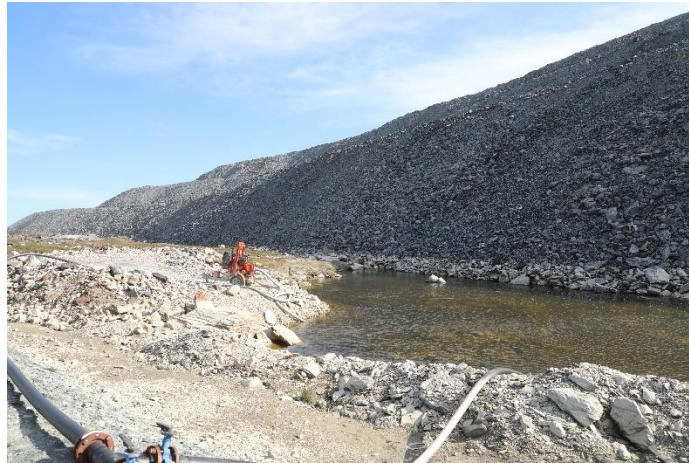
- d) In 2013, Agnico Eagle noted seepage from the Portage waste rock storage facility with potentially acid generating rock (which has a high sulphur content, heavy metals, and other contaminants) at a location near the south shore of a fish bearing lake (referred to as North Pole 2 or NP-2 lake) (see [Photo 19](#)). Agnico Eagle staff stated during the site visit that monitoring of the seepage is still ongoing during the open water season and that

accumulated water continues to be pumped directly back to the North Cell tailings storage facility. No seepage was observed since the North Cell was raised during the summer of 2016 as the assumption is that the tailings storage facility was built on an old riverbed system and may have seeped through this system.

Photo 19: Portage Waste Rock Facility Runoff

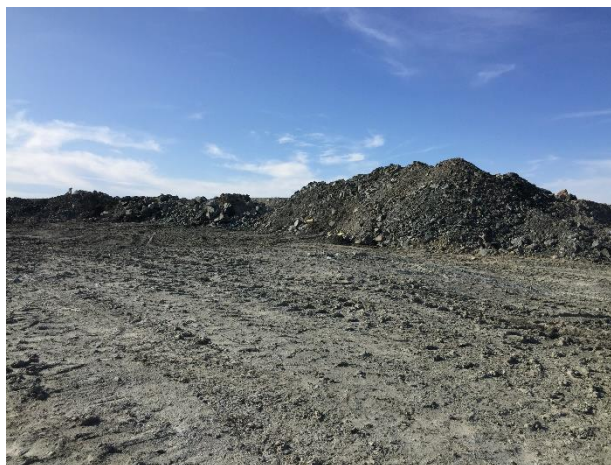
- e) During the site visit, it was observed that the second landfarm constructed in 2017 continues to operate with the addition of on-site nutrients (sewage sludge) to assist in the biodegradation of contaminated hydrocarbon soils (see [Photo 20](#)). The original landfarm, developed in 2013 and located next to the South Cell Tailings Facility was flooded with tailings deposition in 2017.

Photo 20: Landfarm at Meadowbank Mine Site

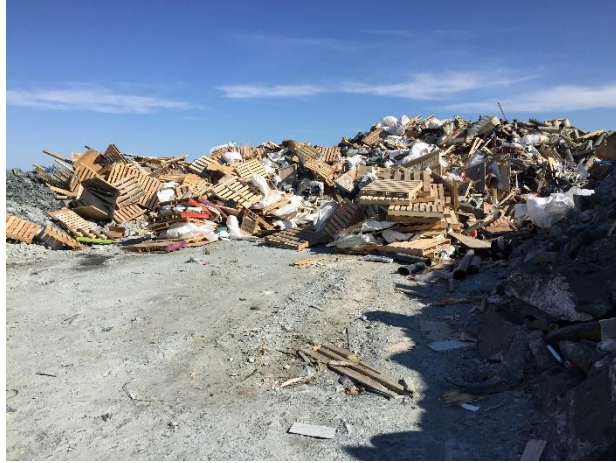
- f) As per previous NIRB site visits, and during the 2019 site visit that Agnico Eagle continues to segregate and store all domestic, hazardous, and combustible wastes in marked seacans prior to these materials being incinerated or shipped to the appropriate and approved off-site disposal facilities (see [Photo 21](#)).
- g) Agnico Eagle stated that the landfill is frequently inspected by employees to ward off any wildlife that may be present, to ensure wastes are segregated appropriately, and that wastes designated to the incinerator or metal dump do not end up in the landfill (see [Photo 22](#)).

Photo 22: Landfill at Meadowbank mine site

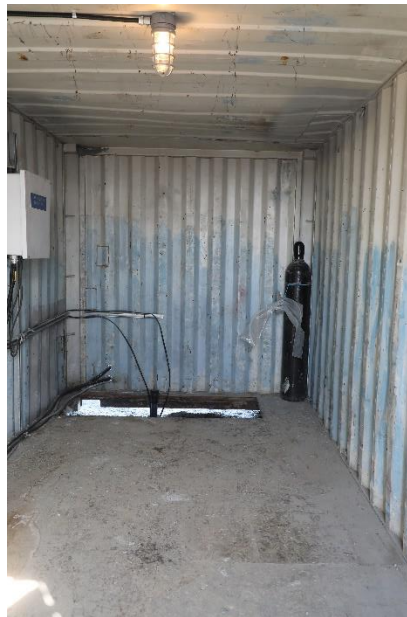
During the site visit, five (5) groundwater monitoring wells were operational and were the same wells in operation since 2018: MW-08-02, MW-16-01, MW-IPD-01, MW-IPD-07 (see [Photo 26](#)), and MW-IPD-09. The modifications to the wells appear to be working as the wells have been functional for two (2) years.

Photo 26: Groundwater monitoring well MW-IPD-07

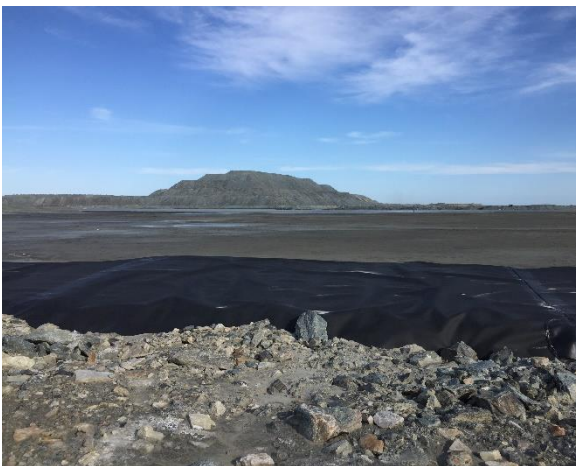
During the site visit, NIRB staff observed that reclamation was ongoing at the North Cell of the tailings storage facility and it was noted that reclamation has not commenced at the South Cell. Agnico Eagle staff stated that tailings will continue to be deposited into South Cell until the cell is full (see [Photo 27](#) and [Photo 28](#)).

Photo 27: Tailings Storage Facility – North Cell

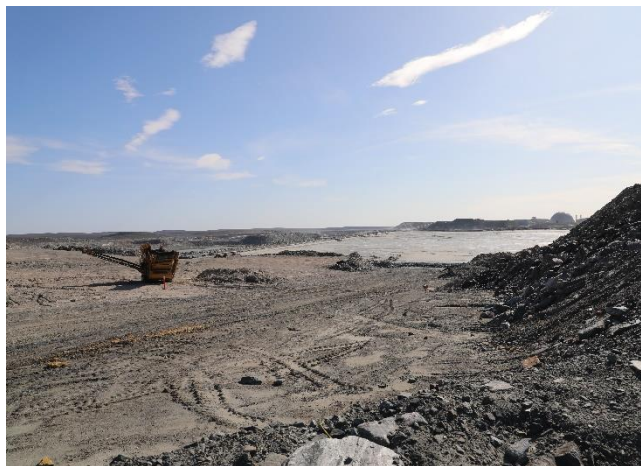
Photo 28: Tailings Storage Facility – South Cell

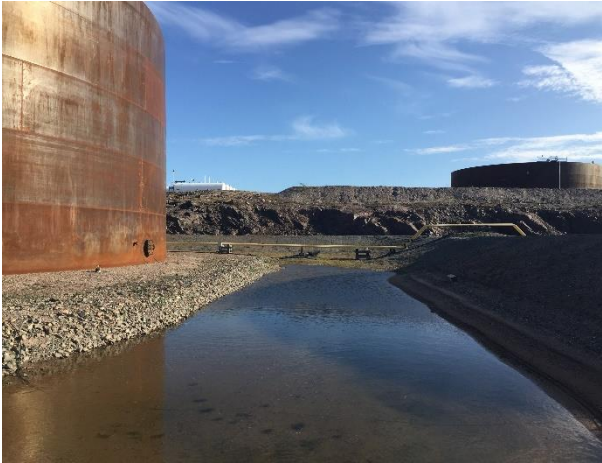
Water was observed within the secondary storage containment facilities for the fuel tank farms but there was no visible sheen on the water or discernable hydrocarbon odours at either the Baker Lake or the Meadowbank site fuel facilities (see [Photo 29](#) to [Photo 32](#)). The liner at the Baker Lake Fuel Storage facility was exposed and it was noted by Agnico Eagle staff that this may be due to the amount of rainfall over the summer that washed away the gravel that usually covers the liner. No indication was provided on whether or not the liner would be fixed or covered with gravel.

Photo 29: Baker Lake Fuel Tank Farm Facility

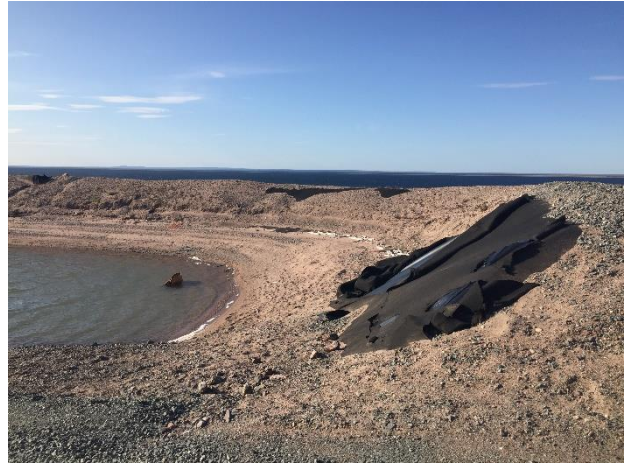
Photo 30: Exposed Liner at the Baker Lake Fuel Tank Farm

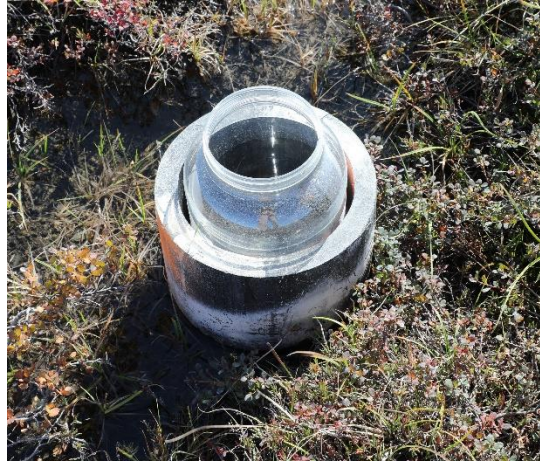
Agnico Eagle staff noted that it continues to apply TETRA flakes (calcium chloride) along three (3) critical areas on a two (2) km section of the AWAR as agreed upon with the local Hunters and Trappers Organization as well as two (2) additional sites. Along each of the five (5) sites, Agnico Eagle also continues to conduct dust sampling to assess dustfall rates in the dust suppression locations, as well as long two (2) reference sites without dust suppression (km 18 and 78). No other dust suppressants are applied along the rest of the AWAR. In addition, dust monitoring continues to be conducted along multiple stations along the AWAR (see [Photo 33](#)).

Agnico Eagle staff also stated that calcium chloride flakes are applied to the areas around the Meadowbank camp site and from the Baker Lake dock facility to the gatehouse. In addition, water is used as the dust suppressant on the mine access roads around the Meadowbank site and within the pits. However, during the site visit NIRB staff noted that the use of water as a dust suppressant did not appear to be effective.

Photo 33: Dust Sampling Station along the AWAR

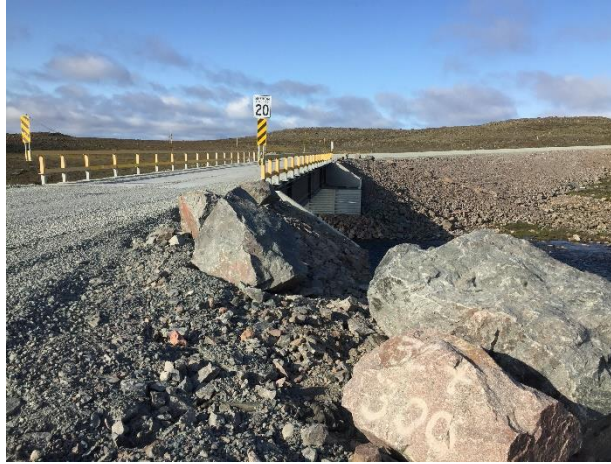
- c) In addition to the caribou observed along the Haul-road, several other species of wildlife were observed including geese, sand-hill cranes, and muskox. Agnico Eagle staff stated that caribou, muskox, and wolves were observed occasionally along the Haul-road.
- d) It was noted that environmental emergency seacans with spill kits were not available at all the bridges along the Haul-road to the Whale Tail site (see [Photo 37](#)). In response to questions, Agnico Eagle staff stated that seacans containing booms, shovels, absorbent

pads, and other miscellaneous spill response equipment are anticipated to be located at all the bridges in the coming year.

Photo 37: Spill response equipment not observed at one of the bridges along the Amaruq Haul-road

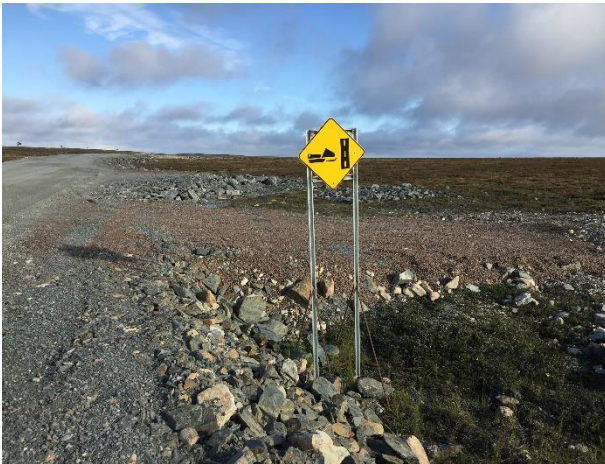
- e) The one (1) snowmachine crossing is located along the Haul-road near km 127 and there were no signs of extreme slopes or rocks at the crossing (see [Photo 38](#) and [Photo 39](#)).

Photo 38: Snowmachine crossing near km 12

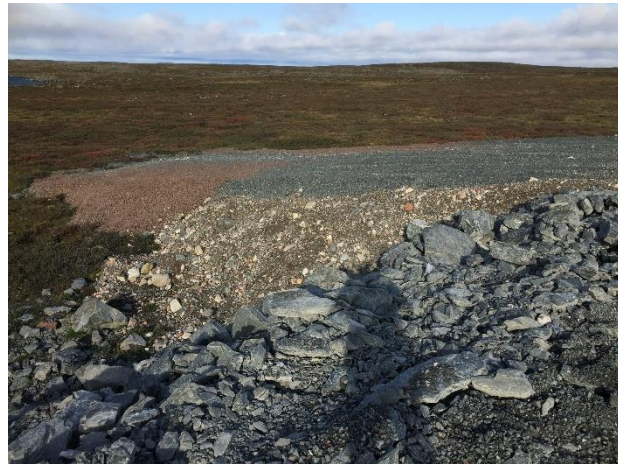
Photo 39: Slope on the other side of the snowmachine crossing near km 12

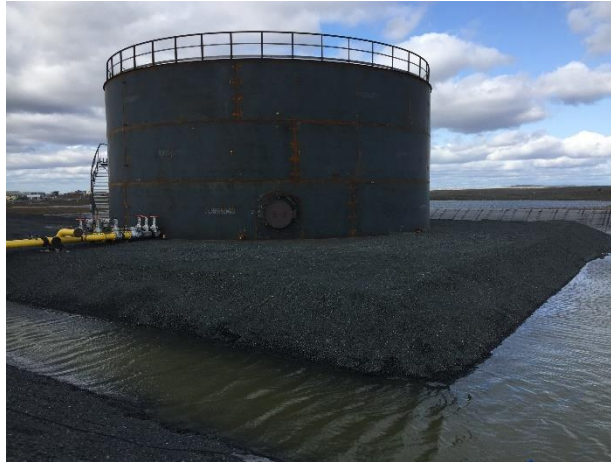
- d) Water was observed within the secondary storage containment facility for the fuel tank farm at the Whale Tail Pit site but there was no visible sheen on the water or discernable hydrocarbon odours (see [Photo 48](#)).

Photo 48: Whale Tail Pit Fuel Tank Farm Facility

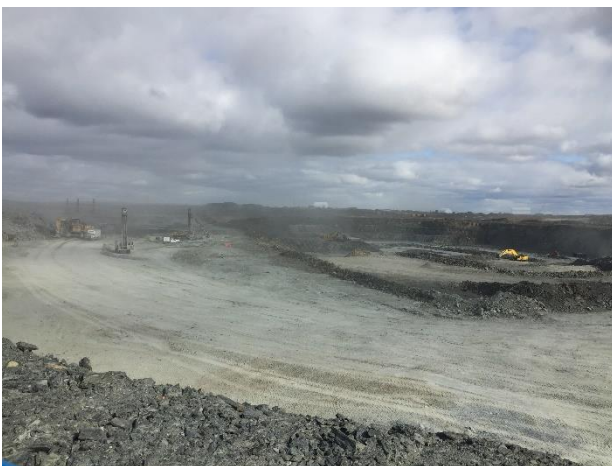
During the site visit, it was noted that dust suppressants were not being applied to the whole AWAR (see [Section 3.2.3.2](#) for further discussion), along the haul-road to the Whale Tail site nor at the Whale Tail site. Agnico Eagle noted that water is the only dust suppressant being used along the Haul-road; however, none was applied due to the heavy rains received. Further, it was observed during the site visit that no dust suppressants were applied at the Whale Tail site including at the North Basin Pit which was later confirmed by the Agnico Eagle staff (see [Photo 41](#), [Photo 49](#) and [Photo 50](#)). The reason for not applying suppressants at the time was due to the heavy rains received in August. Dust monitoring continues to be conducted along multiple stations along the Haul-road which was observed during the site visit (see [Photo 51](#)).

Photo 49: Dust over the North Basin Pit

Term and Condition 2 requires that the Proponent verify commitments to the utilization of dust suppressants along the AWAR, the Amaruq Haul-road and any other roads and trails associated with the Project. To date, this condition has not been met by the Proponent as dust suppressants have not been employed along the whole AWAR, the Amaruq Haul-road and the Whale Tail Pit site roads.

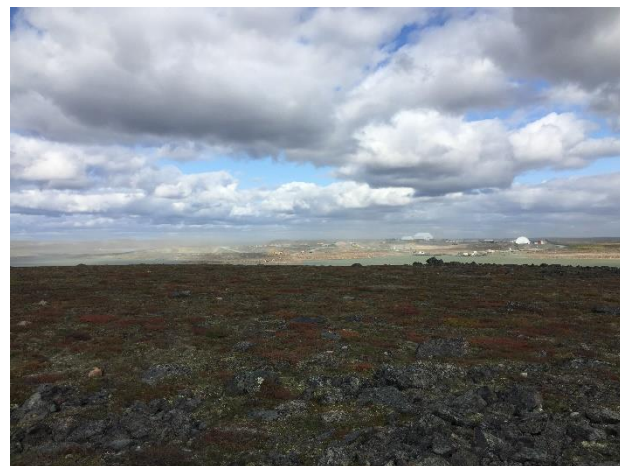
Photo 50: Dust over the Whale Tail site

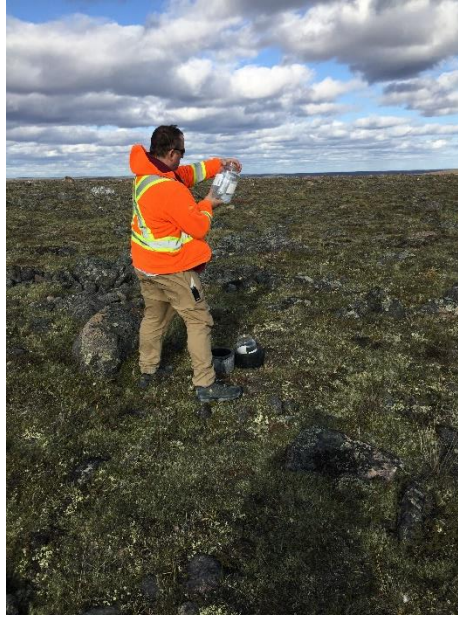
Photo 51: Dust Monitoring Station along the Haul-road
