Report Title: The Nunavut Impact Review Board’s 2019 Site Visit Report for Agnico Eagle Mines Limited’s *Meliadine Gold Mine Project* (NIRB File No. 11MN034)

Project: Meliadine Gold Mine Project
Project Location: Kivalliq Region, Nunavut
Land Tenure: Inuit Owned Land

Site visit date: August 20, 2019
Last site visit: August 17, 2018

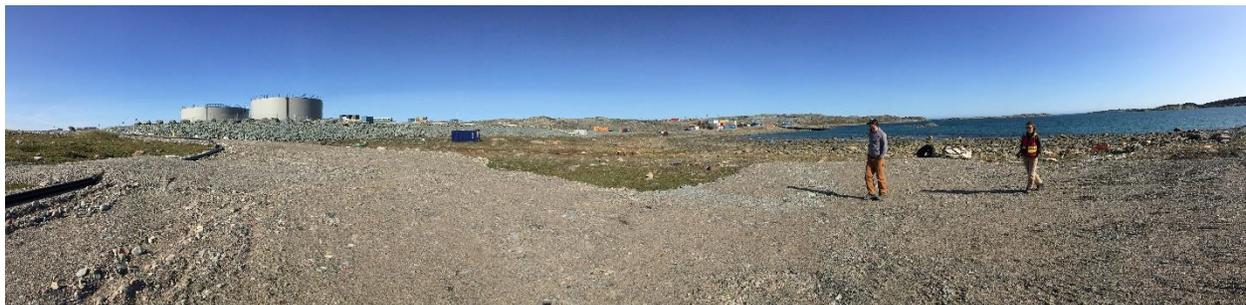
Photo 2: Overview of Itivia Site

- a) Container ships that are associated with the Meliadine project anchor just inside or just outside of Melvin Bay and dry cargo is transported to shore on tug-barges, then lightered to shore using the gravel ramp in Itivia harbour. This ramp is also currently used by the Hamlet of Rankin Inlet during the annual sealift (see [Photo 2](#)). :

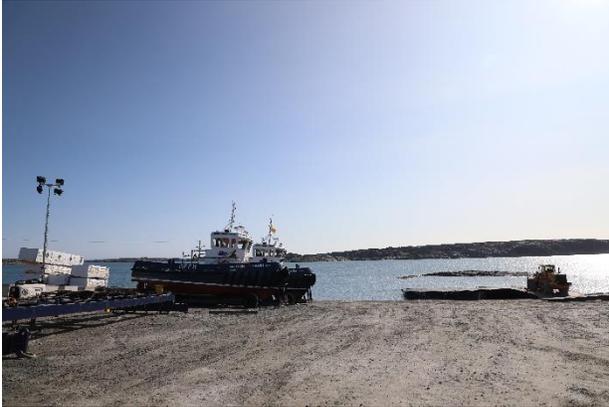
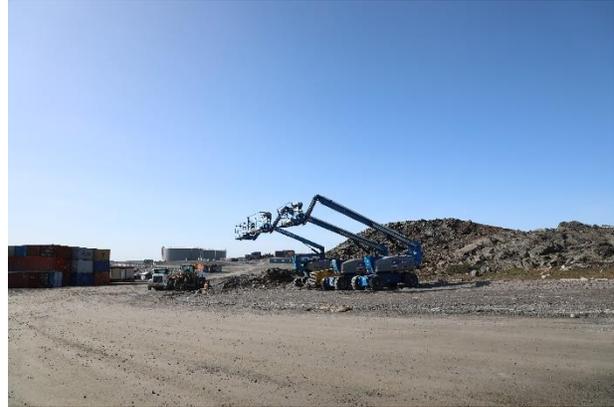
- b) The Itivia site was busy with equipment and seacans being moved around and preparation for another barge to be arriving with additional equipment for offloading (see [Photo 3](#) and [Photo 4](#)).

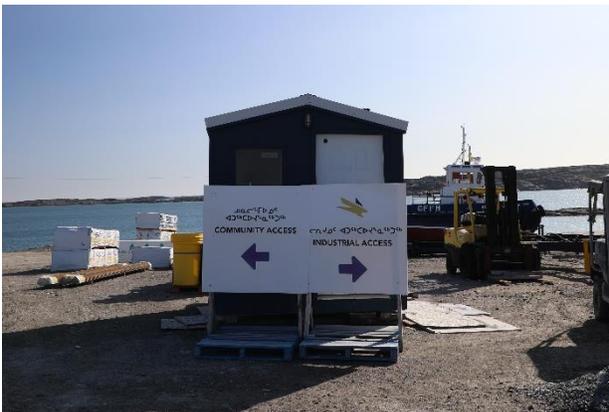
Photo 5. Seacan wall at Itivia separating public and private areas.

- c) It was observed that the signage on the seacan wall was updated and clearly noted to the community the public dock access and the Agnico Eagle barge area (see [Photo 5](#)).
- d) The Saline Water Discharge tank was installed at the Itivia site and appeared to be in working condition (see [Photo 6](#)).
- e) The snowmobile crossing within Agnico Eagle’s Itivia area was also inspected and appeared to be in good repair.
- f) Overall the area appeared to be maintained in good order; however, debris was observed around the Itivia site.

- Ensure the Meliadine mine site and the Itivia site is cleaned of debris and material to reduce amount of garbage and wind-blown material observed during the site visit.
- Implement a recycling program and a waste reduction program is in place at the mine site to reduce the amount of wastes ending up at the landfill by:
 - Finding alternatives to the use of plastic storage containers for single meals at the Meliadine cafeteria.
 - Working with the community and/or schools to create projects that could recycle the wooden pallets and wood.

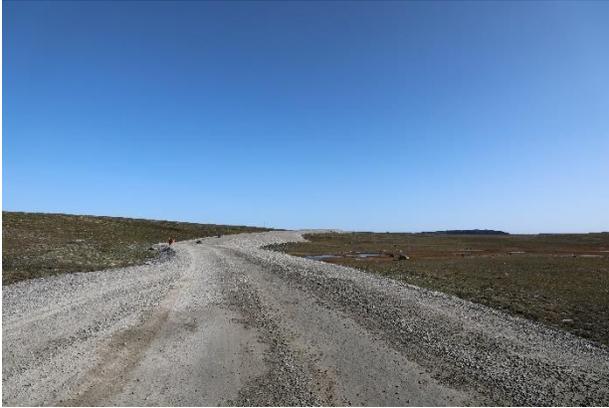
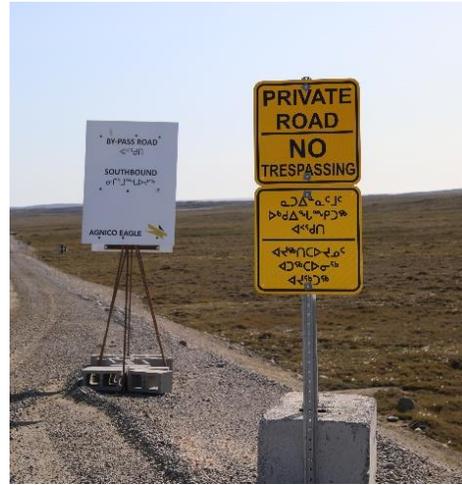
- a) The Bypass road had clear signs noting that the road is private in both English and Inuktitut (see [Photo 7](#) and [Photo 8](#)).
- b) At the snowmachine crossing, there were no signs of extreme slopes or rocks along the side of the AWAR (see [Photo 9](#)).

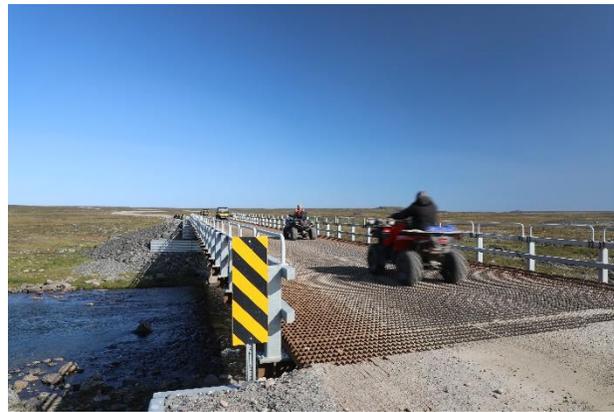
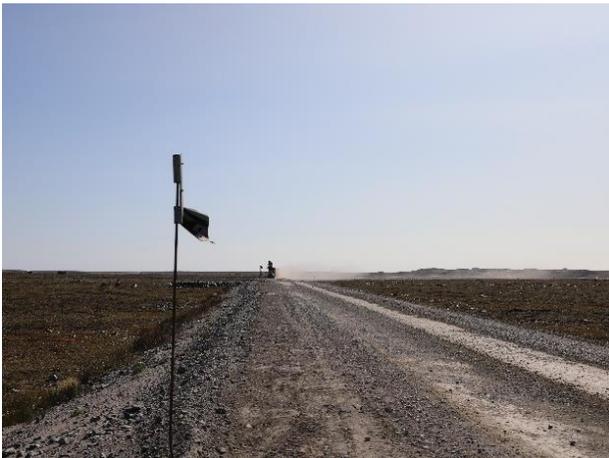
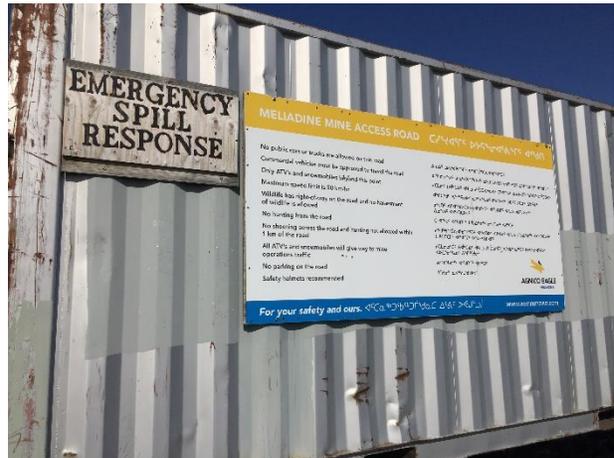
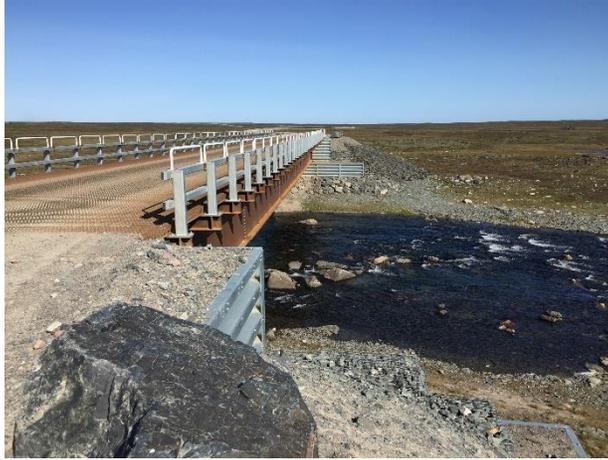
- a) While travelling along the AWAR towards Meliadine, it was observed that the road was extensively used by Rankin Inlet community members (see [Photo 11](#)) along with mine traffic travelling to and from the Itivia area (see [Photo 12](#)).
- b) The NIRB staff requested an update on the plan to build a dedicated ATV/snowmobile connection trail during the site visit and Agnico Eagle staff commented that this trail may not be constructed but discussions are ongoing with the Hunters and Trappers Organization.
- c) The NIRB staff noted that the environmental emergency seacans were located at or near all bridge crossings (see [Photo 13](#) and [Photo 14](#))

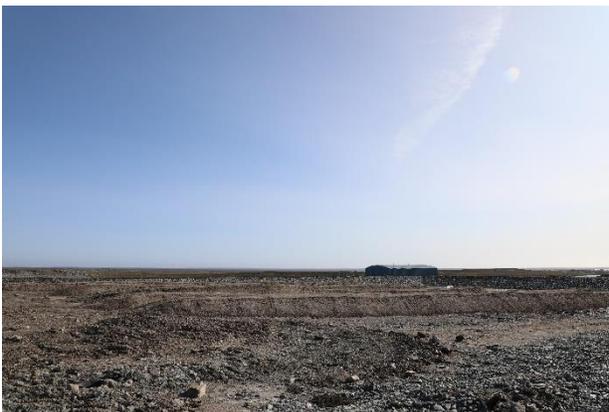
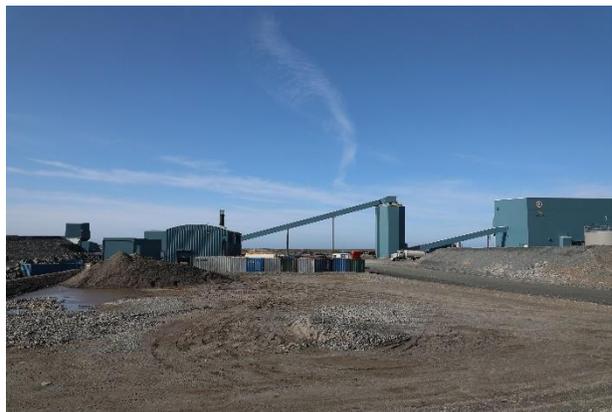
- a) Agnico Eagle constructed a landfarm (referred to as Landfarm A) at the Meliadine mine site in 2018 and it was operational during the NIRB's site visit. Agnico Eagle has started treatment of contaminated hydrocarbon soil on site with nutrients like the Meadowbank Gold Mine site (03MN107) as Agnico Eagle was not having as much success with remediation as it was having at the Meadowbank site. NIRB staff were informed that this landfarm was at capacity (originally designed for a 10-year life) due to the spill that occurred in February 2018 at one of the fuel tank farms (Genset Fuel tank) and an overall increase in spills over the last two years. As such, Agnico Eagle has constructed a temporary landfarm next to Landfarm A which has been developed for overflow of contaminated hydrocarbon soil (see [Photo 15](#) and [Photo 16](#)).

Both the landfarm and landfill were at capacity during the site visit. Agnico Eagle did not appear to have a plan on how these sites would be dealt with as both were at their design capacity. Further, no information was available on when the temporary fuel tank farm and temporary landfarm at the exploration site had not started even though the initial plan was to remediate and clean up these sites by 2018.

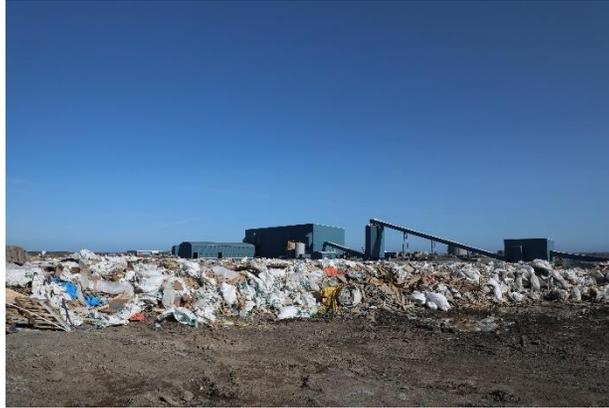
Photo 17. Landfill within the Meliadine mine site.

- b) At the landfill NIRB staff observed numerous wooden pallets in the debris and learned that it is due to the amount of materials being brought to site from the barge season. Last year it was noted by Agnico Eagle staff that plans were in place to send the wooden pallets to

the community of Rankin Inlet which has not yet occurred (see [Photo 17](#)). During the site visit, NIRB staff were informed that this landfill was at capacity (originally designed for a 10-year life) as they underestimated the amount of wastes that were produced during the construction and initial operation periods.

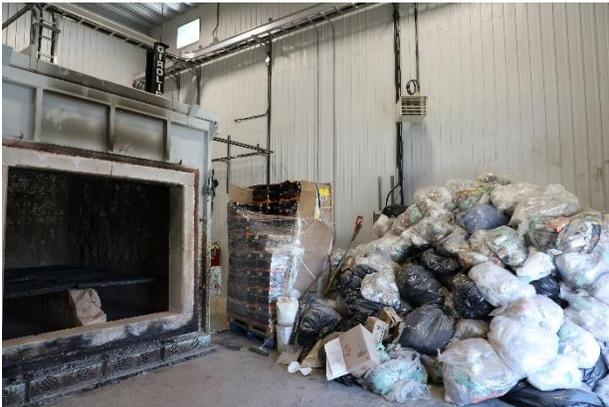
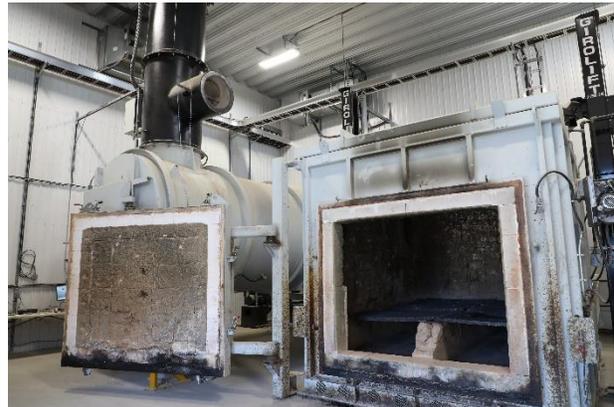
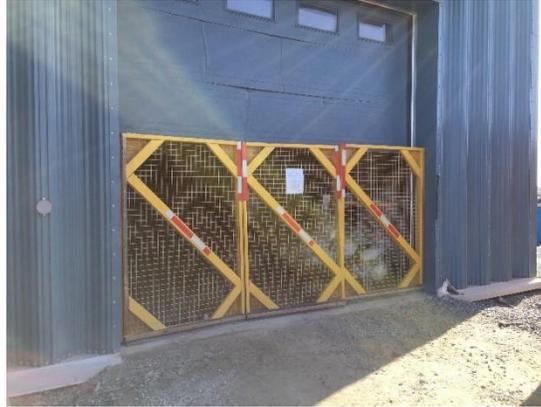
- c) NIRB staff noted that the incinerator appeared to be backlogged as garbage was stacked inside the incinerator building and were informed that the incinerator was not working properly and not reaching the appropriate temperatures for proper combustion and incineration of wastes. Agnico Eagle is working on improving this issue. In addition to the issues, Agnico Eagle has issues with the building that houses the incinerator overheating during incineration employees are required to open the doors. To prevent wildlife from entering the incinerator building, a temporary gate was installed (see [Photo 18](#) through [Photo 20](#)).

- Reduce amount of dust created around the tailings storage facility by finding alternatives for dust suppressants or managing the moisture levels of the tailings.
- Incinerator function and building requirements.

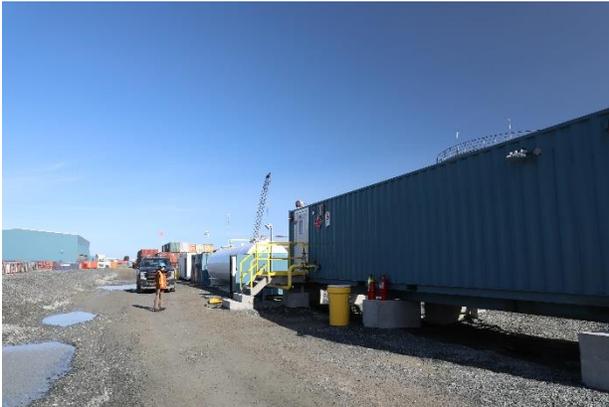
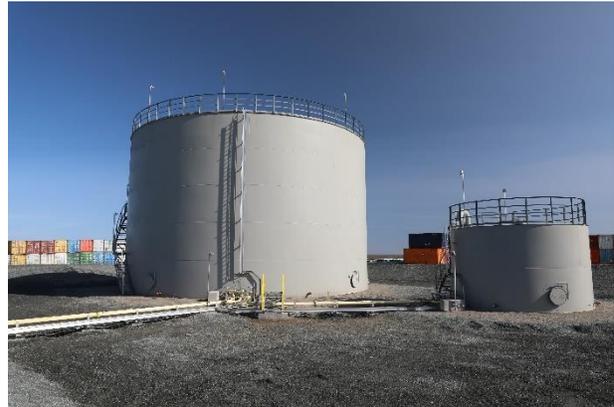
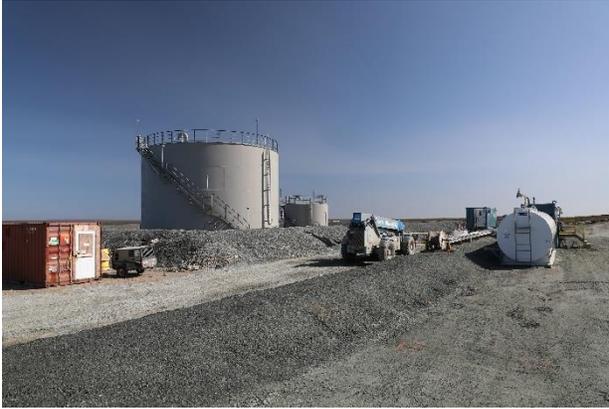
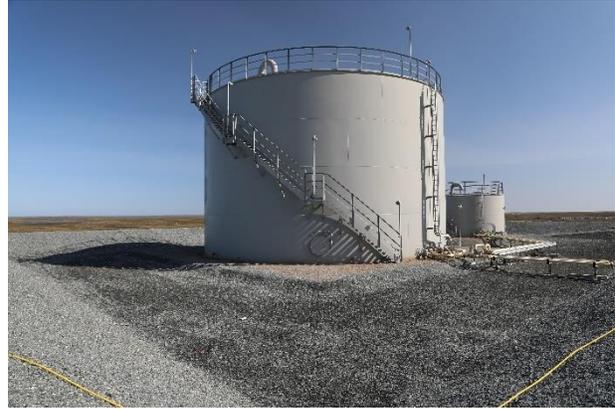
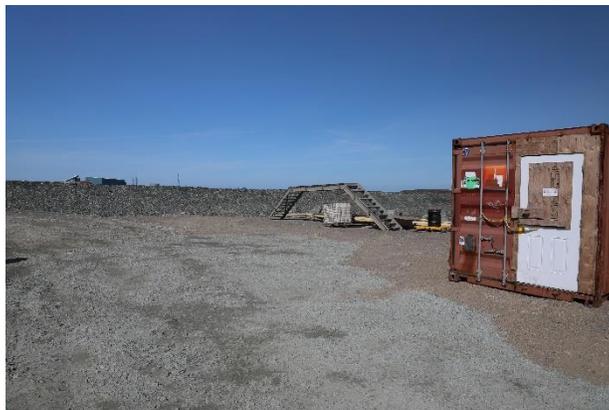
- d) During the site visit, NIRB staff noted that both fuel tank farms and the smaller fuel storage tanks located at various locations around the mine site were within appropriate secondary containment. Further, fuel storage tanks appeared to be handled in a safe and environmentally protective manner. Fuel tank farm #1 was not yet in commission during the site visit as final tests were required before it could be used, while fuel tank farm #2 was being used following improvements to the area and the installation of a liner under the transfer station as identified in 2018. At fuel tank farm #2, there was no evidence of the fuel spill that occurred in February 2018 except for some discernable hydrocarbon odours. Both fuel tank farms did not contain any water; however, there were discernable hydrocarbon odours at both fuel tank farms, and the liner at fuel tank farm #1 was exposed (see [Photo 21](#) through [Photo 25](#)).

**Photo 25: Site of old fuel transfer station at Fuel Tank Farm #2.
Area cleaned up following February 2018 spill.**

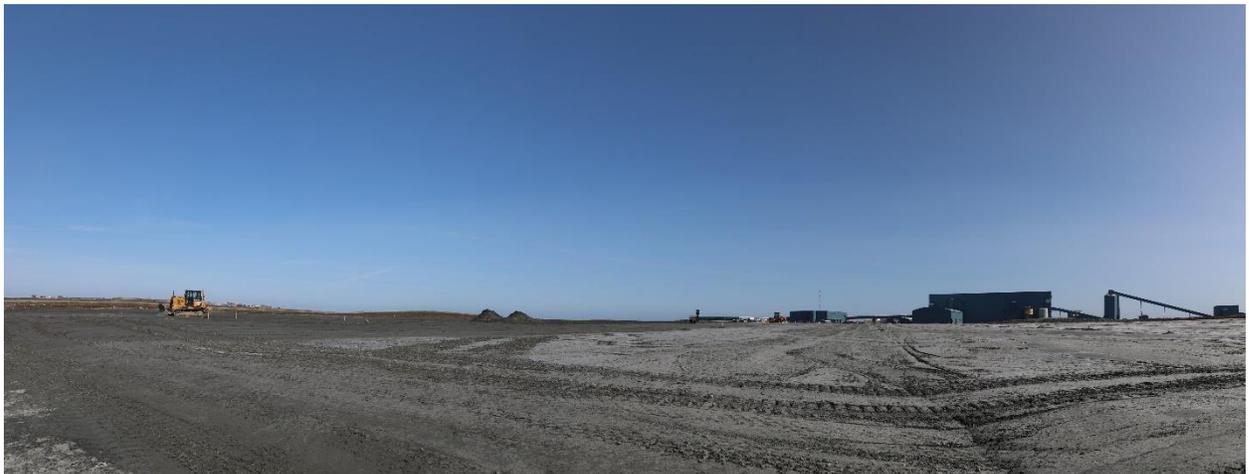
Photo 26: Meliadine Tailings Storage Facility

- e) The NIRB staff also visited the tailings storage facility (dry stack) located west of the mine site (see [Photo 26](#)). The site appeared to be well managed but Agnico Eagle staff noted that the dry stack method for the tailings storage facility has had issues during the summer months due to dust related issues (i.e., high winds have blown the tailings dust around).

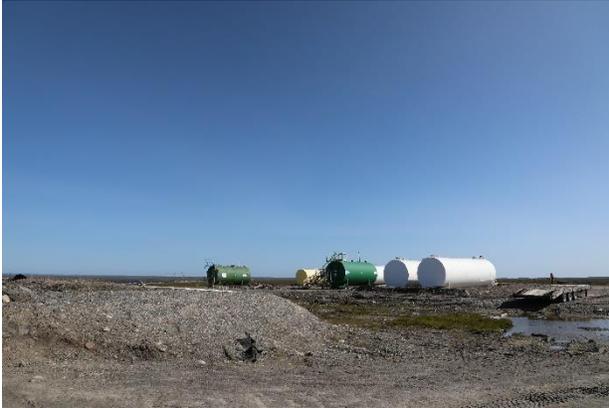
Photo 27. The temporary exploration fuel storage farm.

- f) The site visit also included the exploration/temporary fuel tank storage farm and temporary landfarm as following the 2017 site visit, Agnico Eagle noted that both locations would be decommissioned in the summer of 2018. During the current site visit, decommissioning work on the temporary fuel tank farm and temporary landfarm had not started and Agnico Eagle staff stated that remediation of the site had not commenced (see [Photo 27](#)).

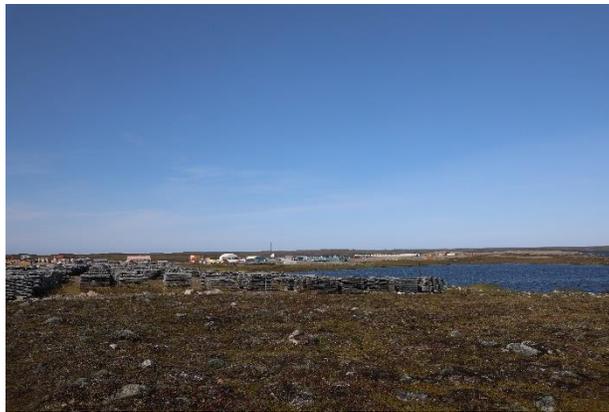
Photo 29. Exploration mine camp at Meliadine

- g) Wildlife observed during the site visit included geese (white-fronted, snow, and Canada), loons, siksik (ground squirrel), ravens, arctic hare and tundra swans.
- h) During the site visit, the NIRB staff were informed that the 200 person exploration camp continued to be used but was being slowly decommissioned (see [Photo 29](#)).

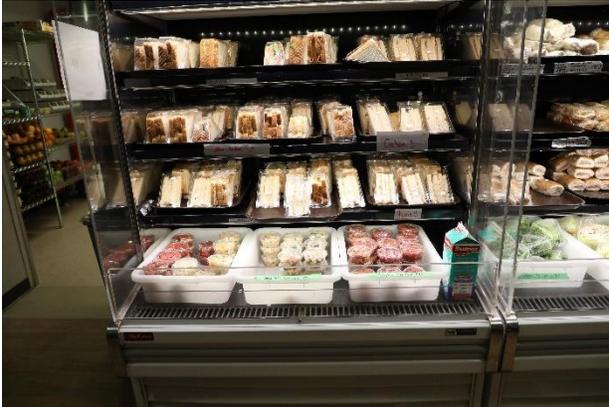
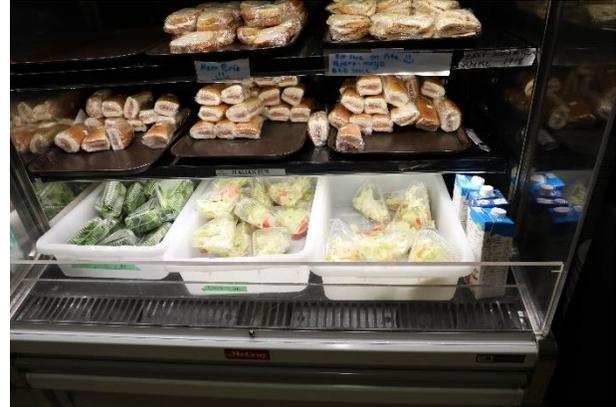
- g) NIRB staff had an opportunity to have lunch at the Meliadine cafeteria and noted that all food was pre-packaged into single serving plastic containers for the lunch crew including salads, sandwiches, and sliced pizza. The NIRB staff noted concern with this setup as it

could create a large quantity of plastic waste. Agnico Eagle staff indicated that they are working on reducing waste overall at the site (see [Photo 30](#) and [Photo 31](#)).

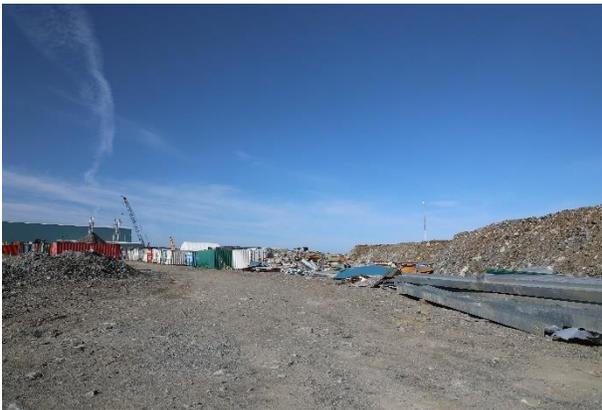
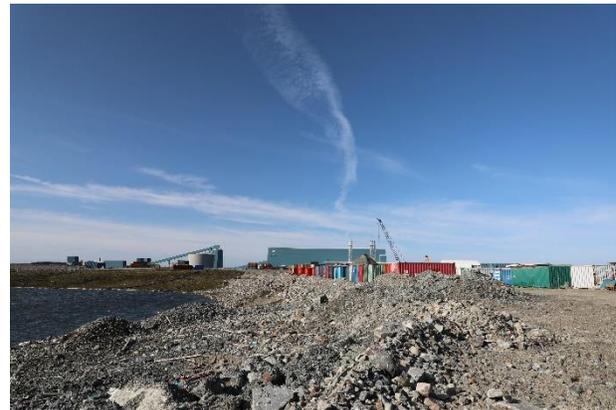
- h) Overall, the Meliadine mine site area appeared to be maintained in good order; however debris including windblown material was observed around the site (see [Photo 32](#) and [Photo 33](#)).

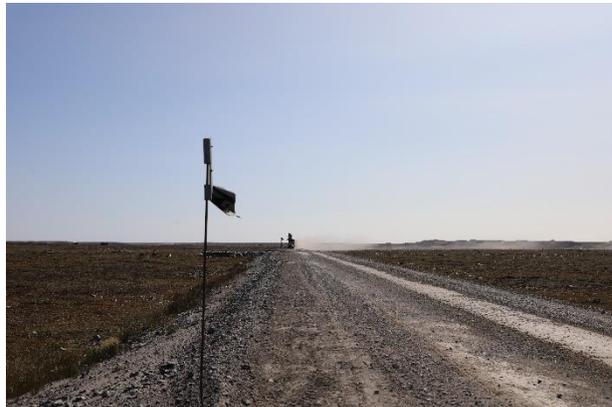
Photo 36: Haul truck along the AWAR creating dust

Agnico Eagle staff also indicated that calcium chloride flakes are applied to the areas around the Meliadine Mine site. In addition, water is used as the dust suppressant on the tailings storage facility. During the site visit, NIRB staff noted that dust suppressants were not applied effectively along the AWAR (see [Photo 36](#)).

Term and Condition 3 requires that the Proponent verify commitments to the utilization of dust suppressants along the AWAR, including any associated trails and trails associated with the Project. To date, this condition has not been fully met by the Proponent as dust suppressants have not been employed sufficiently along the AWAR as dust plumes were observed during the site visit as trucks were driving along the road.

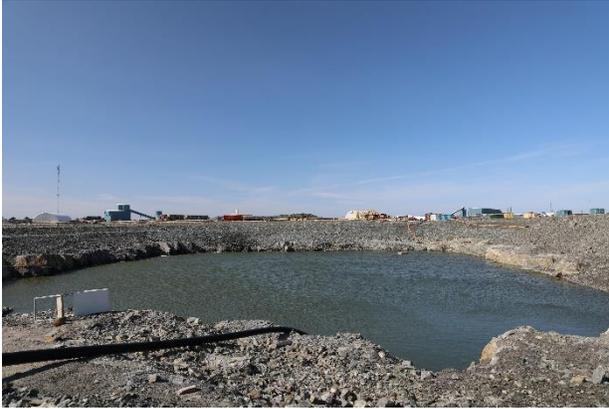
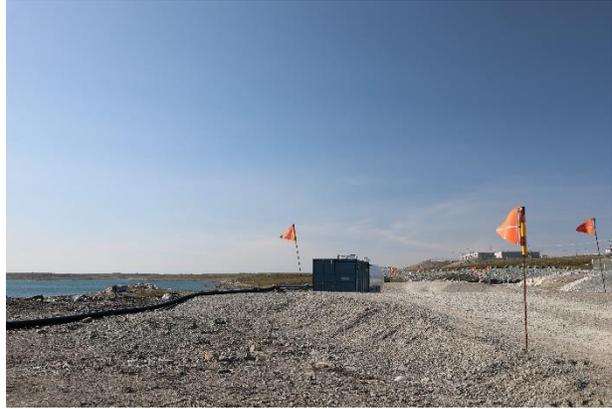
At the saline water management pond, NIRB staff observed the saline water pumped water from the underground to one of the P-Area Containment Ponds. At Collection Pond 5, the three (3) evaporators were not being used to treat water as the saline water is re-used in drilling or trucked to the Saline Discharge Facility at Itivia for eventual release to the marine environment (see [Photo 37](#) and [Photo 38](#)).

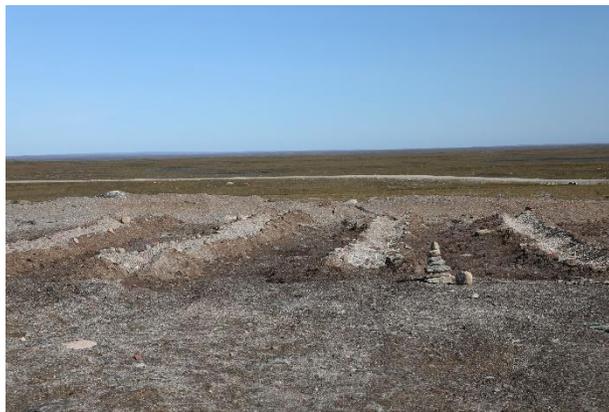
Photo 39: Test plots as part of the revegetation studies

During the site visit, the NIRB staff visited test plots at one of the quarry sites that are being used as part of a revegetation trial in collaboration with Natural Sciences and Engineering Research Council of Canada Collaborative Research and Development grant with the University of Saskatchewan received in June 2019 (see [Photo 39](#)). However, the NIRB staff were informed during the site visit that some of the plots had been destroyed during the removal of soil from the quarry site.

Term and Condition 41 requires the Proponent to develop a progressive re-vegetation program for disturbed areas that are no longer required for operations. Unfortunately, due to unforeseen circumstance a portion of the research program were destroyed.

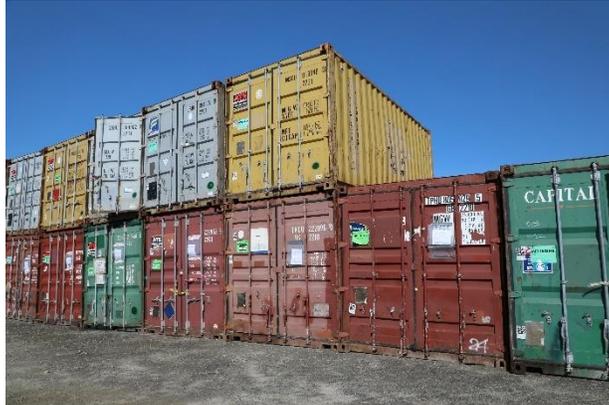
Photo 40. Wastes unsuitable for the landfill are sorted and stored in seacans.

NIRB staff observed waste not suitable for the landfill or for incineration was sorted appropriately (e.g., sewage treatment sludge, batteries, electronics) and was stored in available seacans at the Exploration site for shipment to an appropriate facility in the south (see [Photo 40](#)). These seacans

were appropriately stored to avoid attracting wildlife to the site; however, it was discussed that in 2018 a total of 22 arctic foxes were trapped near the mine site and dispatched by the Government of Nunavut, Department of Environment officers. Agnico Eagle continues to work with the Department to find ways to minimize attracting wildlife to the site.

Term and Condition 75 requires the Proponent to implement mitigation measures and monitoring programs to limit the attraction of predators and scavengers to Project facilities. Even though it was noted during the site visit that segregation and storage of all domestic, hazardous, and combustible wastes appear to be conducted appropriately; however, the site still appears to be attracting predators.
