Summary of 2018 Reportable Spills

TABLE 6.1
BAFFINLAND IRON MINES CORPORATION
MARY RIVER PROJECT
2018 QIA AND NWB ANNUAL REPORT FOR OPERATIONS
LIST OF REPORTED SPILLS AND UNAUTHORIZED DISCHARGES – 2018

APPENDIX E.8.4
INITIAL AND FOLLOW-UP SPILL REPORTS
(PART 1 OF 4)

Re: Follow-up to Spill #18-016
Mary River Project - Water Licence No. 2AM-MRY1325

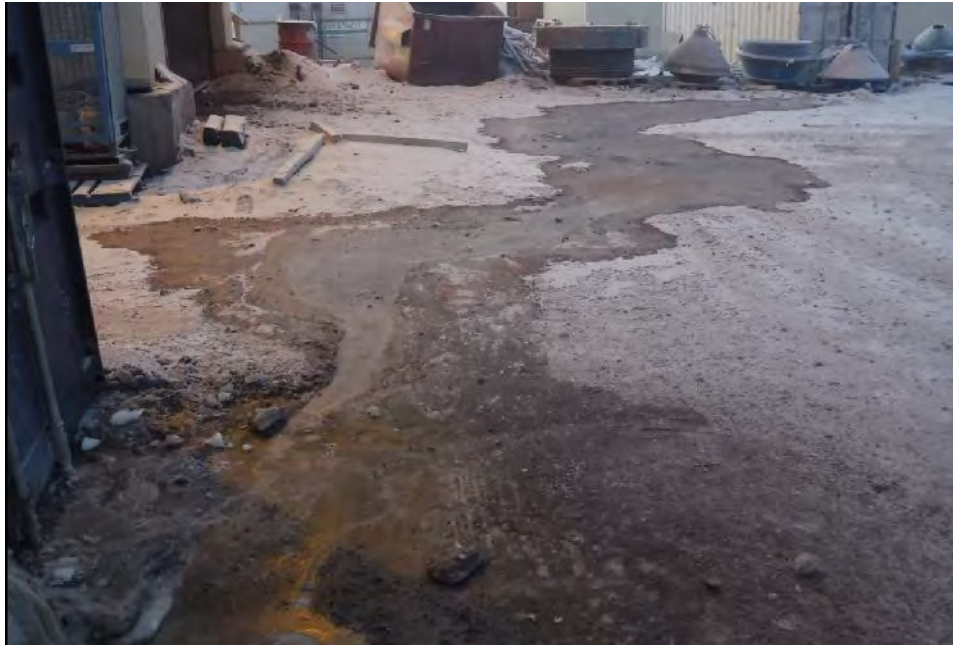
On January 18, 2018 at 06:30 hrs a vacuum truck operator was approaching the wastewater treatment plant (WWTP) at the Mine Site and observed liquid leaking from a vent line on the plant. It was determined that the equalization (EQ) storage tank was full and sewage had spilled over into the exhaust fan line. An investigation determined that a float level switch malfunctioned and did not action the pump which moves waste to the aeration tank from the EQ tank causing the backup and overflow out of the fan vent. Approximately 200L of sewage was released to the WWTP pad, impacting an area of approximately 15m². The location was >100m to the nearest water course which is currently frozen.

Photo 1. Overflow spill on ground surrounding WWTP.

On arrival the operator placed a hose on the vent line to prevent any further spillage and notified supervision and the WWTP operator. A vacuum truck was then used to pump down the level of waste in the EQ tank. Once the pumping system malfunction was determined by the WWTP operator, the operator replaced the float level switch and the system was brought back into normal operation.

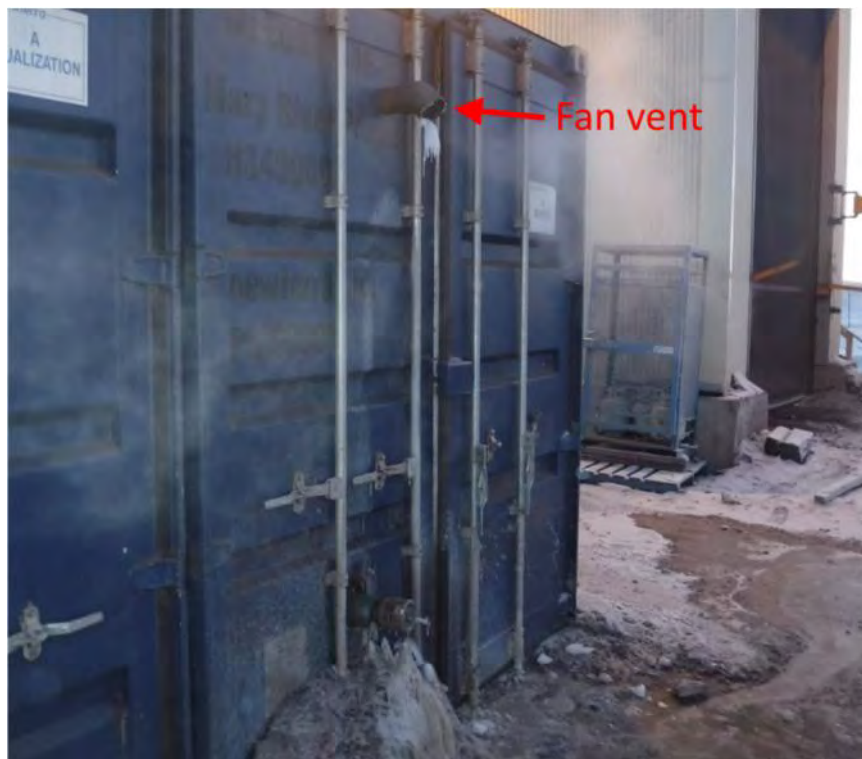
Photo 2. Fan vent discharge location.

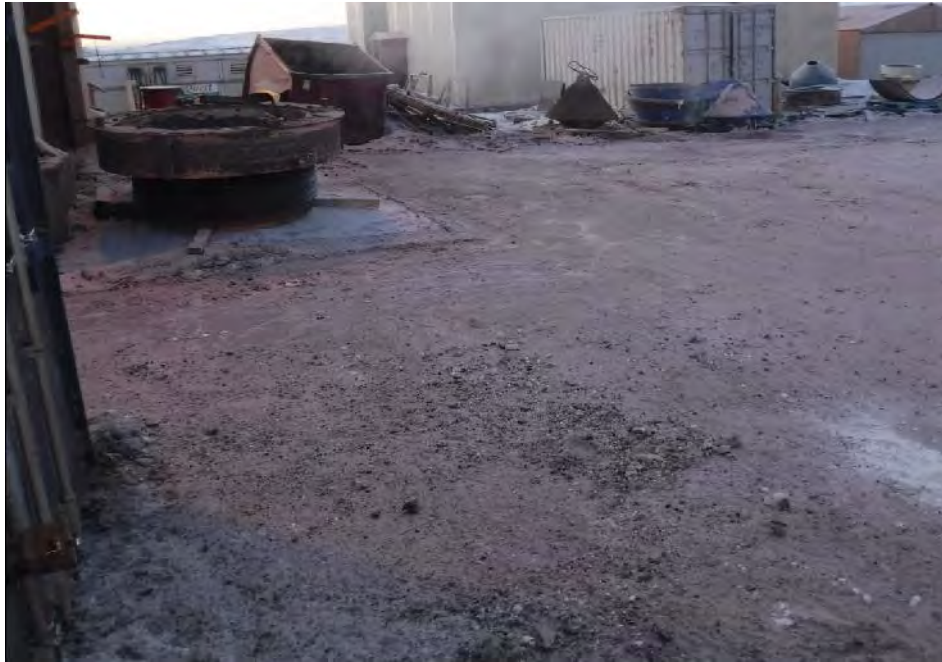
Photo 3. Surrounding WWTP pad after site clean up.

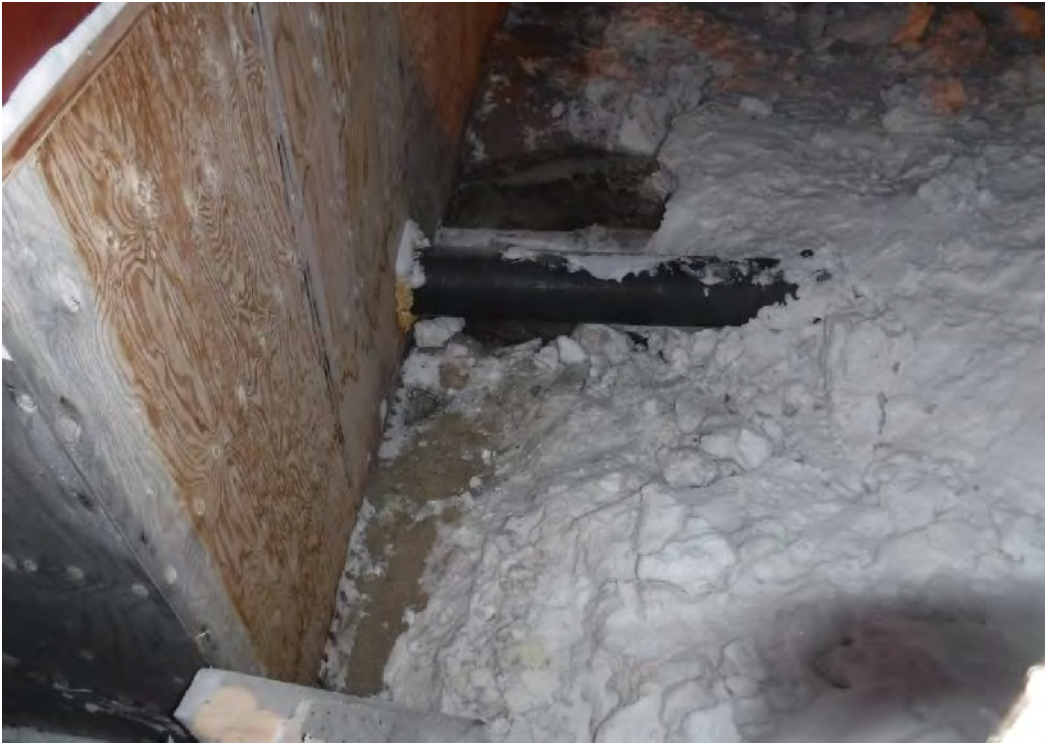
At 03:30 hrs on January 21st, 2018, kitchen staff noticed the high level fault light was on at the Weatherhaven grey water lift station. Upon initial investigation, it was determined that a coupling had failed causing the discharge pipe to separate inside the lift station building. Approximately 400L of grey water was released into the lift station building, migrating out under the base, impacting an area of 10 m². The location of the spill was confined to the Weatherhaven Complex Pad. The spill is >200m from Camp Lake, which is ice covered.

Photo 1. Overflow spill on ground outside Weatherhaven lift station

All influent sources to the lift station were immediately shut off. Grey water released inside the building and surrounding camp pad was sucked up using a vac truck and taken to the Polishing Waste Stabilization Pond. The pipe and fittings were replaced before the lift station was put back into service.

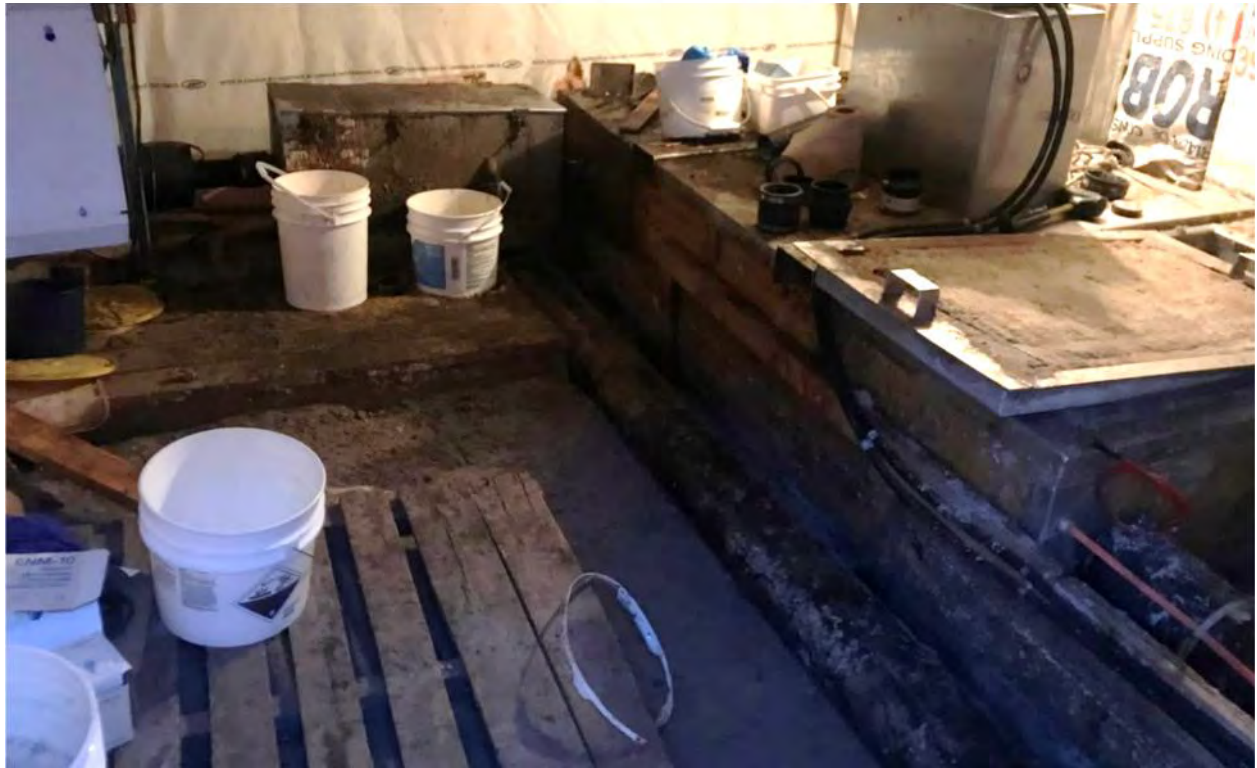
Photo 2. Spill clean up inside Weatherhaven lift station

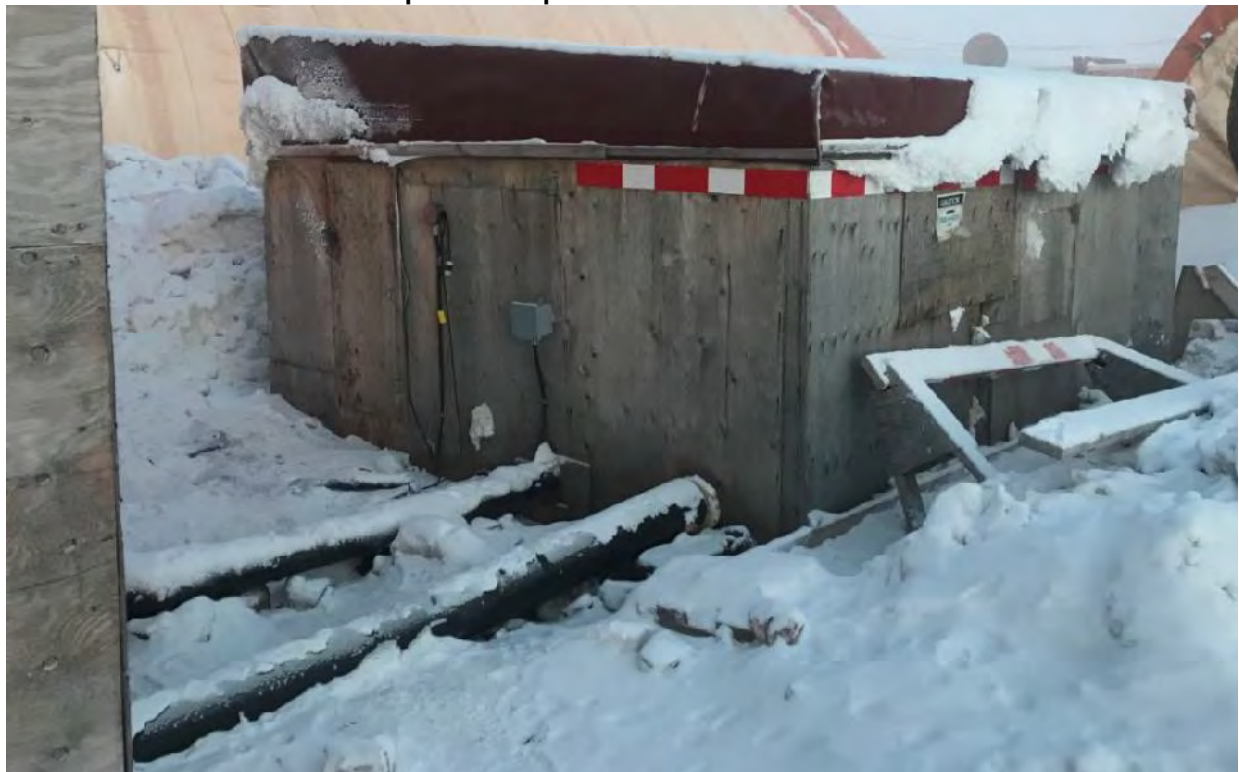
Photo 3. Spill Clean up outside Weatherhaven lift station

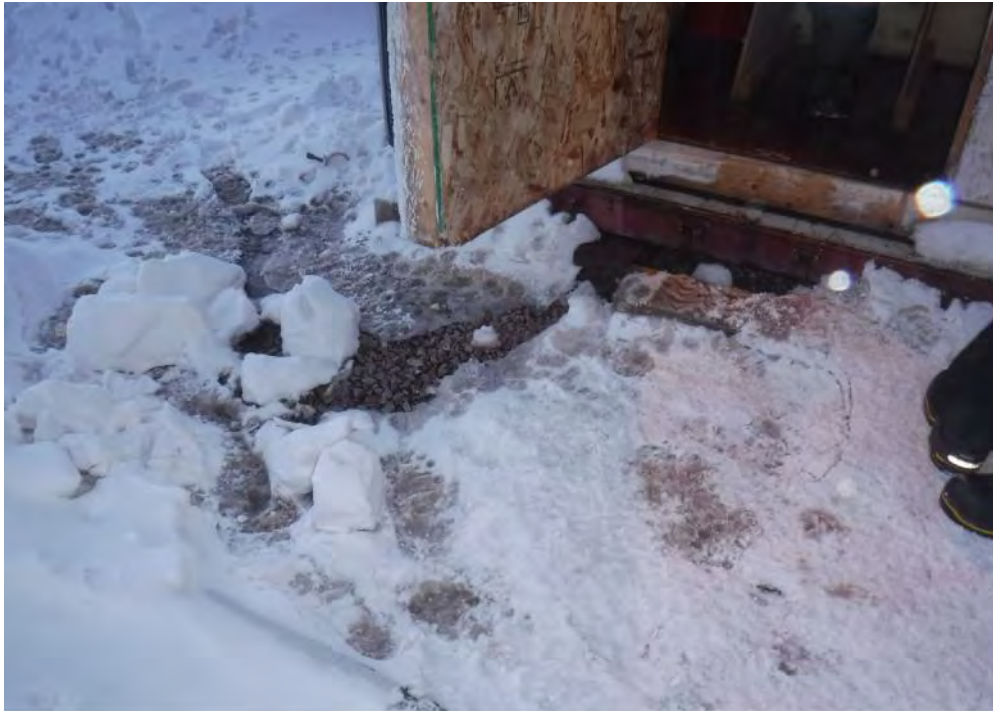
On January 21, 2018 at 12:30 hrs, Site Services Fixed Plant workers noticed raw sewage coming out of the bottom of the main lift station door at the Port Site Complex. Upon initial investigation, it was determined the floatation switch to turn on the pump had failed to trigger, causing the main tank to overflow. Approximately 150L of sewage was released to the adjacent camp pad ground surface, impacting approximately 5 m² area. This location is greater than >100 m to the nearest water course which is currently frozen.

Photo 1. Overflow spill on ground outside PSC lift station

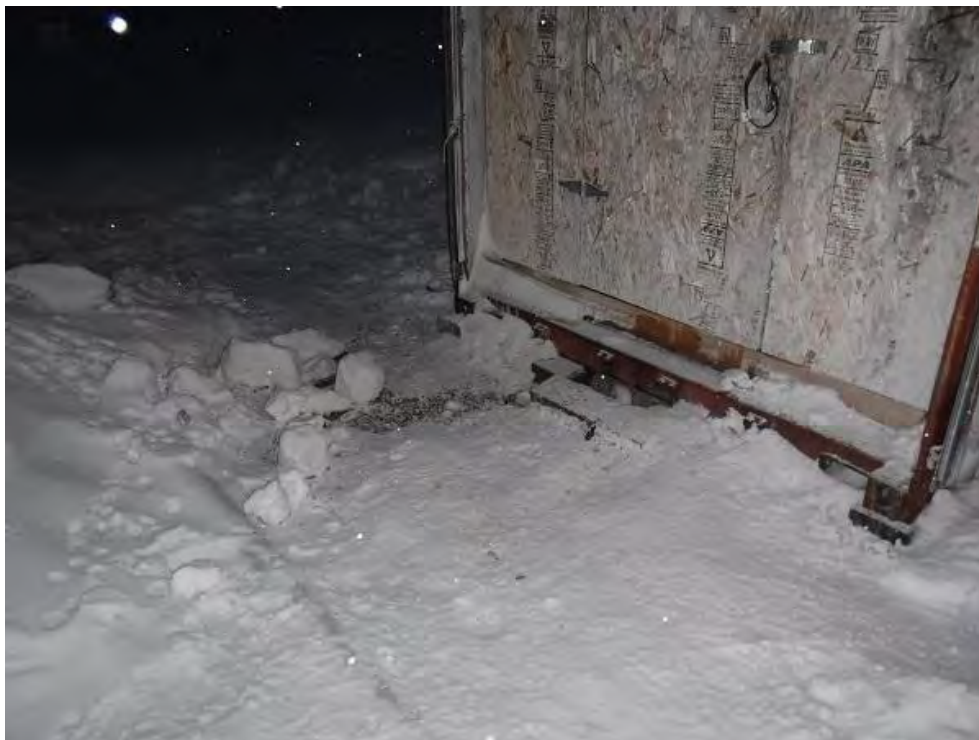
Photo 2. Spill clean up outside PSC lift station

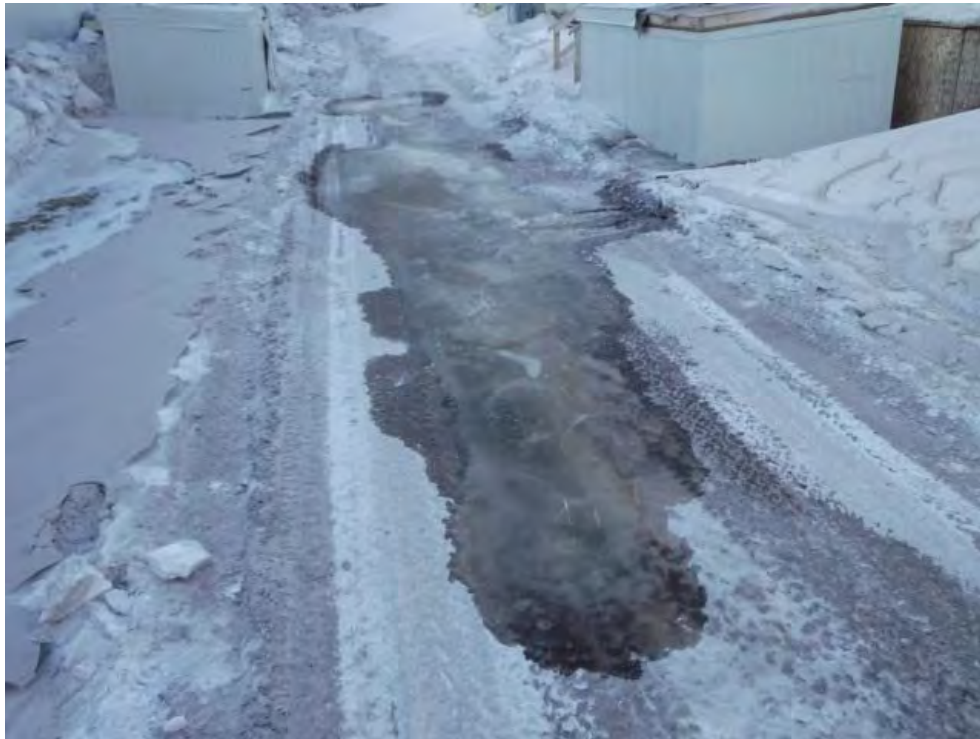
On February 7, 2018 at 09:00 hrs, while conducting inspections of the MSC lift stations, a housing maintainer observed water adjacent to the South AA lift station. Upon initial investigation, it was determined that the lift station pumps had failed to activate, due to the tank floats inside becoming entangled causing the tank to overflow. Approximately 225L of sewage was released to the adjacent ground surface, impacting an area of 14 m² contained to the camp pad. The spill location is greater than 100 m to the nearest water body which is currently frozen and non-fish bearing.

Photo 1. Overflow spill on ground outside MSC AA South lift station

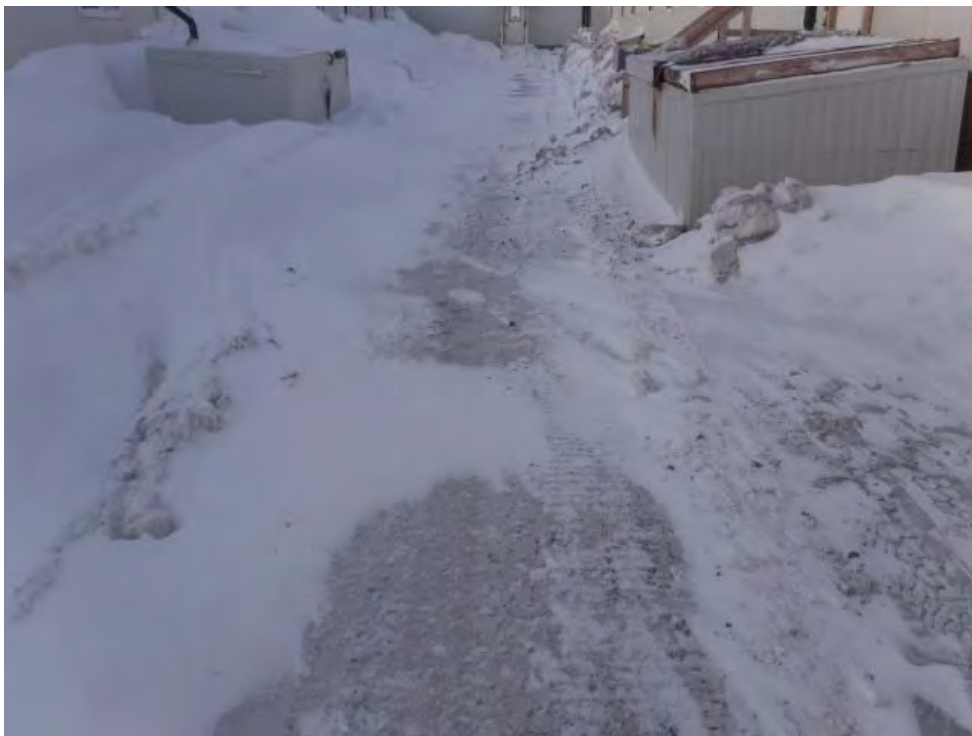
Photo 2. Spill cleaned up outside MSC AA South lift station

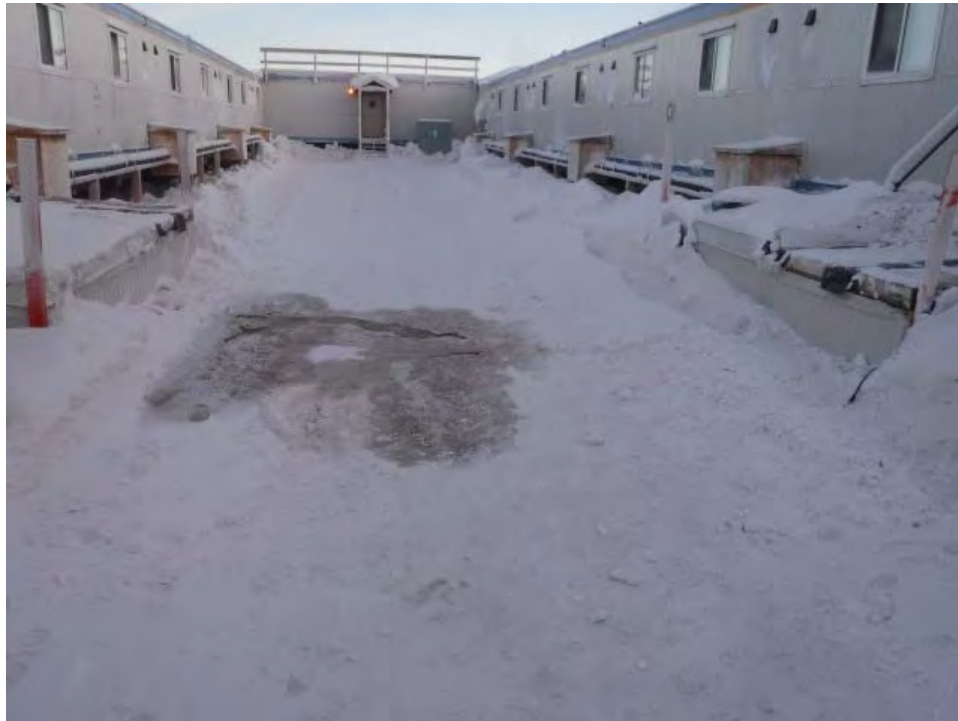
On February 9, 2018 at 11:30 hrs, while conducting inspections of the PSC lift stations, a housing maintainer observed frozen water outside the BB wing north lift station. Upon initial investigation, it was determined that there was a blockage in the discharge line to the main lift station, resulting in the lift station to overflow. Approximately 2m³ of sewage was released to the adjacent camp pad ground surface, impacting an approximate area of 24 m². This spill location is greater than 100 m to the nearest water course which is currently frozen.

**Photo 1. Overflow spill on ground outside PSC
BB North lift station**

Relocate existing warning light to outside the lift station to reduce response time to address possible upset conditions. Additional insulation will be installed at the elbow joint of the discharge line which has proven to be prone to freezing. Continued daily lift station inspections of the system.

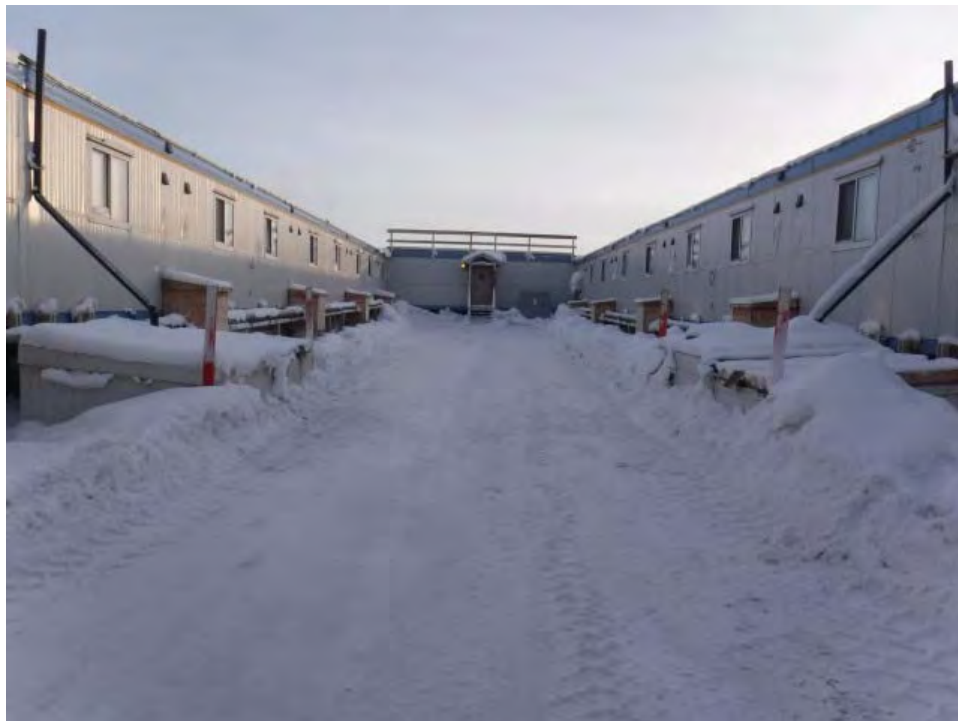
Photo 2. Spill clean up outside PSC BB North lift station

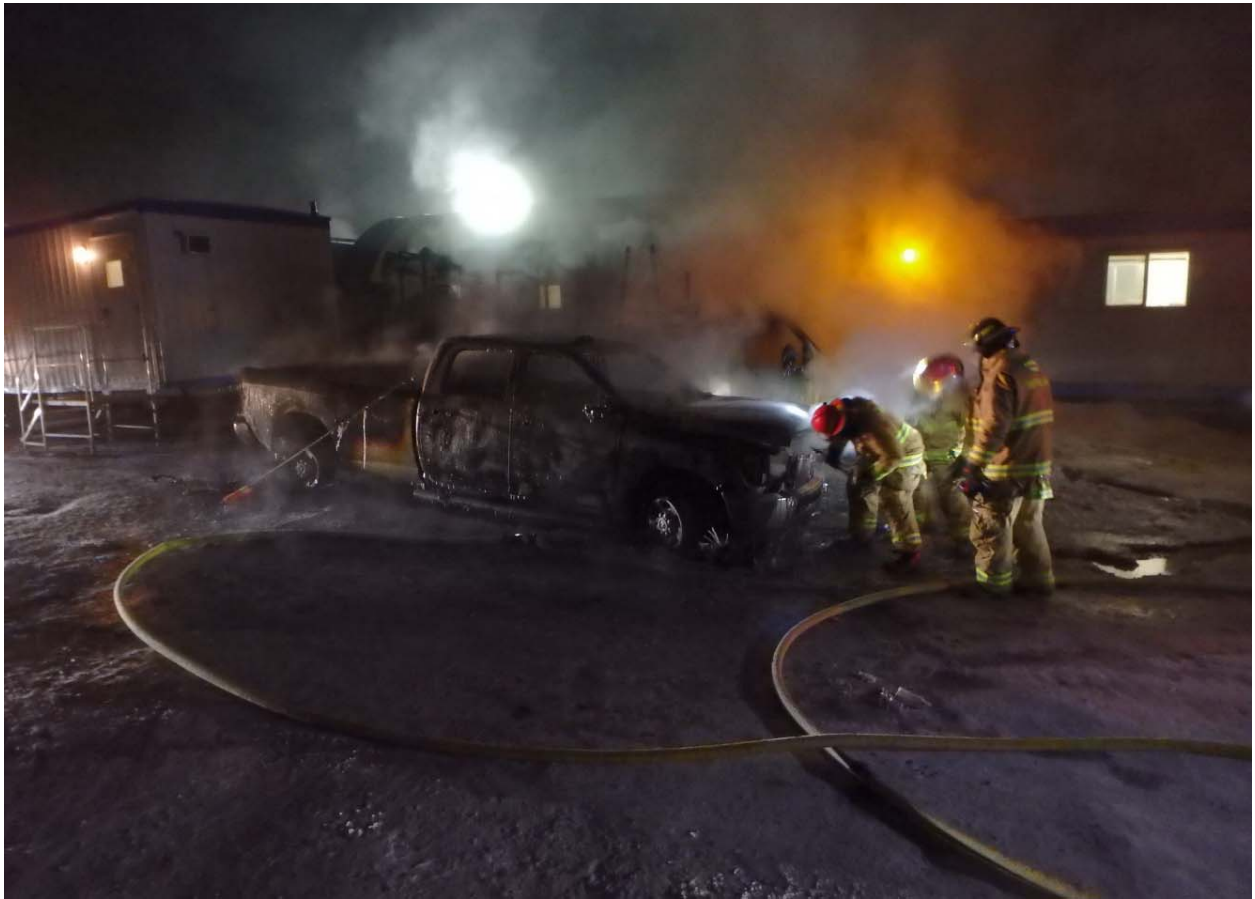
On February 14, 2018 at approximately 06:30, a fire was reported beside the Nuna shop in proximity to the Mine Site Weatherhaven complex. It was discovered that two light vehicles, one pick up, one cube van, had caught fire. The ignition source is unknown. The Mine Rescue Team was dispatched to extinguish the fire, which took approximately one hour. As a result, there was a significant amount of fire impacted water that was produced, which immediately froze to the adjacent pad where the pick ups were parked due to extreme cold conditions. Approximately 10m³ of fire impacted water was produced, confined to the pad. Constructed berms and extreme temperatures mitigated the migration of the water. This spill is >160m to the nearest water course (which is currently frozen).

Photo 1 – Trucks Being Extinguished by MRT Personnel

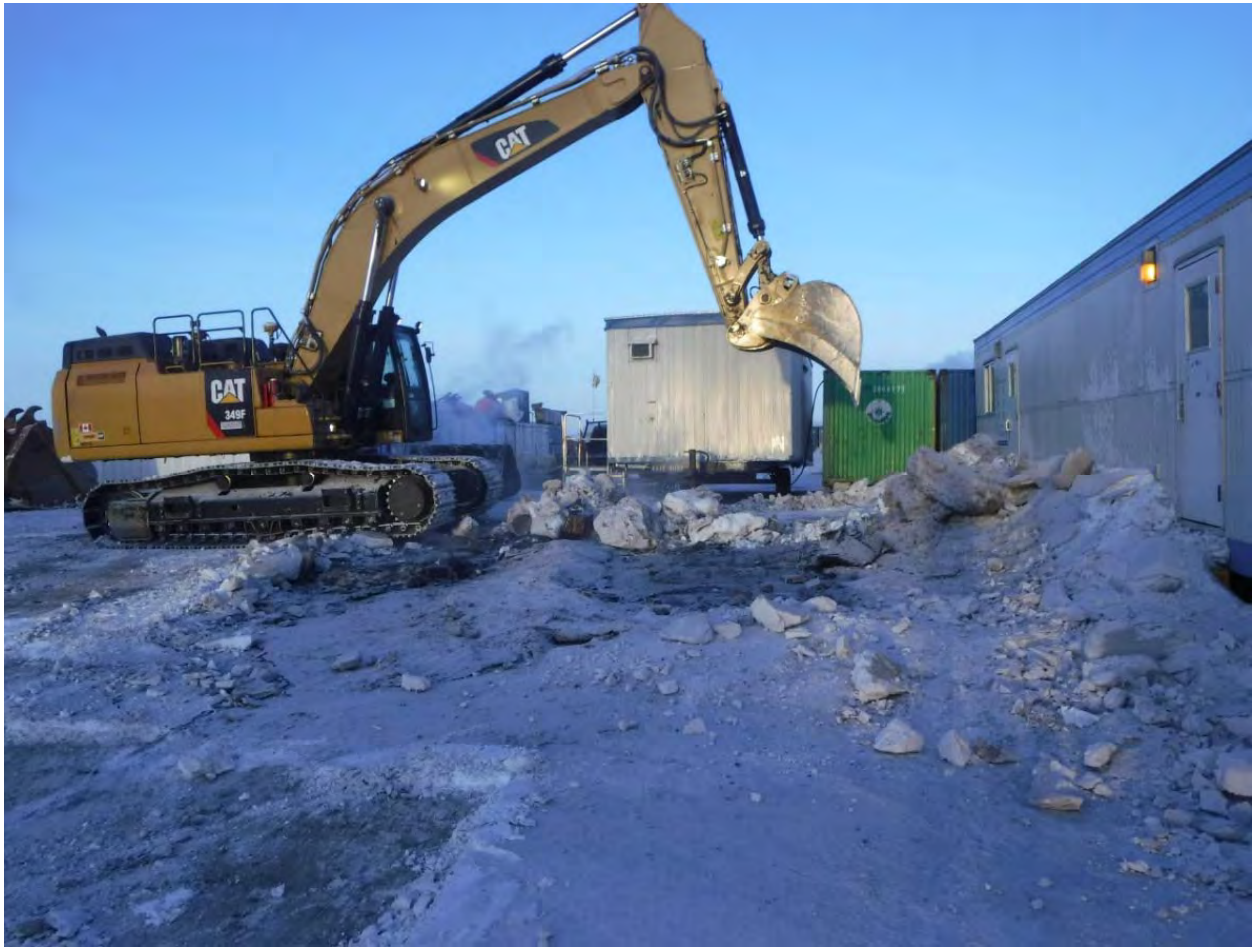
Photo 2 – Impacted ice/snow being scrapped up by excavator

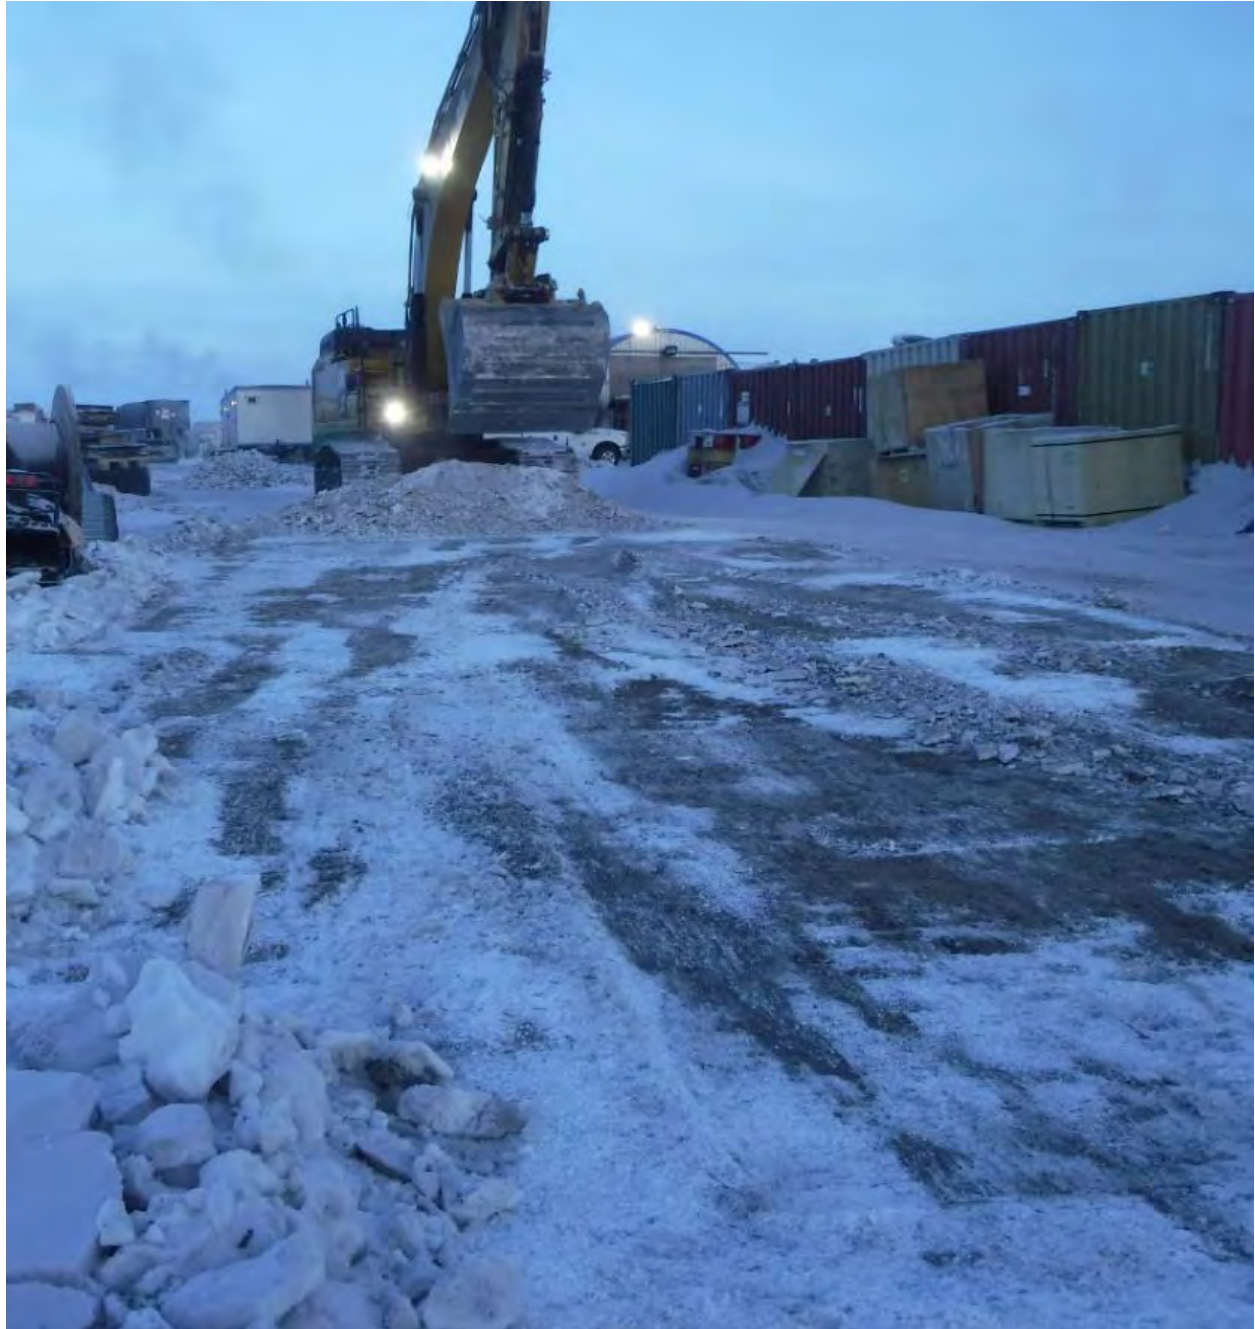
Photo 3 – Impacted ice/snow being scrapped up by excavator

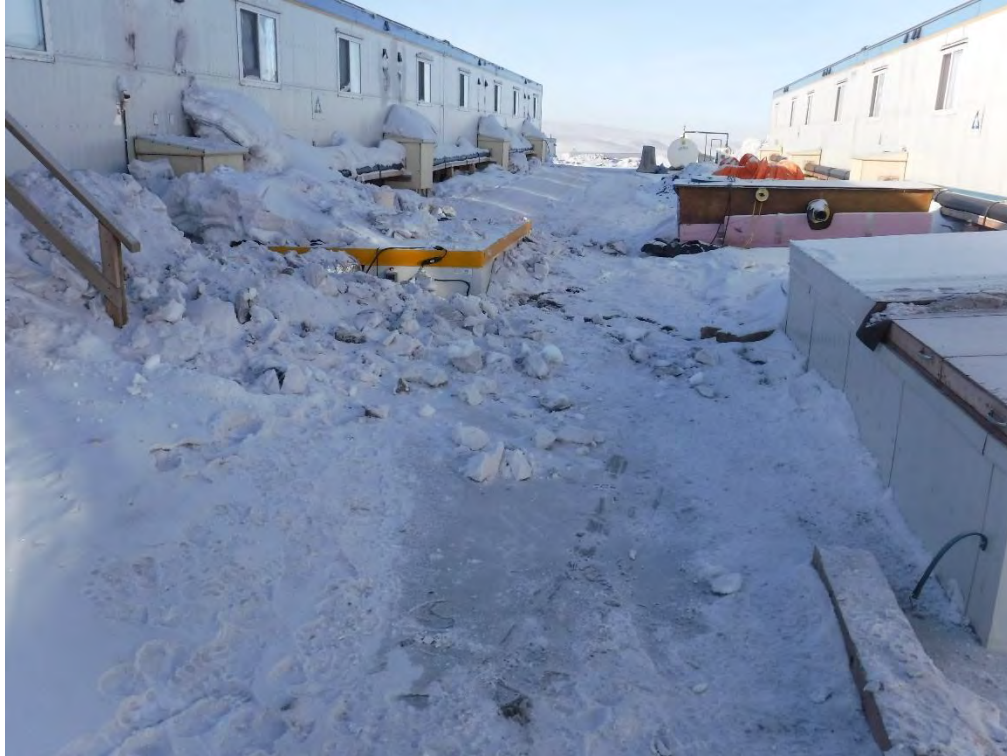
On February 22, 2018 at approximately 07:50 hrs, while conducting inspections of the MSC lift stations, a housing maintainer observed frozen water outside the AD wing north lift station. Upon initial investigation, it was determined that the lift station had overflowed. The lift station was immediately emptied by vacuum truck to prevent further overflow. Approximately 200L of sewage was released to the adjacent camp pad ground surface, impacting an approximate area of 15m². This lift station is emptied via vacuum truck and the increased influent between loads caused the lift station to overflow. This spill is >100 m to the nearest water course (which is currently frozen).

Photo 1: Lift station and camp pad following clean up

Baffinland has recommended more frequent checks and vacuum truck operating so that raw sewage levels stay below the emergency overflow levels of the holding tank.

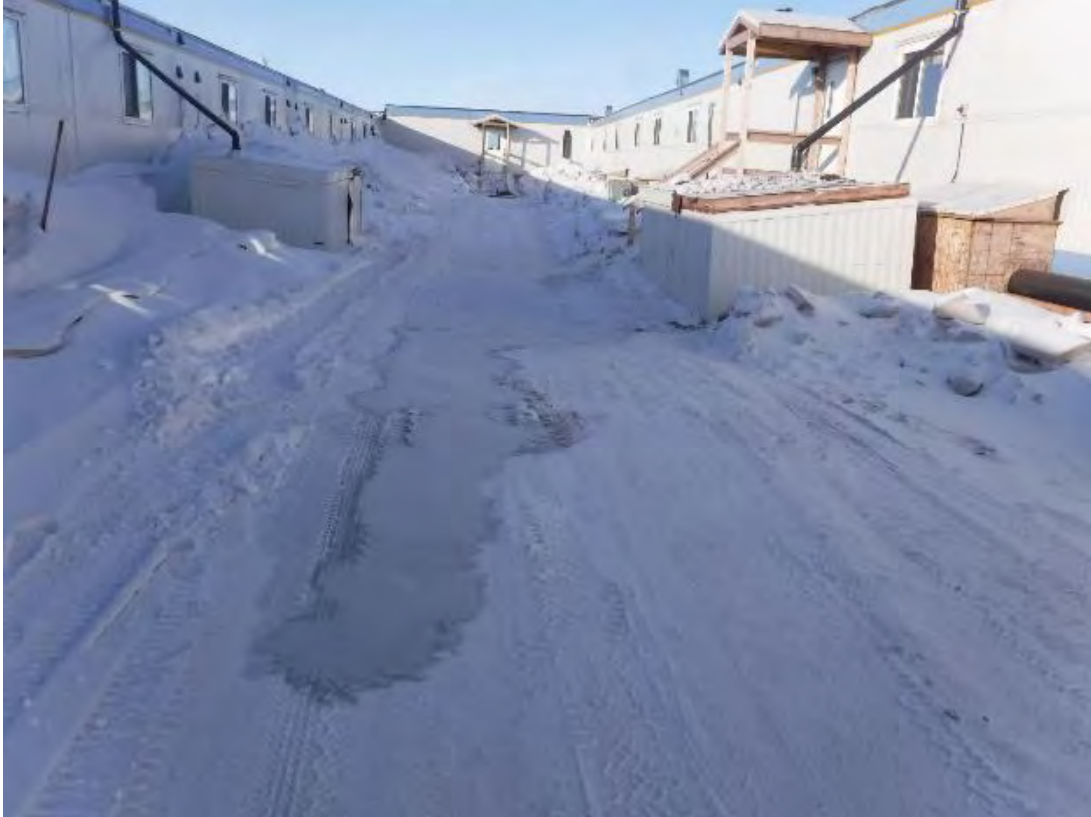
On February 23, 2018 at approximately 16:30 hrs, while conducting routine inspections of the MSC lift stations, a housing maintainer observed frozen water outside the AA wing south lift station. Upon initial investigation, it was determined that there was a blockage in the discharge line to the main lift station, resulting in the lift station overfilling. Approximately 150L of sewage was released to the adjacent camp pad ground surface, impacting an approximate area of 10m². This spill is located greater than 100 m to the nearest water course, which is currently frozen.

Photo 1. Spill location before clean-up

The lift station was immediately emptied by a vacuum truck to prevent further overflow. The contaminated snow was collected and deposited in an engineered lined containment facility. Additional insulation was added to the discharge line, and the heat trace has been tested to confirm it is in good working condition.

Investigate the cause of the frozen discharge line and develop a remedy to prevent the line from freezing again. Continue daily lift station inspections of the system.

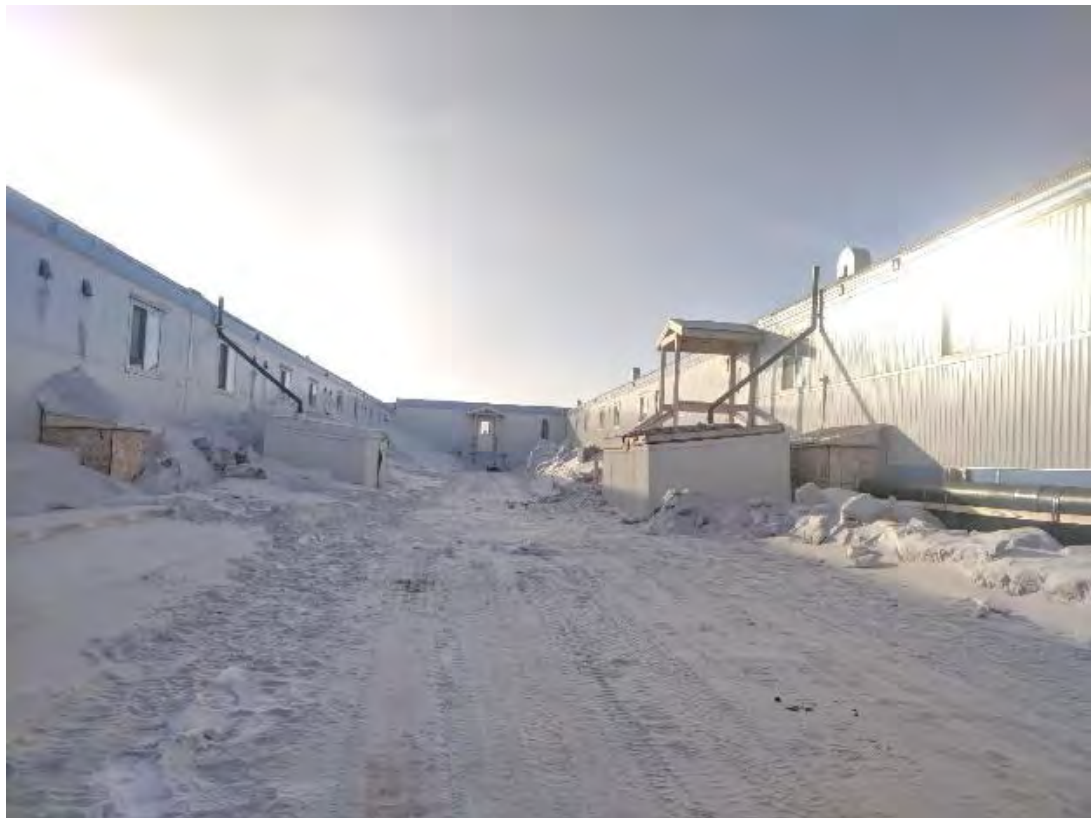
Photo 2. Lift station and camp pad following clean-up

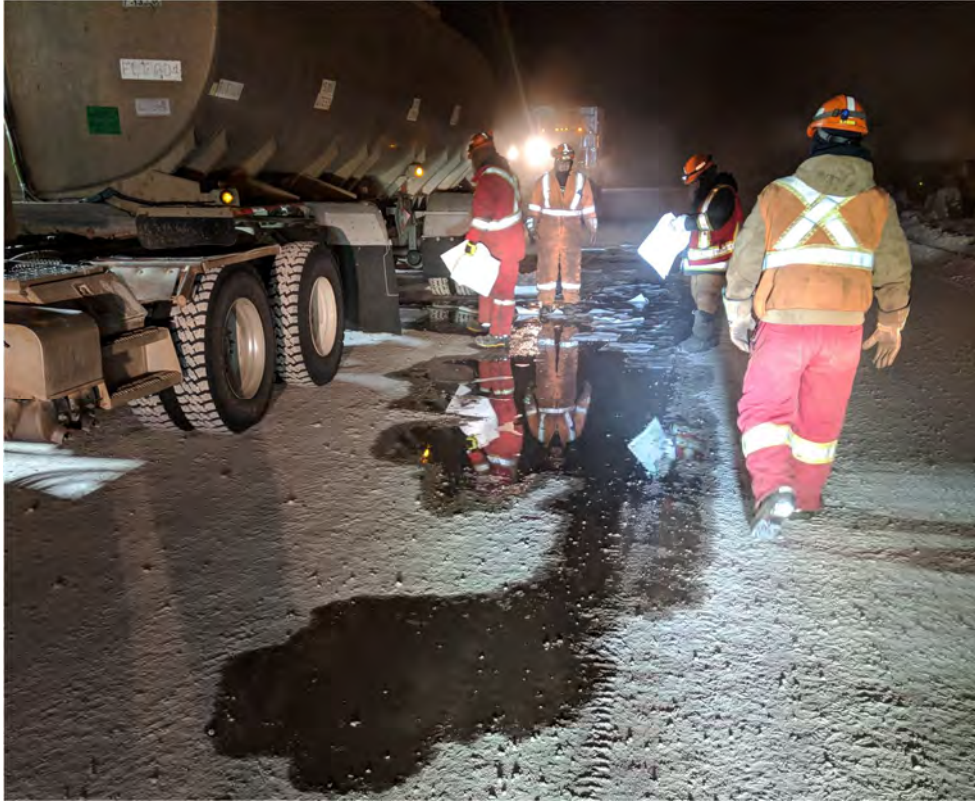
Photo 1. Spill location before clean-up

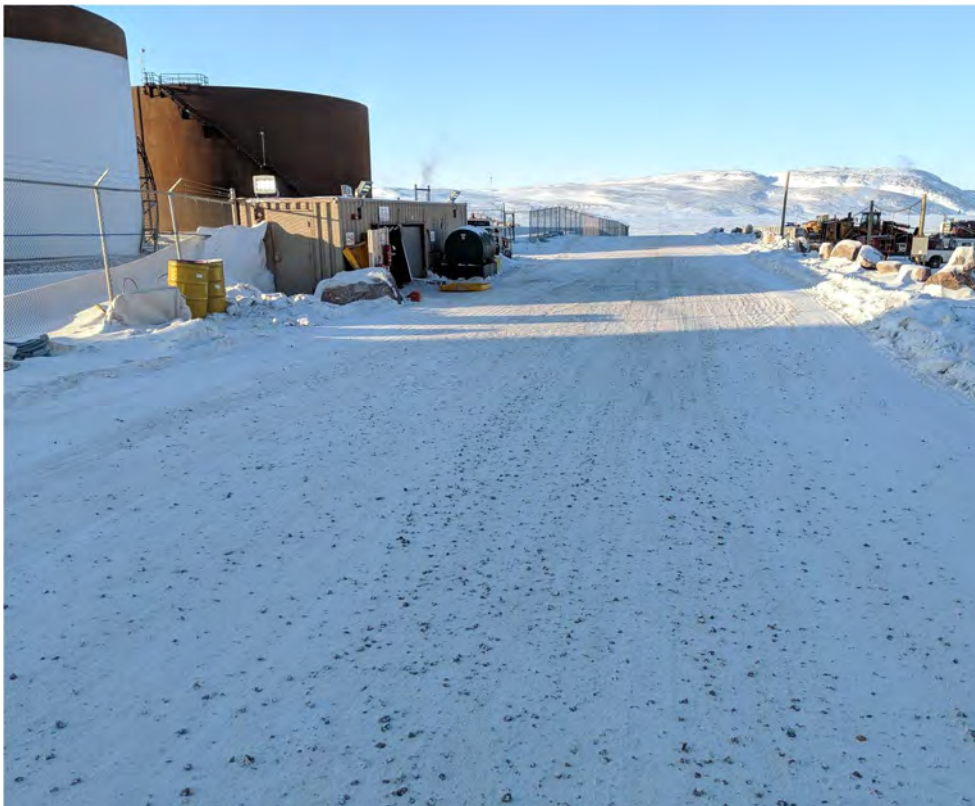
Photo 2. Spill location following clean-up

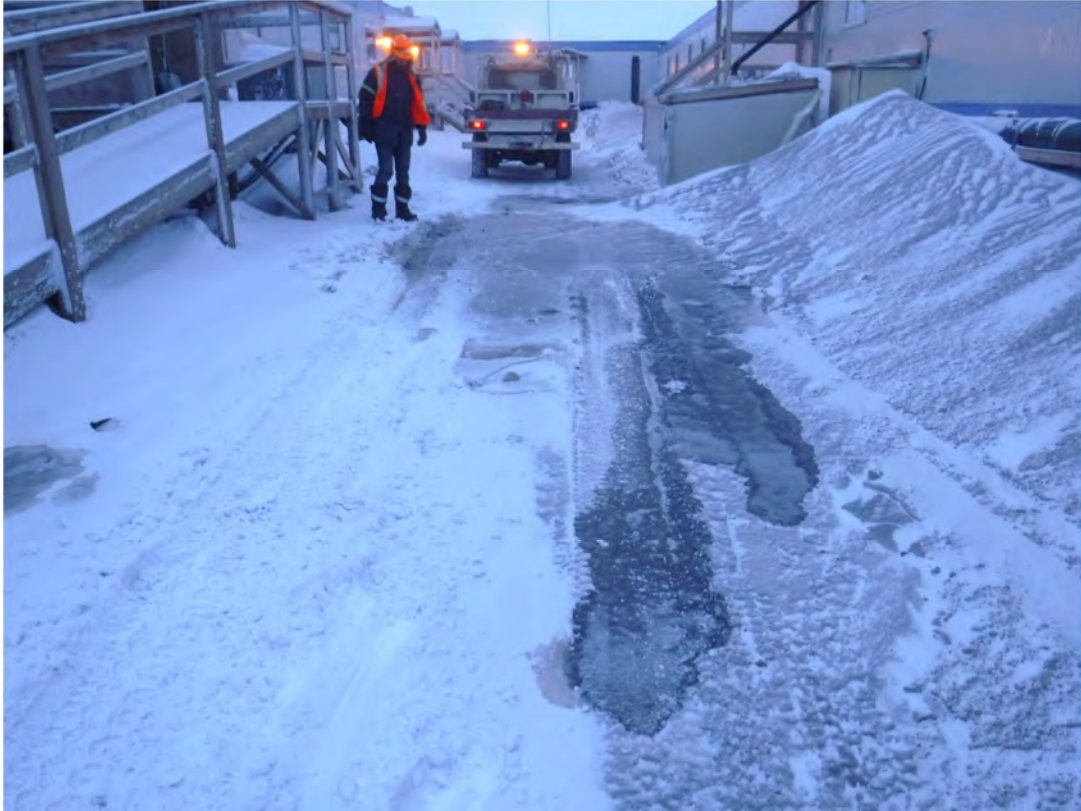
On February 27, 2018 at approximately 06:40 hrs, while conducting inspections of the MSC lift stations, a housing maintainer observed frozen water outside the AE wing south lift station. Upon initial investigation, it was determined that the lift station had overflowed. The lift station was immediately emptied by vacuum truck to prevent further overflow. Approximately 200L of sewage was released to the adjacent camp pad ground surface, impacting an approximate area of 30m². A frost fighter was brought in to heat and thaw the ice blockage in the discharge line and have the system brought back into service. This spill is >100 m to the nearest water course (which is currently frozen).

Photo 1. Spill location before clean-up

Investigate potential causes of the frozen discharge line and develop a remedy to prevent the line from freezing again. Continue daily lift station inspections of the system.

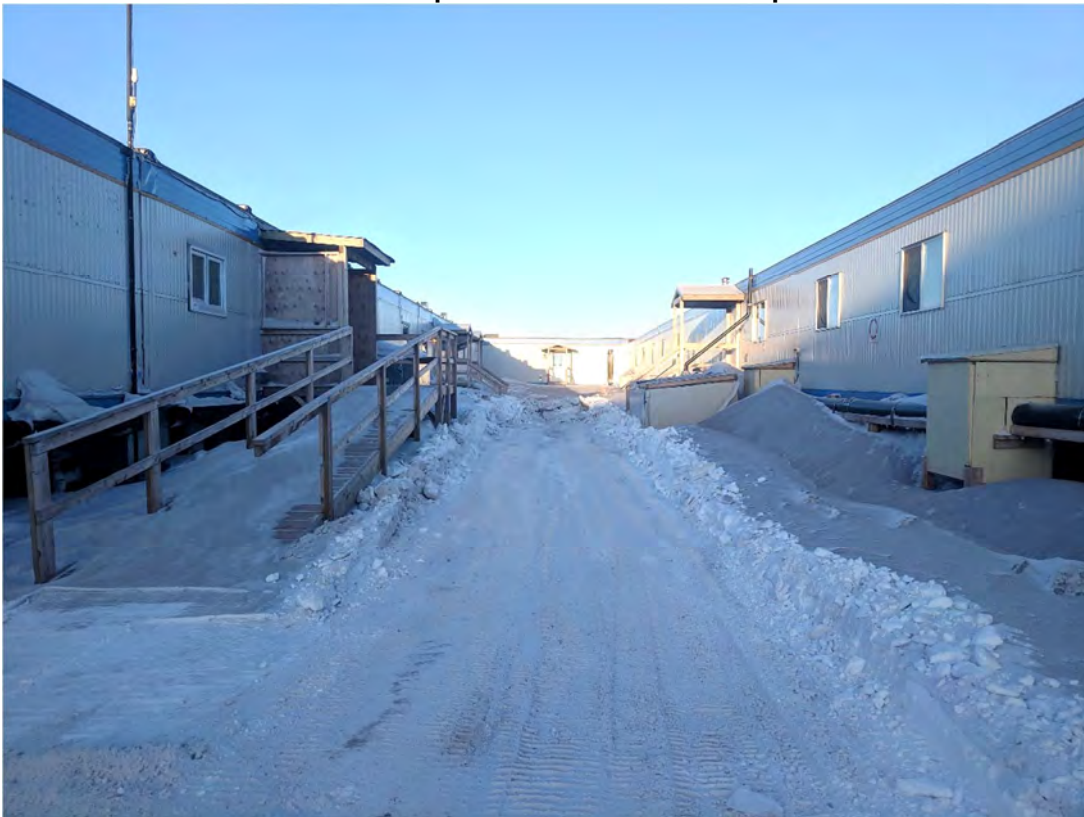
Photo 2. Lift station and camp pad following clean-up

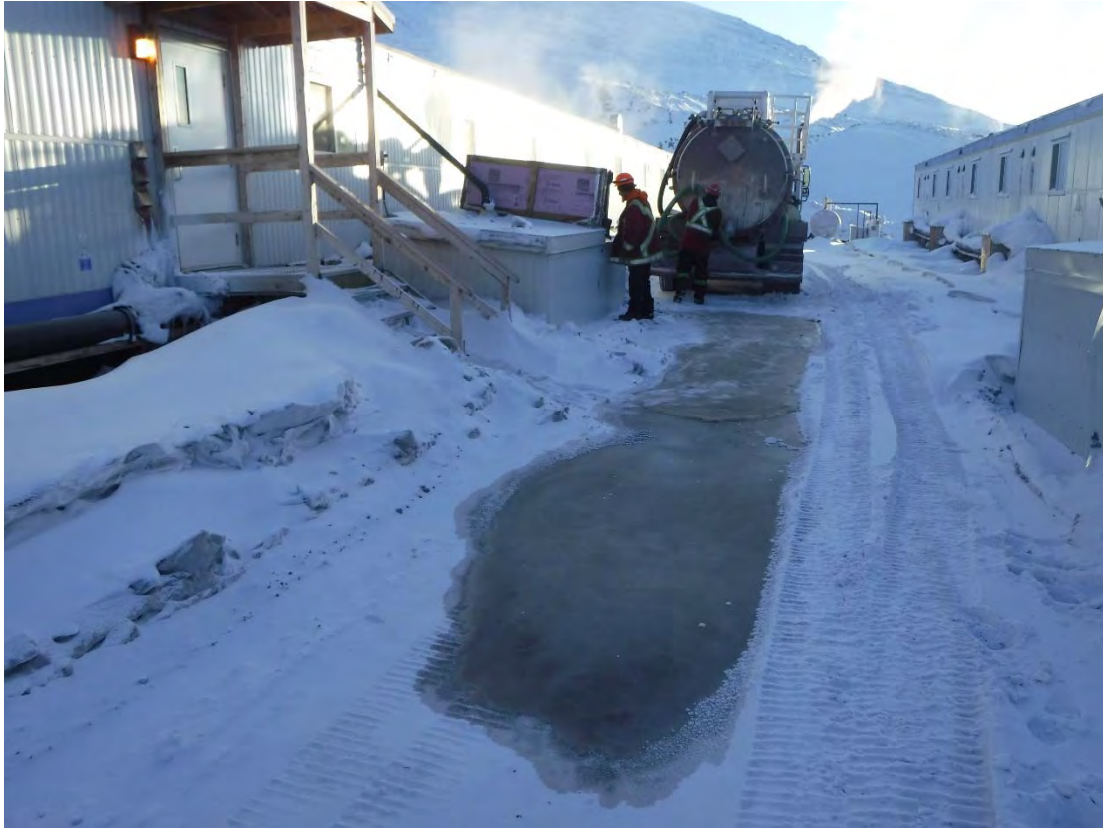
At 10:30 on March 16, 2018, while performing inspections of the Mine Site Complex (MSC) lift Stations, a housing maintainer observed water adjacent to the South AA lift Station. Upon initial investigation, it was identified that the lift station pumps had failed to activate due to the tank floats malfunctioning and the discharge line had plugged due to extreme winter conditions. The lift station was manually pumped down via vacuum truck to prevent further overflow and supervision notified. Approximately 200L of sewage impacted the MSC pad adjacent to the lift station, migrating over an area of approx. 10 m². The spill is >100 m from the nearest water body which is currently frozen.

Photo 1. Spill location before clean-up

The lift station was immediately emptied by a vacuum truck to prevent further overflow. The contaminated snow was collected and deposited in an engineered lined containment facility. Additional insulation was added to the discharge line, and the heat trace has been tested to confirm it is in good working condition. Further repairs were performed and are ongoing to the lift station tank after the tank integrity was called into question.

Repairs to the lift station tank were recommended and will be monitored along with discharge line repairs. Action further repairs, including tank replacement as required. Continue daily lift station inspections of the system.
