Summary of 2018 Reportable Spills

TABLE 6.1
BAFFINLAND IRON MINES CORPORATION
MARY RIVER PROJECT
2018 QIA AND NWB ANNUAL REPORT FOR OPERATIONS
LIST OF REPORTED SPILLS AND UNAUTHORIZED DISCHARGES – 2018

APPENDIX E.8.4
INITIAL AND FOLLOW-UP SPILL REPORTS
(PART 1 OF 4)

Re: Follow-up to Spill #18-016
Mary River Project - Water Licence No. 2AM-MRY1325

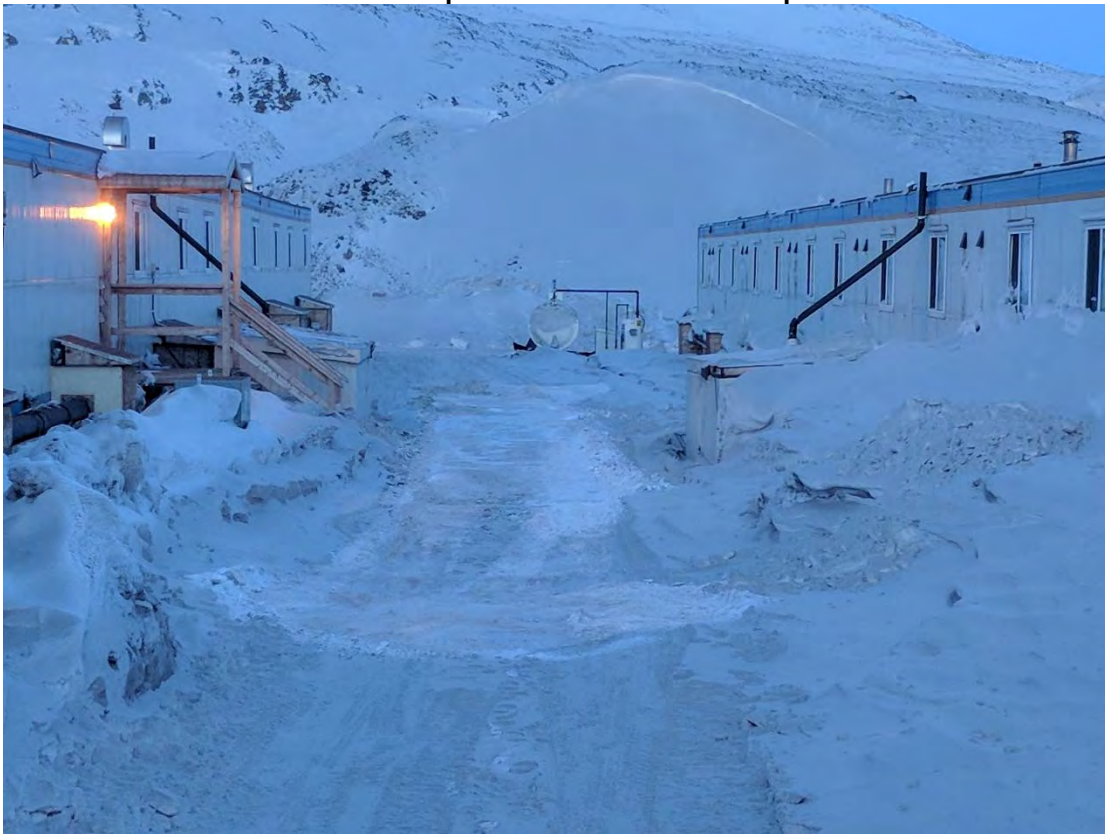
Photo 2. Lift station and camp pad following clean-up

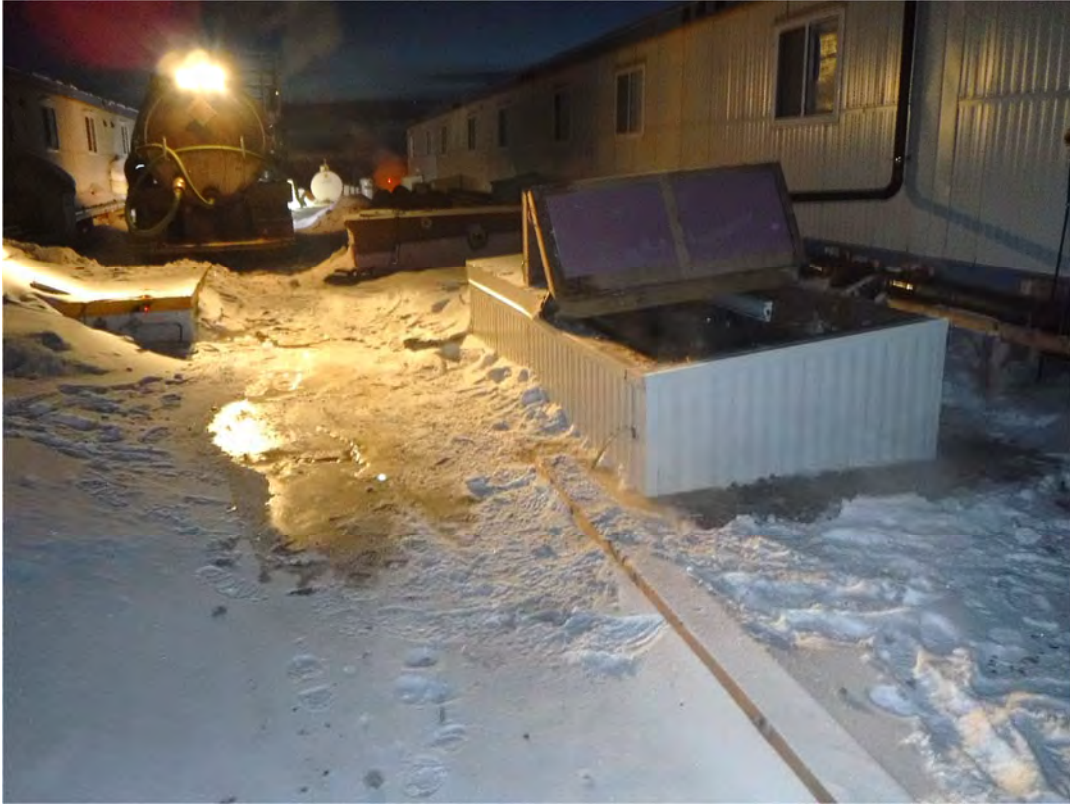
Photo 1. Spill location before clean-up

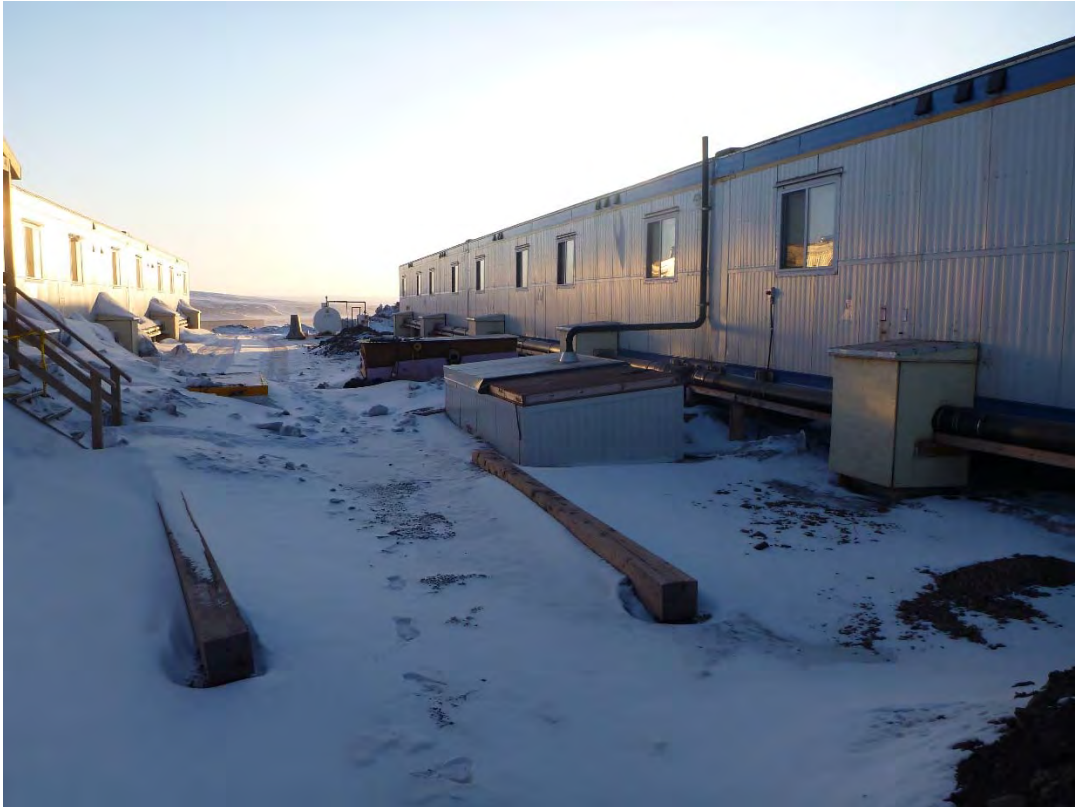
Photo 2. Lift station and camp pad following float readjustment

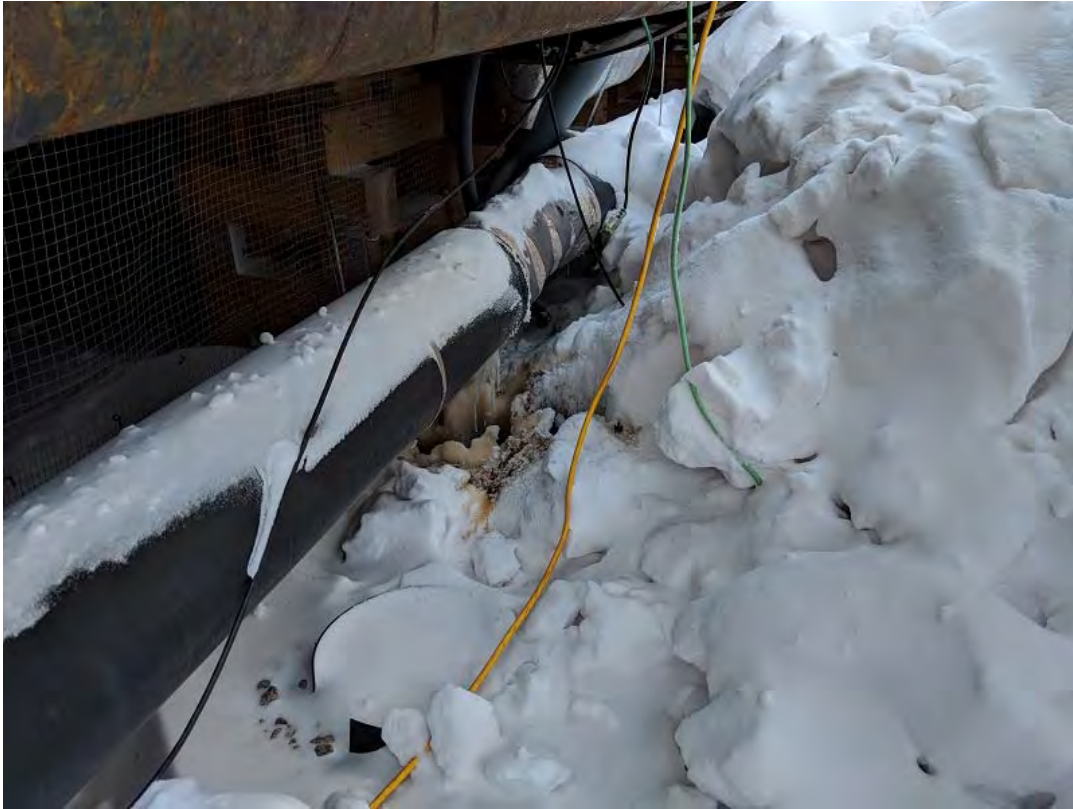
On March 19, 2018 at approximately 09:00 hrs, during routine sewer line and lift station inspections a housing maintainer noticed sewage leaking from the gravity drain line originating at the Port Site Complex men's dry. It was determined that a Fernco coupling had separated on the gravity drain line due to expansion/contraction of the piping system from extreme temperature change. Approximately 300L of raw sewage was released to the adjacent camp pad ground surface, impacting an approximate area of 15m².

Photo 1. Spill location before clean-up

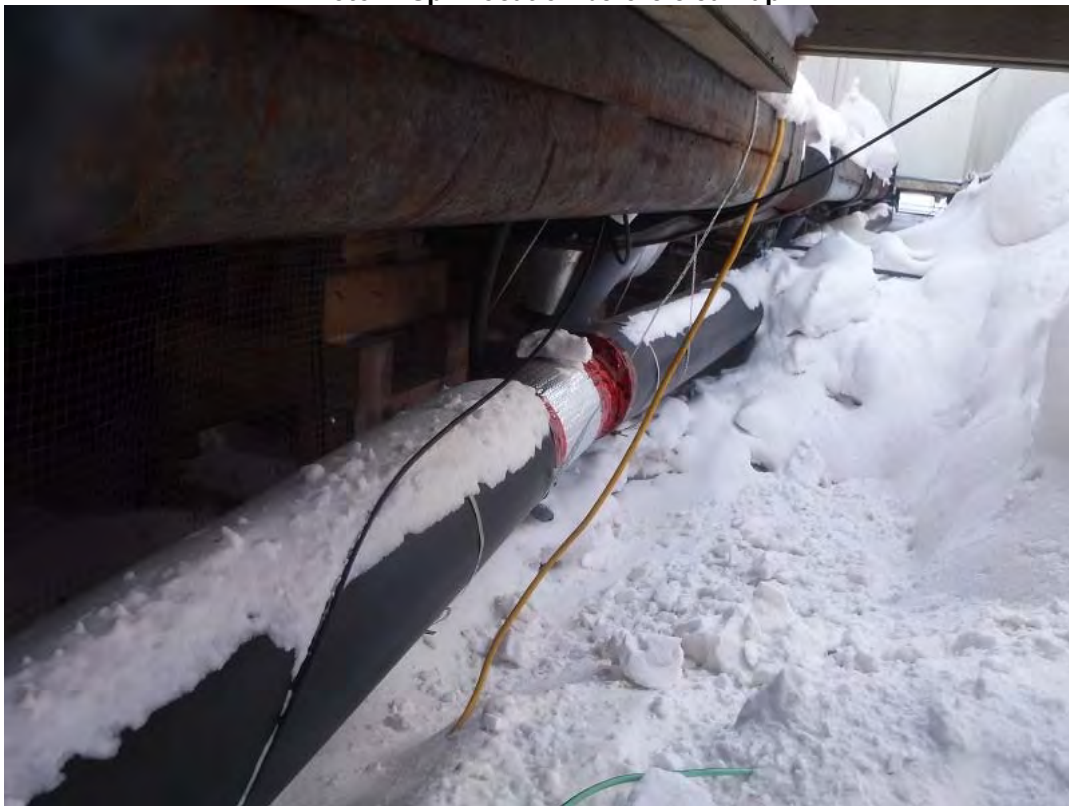
Photo 2. Gravity Drain Line after repairs completed

The repair to the coupler is currently functioning and the gravity line is in operation and inspected regularly.

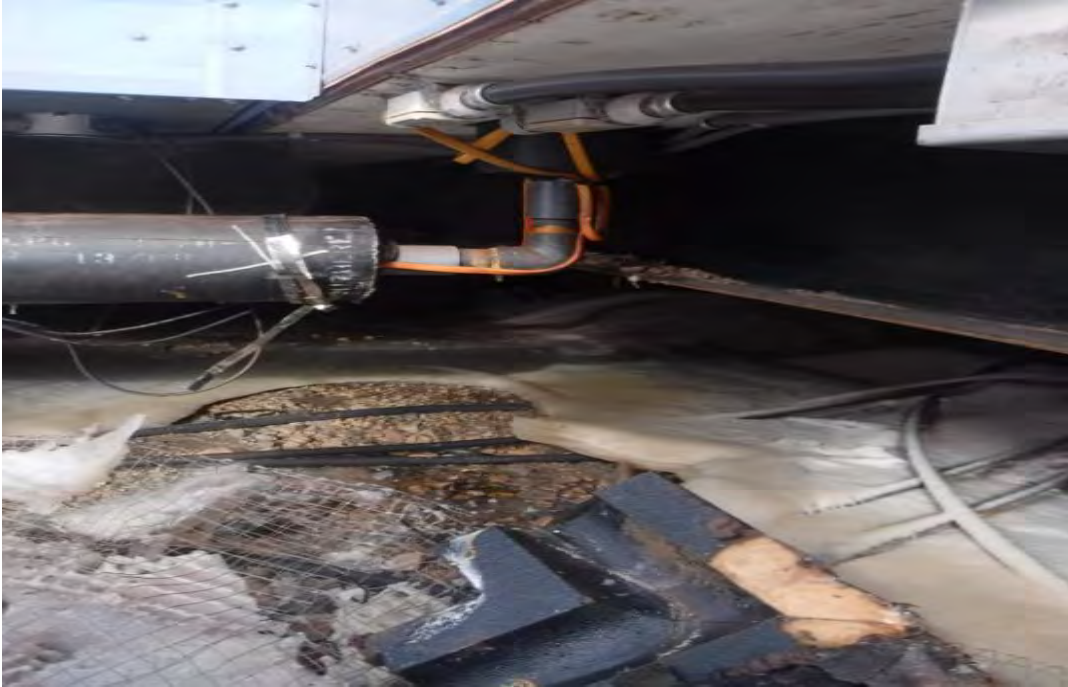
Photo 1. Discharge line before elbow repair

The lift station was immediately shut off to prevent further discharge and Supervision was contacted. The lift station was pumped down by vacuum truck and the elbow was repaired.

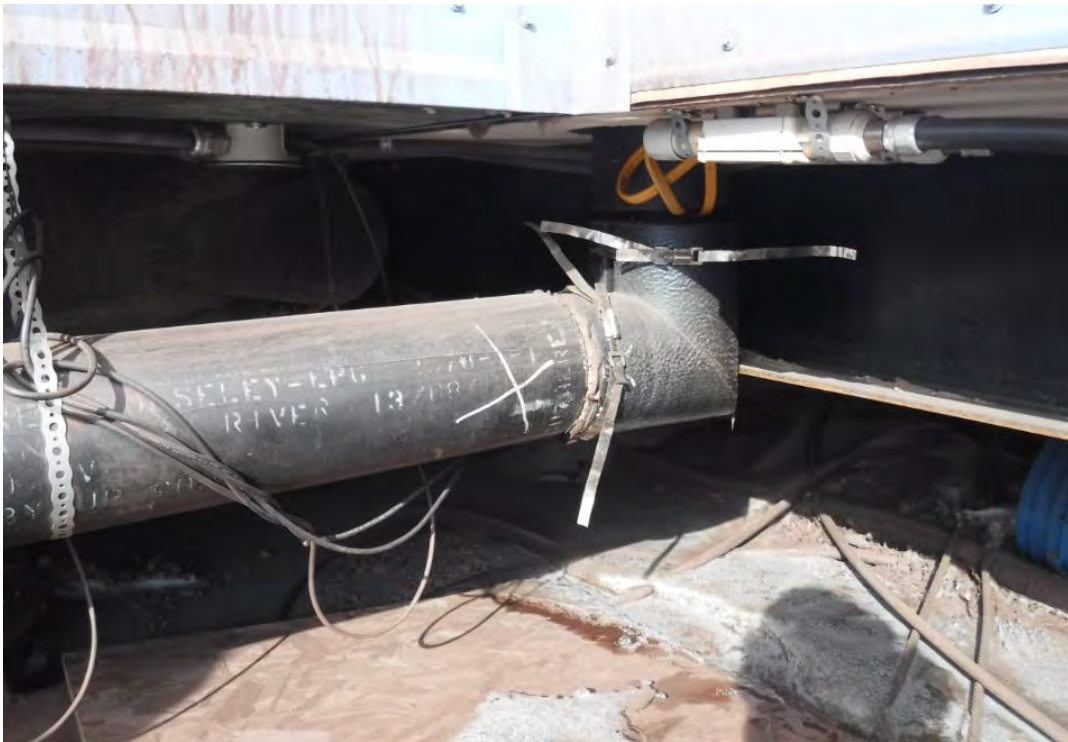
Photo 2. Discharge line following elbow repair

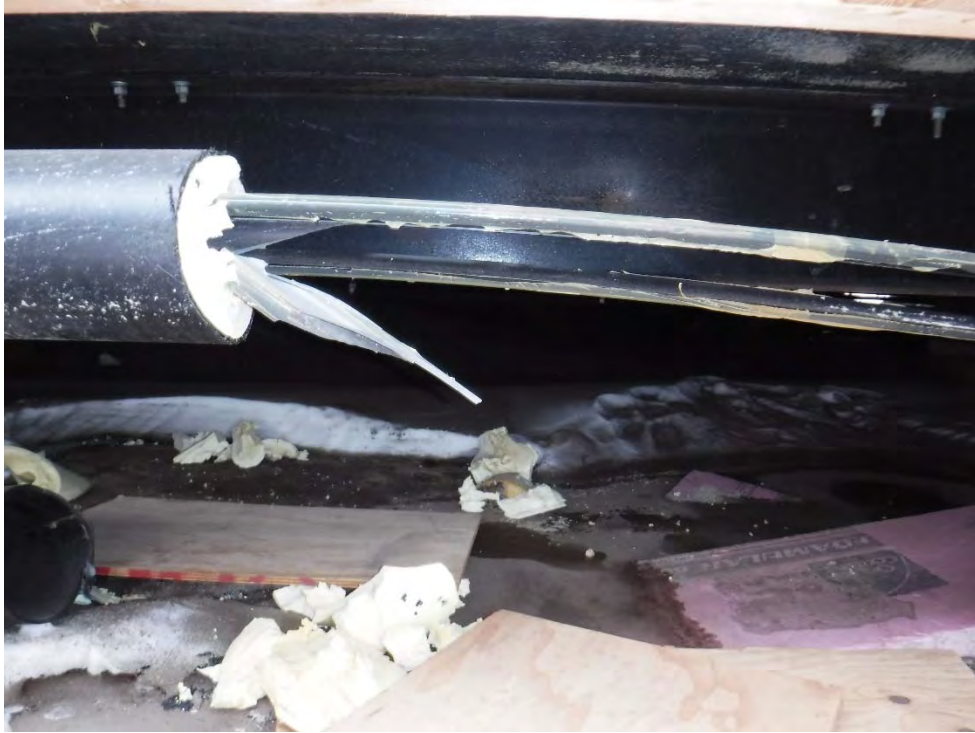
Photo 1. Discharge line in need of repair for approx. 20 feet

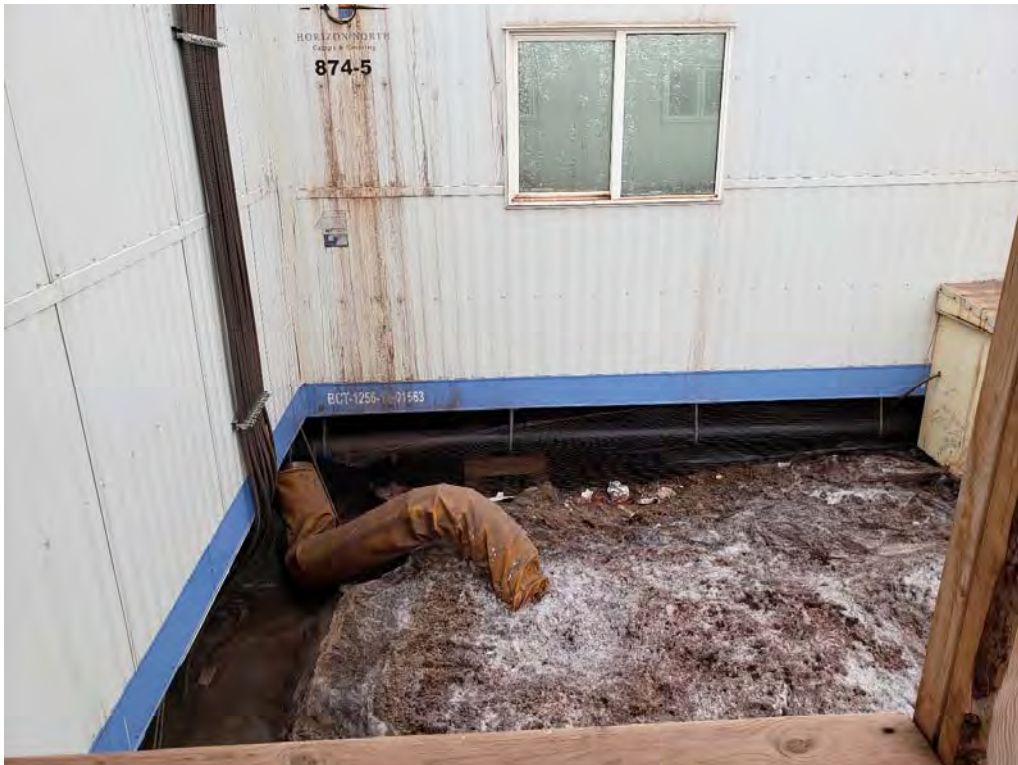
Photo 2. Discharge pipe problematic location

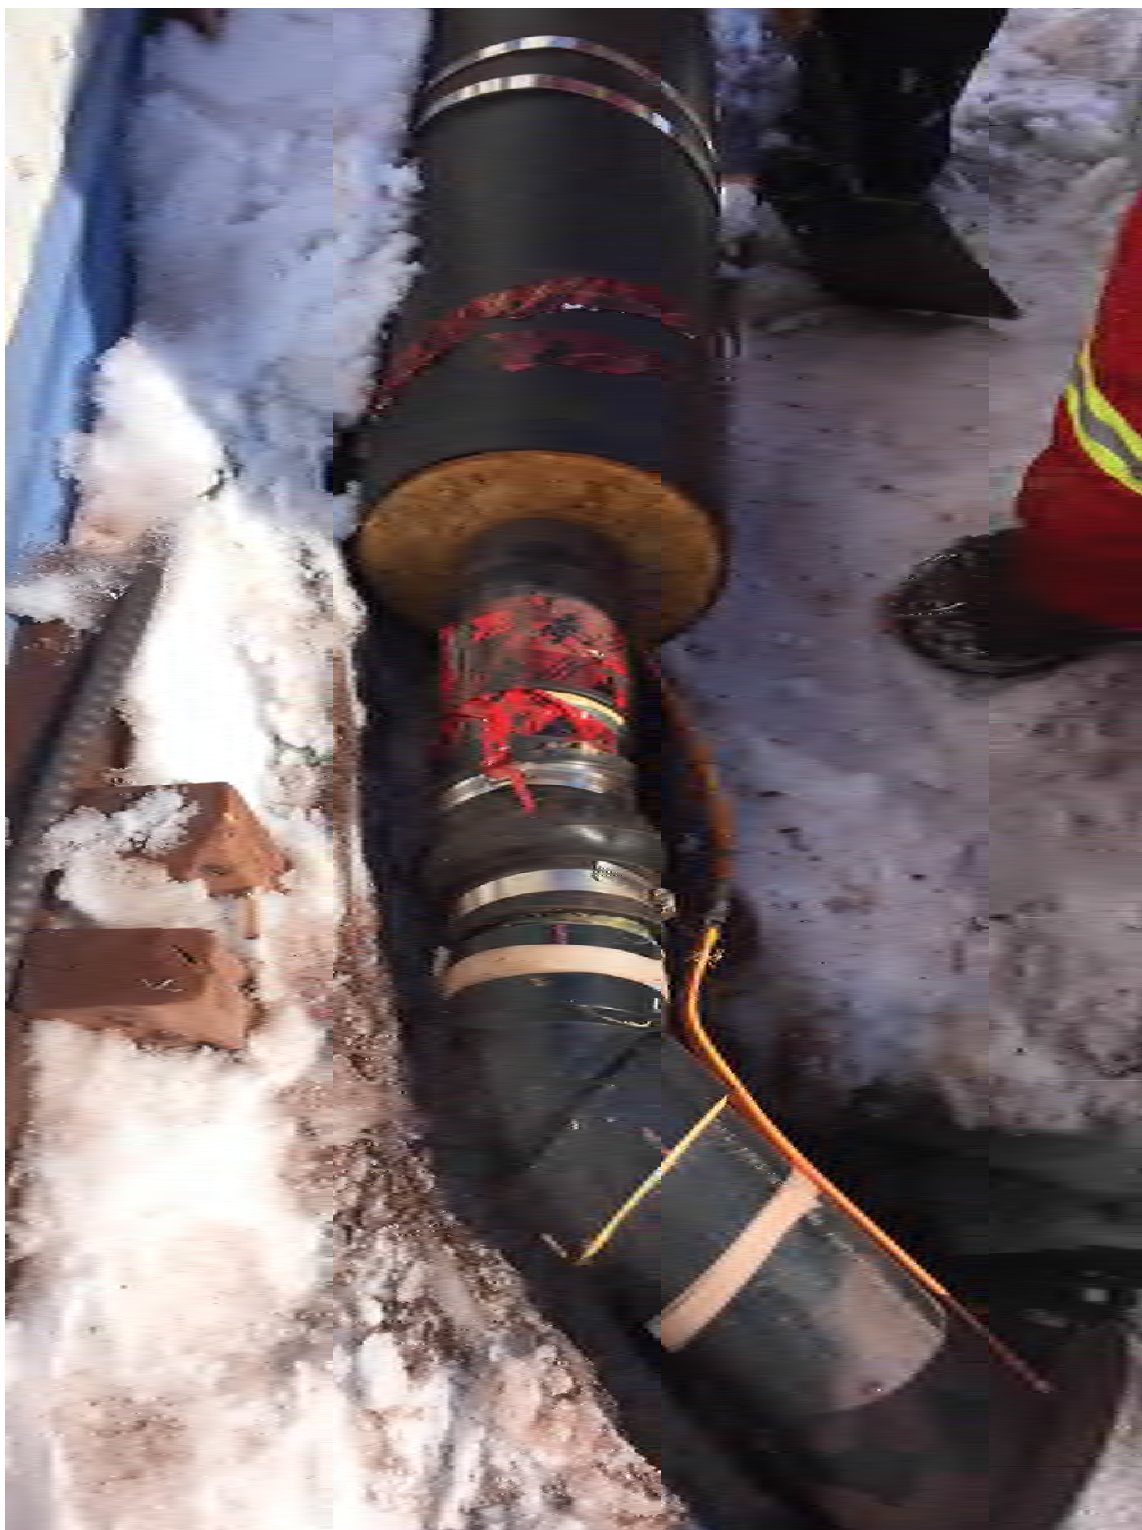
Photo 1: Gravity drain line following repair of the separated coupling.

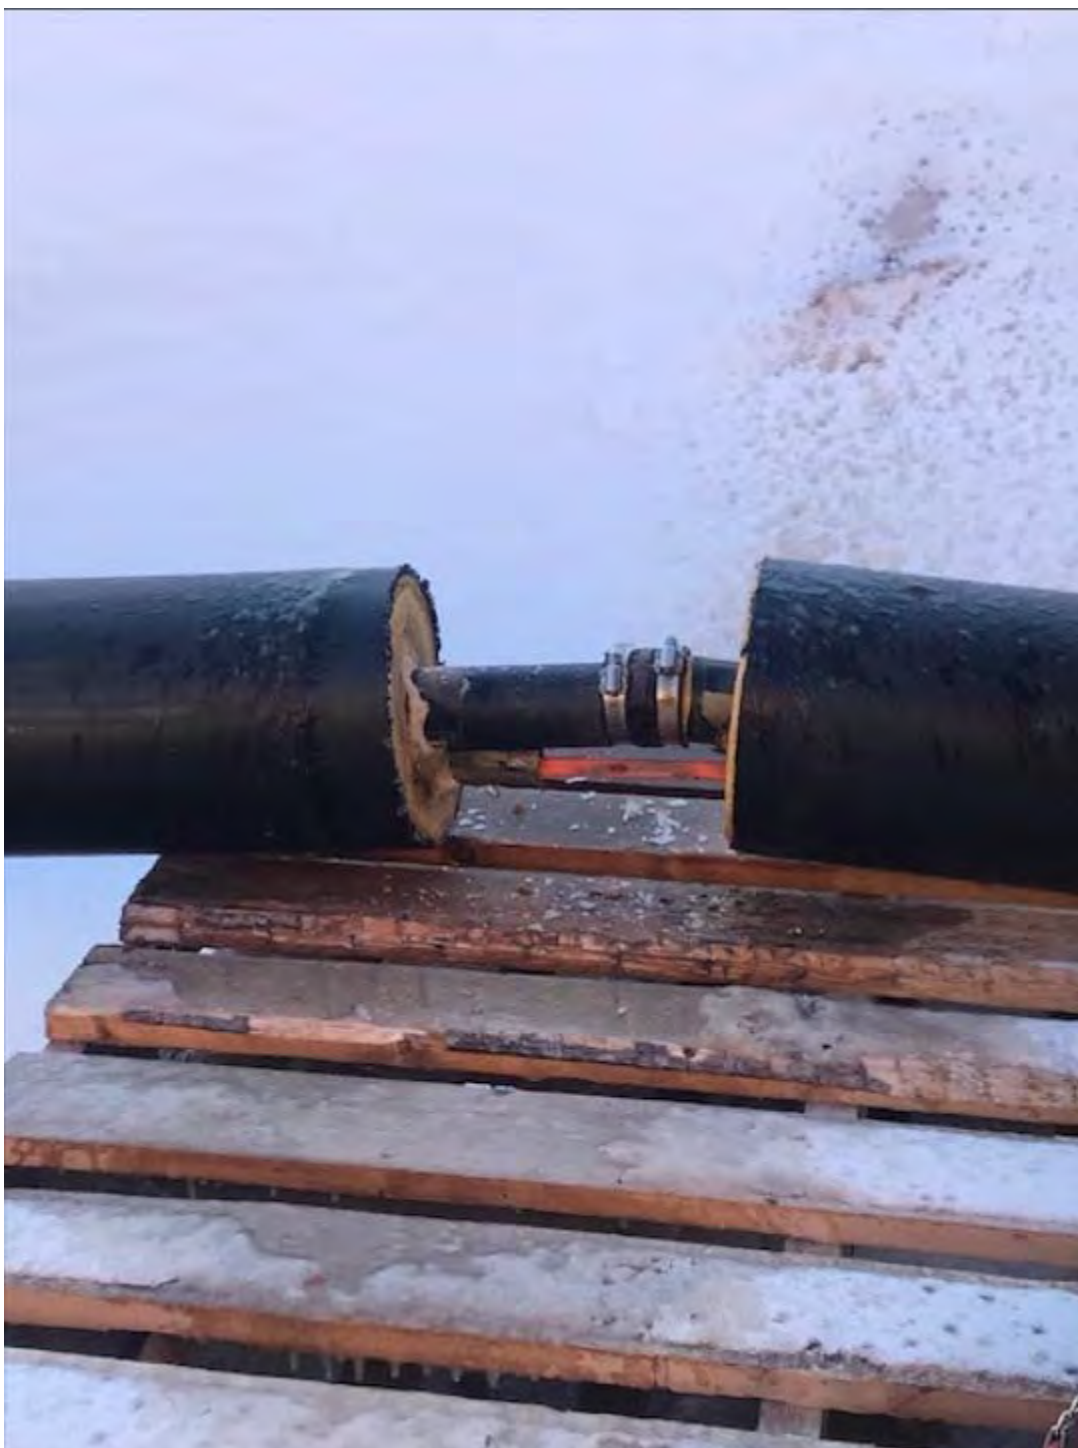
Photo 1. Spill location before repairs are made

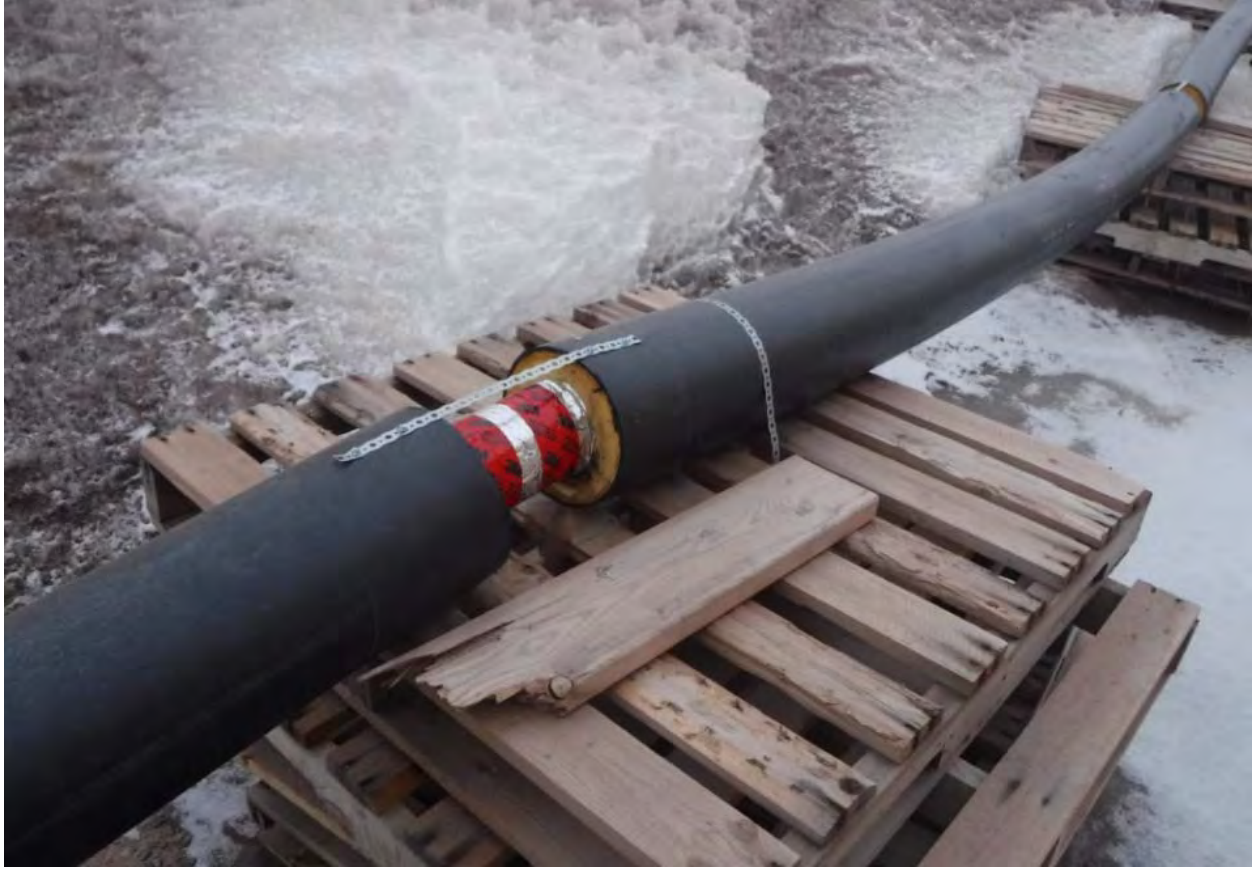
Photo 2. Lift station discharge line after repairs were completed.

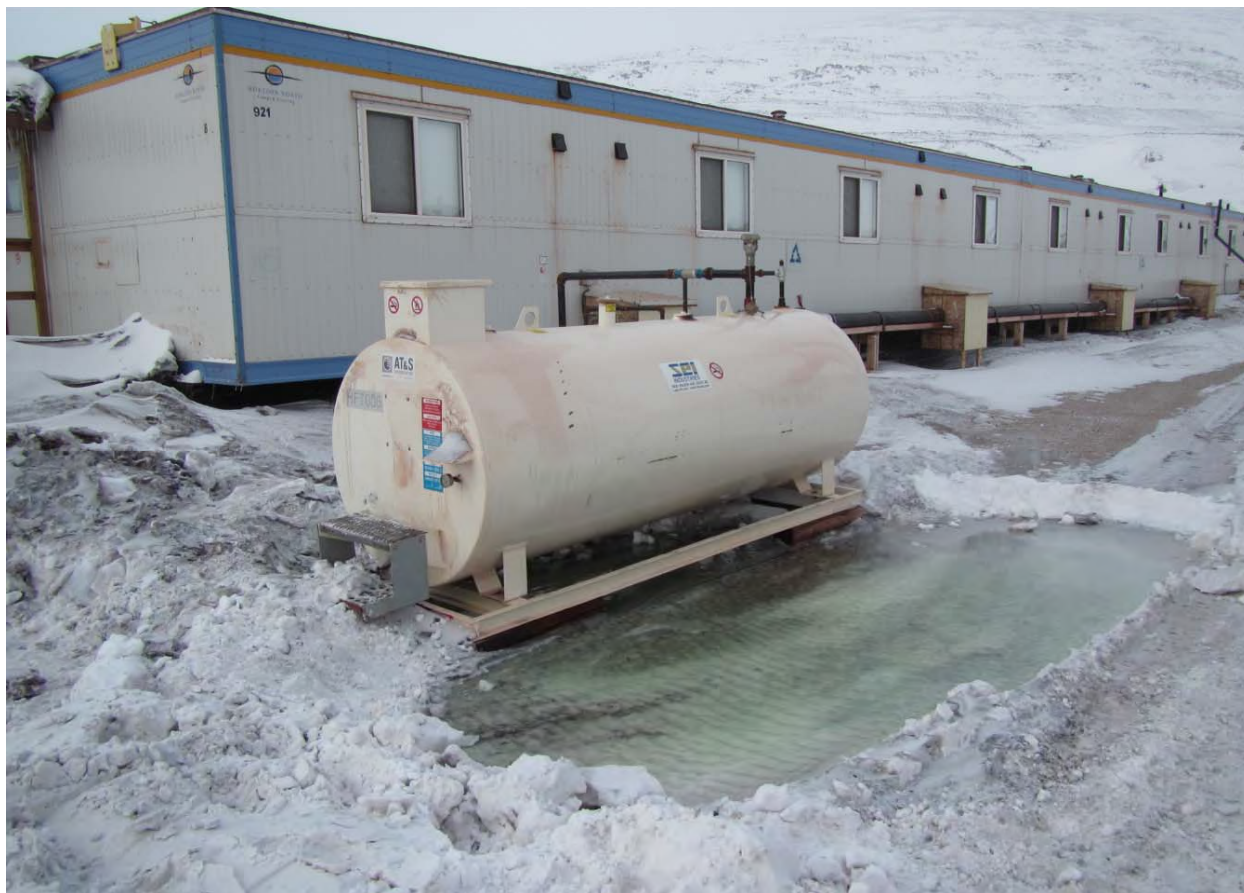
Photo 1. Spill location before clean-up

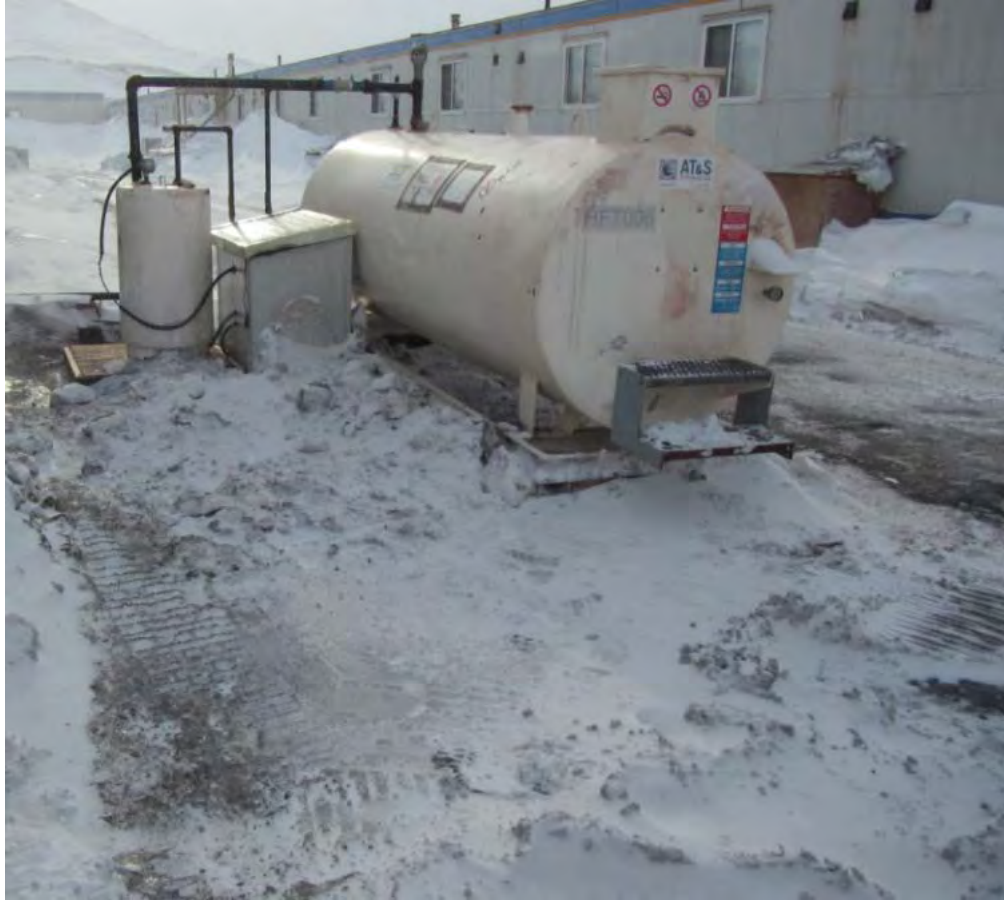
Photo 2. Spill location after cleanup

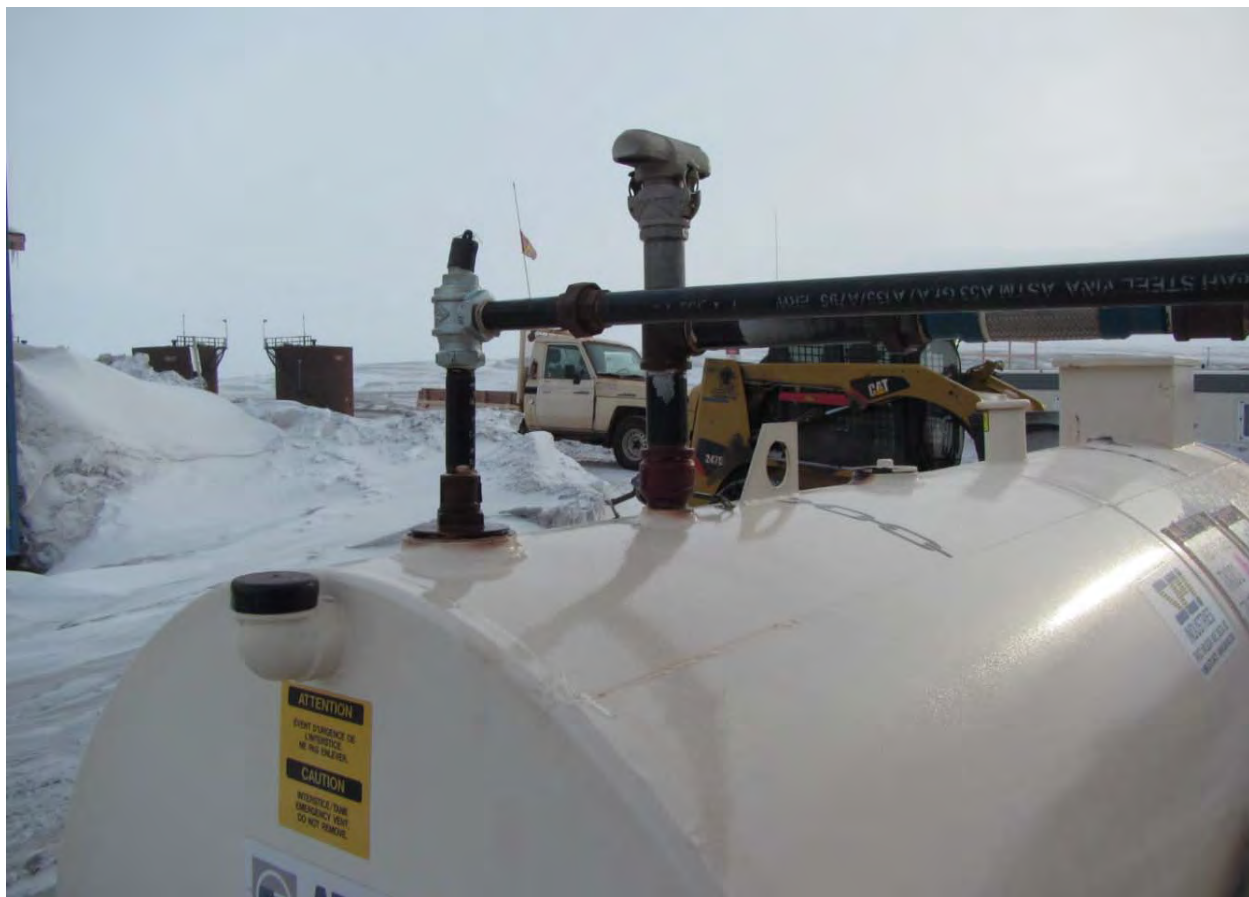
Photo 3. Vent pipe and whistle before retrofit

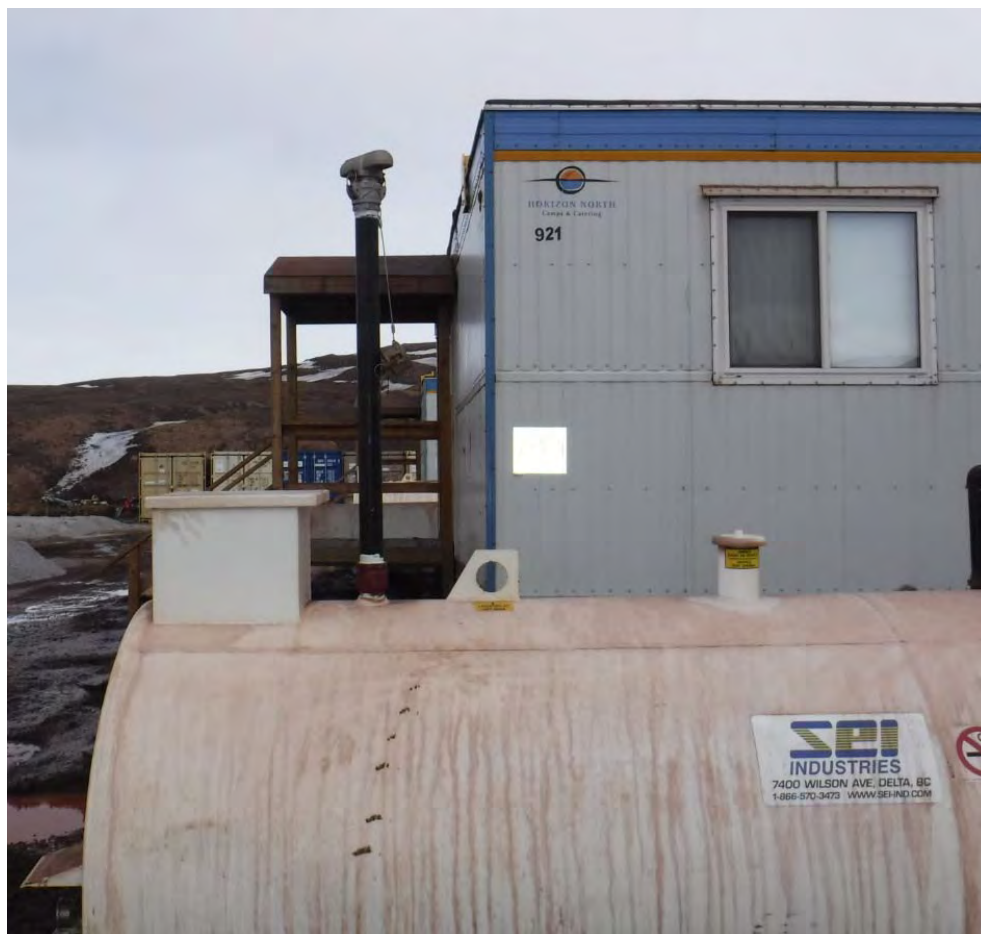
Photo 4. Retrofit implemented on main tank

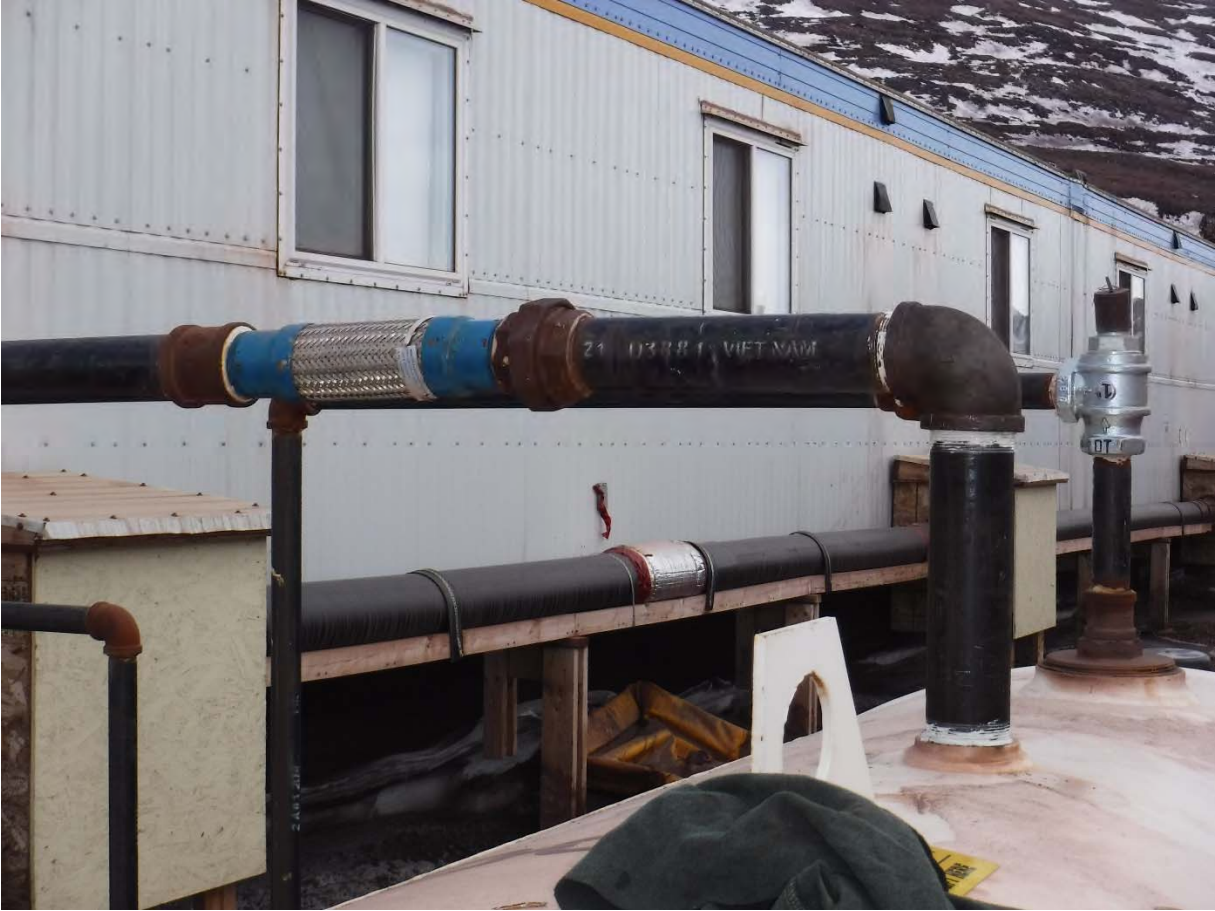
Photo 5. Return line without audible whistle fitting on main tank
