NT-NU SPILL REPORT

Re: Follow-up to Spill #18-148
Mary River Project - Water Licence No. 2AM-MRY1325

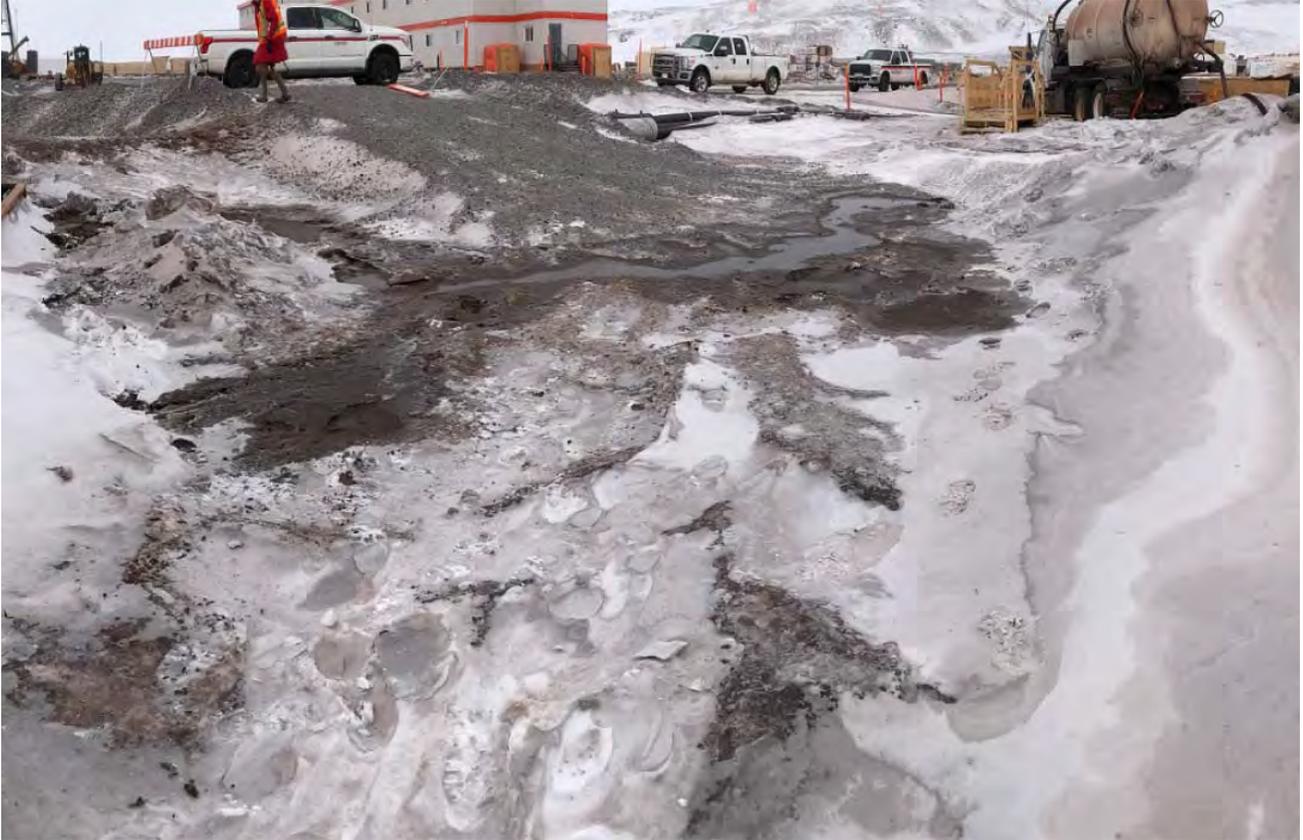
On April 30 at 11:00 Hrs, a vac truck operator discovered water around the outside of the wasting door at the new Waste Water Treatment Plant (WWTP). Upon investigation, it was discovered that the wasting pump had overfilled the tank, overflowing through the door onto the surrounding camp pad. Approximately 1.3 m³ of raw sewage was released and confined to the adjacent pad. Due to a communication breakdown, one WWTP operator had manually overridden the system and failed to communicate the change to his colleague operator. This caused the wasting pumps to operate permanently, not on a timed cycle, resulting in the overflow.

Photo 1. Overflow spill on ground surrounding the WWTP

The power to the plant was shut off and the WWTP operators were called. A vacuum truck was utilised to recover and remove the raw sewage in the plant. The contaminated snow around the plant was excavated and placed in the PWSP for storage and potential future treatment during the open water season.

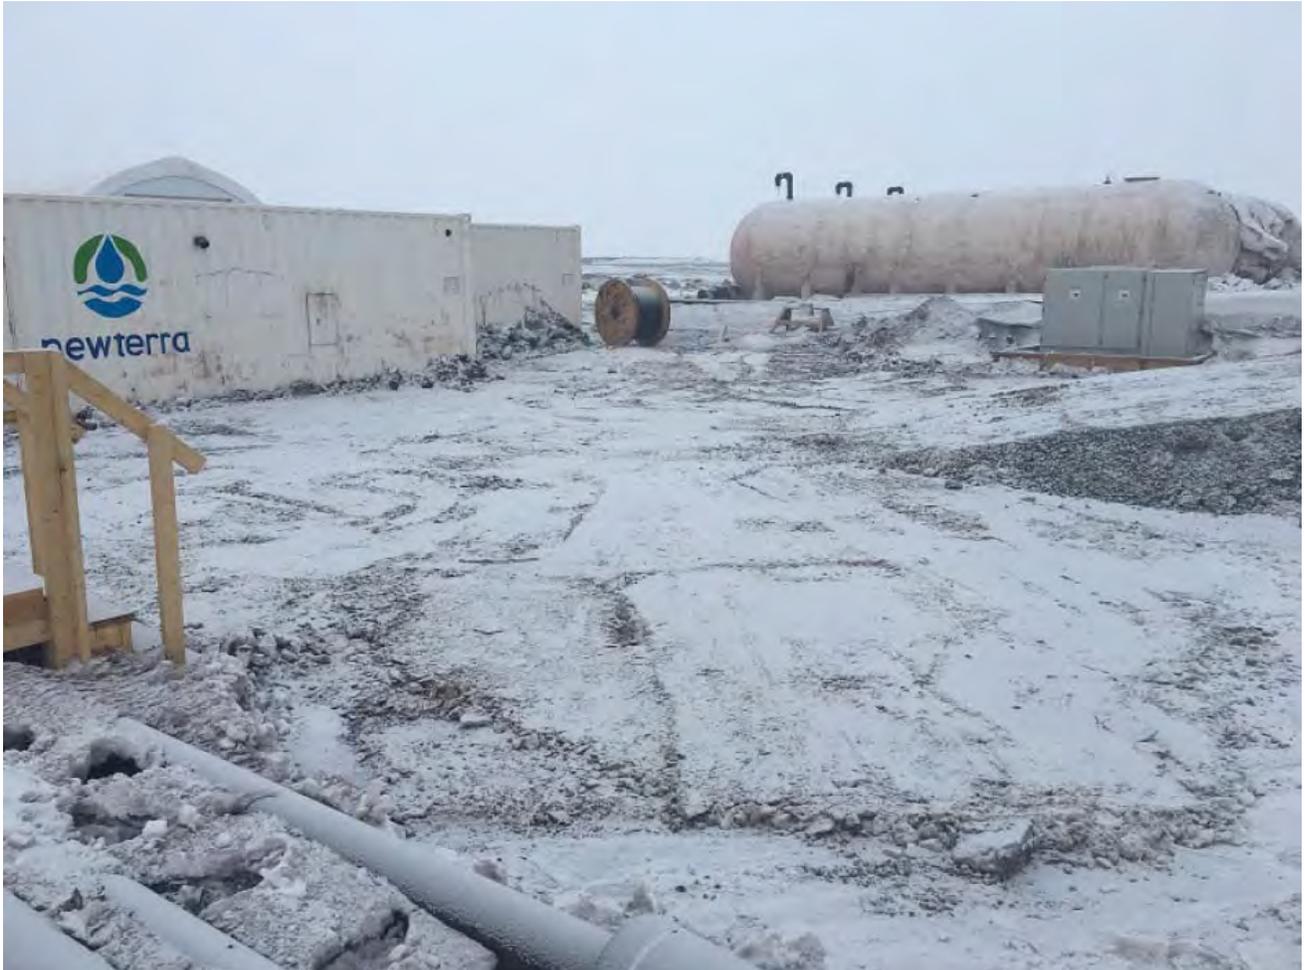
Photo 2. Surrounding the WWTP pad after site clean up.

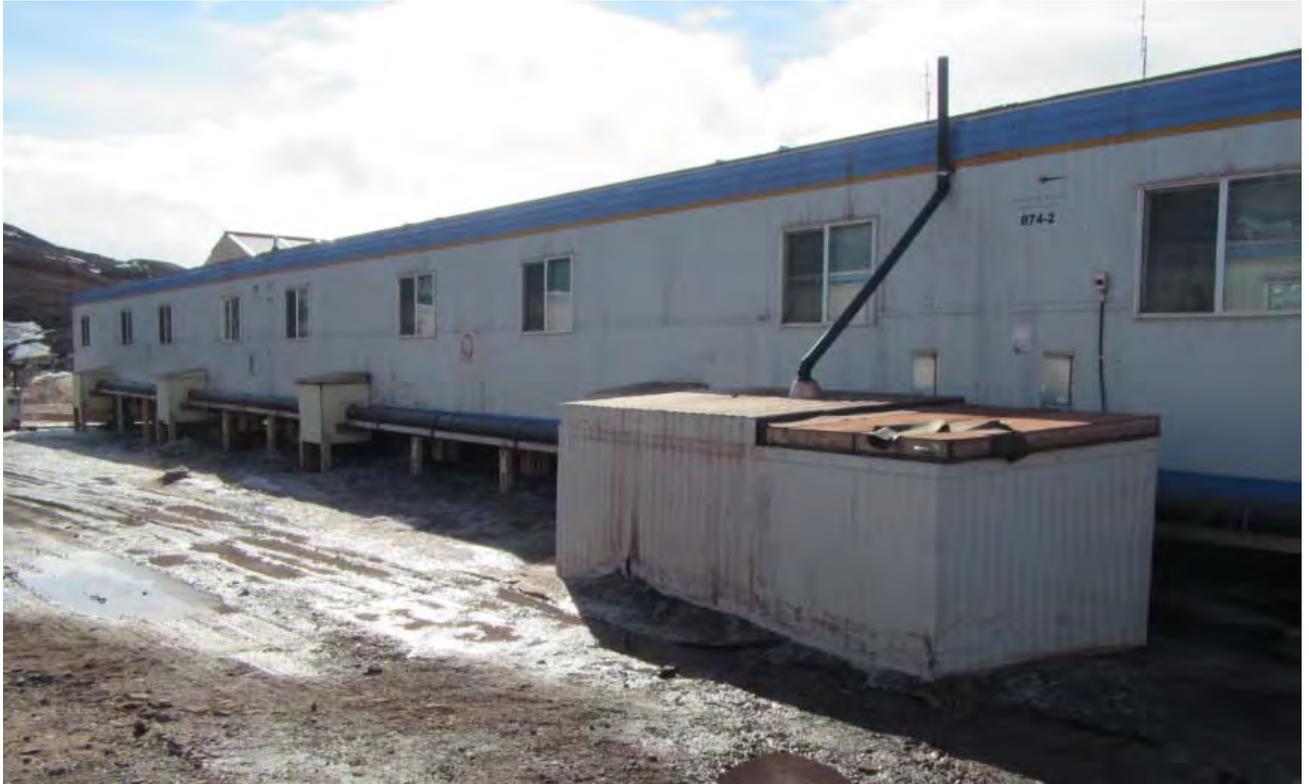
On May 4th, 2018, 20:00 Hrs, an Environment Department employee observed discoloured water near Lift Station 5 at AE Wing North. It was determined to be sewage upon inspection. Housing Maintenance and Surface Works Supervision was notified immediately. The source of the spill was an overflow of lift station 5. The lift station was being discharged through a regular vacuum truck schedule however due to an error in the implementation of this schedule the overflow occurred. Communications and associated vacuum truck scheduling procedures are being revised to prevent an overflow reoccurrence. Approximately 250 Litres impacted the adjacent MSC pad to the lift station migrating over an area of approx. 15m². The spill is >100 m from the nearest water body which is currently frozen.

Photo 1. AE Lift Station after clean up

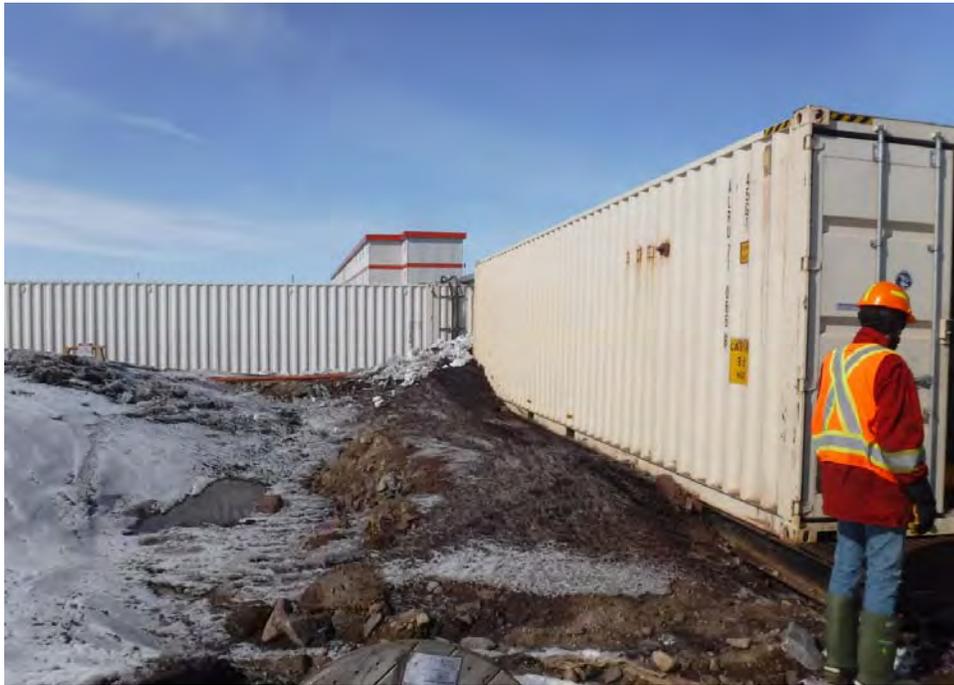
On May 5, 2018 at 11:00 Hrs a vac truck operator was approaching the new wastewater treatment plant (WWTP) at the Mine Site and observed liquid leaking from the effluent tank door. Upon investigation, it was determined that the effluent tank had overflowed and approximately 0.5m³ of treated effluent was released to the WWTP pad, impacting an area of approximately 10m². Communications and associated vacuum truck scheduling procedures are being revised to prevent an overflow reoccurrence. The location is >100m to the nearest water course which was frozen.

Photo 1. WWTP Before clean up

It was recommended that a Standard Operating Procedure (SOP) be implemented to define operational check and balances of the plant while ensuring all communication and responsibility requirements of an operating WWTP and discharge system are clearly outlined. An audio alarm system was recommended for installation to warn of high tank levels

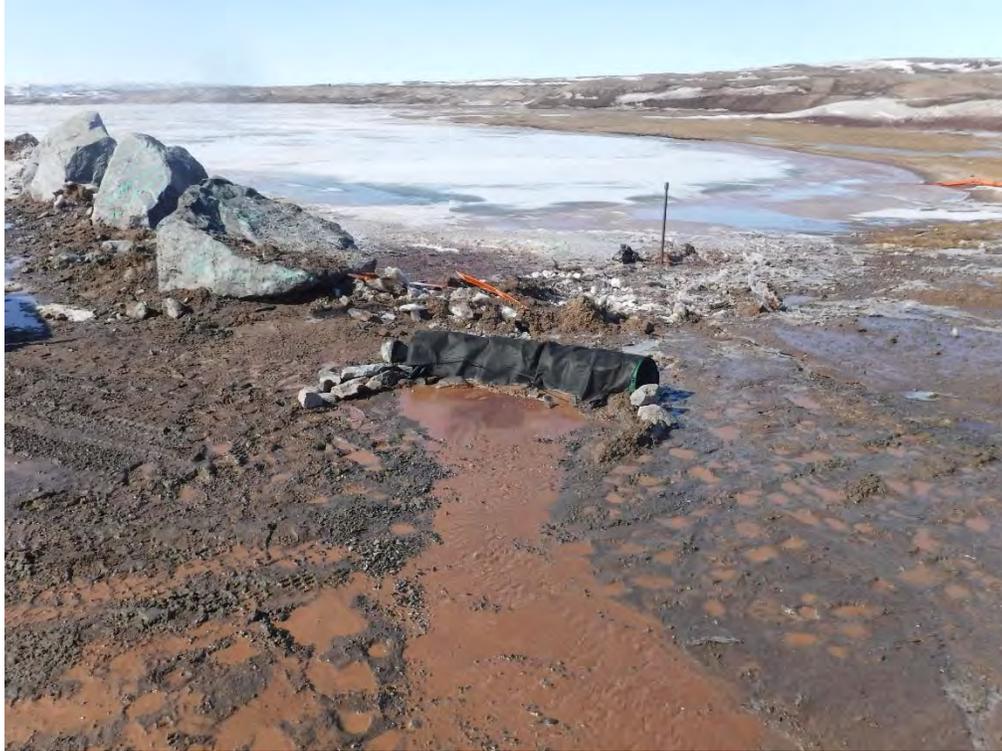
At approximately 13:00 HRS on May 16th, 2018, during the execution of the daily freshet monitoring program at the Mary River Mine Site, environmental technicians observed sediment-laden water to be breaching the series of sediment ponds/check dams that have been constructed along the Camp Lake Jetty access road. Elevated levels of suspended solids were observed from sediment impacted snow melt which mobilized due to the overland flow. In addition to the implementation of erosion and sediment control measures, water quality sampling was conducted of water entering Camp Lake.

Photo 1. May 15, 2018: Sediment-laden water flowing into spring berm before entering Camp Lake

Continued monitoring during freshet conditions and routine maintenance of check dams and settling ponds (i.e. excavation of material) on an as-needed basis.

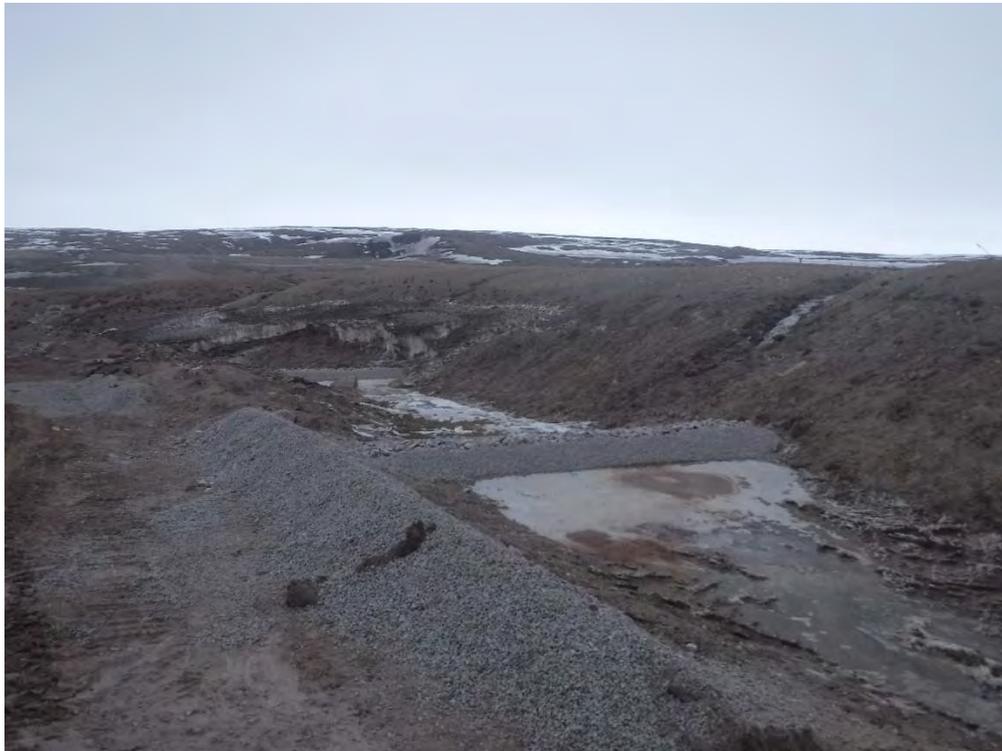
Photo 2. May 22, 2018: Camp Lake Jetty access road drainage channel check dam

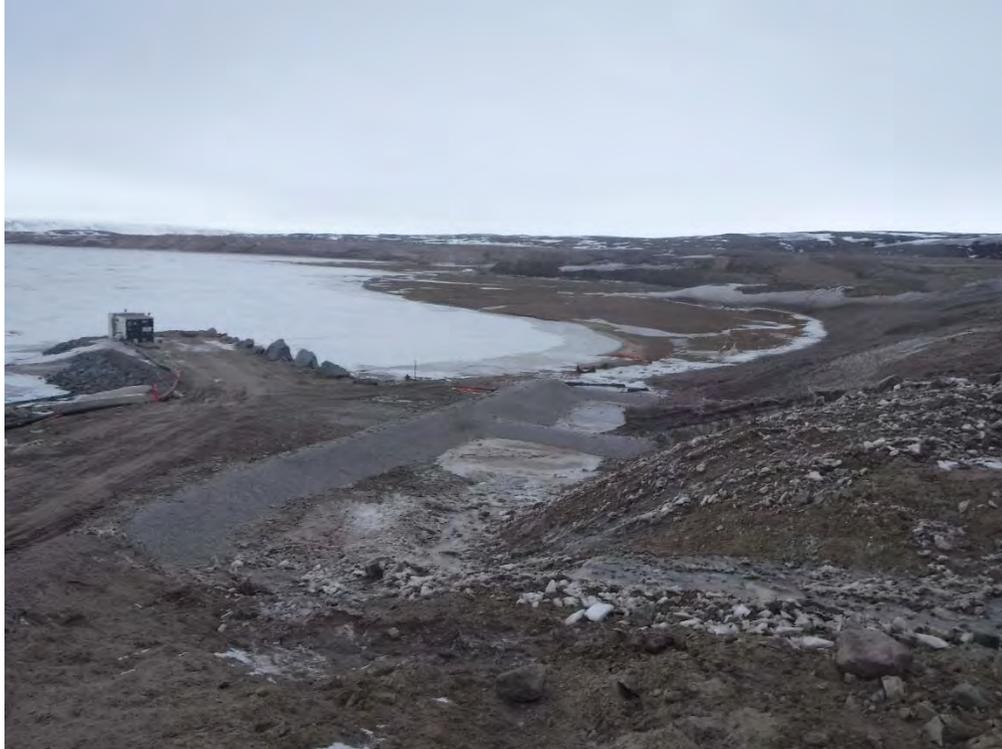
Photo 3. May 22, 2018: Camp Lake Jetty access road drainage channel check dams and berm

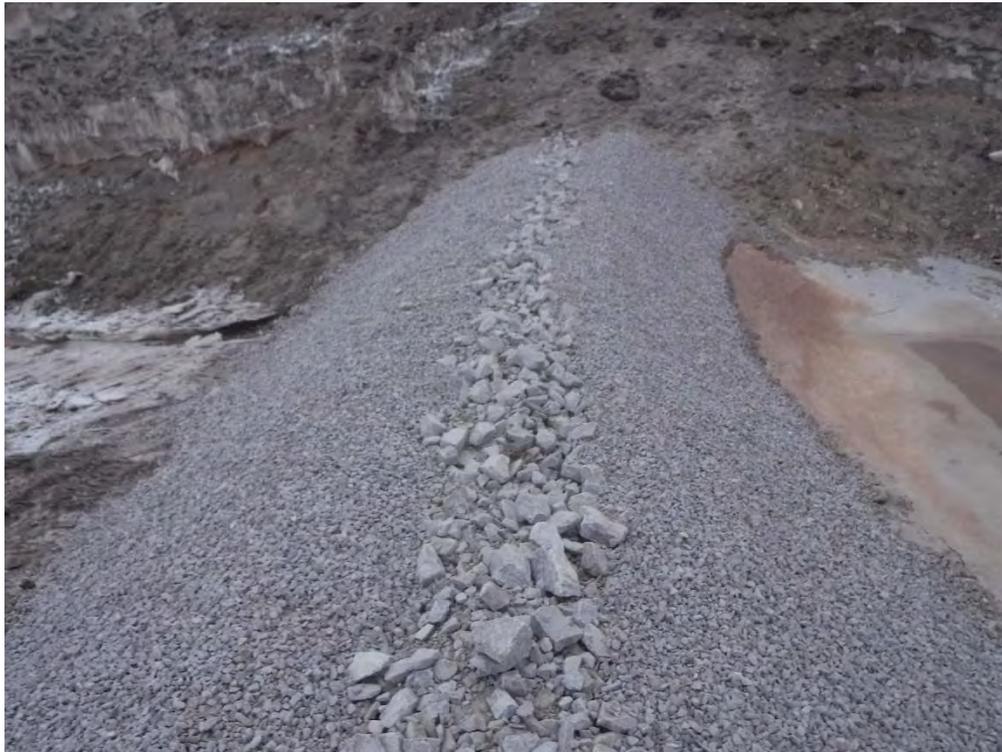
Photo 4. May 22, 2018: Typical check dam/berm cross section

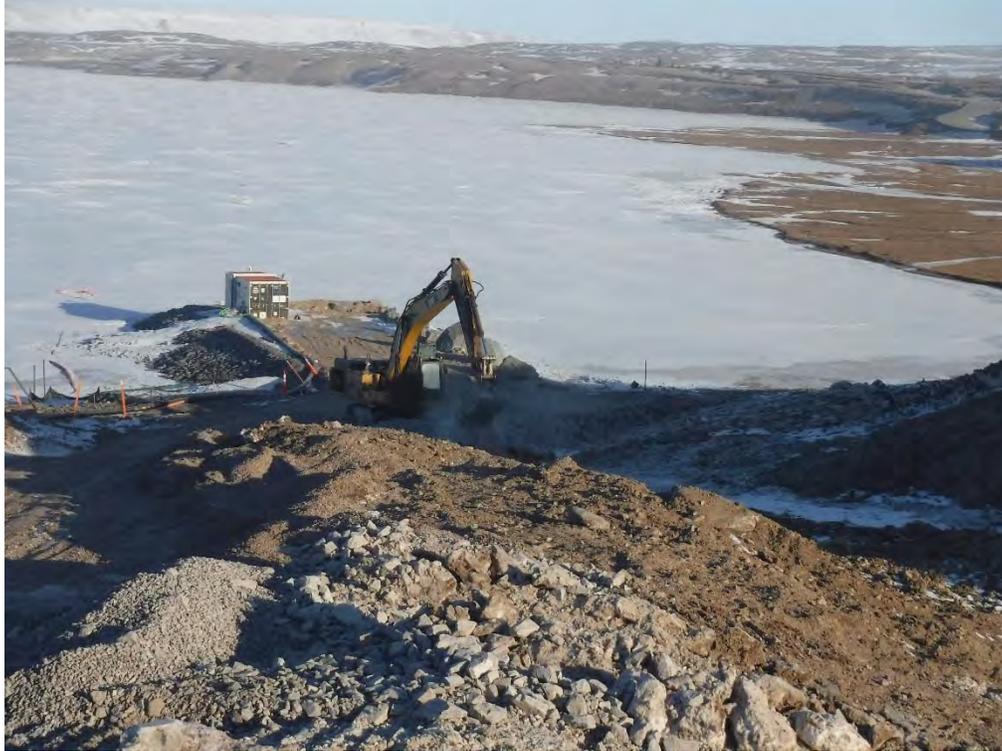
Photo 5: May 21, 2018: Reinforcement of berms/check dams at Camp Lake Jetty, during frozen conditions

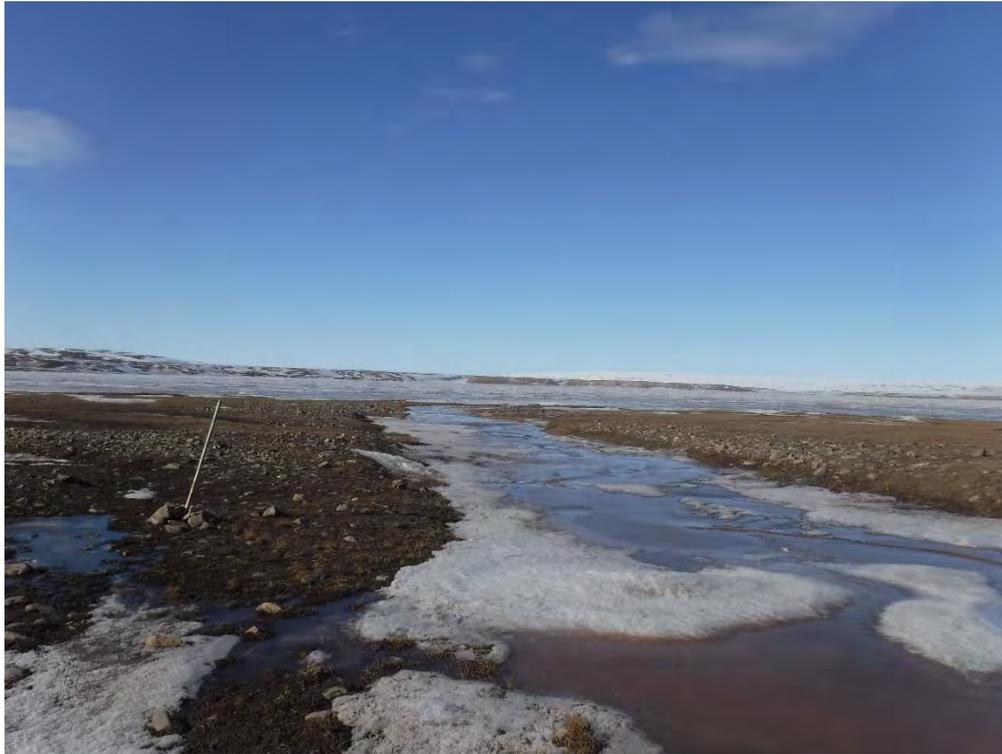
At approximately 15:00 HRS on May 17th, 2018, during the execution of the daily freshet monitoring program at the Mary River Mine Site, environmental technicians observed sediment-laden water to be flowing at multiple locations at the Mary River Mine Site (SDLT and CLT). Elevated levels of suspended solids were observed from sediment impacted snow melt which mobilized as a result of increased overland flow. In addition to the implementation of erosion and sediment control measures in accordance with the Surface Water Management Plan, water quality sampling was conducted of water entering the receiving water bodies. SDLT reports to Sheardown Lake, while CLT reports to Camp Lake.

Photo 1. May 17, 2018: Viewing downstream of sediment-laden water at CLT entering Camp Lake

Upon discovery of the elevated instream TSS conditions at these drainages, personnel worked to install sedimentation mitigation measures, including silt fences and spring berms, in accordance with the Surface Water Management Plan, in an attempt to slow flow and settle sediments prior to entering the streams.

Continued monitoring during freshet conditions and routine maintenance of sediment fences and spring berms, where applicable.

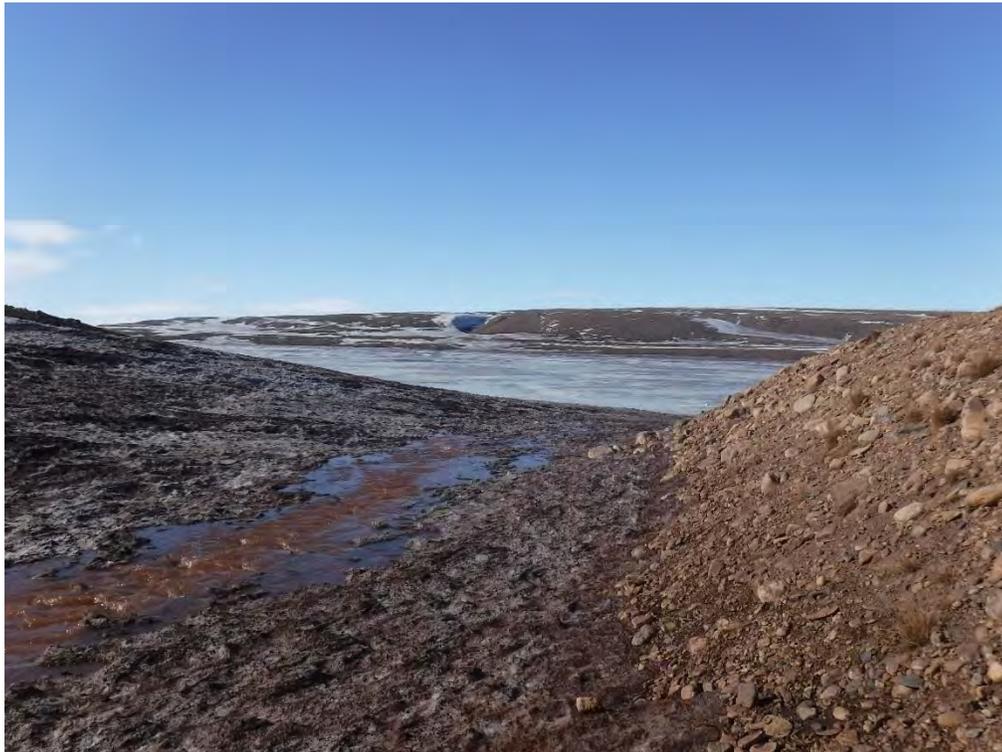
Photo 2. May 17, 2018: Viewing downstream of SDLT of sediment-laden water entering Sheardown Lake

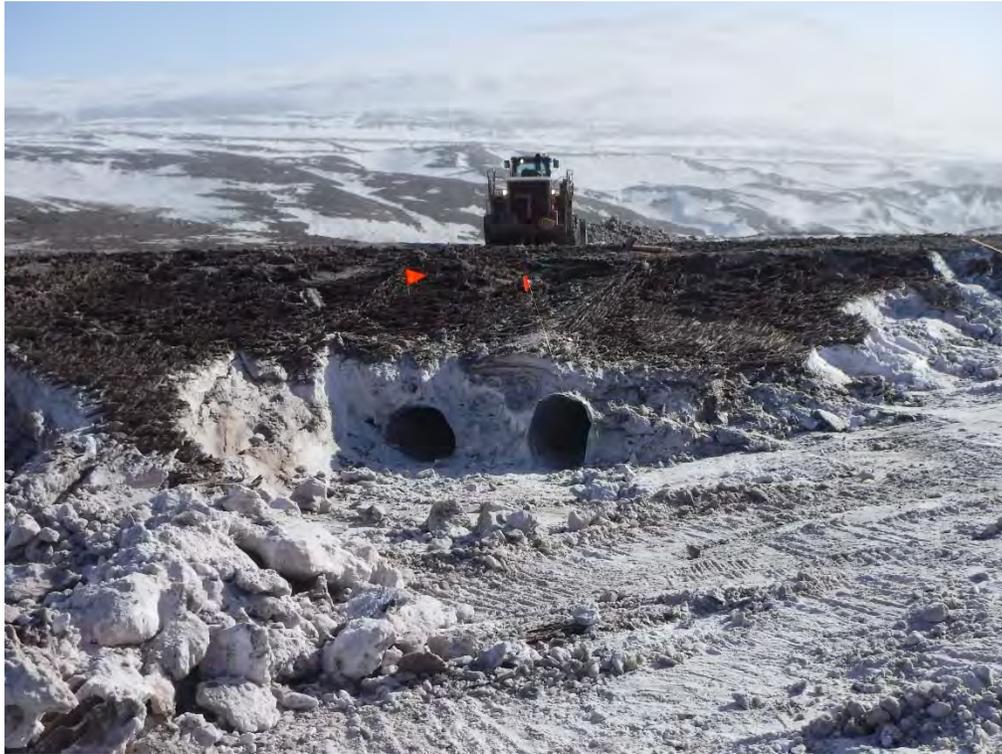
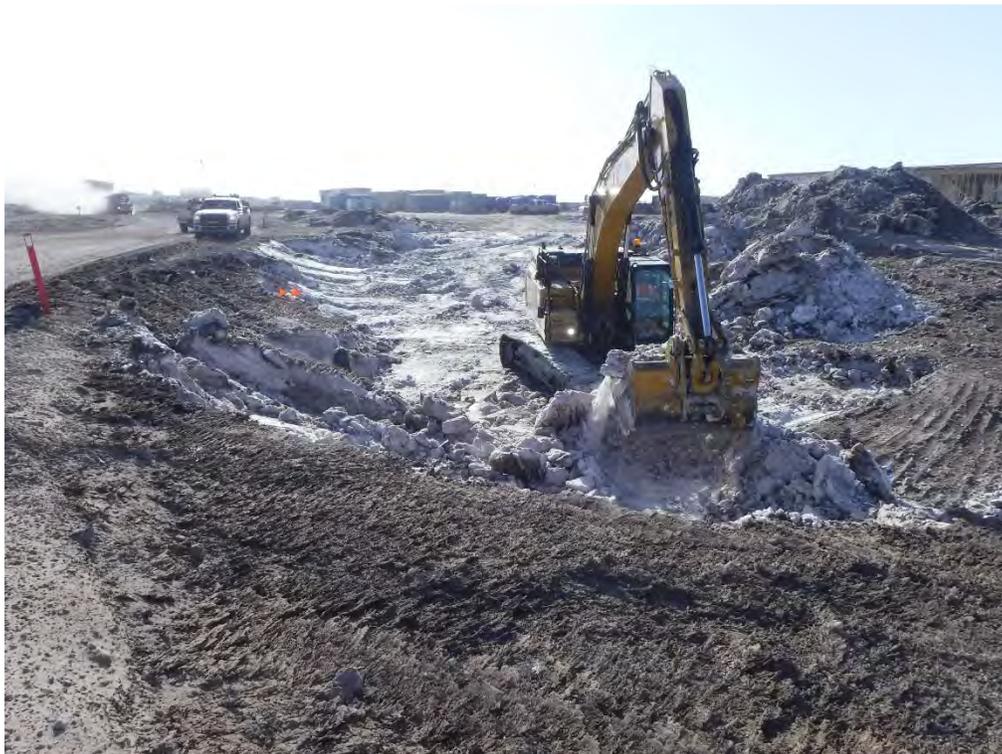
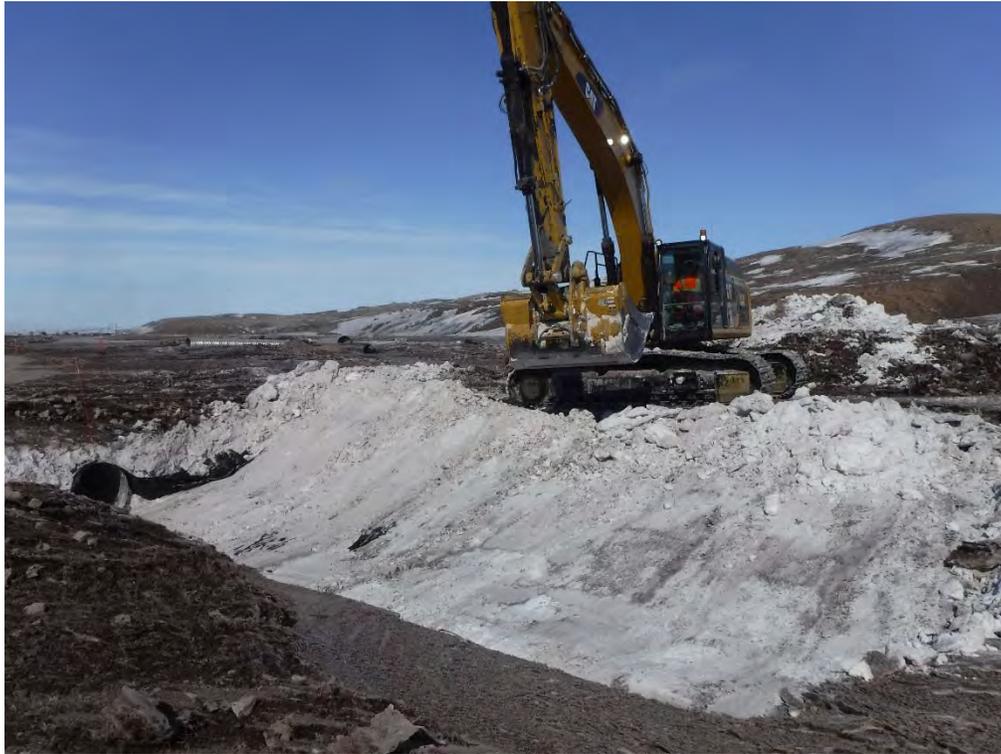
Photo 3. May 9, 2018: Removal of excess snowpack from road crossing above SDLT

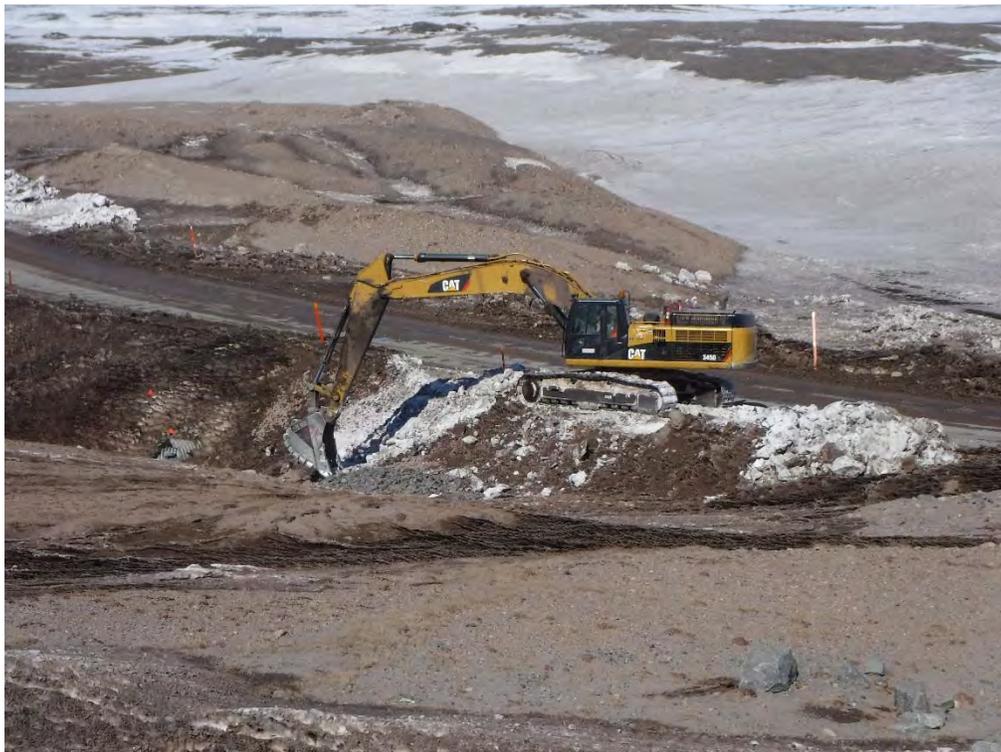
Photo 6. May 13, 2018: Removal of excess snowpack from road crossing above CLT

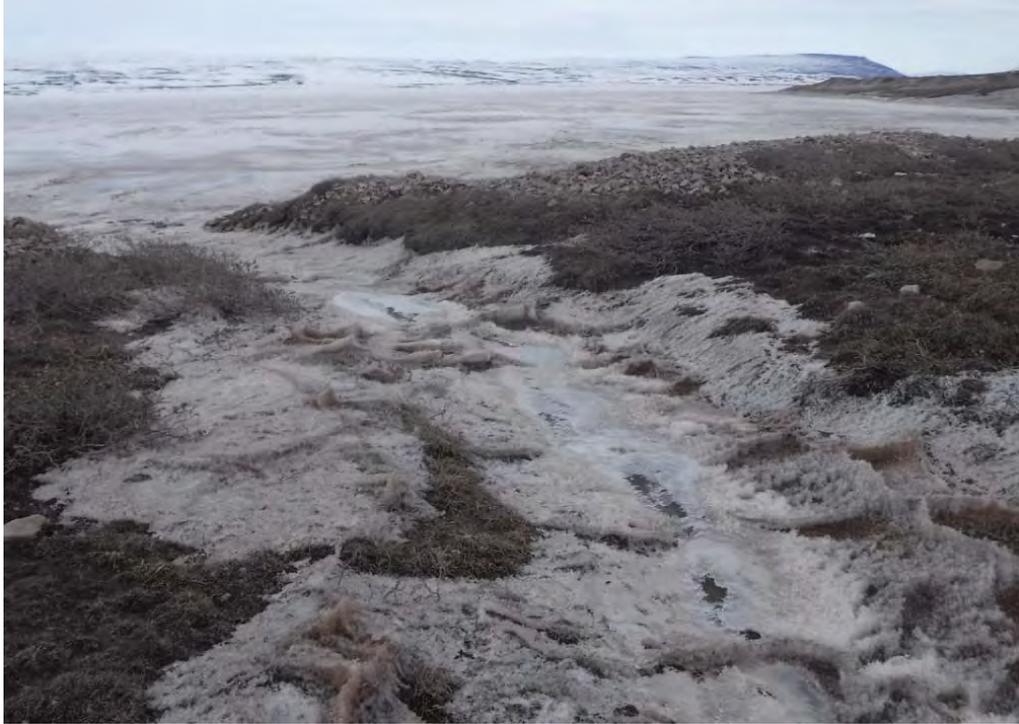
Photo 1. May 30, 2018: Viewing downstream BG27 entering waterbody

Upon discovery of the elevated TSS conditions downstream of the culvert crossing, personnel installed sedimentation mitigation measures. Mitigation measures included riprap armoring of the ditches and silt fences to slow flow velocities and settle sediments prior to entering the culvert and stream, as outlined in the Surface Water Management Plan.

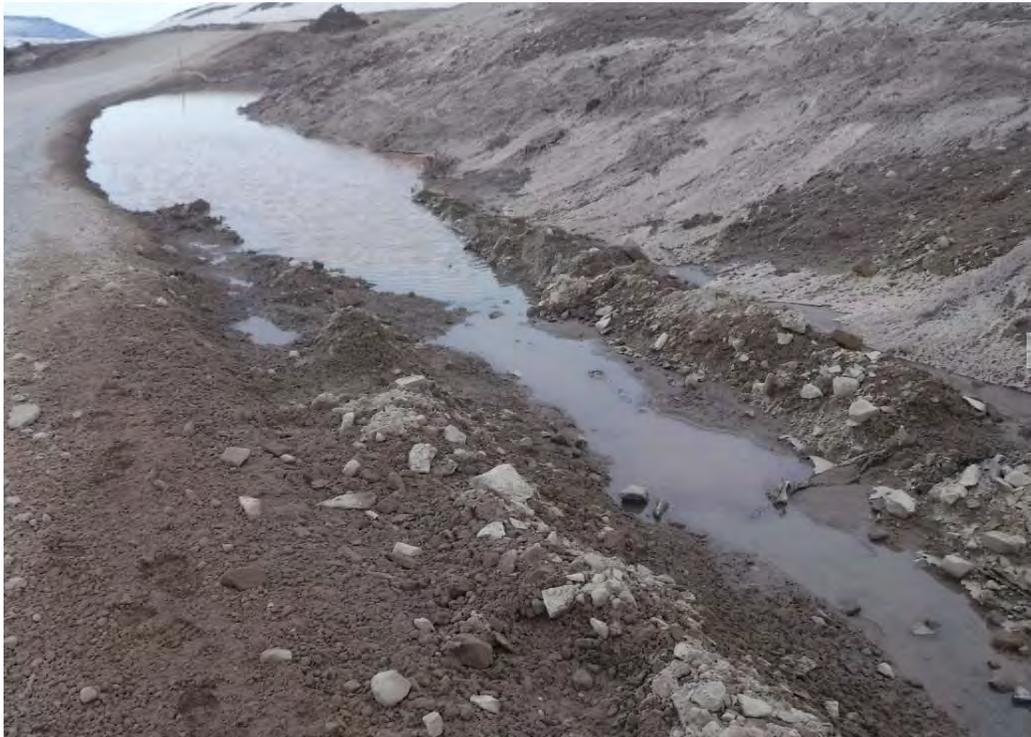
Photo 2. May 30, 2018: Viewing Upstream of BG27

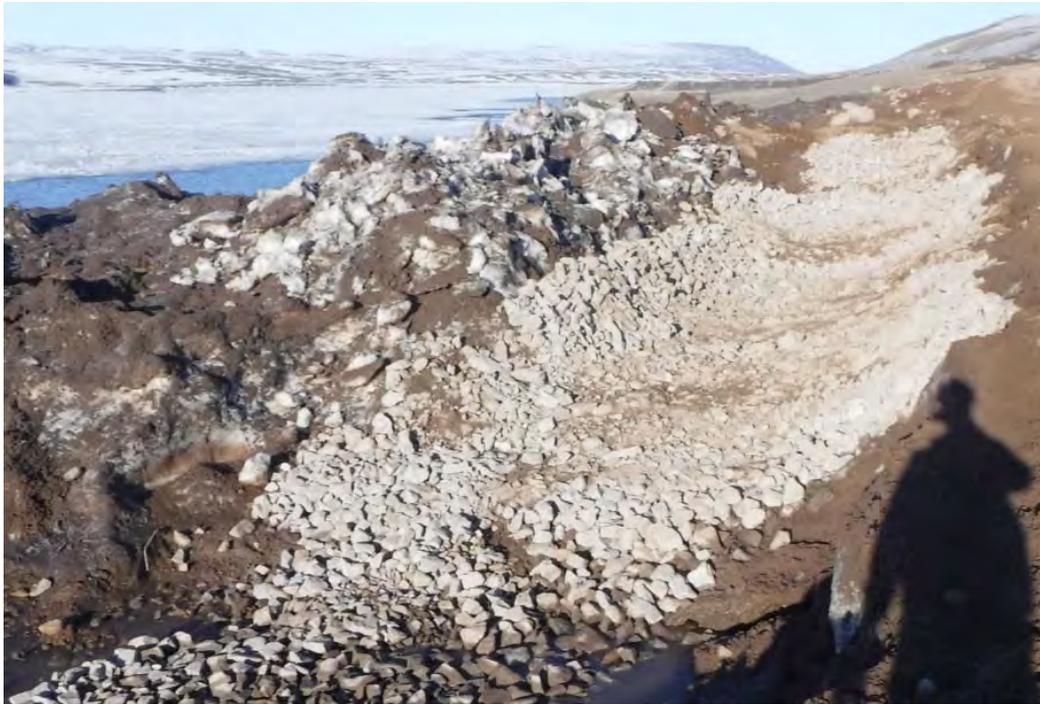
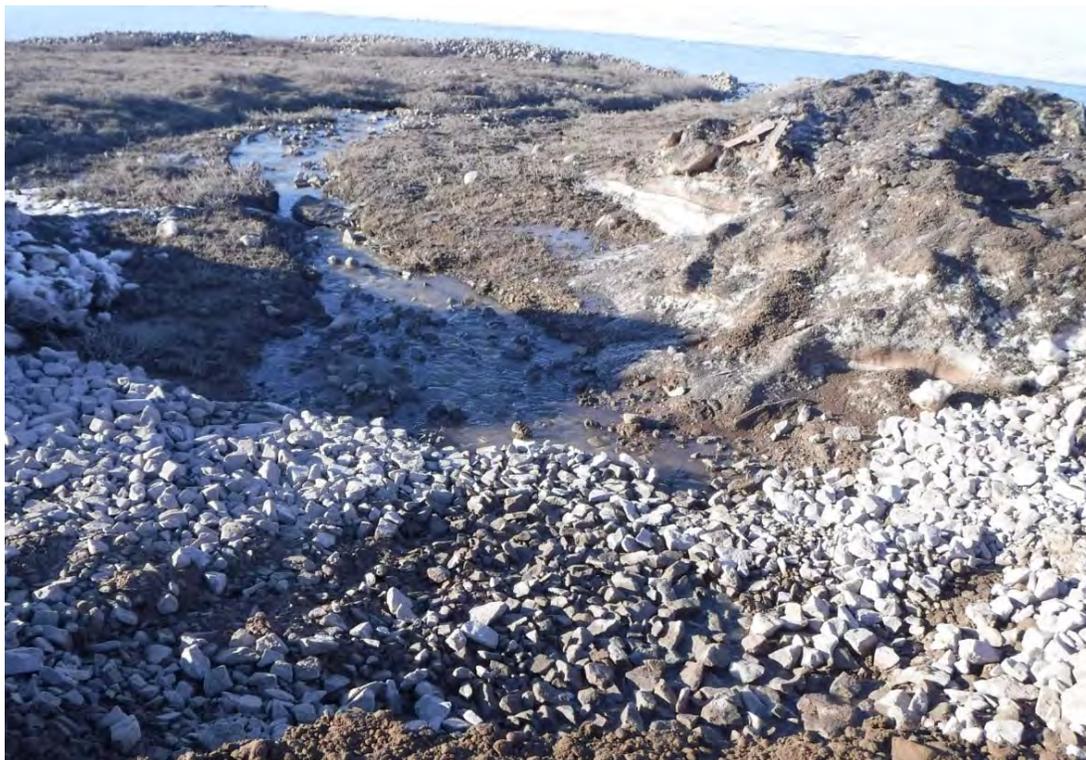
Photo 3. June 6, 2018: Bank armoring with riprap

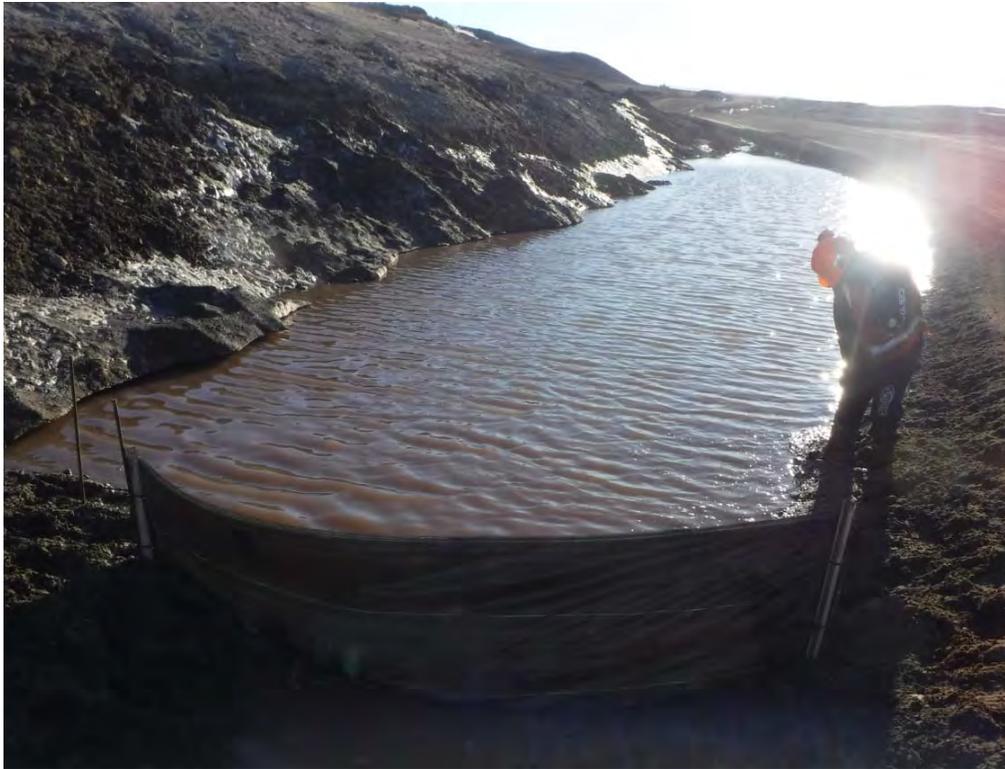
Photo 5. June 6, 2018: Silt fence being installed upstream of crossing

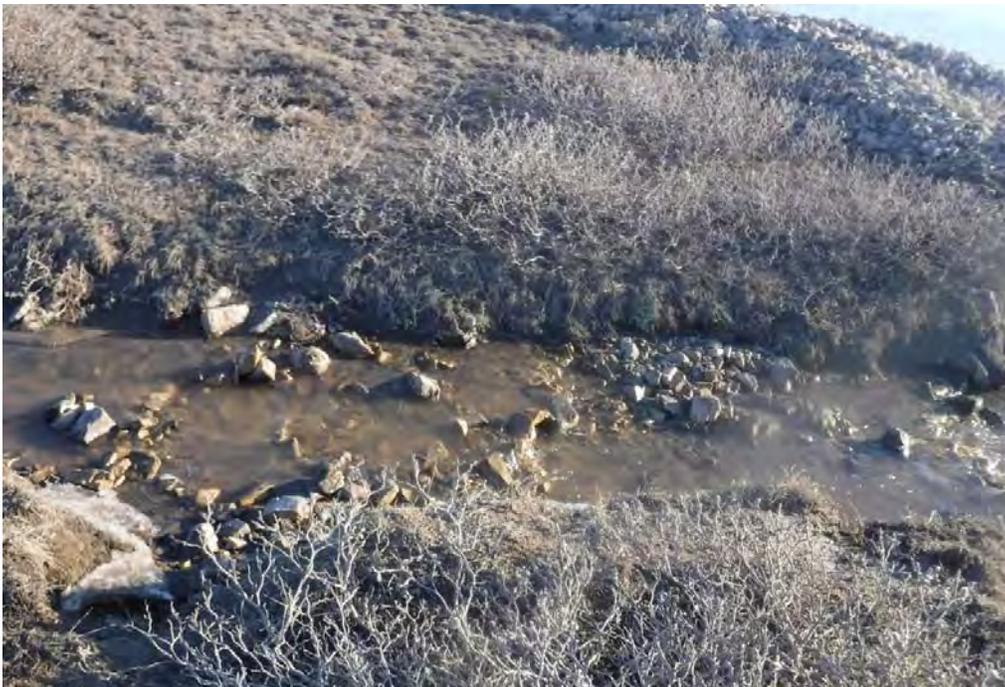
Conditions at BG27 improved following the installation of sediment control measures, with TSS levels returning to below applicable water licence criteria. A more comprehensive Freshet Report will be submitted to document the water quality of surface water crossings along the Tote Road and summarize the areas of concern identified during freshet 2018.

Photo 6. June 7, 2018: Water flowing clear following mitigation measures in place

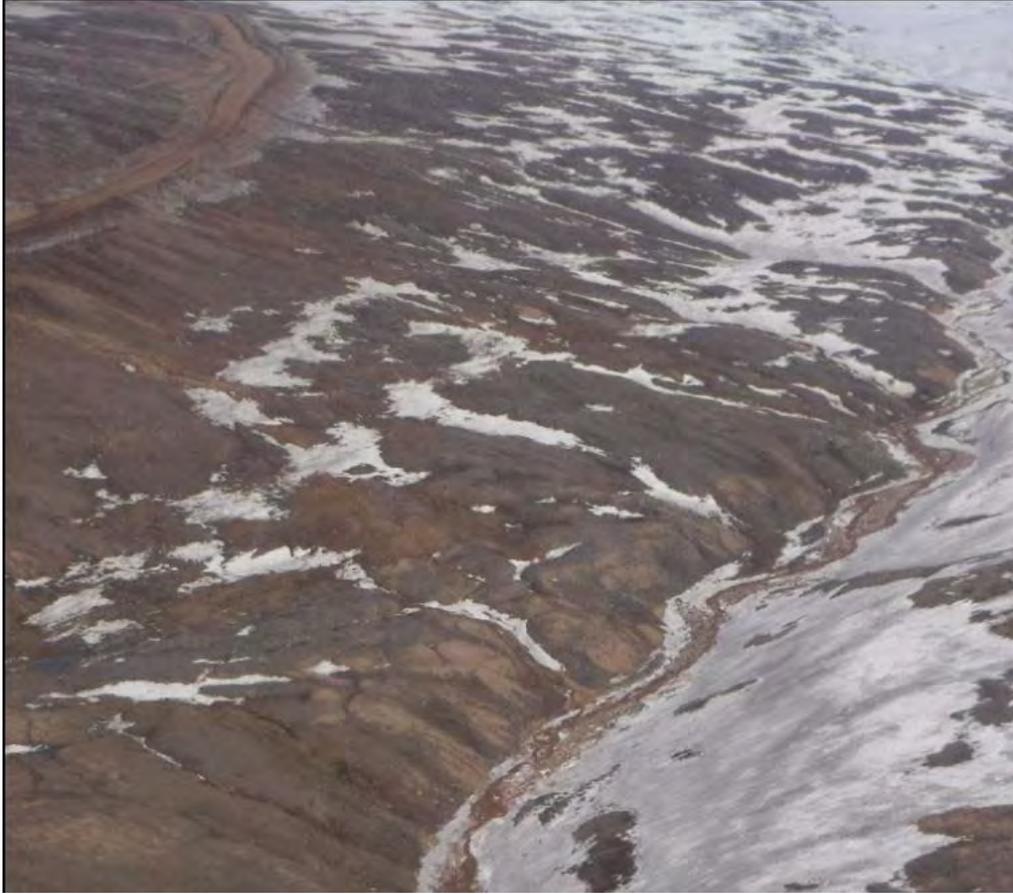
On June 8th, 2018, runoff from the tundra was observed to be flowing into the adjacent ditches between kilometer 107 and 108 along the Mine Haul Road. Upon investigation, surface water runoff from the surrounding tundra entered two culverts resulted in sediment impacted water entering Mary River tributary (non fish bearing). Surface water was immediately diverted away from the Mary River tributary preventing any potential sedimentation impact.

Photo 1. June 9, 2018: Mine Haul Road and Mary River Tributary

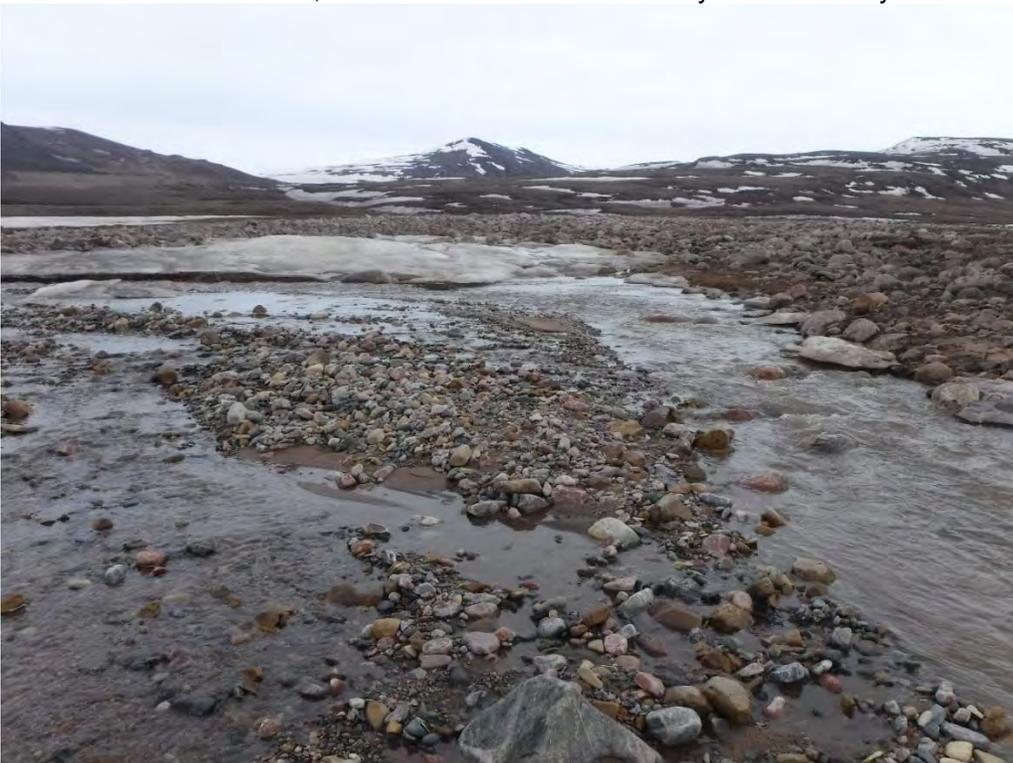
Photo 2. June 13, 2018: Mary River downstream of Mary River Tributary

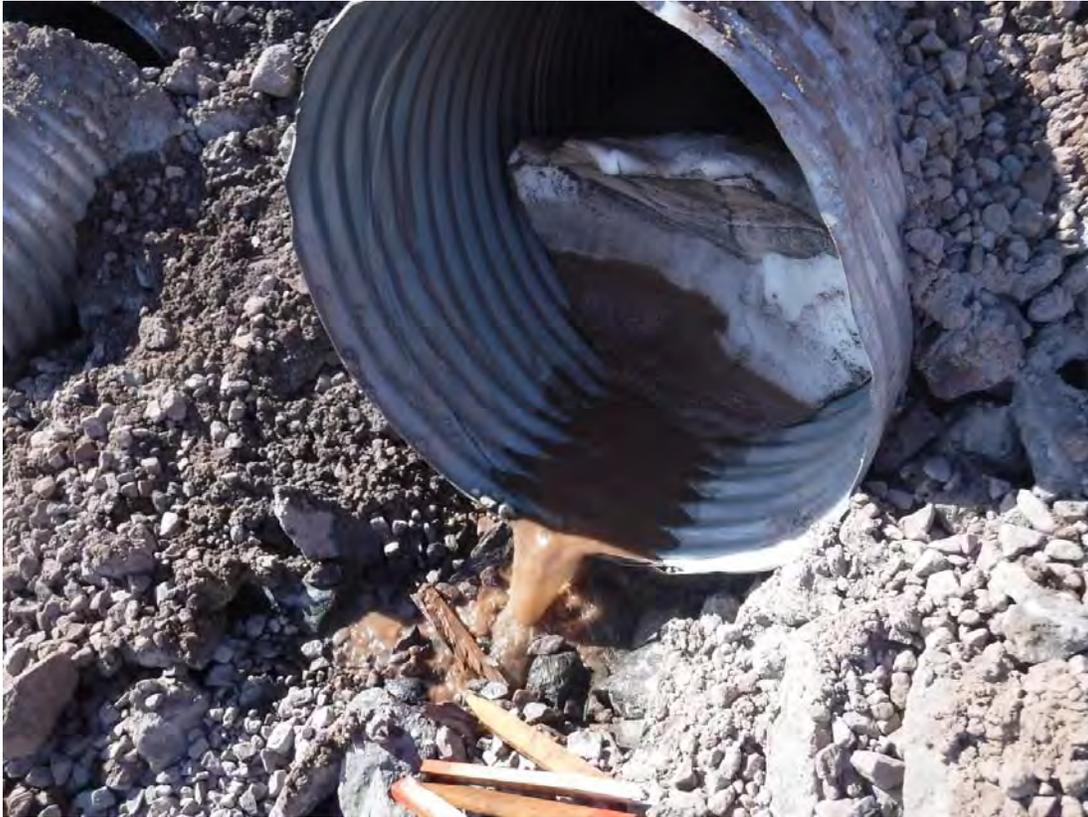
Photo 3. June 10, 2018: Minimal flow from culvert outlet after inlet was blocked off to divert runoff from the Mine Haul Road

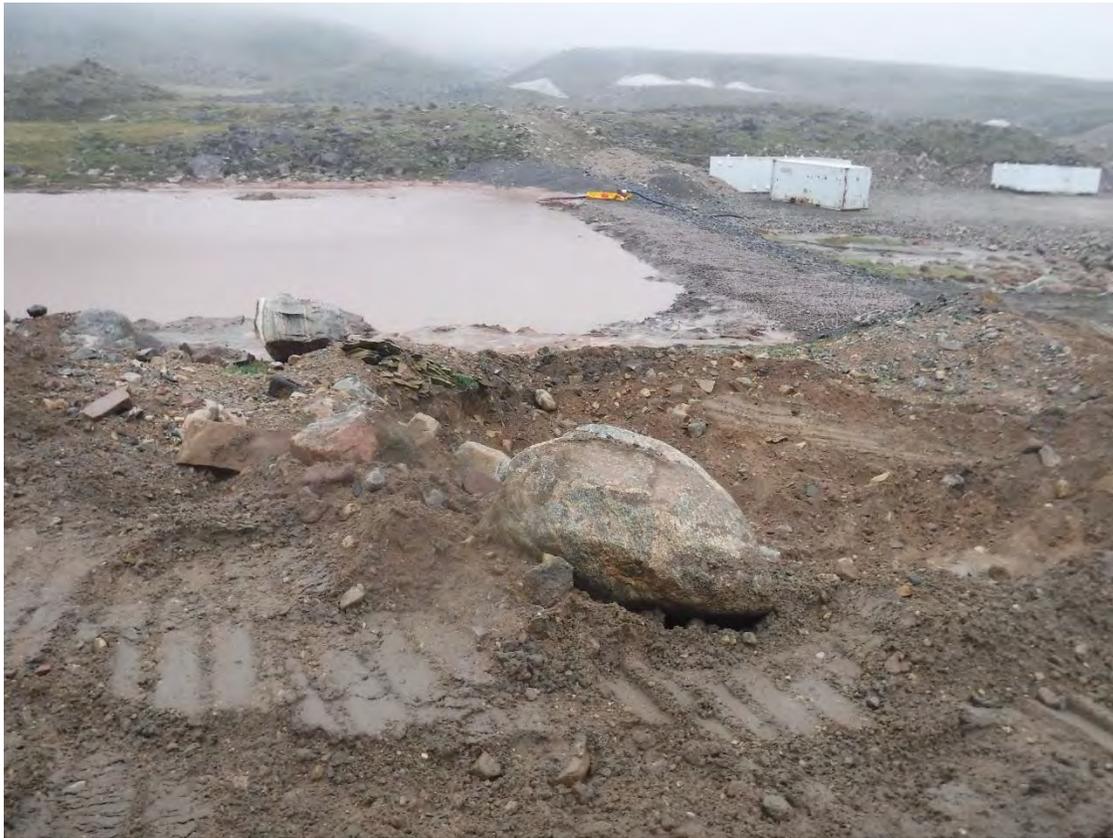
Photo 4. July 9, 2018: Reinforcement of Check Dams as part of ongoing maintenance
