NT-NU SPILL REPORT

Re: Follow-up to Spill #18-148
Mary River Project - Water Licence No. 2AM-MRY1325

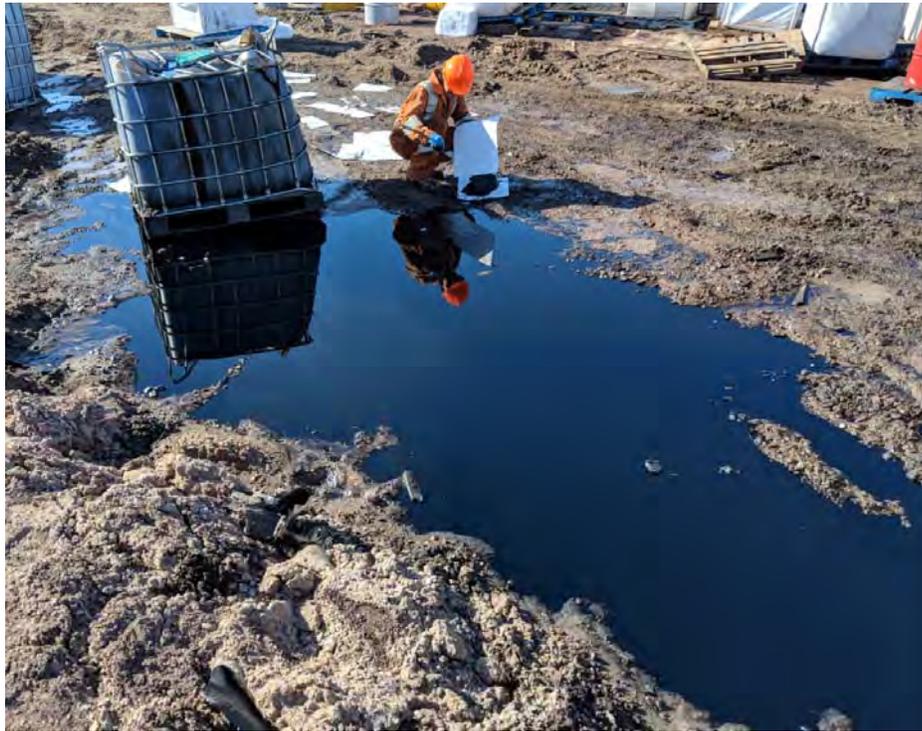
On June 14 2018, during an inspection a spill was discovered at the Port Site Hazardous Waste Berm #1 (MP-HWB-01). Upon investigation, it was determined that the source of the spill was caused by damage to a waste oil tote. The spill is contained within the MP-HWB-01 which is an engineered lined containment berm. Estimates of product released is approx. one cubic metre.

Photo 1. MP-HWB-01 oil spill

Upon discovery of the spill, crews cleaned up waste oil using absorbent pads and the contaminated berm cover material was removed. Clean material was then placed in the influenced areas to return the berm back to its original condition. The damaged tote was pumped out and packed for backhaul disposal. The remaining water in MP-HWB-01 was transferred to the contaminated snow dump to be treated utilizing the oily water treatment facility

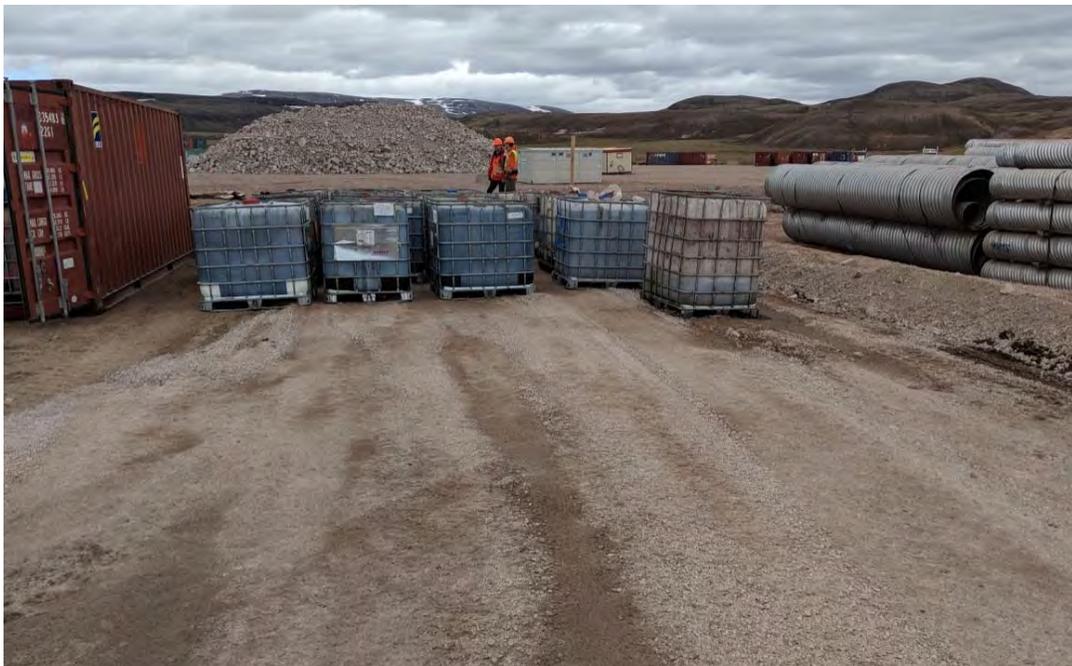
Photo 2. MP-HWB-01 after clean up

The containment berm has been cleaned of all oil and contaminated material. Influenced area has been replaced with clean cover material.

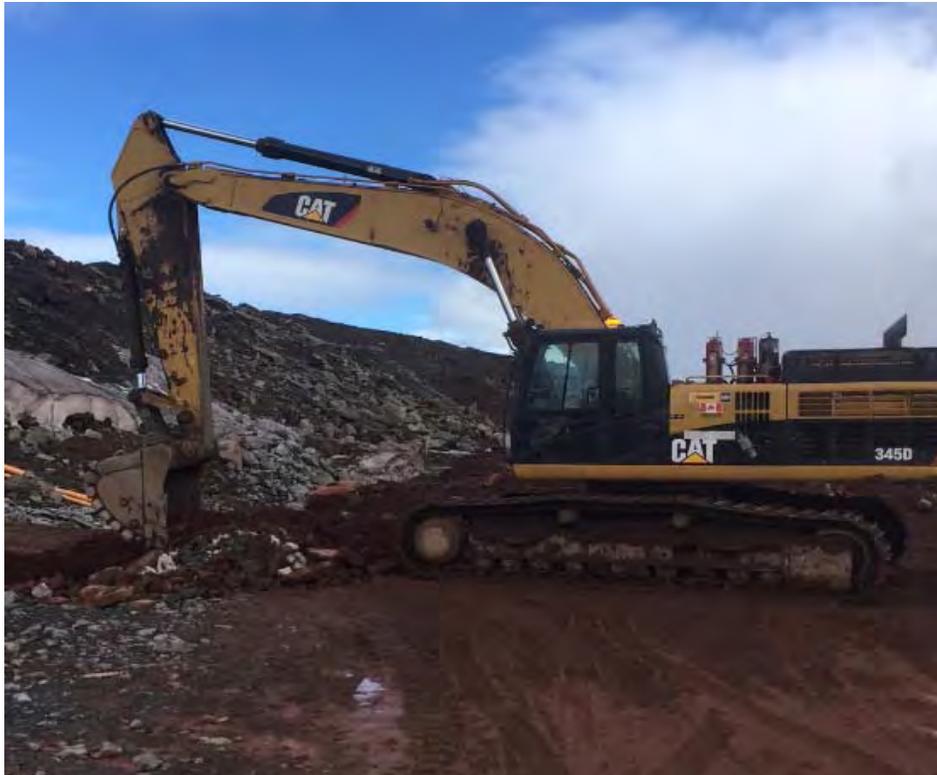
On June 19th, personnel monitoring the Waste Rock Stockpile Pond (MS-08) and facility's ditching, observed an overflow of water from the west drainage ditch of the facility. This water under normal operating conditions reports to the Waste Rock Stockpile Pond. Upon investigation, the overflow was resultant of specific berm walls being insufficient to contain the surface water flow sourcing from the stockpile and reporting to the Waste Rock Stockpile Pond at a crossing where a culvert was installed which resulted in pooling water and overflow.

Photo 1. June 19th, 2018 -Heavy equipment support upon discovery to arrest over flow from West Drainage Ditch.

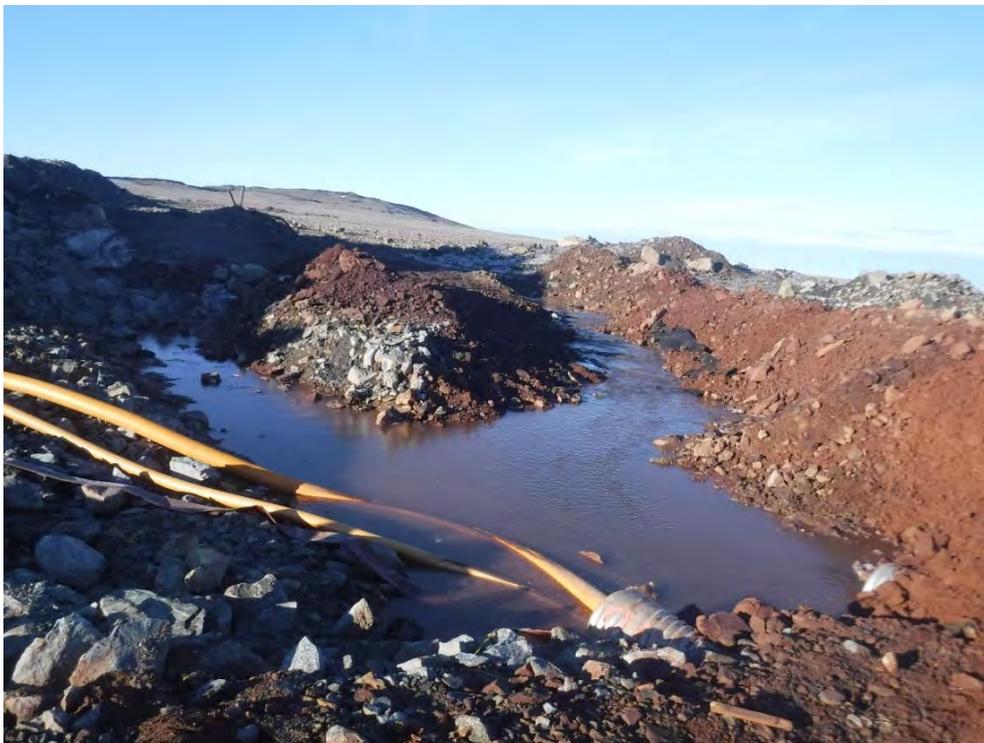
The West drainage ditch is flowing as intended and no further overflow has been observed from either drainage ditch resident of the facility during daily monitoring.

Photo 2. June 20th, 2018 – West drainage ditch inflow into the Waste Rock Stockpile Pond following berm reinforcement.

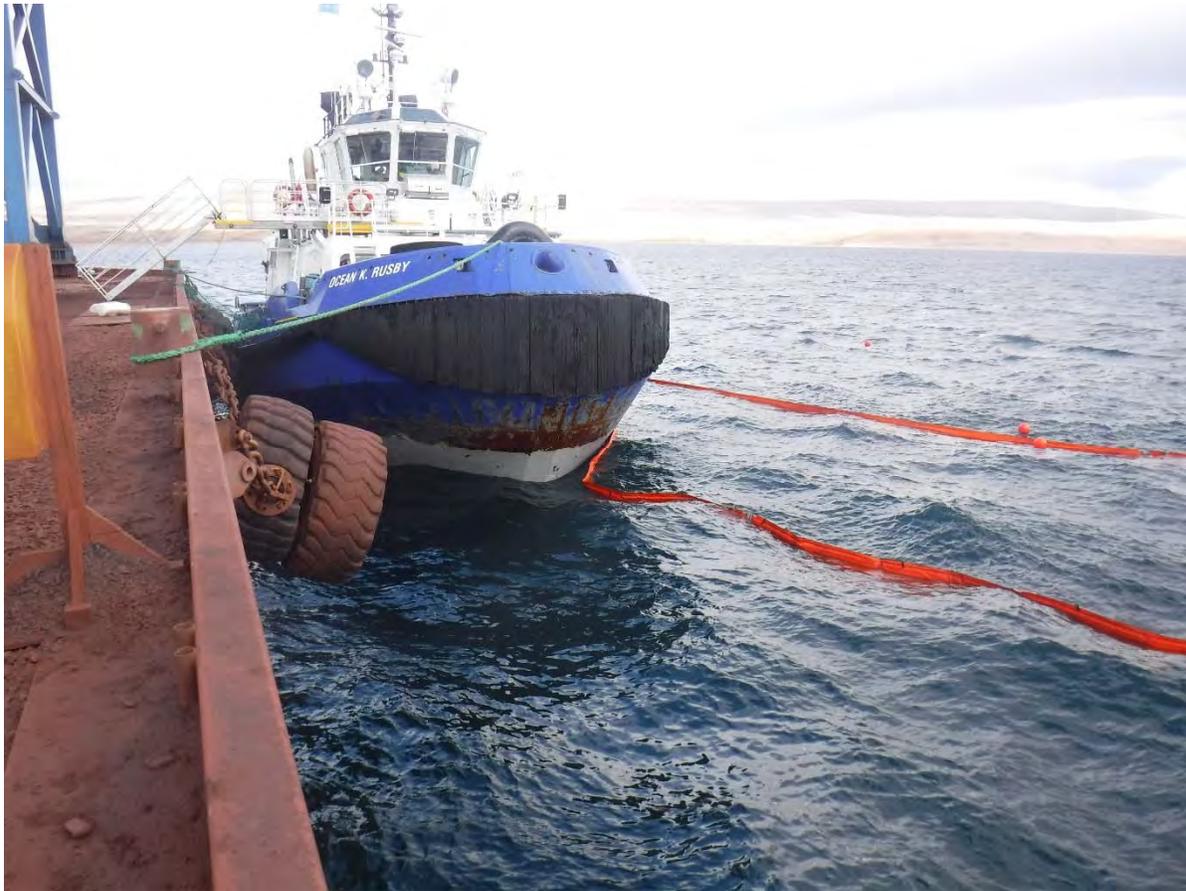
Photo 1 – OCEAN K. RUSBY at Milne Port upon arrival with two spill containment booms in place, July 22nd, 2018.

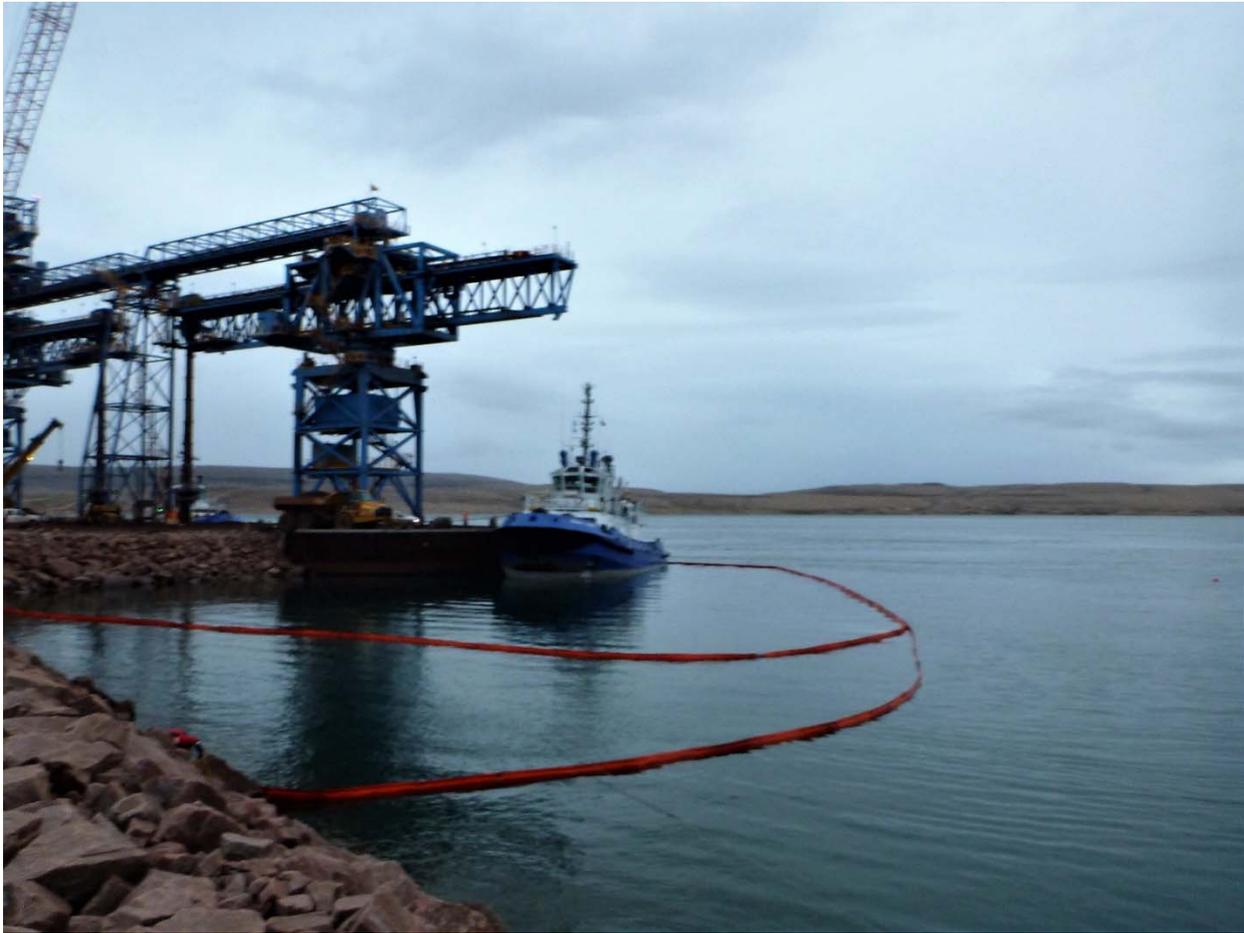
Photo 2 – July 24th, 02:00. Vessel following relocation contained within double booms.

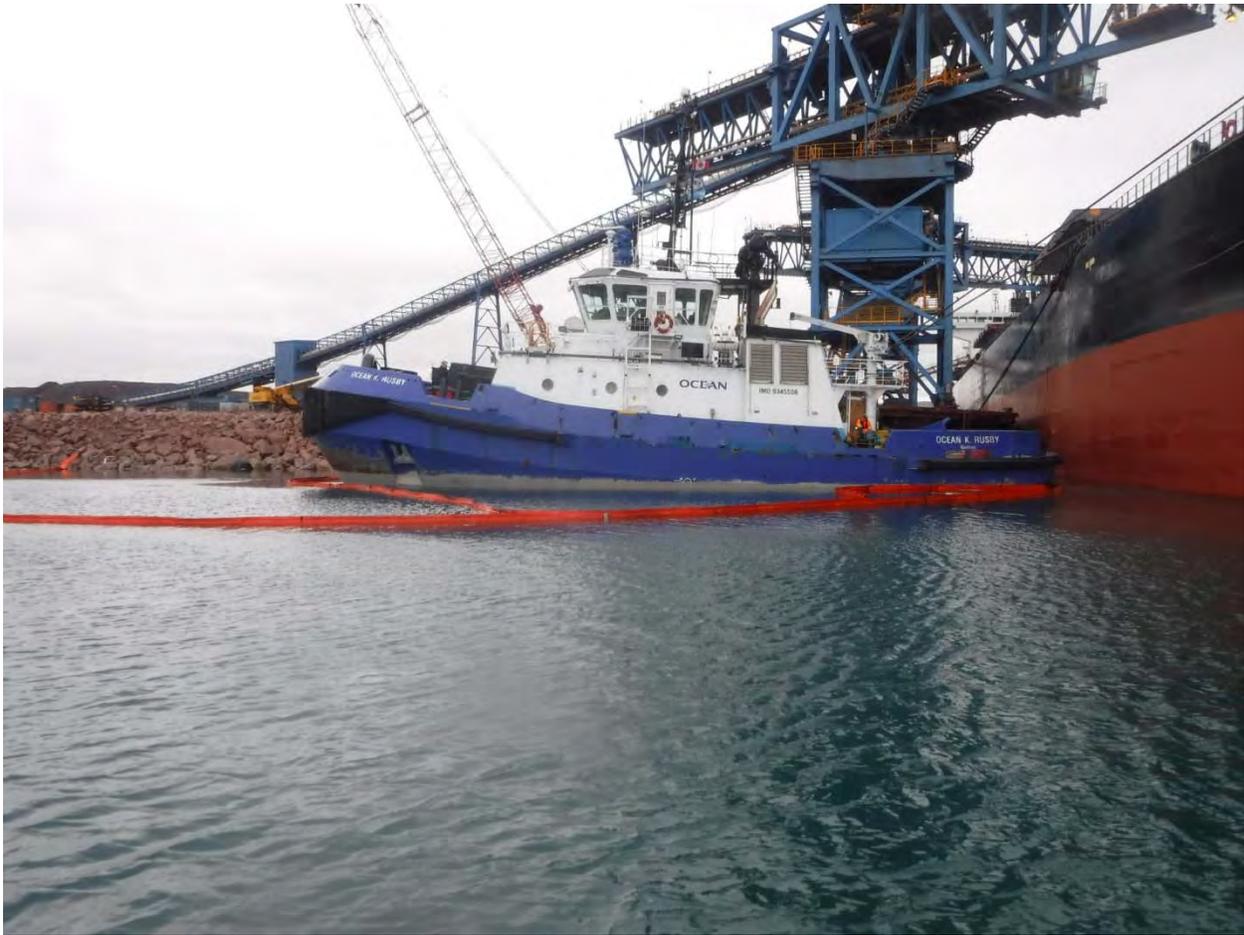
Photo 3 – OCEAN K. RUSBY at East side of Milne Port Ship Loading dock with two spill containment booms in place, July 27th, 2018.

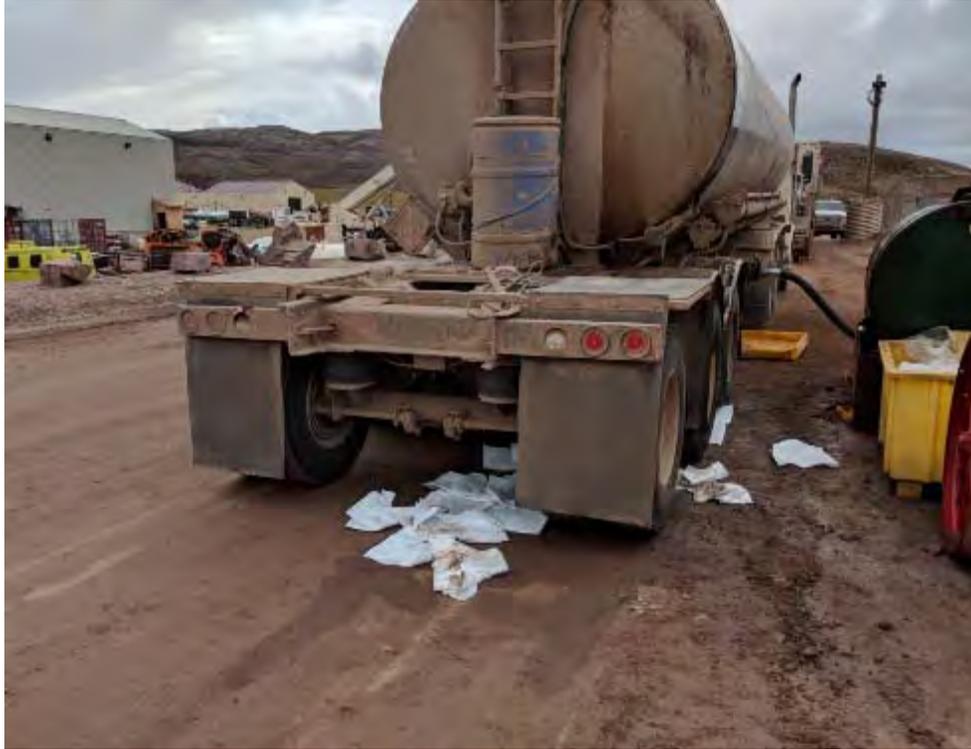
Photo 1. Spill location before clean-up

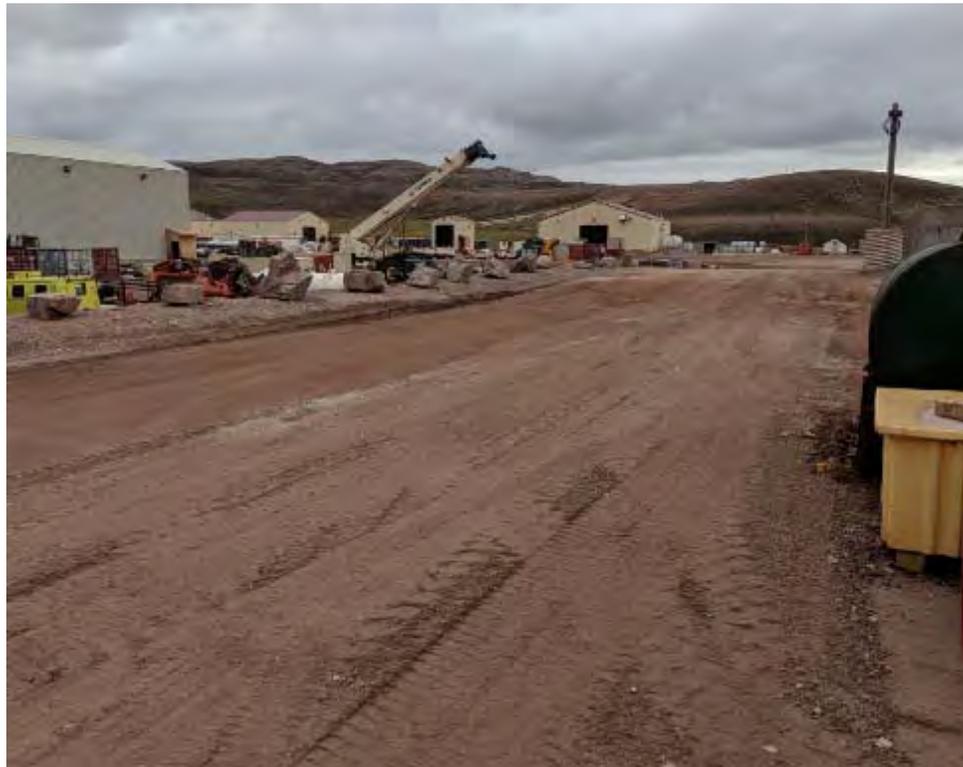
Photo 2. Spill location following clean-up

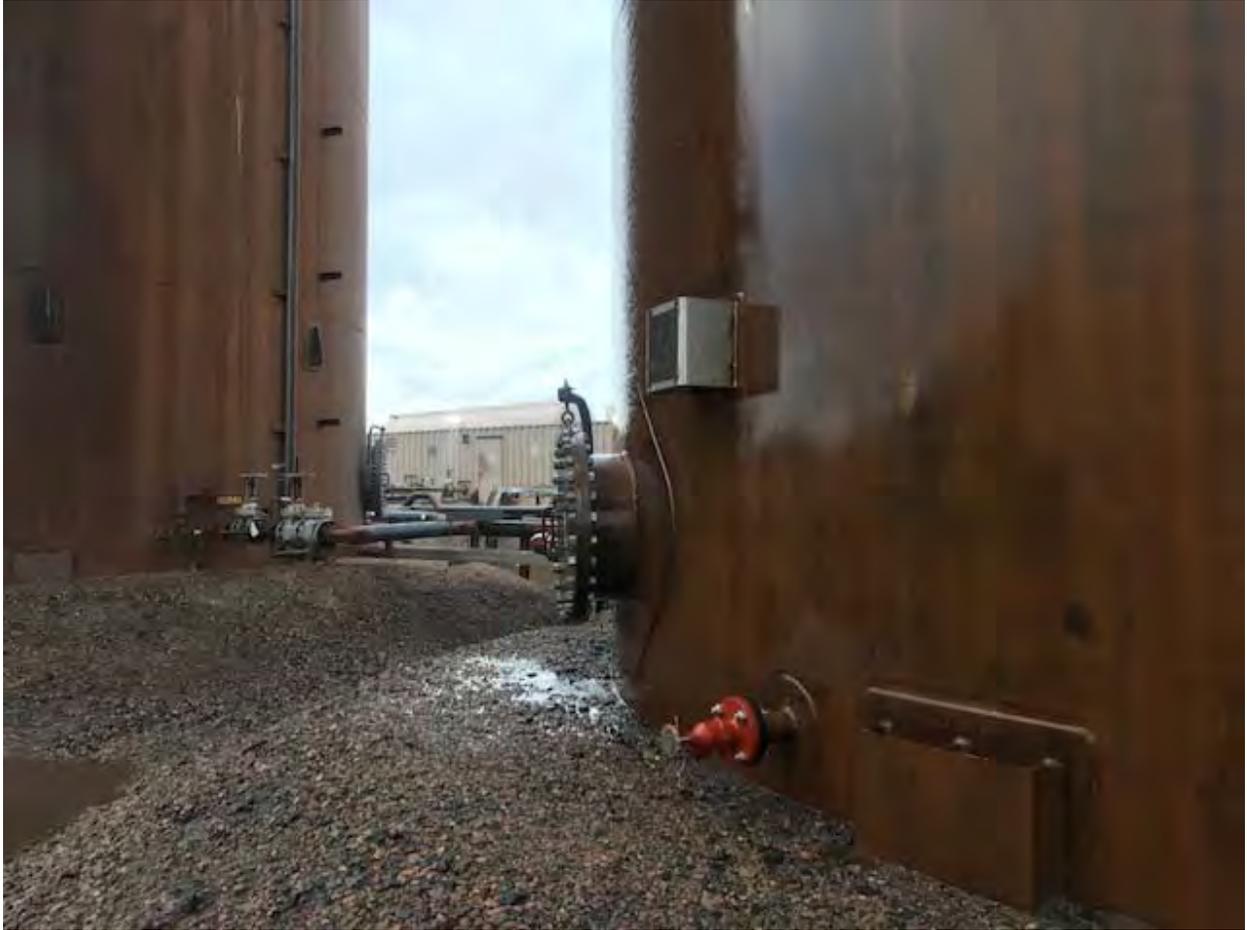
On August 27, personnel observed a release of Arctic diesel in the Bulk Fuel Tank Farm at the Mine Site. Upon initial investigation, a bulk fuel tank in a lined engineered containment facility experienced an overflow of diesel from the top of the tank during resupply operations. The fuel tanker resupply was immediately arrested upon overflow discovery and lines were isolated and closed from the fuel resupply module. Spill clean-up in the lined berm mitigated berm contamination. Approximately 1.1 m³ was released and contained in the lined engineered berm, with no possibility of migration outside of containment, and is >100 meters from the nearest water course.

Photo 1. Spill location, TK-001.

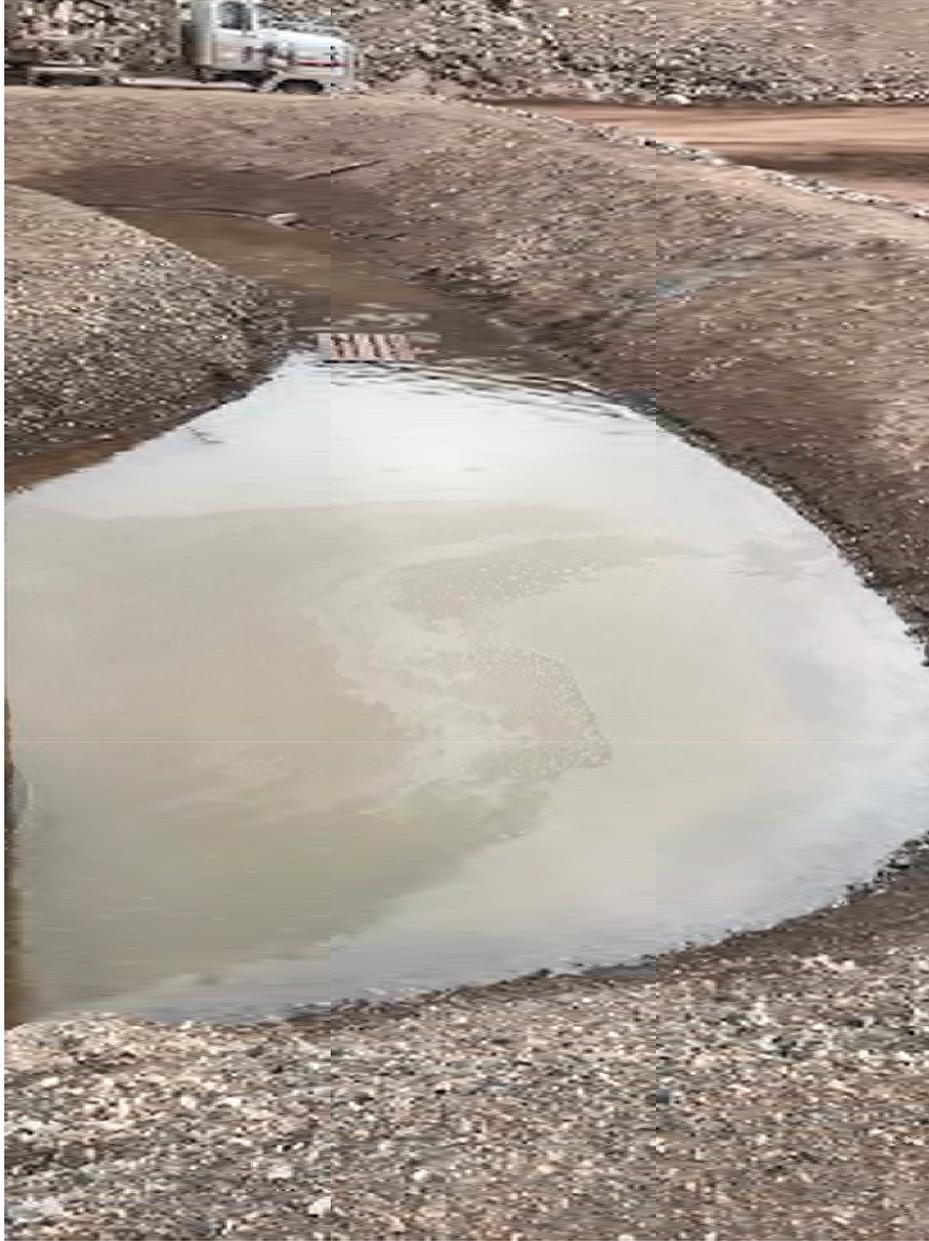
Photo 2. Spill contained within fuel mod berm.

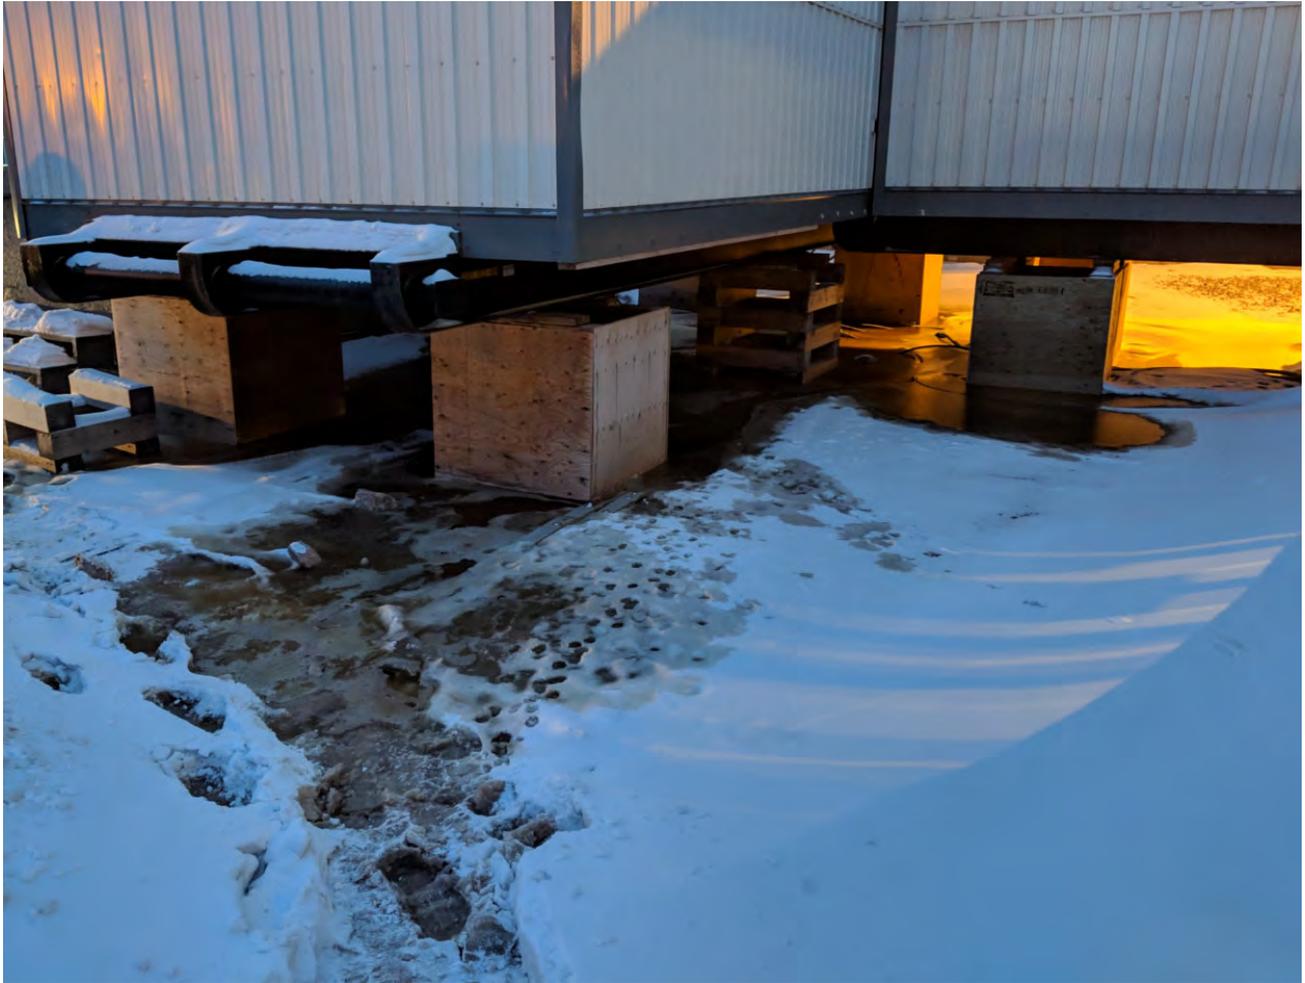
Photo 1. Overflow spill on ground surrounding the holding tank. Oct 25, 2018.

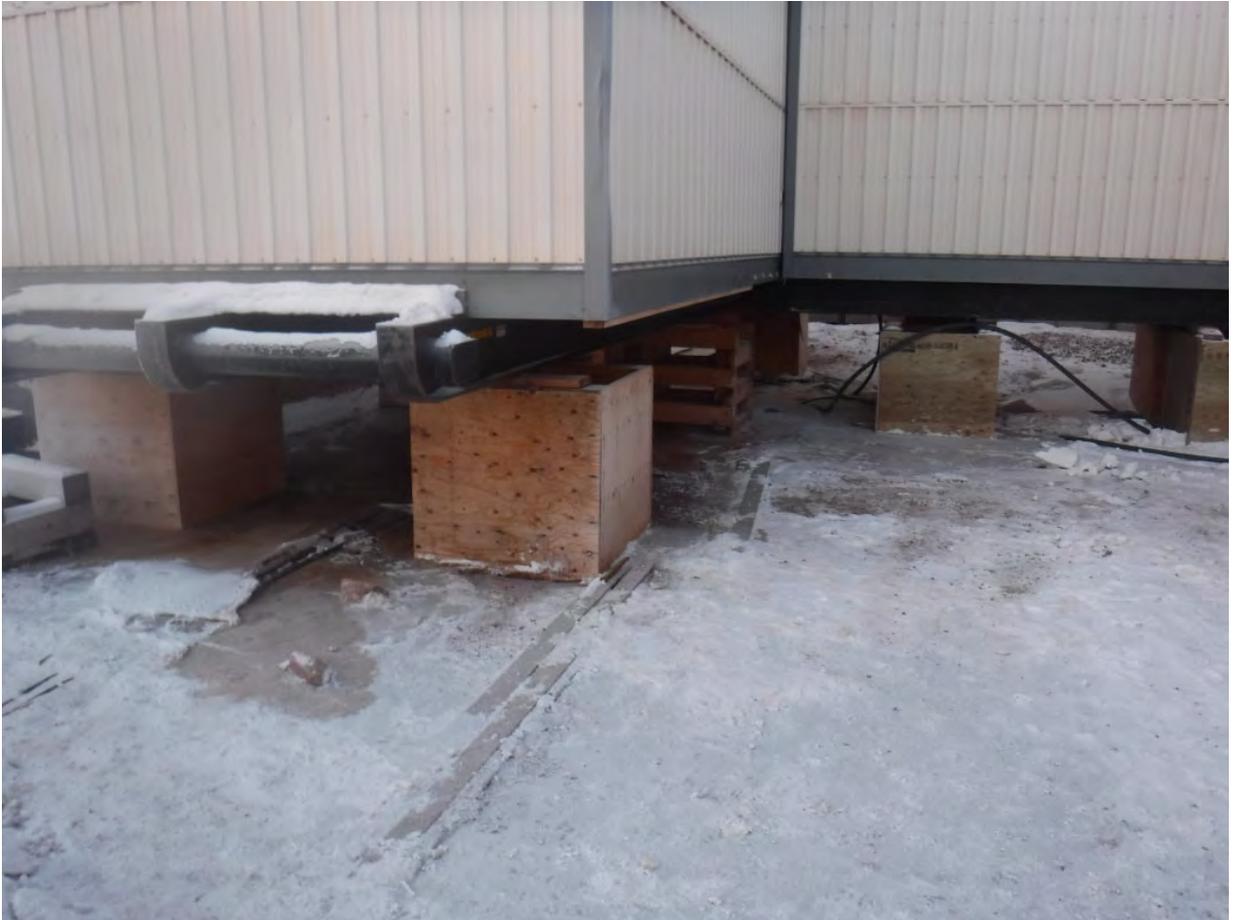
Photo 2. Holding tank area after site clean up. Nov 01, 2018.

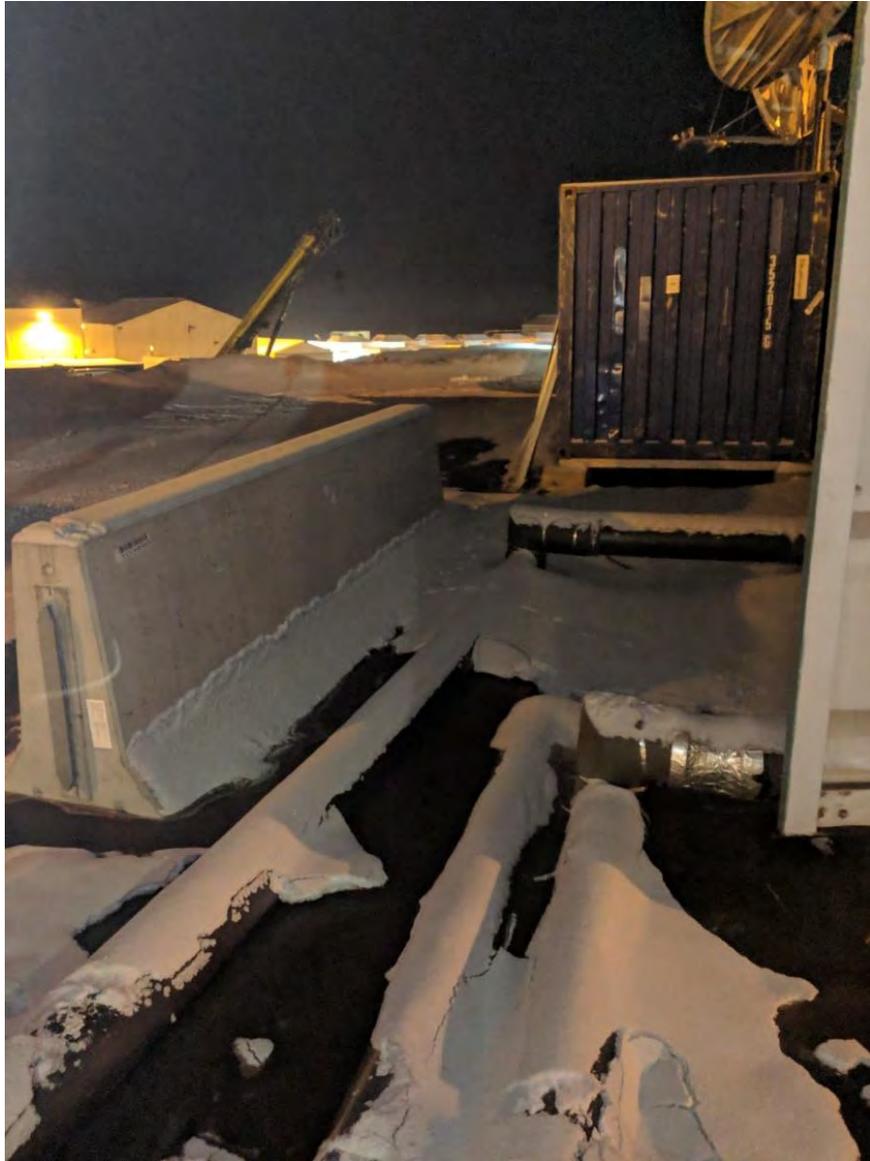
Photo 1. Overflow release on camp pad adjacent to main holding tank..

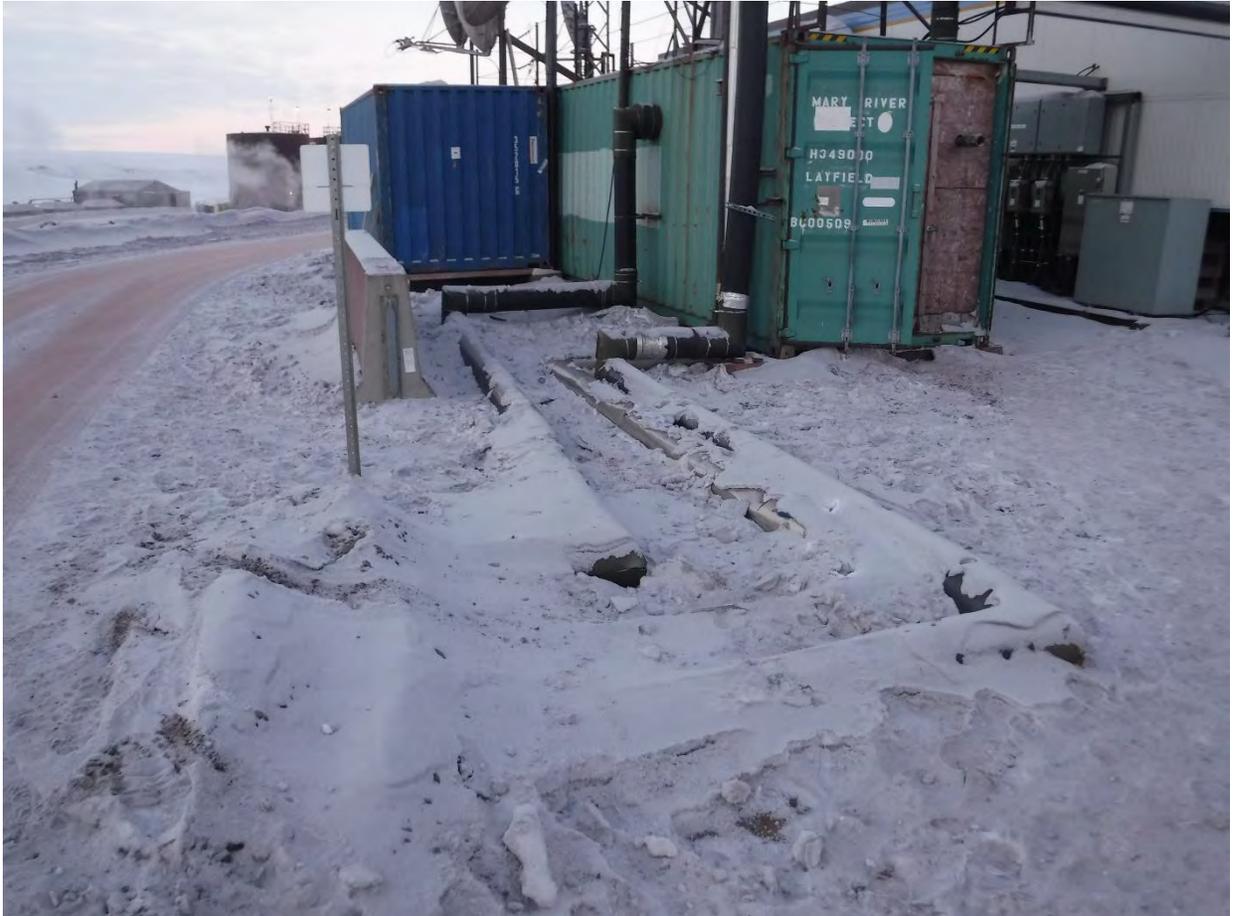
Photo 2. Overflow release after site clean up..

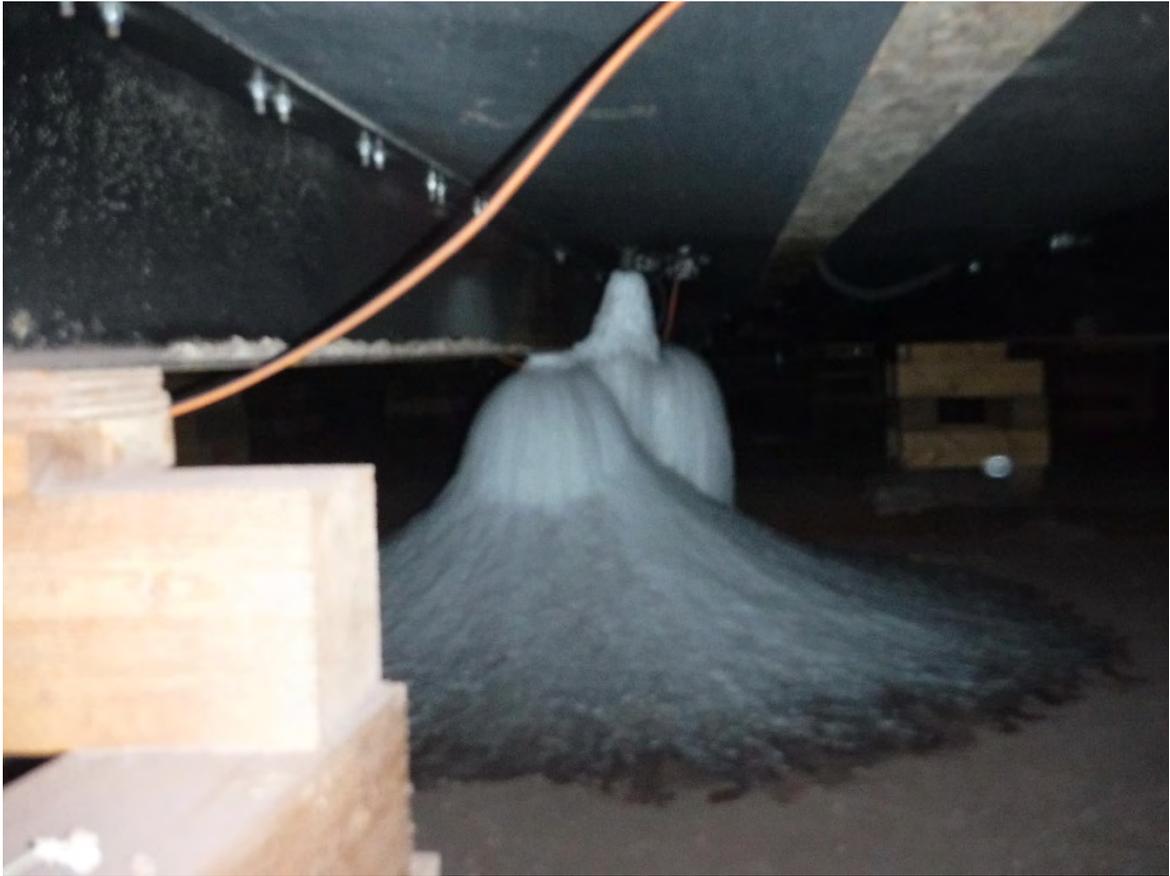
Photo 1 - Potable Water Release (Nov. 19, 2018)

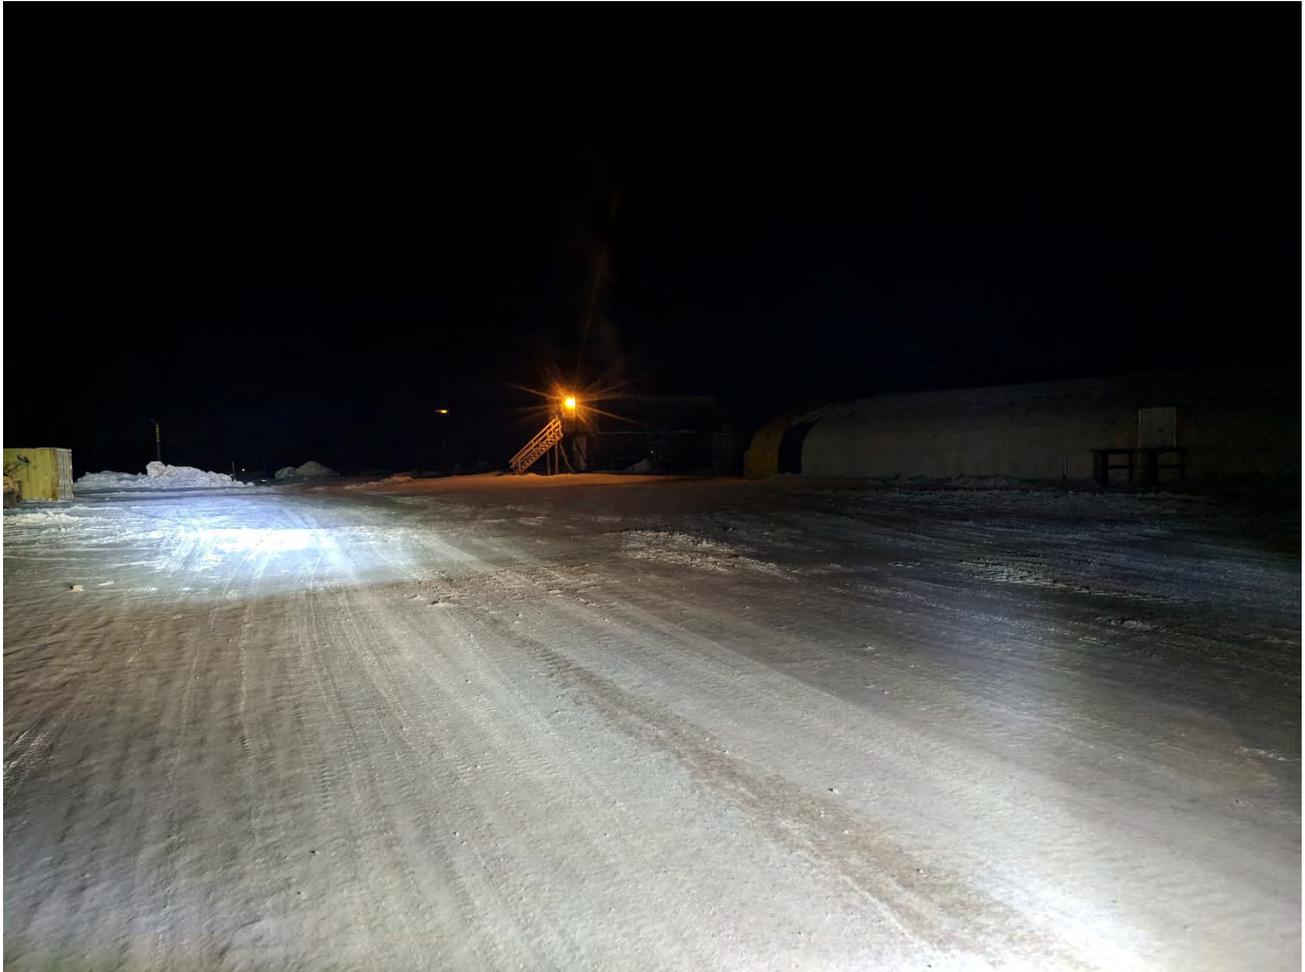
Photo 1. Sewage drainage release on camp pad adjacent to RBC holding tank.

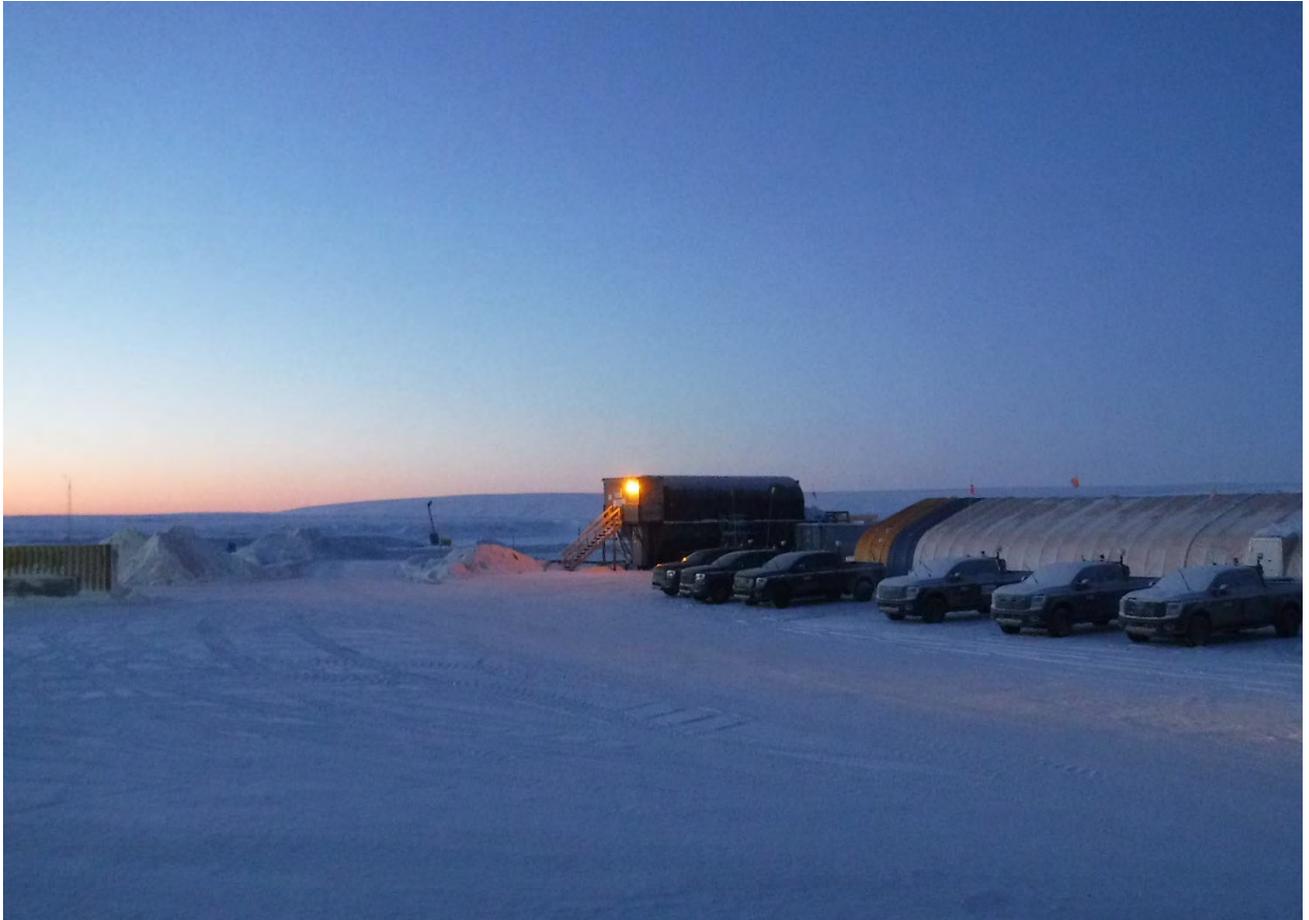
Photo 2. Camp pad adjacent to RBC holding tank after site clean-up.
