**Re: Follow-up to Spill #18-479, Reported on December 15, 2018**  
**Mary River Project - Water Licence No. 2AM-MRY1325**

**Re: Follow-up to Spill #18-481**  
**Mary River Project - Water Licence No. 2AM-MRY1325**

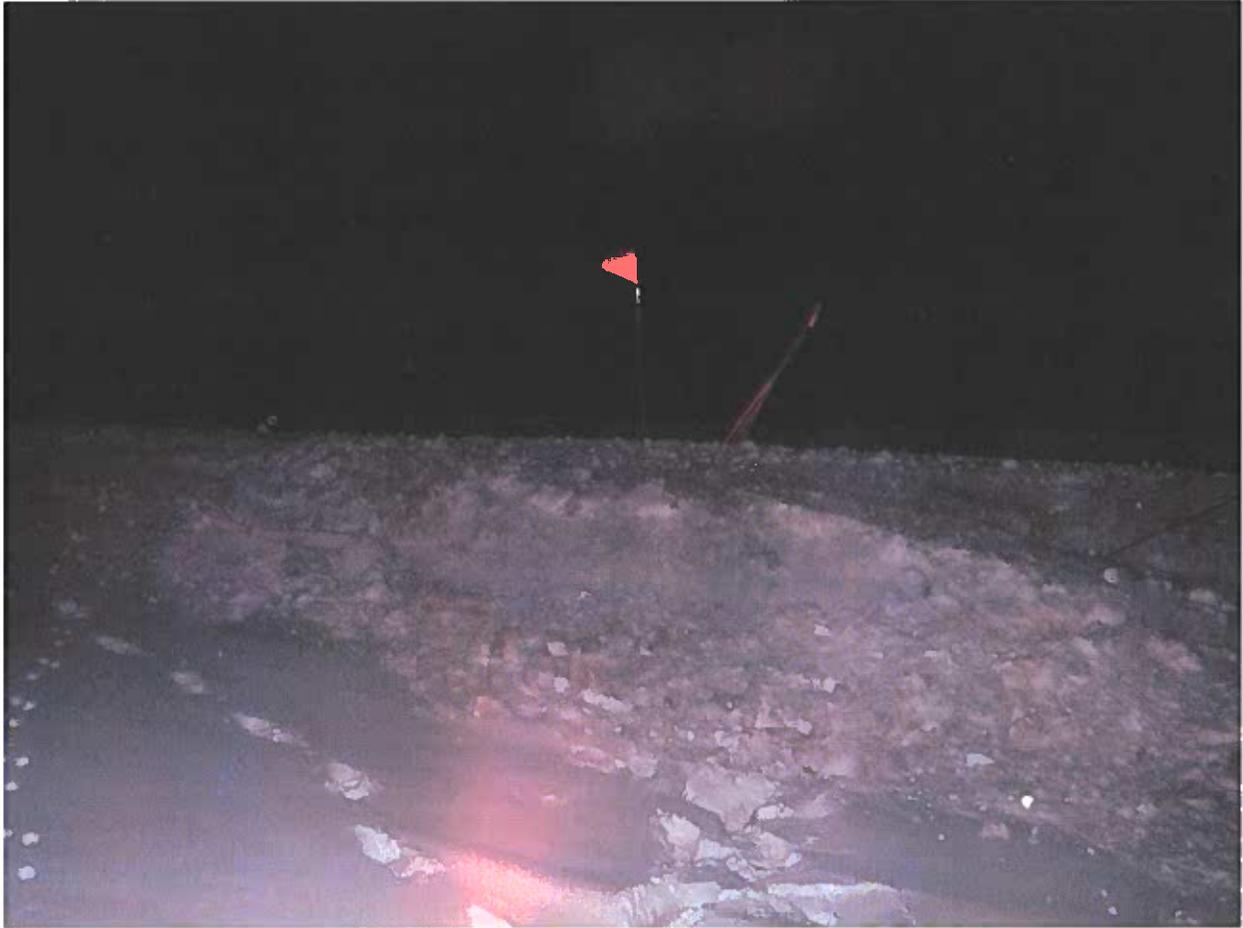
On December 14, a raw water truck was reported to have veered off the Tote Road and come to rest on its side at KM21. The Emergency Response Team (ERT) was dispatched to retrieve the driver and passenger, and to respond to a potential spill. Upon initial investigation, it was determined that approximately 100L of diesel fuel and 10L of hydraulic oil were released onto the snow covered tundra surface adjacent to the Tote Road, impacting approximately 75m<sup>2</sup>. The source of the release was arrested and contained with no ability to migrate beyond the immediate impact area. The spill location was situated 90m away from Phillips Creek which is currently frozen.

**Photo 1. Spill location, KM21.**

Upon arrival, the ERT worked swiftly to identify and arrest the source of release. The spill was successfully contained to the immediate impact area adjacent to the Tote Road with no further migration. Contaminated snow and ice was promptly segregated and clean up of the material was initiated. On December 15<sup>th</sup> personnel returned to auger the ice surrounding the contaminated area to ensure that water released from the damaged truck was frozen to prevent further potential spread during remedial excavation. On December 23<sup>rd</sup> the water truck was extracted from the side of the road with no further spills. The contaminated snow and ice was excavated and transported to a lined engineered containment facility at the Milne Port Site.

A structured progressive driving training program is to be implemented for drivers with limited experience operating equipment on the Mary River Project.

Further signage will be installed on the Milne Inlet Tote Road to identify areas that are narrow.

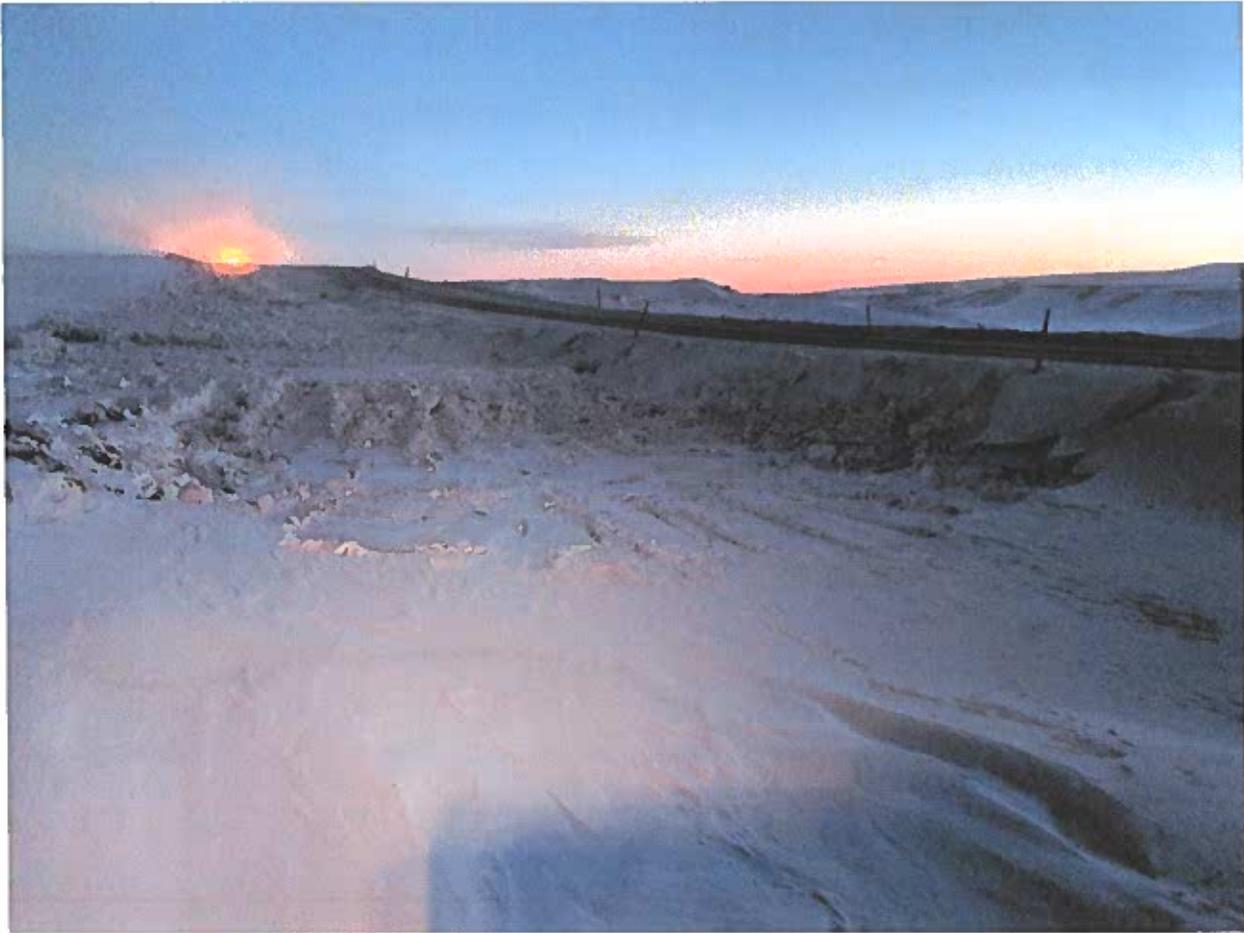
**Photo 2. Contaminated snow and ice removed from impacted area.**

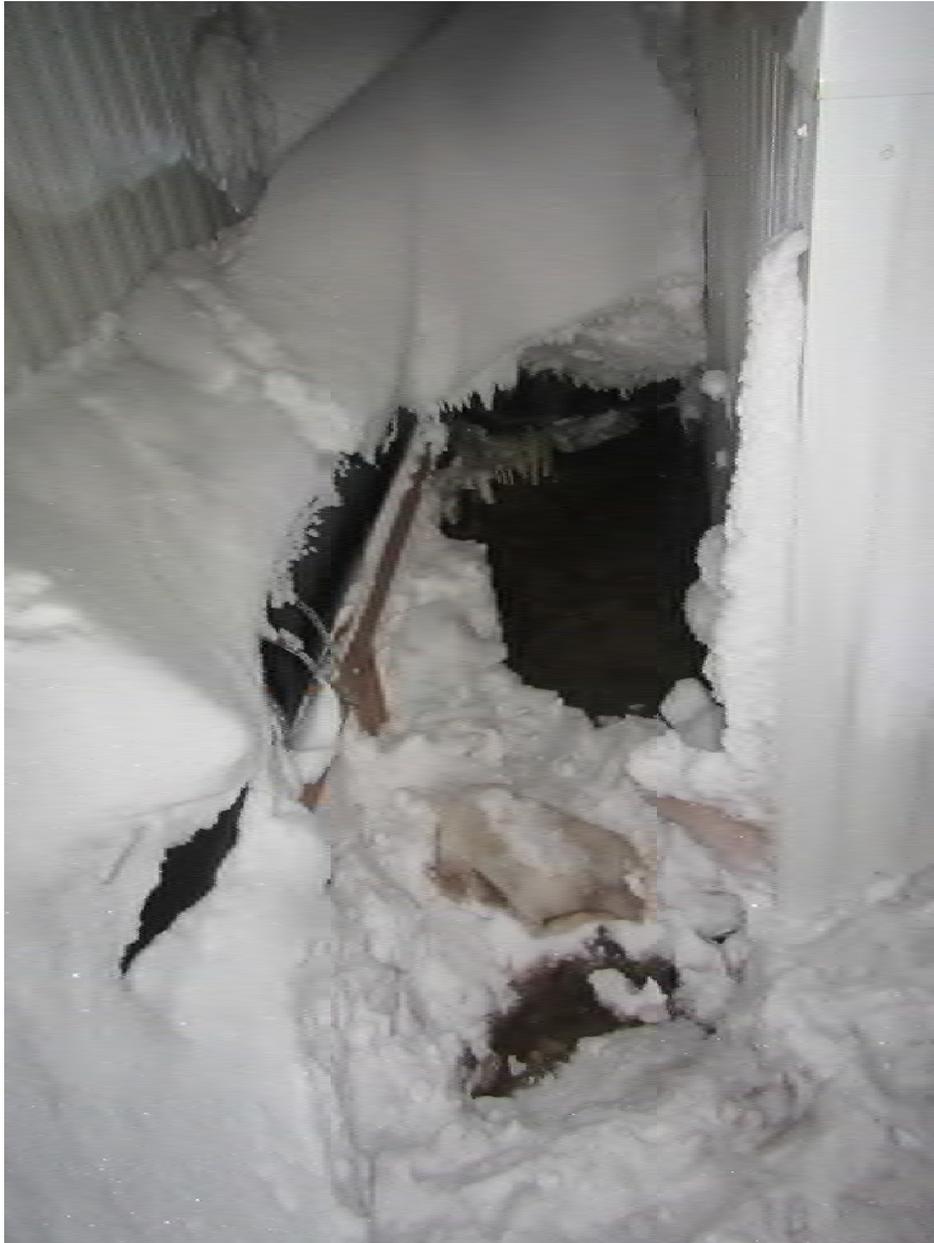
On December 18, 2018 at approximately 17:15 hrs, while conducting inspections of the MSC lift stations, a housing maintainer observed liquid behind the AC wing north lift station. Upon initial investigation, it was determined that the lift station had overflowed. The housing maintainer immediately engaged pump two to empty the lift station and prevent further overflow. Upon further investigation, the housing maintainer noticed the Fernco coupler had separated from the 4" gravity drain directly behind the lift station. Approximately 600L of sewage was released to the adjacent camp pad ground surface, impacting an approximate area of 15 m<sup>2</sup>. This spill is >100 m to the nearest water course, which is currently frozen.

**Photo 1. Sewage release on camp pad adjacent to AC North lift station.**

The sewage release was immediately arrested, and the lift station holding tank pumped down to prevent further release. The contaminated snow was collected and deposited in an engineered lined containment facility. The coupling was repaired and the gravity line was subsequently reconnected.

Continue daily inspections of lift stations and snow/ice removal from lines to mitigate potential releases.

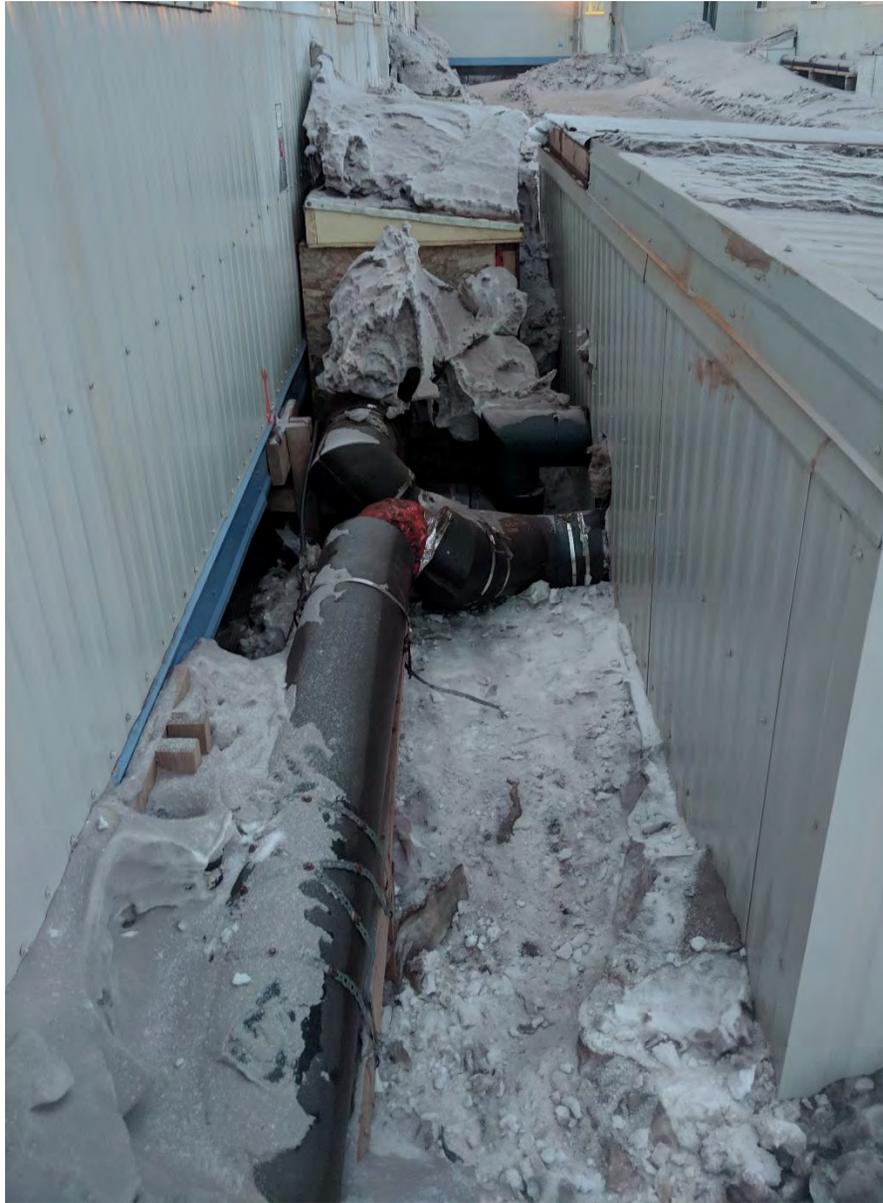
**Photo 2. Contaminated snow removed from camp pad adjacent to AC North lift station.**
