WATER LICENCE INSPECTION FORM

Licensee		Licensee Representative	
Canadian North Resources and Development Corp.		Trevor Boyd- Off site representative	
Licence No. / Expiry		Representative's Title	
2BE-FER1318		Vice president, Exploration	
Land / Other Authorizations		Land / Other Authorizations	
KVCL305H27		N2013X0023 (not issued)	
Inspector		Inspector	
KVRW06F09		WRO C. Wilson	
Activities Inspected			
<input checked="" type="checkbox"/> Camp	<input type="checkbox"/> Drilling	<input type="checkbox"/> Mining	<input type="checkbox"/> Construction
<input checked="" type="checkbox"/> Roads/Hauling	<input checked="" type="checkbox"/> Other: Water Discharge		<input checked="" type="checkbox"/> Reclamation
			<input checked="" type="checkbox"/> Fuel Storage

Date: July 21, 2014	Authorization Number: 2BE-FER1318	Camera/Model: Sony DSC-HX50V Cyber shot	Inspector WRO Wilson
-------------------------------	---	---	--------------------------------

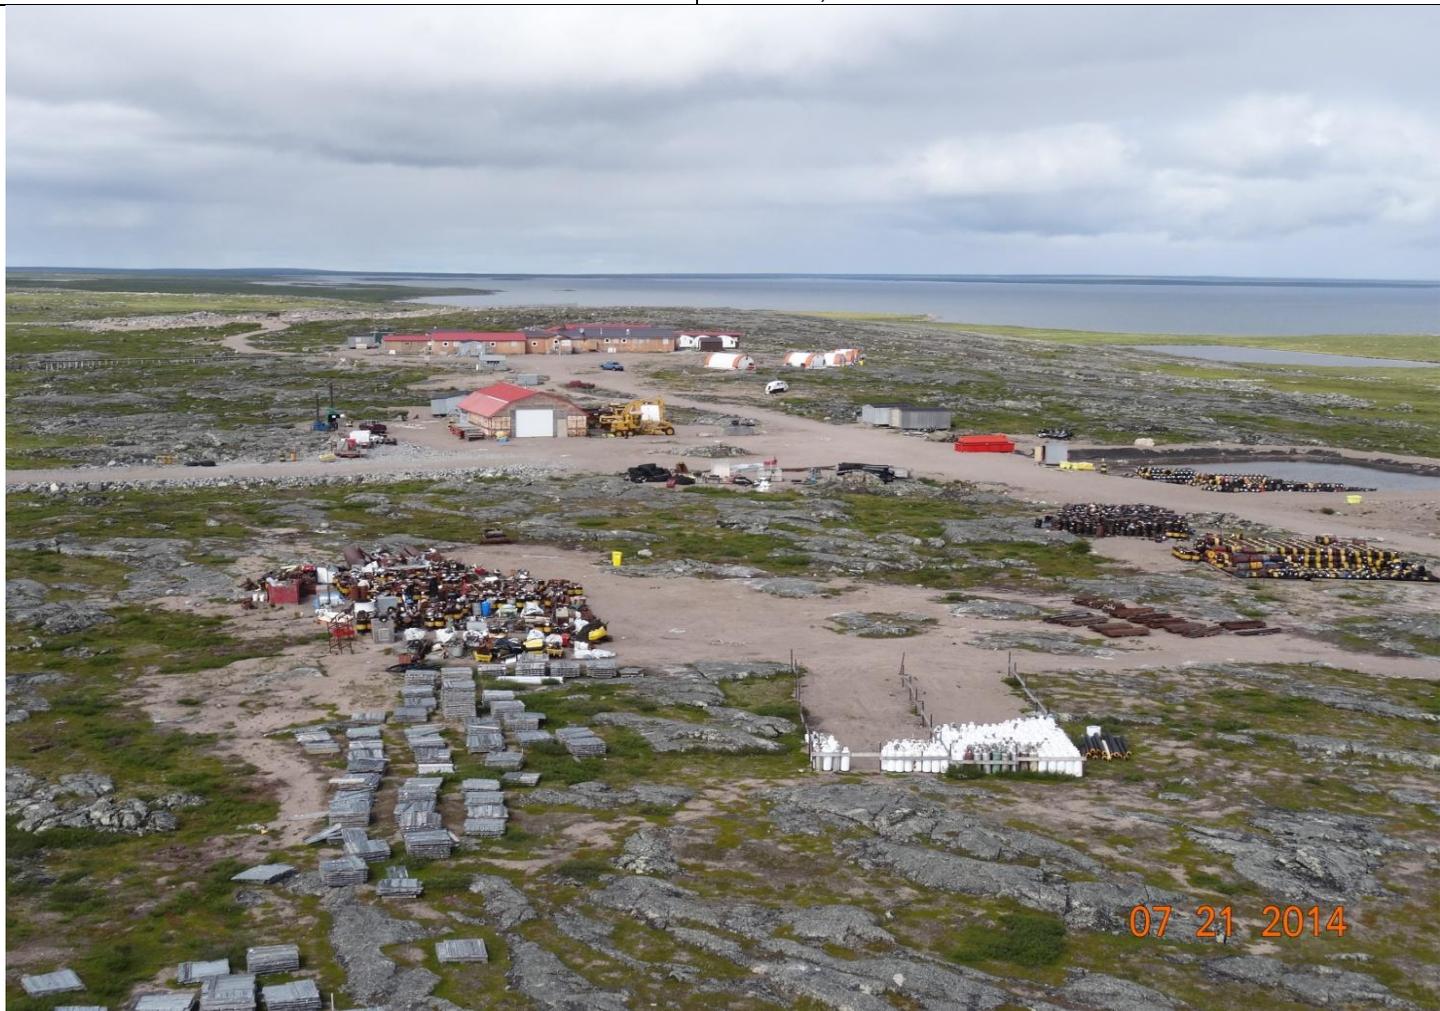
Locations name: PHOTO 1	Lat/Long (DD.MM.SS.SS, NAD83) N°62 53' 33", W 96° 54' 05"
-----------------------------------	---

Description:
Ferguson Lake Project July 21st, 2014

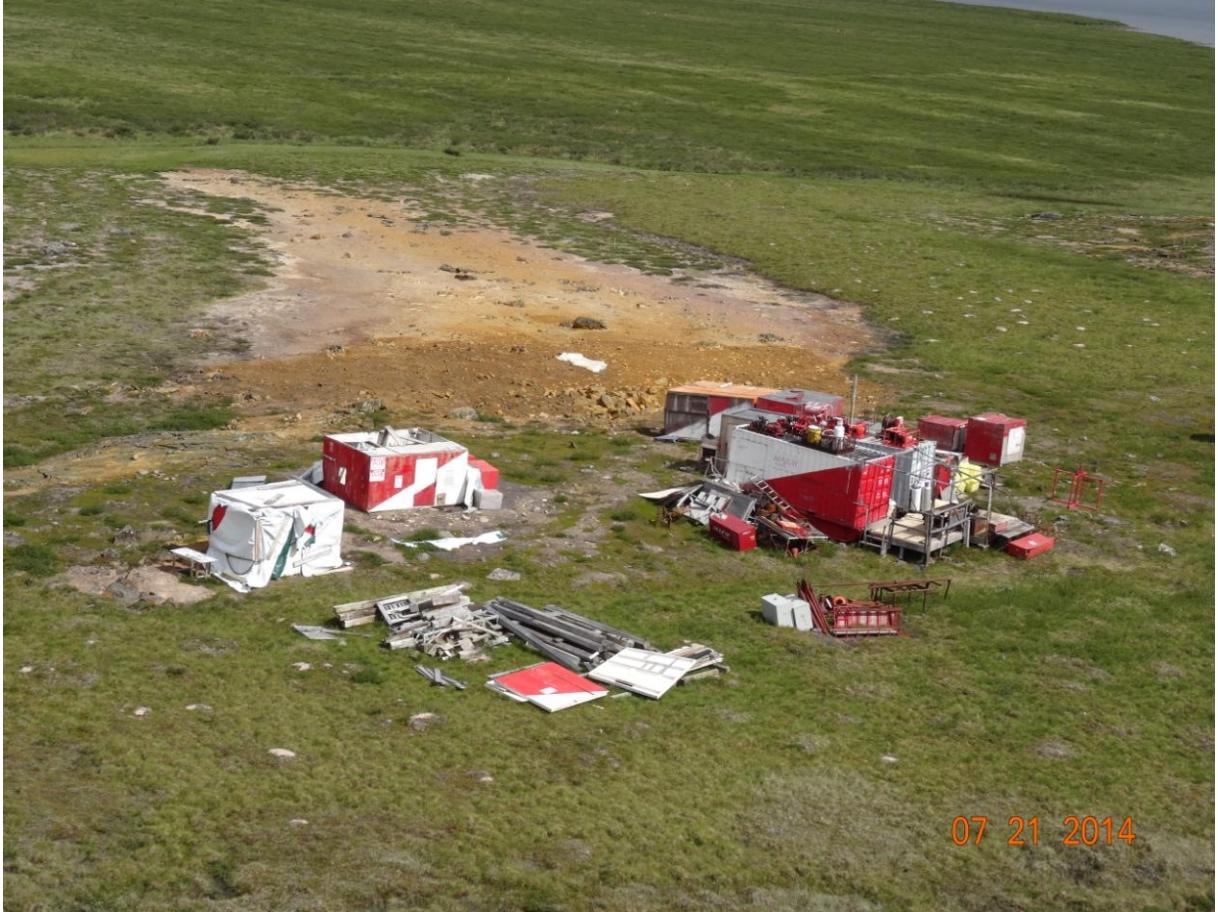
PHOTO 2

3. A large amount of hazardous waste and bulky metals still remain at the site (photo 2) though discussions with the proponent have suggested a plan to winter haul materials out to Rankin Inlet in 2016 which will be shipped from there down south for proper disposal.

7. The 2013 annual report was submitted.
8. The staging area located at N62° 52' 9.768" W96° 55' 29 7.48" appears to have some erosion occurring on the down slope side. The area has become red (photo 2 and 3) and has been eroding progressively over the last three years. The proponent will discuss this location and provide information to the inspector before June 29th, 2015.

Staging area. Red brown cover next to staging area.

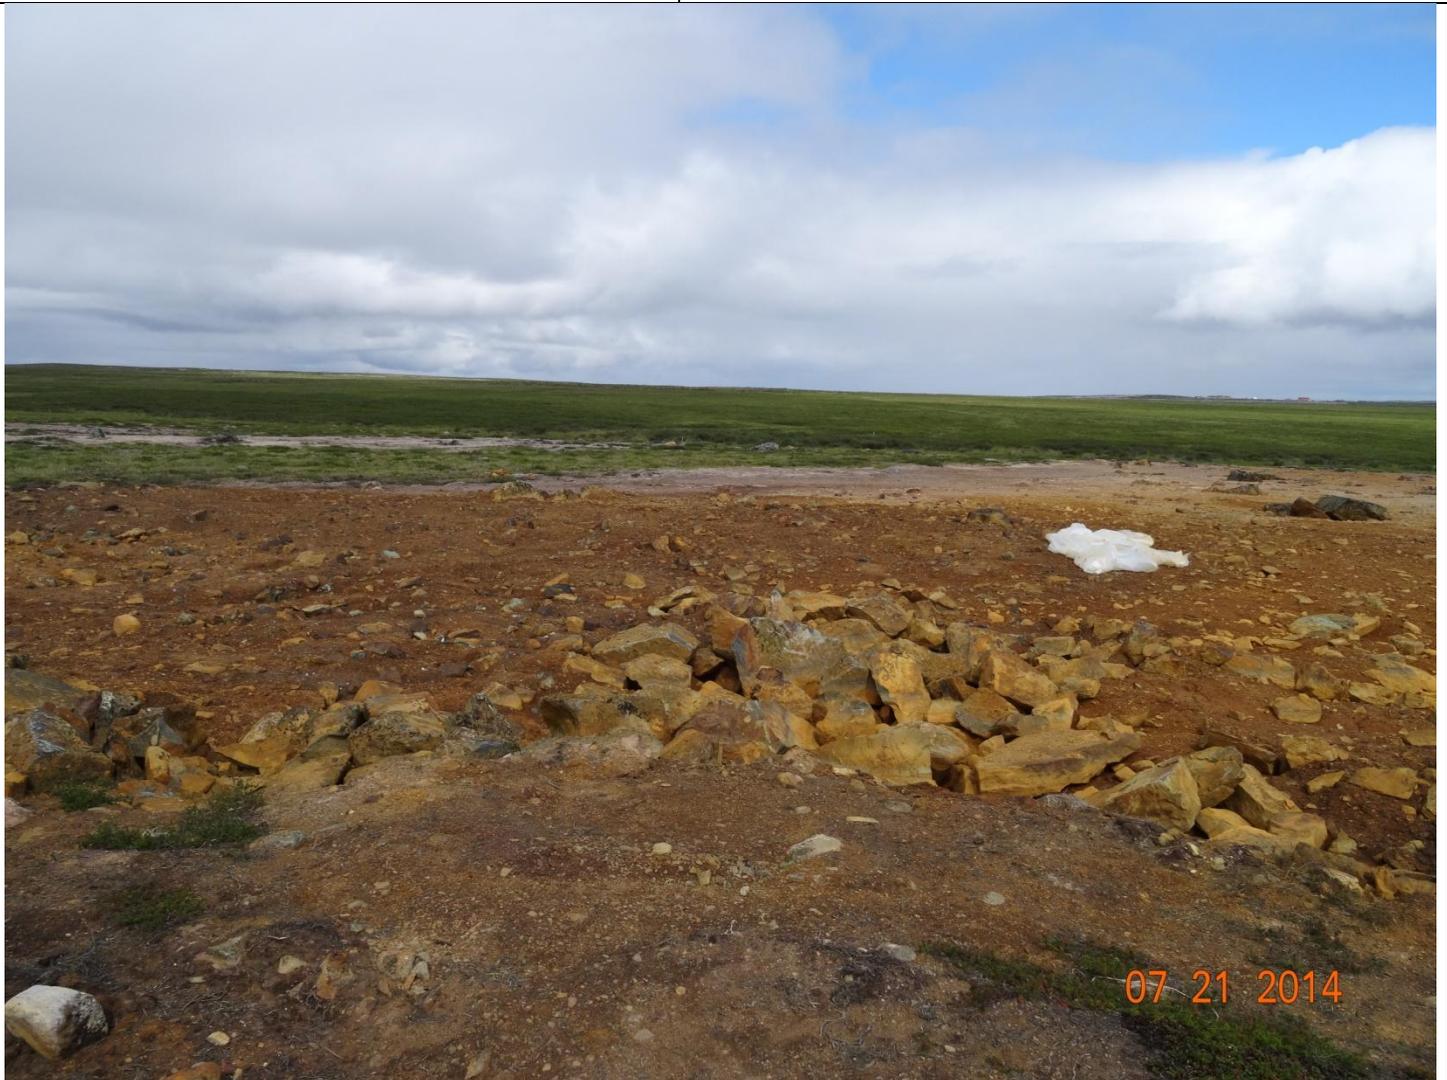
PHOTO 3

Red, eroded cover at staging area

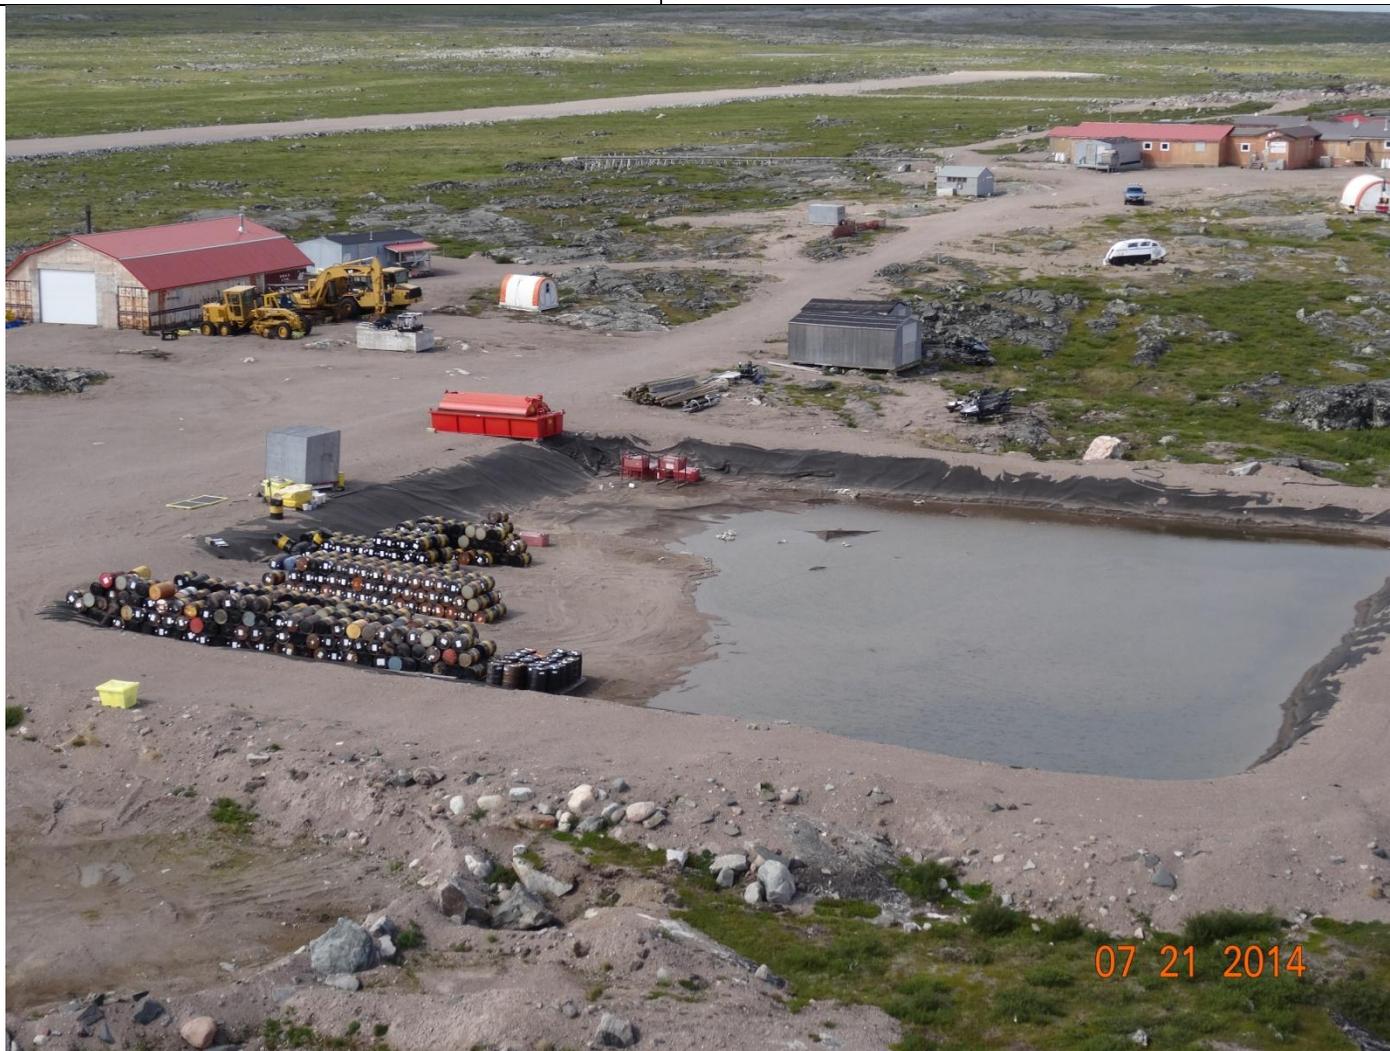
PHOTO 4

4. The site was orderly with no domestic waste or windblown debris which was a concern in previous inspections.
5. The Ferguson Lake Project utilizes a 40m x 40m lined earthen berm referred to as a Fuel Containment Area (FCA) as a secondary containment unit for fuel and hazardous waste storage (photo 4). In previous inspection it has been noted that the FCA fills with a large amount of freshet water during the spring. In previous years this water has been sampled and discharged annually during the summer care and maintenance. As per PART D item 10 of the current water Licence the proponent is required to provide 10 day notification to the inspection prior to the release of effluent from the FCA. No Notification was received by the AANDC Field Operations Unit or the Inspector.

Fuel Containment Area (FCA) with fresh water.

- The proponent shall submit to the Inspector the sampling results and analysis of the FCA prior to discharge as discussed in PART D item 11. The Proponent shall also include the co-ordinates of the discharge as required PART J item 3. This information will be provided to the Inspector no later than March 31st, 2015.
- The proponent shall submit a revised Abandonment and Reclamation Plan to capture the current state of the project and to included the requirements of PART I item 1. This plan will consider the intent of PART B item 5, 6, 7 and 8 and be submitted to the Nunavut Water Board's Manager of Licensing and the Inspector no later than June 29th, 2015.
- The proponent shall revise the plan titled "Ferguson Lake Spill Contingency Plan" to include the requirements of PART H
