PROJECT		<b>AGNICO EAGLE MINES LIMITED MEADOWBANK GOLD PROJECT NUNAVUT</b>		
TITLE		<b>VAULT DIKE TEMPERATURE DATA (Aug 1/18 to Aug 21/19)</b>		
	PROJECT No.	PHASE No.		
	DESIGN TD 28AUG14	SCALE	AS SHOWN	REV.
	CADD TD 28AUG14	<b>FIGURE 54</b>		
	CHECK PG 28AUG14			
REVIEW

**APPENDIX D**

**All Weather Private Road**

**AWPR Observations**

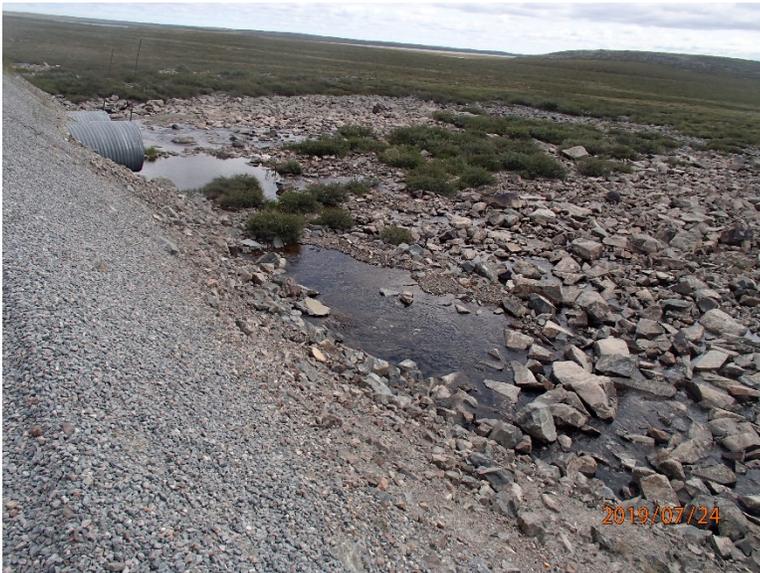
**Photograph D2-2: PC-17A km 8+830**

**Photo Number:** 196

**Description:** View of the culverts outlet. No sign of degradation since last year but the flow moved further south (5-10 m from culvert).

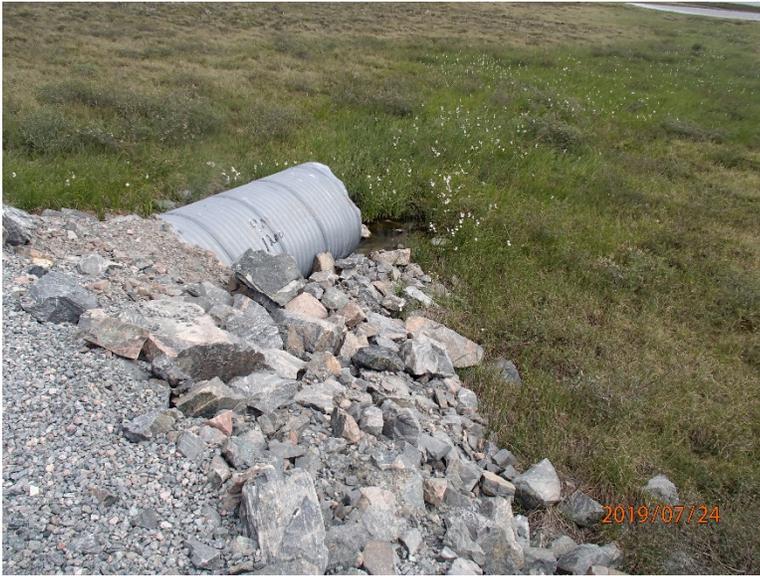
**Photograph D2-3 R-04 km 12+050**

**Description:** View of the culvert inlet. In good condition.

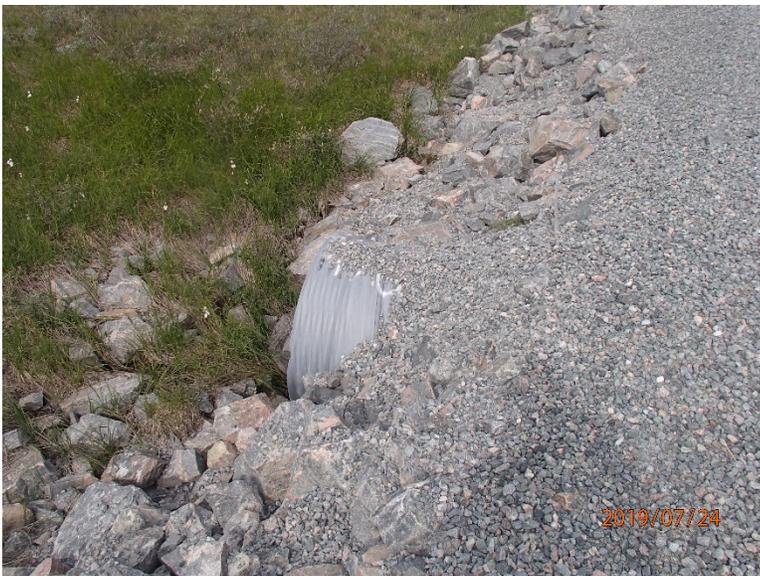
**Photograph D2-4: R-04 km 12+050**

**Description:** View of the culvert outlet. In good condition.

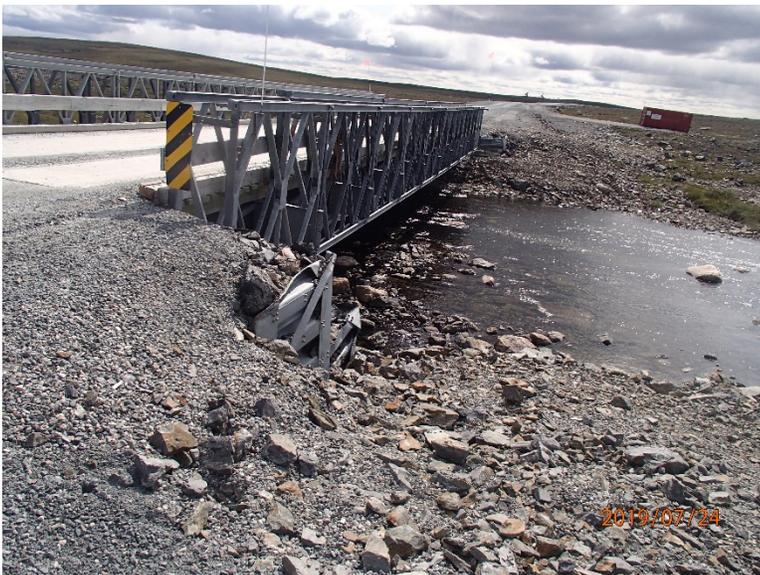
**Photograph D3-10 Bridges 5 – R15 km 69+200**

**Description:** Looking at the south abutment. Damage to the bin wall likely caused during snow removal activities. Bridge is tipping toward the west side on the abutment.

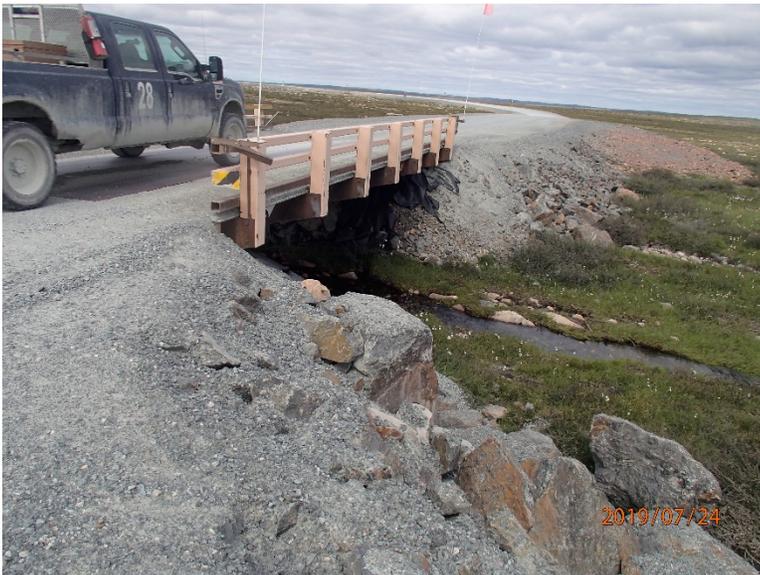
**Photograph D3-11 Bridges 6 – R16 km 73+800**

**Description:** Looking at the north abutment. In good condition.

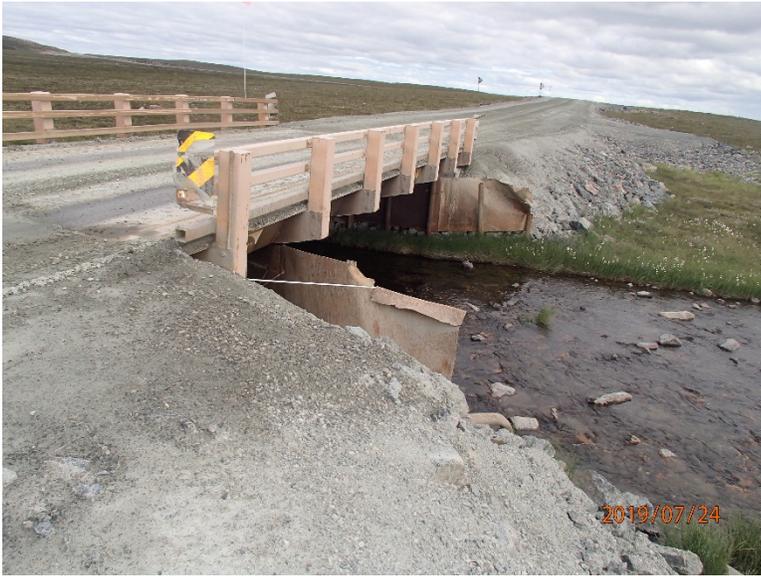
**Photograph D3-15 Bridges 8 – R19 km 83+150**

**Description:** Looking at the north abutment. Minor damage to steel plate due to snow removal activity.

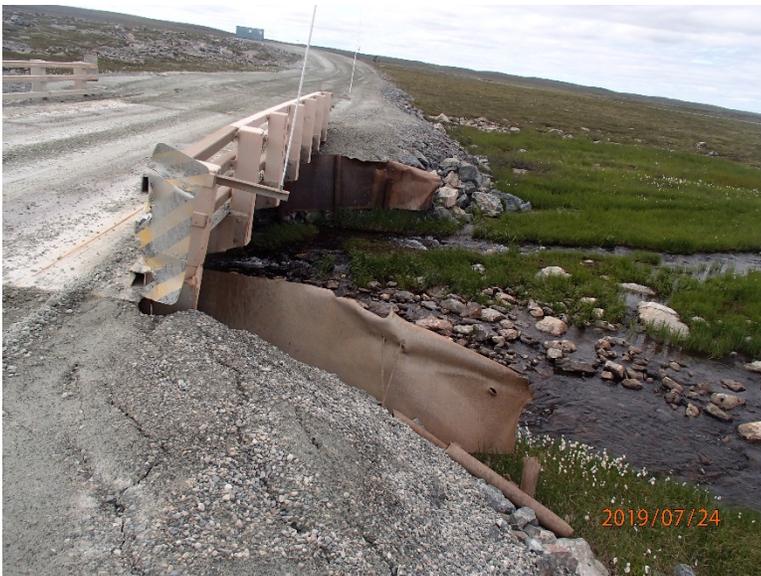
**Photograph D3-16 Bridges 8 – R19 km 83+150**

**Description:** Looking at the south abutment. Minor damage to steel plate due to snow removal activity.

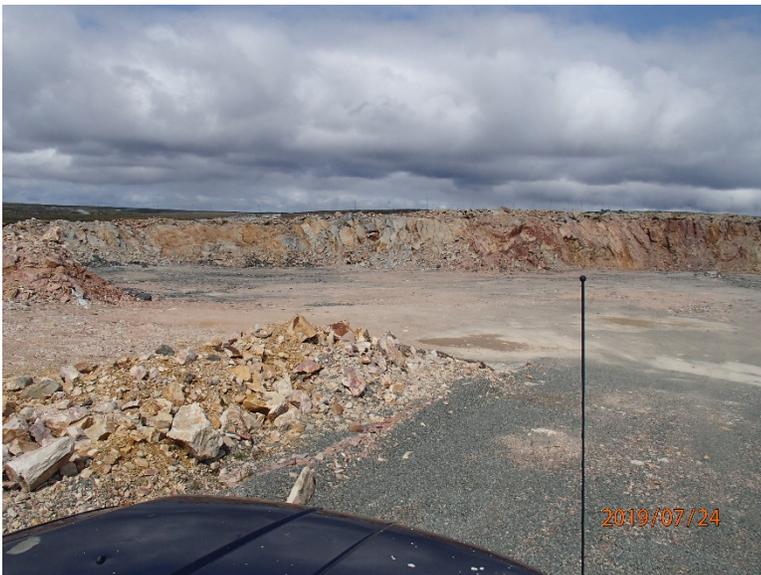
**Photograph F-8: Quarry 5 – km 34+650**

**Description:** View of north and west walls. In good condition.

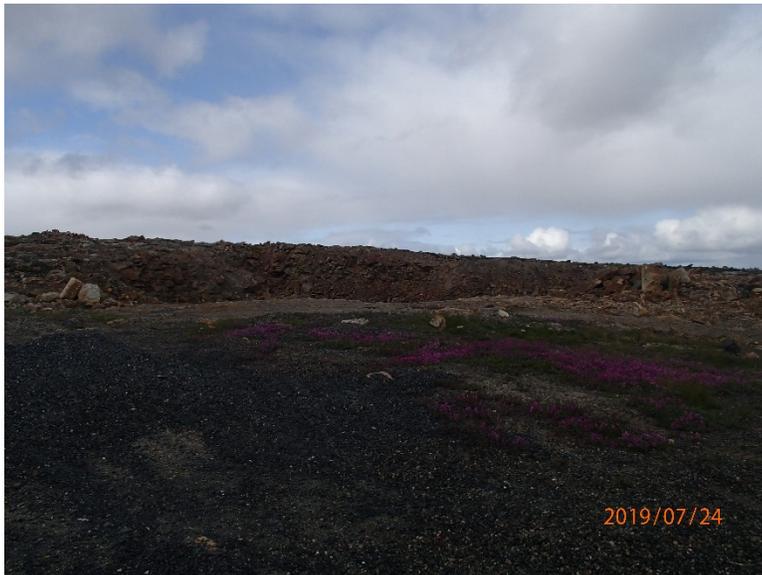
**Photograph F-11: Quarry 7 – km 39+800**

**Description:** The quarry walls are in unstable condition. Scaling is recommended before resuming activities..

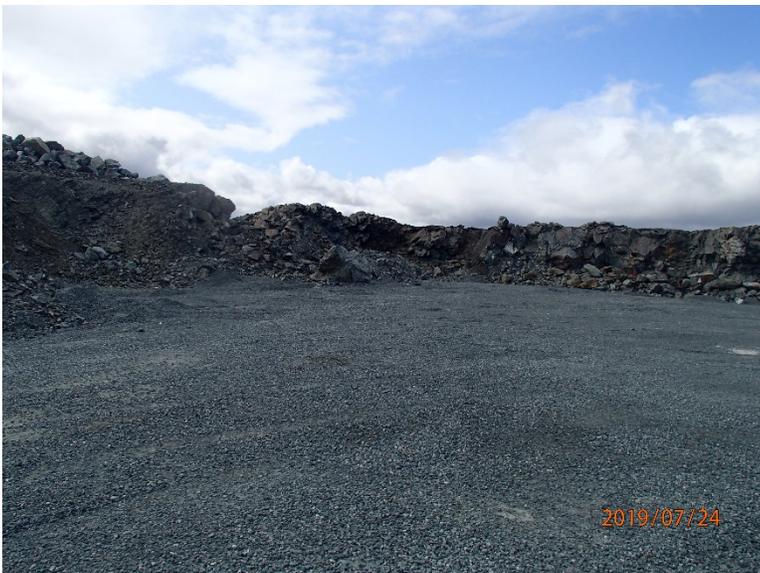
**Photograph F-14: Quarry 9 – km 44+600**

**Description:** View of west and south walls. Presence of loose blocks at the base of the wall.

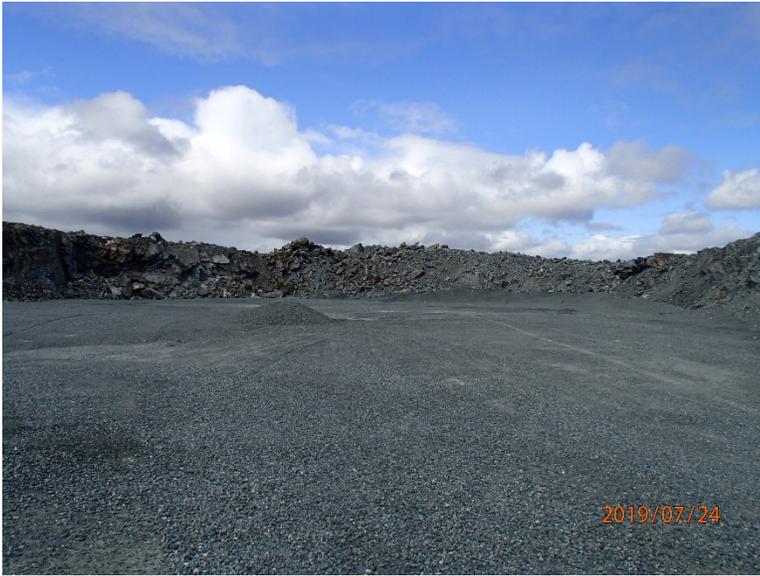
**Photograph F-15: Quarry 9 – km 44+600**

**Description:** View of north and east walls. View of a pile of loose material.

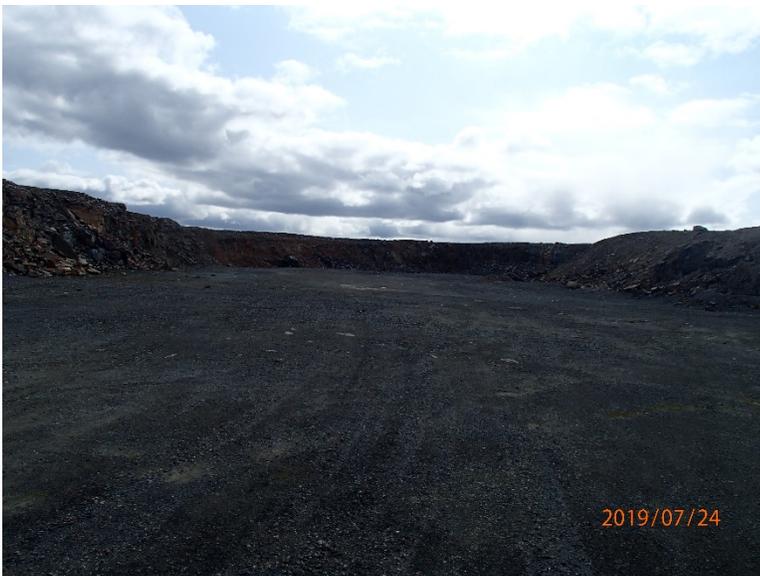
**Photograph F-24: Quarry 16 – km 70+400**

**Description:** View of the south and west walls. Presence of loose rocks on steep wall but in general good condition.

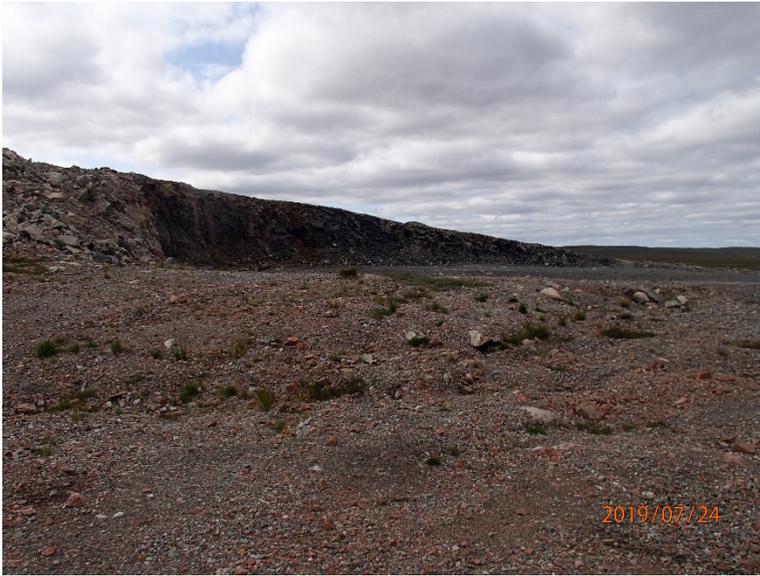
**Photograph F-25: Quarry 18 – km 80+200**

80+200	Quarry 18		In general good condition, south wall is high (about 8 m) with some loose blocks.	14w 627370 /7202154	239
80+950	R-18A	3x1200 mm CSP	In good condition.	14w 627556 /7202800	240
82+500	R-18B	1X600 mm CSP	In good condition, installed above ground surface (water can flow below culvert).	14w 627034 /7203901

**Description:** View of the south wall. In general good condition, south wall is high (about 8 m) with some loose blocks

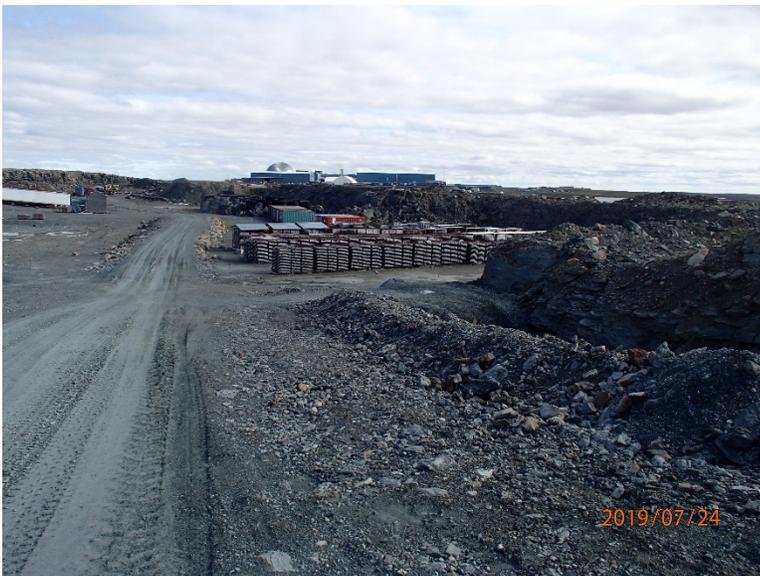
**Photograph F-28: Quarry 23 (Airstrip Quarry)**

**Description:** Loose rocks on top of steep wall (bermed). The quarry is used to store equipment.

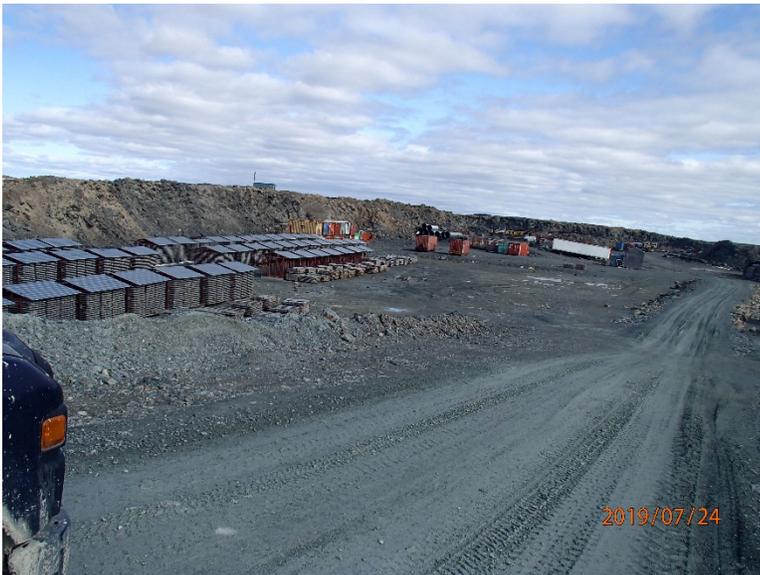
**Photograph F-29: Quarry 23 (Airstrip Quarry)**

**Description:** Loose rocks on top of steep wall (bermed). The quarry is used to store equipment.

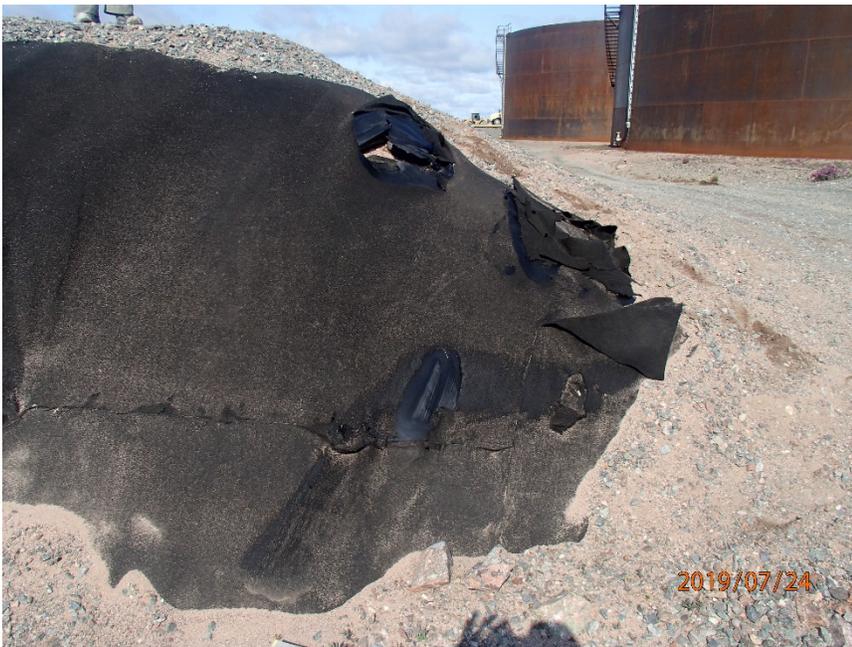
**Photograph G1-6 Baker Lake Tank Farm**

**Description:** Looking southwest. The geomembrane between the south side of tank 2 and 3 is damaged.
