APPENDIX M

ALL-WEATHER ACCESS ROAD

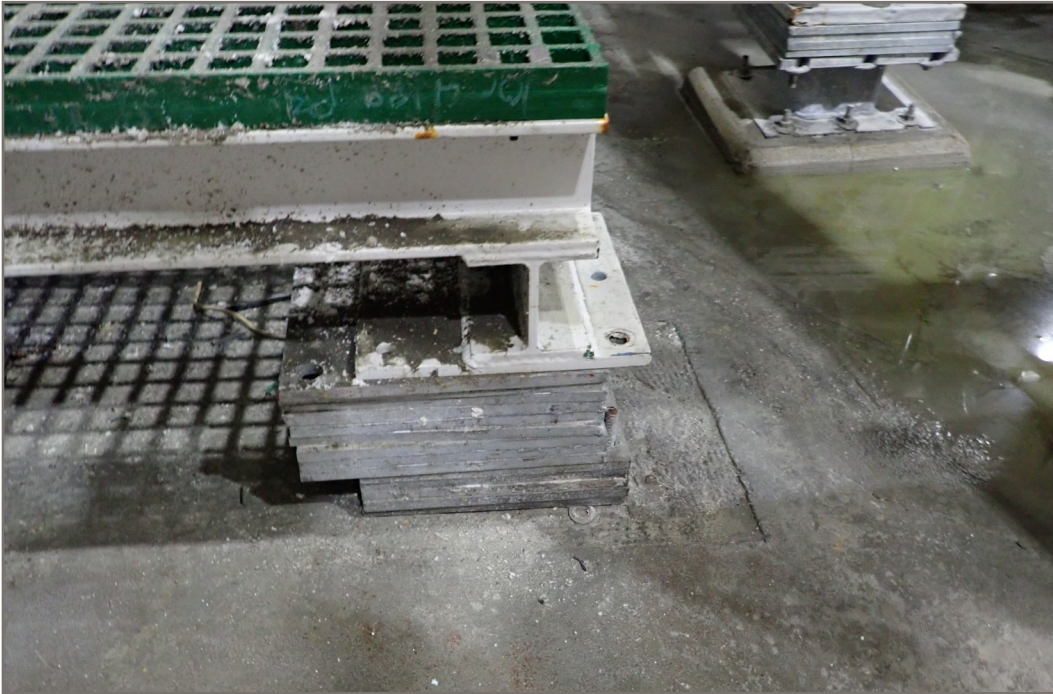
Photo 9: SWTP Shims to level the plant

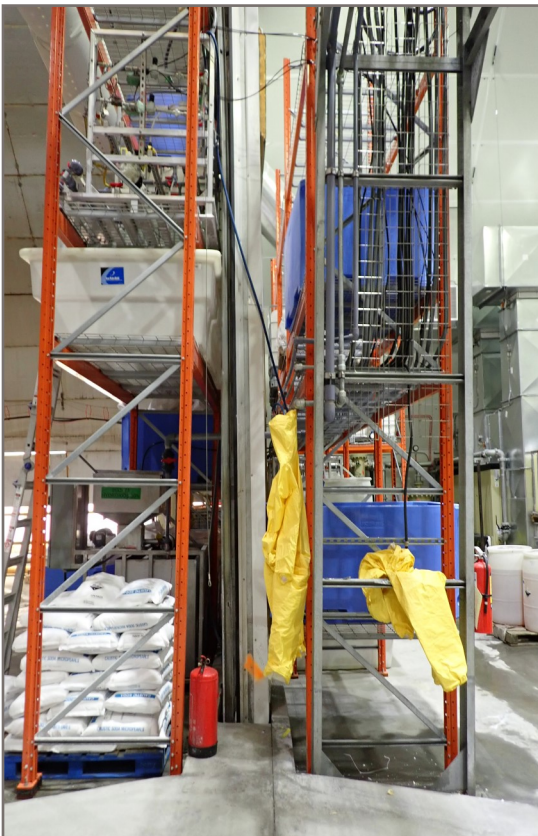
Photo 10: SWTP Racking not level

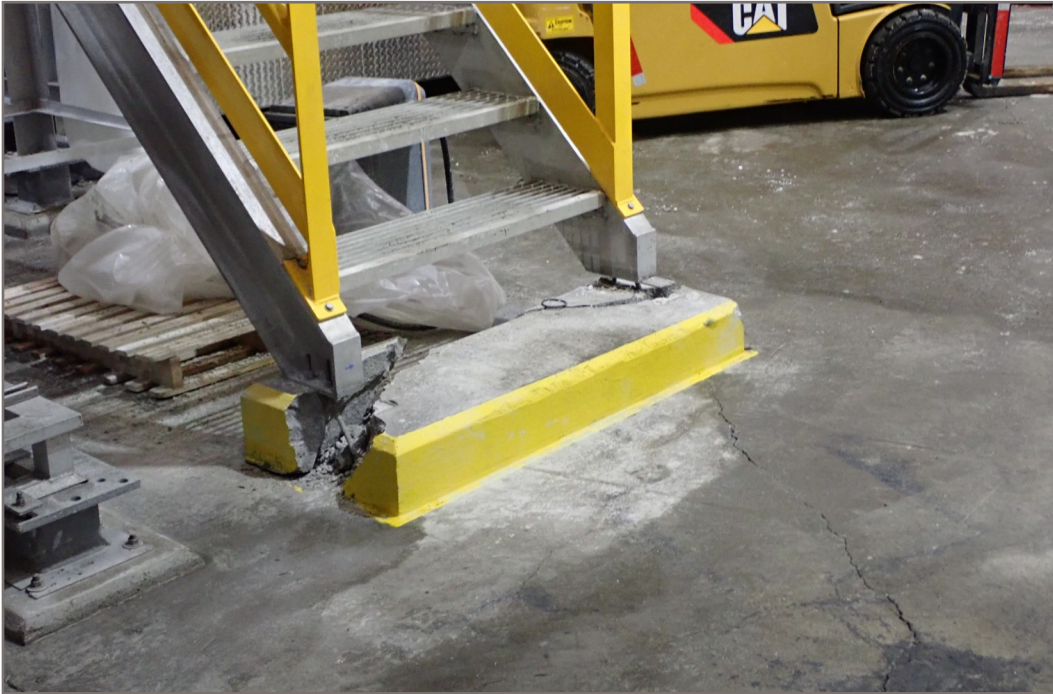
Photo 11: SWTP Distress due to floor movement

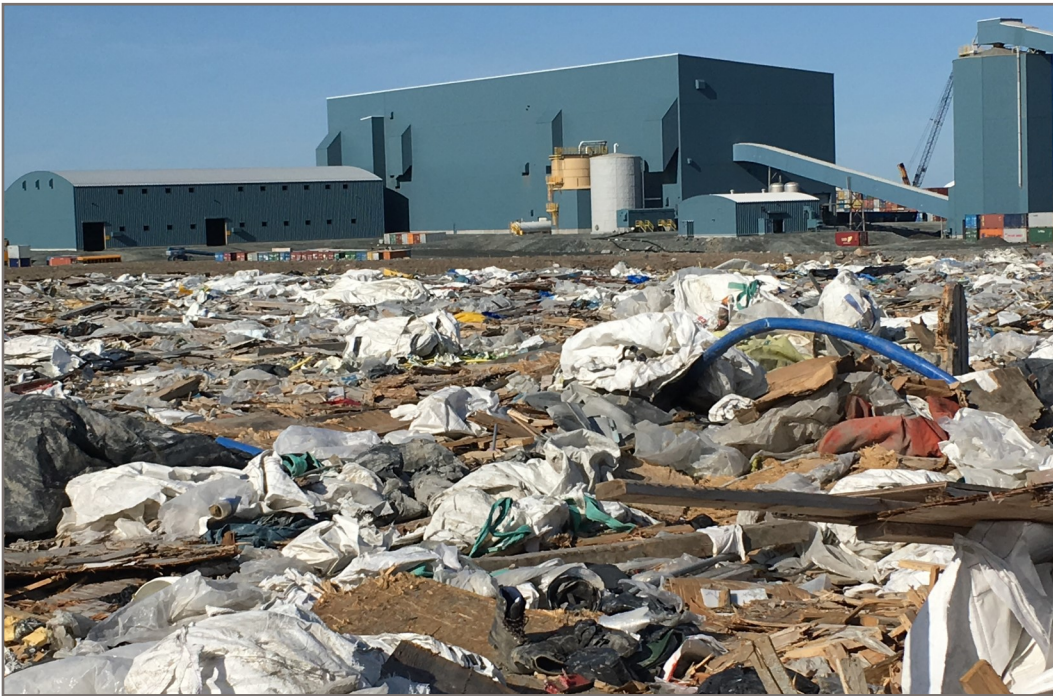
Photo 15: Landfill debris

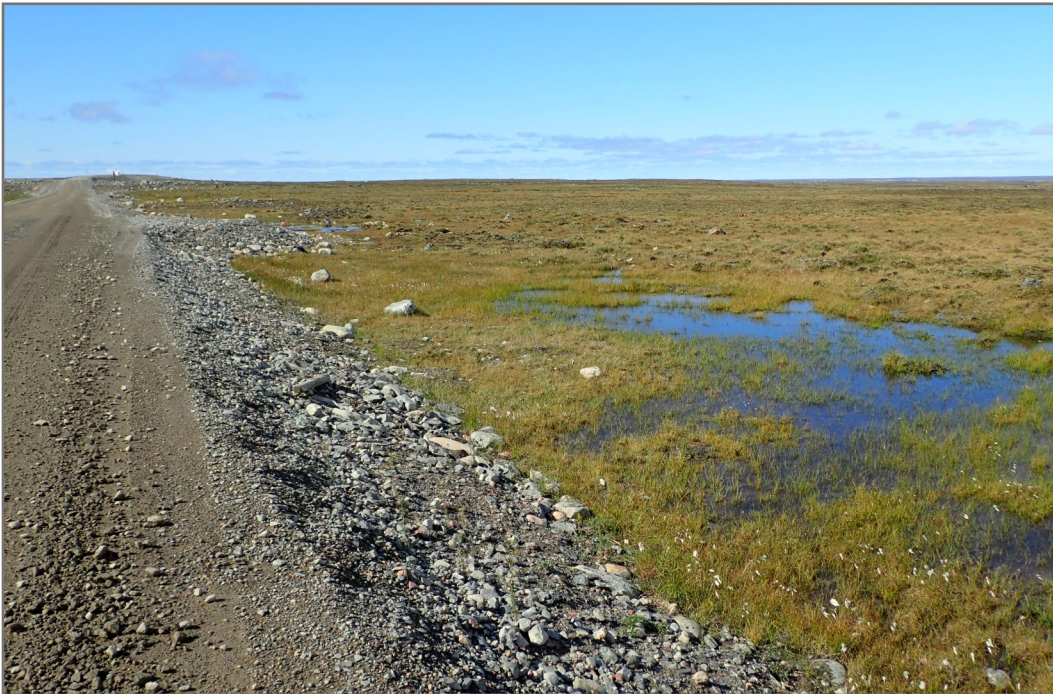
Photo 12: km 19.5 no culvert
