JERICHO DIAMOND MINE OPERATION, MAINTENANCE AND SURVEILLANCE PLAN

NUNAVUT IMPACT REVIEW BOARD FILE #16UN058 2019 ANNUAL REPORT

May 4, 2020

**APPENDIX B:
JERICHO MINE SITE
OPERATION, MAINTENANCE AND SURVEILLANCE PROGRAM
2019 REPORT – FINAL**

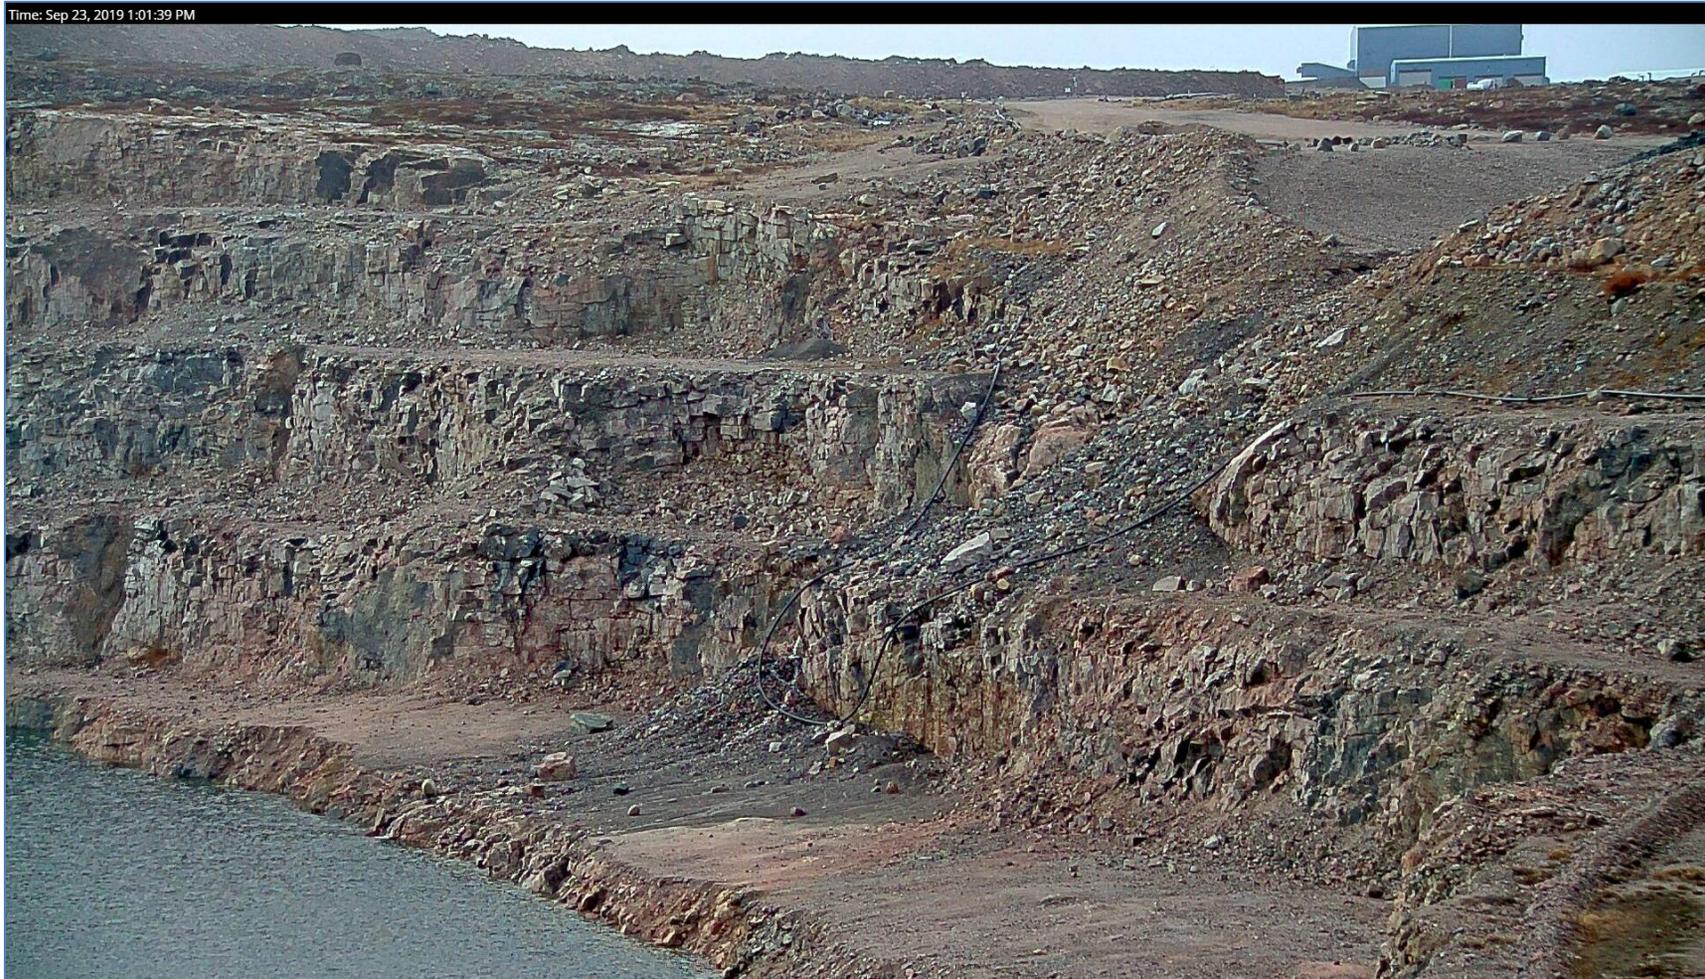
The installation of the remote camera now provides an inspection tool to view the Open Pit water level, as well as visual change of any further erosion of the C1 Channel into the pit. Figure 1 was an image collected from the camera on September 23, 2019.

Figure 1 – Remote Camera Image of Open Pit from September 23, 2019

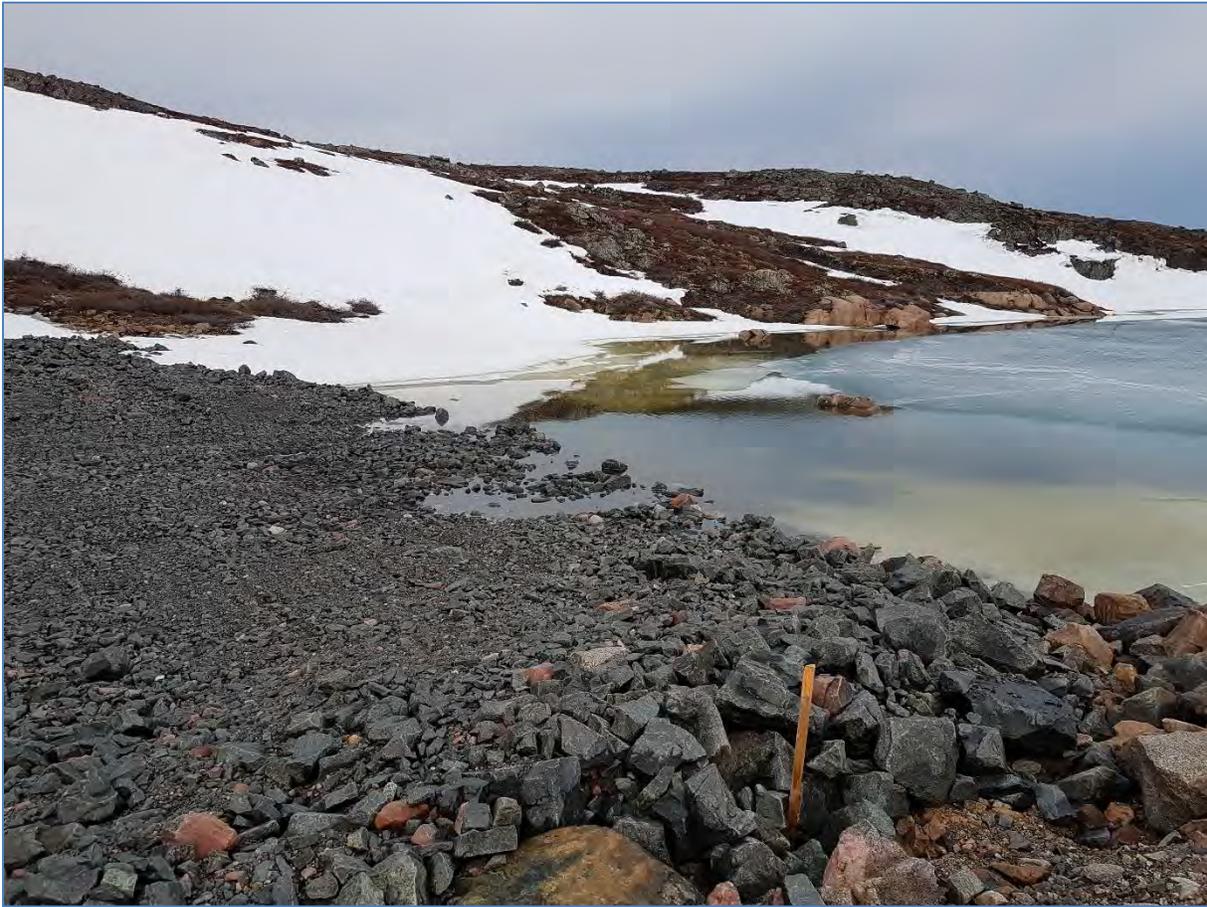
Photo 1: June 17, 2019 West Dam Breach, Looking E – Spring inlet water level.

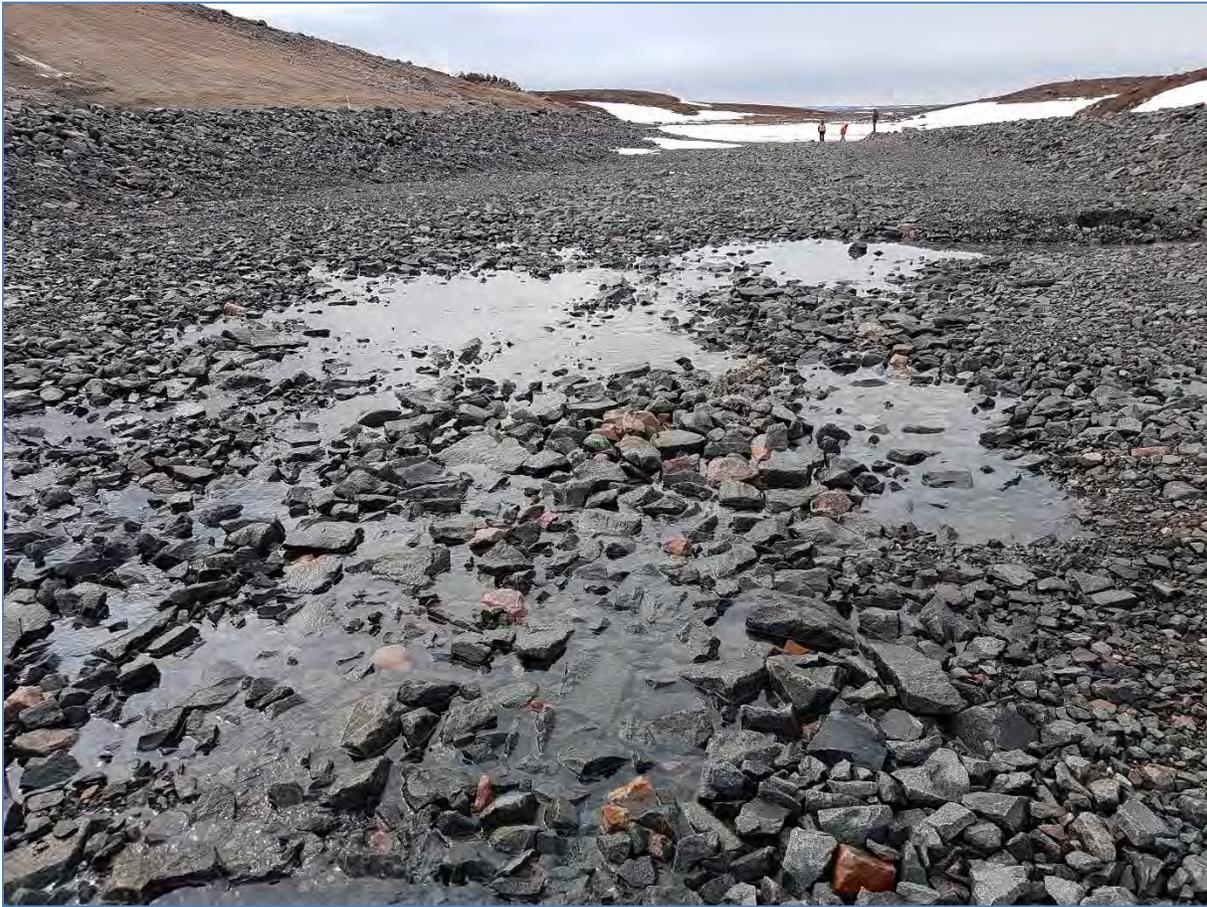
Photo 2: June 17, 2019 West Dam Breach, Looking W across Channel Base – Spring flowing water.

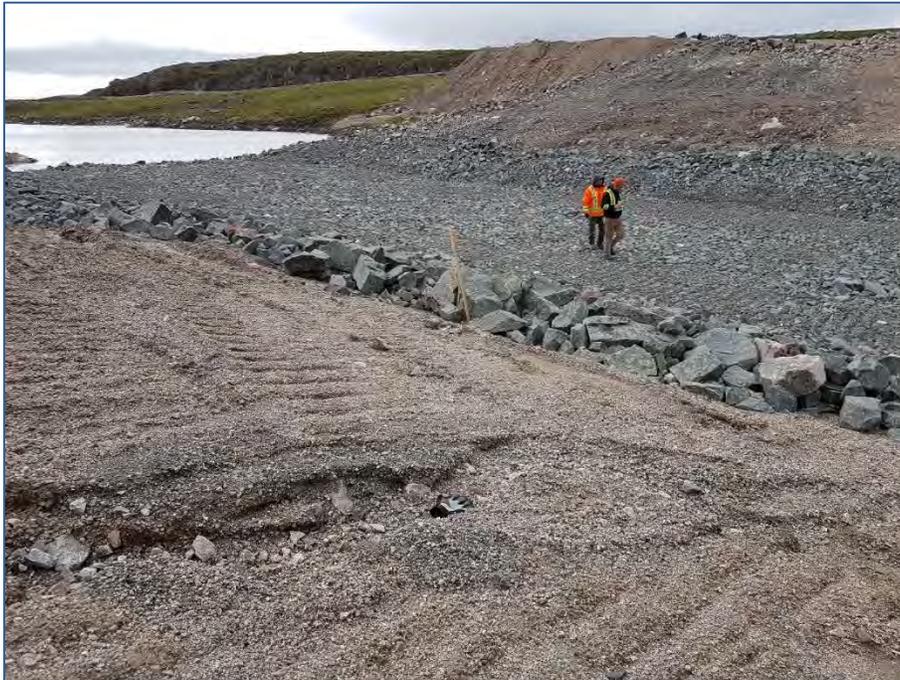
Photo 3: August 3, 2018 West Dam Breach – 2018 photo of erosion gully on North Bank.

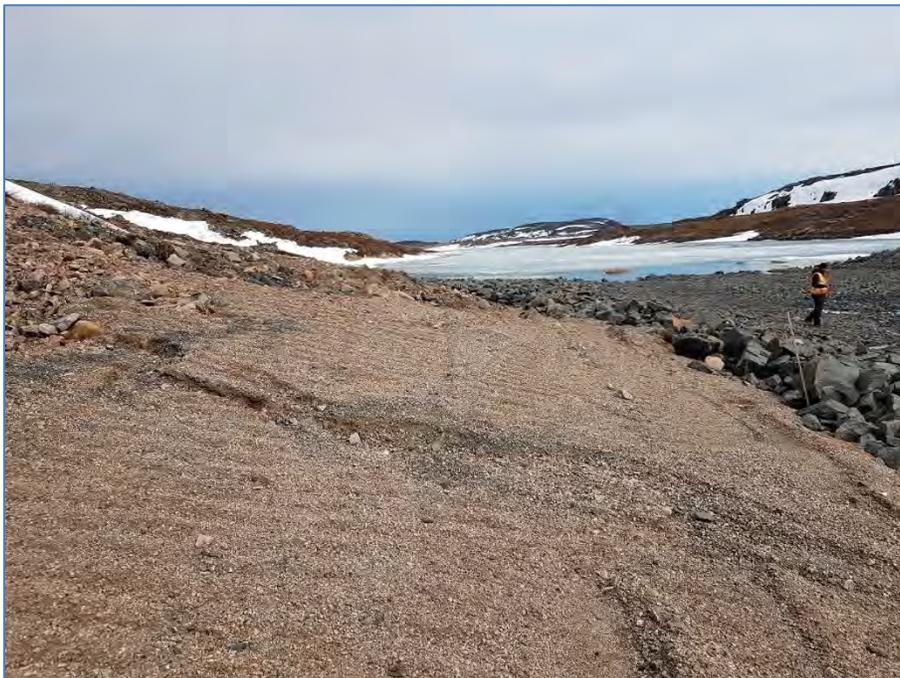
Photo 4: June 17, 2019 West Dam Breach – No significant change in erosion gully on North Bank.

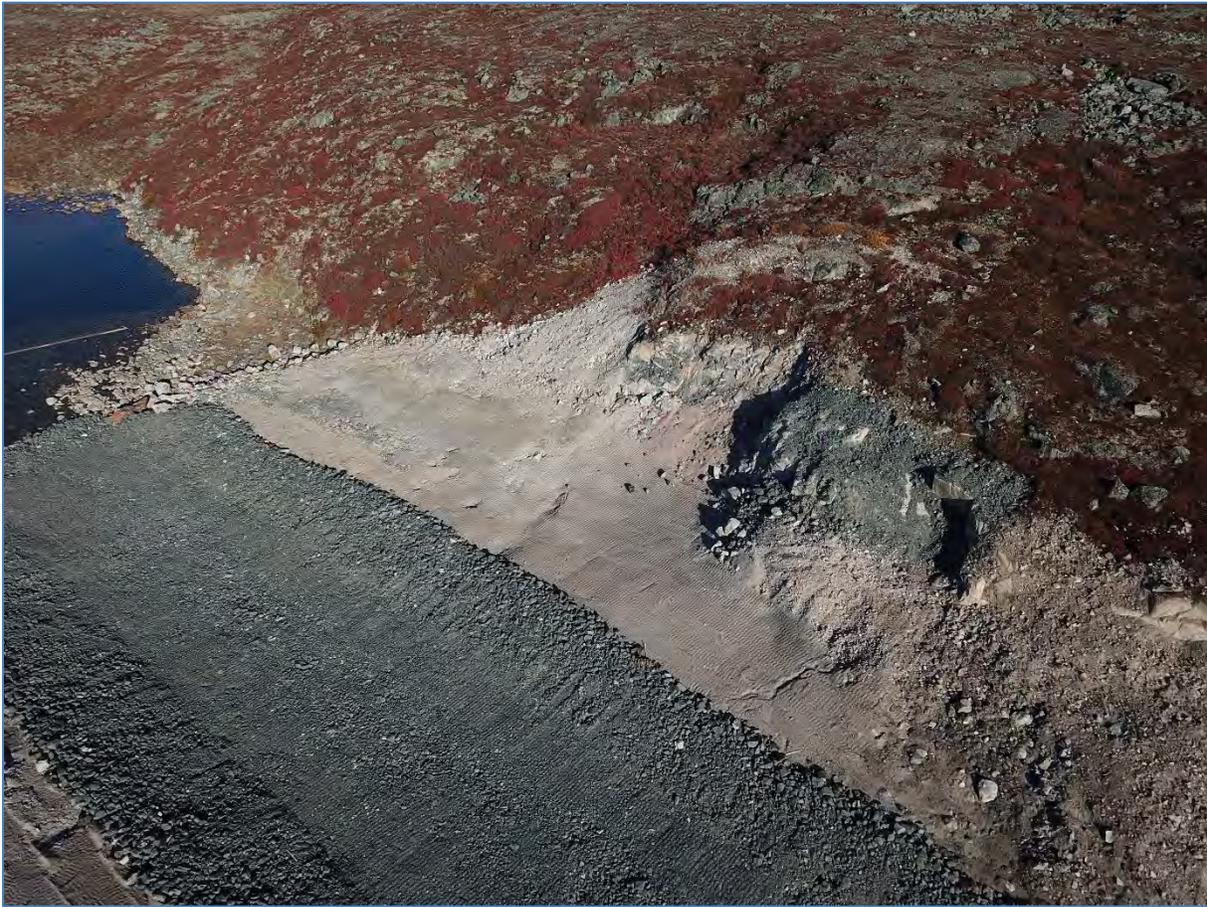
Photo 5: Sept. 11, 2019 West Dam Breach – Fall aerial photo of North bank.

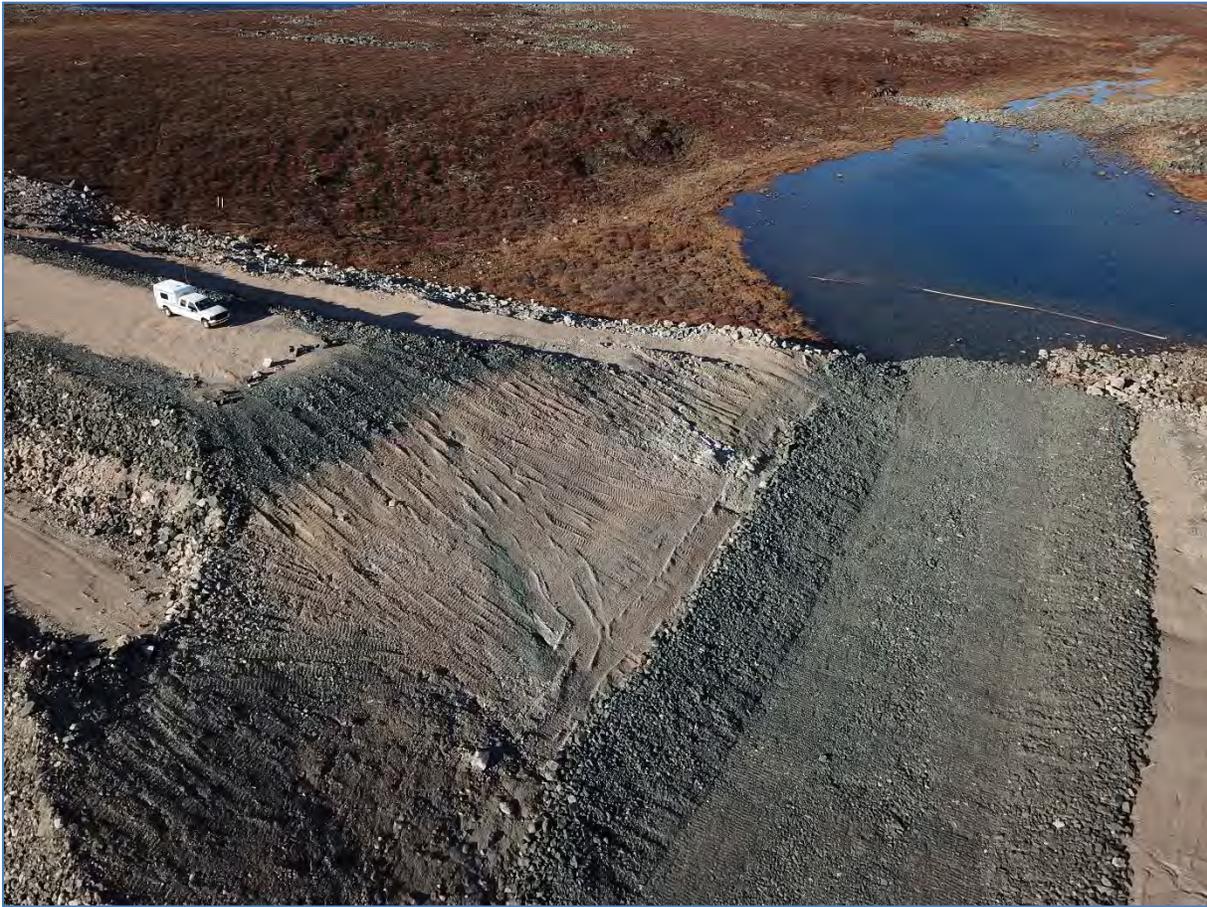
Photo 6: Sept. 11, 2019 West Dam Breach – Fall aerial photo of South bank.

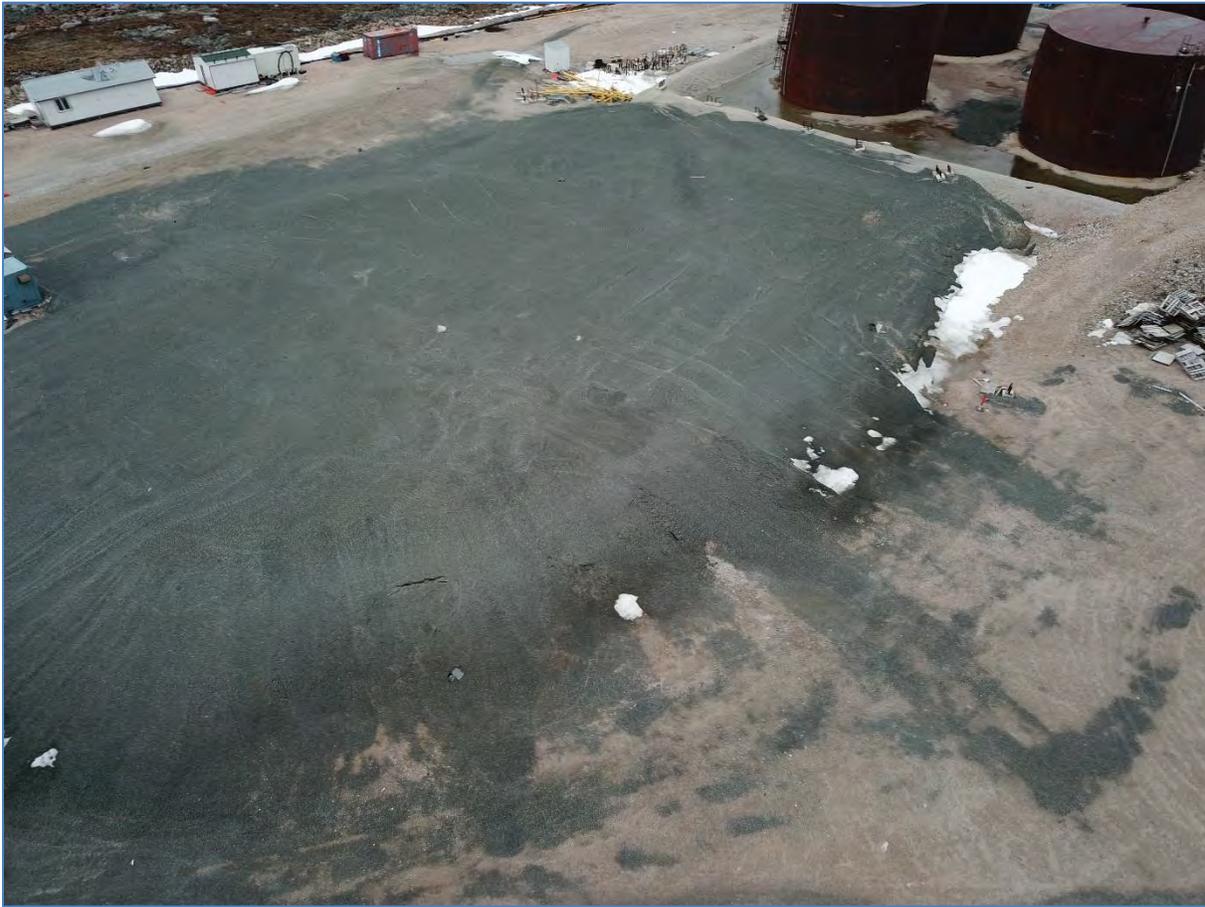
Photo 7: June 18, 2019 PHC Containment Cell Cover, Looking N – Some settlement and drainage erosion along East Bank.

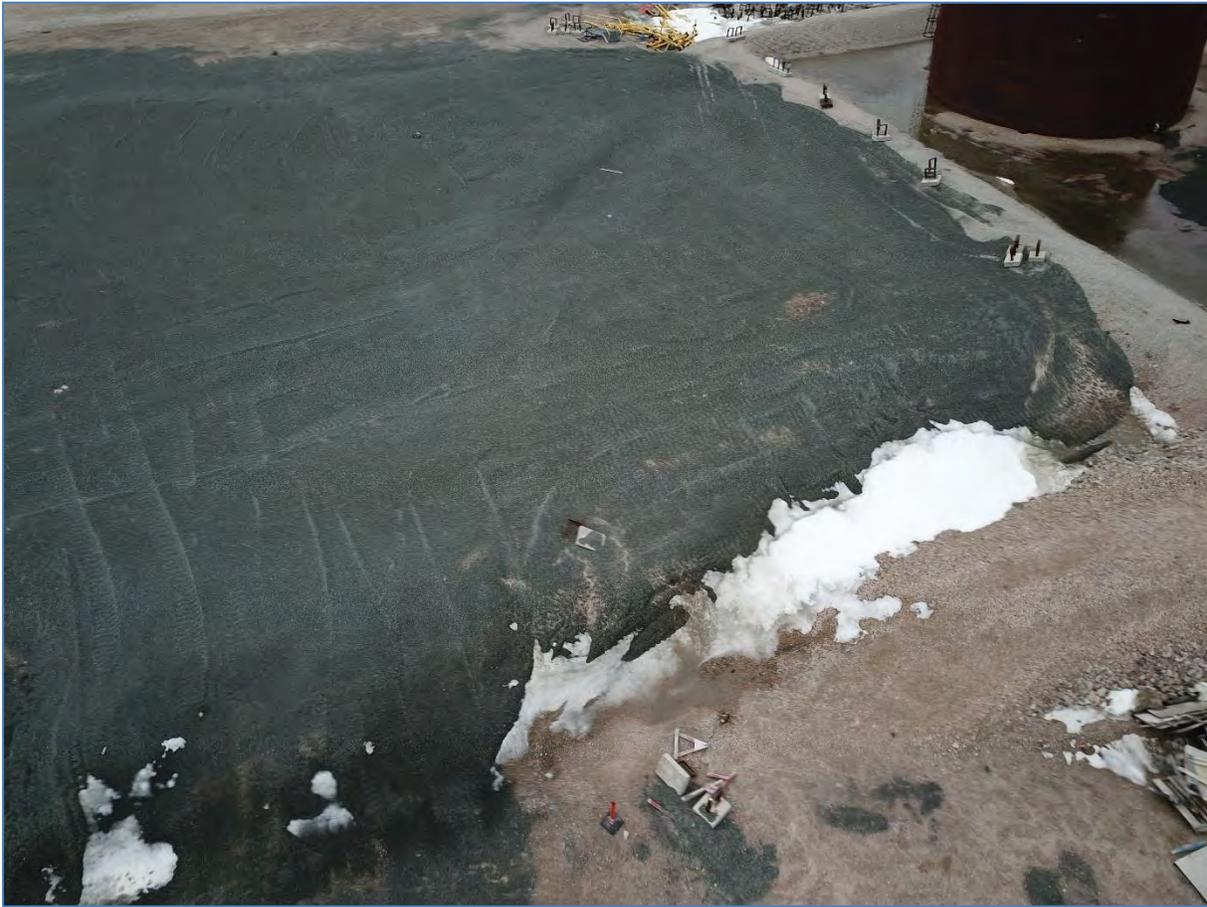
Photo 8: June 18, 2019 PHC Containment Cell Cover, Looking NW – Drainage erosion in north corner of East Bank.

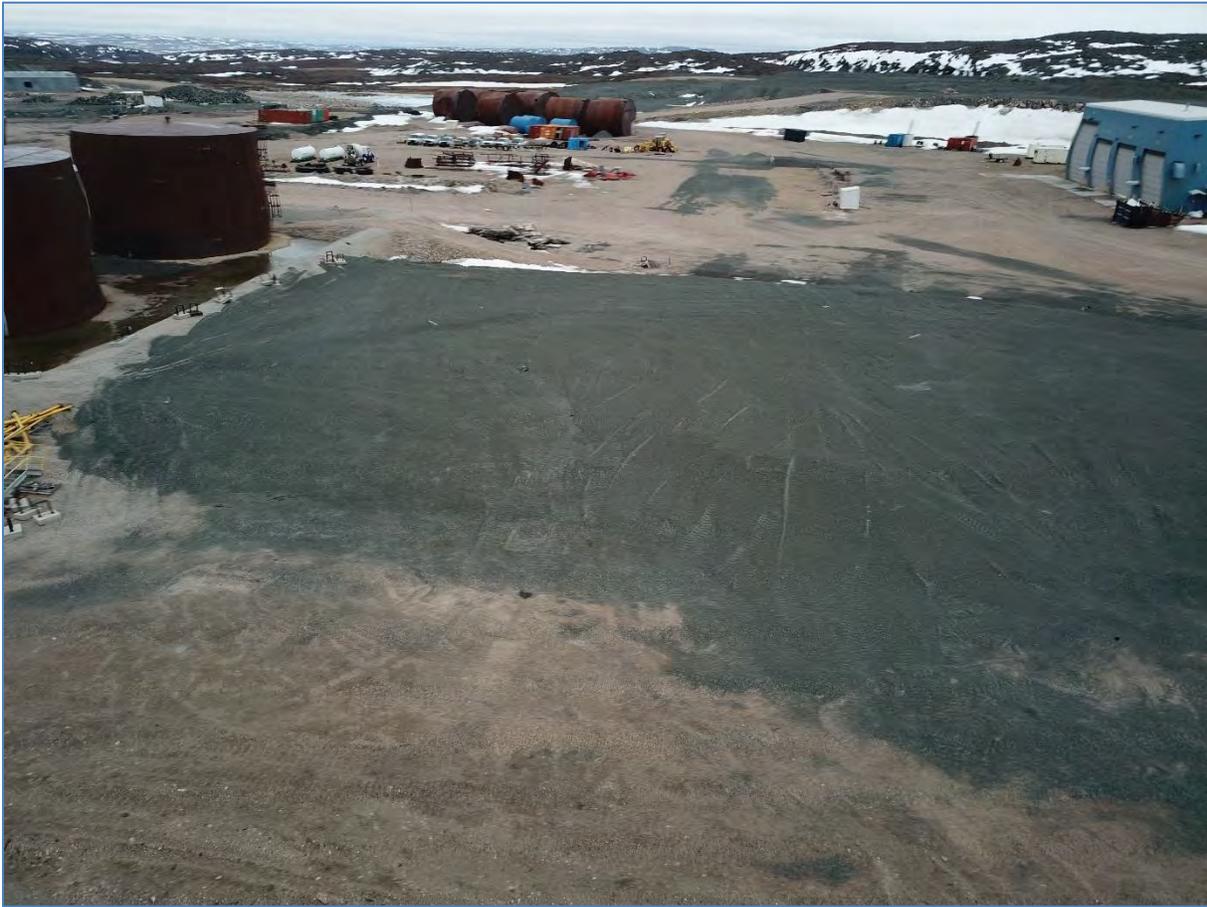
Photo 9: June 18, 2019 PHC Containment Cell Cover, Looking E – Photo of West Bank.

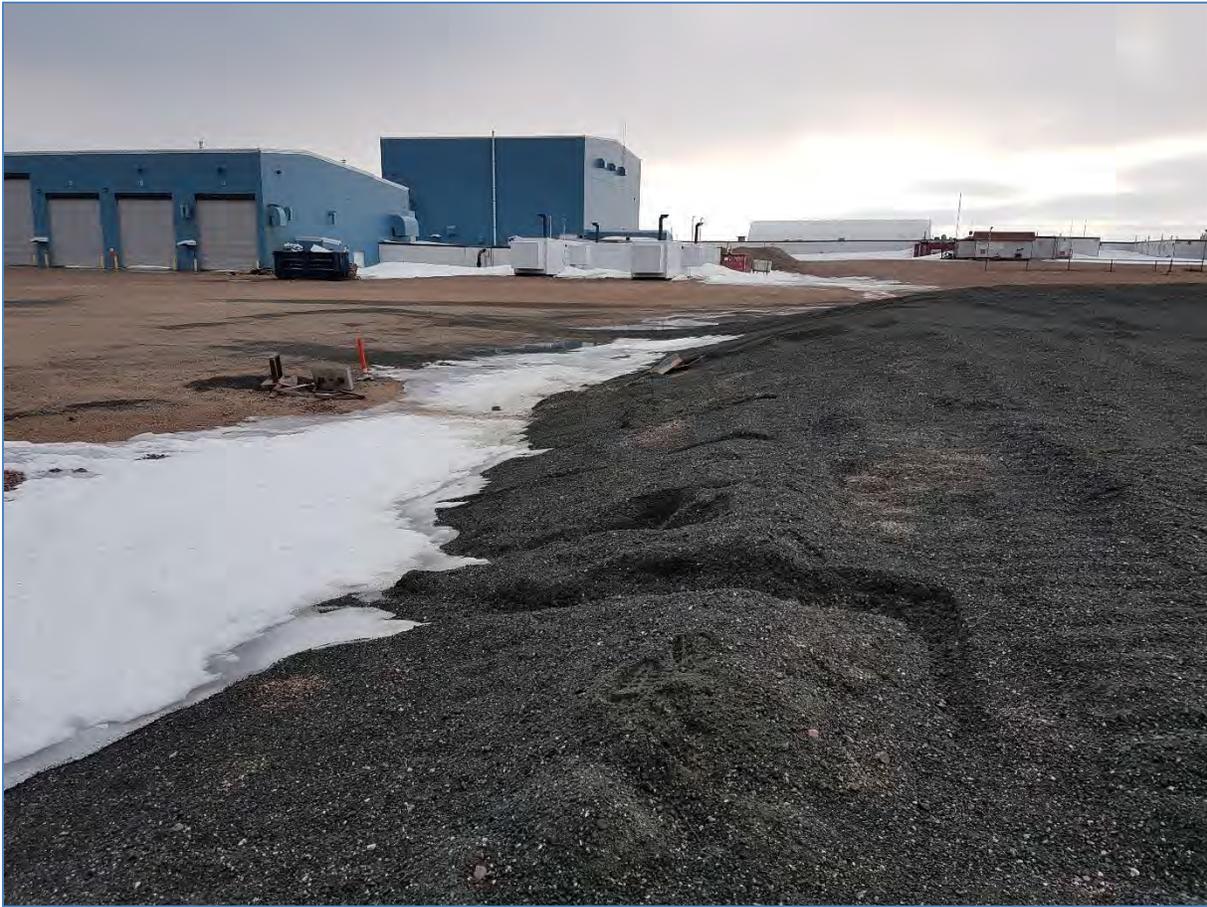
Photo 10: June 17, 2019 PHC Containment Cell Cover, Looking S – Drainage erosion on East Bank.

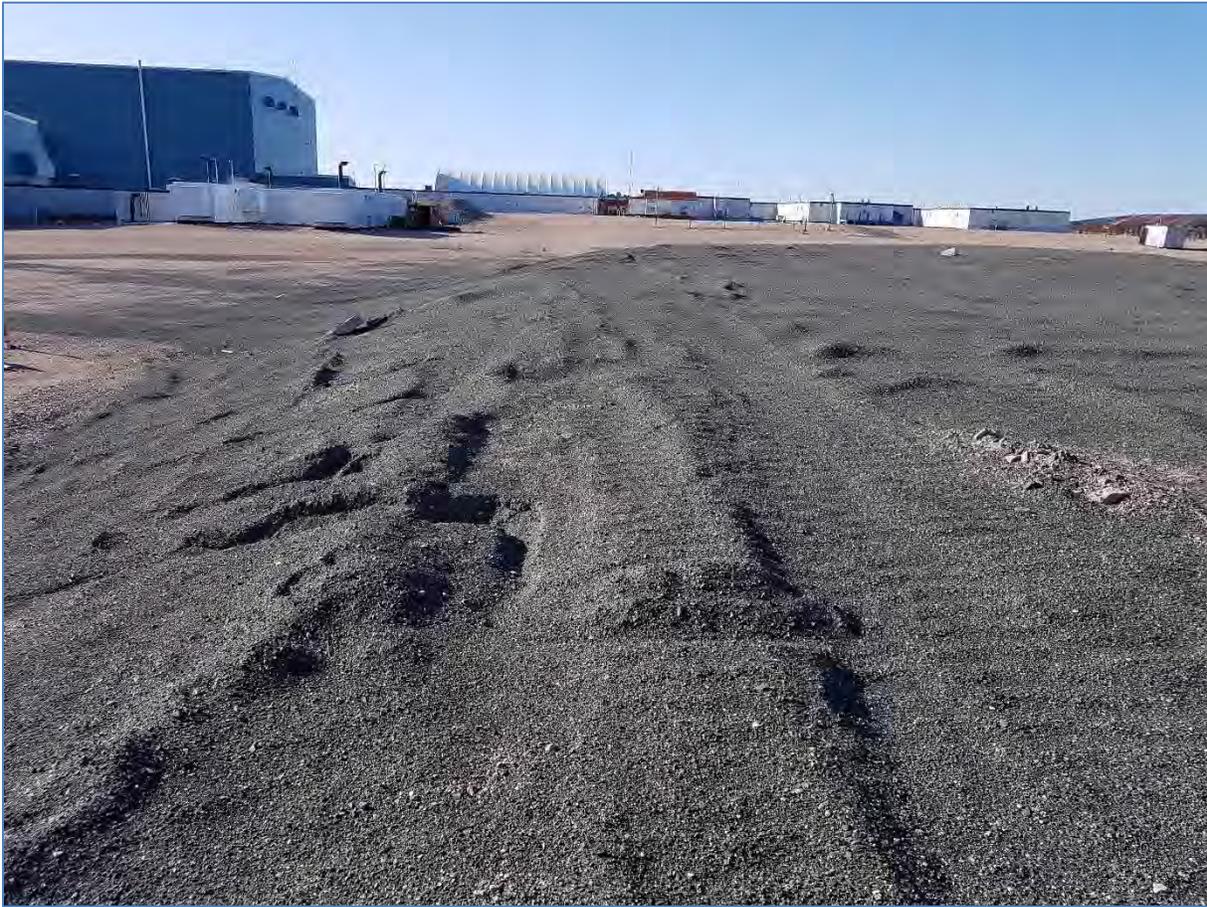
Photo 11: Sept. 11, 2019 PHC Containment Cell Cover, Looking S – Fall photo of East Bank.

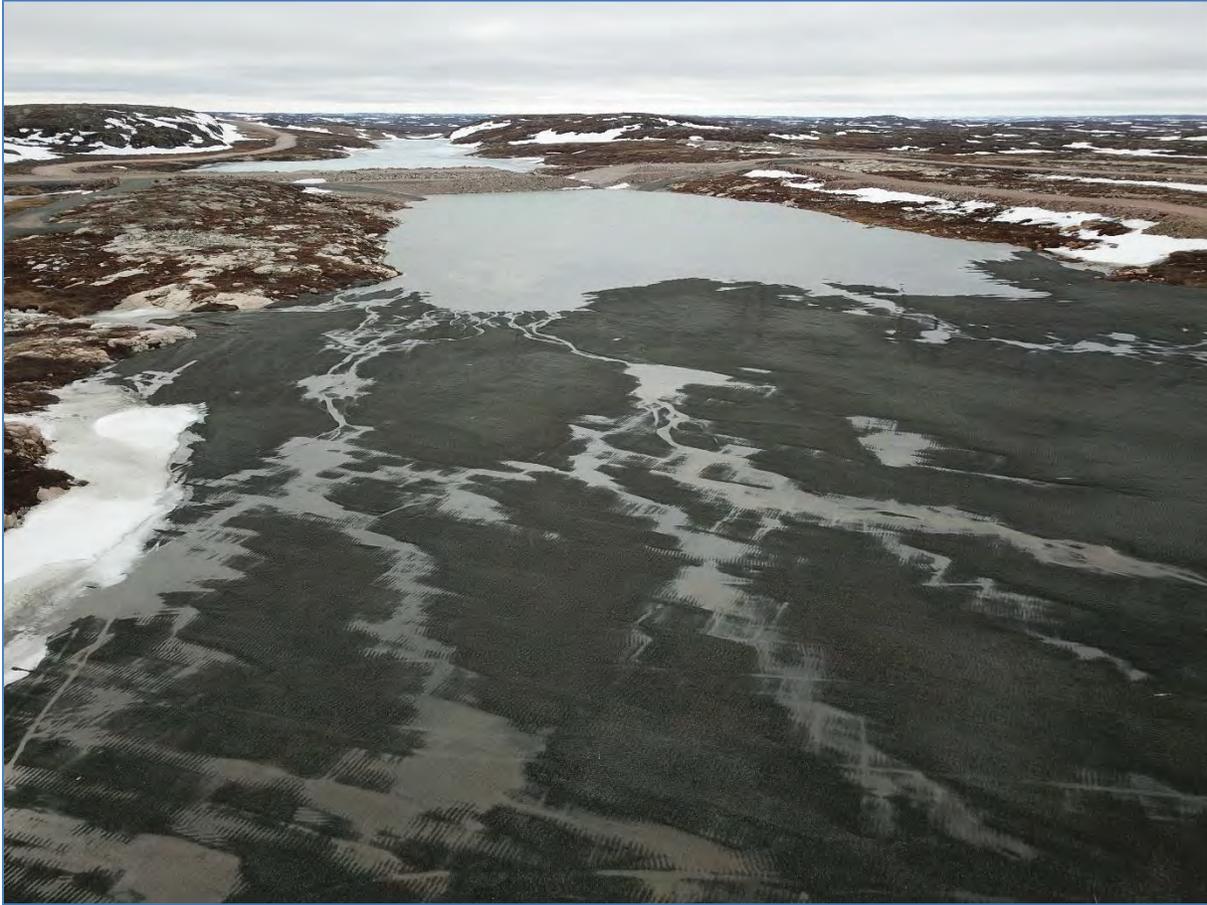
Photo 12: June 18, 2019 PKCA Cover, Looking W – North PKCA.

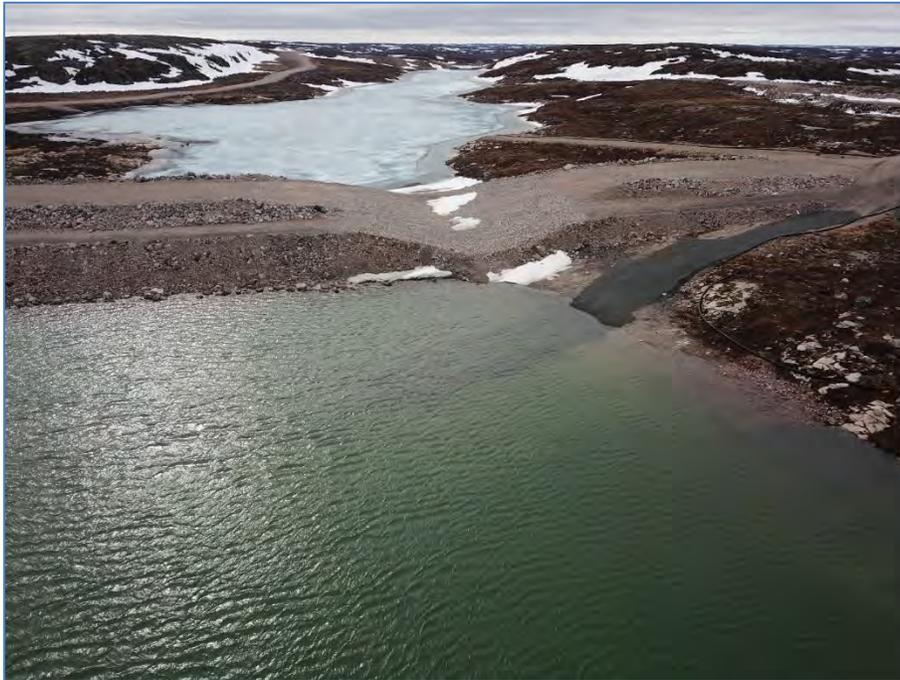
Photo 13: June 18, 2019 PKCA Cover, Looking W – Ponded water covering access road.

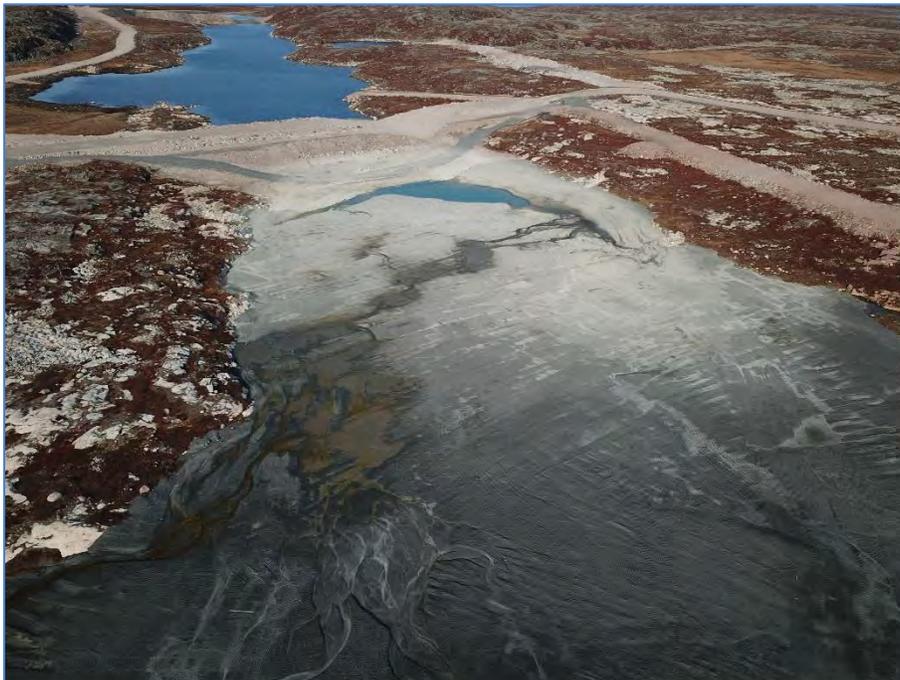
Photo 14: Sept. 12, 2019 PKCA Cover, Looking W – Remaining ponded water during Fall visit.

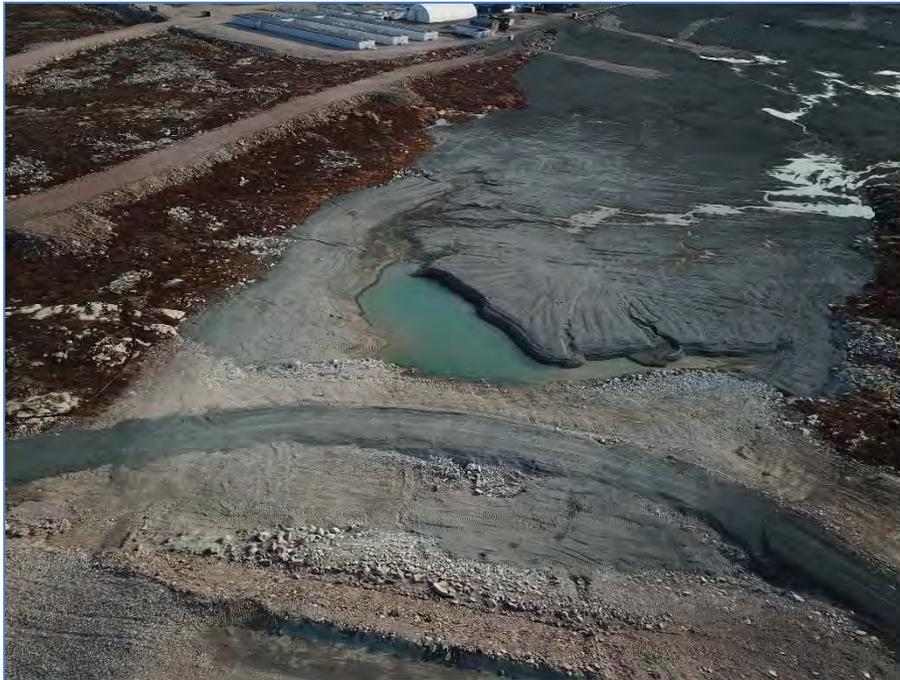
Photo 15: Sept. 12, 2019 PKCA Cover, Looking E – Downstream section of PKCA.

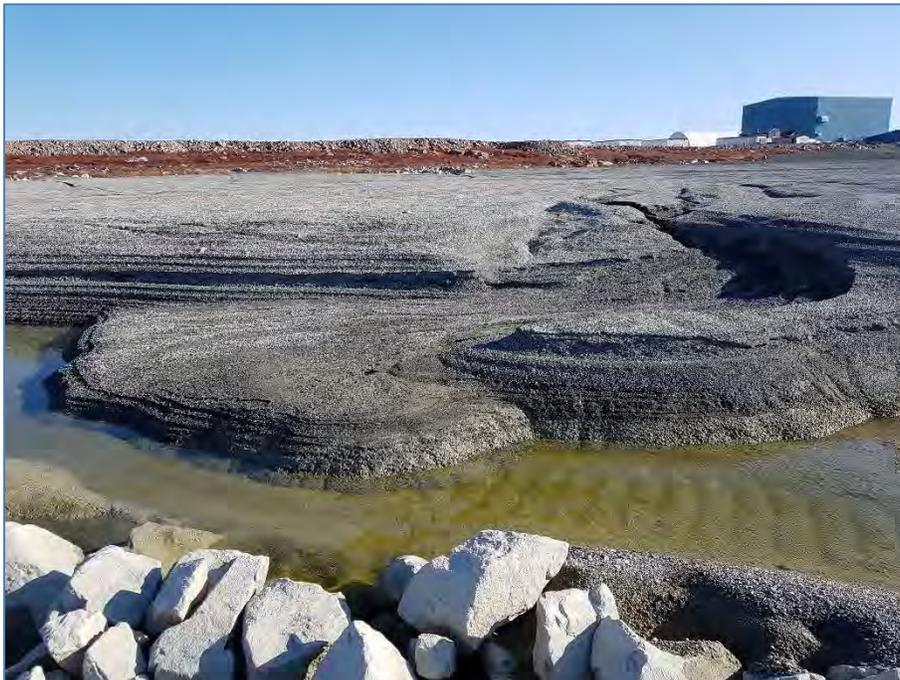
Photo 16: Sept. 11, 2019 PKCA Cover, Looking E – Downstream section of PKCA.

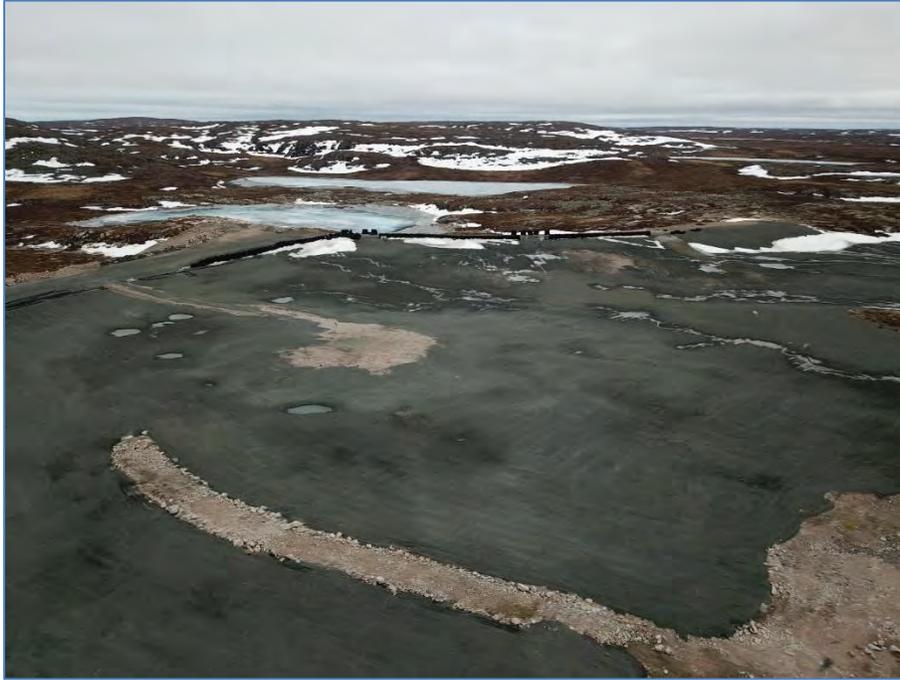
Photo 17: June 18, 2019 PKCA Cover, Looking SE – East PKCA.

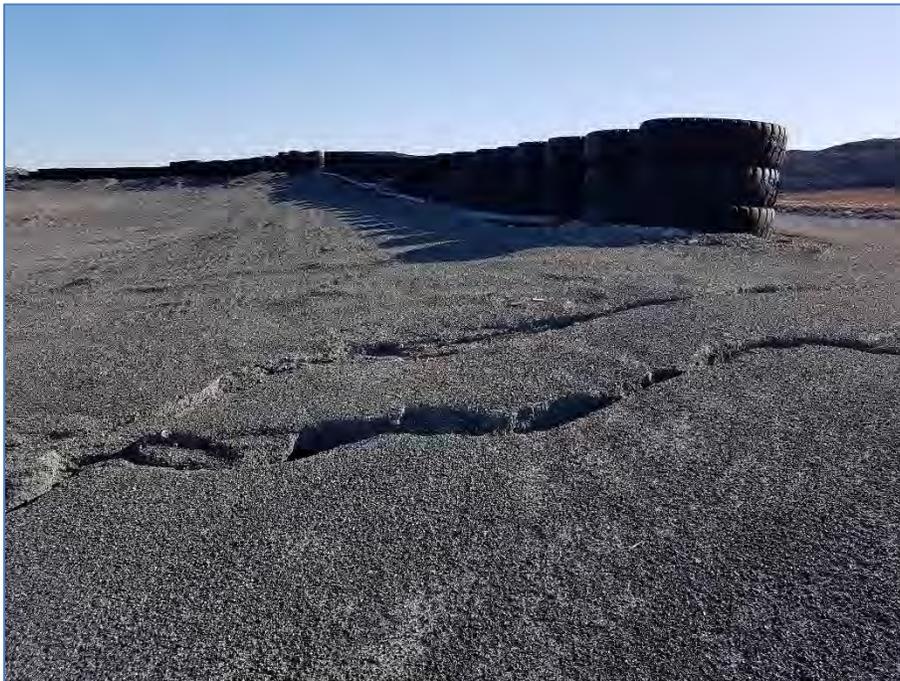
Photo 18: Sept. 11, 2019 PKCA Cover, East PKCA – Some erosion from drainage into PKCA.

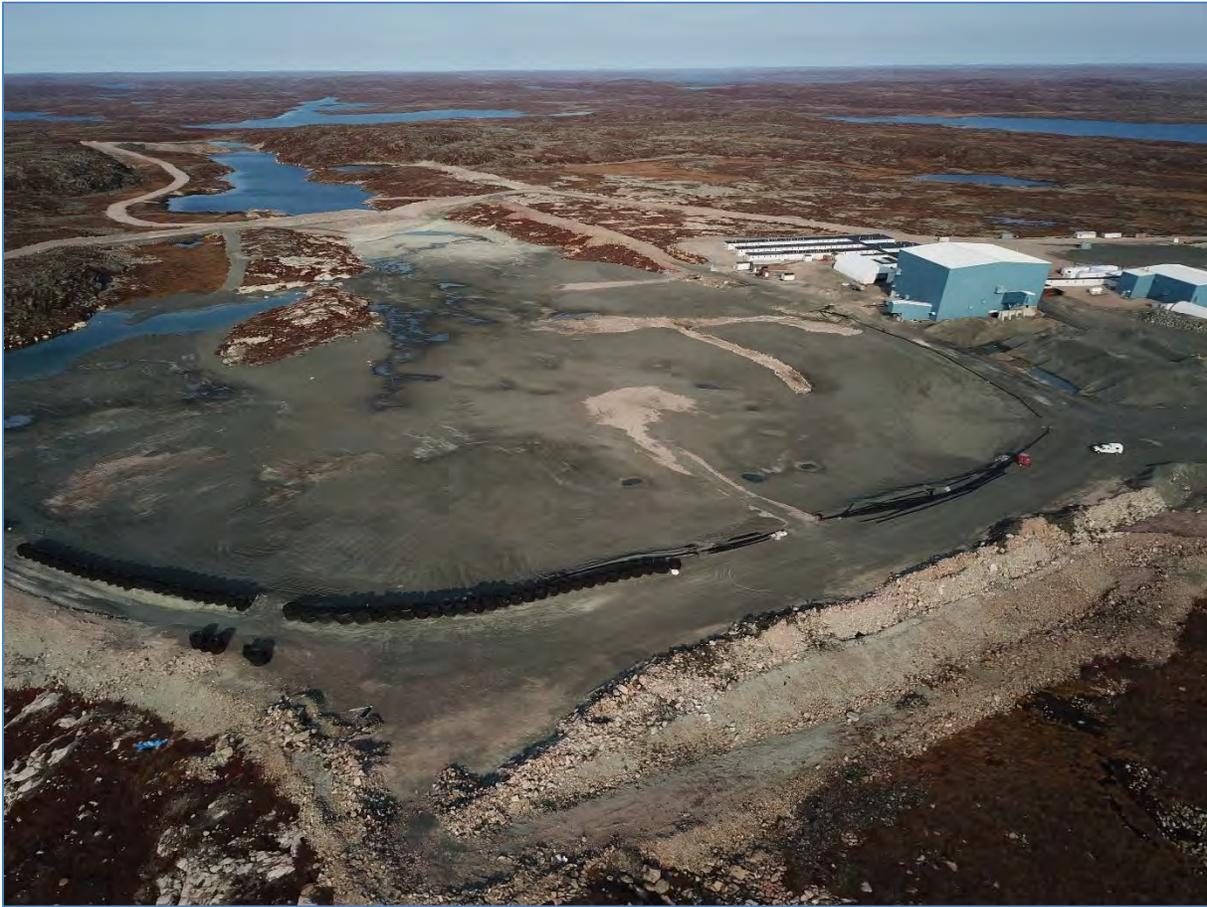
Photo 19: Sept. 12, 2019 PKCA Cover, Looking W – East PKCA.

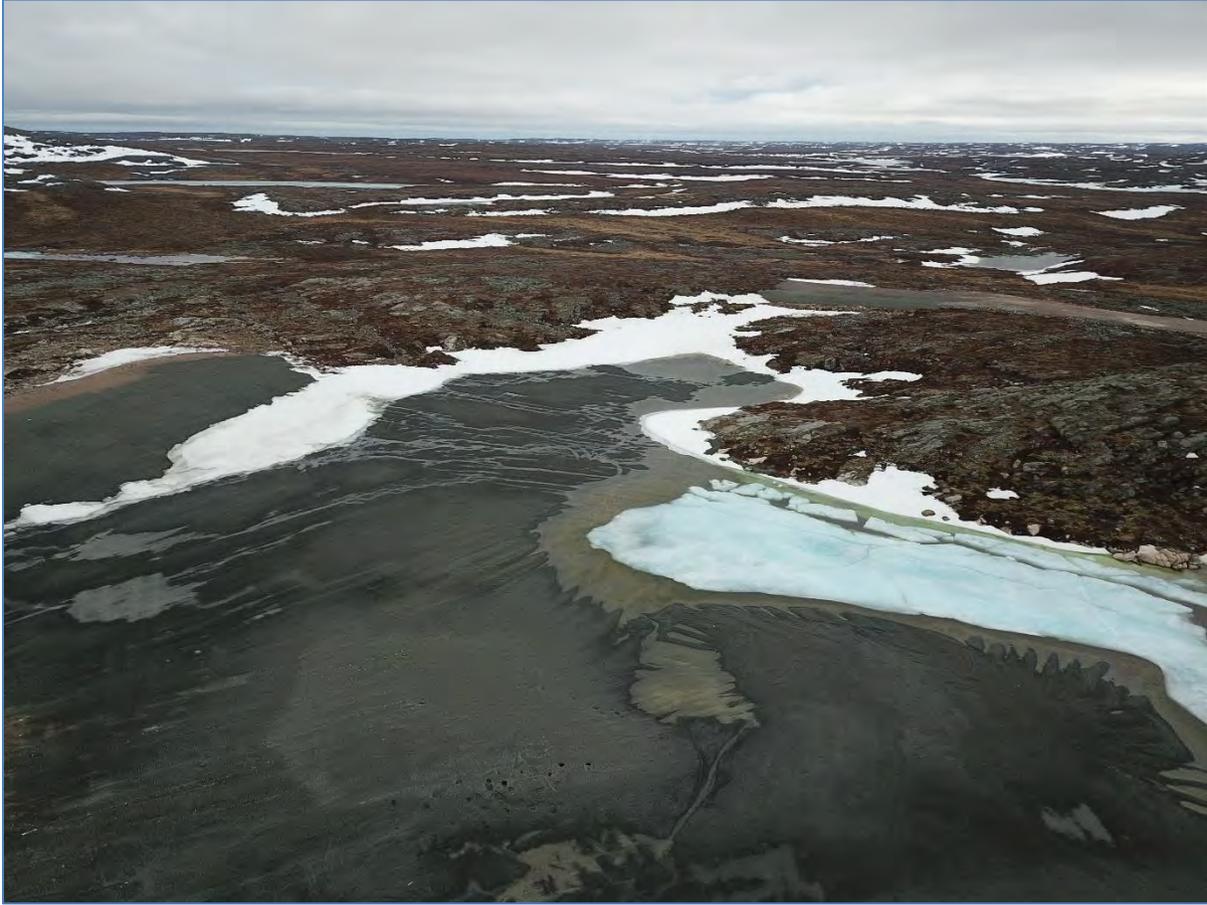
Photo 20: June 18, 2019 PKCA Cover, South PKCA – Looking S, potholes at bottom of photo.

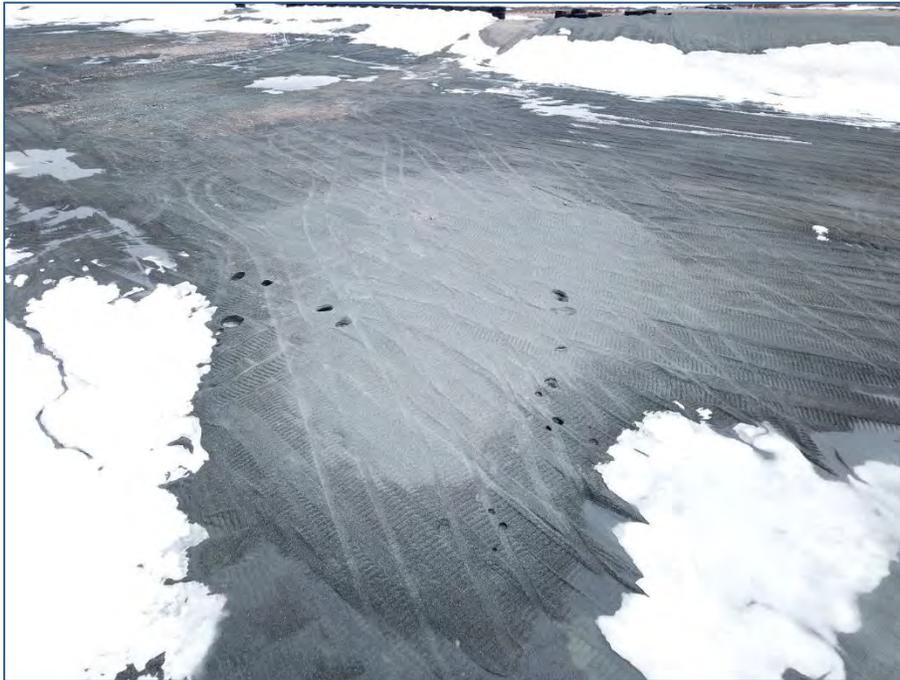
Photo 21: June 6, 2018 PKCA Cover, Southeast PKCA – 2018 aerial photo of potholes.

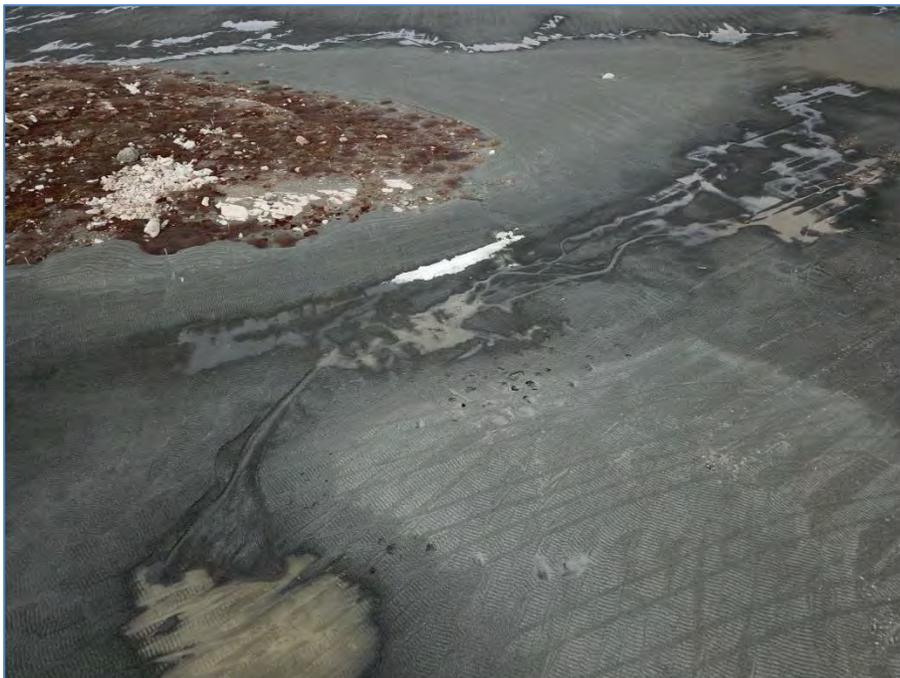
Photo 22: June 18, 2019 PKCA Cover, Looking N – View of potholes (note that the center potholes here were covered by snow in the 2018 photo above).

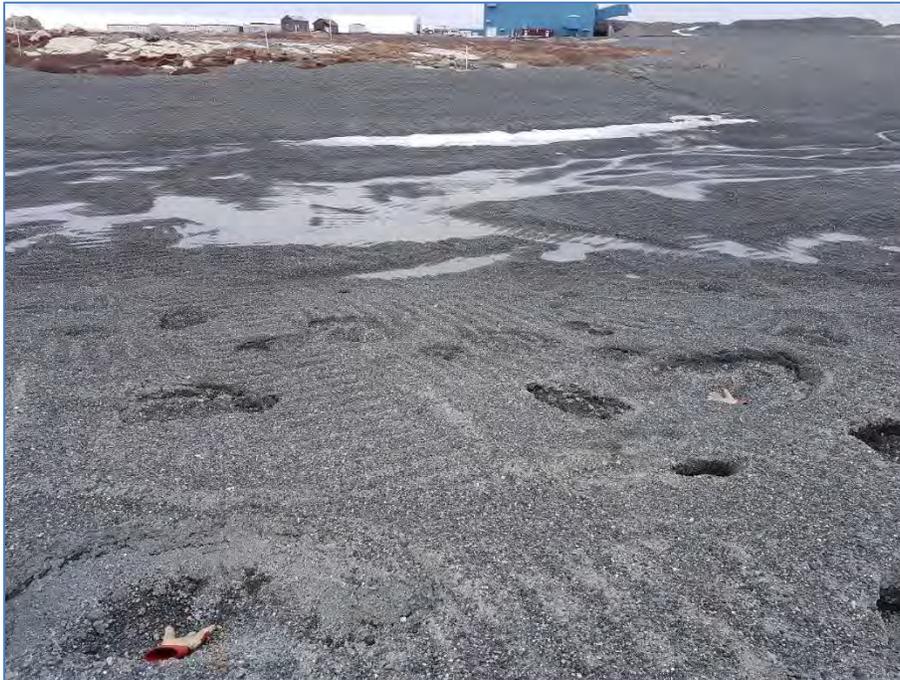
Photo 23: June 18, 2019 PKCA Cover, Looking N – View of potholes.

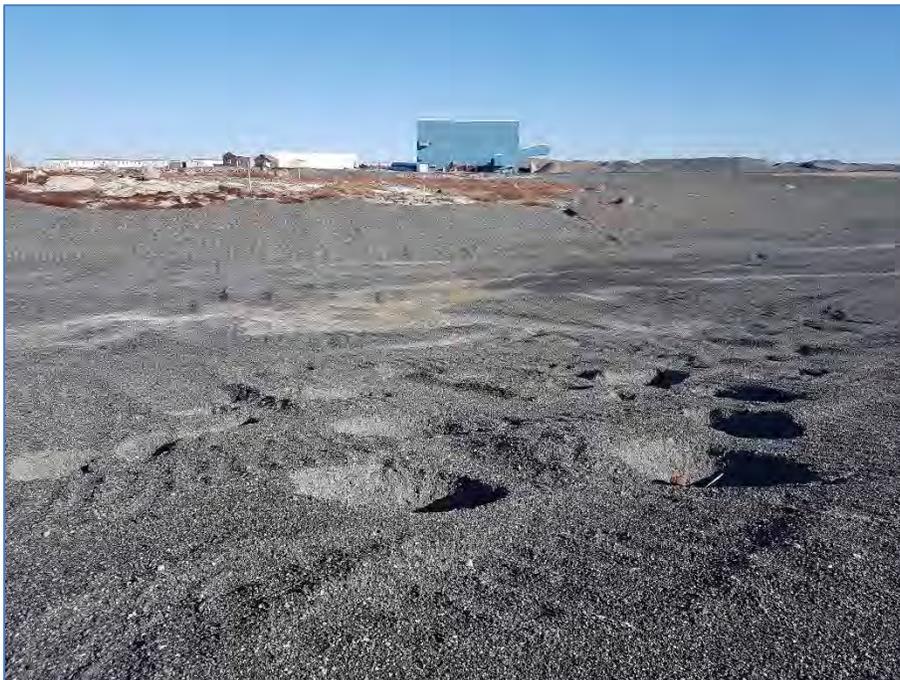
Photo 24: Sept. 11, 2019 PKCA Cover, Looking N – Fall view of potholes.
