JERICHO DIAMOND MINE OPERATION, MAINTENANCE AND SURVEILLANCE PLAN

NUNAVUT IMPACT REVIEW BOARD FILE #16UN058 2019 ANNUAL REPORT

May 4, 2020

**APPENDIX B:
JERICHO MINE SITE
OPERATION, MAINTENANCE AND SURVEILLANCE PROGRAM
2019 REPORT – FINAL**

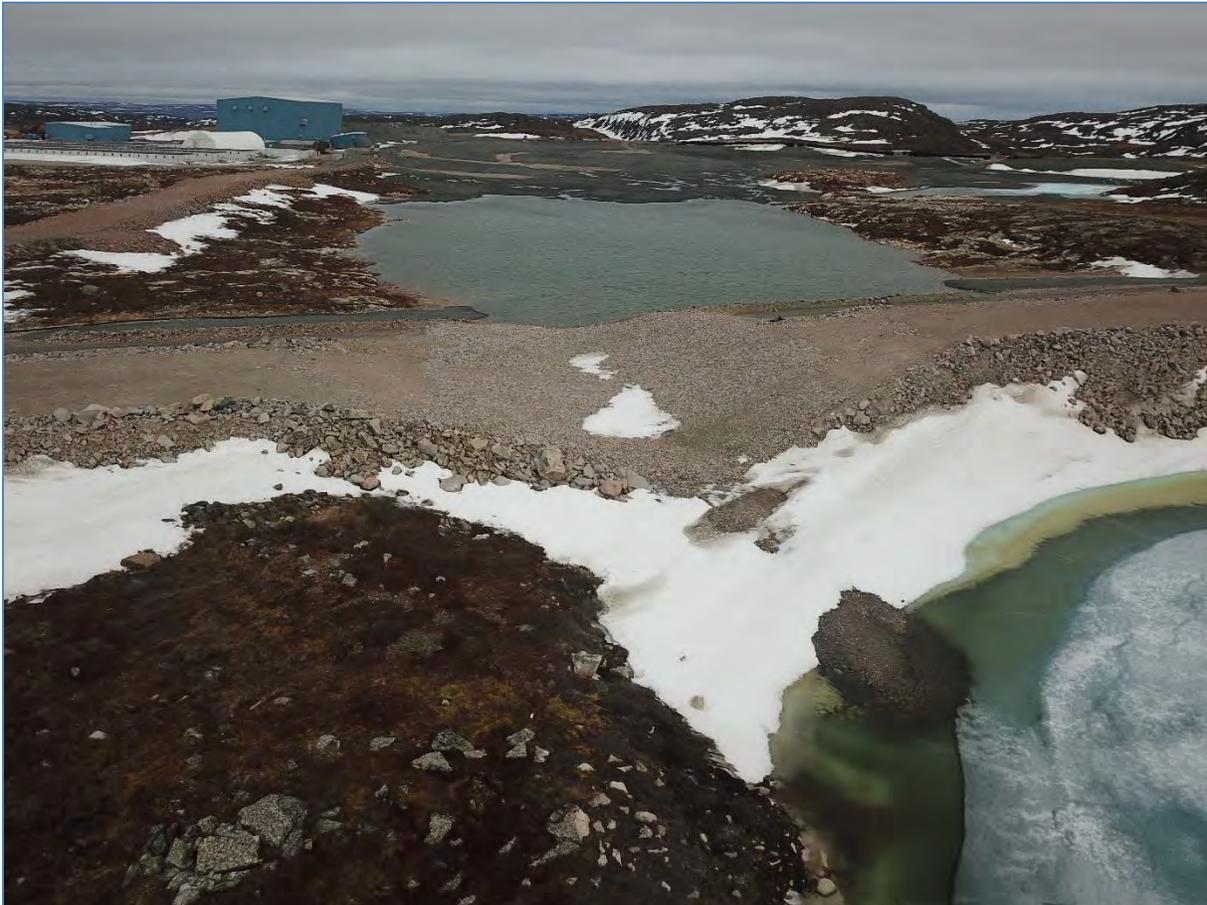
Photo 25: June 18, 2019 Divider Dike A, Looking E – Dike and energy dispersion ramp.

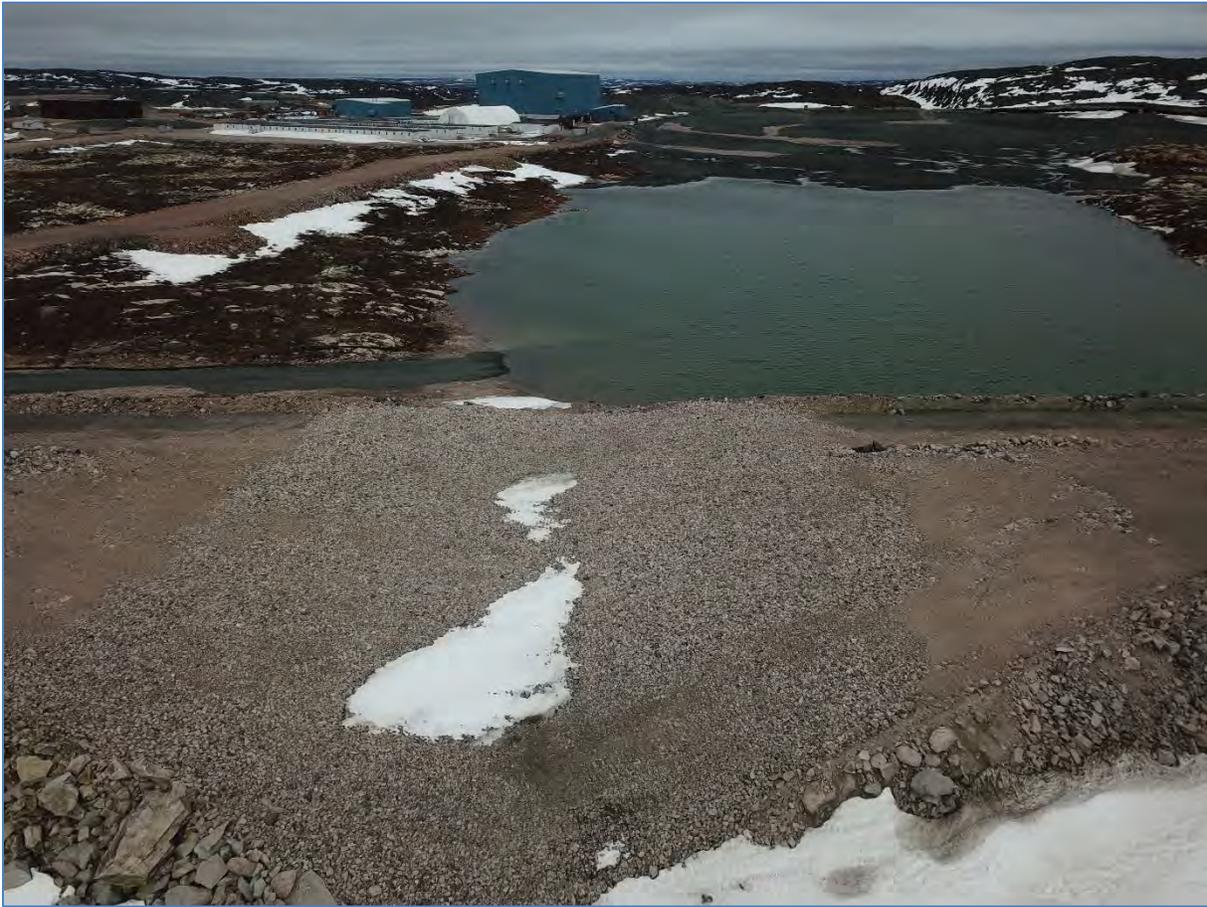
Photo 26: June 18, 2019 Divider Dike A, Looking W.

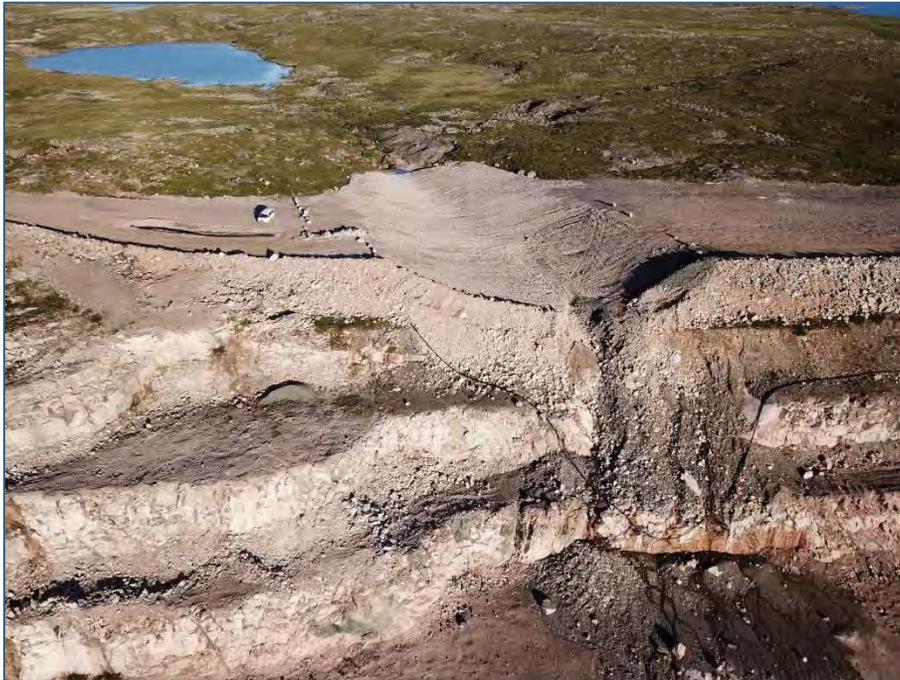
Photo 27: August 4, 2018 C1 Channel, Looking West – 2018 photo of erosion at outlet into Pit.

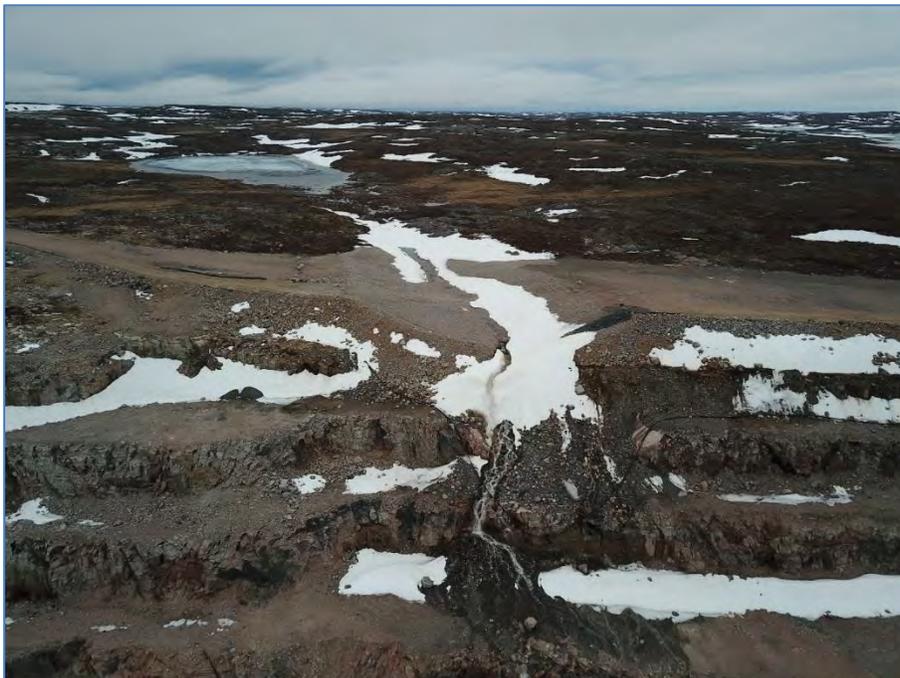
Photo 28: June 19, 2019 C1 Channel, Looking W – Erosion at outlet into Pit.

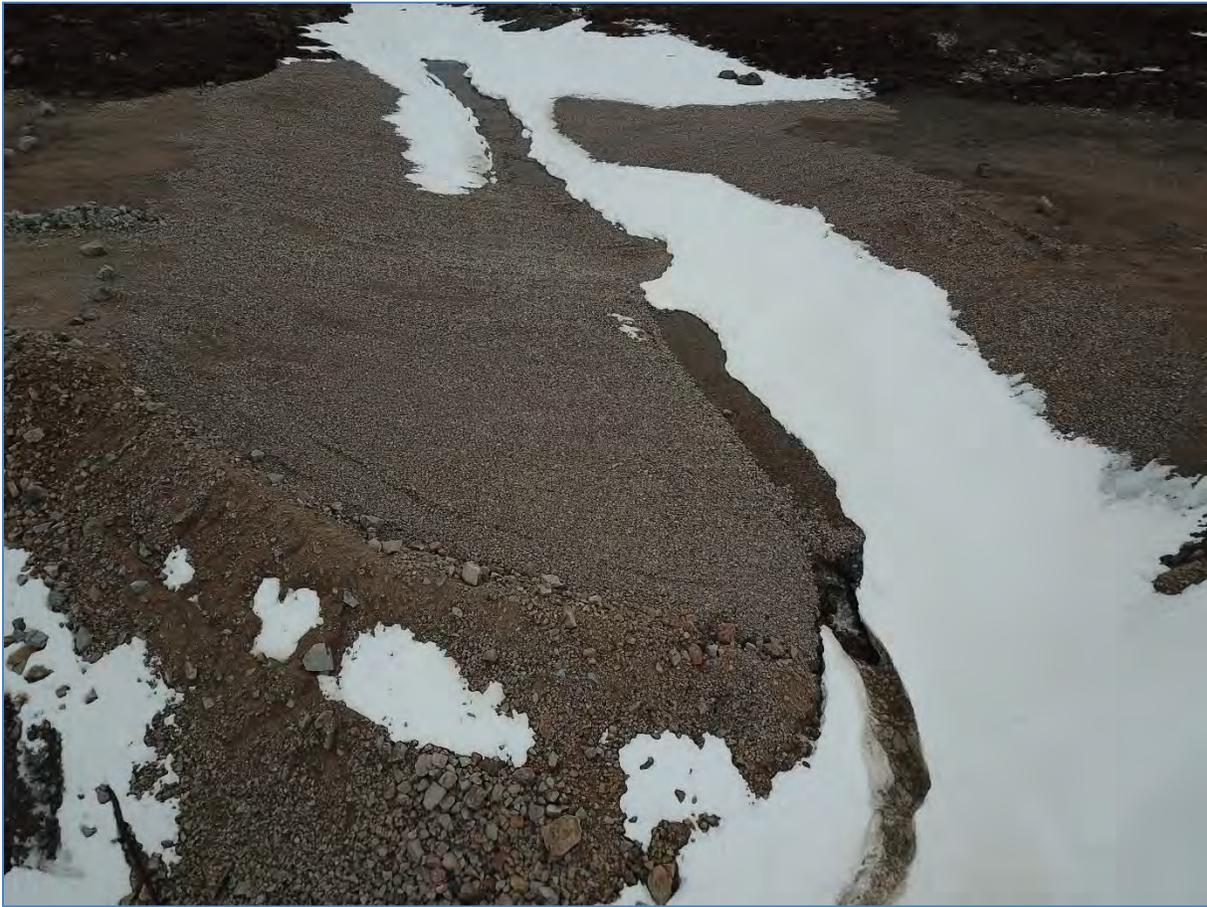
Photo 29: June 19, 2019 C1 Channel, Looking W – Channel Base with snow.

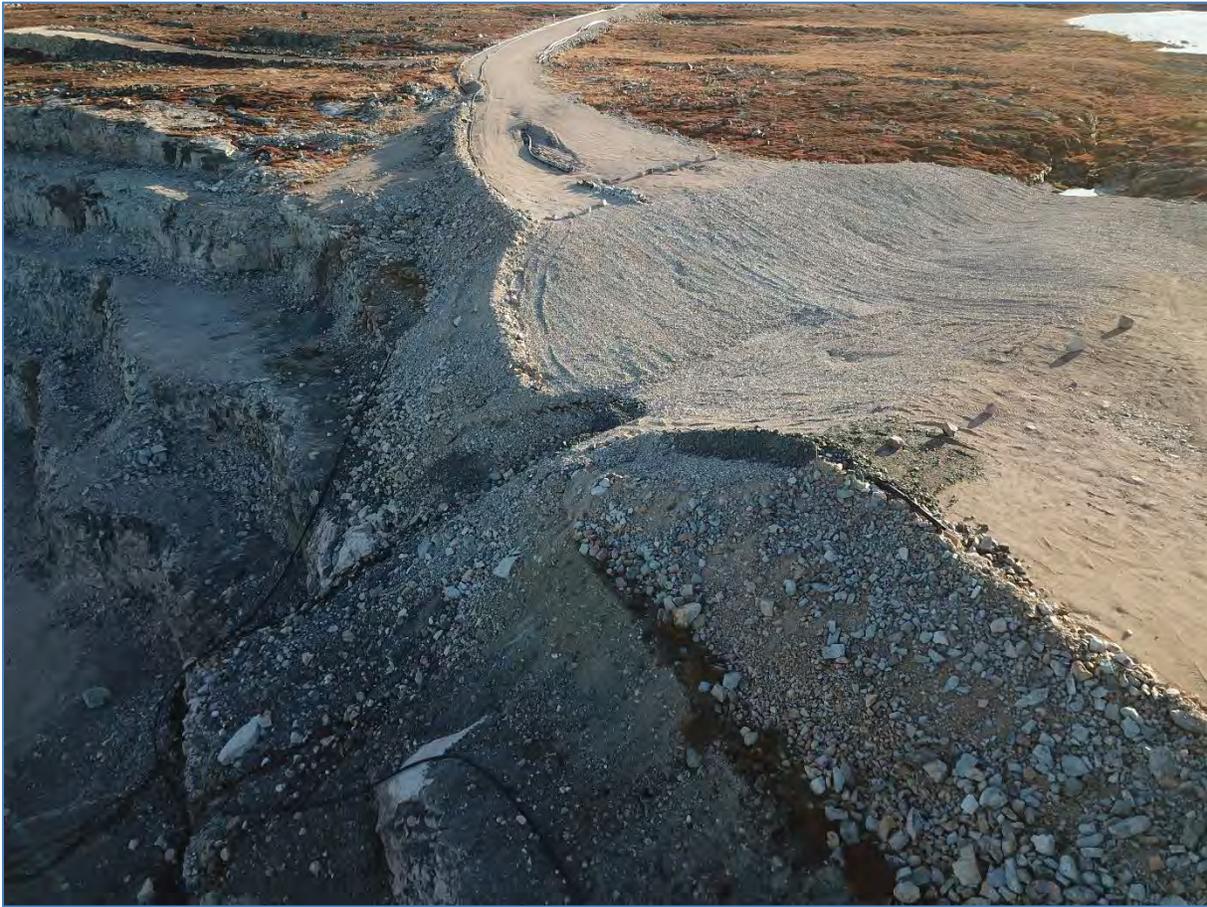
Photo 30: Sept. 10, 2019 C1 Channel, Looking W – Channel Base and inflow into Pit.

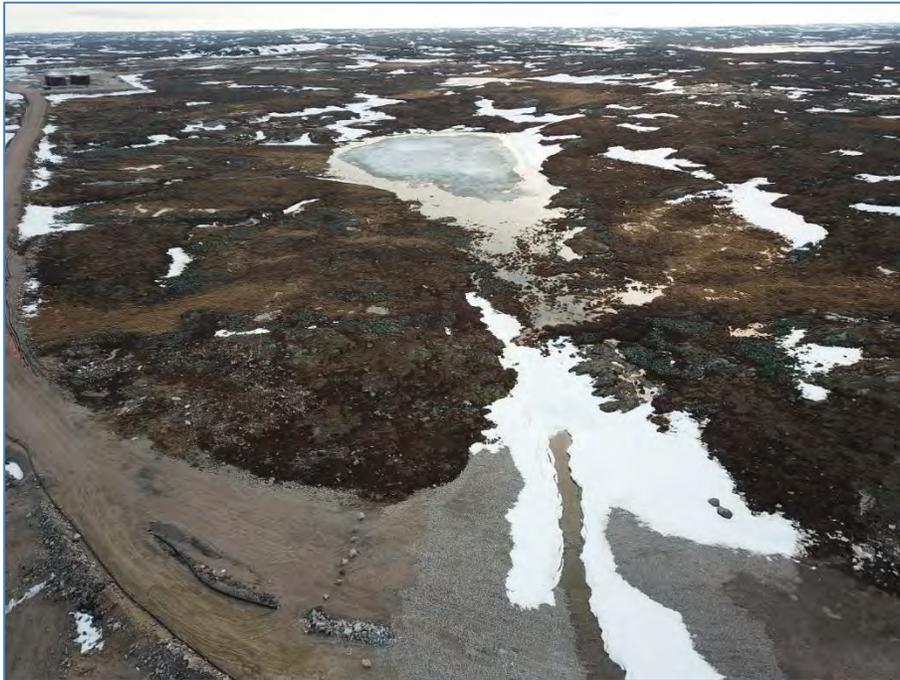
Photo 32: June 17, 2019 C1 Channel, Looking W – Upstream catchment.

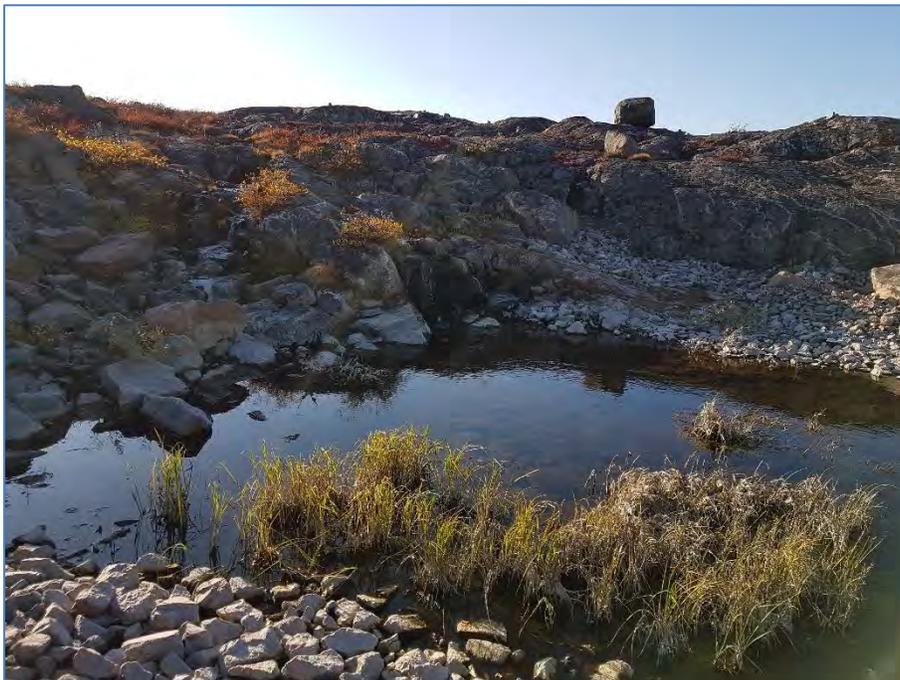
Photo 33: Sept. 10, 2019 C1 Channel, Looking W – Upstream water inflowing during Fall visit.

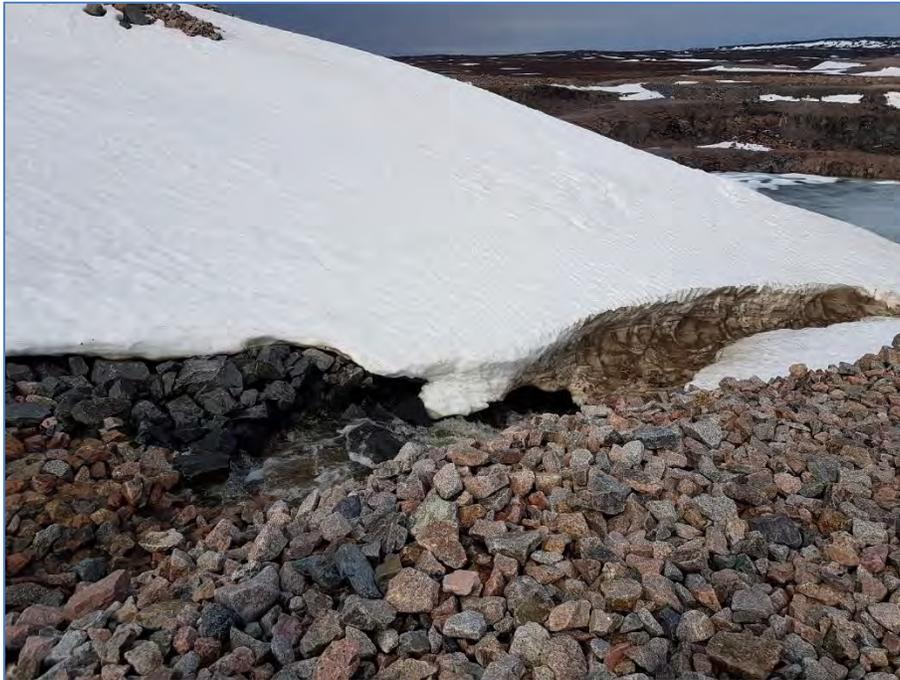
Photo 34: June 17, 2019 C1 Channel, Looking E – Water runoff under snow into Open Pit.

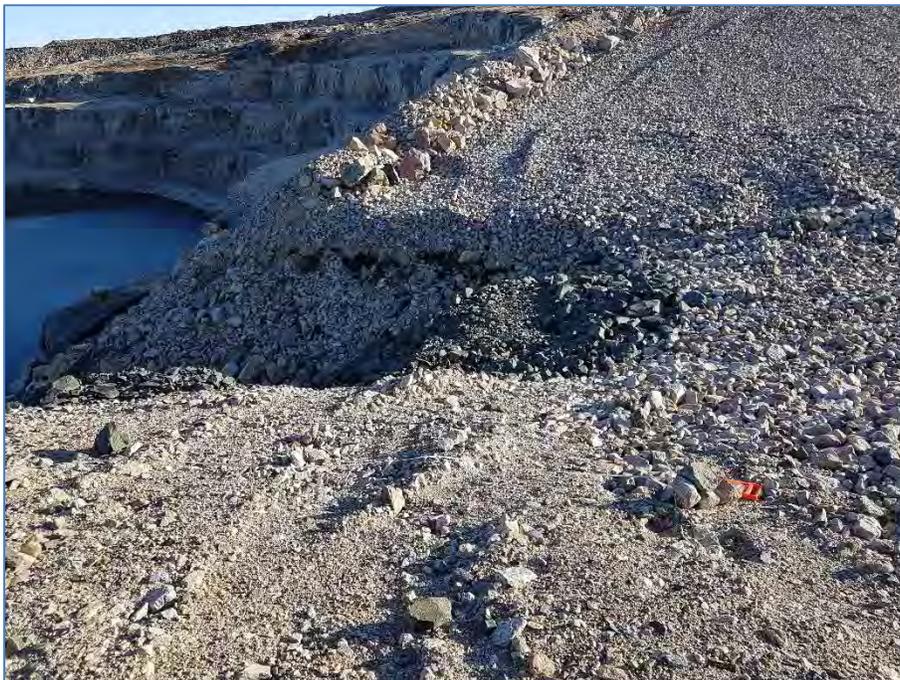
Photo 35: Sept. 10, 2019 C1 Channel, Looking E – Eroded section into Open Water @ 6.3 m in Fall.

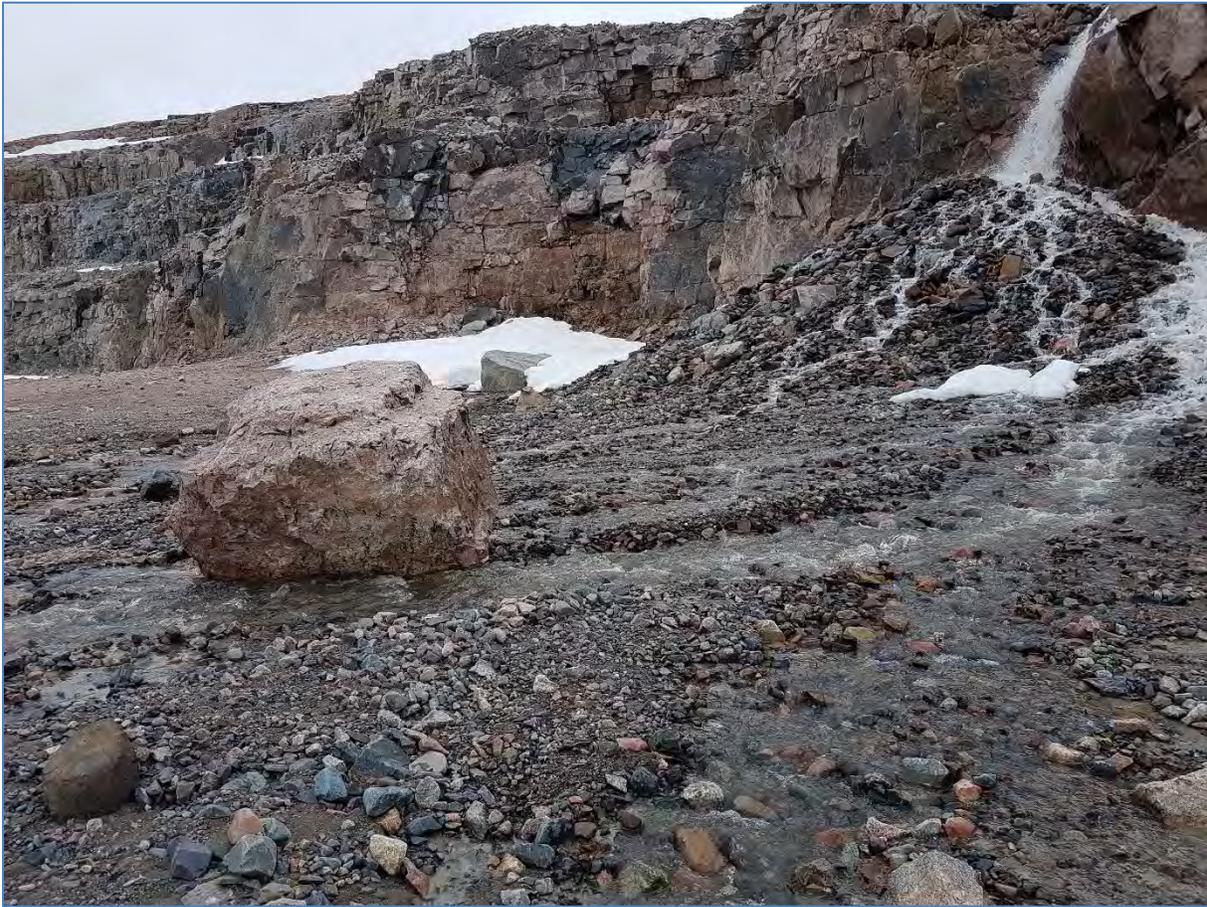
Photo 36: June 18, 2019 C1 Channel Runoff – Spring runoff.

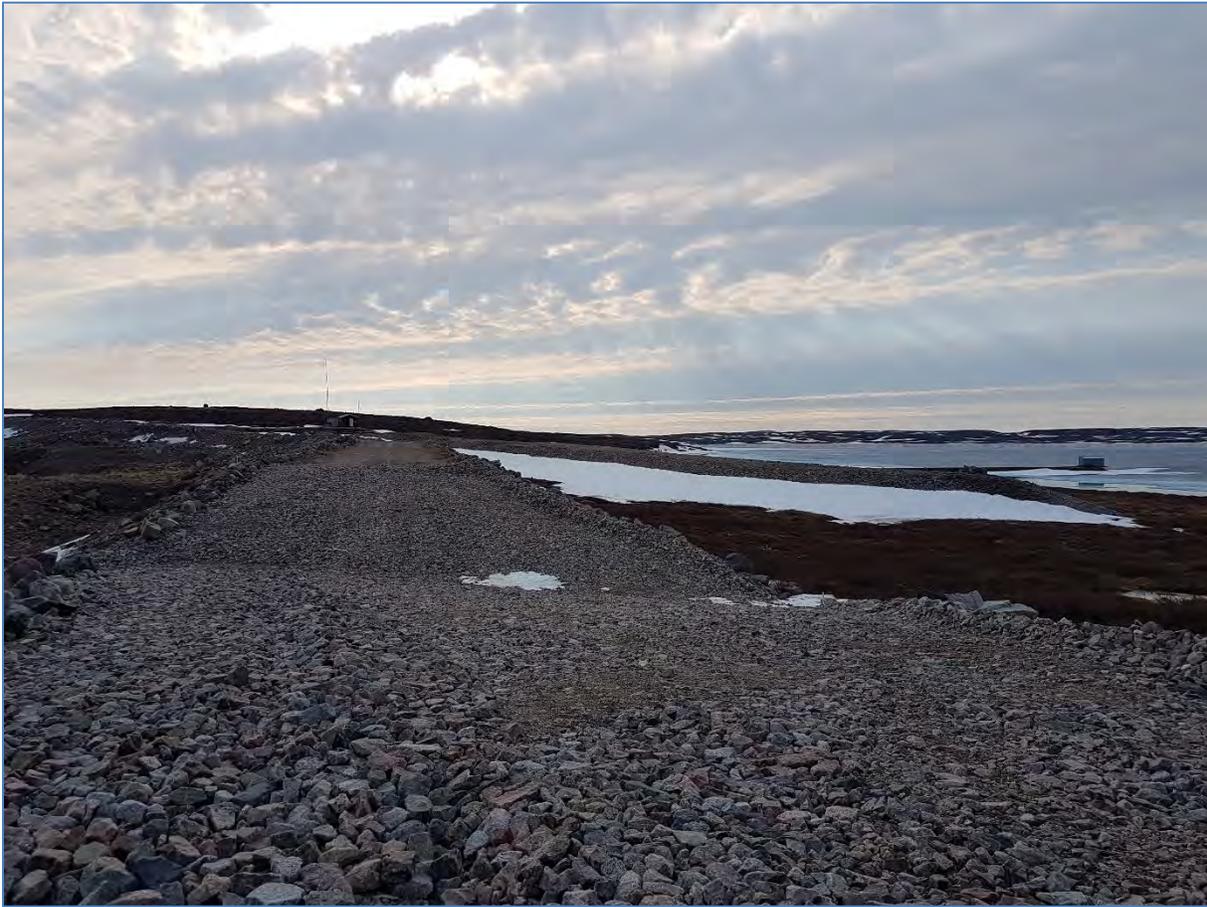
Photo 37: June 17, 2019 Pit Outflow, Looking W.

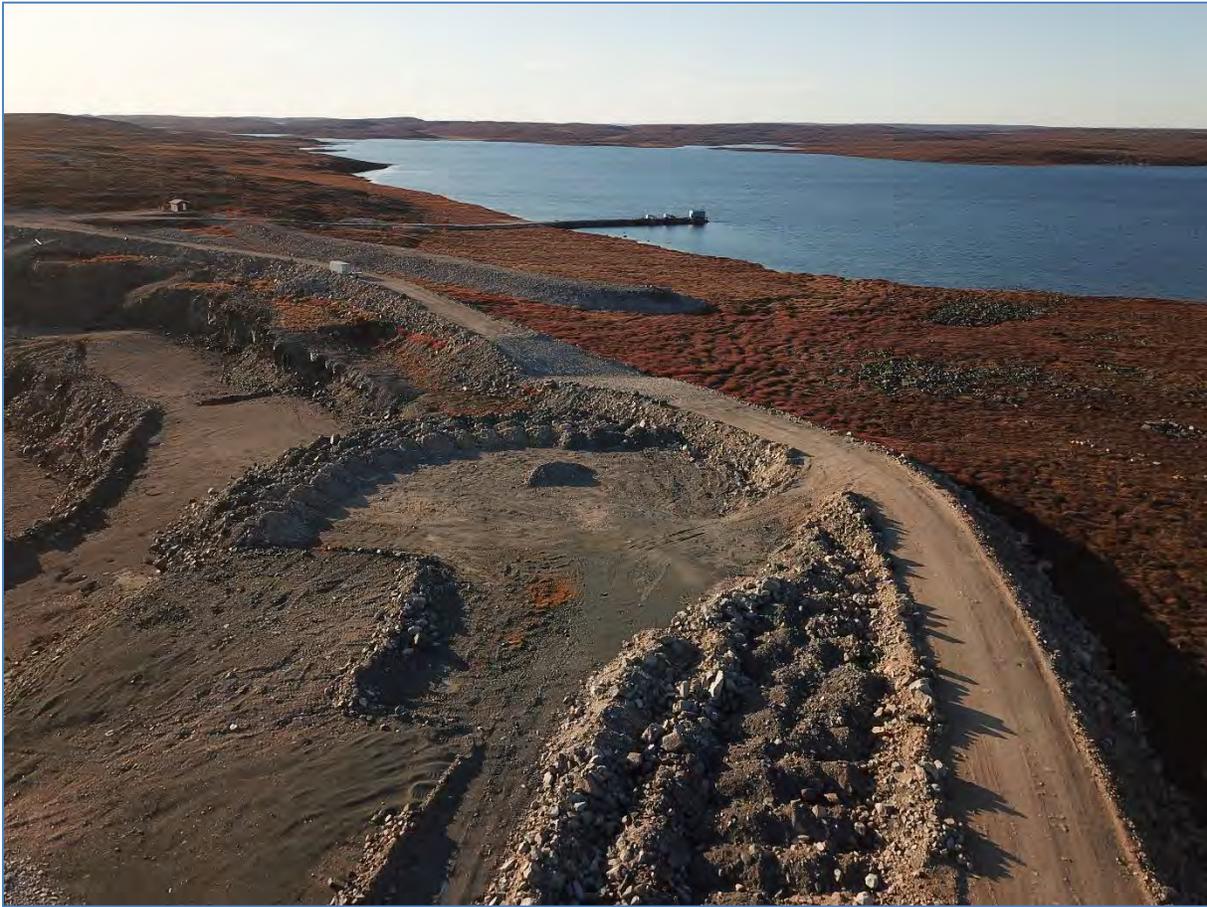
Photo 38: Sept. 10, 2019 Pit Outflow – Aerial photo of Outflow and Pit Perimeter road.

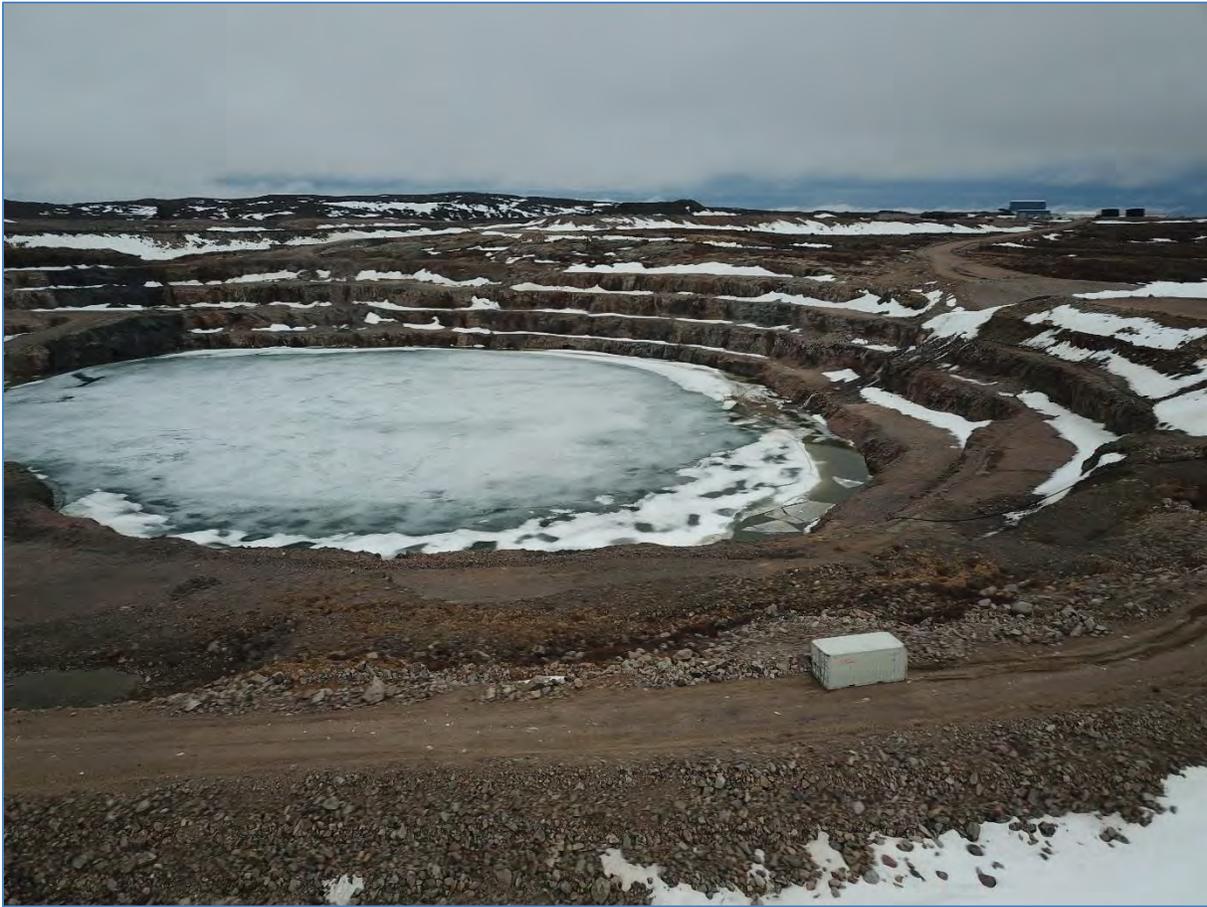
Photo 39: June 19, 2019 Open Pit, Looking E – Photo of early staging for remote camera location.

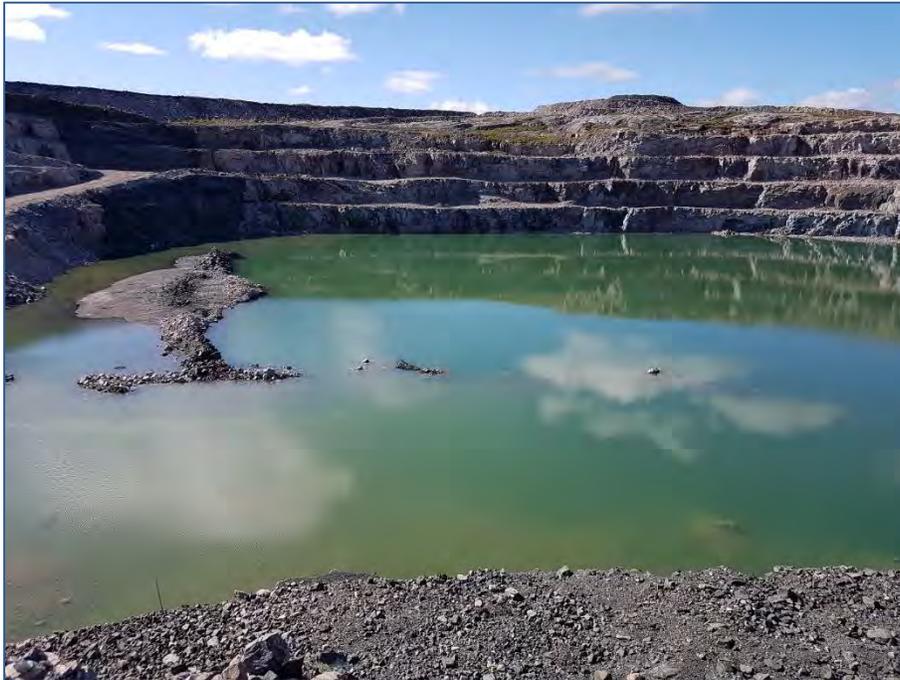
Photo 40: August 4, 2018 Open Pit, Looking South – 2018 photo of Open Pit Water Level.

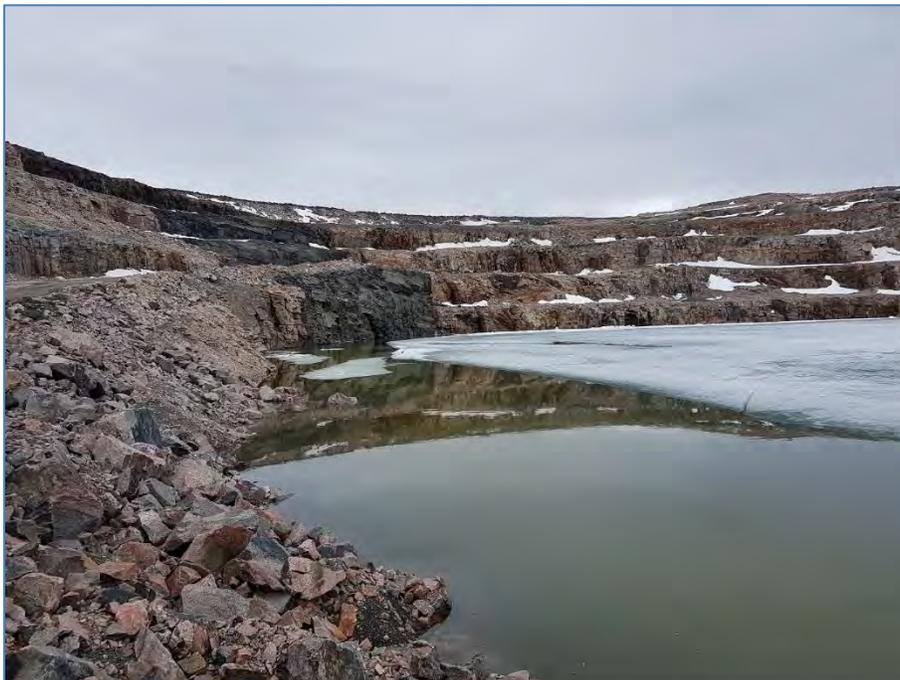
Photo 41: June 19, 2019 Open Pit, Looking S – Spring pit water level.

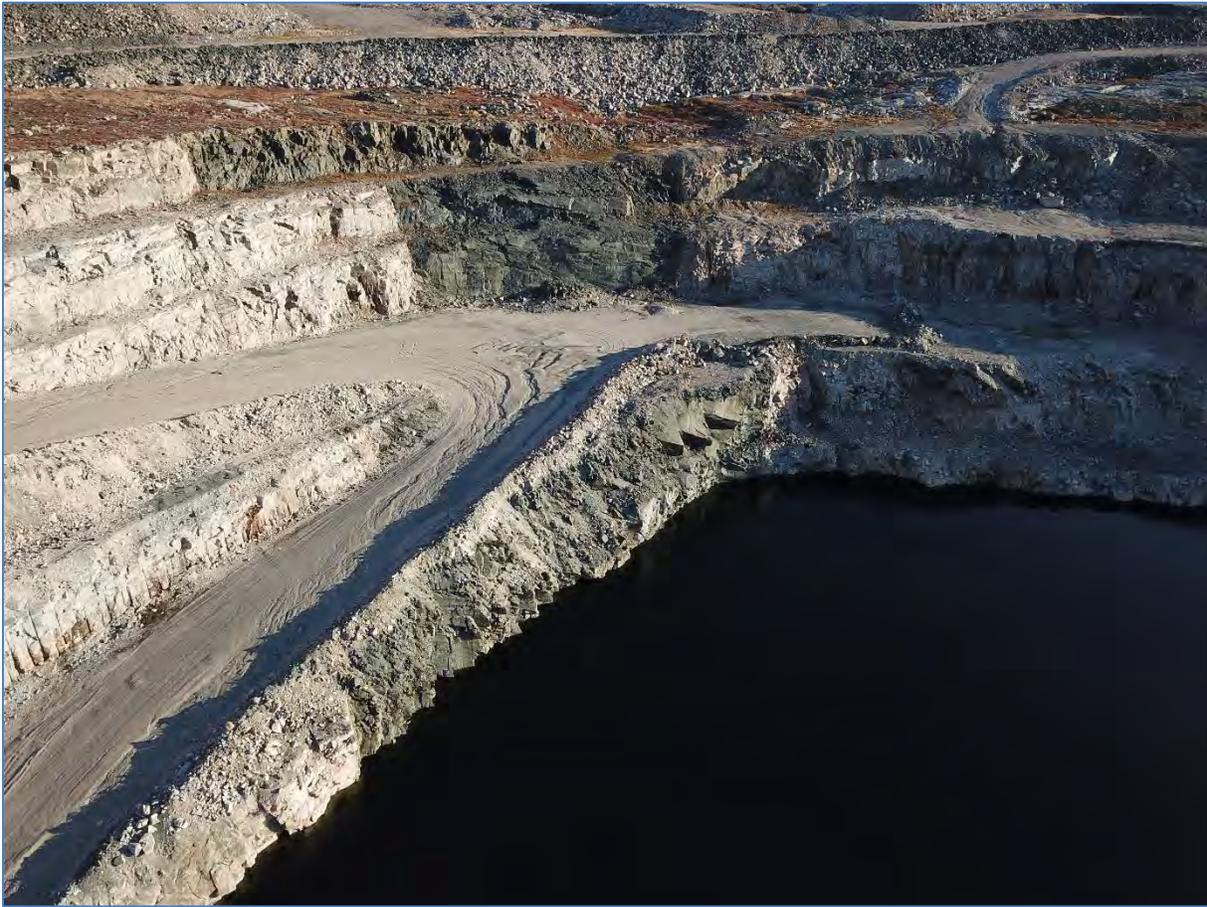
Photo 42: Sept. 10, 2019 Open Pit, Looking S – Fall pit water level.

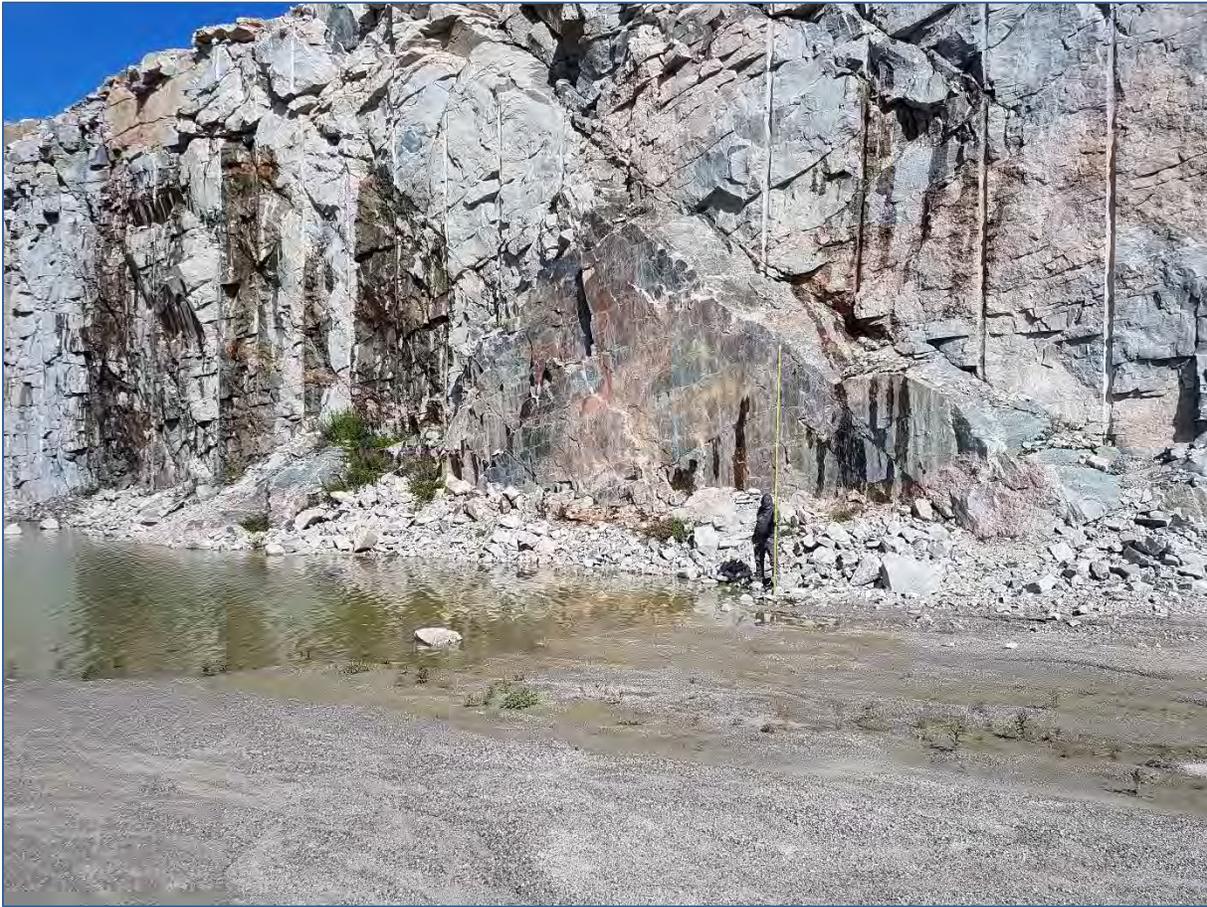
Photo 43: August 4, 2018 Open Pit – 2018 photo of Water Level Survey.

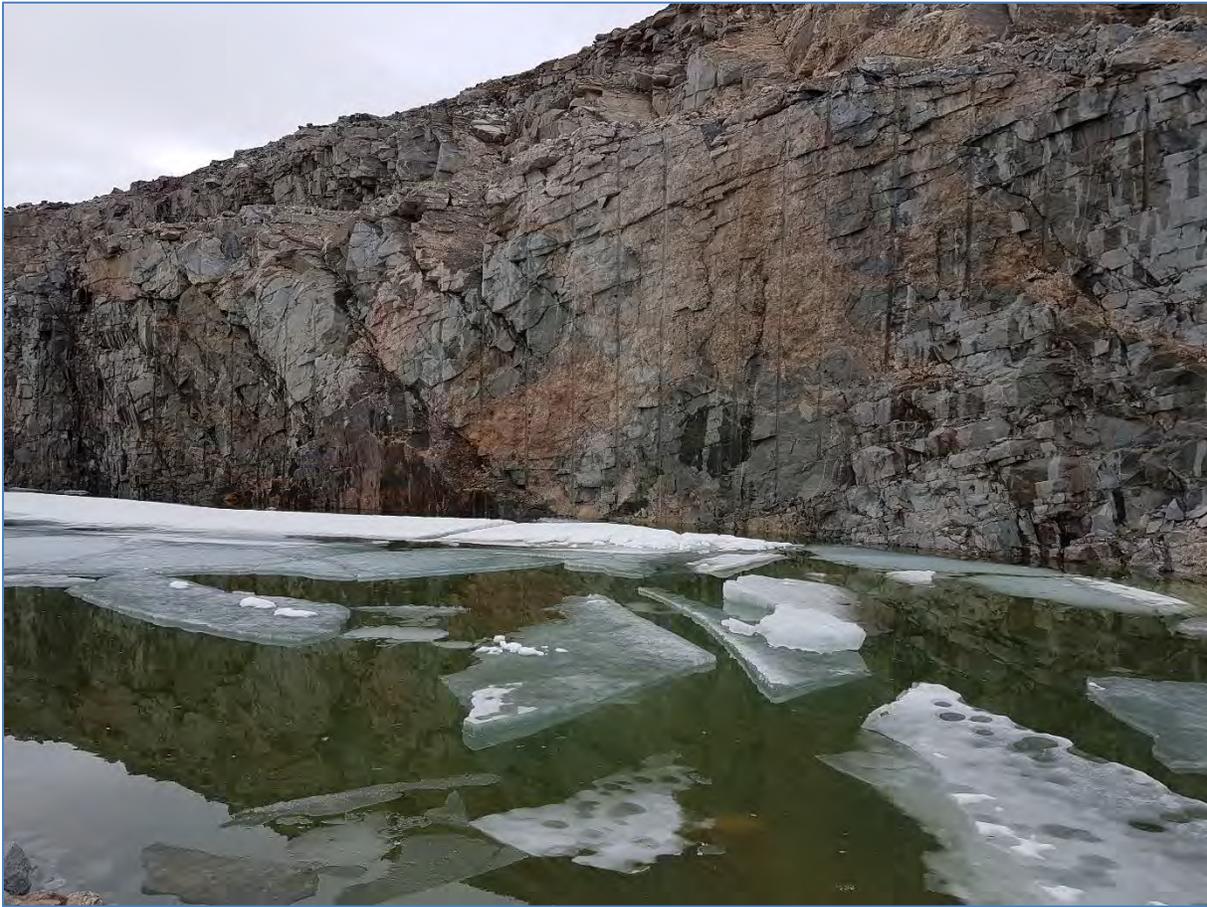
Photo 44: June 19, 2019 Open Pit – Photo of pit water level.

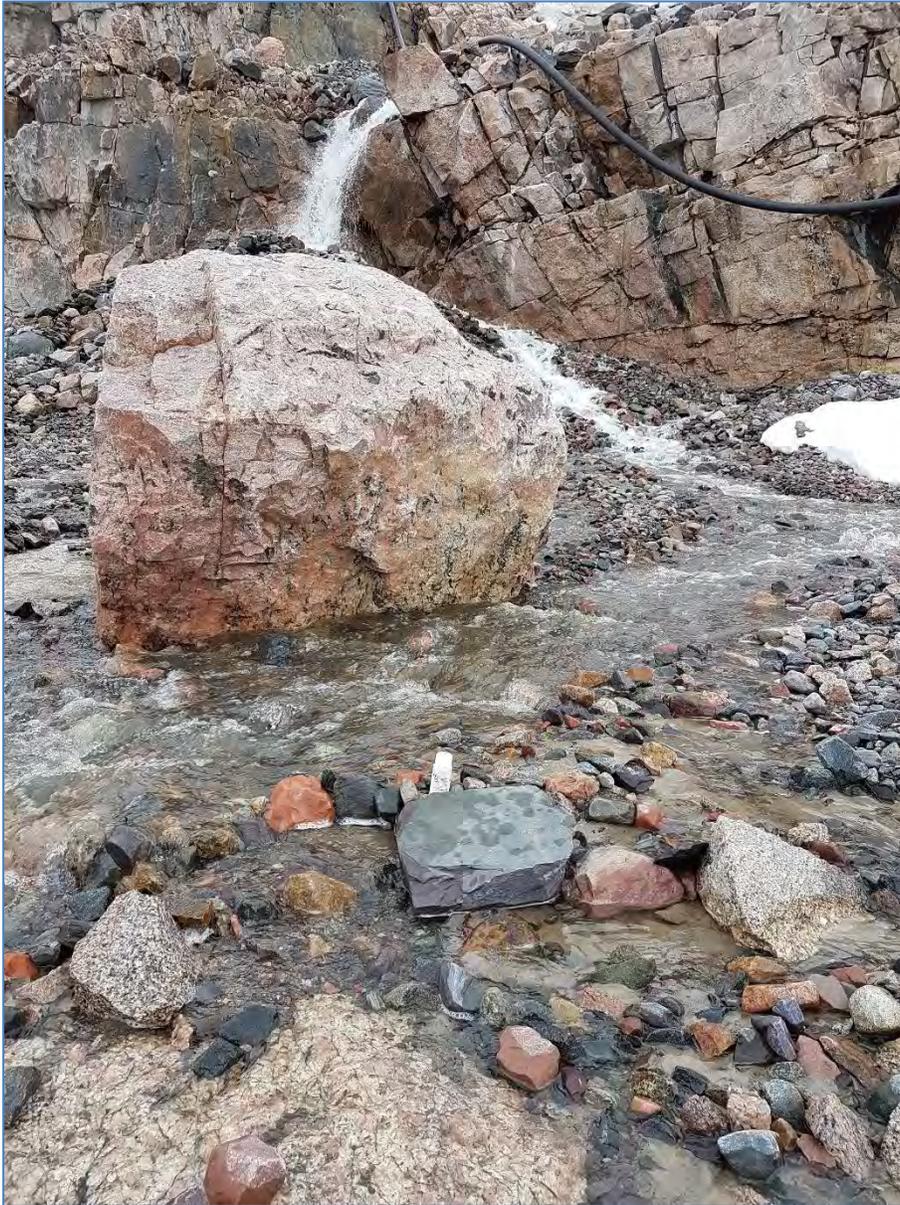
Photo 45: June 19, 2019 Open Pit – Photo of Spring sample location for freshet water into pit.

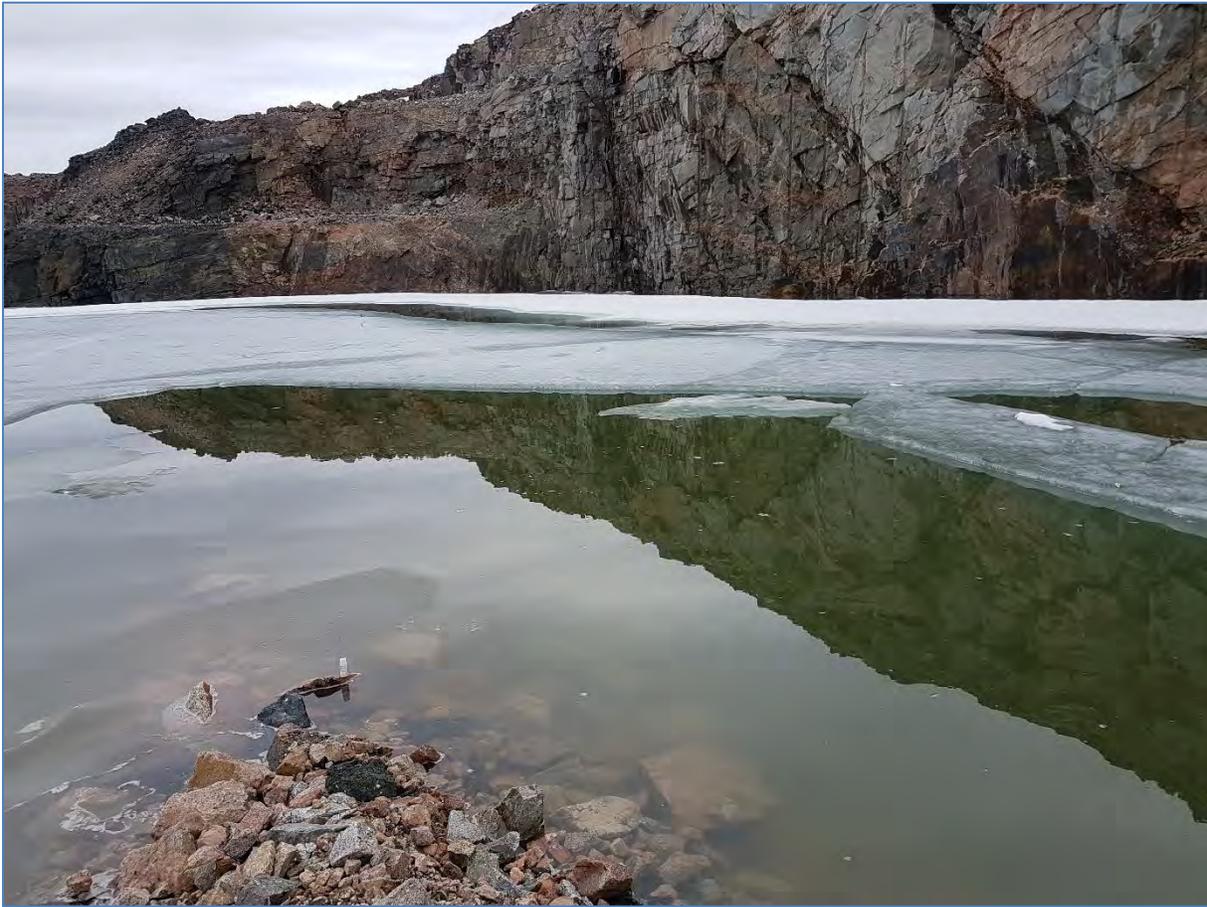
Photo 46: June 19, 2019 Open Pit – Photo of Spring pit water sample location.

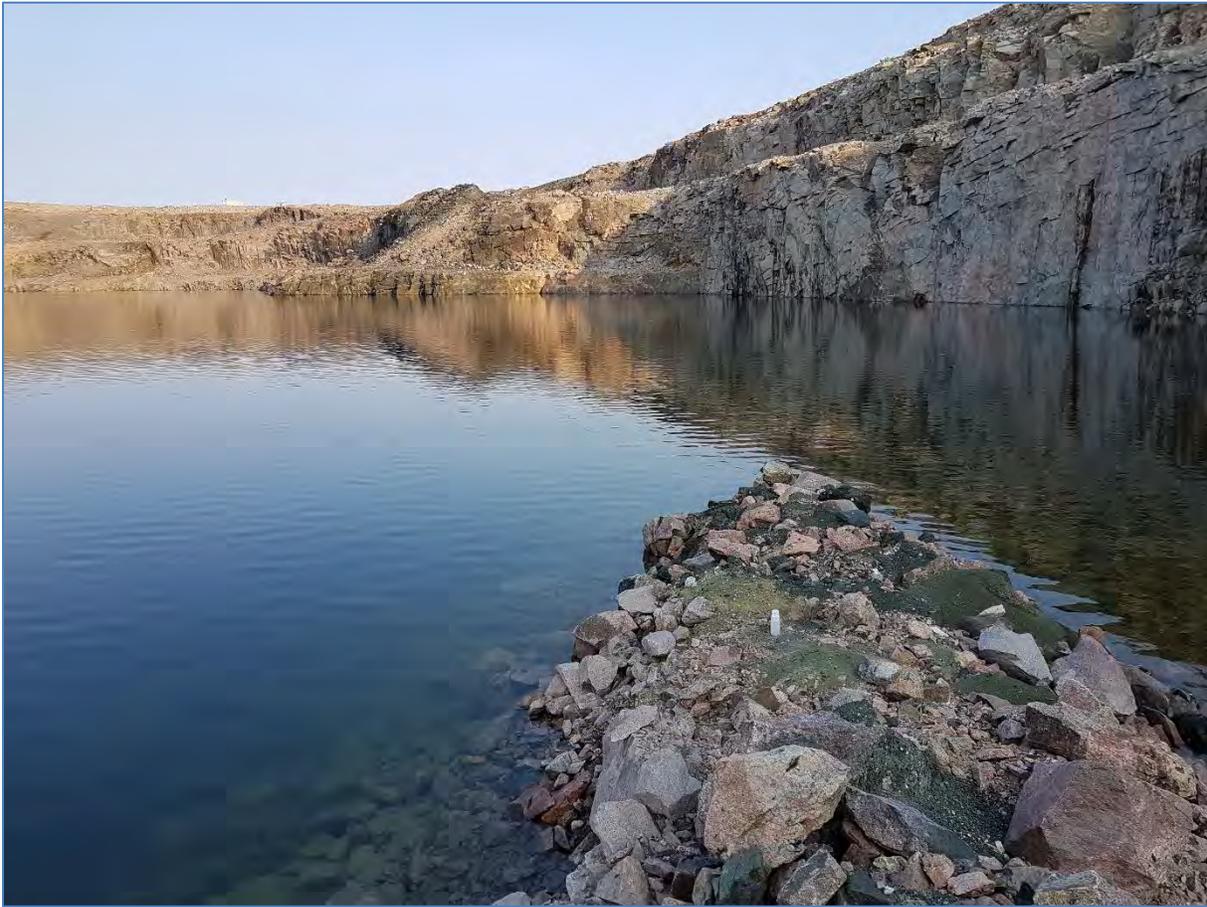
Photo 47: Sept. 12, 2019 Open Pit – Photo of Fall pit water sample location.

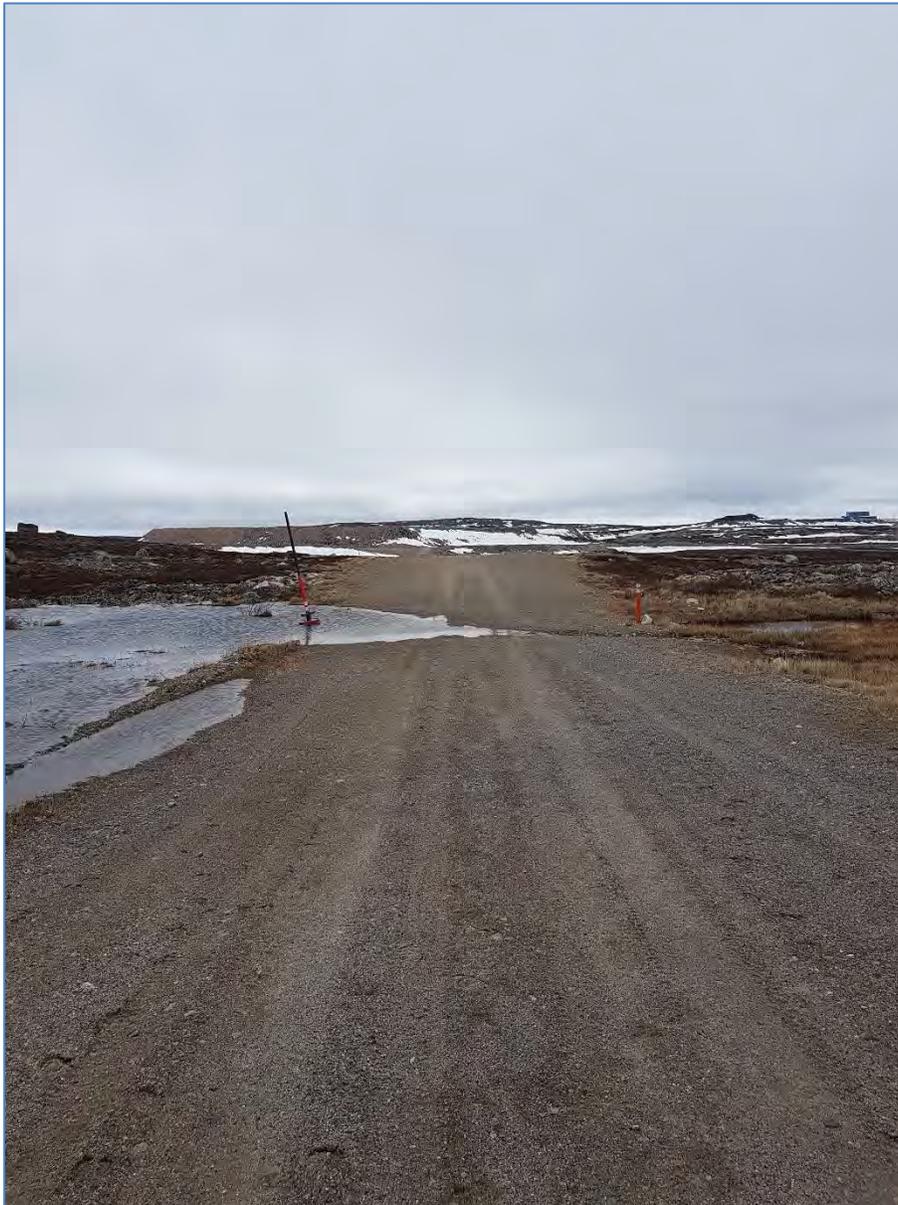
Photo 48: June 18, 2019 Road Section – Photo of partially flooded Main Road section between HWTA and Open Pit, UTM coordinates 12 W N478868 E7320754.

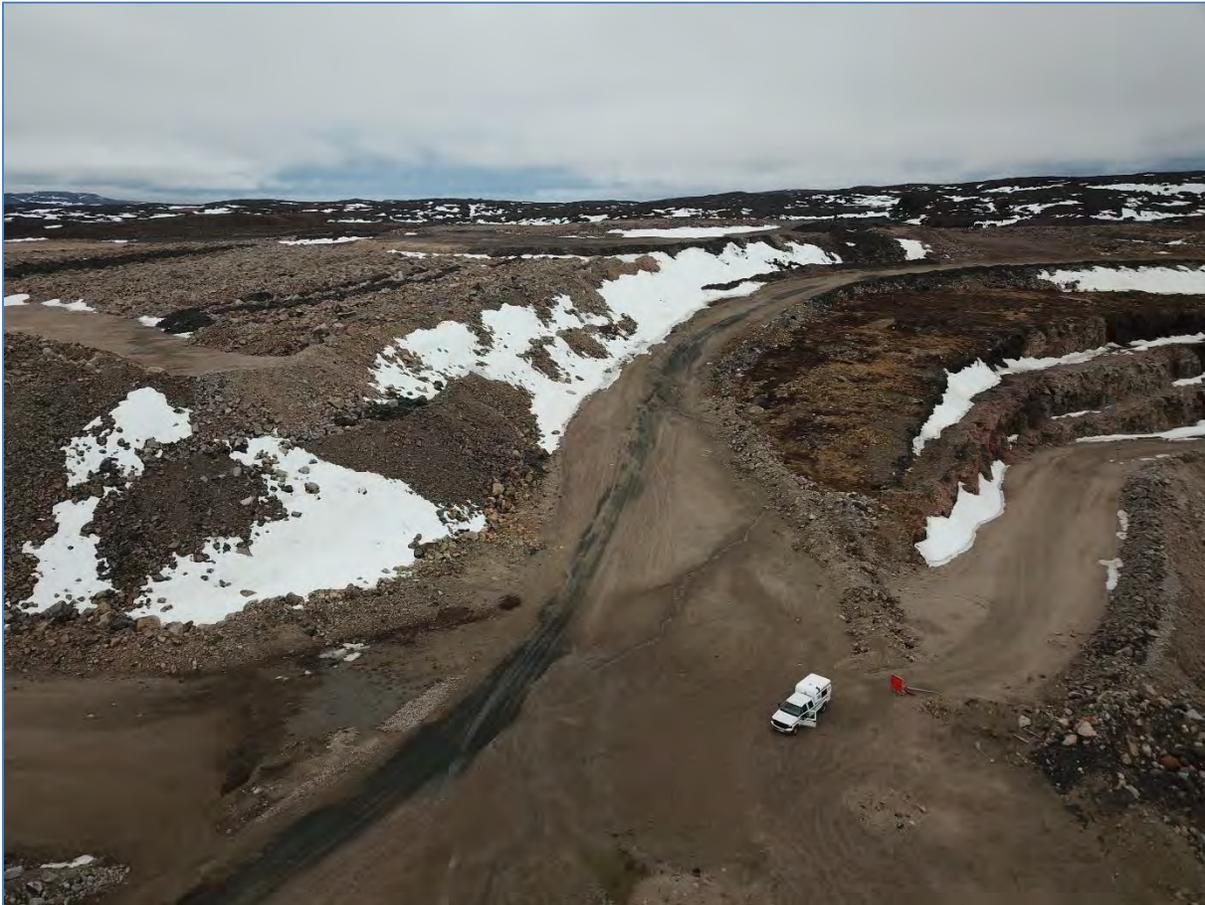
Photo 49: June 18, 2019 Road Section – Photo of Main Road section by N pit access with drainage erosion, UTM coordinates 12 W N478414 E7319738.
