JERICHO DIAMOND MINE OPERATION, MAINTENANCE AND SURVEILLANCE PLAN

NUNAVUT IMPACT REVIEW BOARD FILE #16UN058 2019 ANNUAL REPORT

May 4, 2020

**APPENDIX B:
JERICHO MINE SITE
OPERATION, MAINTENANCE AND SURVEILLANCE PROGRAM
2019 REPORT – FINAL**

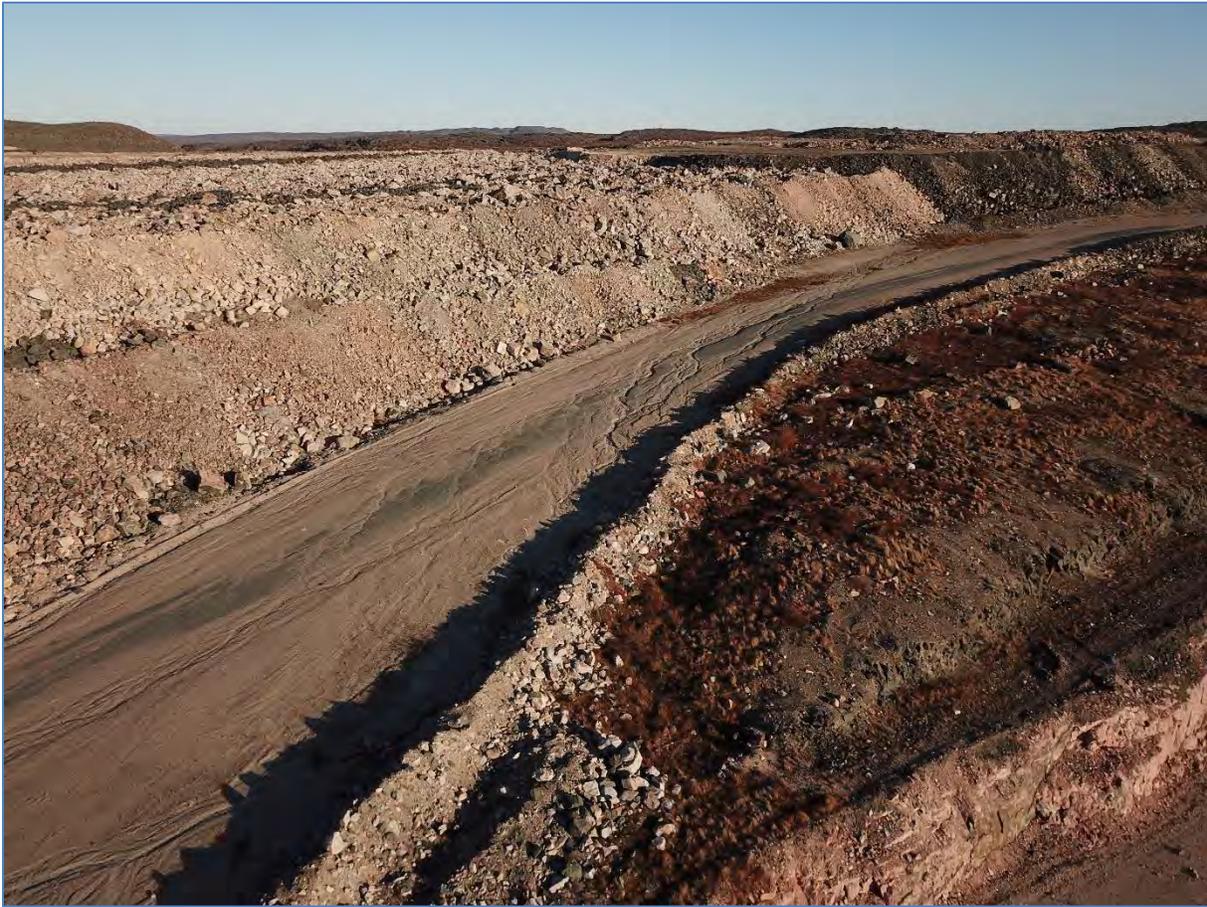
Photo 50: Sept. 10, 2019 Road Section – Fall Photo of Main Road section by N pit access with drainage erosion.
