Geotechnical Investigation

Project Name
Geotechnical Investigation, Airside Surface Rehabilitation
Aggregate Search and Airside Surfaces Assessment,
Whale Cove Airport, Whale Cove, Nunavut

Project Number
OTT-00249103-A0

Date Submitted
January 16, 2019

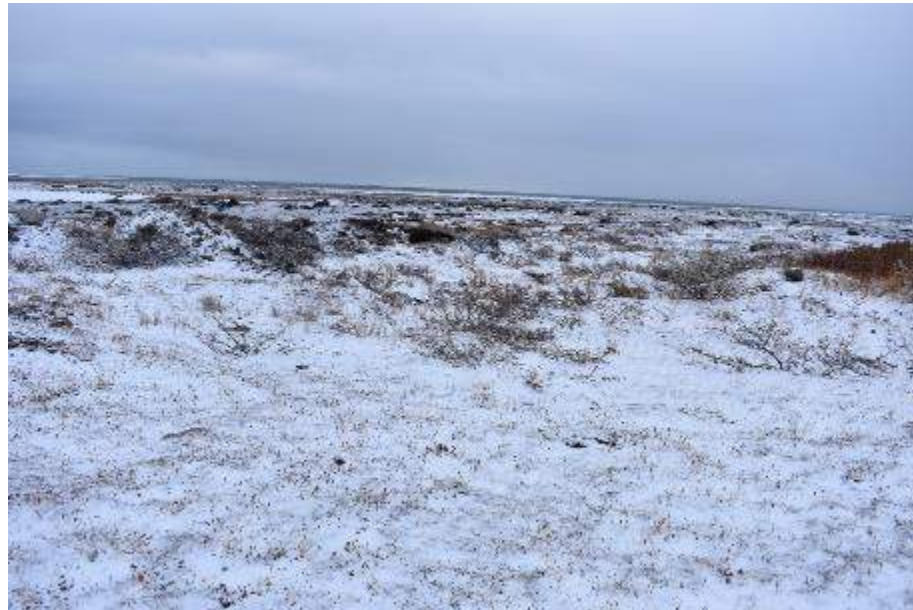
PhotoA7:General Location of Test Pit 4

The surficial deposit encountered at this location consisted of sand and gravel with cobbles and boulders (Photos A7 and A8). It extended to the entire depth investigated, i.e. 1.75 m. This material comprises of 3 percent clay and silt, 52 percent sand and 45 percent gravel (Figure 7). The percentage of crushed particles for this sample was established as 70 percent.

It is noted that Quarry No. 4 located approximately 1 km east of the south end of the runway satisfies most of the selection criteria listed above and therefore continued use of this source is recommended for the production of the base levelling material. However, this material contains a lower percentage of fines than desirable. Geologically, the quarry is located in the deposit described as RT_v , i.e. a thin veneer of till underlain by bedrock. The till has been described as gravelly, sandy, silty diamicton (i.e. unsorted to partly sorted). It is therefore possible that the percentage of fines may vary considerably with location and required percentage of fines may be achievable by mixing the finer material with the coarser material. However, if this is not successful, a source of finer material may have to be sought.

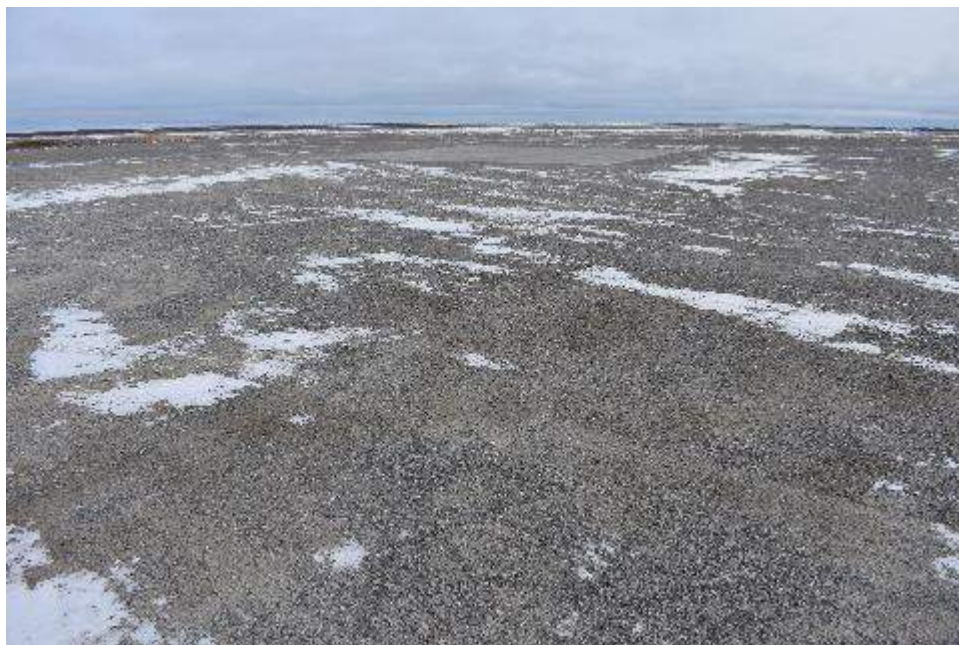
The apron is a gravel pad, well compacted but uneven with a concrete parking pad for the aircraft at its center (Photo B2). The apron surface is ravelled (Photo B3). There are plug-in points along the north edge of the apron (Photo B4). The apron drains to the north and east. The north and east side slopes appear to be in good shape with little to no sign of erosion. A shallow ditch or swale runs along the toe of both slopes and shows no signs of ponding (Photo B5). The west side of the apron, north of the terminal, is level with the parking lot and access road. All apron lighting is in good condition and working and all apron lights have their snow markers attached (Photo B6). The south side of the apron/taxiway is comprised of a shallow slope that grades to natural ground leading to a ditch and a pond beyond, west of the south end of the runway (Photo B7).

Photograph No. B2
Apron with the concrete parking pad, looking northeast

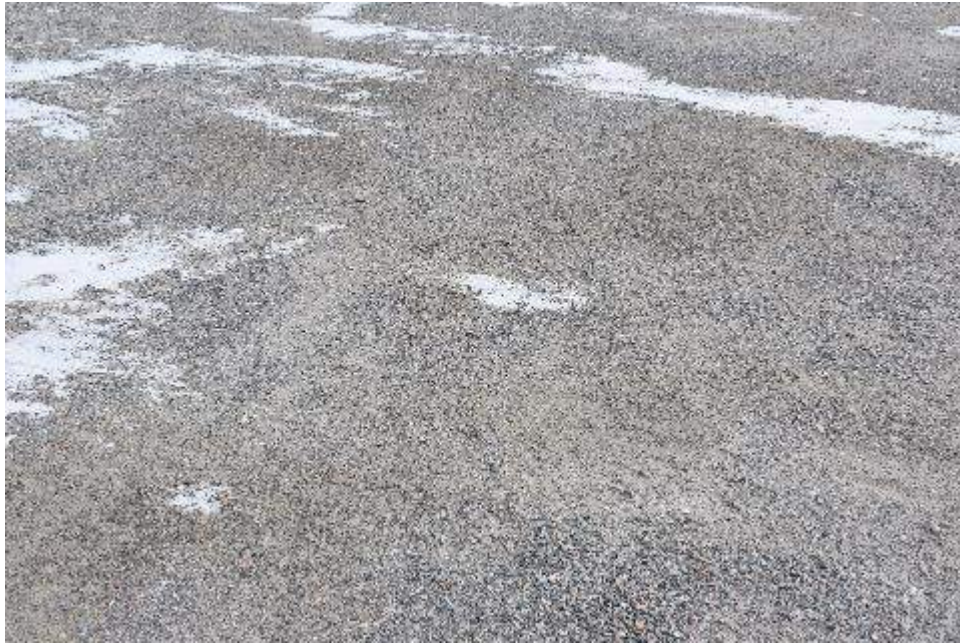
Photograph No. B3
Raveled, uneven ground of the apron, looking north

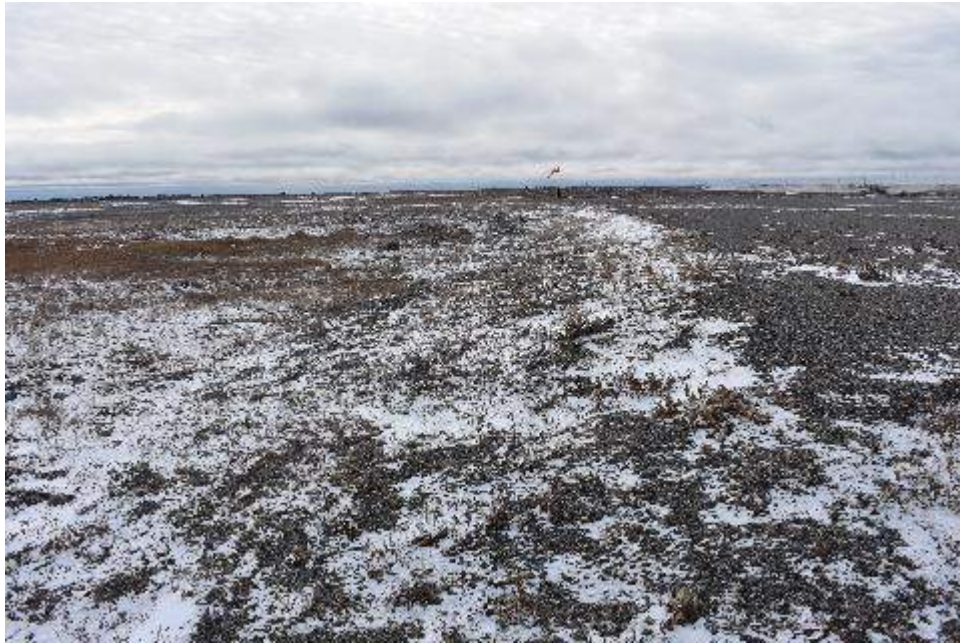
Photograph No. B5
Slope on the north side of the apron, draining to the swale, looking east

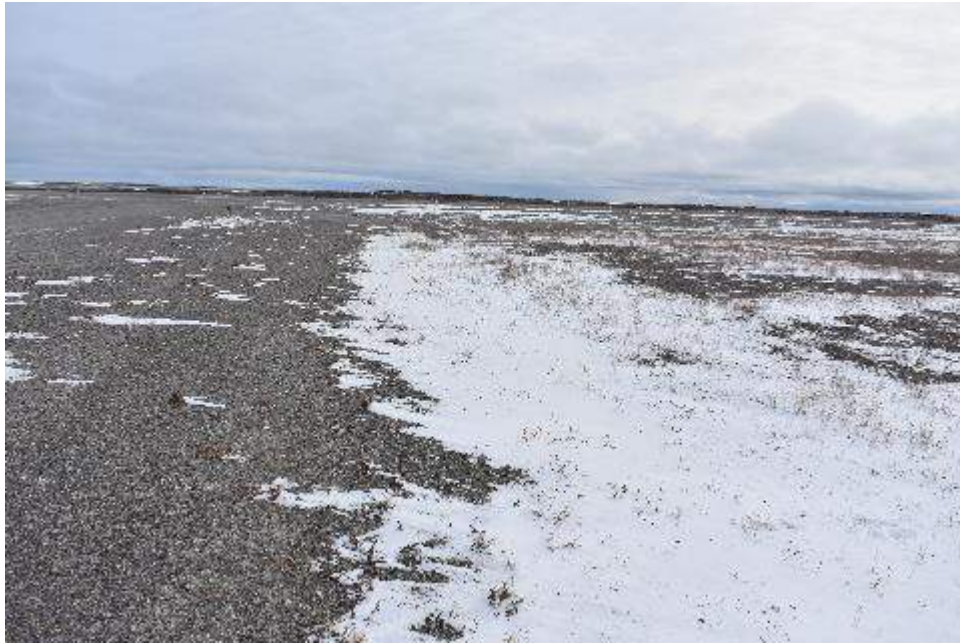
Photograph No. B7
South side of apron / taxiway side slope, looking east

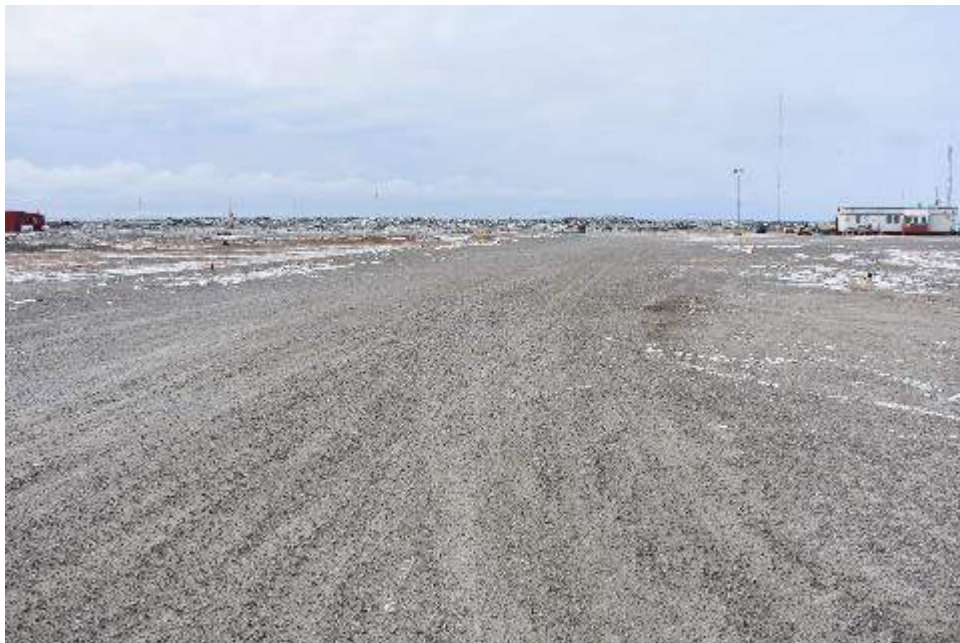
The taxiway is located east of the apron extending easterly from the south side of the apron (Photo B8). It is about 80 m long and is well compacted. The surface is uneven with no apparent crown. The south side of the taxiway slopes down to the natural ground and a pond further south. The north side slope of the taxiway is a long, gentle slope. Taxiway lighting is in good condition with all snow markers attached. Signage for the runway/taxiway is missing. Wiring for the signage on both sides of the intersection of the taxiway and runway is in place, but no signs have been installed or they have been damaged and removed (Photo B9).

Photograph No. B8
Taxiway and apron, looking west

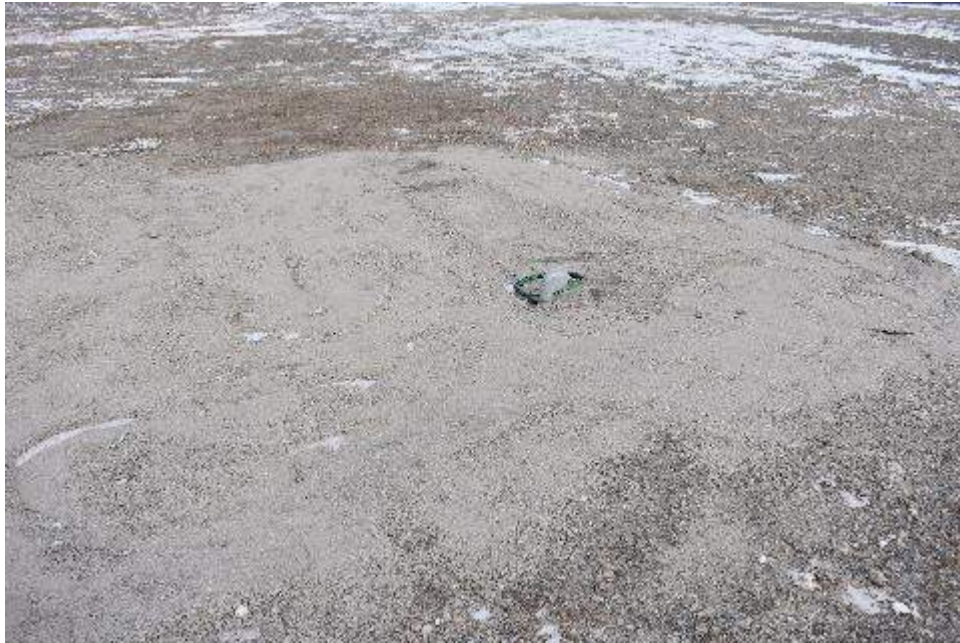
Photograph No. B9
Taxiway / runway signage wiring, looking northeast

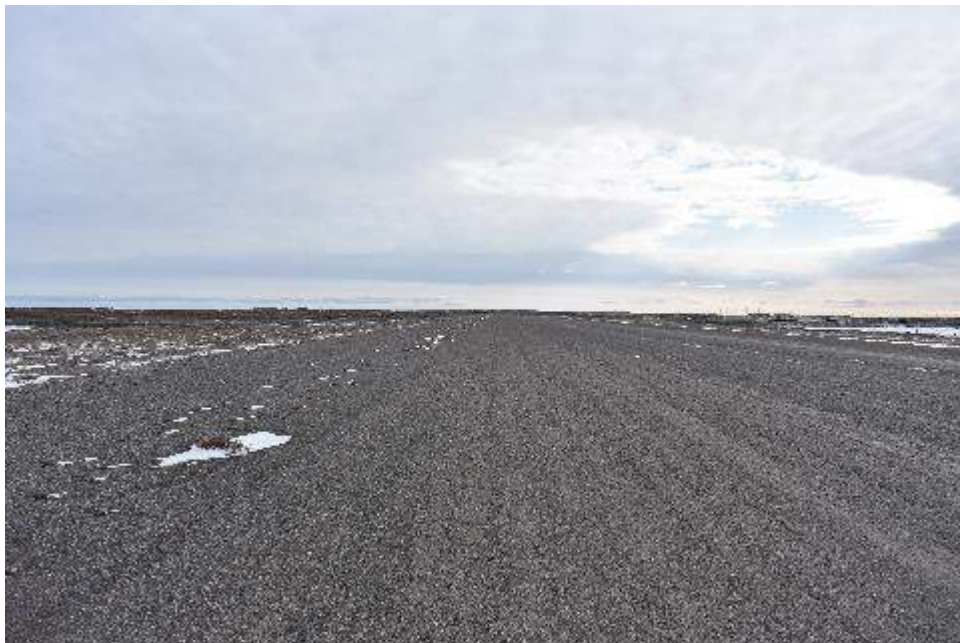
The runway surface close to the north end including the aircraft wheel paths is well compacted but is raveling (Photo B10). Another area that exhibits raveling is located north of the taxiway and extends in a

Moreover, the runway has ravelled. The cause of ravelling is considered to be the loss of fines from the surface material due to jet propeller blast, tire action and inadequate compaction. This results in loose surficial gravel being pushed aside under the wheels of the aircrafts resulting in ravelling.

Photograph No. B10
North end of runway, looking south

- 1.) The runway cross fall should be improved to between 1 percent and 1.5 percent to facilitate better drainage of the runway surface. The runway shoulders should be reinstated.

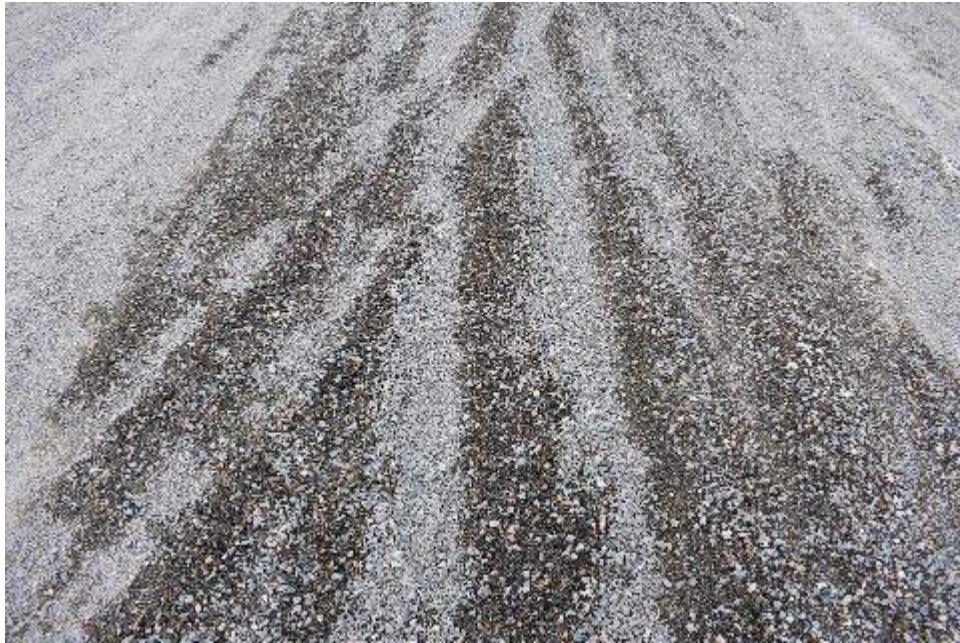
northerly direction from this location (Photo B11). This area is also well compacted under the wheel paths, but loose surficial gravel is evident between the wheel paths (Photo B12). From 60 m north of the taxiway, the centre part of the runway is raveled in a northerly direction (Photo B13).

Photograph No. B11
Raveling at the center of the runway, looking north

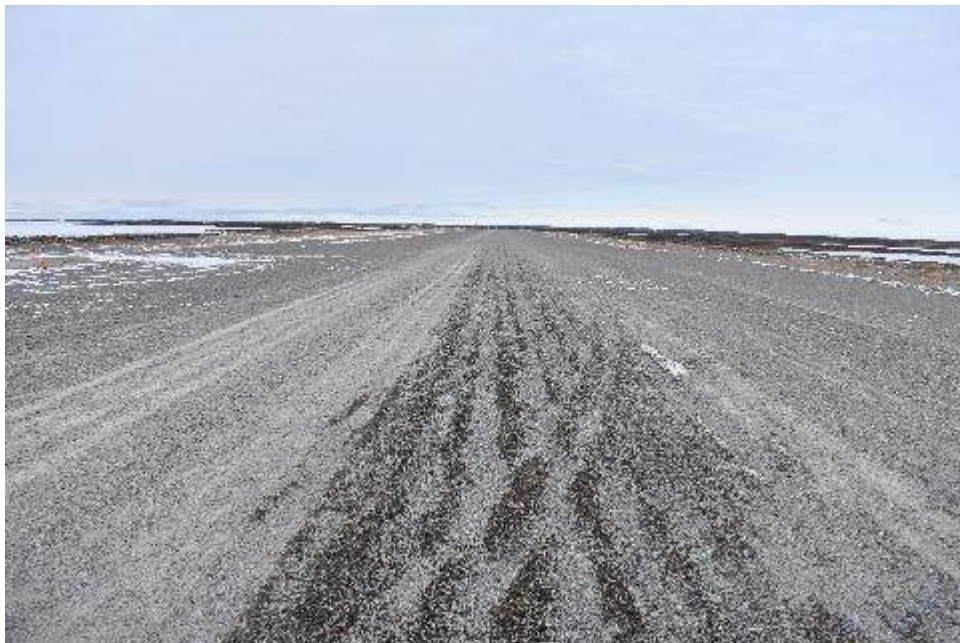
Photograph No. B12
Runway north of the taxiway, looking north

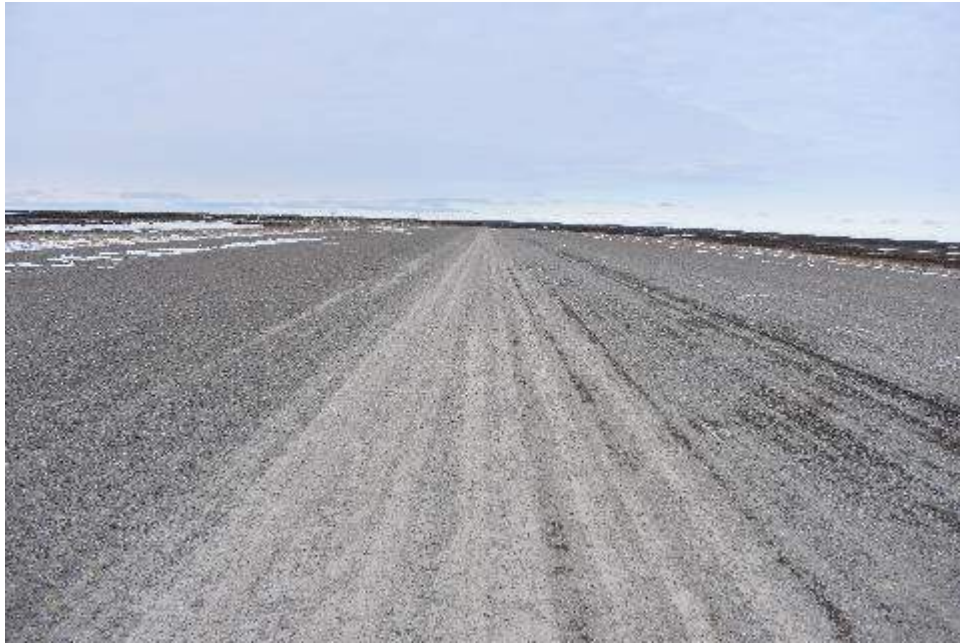
Photograph No. B13
North runway from 60 m north of the taxiway, looking north

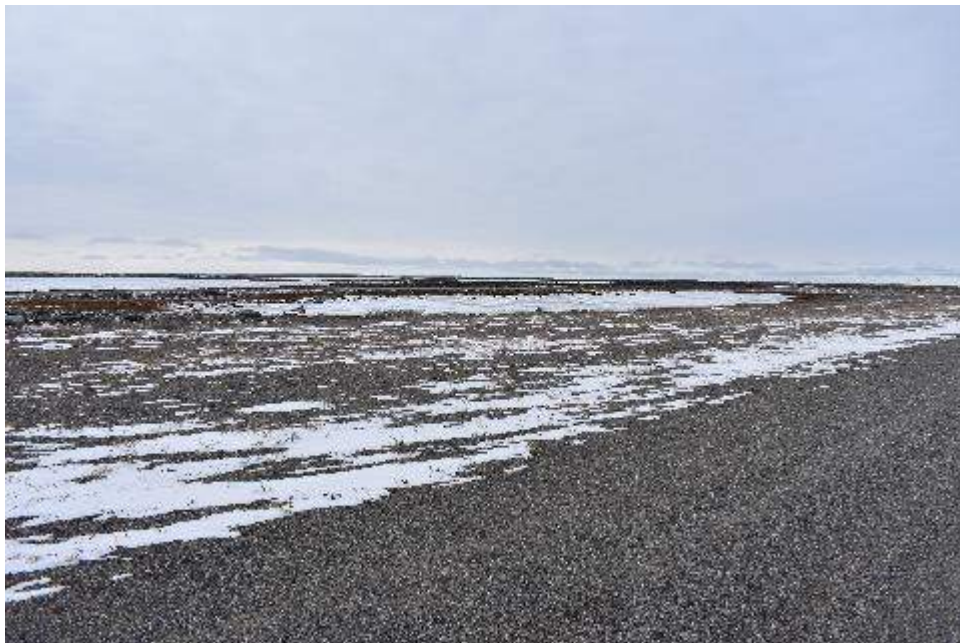
The west half of the runway from the taxiway to Station 0+770 approximately drains to a pond located west of the runway (Photo B14). North of this location, the west half of the runway drains into a ditch located along the west side of the runway. This drainage ditch extends in an easterly direction at the north end of the runway (Photo B15) and drains into a pond located northeast of the runway (Photo B16). The east half of the runway generally drains to the low-lying area located east of the runway, and to a number of ponds beyond. These ponds eventually drain to the Hudson Bay (Photo B17).

Photograph No. B14
Pond, west of the north runway, looking northwest

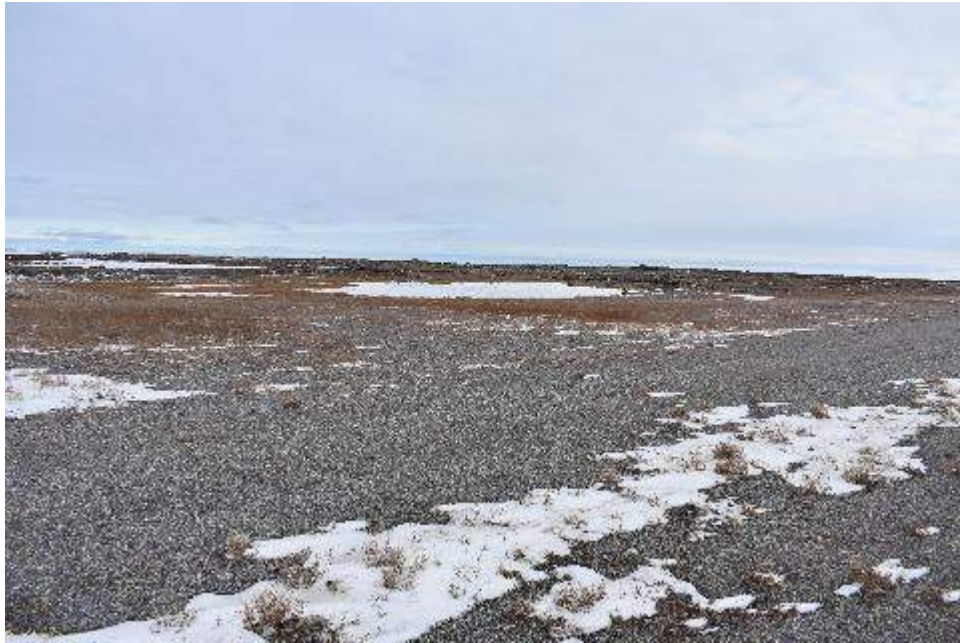
Photograph No. B17
Pond southeast of the runway, looking southeast
