Nunavut Impact Review Board

2020 Site Update Report

Meadowbank Gold Mine Project (NIRB File No. 03MN107) & *Whale Tail Pit Project* (NIRB File No. 16MN056)

Agnico Eagle Mines Limited

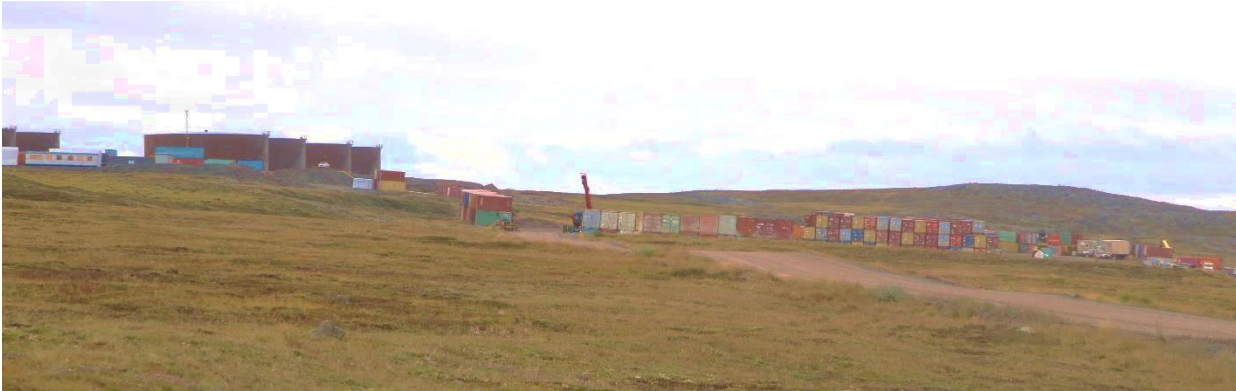
- a) NIRB staff noticed that the Baker Lake marshalling facility was busy with trucks driving seacans to and from the Mine Site ([Photo 2](#), Photo 3).
- b) There are currently four (4) emergency seacans located at the Baker Lake Tank farm including a new seacan installed in 2020 to meet the updated Oil Pollution Emergency Plan, Version 11 (Photo 4).

Photo 2: Baker Lake Marshalling Facility

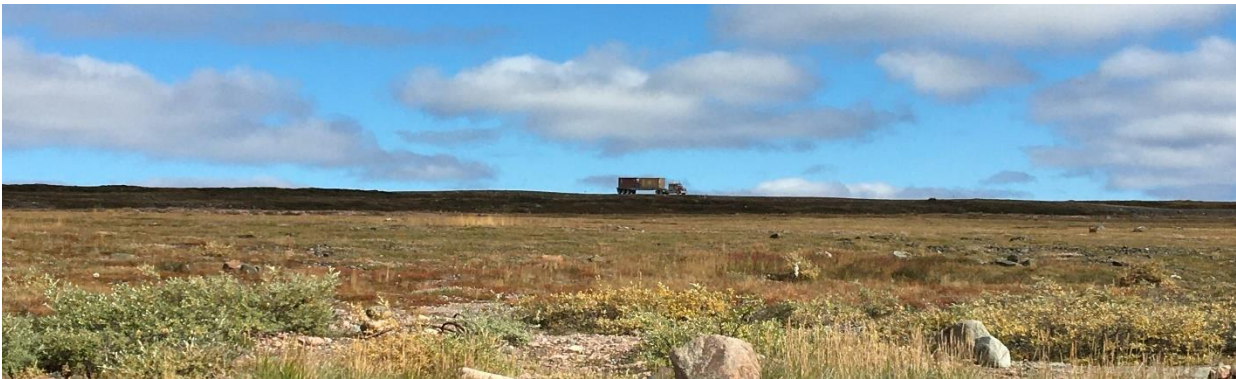
Photo 3: Trucks to Baker Lake Marshalling Facility

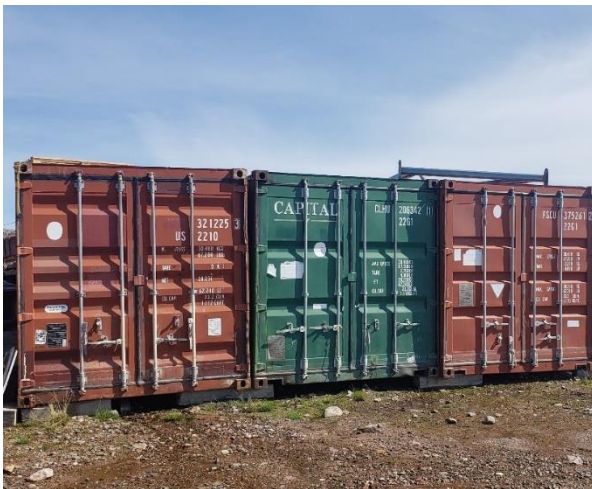
Photo 4: Emergency Sea Cans

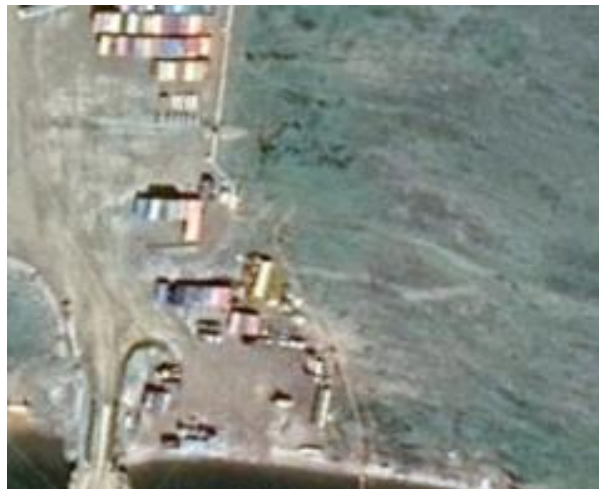
- c) Agnico Eagle confirmed that the lower all-terrain vehicle (ATV) trail that goes through the Baker Lake bulk fuel storage facility/marshalling area remains in place allowing members of the community to travel to their cabins along the shoreline (Photo 5).
- d) Agnico Eagle noted that there is 24-hour security at the Baker Lake facility.

Photo 5: Lower ATV Trail

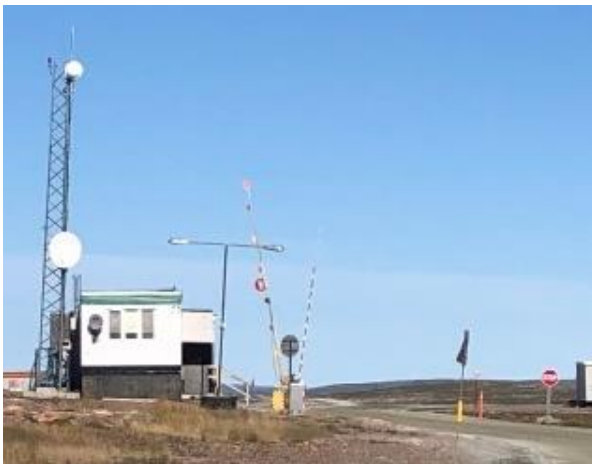
- a) There is a manned gatehouse at kilometre (km) 5 (Photo 8).
- b) The AWAR has snowmobile crossings at kilometre (km) 10 and 98 with signage (Photo 9). There are no designated wildlife crossings.

Photo 8: Gatehouse

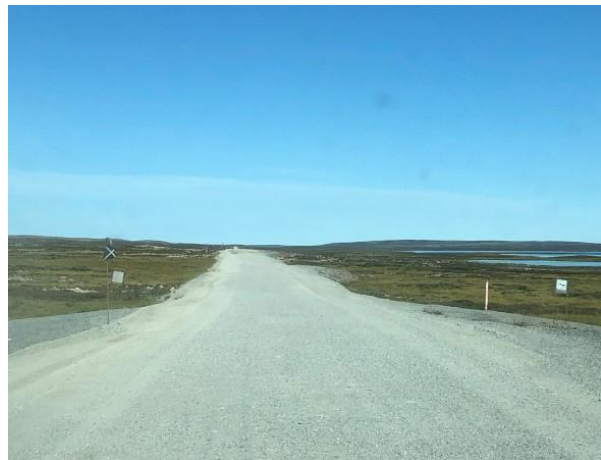
Photo 9: Snowmobile Crossing

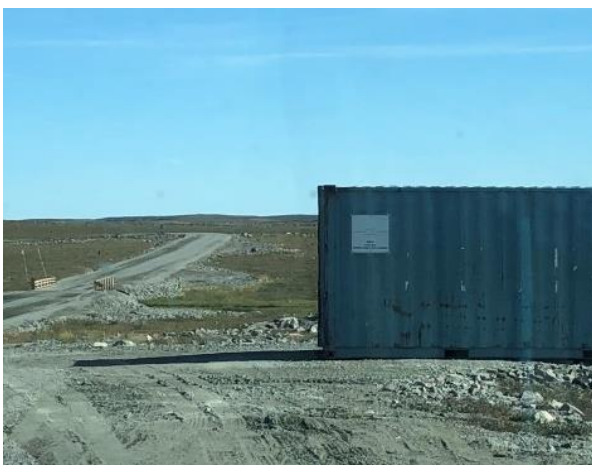
Photo 10: Emergency Seacan at Bridge

- a) Seacans with emergency spill response equipment are located at every bridge crossing (Photo 10).
- b) The spawning habitat rock structure located at the first bridge (Photo 11) was monitored in 2019 (see *2019 Annual Report*) with the next monitoring campaign planned for 2021.

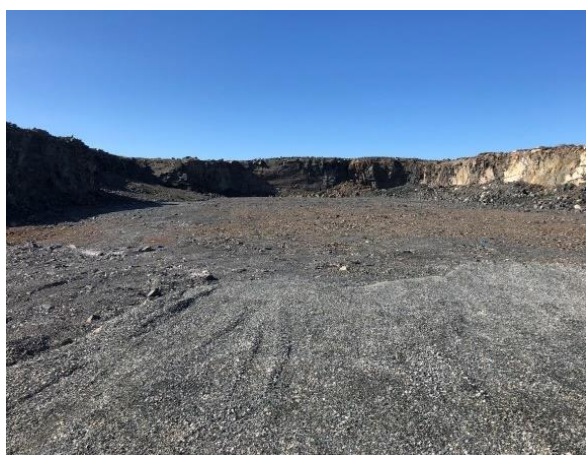
- e) Remediation has been ongoing at Quarry 22 following storage of contaminated hydrocarbon soil in previous years with the soil/gravel still testing positive for hydrocarbons (Photo 12). In 2020 Agnico Eagle tried to prevent nesting with a bird decoy (Photo 13) and bird cannon; however, the birds were not deterred and nested in 2020 and the equipment was removed.

Photo 12: Quarry 22

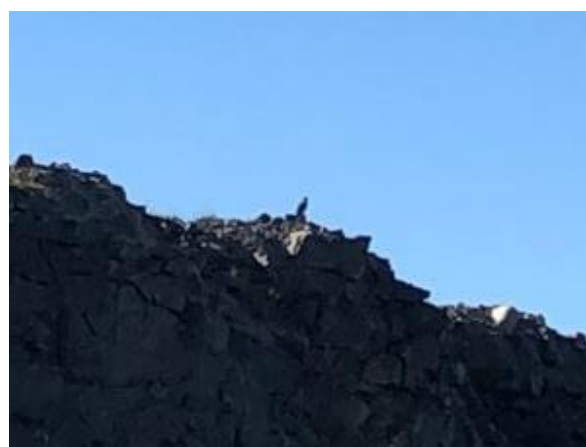
Photo 13: Bird Deterrent at Quarry 22

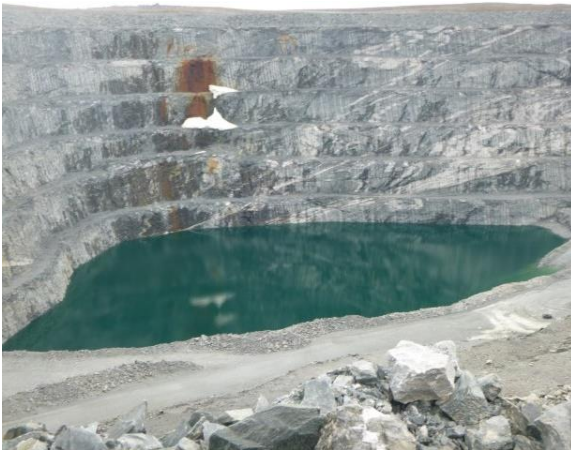
- a) Active mining was completed at all pits by the end of fourth quarter in 2019. Some residual stockpiles are still being processed at the mill.
- b) Mining completed in Vault Pit in March 2019. As observed in previous years, an ice sheet had formed on the walls of the Vault Pit and remains present in 2020 (Photo 14 and Photo 15).

Photo 14: Vault Pit Ice Sheet

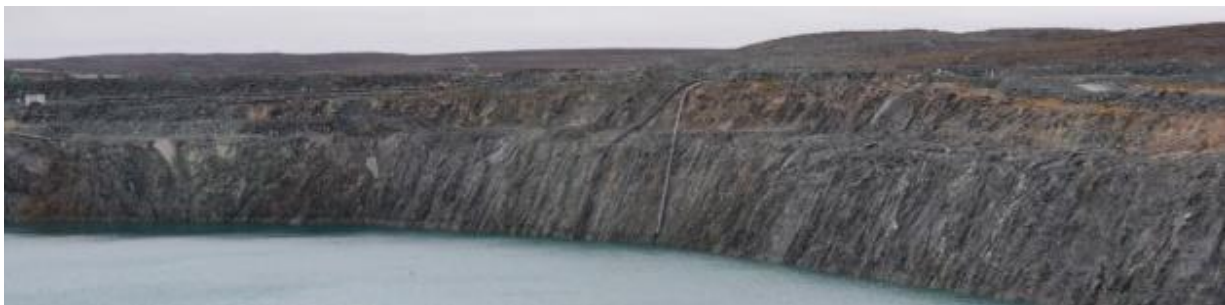
- d) Mining at Goose Pit was completed in April 2015. Tailings continue to be deposited into the mined-out pit (Photo 18).

Photo 18: Goose Pit (black pipe used for in-pit tailings)

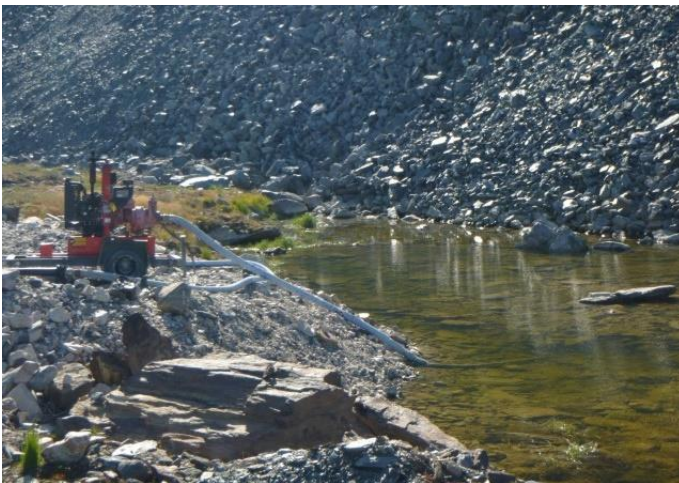
Photo 21: Seepage from Portage Waste Rock Storage Facility

- f) In 2013, Agnico Eagle noted seepage from the Portage waste rock storage facility with potentially acid generating rock (which has a high sulphur content, heavy metals, and other contaminants) at a location near the south shore of a fish bearing lake (referred to as North Pole 2 or NP-2 lake). Agnico Eagle stated that in 2020 seepage water continued to be pumped to the Tailings Storage Facility North Cell (Photo 21).

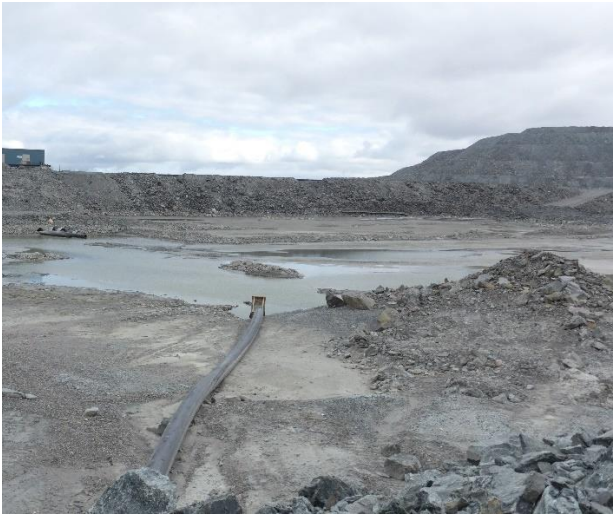
- g) The original landfarm, developed in 2013 and located next to the South Cell Tailings Facility, was flooded with tailings in 2017 (Photo 22). The second landfarm located to the east of landfarm 1, remains in use (Photo 23).

Photo 22: Landfarm 1

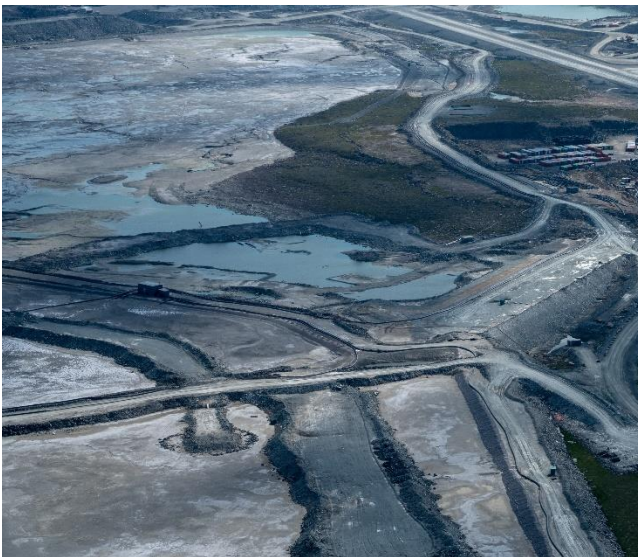
Agnico Eagle stated that no tailings were disposed at the Tailings Storage Facility (TSF) in 2020. Reclamation is ongoing on the North Cell with new capping present (Photo 34). No update was provided on reclamation of the South Cell in 2020 (Photo 35).

Photo 34: Tailings Storage Facility – North Cell

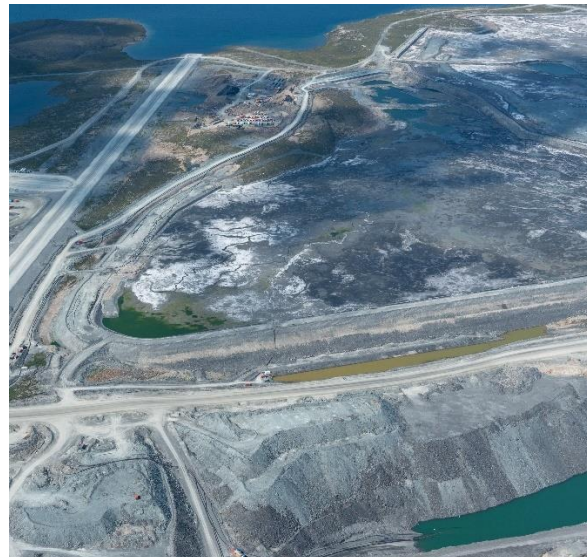
Photo 35: Tailings Storage Facility – South Cell

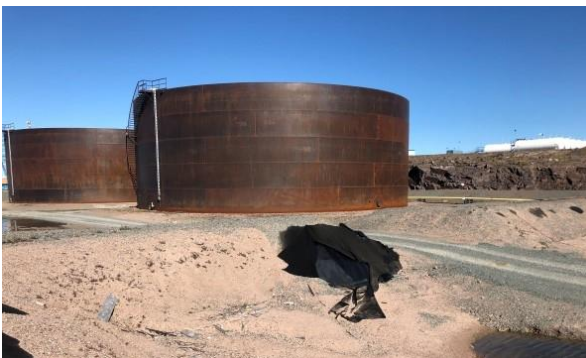
During their 2019 site visit NIRB staff noted that the liner at the Baker Lake Fuel Storage facility was exposed and Agnico Eagle informed the NIRB that it continues to be exposed in 2020 (Photo 40). Agnico Eagle noted no liner is seen exposed at the Meadowbank Tank Farm. As with 2019, water pooled within the secondary containment facility at the Meadowbank fuel tank farm in 2020 (Photo 41). This water is discharged towards the Stormwater Management Pond which is then directed to the Tailings Storage Facility.

Photo 40: Exposed Liner at Fuel Tanks

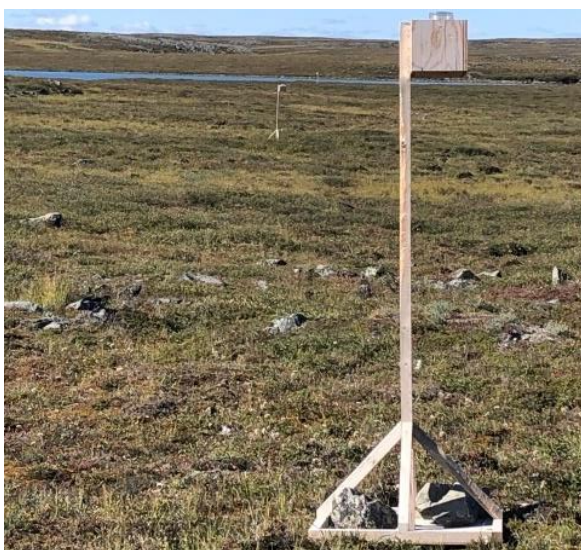
Agnico Eagle staff indicated that it continues to apply calcium chloride dust suppressant along three (3) critical areas and two (2) additional areas for two (2) km sections of the AWAR. Along each of the five (5) sites, Agnico Eagle also continues to conduct dust sampling to assess dustfall rates in the dust suppression locations, as well as two (2) reference sites without dust suppression (km 18 and 78). In 2019 dustfall monitoring stations were moved from the ground to poles with one transect continuing to have on the ground collectors for comparison (Photo 42 and Photo 43).

Photo 42: Dust Fall Transect

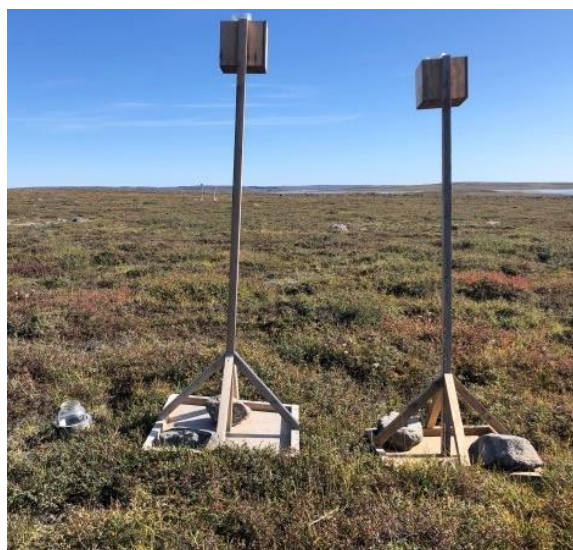
Photo 43: Dust Fall Monitoring Stations

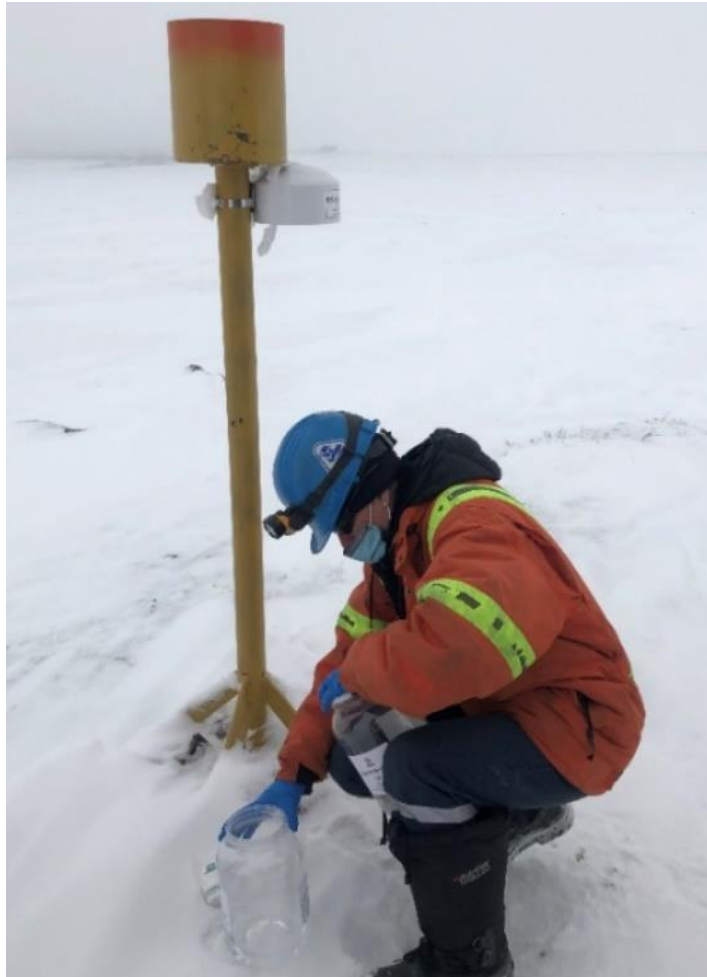
Condition 1 was revised during the Whale Tail Expansion Reconsideration to include a requirement for the Proponent to undertake continuous NO₂ monitoring downwind of mining activities. There is currently one (1) station with dustfall and NO₂ samplers on site (Photo 69). Agnico Eagle noted that a NO₂ continuous monitoring station will be installed by the end of 2020.

Photo 69: Dust and NO₂ sampler at station DF-6

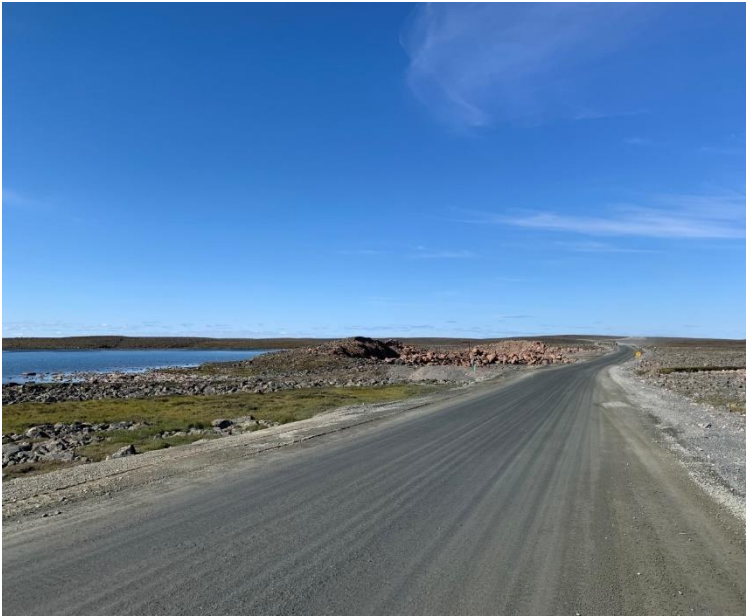
During their 2019 site visit, NIRB staff observed that dust suppressant was not being applied to the whole AWAR (see section 2.1.2.2), along the Whale Tail Haul Road (WTHR) nor at the Whale Tail site. In 2020 Agnico Eagle noted that calcium chloride dust suppressant was applied to the entire length of the WTHR (Photo 70). Also similar to the AWAR, dust monitoring stations have

Photo 70: Whale Tail Haul Road After Dust Suppression

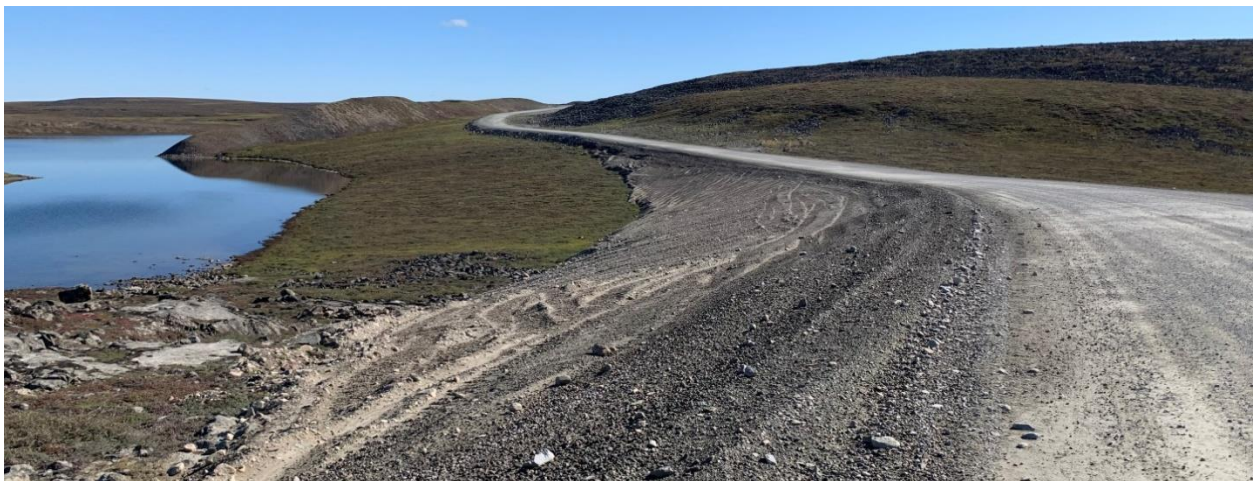
During their 2019 site visit Agnico NIRB staff noted that no specific caribou/wildlife crossings were in place. In addition, it was observed that the Haul-road was not sloped to assist wildlife in crossing the road. Agnico Eagle stated that the snowmobile crossing also serves as the wildlife crossing and that no additional crossings were needed by the Baker Lake Hunters and Trappers Organization (BLHTO). In 2020 Agnico Eagle also updated that the WTHR has since been resloped allowing easier crossing (Photo 72).

Photo 72: Whale Tail Haul Road Resloped
