**Report Title:** The Nunavut Impact Review Board's 2020 Site Update Report for Agnico Eagle Mines Limited's *Meliadine Gold Mine Project* (NIRB File No. 11MN034)

**Project:** Meliadine Gold Mine Project  
**Project Location:** Kivalliq Region, Nunavut  
**Land Tenure:** Inuit Owned Land

**Project Owner:** Agnico Eagle Mines Limited  
Meliadine Mine Site  
Rankin Inlet, NU  
X0C 0G0

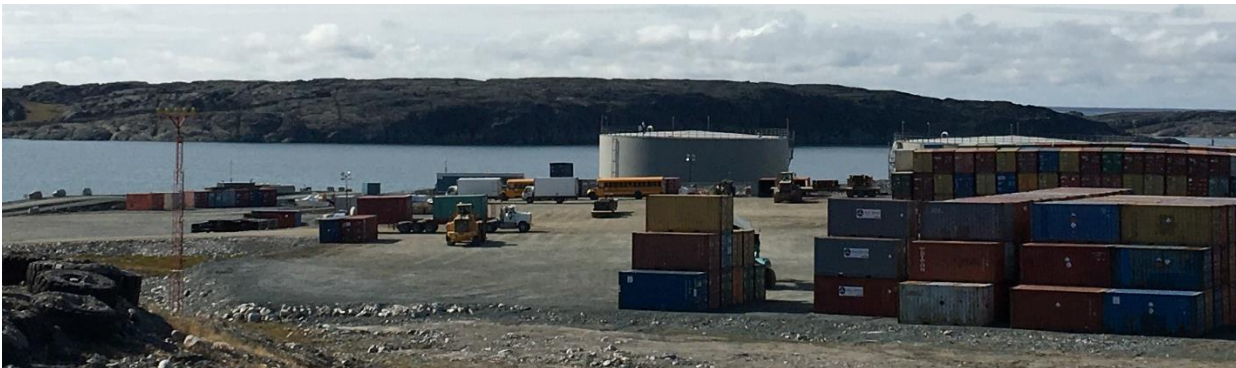
**Photo 2: Itivia Harbour**

- a) The NIRB staff observed that the Itivia site was busy with equipment and seacans being moved around (Photo 2).

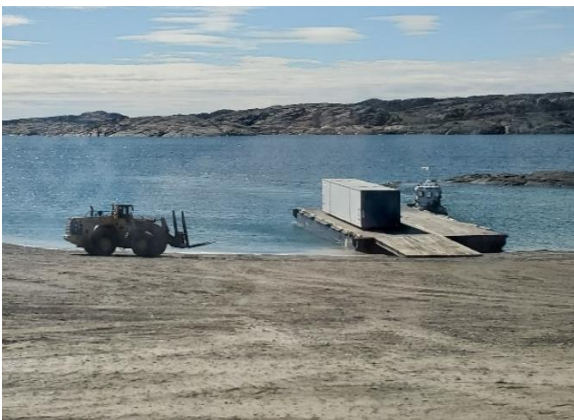
**Photo 3: Community Barge Area**

- b) Itivia is shared between the community and Meliadine gold mine with laydown area for the mine separate from the community laydown area (Photo 3 and Photo 4).

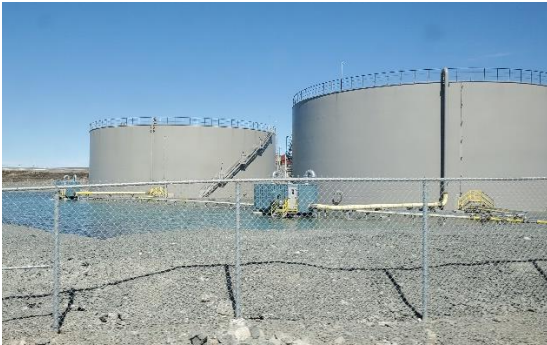
**Photo 5: Itivia Fuel Tank Farm**

- c) Agnico Eagle informed NIRB that the secondary containment is functioning appropriately at the Itivia fuel farm (Photo 5).
- d) Three (3) seacans of spill response equipment are located on site (Photo 6).

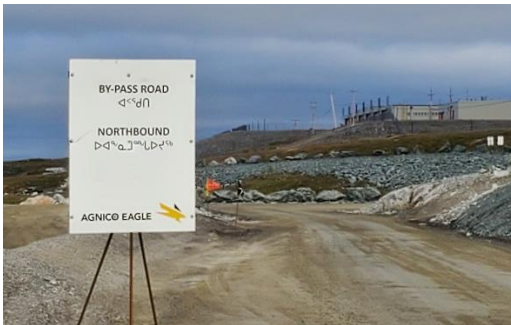
**Photo 7: Bypass Road**

- a) The Bypass road had clear signage in both English and Inuktitut (Photo 7).
- b) There is a marked snowmobile crossing to allow access to Itivia Bay (Photo 8).
- c) The NIRB staff observed saline water trucks along the Bypass Road (Photo 9).

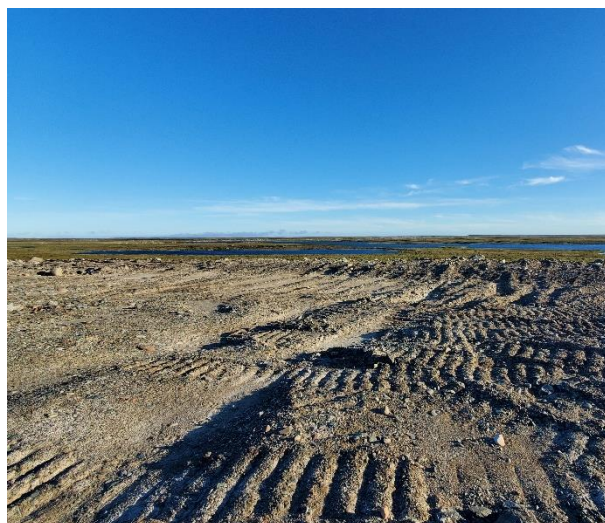
**Photo 16: Quarry at Kilometre 27**

- d) Agnico Eagle noted that quarry and esker reclamation along the road was not done in 2020 as it was completed in 2019 (Photo 16).
- e) The Proponent indicated that there are no wildlife crossings on the AWAR, as the embankment gradient is gradual enough not to impede crossing.

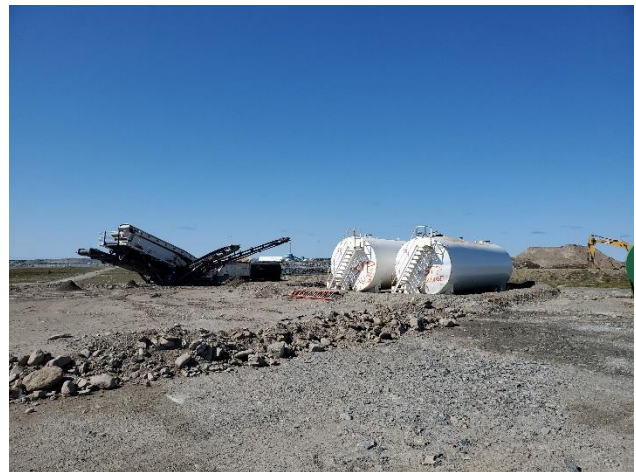
**Photo 19: Fuel Tank Farm**

- a) Agnico Eagle noted that the exploration camp is still in use with a capacity of 144 persons (Photo 17).
- b) Screening (sorting out coarse-grained material) at the exploration camp landfarm took place during summer 2020 (Photo 18).
- c) The fuel tanks containing sewage sludge had a small berm built around them as secondary containment. Agnico Eagle indicated that they are evaluating shipping the empty fuel tanks off site (Photo 19).

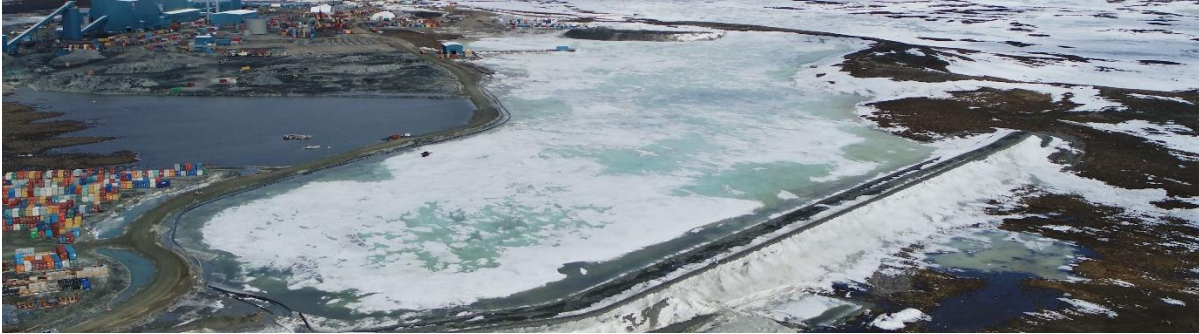
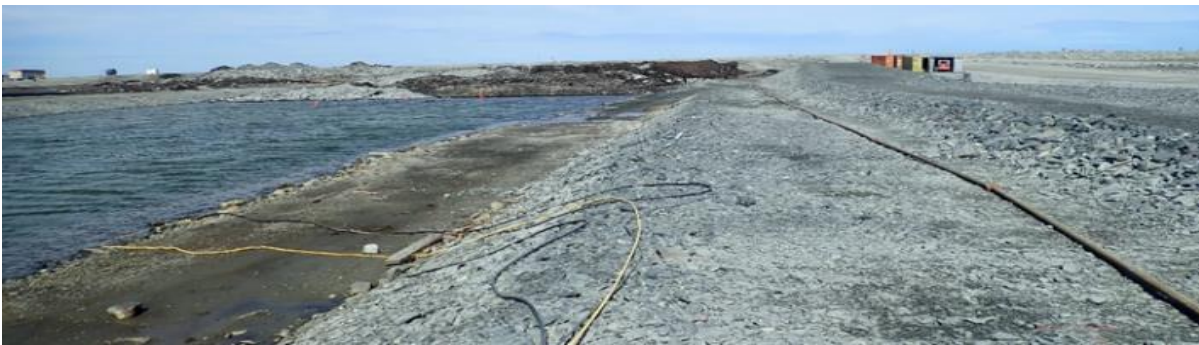
- f) The water management strategy includes use of containment ponds to handle contact water and treated groundwater. Dikes are surveyed monthly (Photo 25 and Photo 26).

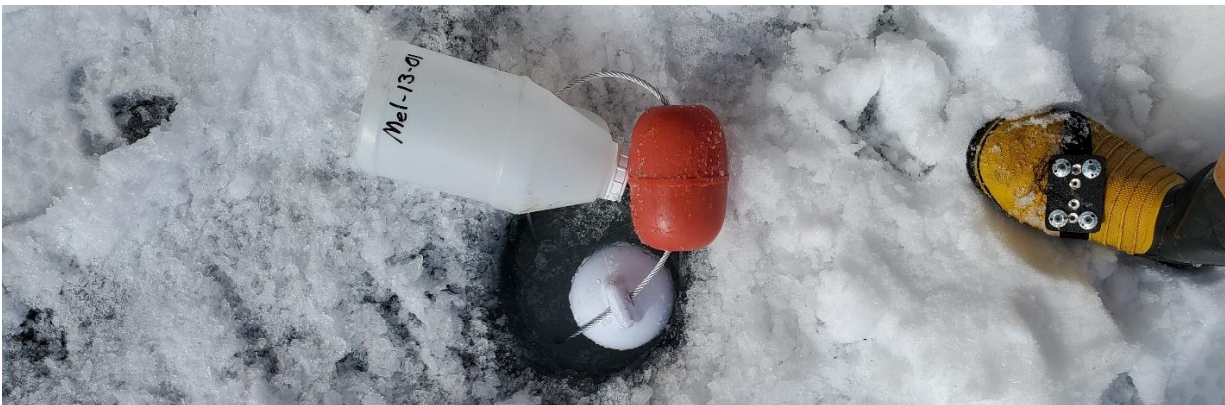
**Photo 27: Additional monitoring at Mel-13**

- g) In 2019 Agnico Eagle was unable to drawdown on CP-1 due to high Total Dissolved Solid levels, therefore requiring an emergency water licence amendment in 2020 to allow discharge into Meliadine Lake. Agnico Eagle informed the NIRB that in response increased monitoring is occurring with development of a Water Quality Monitoring Optimization Plan and three (3) additional continuous monitoring probes were added for internal data collection at the Meliadine Lake diffuser (Photo 27). One (1) was lost during ice break up.

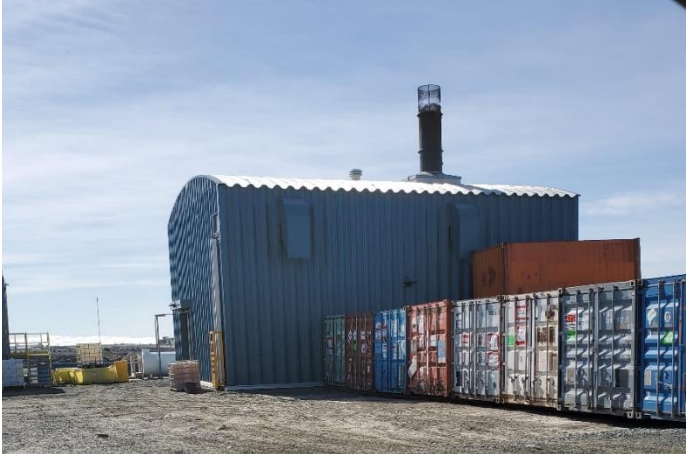
**Photo 28: Incinerator**

h) During the 2019 site visit<sup>2</sup> the NIRB staff were informed that Agnico Eagle had issues with the building that houses the incinerator overheating during incineration. To remediate this the incinerator doors are kept closed except during summer when a steel grating is used to keep wildlife out while the door is open to allow heat to escape (Photo 28).

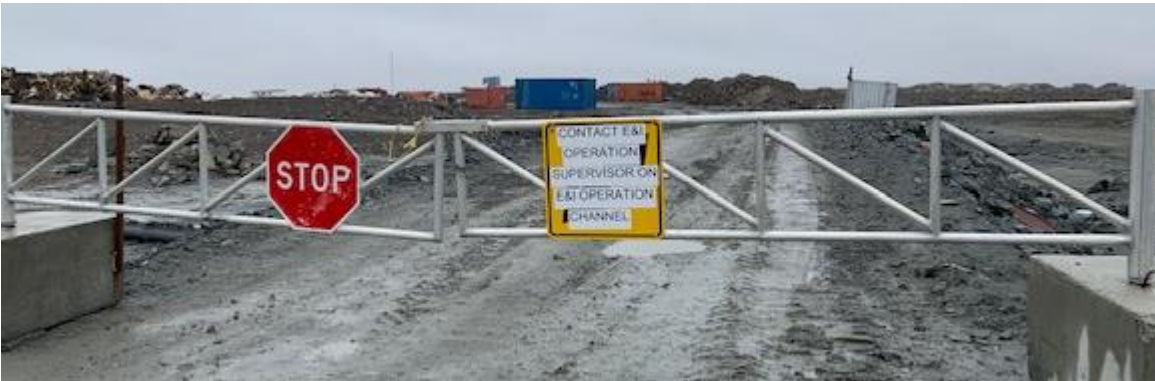
**Photo 29: Landfill Access Gate**

i) The landfill is not fenced but Agnico Eagle noted that a gate was installed to control access (Photo 29).

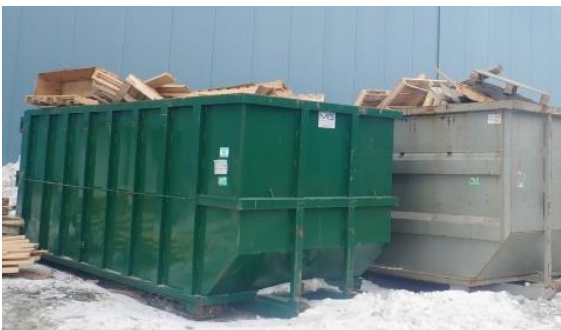
**Photo 30: Waste Sorting**

j) Waste is sorted at landfill and signage is present to ensure proper waste sorting. Agnico Eagle notified the NIRB that labelling and inspection of waste sorting was improved in 2020 as compared to the 2019 site visit (Photo 30 and Photo 31).

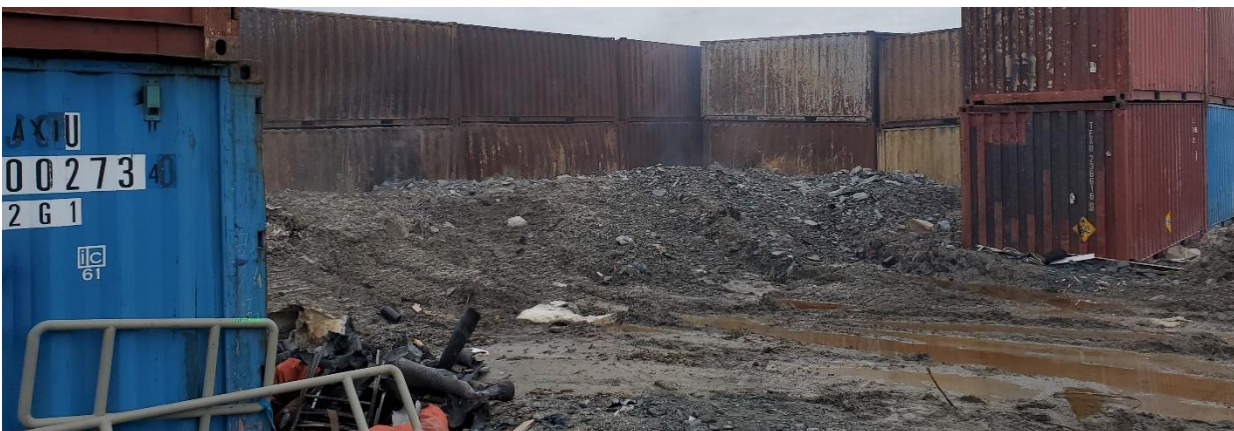
**Photo 34: Temporary Landfill Post Fire**

- o) In 2020, the NIRB was informed of a fire at the temporary landfill sorting area. The fire was extinguished with no injuries or damage to infrastructure. The burnt material was smothered with clean till and to avoid reignition will remain undisturbed for several months (Photo 34).

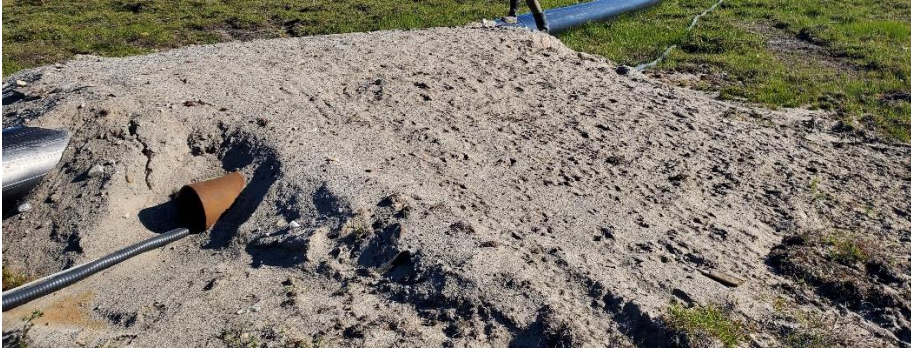
**Photo 35: Wildlife Pipeline Crossings**

p) Agnico Eagle stated that wildlife crossings have been established over waterlines at site (Photo 35).

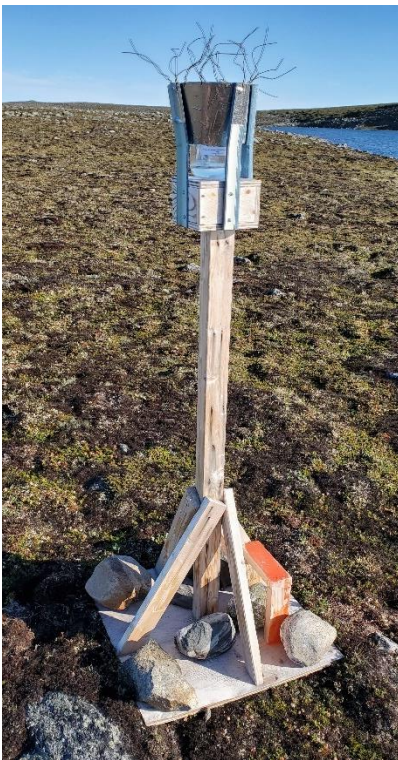
**Photo 46: Dust Monitoring Station**

- a) Agnico Eagle informed the NIRB that additional dust monitoring stations were added along the AWAR (Photo 46).
- b) Partisol units, used to measure total suspended dust, have not been functioning for the majority of 2019 and 2020 and have yet to be installed.
- c) Calcium chloride was used as a dust suppressant along the AWAR and at site (Photo 47).

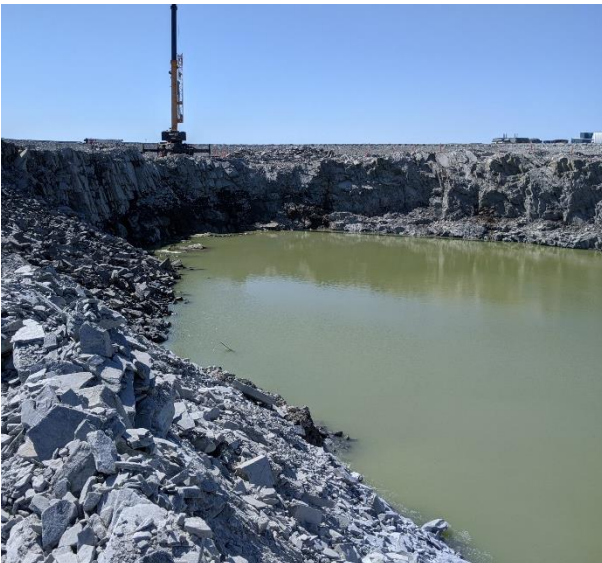
**Photo 49: SP-2**

- e) Groundwater is stored within the saline ponds (Photo 49 and Photo 50).
- f) In 2020 increase saline water was trucked from the mine site to Itivia Harbour where it was transferred to the saline tank and discharge was doubled through the pipeline to a diffuser in Melvin Bay (Photo 51 and Photo 52).

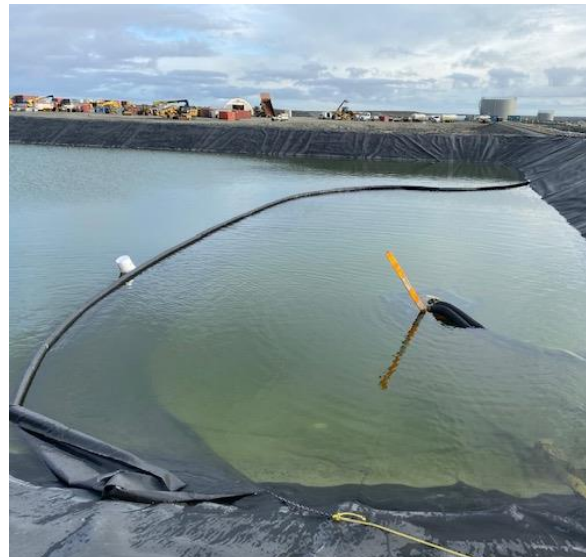
**Photo 50: Turbidity curtain at SP-3**

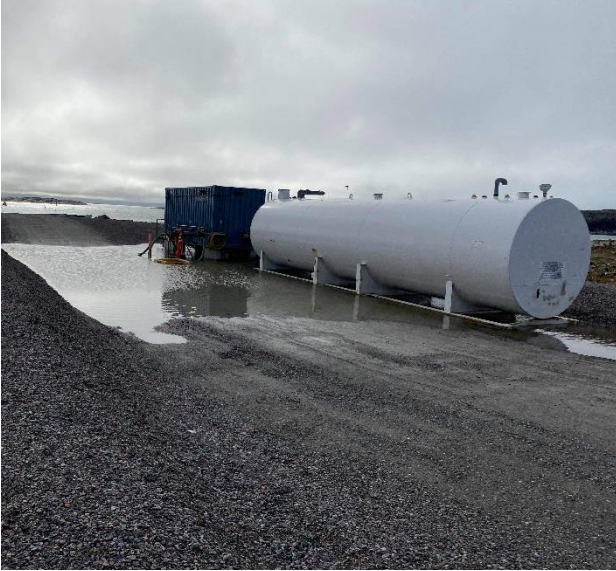
**Photo 51: Truck Unloading Station and Saline Tank**

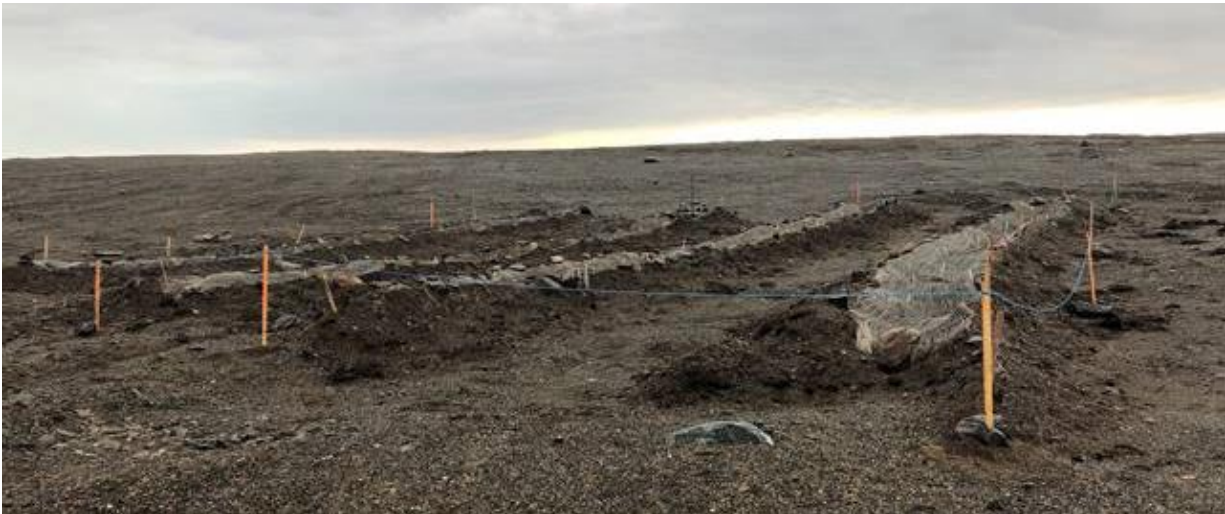
**Photo 53: Revegetation Study Plots**

- g) During the 2019 site visit, the NIRB staff were informed that some of the plots for the revegetation study with the University of Saskatchewan had been destroyed during the removal of soil from the quarry site. In 2020, Agnico Eagle has provided a photo update of the site which is now marked to prevent future incidents (Photo 53).

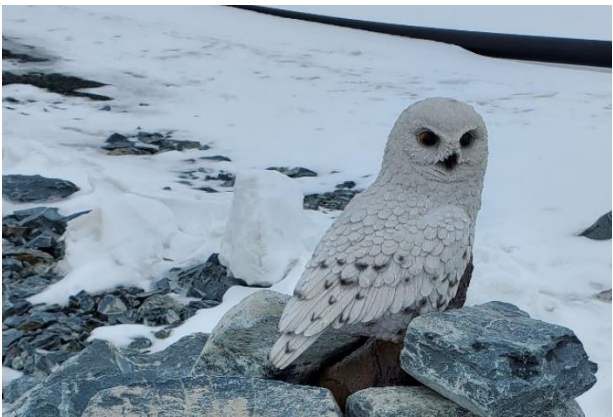
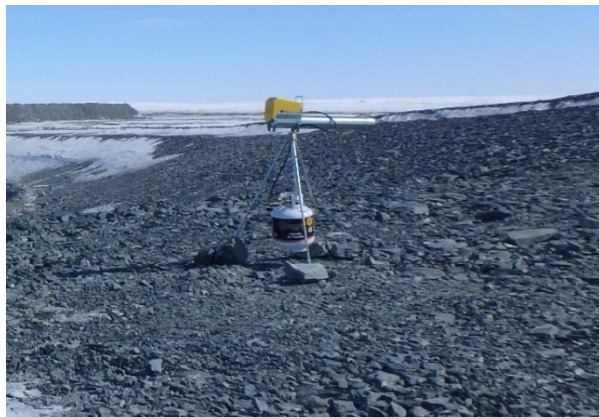
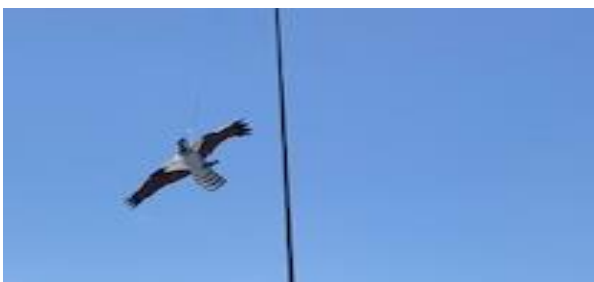
h) Bird deterrents, including snowy owl effigies for raptors, bird cannons for ravens, and bird kites are placed at the pits and landfarm. Agnico Eagle observed that the snowy owl effigies worked well to prevent raptors from nesting (Photo 54, Photo 55 and Photo 56).
