Appendix 6 : 2020 Annual Geotechnical Inspection Report

2020 Annual Geotechnical Inspection Meliadine Gold Project, Rankin Inlet, Nunavut

PRESENTED TO
Agnico Eagle Mines Limited

FEBRUARY 2021
ISSUED FOR USE
FILE: 704-ENG.EARC03140-15

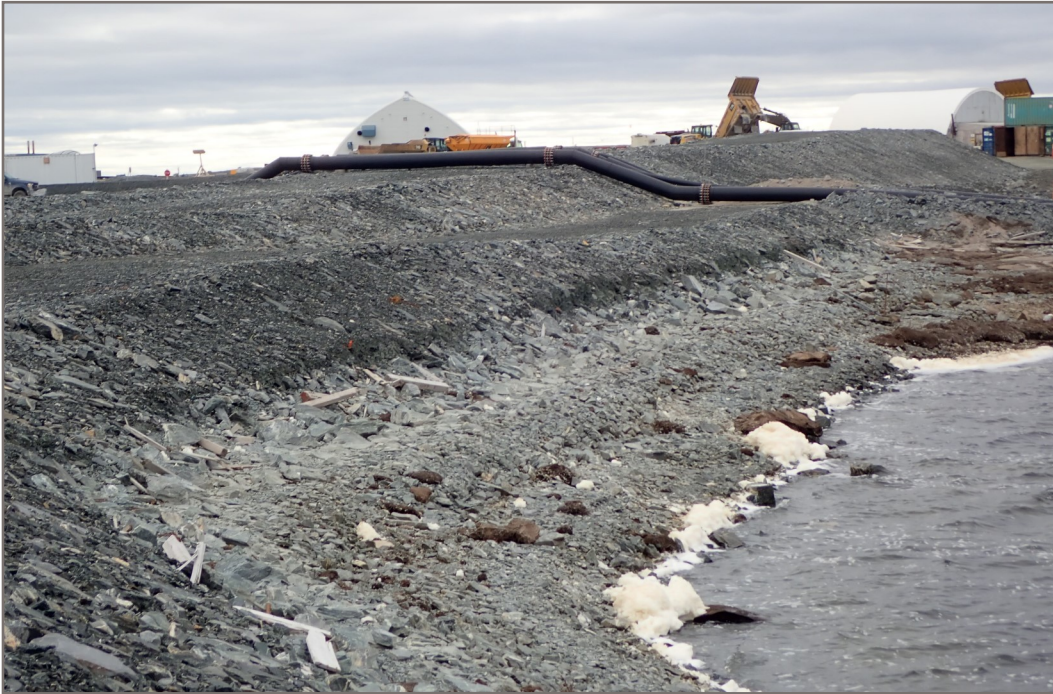
Photo 1: Dike D-CP1 - Upstream face—some wave and ice erosion evident

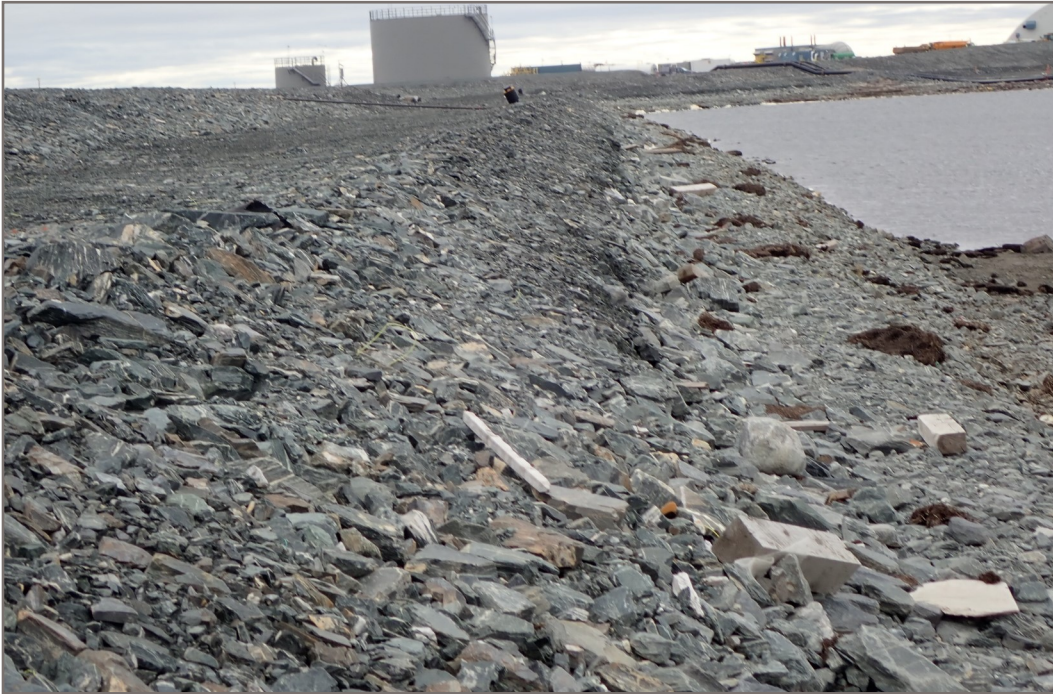
Photo 3: Dike D-CP1 - Upstream face—some wave erosion evident, scarp approximately 1 m high.

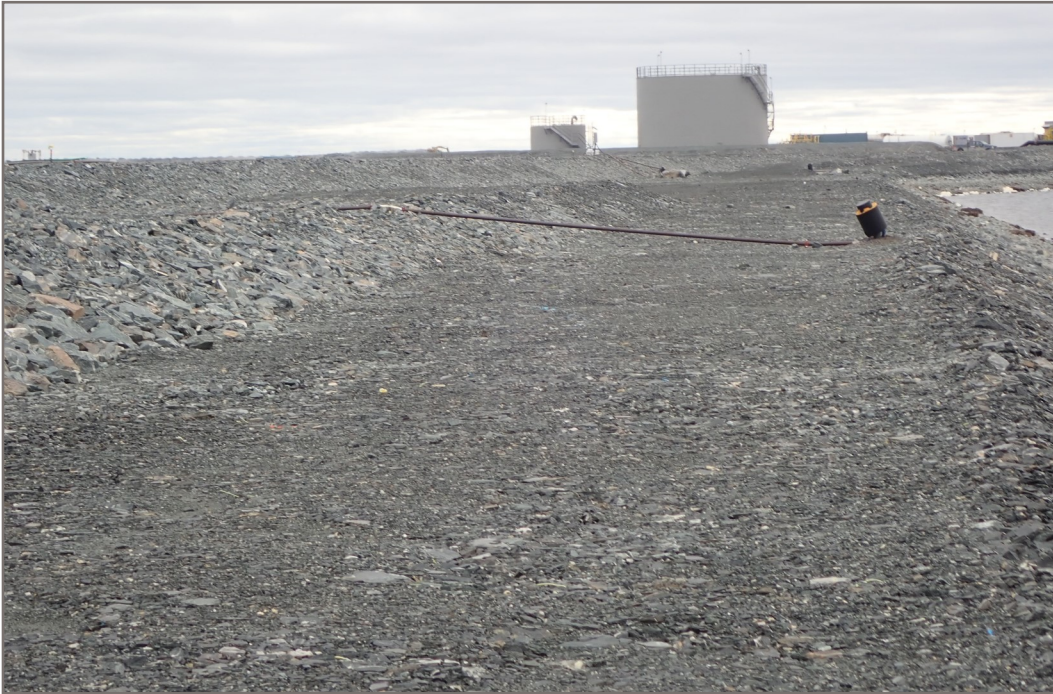
- Overall, the dike appeared stable, with no significant geotechnical concerns identified.
- Minor cracking and small settlement were observed along portions of the upstream and downstream crest (e.g., Photos 5 and 7, Appendix B). The largest cracks were up to 3 cm wide. The cracking was less prevalent than observed in August 2019.

Photo 5: Dike D-CP1 - Upstream crest—some settlement is evident

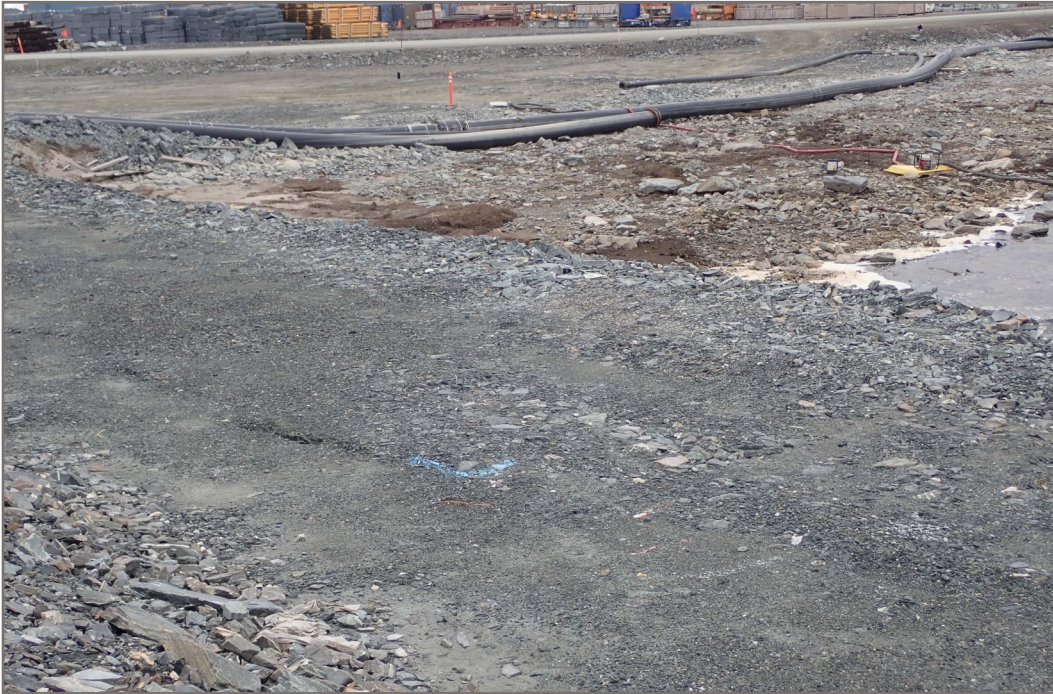
Photo 7: Dike D-CP1 - Upstream crest—similar condition to 2019.

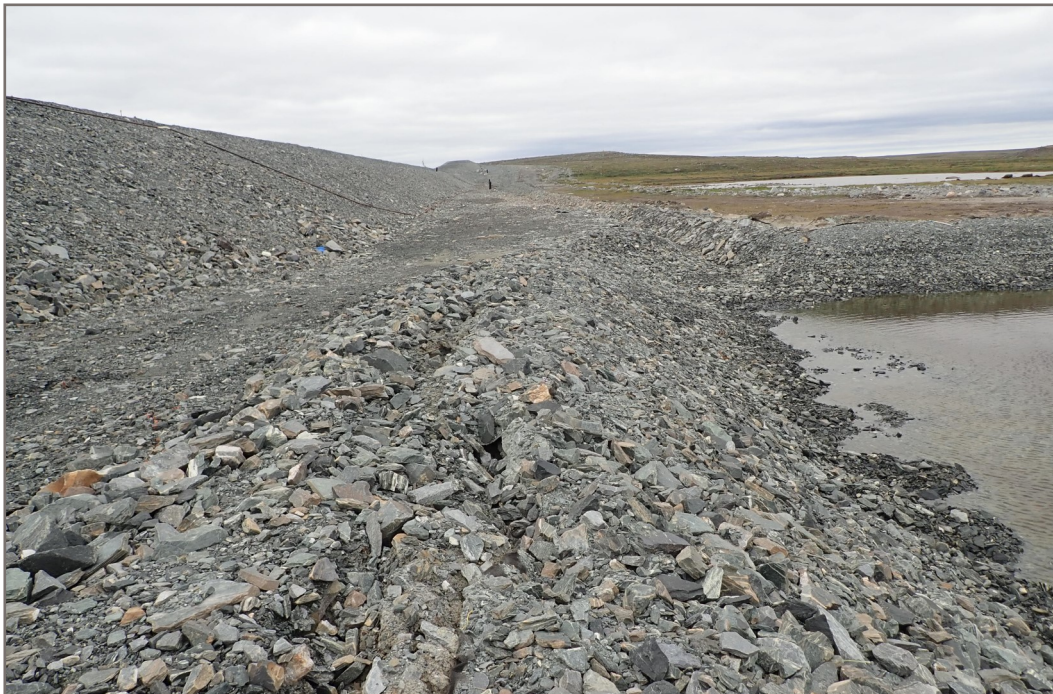
Photo 8: Dike D-CP1 - Downstream water collection pond, some cracking and subsidence at the upstream crest of the pond .

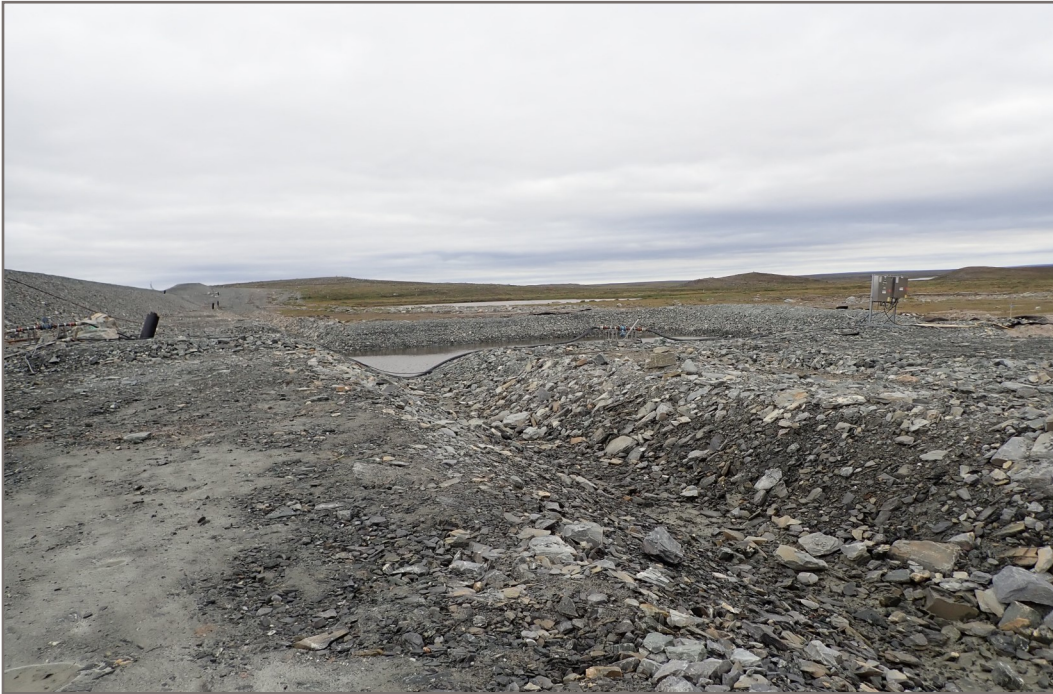
- No seepage was observed from the downstream toe.
- The water levels in the downstream collection channel pond and channels was relatively low (Photos 9, 11, and 14, Appendix B) at the time of the site visit. It is understood the sump was pumped out following freshet.

Photo 9: Dike D-CP1 - water collection channel at downstream toe of Dike (south end.)

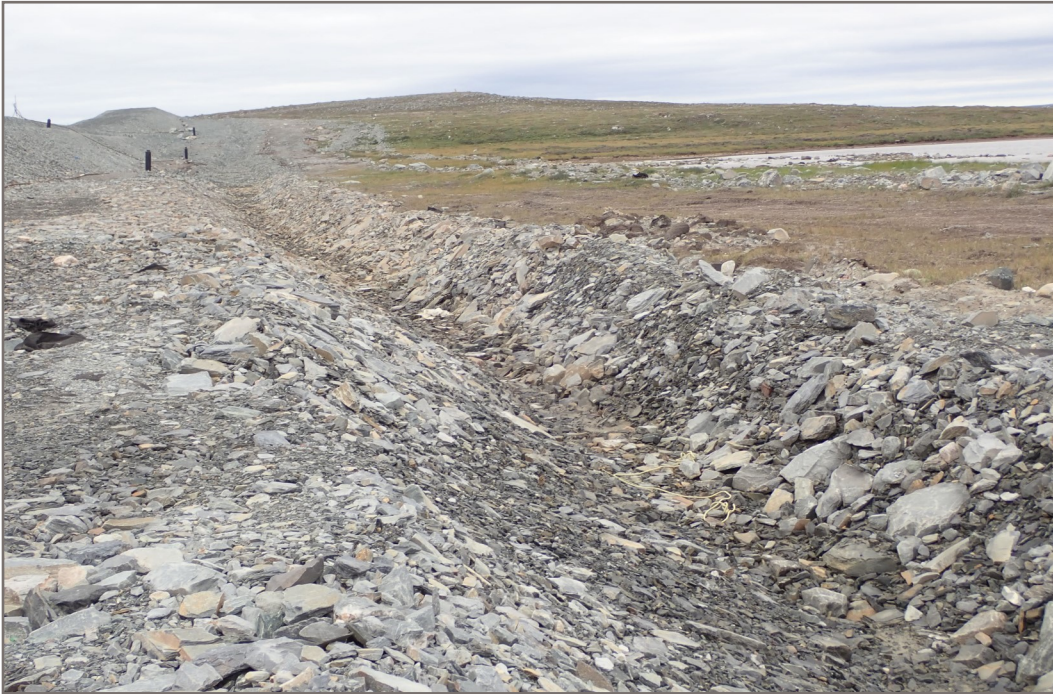
Photo 11: Dike D-CP1 - Water collection channel downstream of the Dike.

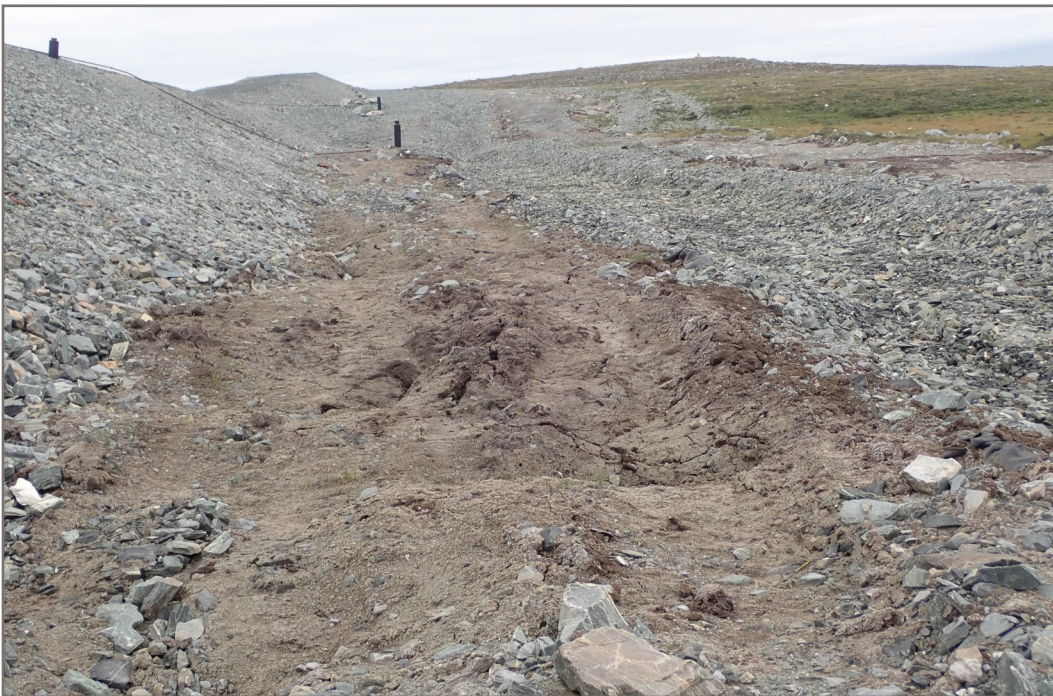
Photo 12: Dike D-CP1 - ground between the dike toe and water collection channel, settlement and subsidence

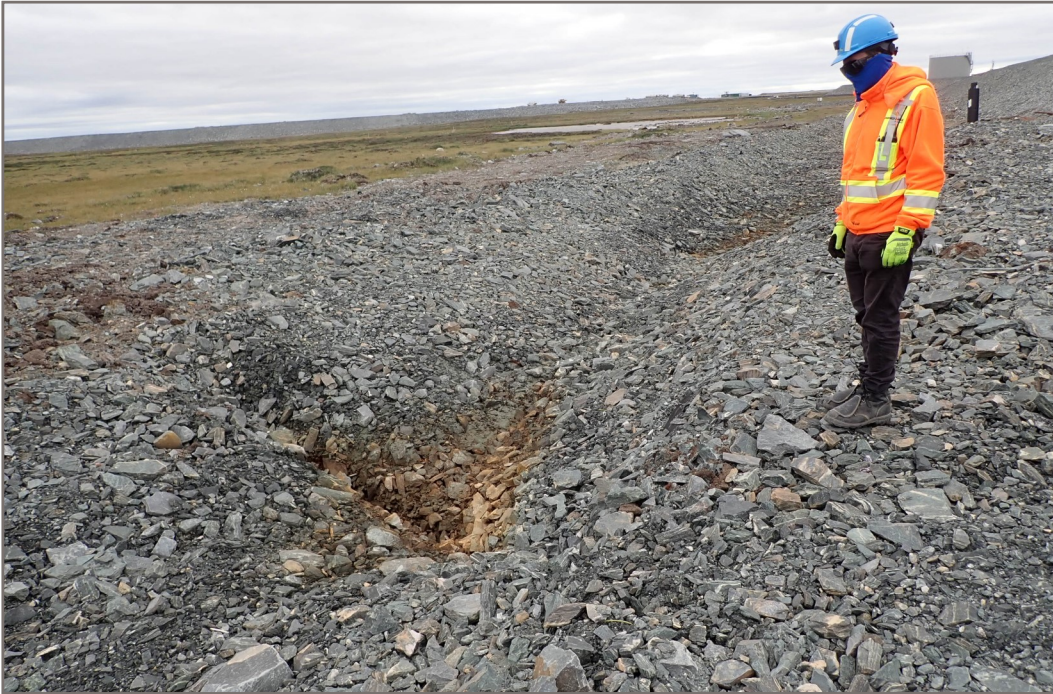
Photo 13: Dike D-CP1 - Subsidence in water collection channel, possibly caused by thaw of ice wedge below channel.

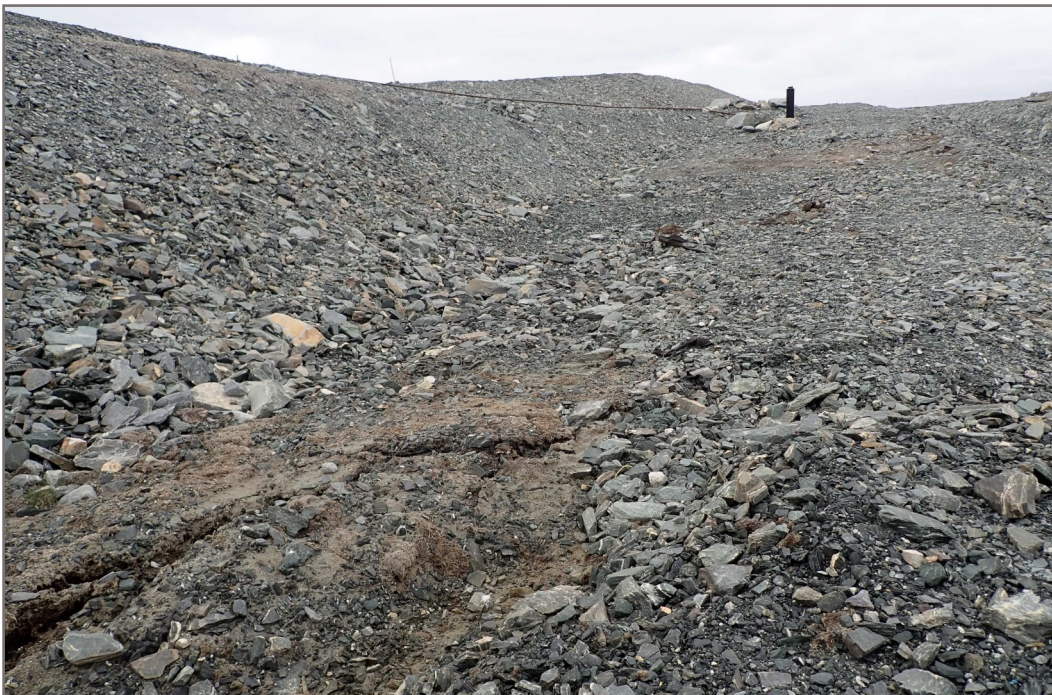
Photo 14: Dike D-CP1 - Subsidence and cracking between dike toe and water collection channel.

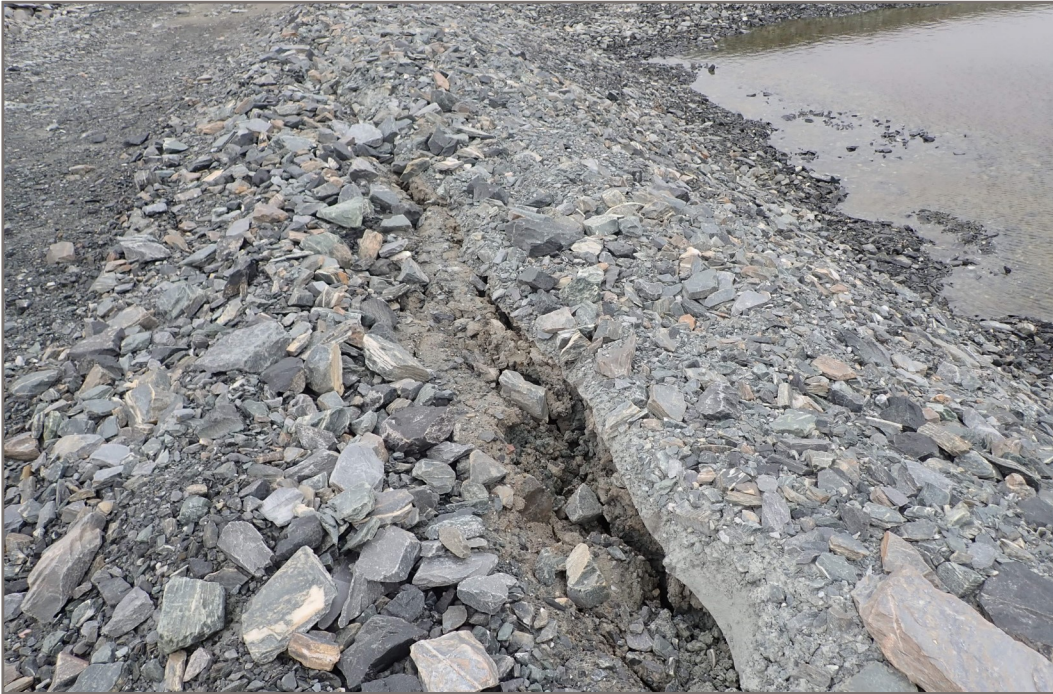
Photo 15: Dike D-CP1 - Subsidence and cracking at water collection pond downstream of the dike.

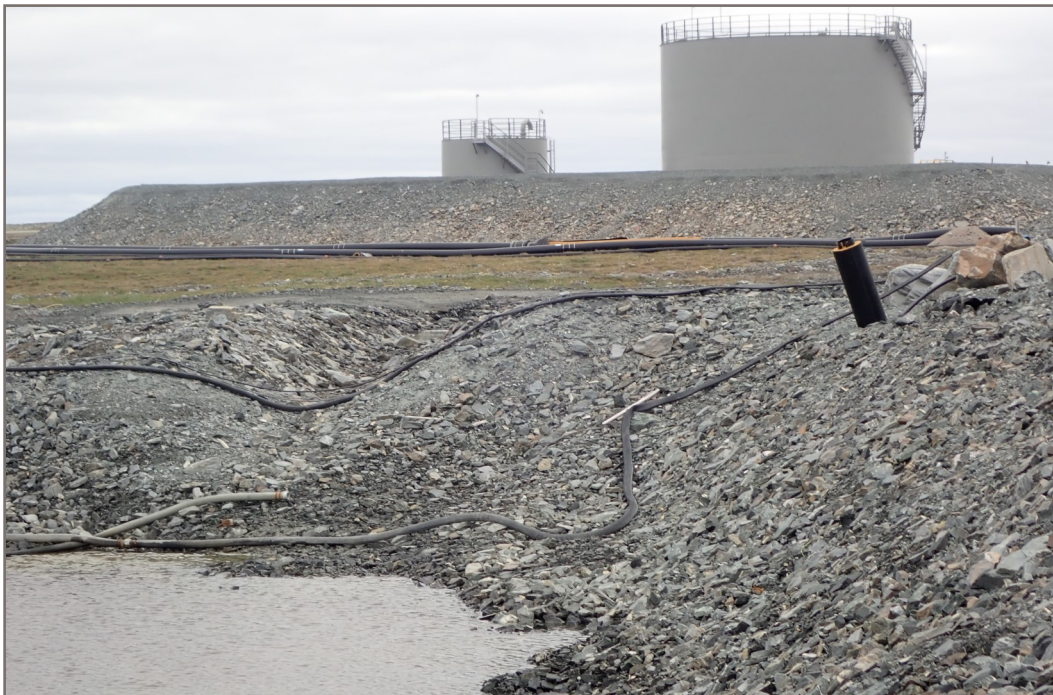
Photo 16: Dike D-CP1 - Subsidence at southeast corner of water collection pond downstream of the dike.

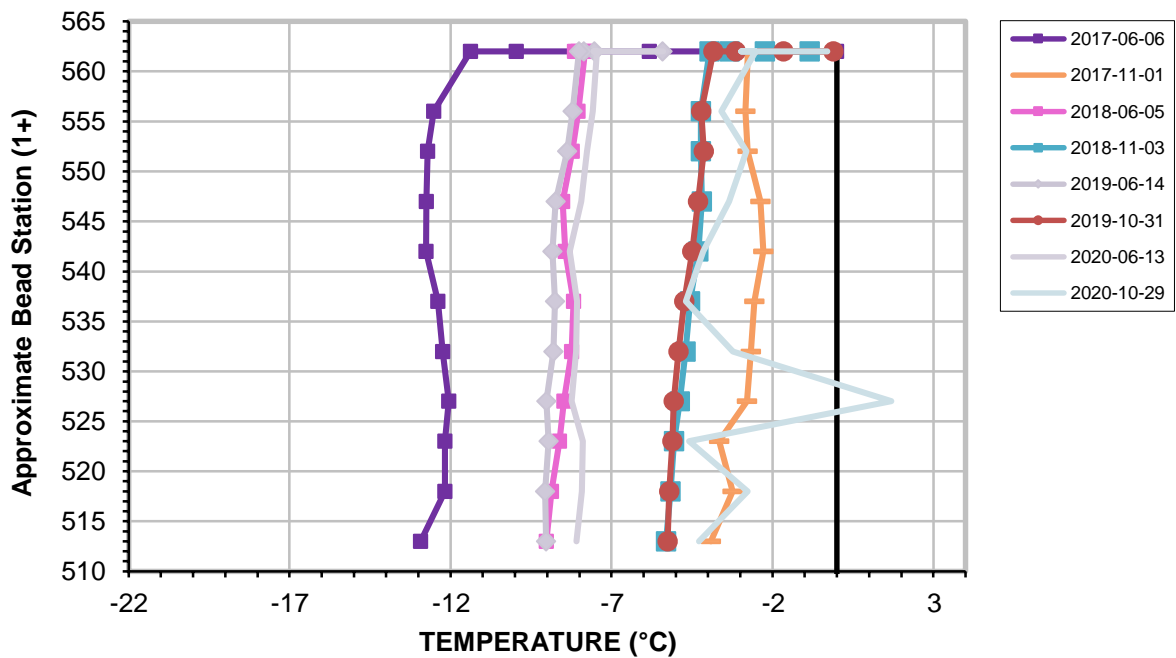
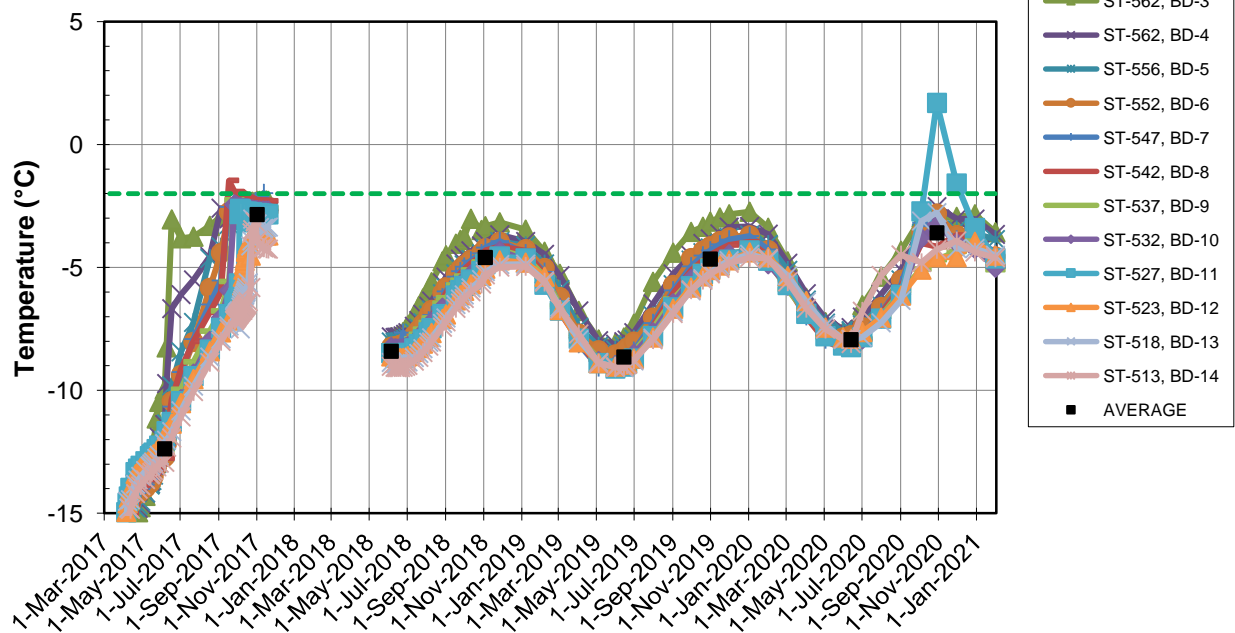
Horizontal Ground Temperature Profile for Cable HGTC-01
Dike D-CP1

Bead 11 of HGTC-1 warmed to 1.7°C in the October 2020. The temperature dropped to -1.6°C in November, but still warmer than expected. It recovered the expected temperature range in December. The temperature rise was investigated by Agnico at the time of occurrence. There was no ponded water near the location and sign of infiltration.
