APPENDIX G

SALINE PONDS

APPENDIX H

DIVERSION CHANNELS AND BERMS

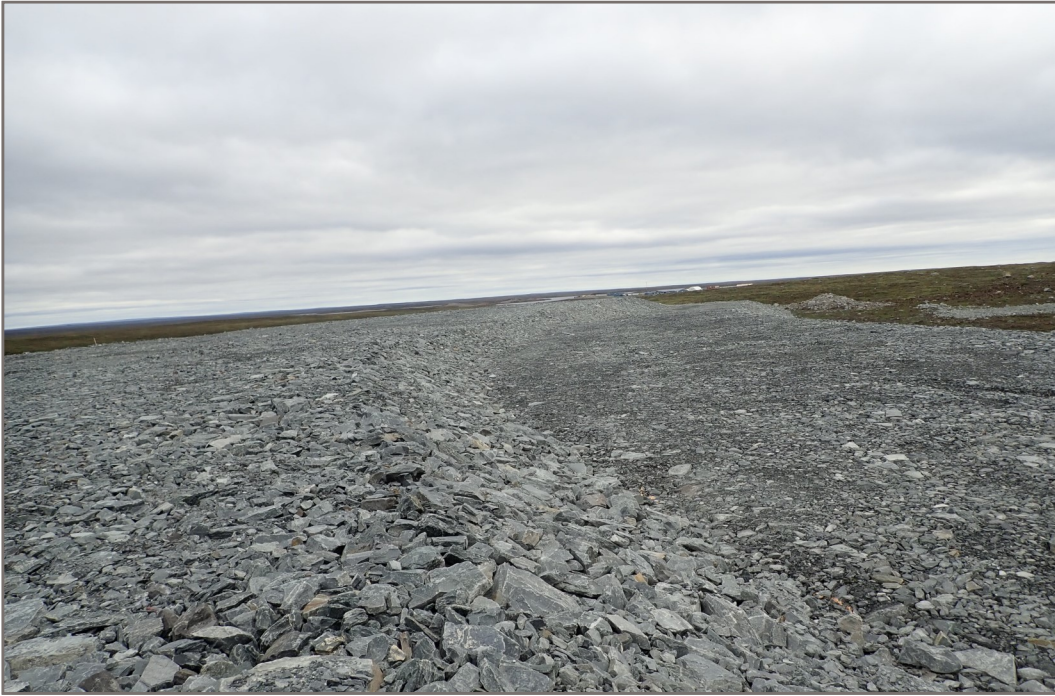
Photo 15: Berm CP6 - Crest and rockfill cover over upstream ground

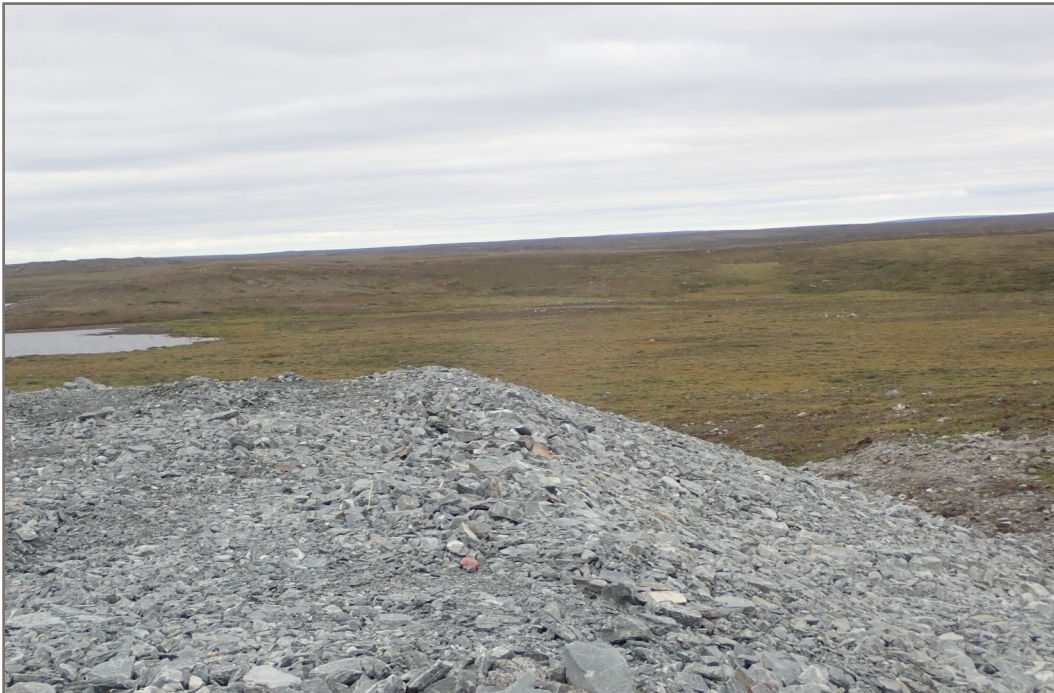
Photo 16: Pond CP6 - Crest of CP6 Berm

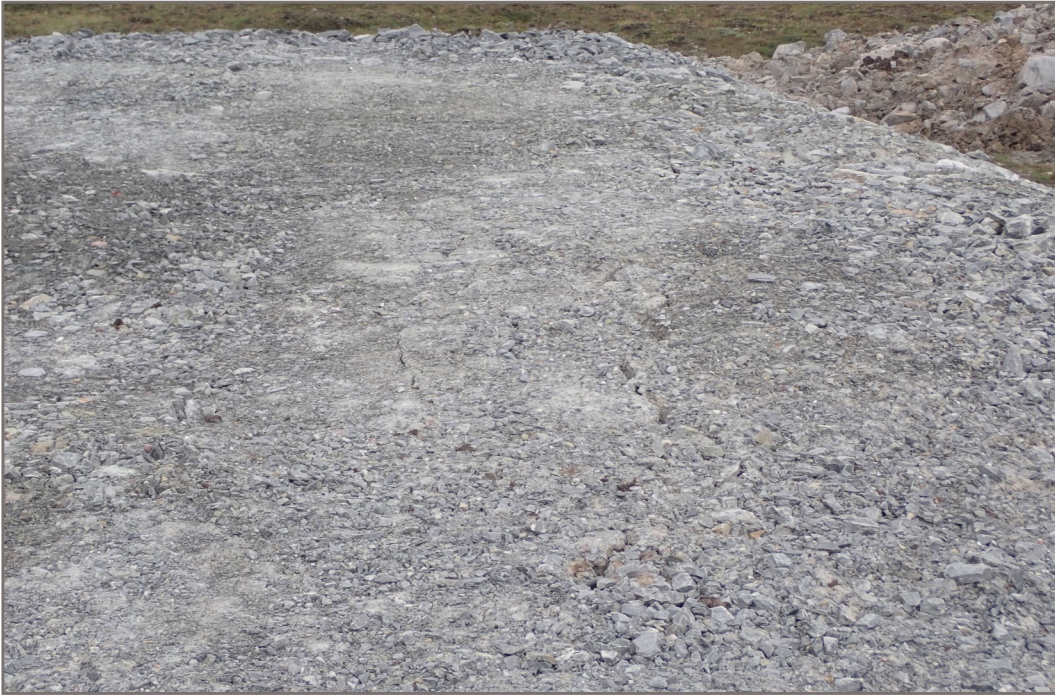
Photo 17: Berm CP6 - minor cracking in upstream/till cover.

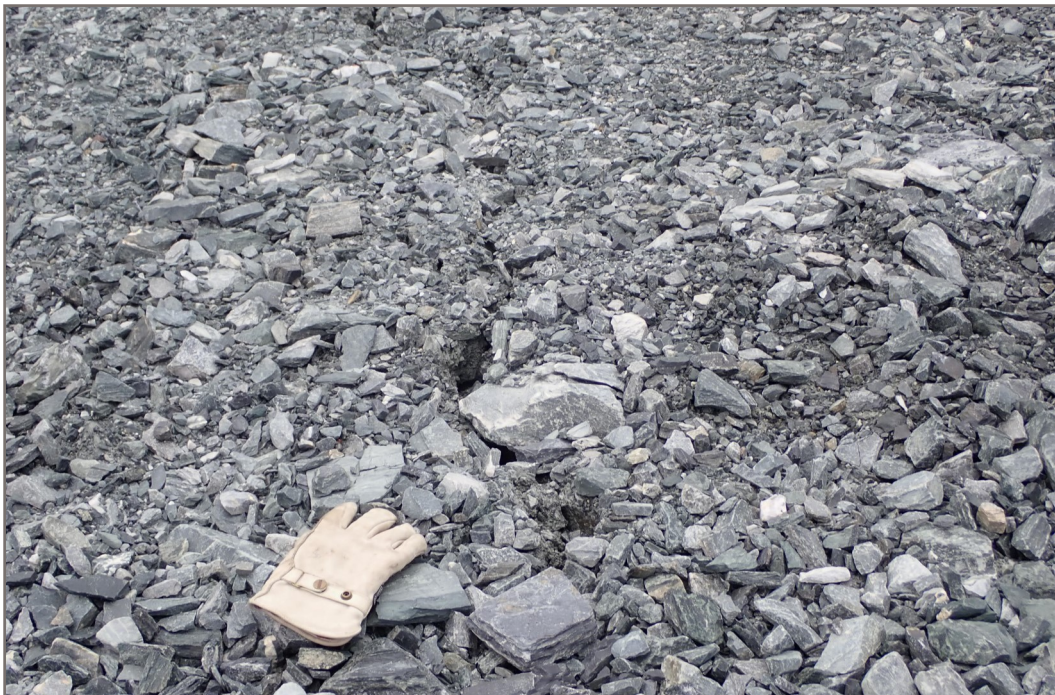
Photo 18: Berm CP6 - Cracking in rockfill berm cover.

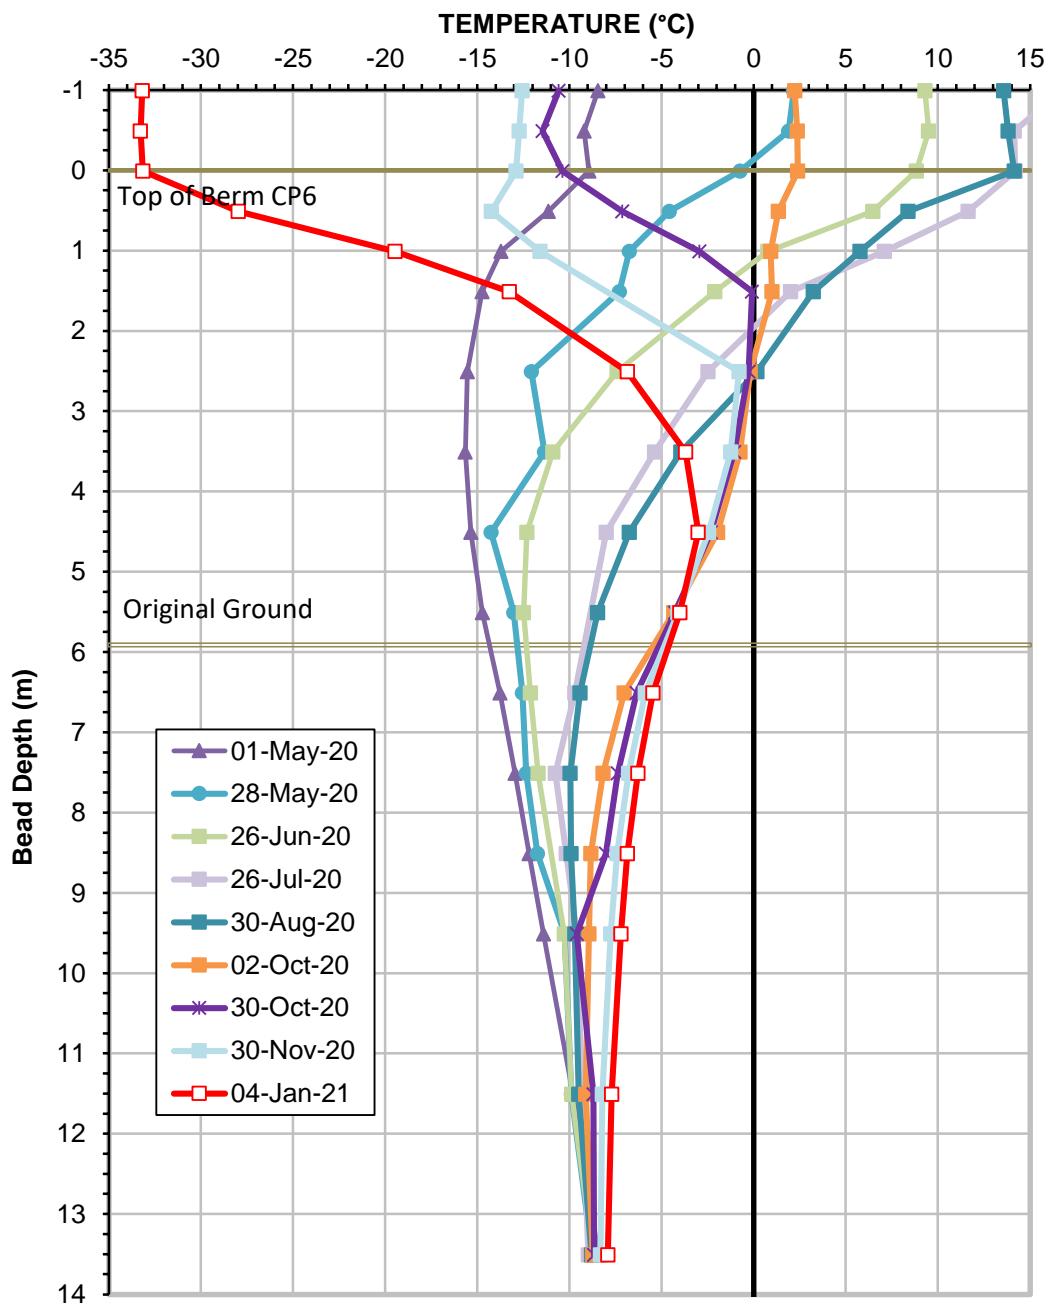
**Ground Temperature Profile for Cable GTC-01
Berm CP6**

Serial No.: 2728
Date Installed: April 23, 2020

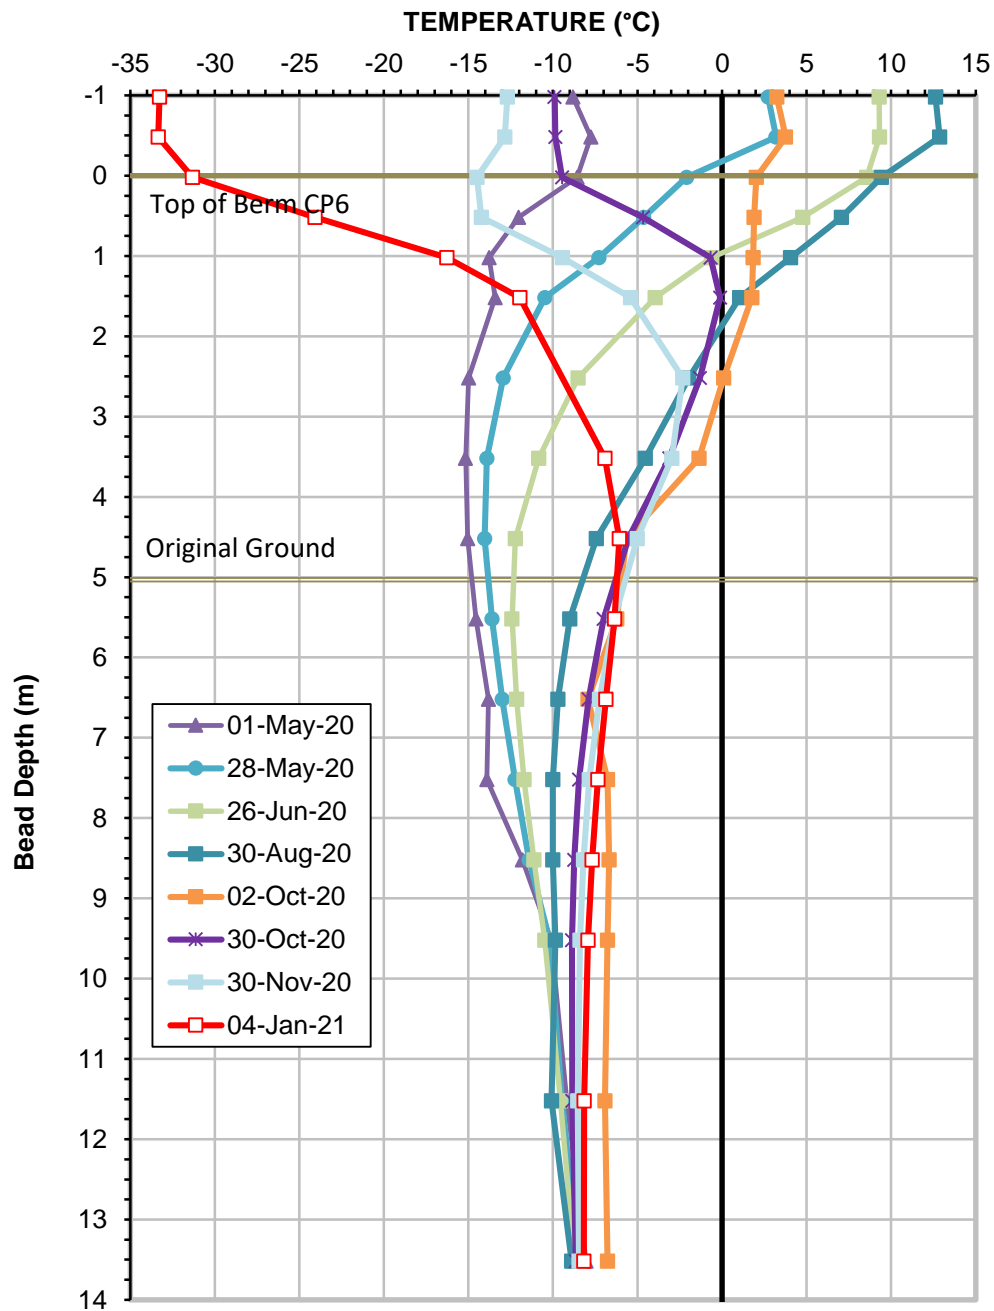
**Ground Temperature Profile for Cable GTC-02
Berm CP6**

Serial No.: 2729
Date Installed: April 23, 2020

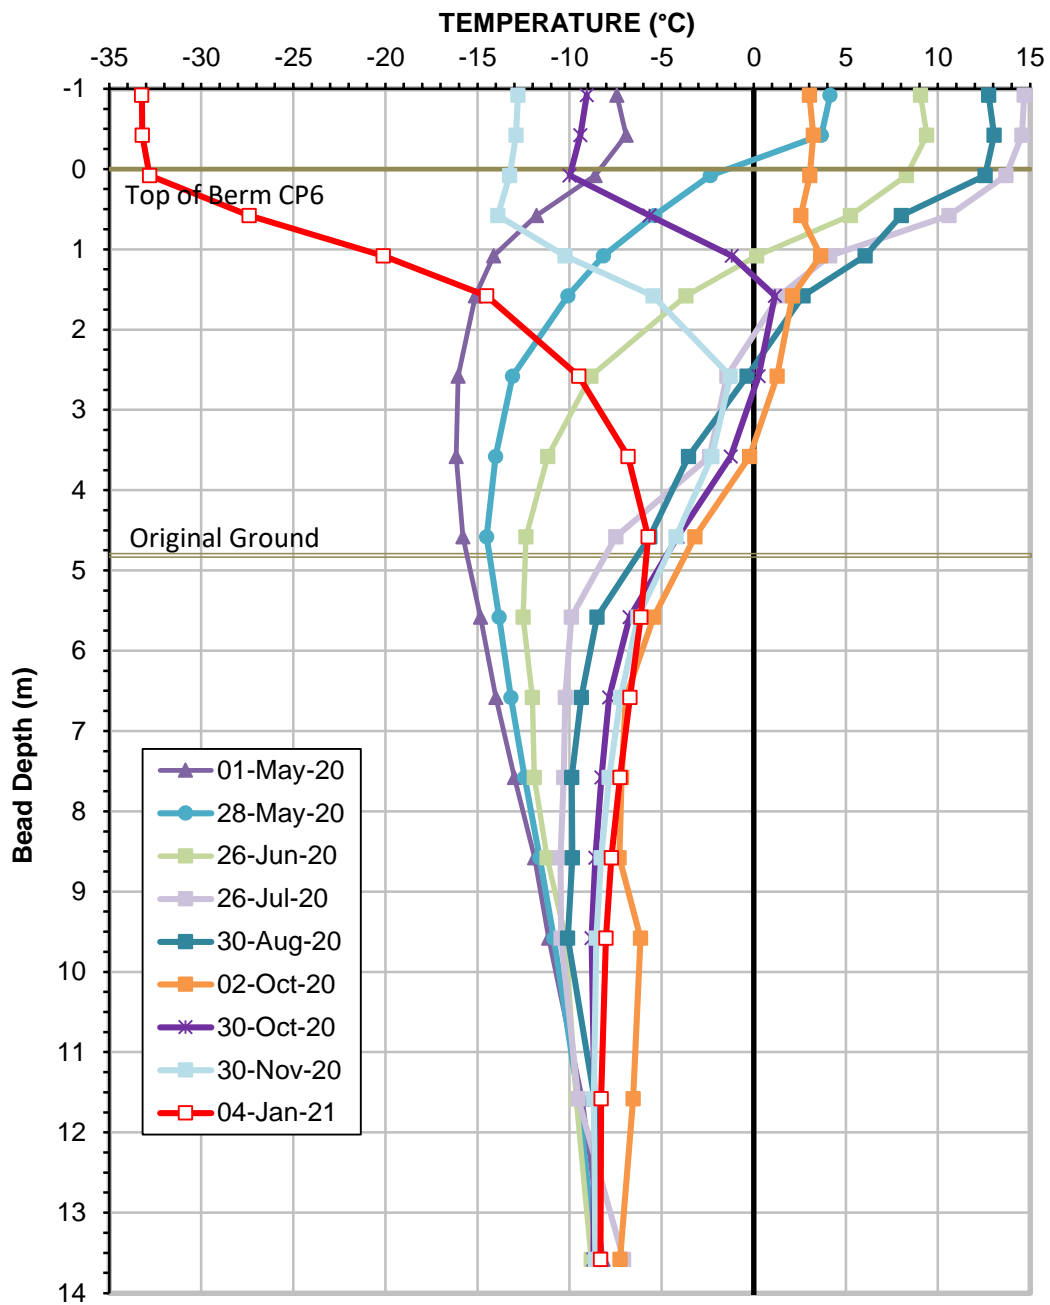
Ground Temperature Profile for Cable GTC-03
Berm CP6

Serial No.: 2730
Date Installed: April 23, 2020

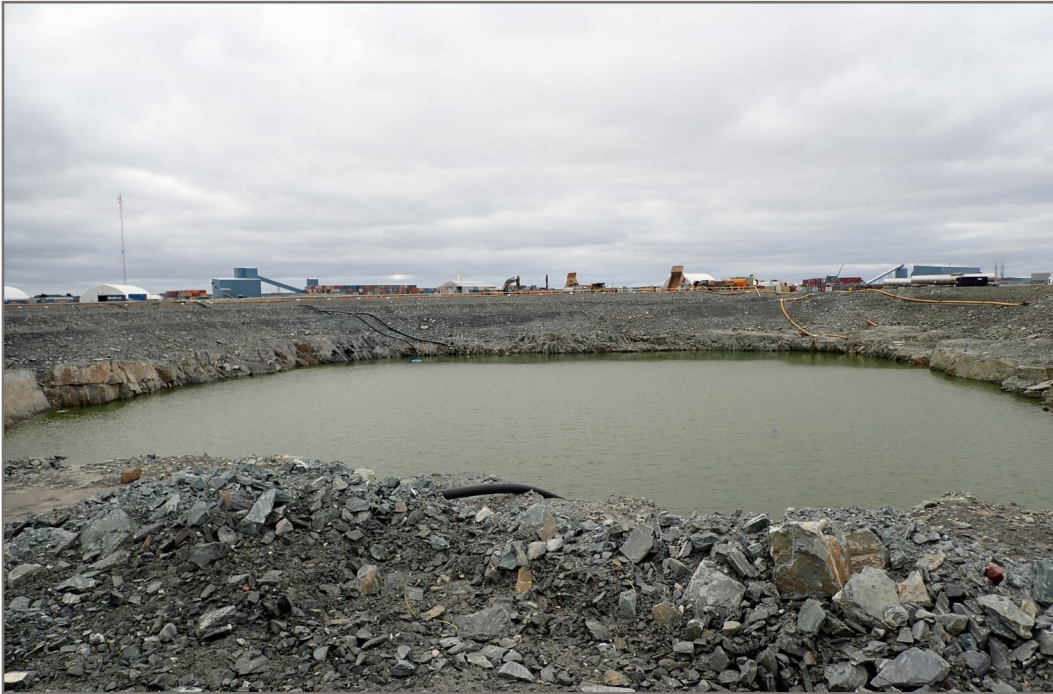
Photo 1: SP1 Saline Pond - looking towards the west, thermal berm at crest.

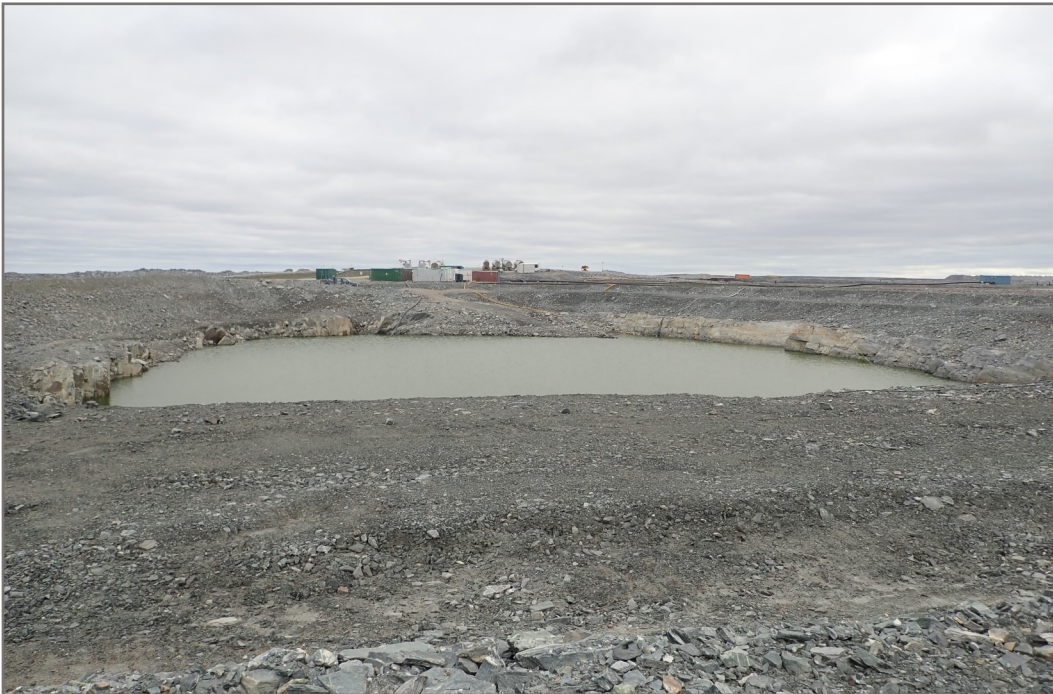
Photo 2: SP1 Saline Pond - Overburden bedrock contact.

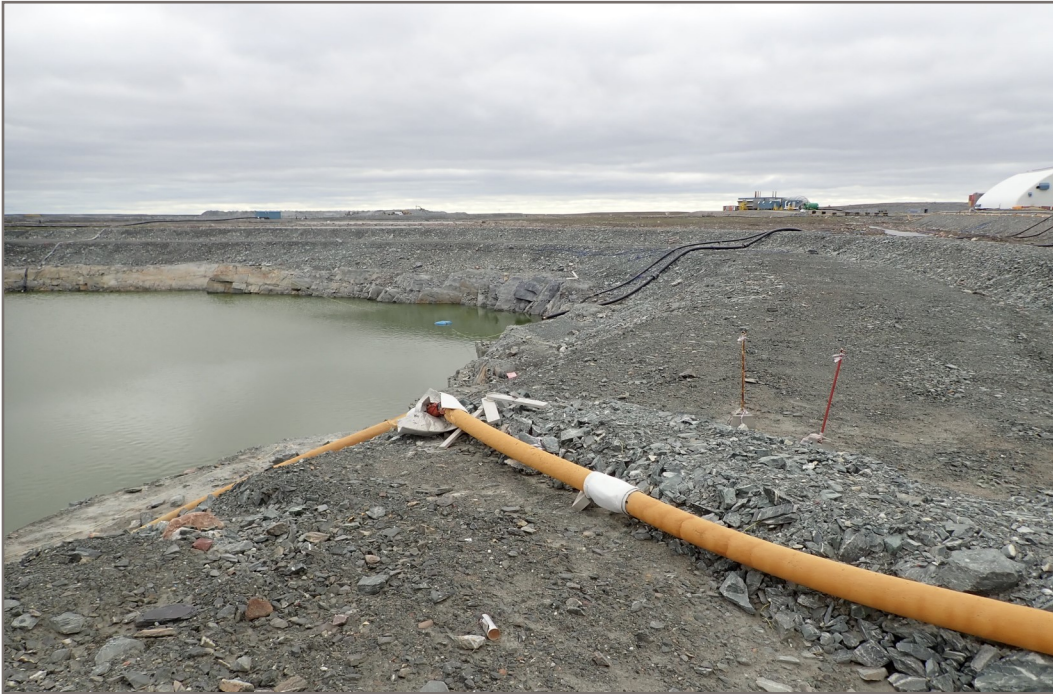
Photo 3: SP1 Saline Pond - discharge line into pond.

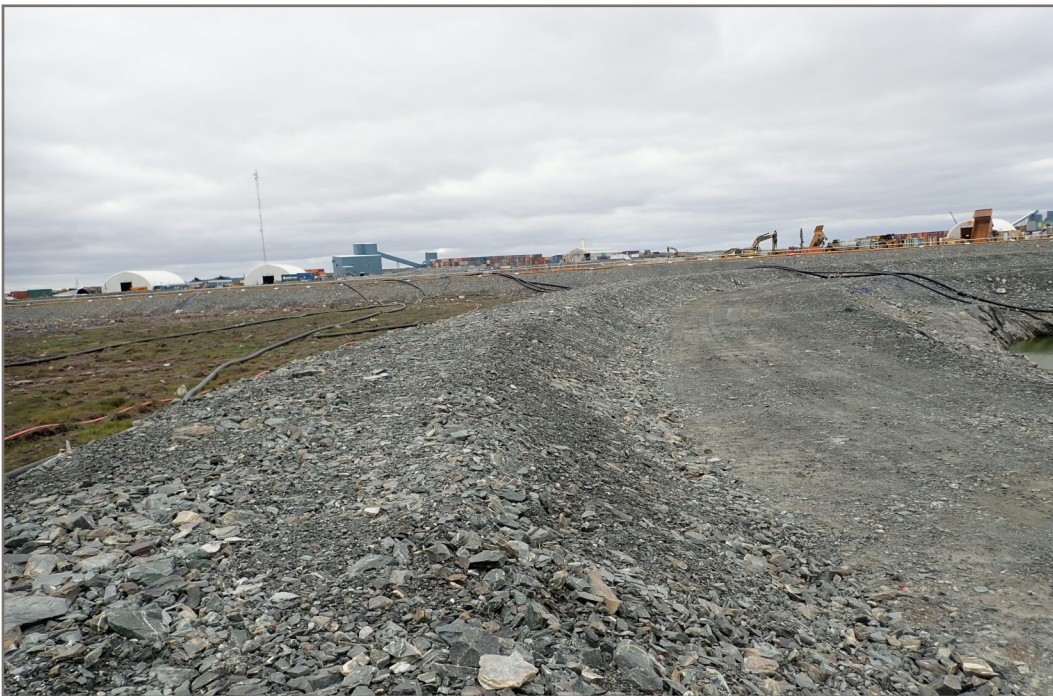
Photo 4: SP1 Saline Pond - thermal berm at crest.

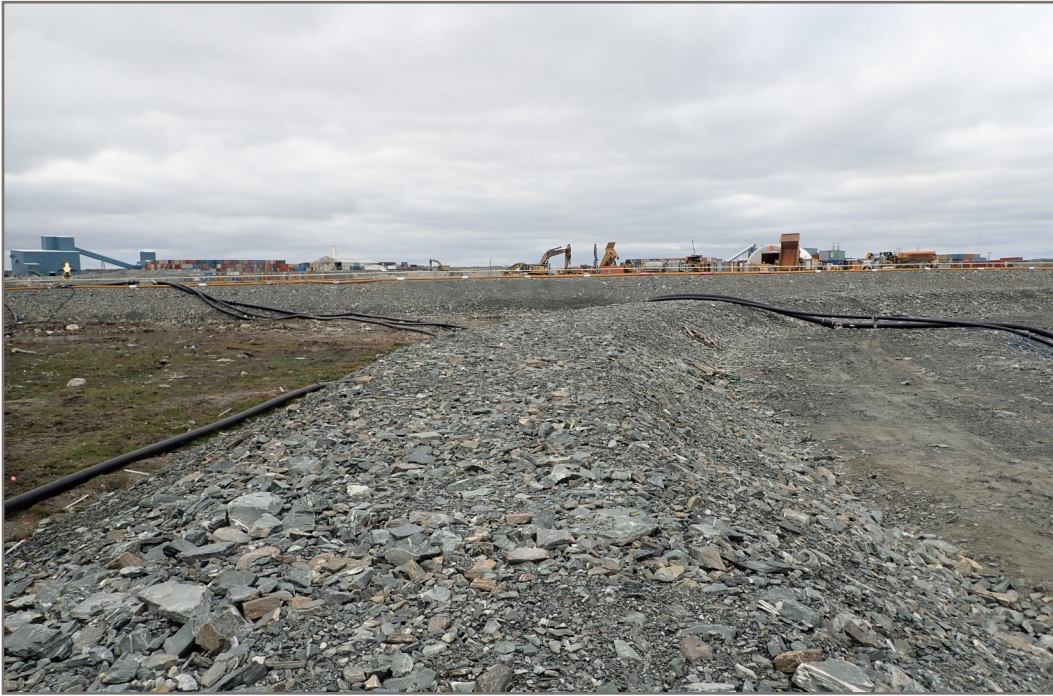
Photo 5: SP1 Saline Pond - looking north.

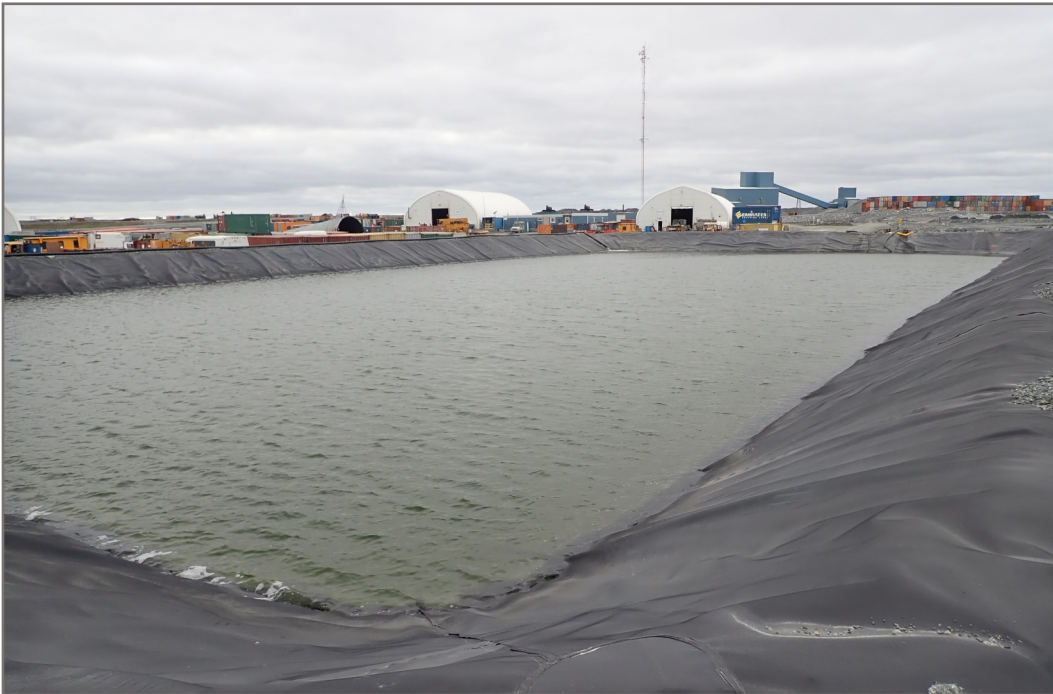
Photo 6: SP3 Saline Pond - looking west.

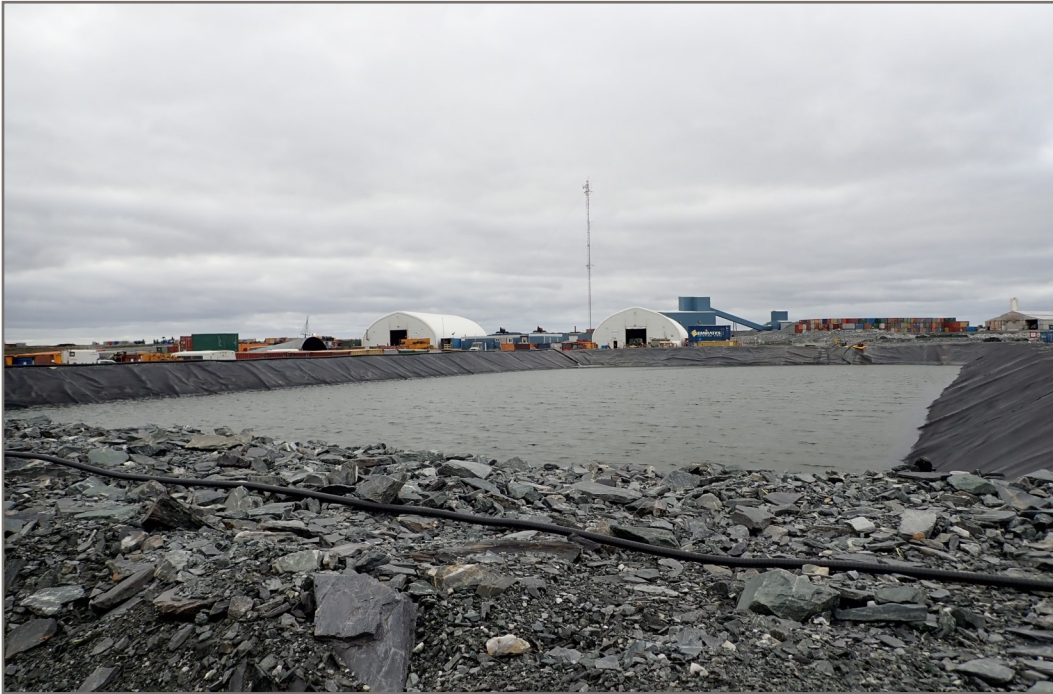
Photo 7: SP3 Saline Pond - looking north

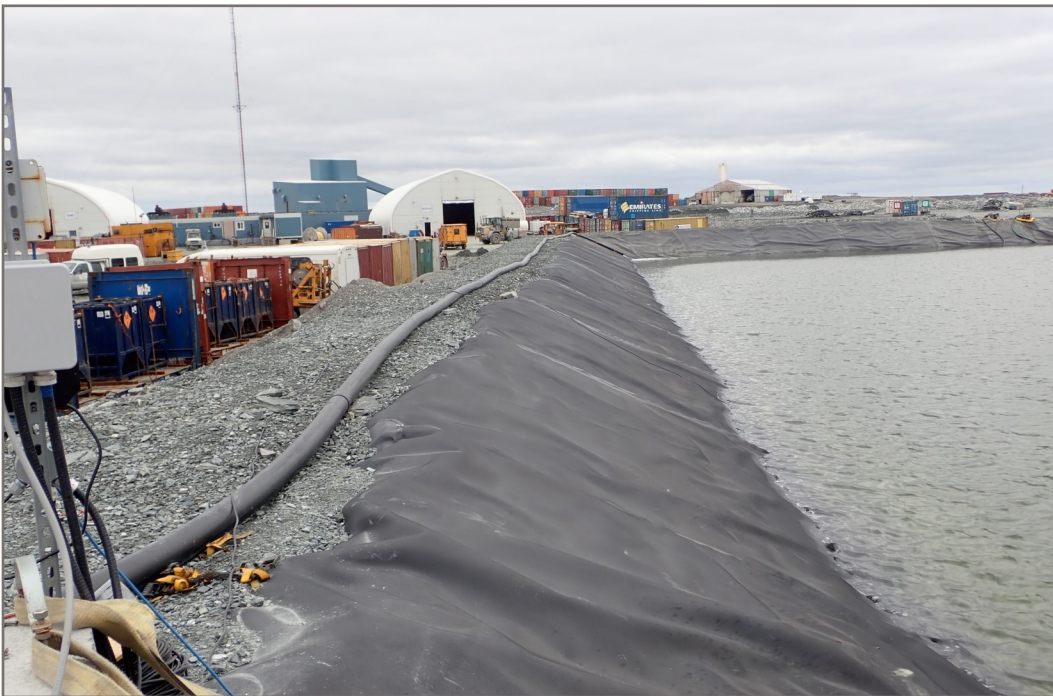
Photo 8: SP3 Saline Pond - west berm.

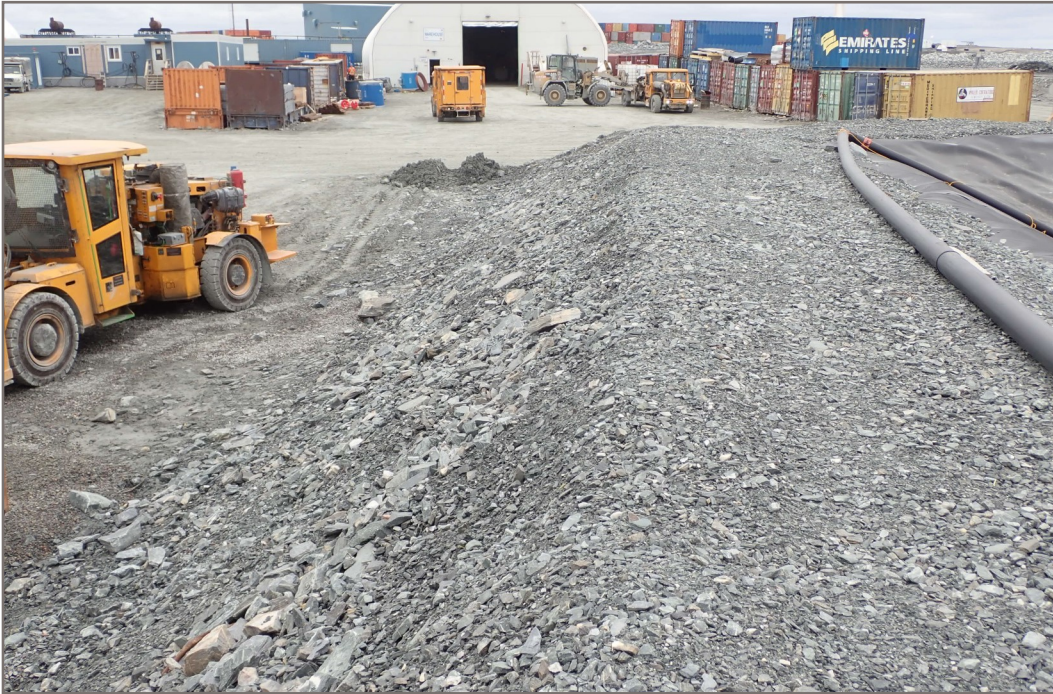
Photo 9: SP3 Saline Pond - looking west.

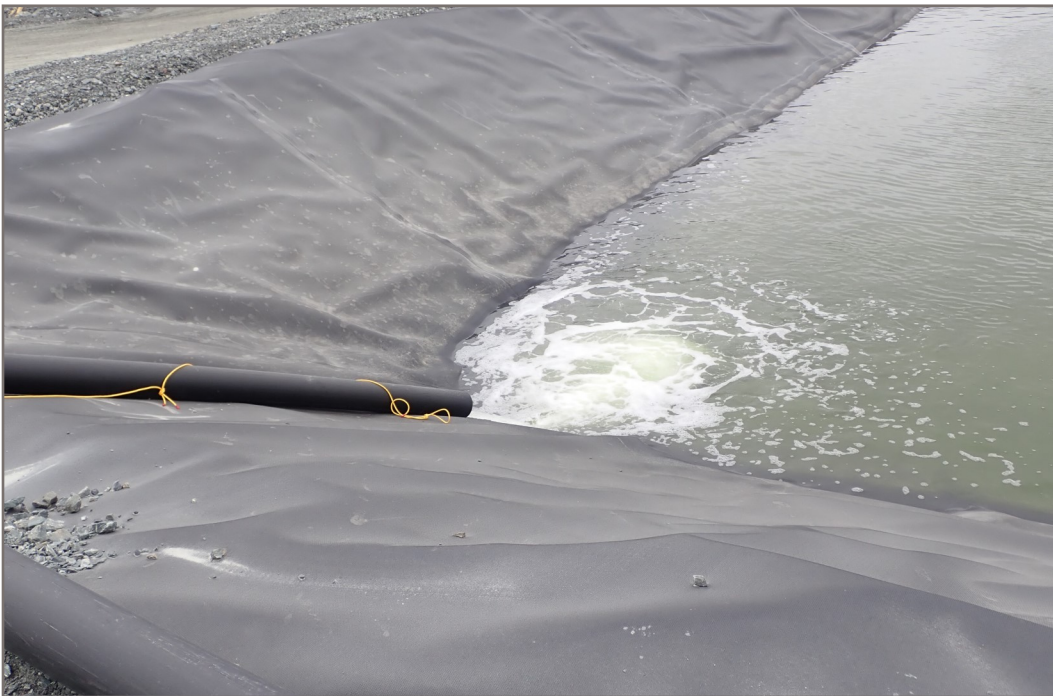
Photo 10: SP3 Saline Pond - Inflow discharge at northwest corner

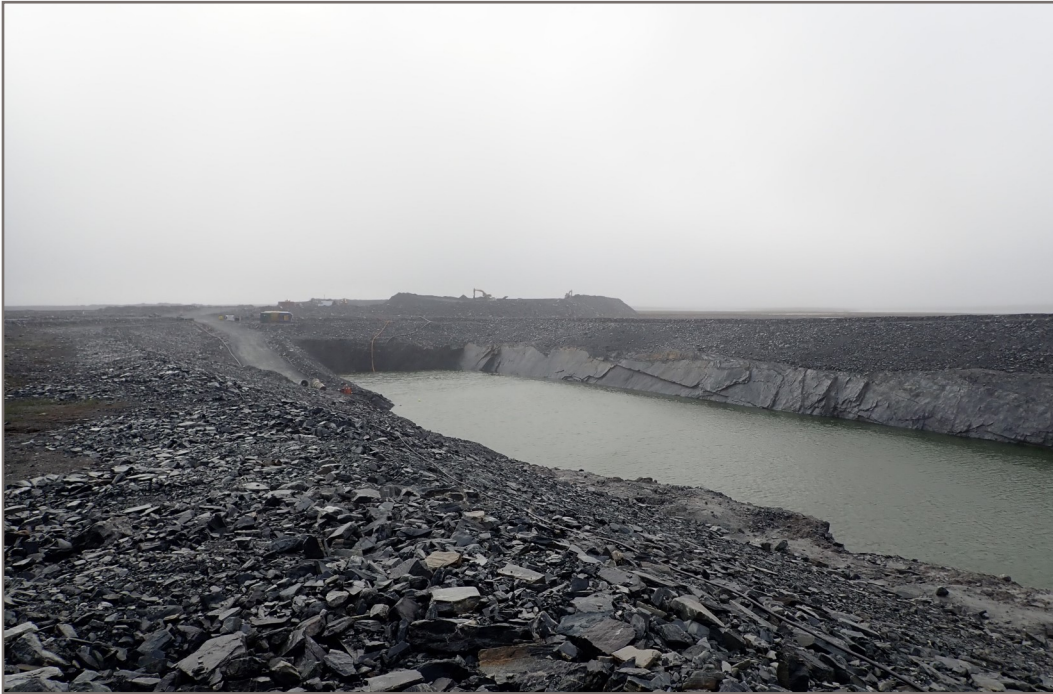
Photo 11: SP4 Saline Pond - looking east. Rockfill covered overburden slope over bedrock.

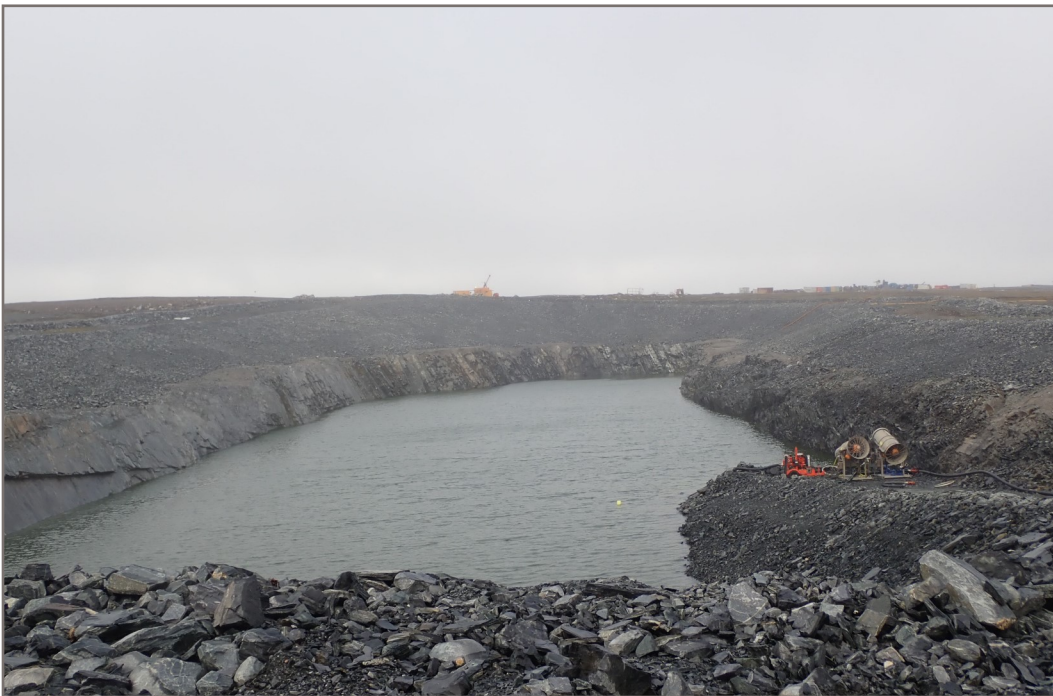
Photo 12: SP4 Saline Pond - looking west. Ramp into pond.

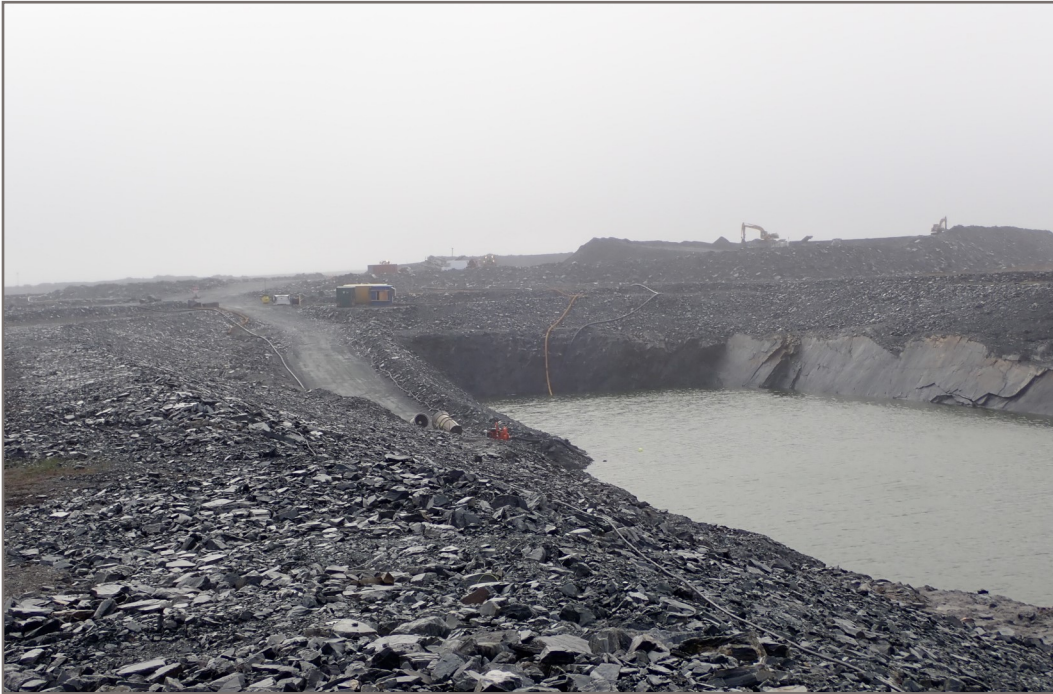
Photo 13: SP4 Saline Pond - looking southeast

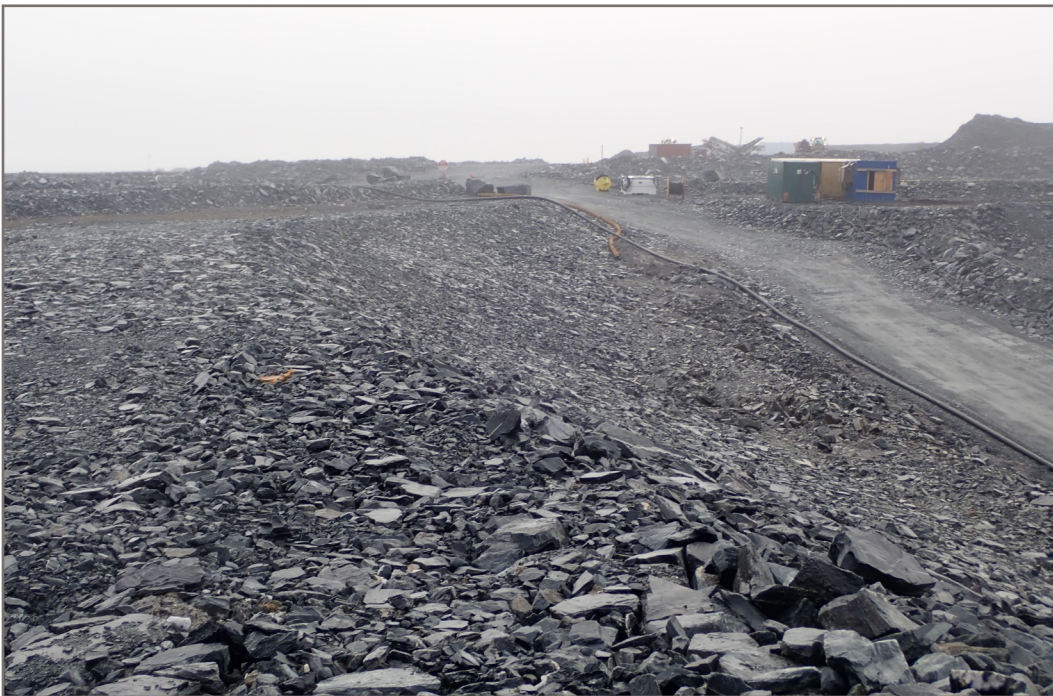
Photo 14: SP4—Rockfill covered overburden slope.

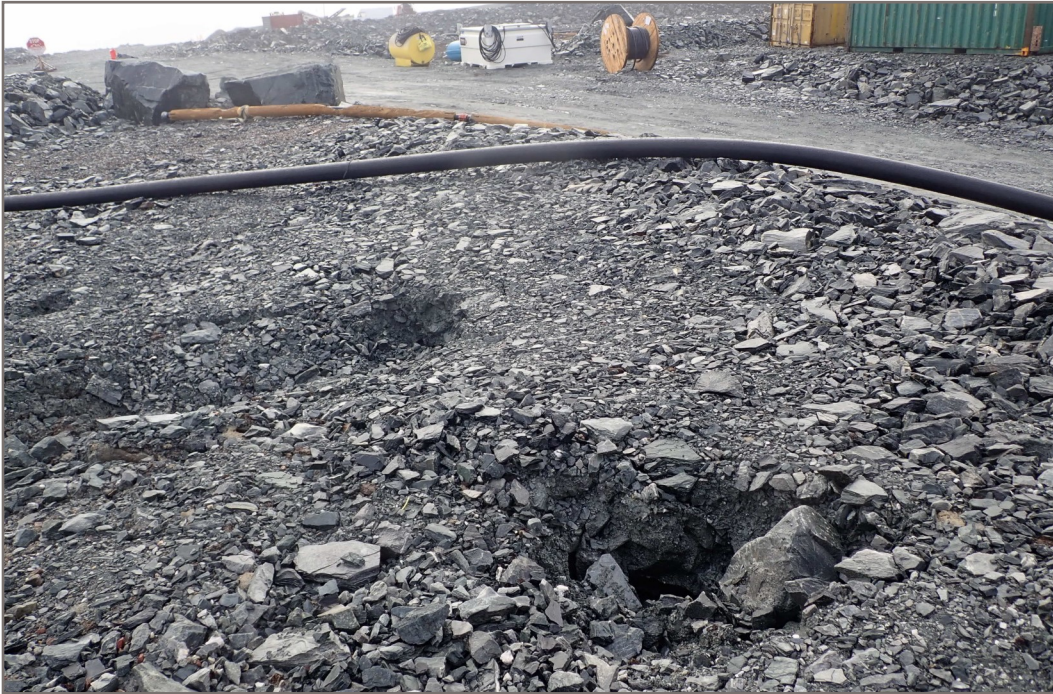
Photo 15: SP4 Saline Pond—Subsidence in rockfill at crest of slope.

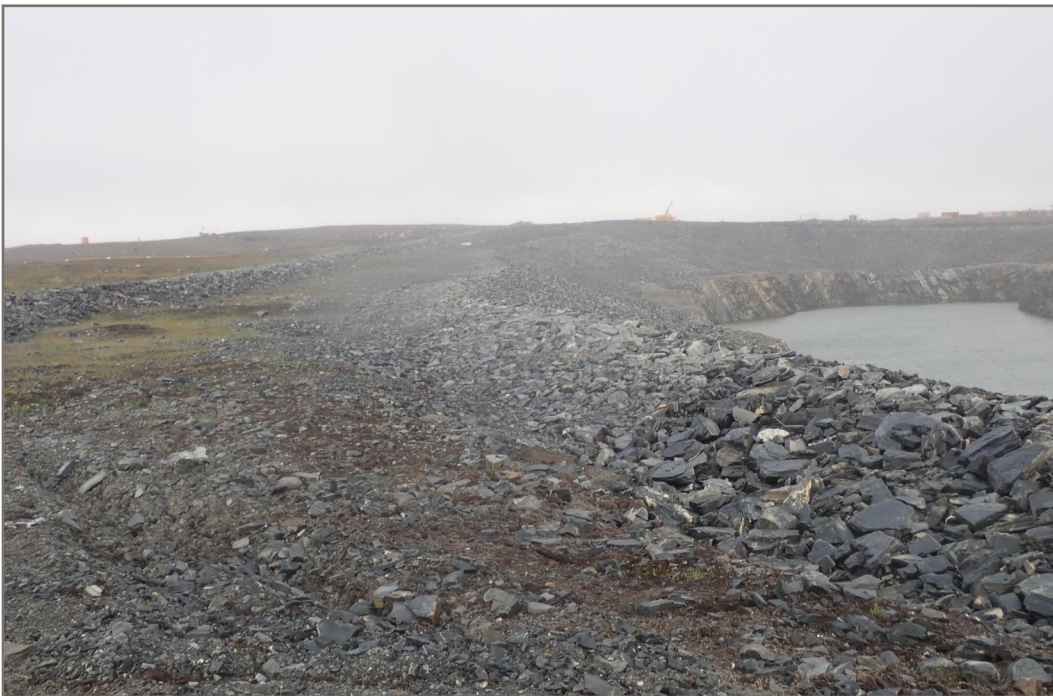
Photo 16: SP4 Saline Pond - Settlement of rockfill covering overburden slope.

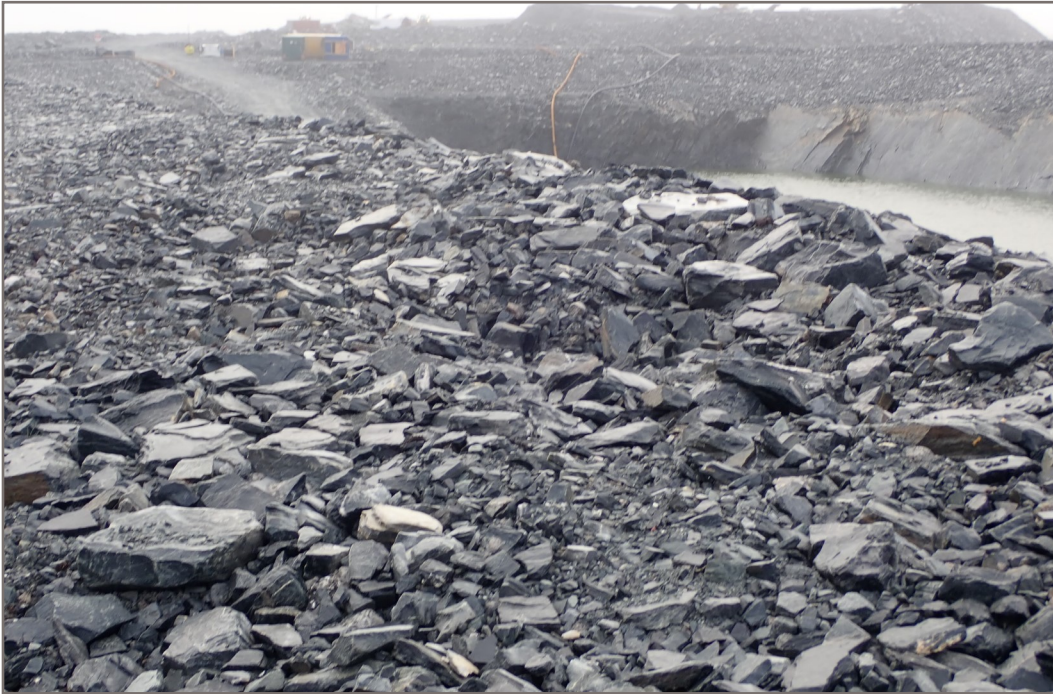
Photo 17: SP4 Saline Pond —Settlement in rockfill covering overburden slope.

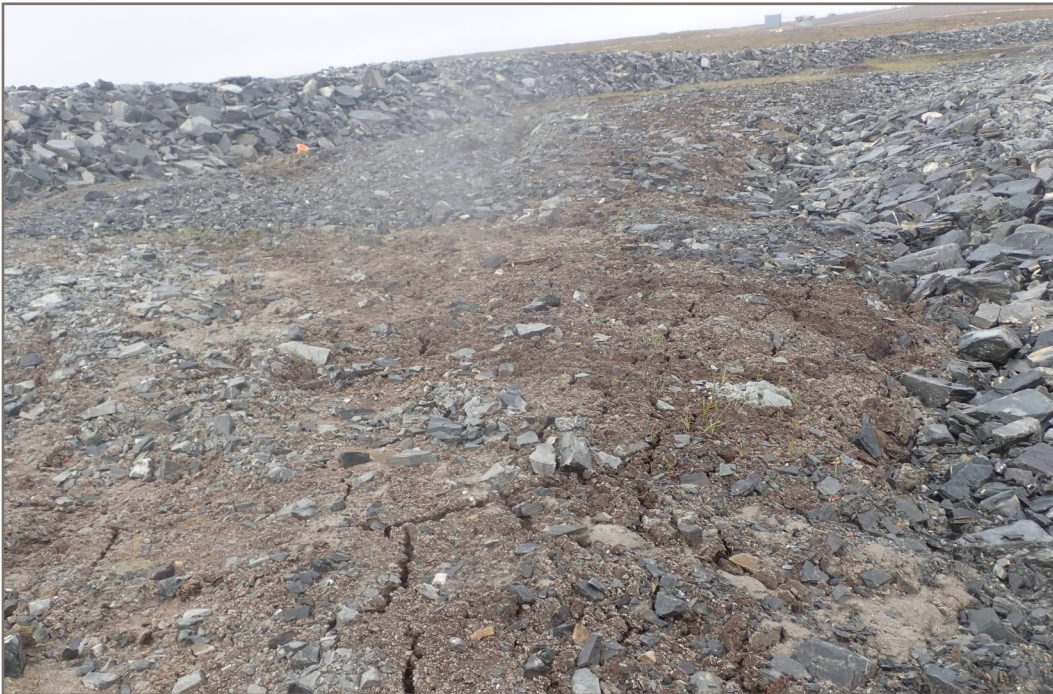
Photo 18: SP4 Saline Pond—Cracking in disturbed overburden above rockfill covered slope.

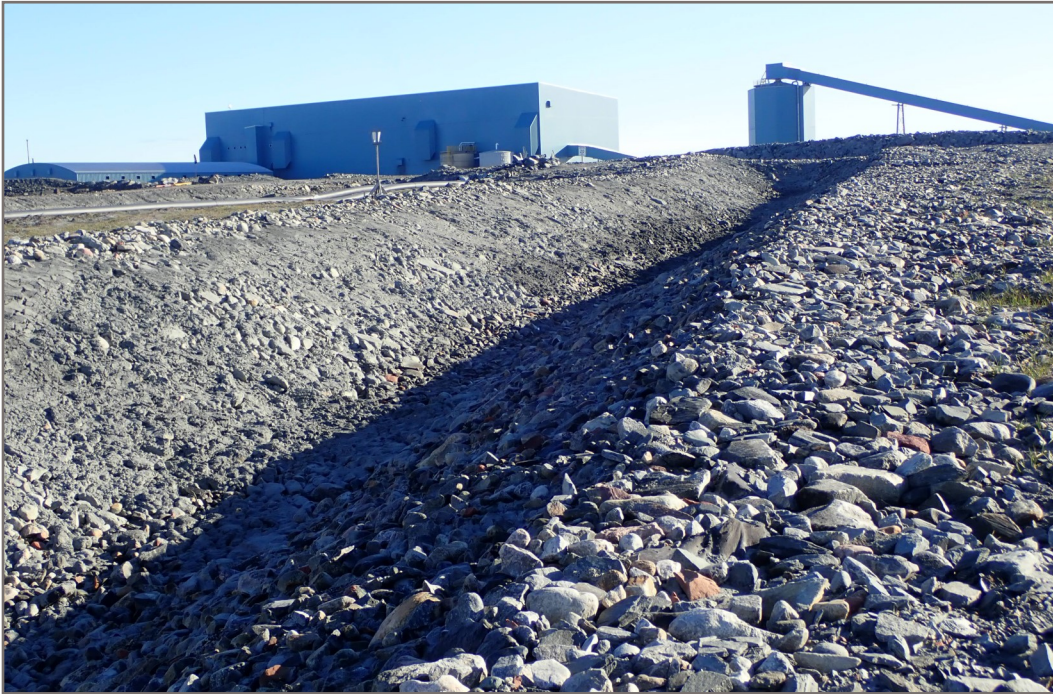
Photo 1: Channel 4 - Upper reach, below landfill

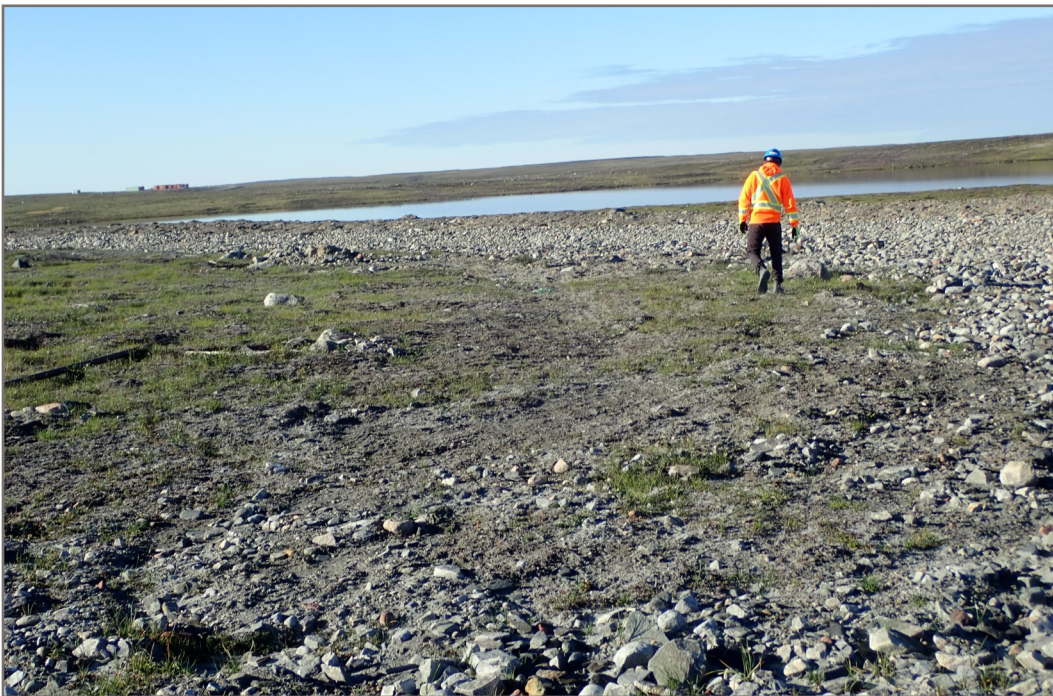
Photo 2: Channel 4—Original ground adjacent to upper reach. Ground covered with fines.

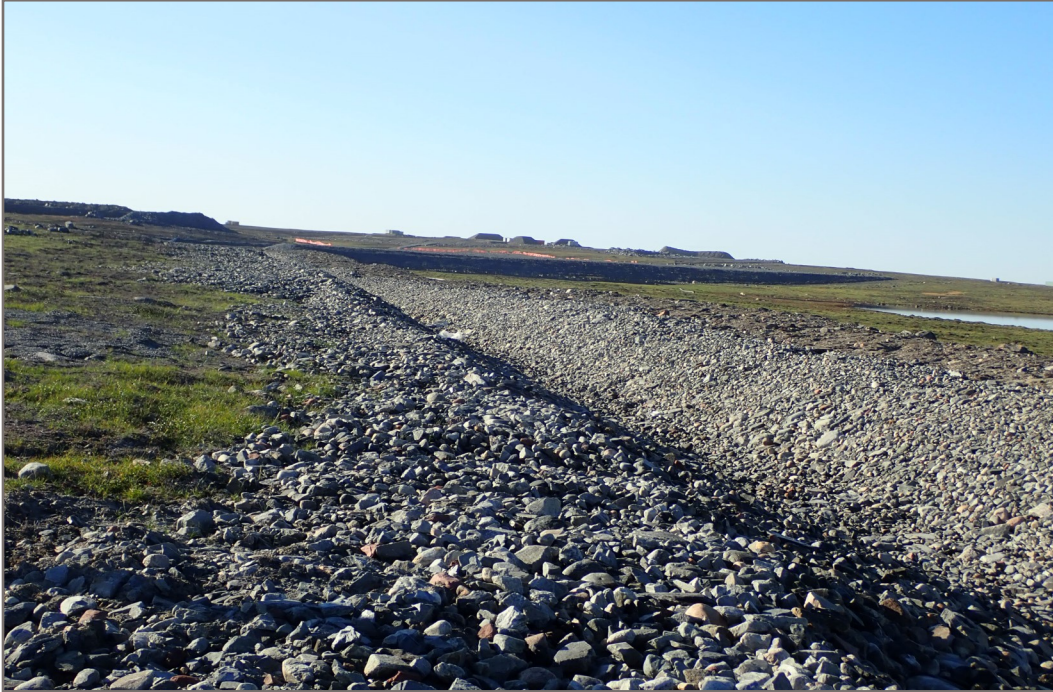
Photo 3: Channel 4 - Lower reach above Lake B7
