APPENDIX G

SALINE PONDS

APPENDIX H

DIVERSION CHANNELS AND BERMS

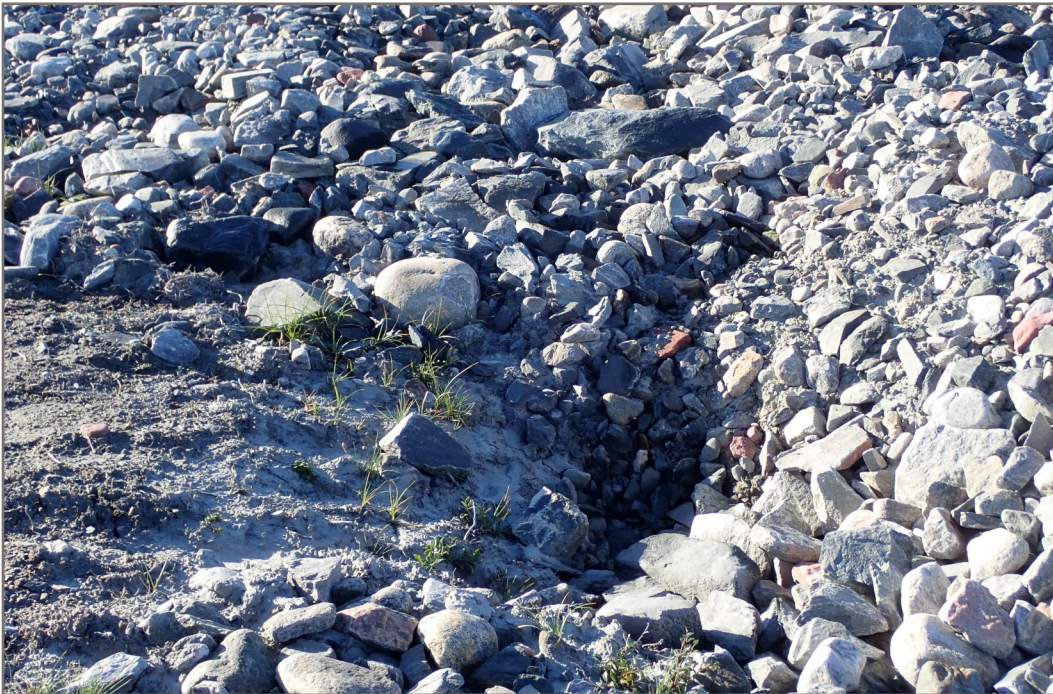
Photo 4: Channel 4 - Minor subsidence between original ground and channel rip rap.

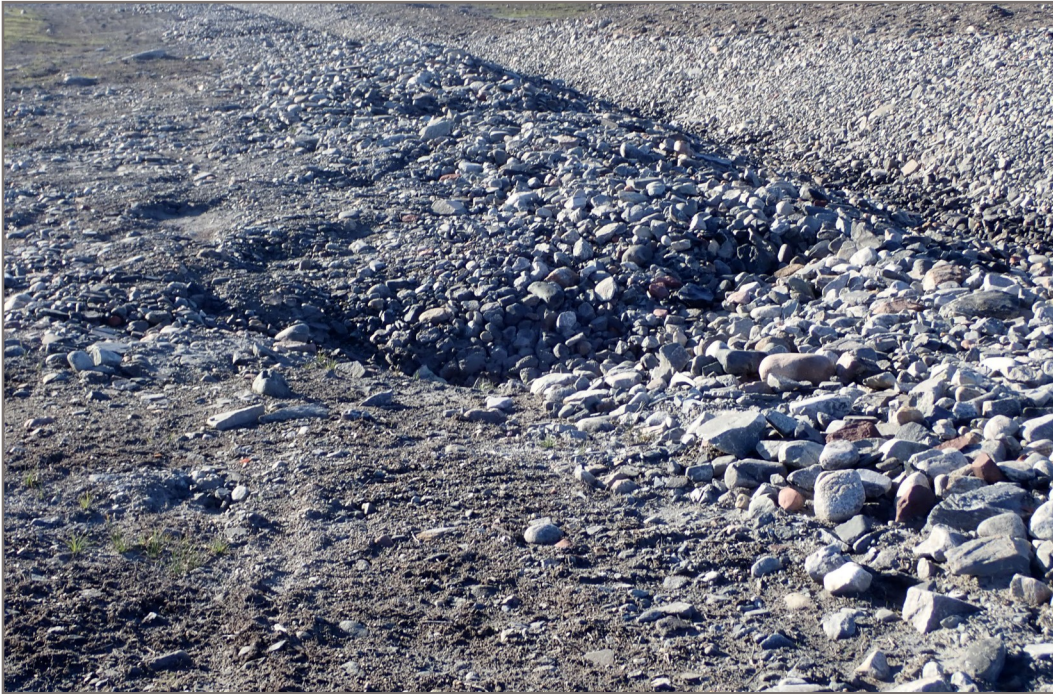
Photo 5: Channel 4 - Subsidence in rip rap—in upstream slope (east) slope of the channel.

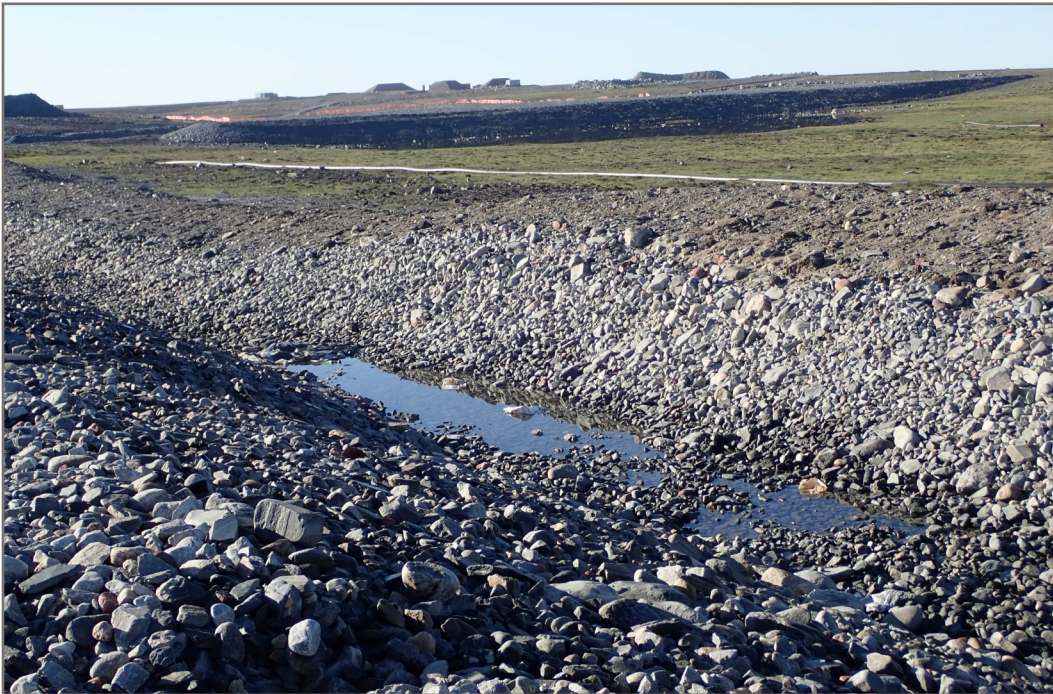
Photo 6: Channel 4 - Lower reach channel, minor ponding.

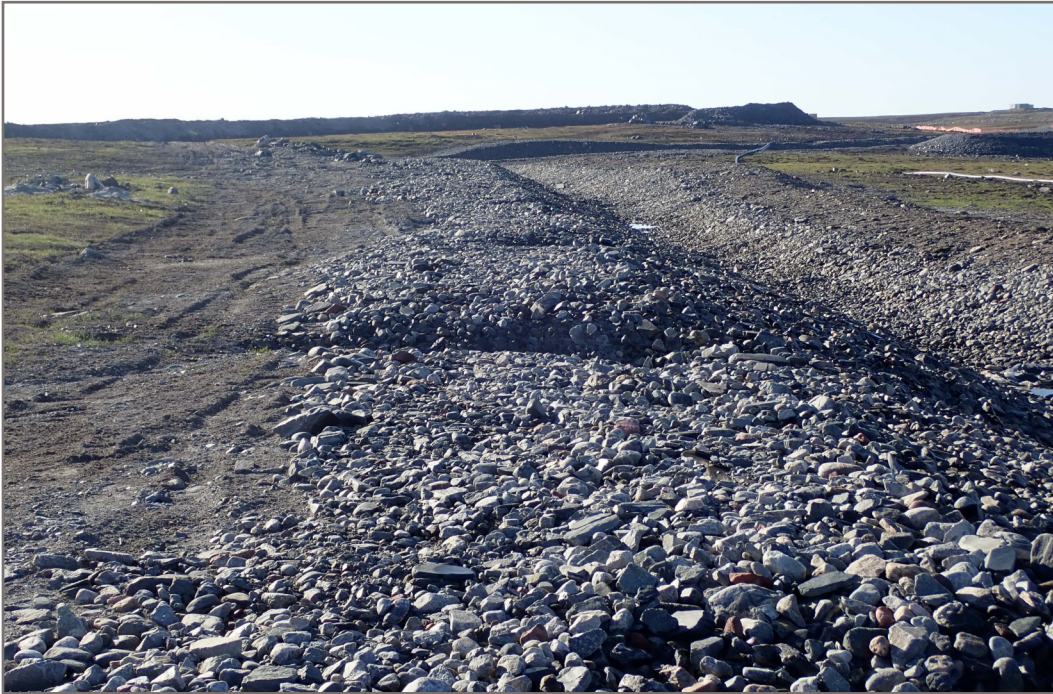
Photo 7: Channel 4 - Subsidence in rip rap—in upstream slope (east) slope of the channel.

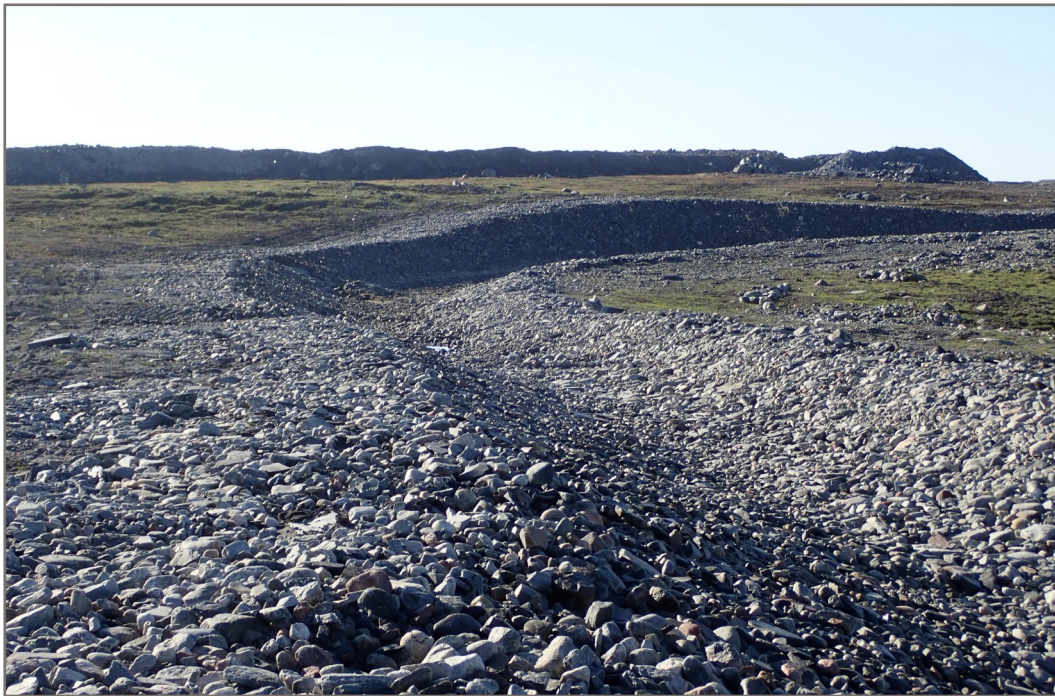
Photo 8: Channel 4 - Lower reach of channel prior to Berm CP4.

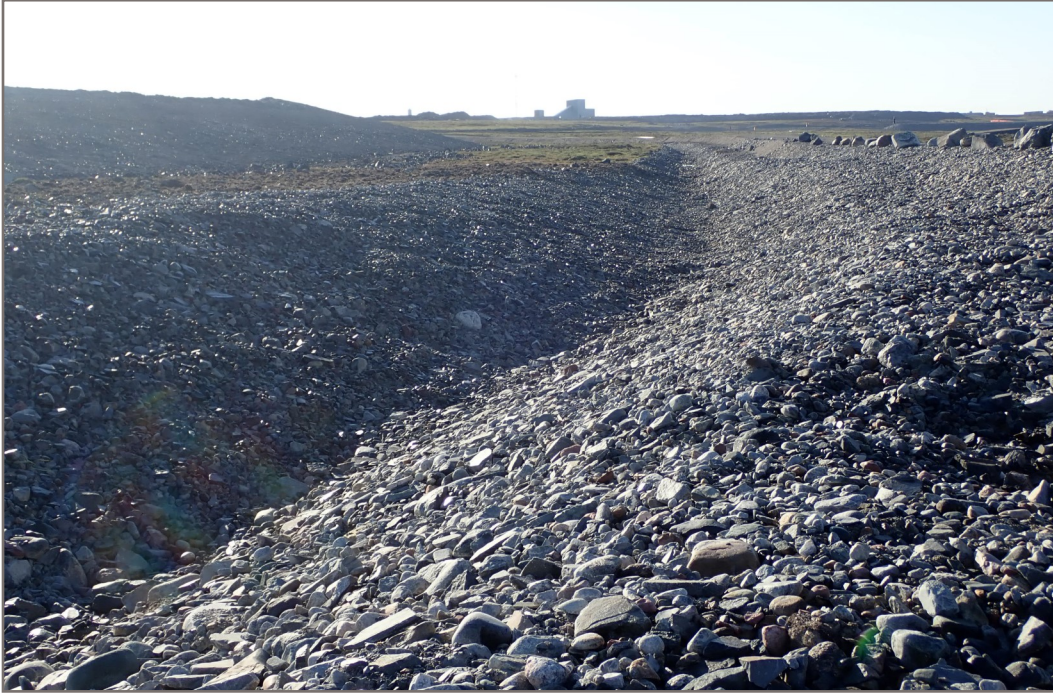
Photo 9: Channel 3 - Channel at CP3 Inlet.

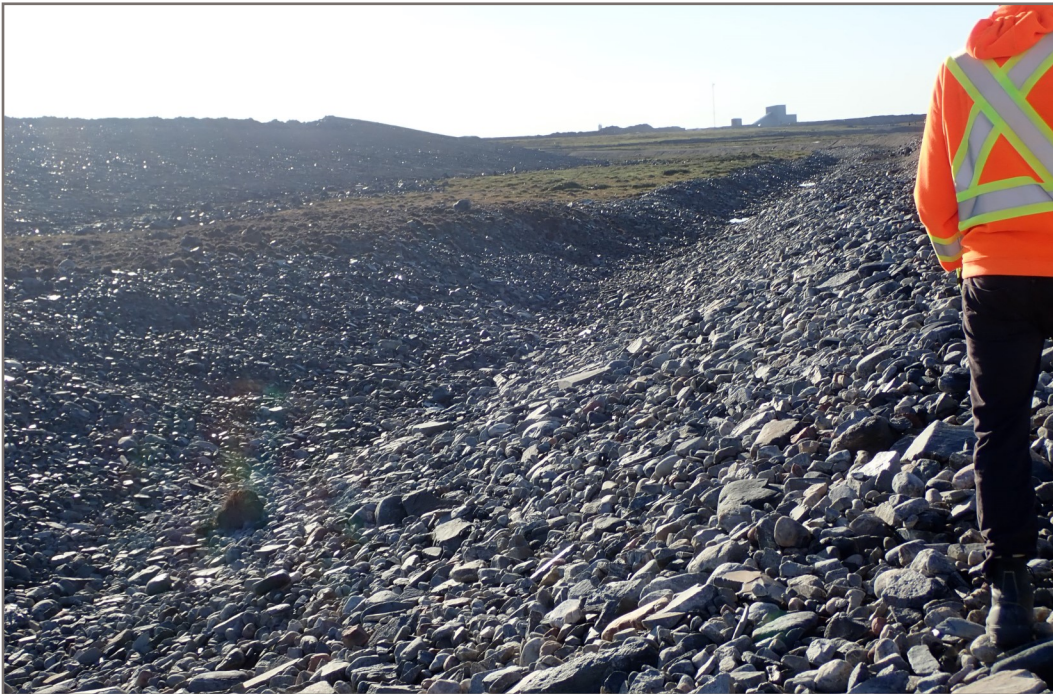
Photo 10: Channel 3 - Lower reach of Channel 3, good condition.
