## APPENDIX I

### TAILINGS STORAGE FACILITY

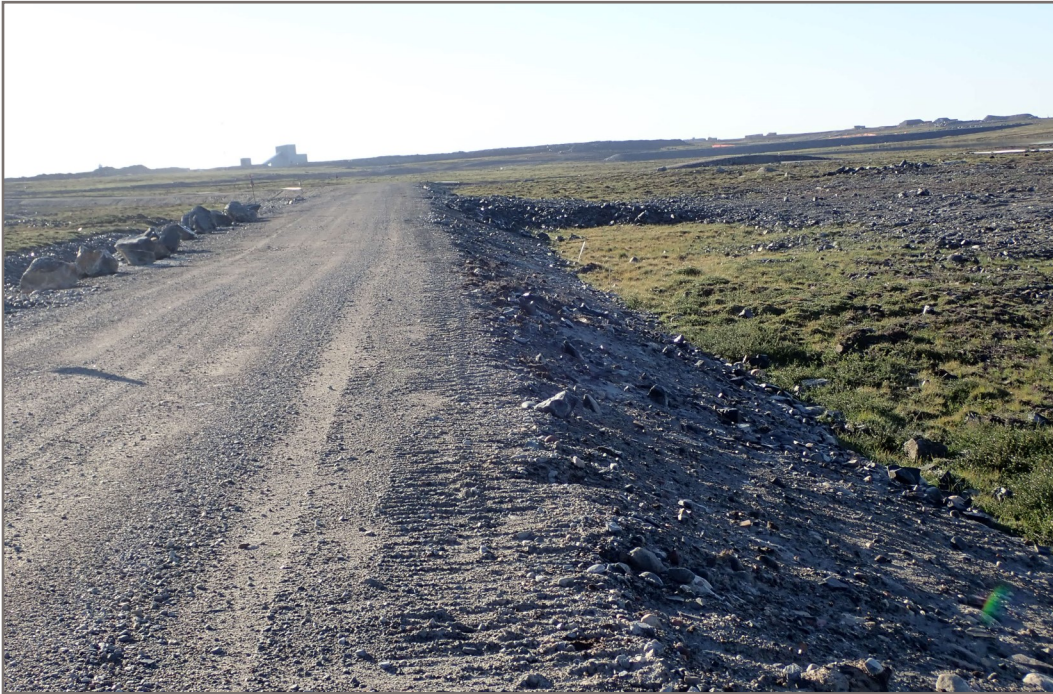
**Photo 11:** Channel 3 - Downstream slope of road adjacent to Channel 3.

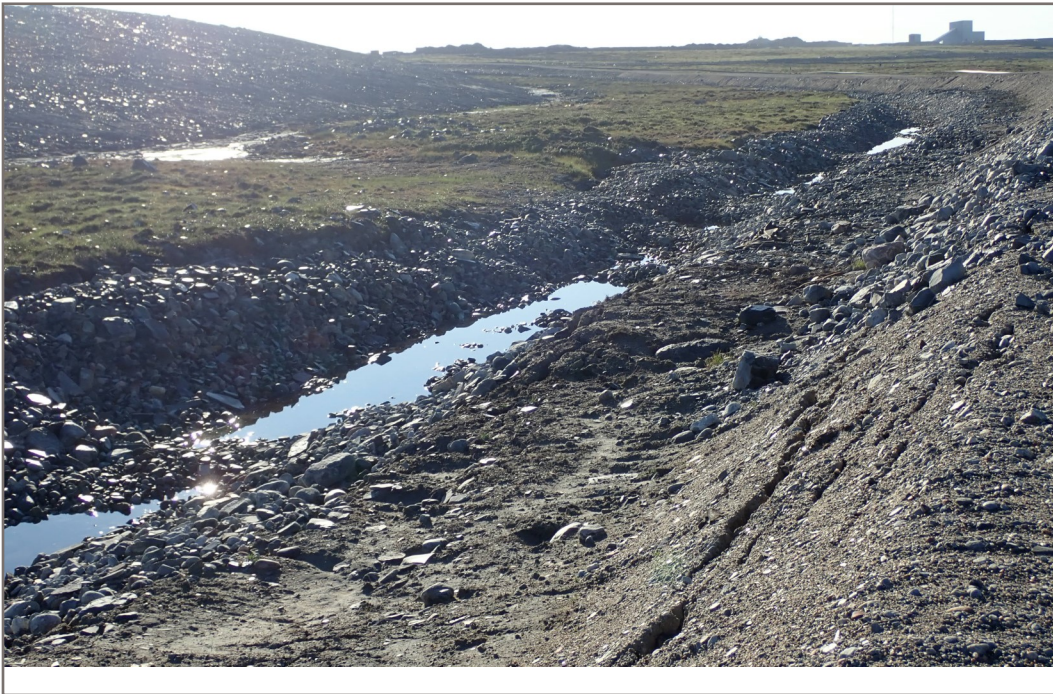
**Photo 12:** Channel 3 - Ponding in channel; appears to be some subsidence in base of channel resulting in rip settling and cracking in road side slope.

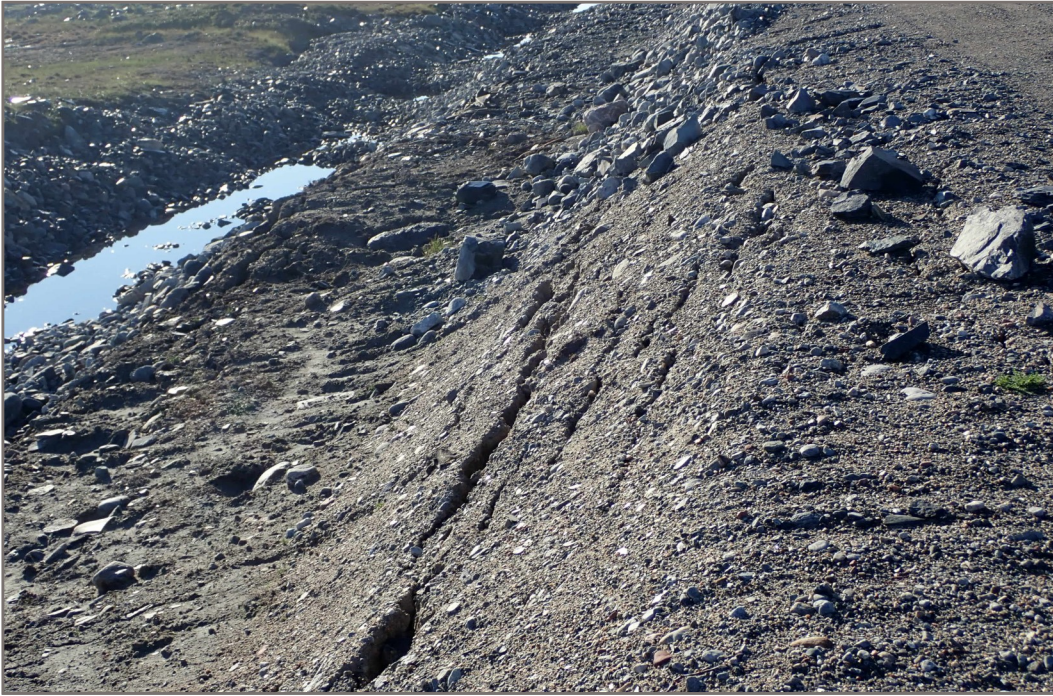
**Photo 13:** Channel 3 - Cracking in road side slope adjacent to channel.

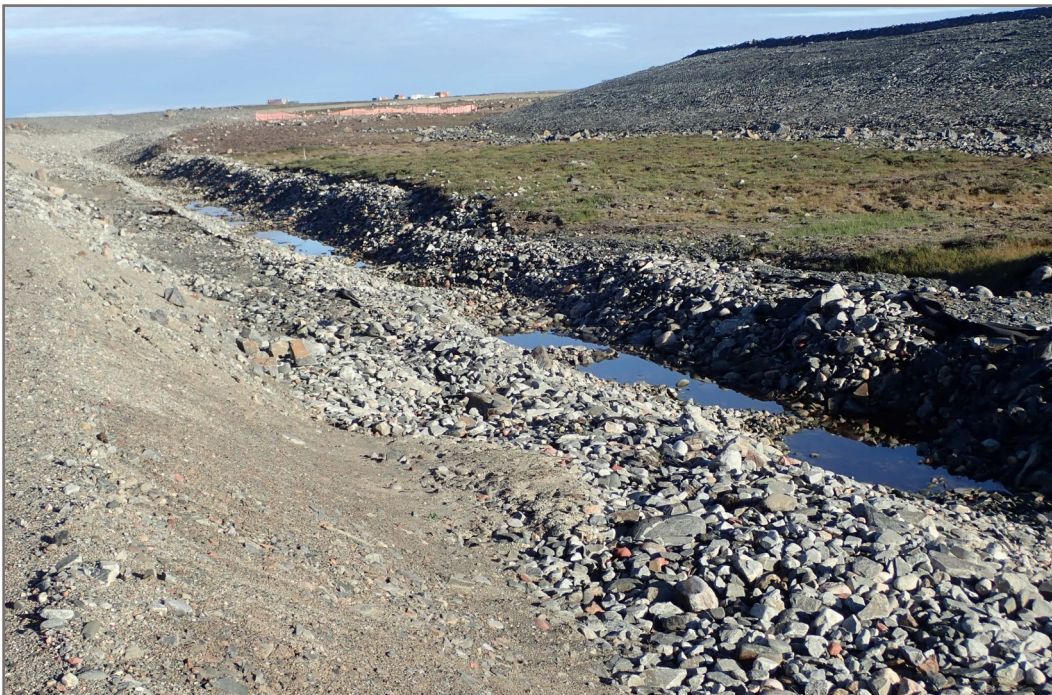
**Photo 14:** Channel 3 - Ponding in channel; appears to be some subsidence in base of channel resulting in rip settling and cracking in road side slope.. High points (less subsidence) resulting in ponding.

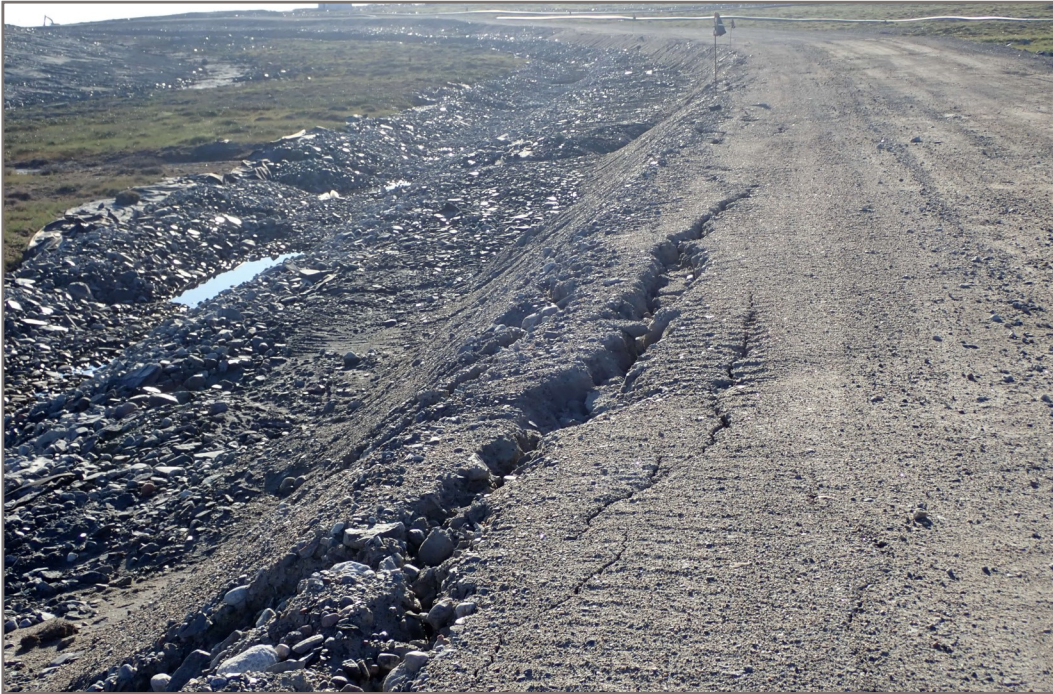
**Photo 15:** Channel 3 - Cracking in road side slopes.

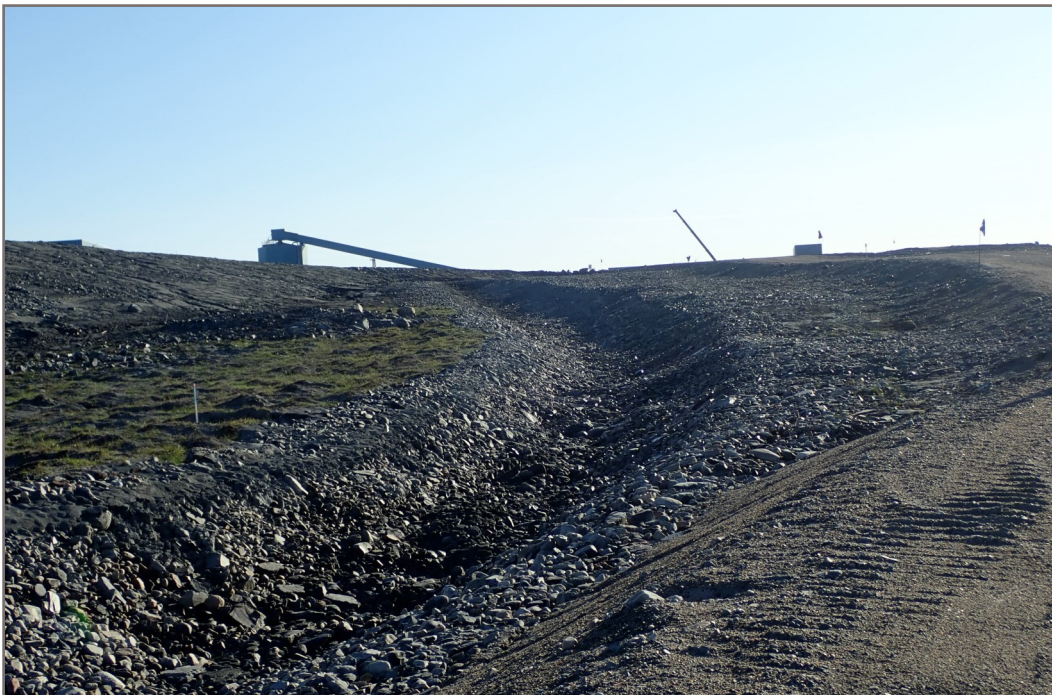
**Photo 16:** Channel 3 - Upper reach of channel.

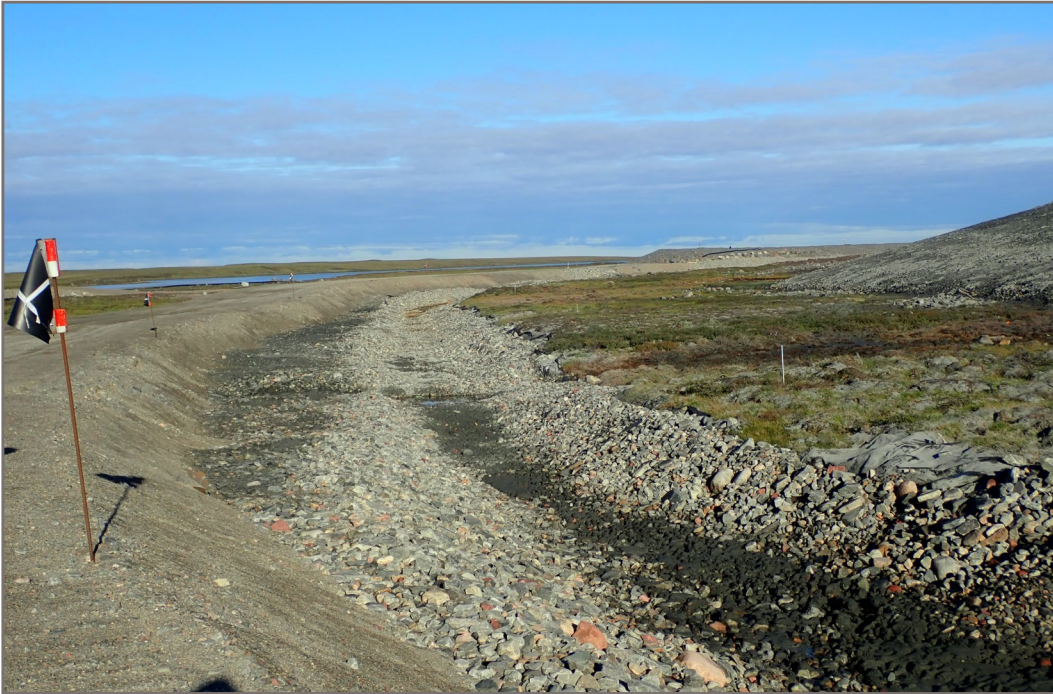
**Photo 17:** Channel 3 - Upper reach of channel

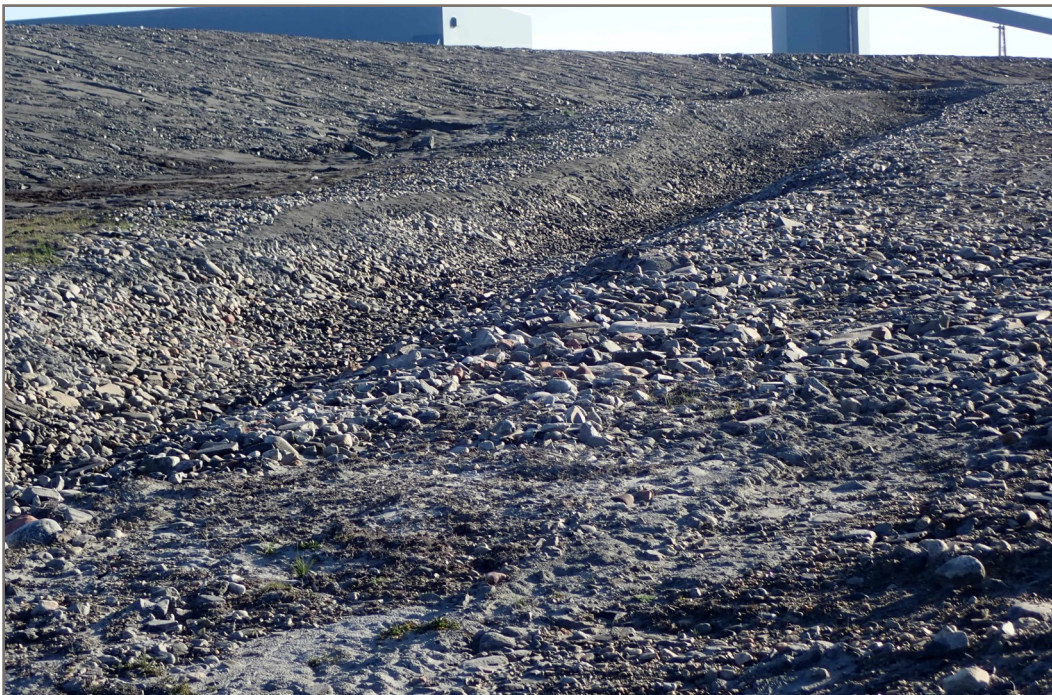
**Photo 18:** Channel 3 - Upper reach of channel, TSF on right of photo.

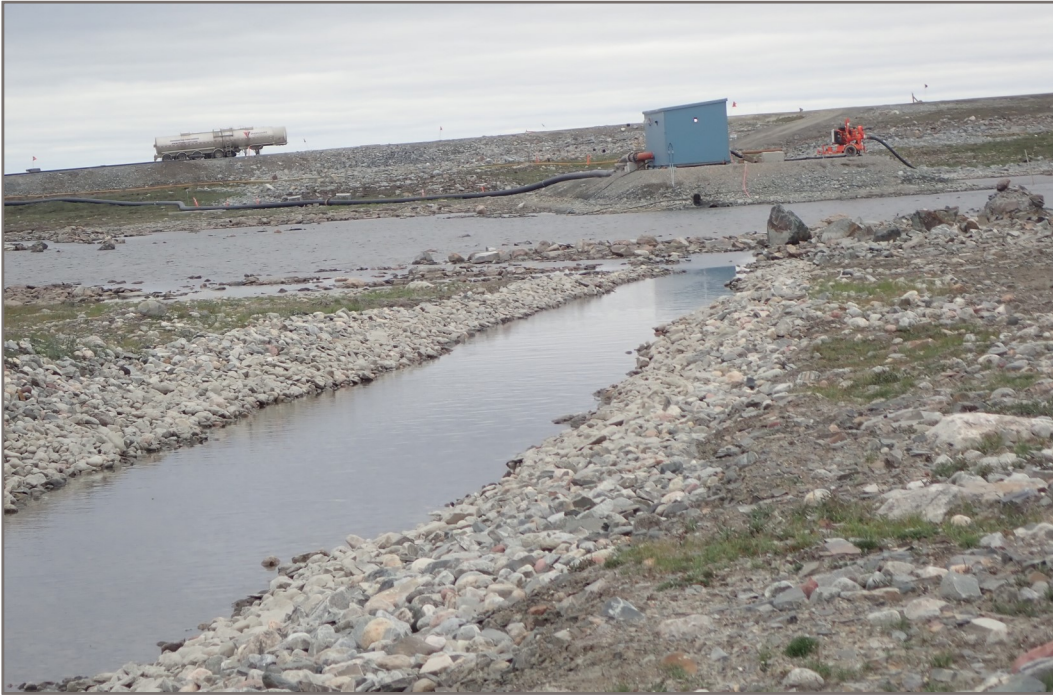
**Photo 19:** Channel 5 - Lower reach of channel

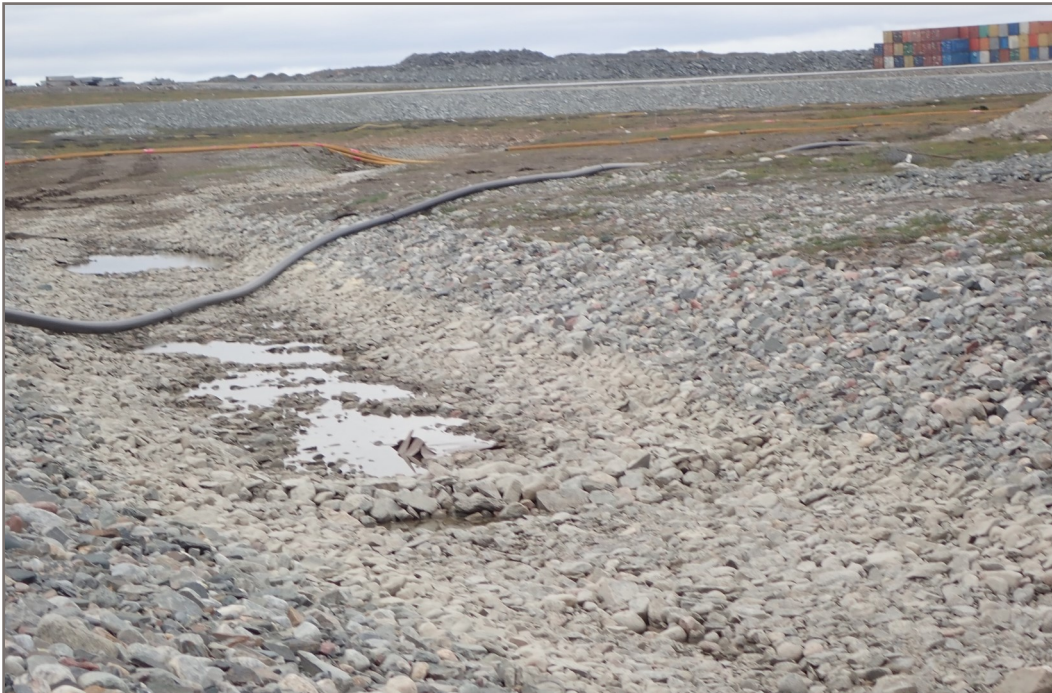
**Photo 20:** Channel 5—Settlement and ponding

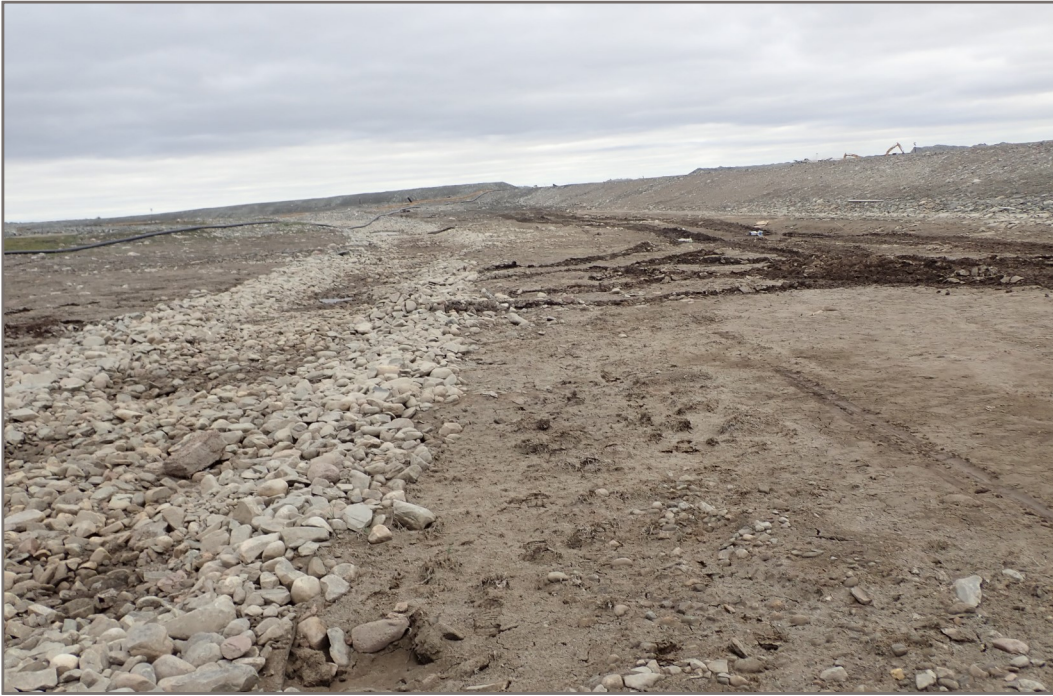
**Photo 21:** Channel 5 - Disturbance next to channel

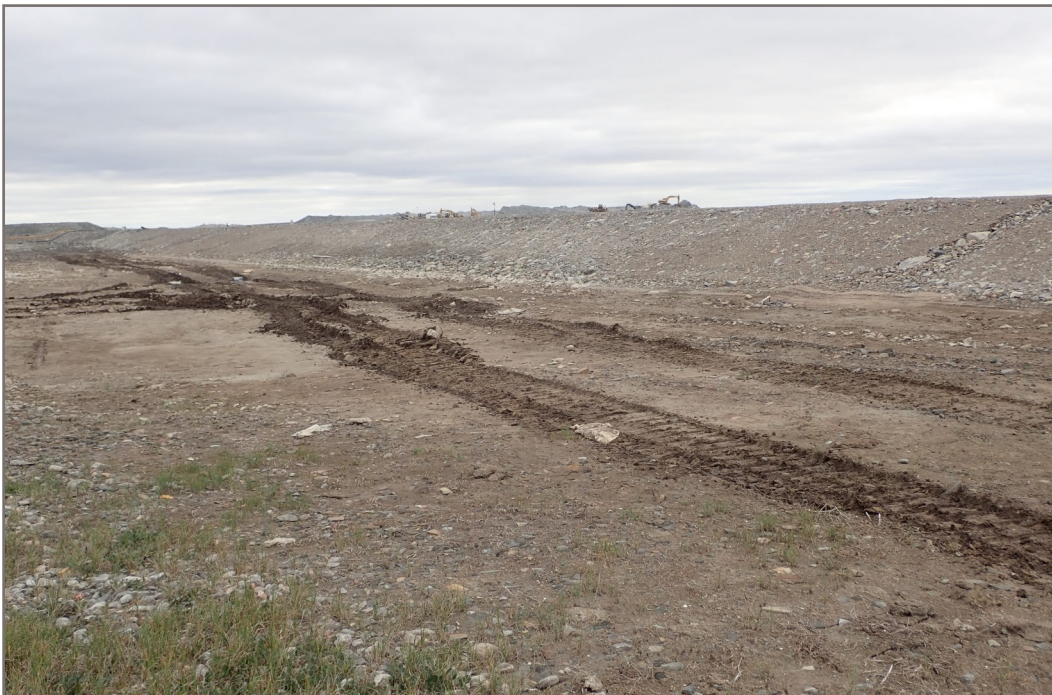
**Photo 22:** Channel 5—Disturbance next to Channel, Berm adjacent to channel.

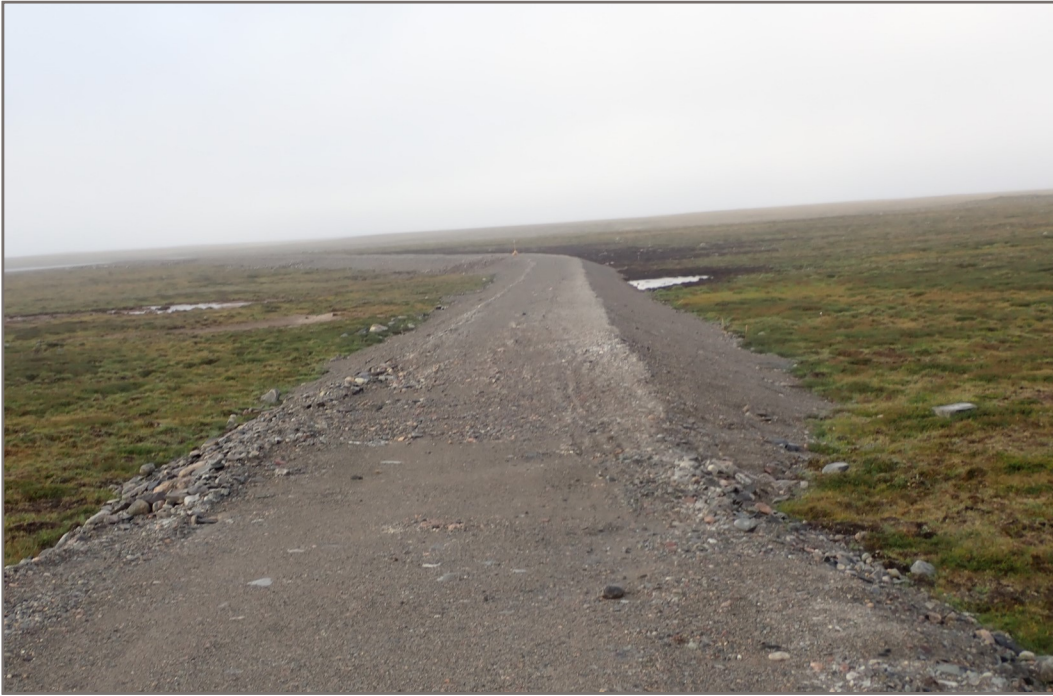
**Photo 23:** Berm 2 - Typical Profile

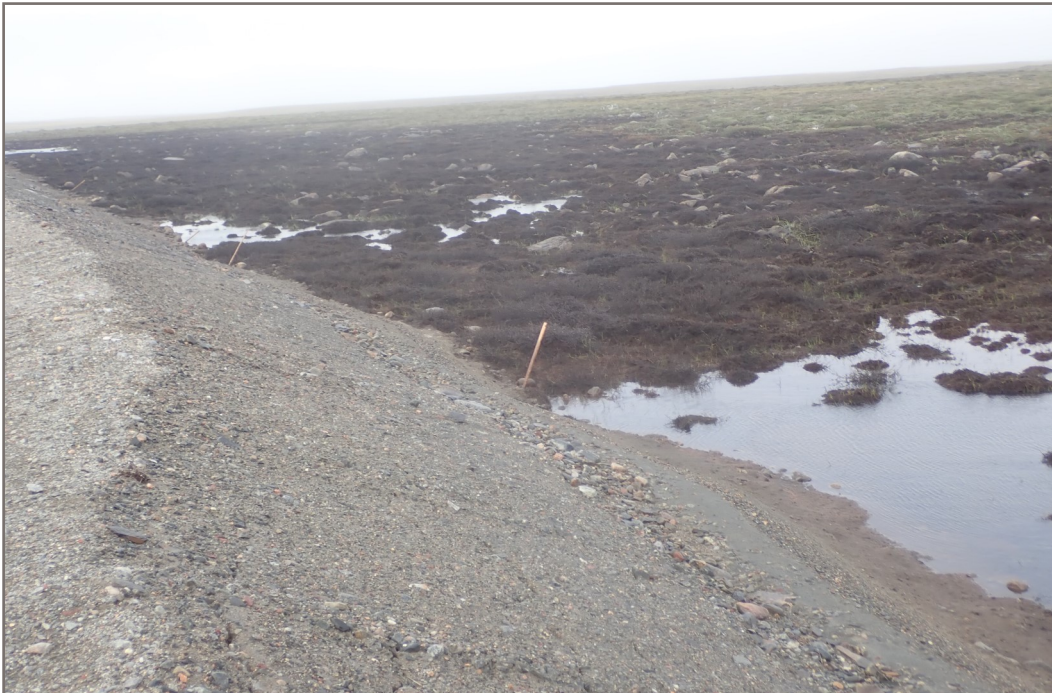
**Photo 24:** Berm 2—Ponded water upstream of Berm 2—Wave wash zone indication of higher water level.

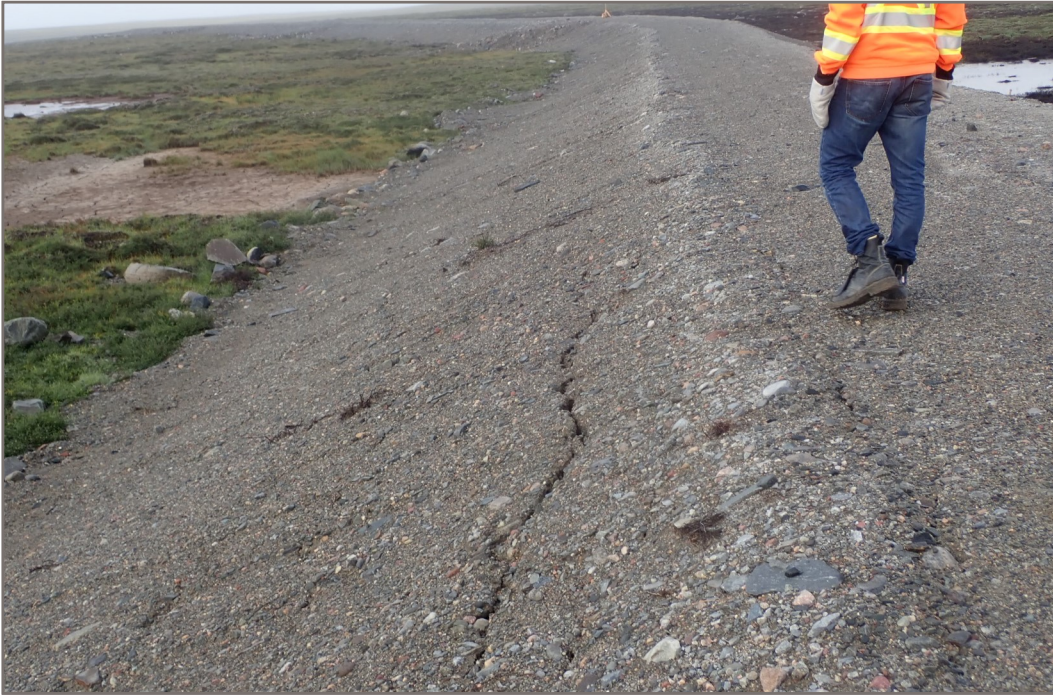
**Photo 25:** Berm 2—Cracking on side slope.

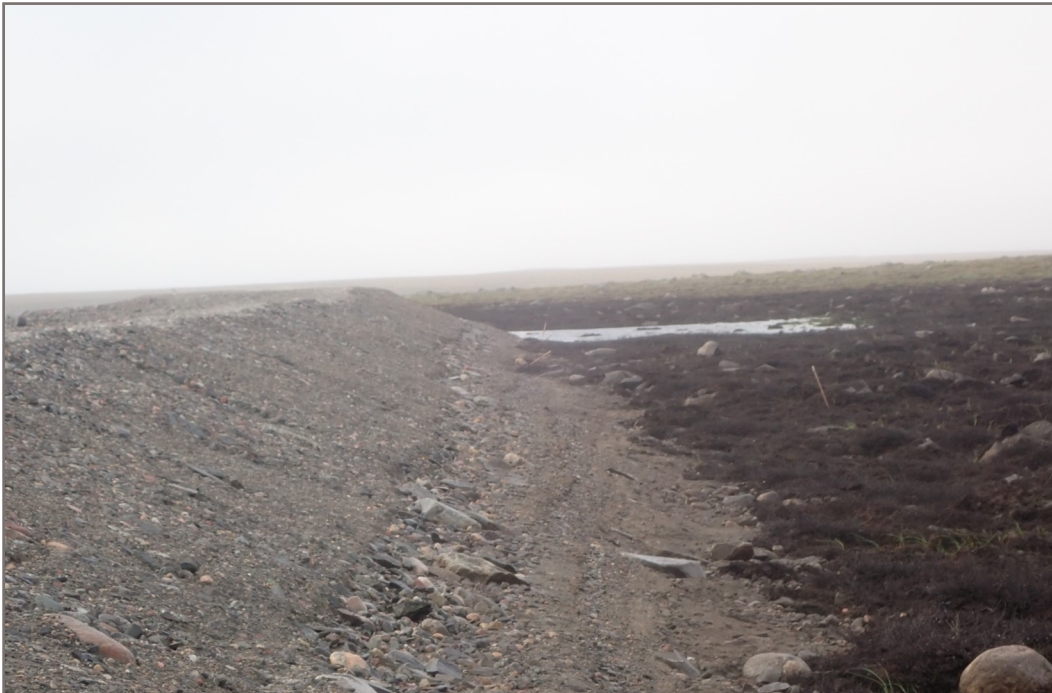
**Photo 26:** Channel 2—Minor surface erosion along berm from ponded water.

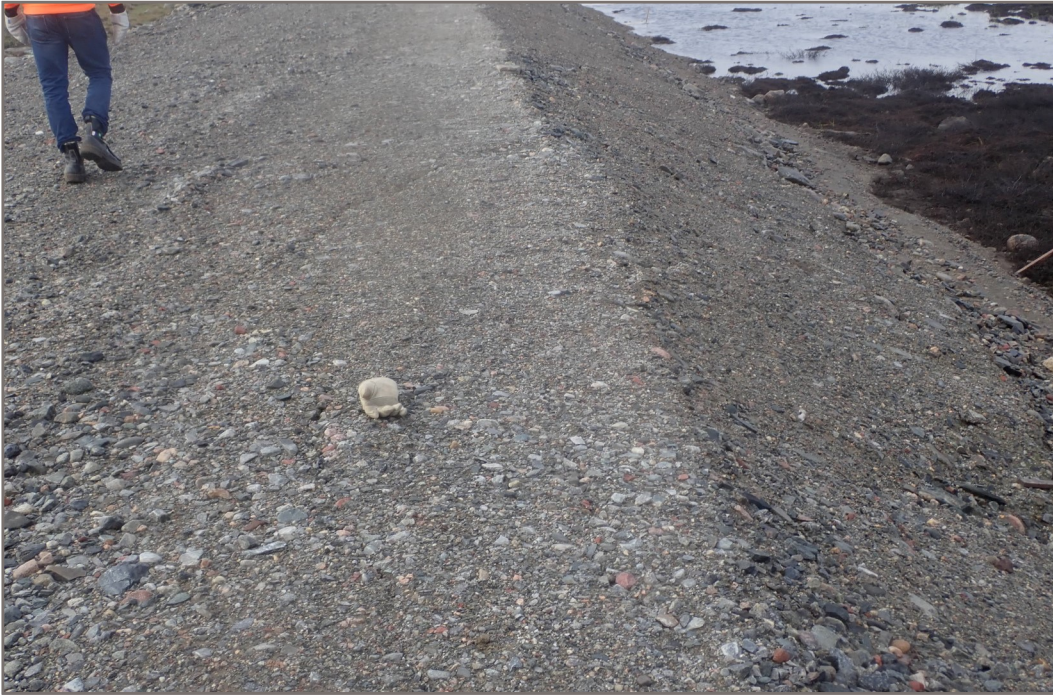
**Photo 27:** Berm 2—Minor cracking on berm crest.

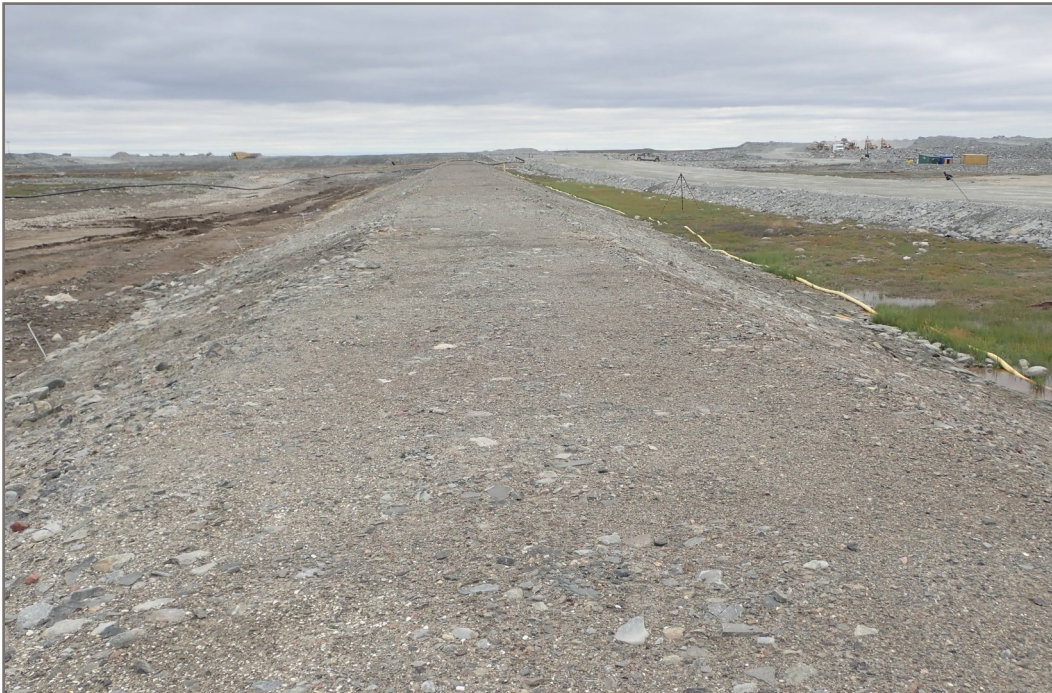
**Photo 28:** Berm 3—Typical Section, Channel 5 on left.

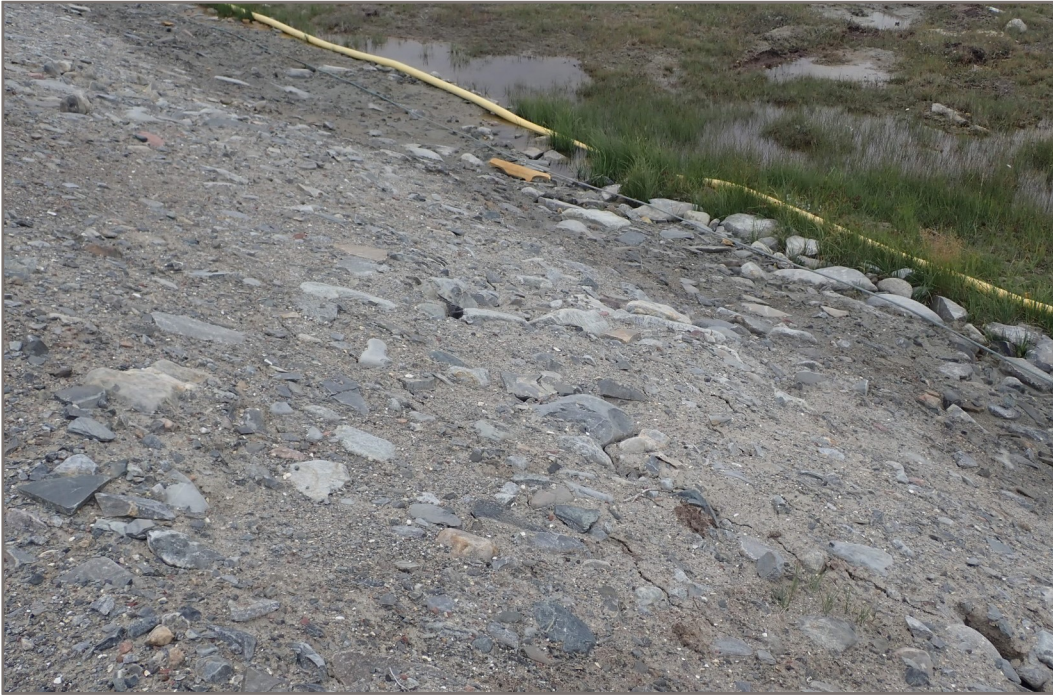
**Photo 29:** Berm 3—Minor cracking in berm.

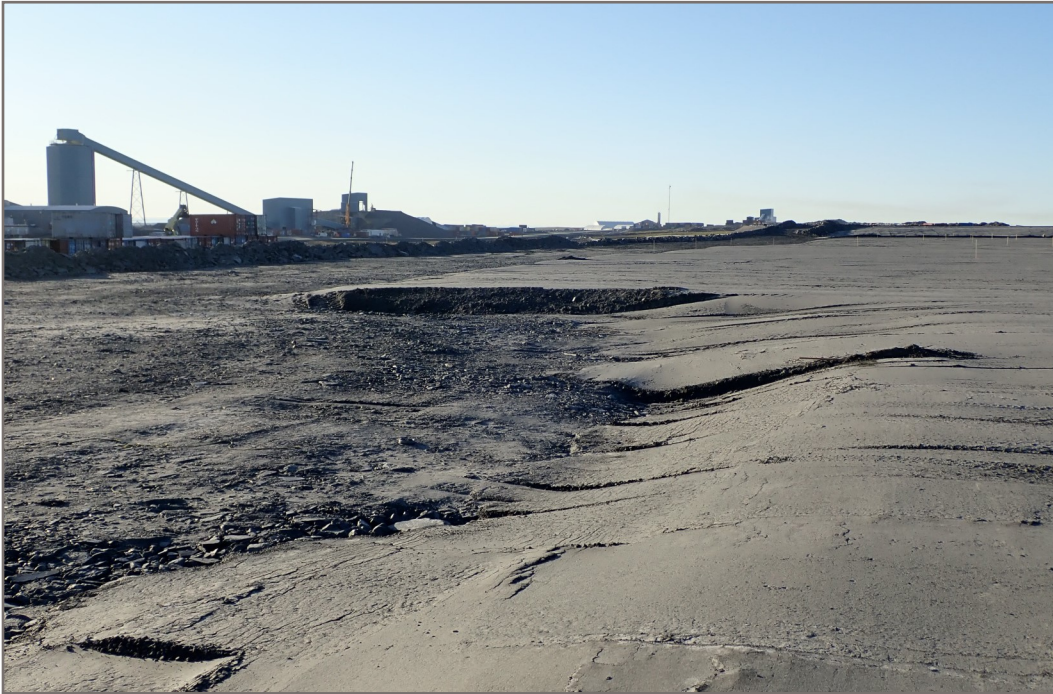
**Photo 1:** TSF - Tailing surface, northeast side, compacted, approximately 300 mm lift thickness

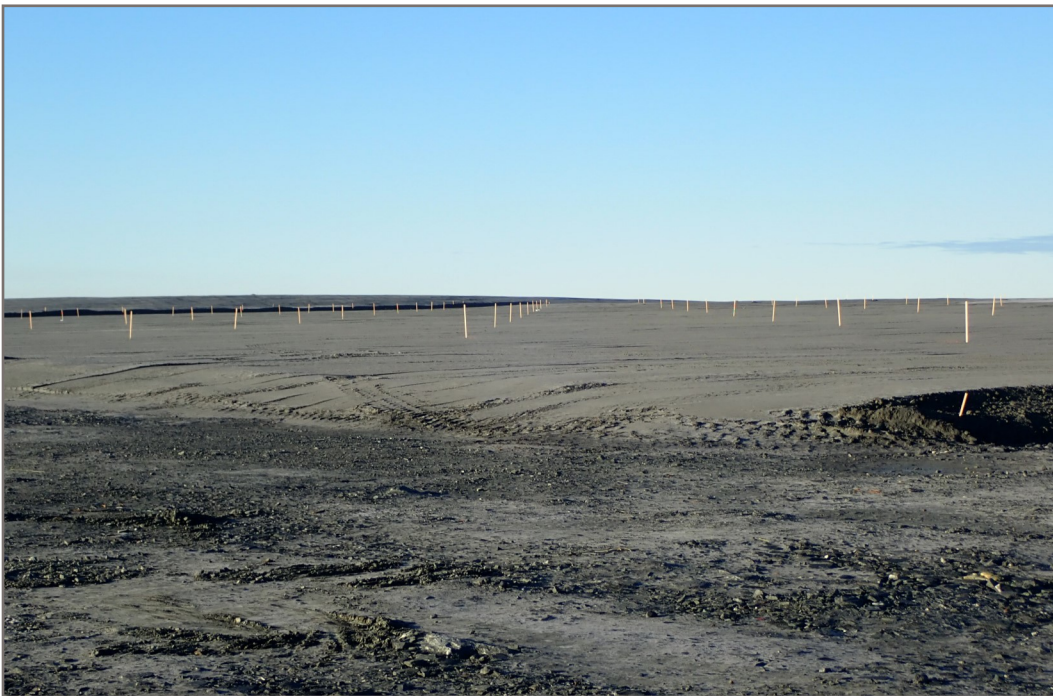
**Photo 2:** TSF—Tailings surface, grade stakes used for lift control

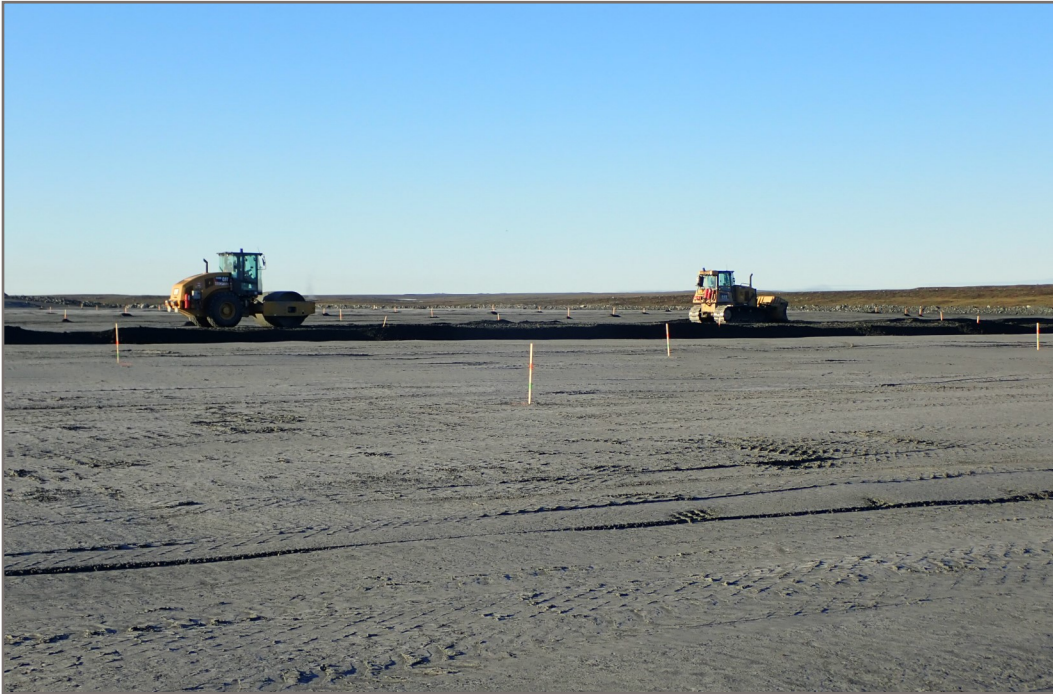
**Photo 3:** TSF - Placing and compacting tailings.

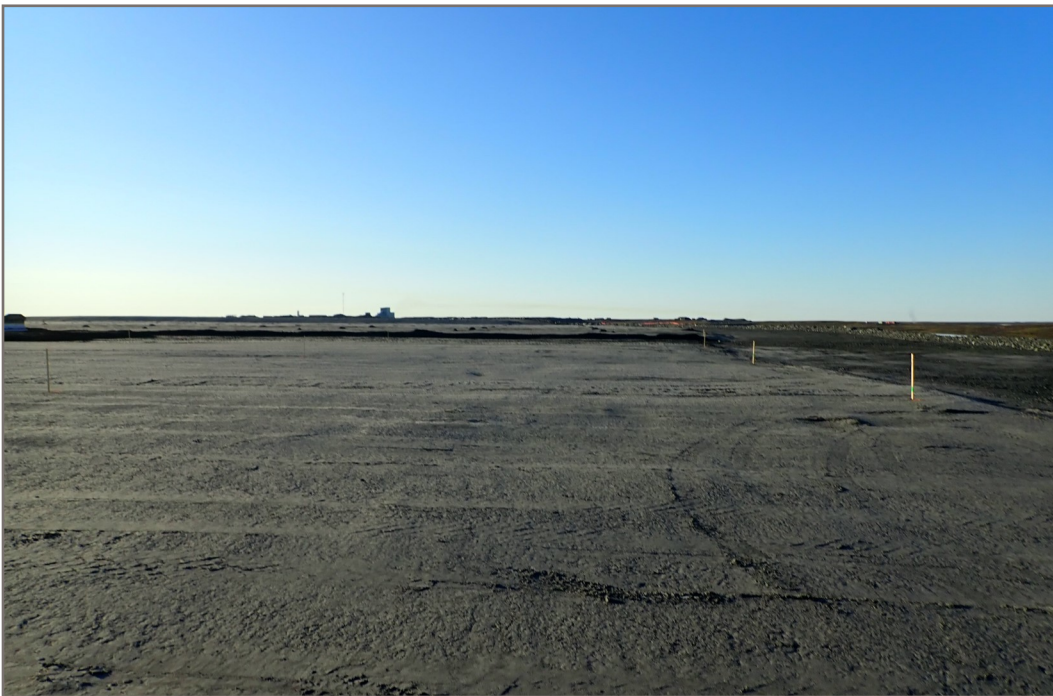
**Photo 4:** TSF - Placed tailings

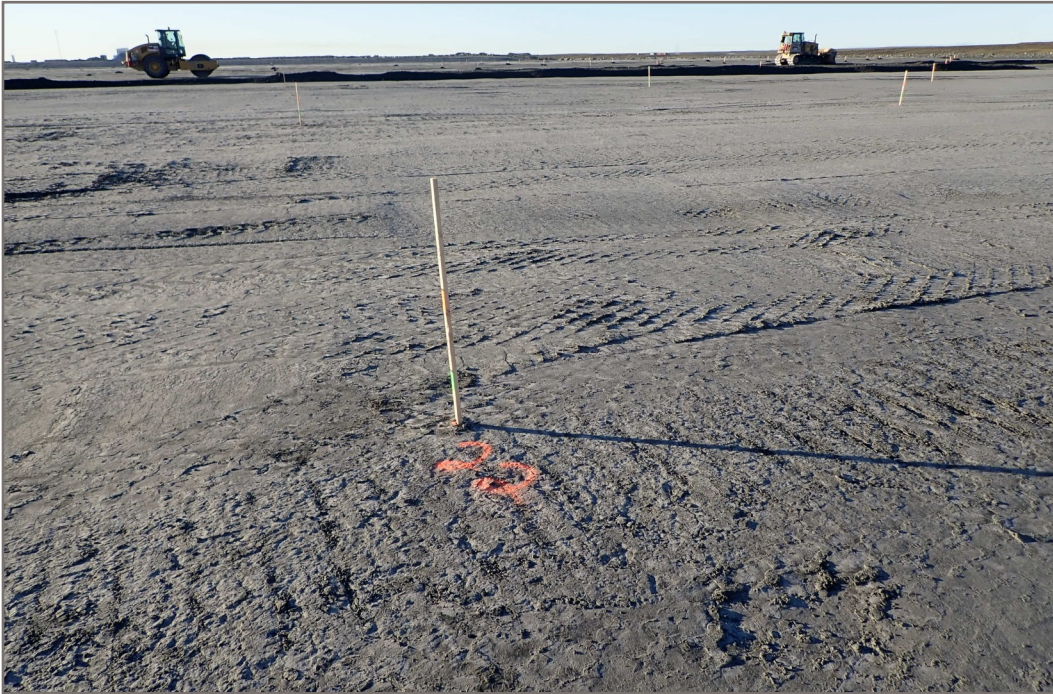
**Photo 5:** TSF - Placed tailings.

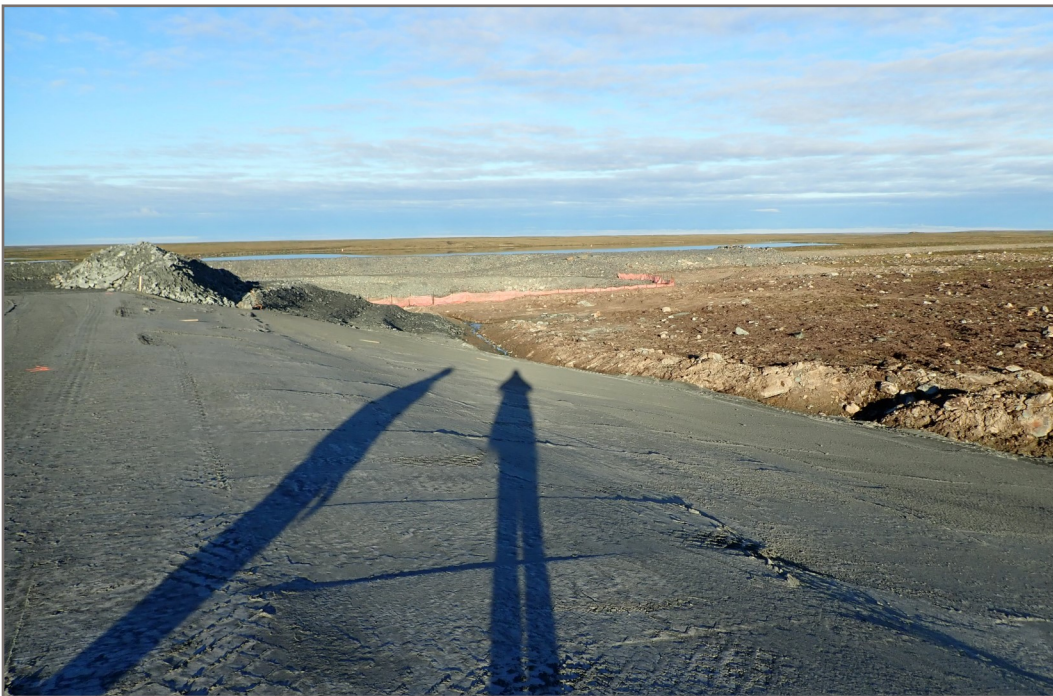
**Photo 6:** TSF - Slope between Cell 1 and future Cell 2.

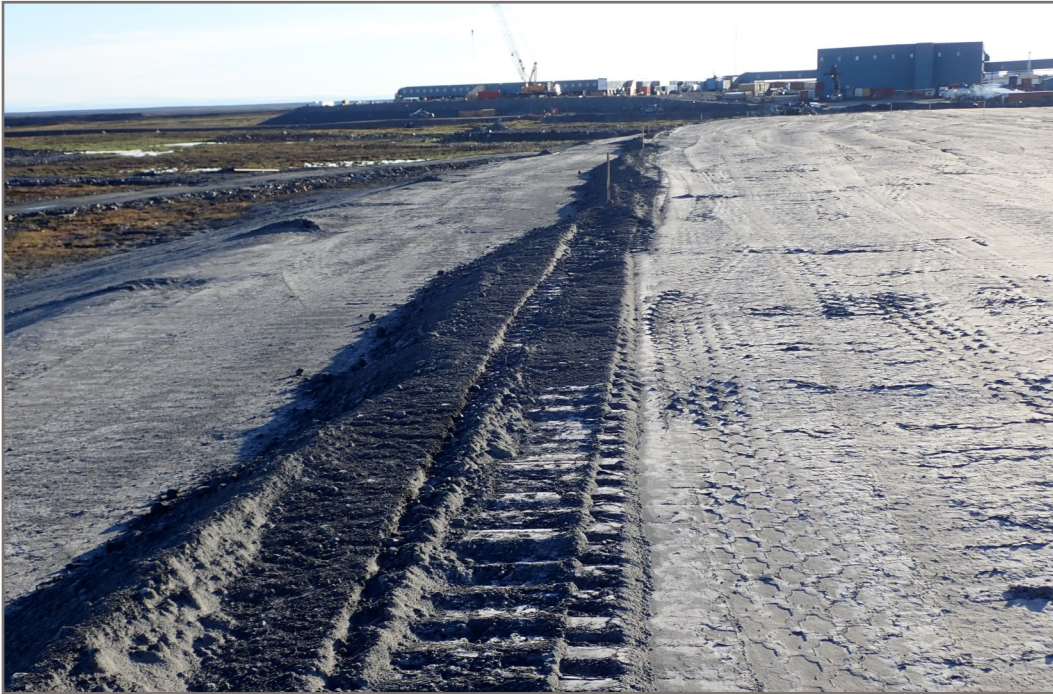
**Photo 7:** TSF - Slope between Cell 1 and future Cell 2. White precipitate on portions of the tailings surface.

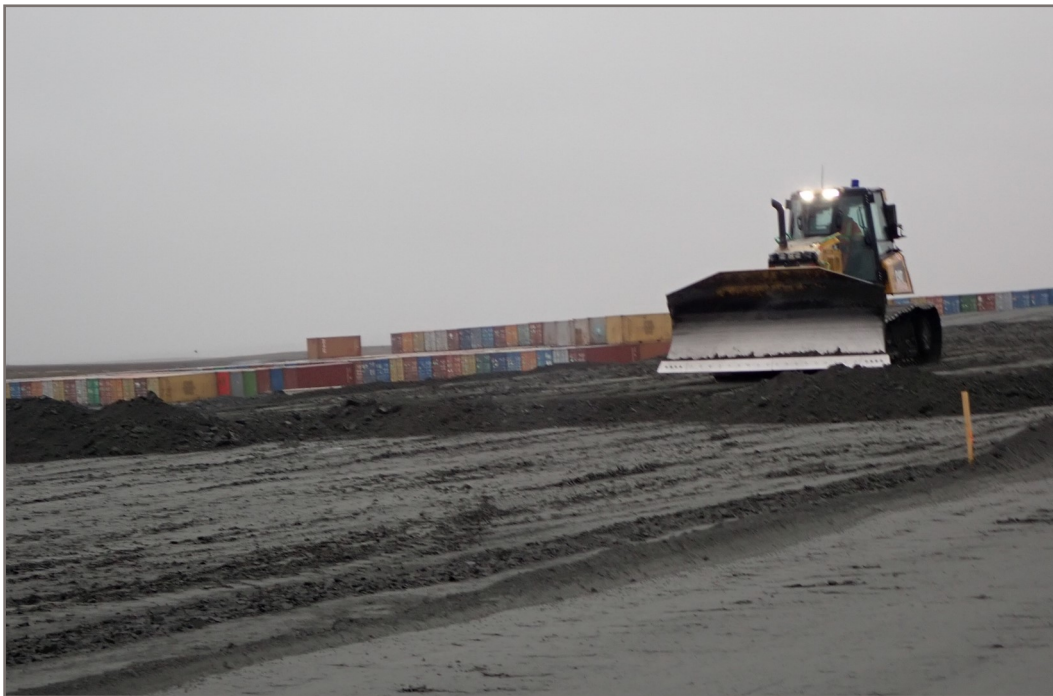
**Photo 8:** TSF - Spreading tailings, prior to compaction.

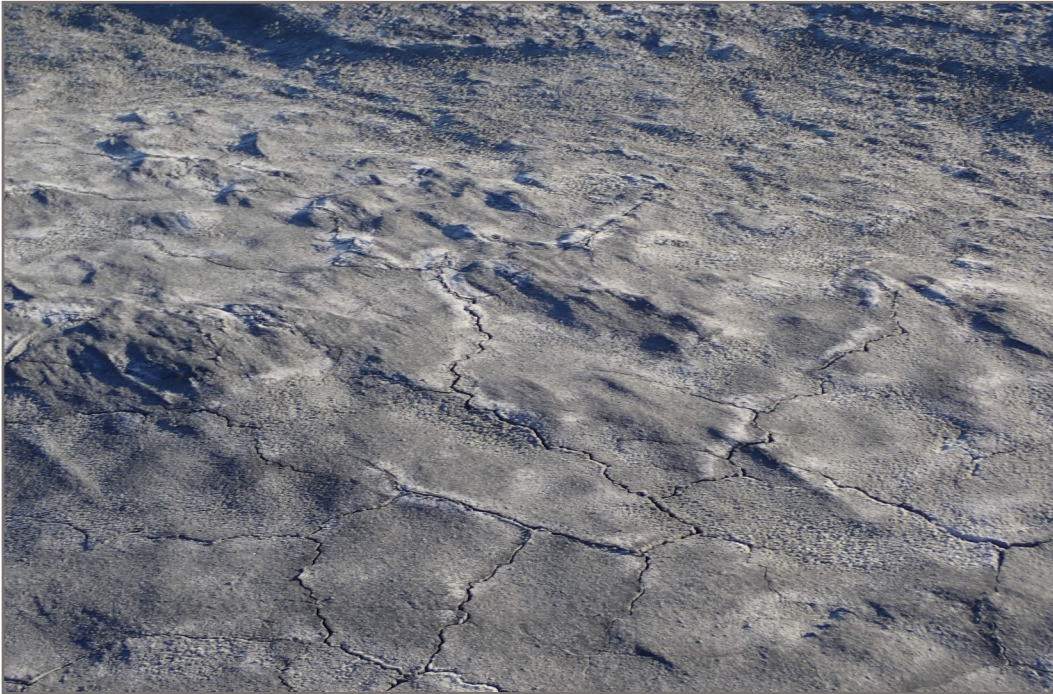
**Photo 9:** TSF - Desiccation of tailings, reported to be placed approximately three months prior.

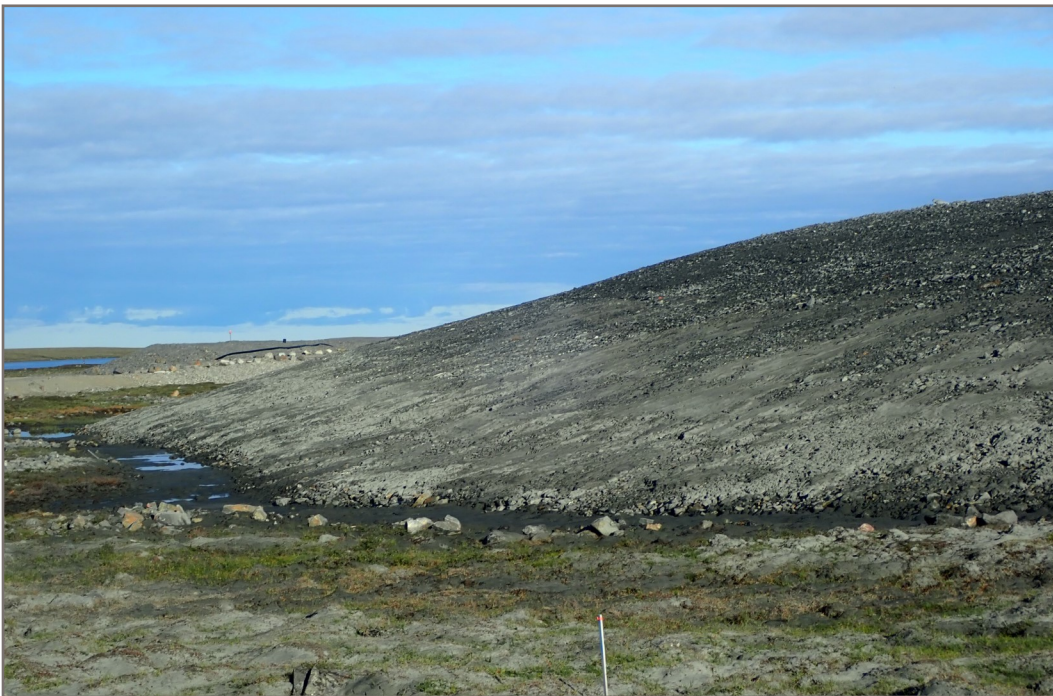
**Photo 10:** TSF - Rockfill covered slope of TSF. Some fine sediment at toe of slope, reported due to tailings contaminated snow placed in the area.

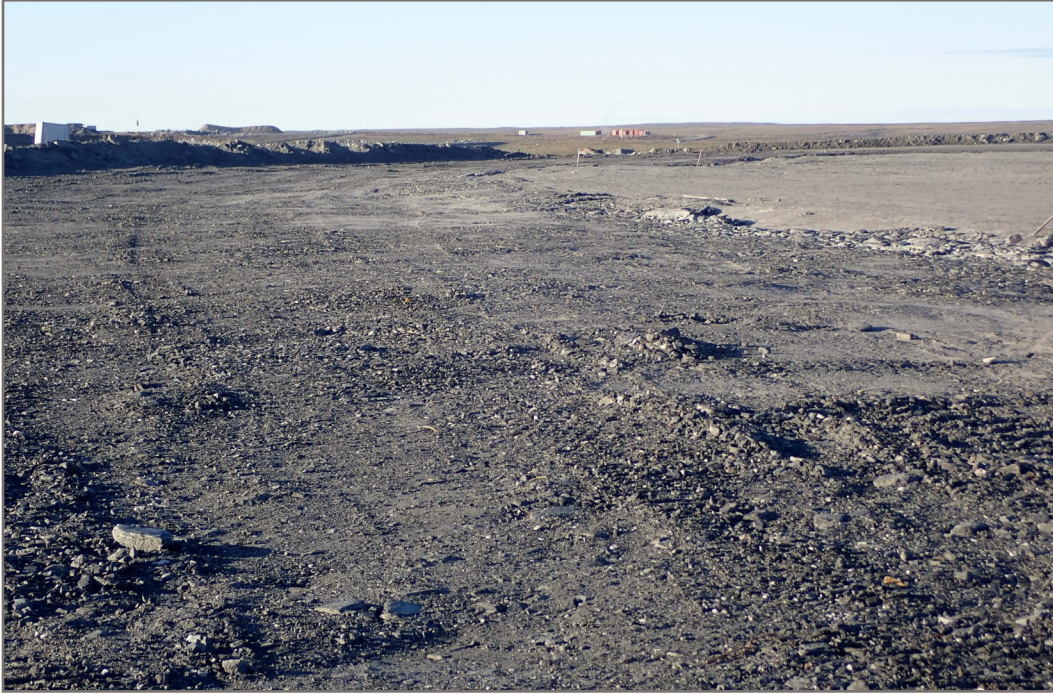
**Photo 11:** TSF - Crest of rockfill covered slope.

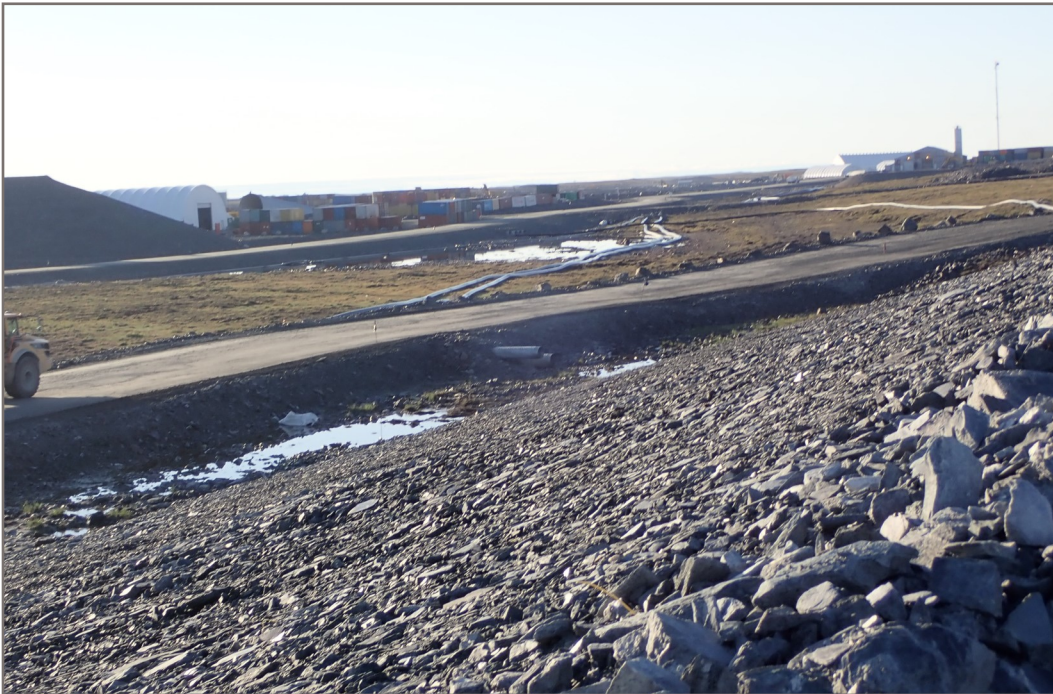
**Photo 12:** TSF - Rockfill covered TSF slope
