## APPENDIX I

### TAILINGS STORAGE FACILITY

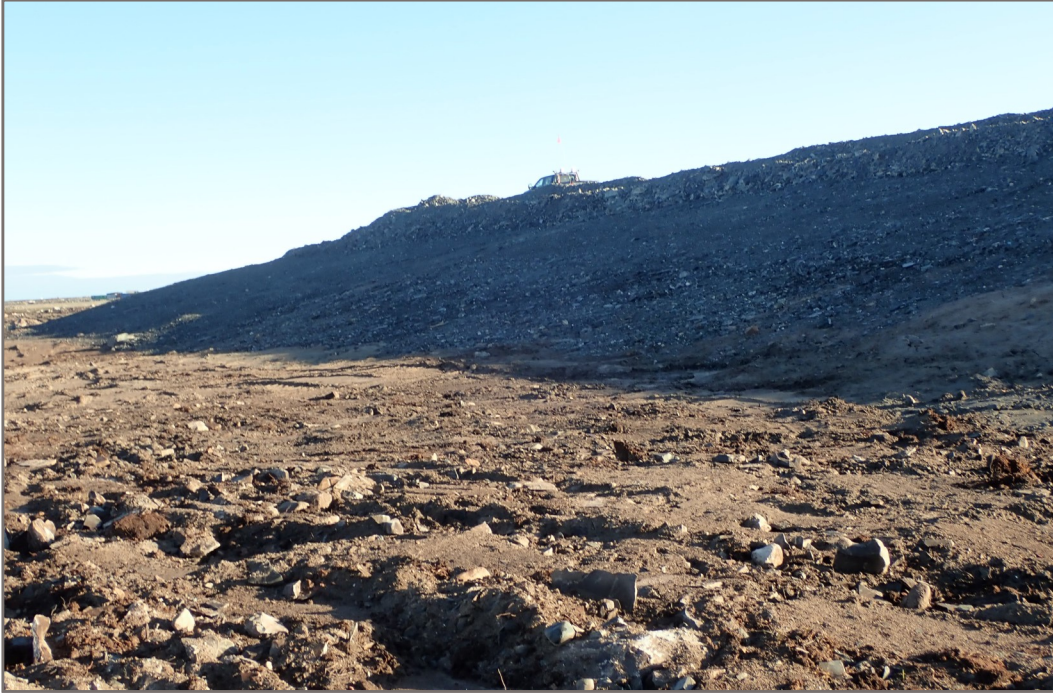
**Photo 13:** TSF - Rockfill covered TSF slope above CP3.

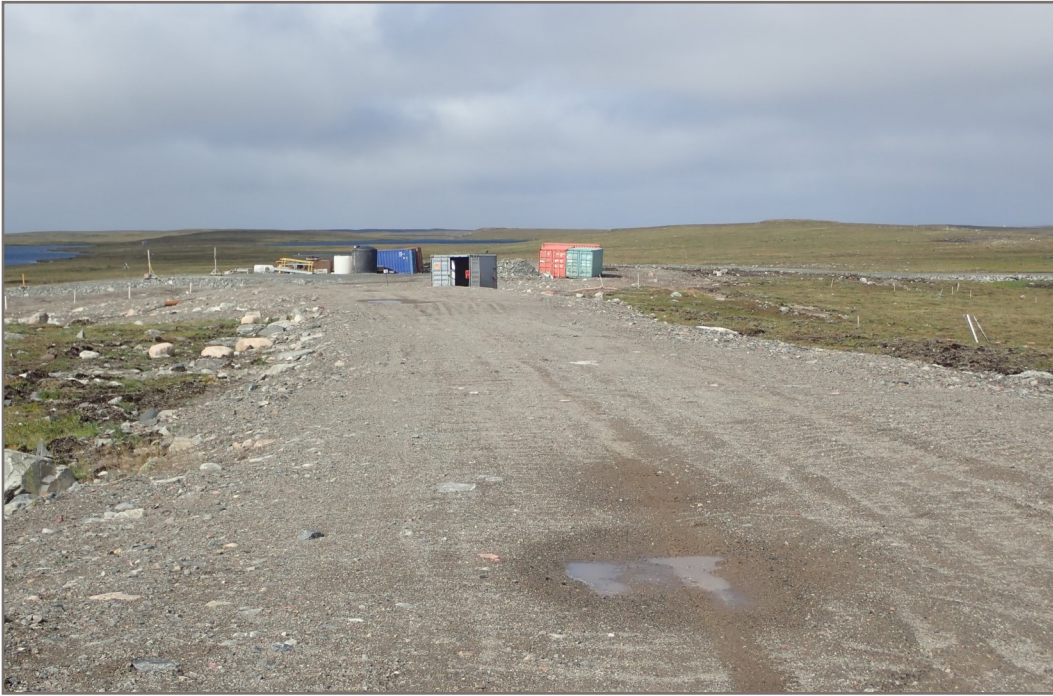
**Photo 1:** Site Roads—Road to Wes Mag Borrow

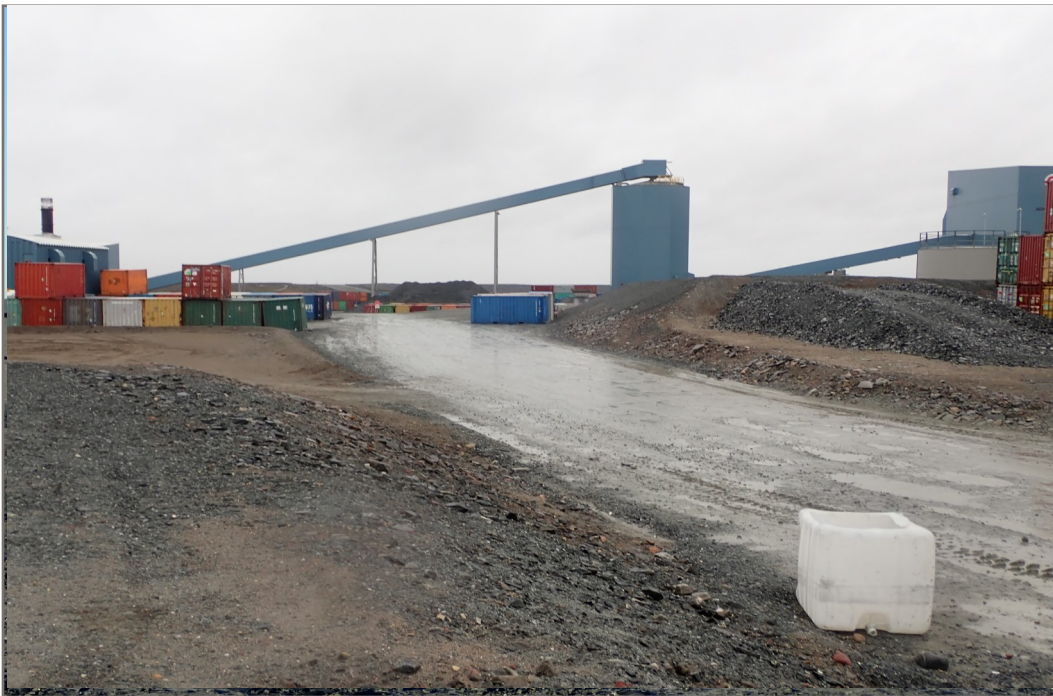
**Photo 2:** Site Roads—Industrial Pad

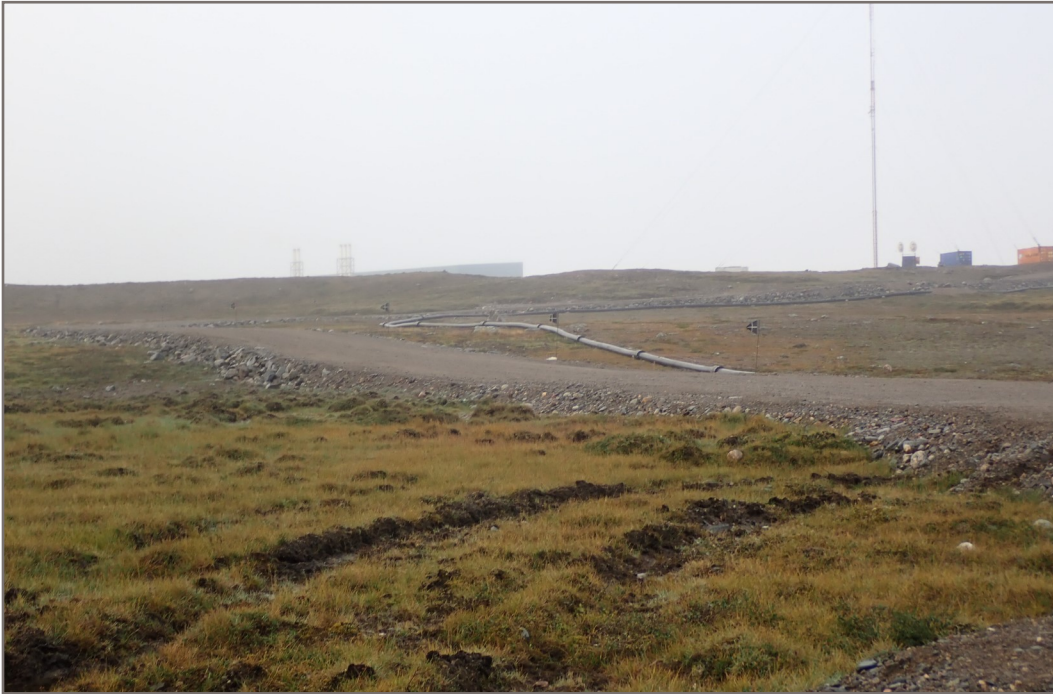
**Photo 3:** Water Intake Road.

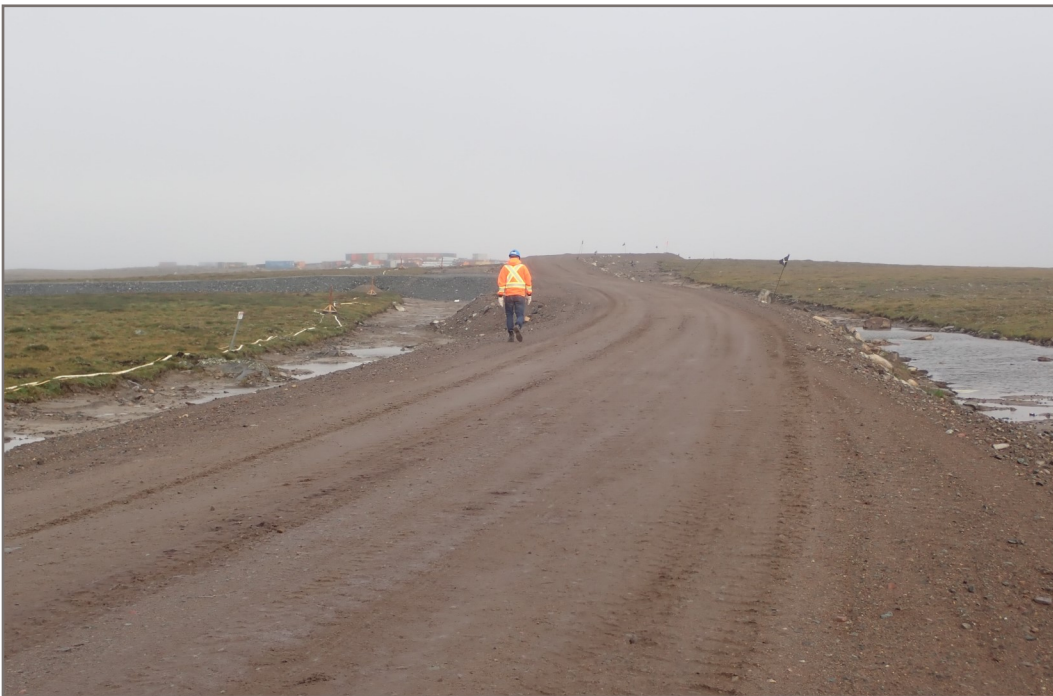
**Photo 4:** Site Roads—Road to Emulsion Plant

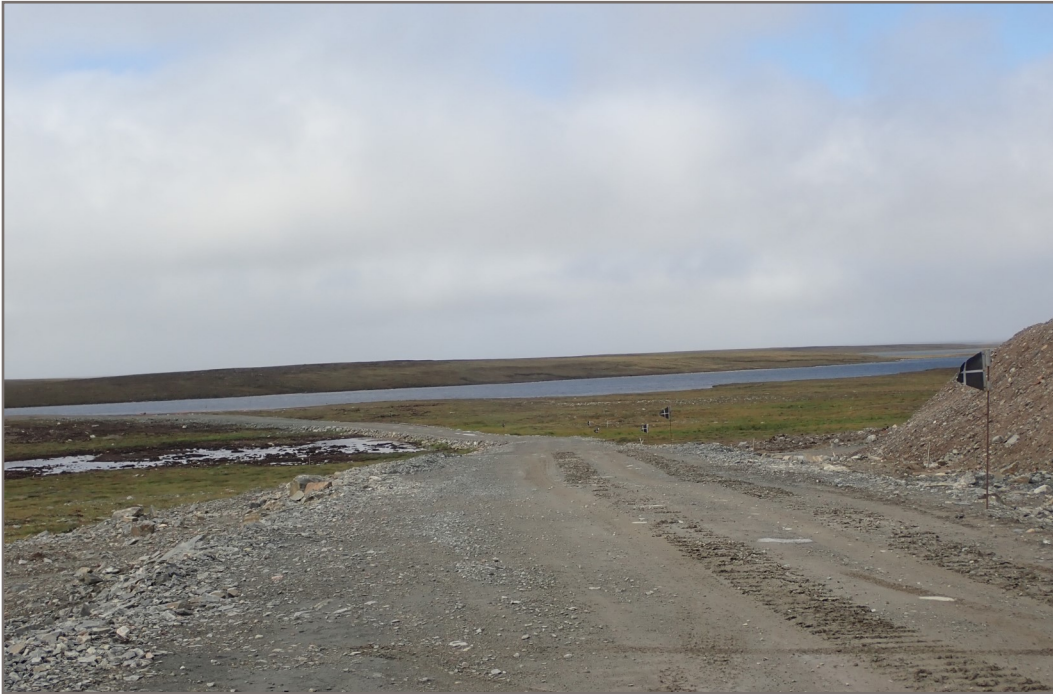
**Photo 5:** Site Roads—Magazine Access Road

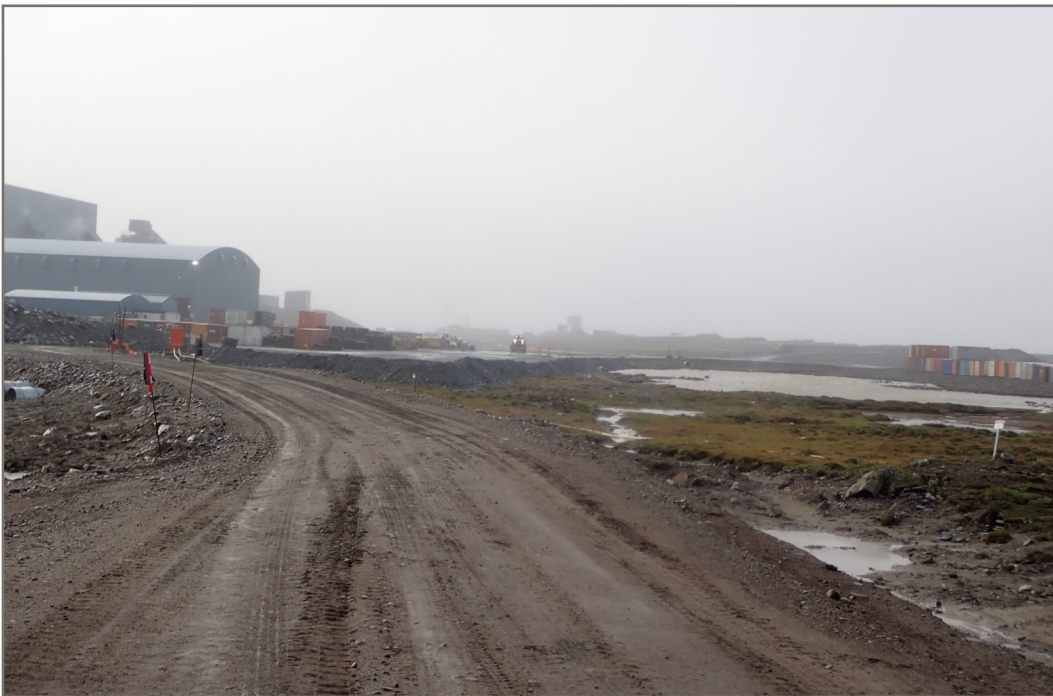
**Photo 6:** Site Roads—Road from Emulsion Plant to the Industrial Pad
