## APPENDIX L

### ORE STOCKPILES

## APPENDIX O

### ALL-WEATHER ACCESS ROAD (AWAR)

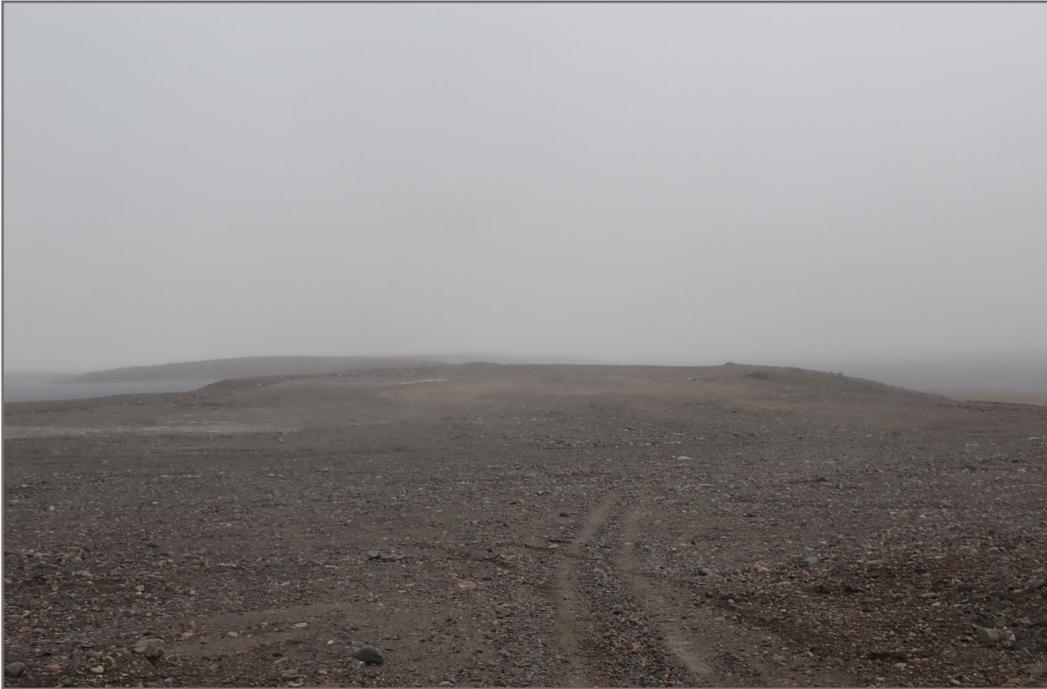
**Photo 1:** Meliadine North North Esker Borrow

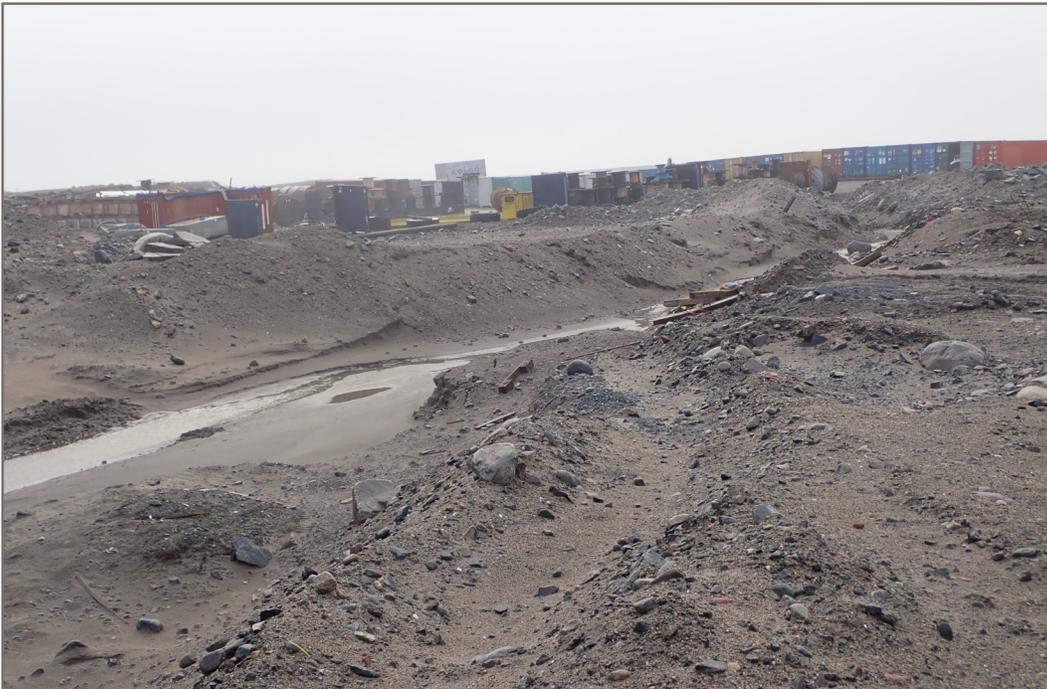
**Photo 2:** Meliadine Esker—drainage channel

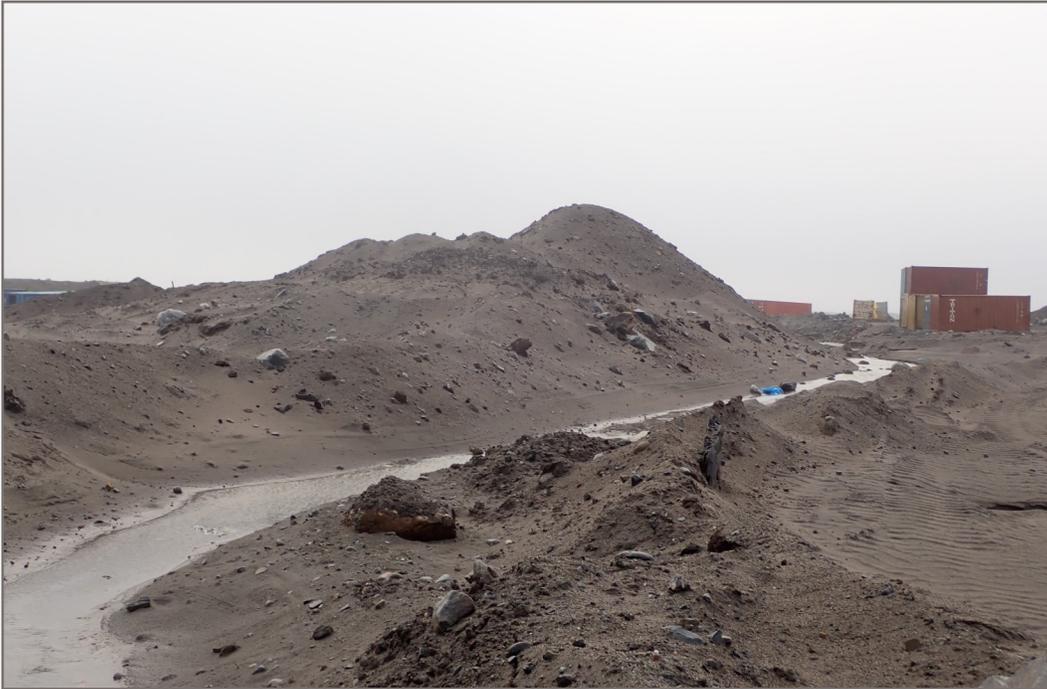
**Photo 3:** Meliadine Esker Borrow—drainage channel

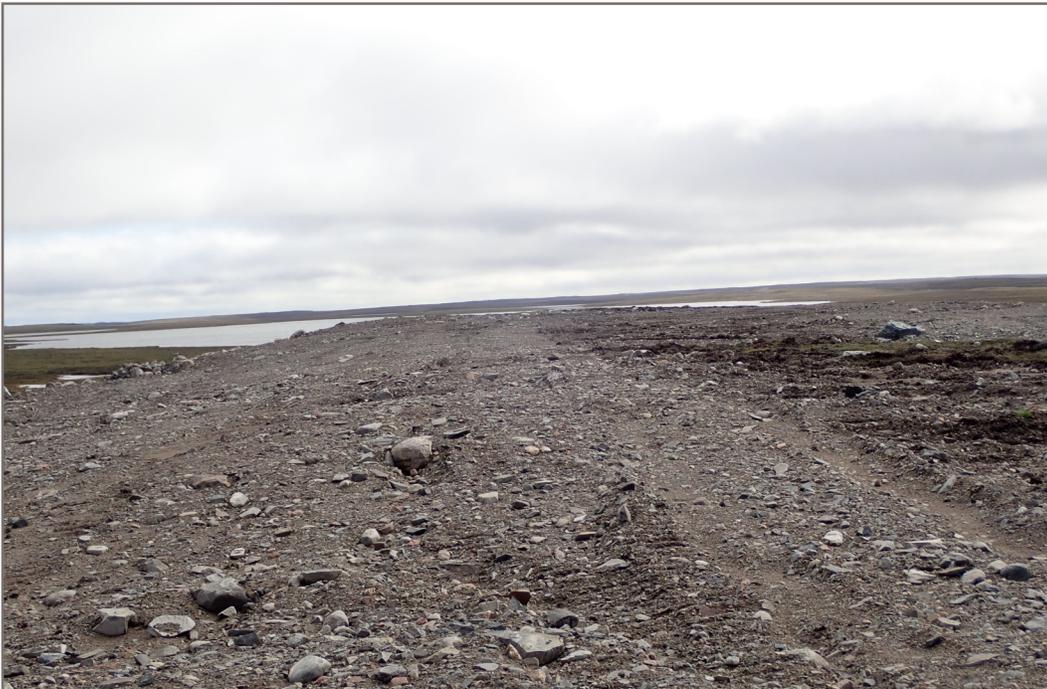
**Photo 4:** Wesmag Borrow

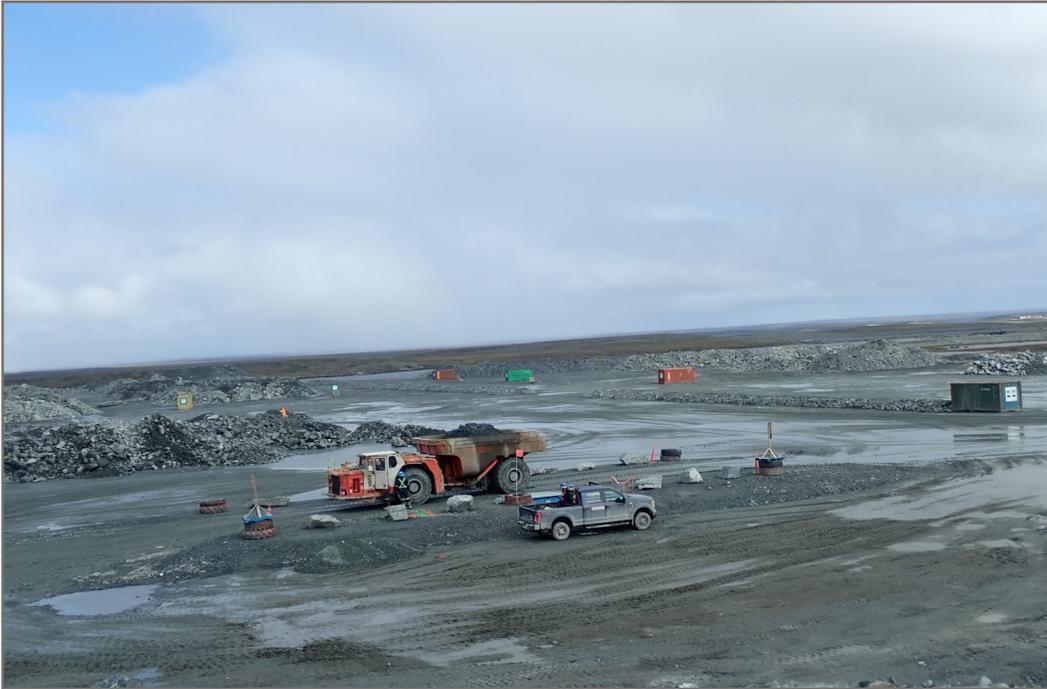
**Photo 1:** Ore Stockpile Area

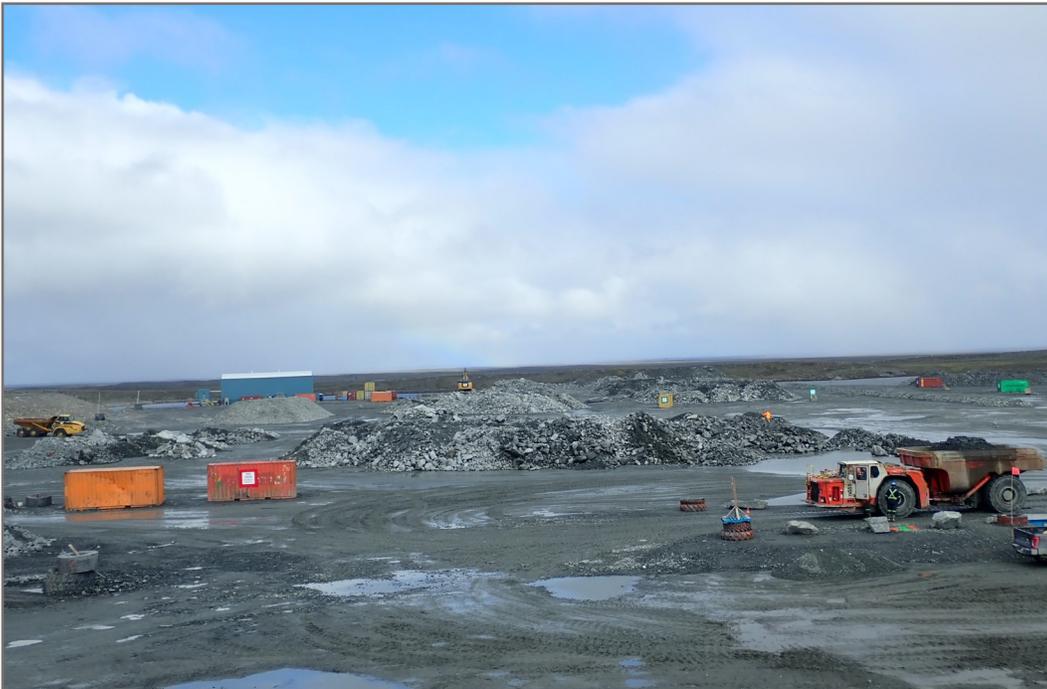
**Photo 2:** Ore Stockpile Area

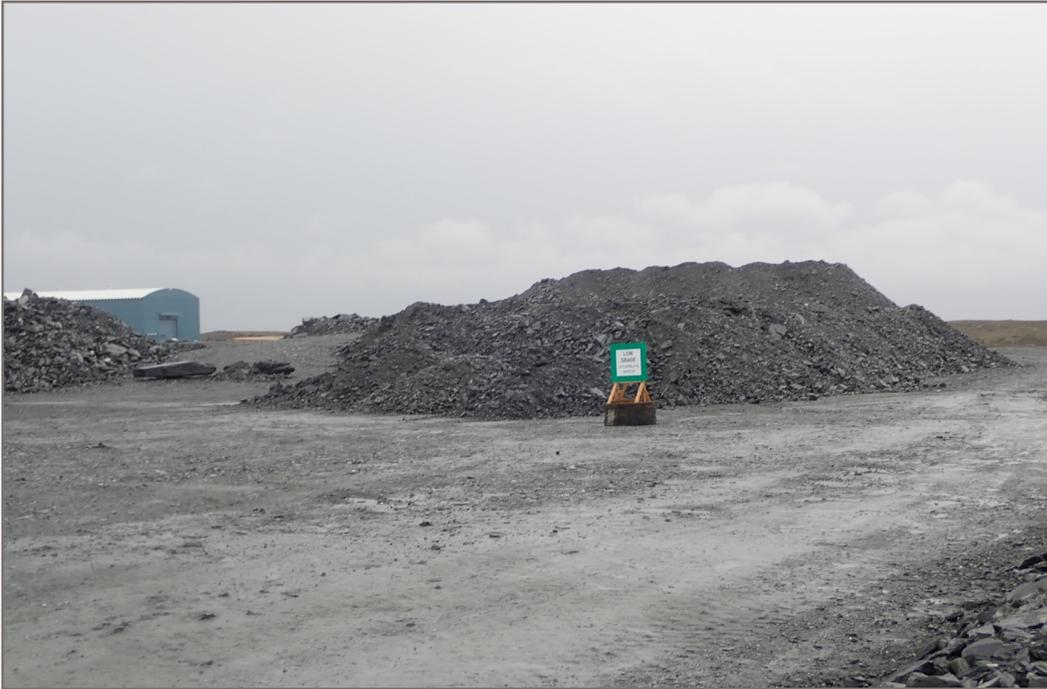
**Photo 3:** Ore Stockpile—Low Grade

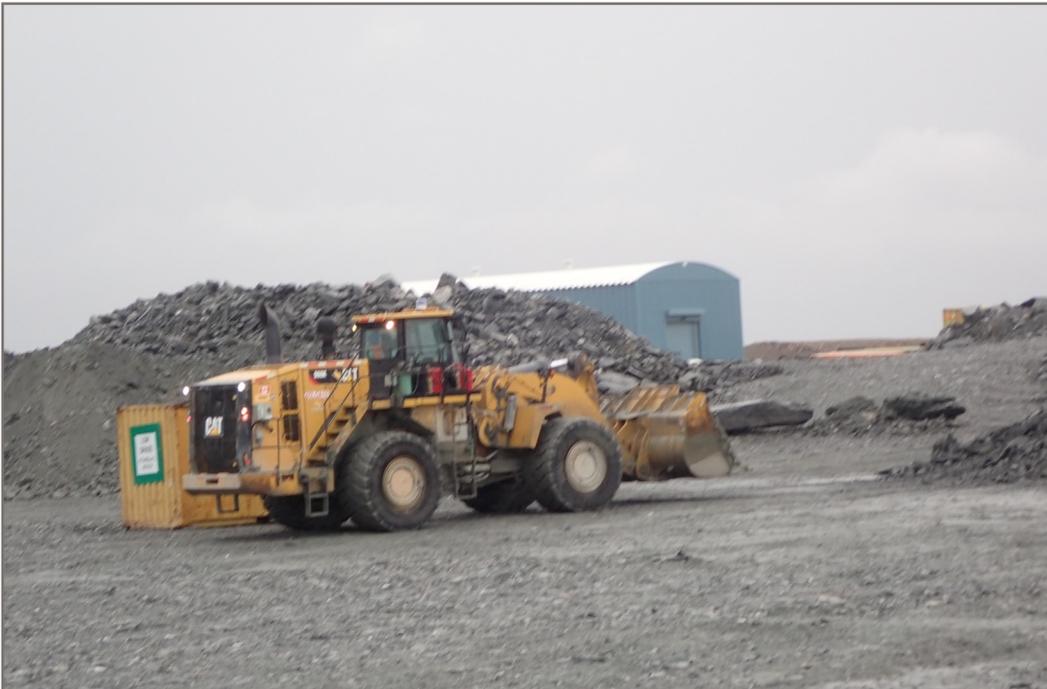
**Photo 4:** Ore Stockpile—Loader

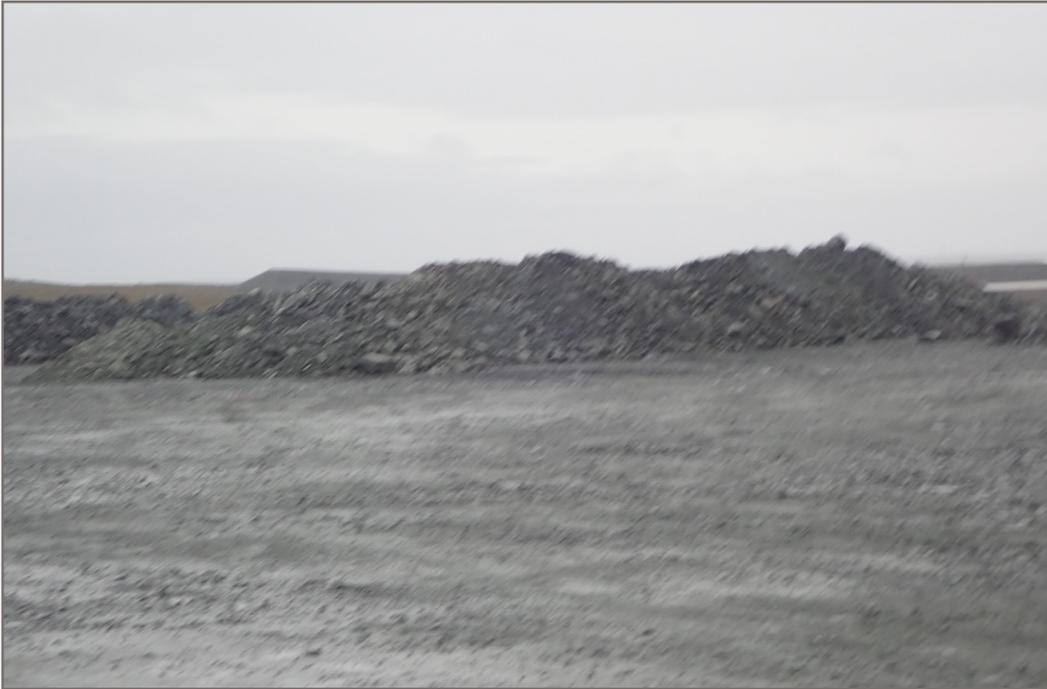
**Photo 5:** Ore Stockpile,

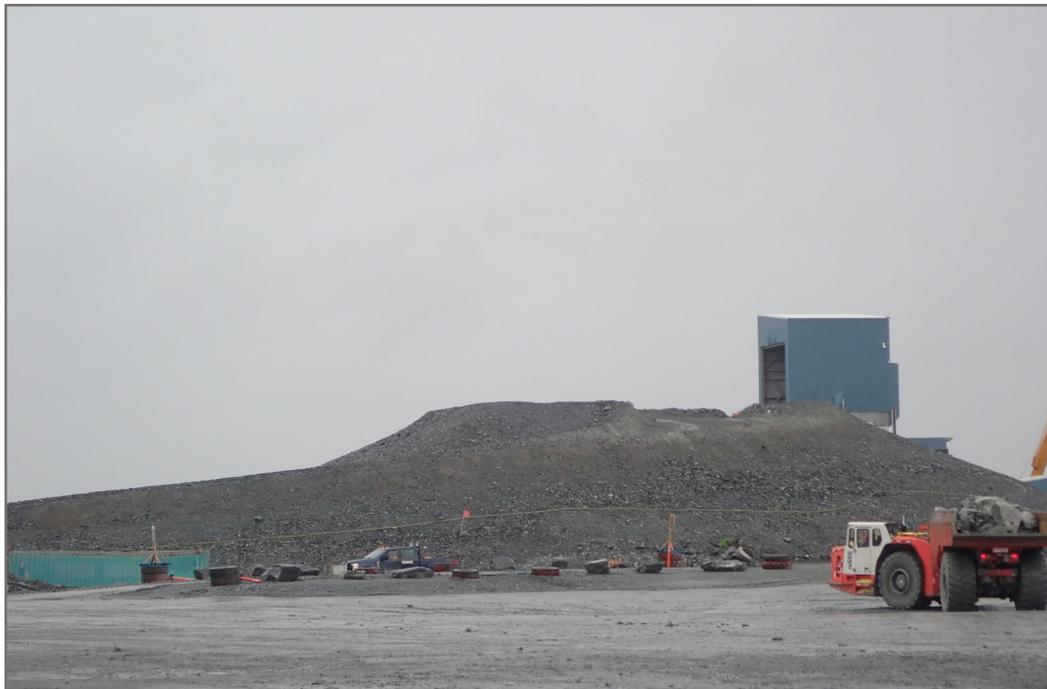
**Photo 6:** Ore Stock Pile

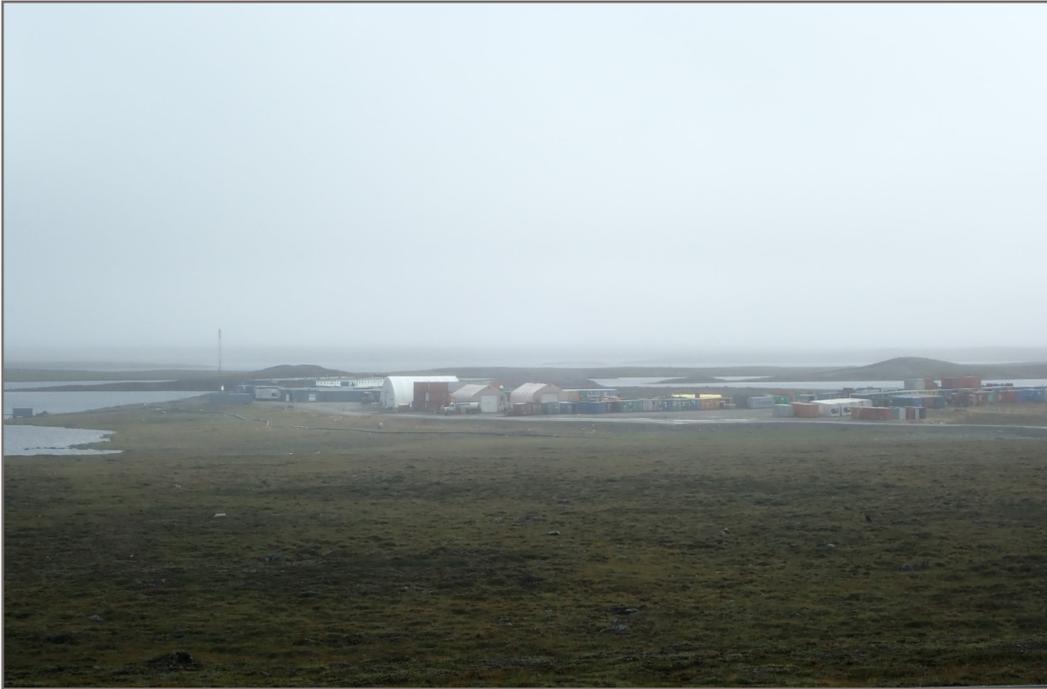
**Photo 1:** Exploration Camp

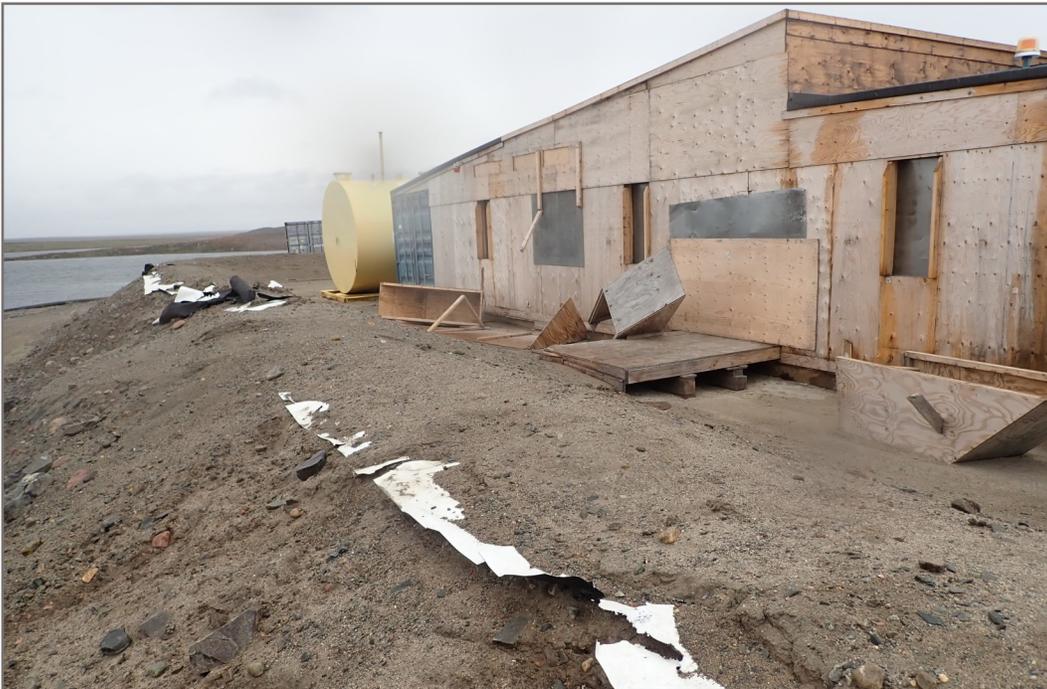
**Photo 2:** Exploration Camp Fuel Storage

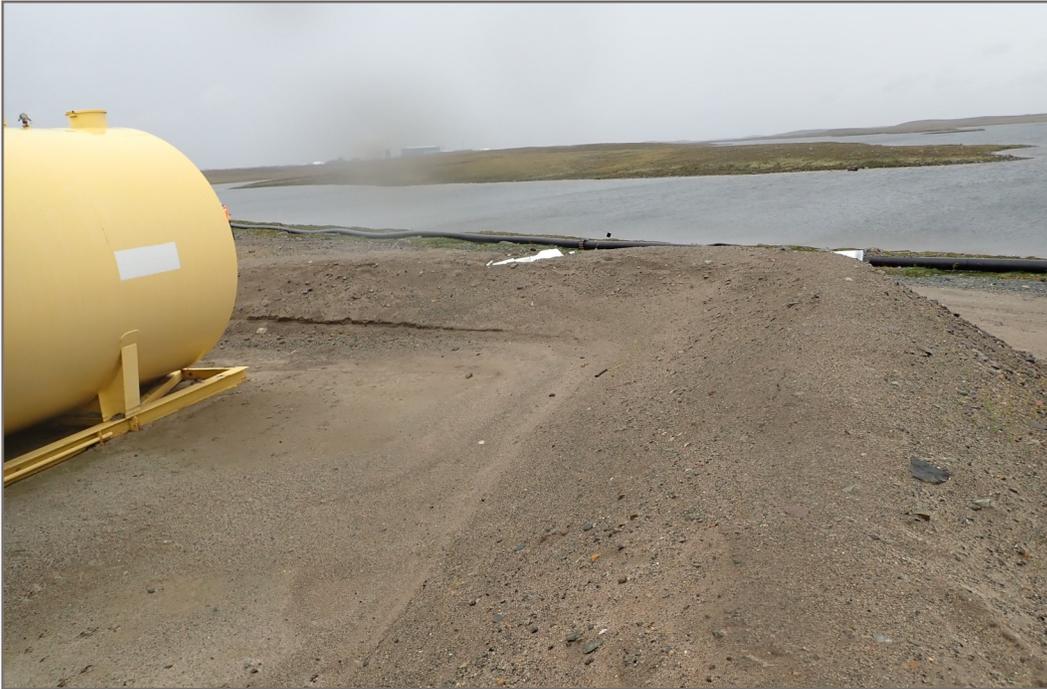
**Photo 3:** Exploration Camp Fuel Storage

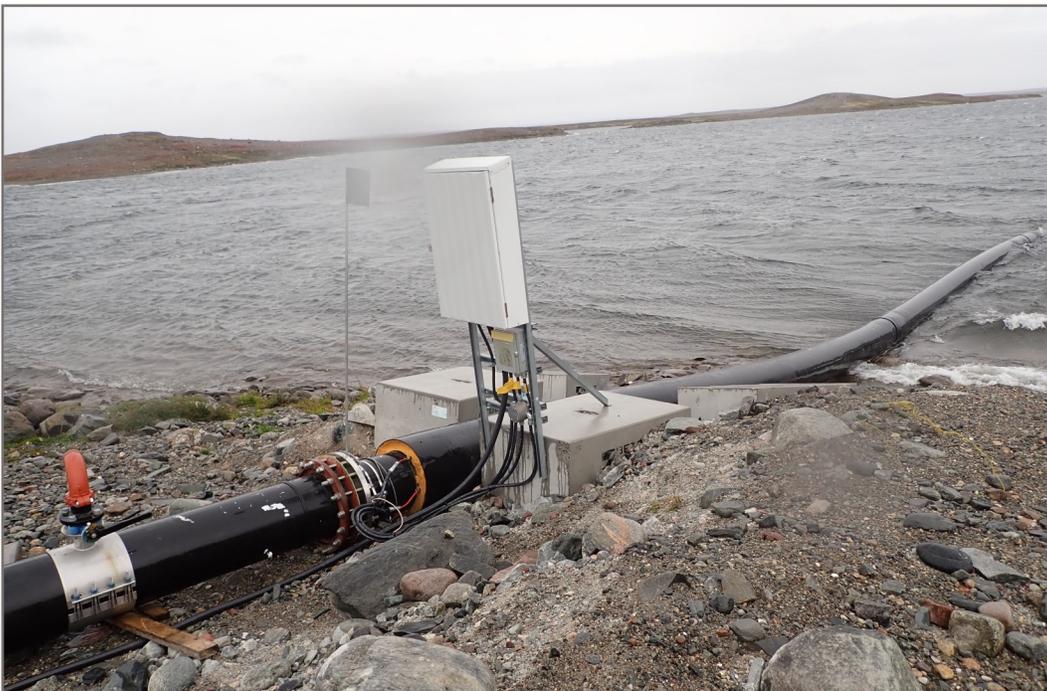
**Photo 4:** Exploration Camp—Diffuser line

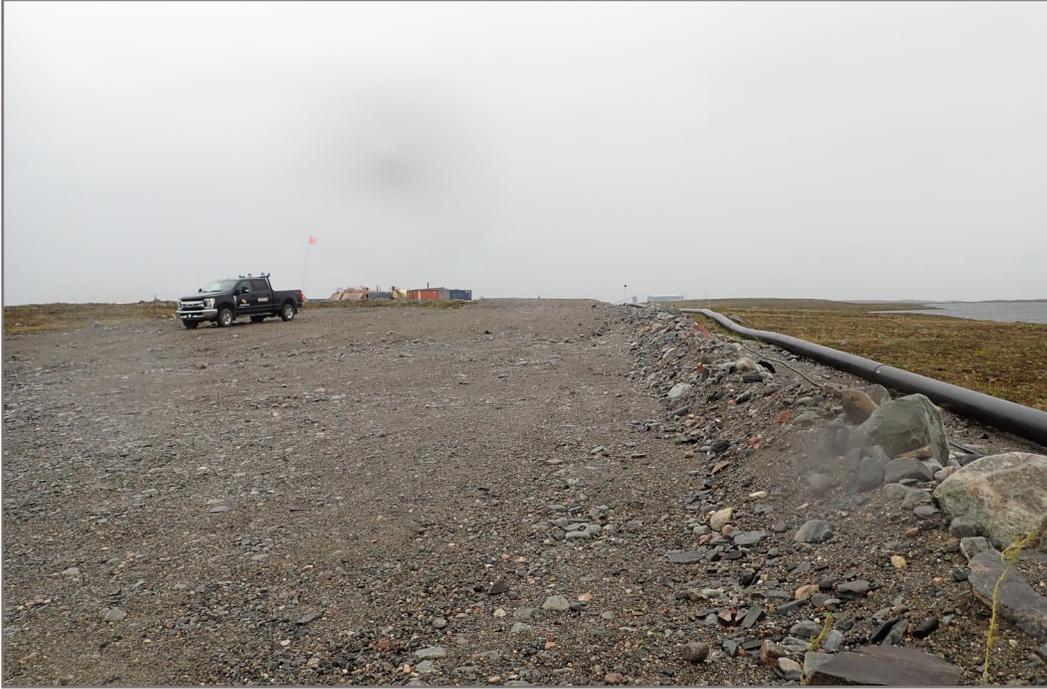
**Photo 5:** Exploration Camp—Road to diffuser line

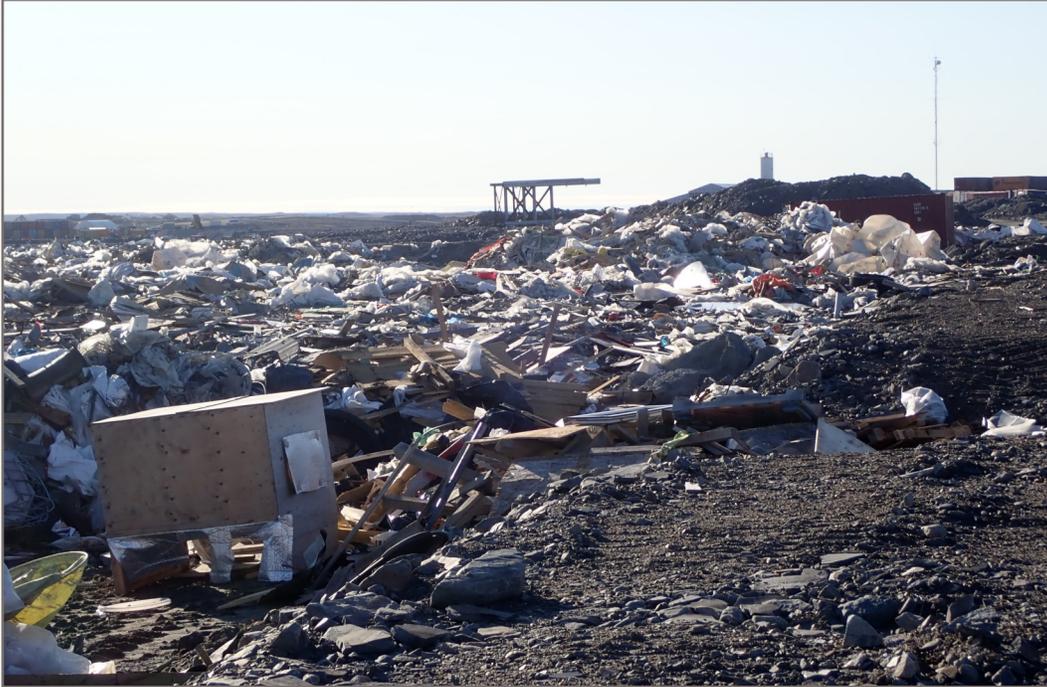
**Photo 1:** Landfill—Dry waste including, wood, steel, plastic, and other.

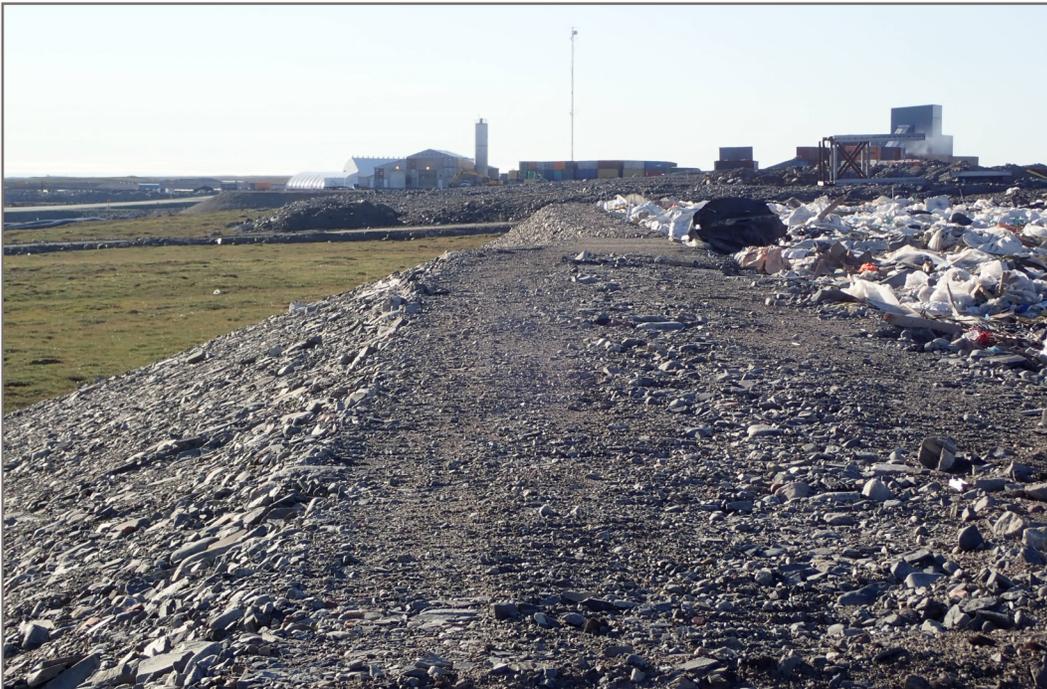
**Photo 2:** Landfill—East berm, waste close to crest.

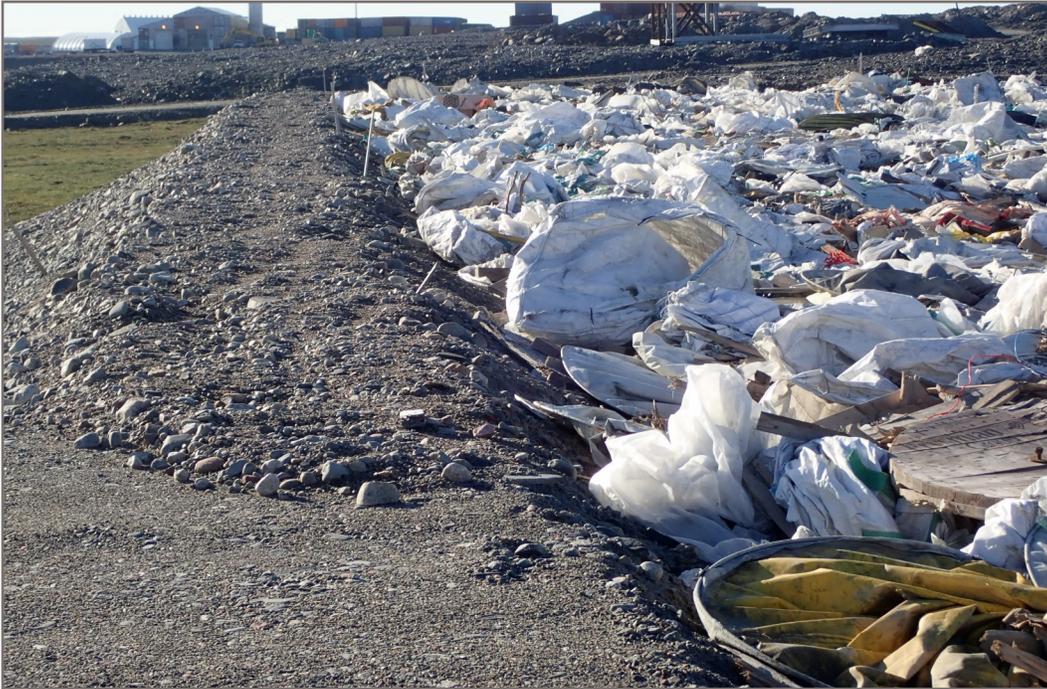
**Photo 3:** Landfill– Perimeter Berm, looking south.

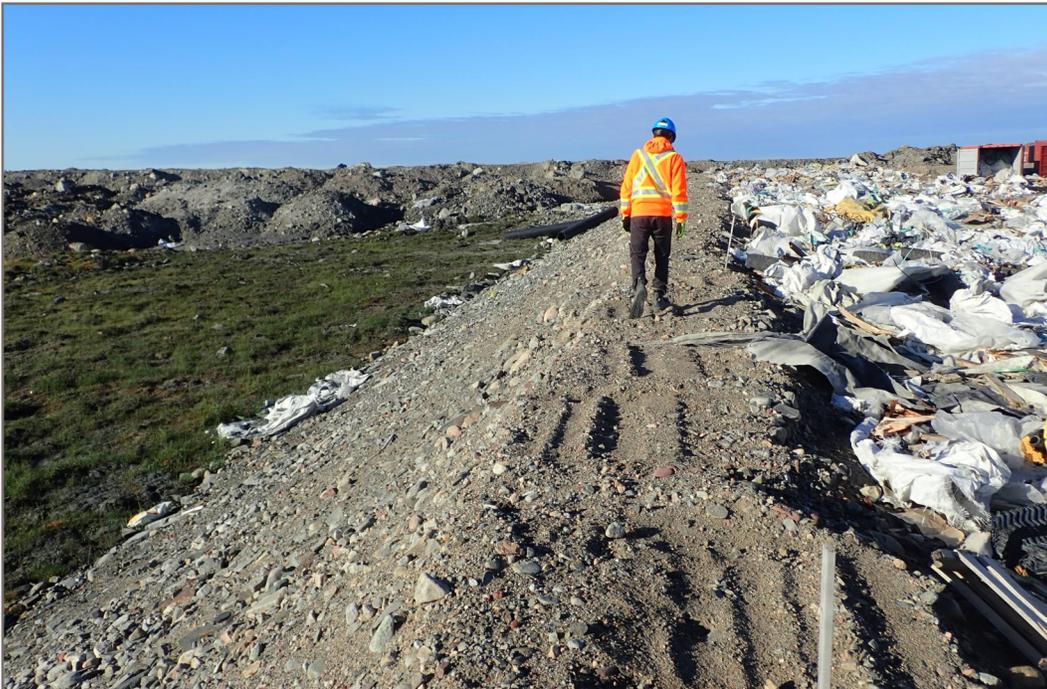
**Photo 4:** Landfill—South Berm.

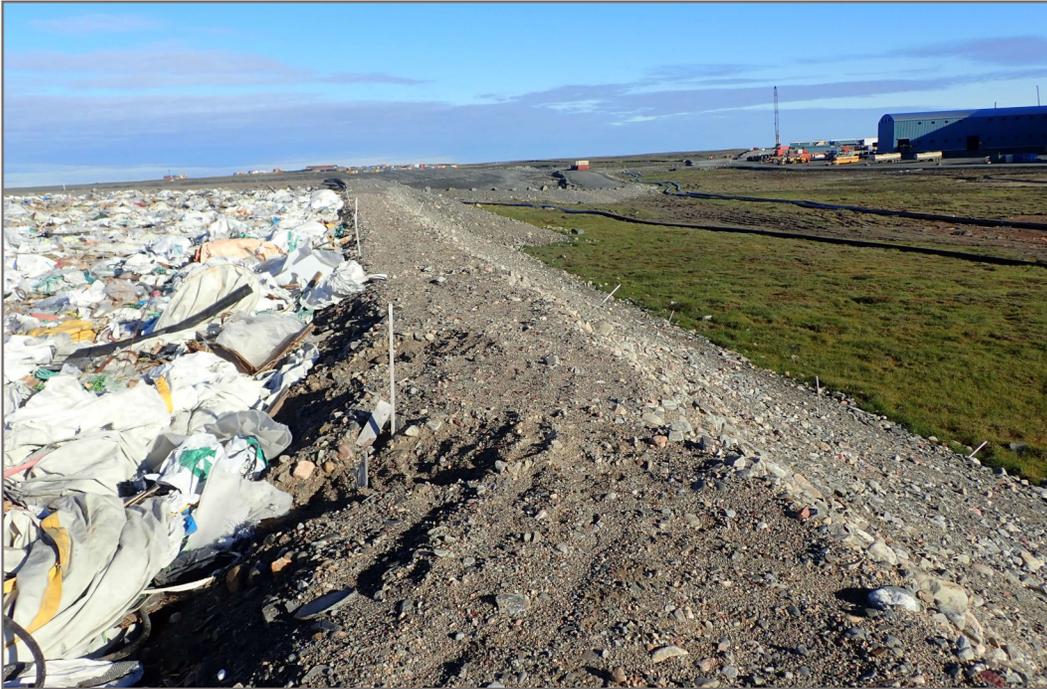
**Photo 5:** Landfill - West berm—esker fill.

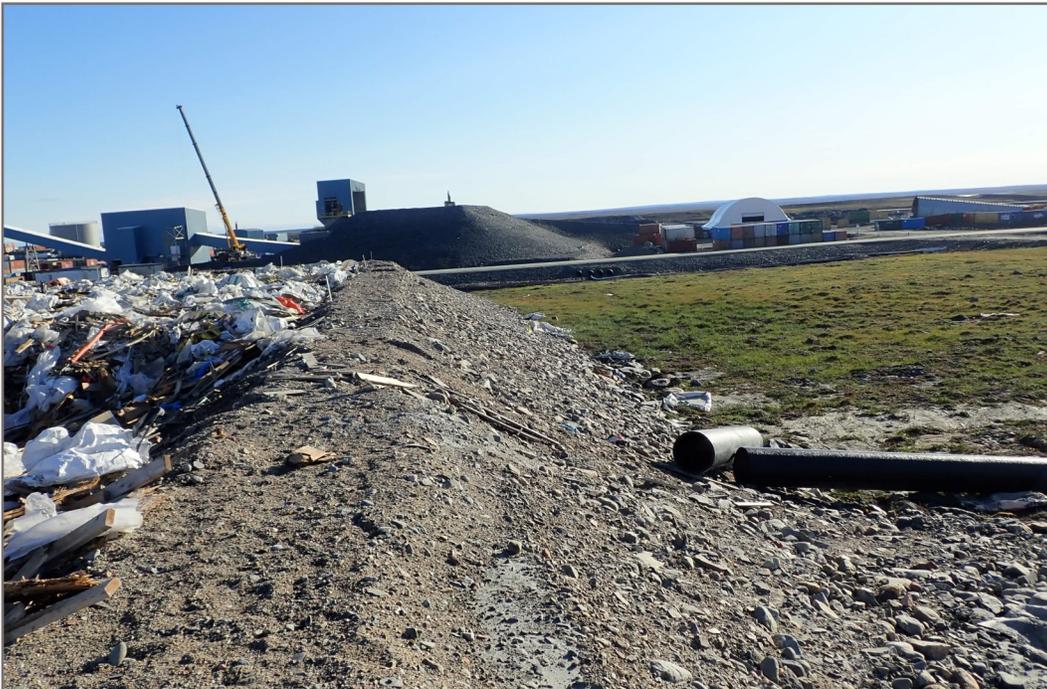
**Photo 6:** Landfill— South berm.

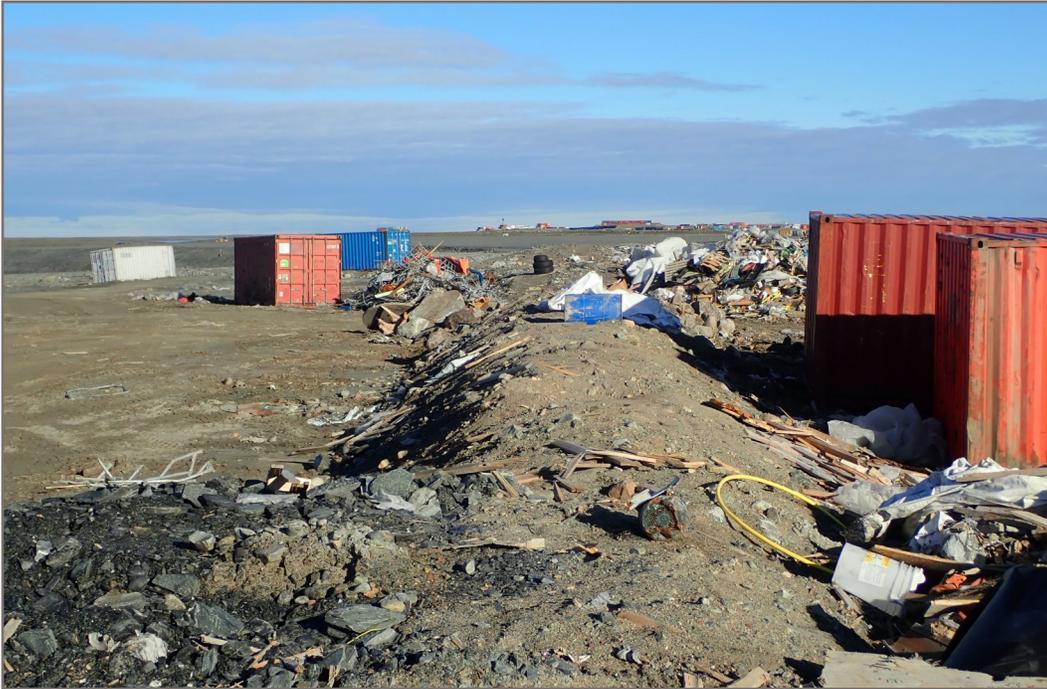
**Photo 7:** Landfill - west berm.

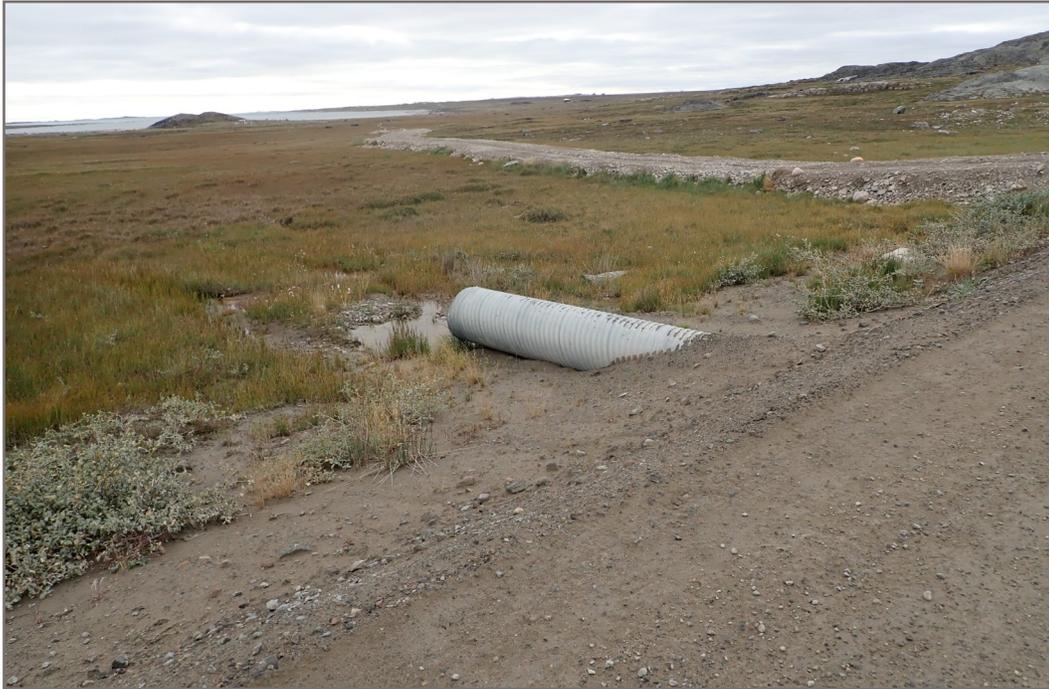
**Photo 1:** Culvert km 5.5

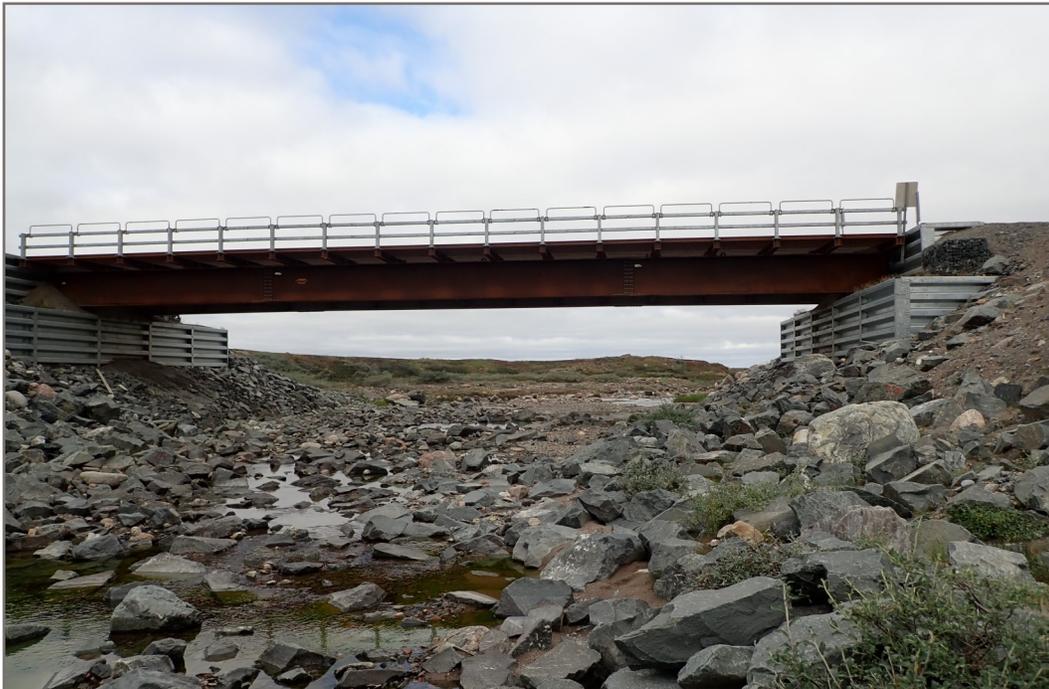
**Photo 2:** Char River Bridge

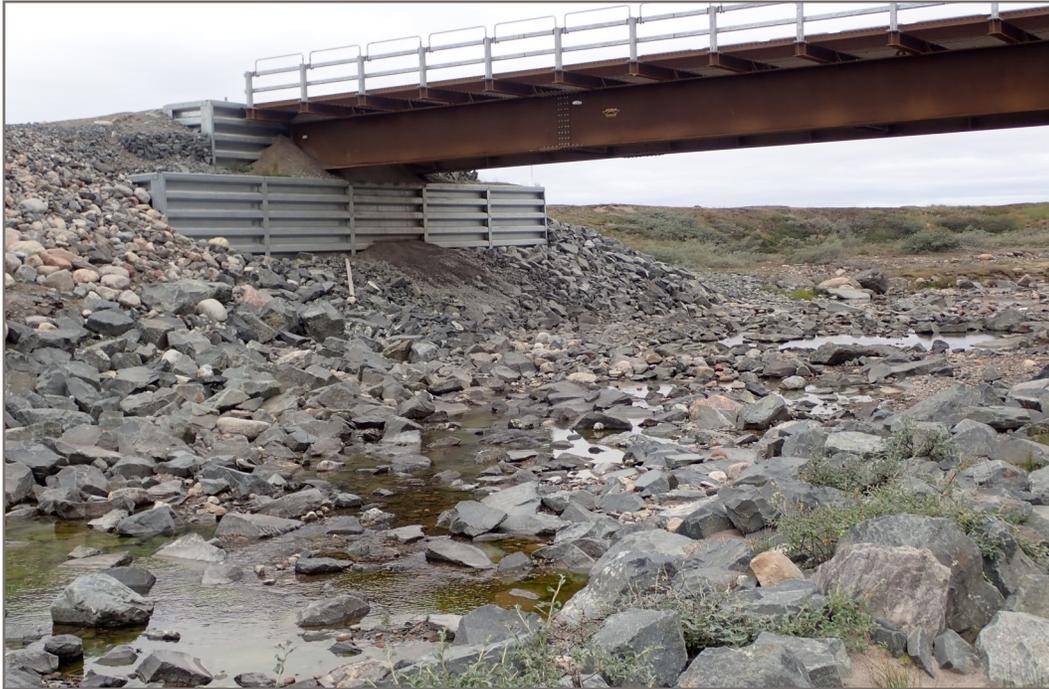
**Photo 3:** Char River Bridge—North abutment

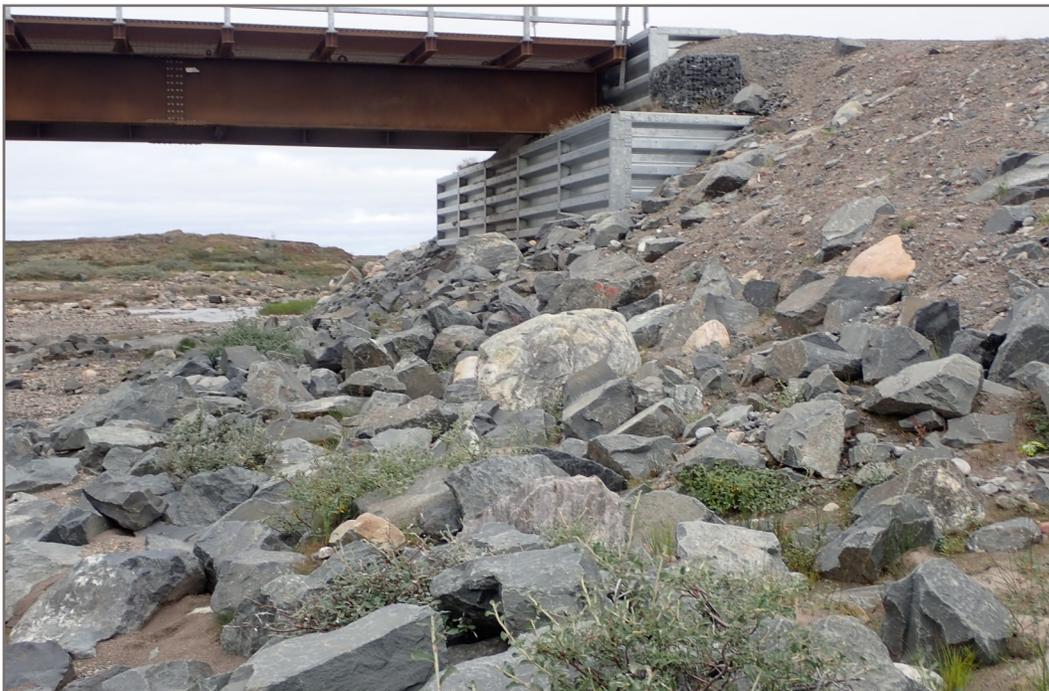
**Photo 4:** Char River Bridge—South Abutment

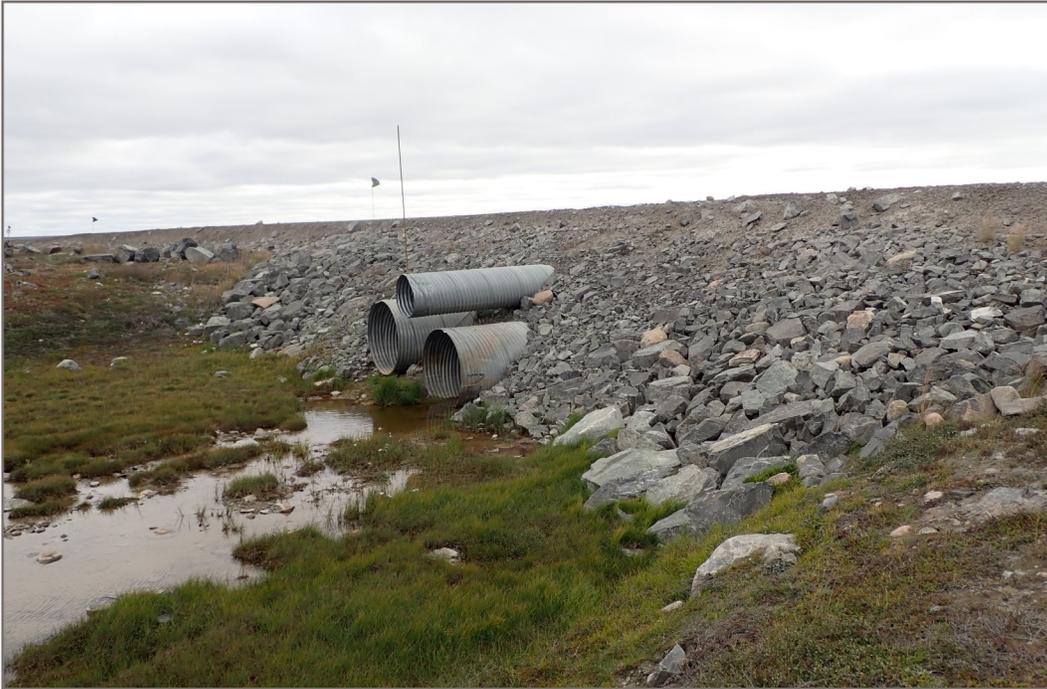
**Photo 5:** Culvert km 6.2

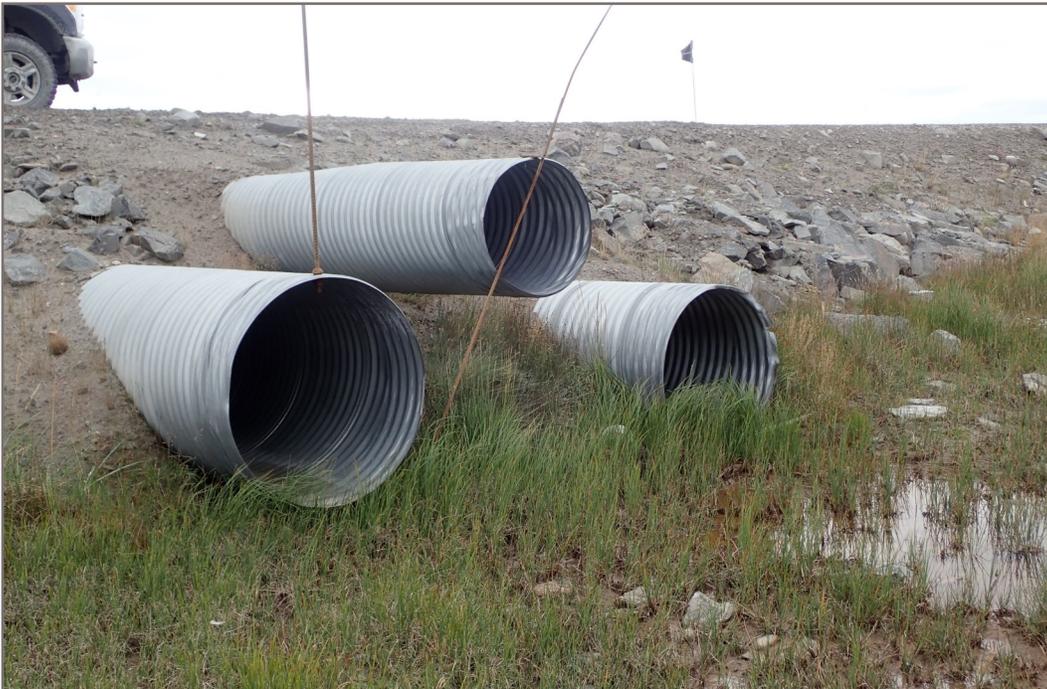
**Photo 6:** Culvert km 7.0

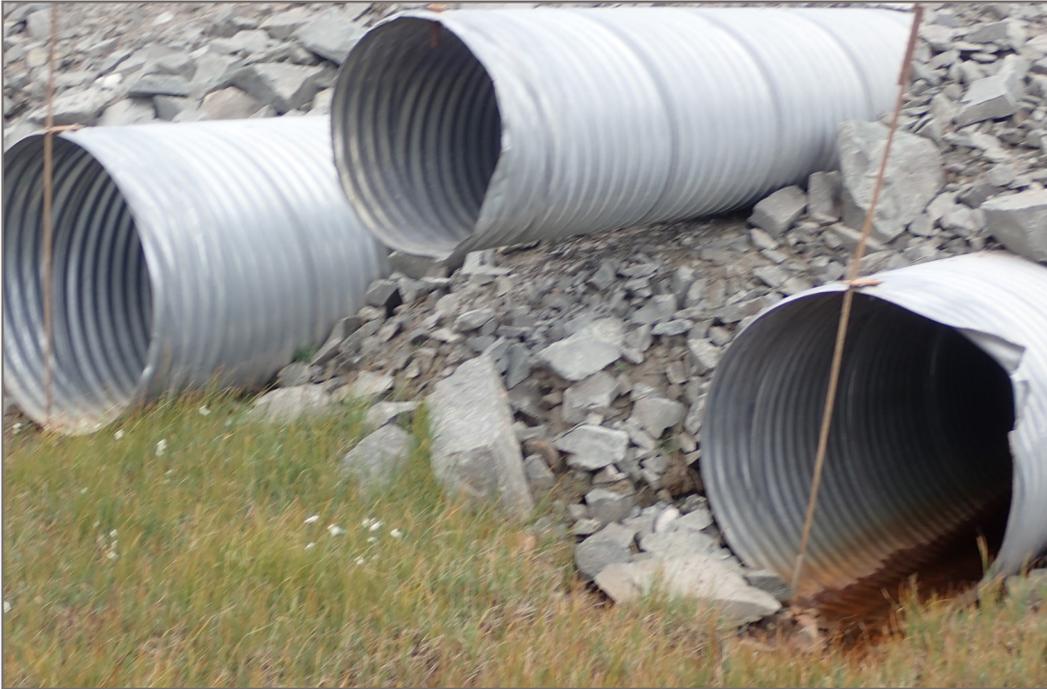
**Photo 7:** Culvert km 7.1

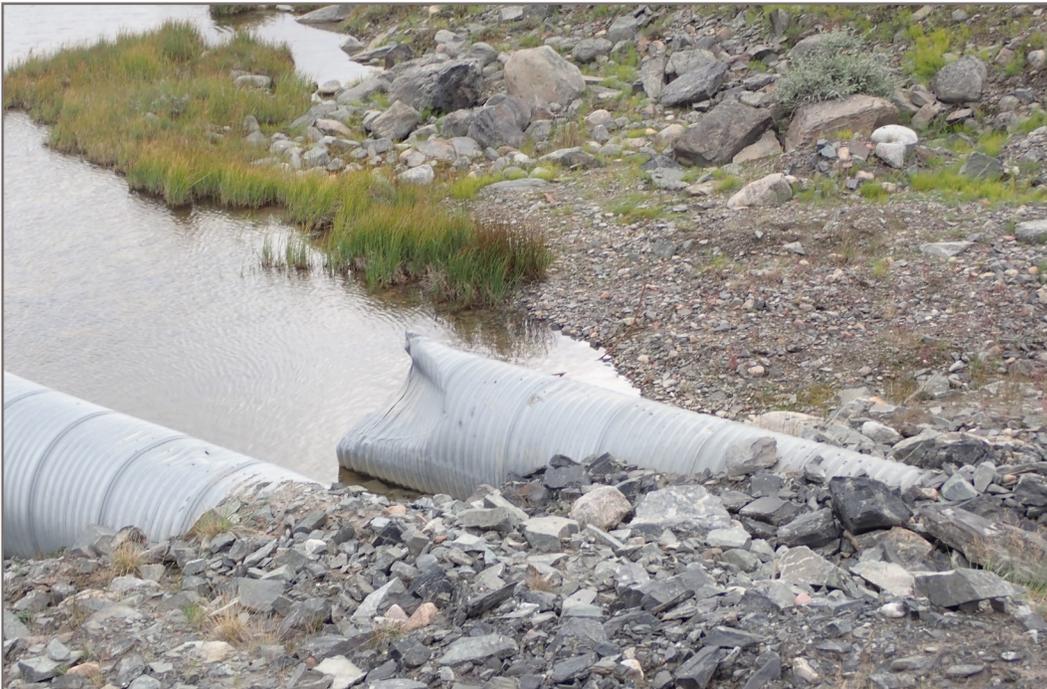
**Photo 8:** Culvert km 7.4—Damage to culvert inlet

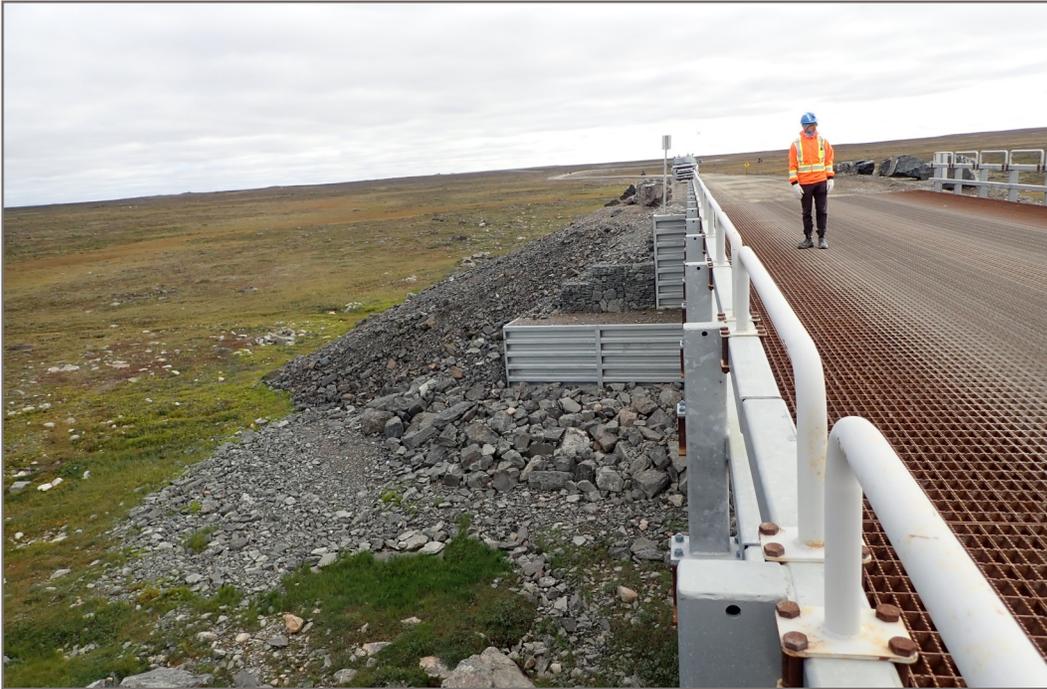
**Photo 9:** Meliadine River Bridge north abutment
