## APPENDIX L

### ORE STOCKPILES

## APPENDIX O

### ALL-WEATHER ACCESS ROAD (AWAR)

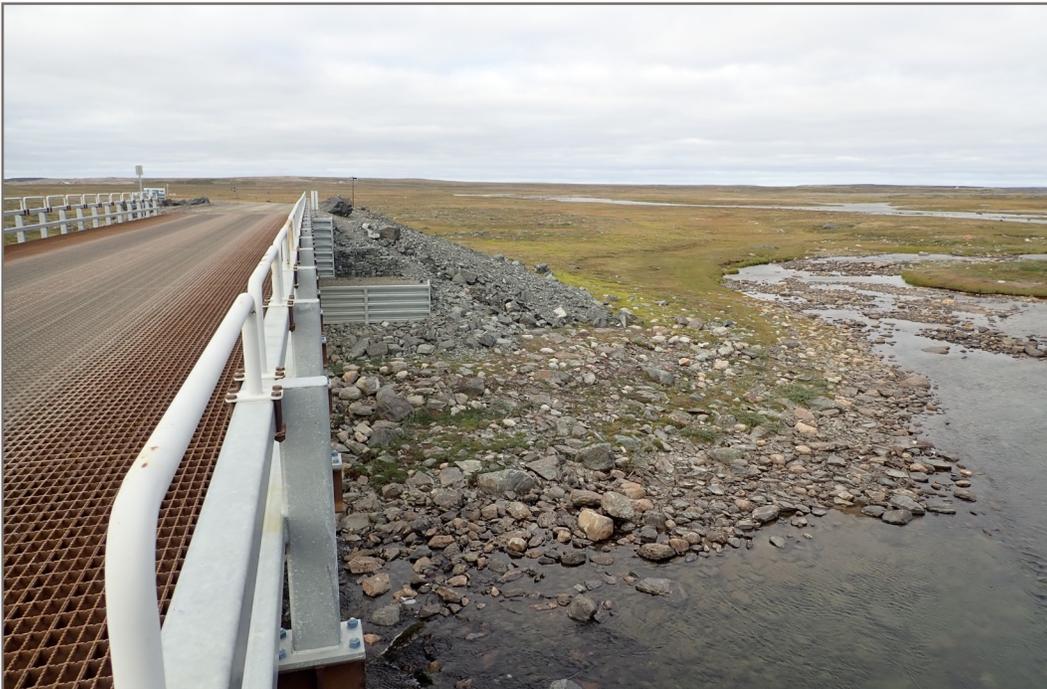
**Photo 10:** Meliadine River Bridge South Abutment

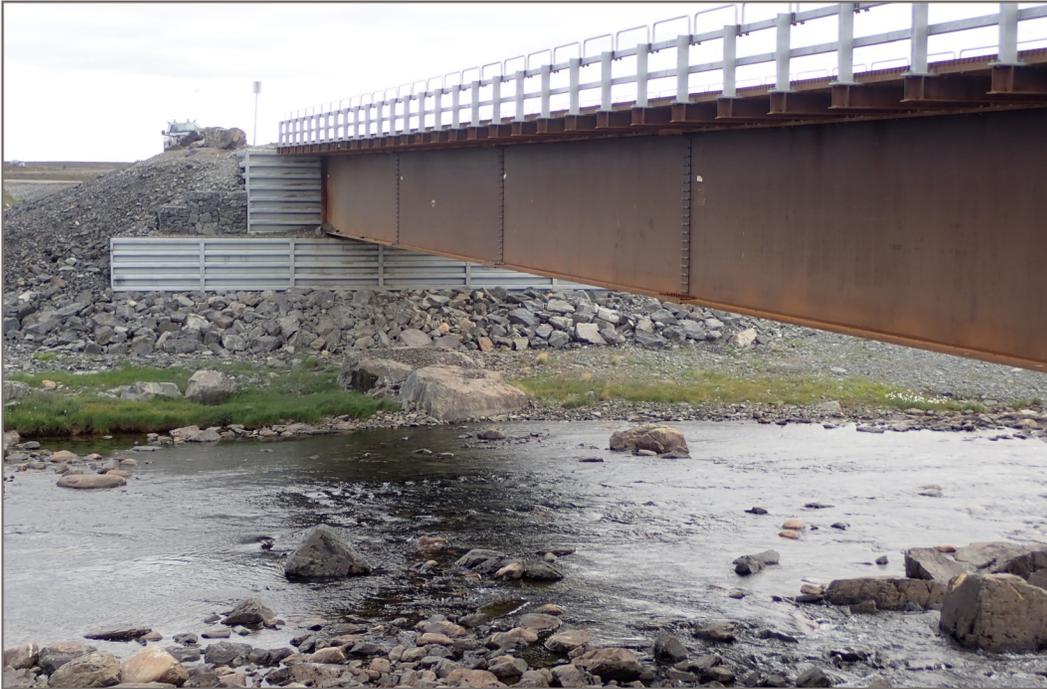
**Photo 11:** Meliadine River Bridge north abutment

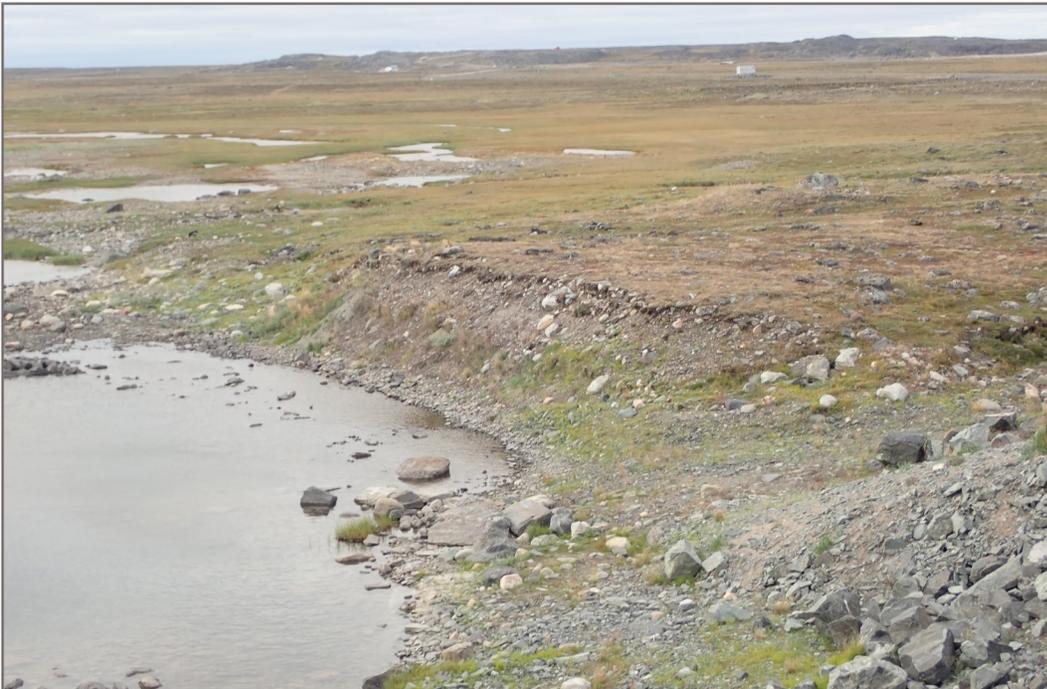
**Photo 12:** Meliadine River Bridge—Shoreline downstream of bridge—erodible sand and gravel deposit.

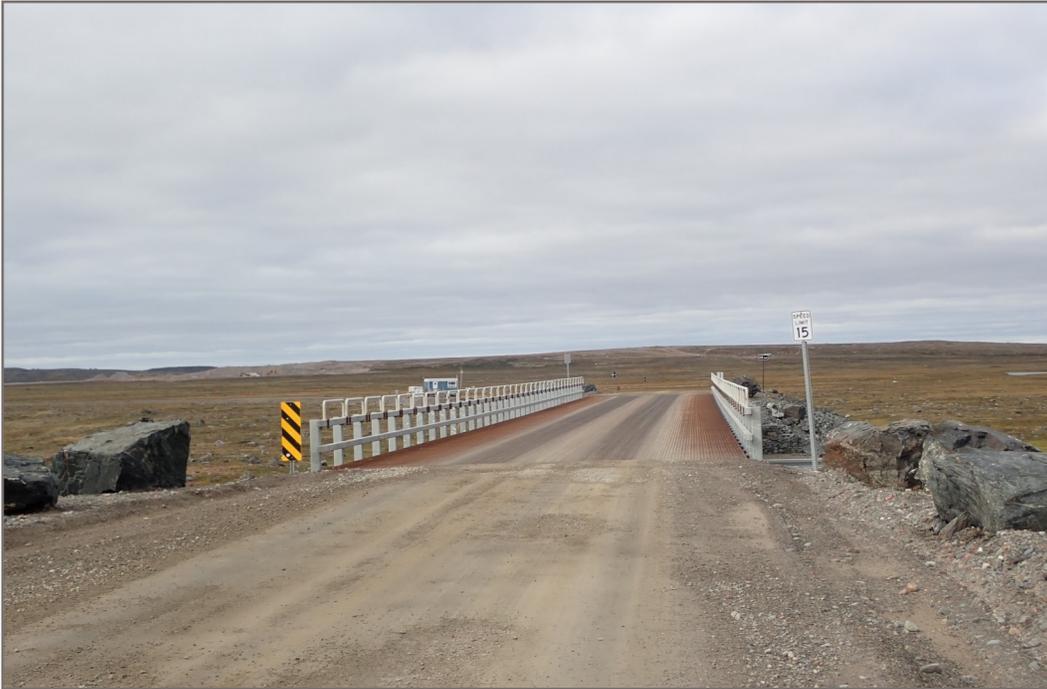
**Photo 13:** Meliadine River Bridge

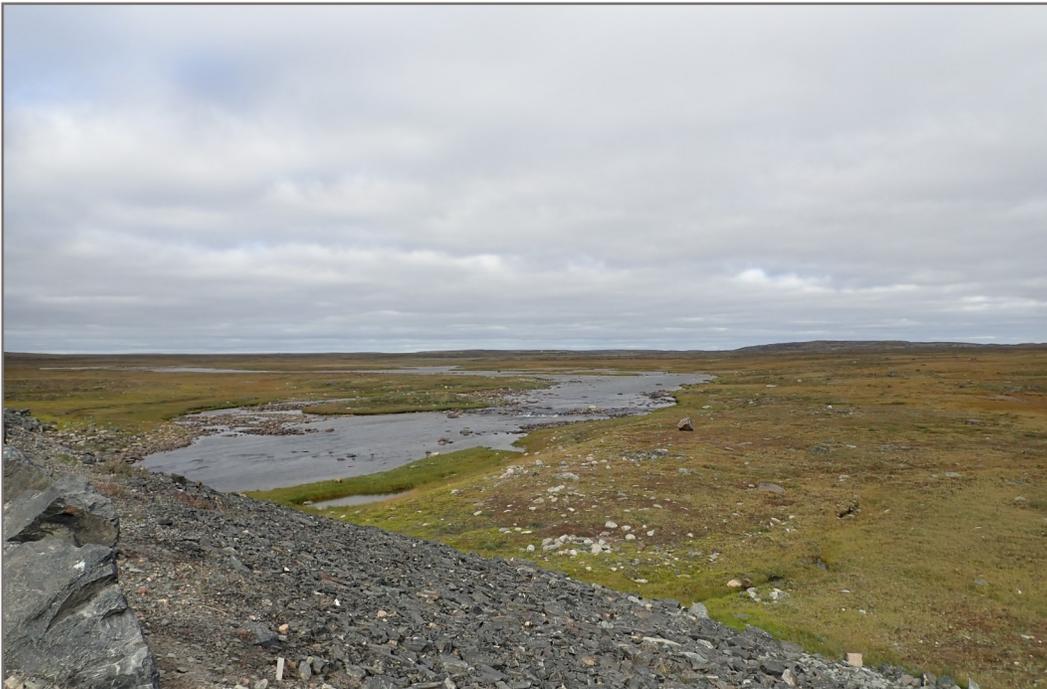
**Photo 14:** Meliadine River

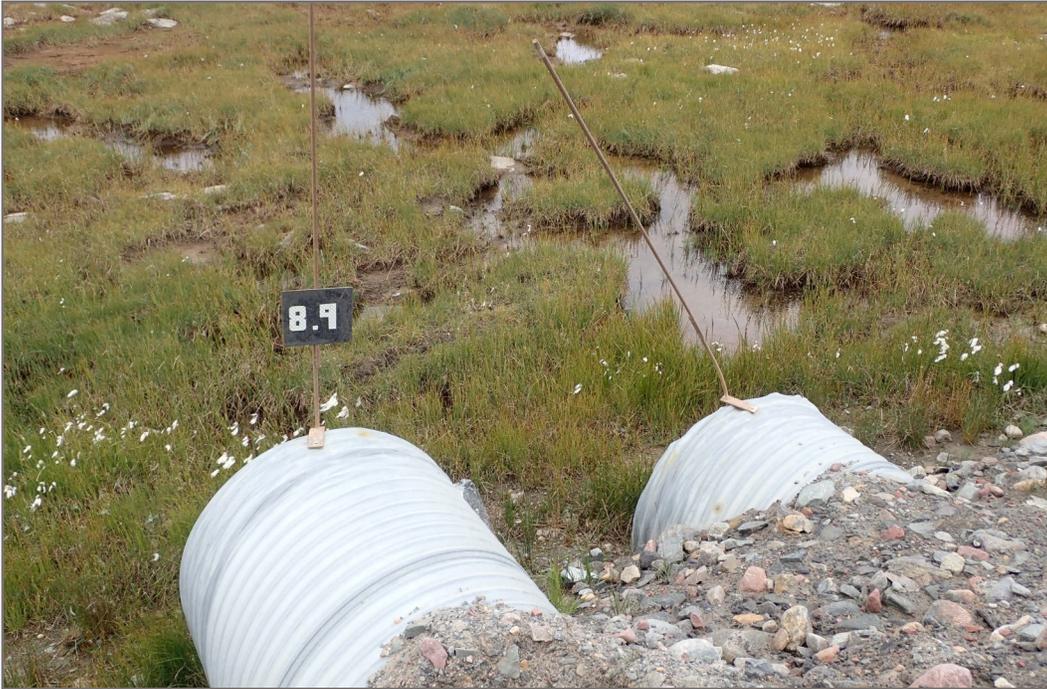
**Photo 15:** Culvert km 9.1

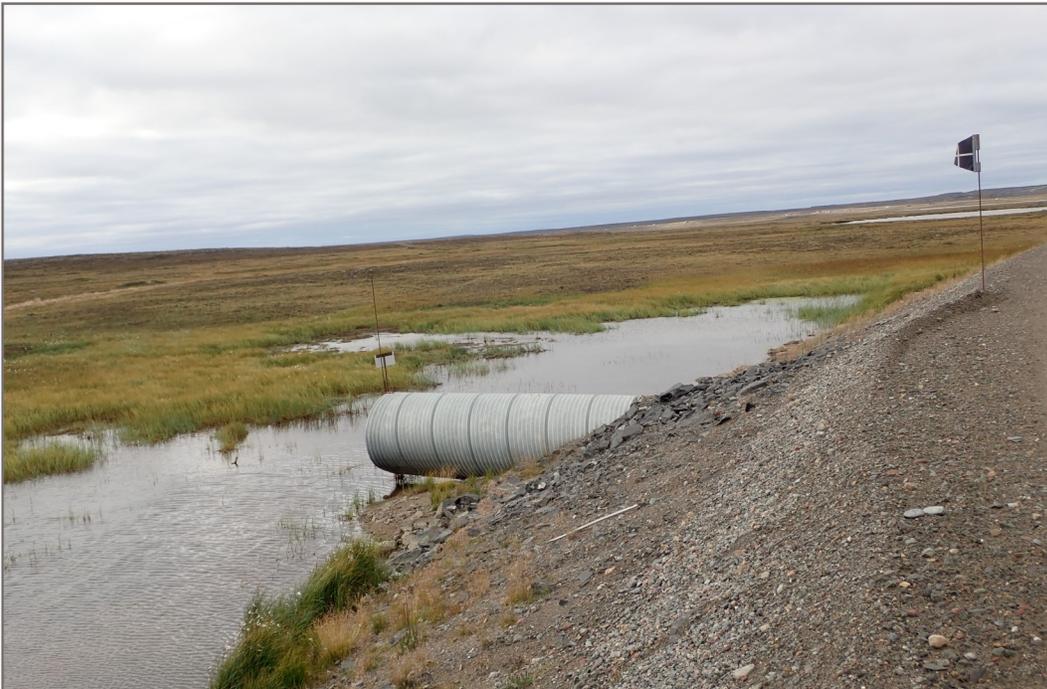
**Photo 16:** Culvert km 9.5
