Freshet 2020 Monitoring Report

BAFFINLAND IRON MINES CORPORATION
MARY RIVER PROJECT**Freshet 2020 Monitoring Report****Rev 0**

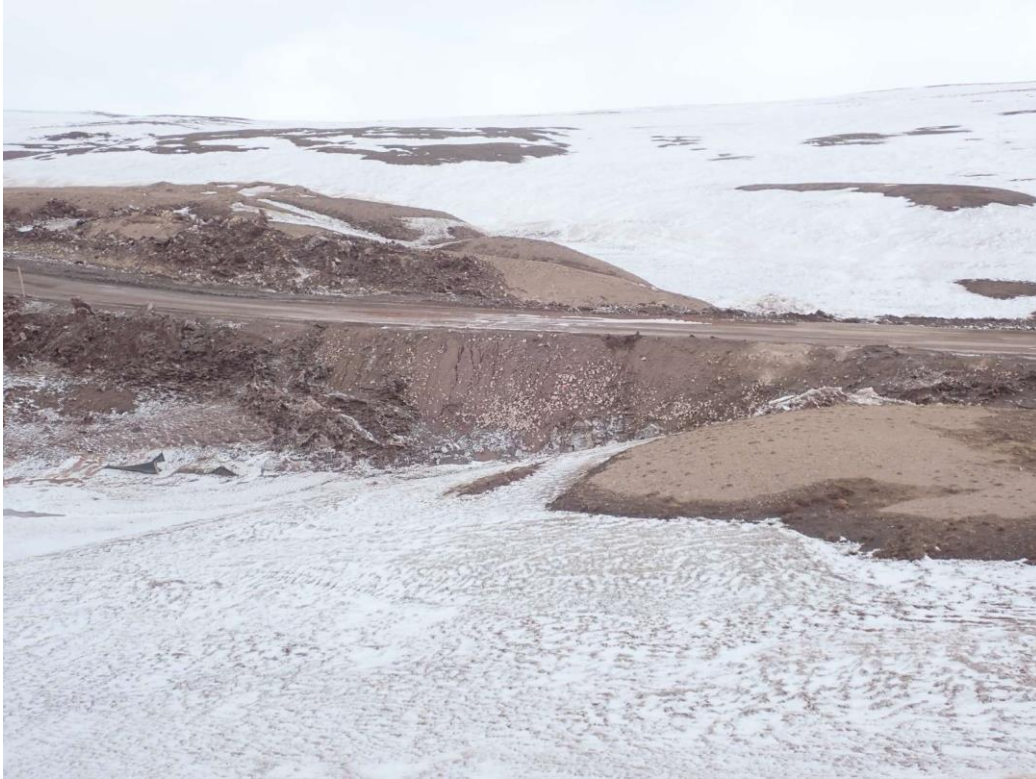
Photo 1. Snow Clearing at the Outlet of BG-01 (May 14, 2020)

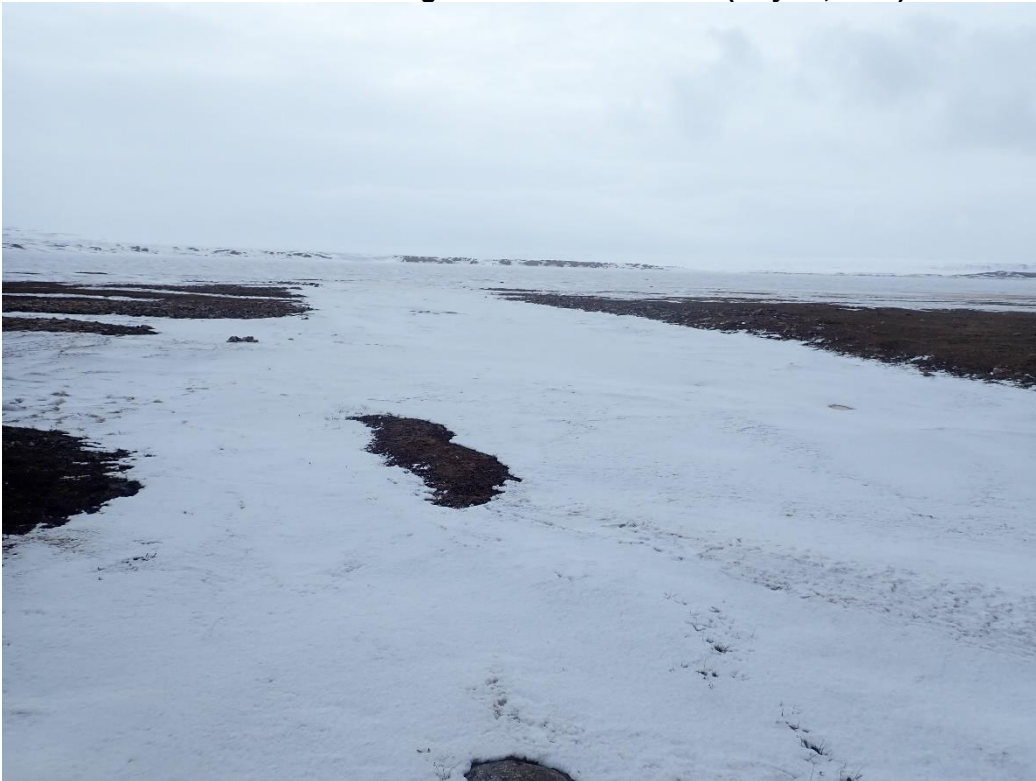
Photo 2. CLT Outfall on May 14, 2020

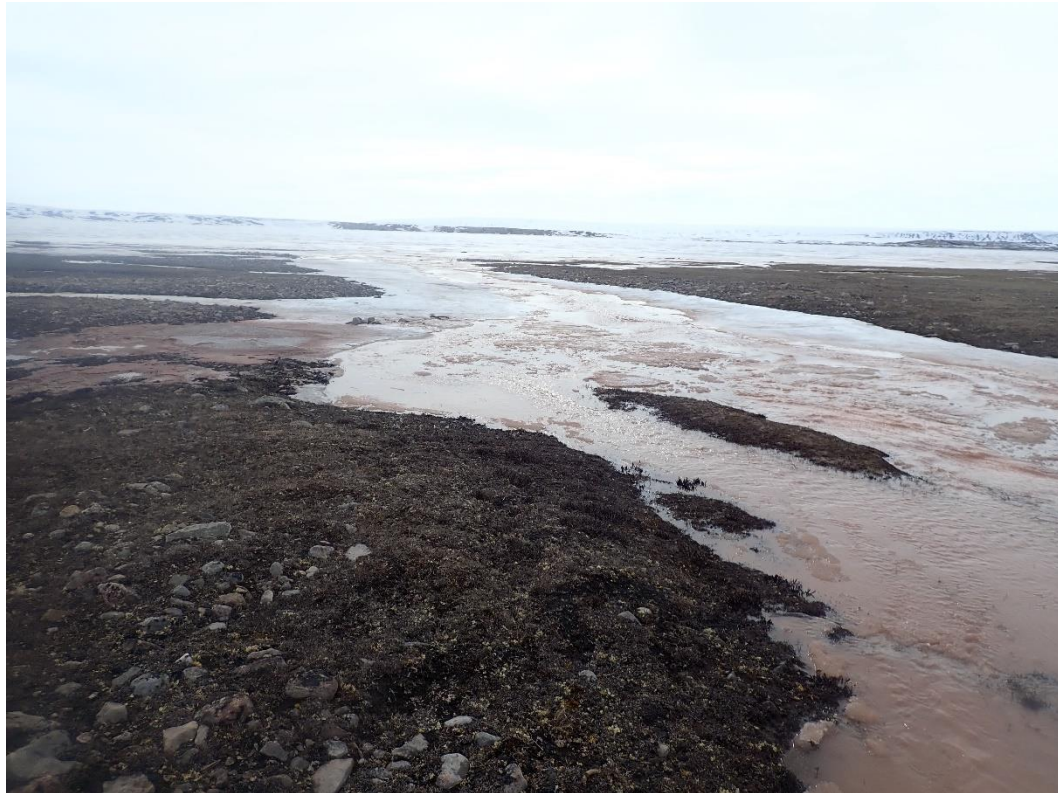
Photo 3. CLT Outfall on May 16, 2020

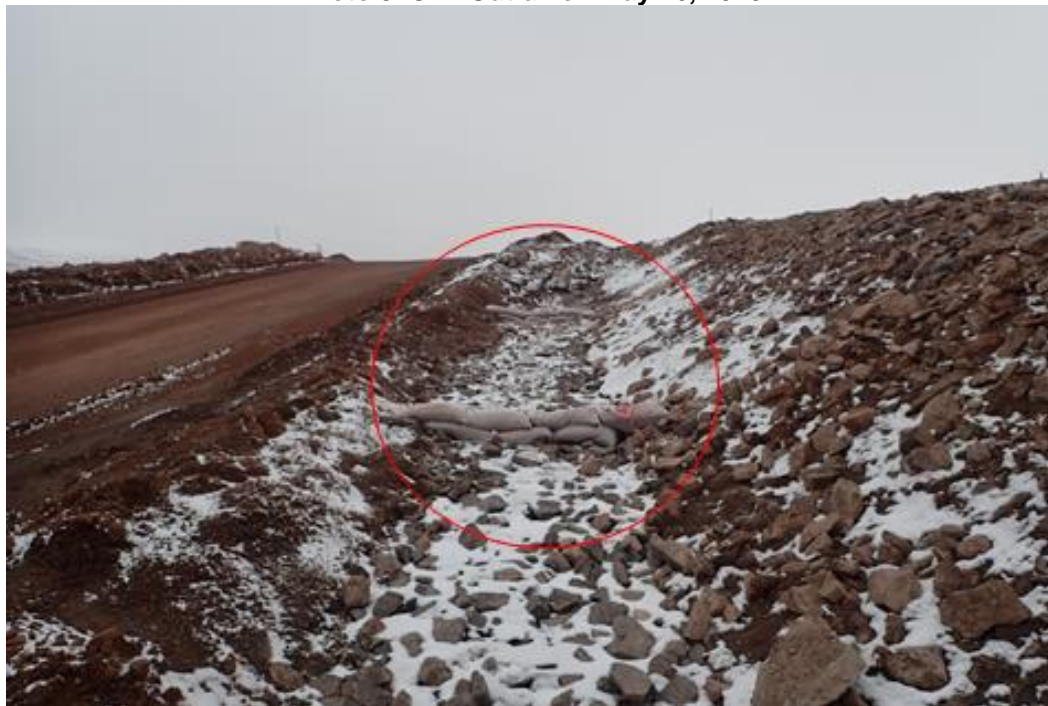
Photo 4: BG-01 Downstream Ditch with Sand Bags (May 18, 2020)

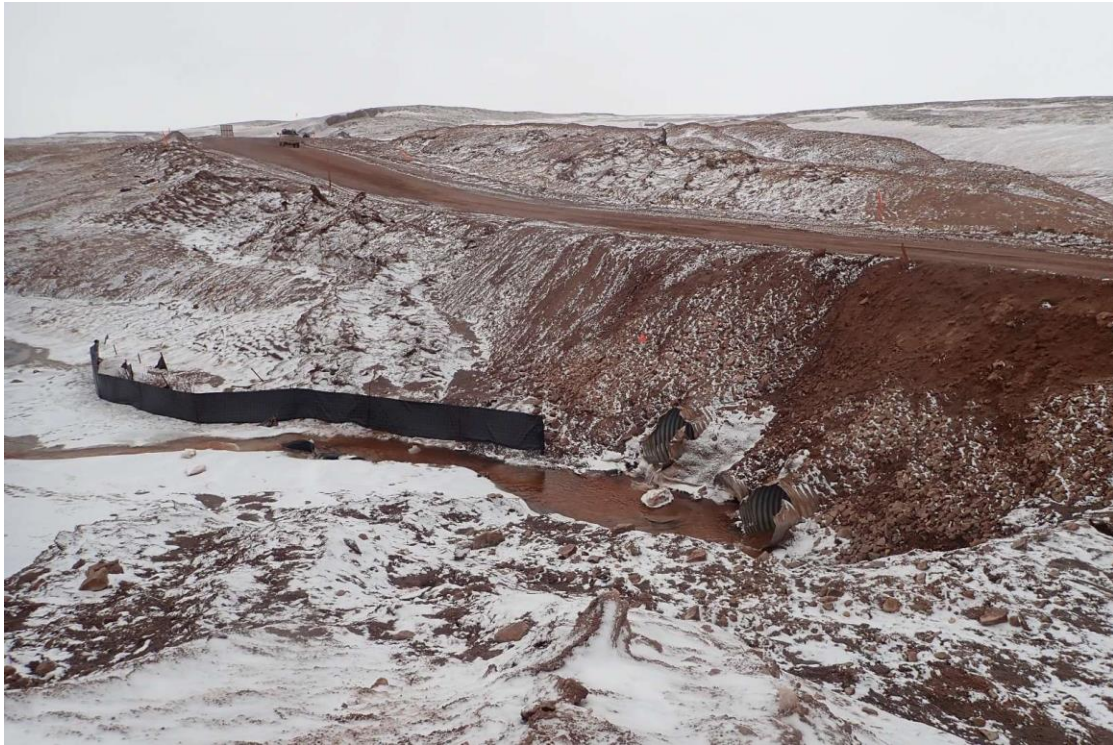
Photo 5. Silt Fencing at the Outlet of BG-01 (May 18, 2020)

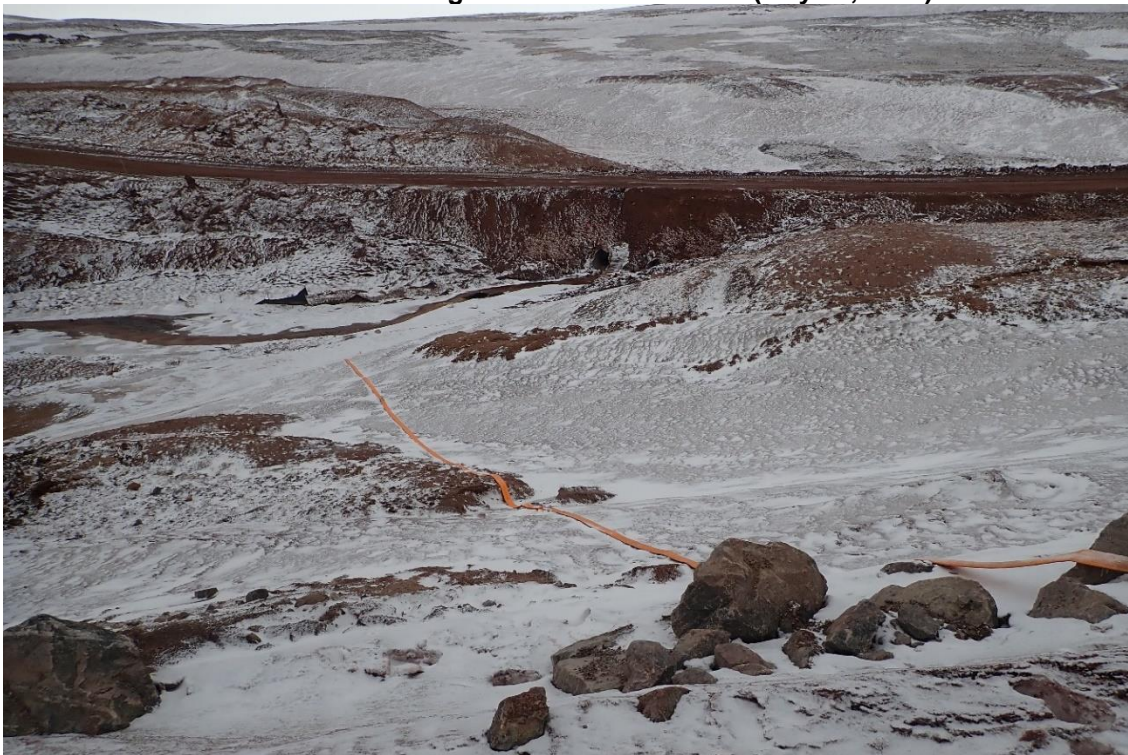
Photo 6. Pumping Diversion from Unstable Sandy Slope at the Outlet of BG-01 (May 18, 2020)

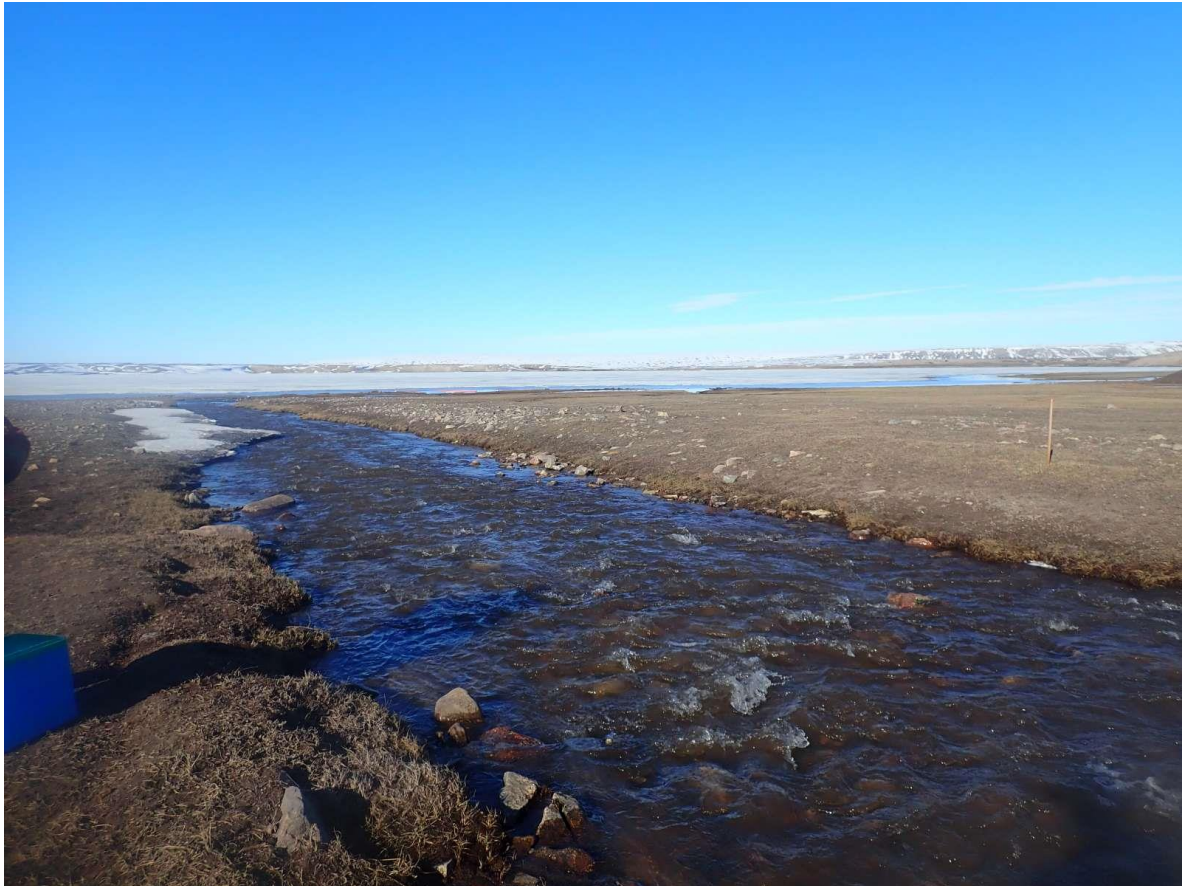
Photo 7. CLT Outfall on June 11, 2020

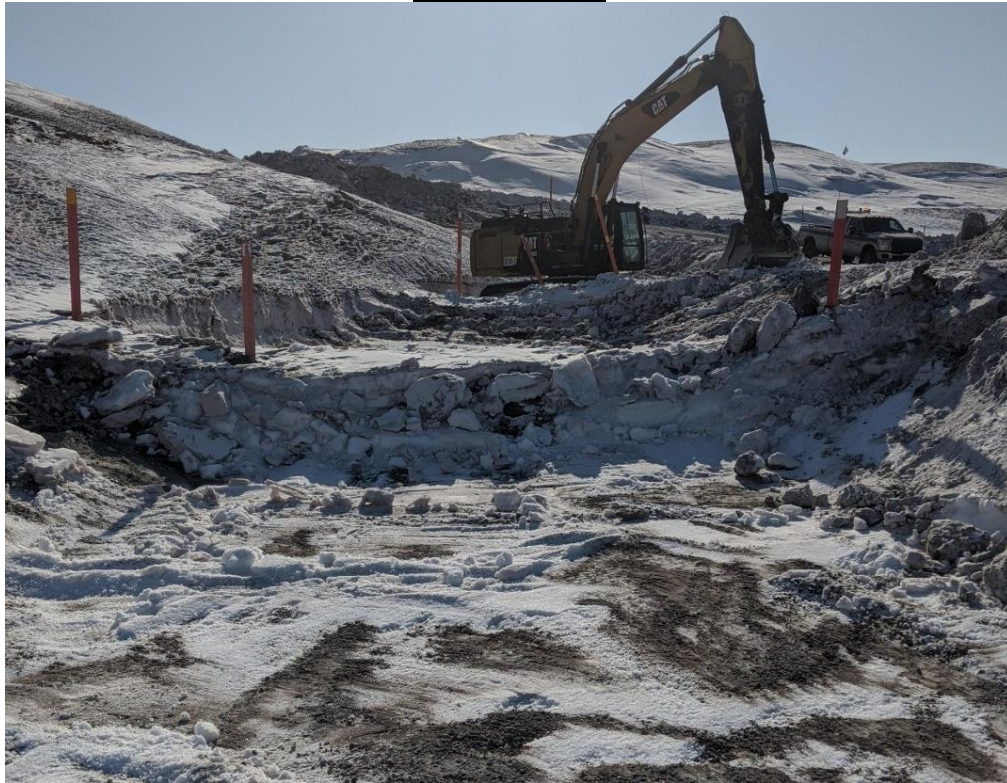
Photo 1. Snow Removal at the Camp Lake Check Dams on April 21, 2020

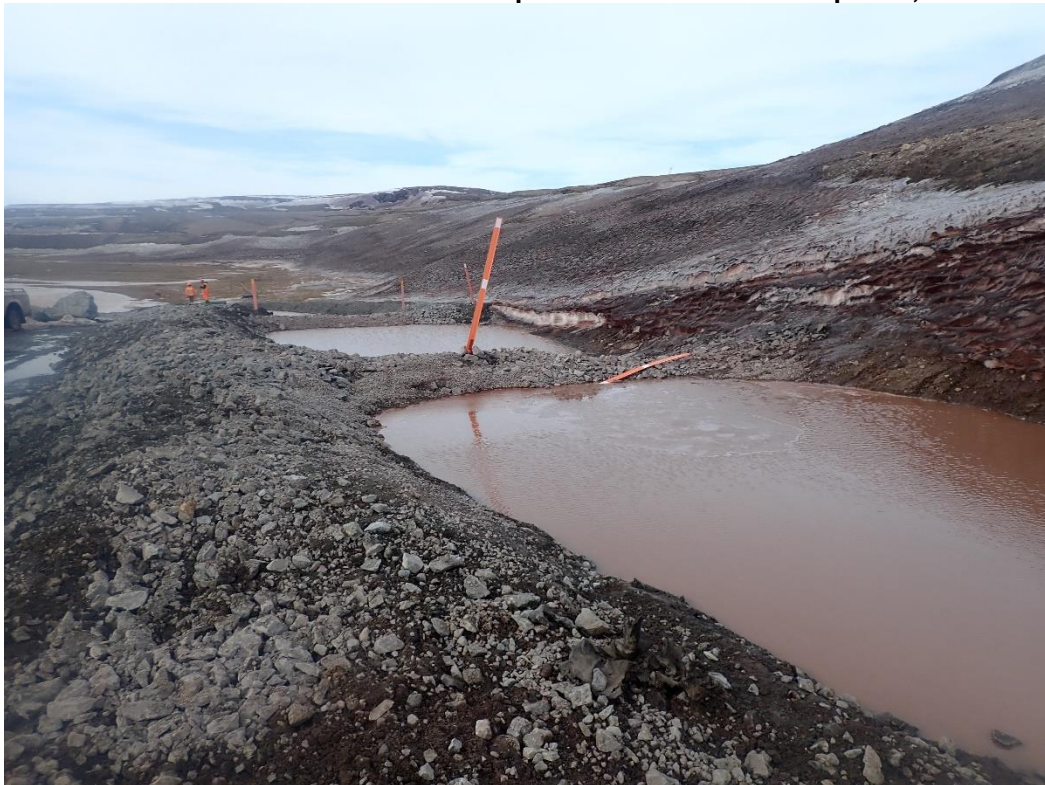
Photo 2. Camp Lake Check Dams on May 16, 2020

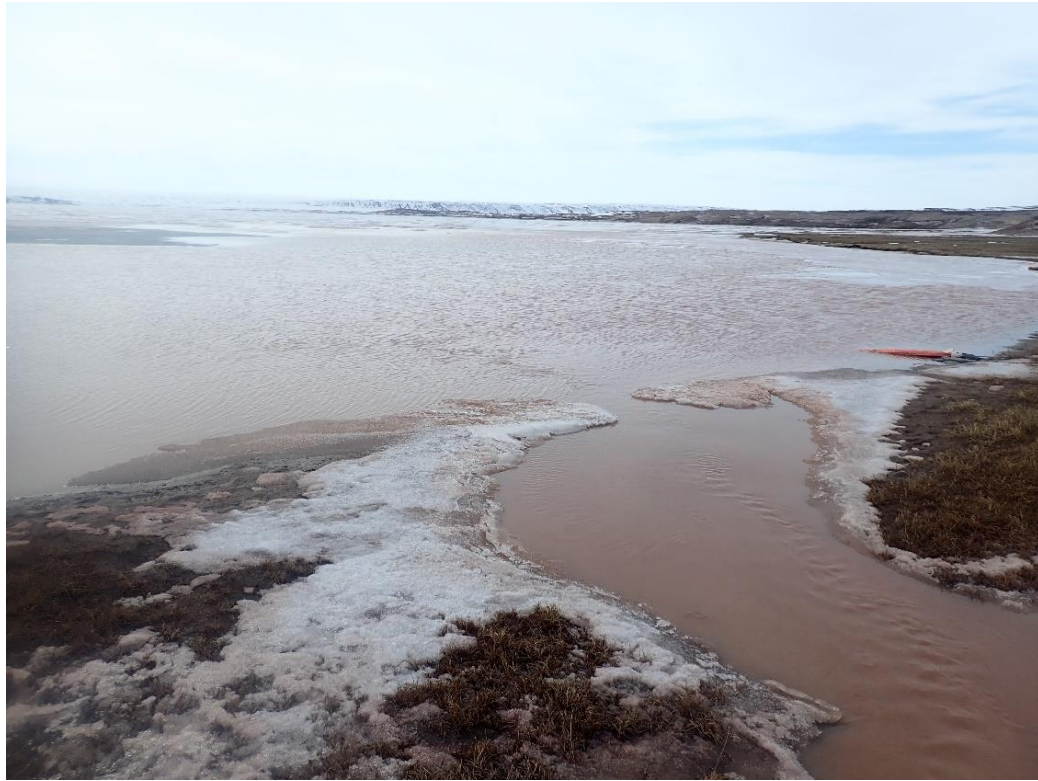
Photo 3: CLSP Outfall on May 16, 2020

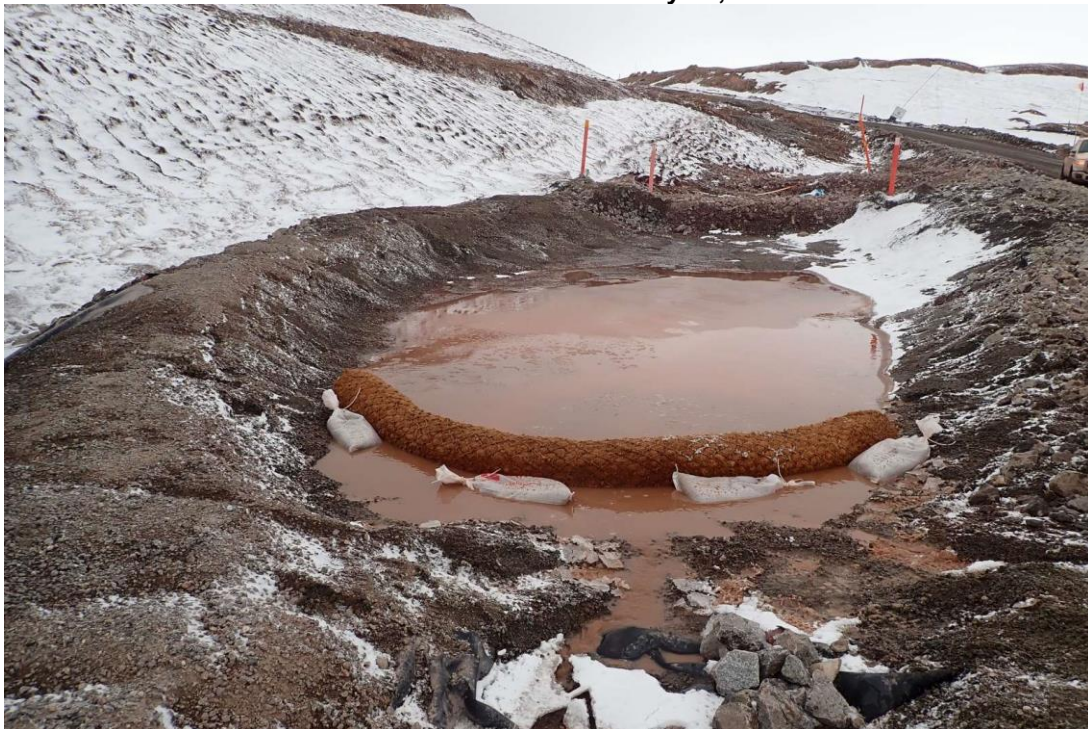
Photo 4: Camp Lake Sump with Coir Log on May 18, 2020

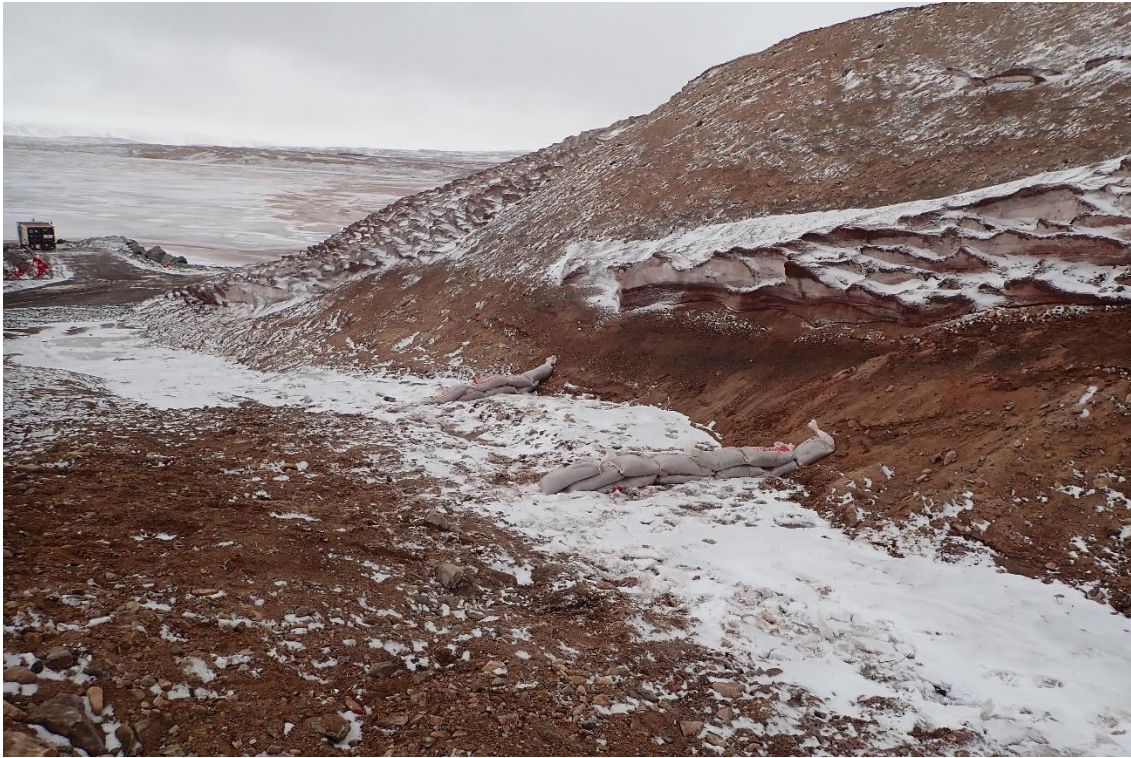
Photo 5: Camp Lake Check Dams with Sand Bags on May 18, 2020

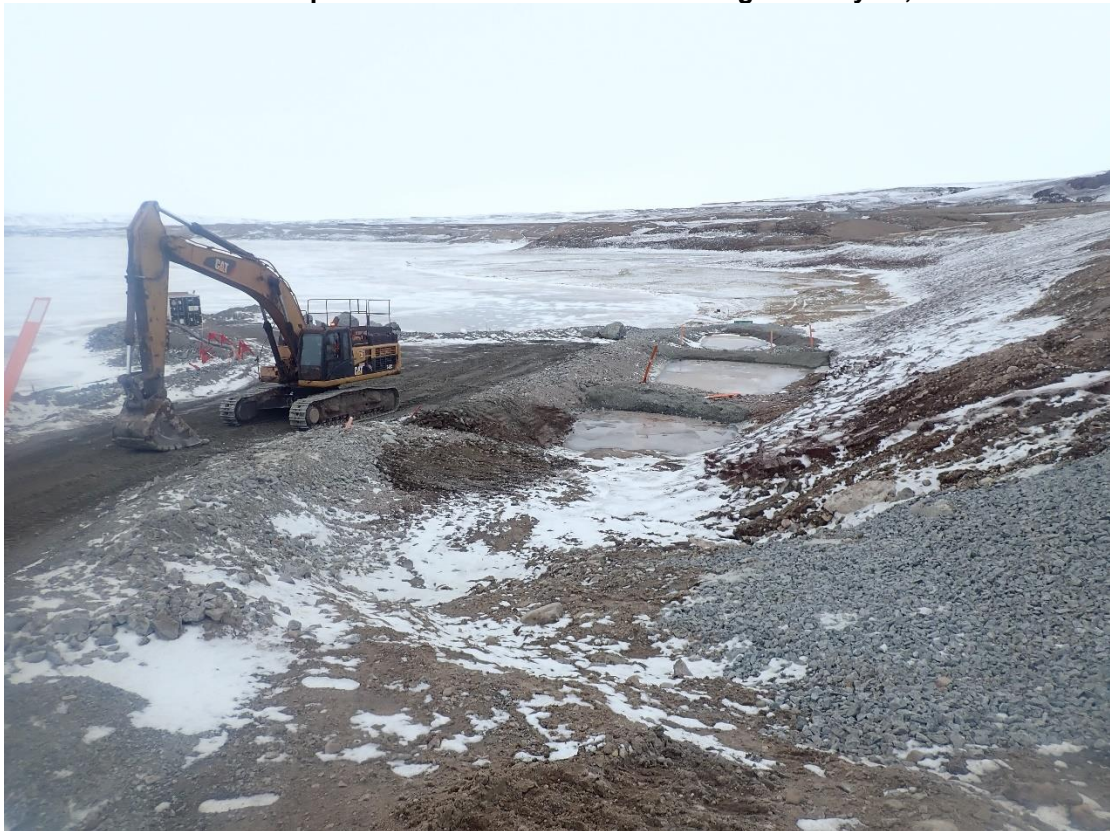
Photo 6: Camp Lake Settling Improvements on May 21, 2020

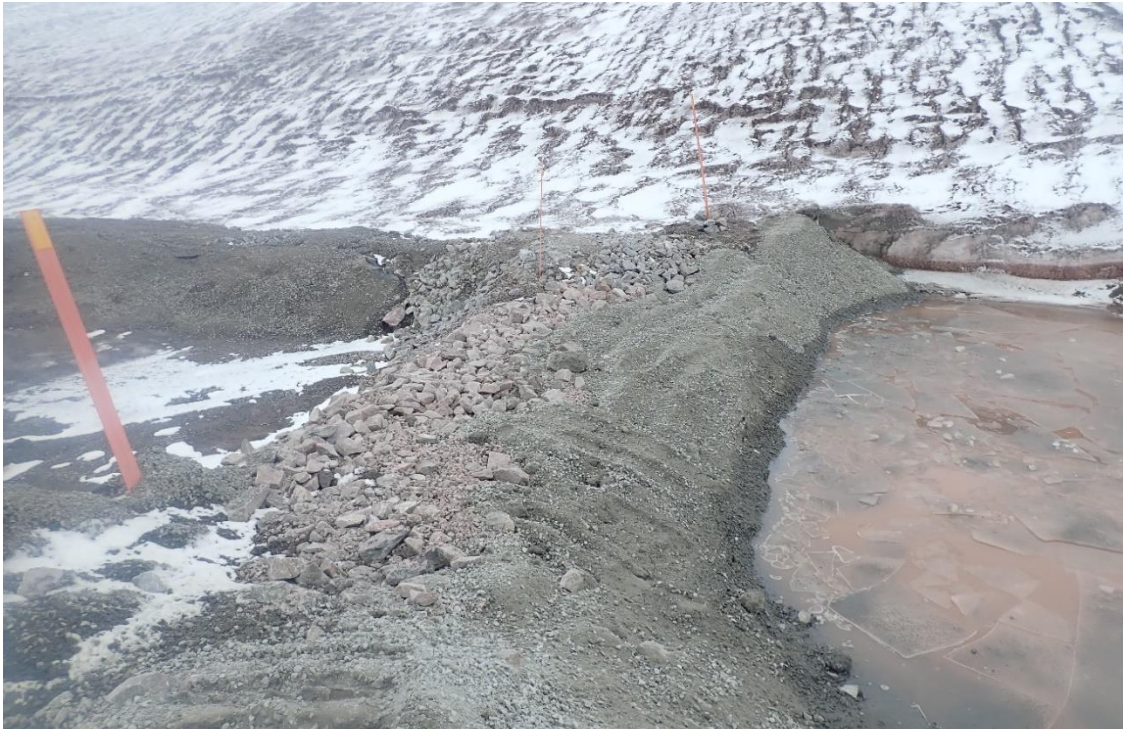
Photo 7: Camp Lake Check Dam Improvements on May 21, 2020

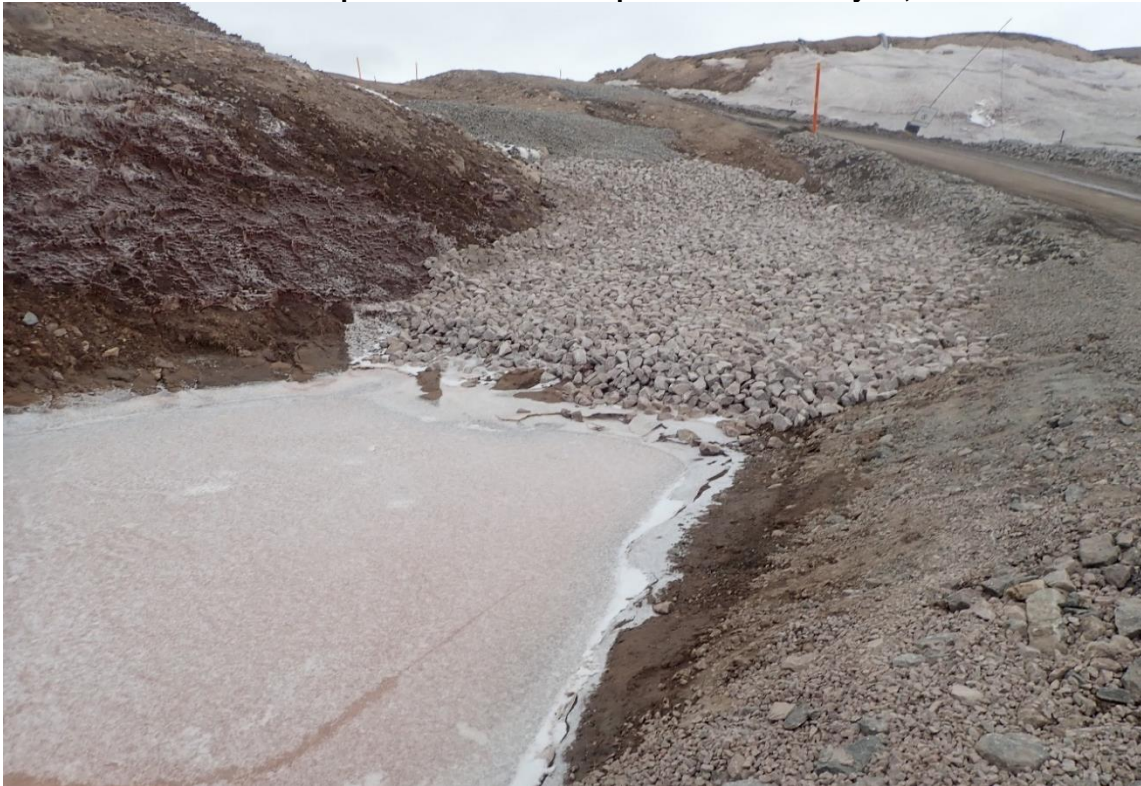
Photo 8: Camp Lake Slope Rip Rapping on May 23, 2020

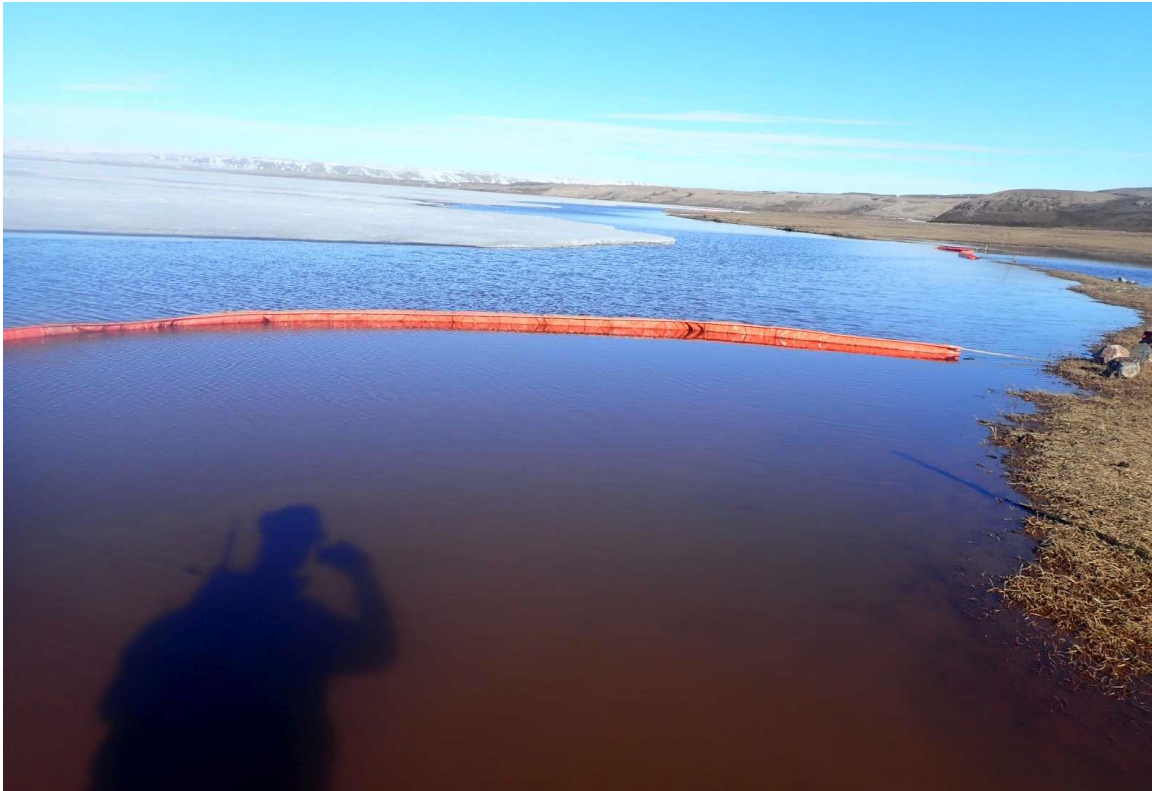
Photo 9: CLSP Outfall into Silt Curtain on June 11, 2020

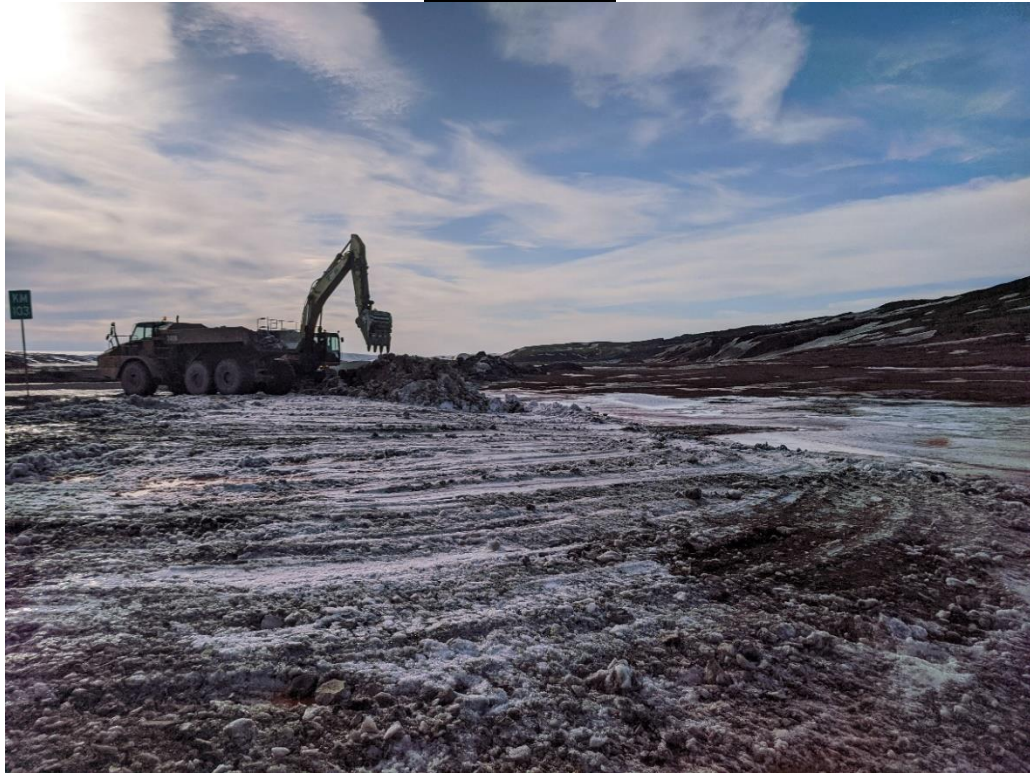
Photo 1: Snow removal upstream of SDLT-OUT on May 16, 2020

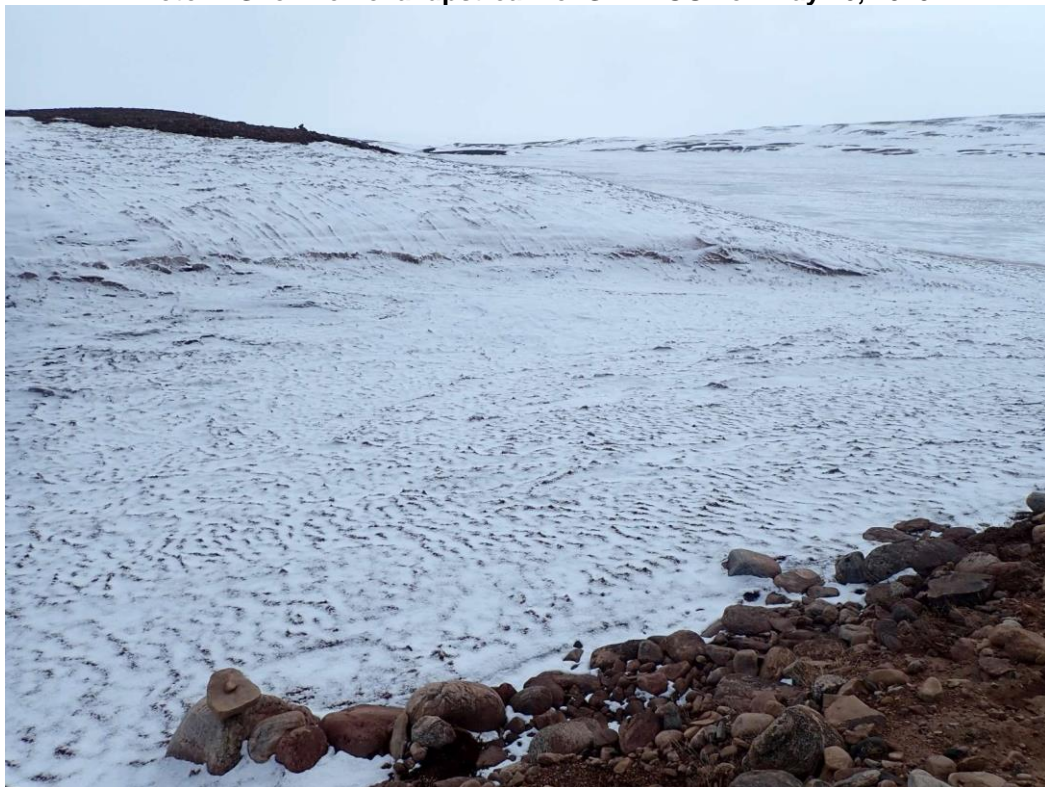
Photo 2: SDLT Outfall on May 14, 2020

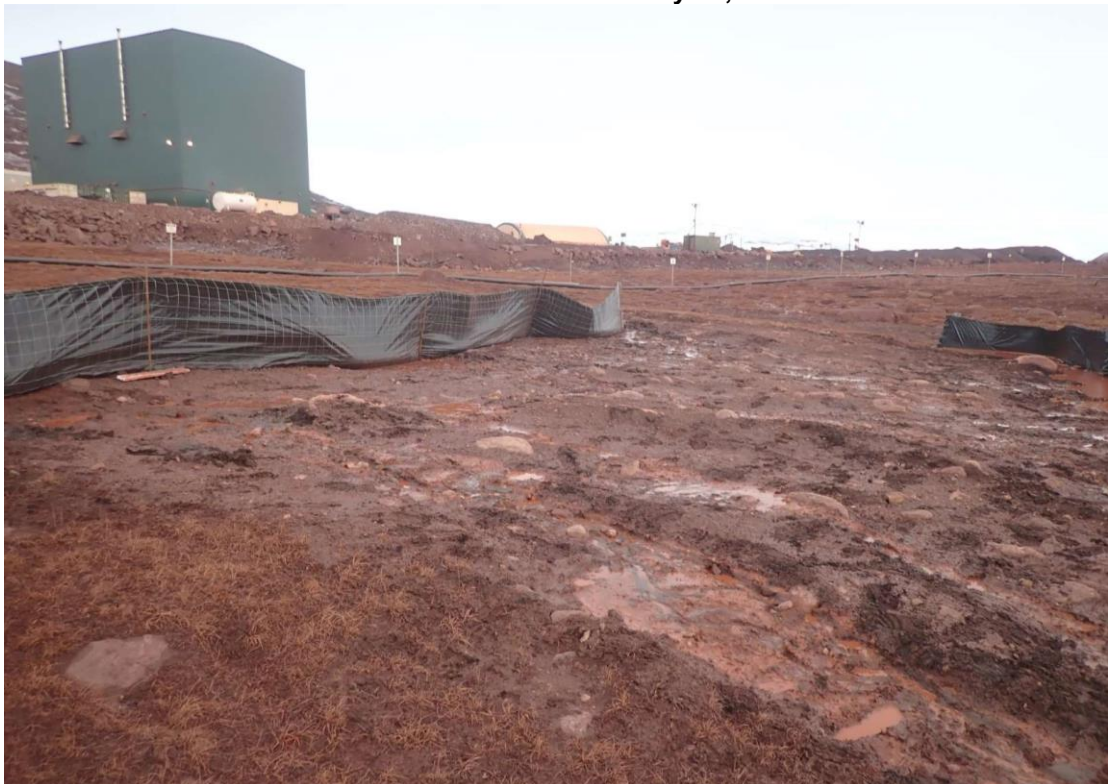
Photo 4. Erosion and Sediment Control Down Slope of Power Generation Building Minimizing Sediment Entering CV-187 (May 22, 2020)

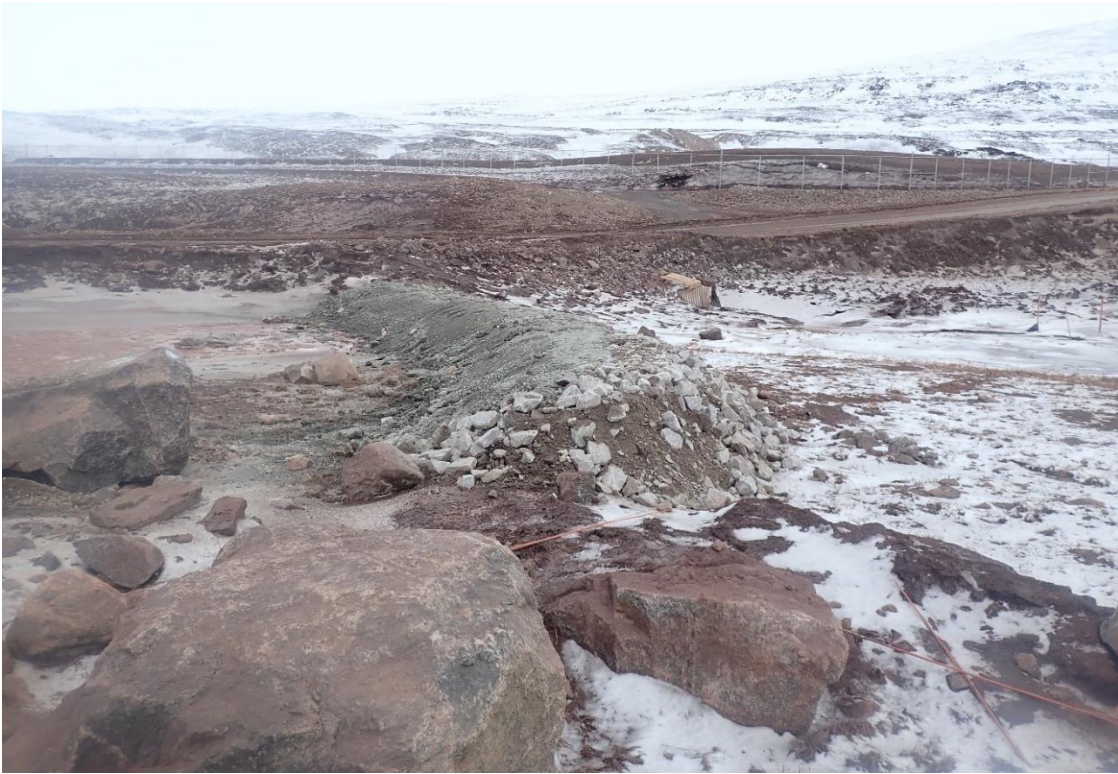
Photo 5. Check Dam Reinforcement and Expansion at the Inlet of CV-187 (May 20, 2020)

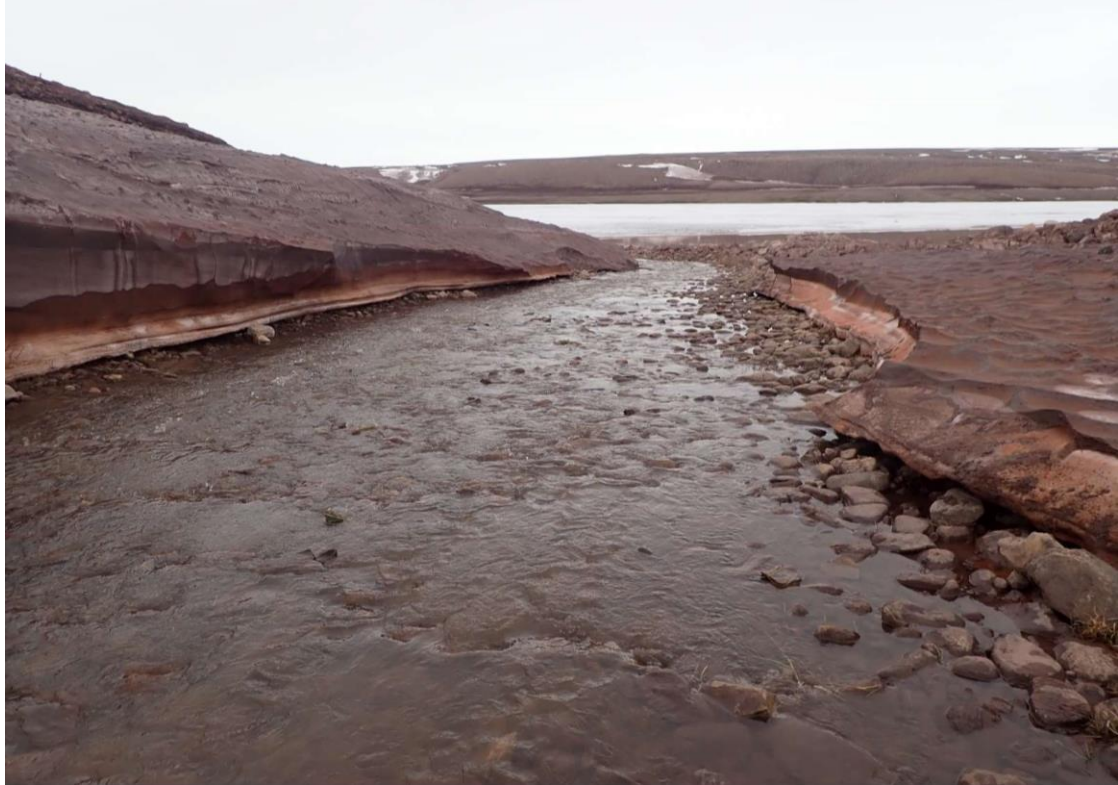
Photo 6: SDLT Outfall on June 13, 2020

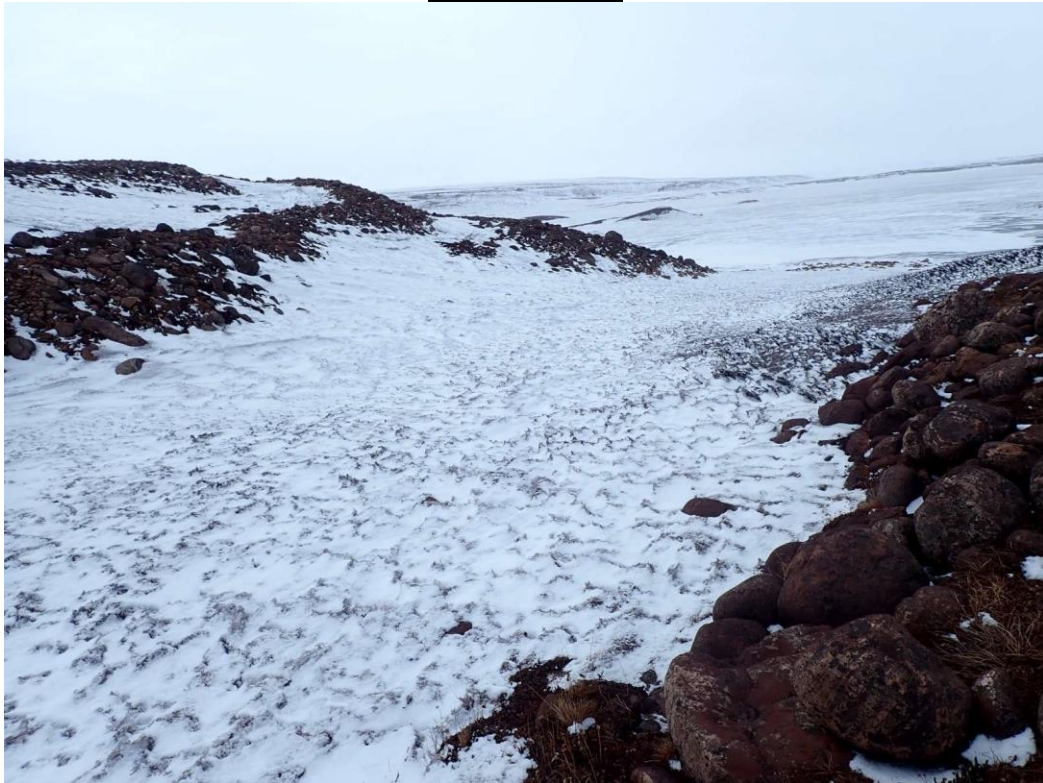
Photo 1: LDFG Outfall on May 14, 2020

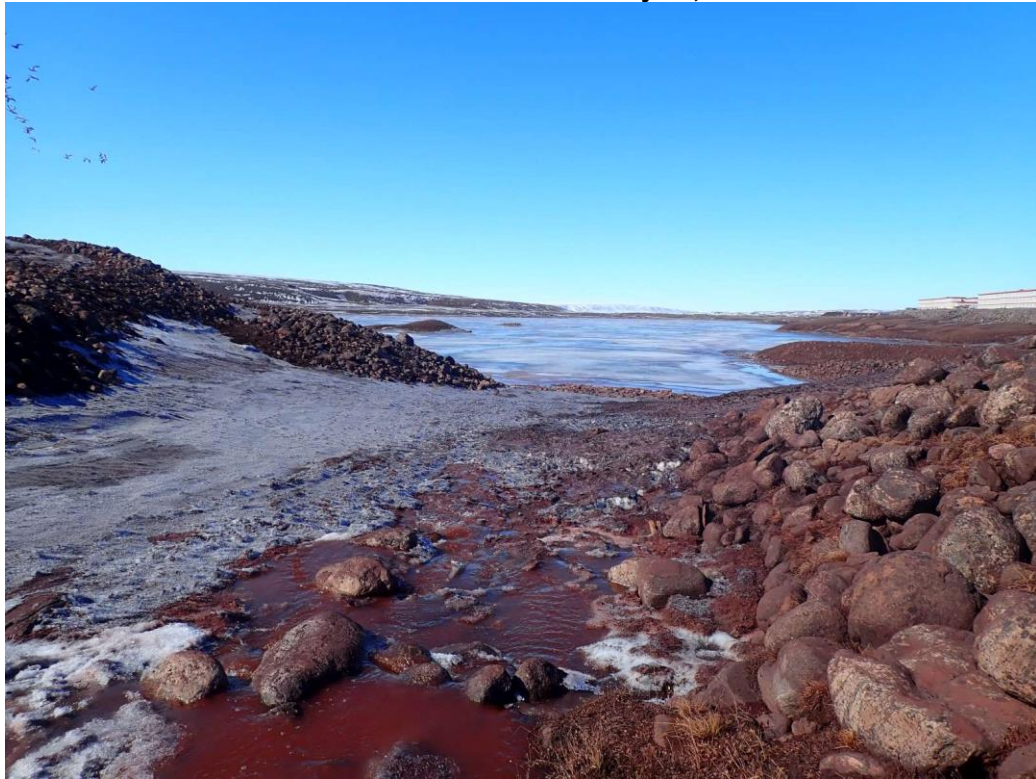
Photo 2: LDGF Outfall on May 17, 2020

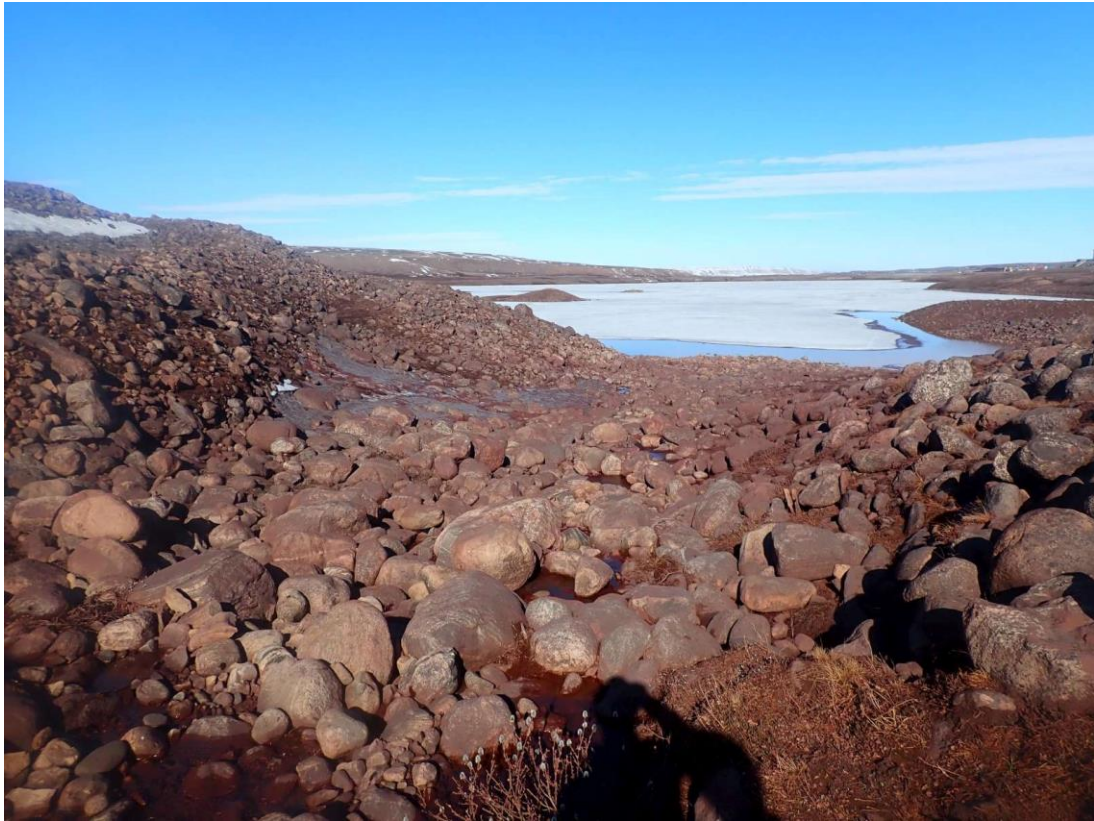
Photo 3: LDGF Outfall on June 11, 2020

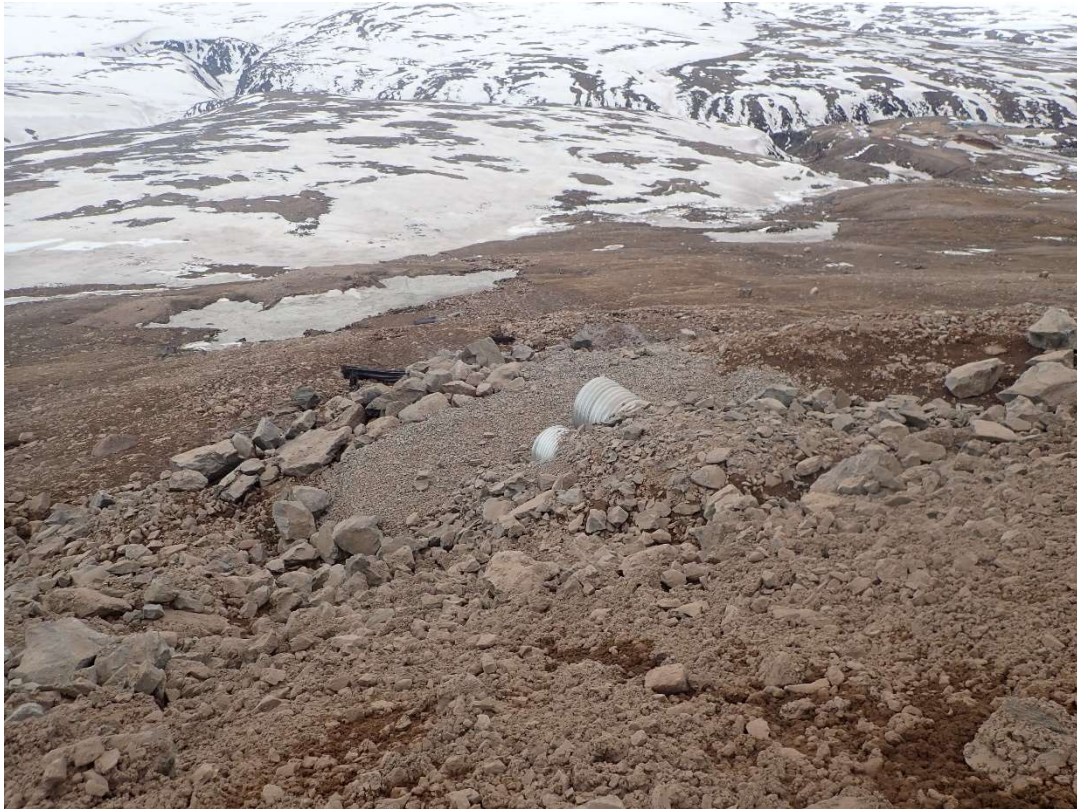
Photo 1.

KM106.5 Extended Culvert with Rip Rap

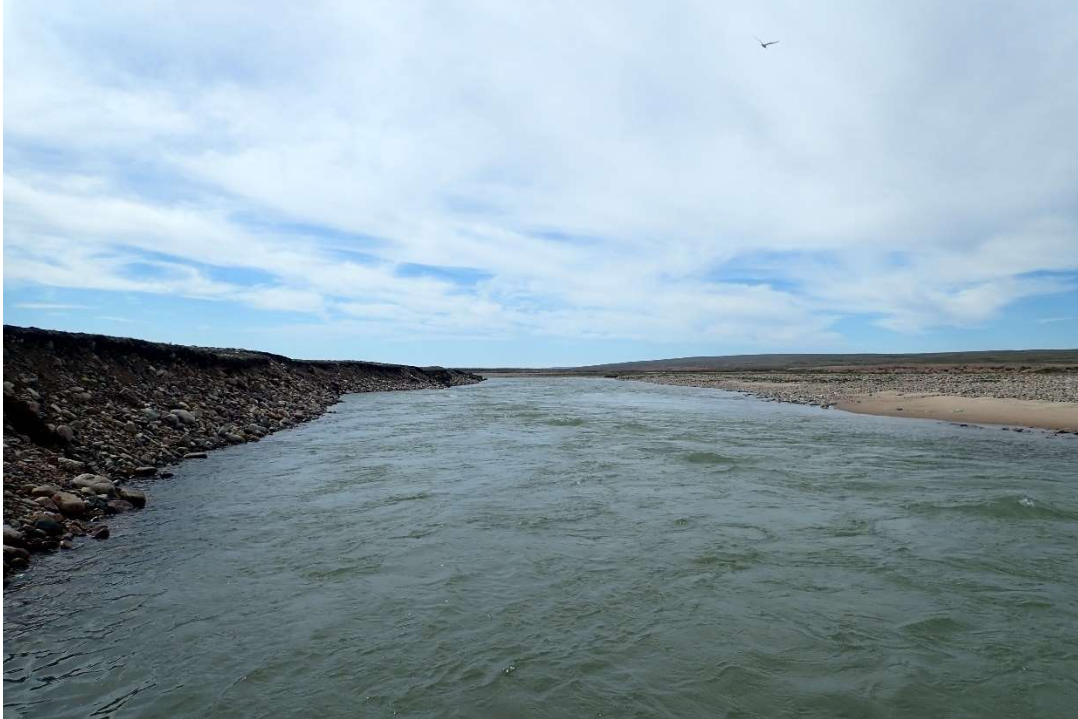
Photo 5. Water quality at E0-20 on Mary River on July 3, 2020

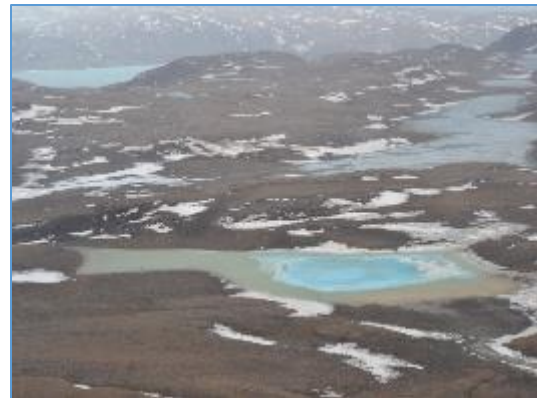
Figure 2. Overview of water bodies in the area.

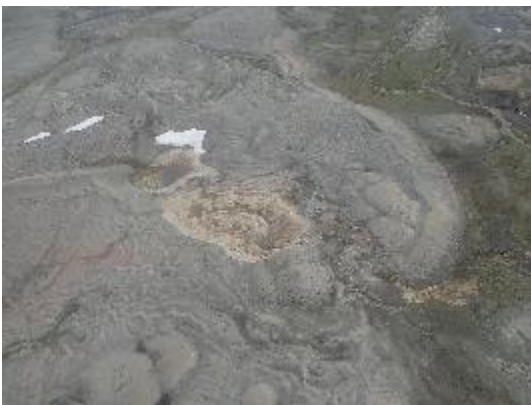
Figure 3. Overview of the affected area.

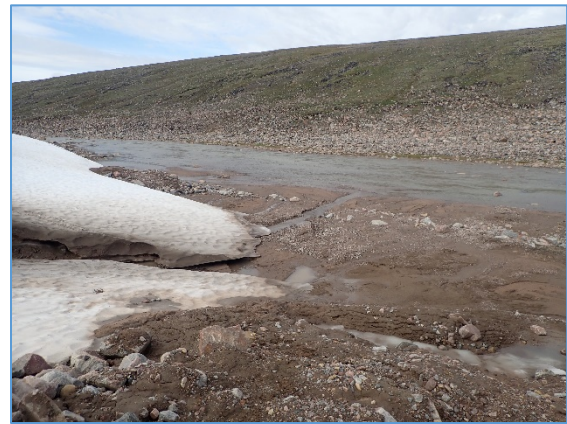
Figure 2. Turbid flow entering the Mary River.
