Freshet 2020 Monitoring Report

BAFFINLAND IRON MINES CORPORATION
MARY RIVER PROJECT**Freshet 2020 Monitoring Report****Rev 0**

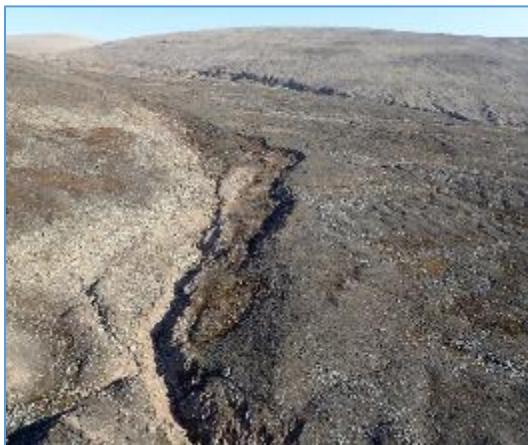
Description: Substrate is an unstable mix of gravel, cobble and sand/silt (Fig. 1). Sediment from the sliding slope was observed entering the Mary River (Fig. 2). The sediment carried into the Mary River from the affected slope was observed to increase downstream turbidity in the Mary River. UTM coordinates for a water quality monitoring location downstream of the confluence are NAD83, Zone 17N, 573616 E, 7925011 N. UTM coordinates for a water quality monitoring location upstream of the confluence are NAD83, Zone 17N, 573616 E, 7925011 N. Water quality samples collected upstream and downstream of the affected section of the Mary River on July 15, 2020 indicated that downstream total suspended solids (TSS) increased to 18.6 mg/L from the upstream TSS of 10.8 mg/L due to the event. Water quality samples collected upstream and downstream of the affected section of the Mary River on July 19, 2020 indicated that downstream total suspended solids (TSS) increased to 11.8 mg/L from the upstream TSS of 3.9 mg/L due to the event.

Figure 1. Substrate of sliding slope.

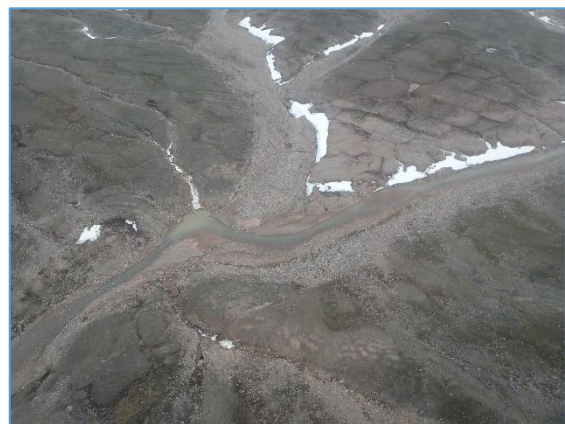
Figure 2. Sediment entering the Mary River.

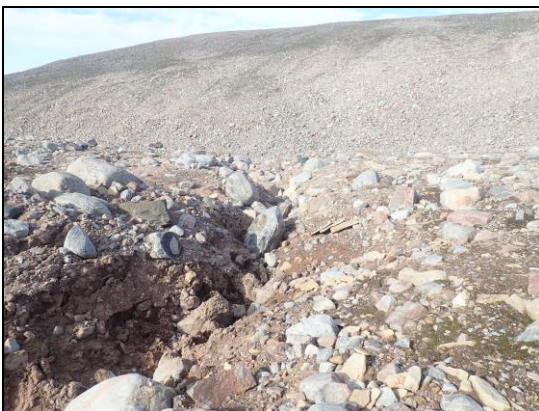
Description: Substrate is an unstable mix of gravel, sand/silt and large boulders (Fig. 2). Flow from the slumping hills enters a tributary that joins the Mary River downstream (Fig. 3).

Figure 2. Substrate of slumping hills.

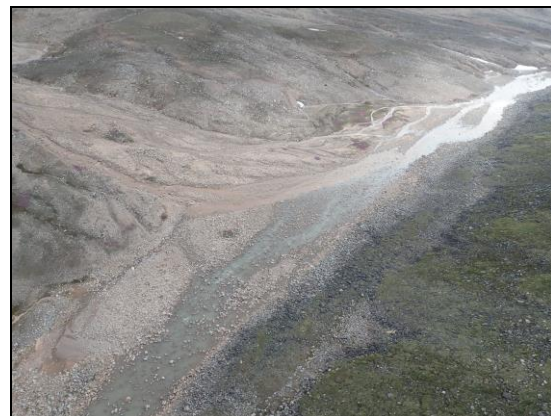
Figure 3. Turbid flow from MR-NATSED-4 entering the Mary River.

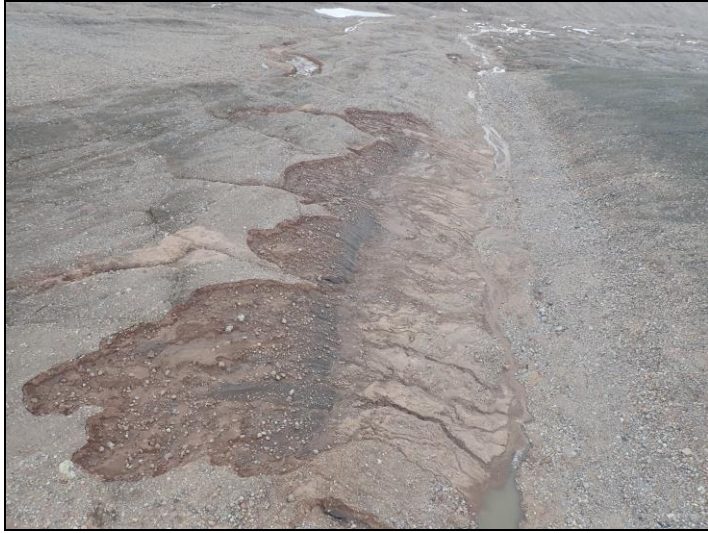
Figure 4. Aerial photograph of sloughed hillside.
