Report title: Summer 2021 Site Update Report for the Nunavut Impact Review Board's Monitoring of Baffinland Iron Mines Corporation's *Mary River Project* (NIRB File No. 08MN053)

Project: Mary River Project

Report Prepared by: Guillaume Daoust, Technical Advisor I

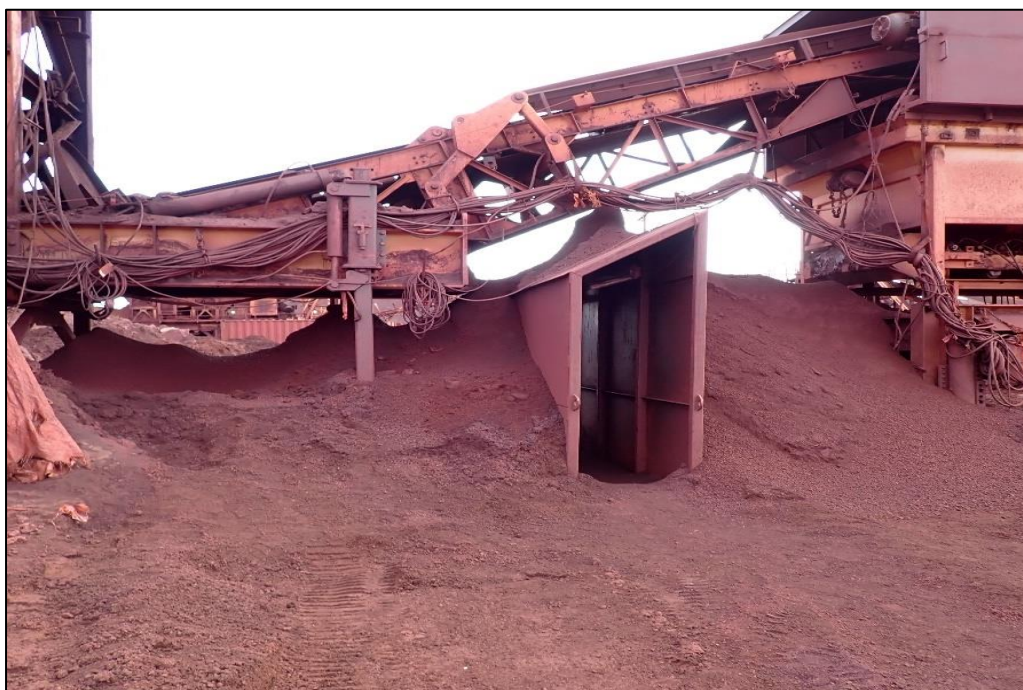
Photo 14: Iron Build-up Under Crusher Equipment at Transfer Point

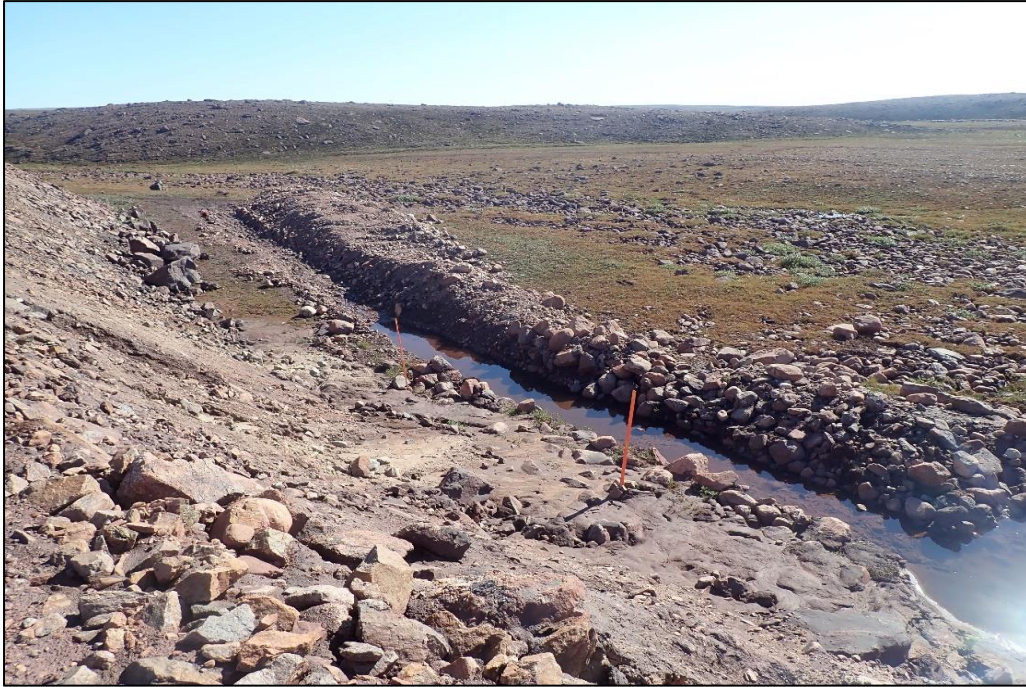
Photo 17: View of the Tundra Surrounding the Crusher Plant Pond and Ditches

Understanding that dust is a recurring concern by communities, NIRB staff appreciate Baffinland expanding the dust monitoring with an additional station ([Photo 83](#)) and conducting dust suppression mitigation ([Photo 42](#) and [Photo 43](#)). However, there are clear observations of dust deposition on the snow surface ([Photo 19](#)) and obvious dust layers in the snow cut surface from the freshet preparation ([Photo 21](#)). The NIRB will continue to track this topic.

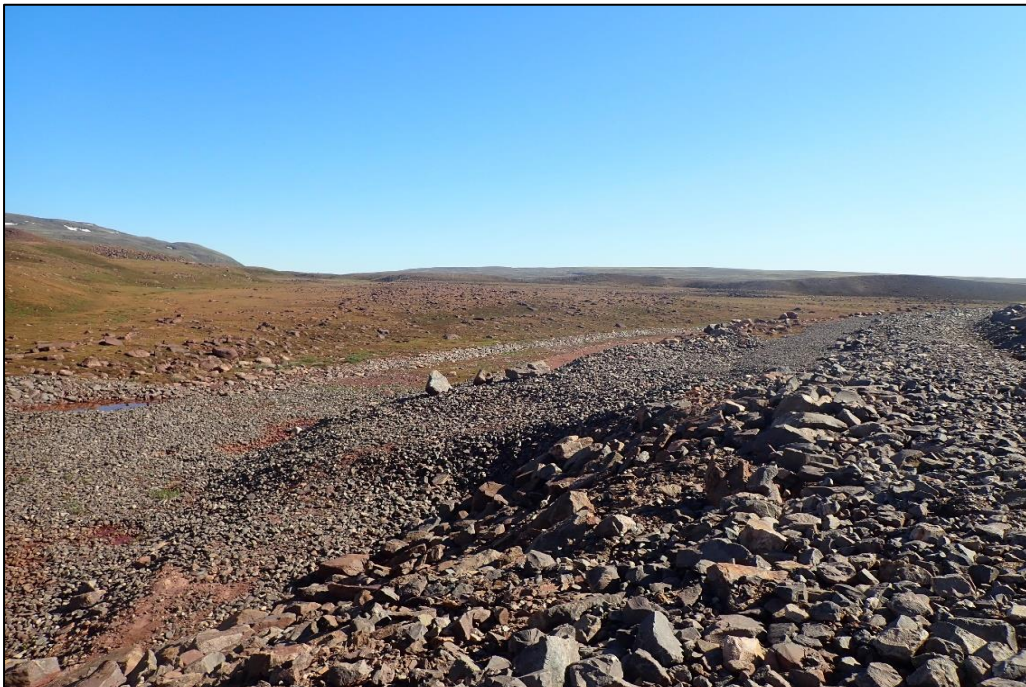
Photo 18: Another View of the Tundra Surrounding the Crusher Ore Stockpile Stormwater Pond and Ditches

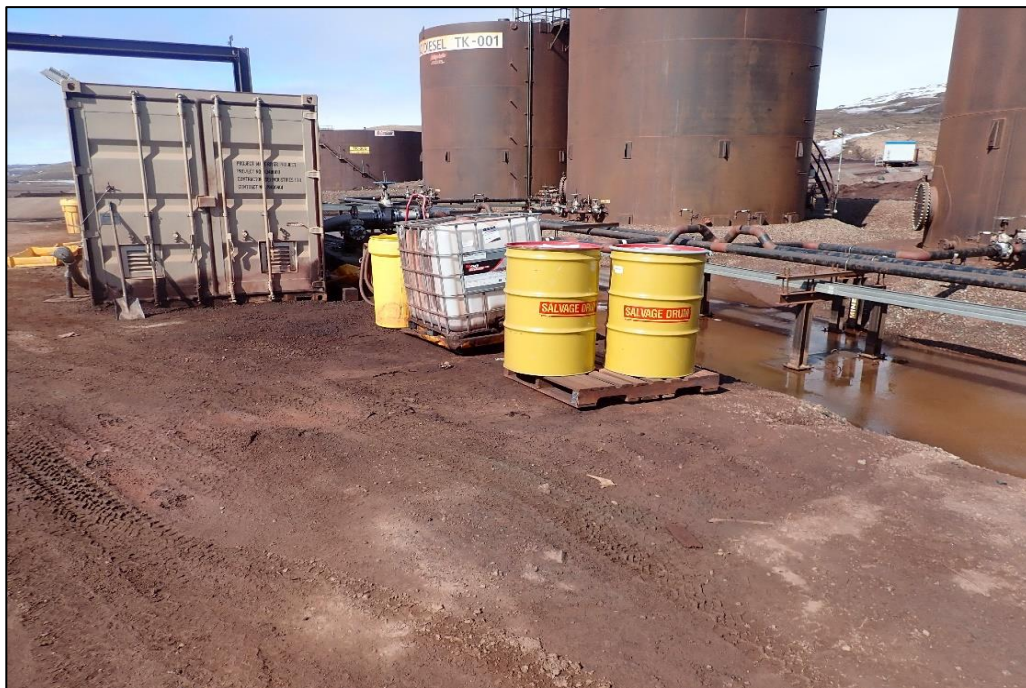
Terrestrial Wildlife Habitat and Waste Management		
54	Terrestrial Environmental Management Plan	Evidence of wildlife video-surveillance was provided in Photo 40 : Wildlife Camera at KM42 .
64	Waste Management – Carnivore Deterrents	Evidence of skirting around the Sailiivik complex in Photo 3 : Sailiivik Accommodation Complex with Metal Skirting Around the Base. The Photo 24 : Fencing at Mine Site Landfill looking North and Photo 25 : Fencing at Mine Site Landfill looking reveal fencing around the mine site landfill.
Marine Environment- Spill Prevention		
92	Spill Response Equipment	Evidence of spill response equipment located on site was provided in Photo 29 : Spill Response Equipment at the MS-03 Tank Farm and Photo 63 .
Socioeconomic Impacts

Photo 29: Spill Response Equipment at the MS-03 Tank Farm

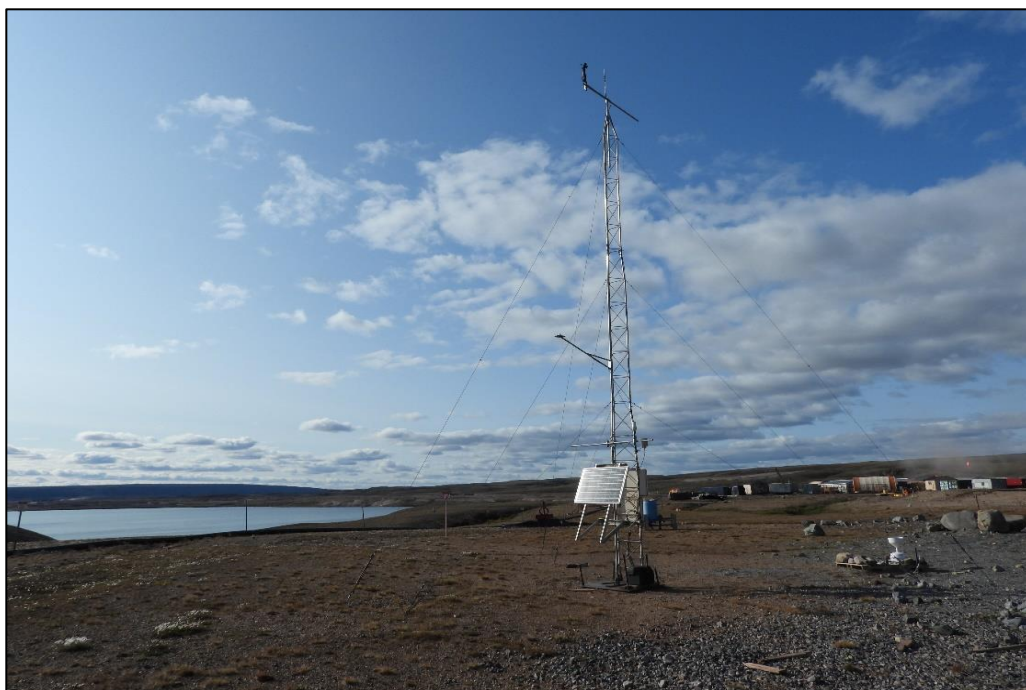
T&C No.	Category	Observation
Meteorology and Climate		
5	Weather Stations	Evidence of weather stations installed on site was provided in Photo 30 .
10	Dustfall Monitoring	Evidence of dustfall monitoring stations were provided at the Mine Site, Photo 16 : Dustfall Monitoring Station Towards Deposit 1, along the Tote Road, Photo 41 : Dustfall Monitoring Station at KM25, and at Milne Port, Photo 83 : One of the New Dust Collectors around Milne Port. Evidence of dust mitigation measures appear in Photo 42 : Truck Wetting the Tote Road for Dust Suppression and Photo 43 : Tire Drag for Dust Suppression.
11	Incinerator	Evidence of waste management practices at the incinerator facilities at both the Mine Site and Milne Port are shown in Photo 23 : Waste Segregation in the Incinerator Building and Photo 59 : Waste Sorting Bins Outside the Incinerator Facility.
Groundwater and Surface Water		
23	Groundwater Monitoring	Evidence of compliance was provided in Photo 26 : Groundwater Monitoring Wells Near the Mine Site Landfill.

Photo 30: Weather Station at the Weatherhaven

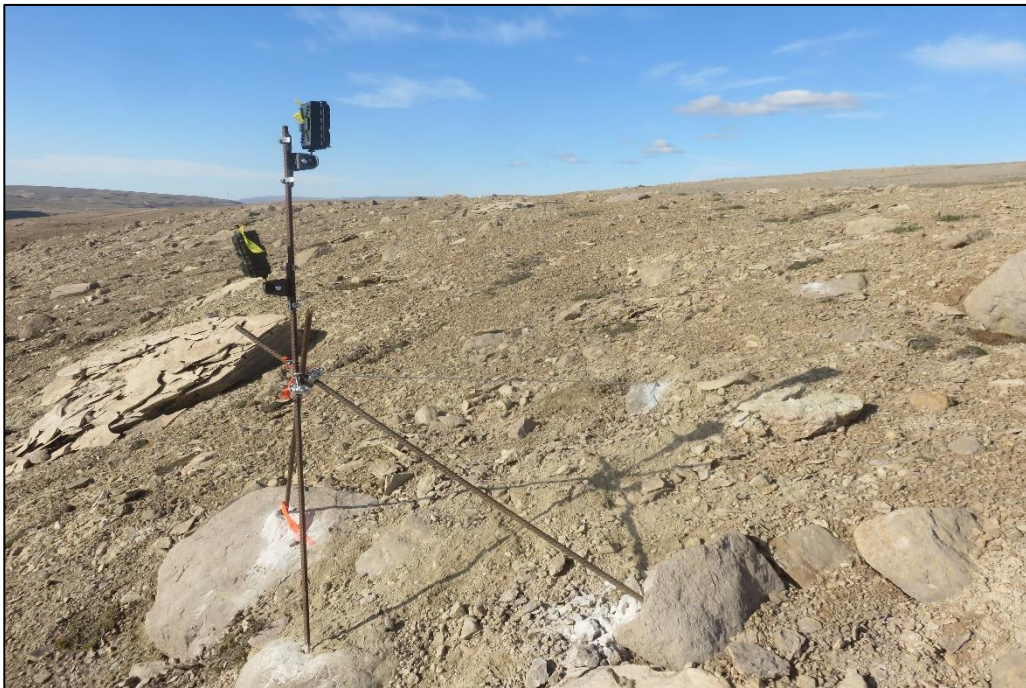
Photo 40: Wildlife Camera at KM-42

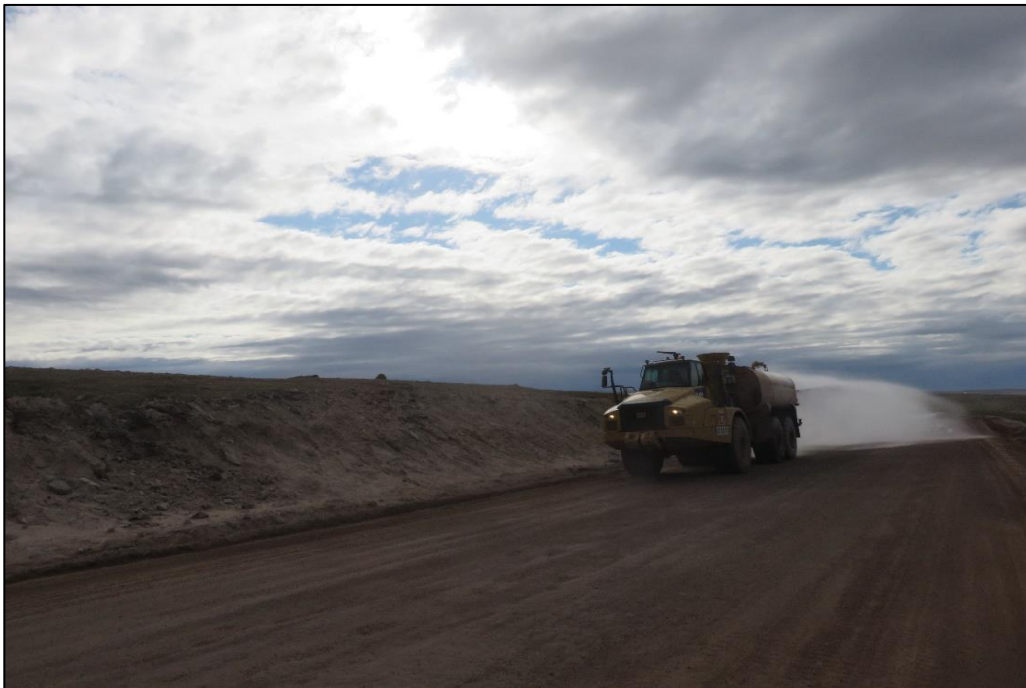
Photo 42: Truck Wetting the Tote Road for Dust Suppression

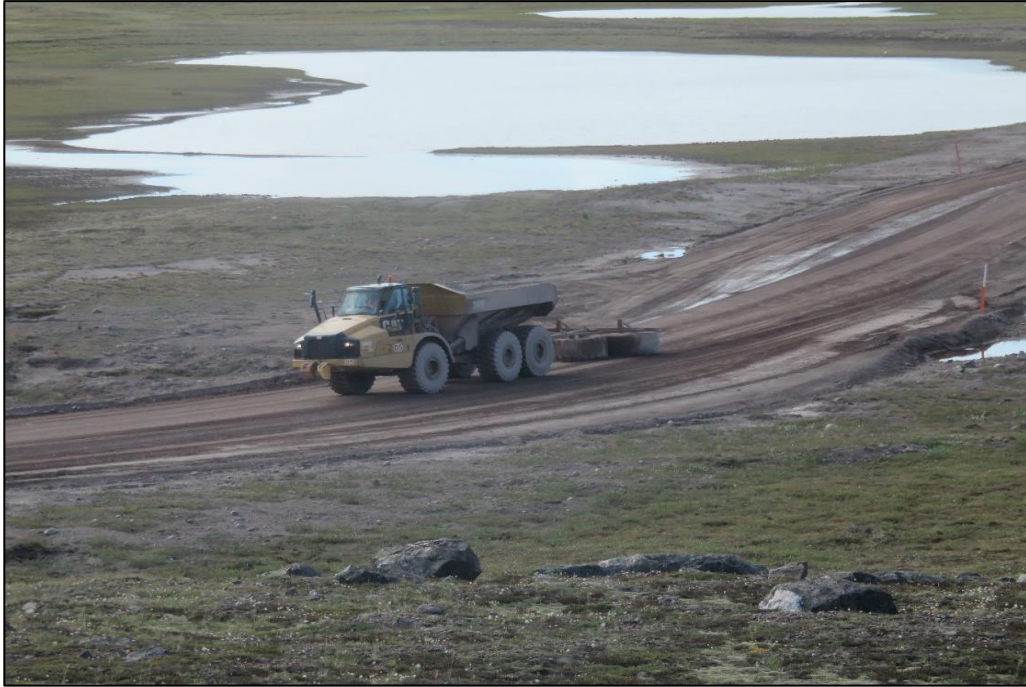
Photo 43: Tire Drag for Dust Suppression

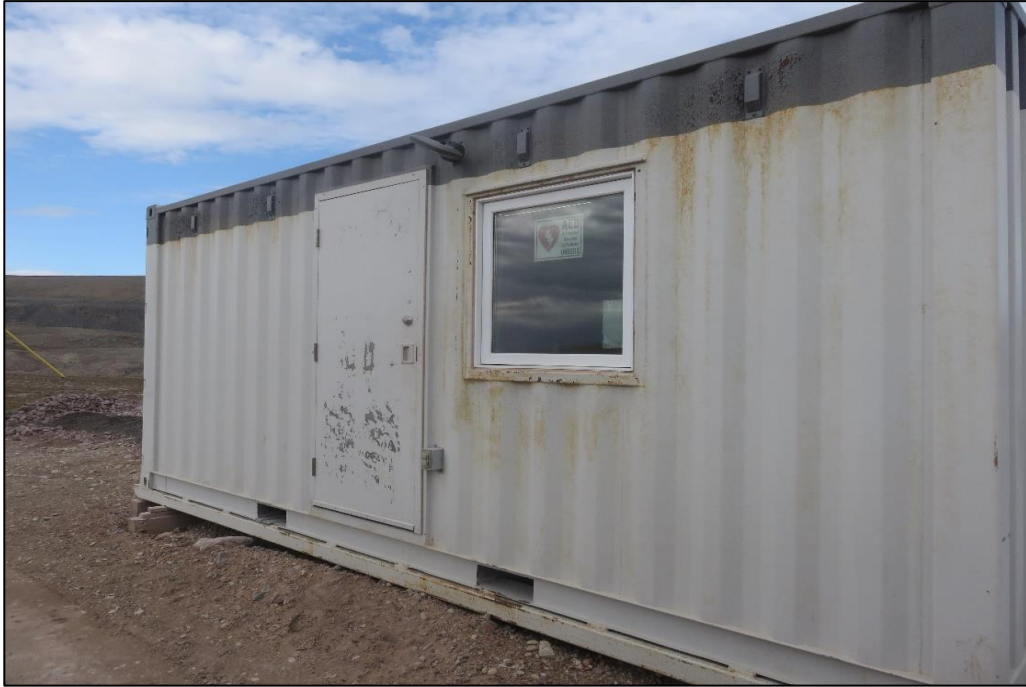
165	Emergency Shelters	Photo 45 and Photo 46 show the emergency shelter constructed and maintained along the Tote Road for both employees and land users.
-----	--------------------	--

Photo 45: Emergency Shelter at KM40

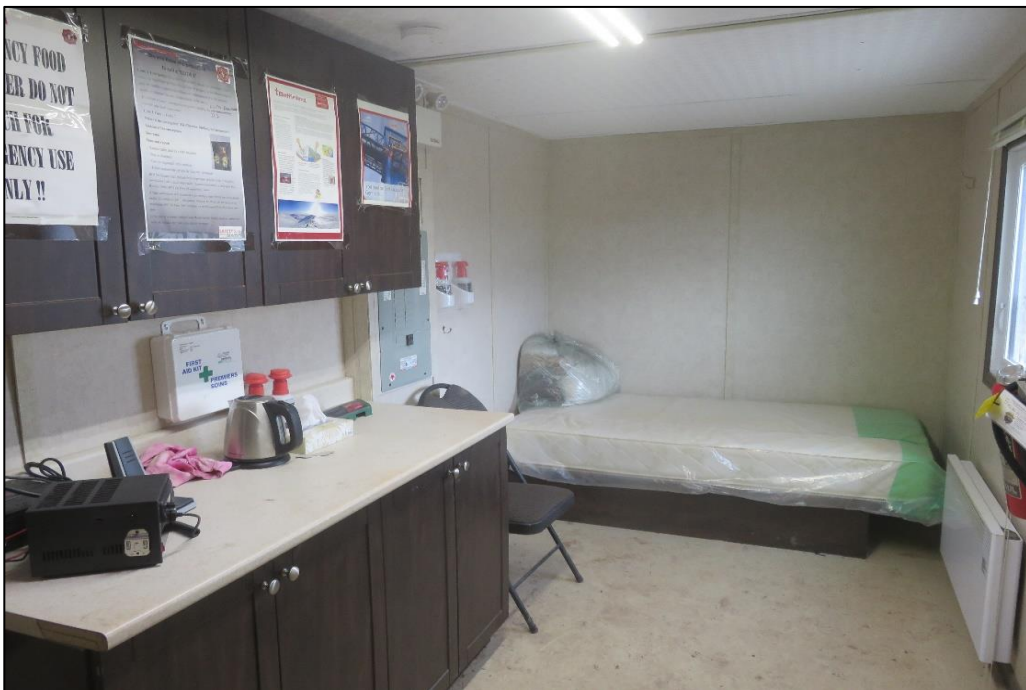
Photo 46: Interior of Emergency Shelter

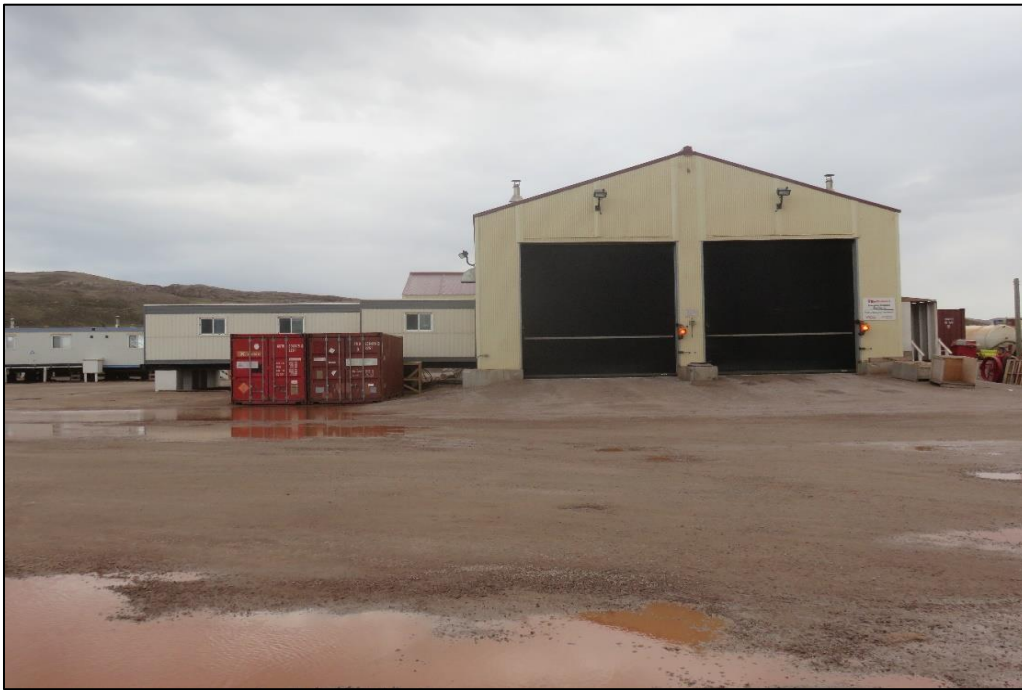
Photo 63: Storage of Spill Response Equipment Located Next to Emergency Response Team Shop
