# Meliadine Gold Mine Project

# Agnico Eagle Mines Limited

NIRB File No. 11MN034

**Report Title:** The Nunavut Impact Review Board's 2021 Site Update Report for Agnico Eagle Mines Limited's *Meliadine Gold Mine Project* (NIRB File No. 11MN034)

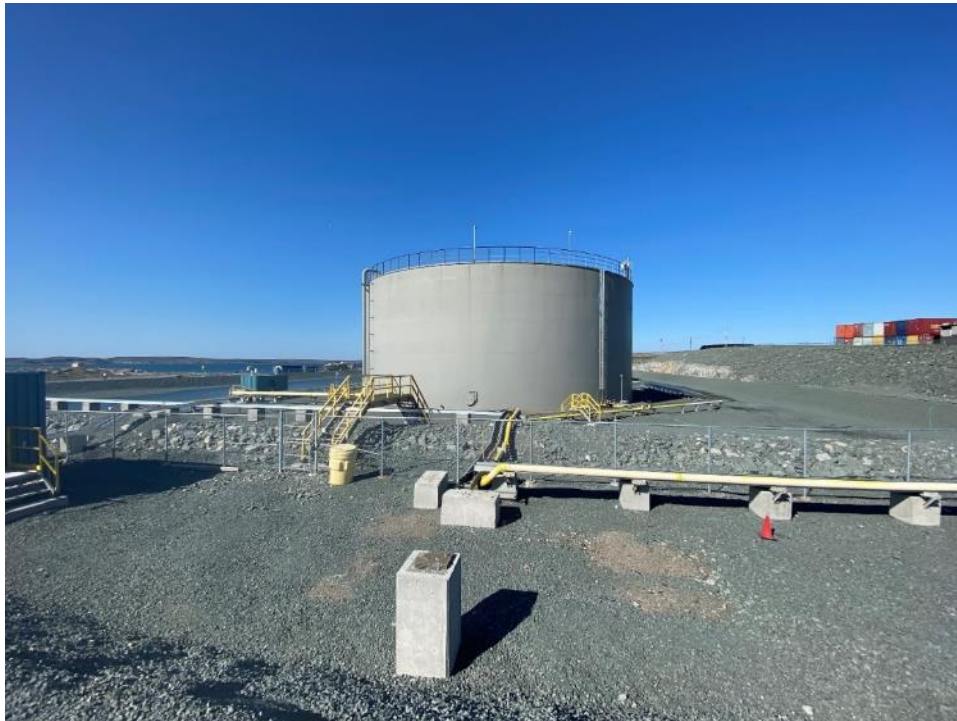
**Photo 2: Fuel Farm 2 and Secondary Containment**

T&C No.	Category	Observation
64, 67 & 77	Marine Environment - Accidents and Malfunctions	<a href="#">Photo 2</a> demonstrates secondary containment of the fuel farm at Itivia Harbour next to Melvin Bay.
75	Predatory Attractants	<a href="#">Photo 44</a> provides evidence that incinerator doors are kept closed to prevent wildlife. <a href="#">Photo 45</a> demonstrates management of food waste. <a href="#">Photo 46</a> , <a href="#">Photo 47</a> , and <a href="#">Photo 48</a> demonstrate improvements to the waste segregation on site.
110	Individual and community wellness	<a href="#">Photo 58</a> and <a href="#">Photo 59</a> show programs for country food and sewing at the mine site. <a href="#">Photo 61</a> , <a href="#">Photo 63</a> , and <a href="#">Photo 64</a> demonstrate cultural programs and activities in the communities of Rankin Inlet and Arviat.
124	Spill preparedness	<a href="#">Photo 14</a> shows the emergency spill response seacans along the all-weather access road.

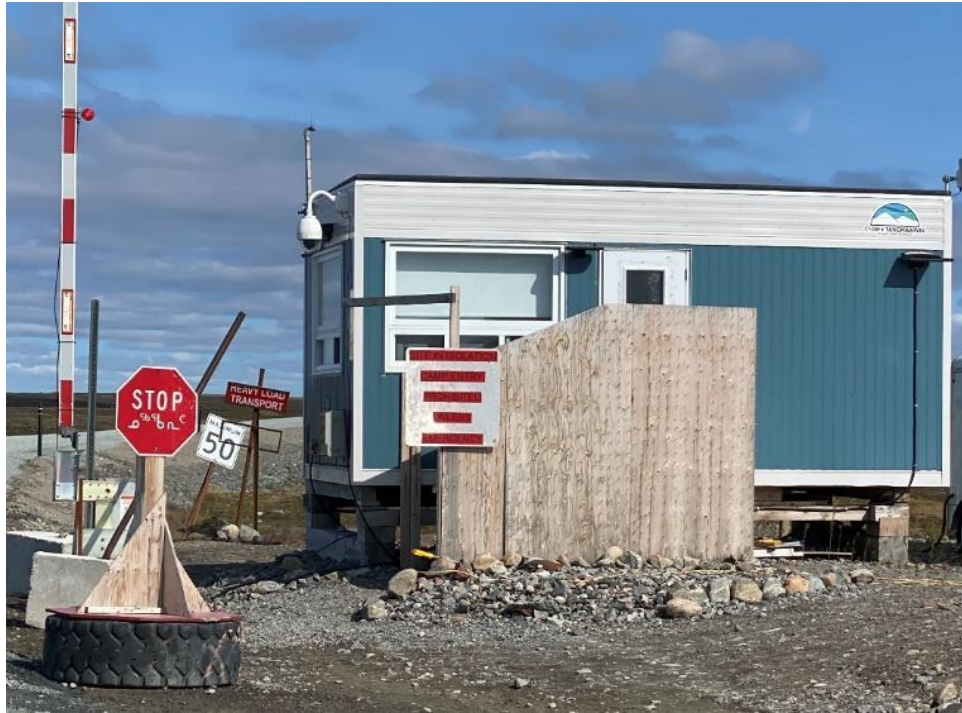
Photo 6: Gatehouse at KM 8

125	Accidents and Malfunctions – All weather access road	<a href="#">Photo 6</a> shows the gatehouse at KM 8 for access to the all-weather access road. <a href="#">Photo 7</a> , <a href="#">Photo 8</a> , <a href="#">Photo 9</a> , and <a href="#">Photo 10</a> show the health and safety, and public usage signage for the all-weather access road.

- In 2020 stop signs were added on both sides of the gatehouse to better control the traffic on the road.

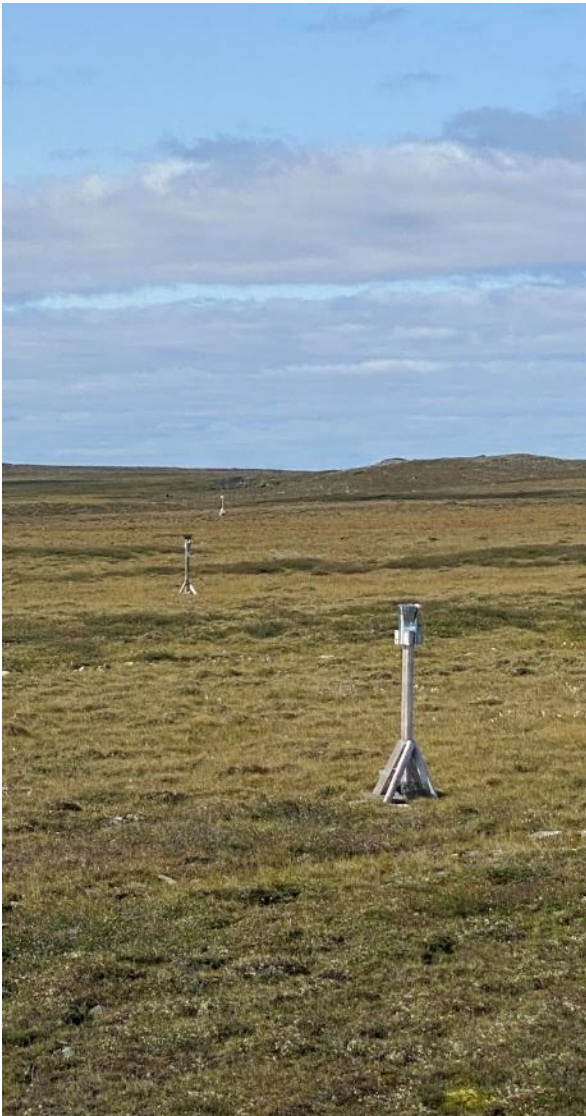
Photo 15: Dustfall Monitoring Transect

T&C No.	Category	Observation
1 & 3	Air Quality Monitoring Plan	<a href="#">Photo 15</a> and <a href="#">Photo 16</a> provide evidence of dustfall monitoring along the all-weather access road. <a href="#">Photo 56</a> shows the equipment used for air quality monitoring.
10 & 11	Noise and Vibration Abatement Plan	Photo 54 and Photo 55 show the equipment used for blast monitoring and noise monitoring, respectively.
25	Groundwater Quantity and Quality	Photo 3 and Photo 4 show the saline effluent discharge facility and filtration station at Itivia Harbour. <a href="#">Photo 34</a> and <a href="#">Photo 35</a> depict the saline ponds for on-site saline water storage.
41	Reclamation and re-vegetation	<a href="#">Photo 51</a> shows the revegetation plot.
61 & 74	Bird Deterrents	<a href="#">Photo 53</a> provides evidence of a bird deterrents.

- Water and calcium chloride were used along the AWAR to limit dust emissions.
- Agnico Eagle restarted monitoring transects south of the gatehouse which were suspended in 2020 due to COVID-19 restrictions.
- The dustfall stands on the Bypass Road were adjusted at certain distances from the road to reflect the updates made in the Air Quality Monitoring Plan version 3 (June 2020).

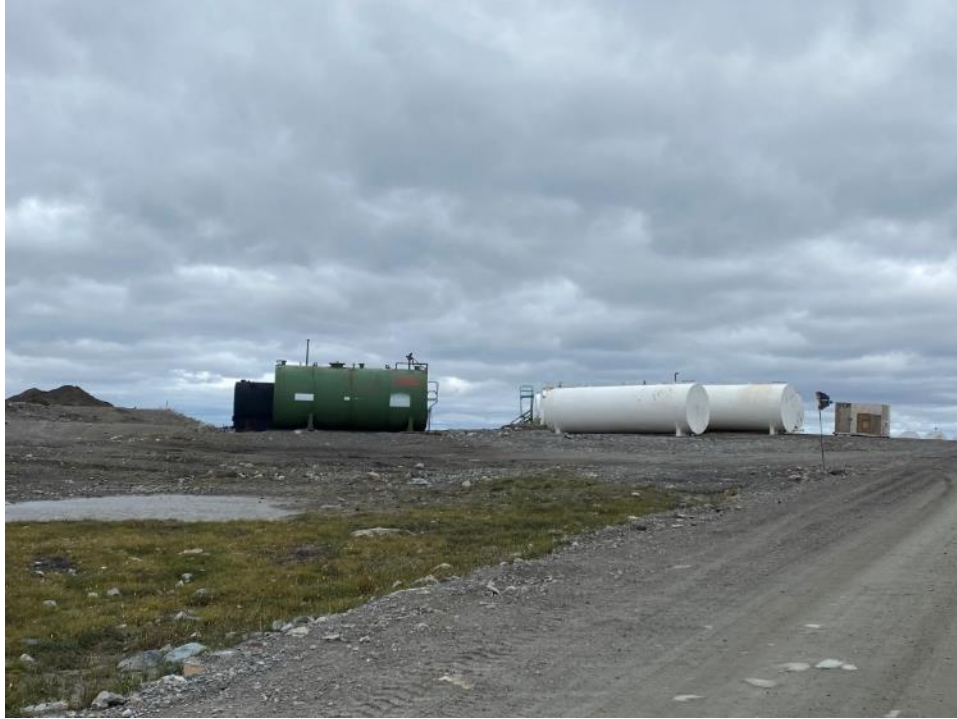
**Photo 21: Exploration Camp Fuel Tanks**

- In the summer of 2021, Agnico Eagle conducted a site clean up around the Exploration Camp (Photo 20).
- Agnico Eagle is evaluating shipping the empty fuel tanks off site. These tanks contained sewage sludge and had a secondary gravel berm constructed around them in case of spills or leaks (Photo 21).
- The rows of contaminated soil in the landfarm were turned (Photo 22).
- On June 4th, 2021, a 250-litre fuel spill occurred at the Exploration Camp core shack due to the failure of a fuel line. In July 2021, dismantling of the core shack building started, to allow soil remediation (Photo 23).

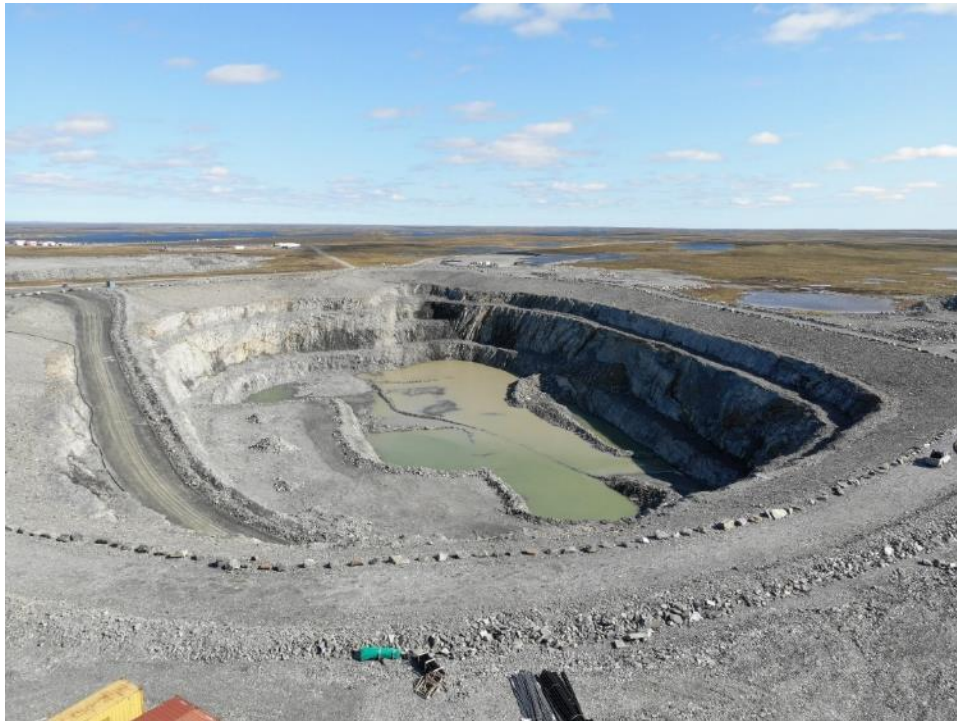
Photo 25: Tiriganiaq Pit 2

- In 2021 Tiriganiaq Pit 2 is being used to store saline effluent from the underground mine (Photo 25).
- A wash bay was commissioned for cleaning of underground and surface equipment.

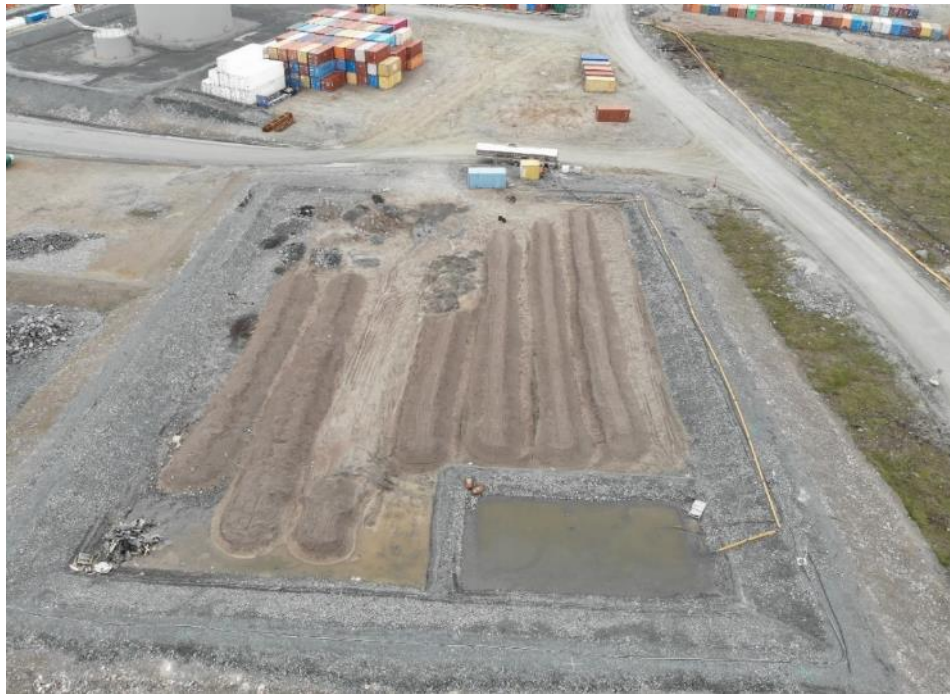
**Photo 40: Landfarm A**

- The temporary sorting pad was used for hazmat sorting in May 2021. As of August 30, 2021, it contains approximately 150 cubic meters (m<sup>3</sup>) of unsorted, contaminated gravel from a recent spill excavation. Agnico Eagle will screen this material prior to deposition in Landfarm A (Photo 40).

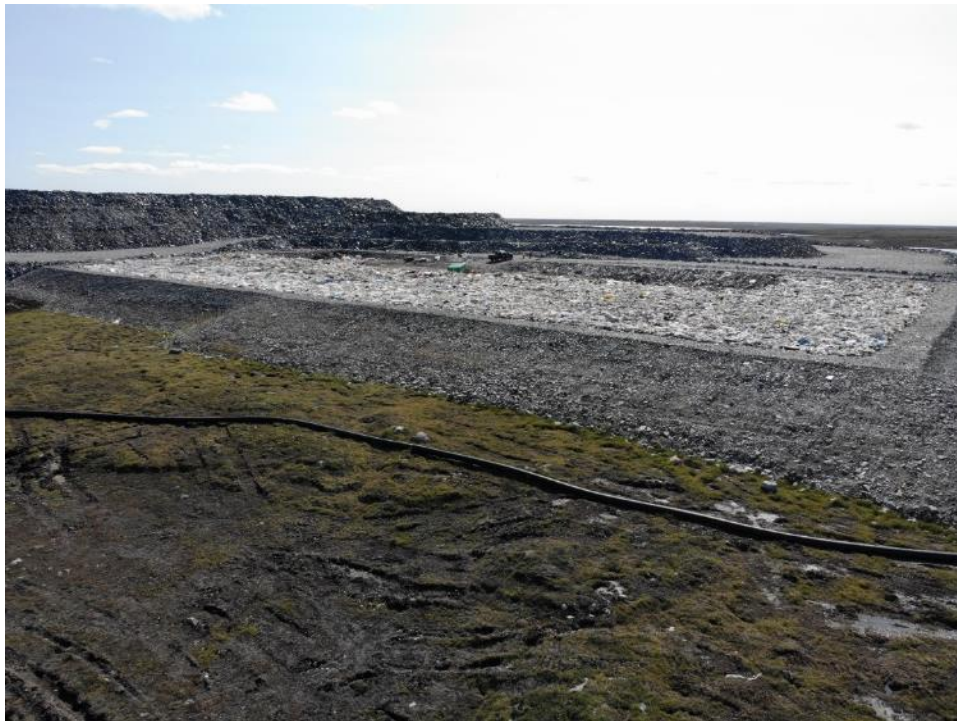
Photo 42: Landfill

- An oil separator system has been installed at the Landfarm A site to treat accumulated sump water (Photo 41).
- A landfill volume survey was completed on August 10, 2021. The current volume is 13,587.7 cubic meters (Photo 42).

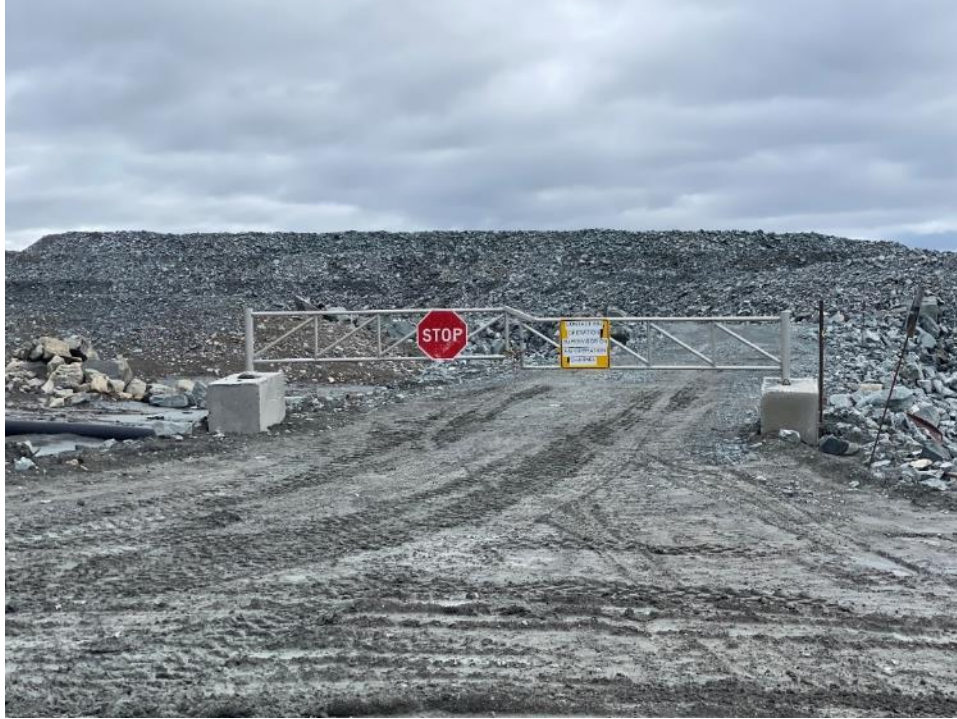
**Photo 43: Landfill Gate**

- A gate was installed to control access to the landfill in 2020. In 2021, no animal deterrents were placed at the landfill (Photo 43).
- Incinerator doors are kept closed to prevent wildlife. During summer, a steel grating is used to keep wildlife out while the door is open to allow heat to escape (Photo 44).

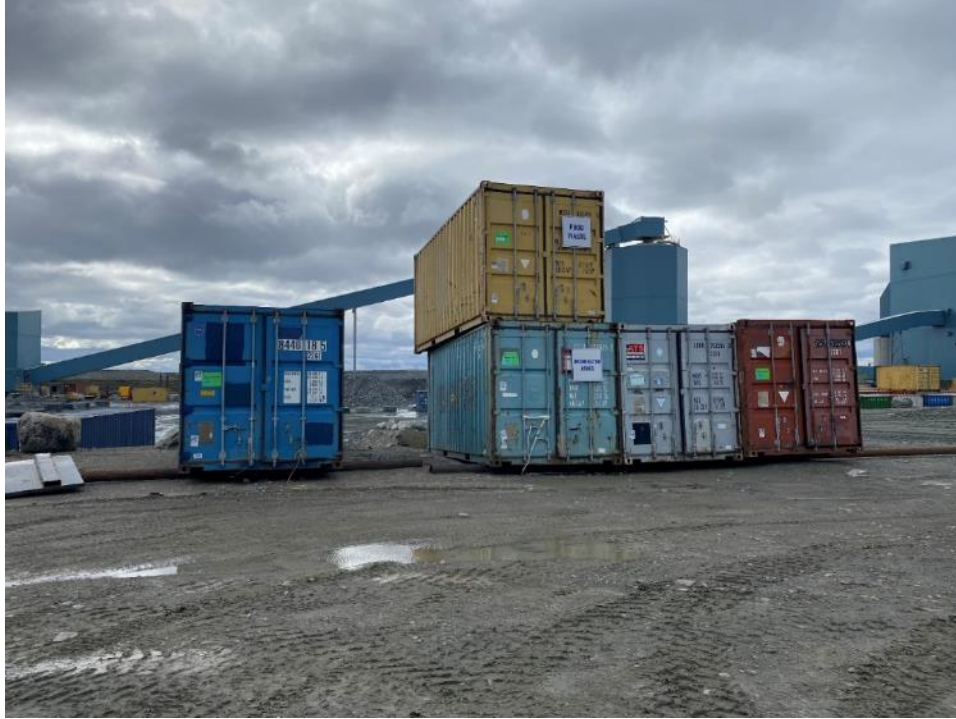
**Photo 45: Example Stacked Food Waste Seacan**

- There is a backlog of food waste on-site to be burnt. In the meantime, food waste seacans are double stacked to prevent any wildlife from accessing them (Photo 45).
