# Nunavut Impact Review Board 2021 Site Visit Report

## **Doris North Gold Mine and Phase 2 Hope Bay**

TMAC Resources Inc.

NIRB File No. 05MN047 and 12MN001

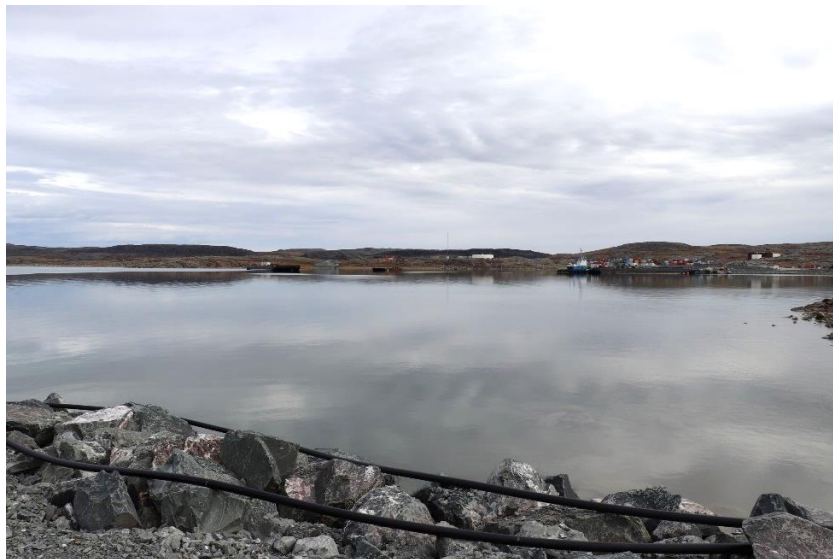
**Photo 3: Roberts Bay**

The Roberts Bay area ([Photo 3](#)) serves as the Project's marine access hub and is linked to the main camp and mine site by a 4.8 km all-weather road. The area is used for staging of fuel ([Photo 4](#), [Photo 5](#), [Photo 6](#)) and supplies in support of the ongoing construction and operation phases of both Projects.

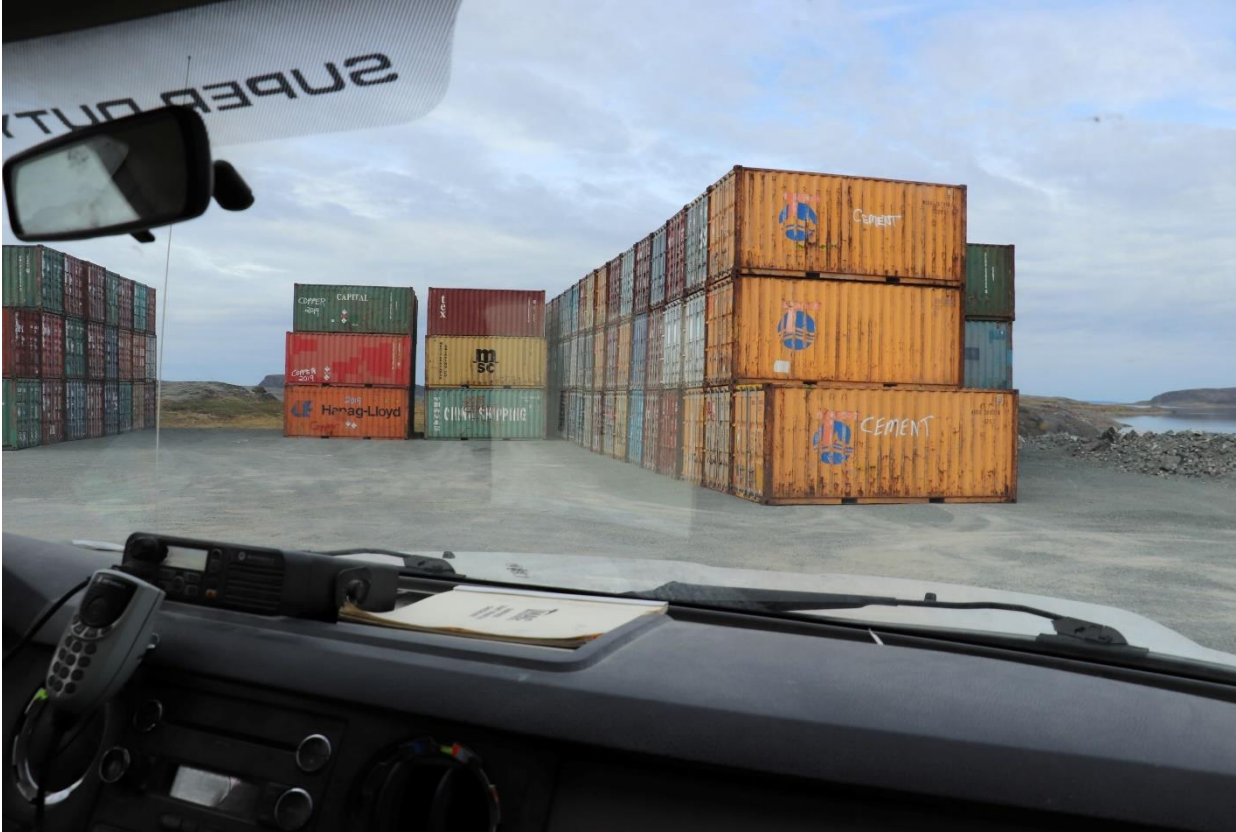
**Photo 7: Seacans at Roberts Bay**

Several hundred seacans were stored at Roberts Bay ([Photo 7](#), example). NIRB Staff were informed that a sealift ship had been chartered to backhaul up to 500 seacans, with most filled with material such as solid waste, metal to be recycled, tires, and contaminated soil, for disposal in the south.

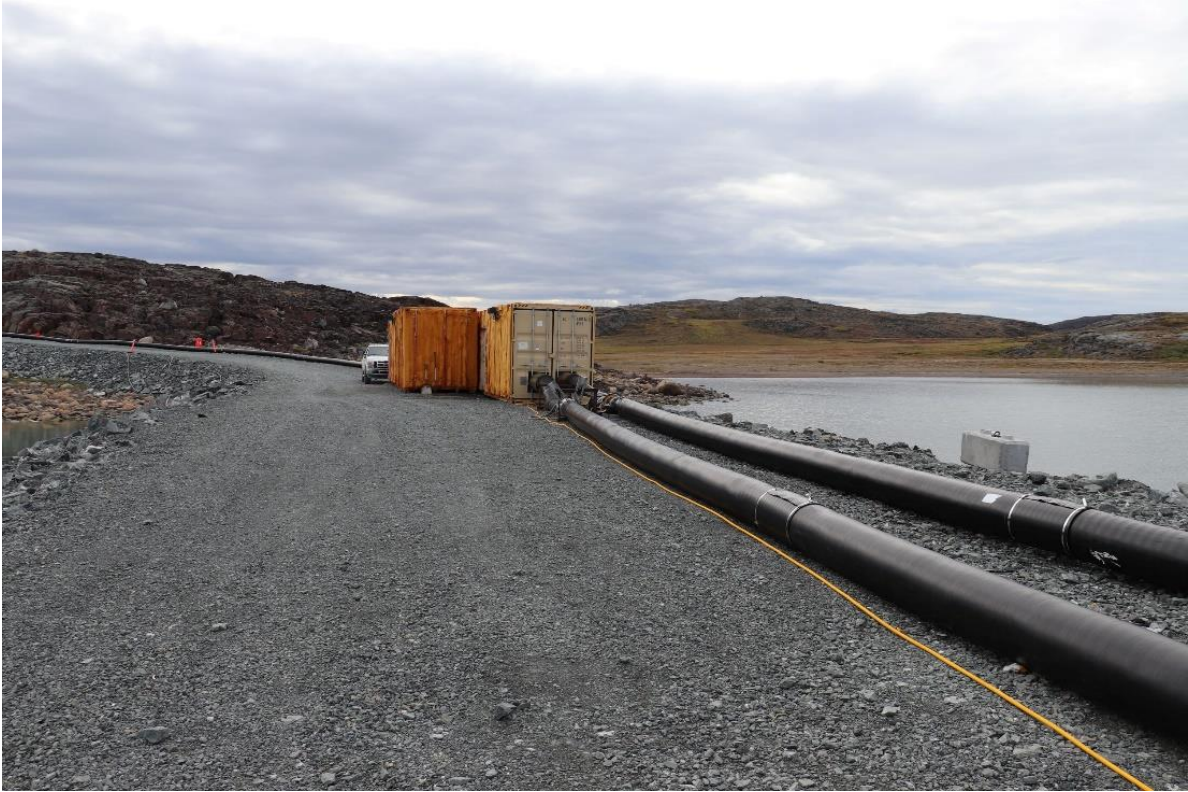
The saline discharge pipeline running from the mine site to Roberts Bay was observed alongside the Main road and proceeding to the outfall jetty ([Photo 8](#), [Photo 9](#)). At the jetty, it was observed that the saline line had been struck multiple times by vehicles turning on the jetty based on the number of impact marks and scratches observed on the pipe insulation. While any damage appeared to be superficial, it is noted as an issue that should be addressed ([Photo 10](#)).

**Photo 8: Saline Discharge Line and Water Recirculation Line**

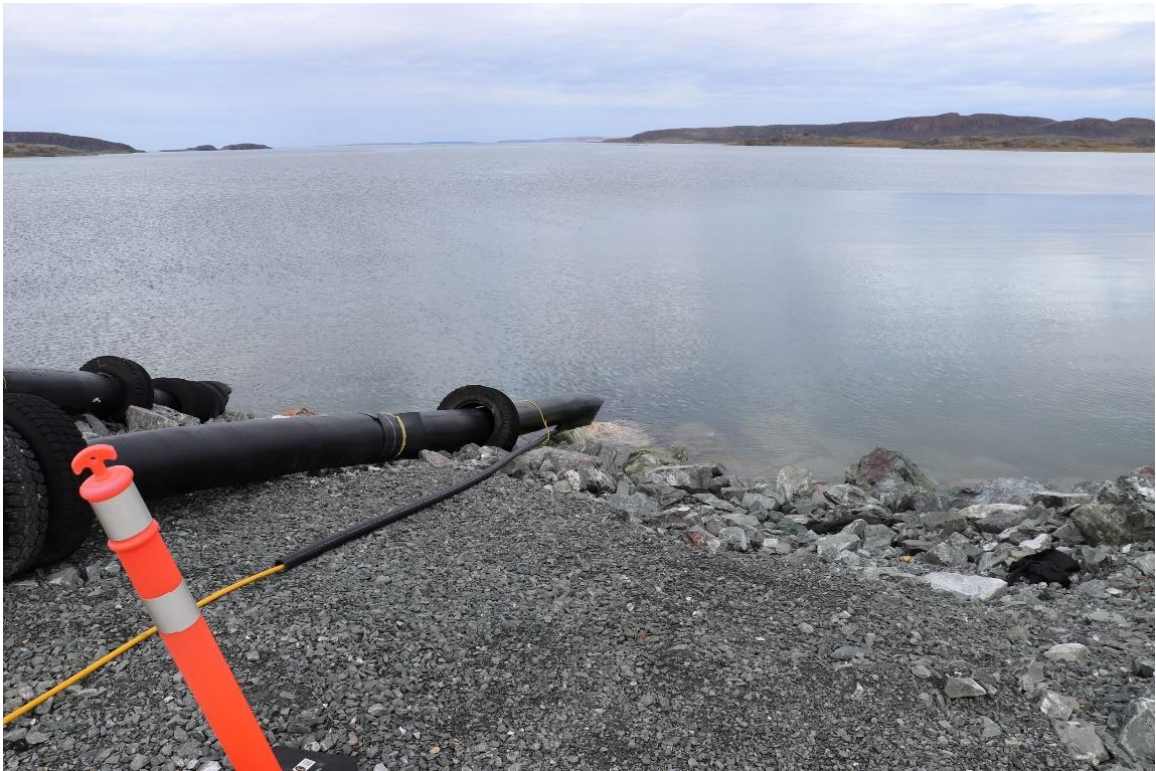
**Photo 9: Saline Line into Roberts Bay**

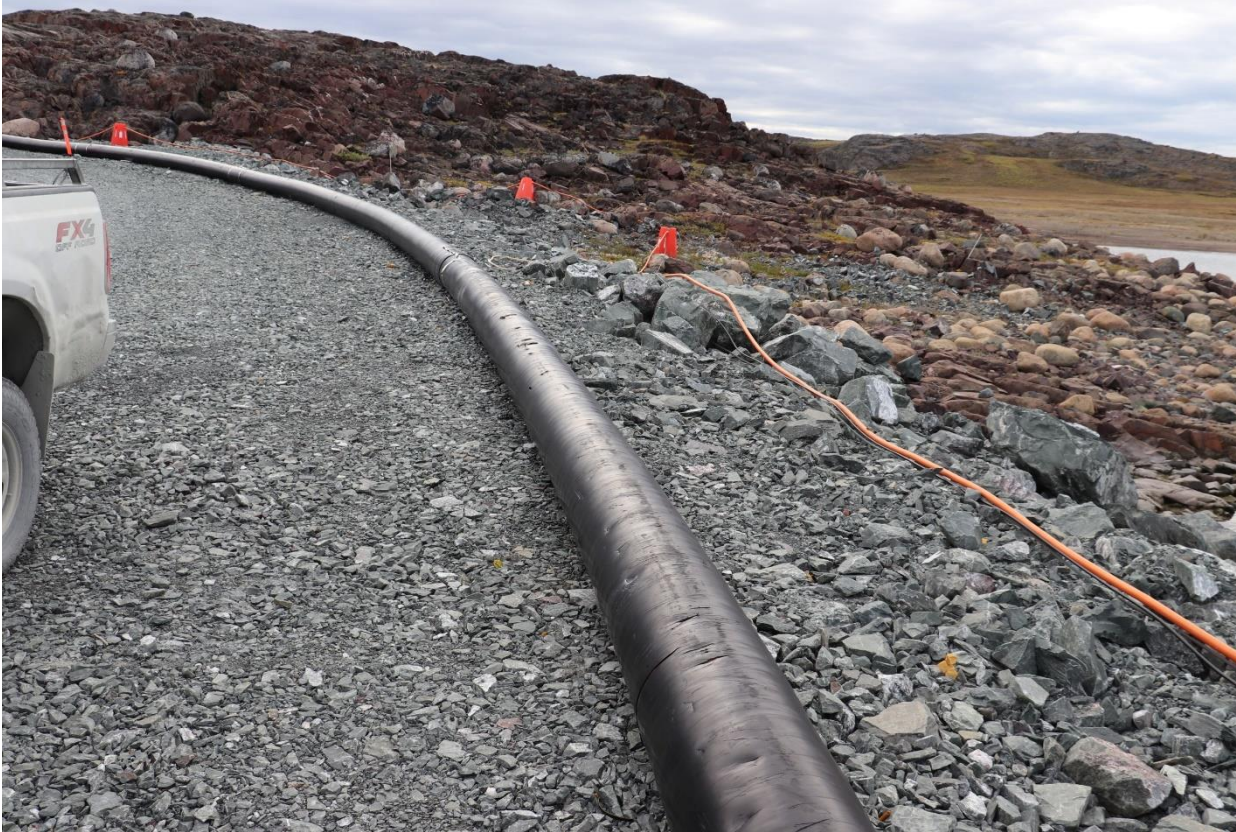
**Photo 10: Damage to Saline Line from Vehicles**

As previously stated, superficial damage was observed on the saline discharge line at the jetty due to vehicles striking it while turning. Adjustments to operations should be considered to either prohibit turning of vehicles on the jetty without a second person to direct the turning vehicle, or to have some form of barrier to prevent the pipeline from being struck by vehicles.

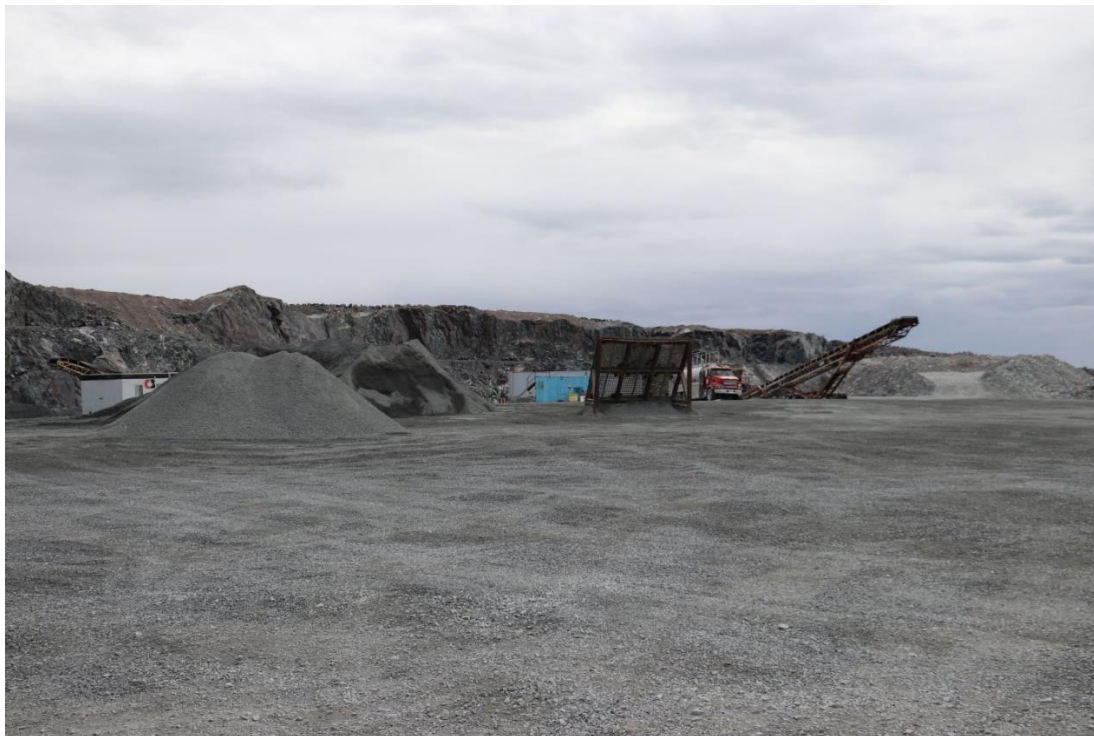
**Photo 11: Quarry 2**

Quarry 2 ([Photo 11](#)) is adjacent to the all-weather road and the sewage discharge outfall is approximately 60 metres west of the all-weather road adjacent to the laydown area south of Roberts Bay. Conversion of the quarried-out area to a landfill has not yet begun, with quarry operations still ongoing. The burn pan ([Photo 12](#)) continues to be used to manage applicable solid waste such as clean wood.

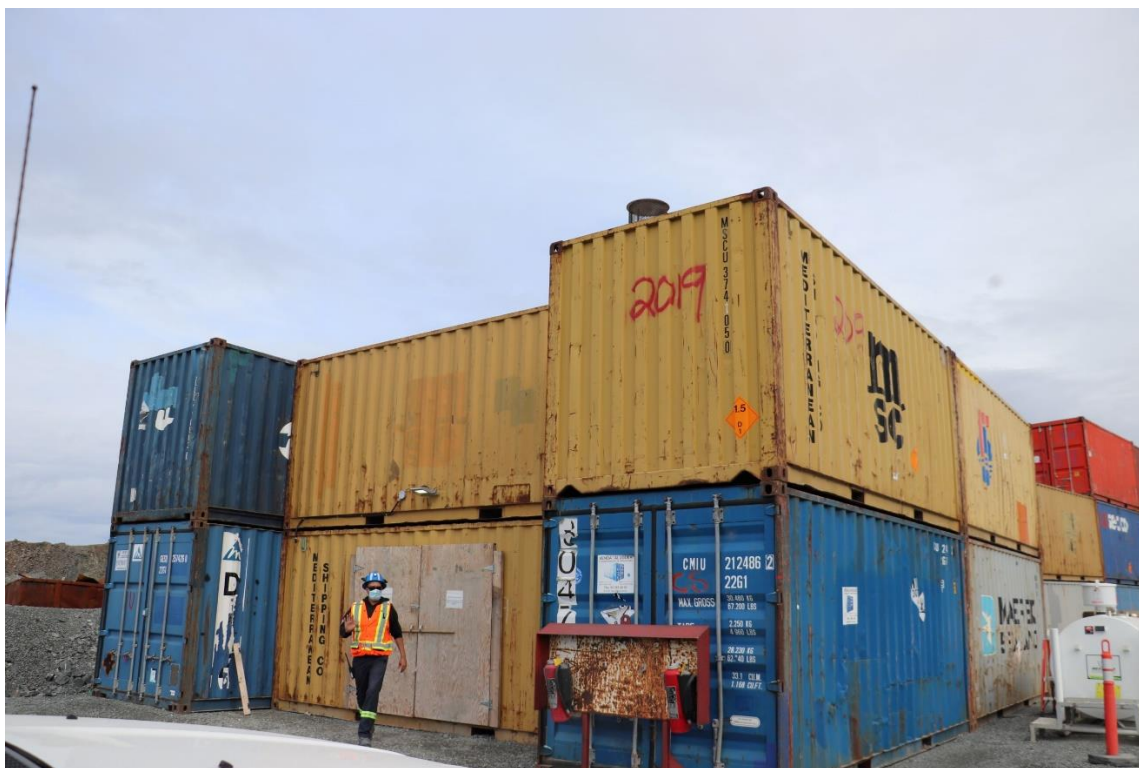
**Photo 13: Incinerator Enclosure**

The incinerator which arrived in 2019 is surrounded by an enclosure made of seacans ([Photo 13](#)), as Site staff reported that operations during the winter of 2019-2020 was extremely uncomfortable for operators as the incinerator was open to the elements. The seacan wall that was constructed offered operators greater protection from wind ([Photo 14](#)), and planning is underway for the construction of a roof to provide additional protection.

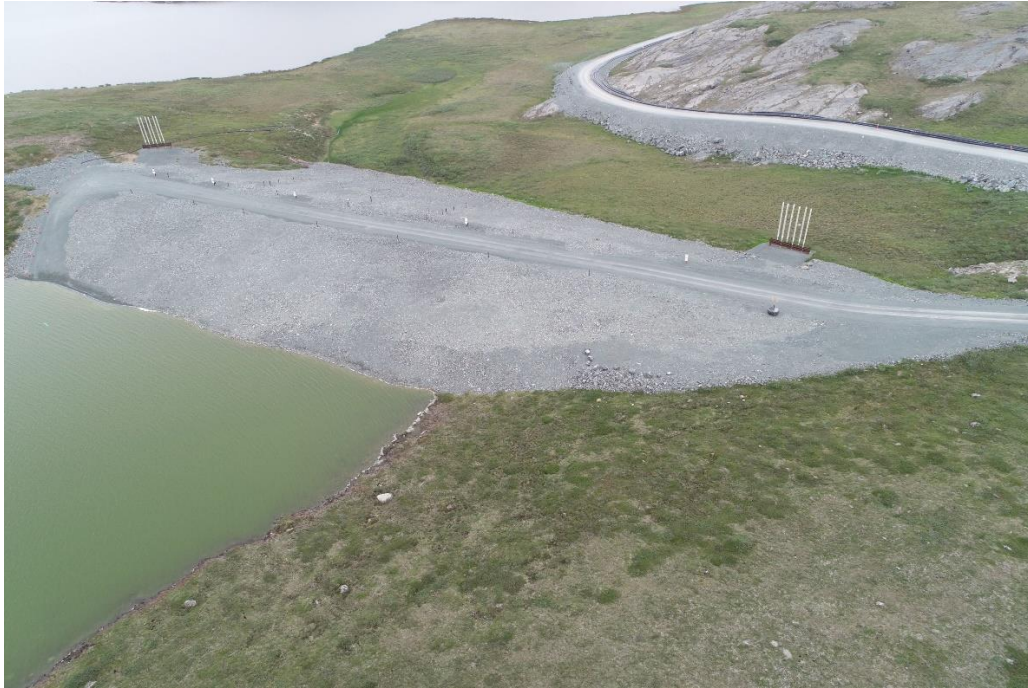
During the 2021 site visit, Site and NIRB staff visited the North ([Photo 15](#)) and South Dams ([Photo 16](#), [Photo 17](#)) at the TIA. Site staff confirmed that monitoring of both dams indicated they were stable with no issues. Stakes are in place indicating the expanded base of the South Dam required for the increase in height, as per the plans for Phase 2 ([Photo 18](#)).

**Photo 15: North Dam (Photo by Agnico Eagle)**

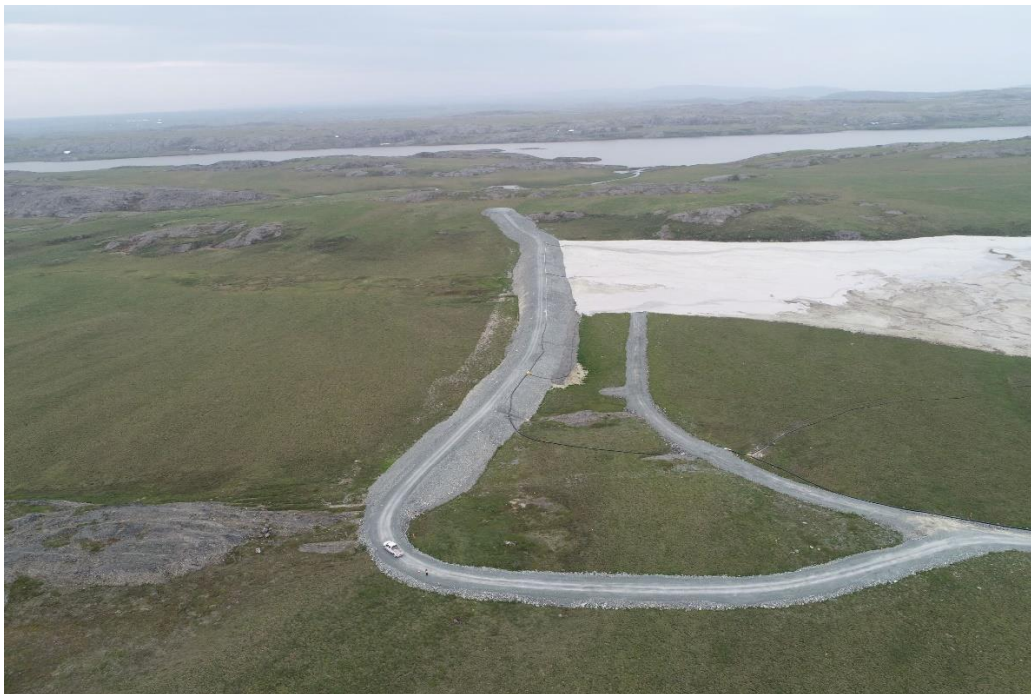
**Photo 16: South Dam (Photo by Agnico Eagle)**

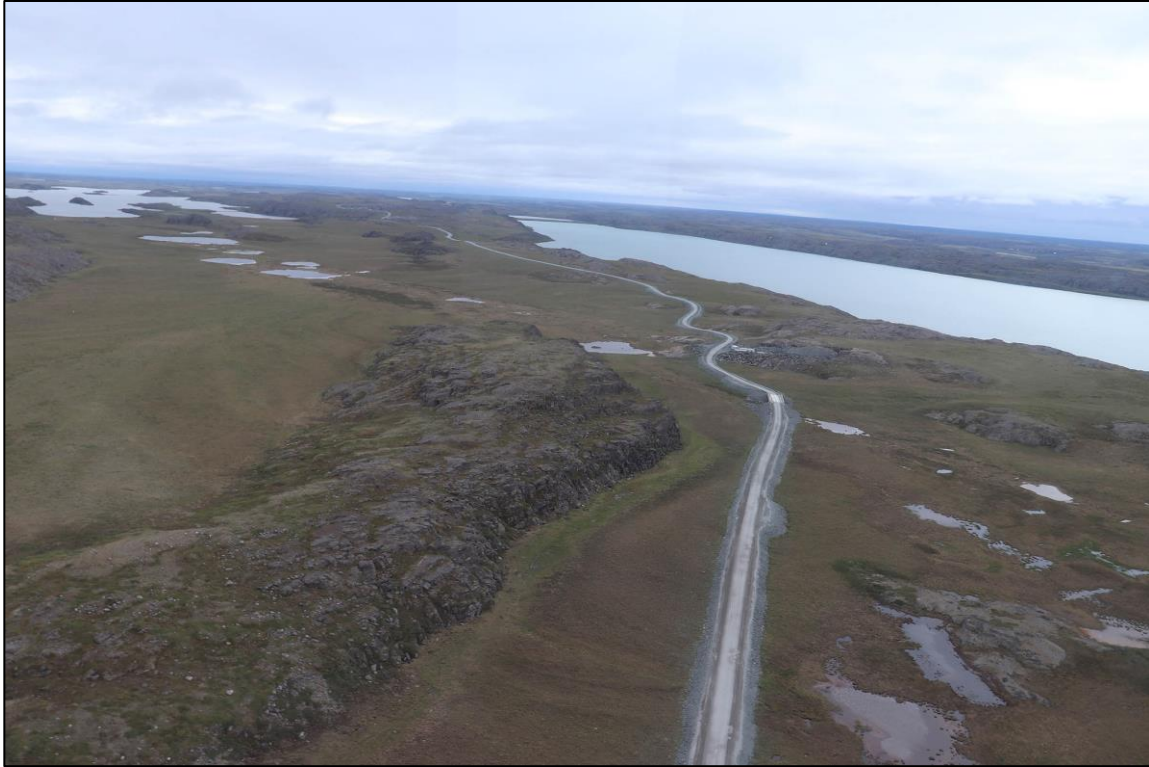
Site and NIRB staff drove the all-weather road to the Madrid North site. The road was in a similar condition as noted in the 2019 Site Visit ([Photo 22](#)).

**Photo 22: Doris-Madrid Road Looking South (2019)**

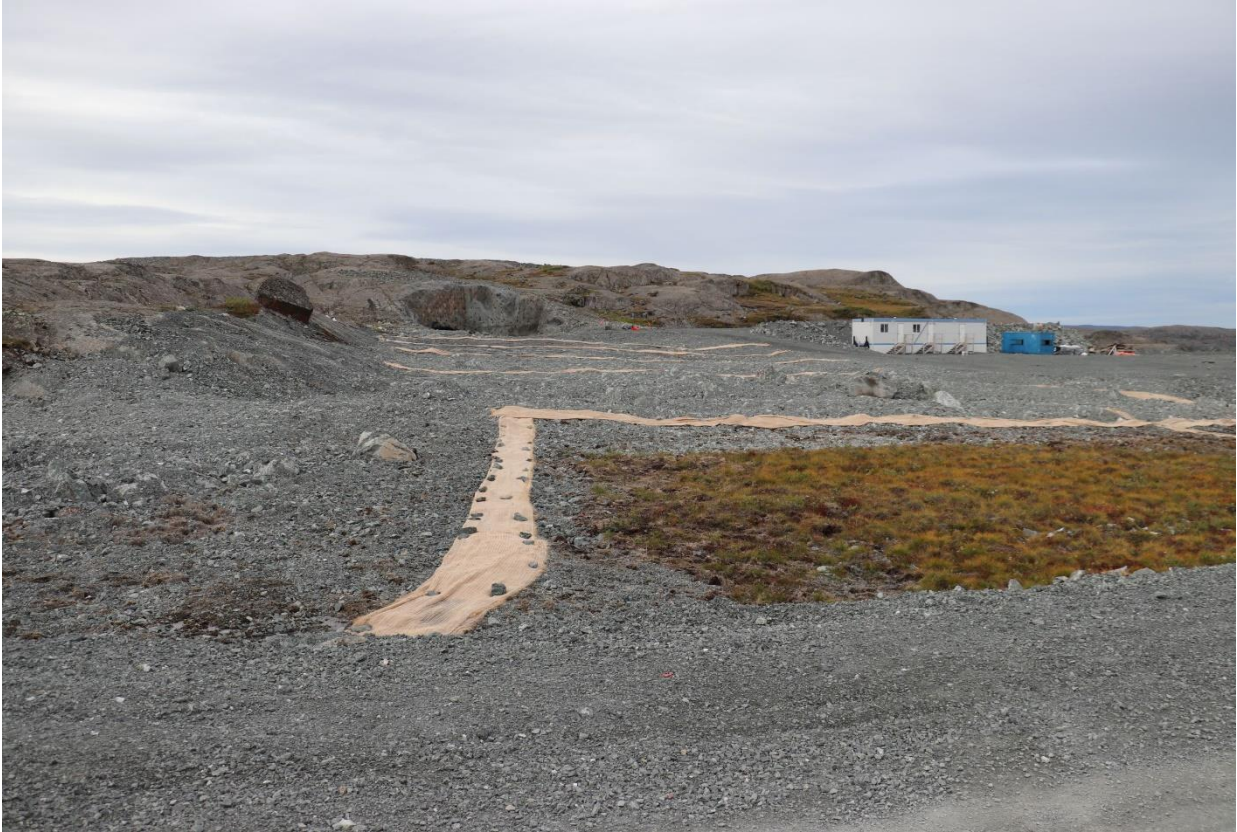
**Photo 23: Madrid Portal**

At the Madrid North site, NIRB staff observed drilling operations in progress to confirm the structure of the Madrid deposits for the re-evaluation of the mine plans for the area. Aside from drilling, no operational activities were being carried out at Madrid. The existing portal was temporarily closed with a curtain, some infrastructure was removed, and the access to the portal from the main road was removed. Coconut fibre mats were placed to control erosion and were functioning ([Photo 23](#)).

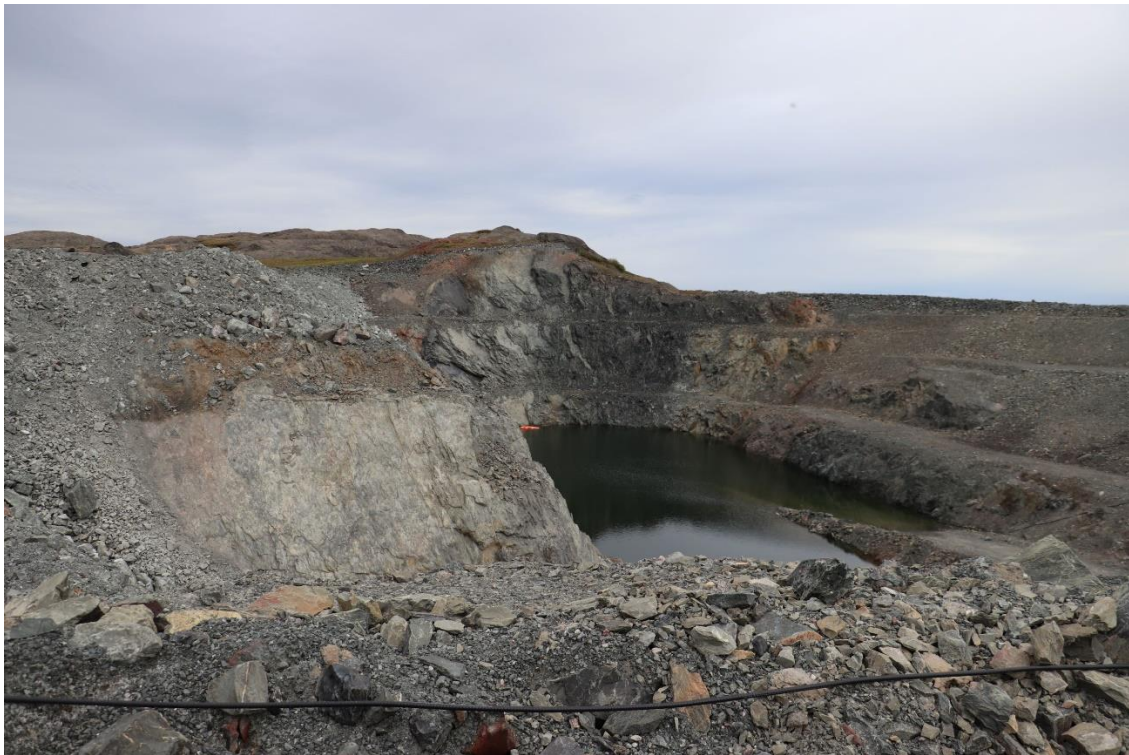
**Photo 24: Naartok East Crown Pillar Pit**

The Naartok East crown pillar pit has water collecting in the bottom and has not been remediated. Site staff indicated that the revised planning for Madrid operations currently underway, was considering the potential of relocating the primary portal to be in the pit, thus no remediation activities will be carried out until final plans are determined ([Photo 24](#)).

During the NIRB's August 2021 site visit, it was noted that the Naartok Crown Pillar Pit does not have any diversion or fencing to prevent wildlife from approaching the pit. As this represents a potential hazard, some form of protection or diversion should be considered to reduce the risk of wildlife injury and the NIRB will track the issue for future site visits.

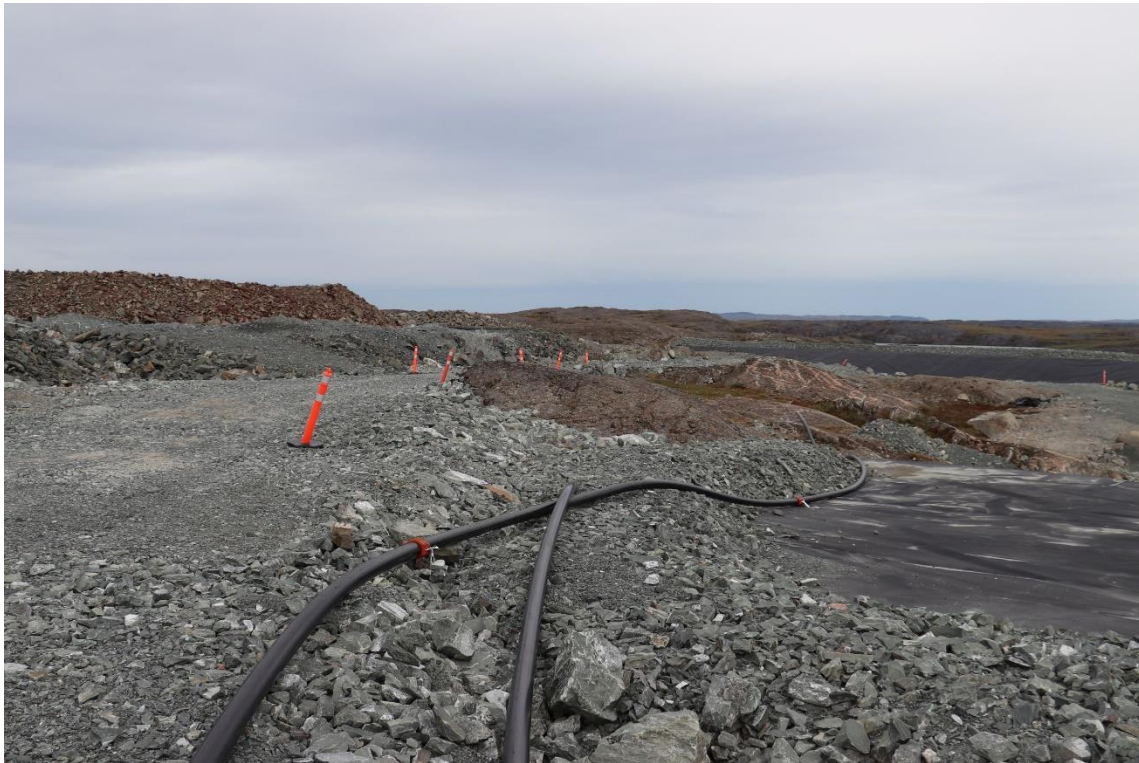
**Photo 25: Madrid Waste Rock Pile Contact Pond**

The waste rock pile was in use while construction was carried out at Madrid and the contact water pond associated with the pile was dry at the time of the 2021 site visit. Site staff indicated that a potential leak had been discovered with water emerging from the toe of the pond berm during spring melt, potentially from an undiscovered fracture in the bedrock. An engineering study is to be carried out to identify if this is the case and develop mitigation measures as required ([Photo 25](#)).
