ANNUAL REPORT:
Ulu Gold Project
Exploration and Progressive Reclamation
20EN001
2BM-ULU2030

Kitikmeot Region, Nunavut

March 2022

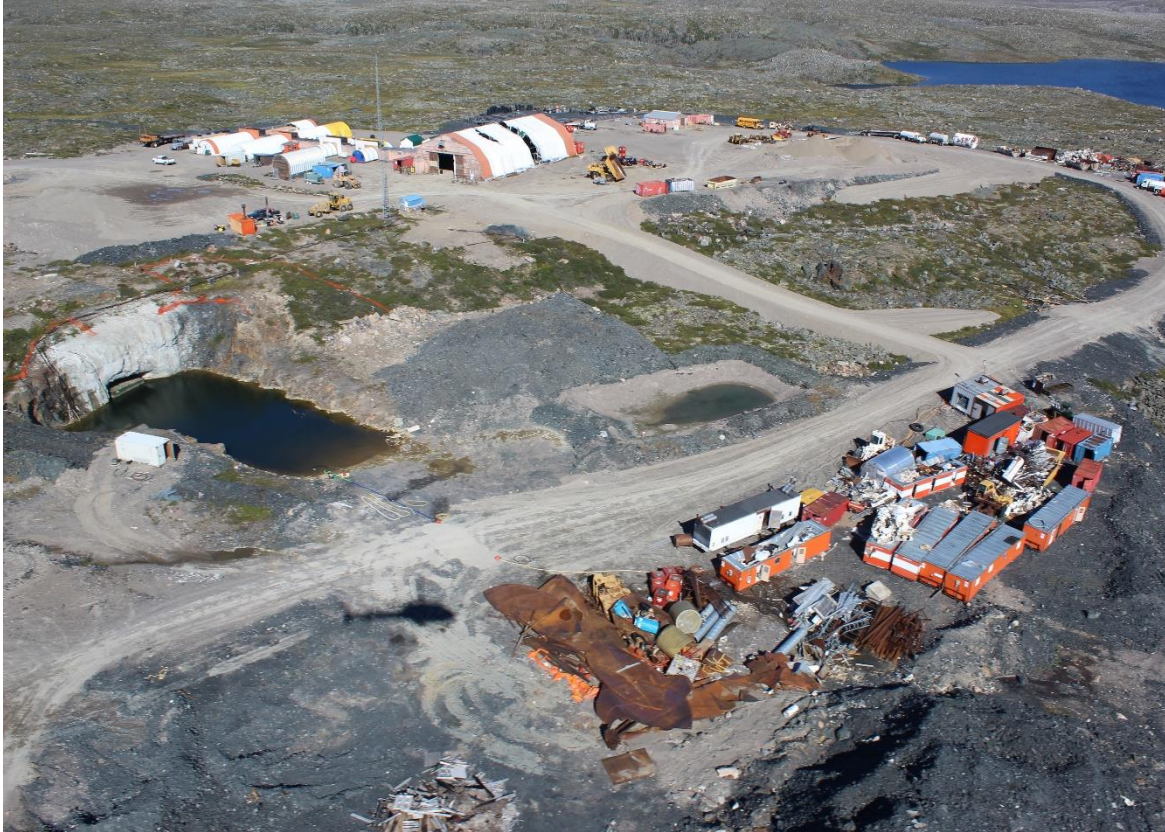
Photo 3. Legacy waste, lower landfill staging area, portal and mine sump.

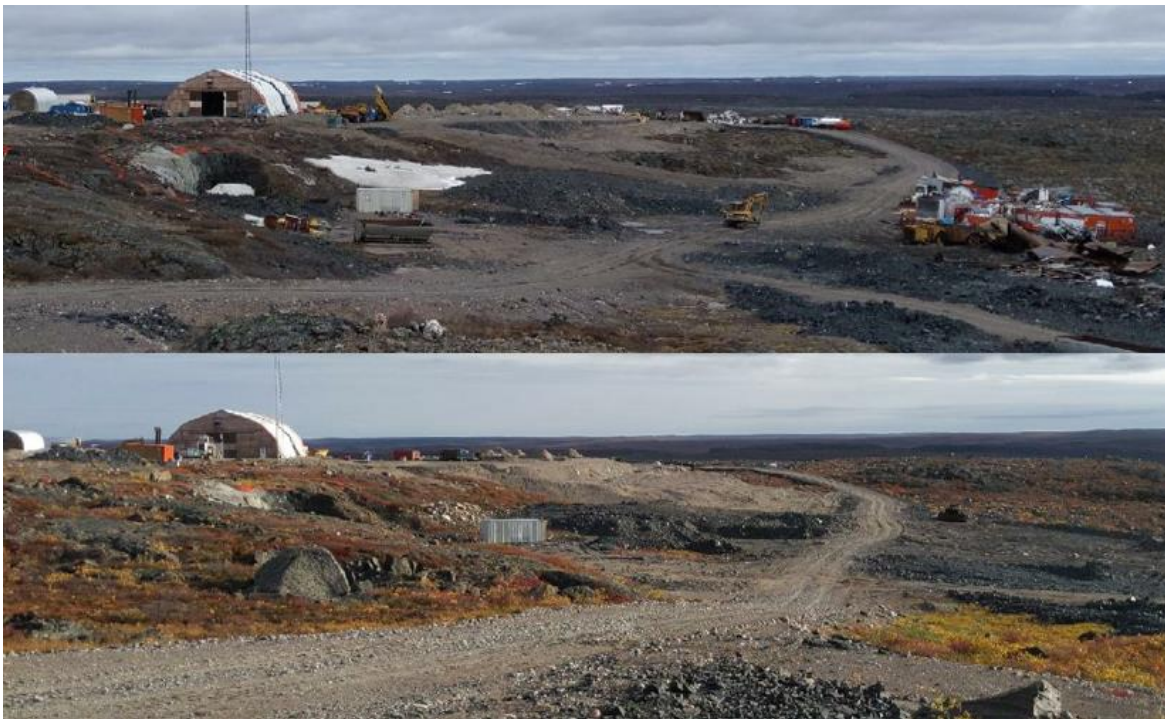
Photo 4. Ulu landfill area, before and after.

The landfill base was prepared by removing boulders and placing esker and contaminated soil meeting subsurface criteria to create a base for safe operation. All of the legacy waste, with the exception of the camp, shop, equipment currently in use and a few additional pieces of heavy equipment, were placed in the landfill. Contaminated soil meeting surface and subsurface criteria was placed in the landfill accordingly, and an interim esker cover placed on top. Altogether, 12,785 m³ of material was placed in the landfill including waste, esker fill and interim cover. All landfilling occurred according to the approved *Landfill Management Plan*.

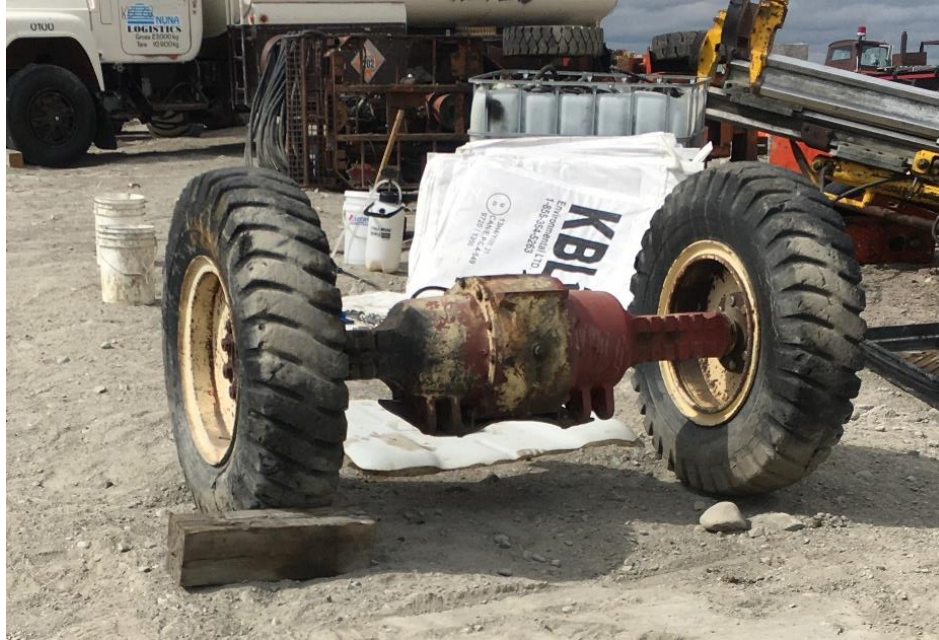
Photo 5. Equipment deconstructed for safe draining, washing and disposal in the landfill.

The surface fleet was assessed by qualified heavy duty equipment technicians, and critical and preventative maintenance and repairs were ongoing throughout the season. Retired equipment was decontaminated (flushing, removal of components, surface washing), and broken down into smaller pieces in preparation for landfilling. Photos of the equipment decontamination are provided in Appendix C.

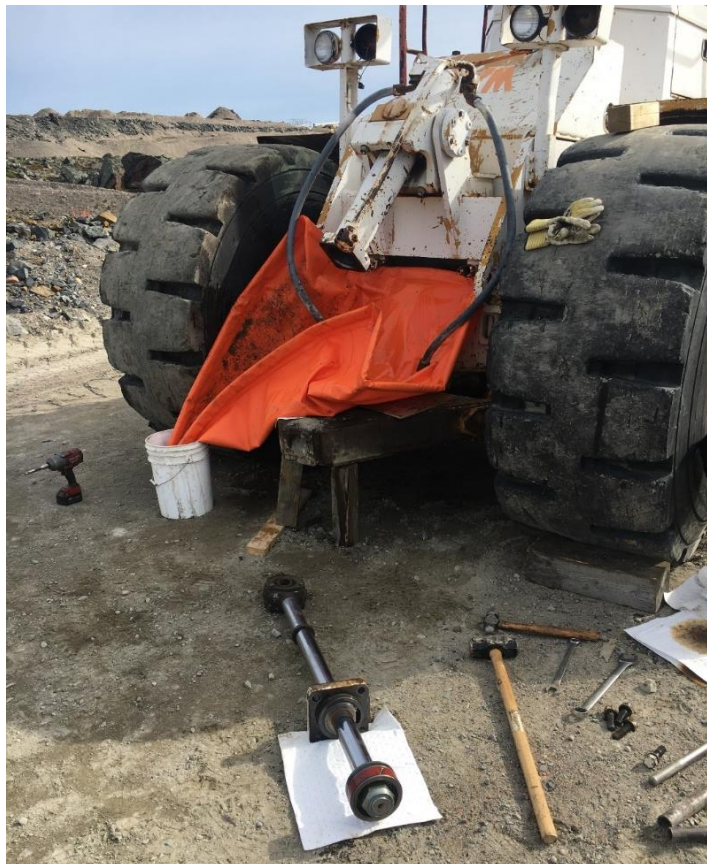
Photo 6. Equipment drained of fluids prior to disposal in the landfill

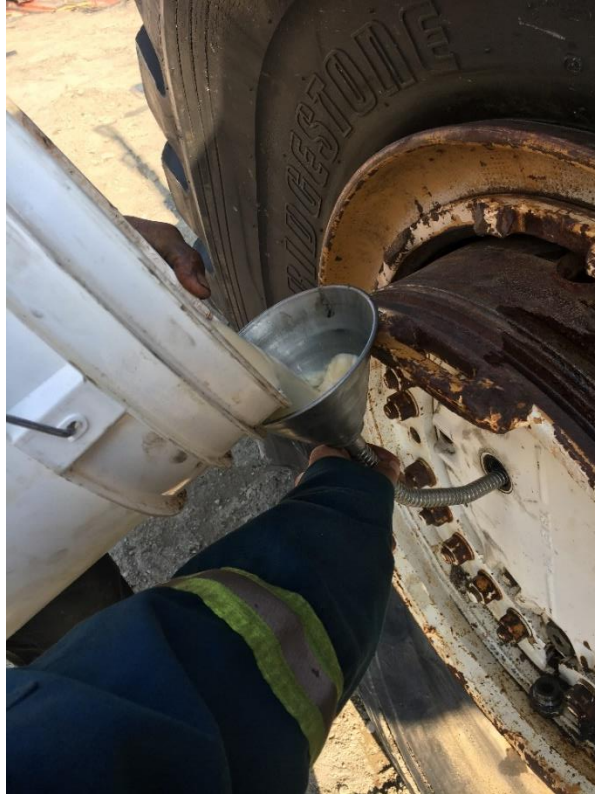
Photo 7. Following draining, fluid reservoirs on each piece of equipment were flushed to remove residual hydrocarbons prior to disposal in the landfill.

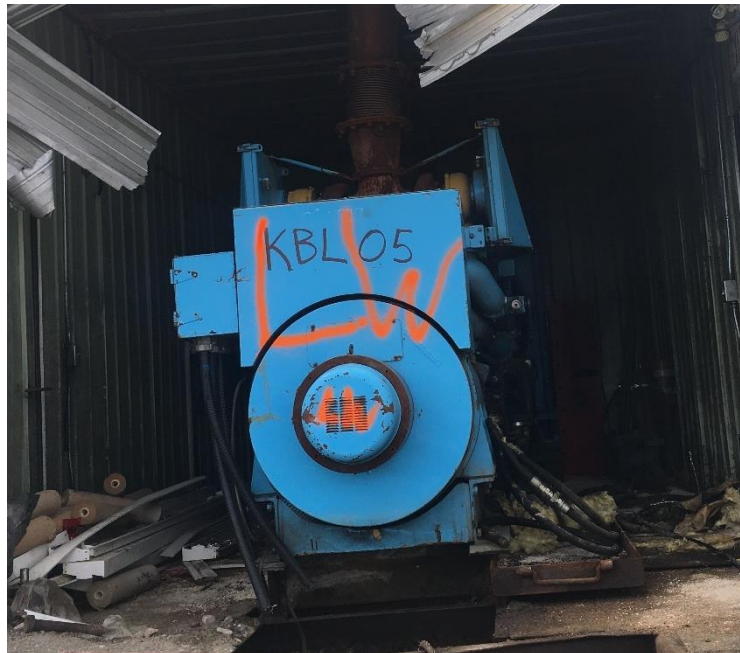
Photo 8. Prior to draining and flushing, each piece of equipment was marked with a unique identifier (i.e. KBL05). Following draining, flushing and inspection, each piece was signed off (i.e. LW) and marked ready as for disposal in the landfill.

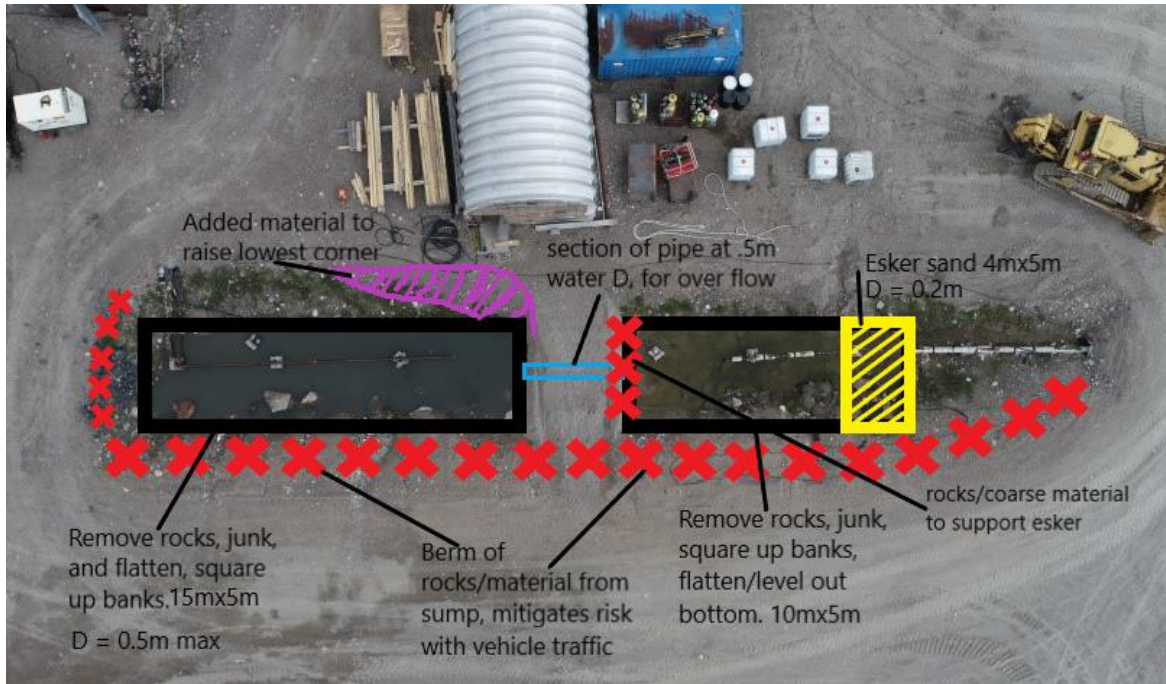
Photo 9. Improvements made to Ulu greywater sump

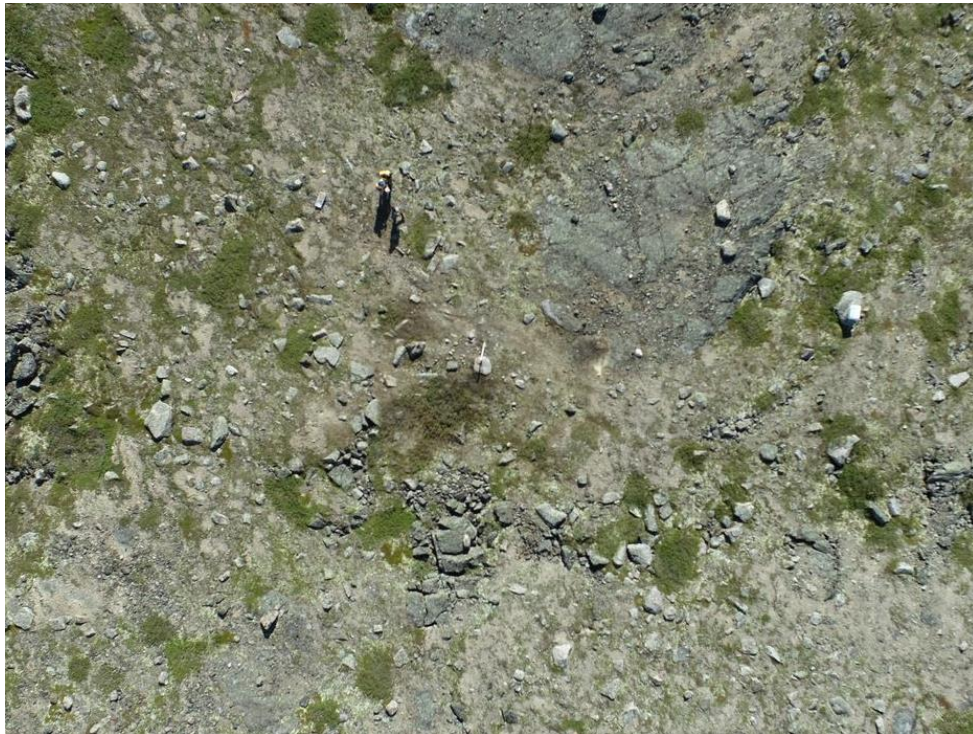
Photo 12. Aerial view of a drill site, post-drilling. Collar remains in place for future drilling (centre of image).

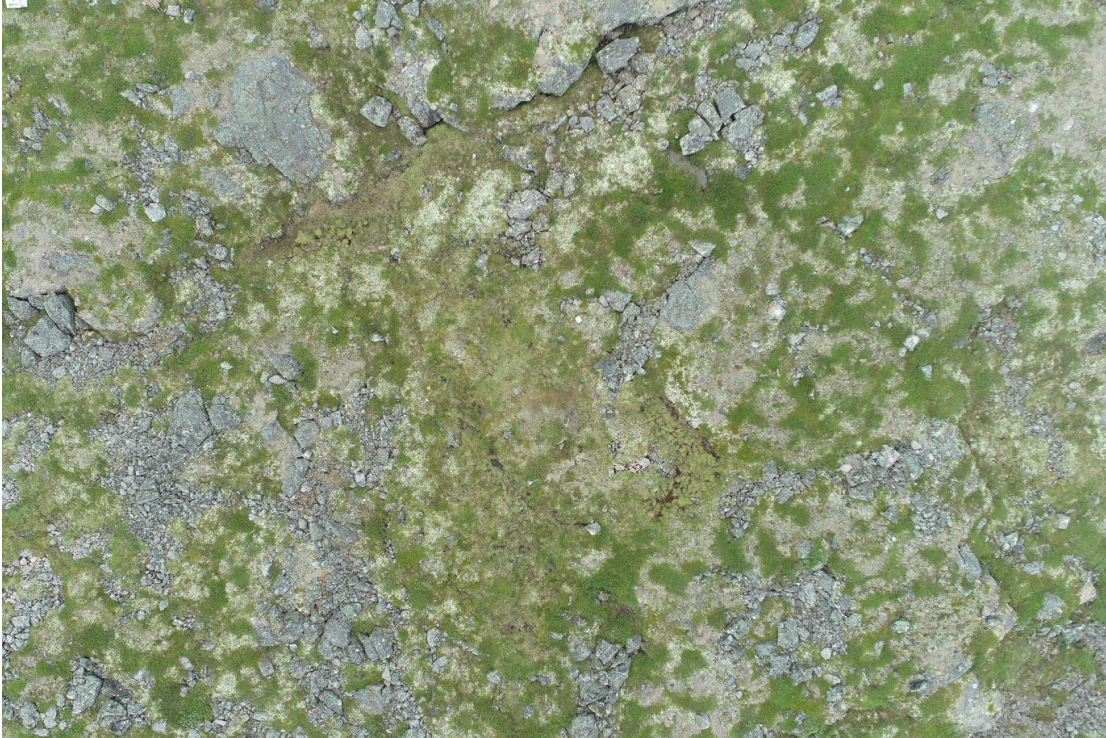
Photo 13. Aerial view of a drill site, post-drilling, collar removed

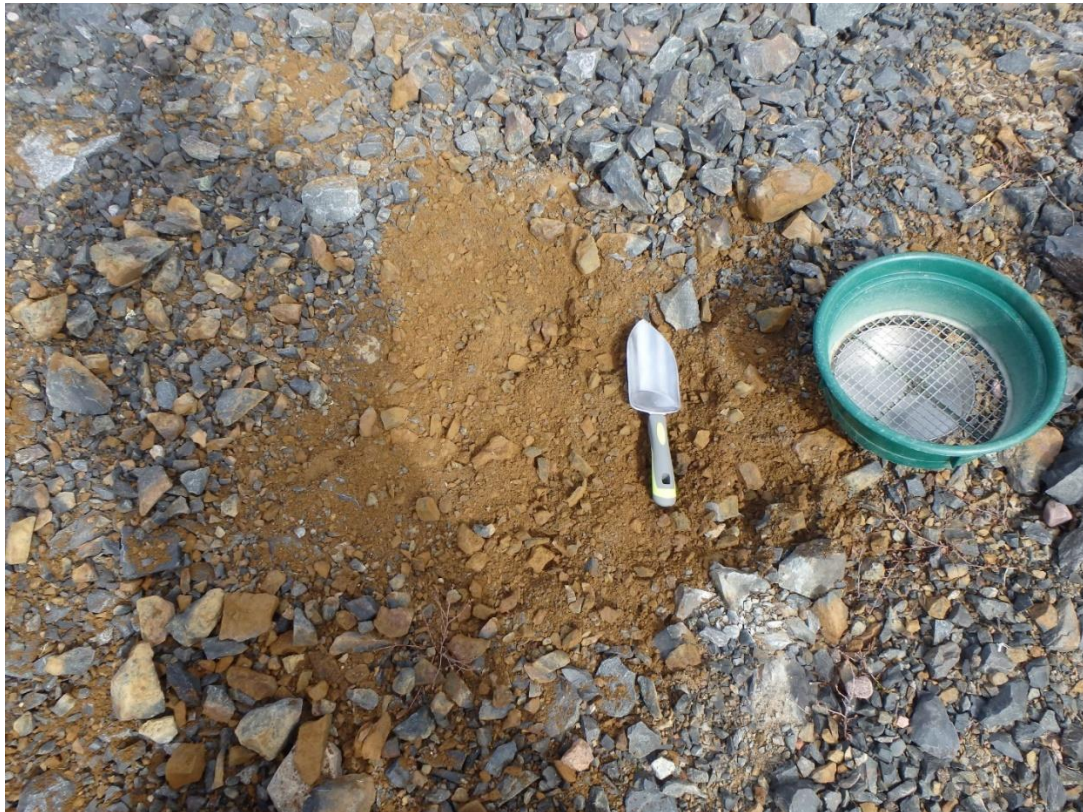
Historic water licence inspection reports (CIRNA 2015, CIRNA 2016, CIRNA 2017a) indicate that road washouts were observed along the road to the airstrip (Culvert 6) and near former Camp 3. The inspector indicated in 2017 that ore was reportedly used to repair the washout and requested confirmation to the Inspector and the NWB that construction materials used were from an approved source and free of metal leaching and acid rock drainage (MLARD; CIRNA 2017b). The previous owner's follow-up report (BCC 2017) disputes the use of waste rock in the repairs and indicates that confirmation of construction material characteristics would be provided in 2018. To date, no such records have been found. Accordingly, Blue Star undertook to have its project geochemist conduct a field reconnaissance of all infrastructure including the Culvert 6 and Camp 3 road repairs to identify areas where potentially acid generating (PAG) rock may have been used in construction.

Both the Culvert 6 and Camp 3 road repair locations were found to have PAG, intermittent flow and are located upstream of fish bearing waters. Given the potential for ARD and release of a deleterious substance harmful to fish, remedial measures were undertaken in September: the road bed and shoulders were excavated to remove PAG rock, and the road bed reconstructed with non-PAG esker materials. PAG rock that had rolled downslope from the road during past repair work was collected by hand to the greatest extent possible. Sediment and erosion control measures were in place throughout construction, water quality monitoring was undertaken, and silt fencing remains in place. PAG rock removed from the road bed has been relocated to the ore pad and temporarily stored with other PAG rock.

Photo 14. Visible oxidation in road bed at Culvert 6.

Blue Star confirms that materials used for road repairs were from an approved source, being the quarry licenced under KTCA20Q004, and are geochemically suitable as reported to the NWB in 2020.

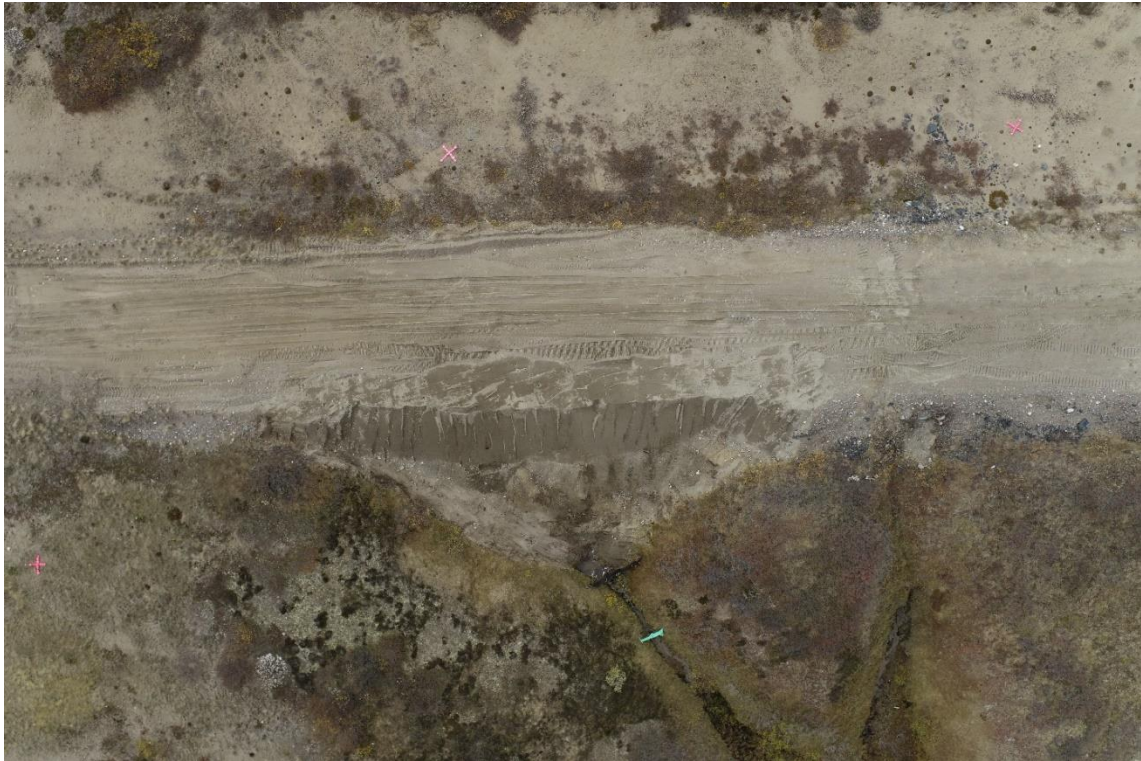
Photo 15. Completed road works near Camp 3
