Nunavut Impact Review Board

2022 Site Visit Report

Back River Gold Mine Project

NIRB File No. 12MN036

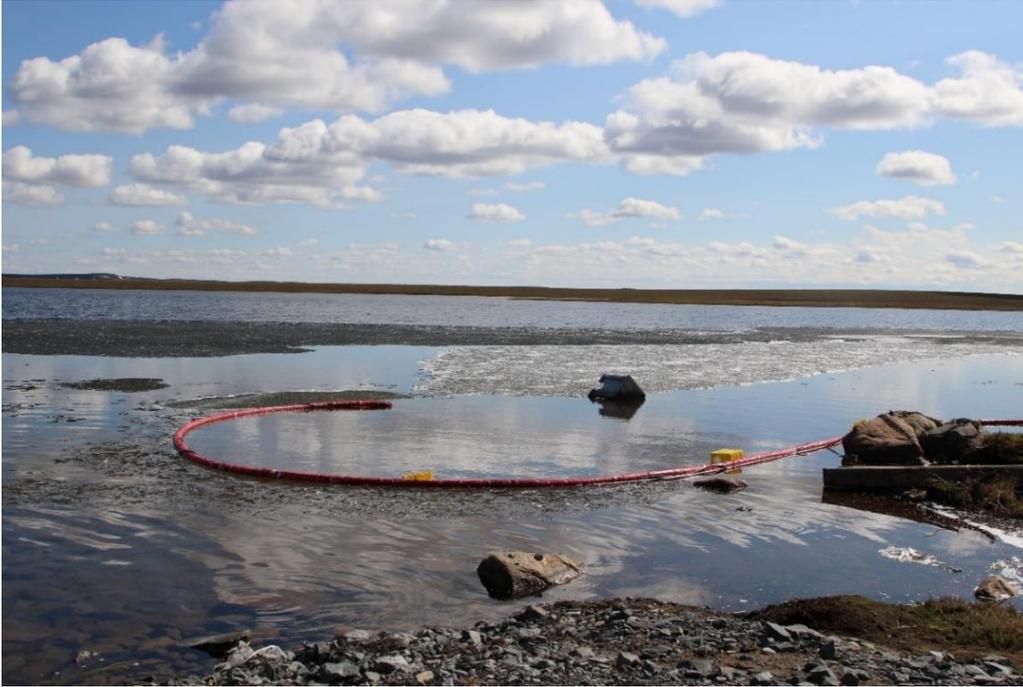
The water intake for the camp comes from the Goose Lake (Photo 3). Mr. Keefe advised the Monitoring Officers and CIRNAC that Sabina's intake of water is under the total permitted. NIRB and CIRNAC staff observed that the structure used to keep the waterline open in the winter was submerged; however, it was to be removed in the coming days as the ice had melted off Goose Lake. Sabina Staff confirmed that the water intake was covered by a screen.

Photo 3: Water Intake into Goose Lake

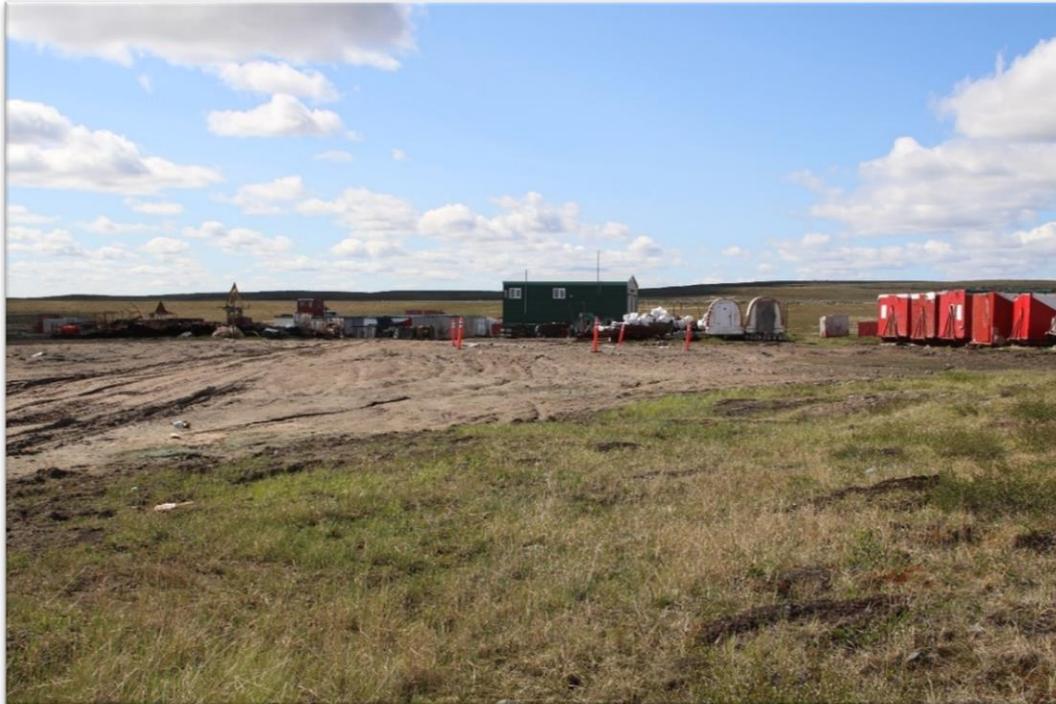
The drilling laydown area for Sabina's contractor is located south of the exploration camp (Photo 5). It is composed of a maintenance shop and storage buildings. Next to the drilling laydown was the past exploration site and future Goose Pit which Sabina had conducted trenching in 2018 (Photo 6). All the explorations were decommissioned, and the area remains erosion control. NIRB and CIRNAC staff noted some damage to the tundra (Photo 7) next to the exploration site from runoff. The sump within the footprint of the proposed Goose Main Pit has signs of erosion where down slope there is ponded water and vegetation appeared discoloured.

Photo 5: Drilling Laydown Area on Goose Main Pit

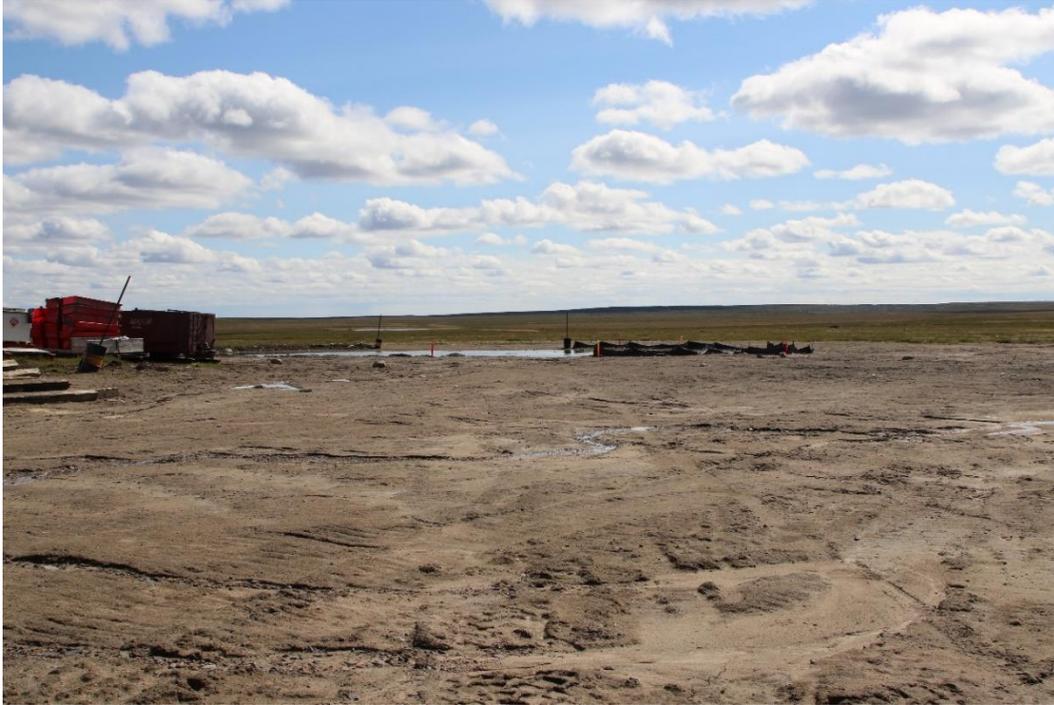
Photo 6: Future Pit with Sump and Erosion Control

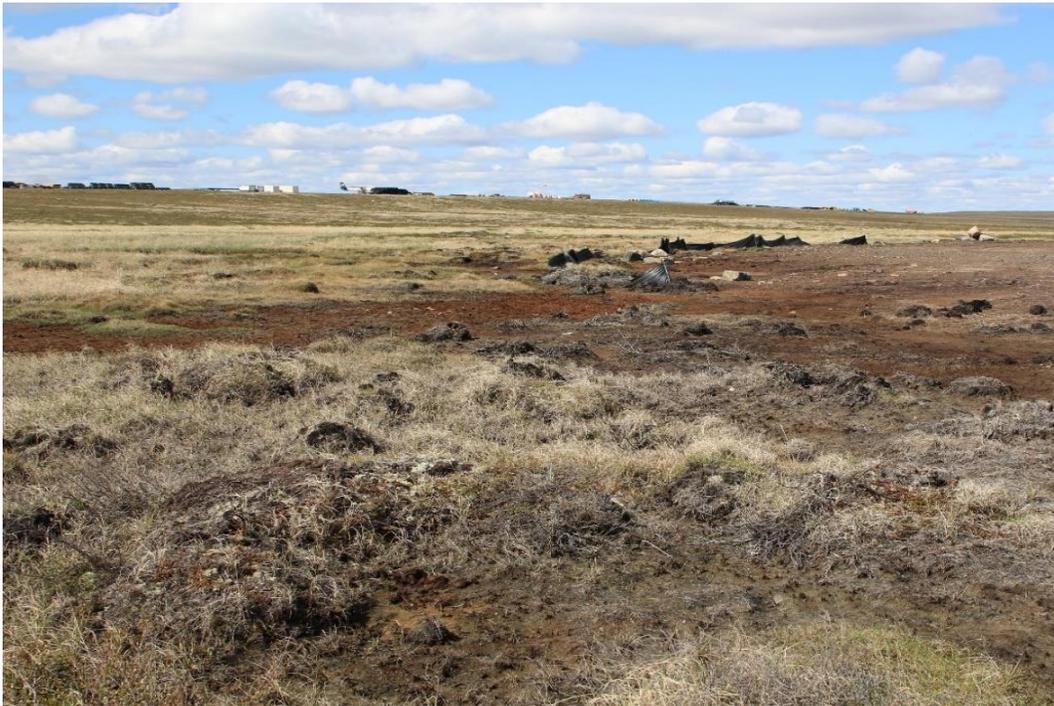
Photo 7: Discolored Tundra Downslope of Sump

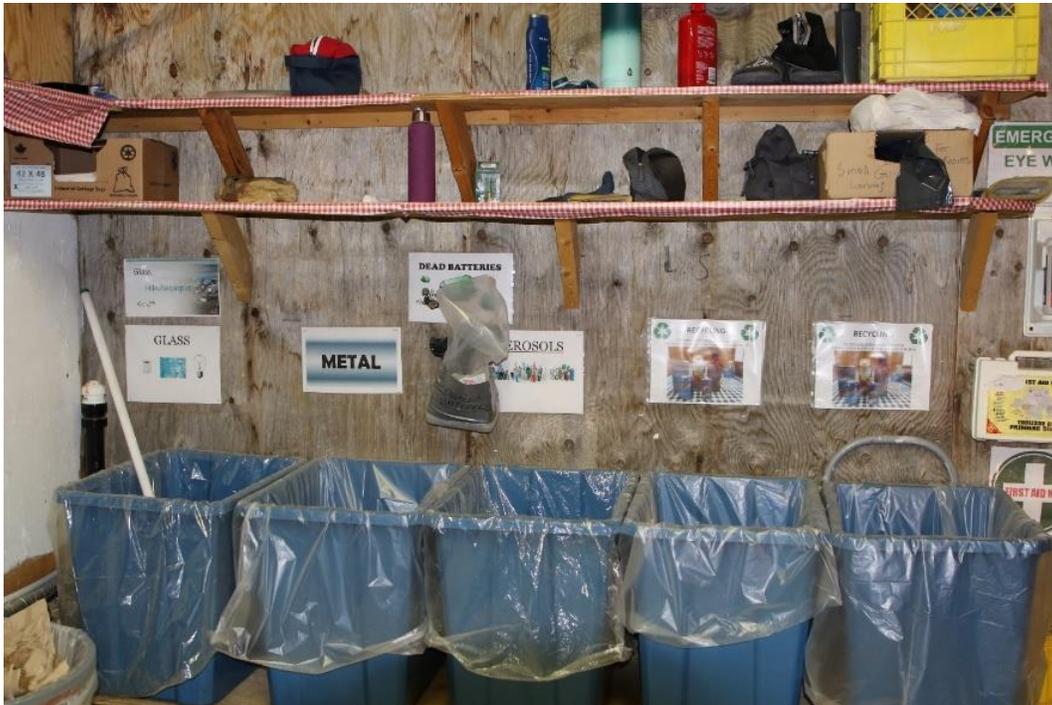
Within the Goose camp, waste is segregated as shown on Photo 8 with combustible and non-hazardous waste sent to the incinerator (Photo 9), and clean wood and cardboard to the burn box (Photo 10). Outside

Photo 8: Waste Segregation at Goose Camp

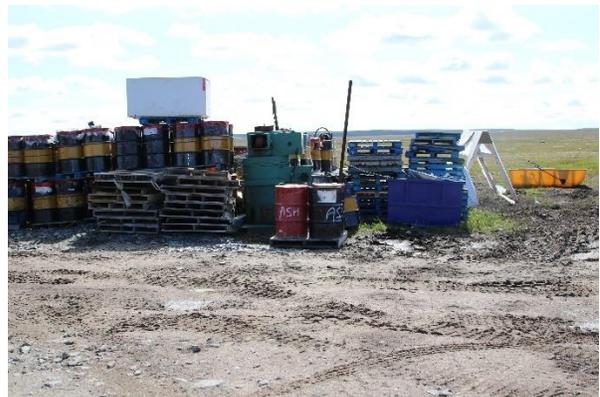
the incinerator, other waste segregation containers were placed for non-combustible waste (Photo 11). Currently the ash from the incinerator is stored (Photo 12) and will be tested when Sabina has its permanent landfill where it will be disposed if it meets criteria.

Photo 12: Stockage of Ash and Other Non-combustible Waste

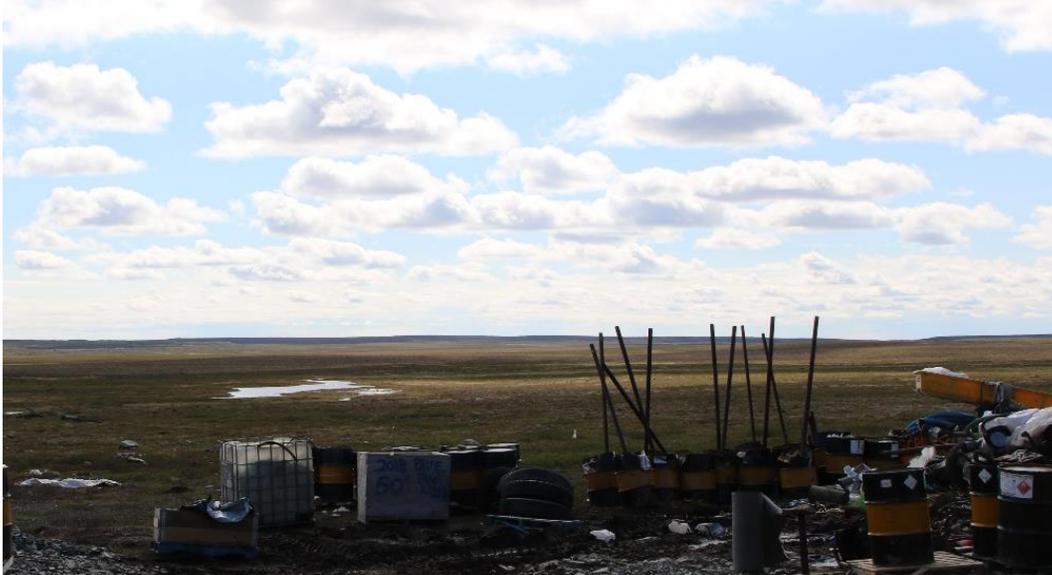
Some non-combustible waste is stored in this area and moved via the winter road to the Marine Laydown Area to be shipped off site. Some non-hazardous materials are to be disposed of within the Goose Pit Waste Rock Pile; however, as mining has not yet started, Sabina had the temporary landfill beside to the incinerator at camp where materials would be stored temporarily before being moved to the Goose Lake Quarry until mining starts. During the site visit, NIRB and CIRNAC staff observed that some of the waste material in the incinerator temporary landfill was food and fuel containers. CIRNAC advised the Proponent and Sabina committed to remediating the situation as soon as possible as this did not follow the *Back River Project Landfill and Waste Management Plan* and may be a wildlife attractant.

Photo 13: Temporary Landfill Next to the Incinerator

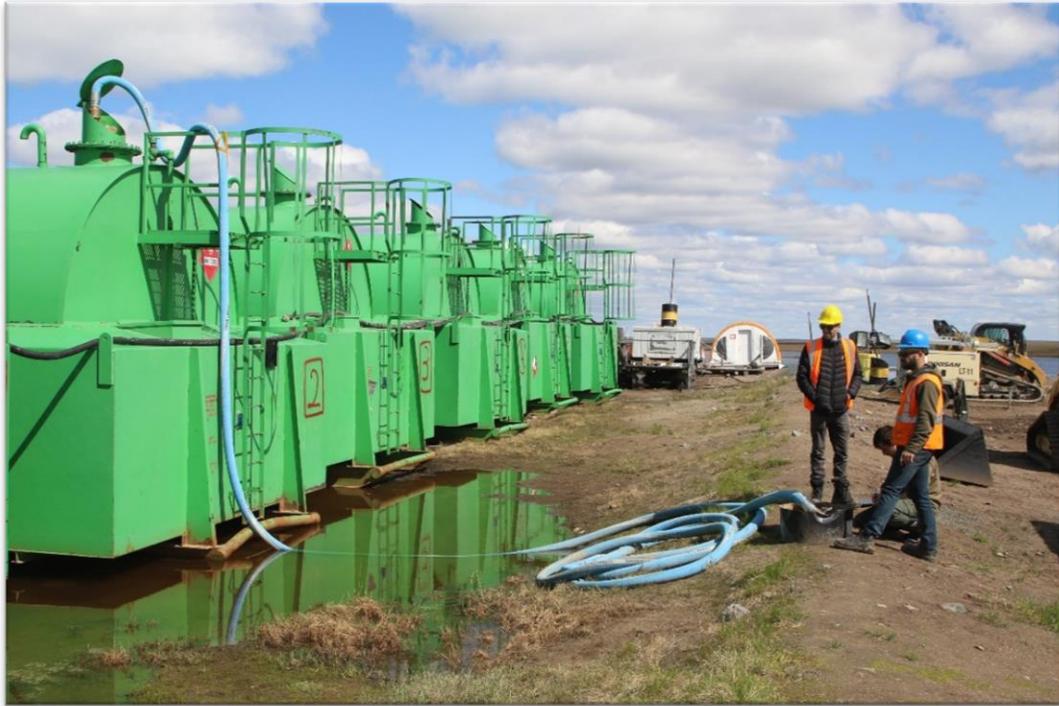
Overall, the bulk diesel fuel and hazardous materials were well managed at Goose Camp. Bulk diesel fuel was contained in double walled tanks within a containment (Photo 14). Some ponding was observed as there had been rains in the days prior to the site visit. Should the water become an issue (*i.e.*, will not dry up or continue to build up throughout the summer) it will be tested prior to pumping and release. Heating fuel was also contained to prevent spills at the accommodation's buildings (Photo 15) with Sabina heating some facilities with used oil (Photo 16).

Photo 14: Tankfarm and Berm

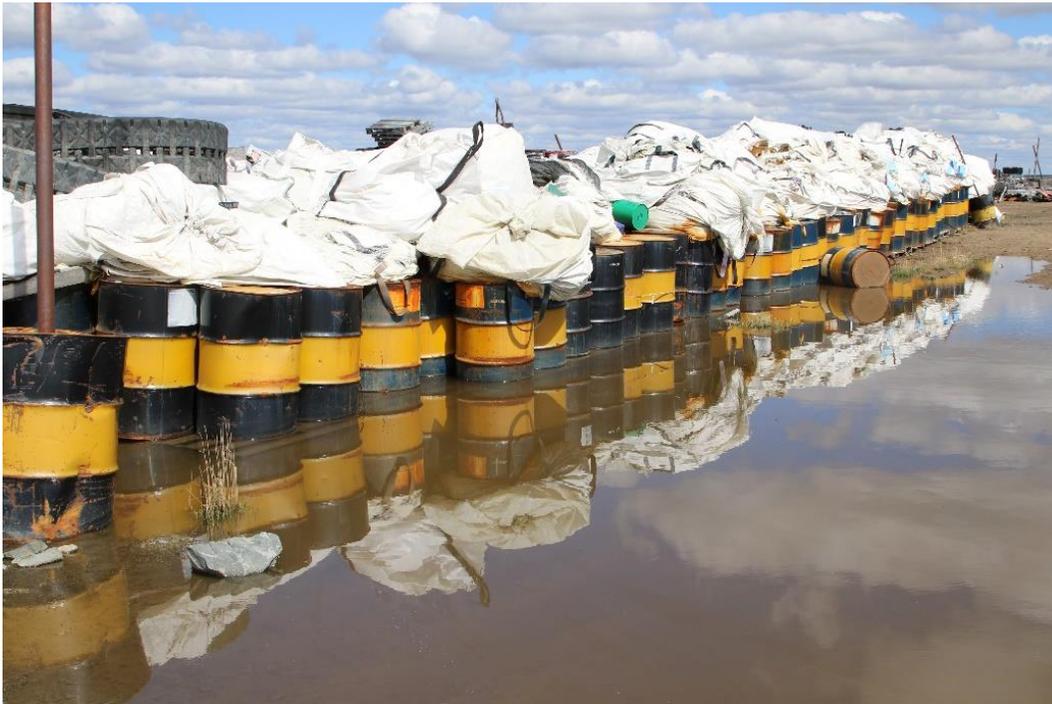
Laydown and storage areas at the Goose Lake Camp were tidy. Sabina had placed bagged old exploration materials on top of empty fuel barrels so that they could be located and removed during the ice road season to allow back hauling and these bags disposed of at appropriate locations. Staff observed that the bags were stored on top of a pond which had a visible sheen indicating potential hydrocarbon contamination (Photo 18). CIRNAC advised the Proponent to collect samples of the water and address any issues that the testing noted.

Photo 18: Bagged Waste Piled on Top of Empty Drums

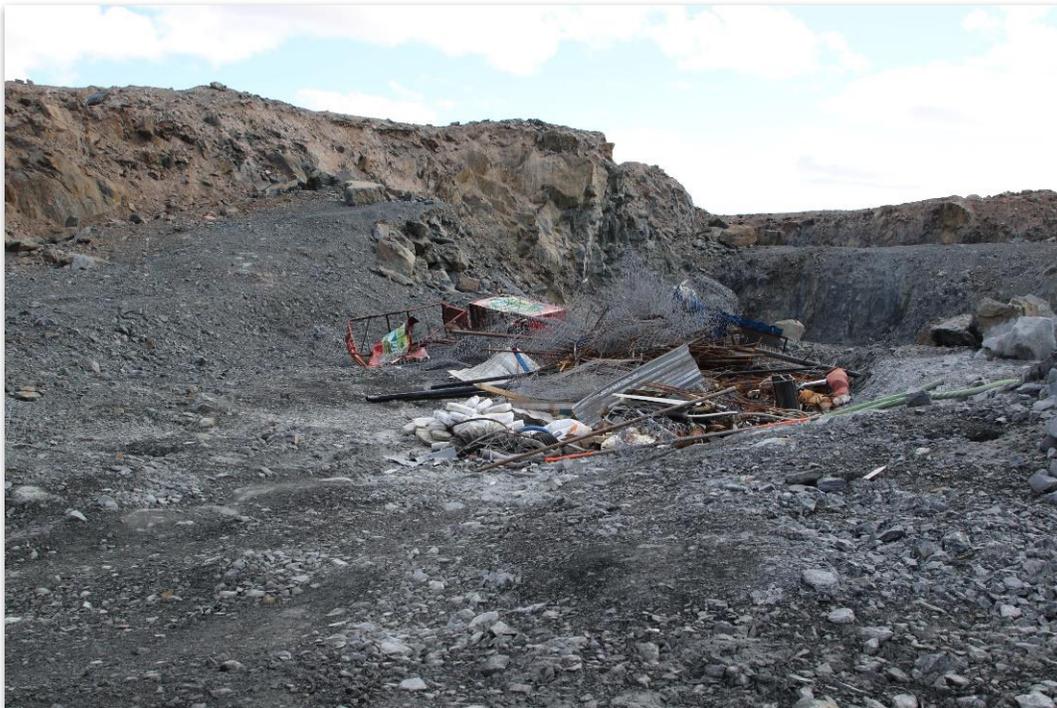
The Goose Lake quarry located west of the Camp at the middle of the road connecting to the future Goose Camp (Photo 19). Some non-hazardous waste is piled in the quarry until the permanent landfill located at the Waste Rock Storage Area is operational.

Photo 19: Temporary Landfill Quarry with Metal Waste and Concrete

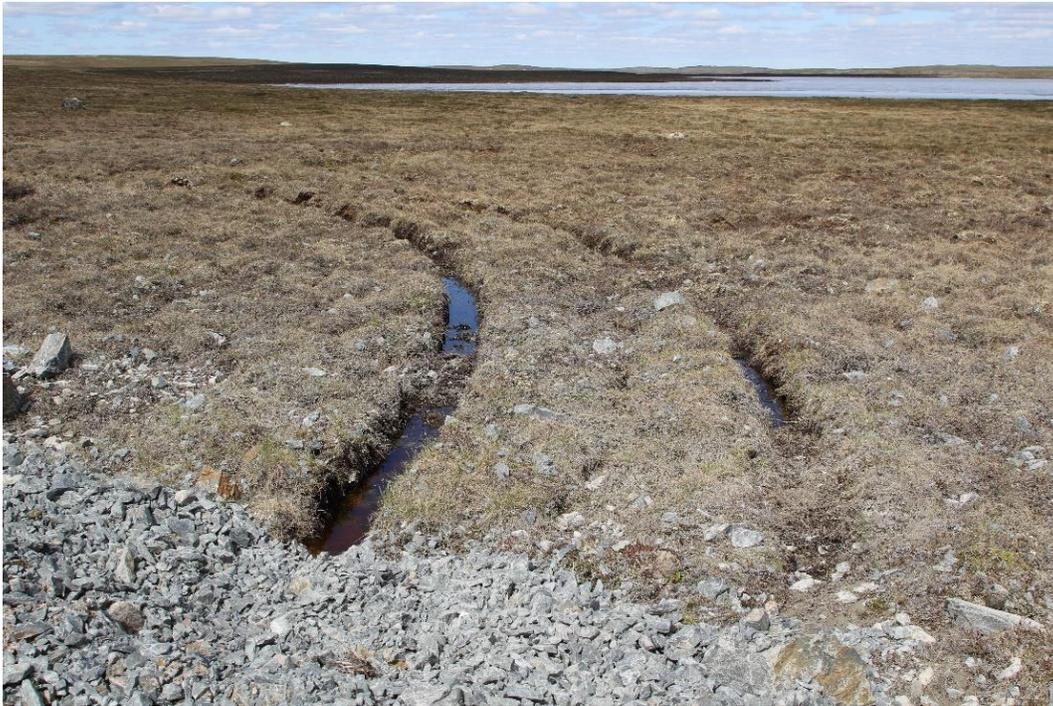
Sabina showed Monitoring Officers an area being monitored monitoring next to the road (Photo 20) and Sabina said it was watching the area to ensure that the tundra recovered and would undertake active remediation as necessary (Photo 21). On the connecting road to Goose camp, all culverts were well managed, and no water management was noted by the Monitoring Officers (Photo 22) and the road appeared well-managed. Sabina observed that it would be replacing two (2) of its bridges in this summer (Photos 23 and 24).

Photo 20: Damaged Tundra on the Road between Goose Camp and the Air Strip

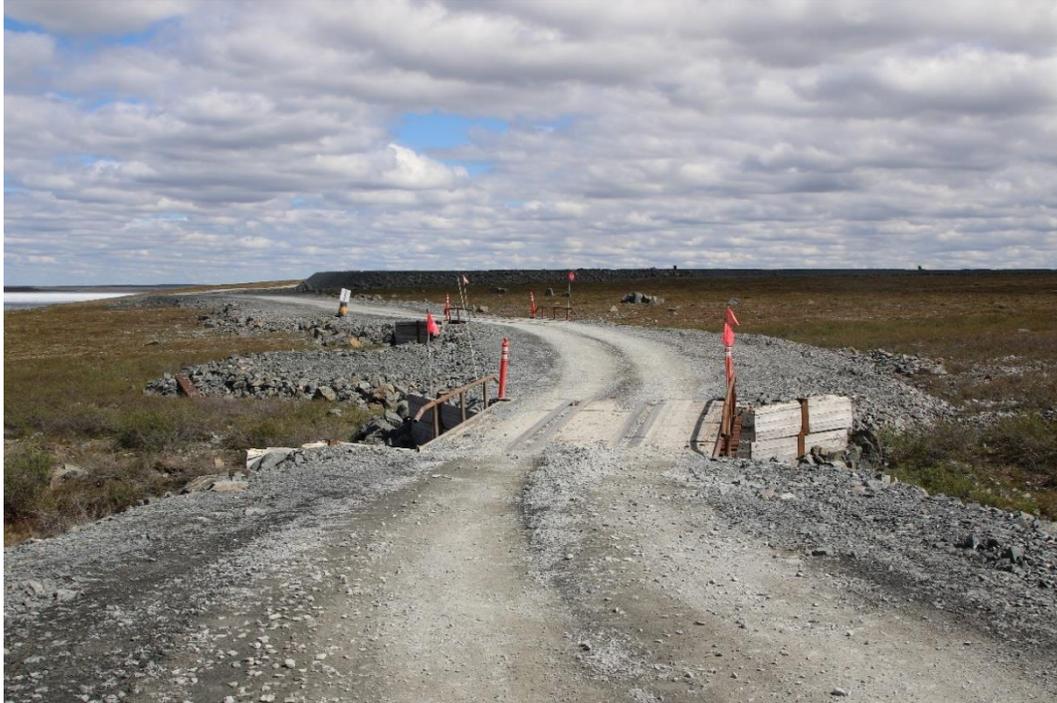
Photo 22: Bridges to be Replaced in 2022

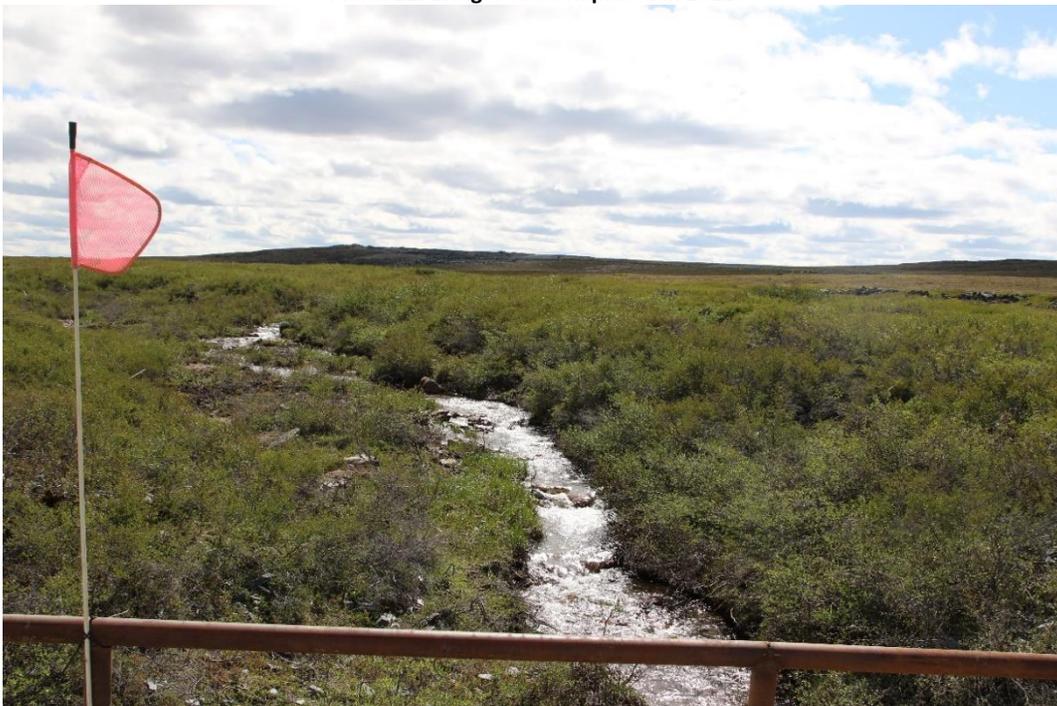
Photo 23: Rascal Creek, to be Rerouted in 2022

26	Fish Passage	-Discussed the rerouting of Rascal Stream East near the airstrip in 2022 and progress will be observed at the next summer site visit.
29	Water Crossings	-Discussed that water crossings would be upgraded in 2022 as the project starts construction. Changes will be observed in the next site visit.
30	Monitoring Program for Culverts	-Observed all culverts were open and free of debris
Vegetation		
33	Invasive Species	-Discussed the inspections that occur on equipment and/or materials prior to barging to site and vegetation programs at site.
Terrestrial Wildlife and Wildlife Habitat		
37	Wildlife Mitigation and Monitoring Program	-Observed Wildlife Log at the Marine Laydown Area
38	Wildlife Monitoring	-Discussed caribou collar data and information is primarily received through the NWT.
Terrestrial Wildlife and Wildlife Habitat Cont.		
40	Caribou Monitoring	-Discussed caribou collar data and information is primarily received through the NWT.

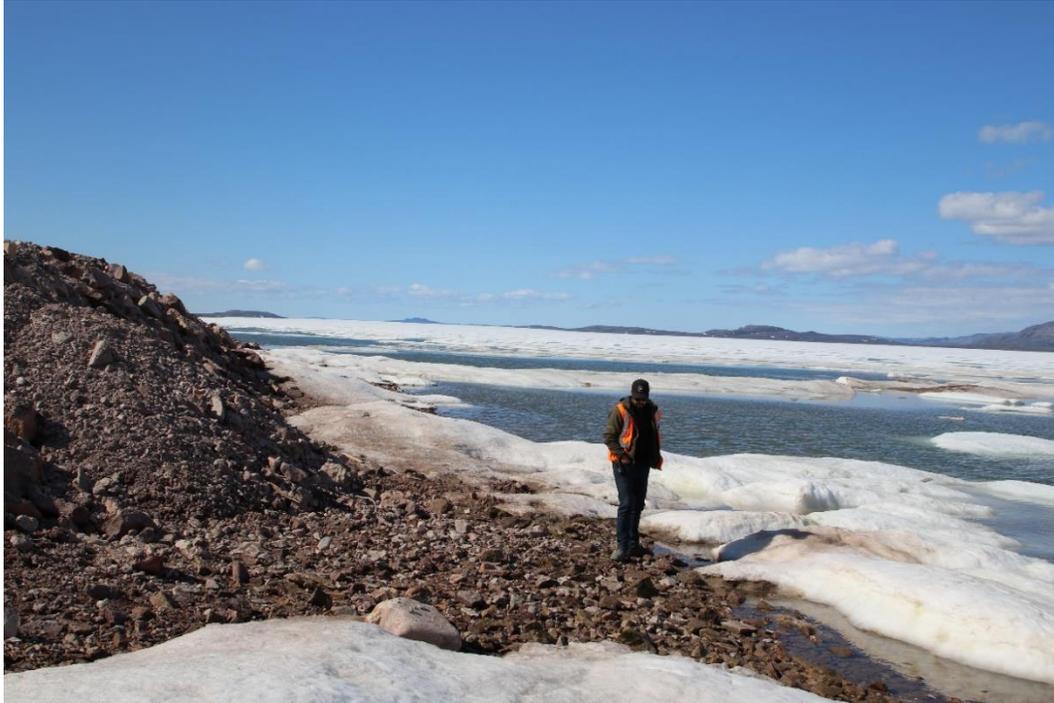
Overall, the camp appears to be well organized and clean (Photo 31). The MLA Landing off Bathurst Inlet is expected to be modified in the summer of 2022 (Photo 32) and be built out to about where the person is standing.

Photo 32: Barge Landing to be Extended in 2022

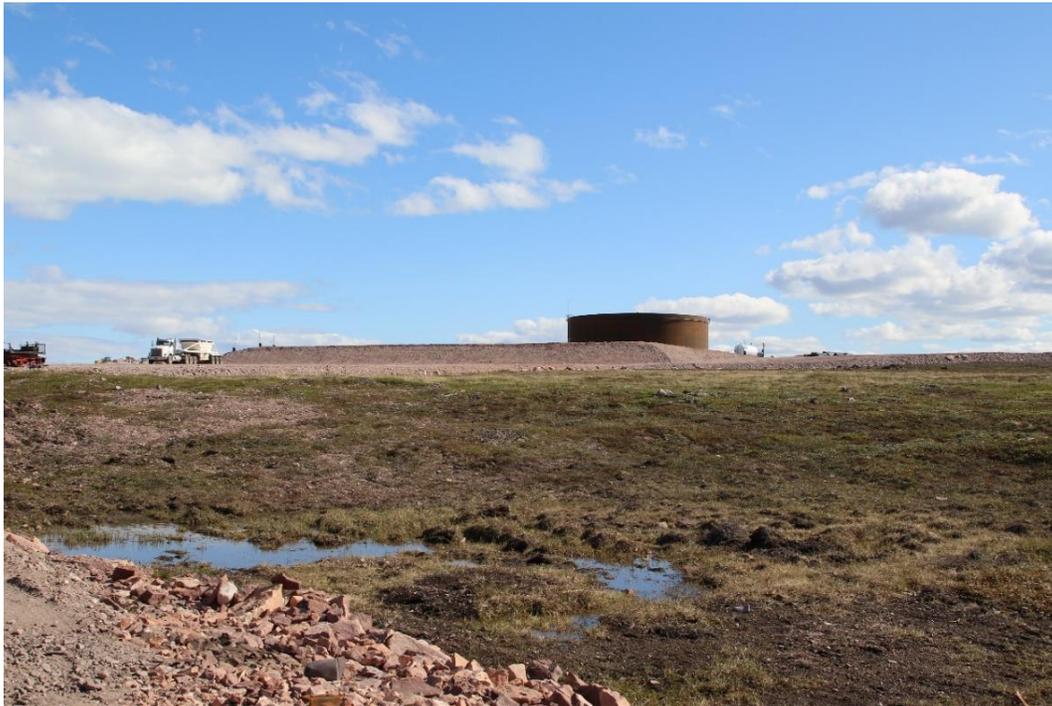
Sabina constructed a permanent Bulk Fuel Tank Facility within the Quarry Area (Photo 38) where all fuel will be moved to shortly. The previously proposed area was in a downslope area but during construction Sabina decided moved the tankfarm to an upslope location where the tank would be in a better location for protection of the environment and maintenance of the facility. The tankfarm was well maintained and while it currently has ponding water is contained and will be pumped out shortly (Photo 39).

Photo 38: MLA New Tankfarm

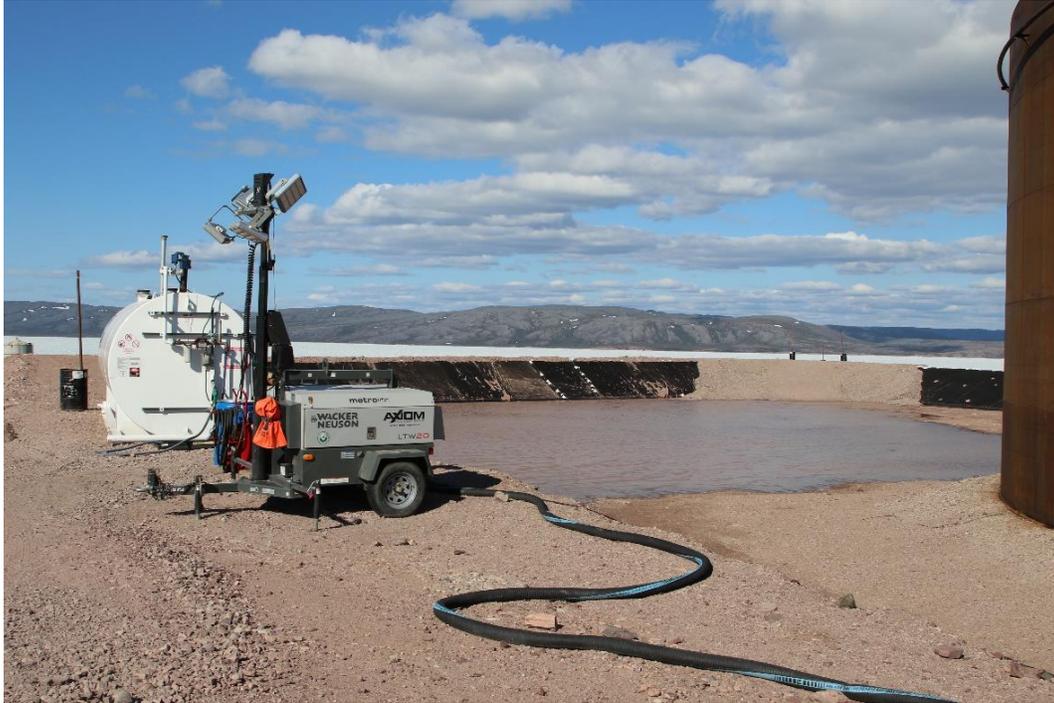
Photo 39: Containment at the Tankfarm

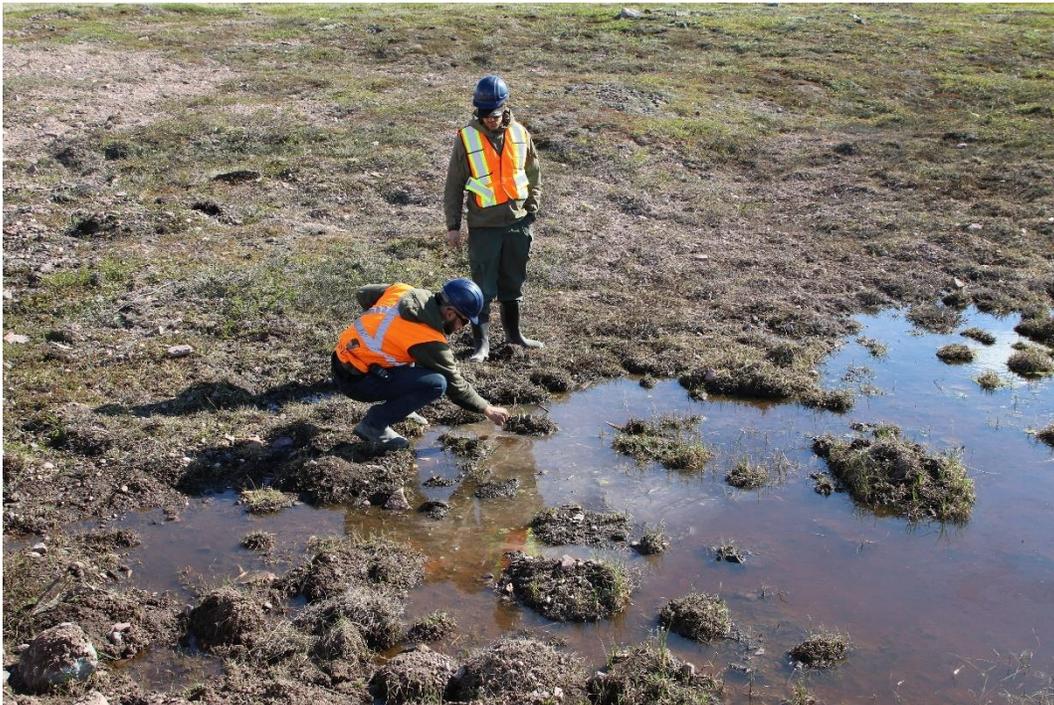
CIRNAC requested water be sampled in one (1) spot near the new tank to ensure that the water was being properly handled as there was a sheen on the water. CIRNAC was going to follow up to discuss further steps once the sample was analyzed (Photo 40).

Photo 40: Water Sampling at area near MLA Tankfarm

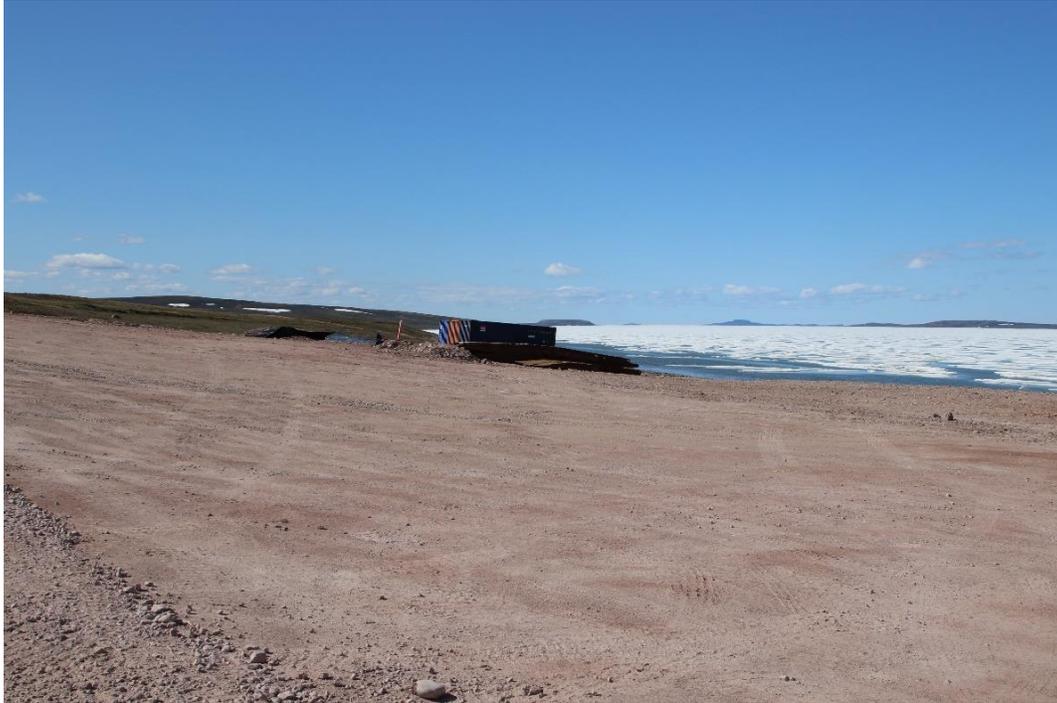
Laydown Pads, a Freight Storage Pad, and the Shoreline Pad for the receipt of sealift barges were constructed. During the site visit the Monitoring Officers noted the Laydowns are well organized and clean (Photo 42 & 43). The Spill Containment materials were located in seacans beside the Barge Landing Area in Photo 42.

Photo 42: Laydown Area and Spill Containment Seacans Beside the Port

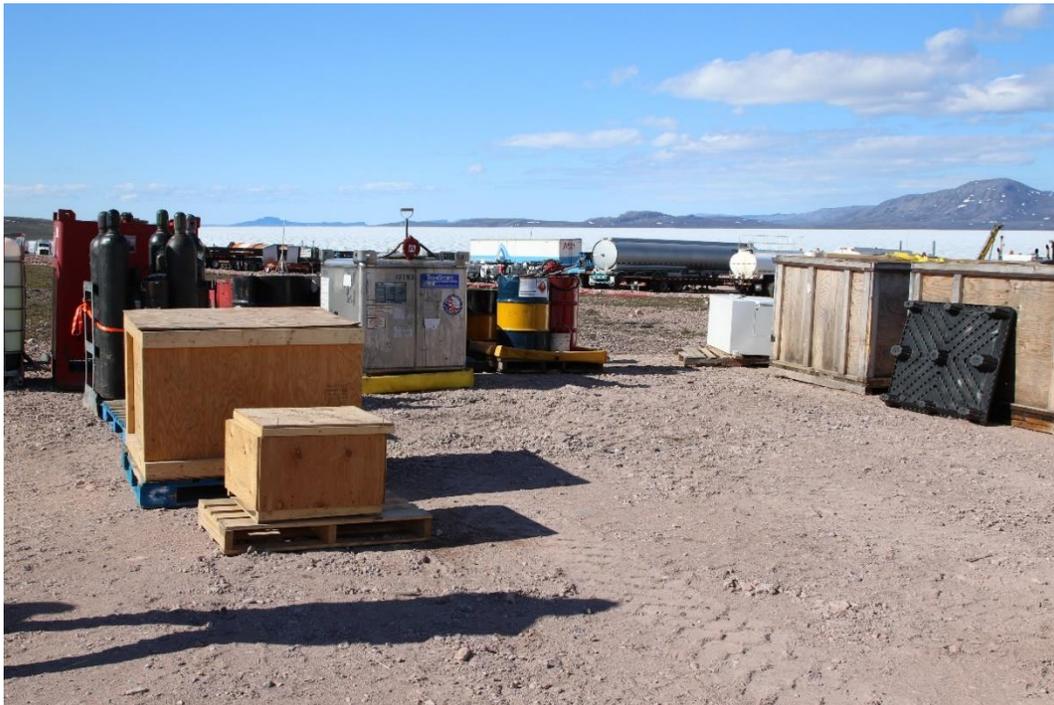
NIRB and CIRNAC staff also noted the trailers for the future Goose Camp were stored at the MLA (Photo 44) and waiting to be transported on the Winter Ice Road. All oil and/or fuel containers were contained in berms (Photo 45). The area is large enough to contain materials from both the 2021 and 2022 shipping season.

Photo 45: Fuel and/Oil Stored in Insta-berm Adjacent to Camp

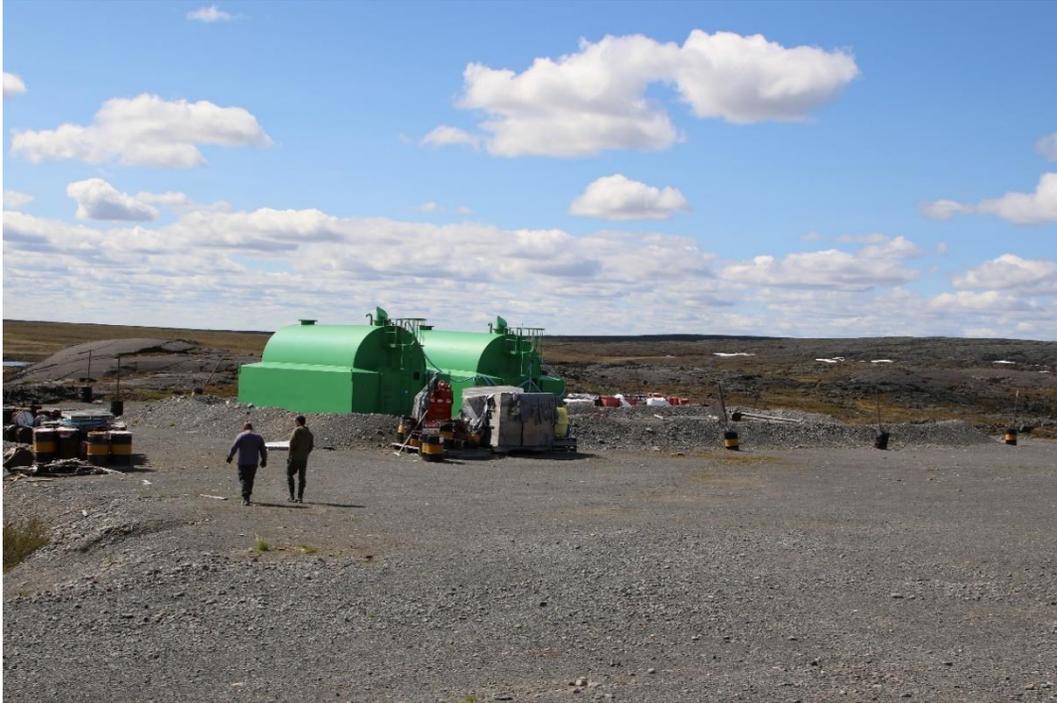
Overall, the George Exploration Camp is well maintained with proper containment of fuels and hazardous materials (Photo 52 & 53). The storage area away from main camp needs some maintenance but will be addressed as the Camp reopens.

Photo 52: Tankfarm with Berm

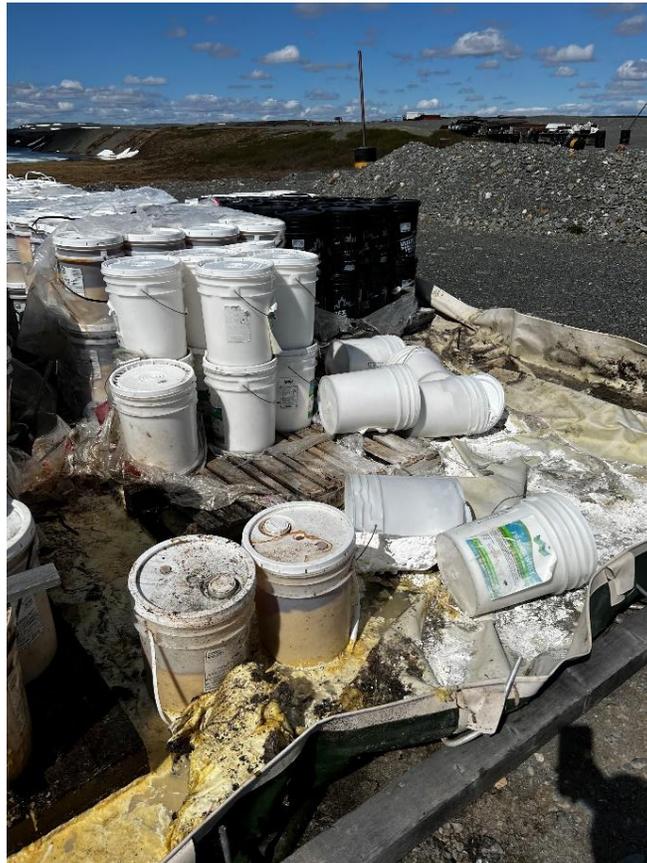
Photo 53: Hazardous Materials Contained in a Berm and Clean Up to Happen Soon
