Nunavut Impact Review Board Site Visit Report

Meliadine Gold Mine Project

Agnico Eagle Mines Limited

NIRB File No. 11MN034

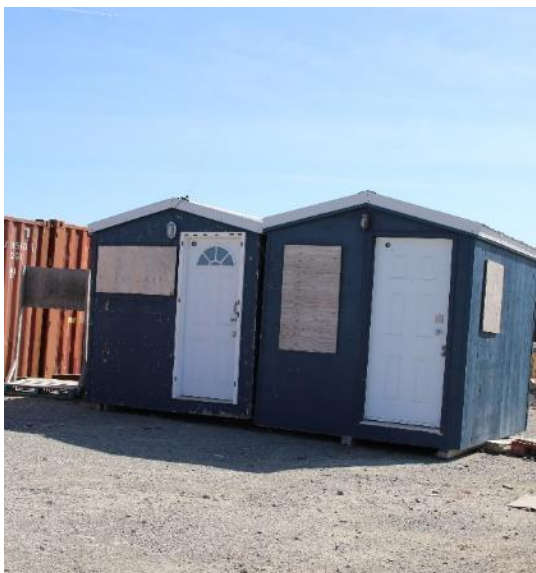
- c) It was observed that the signage on the seacan wall was updated and clearly noted to the community the public dock access and the Agnico Eagle barge area (see [Photo 4](#)).
- d) The Saline Water Discharge tank was installed at the Itivia site (see [Photo 5](#)); however, in 2022 Agnico Eagle is storing the saline groundwater in Tiriganiaq 2 instead of trucking and discharging to Itivia Harbour. (Term and Condition 25)
- e) The snowmobile crossings within Agnico Eagle's Itivia area appeared to be in good repair (Photo 6).

Photo 4. Seacan Wall at Itivia and Huts for Monitoring Unloading of the Sealift.

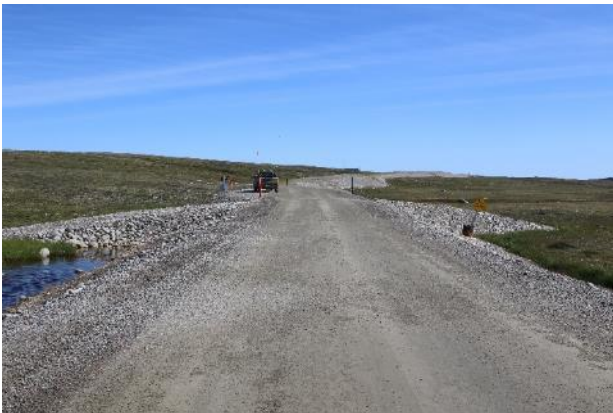
- a) The Bypass Road had clear signs noting that the road is private in both English and Inuktitut (see [Photo 7](#) and [Photo 8](#)) (Term and Condition 125c).

Photo 7: Bypass Road

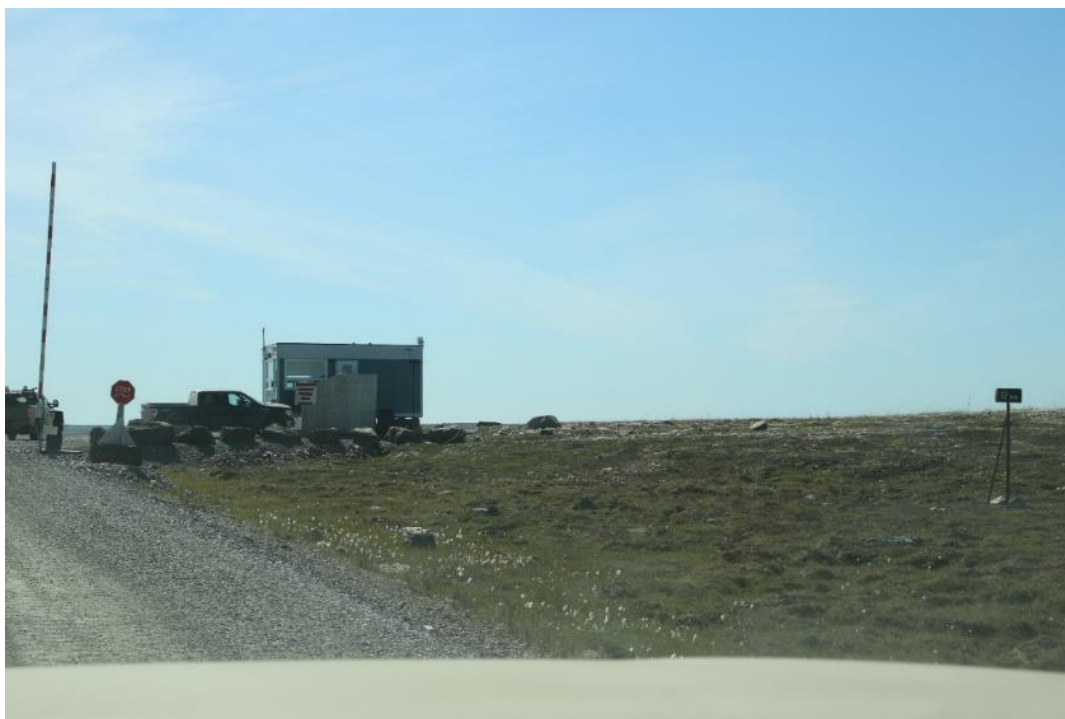
- a) The new Gatehouse has cameras to monitor for caribou and is better situated to observe caribou around site. The Gatehouse was relocated as Rankin Inlet wanted better access to the berries that were at the previous gatehouse. This also allows traffic to be monitored closer to the mine site and community members better access to an area important to them. (Terms and Conditions 38 and 125a)
- b) The NIRB staff noted that the environmental emergency seacans were located at or near all bridge crossings (see [Photo 11](#)).
- c) Agnico Eagle continues to apply TETRA flakes (calcium chloride) on all portions of the AWAR it manages as well as continues to monitor for dust. (Terms and Conditions 1 and 3)
- d) The AWAR also has traffic signs in both Inuktitut and English as well as speed signs.

Photo 9. New Gatehouse on the All-weather Access Road.

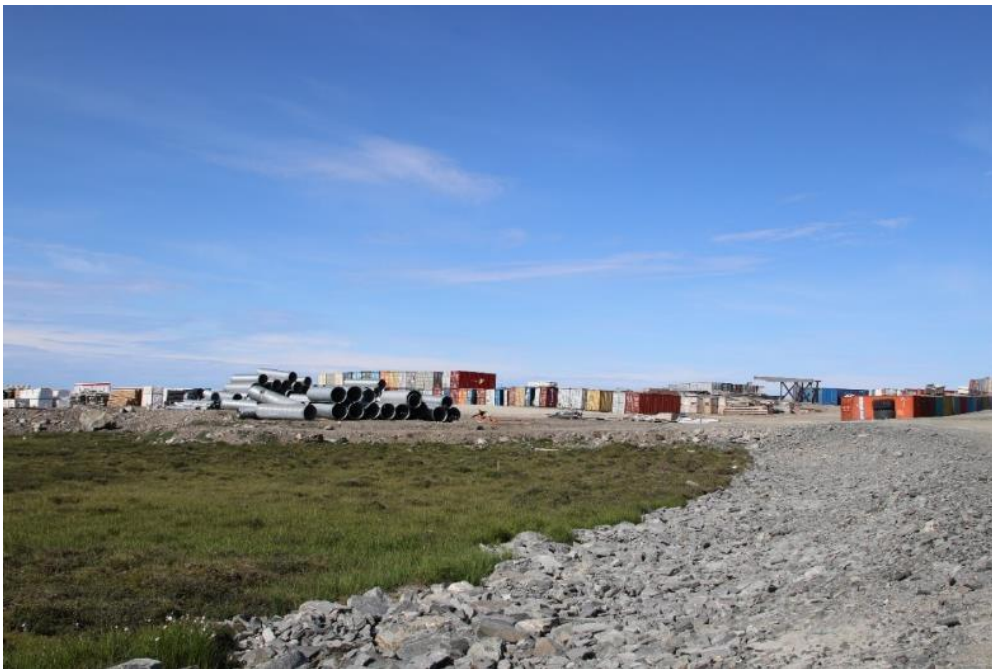
NIRB and Agnico Eagle drove through the Storage Pad and items were in order and the pad appeared in good repair.

Photo 16: Contractor Storage Pad

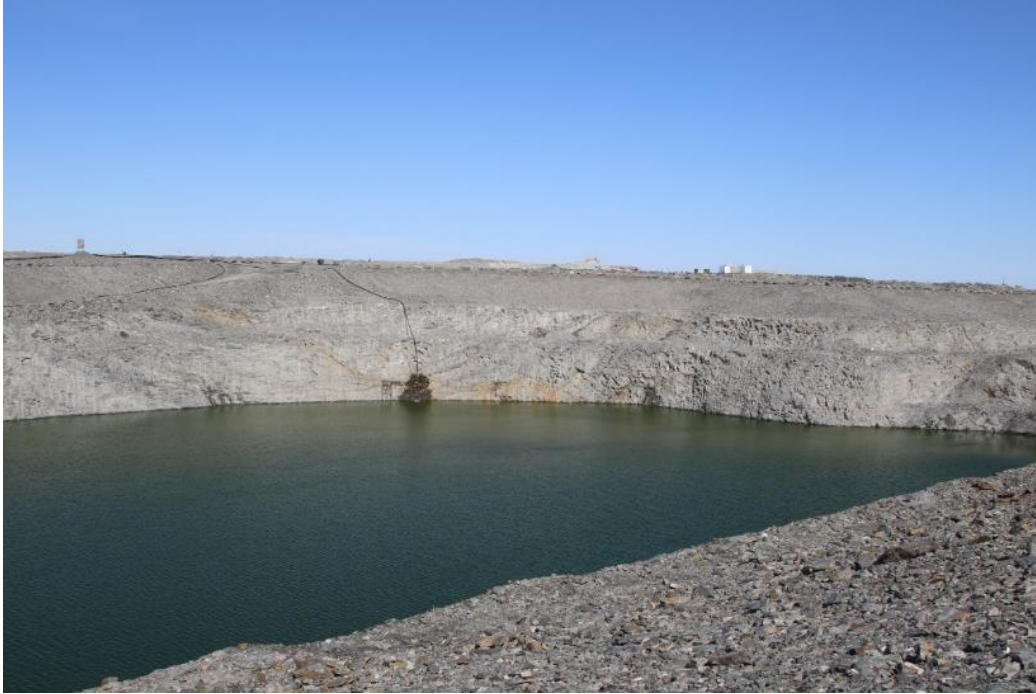
- Tiriganiaq Pit 2 is where Agnico Eagle is currently storing its saline groundwater onsite. Agnico Eagle informed NIRB staff that no trucking of saline groundwater for discharge into Itivia Harbour would happen in 2022.

Photo 24: North Half of Tiriganiaq Pit 2

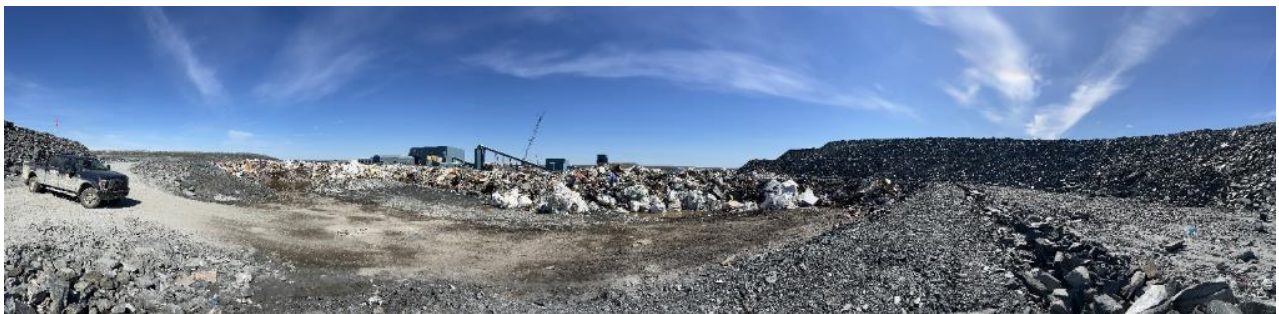
NIRB staff observed the current landfill. Once filled, this location would be buried in the Waste Rock Pile like at Agnico Eagle’s other Kivalliq mine site and a new landfill started (see [Photo 31](#)).

Photo 31. Landfill within the Waste Rock Pile.

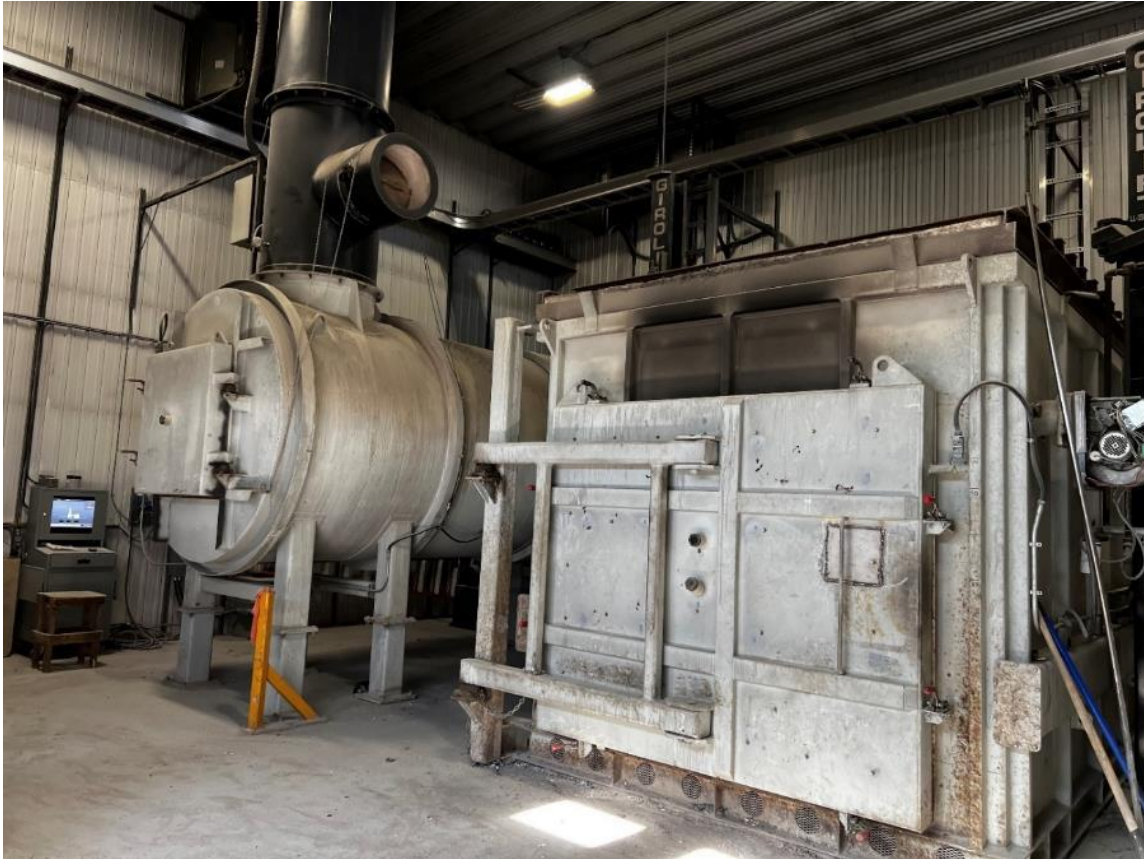
NIRB staff were informed that the incinerator was functioning much better than it had in previous site visits (see [Photo 34](#)). (Term and Condition 4)

Photo 34: Meliadine Incinerator

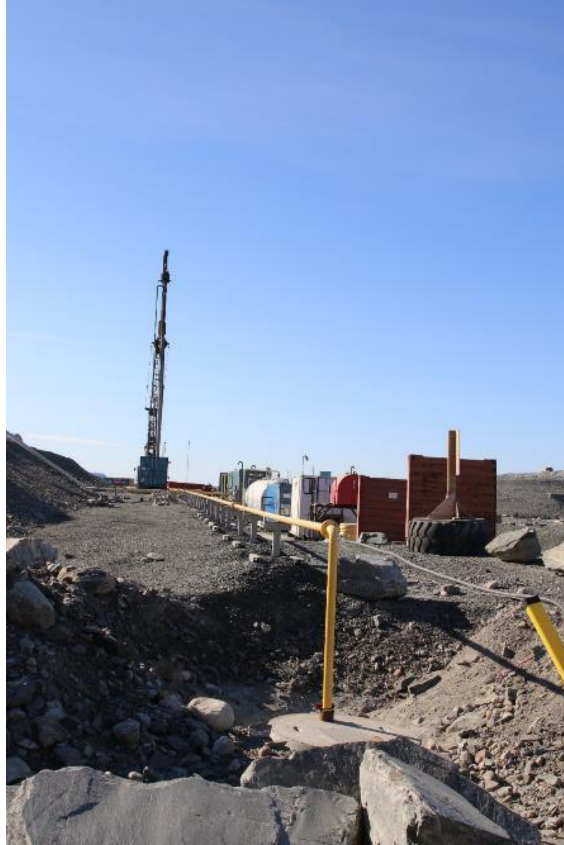
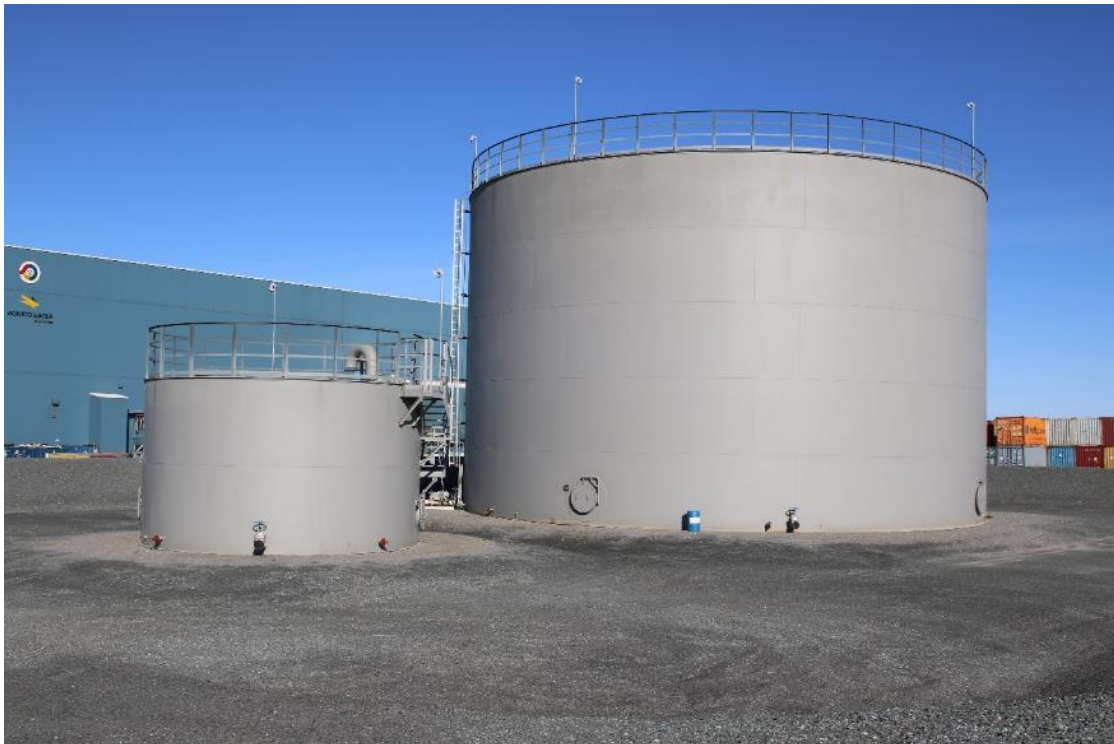
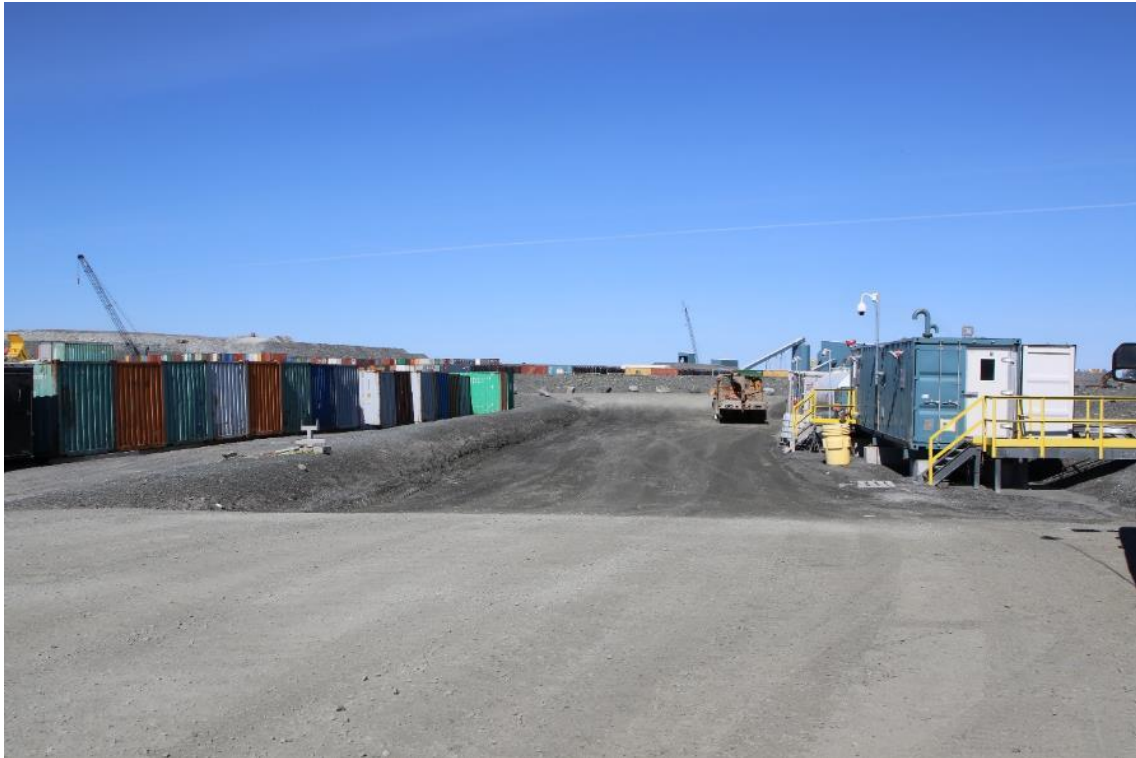
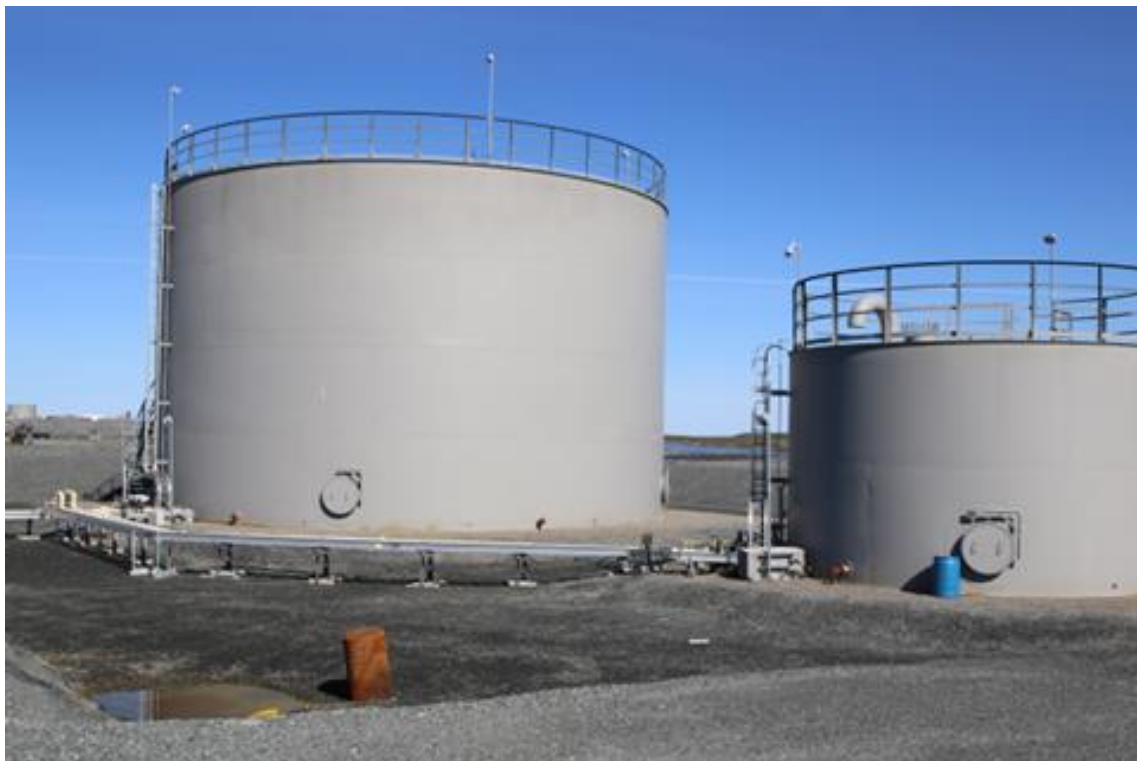
During the site visit, NIRB staff noted that both Fuel Tankfarms and the smaller fuel storage tanks located at various locations around the mine site were within appropriate secondary containment. Further, fuel storage tanks appeared to be handled in a safe and environmentally protective manner. Fuel Tankfarm #1 was commissioned since the last site visit and Fuel Tankfarm #2 was also operating (see [Photo 35](#) through [Photo 38](#)).

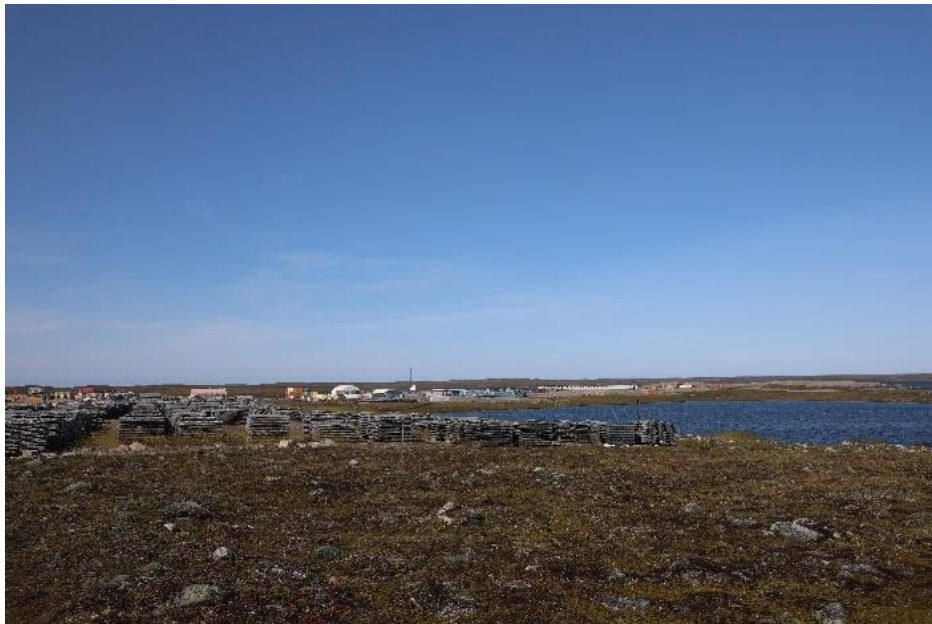
The 200-person exploration camp was decommissioned and only the accommodations trailers remain active as additional bed space for Agnico Eagle when required (see [Photo 68](#)).

Photo 68. Exploration mine camp at Meliadine (2019)

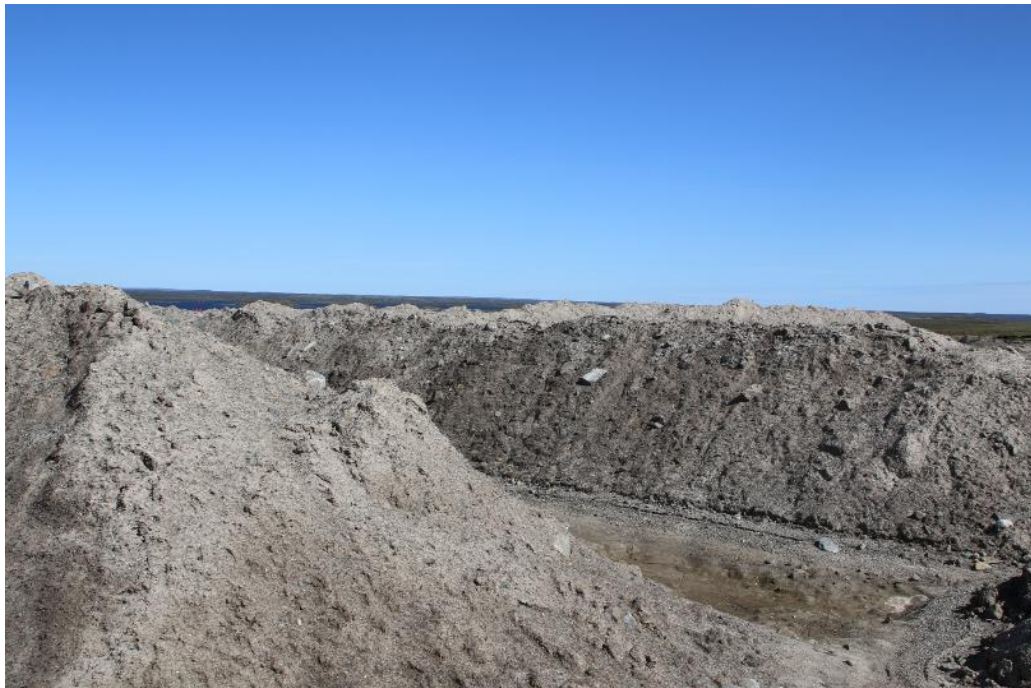
- The site visit viewed the exploration/temporary fuel tank storage farm and temporary landfarm. The tanks have been removed and is now a landfarm and remediation is underway (see Photo 72).

Photo 72: Temporary Landfarm by Exploration Area, Former Temporary Fuel Storage Area

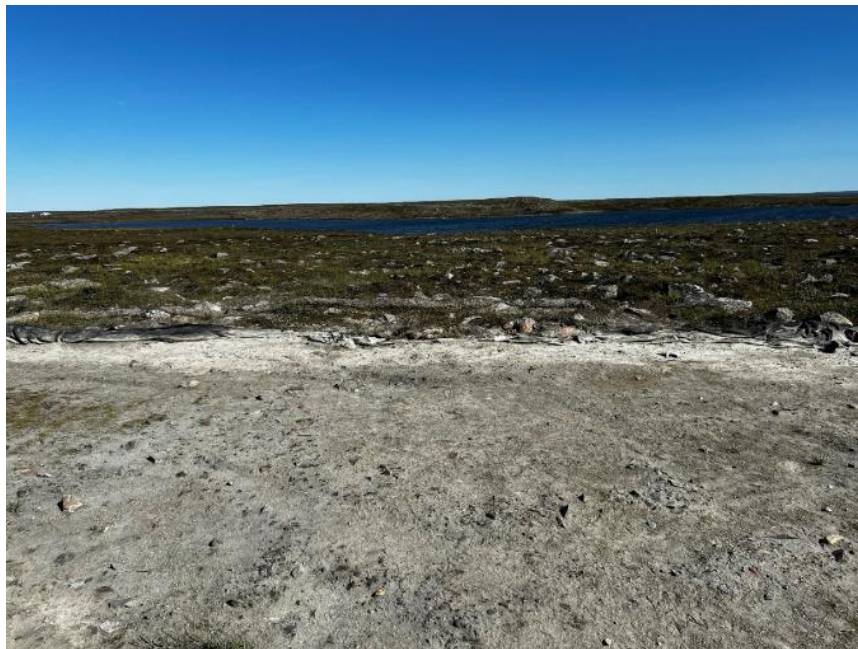
The NIRB observed erosion fences around the Meliadine Site, and this was an area that should be assessed for effectiveness of the fence and if any repairs are required.

Photo 74: Erosion Fences by Construction Laydown Area

28	Sediment and Erosion Management	NIRB noted some erosion fences needed repairs and discussed this with Agnico Eagle. Will follow up in 2023.

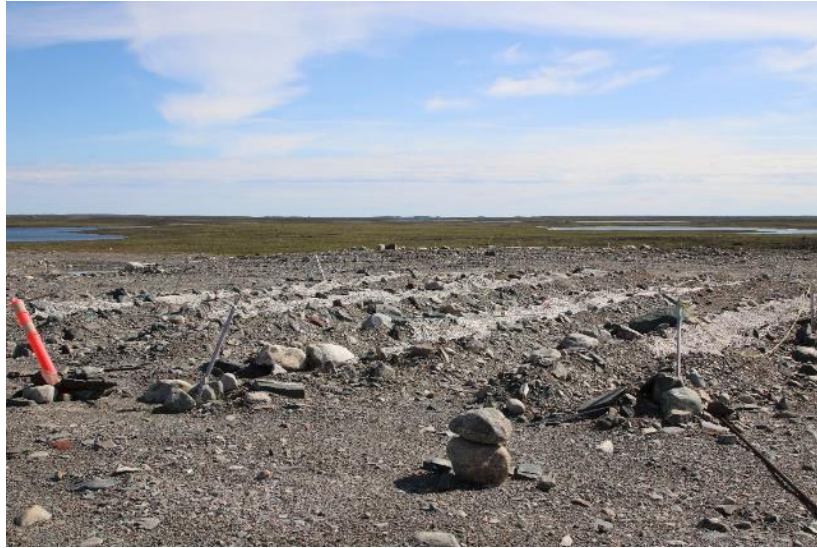
NIRB and Agnico Eagle staff visited the test plots that are used as part of a revegetation trial in collaboration with the University of Saskatchewan through a Natural Sciences and Engineering Research Council of Canada Collaborative Research and Development grant received in June 2019 (see [Photo 75](#)).

Photo 75: Test plots Area 1

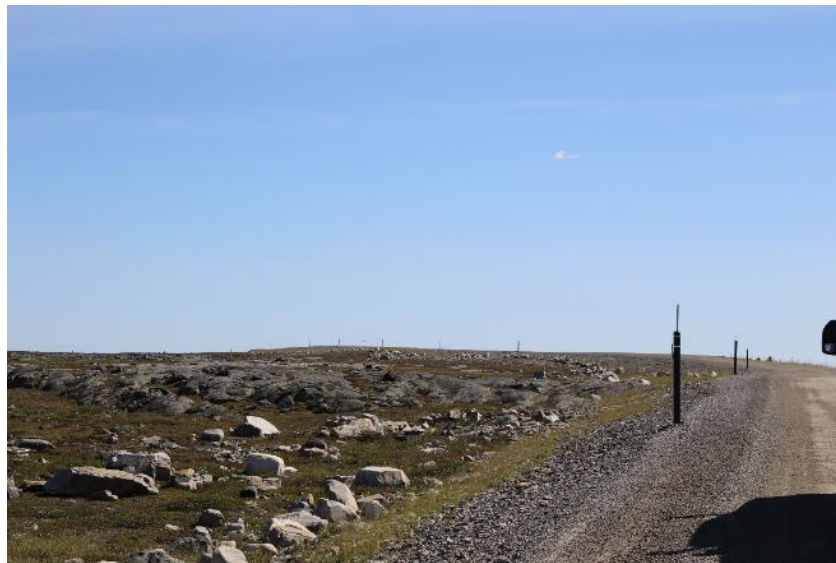
The NIRB saw that the flags had been taken down along the road to limit disturbance to caribou when they are in the area. Flags will remain down until later in the fall when they will be put up again to help with navigation on the A WAR in the winter.

Photo 77: Poles with Removed Flags on the A WAR

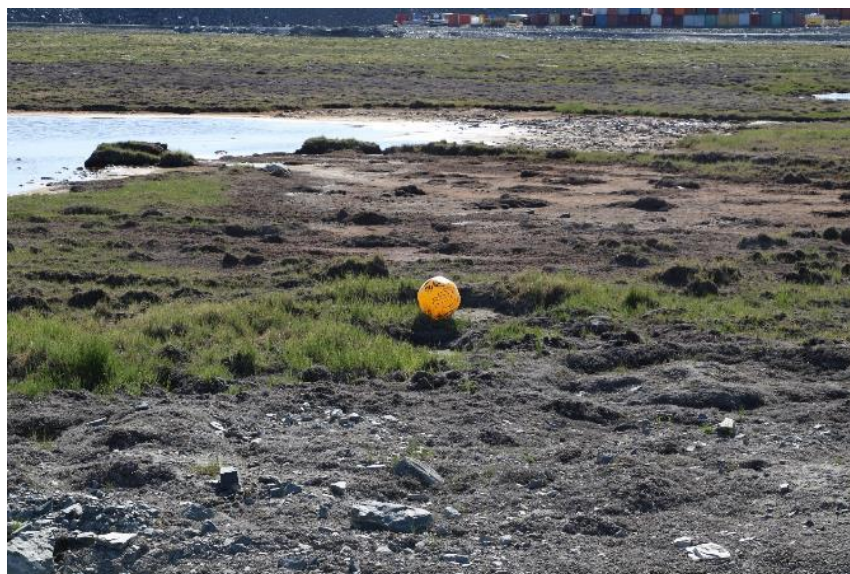
Agnico Eagle discussed challenges it has had with installing bird deterrents at the site. This year they tried installing bird scare balls and had the most success with those. The kestrel kites were attacked by gulls in the area and so did not assist with deterring nesting.

Photo 78: Bird Scare Ball for Deterring Ground Nesting
