## **Committee Bay Project**

## ***Annual Report***

**2022**

North Country Gold Corp.  
January 2023

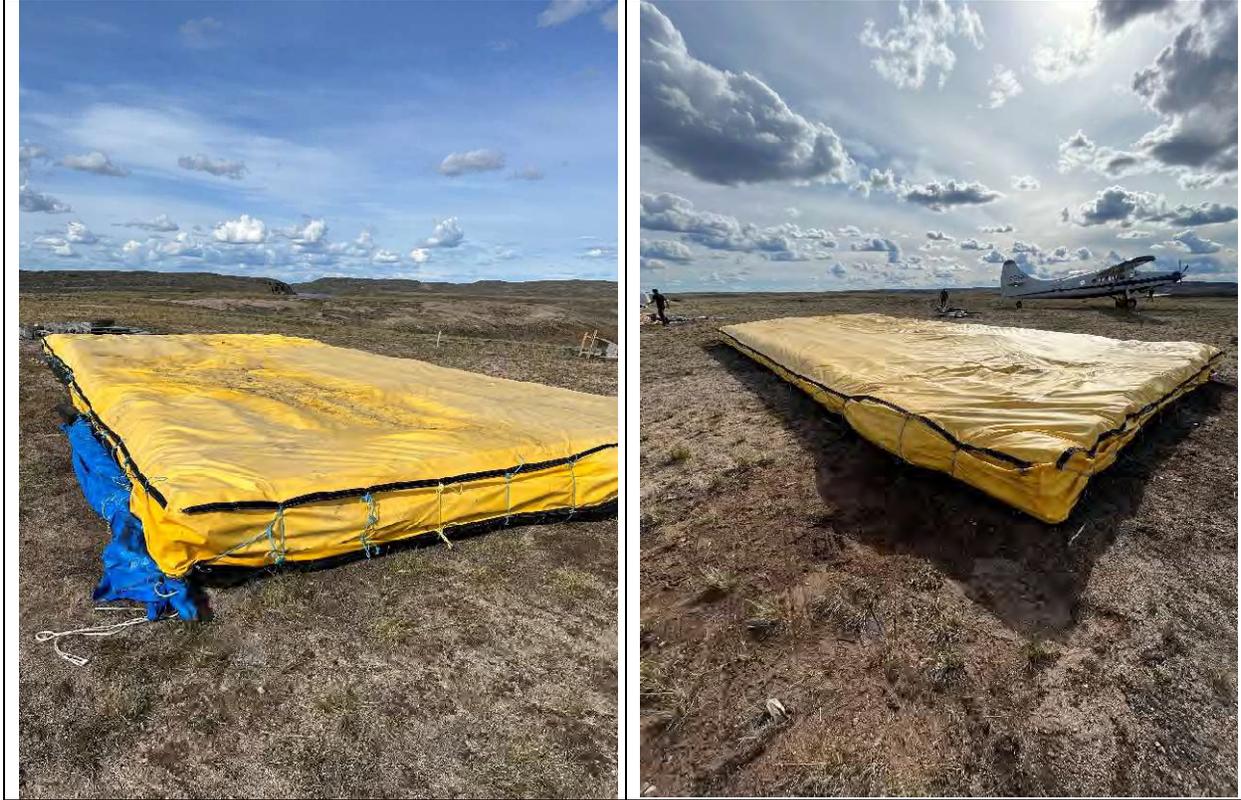
**Point 1: Inspection Photo 1 and 2:**

1. The main fuel cache secondary containment appeared to be full of water. See photos 1 and 2 for photos of containment berms full of water.
2. While on site at Crater Camp it did not appear that any of the tent heating fuel tanks have any covers installed, the secondary containment in place had significant water pooling. See photos 3 and 4 for tent heating fuel tanks.
3. it was noted that there is no berm surrounding the grey water sump, It does not appear that the sumps are constructed in a way to prevent melt water and/or rain water from flooding the sump . See photo 5 for the sump.
4. During the inspection the majority of secondary containment was either full with rainwater, damaged and had no secondary containment covers. See photos 3-9 for fuel storage mentioned.

Main fuel cache containment cover straightened and properly tied down, voids filled with empty drums.

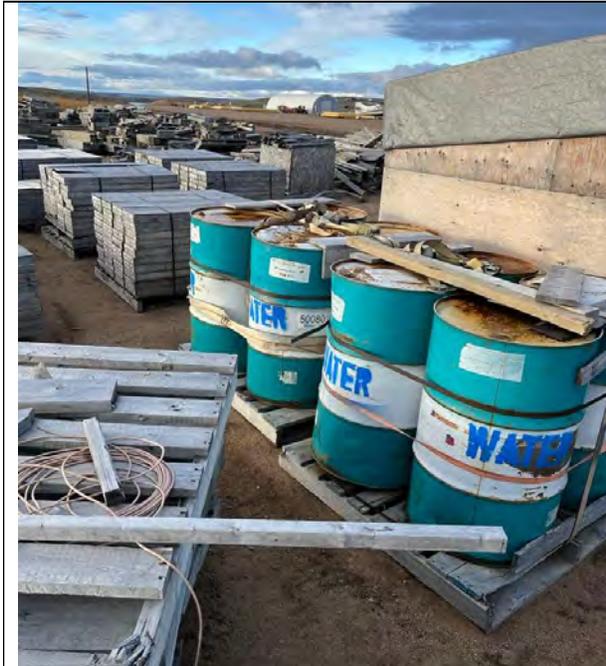
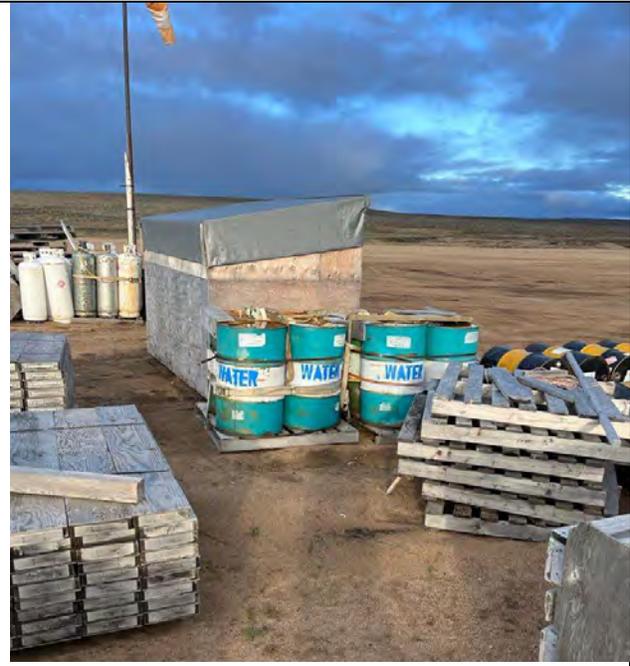
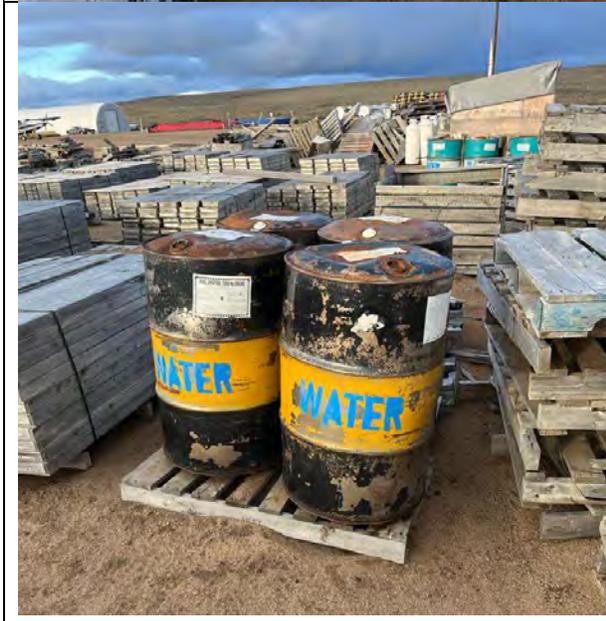
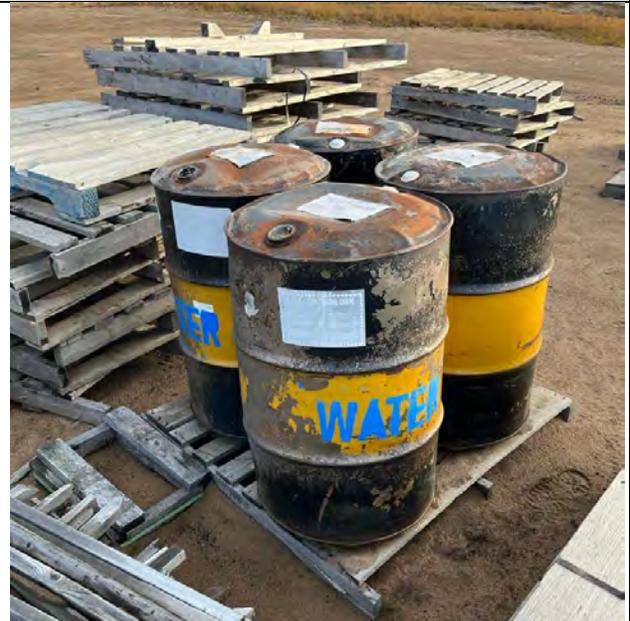
**Point 2: Inspection Photo 11:**

1. While on site there was significant erosion near the sump, the licensee appears to be using fabric to slow the erosion. See photo 10 for the erosion noted.
2. There was approximately 12 barrels outside of containment near the wind sock and drill core storage, See photo 11 for the fuel outside of containment.

9 drums next to small shack on fixed wing apron are filled with water as ballast/anchors for fixed wings, now sprayed with "WATER" stencil.

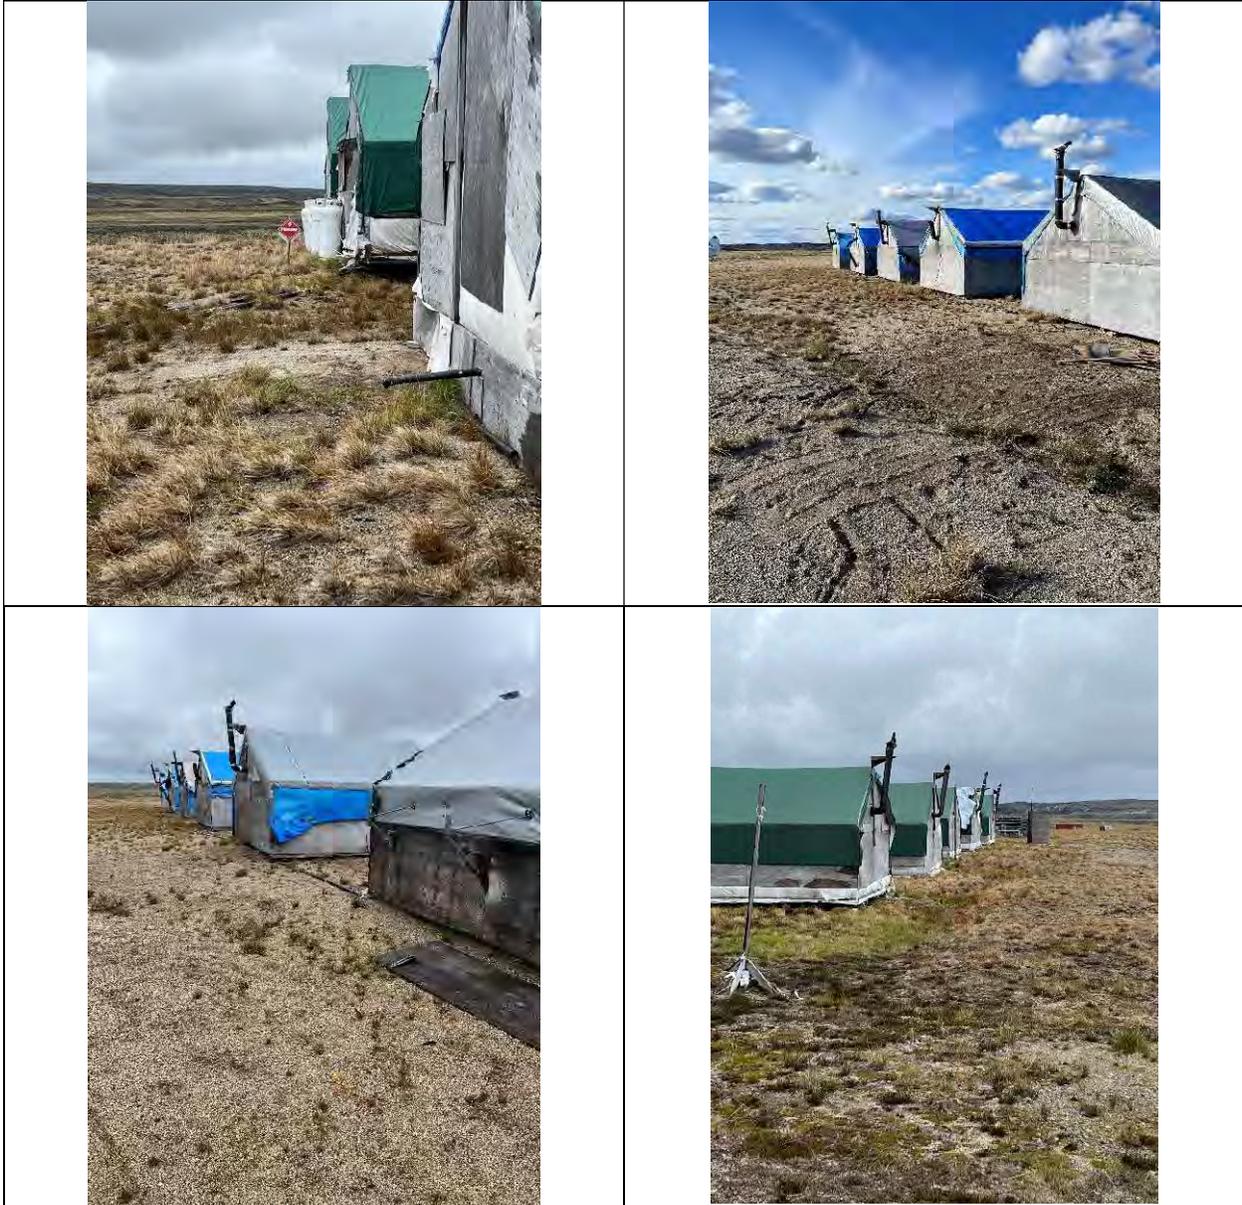
**Point 1: Inspection Photo 12 & 14:**

1. while on site some tent heating fuel tanks covers installed were not operating as intended. See photos 12 for the covers referred to.
2. There was approximately 9 barrels outside of containment within this camp, see photos 13 and 14 for the fuel outside of containment.
3. While on site it appeared that the grey water sump and the outhouse sump appeared to be less than 31m away from pooling water. See photo 15 for the photos of the sump.
4. It was noted that there is no berm surrounding the grey water sump. It does not appear that the sumps are constructed in a way to prevent melt water and/or rain water from flooding the sump. See photo 15 for the sump.

Damaged drum covers removed, tent heating fuel drums and berms stored indoors.

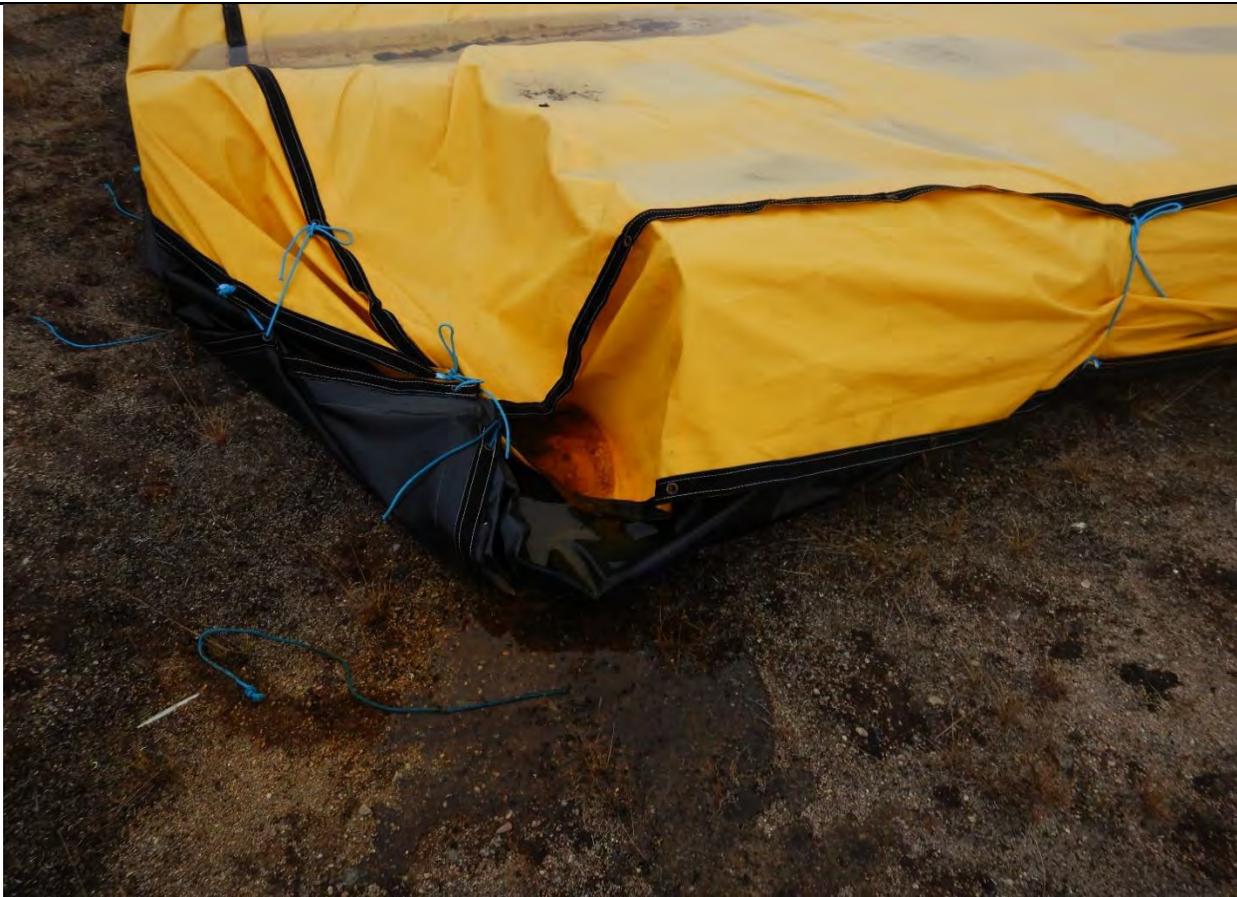
**Photo 1**

**Description: Containment full of water.**

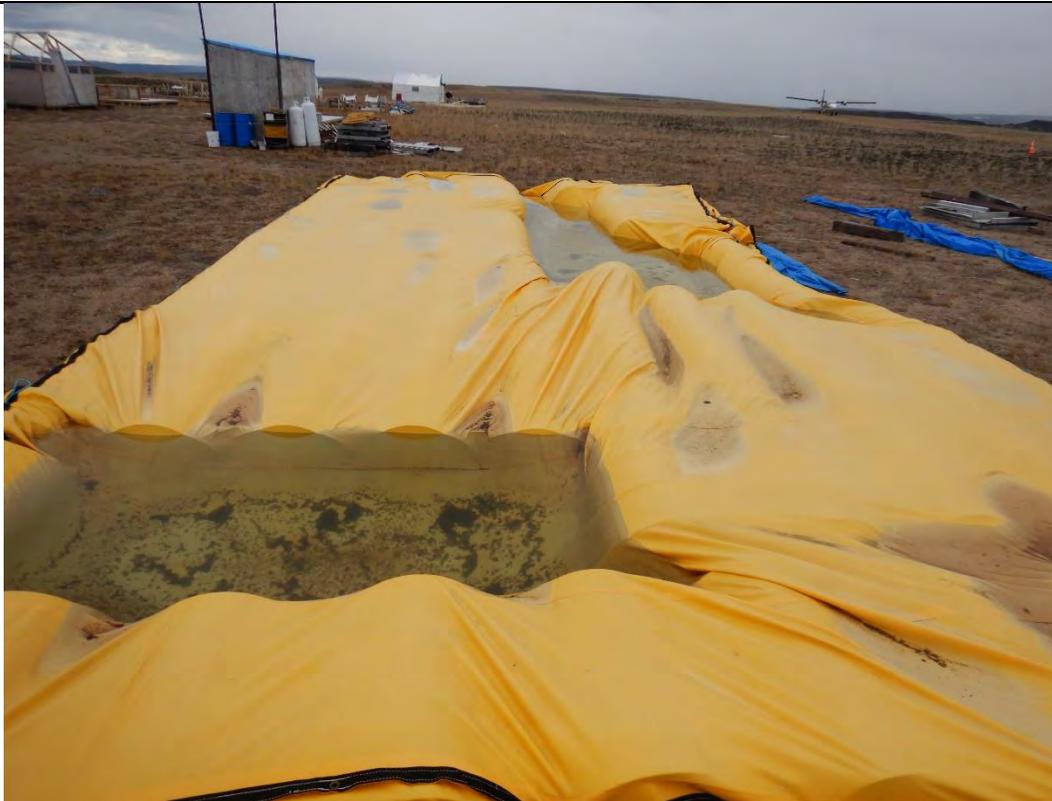
Photo 2

Description: pooling water on top of containment.

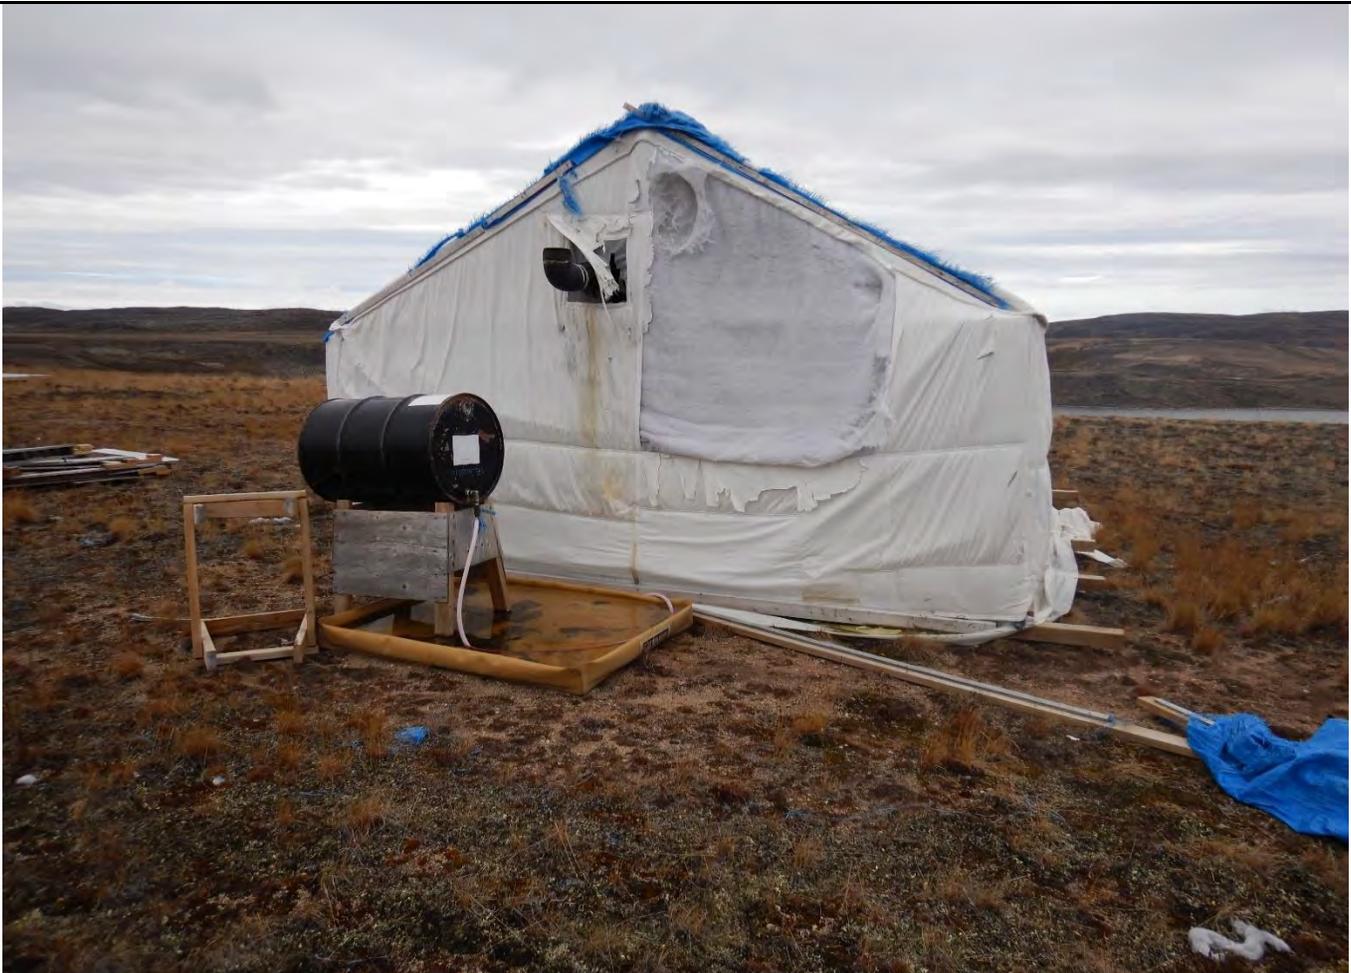
Photo 3

Description: heating stove tank without required covering.

Uncovered tent heating fuel drums and berms were removed and stored indoors.

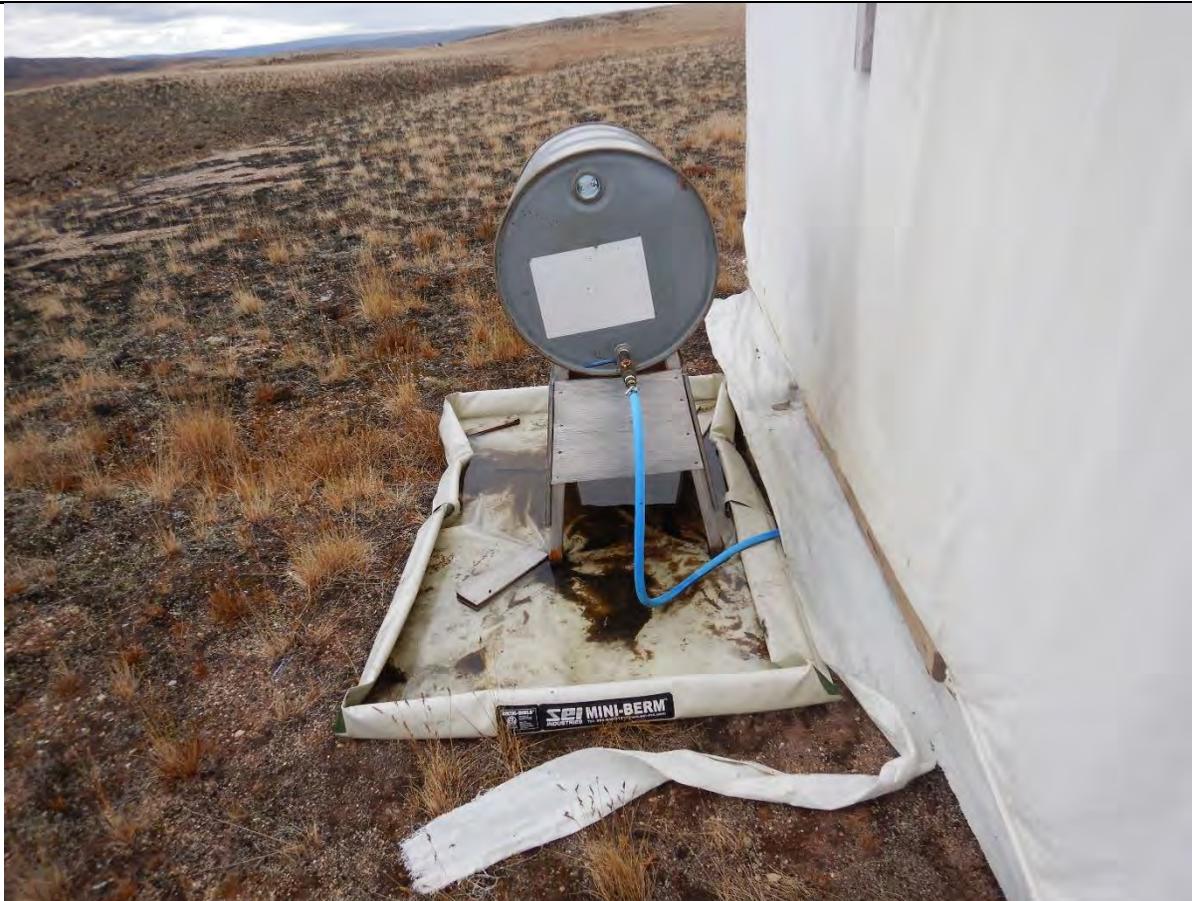
Photo 4

Description: heating stove tank without required covering and damaged secondary containment.

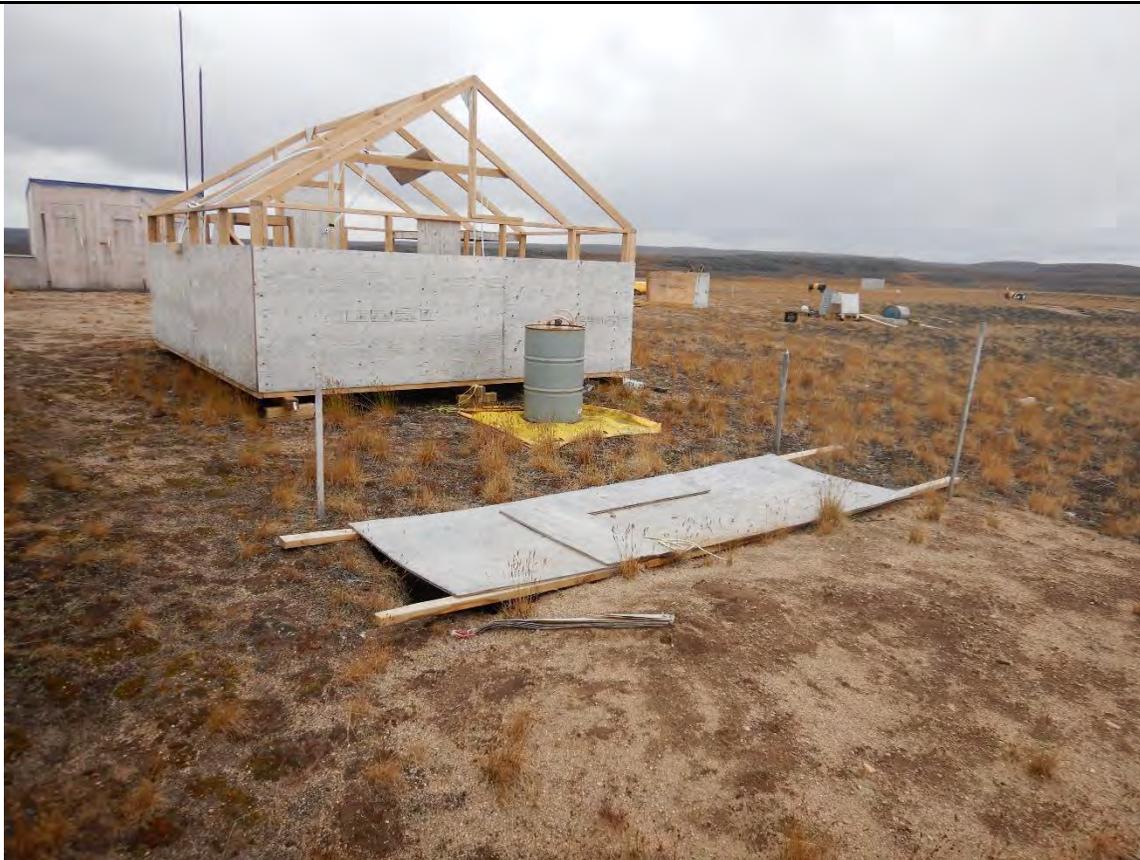
Photo 5

Description: partially covered sump and damaged secondary containment.

Grey water sump cover removed and sump completely filled in and levelled.

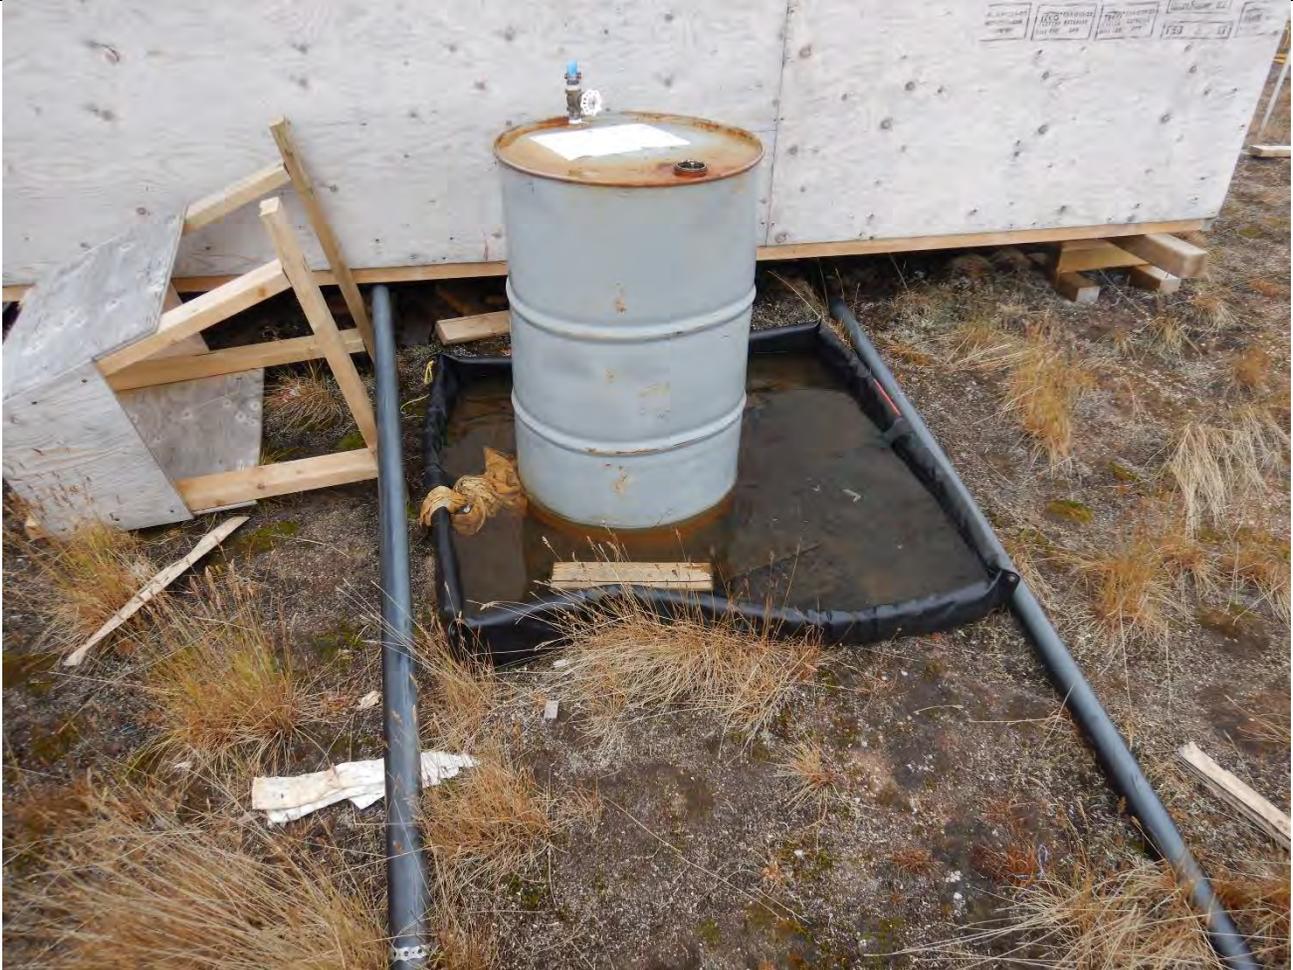
Photo 6

Description: secondary containment full of water.

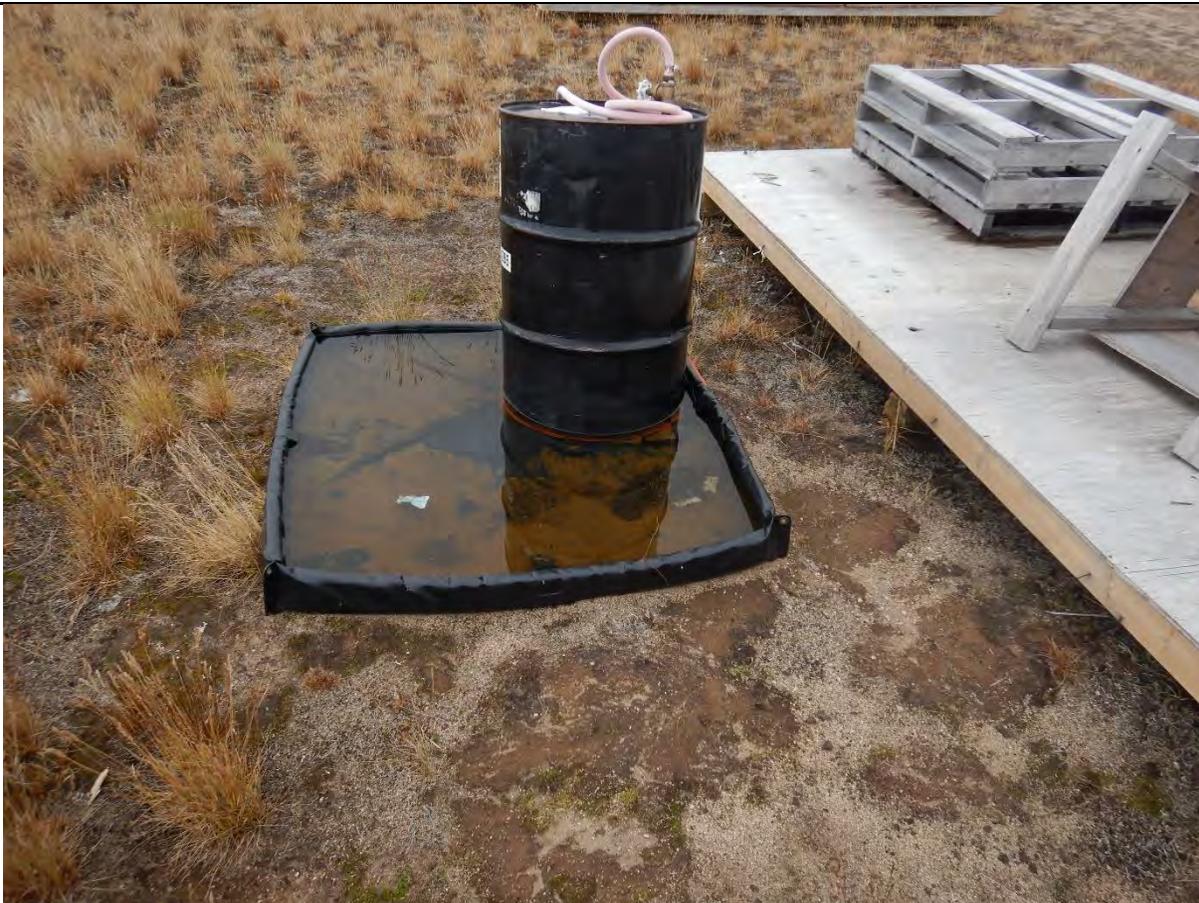
Photo 7

Description: secondary containment full of water.

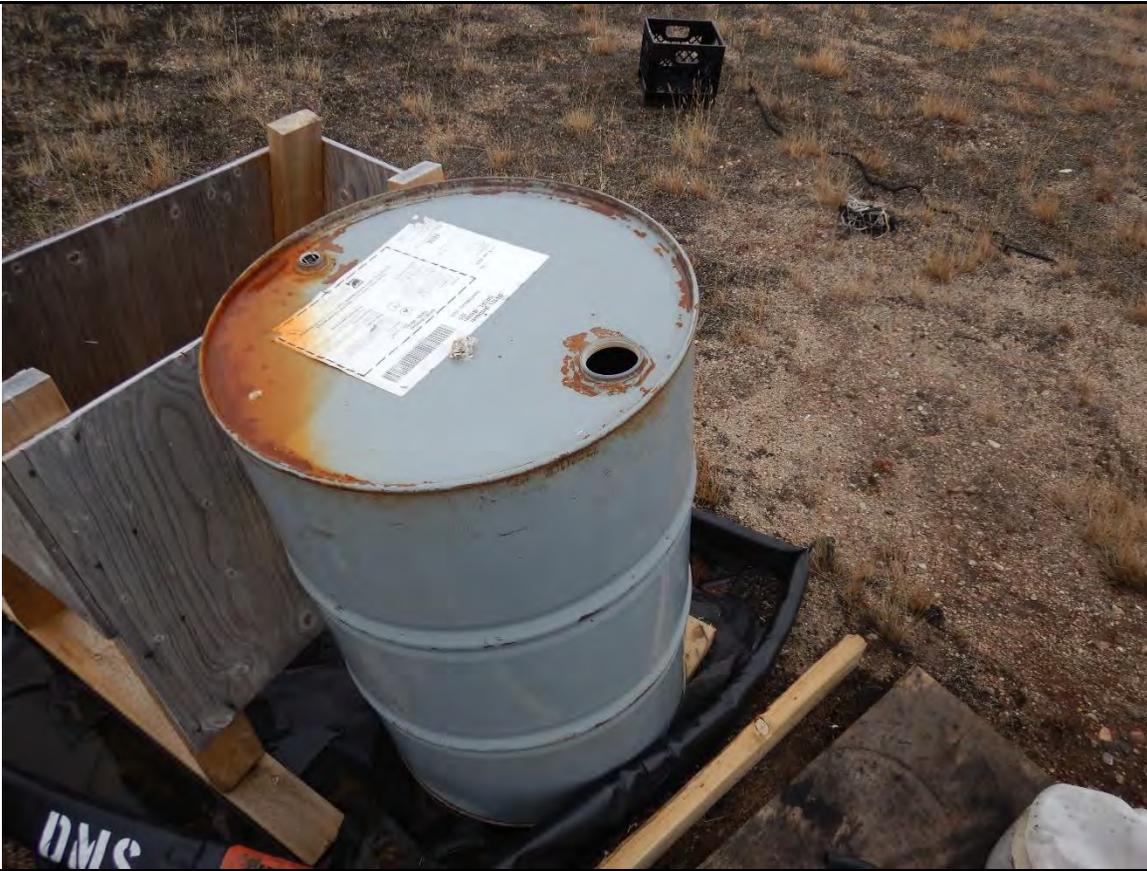
Photo 8

Description: wood within the containment pushing down the containment wall.

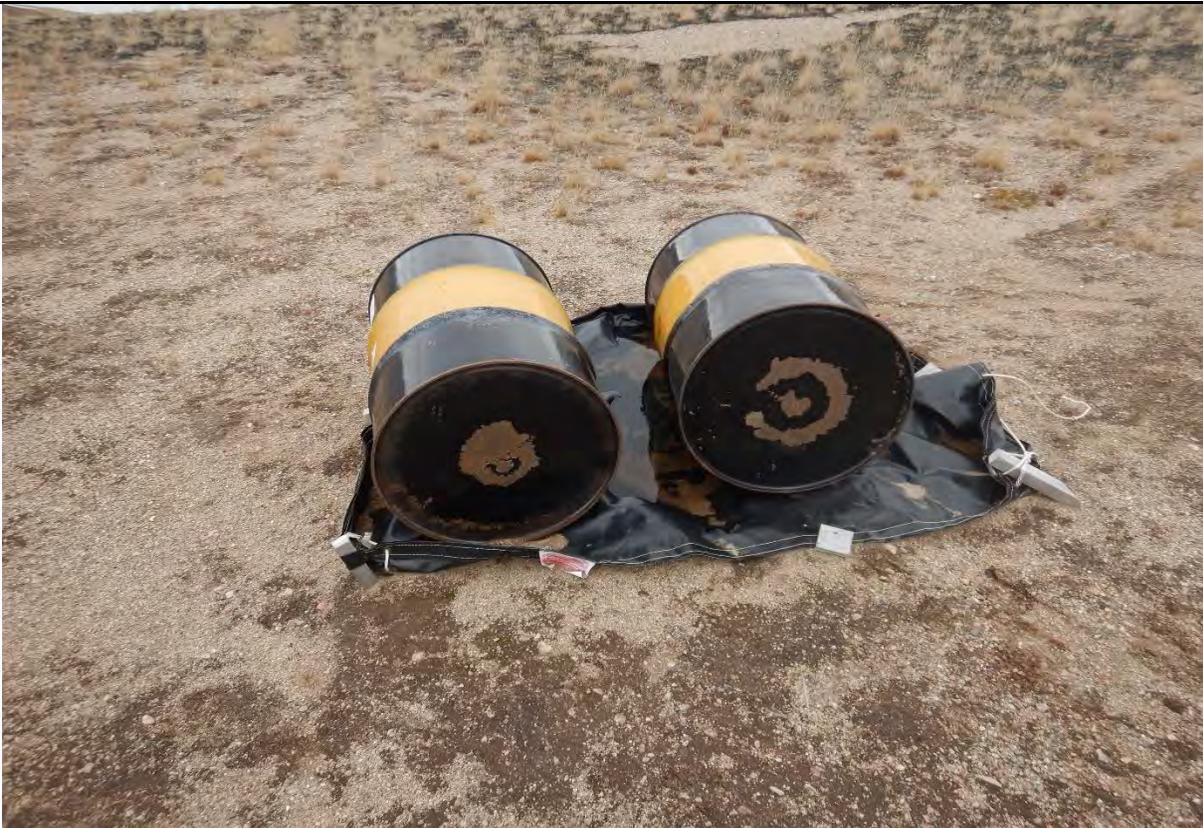
Photo 9

Description: damaged containment.

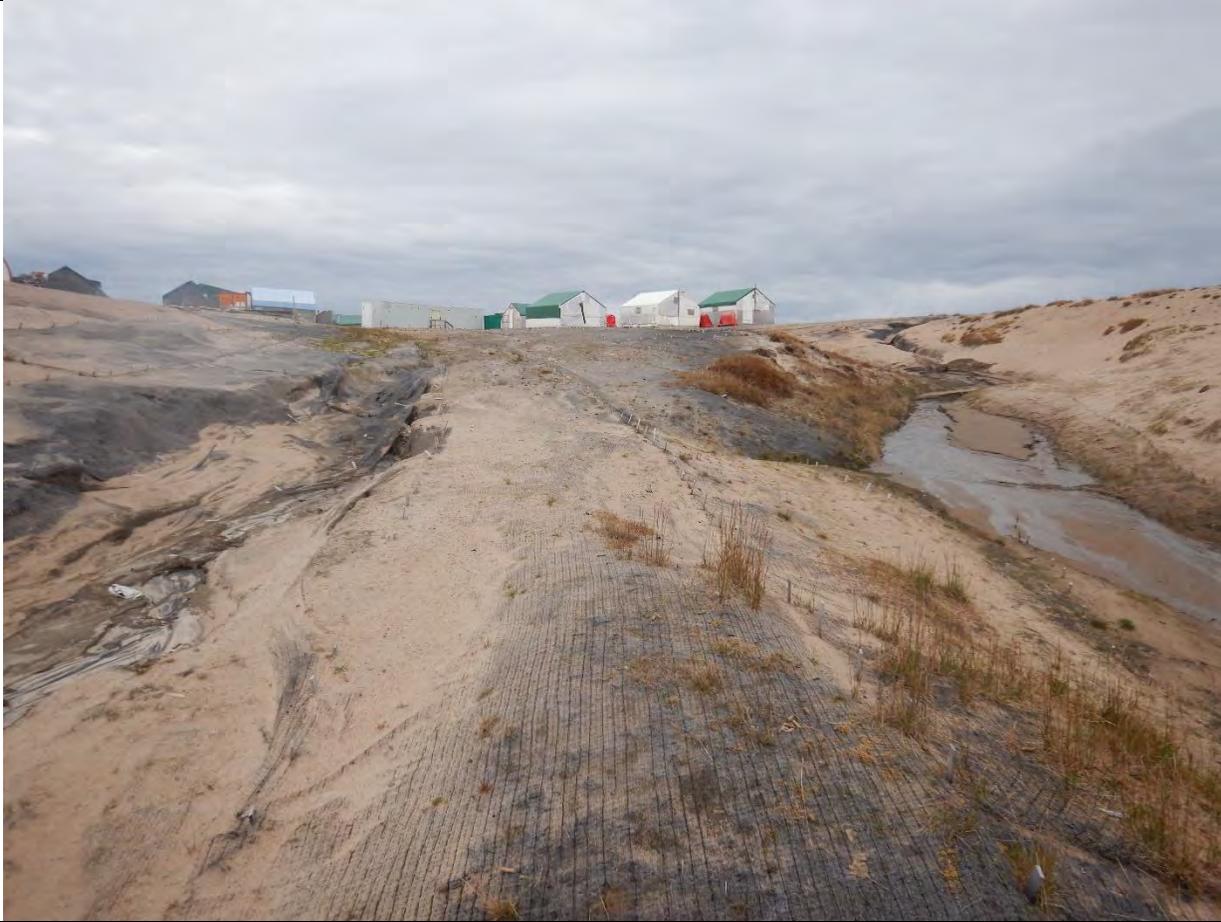
Photo 10

Description: erosion near sump.

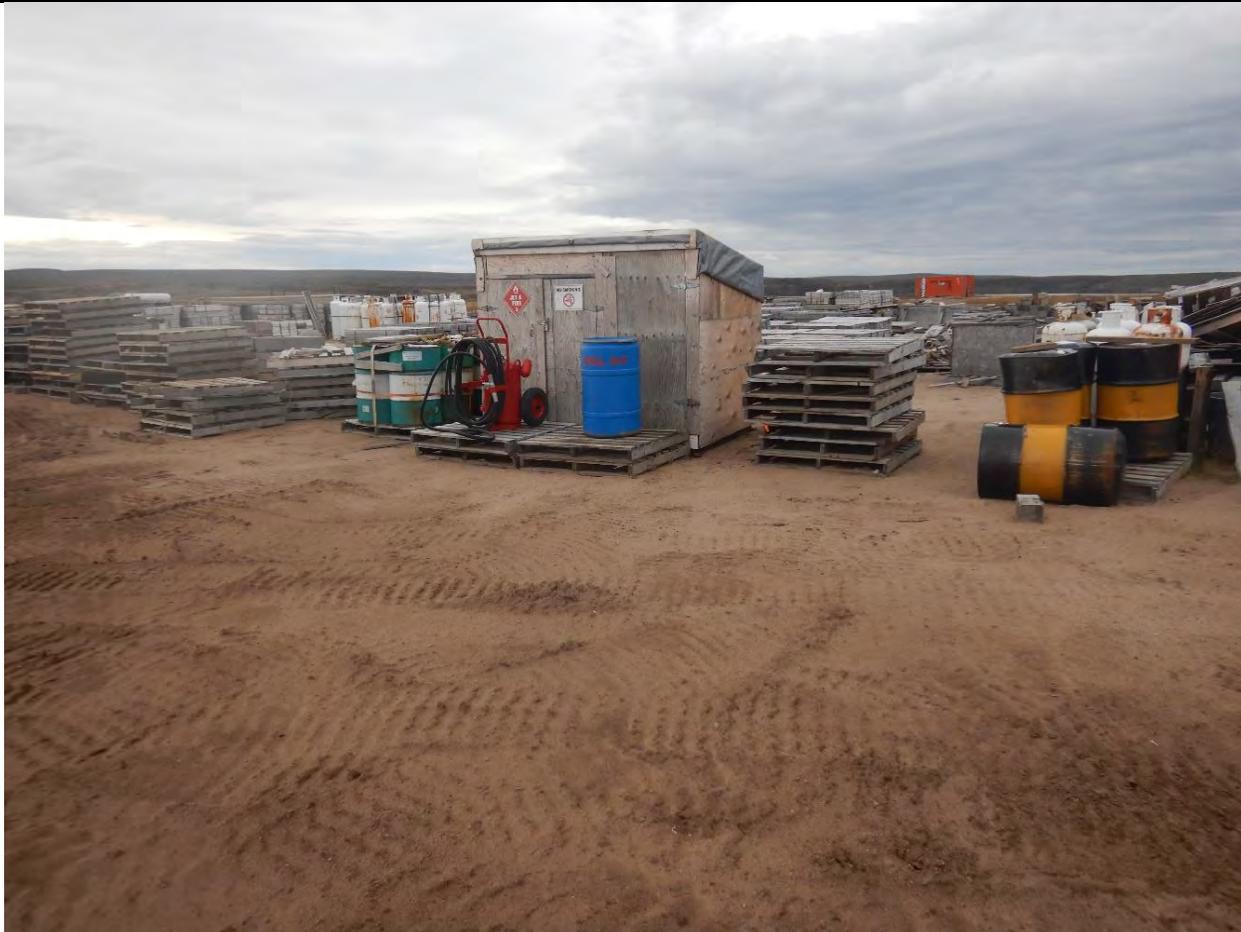
Photo 11

Description: 12 barrels outside of containment.

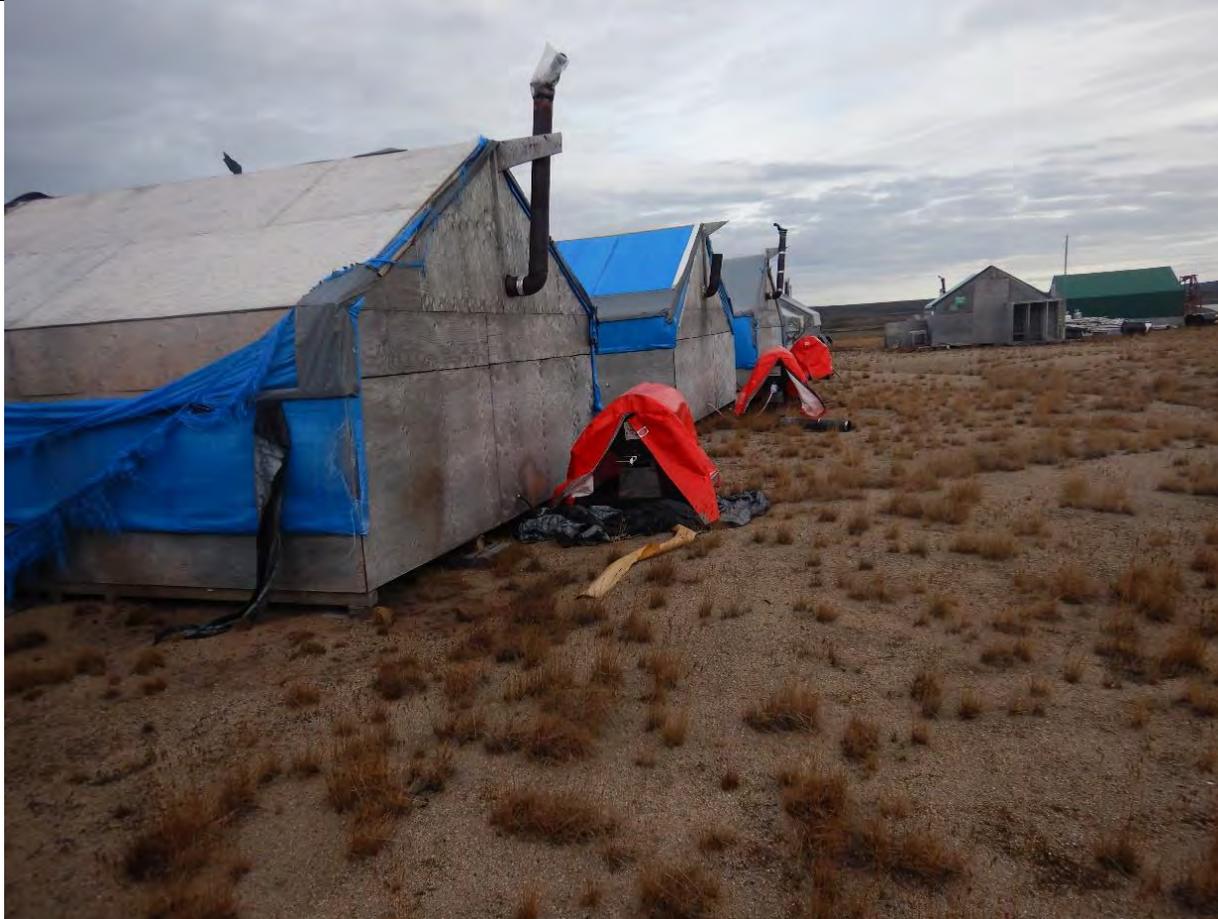
Photo 12

Description: tank covers open.

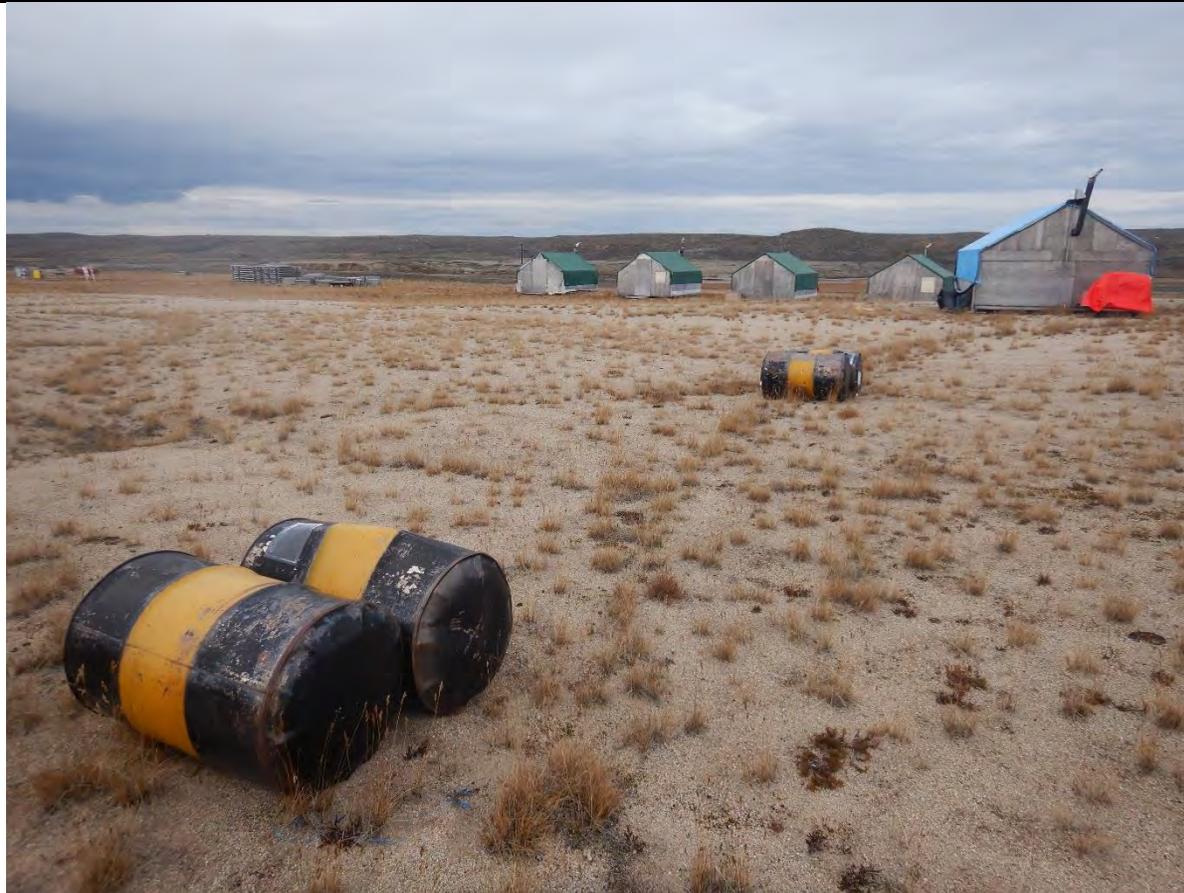
Photo 13

Description: barrels outside of containment.

Various drums lying next to the strip in pairs are drums filled with water as ballast/anchors for fixed wings, now sprayed with "WATER" stencil.

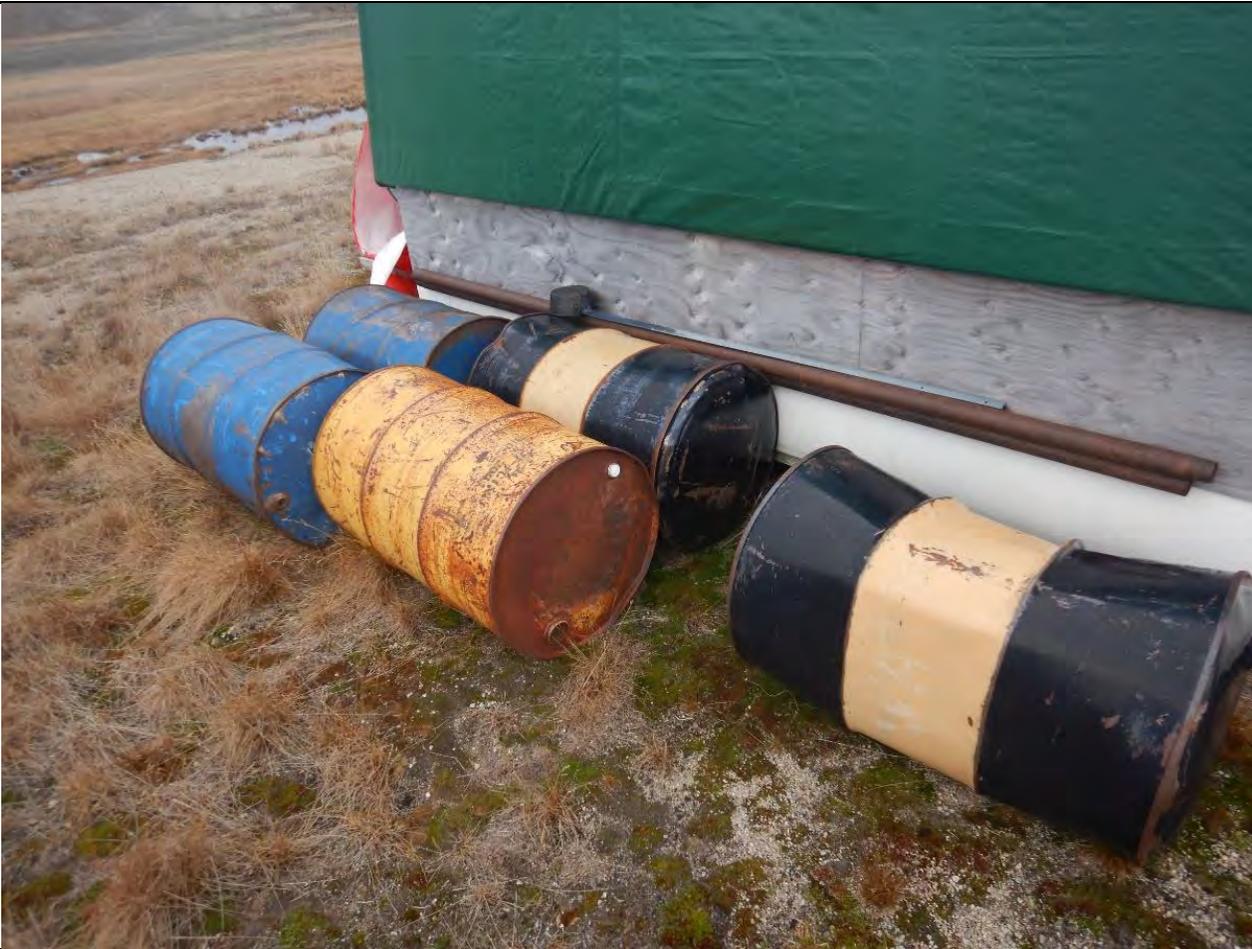
Photo 14

Description: barrels outside of containment.

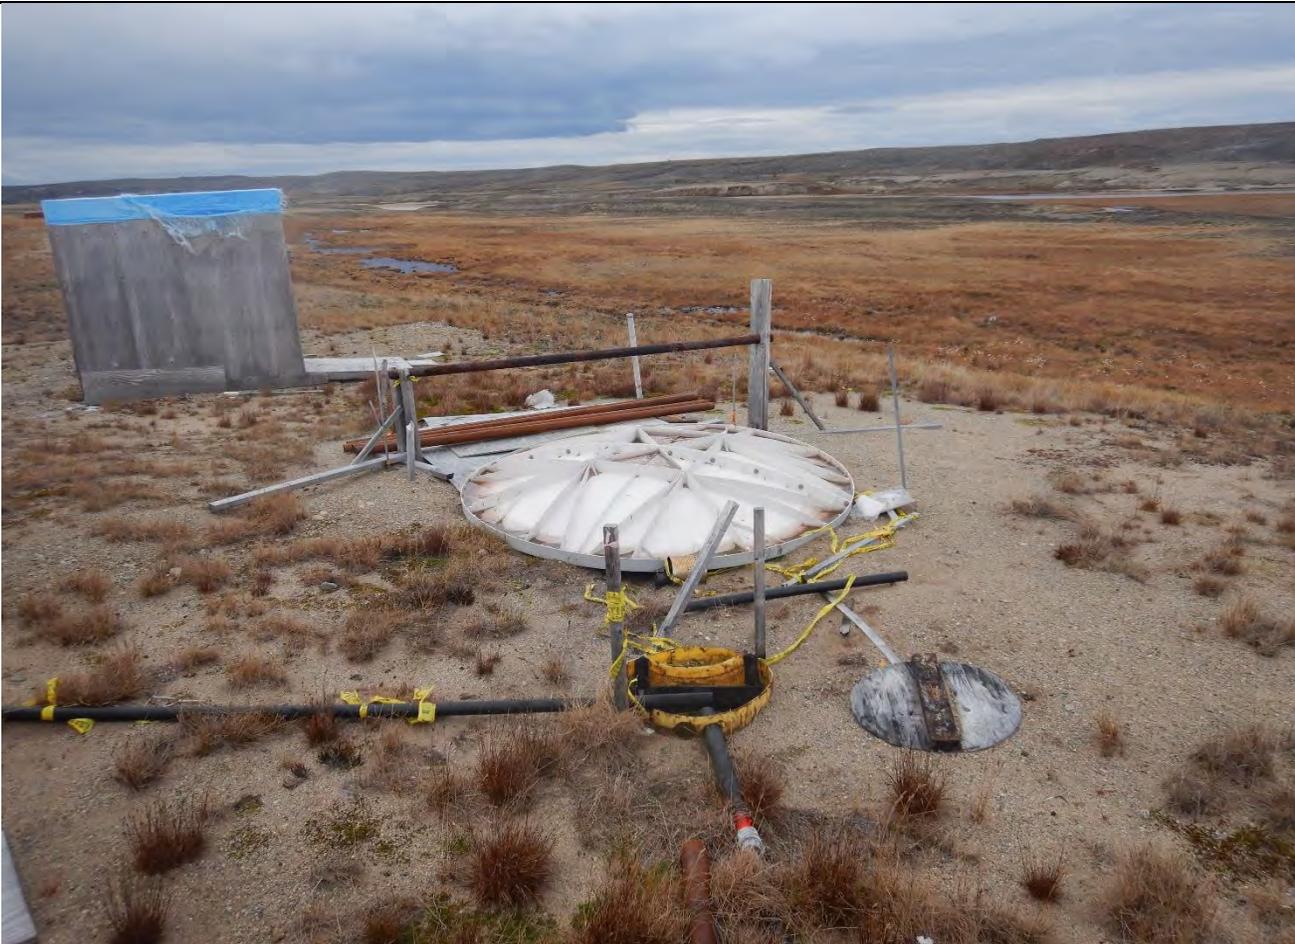
Photo 15

Description: sump without berms to prevent flooding.

Greywater sump now has a berm surrounding it to keep rain water/snow melt out.
