Attention **Merle Keefe, Environmental Permitting Manager for Sabina Gold and Silver**
Subject **Goose Project Site – 2021 Annual Geotechnical Inspection**
Project 1CS020.021

The 2021 AGI for the Goose site is the subject of this memorandum.

2021 Annual Inspection

DRAWING TITLE: General Arrangement
Comparison of 2021 Infrastructure to
Final Development Plans

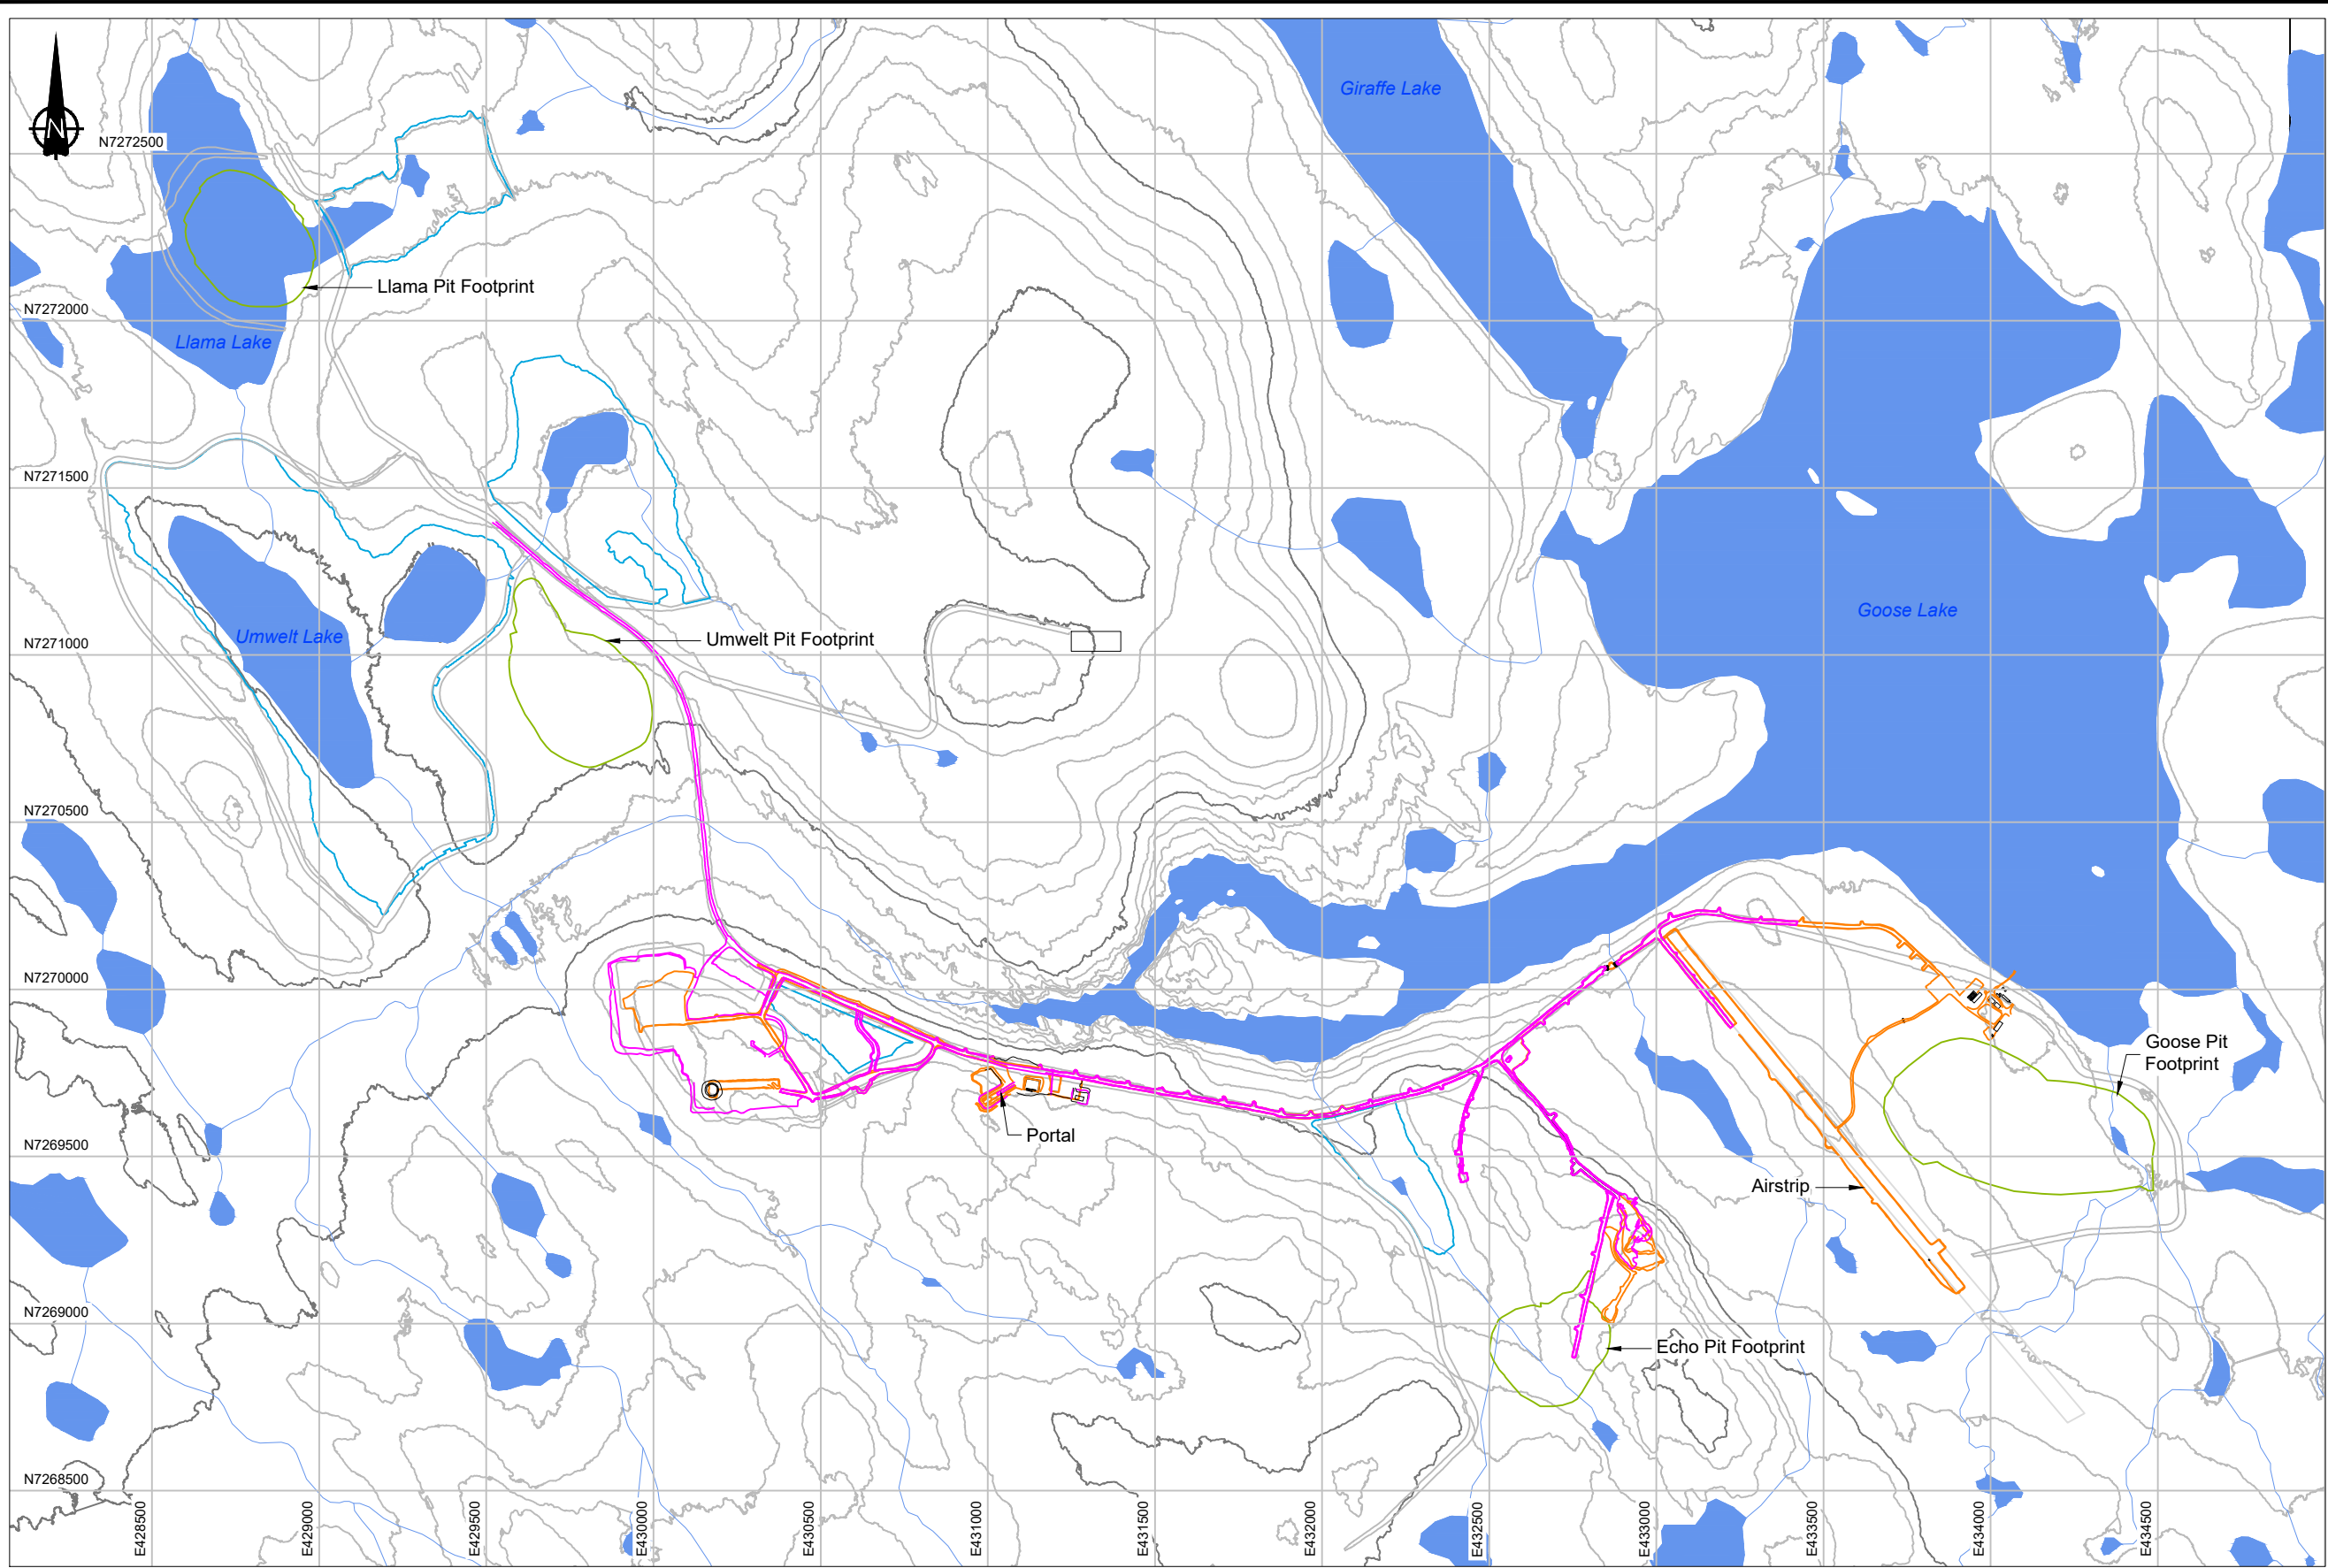
DATE: March 2022	APPROVED: JBK	FIGURE: 1
---------------------	------------------	--------------

Notwithstanding the observations and recommendations provided in this AGI (see Attachment 1), the Back River site is performing in reasonable accordance with predicted geotechnical expectations. The main observation as part of the 2021 AGI was that, as the site is currently in a transition stage and that many of the pads and roads and water conveyance (culvert) structures were at an interim state. Figure 1 shows recent earthwork progress at the Goose site, in comparison to the final design footprints, and highlights some of the current in progress areas that Saina is working on as Goose moves from exploration towards a development and operational stage.

Specifically, many of the areas of the roads, and area along the southwestern side of the Goose Airstrip expansion had fill thicknesses less than the final design thickness. If these areas are left in an underbuilt stage for multiple years, then the active layer in these areas would be expected to deepen, and either require more long-term maintenance (until conditions stabilize), or additional fill thicknesses (to accommodate a deepening active layer).

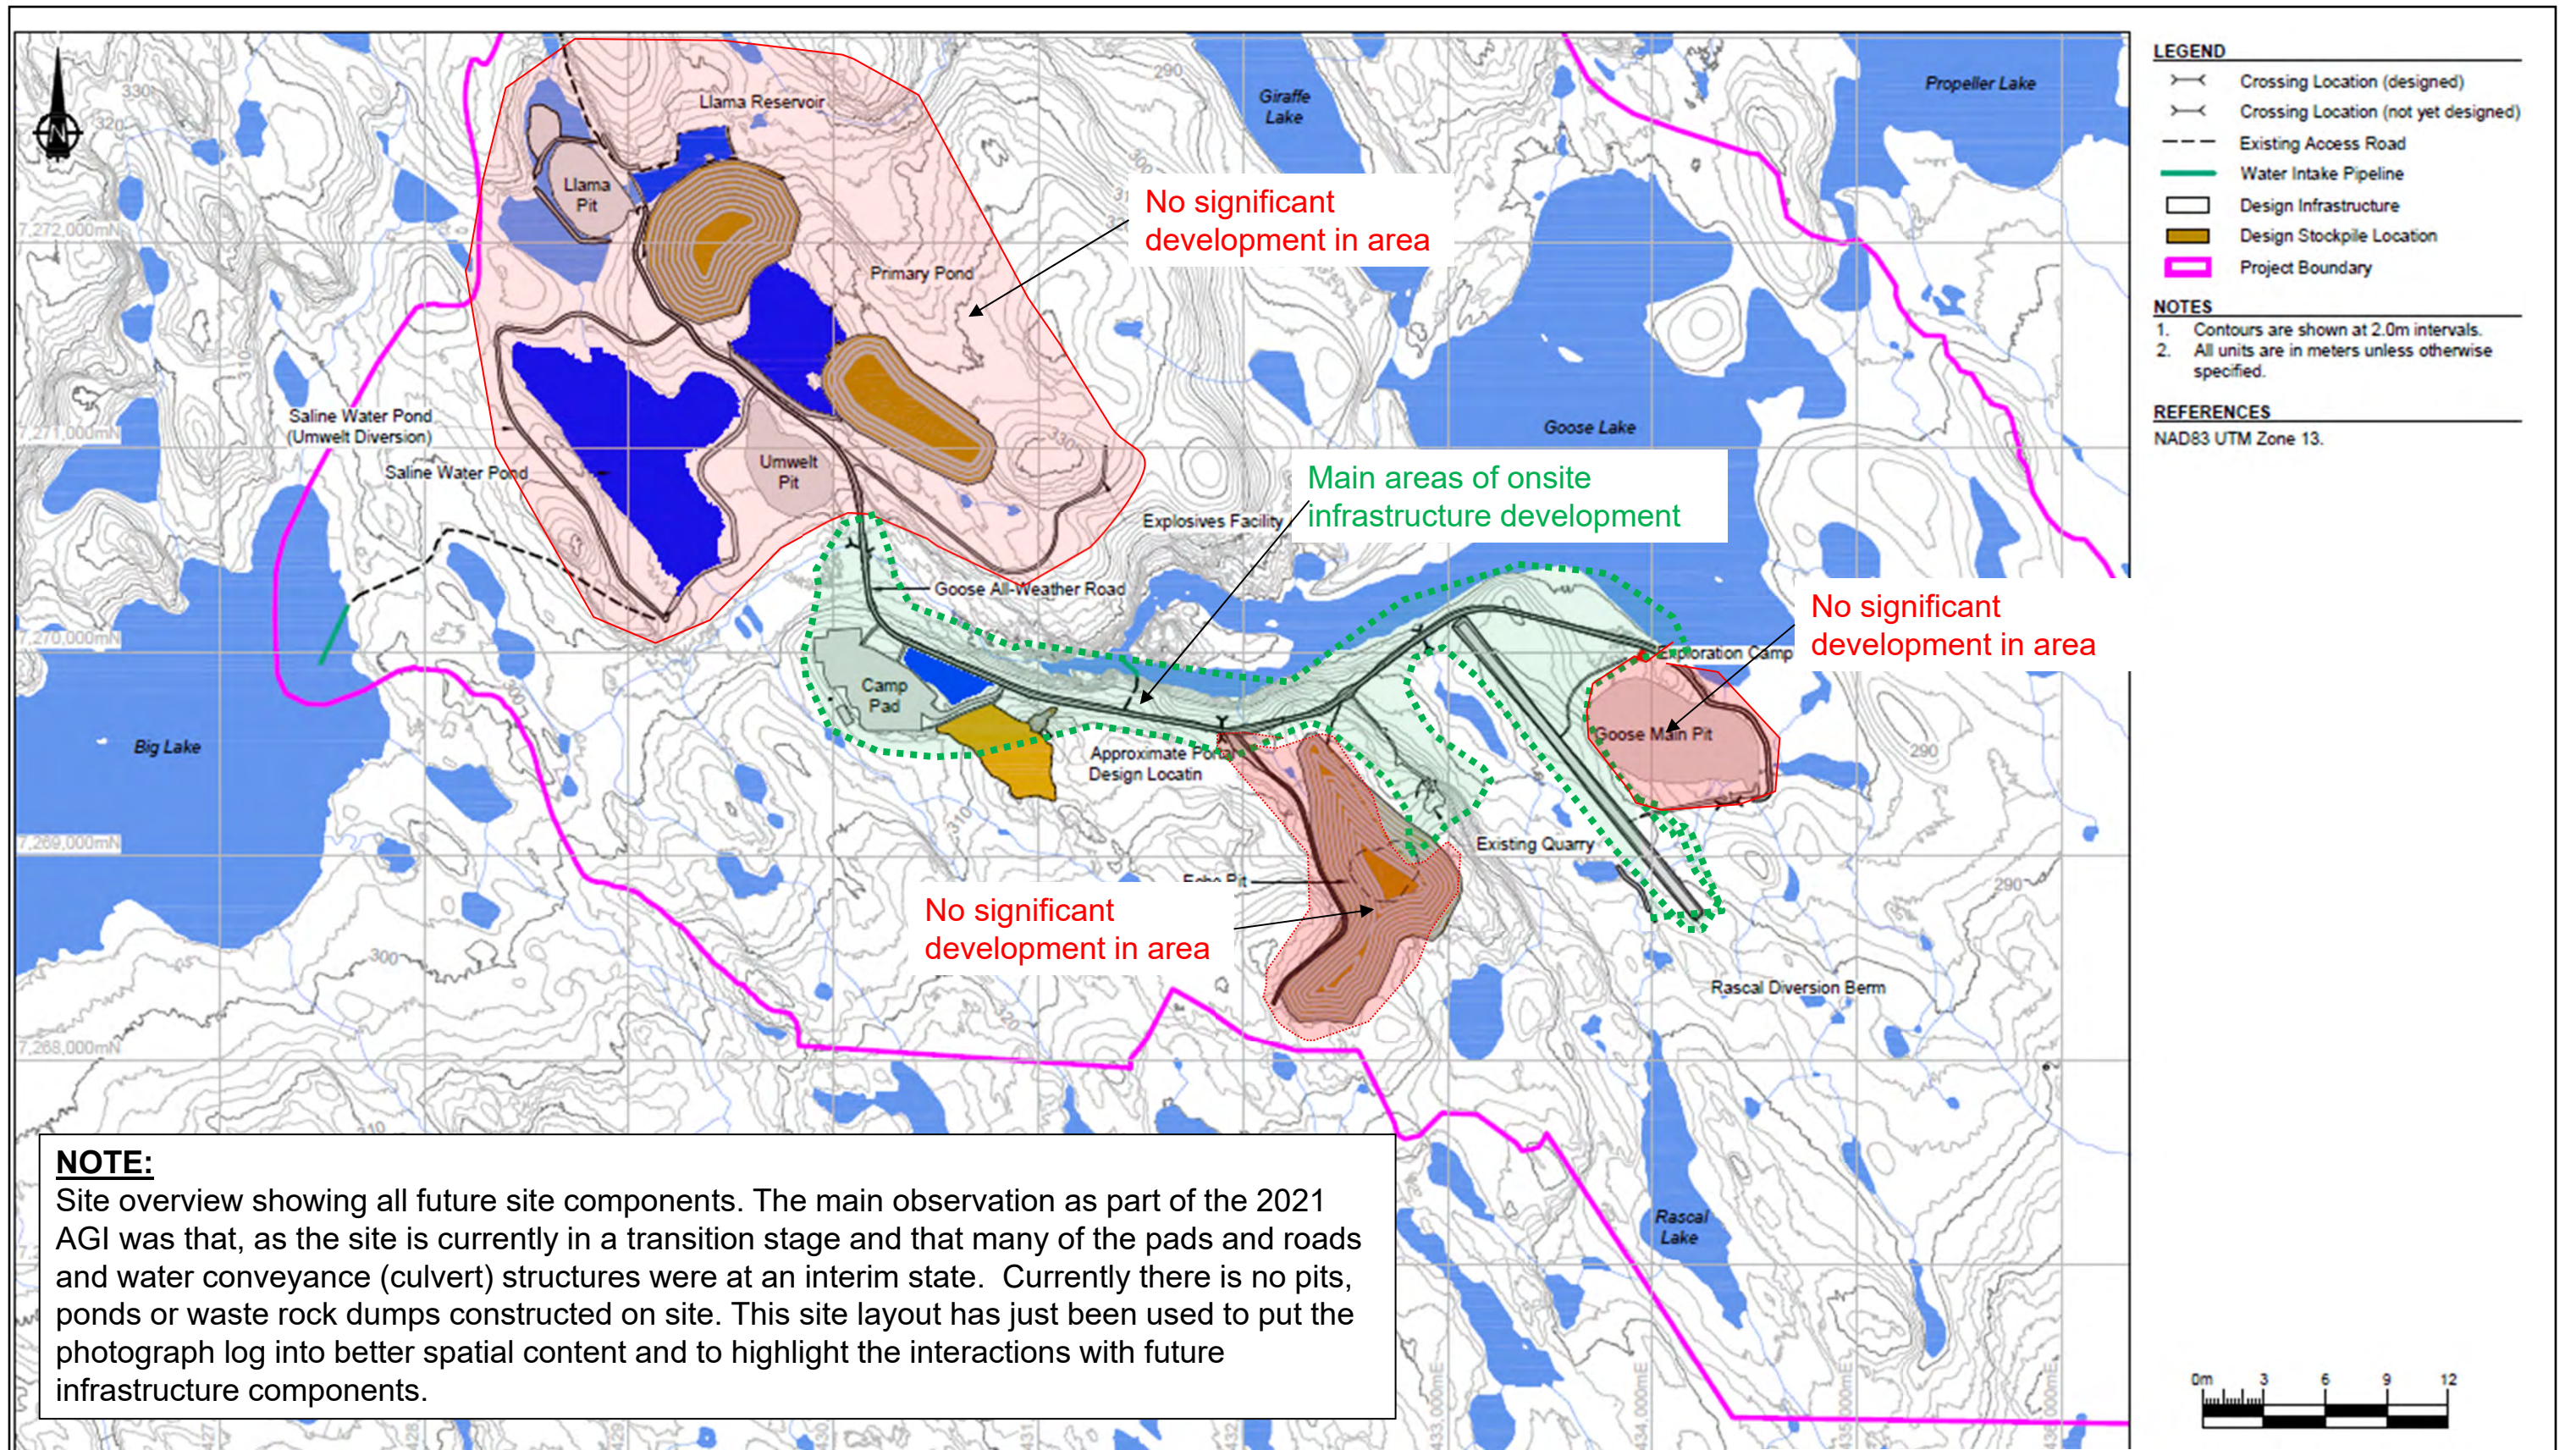
Date: Feb 2022
Approved: DG / JBK
Figure: 1a

Site overview showing all future site components. The main observation as part of the 2021 AGI was that, as the site is currently in a transition stage and that many of the pads and roads and water conveyance (culvert) structures were at an interim state. Currently there is no pits, ponds or waste rock dumps constructed on site. This site layout has just been used to put the photograph log into better spatial content and to highlight the interactions with future infrastructure components.

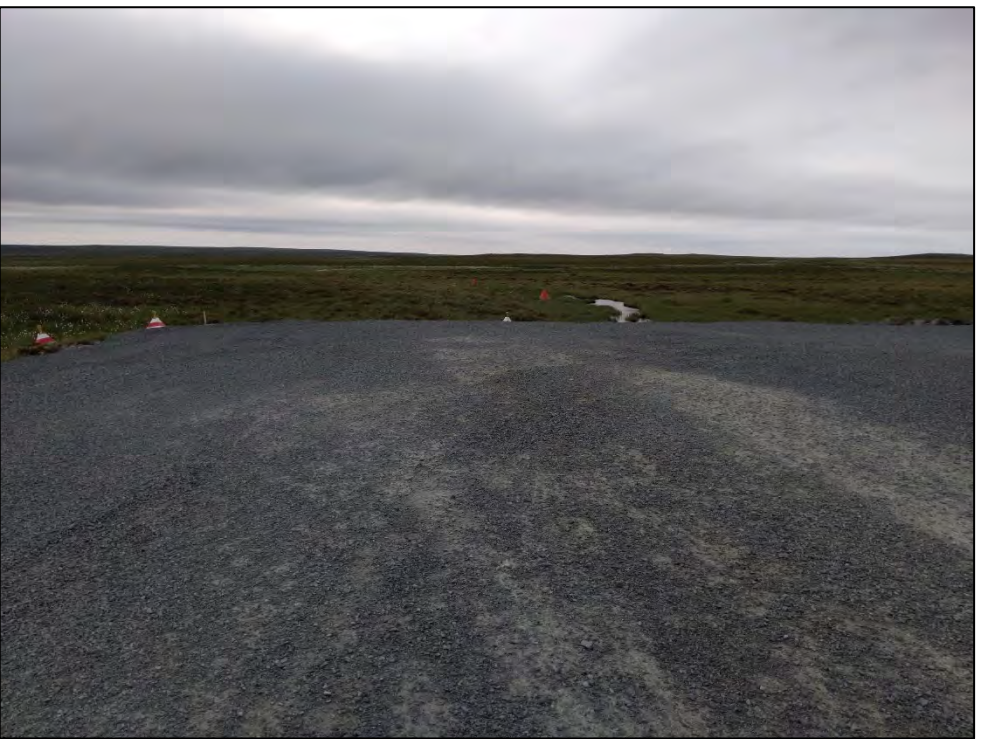
Photo 26 – Southern end of airstrip where think fill note, no cracking or undulation observed

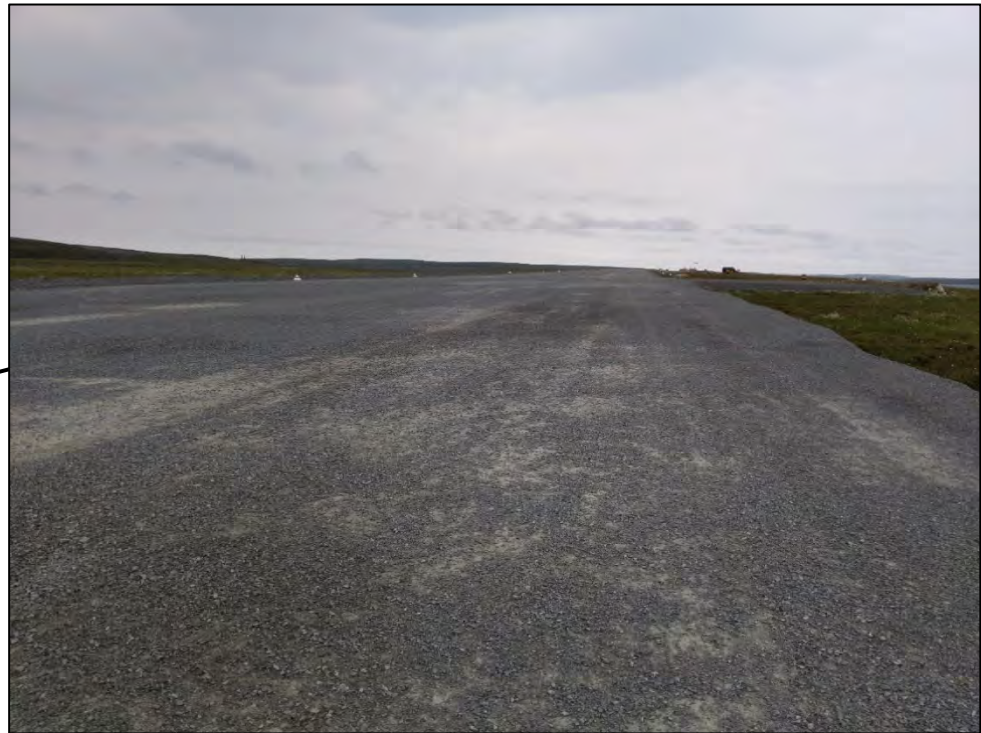
Photo 27 – View northerly direction of airstrip surface, no cracking observed despite lower fill thickness
