2021 Back River Geotechnical Inspection		
		Camp Contact Water Pond Footprint		
	Back River Project	Date: Feb 2022	Approved:	Figure: 21

2021 Back River Geotechnical Inspection		
		Camp Contact Water Pond Footprint		
Job No: 1CS020.021 Filename: BackRiver_2021GeotechInspection_PhotoLog	Back River Project	Date: Feb 2022	Approved: DG / JBK	Figure: 23

2021 Back River Geotechnical Inspection

**Camp Contact Water Pond
 Footprint**

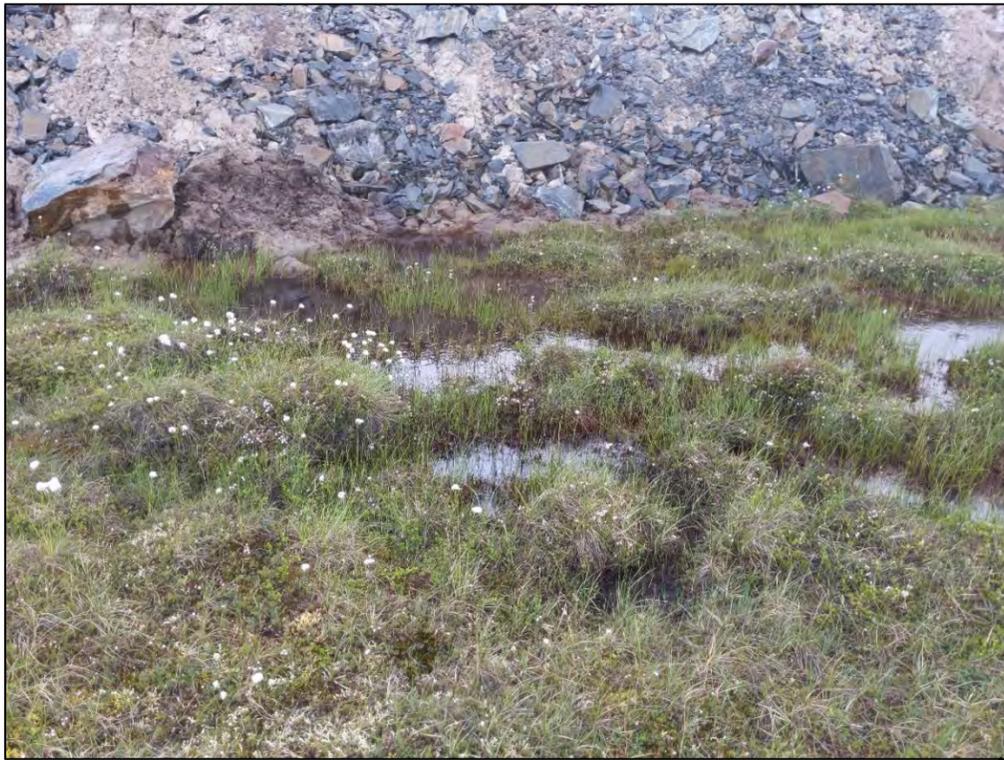
Photo 9 – Some ponded water observed within footprint

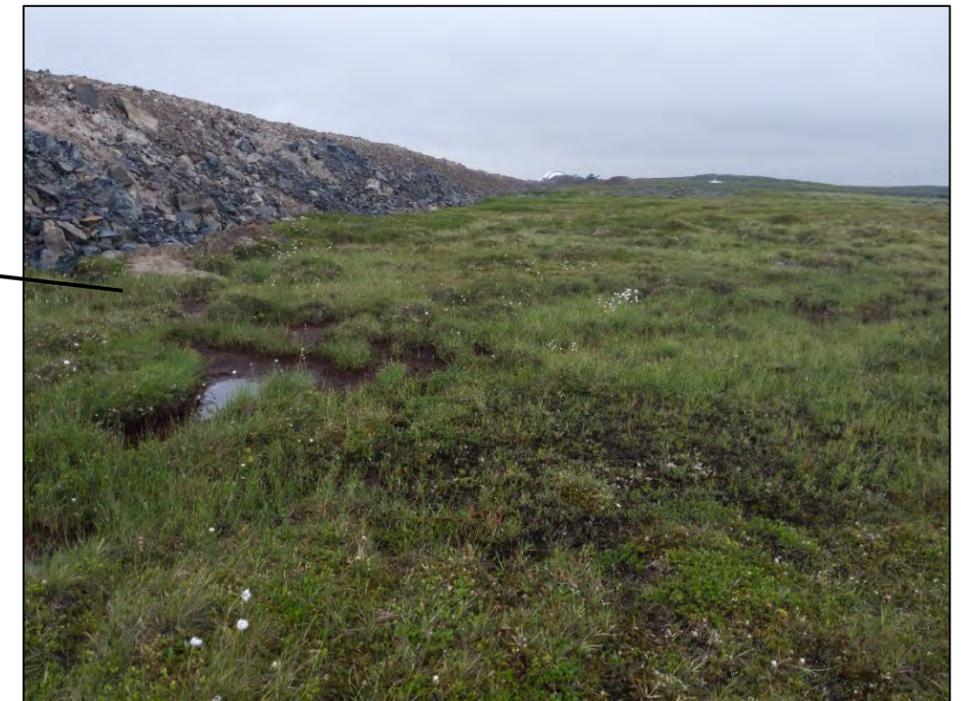
Photo 12 – Some ponded water observed within footprint

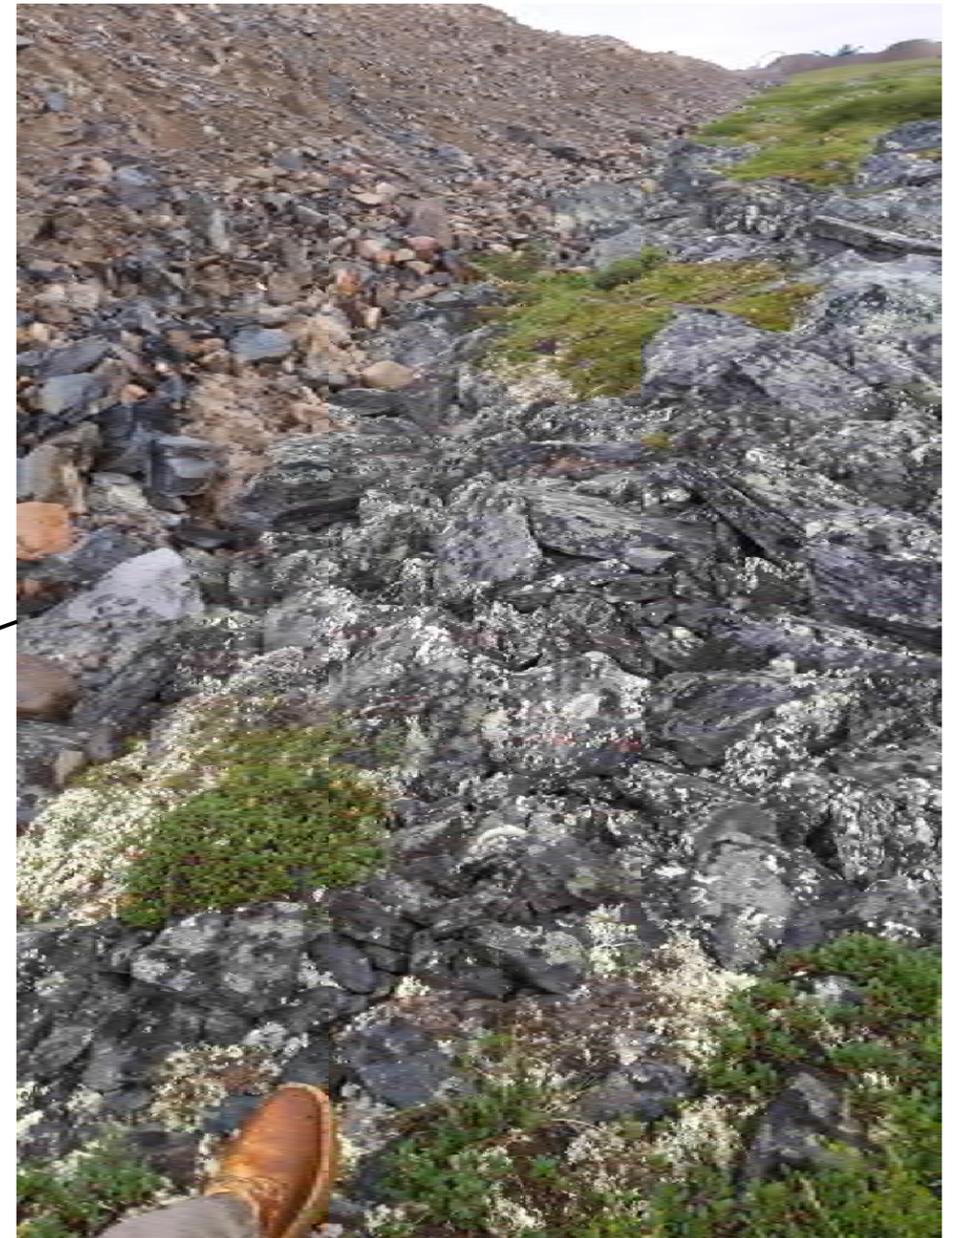
Photo 16 – Fractured rock extending under CWO embankment area

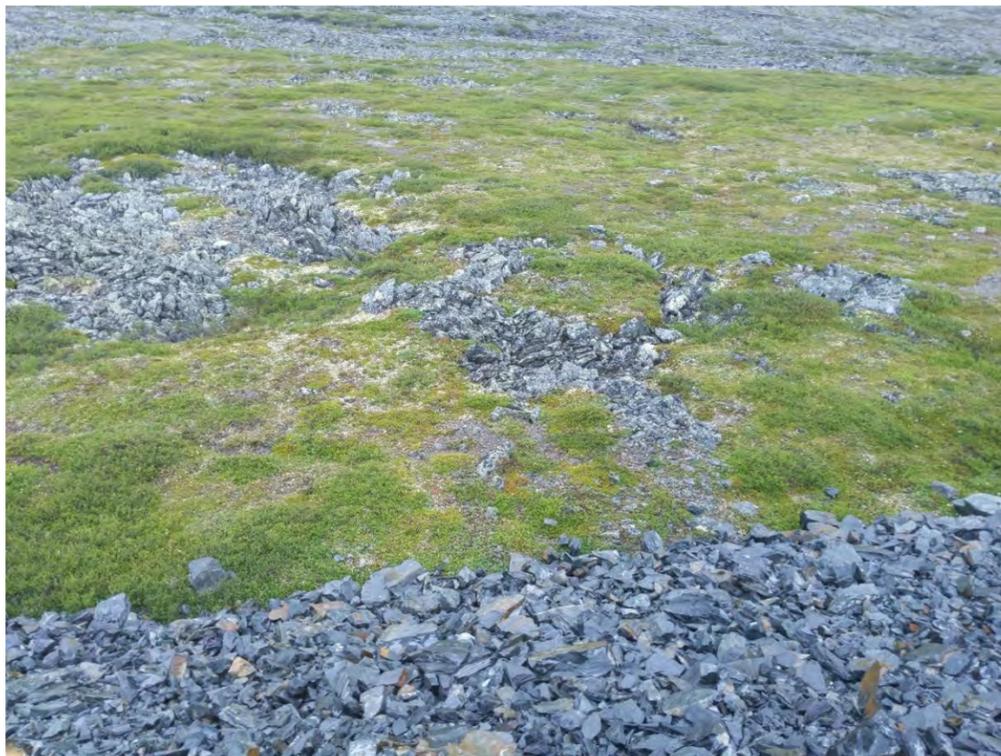
Photo 14 – Fracture rock extending beyond CWP embankment area

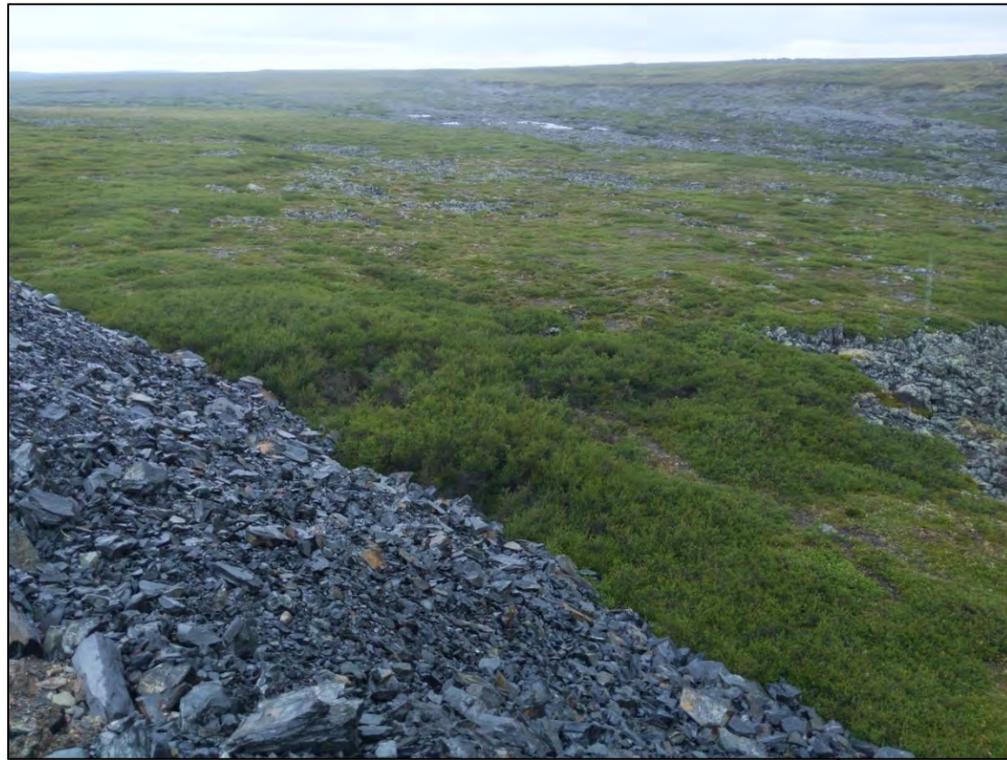
Photo 17 – View downstream from road

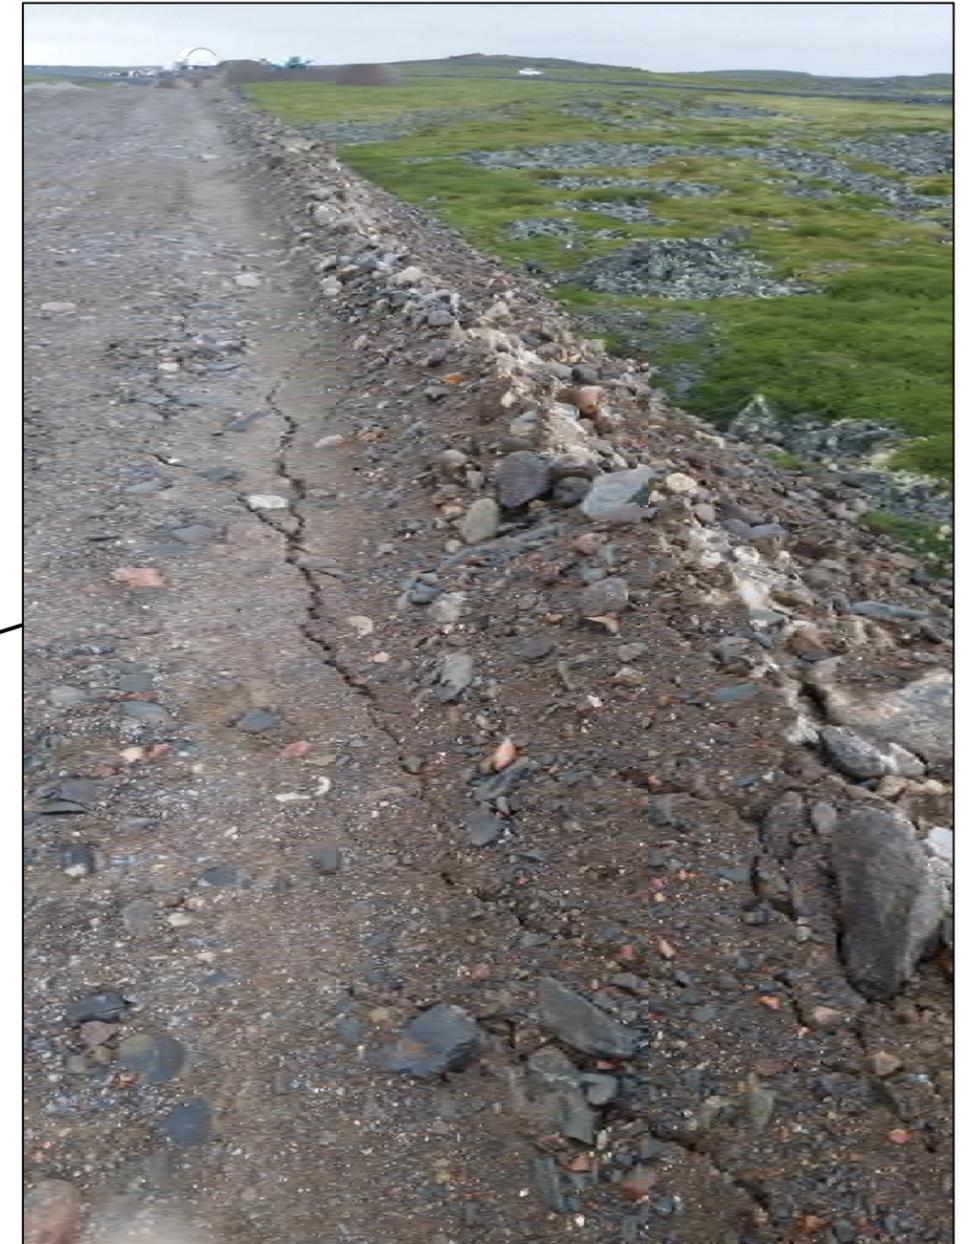
Photo 23 – Note cracks on roadway, road fill ~4 m above tundra

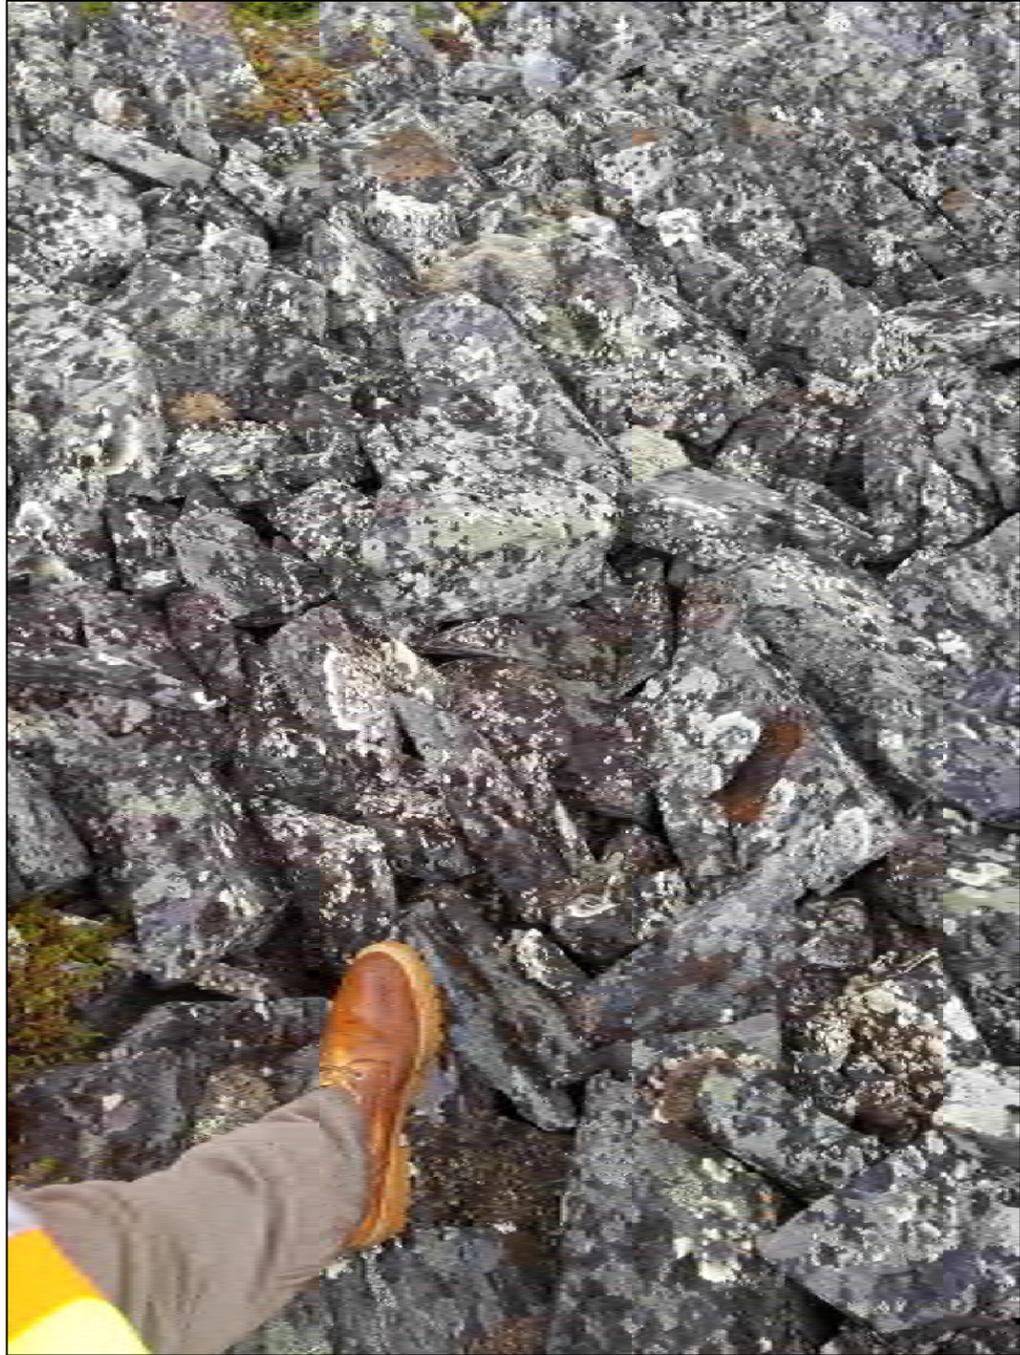
Photo 26 – Highly fracture rock outcrop

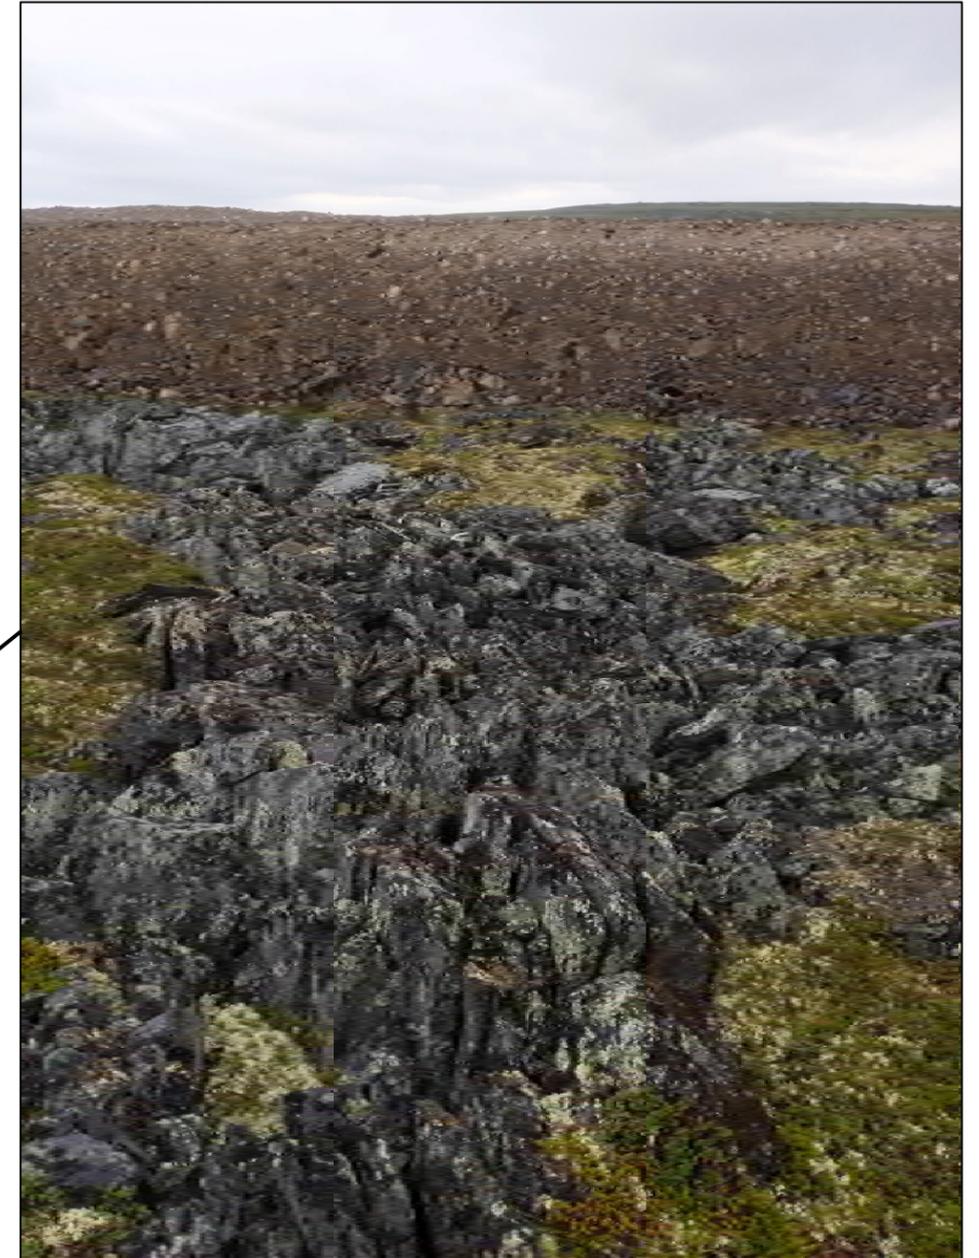
Photo 27 – Highly fractured rock outcrop extending through planned embankment area

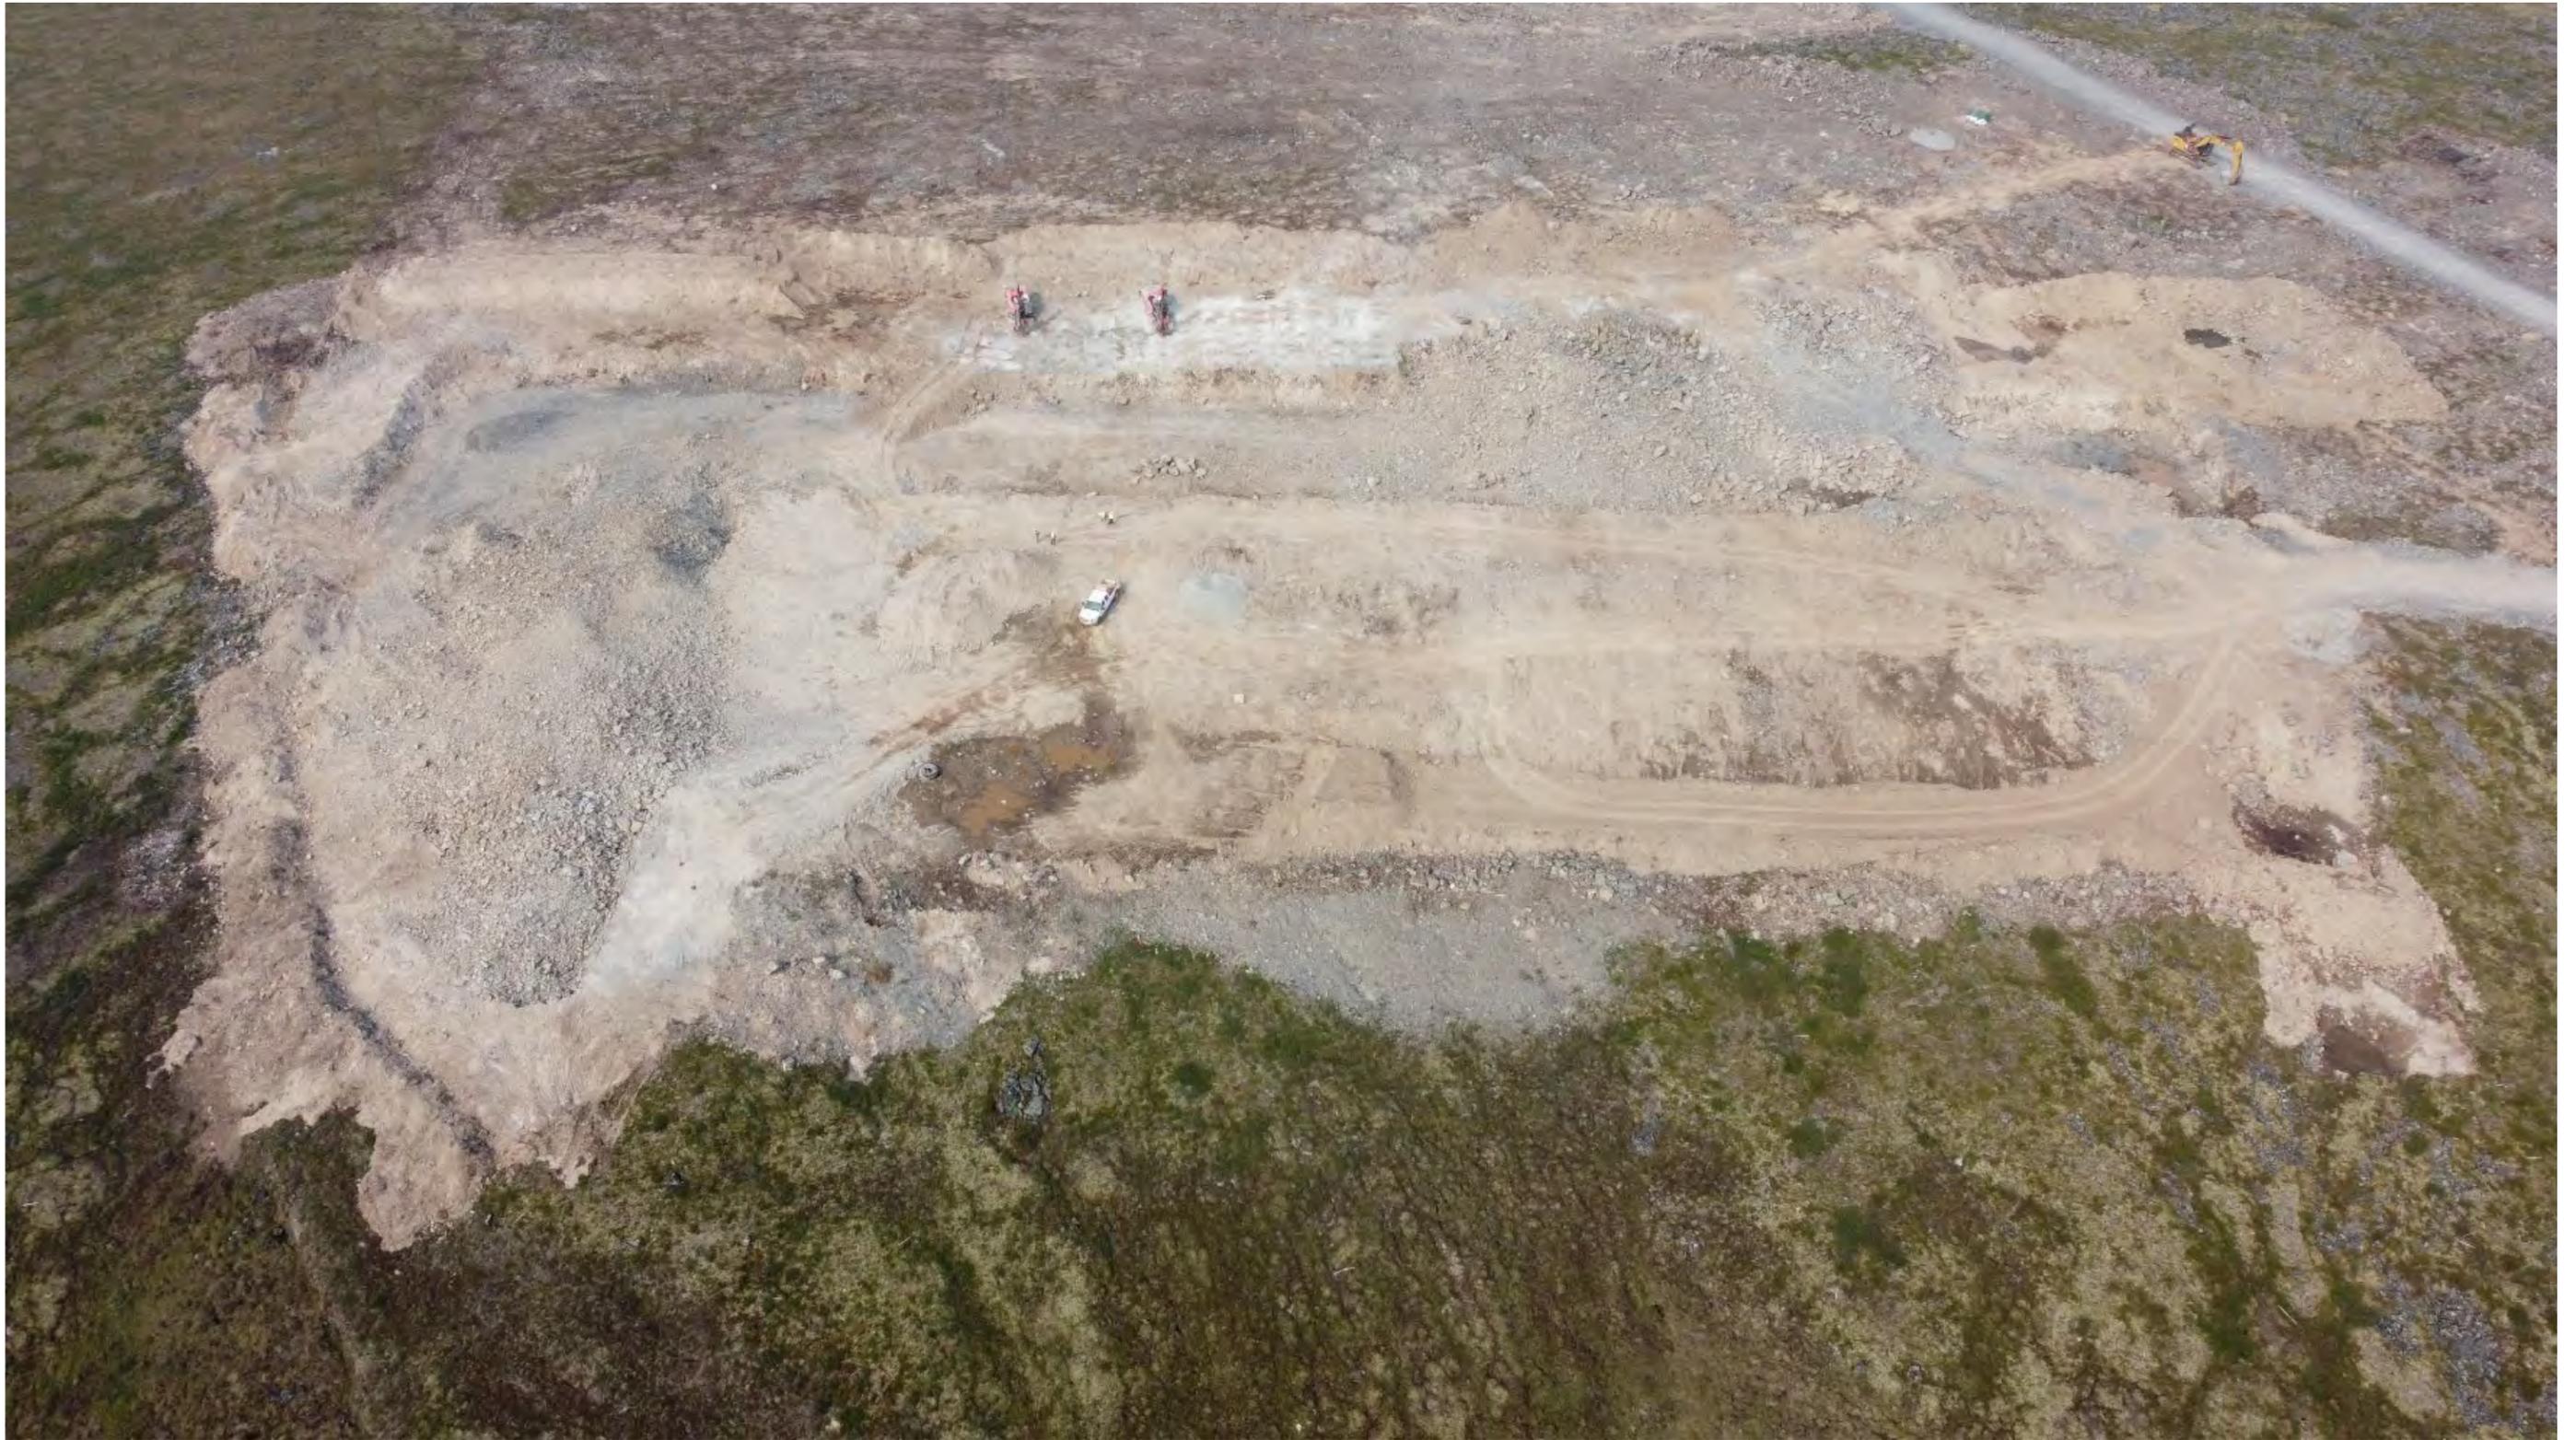
Note: At the time of the summer SRK inspection there were no tanks installed on site at the plant site pad. This photo shows an overview of the site development activities at the plant site pad area at the time of the summer 2021 inspection. This location was in a state of active development
