**ATTACHMENT C**

# 2022 Piezometric Data

2022 GROUNDWATER MONITORING PROGRAM  
WHALE TAIL MINE, NUNAVUT

**2022 Seepage Survey  
Photographs (provided by Agnico  
Eagle)**

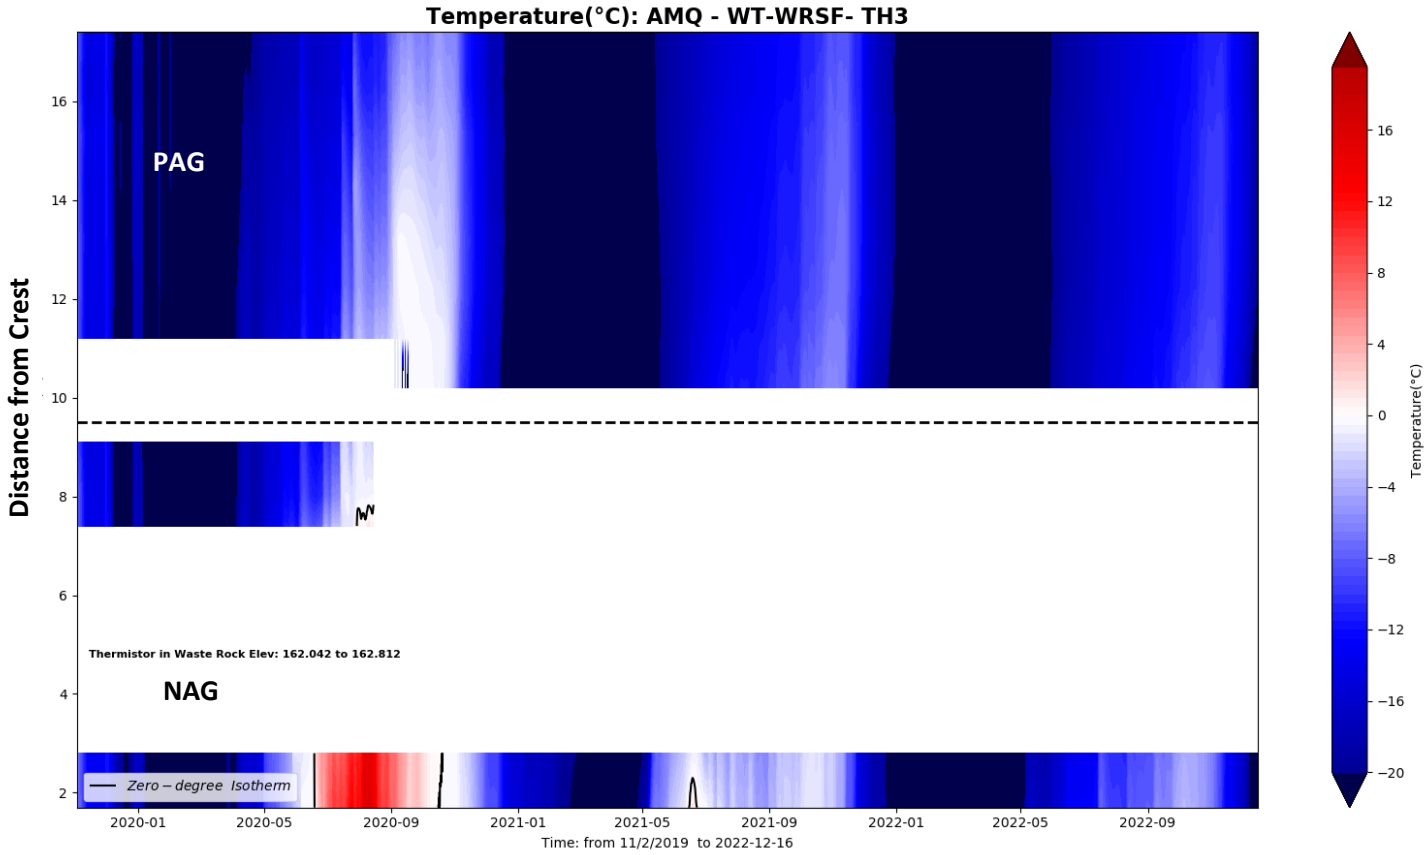
WT WRSF TH3

This instrument is installed horizontally and chart needs to be read accordingly  
Beads 3 to 10 are not working

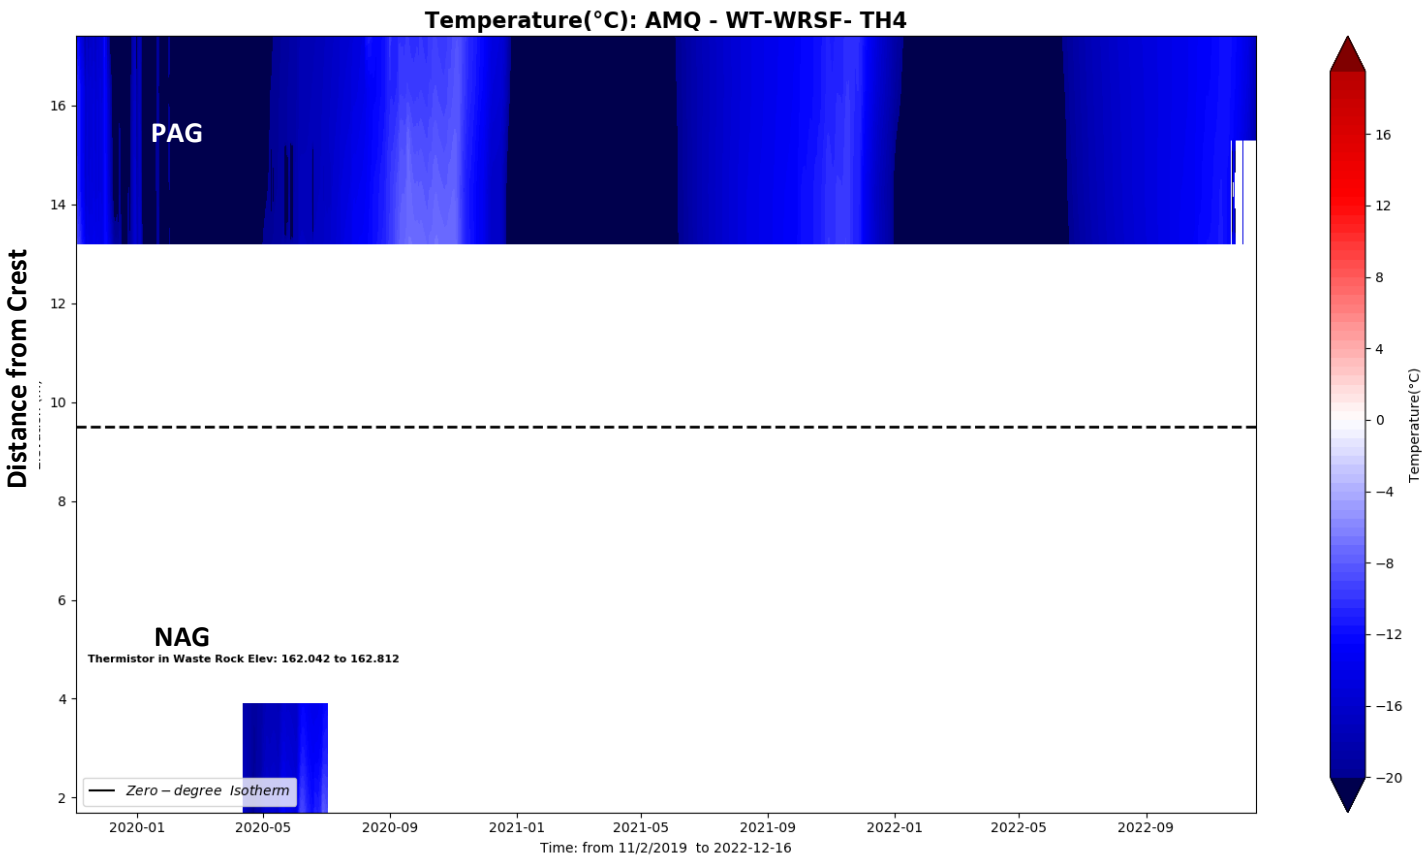
WT WRSF TH4

Beads 3 to 10 are not working

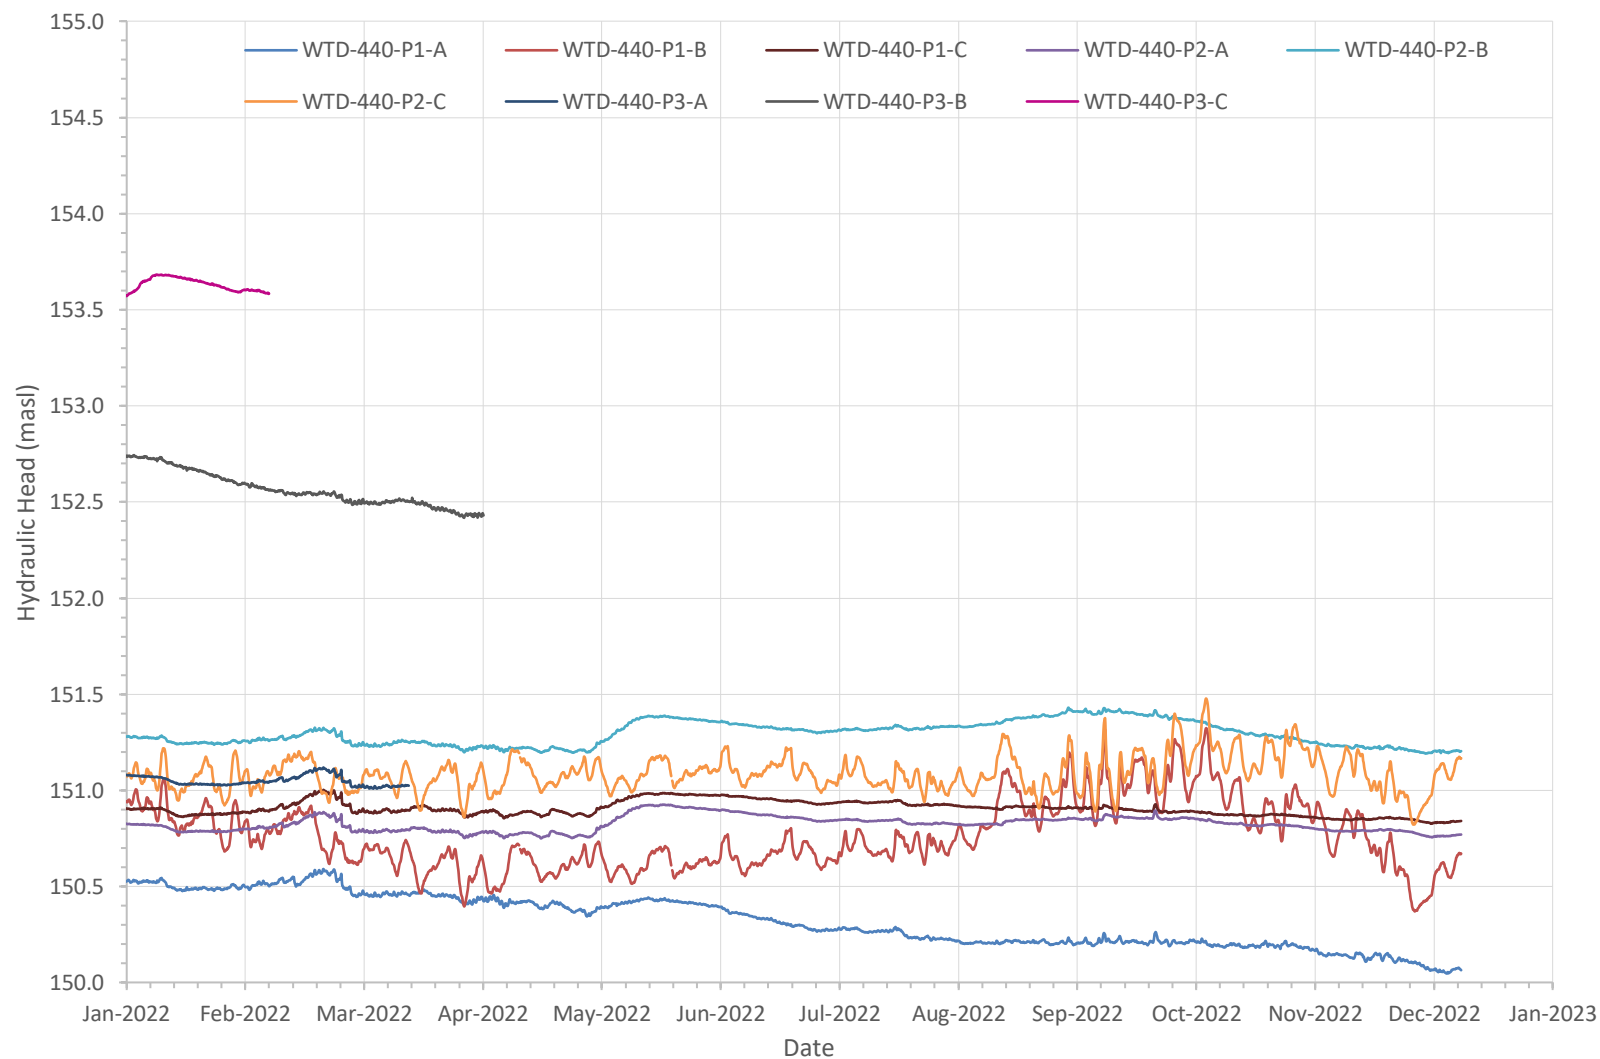
FIGURE  
C-4

Notes:  
WTD-440 series piezometers installed  
Hydraulic head data unavailable for WTD-440-P3-C from March 6 to December 31, 2022, for WTD-440-P3-B from April 29 to December 31, 2022, and for WTD-440-P3-A from April 10 to December 31, 2022, due to equipment malfunction.

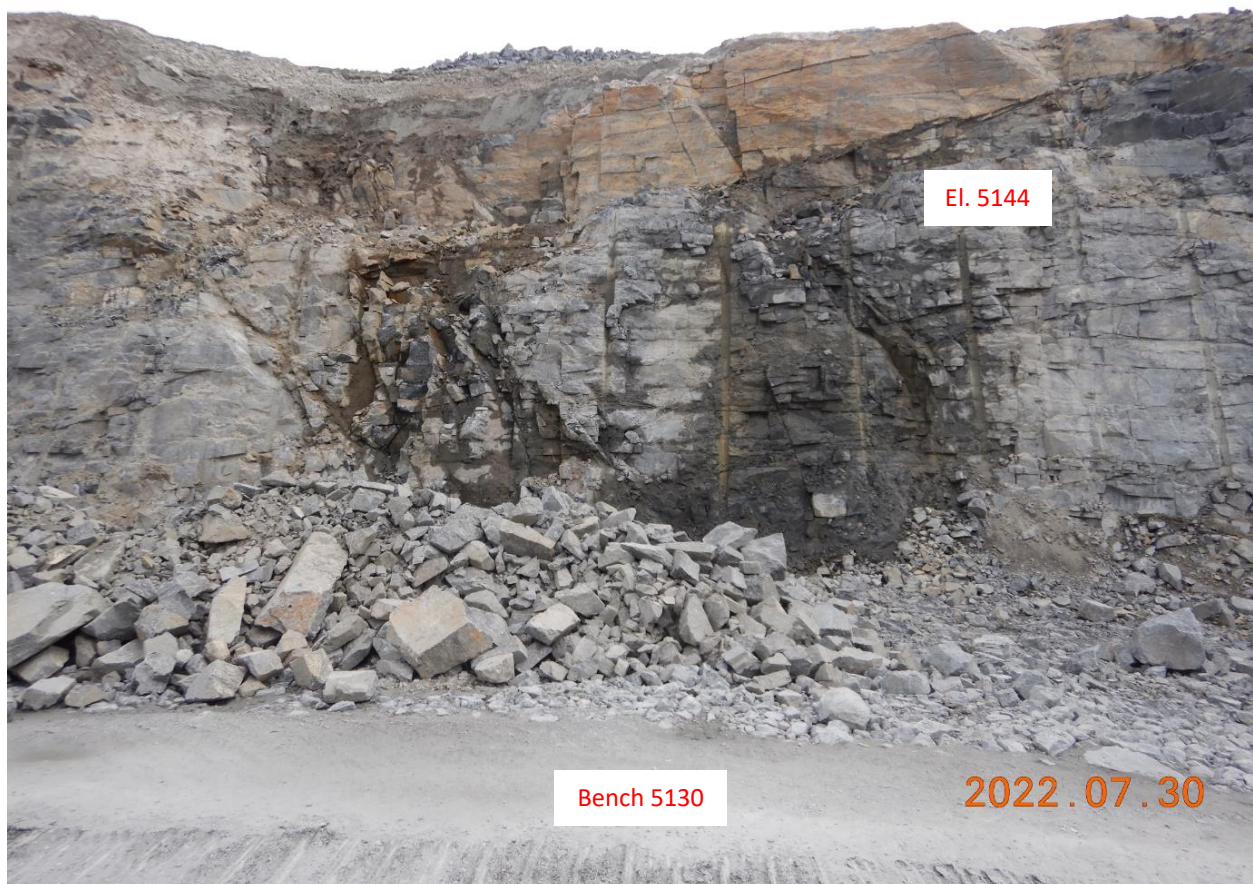
Photo 1: Pit seepage along Whale Tail Pit south wall, concentrated water source type, flowing joint (water source is related to ongoing water management operations), looking south (July 30, 2022).

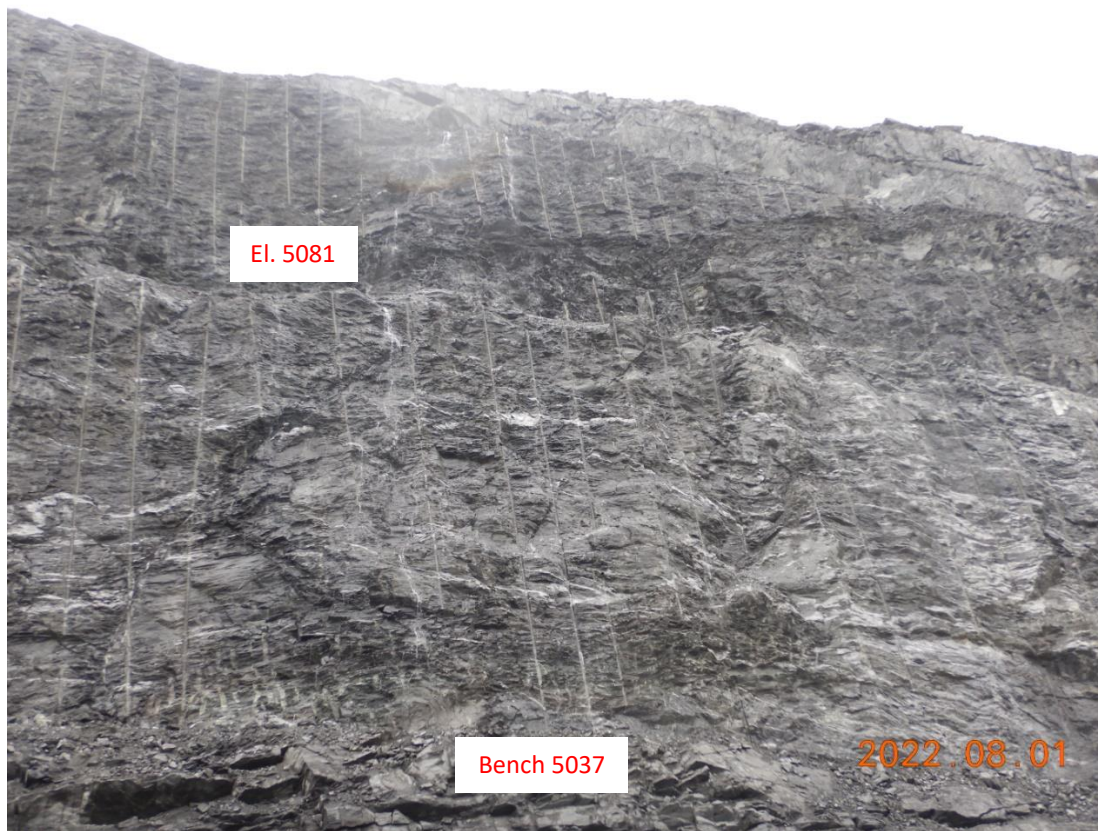
Photo 3: Pit seepage along Whale Tail Pit south wall; flow coming from the ramp during a rainy day but precipitation does not justify the amount of concentrated water (August 1, 2022).
