Meadowbank and Whale Tail 2022 Annual Geotechnical Inspection

REPORT**2022 Annual Geotechnical Inspection***Meadowbank Complex, Nunavut*

1617-2146800622-5000-RA-Rev0

16 December 2022

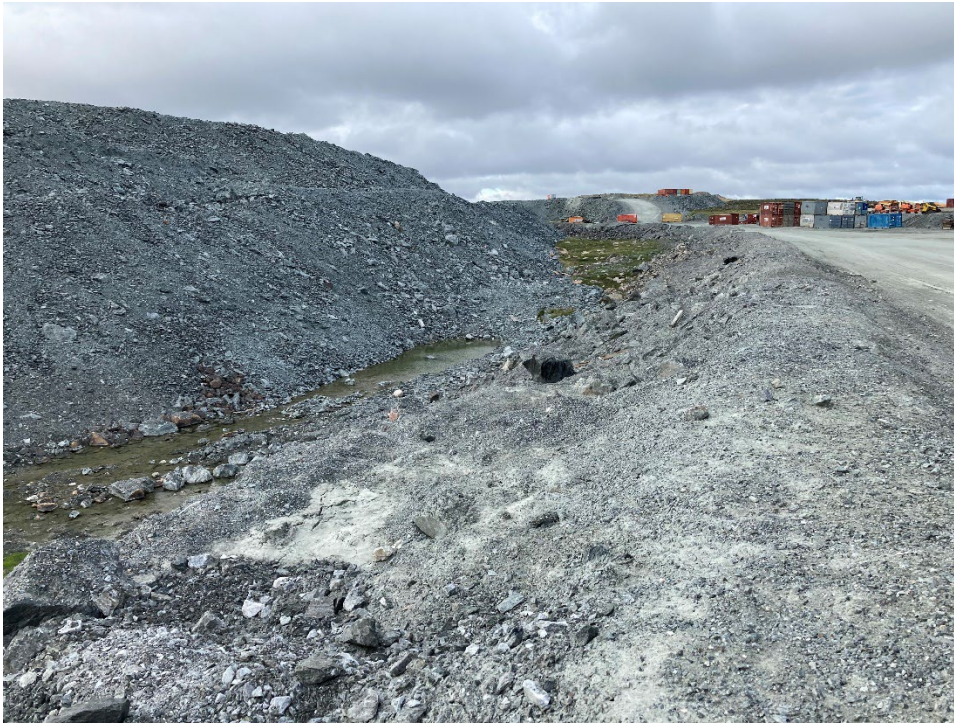
Photograph A2-5 South Camp Dike

Description: From the north abutment, looking south at the downstream slope. There is some water ponding, from run-off.

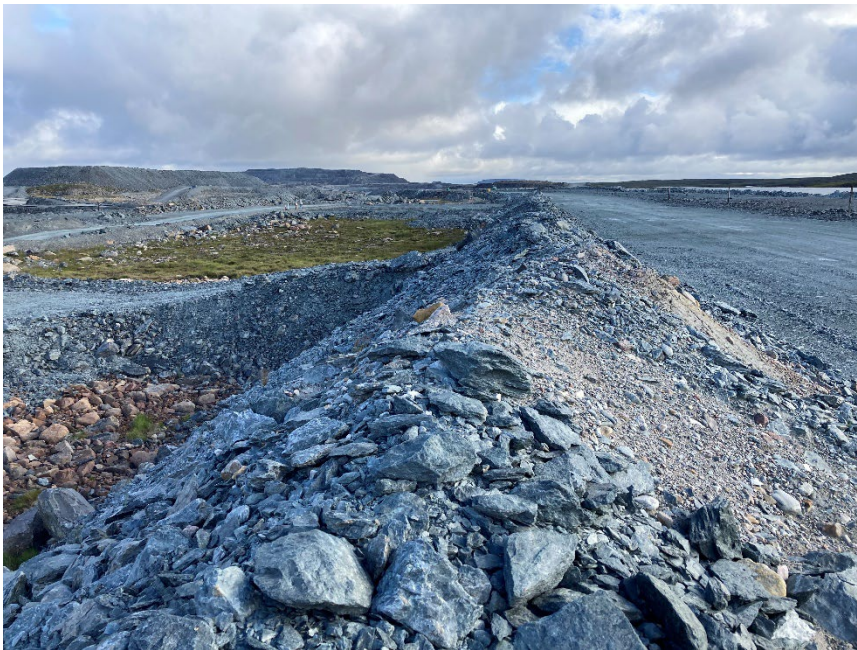
Photograph A3-10 Bay Goose Dike

Description: From approximately Sta. 31+080 on the crest, looking southwest at the pond of water at Central Channel seepage at Sta. 31+165.

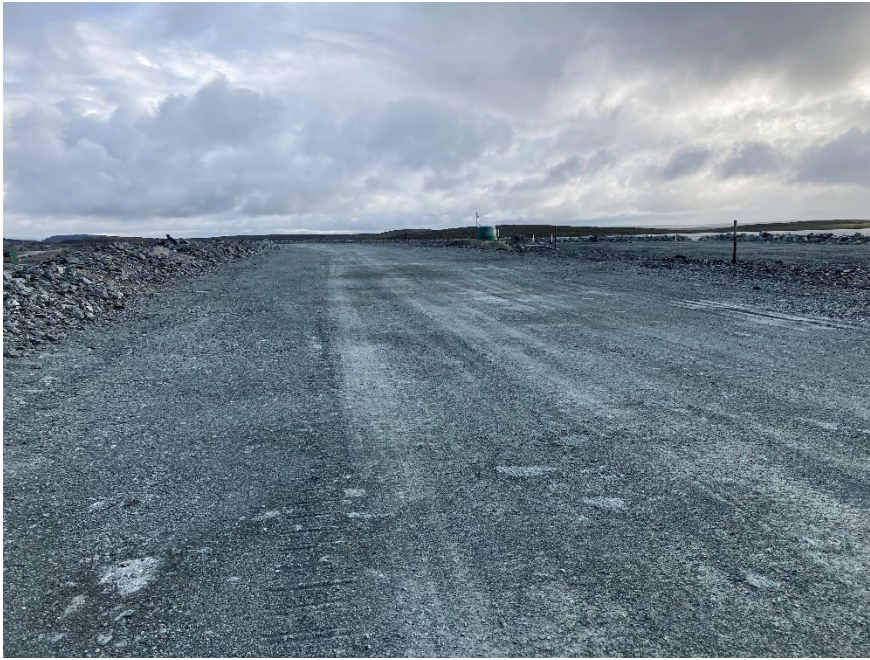
Photograph A3-17 Bay Goose Dike

Description: From approximately Sta. 31+475, looking west at the crest. Old cracks are disappearing.

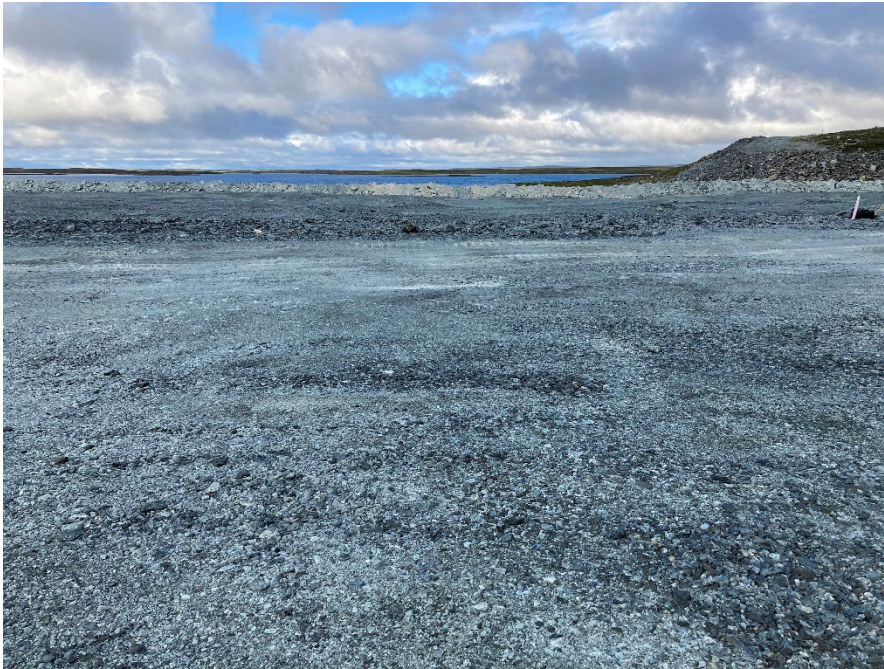
Photograph A3-35 Bay Goose Dike

Description: From approximately Sta. 32+025 (south abutment) looking east at the crest and upstream slope. Zone of high magnitude settlement in the ultramafic cap. The tension cracks seem no longer active.
