Appendix A-5

Wail-Tail Dike

| Project: | Whale Tail Project | Date: | July 27, 2022 |

IVR Dike D-1

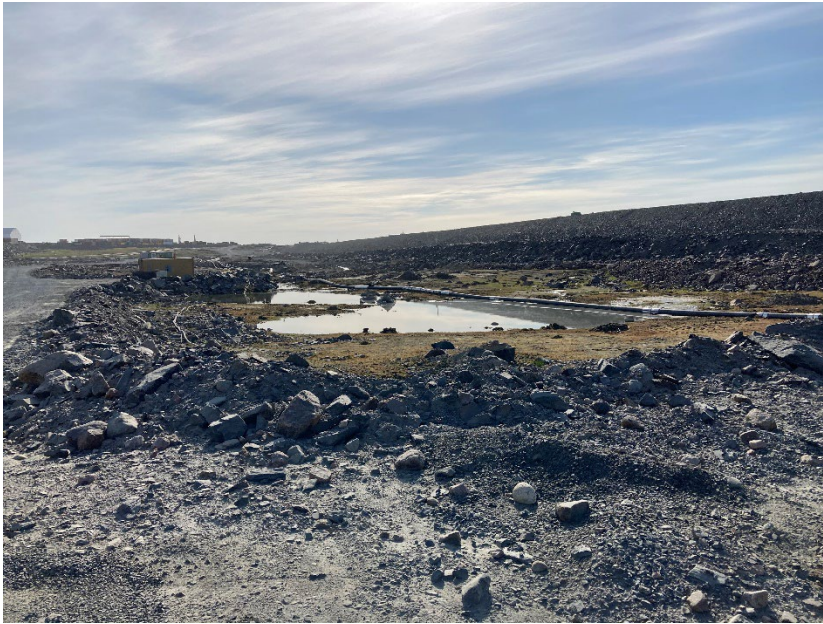
Photograph A5-1 Whale Tail Dike

Description: From approx. Sta. 0+250 downstream (P4 pumping station), looking east. A large amount of water is ponding.

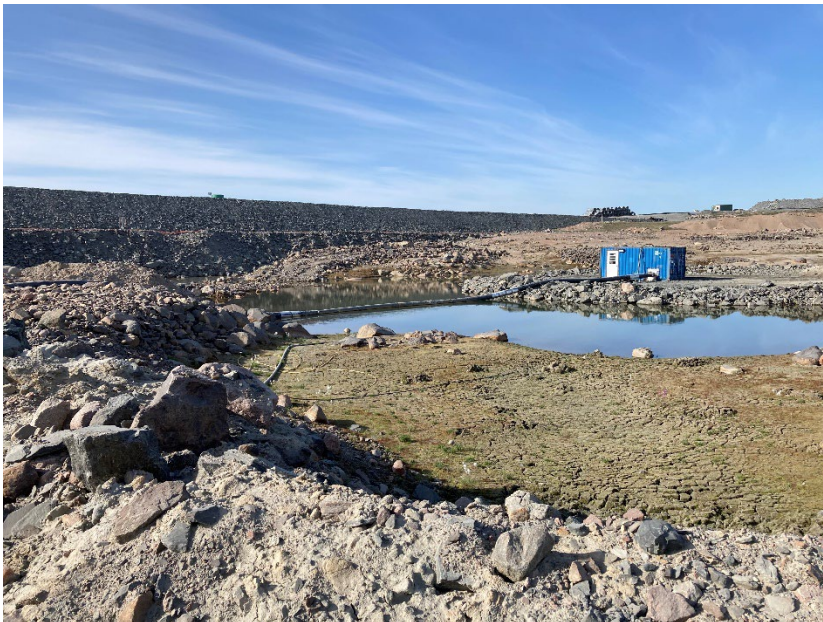
Photograph A5-2 Whale Tail Dike

Description: From approx. Sta. 0+250 downstream (P4 pumping station), looking southwest. A large amount of water is ponding.

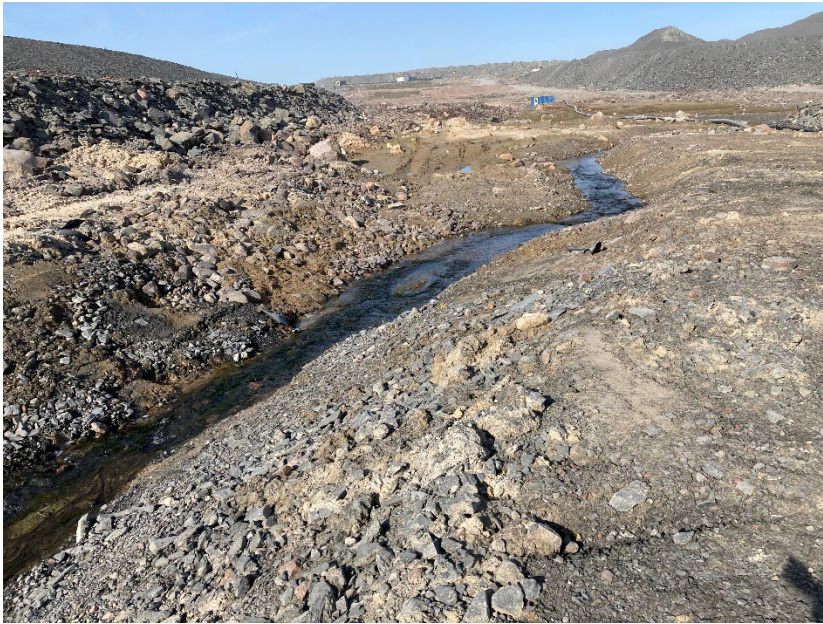
Photograph A5-21 Whale Tail Dike

| INSPECTION ITEM | OBSERVATIONS DATA | PHOTO | COMMENTS & OTHER DATA |
|---|---|---|---|
| 4.1 Seepage from dam | Yes | 117, 118, 112 | Collected in a trench from Sta. 0+430 to 0+720. Seepage interception system pumping water compose of 4 pumping stations (inactive). Sta. 0+150, seepage in the road fill from the dyke toe (flow). |

| INSPECTION ITEM | OBSERVATIONS DATA | PHOTO | COMMENTS & OTHER DATA |
|--|---|---|---|
| 8.7 Weirs and flow monitors | Yes | | 1 V-notch weirs (0+430). The V-notch at Sta. 0+560 is not present anymore. |

Description: From approx. Sta. 0+430 downstream, looking west at the seepage collection trench. V-notch is not present anymore.

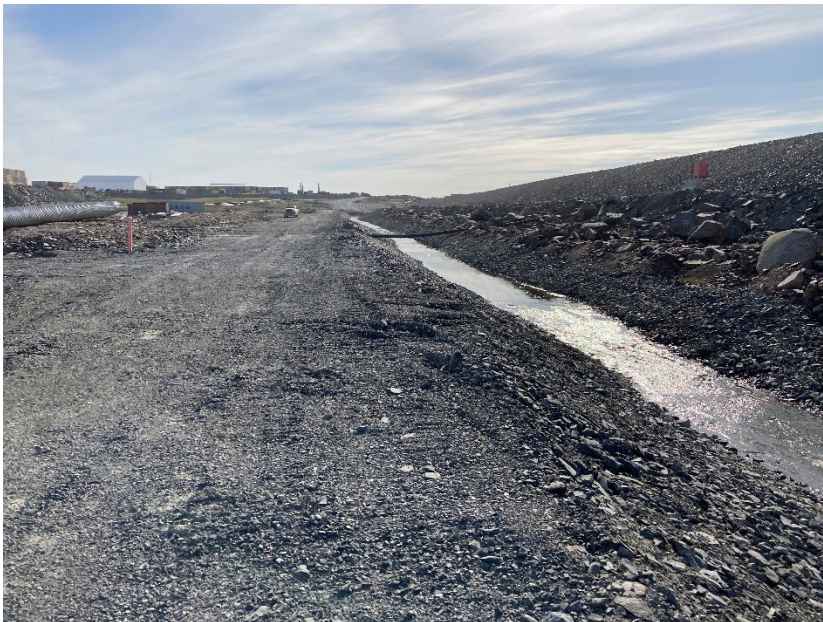
Photograph A5-22 Whale Tail Dike

Description: From approx. Sta. 0+450 downstream, looking east at the seepage collection trench and downstream toe.

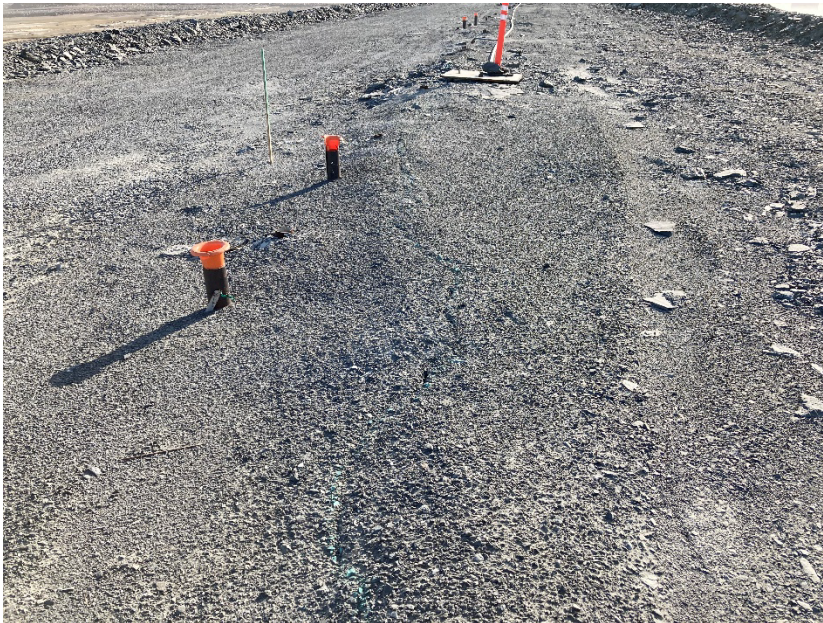
Photograph A5-24 Whale Tail Dike

| INSPECTION ITEM | OBSERVATIONS DATA | PHOTO | COMMENTS & OTHER DATA |
|---|--|--|--|
| 1.4 Surface cracking | Some at the East abutment | 94, 108, 109 | Associated to foundation thawing. Cracks parallel to center line (20 mm wide) depressions (500-700 mm) with some perpendicular to center line. |

Description: From approx. Sta. 0+225 on the crest, looking northeast at the crest platform. Presence of a healing longitudinal tension crack.

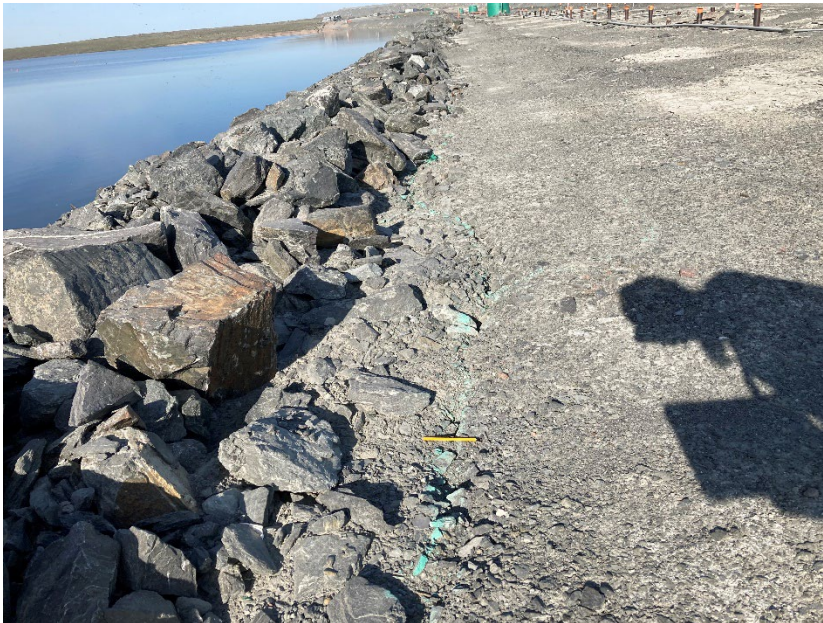
Photograph A5-26 Whale Tail Dike

| INSPECTION ITEM | OBSERVATIONS DATA | PHOTO | COMMENTS & OTHER DATA |
|--|---|--|---|
| 1.5 Unexpected settlement | Some at the East abutment | | Associated to foundation thawing |

Description: From approx. Sta. 0+775 upstream, looking west at the crest platform. Presence of tension crack along upstream crest berm.

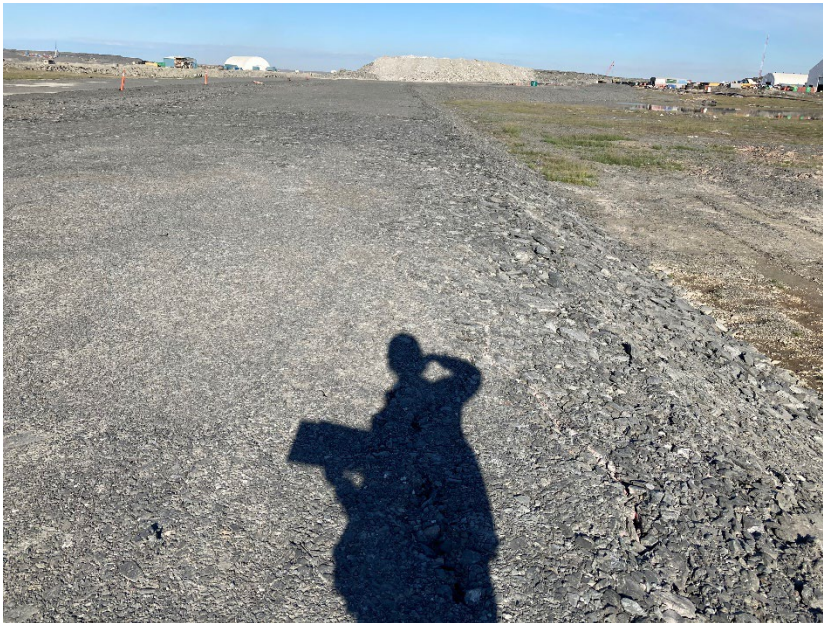
Photograph A6-4 IVR Dike D-1

| INSPECTION ITEM | OBSERVATIONS DATA | PHOTO | COMMENTS & OTHER DATA |
|---|---|--|---|
| 1.4 Surface cracking | Yes | | Likely related to rockfill and shallow foundation thawing after winter construction. Cracks 1-2 m long. |

Description: From approx. Sta. 0+430, looking west at the crest and upstream slope. Presence of old tension cracks.

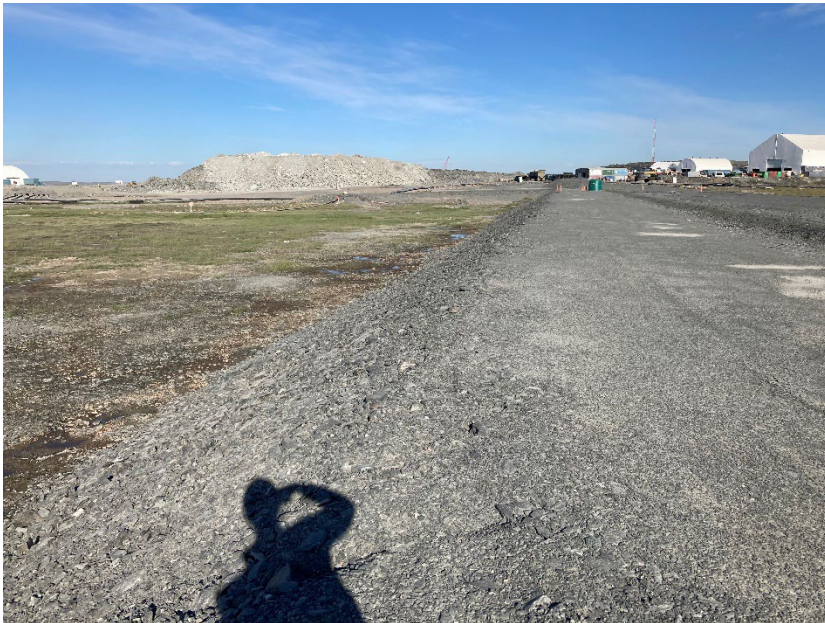
Photograph A6-8 IVR Dike D-1

| INSPECTION ITEM | OBSERVATIONS DATA | PHOTO | COMMENTS & OTHER DATA |
|--|---|---|--|
| 4.1 Seepage from dam | None observed | | Little water ponding at the toe. No flow observed. |

Description: From approx. Sta. 0+300, looking northwest at the crest and downstream slope. Some water ponding at the toe.

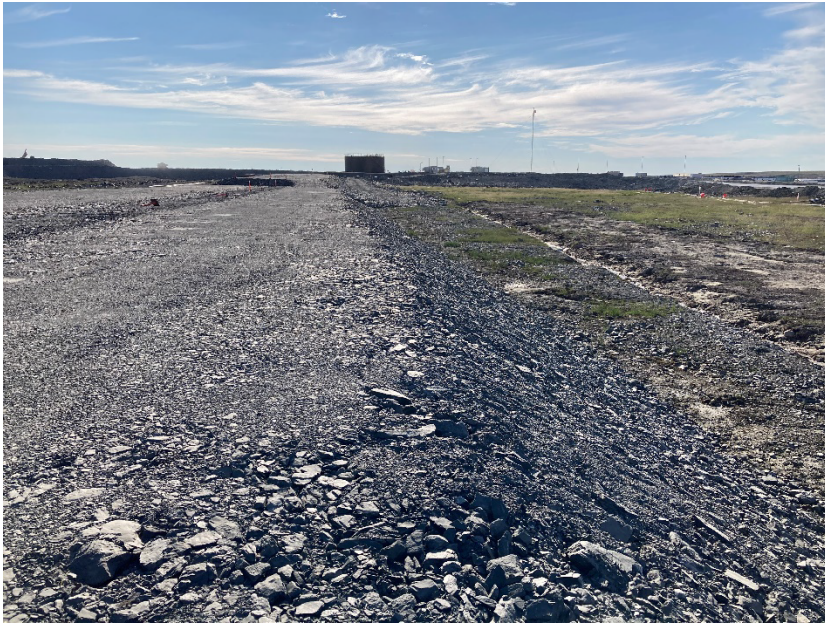
Photograph A6-9 IVR Dike D-1

Description: From approx. Sta. 0+300, looking east at the crest and downstream slope. Some water ponding at the toe.

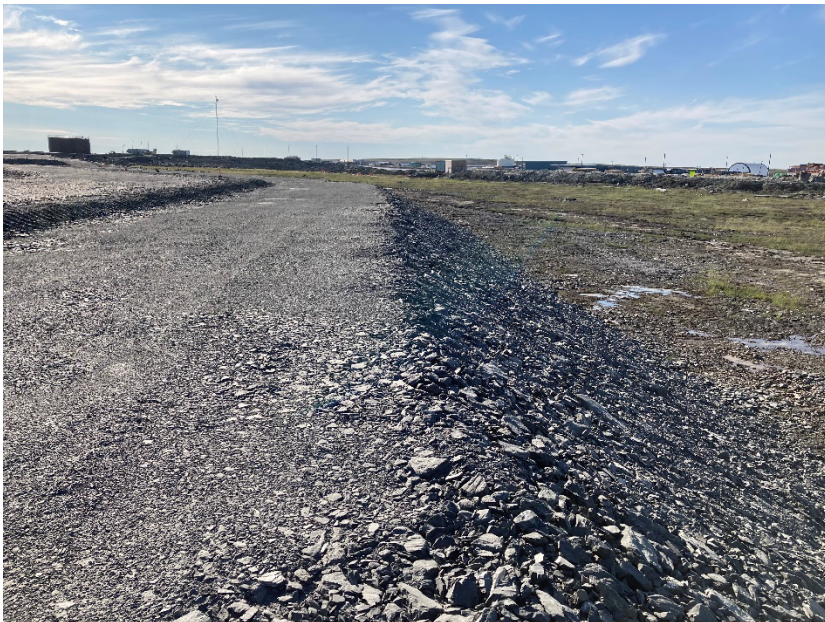
Photograph A6-10 IVR Dike D-1

Description: From approx. Sta. 0+220, looking southeast at the crest and downstream slope. Some water ponding at the toe.

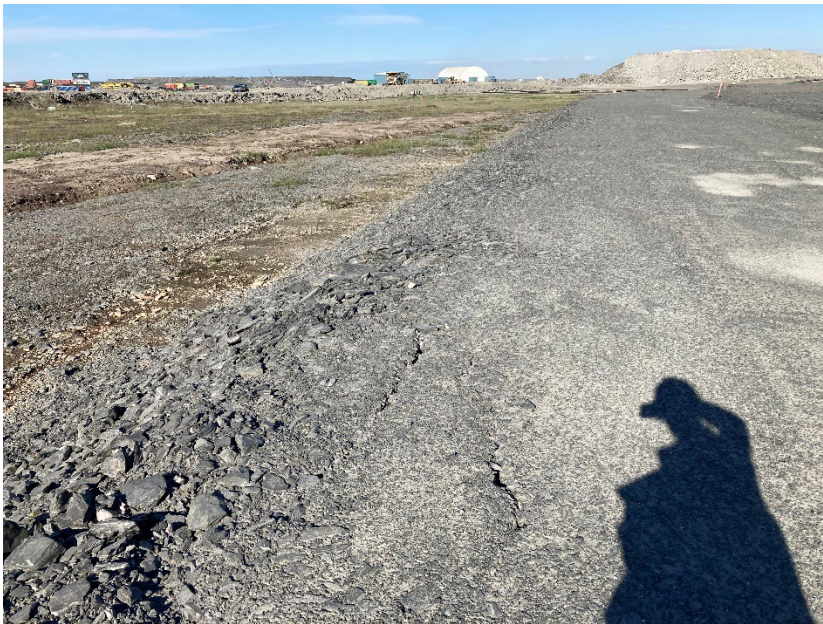
Photograph A6-11 IVR Dike D-1

| INSPECTION ITEM | OBSERVATIONS DATA | PHOTO | COMMENTS & OTHER DATA |
|---|---|--|---|
| 1.5 Unexpected settlement | Yes | | Likely related to rockfill, esker and shallow foundation thawing after winter construction. Settlement of about 200 to 300 mm |

Description: From approx. Sta. 0+395, looking west at the crest. Presence of tension cracks (1-2 m long).

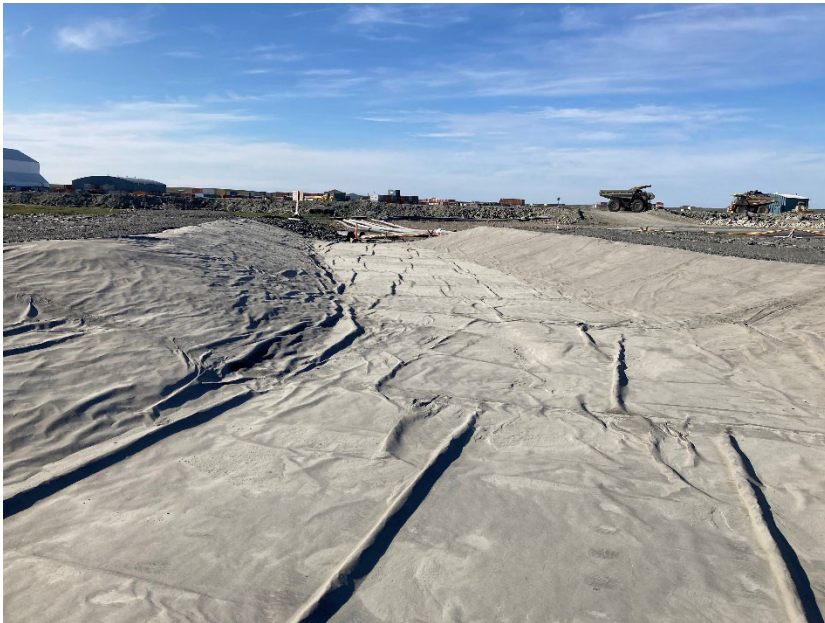
Photograph A6-14 IVR Dike D-1

| INSPECTION ITEM | OBSERVATIONS DATA | PHOTO | COMMENTS & OTHER DATA |
|---|---|---|---|
| 7.6 Presence of debris or blockage | Yes, piping in the lower spillway | | |

Description: From approx. Sta. 0+070, looking southwest at the emergency spillway.
