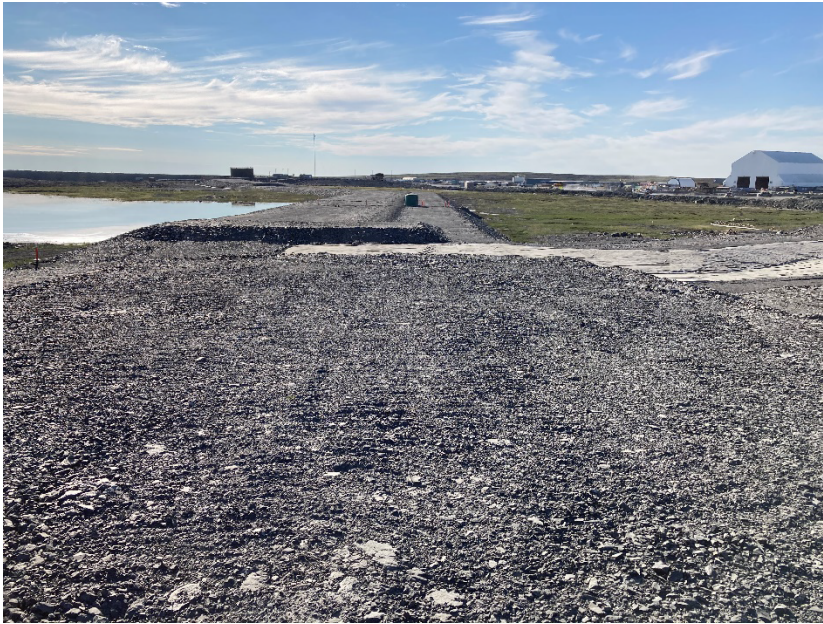
Photograph A6-15 IVR Dike D-1

Description: From approx. Sta. 0+030 (west abutment), looking southeast at the crest. Presence of settlement in the rockfill surface.

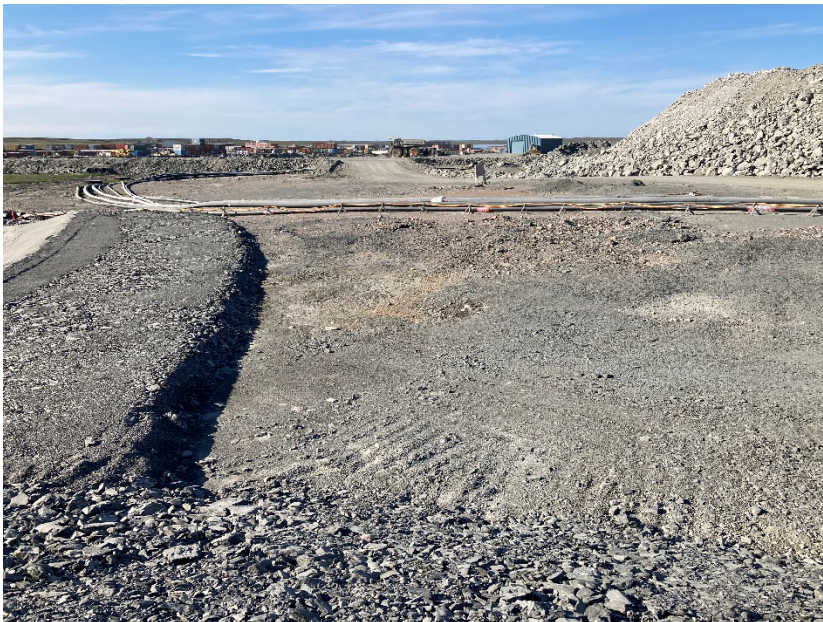
Photograph A6-16 IVR Dike D-1

Description: From approx. Sta. 0+050, looking south at the spillway. Presence of piping at the outlet of the spillway.

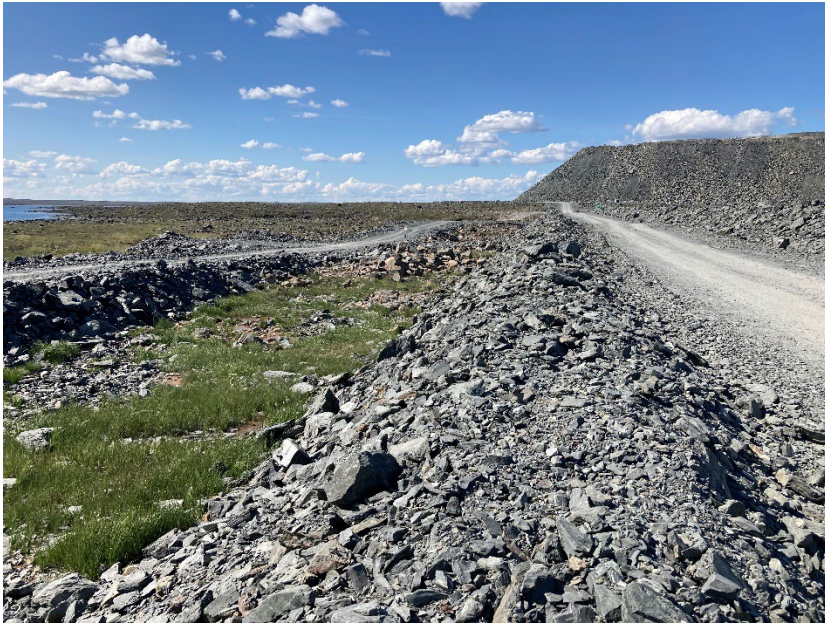
Photograph A7-1 WRSF Dike

Description: From approx. Sta. 0+350 (east abutment), looking west at the dike crest and downstream slope. Presence of water ponding at the toe.

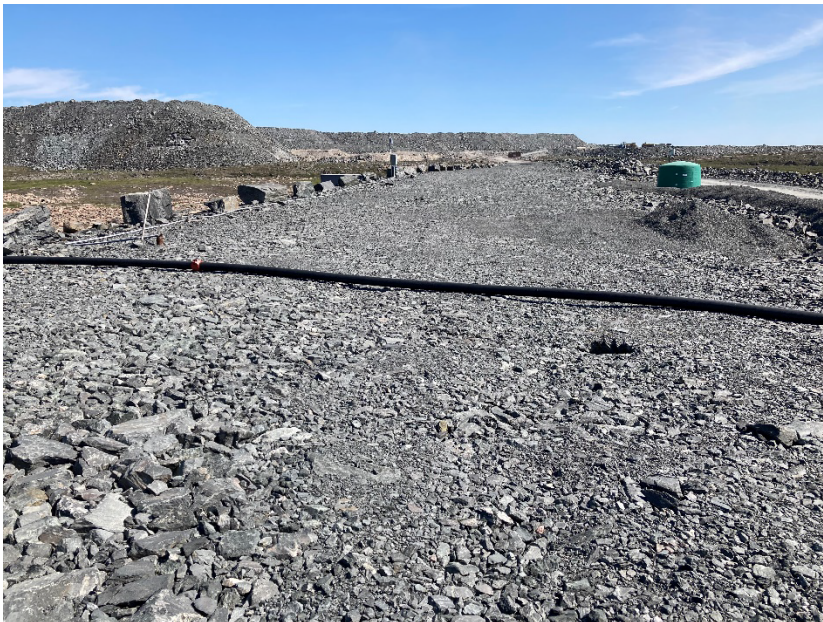
Photograph A7-8 WRSF Dike

Description: From approx. Sta. 0+080 (west abutment), looking east at the upstream thermal berm crest. Presence of holes (approx. 300mm)

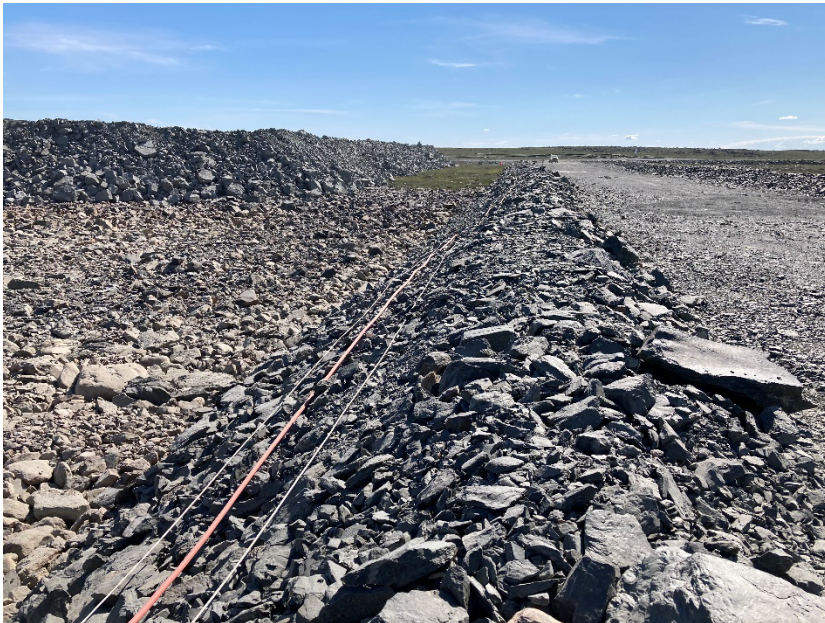
Photograph A8-4 Mammoth Dike

4.1 Seepage from dam	None observed		Water ponding some distance from the toe. No flow observed. The pond was being pumped out at the time of the inspection.

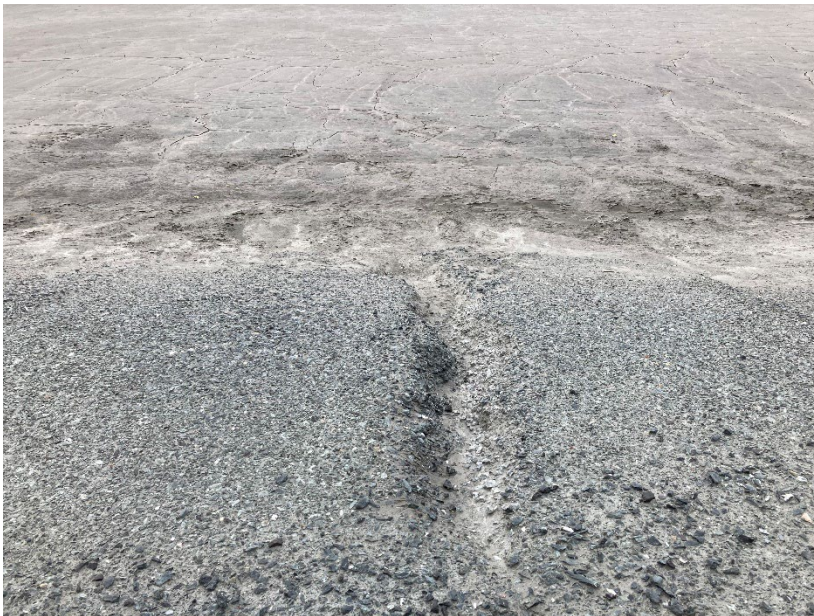
Photograph B1-6 Tailings Storage Facility

INSPECTION ITEM	OBSERVATIONS DATA	PHOTO	COMMENTS & OTHER DATA
2. UPSTREAM SLOPE		345, 346, 347, 348, 349, 354, 355, 351, 352, 353	
2.1 Slope angle	Approx. 3H:1V		Rockfill
2.2 Signs of erosion	Localized erosion features on upstream slope.	351	Due to water discharge from the crest. Some erosion on the fine filter
2.3 Signs of movement (deformation)	None		
2.4 Cracks	None		Surface repaired in 2021
2.5 Face liner condition (if applicable)	In good condition		
2.6 Other unusual conditions	None		
3. DOWNSTREAM SLOPE			
3.1 Slope angle	Approx. 1.2H or 1.3 H:1V variable		Rockfill
3.2 Signs of erosion	None observed		
3.3 Signs of movement (deformation)	None observed		
3.4 Cracks	None observed		
3.5 Seepage or wet areas	None observed		
3.6 Vegetation growth	None observed		
3.7 Other unusual conditions	None

Description: From the North Cell Internal Structure, looking south at the North Cell and upstream slope. Presence of erosion on the upstream slope surface.

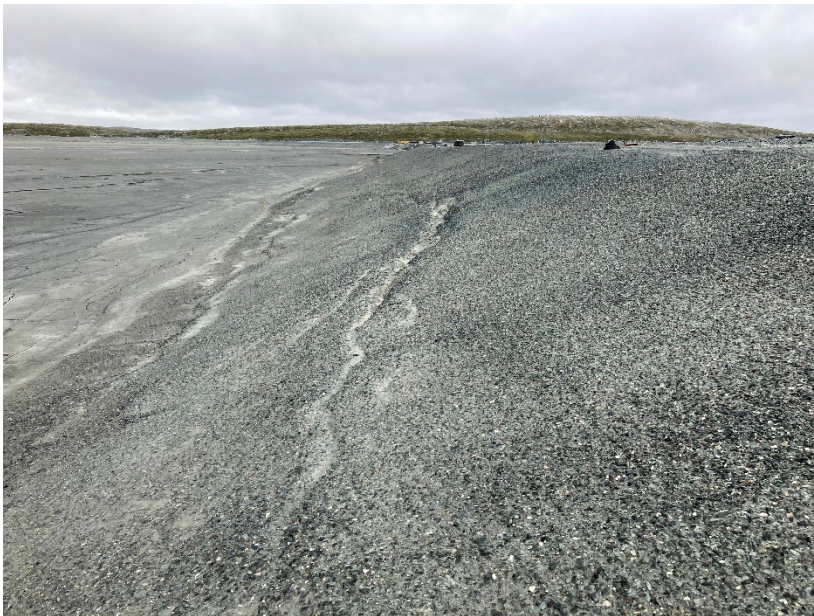
Photograph B1-8 Tailings Storage Facility

Description: From the North Cell Internal Structure at approx. Sta. 2+400, looking northwest at the upstream slope. Presence of tension crack on upstream slope (approx. 10-20 mm wide)

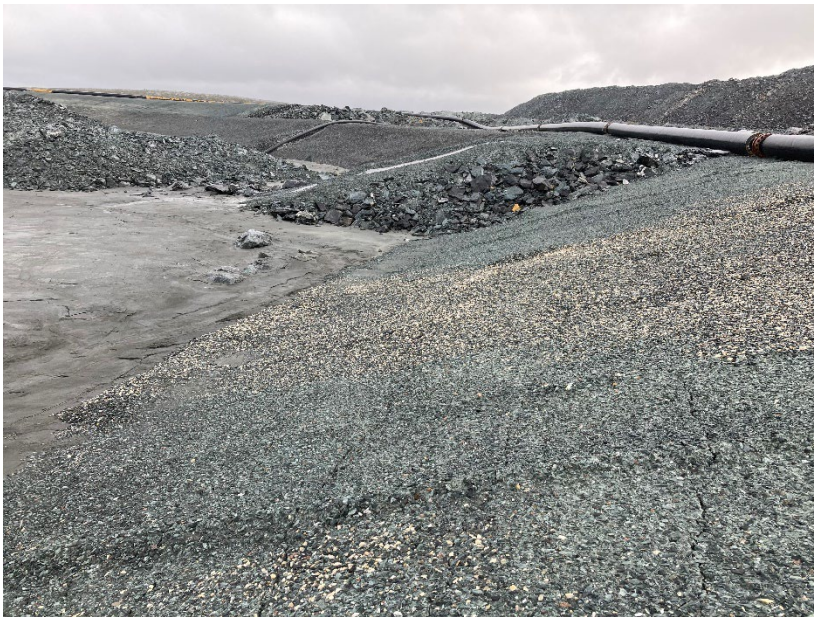
Photograph B1-9 Tailings Storage Facility

Description: From the North Cell Internal Structure at approx. Sta. 2+700, looking northwest at the upstream slope. Presence of tension crack on upstream slope (approx. 10-20 mm wide)

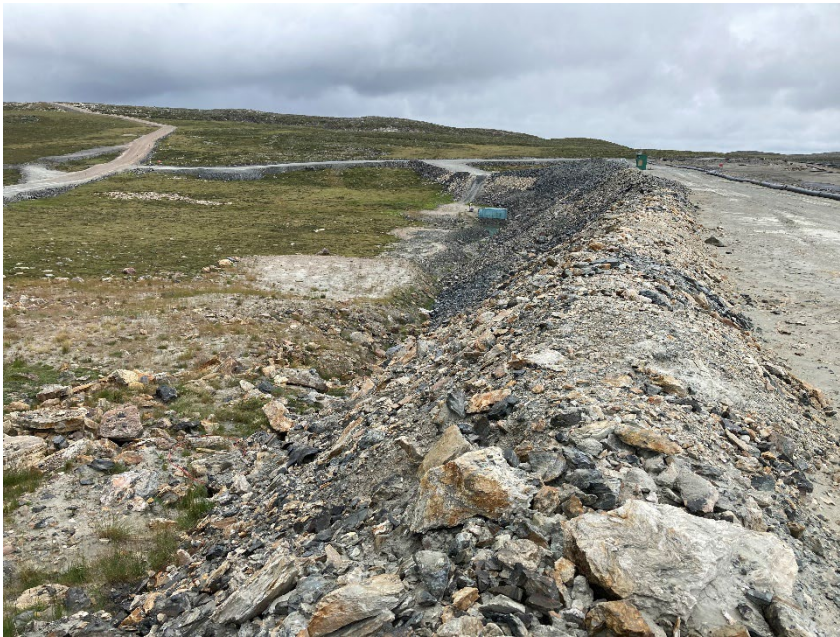
Photograph B2-1 Saddle Dam 1

Description: From the south abutment (Sta. 0+350) looking north at the downstream face. Notice the sea-can container where a sump is installed.

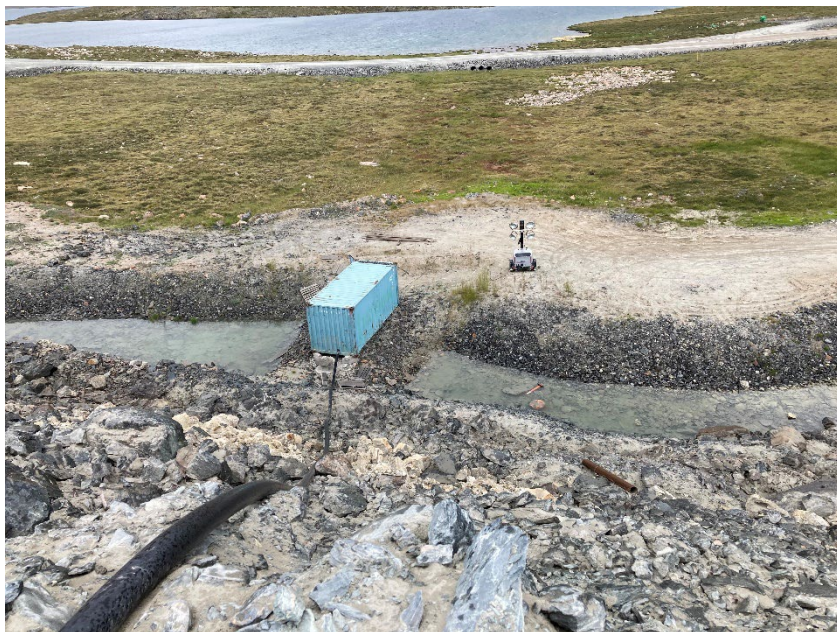
Photograph B2-2 Saddle Dam 1

Description: From Sta. 0+150 looking southwest at the downstream face. Notice the sea-can container where a sump is installed.

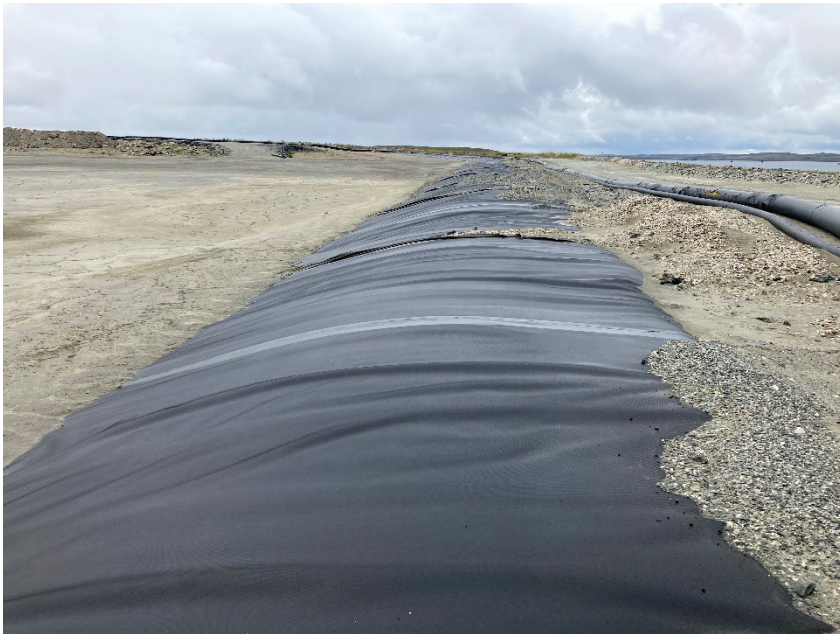
Photograph B2-4 Saddle Dam 1

Description: From approximately Sta. 0+195 upstream, looking south at the upstream slope. Adequate tailings beach against SD1. A small pond of water is present at the surface of the tailings and is not a concern.
