Saddle Dam 2

Client:	AEM	By:	Marion Habersetzer
Project:	Meadowbank	Date:	July 29, 2022
Location:	Saddle Dam 2	Reviewed:	Yves Boulianne

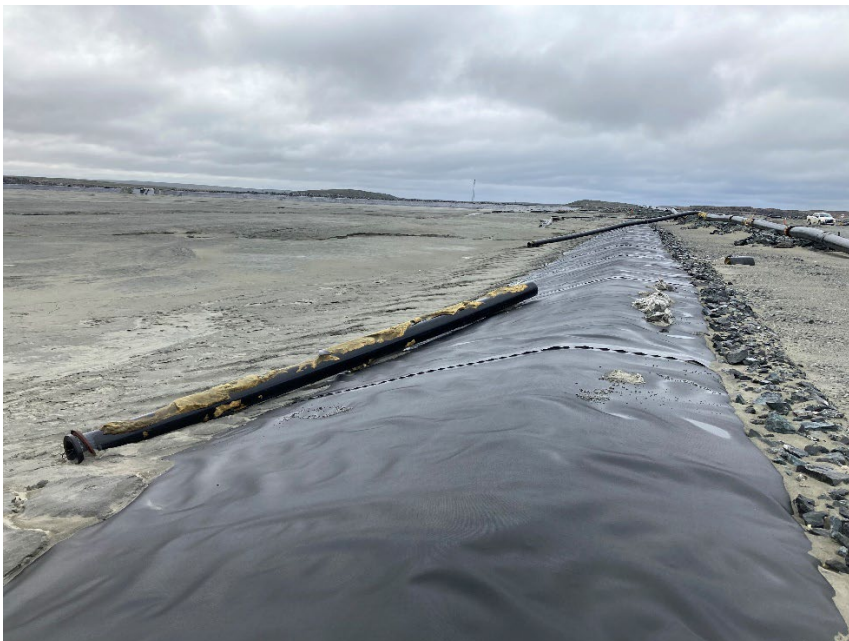
Photograph B6-6 Saddle Dam 4

Description: From 40+300 approximately, looking southeast at the crest and the upstream slope. Presence of a pipe on the liner.

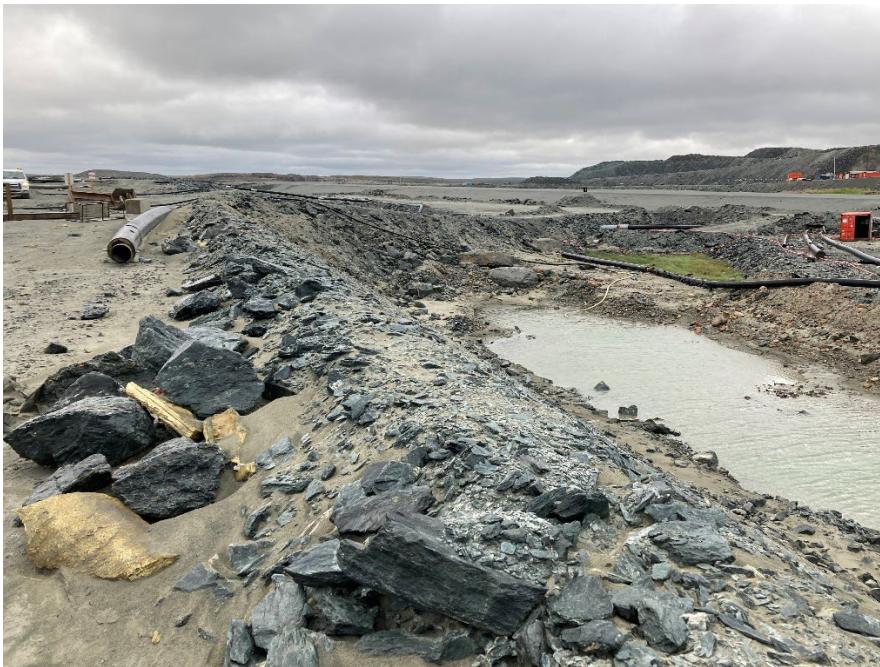
Photograph B6-8 Saddle Dam 4

Description: From 40+450 approximately, looking southeast at the crest and the downstream slope and toe. A large amount of water is ponding at the toe.

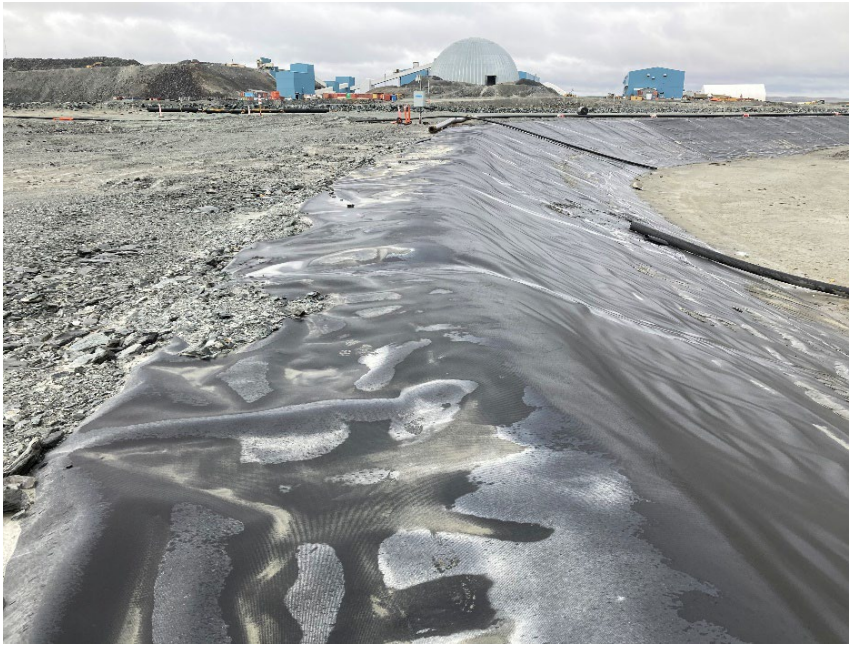
Photograph B7-13 Central Dike and Saddle Dam 5

Description: From approximately Sta. 0+950, looking south at the upstream slope. Presence of rips in the liner.

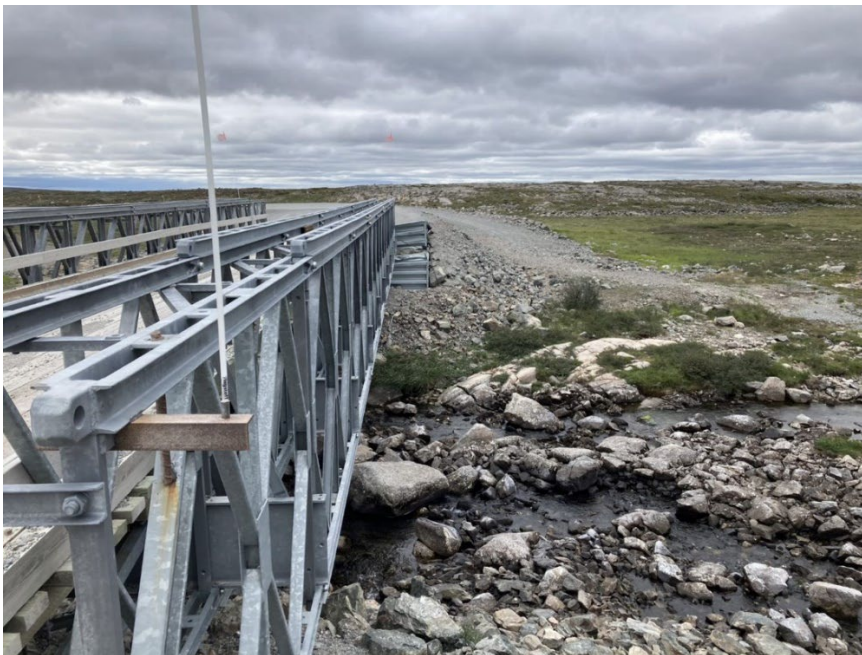
Photograph D3-2 Bridges 1 – R02 km 8+750

Description: Looking at the south abutment. The corrugated steel bin shows deformation under the weight of the bridge.

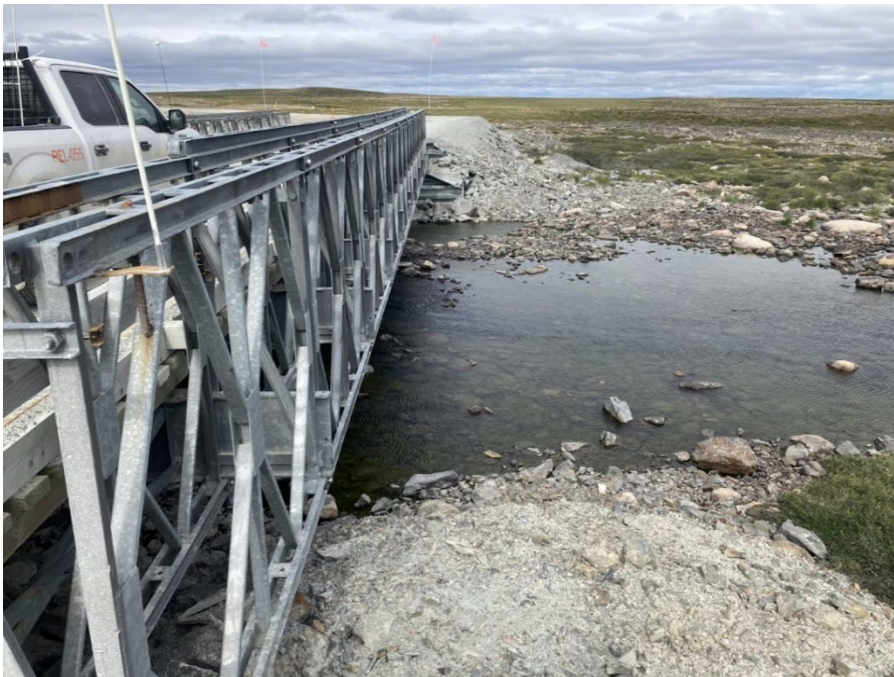
Photograph D3-12 Bridges 6 – R15 km 69+200

Description: Looking at the north abutment. Damage to the bin wall likely caused during snow removal activities. Bridge is tipping toward the west side on the abutment.

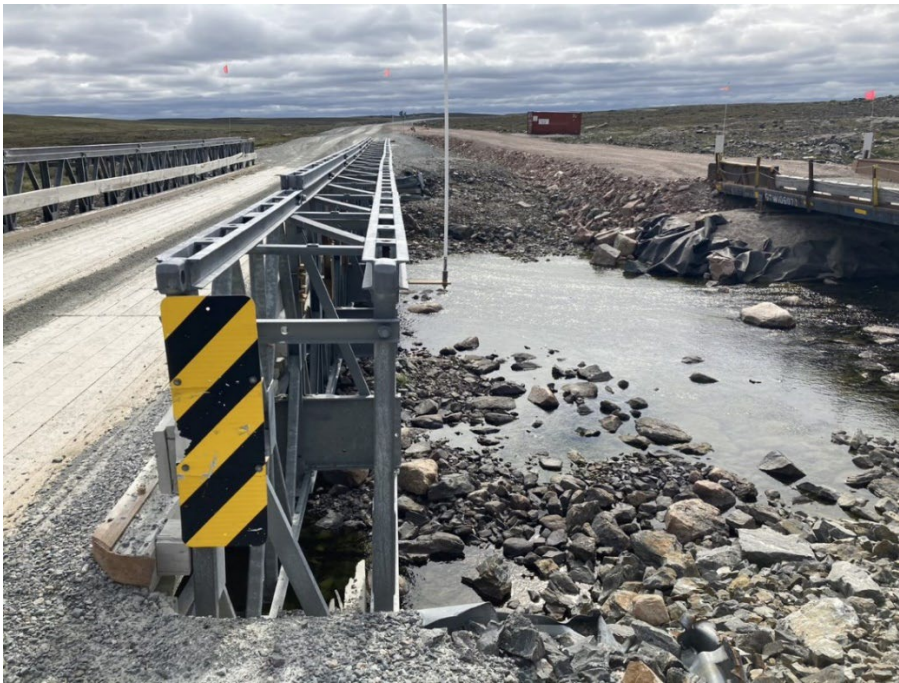
Photograph D3-13 Bridges 6 – R15 km 69+200

Description: Looking at the south abutment. Damage to the bin wall likely caused during snow removal activities. Bridge is tipping toward the west side on the abutment.
