APPENDIX F
QUARRIES

APPENDIX G
BULK FUEL FACILITIES

APPENDIX H
OTHER FACILITIES

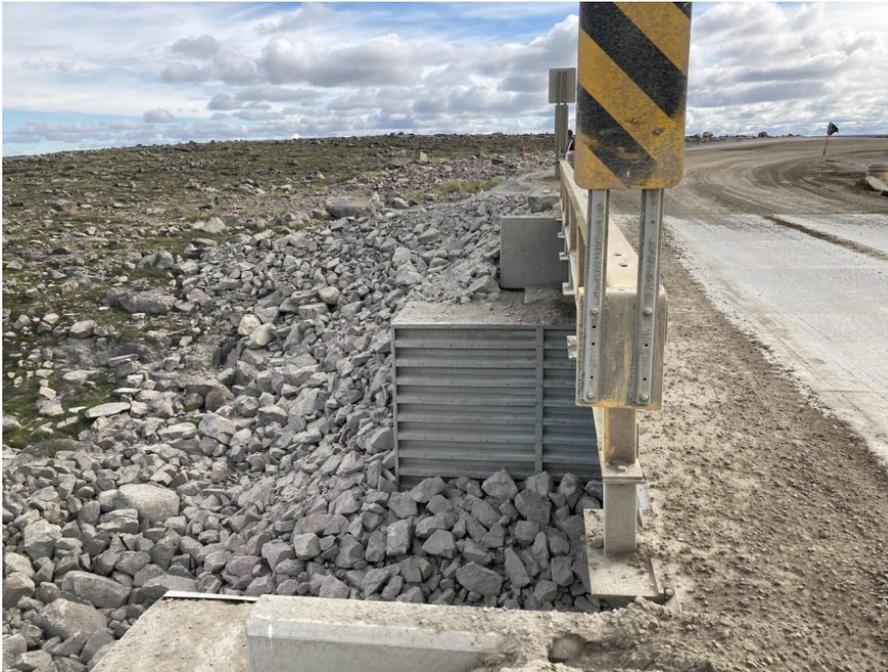
Photograph E2-13 Bridges 6 – km 142+100

Description: Looking at the south abutment.

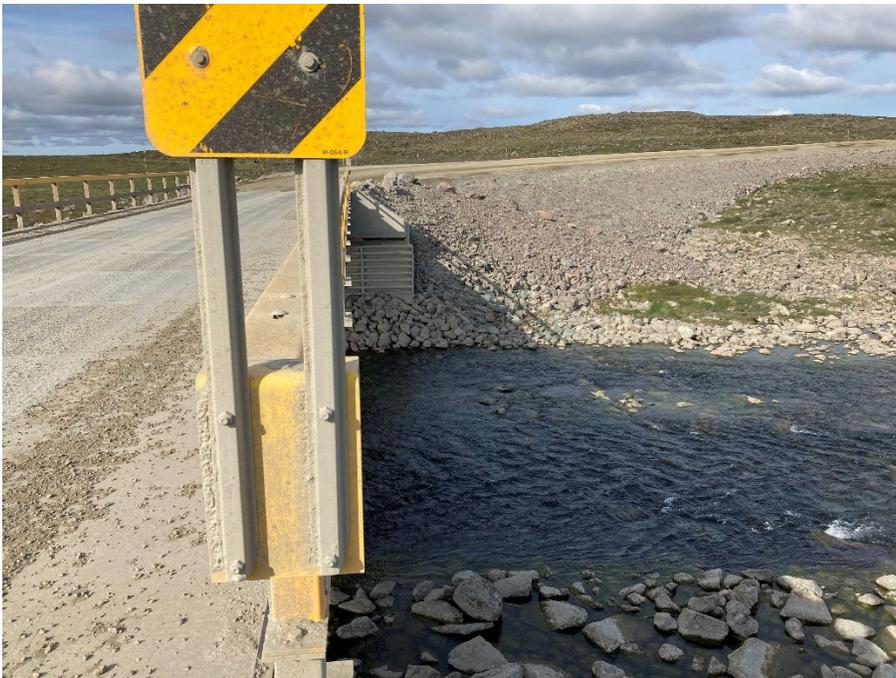
Photograph E2-14 Bridges 7 – km 148+300

Description: Looking at the north abutment.

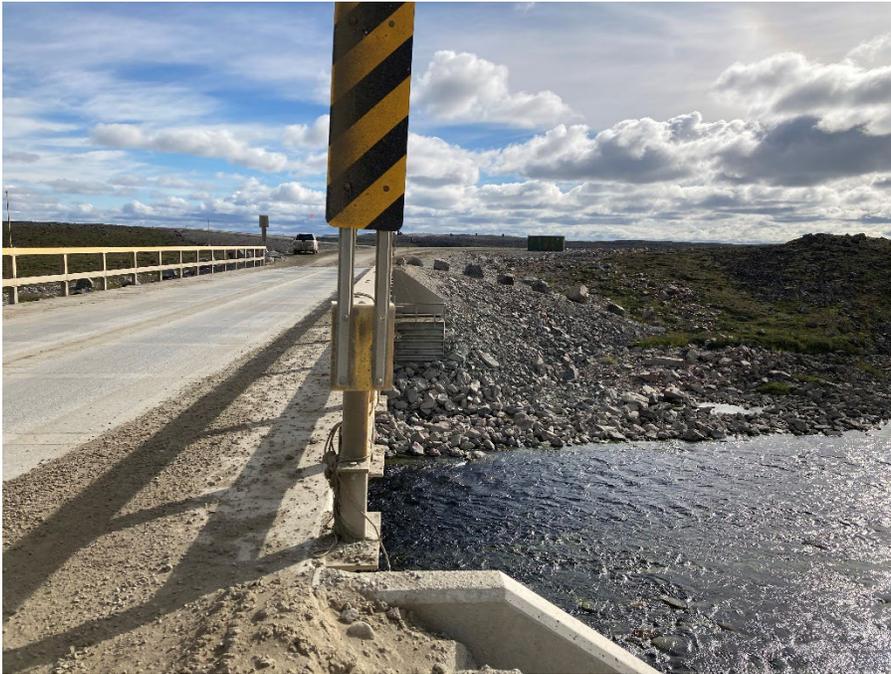
Photograph E2-15 Bridges 7 – km 148+300

Description: Looking at the south abutment.

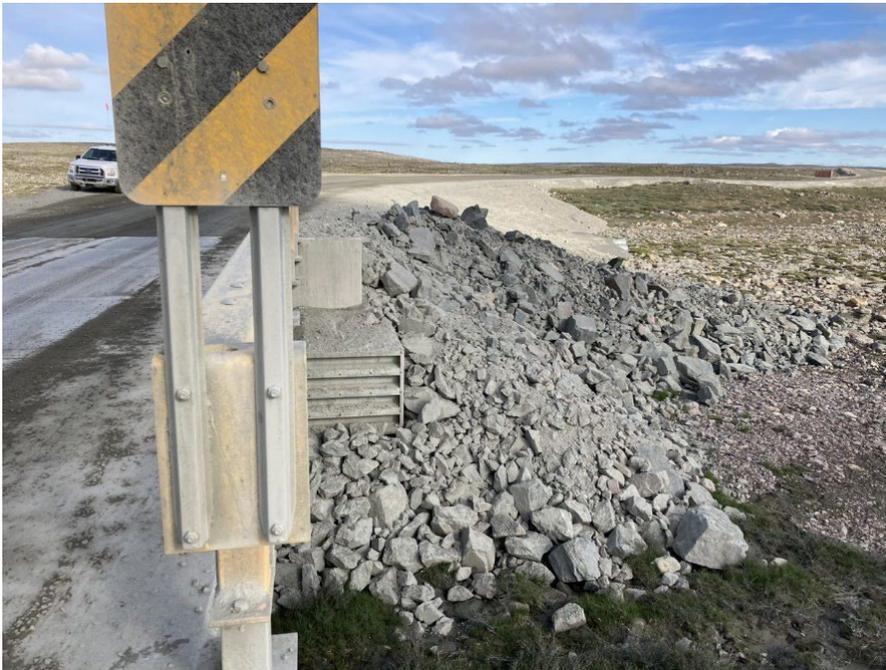
Photograph E2-16 Bridges 8 – km 159+500

Description: Looking at the north abutment.

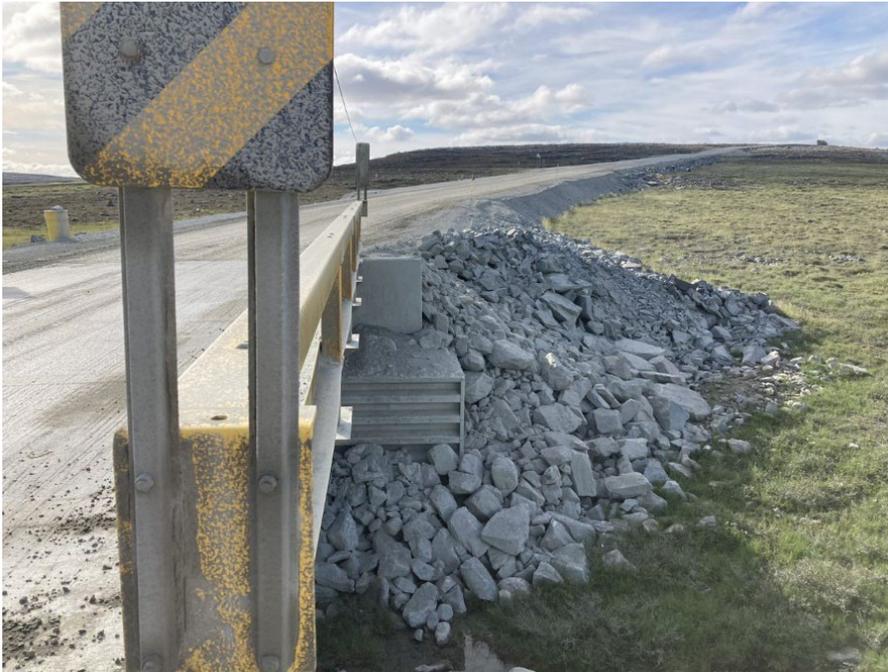
Photograph E2-17 Bridges 8 – km 159+500

Description: Looking at the south abutment.

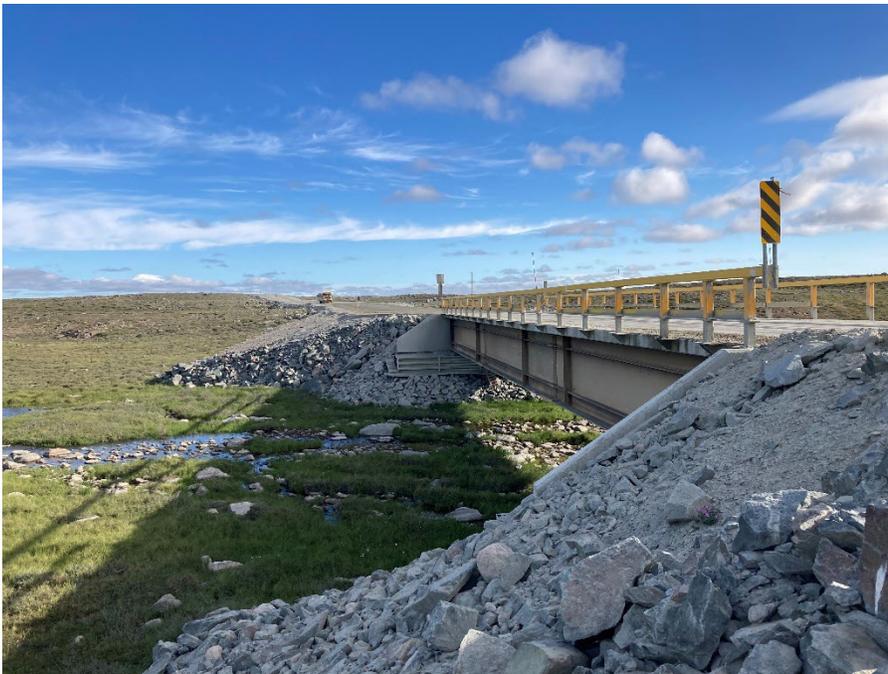
Photograph E2-18 Bridges 9 – km 160+800

Description: Looking at the north abutment.

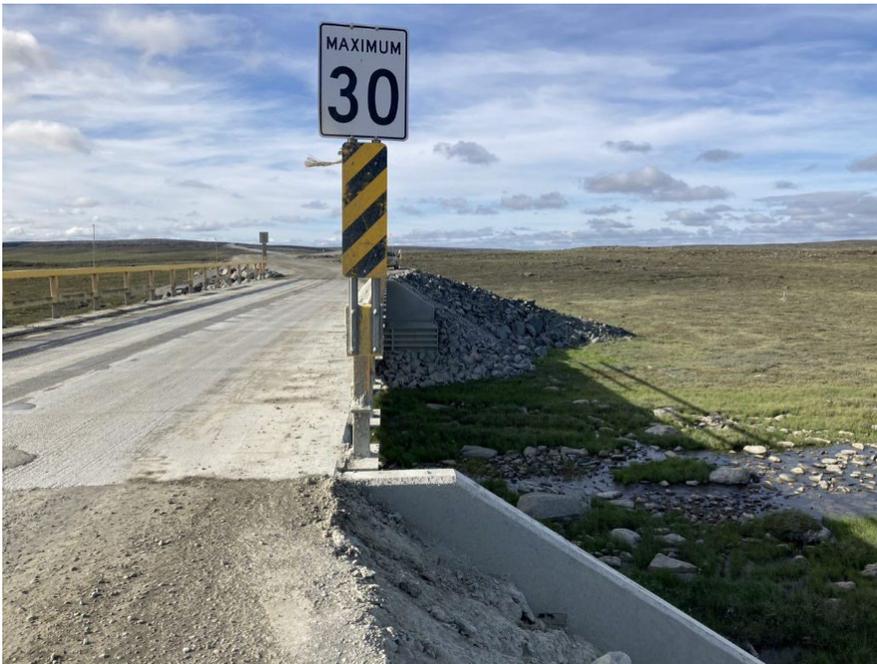
Photograph E2-19 Bridges 9 – km 160+800

Description: Looking at the south abutment.

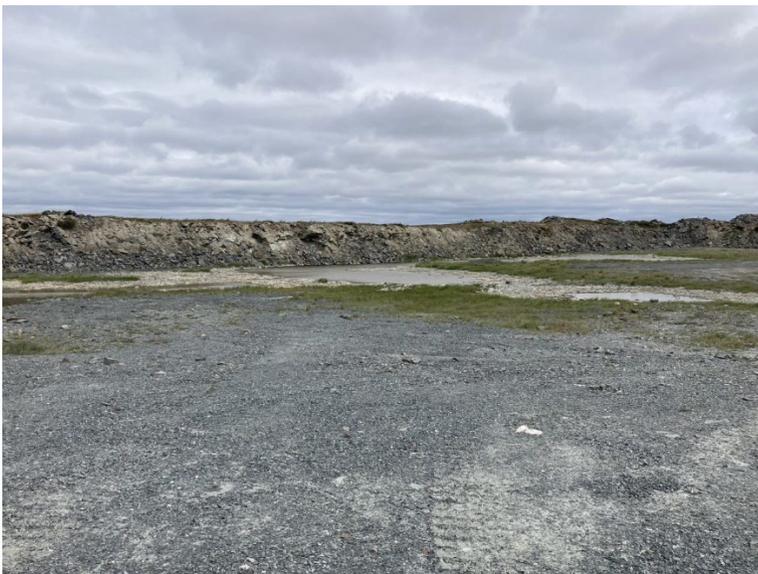
Photograph F-2: Quarry 13 – km 62+350

Description: View of north and west walls. Water ponding in the quarry.

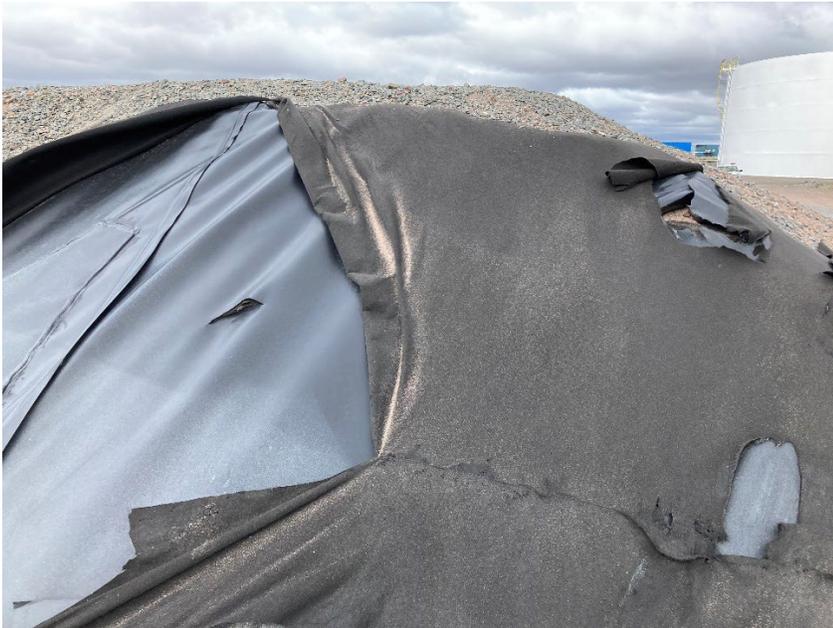
Photograph G1-5 Baker Lake Tank Farm

Description: Looking west. Presence of exposed and damaged geosynthetics in the slope.

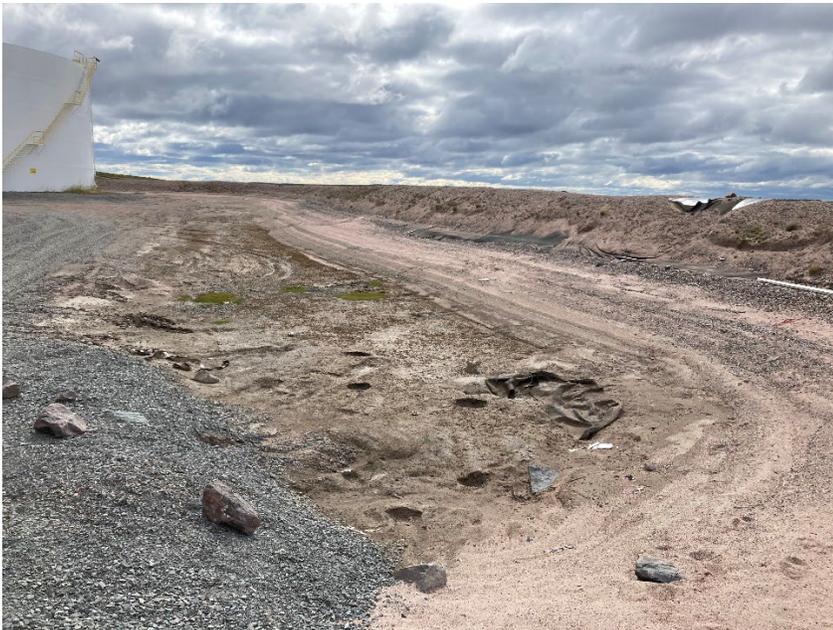
Photograph G1-6 Baker Lake Tank Farm

Description: From the southwestern corner of Tank 3 looking southeast. View of exposed geosynthetics.

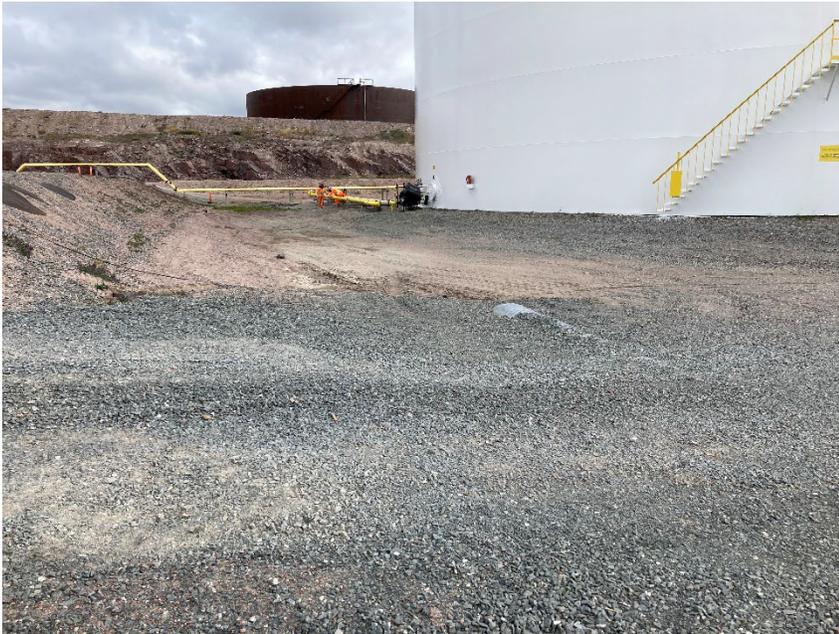
Photograph G1-7 Baker Lake Tank Farm

Description: From the southwestern corner of Tank 3 looking southeast. View of exposed geosynthetics.

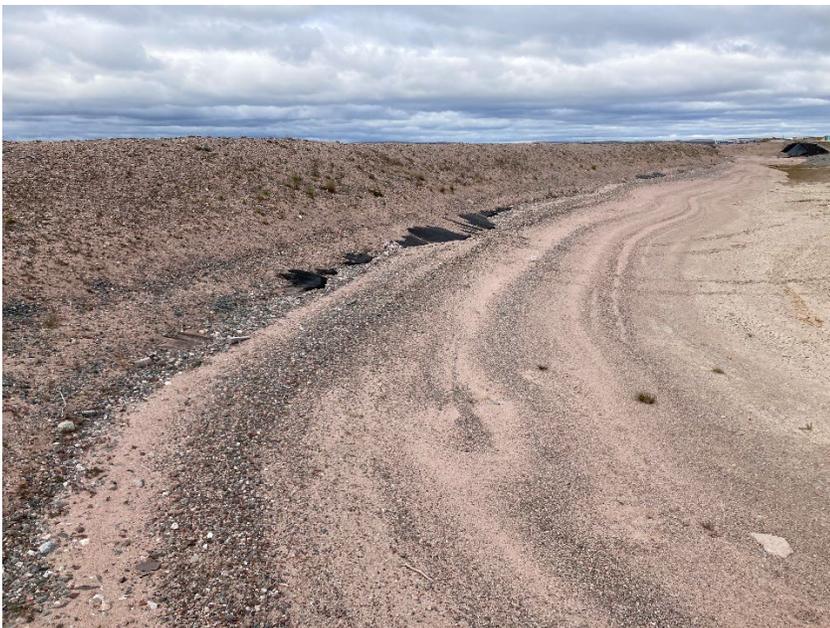
Photograph G1-8 Baker Lake Tank Farm

Description: From the south portion of the site looking northwest at the south side of Tank 3 and 4. View of exposed geosynthetics.

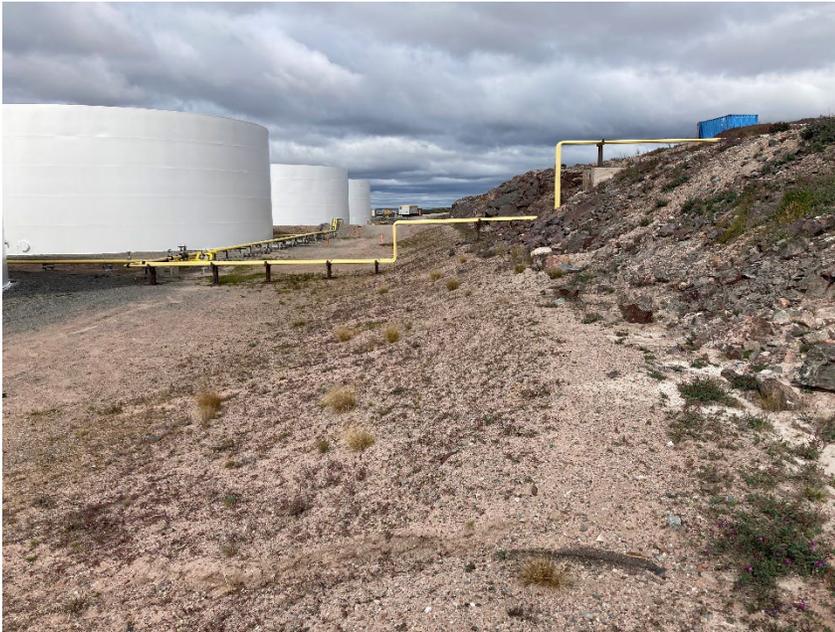
Photograph G1-11 Baker Lake Tank Farm

Description: From the northern side of Tank 4, looking northwest toward Tanks 4, 3, 2, and 1. Presence of exposed liner due to erosion of the granular cover.

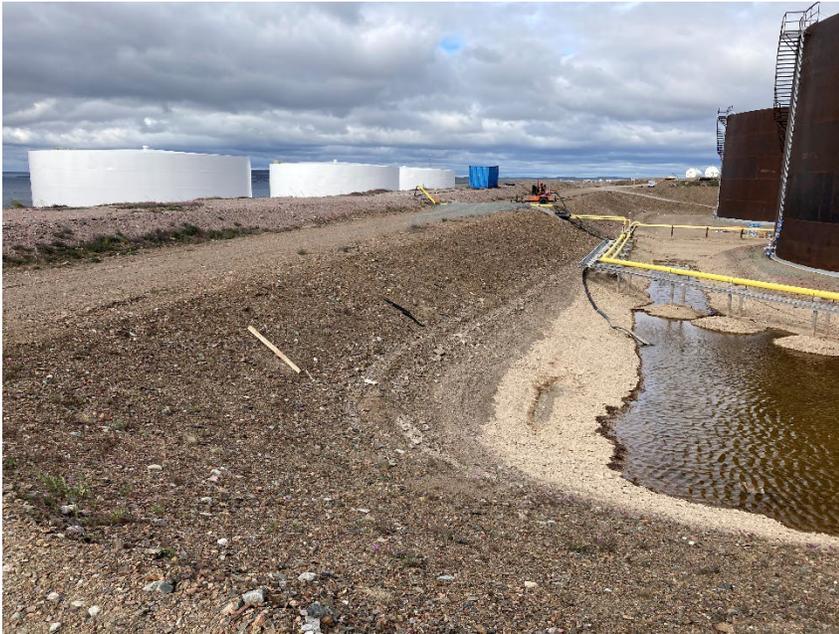
Photograph G1-15 Baker Lake Tank Farm

Description: From the southern corner of Tank 6, looking northeast at the southern side of Tanks 5 and 6. Presence of water ponding.

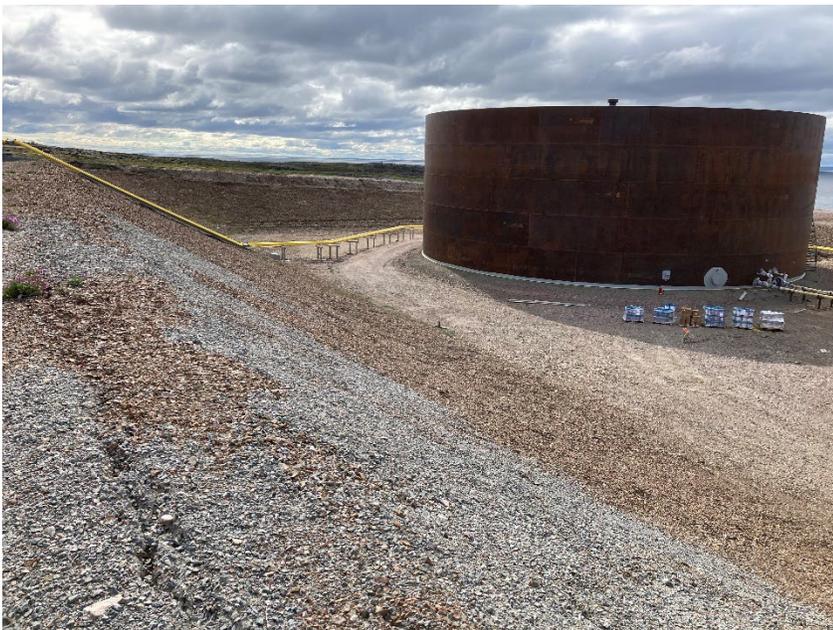
Photograph G1-16 Baker Lake Tank Farm

Description: Looking southeast at the northeastern side of Tank 6. Presence of old tension cracks.

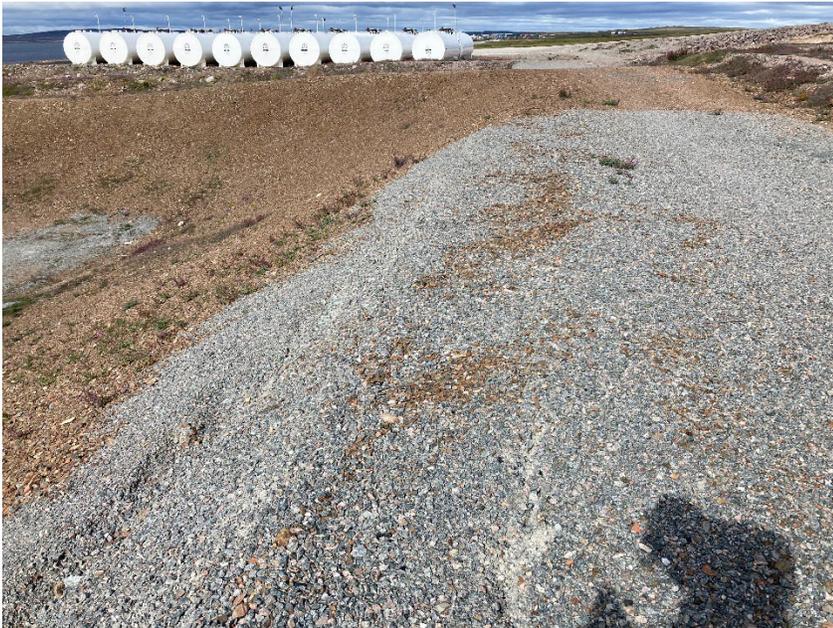
Photograph G1-17 Baker Lake Tank Farm

Description: Looking west at the crest on the northeastern side of Tank 5. Presence of old tension cracks.

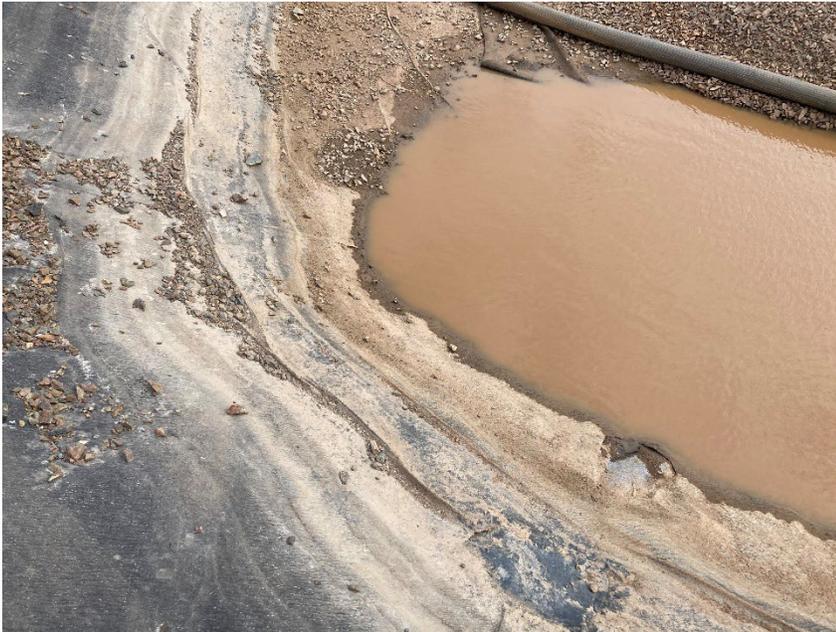
Photograph G1-21 Baker Lake Tank Farm

Description: From the southwestern corner of the Jet A fuel tanks looking northeast. Presence of exposed geomembrane with holes and water ponding.

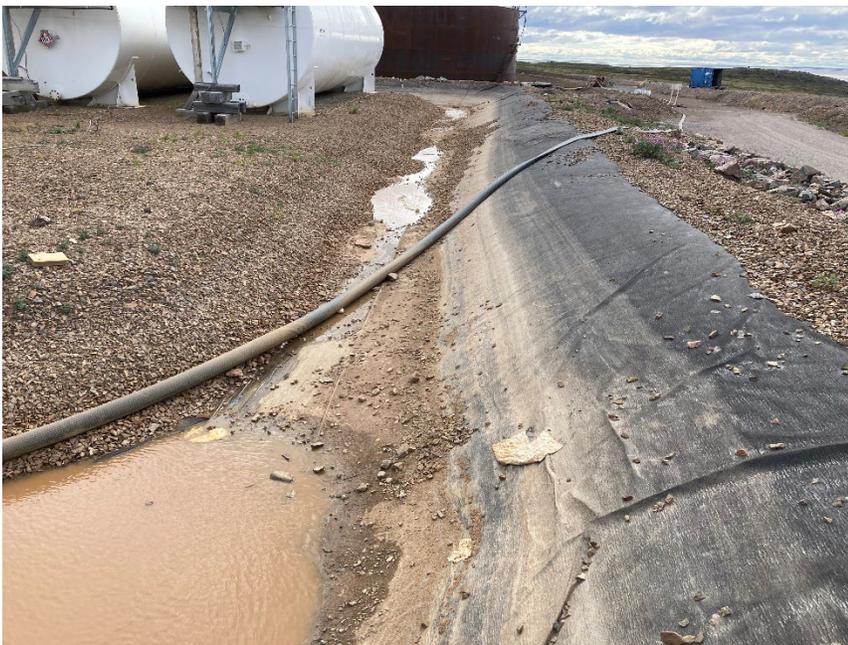
Photograph G1-22 Baker Lake Tank Farm

Description: From the southwestern corner of the Jet A fuel tanks looking east. Presence of exposed geomembrane and water ponding.

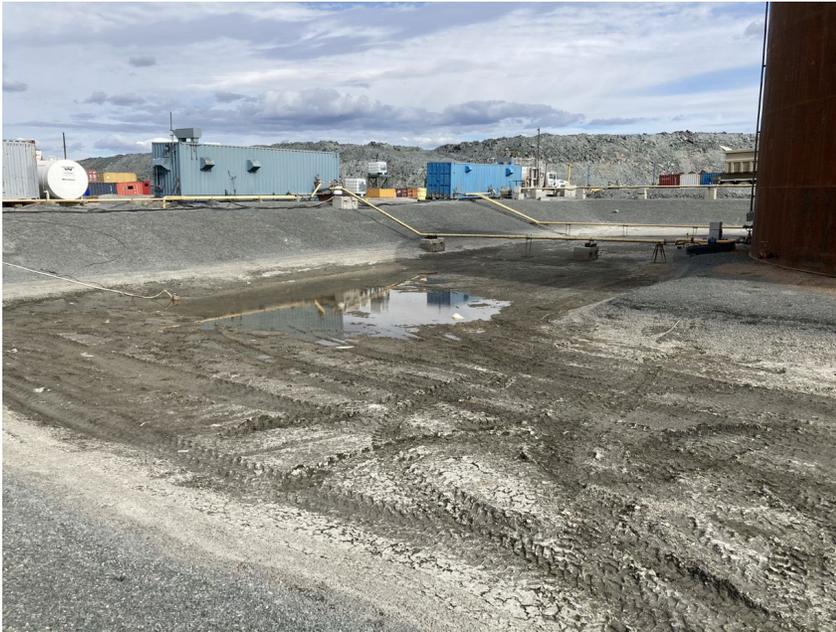
Photograph G2-5 Meadowbank Tank Farm

Description: Looking southeast from the northeastern side of the tank. Presence of water ponding.

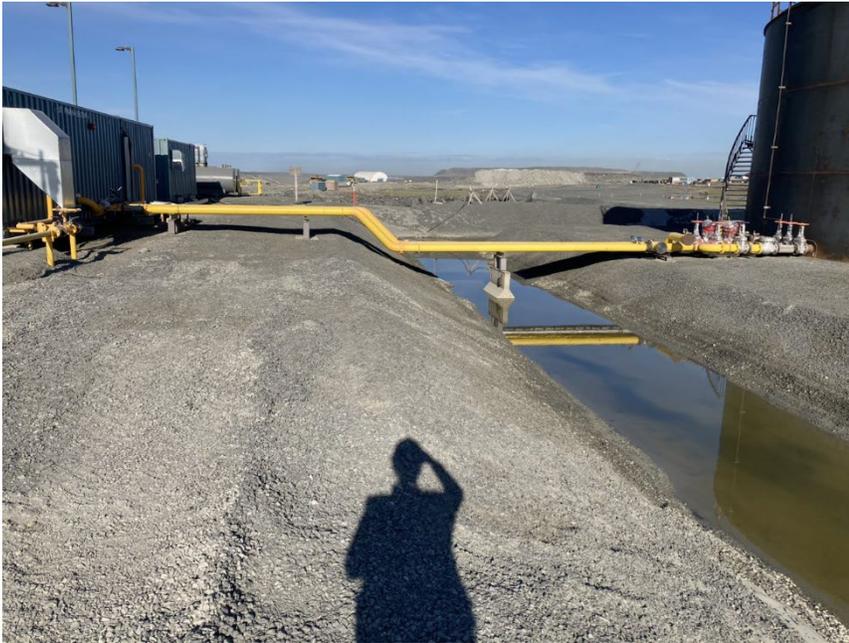
Photograph G3-1 Whale Tail Project Site Tank Farm

Description: From the fuelling pad, looking west at the Tank Farm. Presence of water ponding.

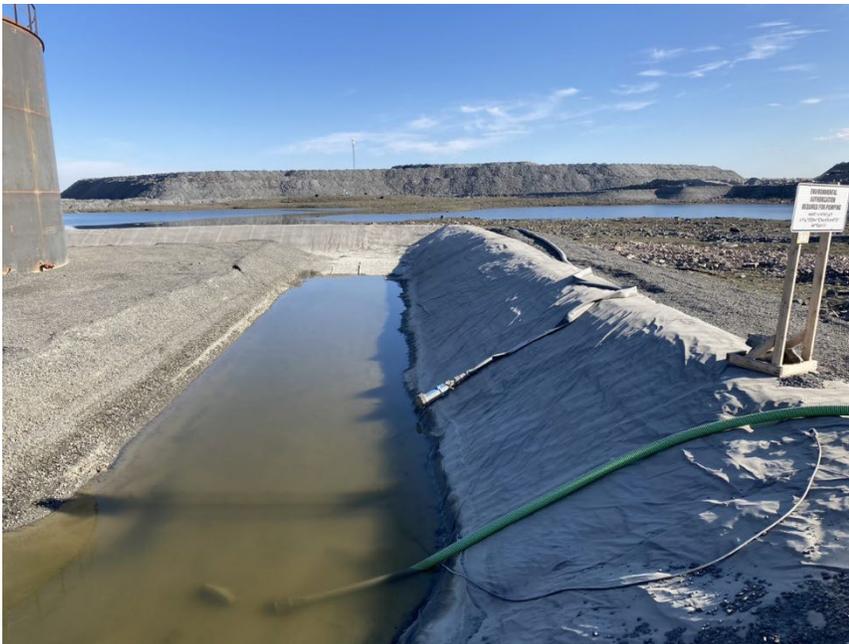
Photograph G3-2 Whale Tail Project Site Tank Farm

Description: From the fuelling pad, looking north at the Tank Farm. Presence of water ponding.

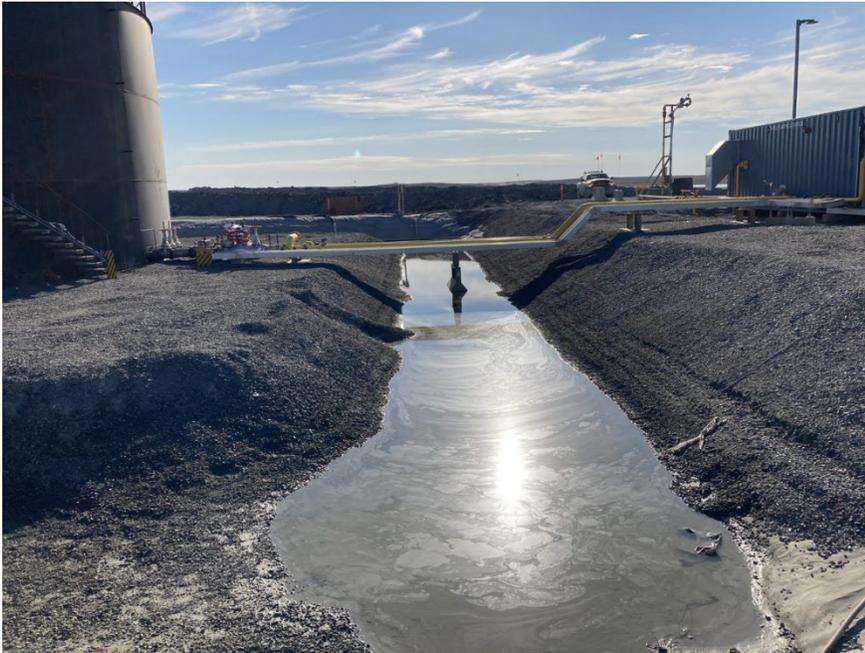
Photograph G3-7 Whale Tail Project Site Tank Farm

Description: From the southwest corner of the tank, looking east. Presence of water ponding.

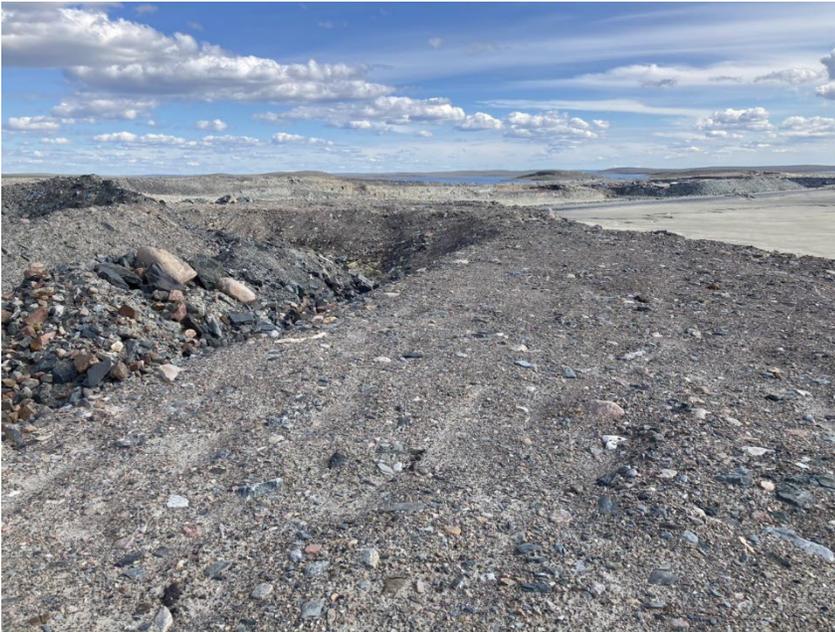
Photograph H5-1 Meadowbank Contaminated Soil Storage and Bioremedial Landfarm Facility

Description: From the eastern side of the Contaminated Soil Storage and Bioremedial Landfarm Facility, looking east at the containment berm. In good condition.

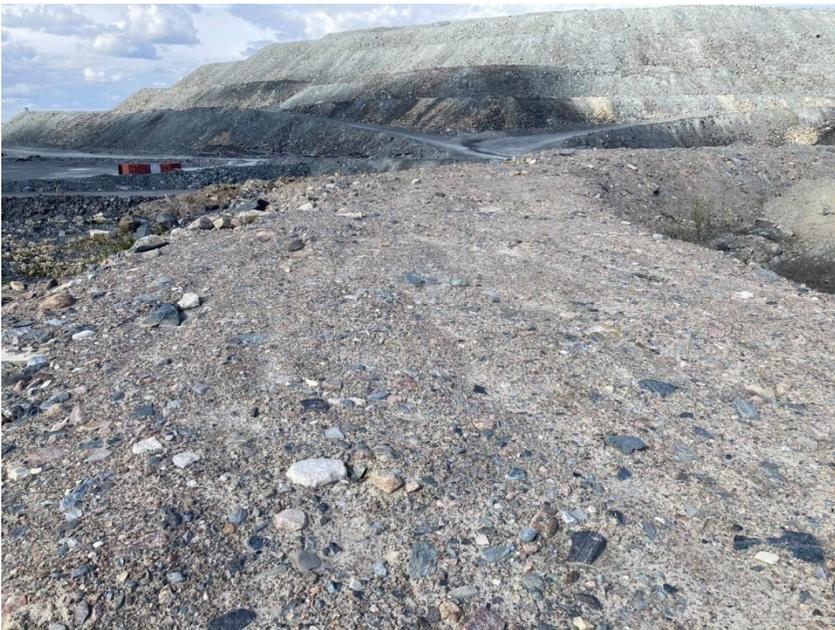
Photograph H5-2 Meadowbank Contaminated Soil Storage and Bioremedial Landfarm Facility

Description: From the northeast extremity of the South Cell, looking northeast at the Contaminated Soil Storage and Bioremedial Landfarm Facility. In good condition.

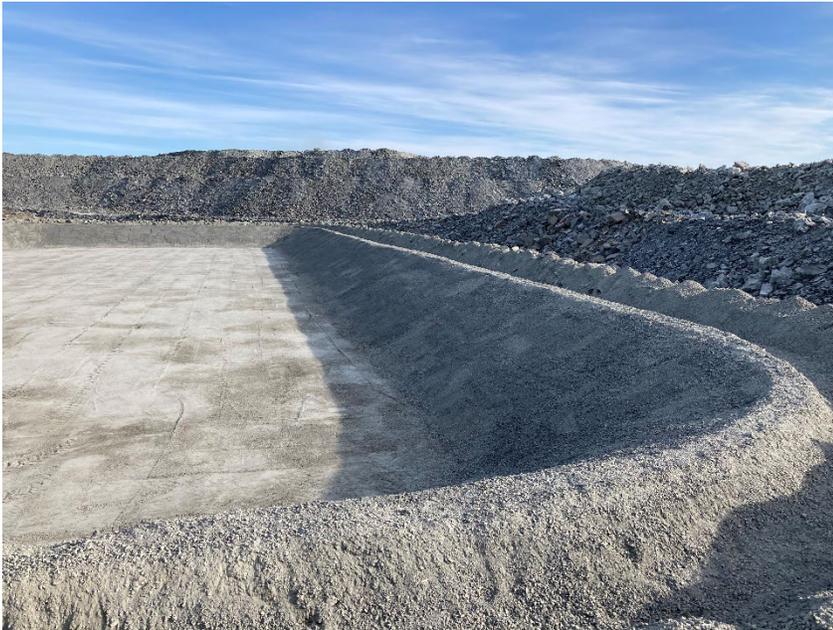
Photograph H5-3 Whale tail Project Contaminated Soil Storage and Bioremediation Landfarm Facility

Description: From the south extremity of the new Whale Tail Project facility, looking north. In good condition, not yet lined.

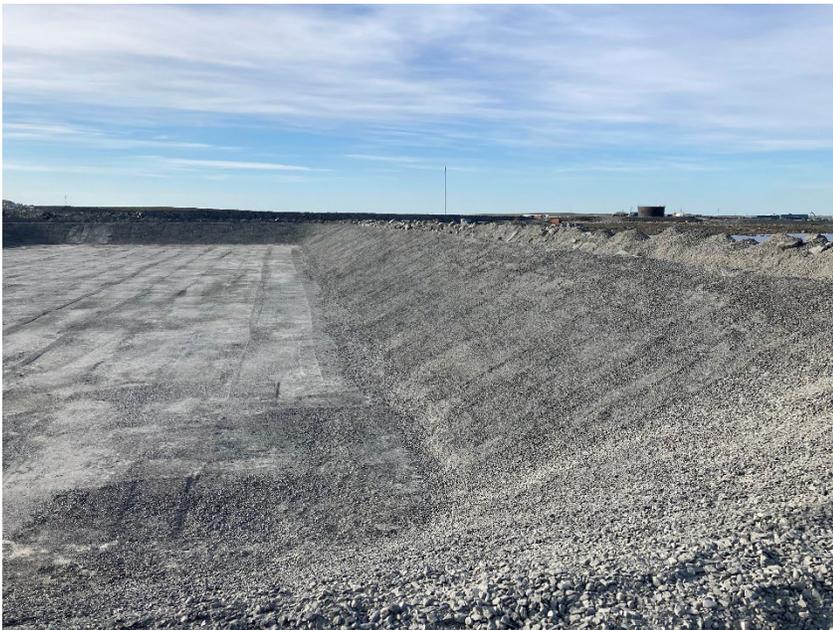
Photograph H5-4 Whale tail Project Contaminated Soil Storage and Bioremediation Landfarm Facility

Description: From the north extremity of the new Whale Tail Project facility, looking south. In good condition, not yet lined.

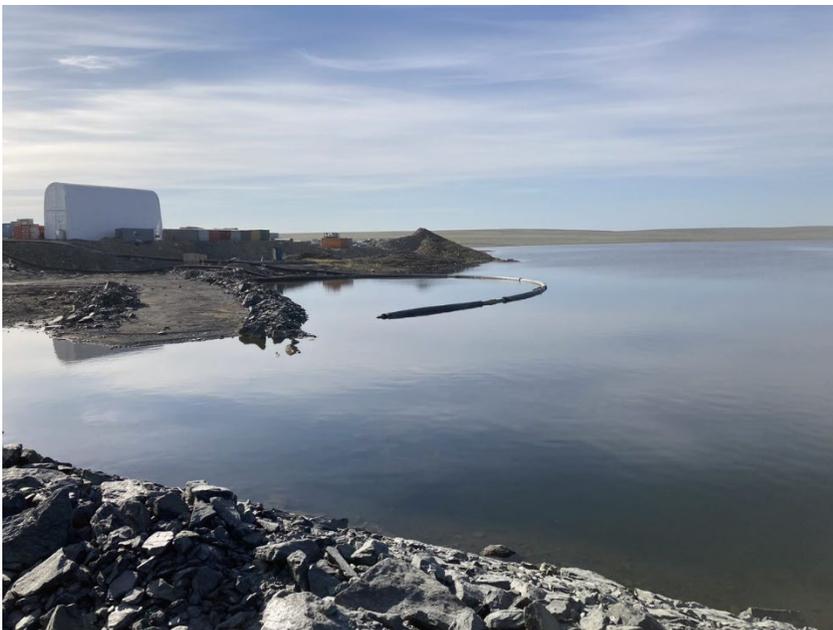
Photograph H9-2 Whale Tail South Diffuser

Description: From the east abutment of Whale Tail Dike, looking south. The diffuser present and working normally.

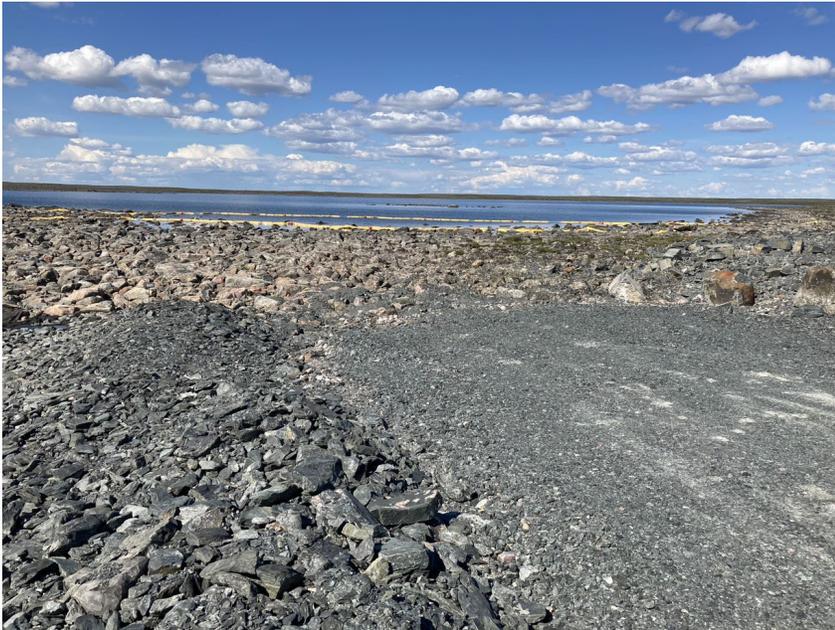
Photograph H10-1 South Whale Tail Channel

Description: From the outlet into Mammoth Lake, looking northwest. Two turbidity barriers are deployed in the lake.

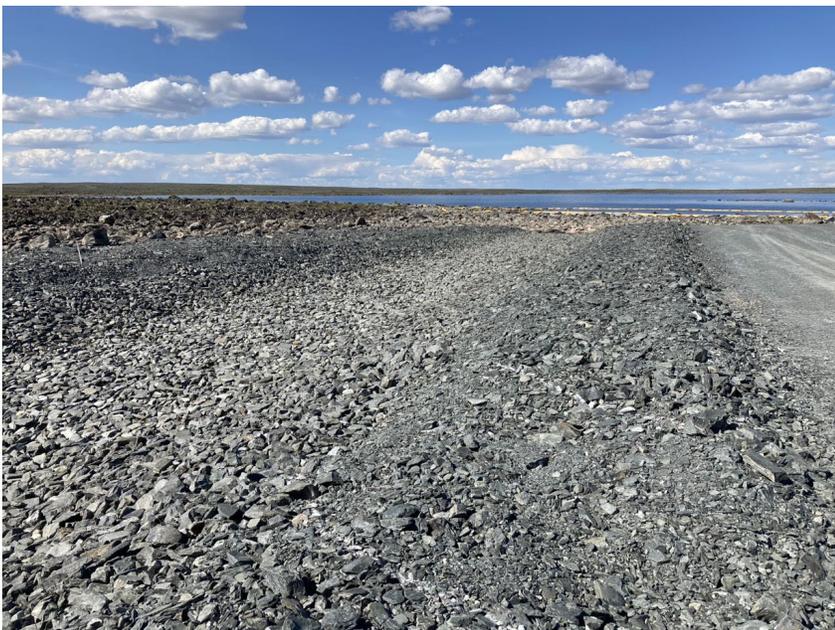
Photograph H10-2 South Whale Tail Channel

Description: From approx. Sta. 0+850, looking west. Settlement in the rockfill slope.

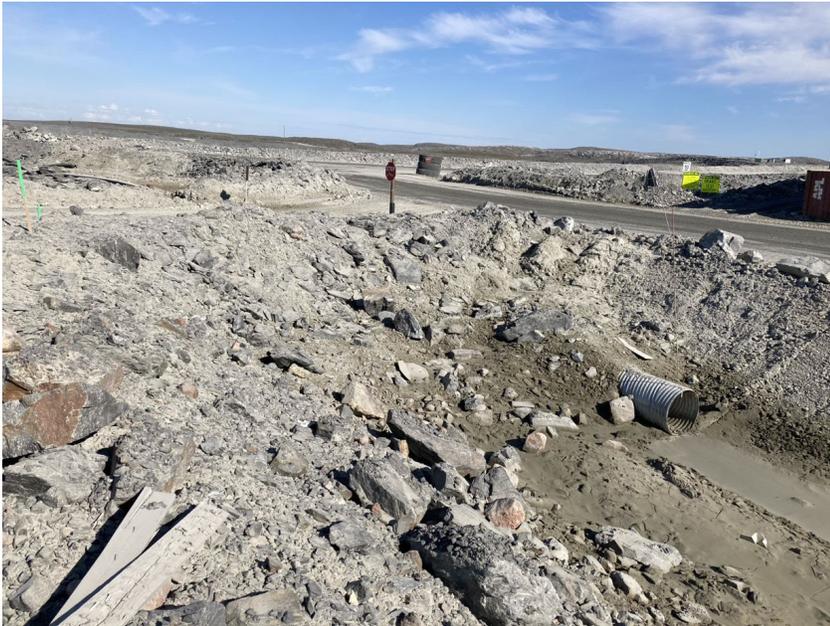
Photograph H11-1 Saline Ditch

Description: From the northern extremity of the Saline Ditch, looking west. The culvert is in good condition. Mud is accumulating in front of the inlet.

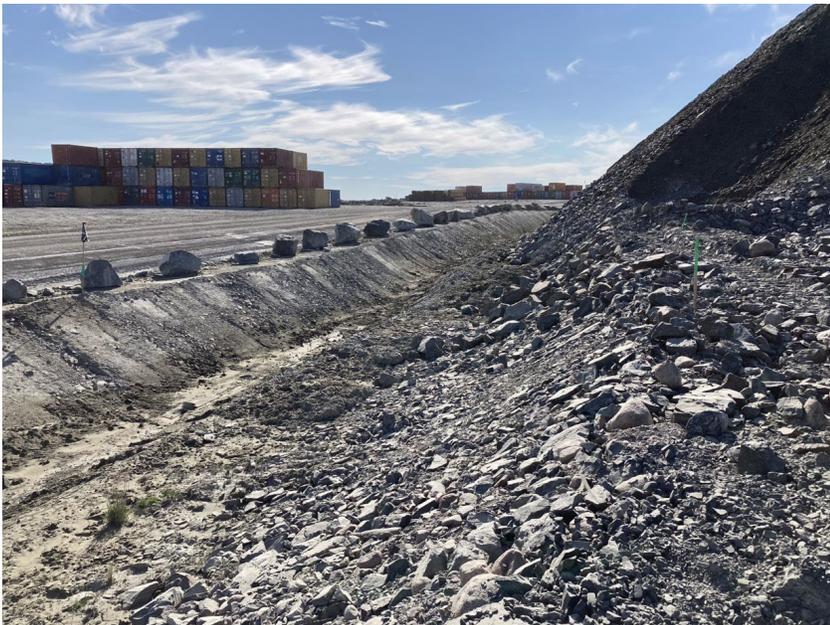
Photograph H11-2 Saline Ditch

Description: From the northern extremity of the Saline Ditch, looking east. Mud and gravel are present in the ditch.
