Nunavut Impact Review Board

2023 Site Visit Report

**Doris North and**

**Phase 2 Hope Bay Belt**

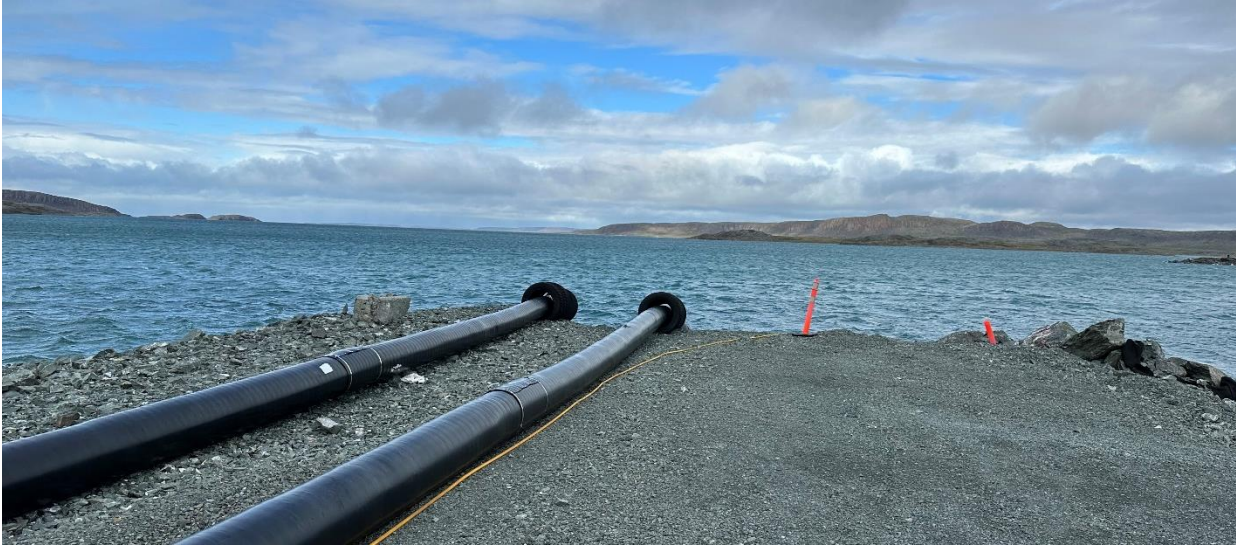
**Photo 1: Saline Discharge and Water Recirculation**

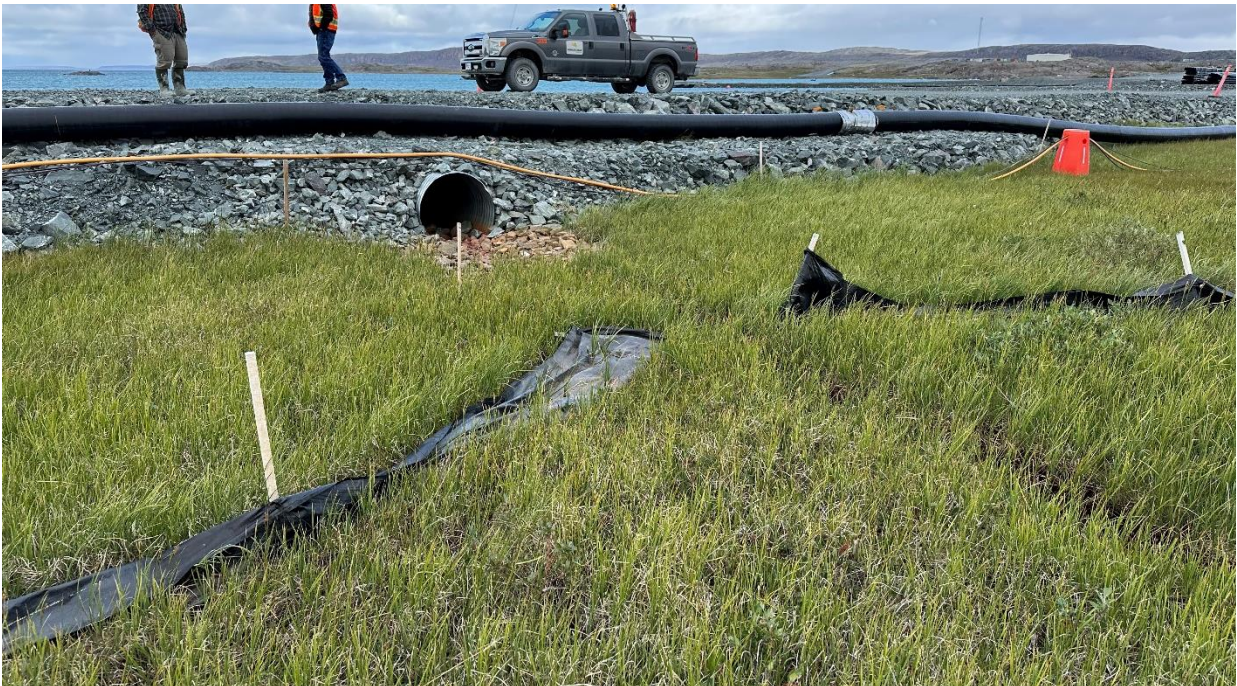
**Photo 2: Culvert on the road going to the saline discharge and sedimentation control**

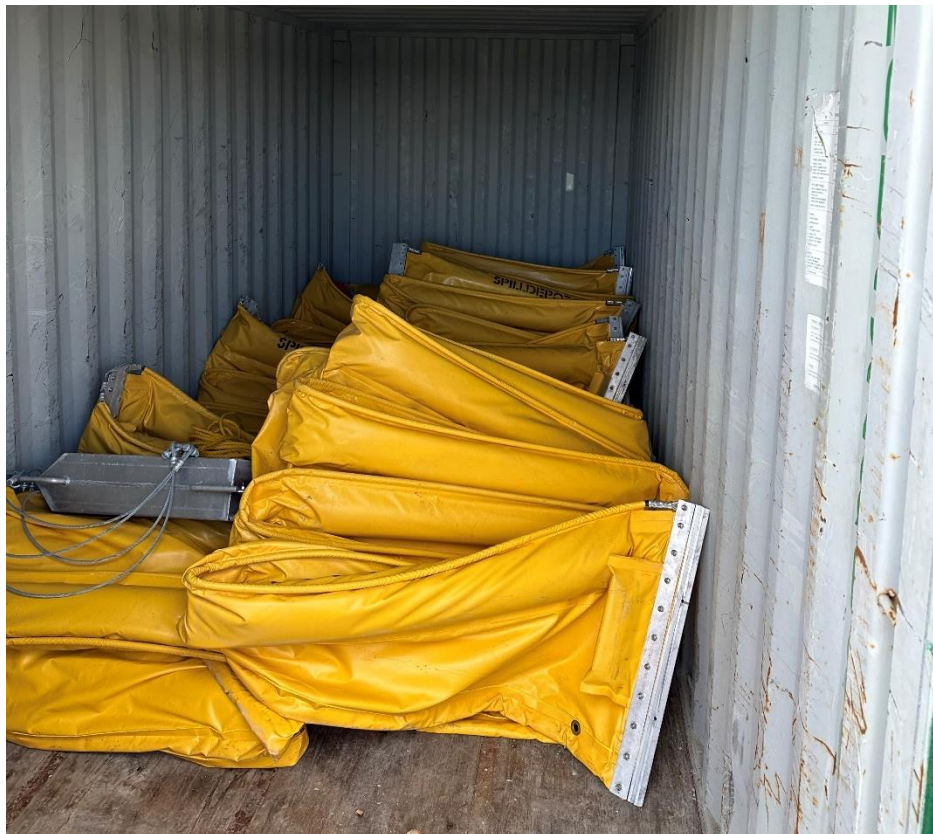
**Photo 4: Spill Equipment in Seacans next to the Robert's Bay Jetty**

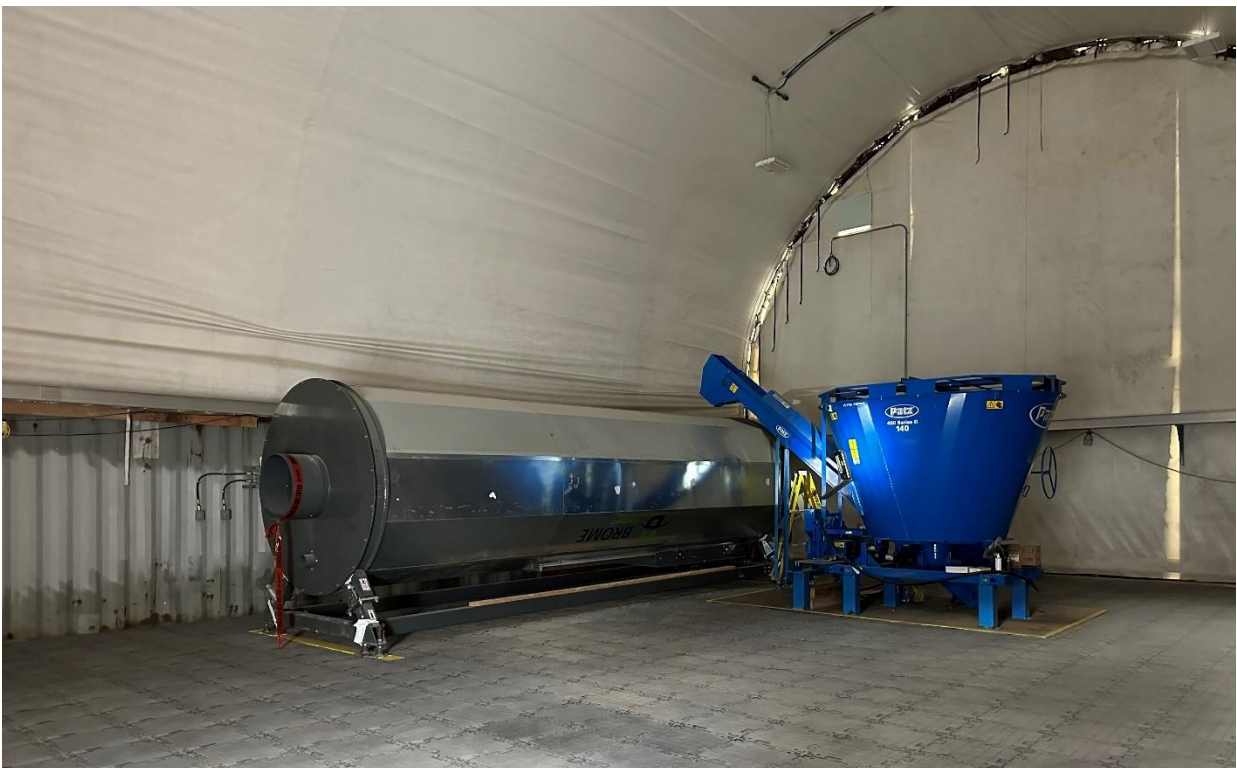
TC#	Subject	Observation
1	Air Quality Monitoring	Dust monitors were observed along Windy Lake Road but as the Madrid North Site is not active, air quality monitoring is limited.
2	Green House Gas (GHG) Reduction	Agnico Eagle built a composter which will help reduce GHG by diverting organic waste from the incinerator <a href="#">Photo 6</a> .

**Photo 6: New industrial composter being installed next to the incinerator**

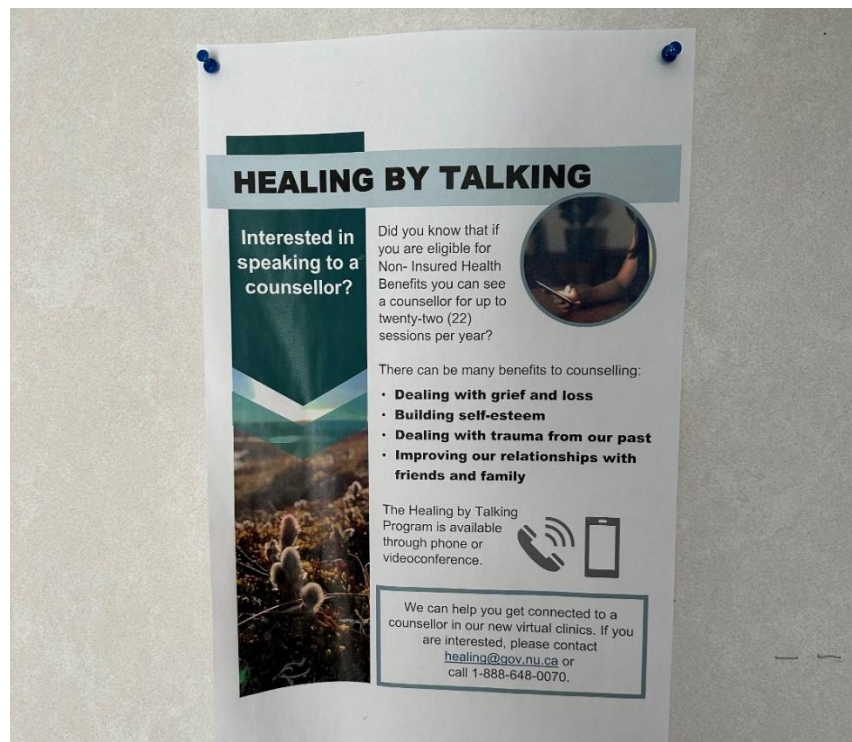
Photo 10: Counselor Information Poster at Doris Camp

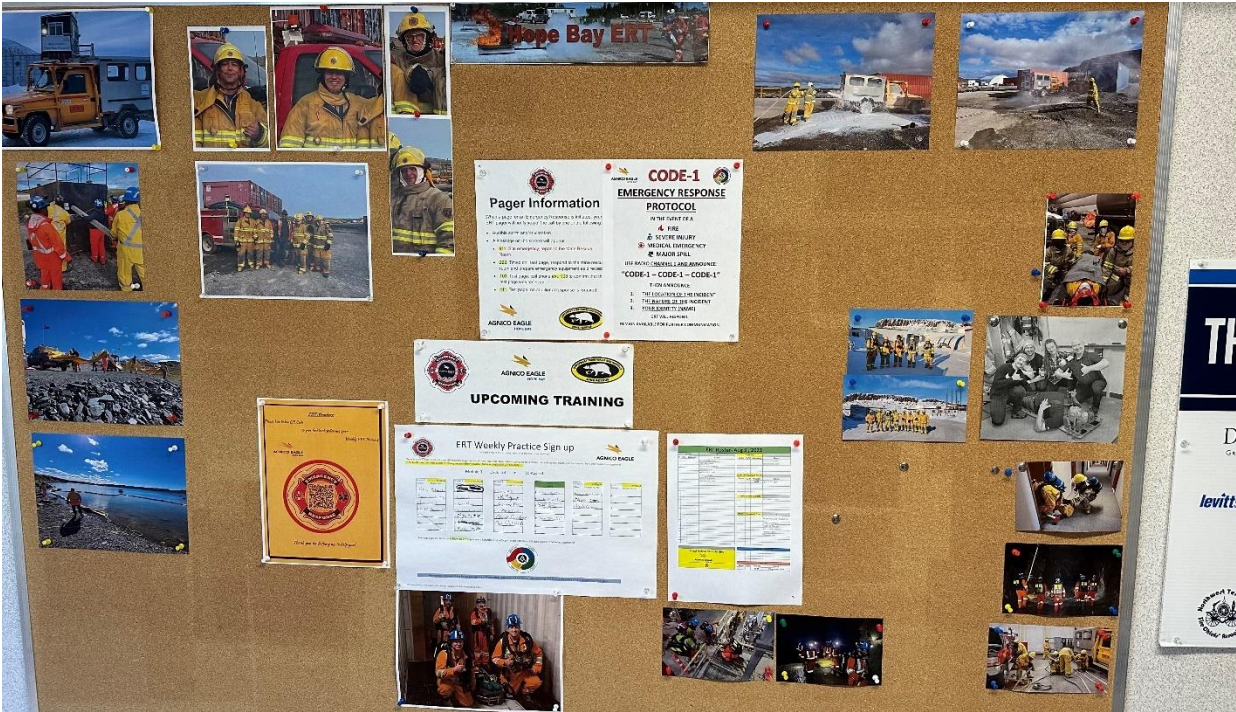
**Photo 11: Emergency Training Board at Doris Camp**

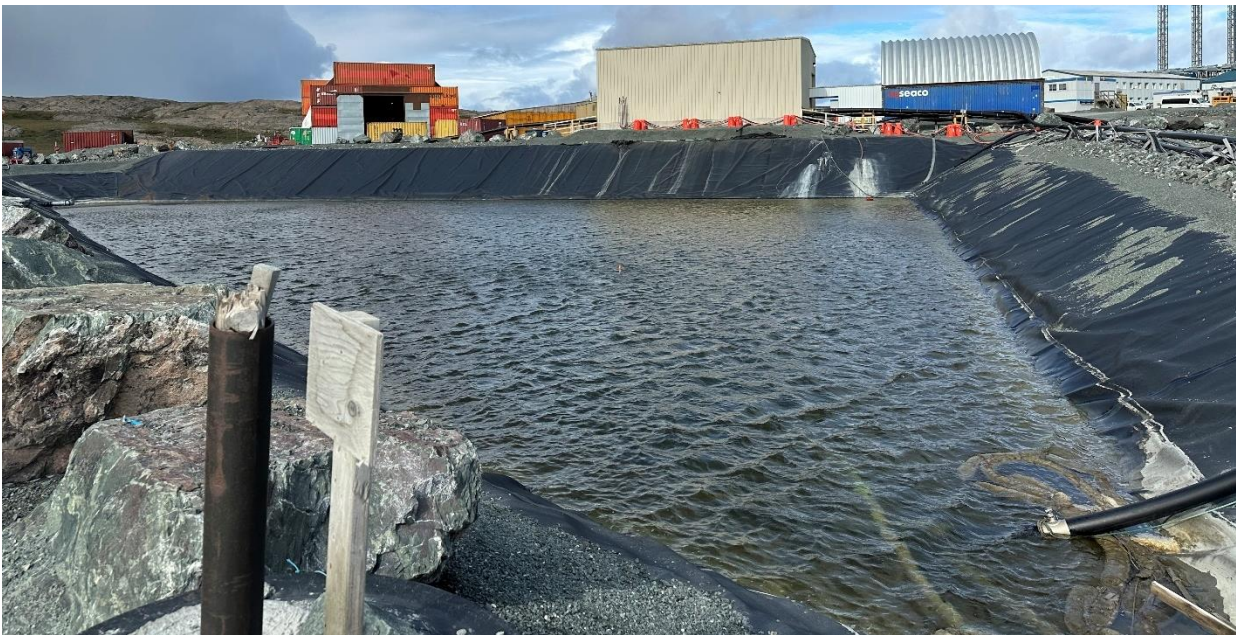
**Photo 12: Sedimentation Pond at Doris North which collects Runoff water from Camp site and discharge into Tailings**

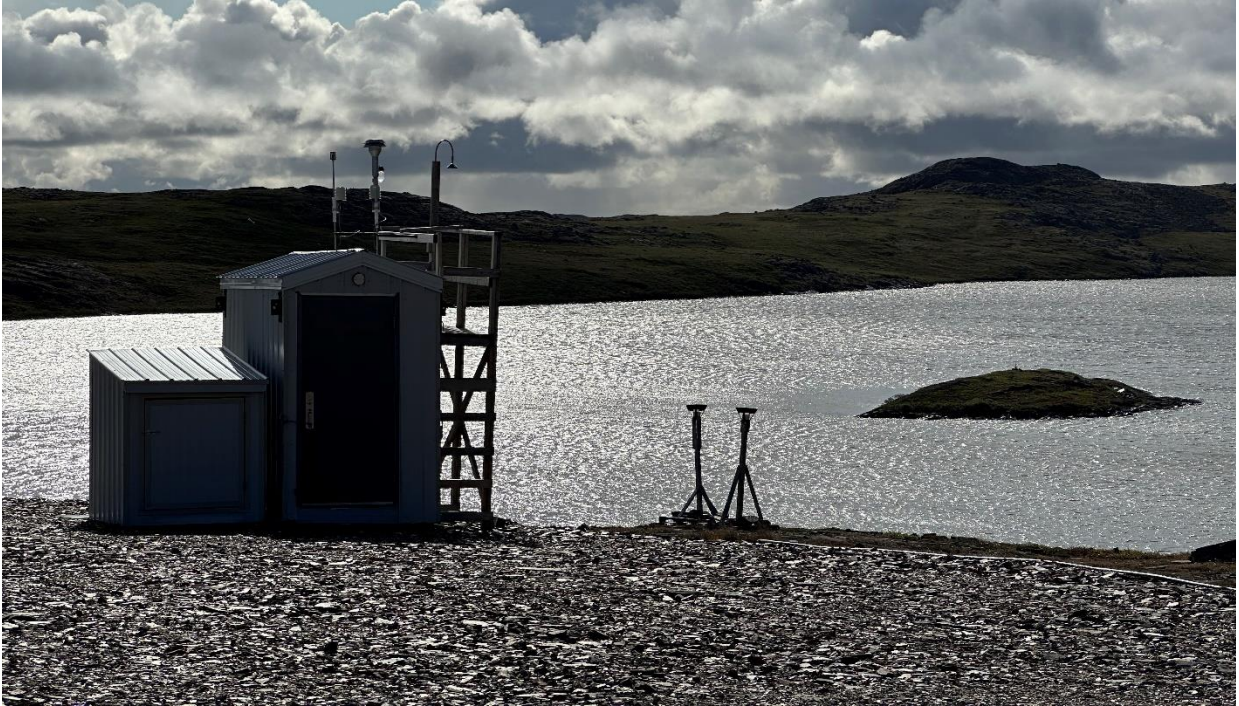
25 & 26	Wildlife-TIA interaction and recording of wildlife at Doris site	Wildlife camera are installed around tailings <a href="#">Photo 17</a> .
30	Air Quality	Dust monitors were visible at multiple location around the site and a continuous air monitor for NO <sub>2</sub> <a href="#">Photo 13</a> .
33	Spill kits at Roberts Bay	Spill equipment were visible around the site <a href="#">Photo 4</a> and a board with upcoming training at the in the main camp <a href="#">Photo 11</a> .

**Photo 13: Continuous Air Quality Monitoring, next to Doris Lake**

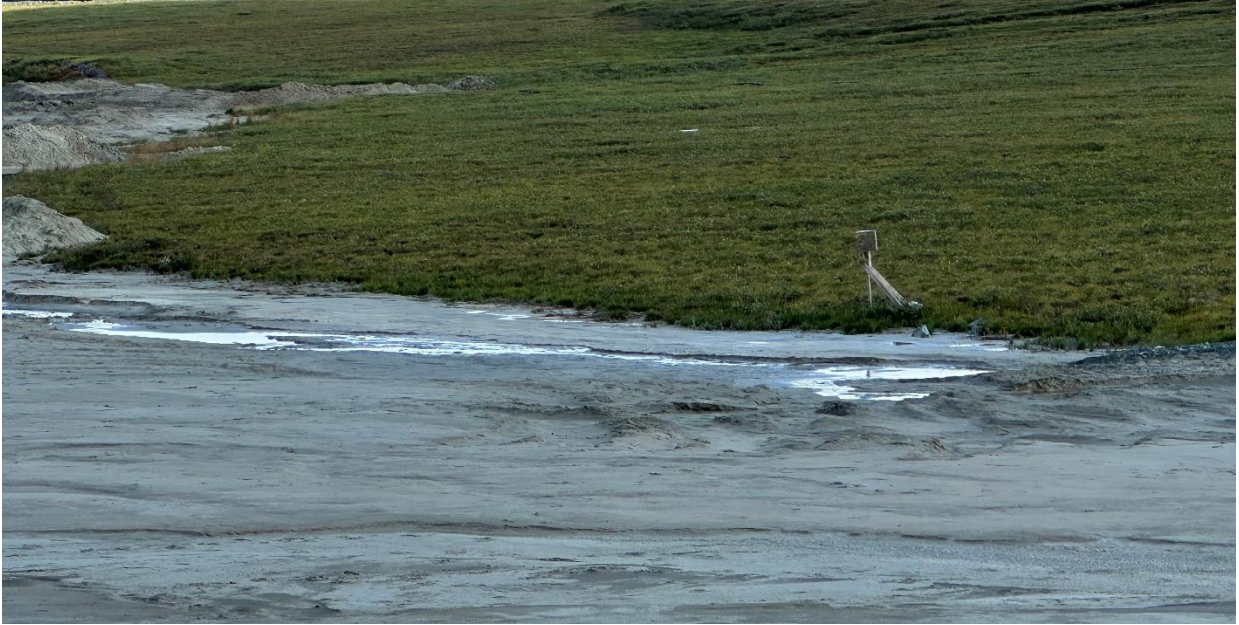
**Photo 17: Wildlife Camera**

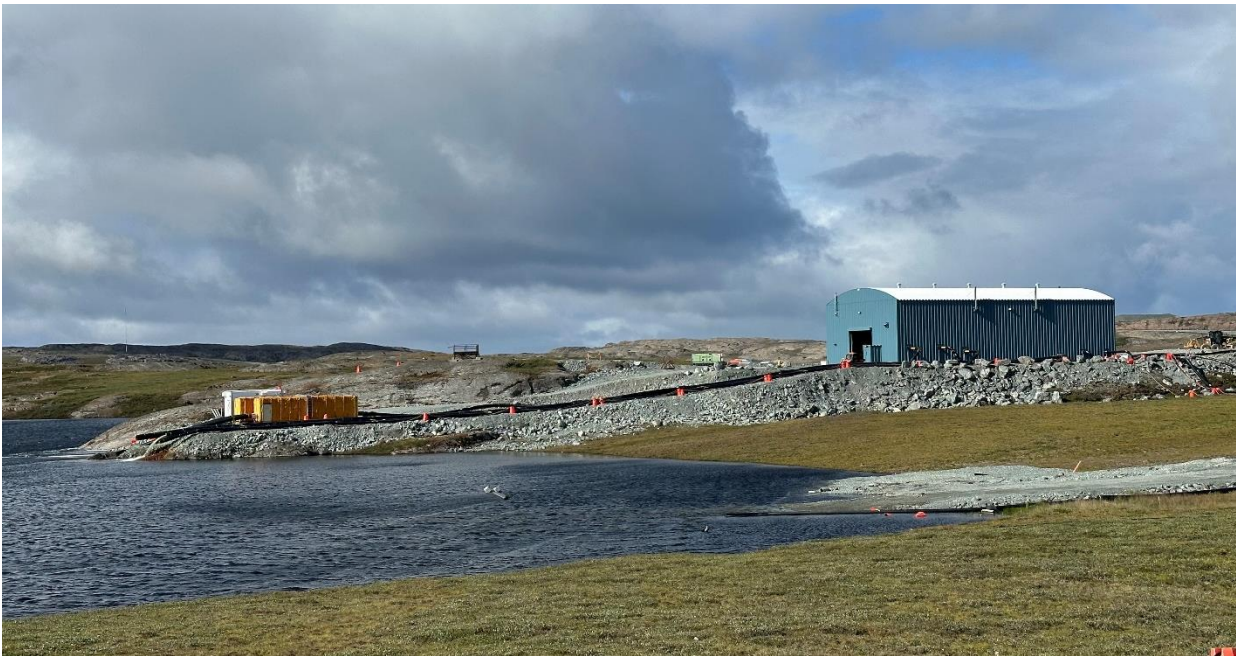
**Photo 20: Discharge point into the Tailings and newly constructed Effluent Water Treatment**

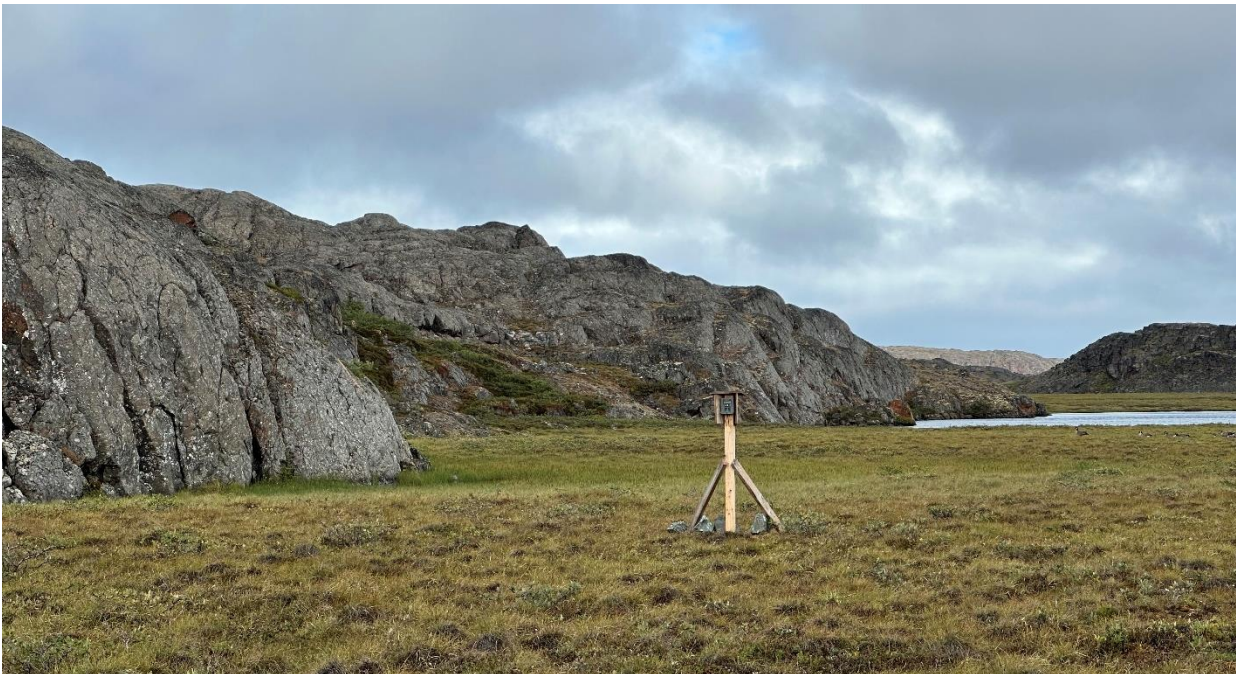
**Photo 23: Wildlife Camera next to wildlife passage.**

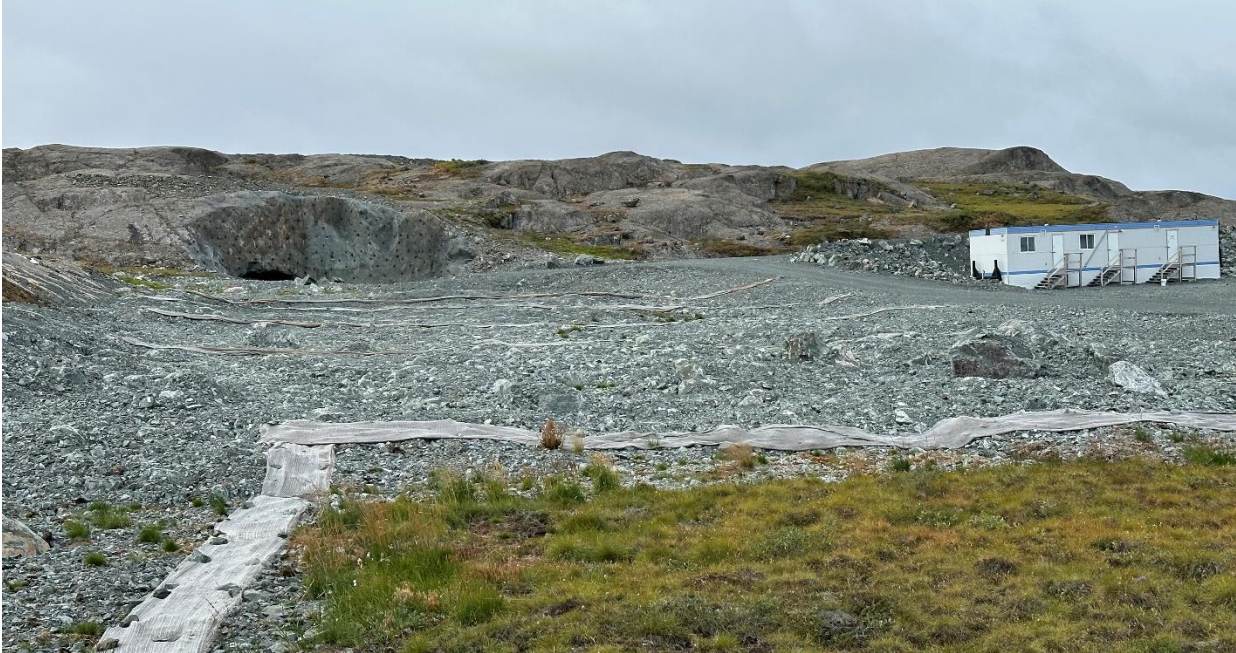
**Photo 26: Sedimentation Control at former Madrid Portal**

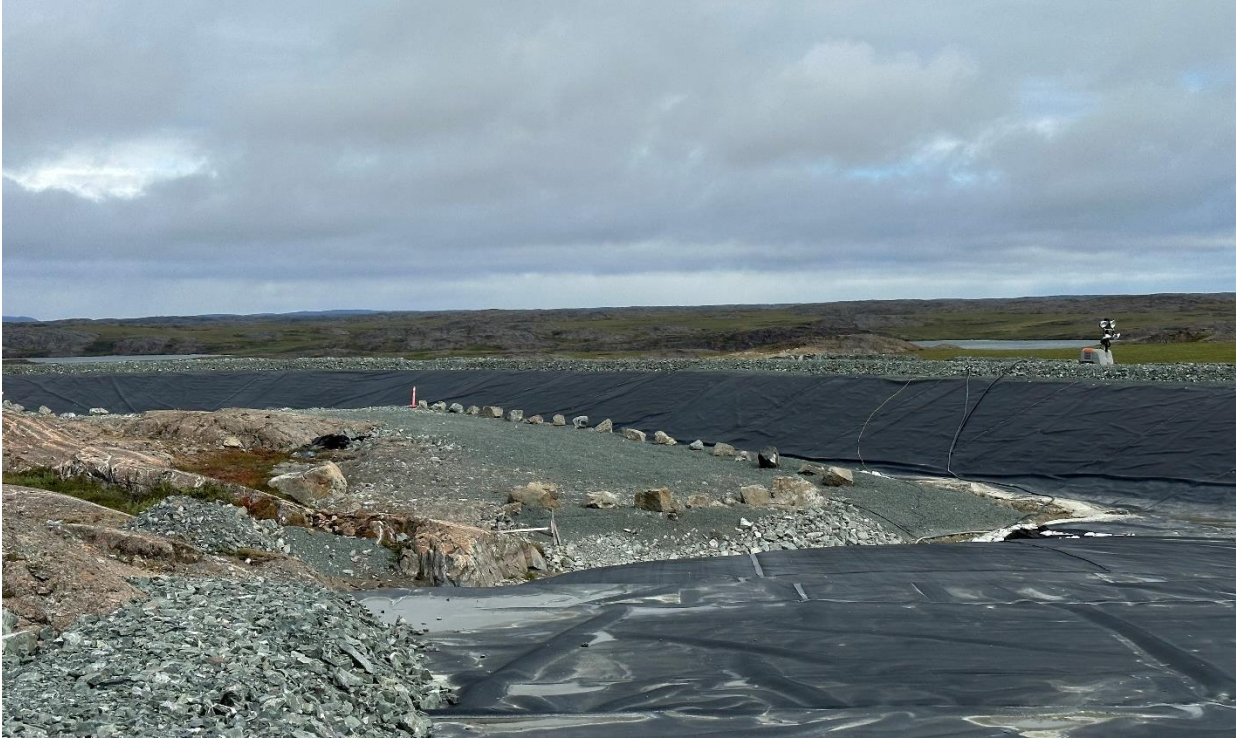
TC#	Subject	Observation
5	Acid Rock Drainage and Metal Leaching Management	Possible bedrock fracture potentially allowing runoff water from Waste Rock Pile to escape contact water holding pond <a href="#">Photo 27</a> . Agnico Eagle constructed multiple sumps around the pond to collect leaking water, <a href="#">Photo 28</a> .
6	Monitor the integrity of infrastructures.	For the infrastructure in place related to the Phase 2 project, monitoring is being conducted. Monitors are currently installed at the South and North Dam, Photo 16 & <a href="#">Photo 21</a> .
7	Erosion Management	Silt fencing and coconut mats are in place to reduce erosion at Madrid portal, <a href="#">Photo 26</a> .
8	Progressive Reclamation	Agnico Eagle started the decommission of Windy Camp, <a href="#">Photo 29</a> & <a href="#">Photo 30</a> .
10	Monitor Surface Water quality	Adjacent to the former Madrid Portal at the Waste Rock Management Area water is monitored to ensure no impact to the surrounding area. A coconut mat was installed in the area to redirect water into the sump. The area around the former Madrid Portal is also observed due to the changing of the rock in the area due to salinity in the previous materials placed on the pad.

Located next to the Madrid Portal, the Potential Acid Generating (PAG) Waste Rock Storage Pile was constructed. This area is monitored with several water monitoring stations and all the water in contact with the PAG waste rock is collected in the waste rock pond. Agnico Eagle discussed a leak that was discovered in 2020 which is still under review to determine the next plans as the liner is compromised. To address the leak, Agnico Eagle constructed a water capture area where the leaked water is collected and pumped back into the pond.

**Photo 27: PAG Waste Rock Pond**

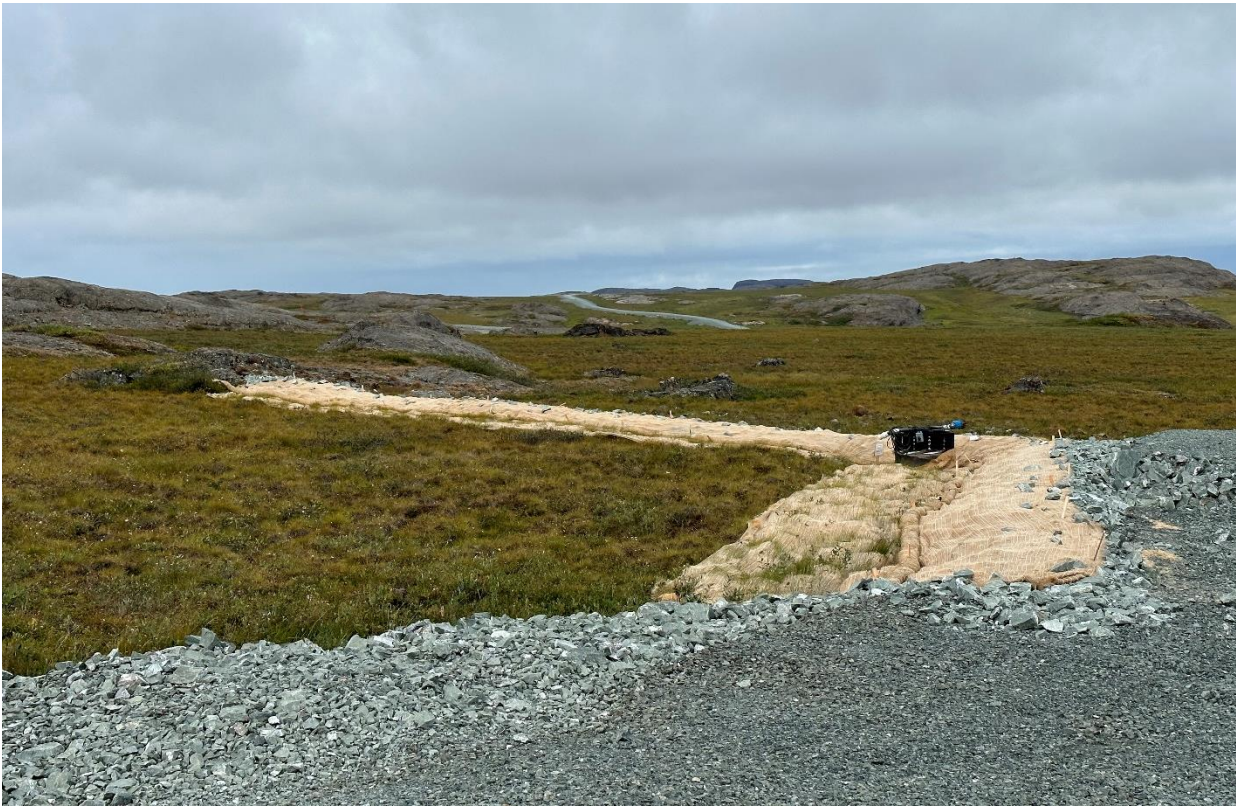
**Photo 28: Collection Sump from the PAG Waste Rock Pond leak and new mat to help redirect water**

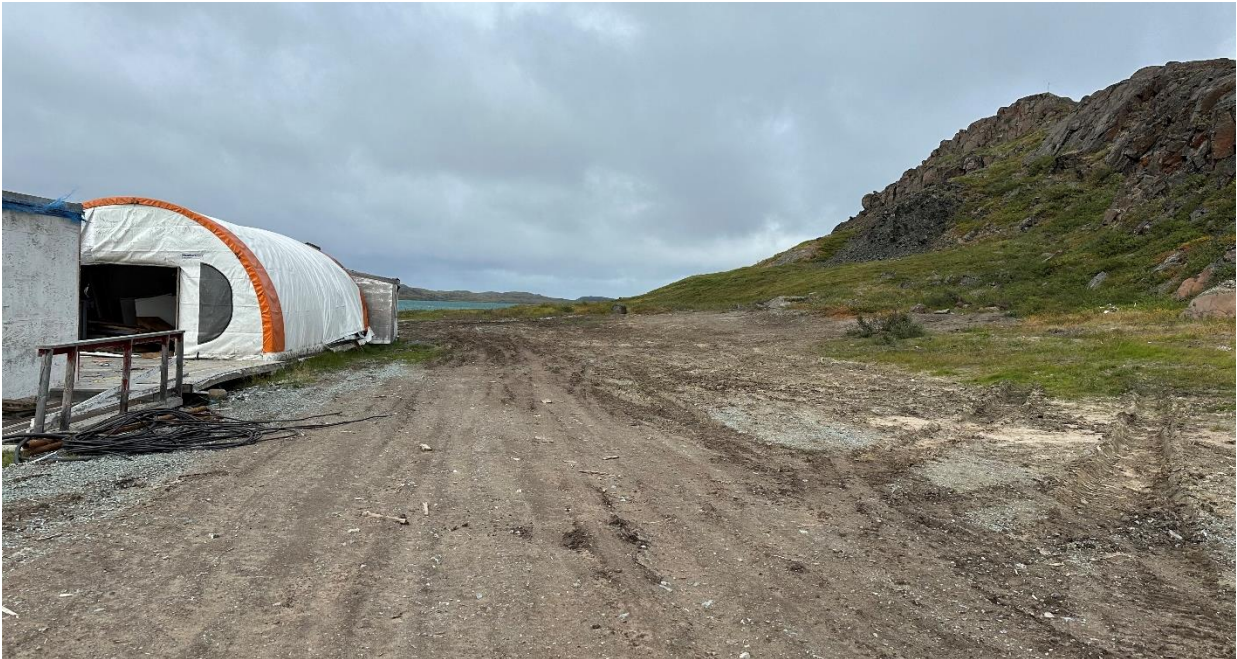
**Photo 29: Windy Camp in decommission process**

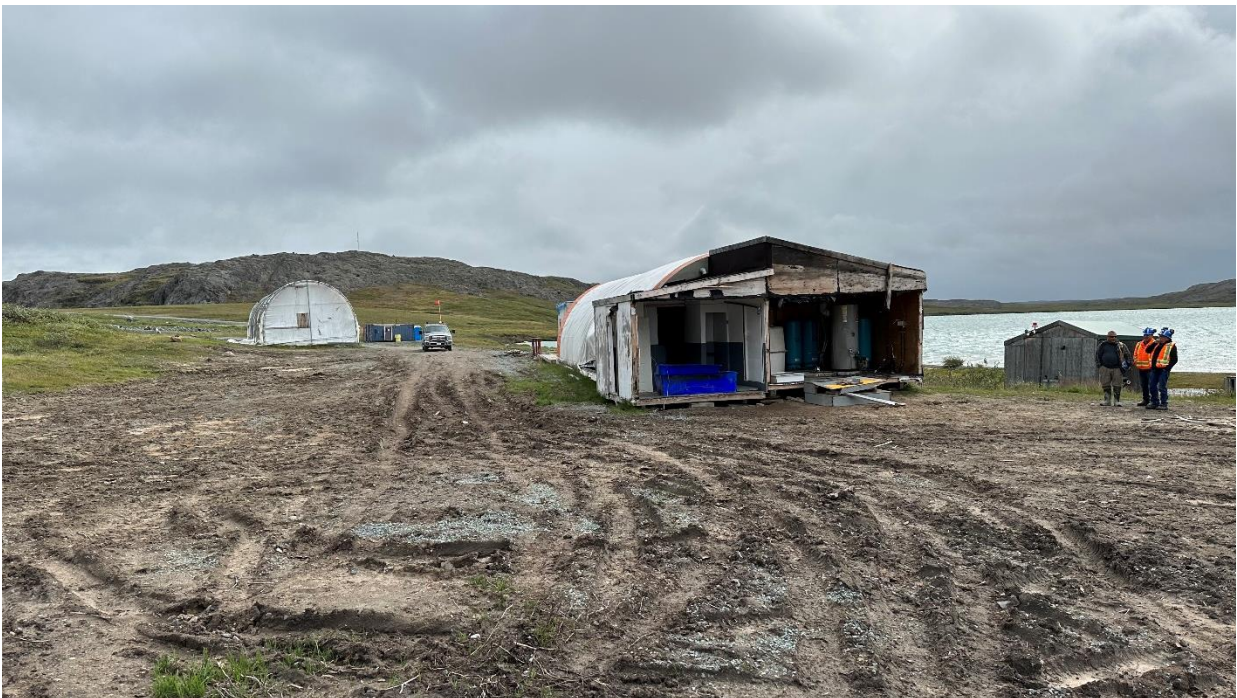
**Photo 30: Windy Camp in decommission process**
