Full Report Title: Nunavut Impact Review Board Community Update and Site Visit Report
Meadowbank Gold Mine and Whale Tail Pit Projects Agnico Eagle Mines Limited NIRB File No. 03MN107 & 16MN056

Projects: Meadowbank Gold Mine and Whale Tail Pit Projects

Site visit date: July 29-30, 2023

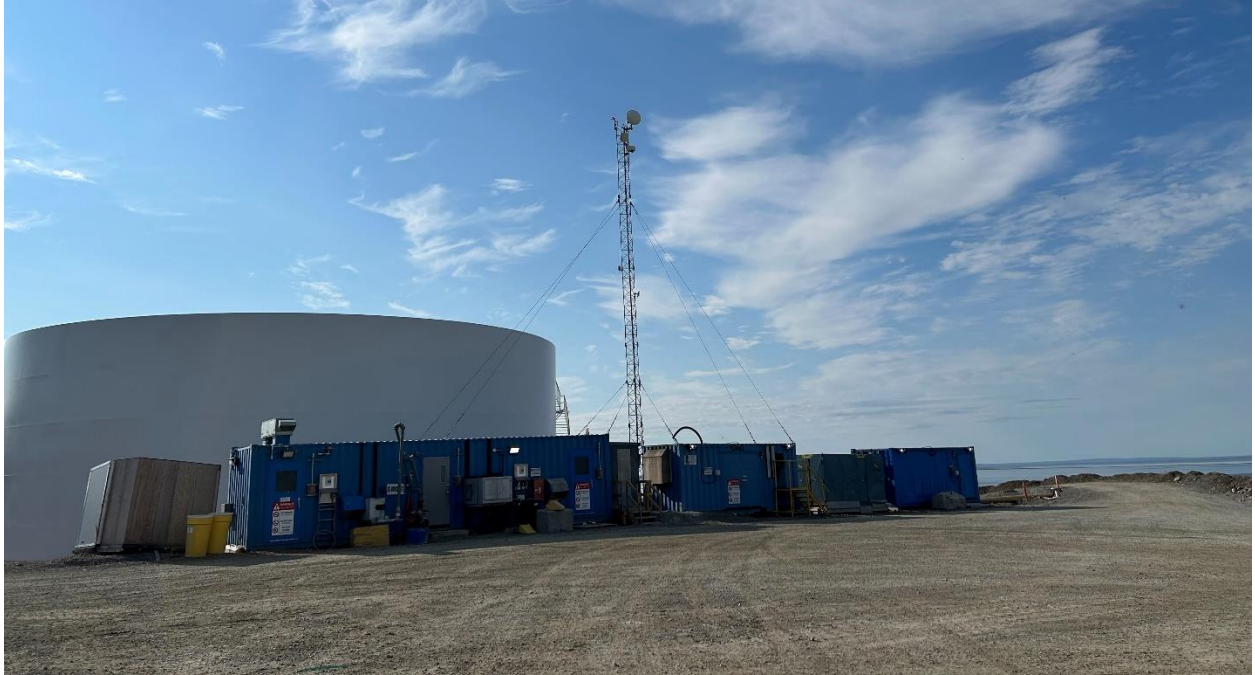
Other		
81	24-hour security at the Baker Lake Facility	24-hour security cameras were observed by NIRB staff at the Baker Lake facilities. The cameras report live feeds to the Meadowbank gatehouse, which is staffed 24 hours per day (Photo 3).

Photo 3: 24-hour security cameras at the Baker Lake Marshalling Facility mounted on a tower. The feeds connect directly to the 24-hour manned gatehouse at kilometer 5 of the AWAR.

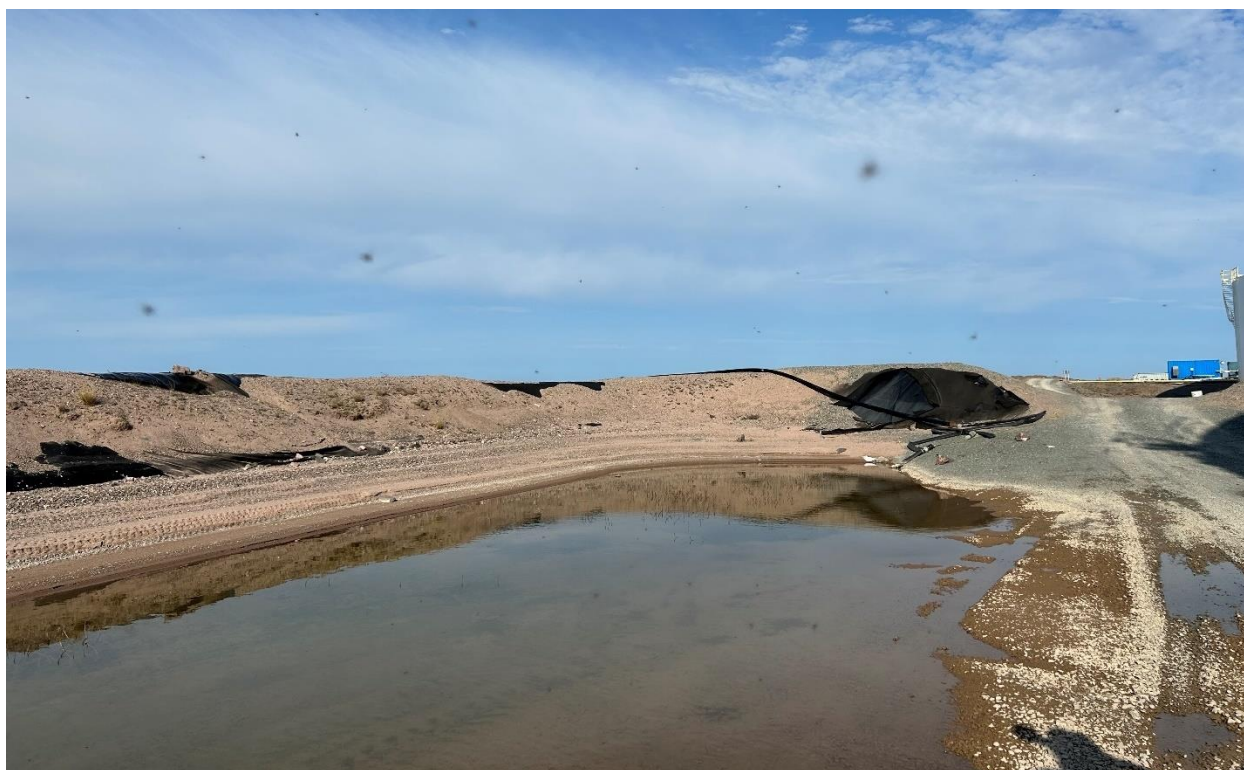
26	Site maintained clean of debris	NIRB staff observed that all areas were kept in a clean state. There was no evidence of wind-blown material viewed around the Meadowbank site or the ancillary facilities in Baker Lake. An active spill cleanup was observed at kilometer 87 of the AWAR. NIRB staff observed the excavated area as well as active pumping of contaminated water from the spill site (Photo 20 and Photo 21).
27	Fuel and hazardous materials storage	NIRB staff noted that fuel and hazardous materials associated with Agnico Eagle's Meadowbank project appear to be stored in a safe and environmentally protective manner (Photo 46) Some secondary containment berms surrounding the fuel storage area at the Baker Lake facilities showed signs of erosion resulting in exposed liners (Photo 8). Secondary containment berms at the onsite tank farm were observed to be intact (Photo 49). Agnico Eagle staff were aware of the areas in need of repairs and intend to re-cover the liners promptly.

Photo 8: Exposed liner at the Baker Lake Marshalling Facility. Pooled water is being pumped out to be stored in the Stormwater Management Pond at the Meadowbank Site.

- Information regarding Air Traffic logs;
- Re-covering of berm liner in the secondary containment berms at the fuel storage areas at the Baker Lake Marshalling Facility; and
- Replacement of caribou migration maps.

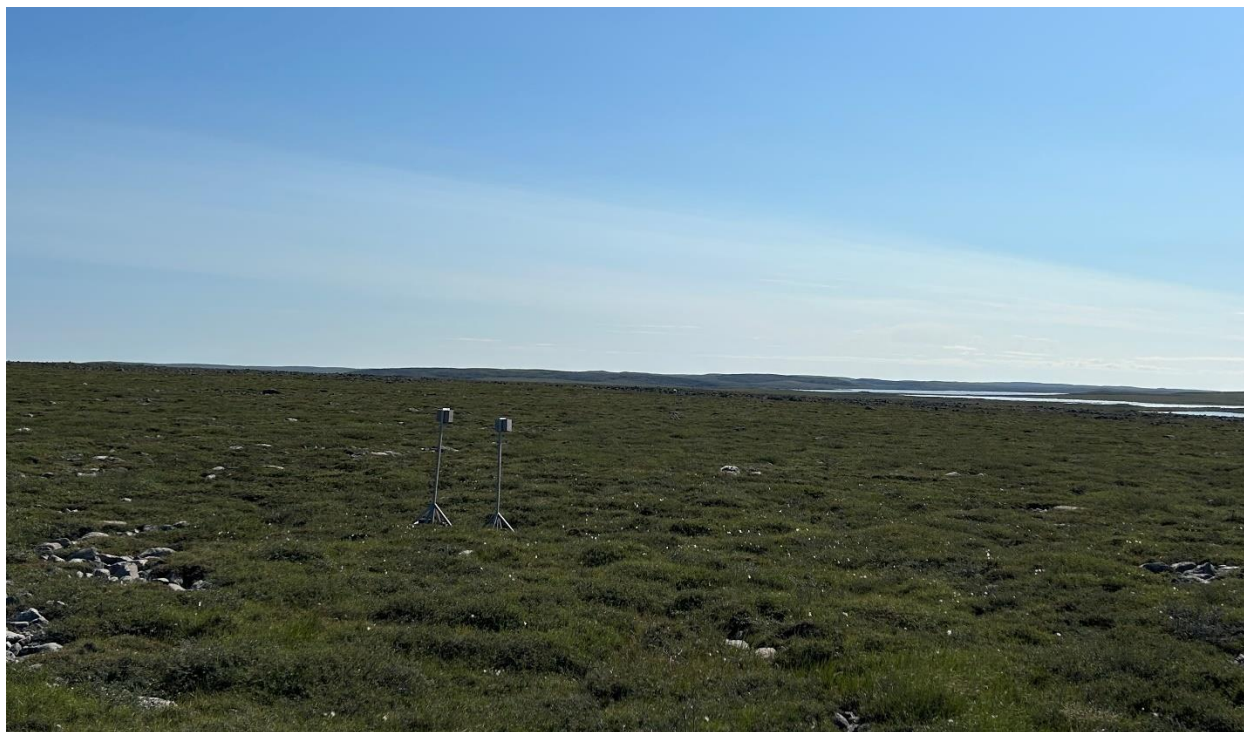
T&C No.*	Topic	Site Observation
Air Quality		
71	Atmospheric monitoring stations	Air monitoring stations have been in place at two (2) locations around the Meadowbank Mine Site since 2010 and programs are in place along the Whale Tail Haul Road and the Whale Tail site.
72	On-site Incinerators	As a result of exceedances found during stack testing in 2022, the incinerator has been removed from the Meadowbank site. A composting program was established in 2019 and was observed by NIRB staff during the site visit (Photo 47). Materials that would normally be incinerated are now redirected to the composter if possible or are otherwise shipped offsite for disposal.
74	Dust Suppressants	<p>The use of Calcium Chloride dust suppressant was observed on five (5) sections of the AWAR at kilometers:</p> <ul style="list-style-type: none"> - 10-12 - 24-26 - 48-50 - 68-70 - 80-84 <p>As well as an additional section at kilometer 95. Photo 18 shows a section of the road that has received dust suppression treatment, while Photo 19 provides an example of the conditions that can be seen on the untreated areas of the road. In addition, roads on the Meadowbank site were observed to be receiving continuous watering.</p> <p>NIRB staff observed dust sampling stations placed along the AWAR at various distances from both the east and west sides the road in two (2) duplicate transects to monitor dust deposition distance from the road. Dust canisters are placed 25, 50, 100, 300, and 1000 metres away from the AWAR. Photo 13 and Photo 14 show dust monitoring equipment in place along the road.</p>

Photo 13: Dust monitoring transect on the AWAR.

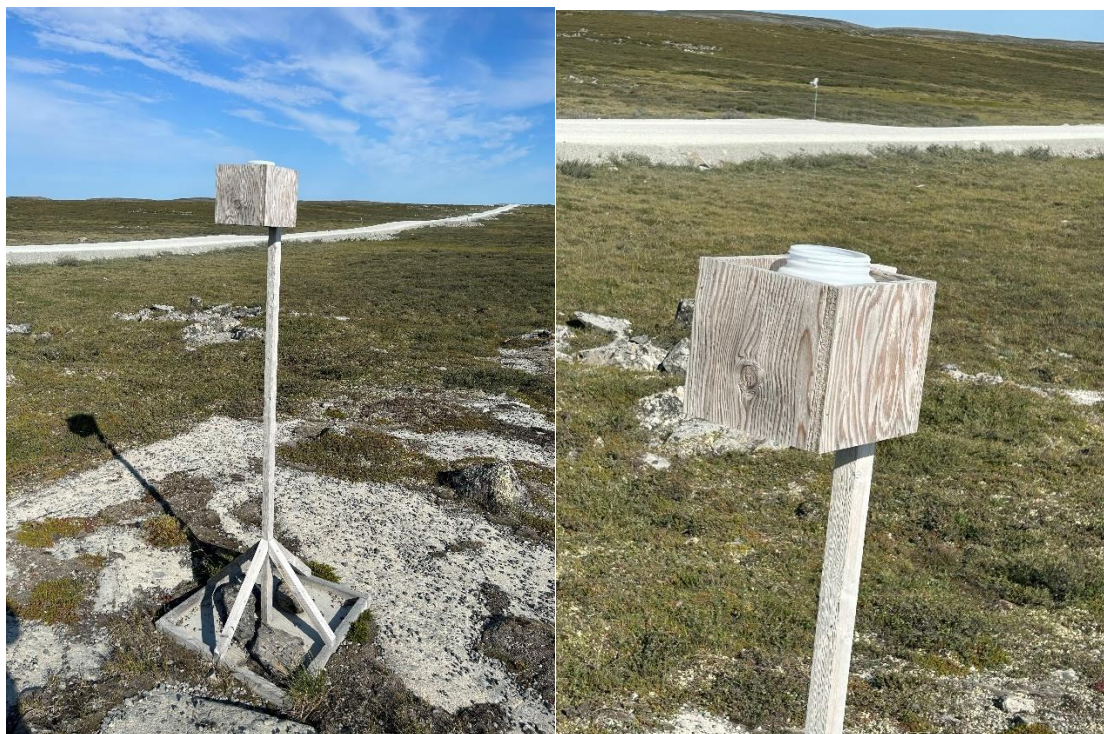
Photo 14: Close up images of dust monitoring equipment. The jars are removed and sent offsite for analysis.

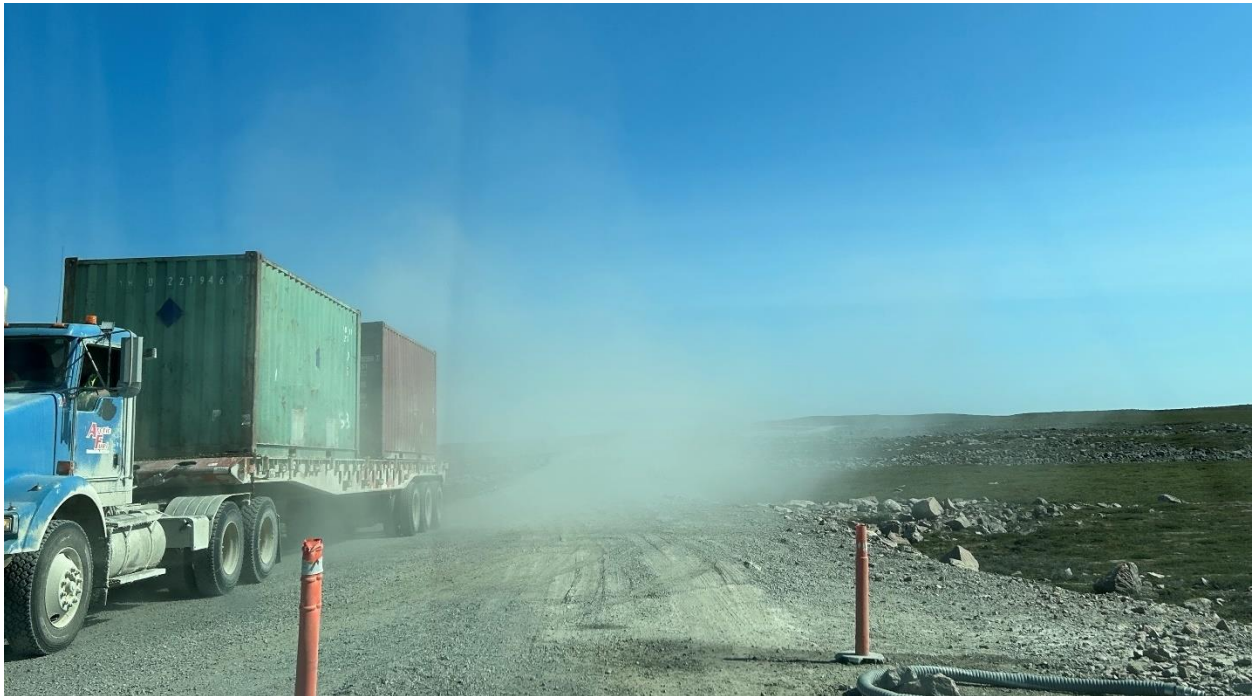
T&C No.*	Topic	Site Observation
Air Quality		
1	Active and Passive Monitoring of Dust fall	Three (3) dust fall monitoring transects were viewed along the Whale Tail Haul Road (WTHR) along with several more present onsite. Agnico Eagle's active NO ₂ monitoring equipment was not in operation for a portion of 2022 due to issues with equipment failure during power outages, but this issue has been resolved through the installation of an automatic shutoff switch. The active NO ₂ monitoring station also houses a passive NO ₂ monitoring station, with another passive station present elsewhere onsite (Photo 52 , Photo 53 , and Photo 54).
2	Dust suppression on roads	Calcium Chloride dust suppressant was applied on the entire WTHR (Photo 55), six (6) sections of the AWAR (Photo 18), and at the Baker Lake Marshalling facilities (Photo 5). Roads at the Whale Tail site received continuous watering via a water truck. Agnico Eagle staff noted that the remaining sections of the AWAR receive regular watering, however this was not observed on the site visit and dusty conditions were noted (Photo 19).

Photo 19: Dusty conditions can be seen on sections of the road that have not received chemical dust suppression treatment.

In addition, Term and Condition 74 requires that the Proponent employ environmentally protective techniques to suppress any surface dust. This condition has not been met by the Proponent as dust suppressants have not been employed along the whole AWAR. Dust suppressants are currently applied at the mine site, along the access road between the Baker Lake facility and the start of the AWAR, along three (3) critical areas of the AWAR at km 10-12, 24-26, and 48-50 as agreed upon with the Baker Lake Hunters and Trappers Organization, as well as two (2) additional sections of the AWAR at km 68-70 and 80-84.

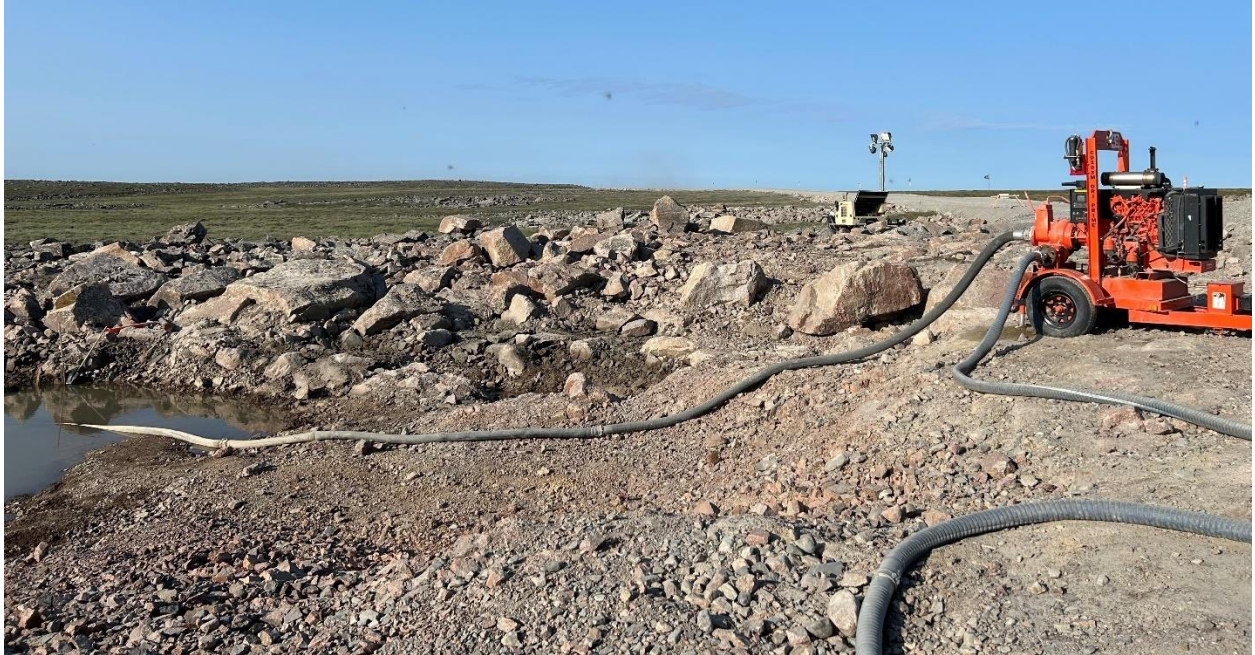
Photo 20: Water pump removing water from a spill cleanup site at kilometer 87 of the AWAR. This was the site of spill in December 2022 and CIRNAC is working with the Proponent on clean-up.

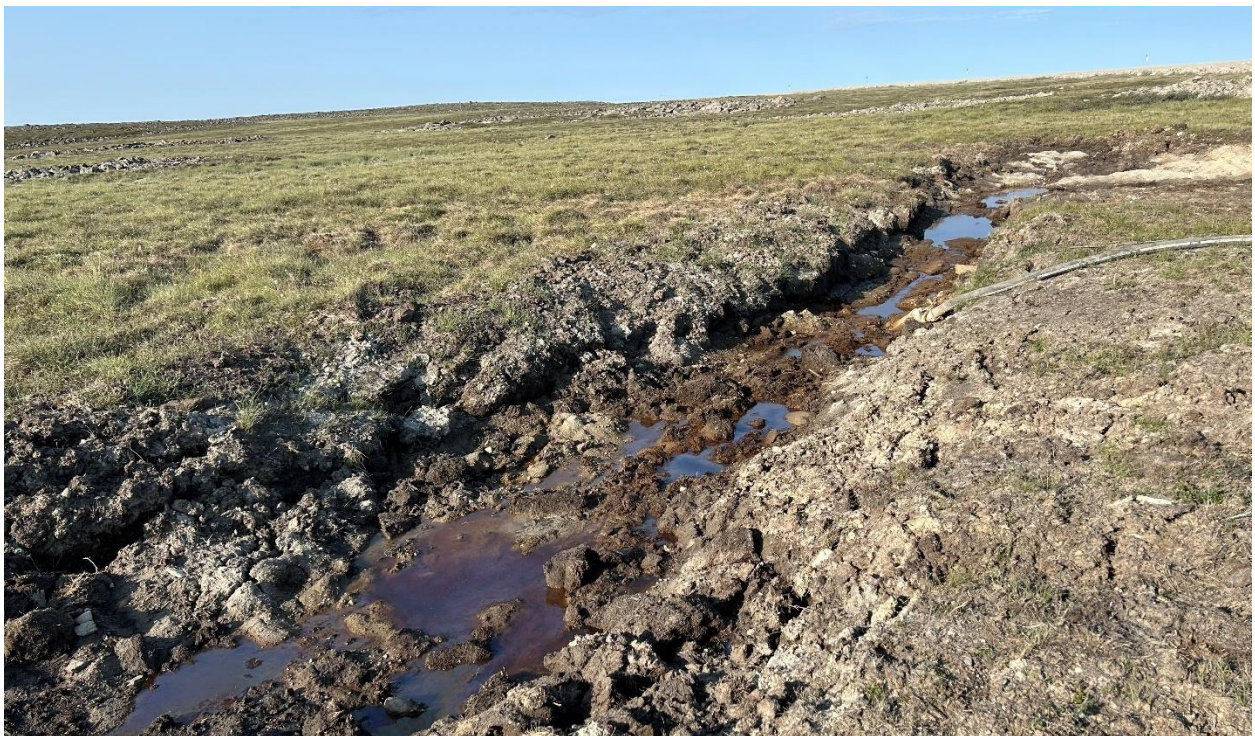
Photo 21: Monitoring of water in the vicinity of the kilometer 87 spill is ongoing. Oil sheens can be seen in standing water.

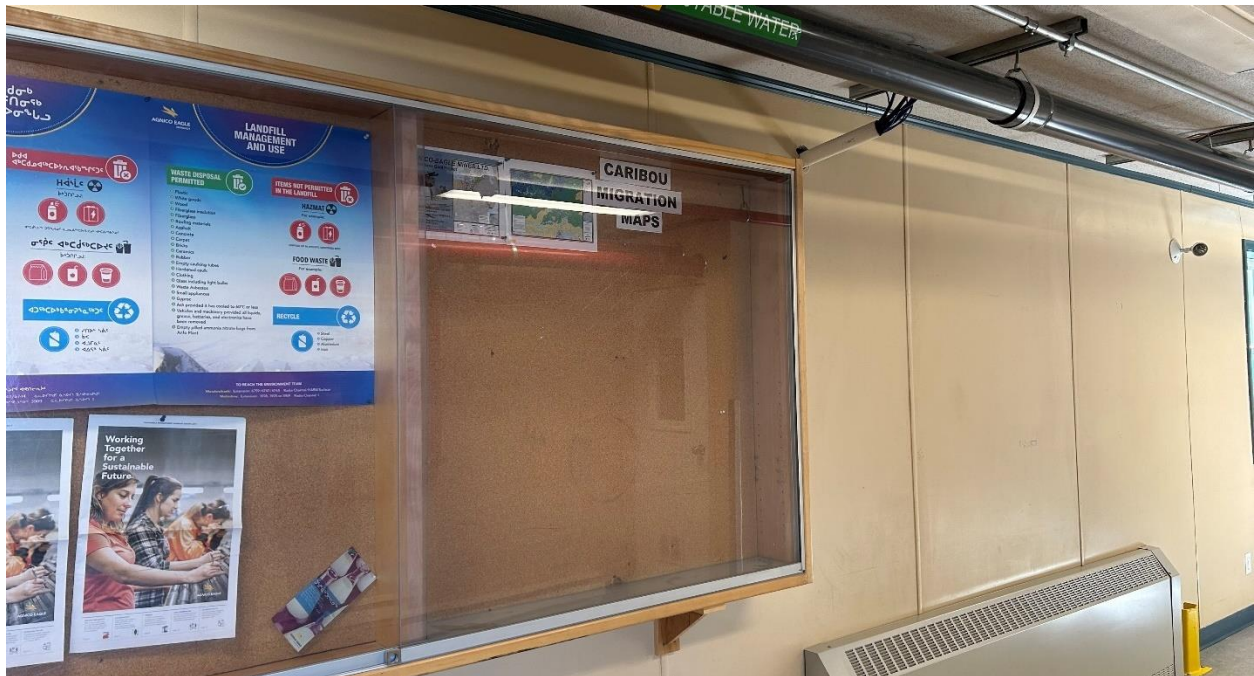
Photo 26: Caribou Migration Maps appeared to be missing.

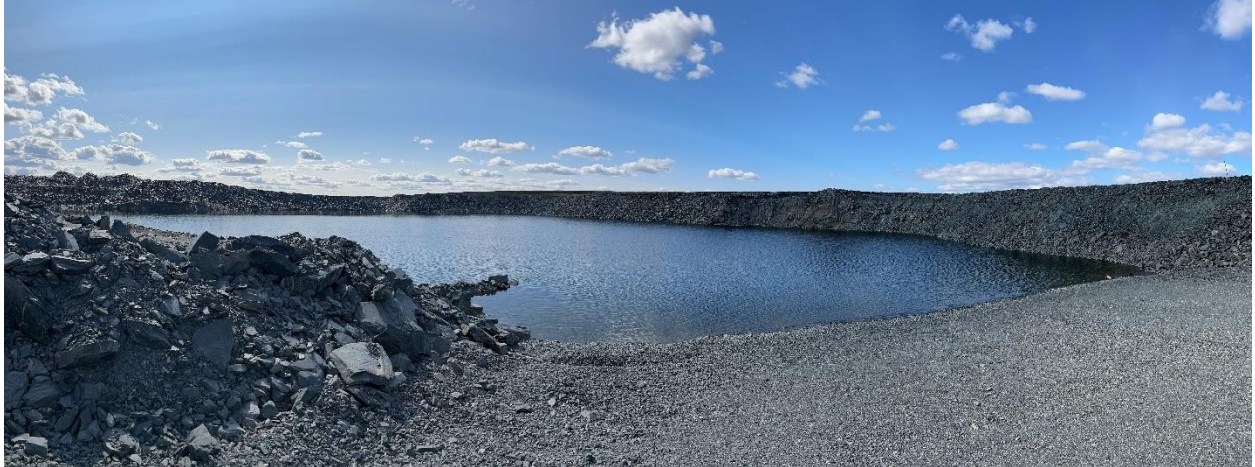
Photo 44: BB Phaser Pit. Caribou tracks were found on the ramp to the pit, which Agnico Eagle staff hypothesized to be the same tracks as seen on the 2022 site visit.

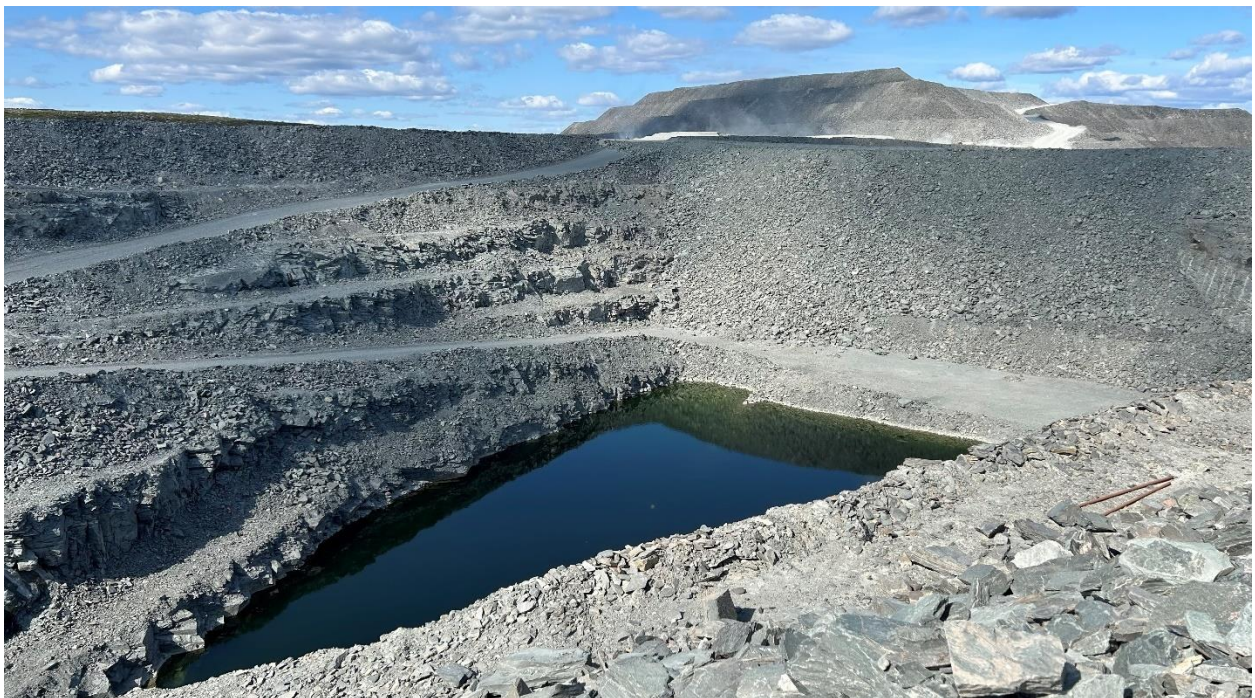
Photo 45: Phaser Pit. The peregrine falcon nest that was observed during 2022 site visit was no longer present and Agnico Eagle staff confirmed that there are no raptor nests currently onsite.

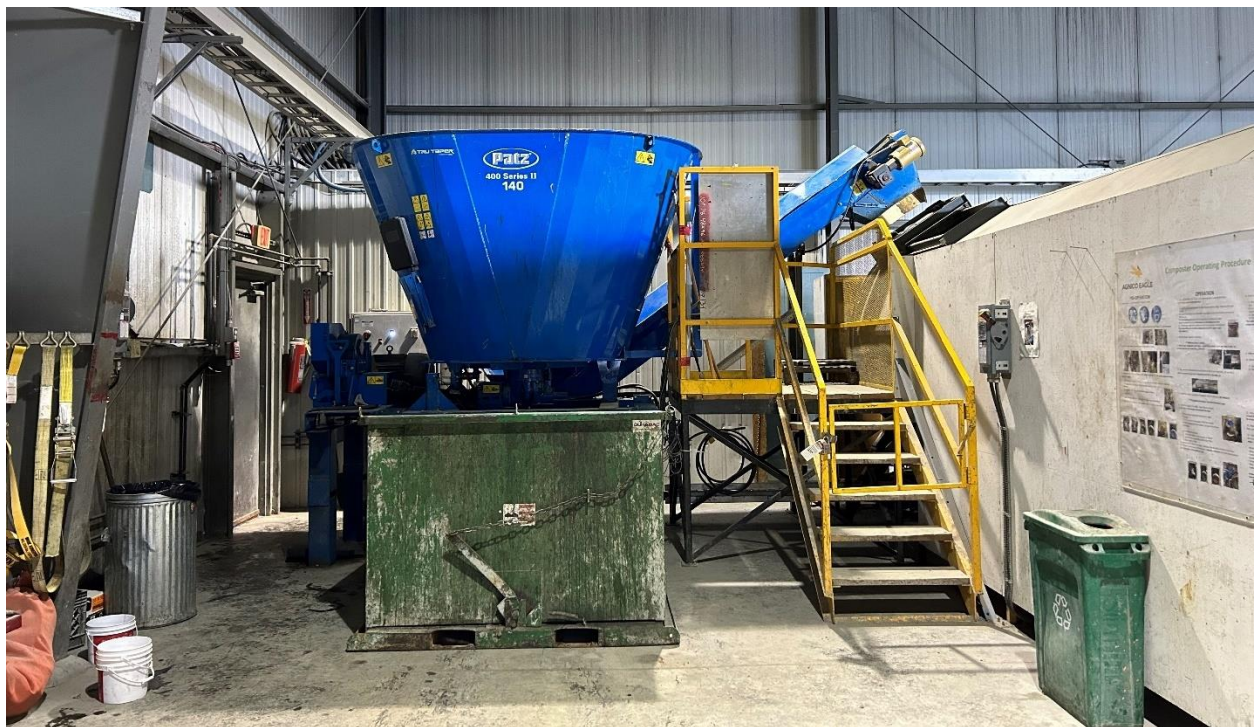
Photo 47: Composter at the Meadowbank Site. The Incinerator was previously housed in the same building but has since been removed due to exceedances during regular stack testing.

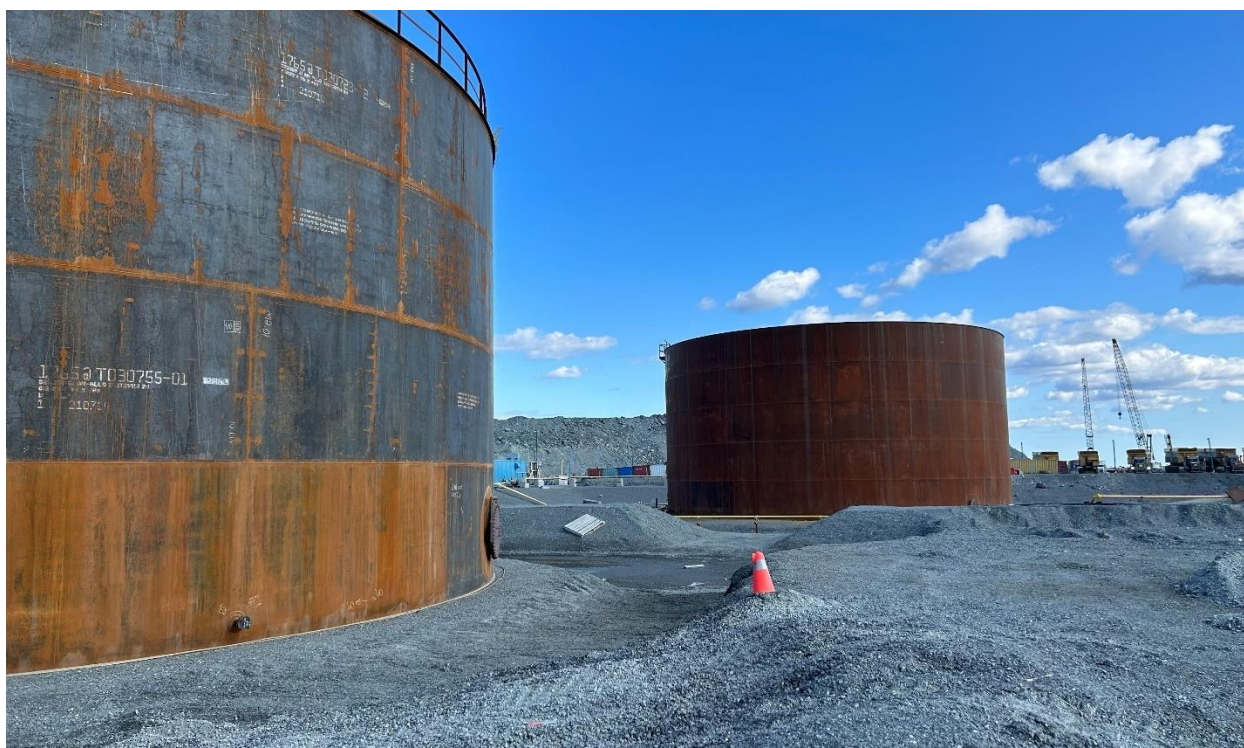
Photo 49: In-tact secondary containment berms at the Meadowbank tank farm, no visibly exposed liners were seen.

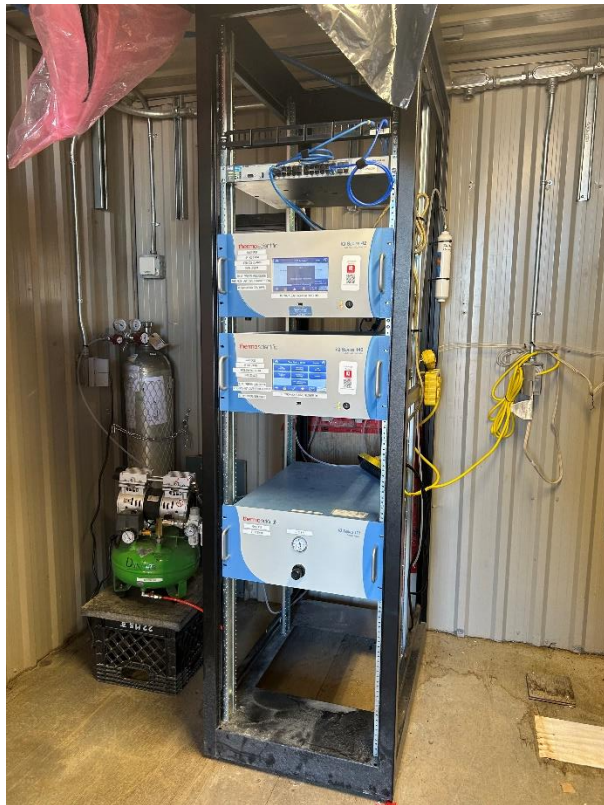
Photo 53 (left): Active NO₂ monitoring equipment with newly installed automatic shutoff switch to prevent equipment failure.

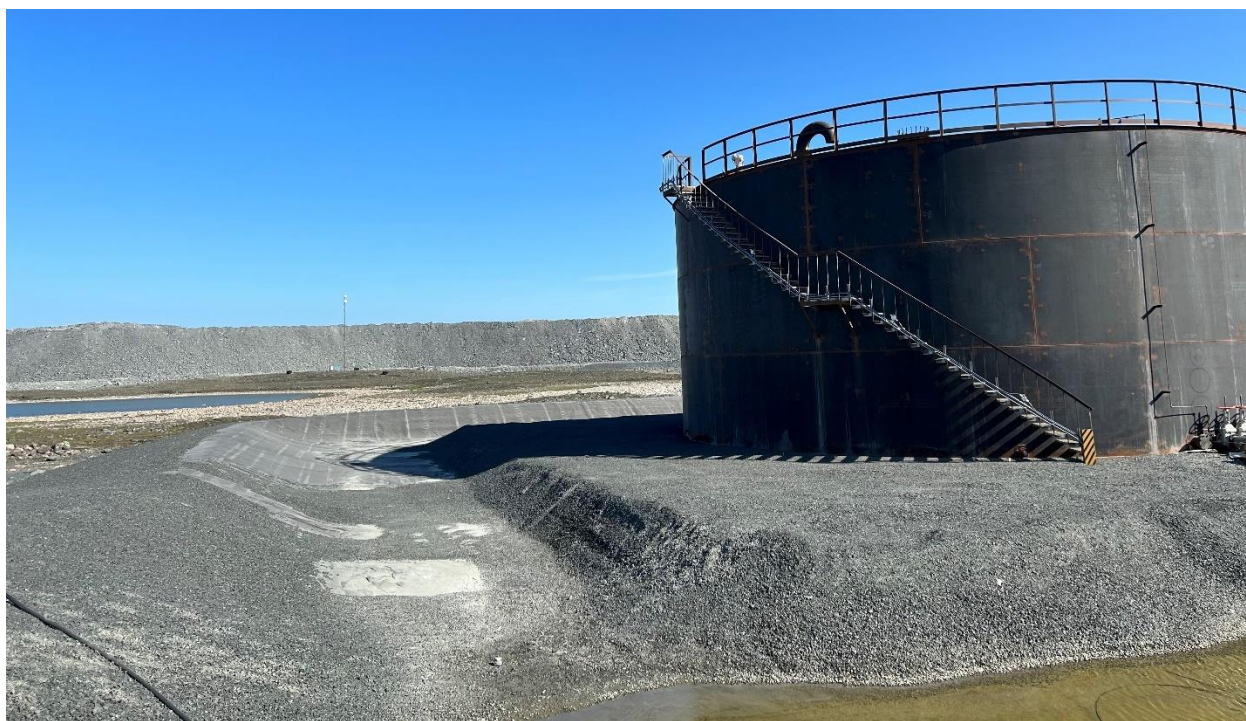
Photo 59: Whale Tail Site tank farm. A large area of exposed liner can be seen in the secondary containment berm.
