Nunavut Impact Review Board

October 2023 Site Visit Report

The Mary River Project

NIRB File No. 08MN053

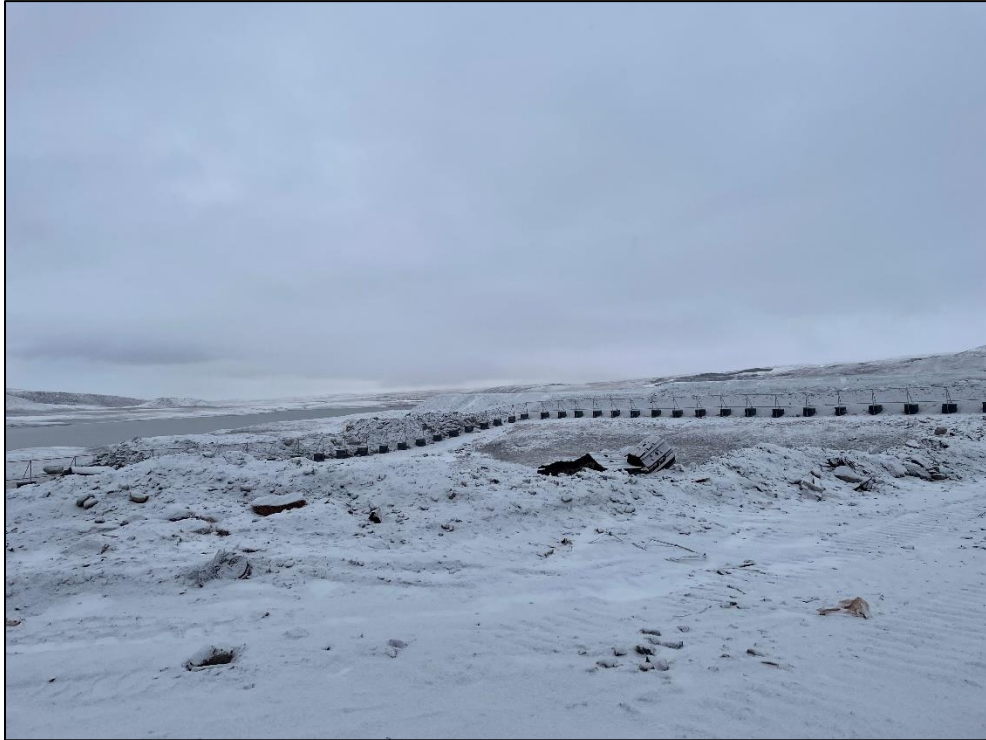
- Rip-Rap and gravel traps were in place near the water intake lines to aid in controlling the flow of water in the spring freshet;
- The landfill is operational with the fencing intact and ongoing management activities are in place with a gate to limit access;

Photo 3: Fence Surrounding the Landfill at Mine Site.

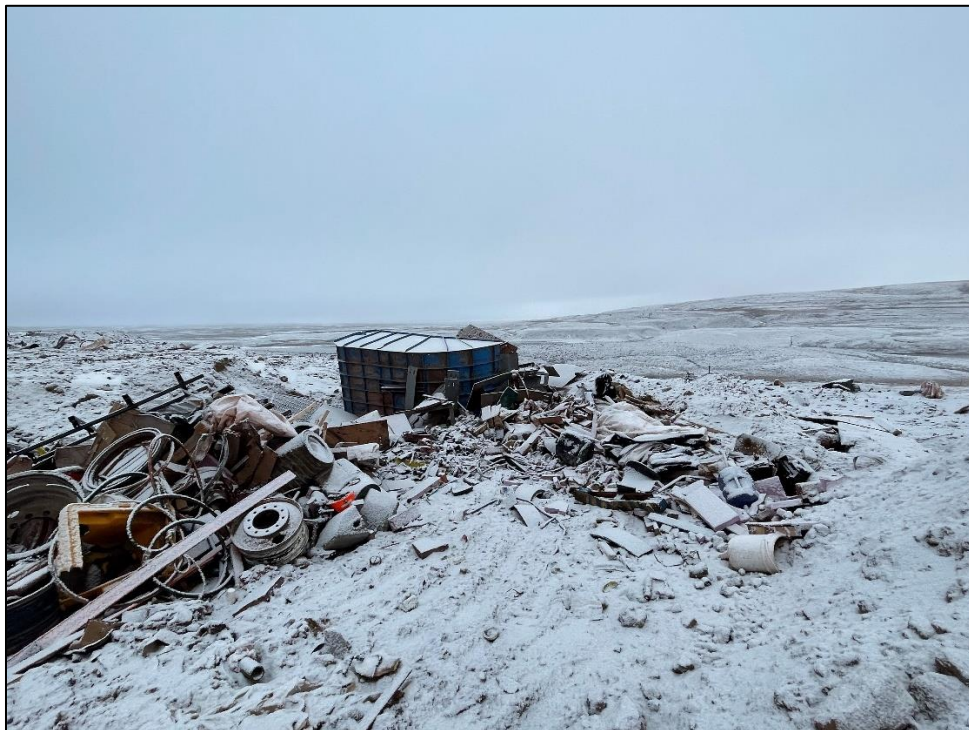
Photo 4: Landfill Contents.

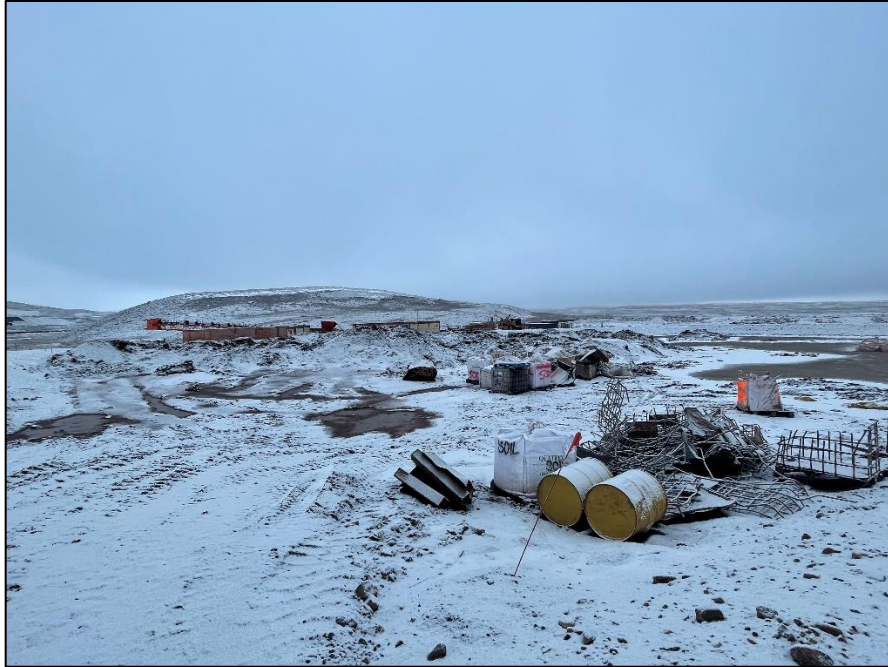
Photo 5: Materials Piled in the Landfill.

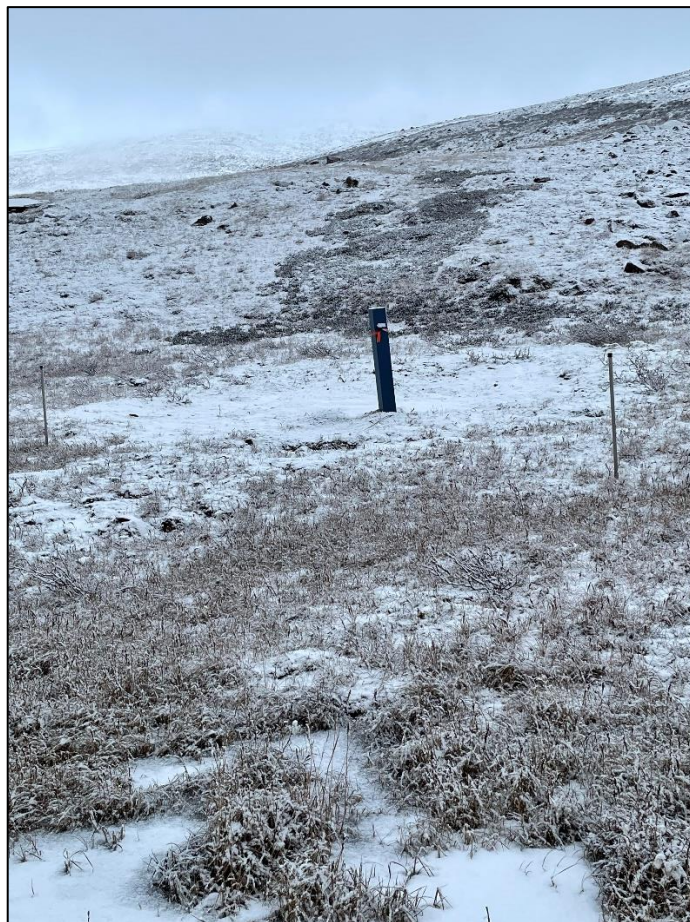
Photo 6: Groundwater Monitoring Station near the Landfill.

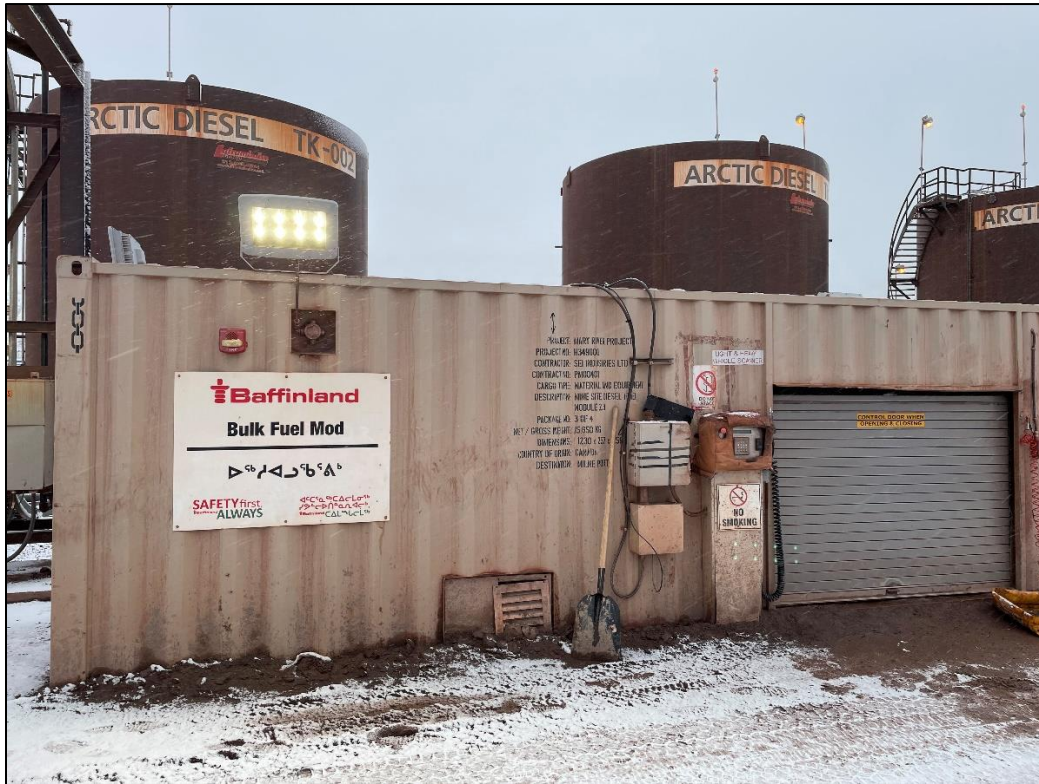
- Camp accommodations appear well maintained;
- The tank farm is clean and organized with secondary containment both under the entire area as well as under specific drip points for fuel filling;

Photo 7: Fuel Tank Farm Fueling Station.

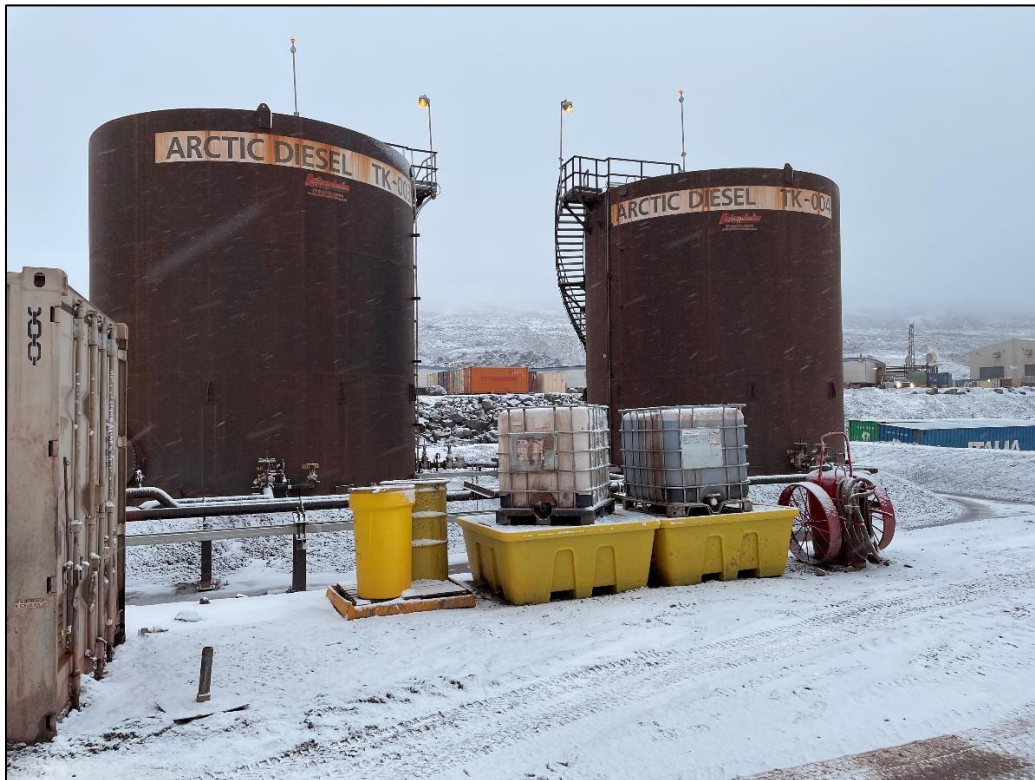
Photo 8: Mine Site Fuel Tank Farm and Secondary Containment.

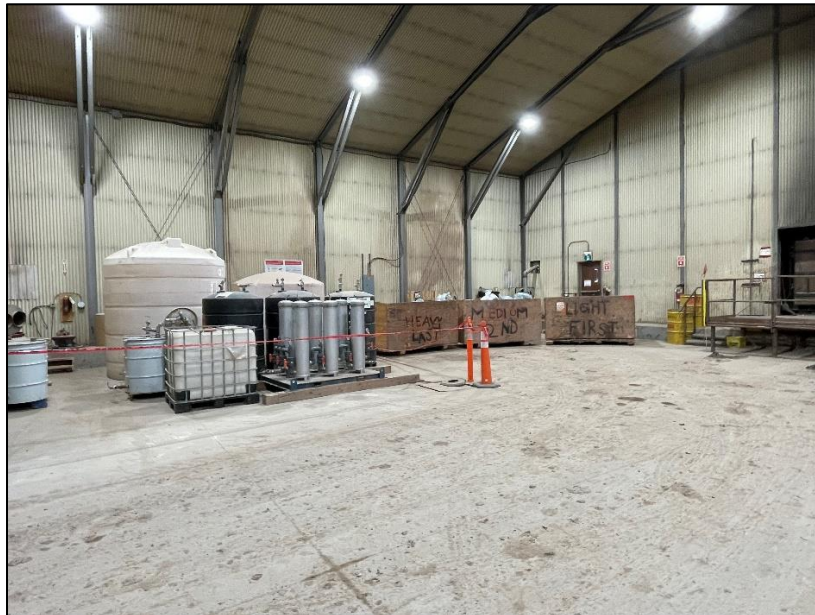
T&C No.	Topic	Site Observation
		& 15).
11	Incinerator	All food waste is incinerated from the kitchen including cardboard that stored food. NIRB Staff visited the Incinerator facility at the Mine Site, it was clean and well organized (Photo 9 & 10).
Hydrology and Hydrogeology		
17	Prevent impacts to water bodies from effluent	Related to Terms and Conditions 24 and 46 Sedimentation ponds were observed at the Ore Stockpile (Photos 35 & 36).
19	Mitigate impacts to natural water flow	Several culverts and ditches were observed along the Tote Road with Rip Rap being stall at many in order to better control the flow of water during freshet (Photos 44-48).
Landforms, Geology and Geomorphology, Soils and Permafrost		
26	Erosion Management	Related to Term and Condition 43 NIRB staff observed Rip Rap along the tote road to control water and prevent erosion (Photos 44 & 48).
28	Permafrost monitoring	NIRB staff observed the monitoring that is occurring at site for various dam structures and other large site infrastructure.

Photo 10: Storage and Waste Bins inside the Incinerator Facility.

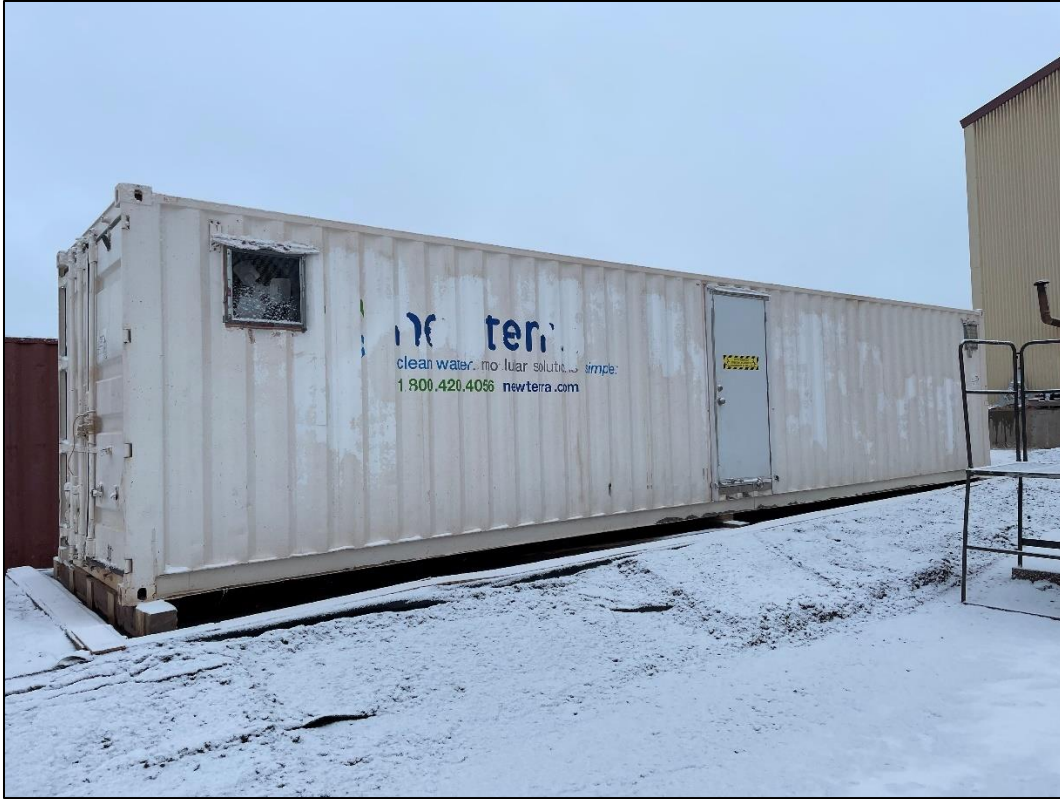
Photo 11: Mobile Oily Water Treatment System stored outside the Incinerator Facility.

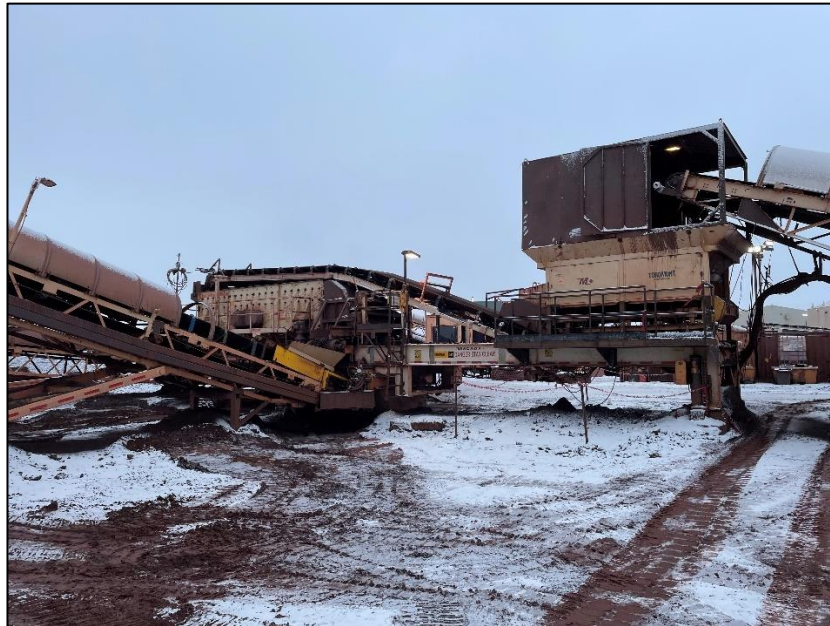
T&C No.	Topic	Site Observation
Air Quality		
5	Weather data available to the community	Information is made available around site as well as online.
10	Dust Management and Monitoring	Dust fall monitoring stations were observed along the Tote Road (Photos 49 & 50). Baffinland has also been trialing some active air monitors to get real time data on data events (Photos 26 & 43). Baffinland is also exploring alternative liquid dust suppression options at the crusher to apply dust suppressant along the conveyors (Photos 16 & 17) in addition to the hoods, shrouds and bellows along the crushing equipment (Photos 14

Photo 14: Hoods and Shrouds along the Crusher Conveyor.

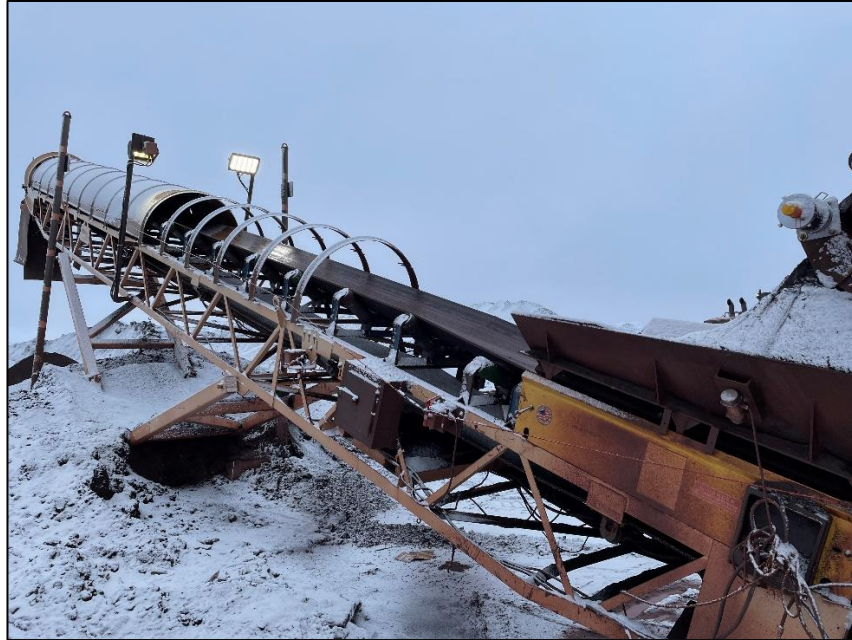
Photo 15: Conveyor System at the Crusher Facility.

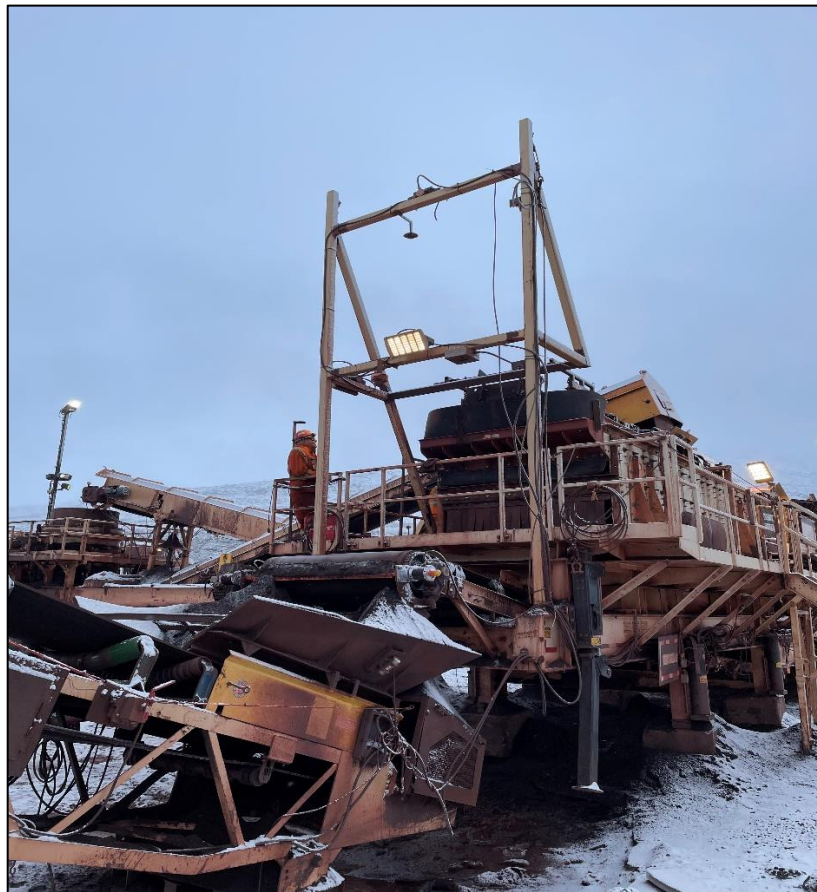
- The visitor Information Center was heated, with radios and translated instructions for community visitors;
- The crusher facility has built storage containers for replacement parts and was in the process of installing additional dust suppression designs in addition to the hoods, shrouds and bellows that have been in place for several years. The new system was designed to overhang the conveyor system and apply liquid dust suppressant to the ore after it is crushed.

Photo 16: New Location for Dust suppressant application trial at the Crusher.

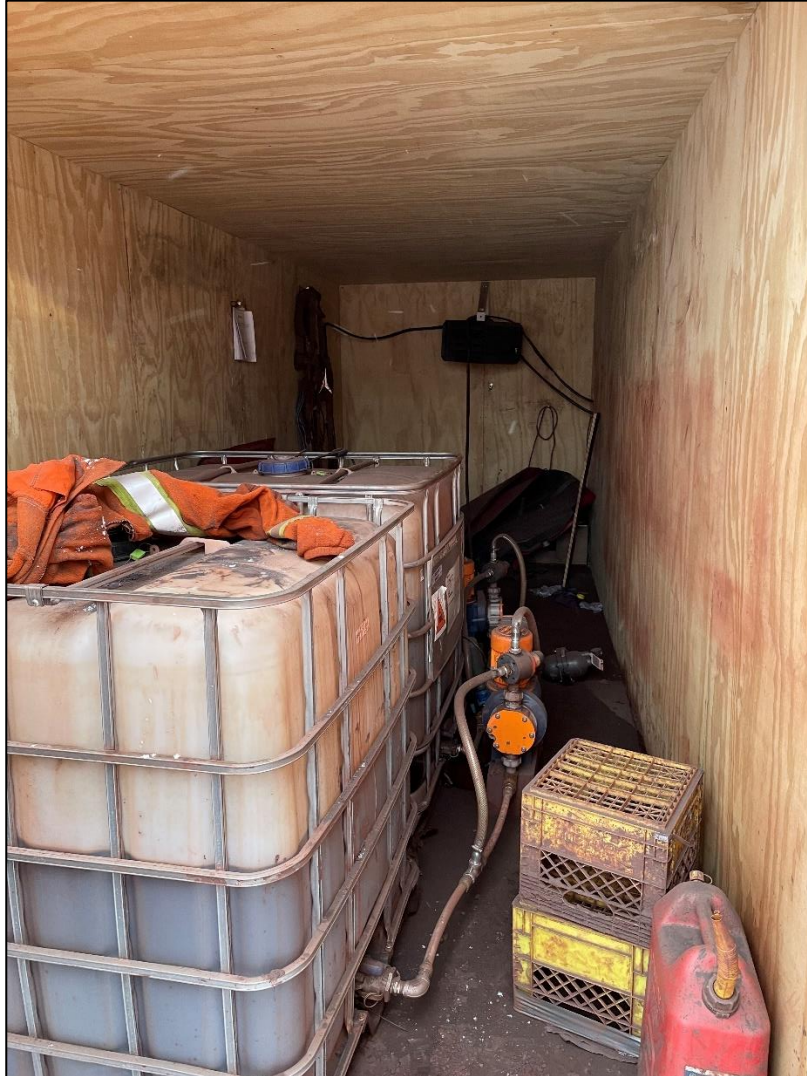
Photo 17: Liquid Dust Suppressant stored in a heated Seacan next to the crusher in preparation for the trial.

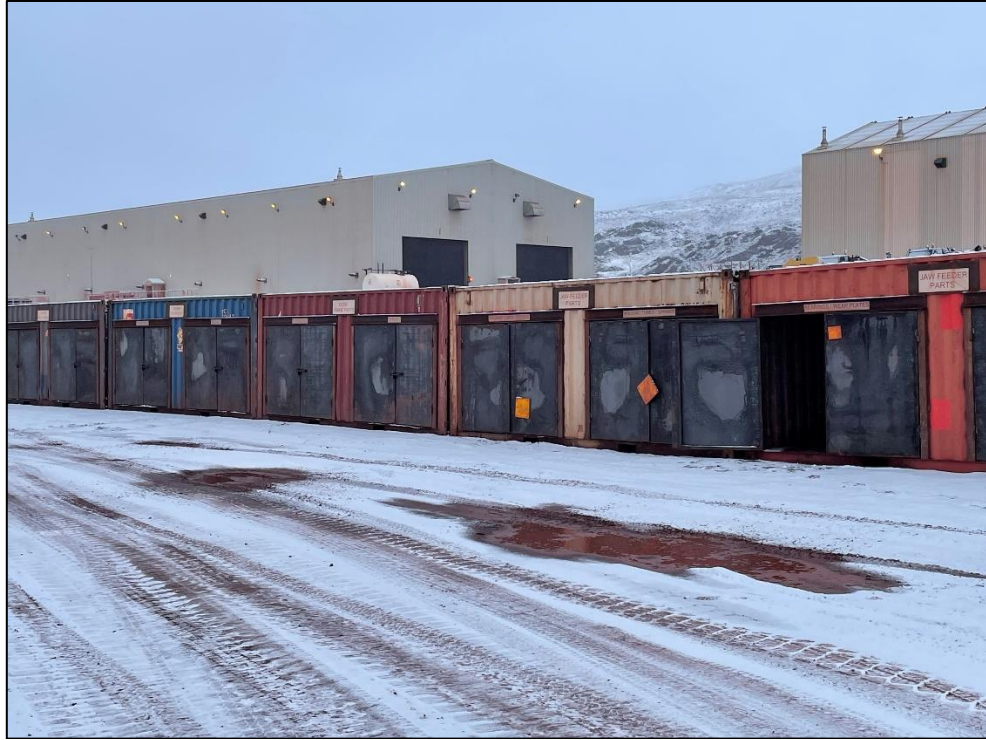
Photo 18: Newly Completed Storage Location for Space Crusher Parts.

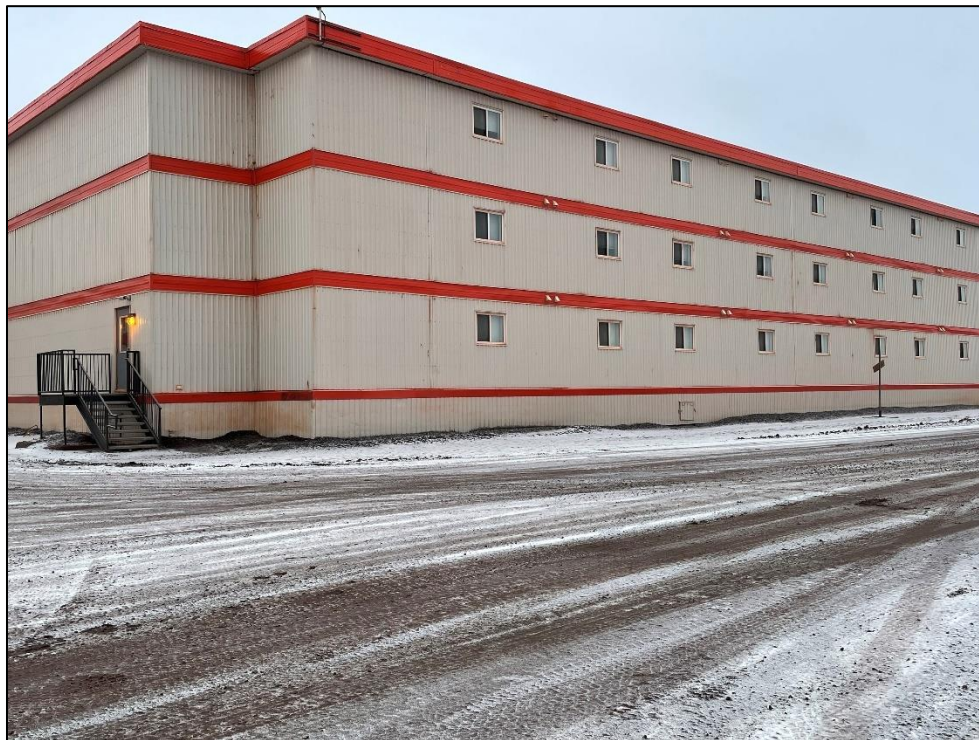
Photo 22: Skirting around Sailavik Accommodations Complex

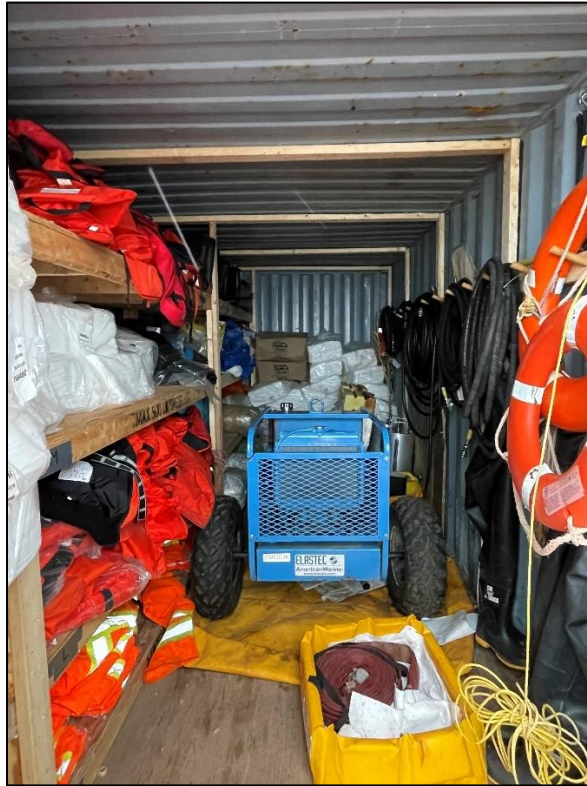
- Spill at Sea response equipment was on shore and ready for use as needed;
- Preparations were being made for winter and sedimentation ponds being pumped out;

Photo 23: Pumps, Hosing and Equipment for Spill at Sea Response, stored at the Beach at Milne Port.

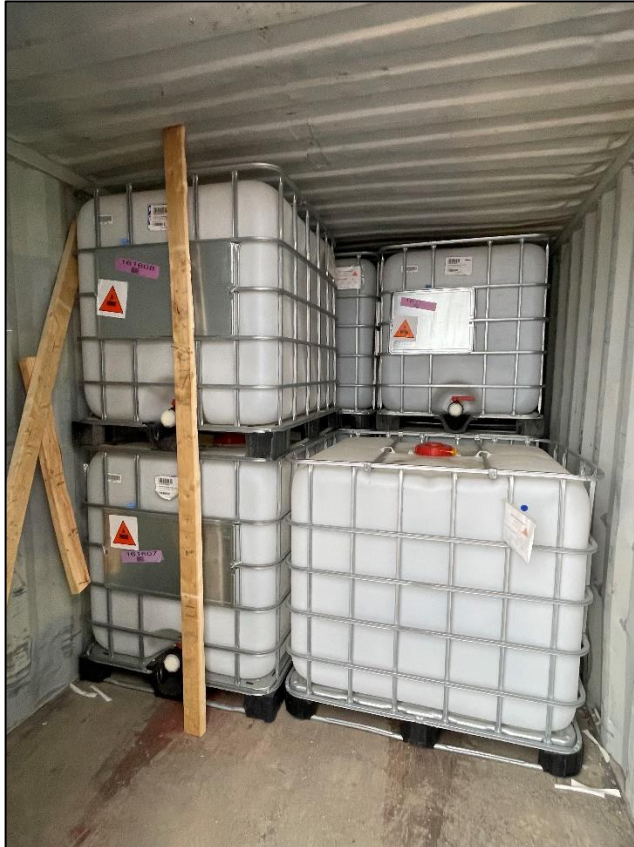
Photo 25: Empty Totes ready on shore for contaminated water to be pumped into if needed.

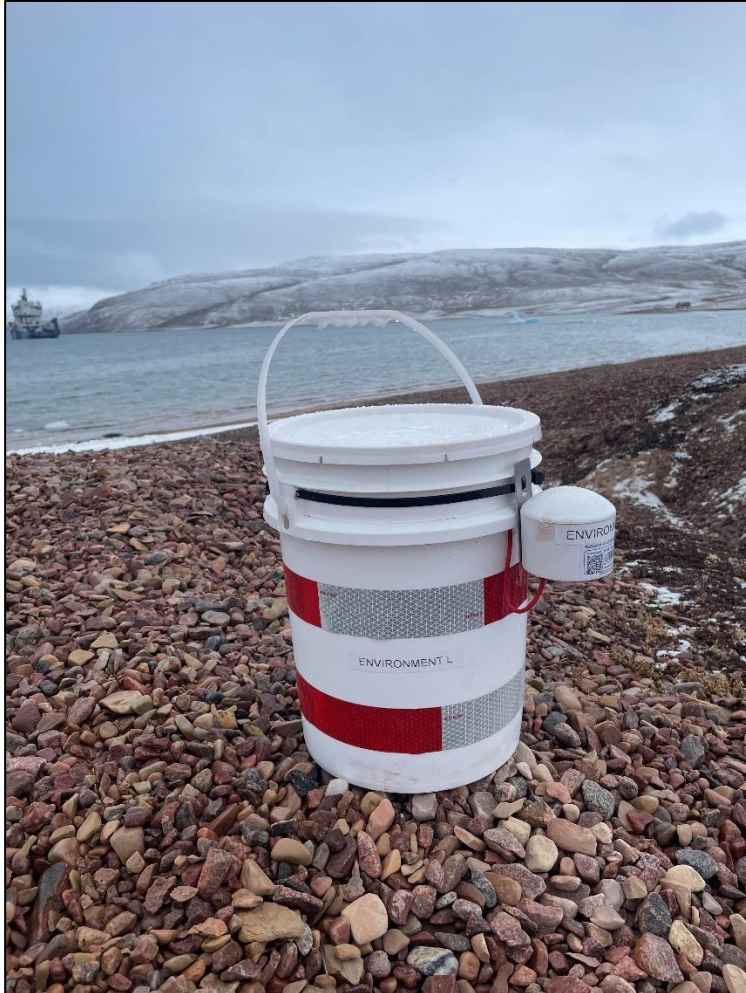
- Mobile, active air monitors have been installed at various locations around site to monitor air quality and dust particulate in real time. This is currently under trial at site but has the potential to allow Environment staff to see live, timing data of where dust events occur and allow staff to react in real time to employ mitigations.

Photo 26: Active Air quality sampling to aid in Dust Mitigation.

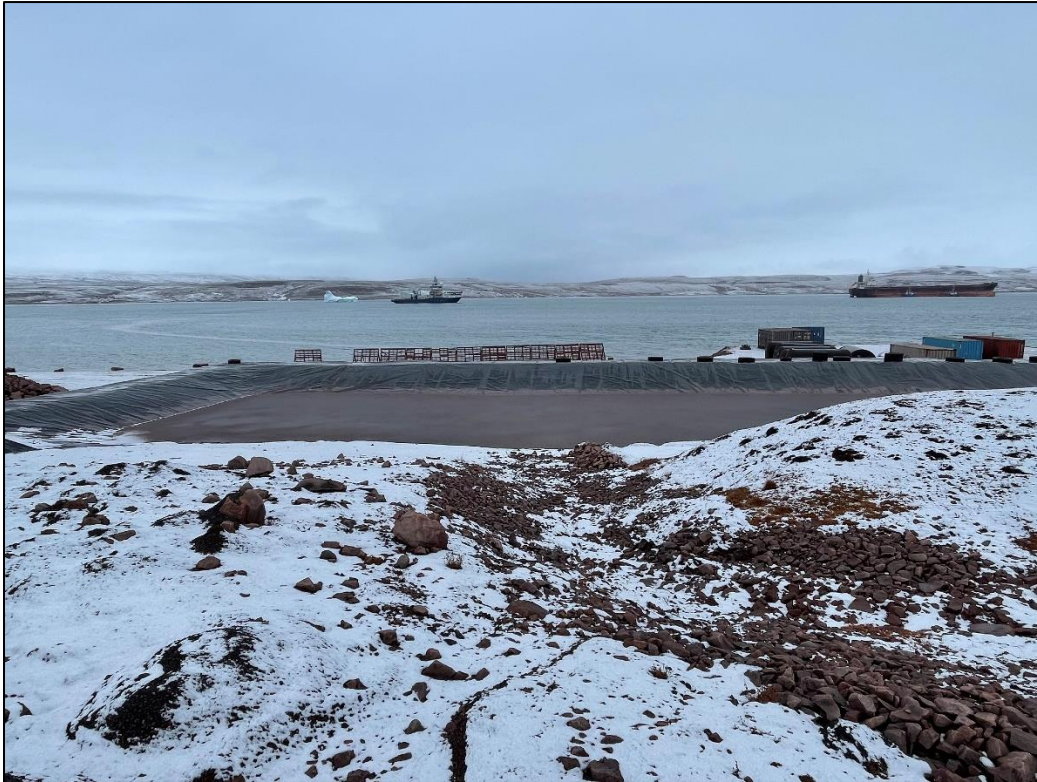
Photo 35: Sedimentation Pond on the North East side of the Stockpile.

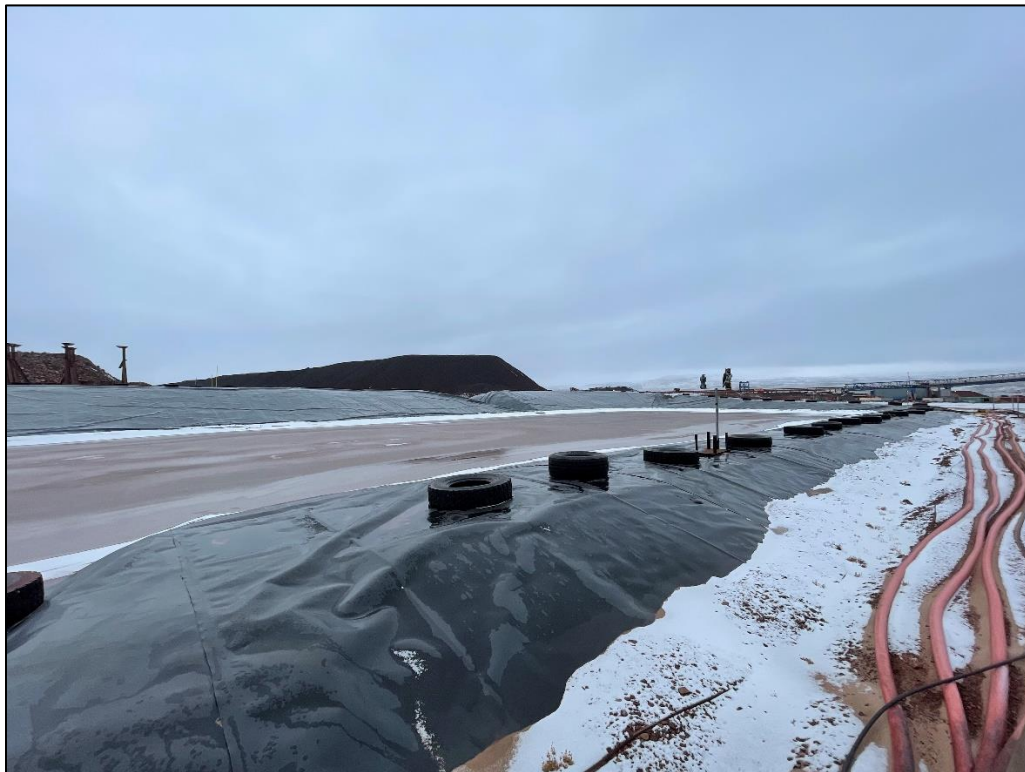
Photo 36: Sedimentation Pond on the East Side of the Stockpile.

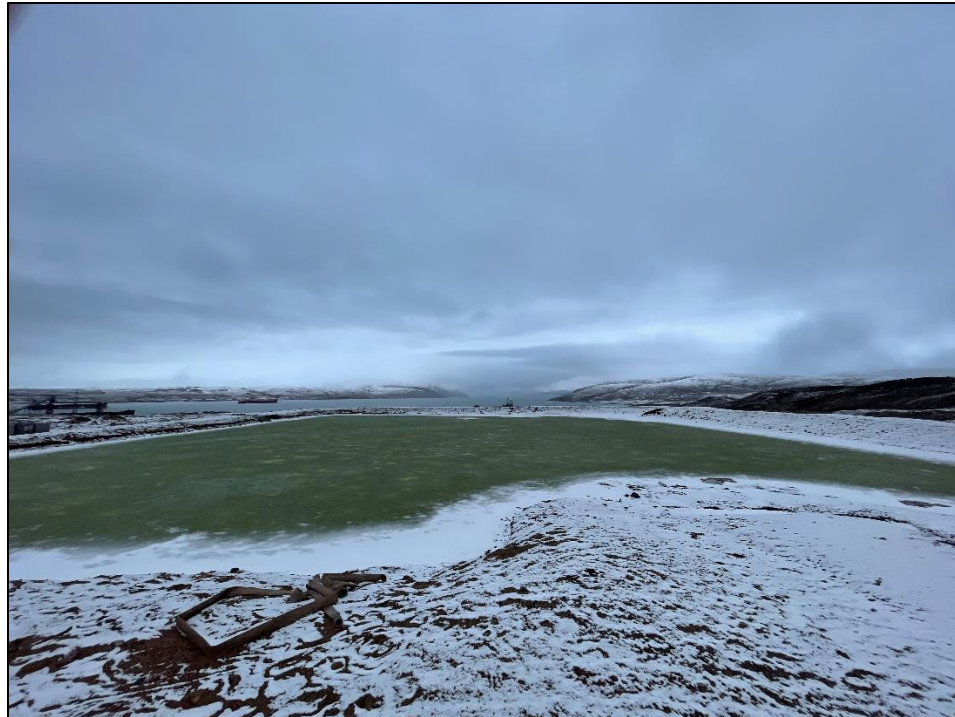
Photo 41: West Cell of the Landfarm.

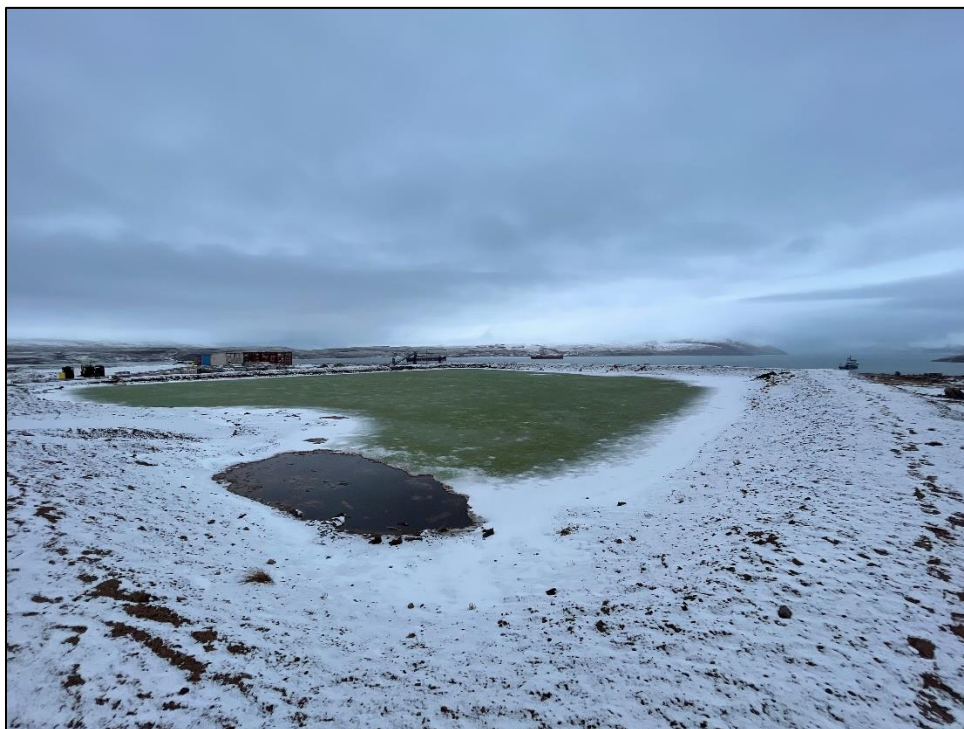
Photo 42: East Cell of Landfarm.

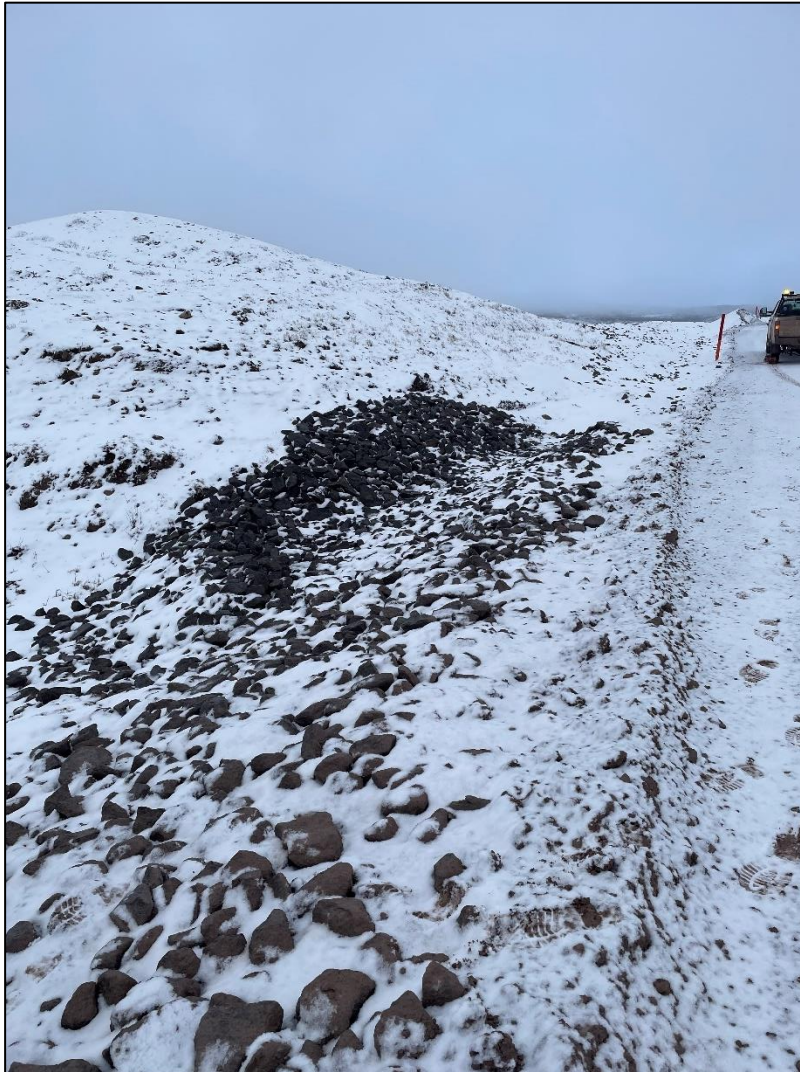
- The Road was closed to Ore Haul Trucks due to weather conditions;
- Dust monitoring was being completed along the Tote Road;
- Emergency Shelters and halfway stop are operational;
- Rip Rap continues to be installed to help control water flow along the road; and
- Snowmobile crossing at KM 90 was clear of obstruction.

Photo 44: Rip Rap installed to aid in controlling water flow at Culvert CV-079.

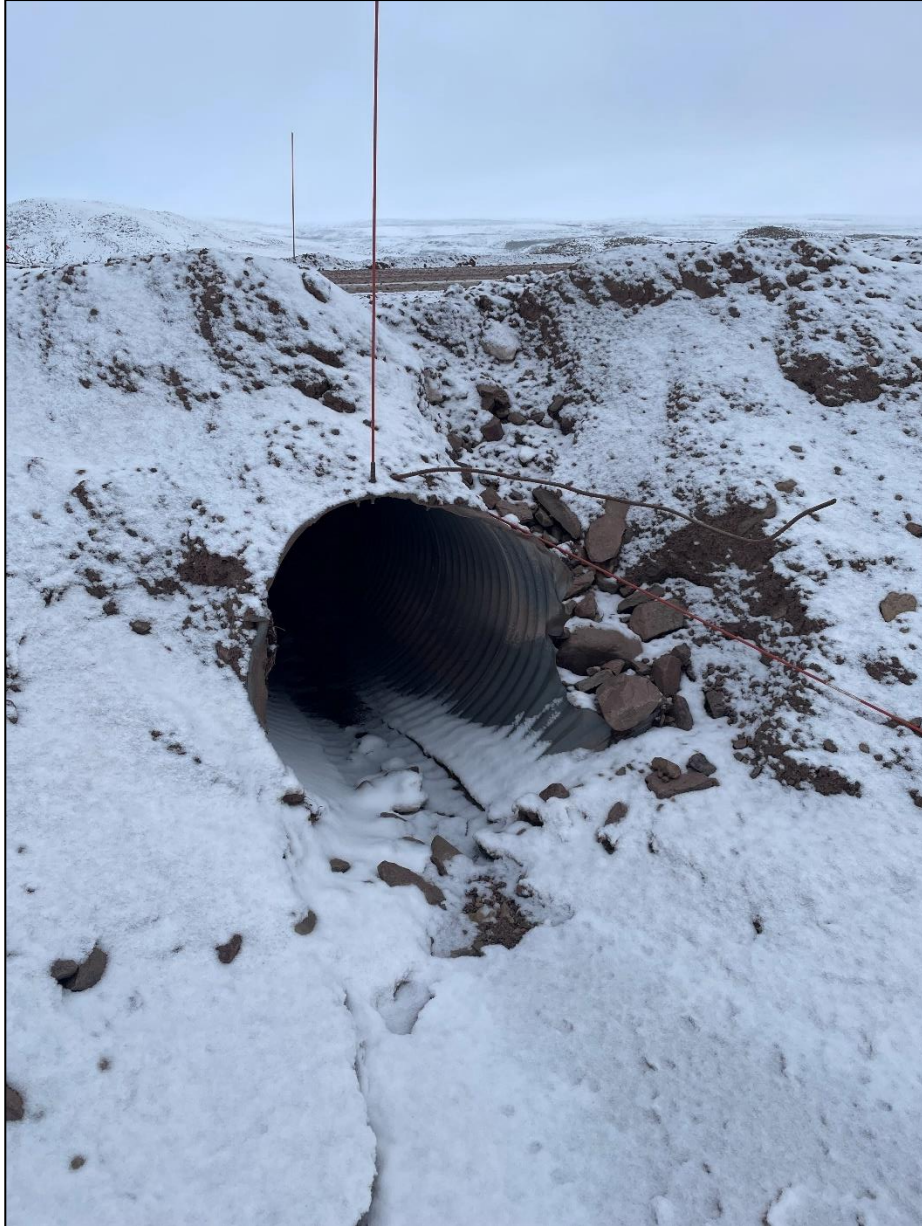
Photo 45: West side of Culvert CV-079.

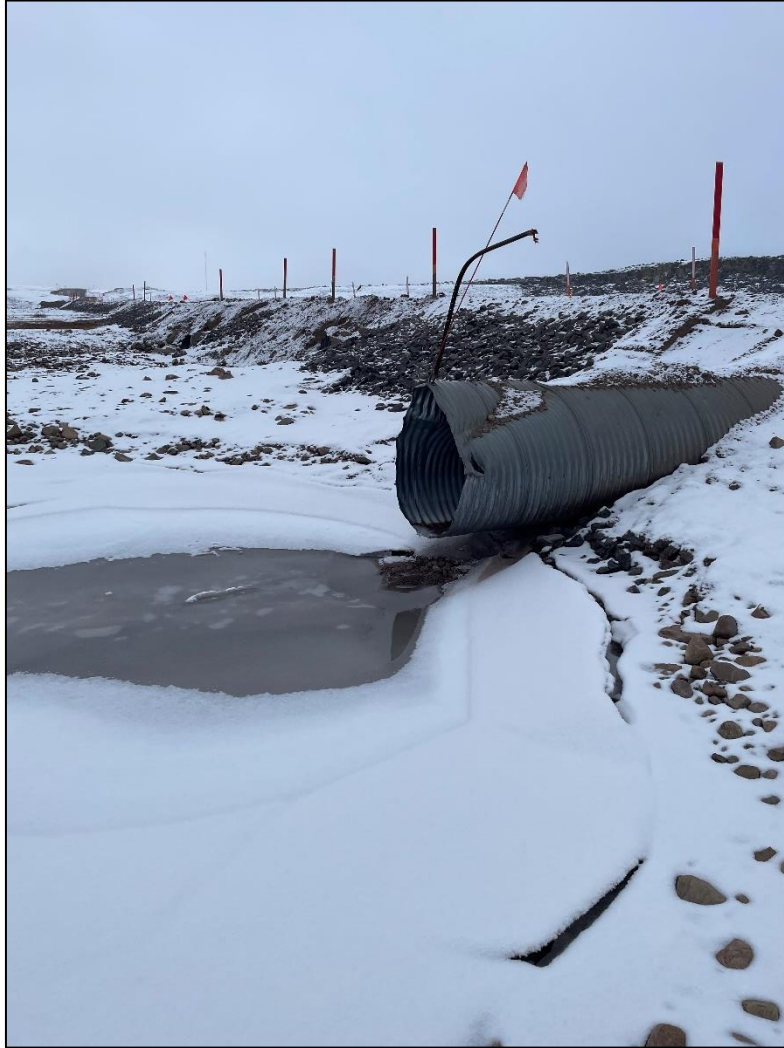
Photo 46: East side of Culvert CV-079.

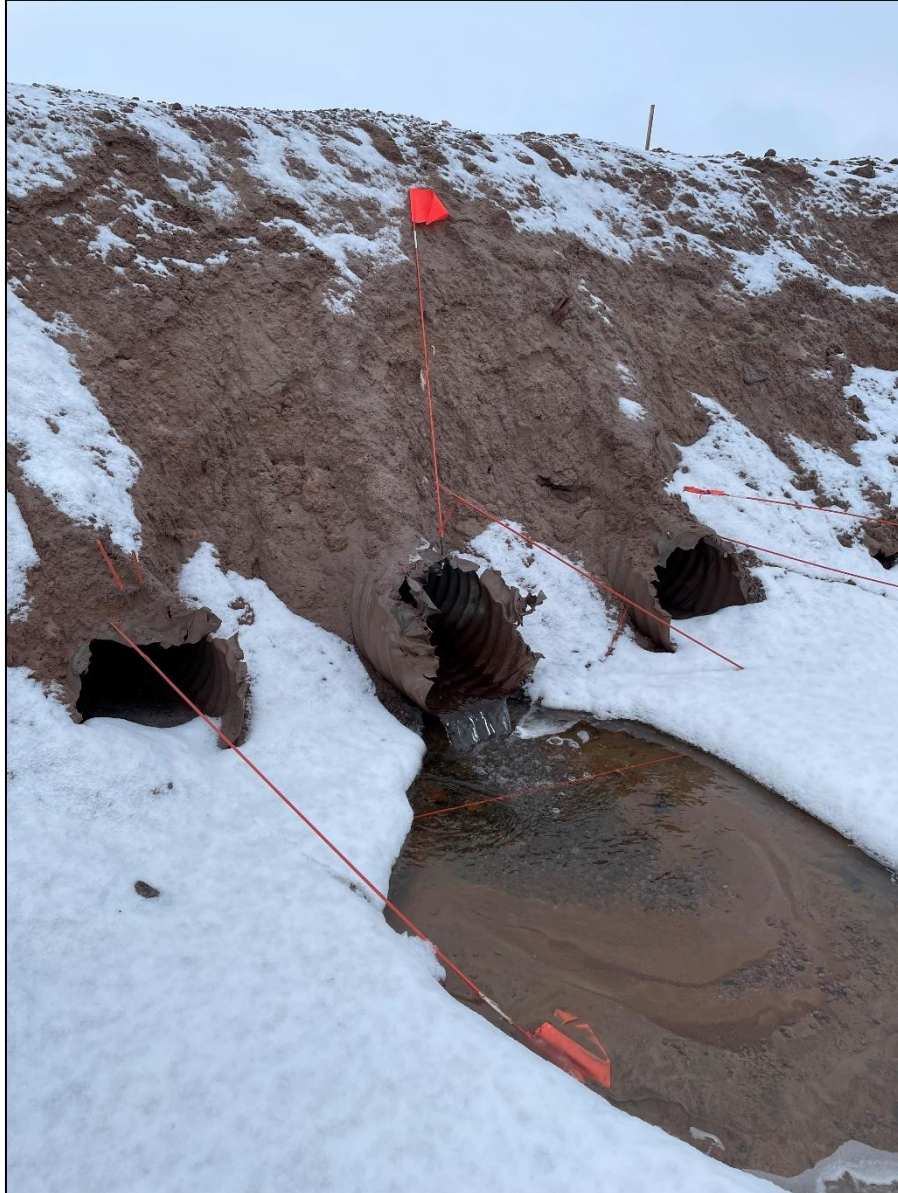
Photo 47: East side of Culvert CV-215.

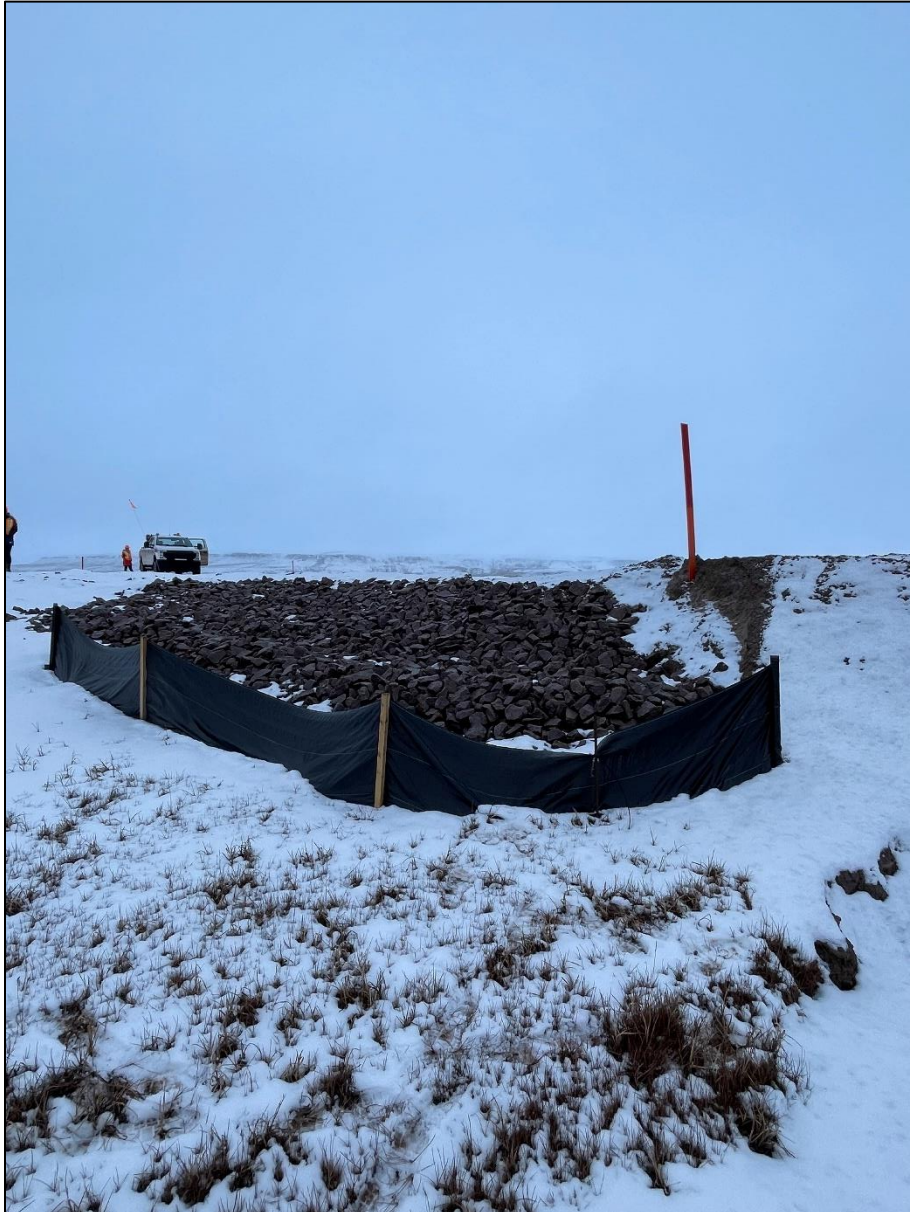
Photo 48: Rip Rap and Check Dam Installed at Culvert CV-215.

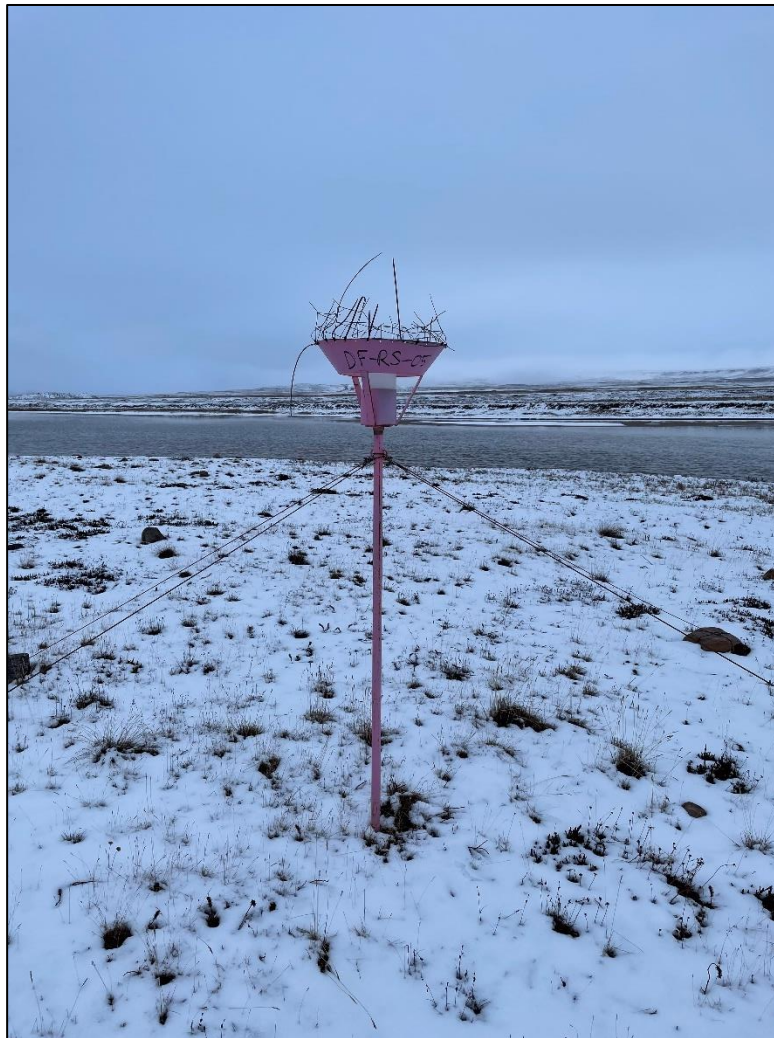
Photo 49: Passive Dust Sampler along the Tote Road

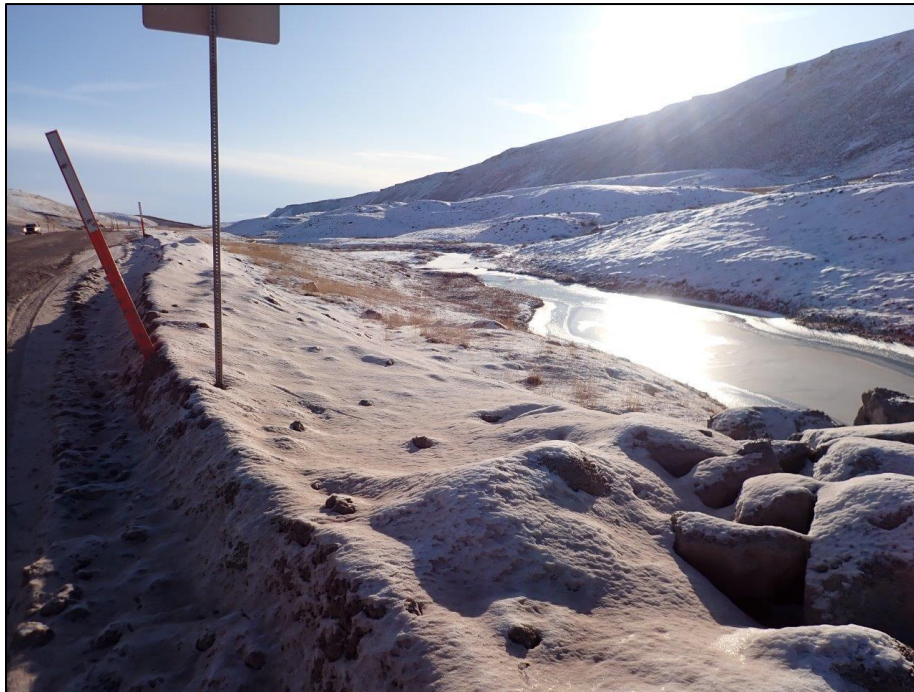
Photo 51: East side of Tote Road Crossing for Snowmobiles and ATVs at KM 90³.

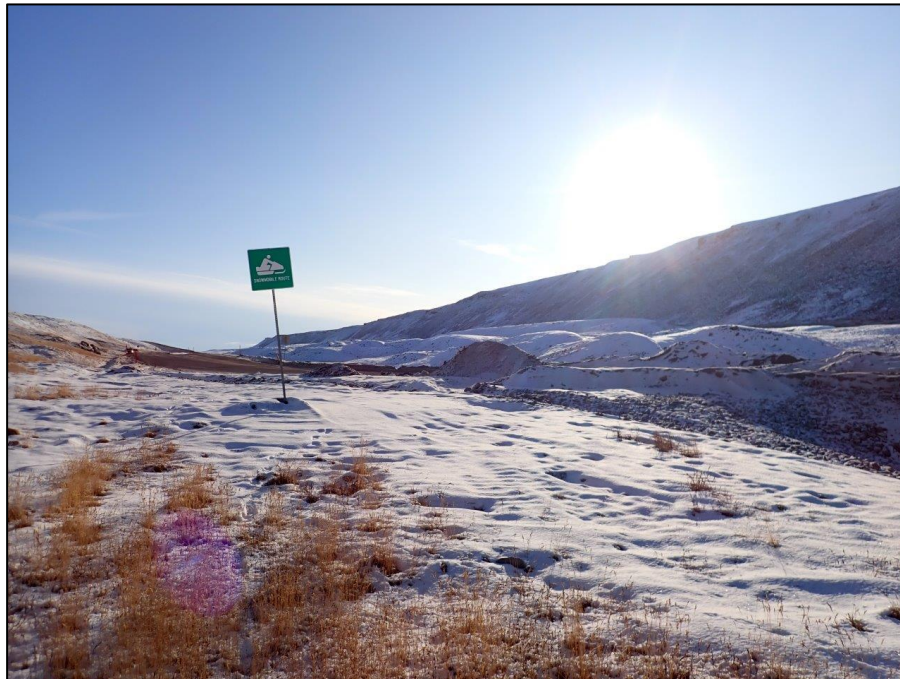
Photo 52: West side of Tote Road Crossing for Snowmobiles and ATVs at KM 90.
