APPENDIX 14 2023 REPORTABLE SPILLS

Re: Follow-up Report Spill #2023-009 – Release of 5 L of Sewage at the Meliadine Gold Project

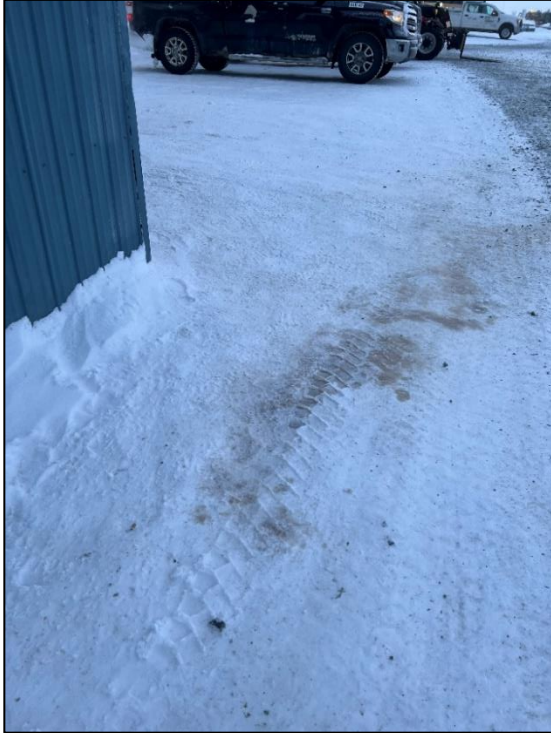
On January 10th, 2023, at approximately 1:00 pm, an estimated 5 L of sewage was spilled on the industrial pad at the multiple service building (MSB) lift station due to the vacuum truck operator deviating from an established procedure. The contents of the vacuum truck were emptied into the MSB lift station and the operator attempted to clear the hose. The operator deviated from the procedure when disconnecting the hose from the lift station and attempted to vacuum out the residual sewage from the hose. Due to the hose being disconnected from the lift station the remaining sewage in the line spilled to the industrial pad. The spilled sewage collected directly on the road behind the vacuum truck and was contained to the local area. No water bodies were impacted by this spill. The closest water body (G2) is approximately 300 meters north, as seen in Figure 1.

Photo 1: Sewage spill location.

Upon observing the spill, the operator shutdown the pump to prevent further spillage. The impacted surface area was hand excavated and an estimated 5 kg of contaminated snow was brought to Landfarm A as per the Spill Contingency Plan.

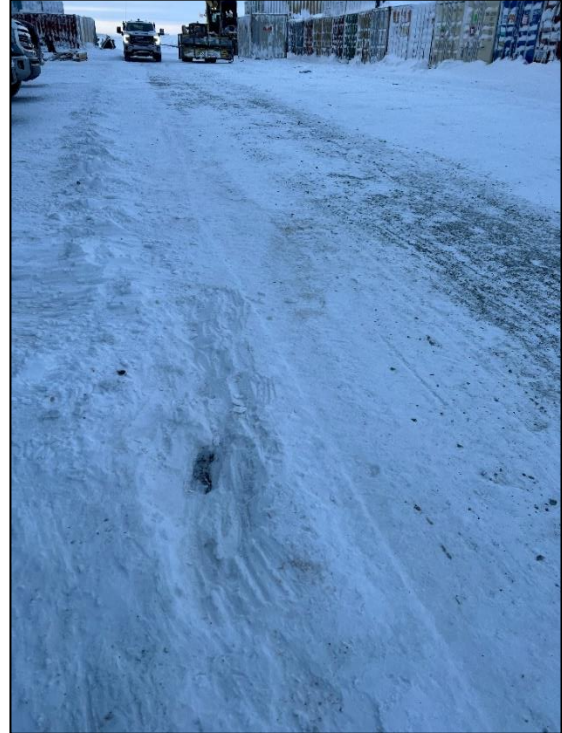
Photo 2: Sewage spill post remediation.

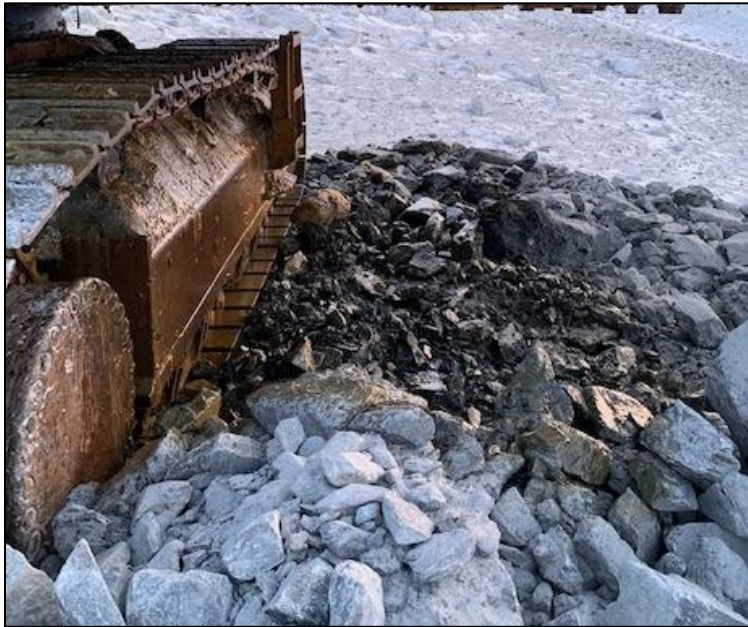
- Extreme temperatures placed additional stress on the hydraulic system causing a system failure.
- Preventive maintenance inspection of the Hydraulic pump compartment and associated equipment was not included in the preventative schedule

Photo 1: Hydraulic oil spill area.

- Frost fighter will be used on hydraulic compartment when starting up in cold temperatures.
- Preventive maintenance schedule has been updated to include visual inspection of the hydraulic pump compartment and associated equipment every 1000 hours.

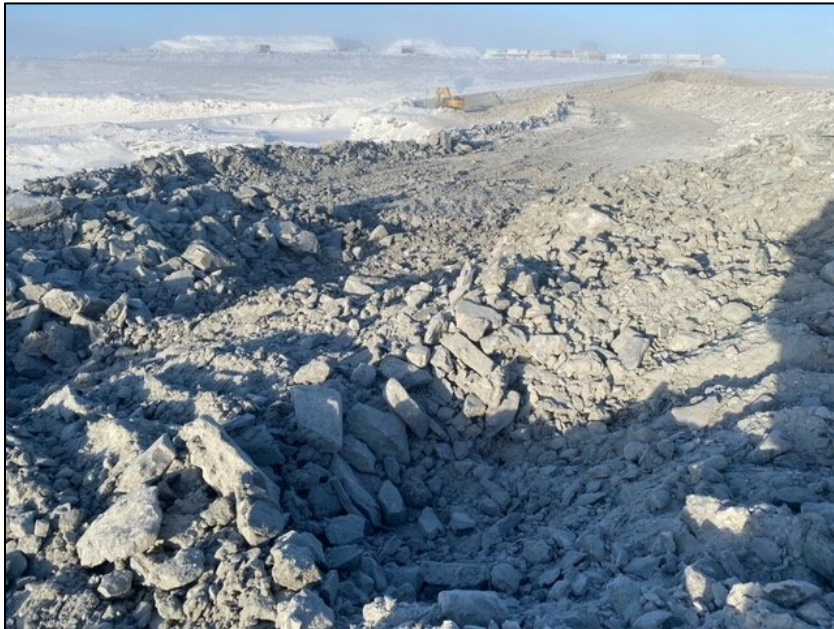
Photo 2: Hydraulic oil spill remediated.

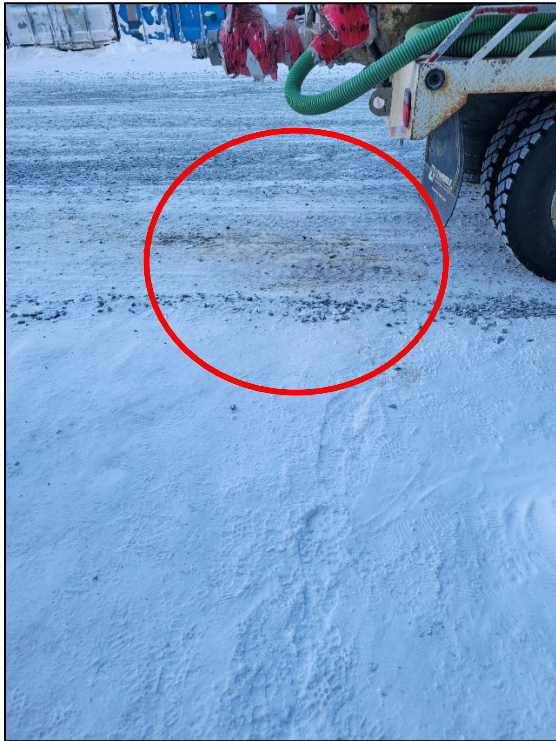
On February 5th, 2023, at approximately 2:30 pm, an estimated 5 L of sewage was spilled onto the industrial pad at the multi service building (MSB) lift station. The vacuum truck operator had finished emptying the sewage into the MSB lift station. The operator emptied the hose according to procedure and was preparing to put the hose back on the truck. It was at this time that residual sewage spilled out of the vacuum truck hose and onto the industrial pad. The spilled sewage collected directly on the road behind the vacuum truck and was contained to the local area. No water bodies were impacted by this spill. The closest water body (G2) is approximately 325 meters north, as seen in Figure 1.

Photo 1: Sewage spill location.

The spill stopped on its own as all residual sewage had exited the vacuum truck hose. The impacted surface area was hand excavated and an estimated 10 kg of contaminated snow was brought to Landfarm A as per the Spill Contingency Plan.

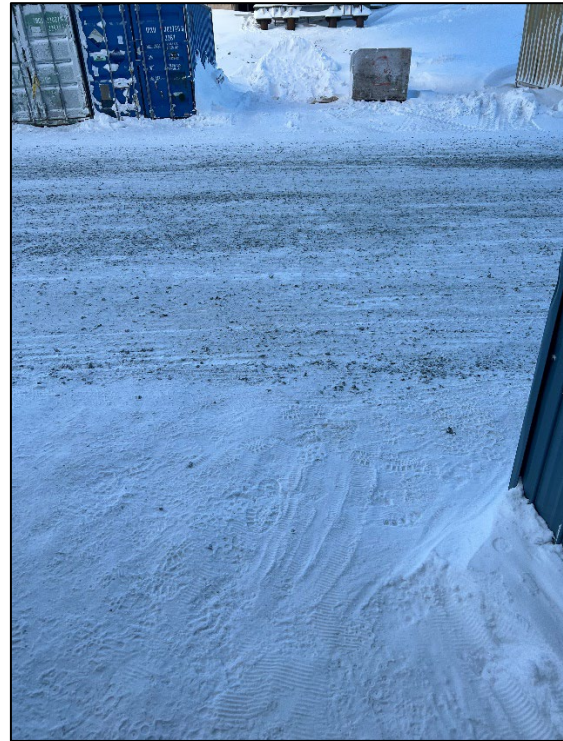
Photo 2: Sewage spill post remediation.

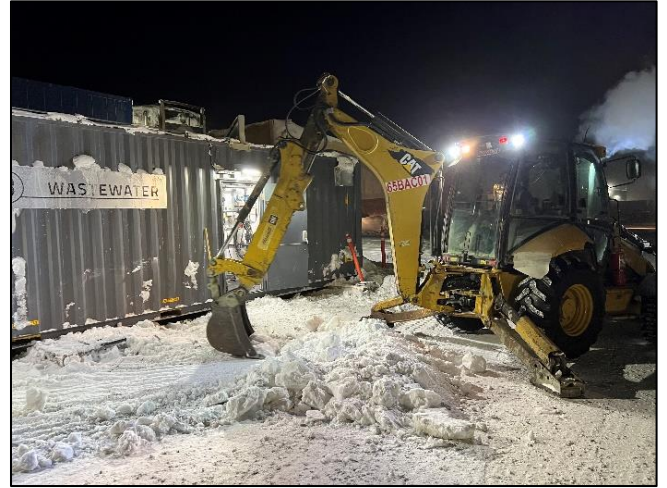
Photo 2: Spill remediation efforts.

As per the spill contingency plan, a neutralizer was used on the sodium hydroxide to adjust the pH of the free liquid to a neutral pH. An industrial vacuum was later used to collect the remaining free liquid which was then transferred into a plastic tote. All contaminated spill rags, free liquid and contaminated ice/snow were brought to the Mill's reagent storage area where it's stored as hazardous waste and will be shipped offsite for disposal.

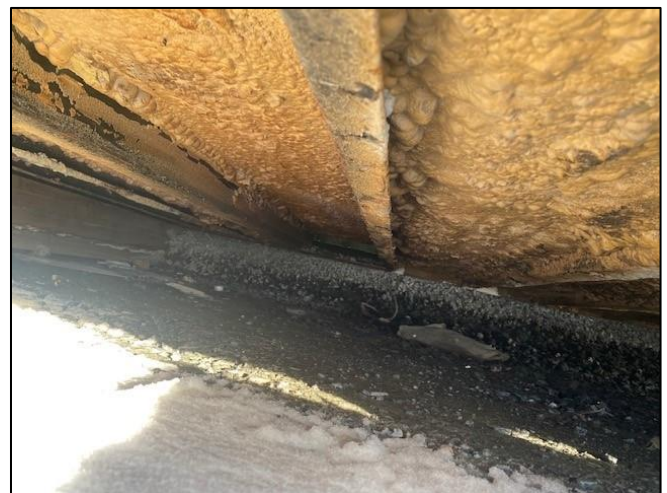
Photo 4: Spill remediation area.

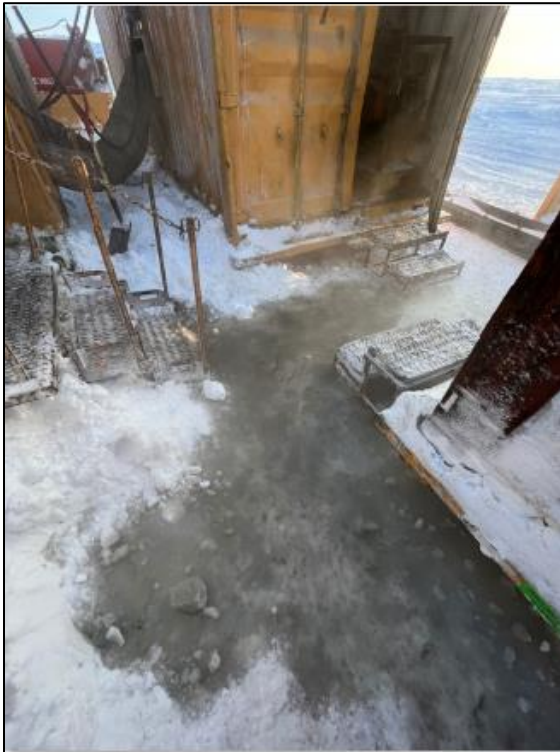
On February 26th, 2023, at approximately 8:00 am, an estimated 50 L of drill cuttings water was spilled onto the ice surface on lake A19. The generator powering the water recovery pan pump failed allowing the water recovery pan to overflow. The spill was located on Lake A19, as seen in Figure 1.

- The failure of the drill site generator resulted in a power loss to the water recovery pan pump allowing it to continue to fill from the water pressure pump.
- Water contaminated fuel was identified in the fuel filter sight glass resulting in a generator failure.

Photo 1: Drill cutting water spill.

- A signal light has been installed in the drills to notify the driller of a generator failure.
- Operating instructions to shut down the water pressure pump during a generator failure has been provided to all drilling employees.
- Direction has been provided to all drilling employees to inspect fuel nozzle to ensure there is no snow inside prior to refueling equipment, therefore preventing equipment failure.

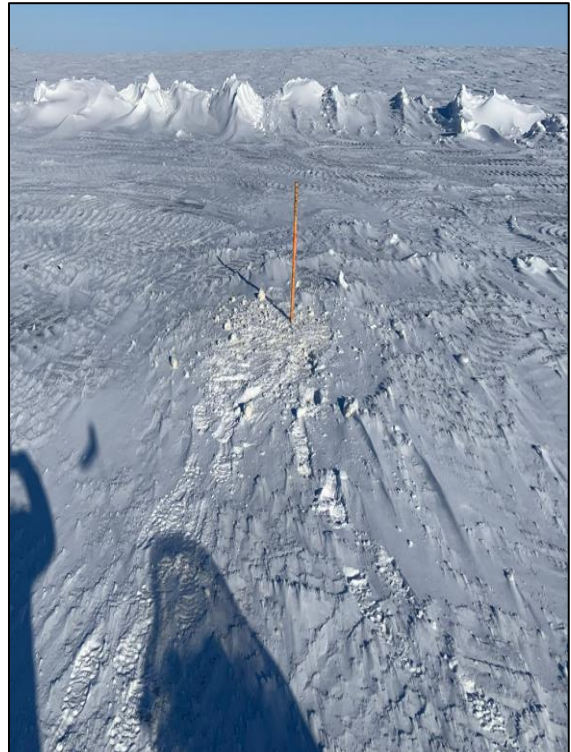
Photo 2: Drill cutting water spill post remediation.

repaired and restarted to lower the volume in the water recovery pan. Clean up of the spilled material occurred on March 14th, 2023, immediately after the drill setup was demobilized from this location. The impacted snow and ice was disposed of on the Waste Rock Storage Facility 3 (WRSF3).

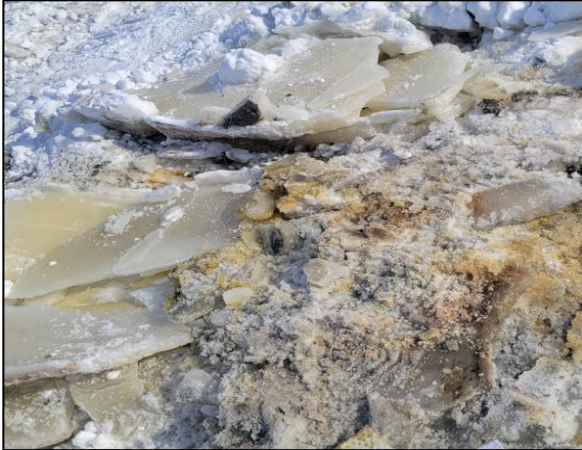
On March 17th, 2023, at approximately 14:00, an estimated 1 L of hydraulic oil was spilled onto the ice surface on Lake A8 as seen in Figure 1. While lowering the drill tower to relocate the drill a hydraulic line was pinched spilling hydraulic oil within the drill and into the water recovery pan. After the water recovery pan was removed and the drill relocated, remnant oil from under the drill floor was observed on the snow.

- The length of the hydraulic line was determined to be too long and allowed excess to become pinched when the tower was lowered.

Photo 1: 1 L hydraulic oil spill location.

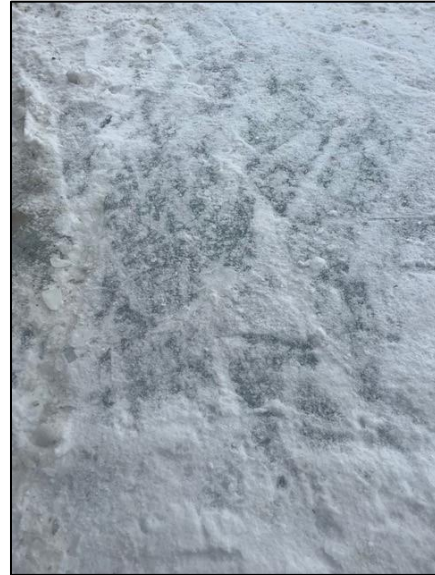
Photo 2: 1 L hydraulic oil spill post remediation.

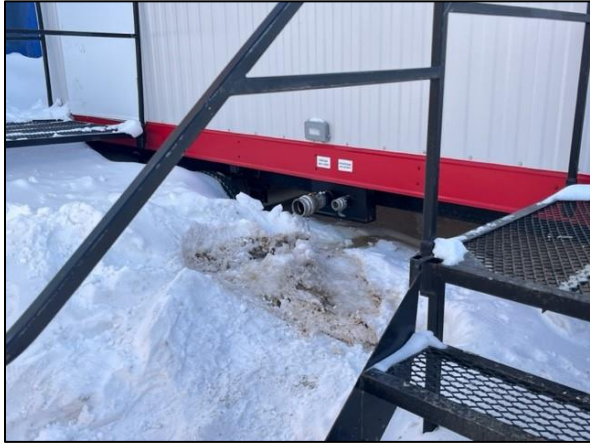
On April 7th, 2023, at approximately 13:30pm, an estimated 20 L of sewage was spilled onto the industrial pad by the powerplant wash car due to a miscommunication between the vacuum truck operators. During normal operations, both vacuum truck operators failed to confirm if hose was connected to the truck prior to transferring material from the lift station. No water bodies were impacted by this spill. The closest water body (G2) is approximately 595 meters northwest, as seen in Figure 1.

- Lack of communication between operators. Both employees had radios but did not use them to confirm that the hose between the lift station and the vacuum truck was secure before the sewage transfer.

Photo 1: 20 L Sewage spill at powerplant washcar.

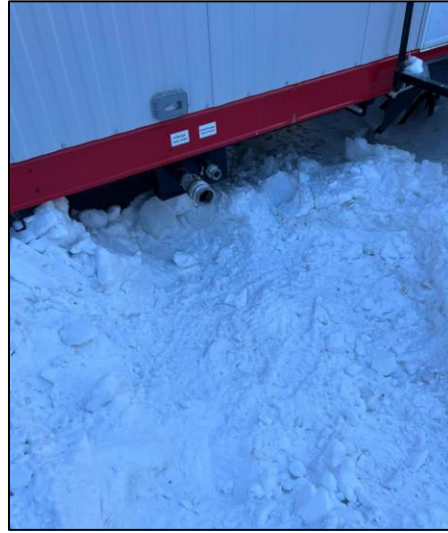
Photo 2: 20 L Sewage spill post remediation.

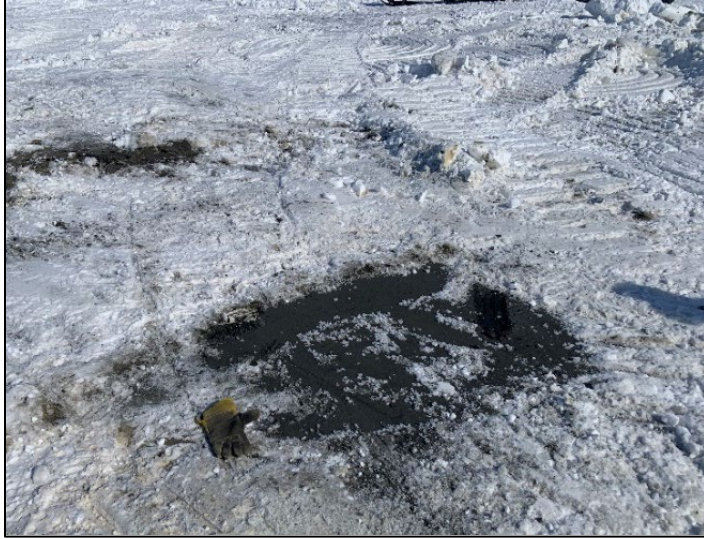
Photos 1: 40 L Drill cuttings water spill.

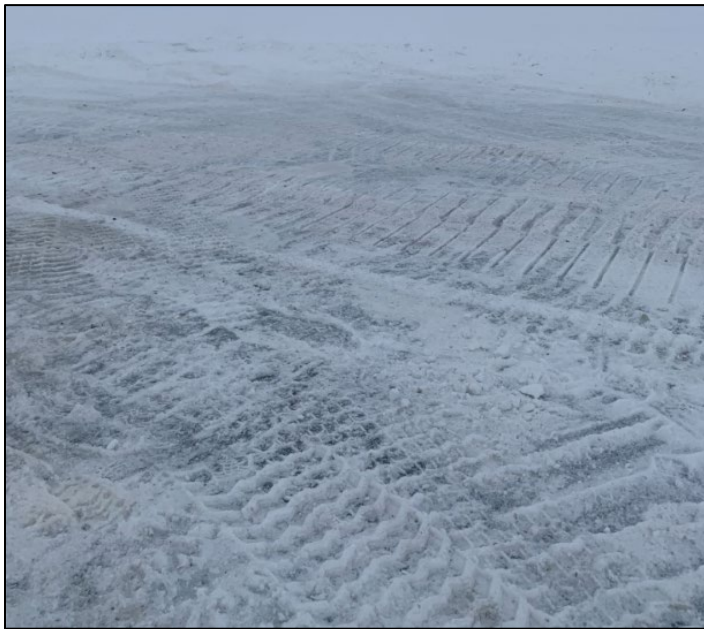
Photos 2: 40 L drill cuttings water spill post remediation.

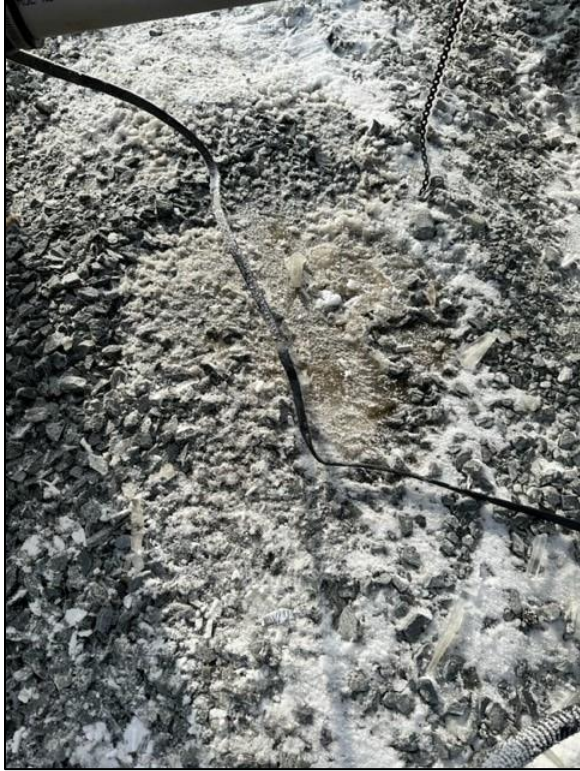
On May 4th, 2023, at approximately 23:00, an estimated 10 L of sewage was spilled onto the fusion pad by the fusion pad wash car due to a fracture in the sewage line. No water bodies were impacted by this spill. The closest water body (J6) is approximately 108 meters south, as seen in Figure 1.

Photos 1: Sewage spill location.

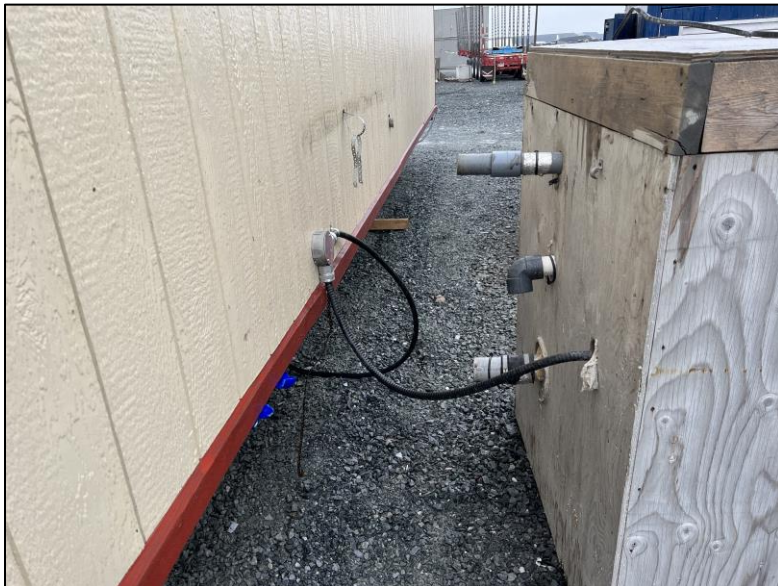
Photos 2: Spill location post remediation.
