NT-NU SPILL REPORT

Re: Follow-up Report Spill #2023-211 – Release of 200 L of Sewage at the Meliadine Gold Mine

On May 22nd, 2023, the Nunavut Spill Line was notified by Agnico Eagle personnel via email (spills@gov.nt.ca) of a spill of approximately 200 L of sewage at the Meliadine Gold Mine site (spill location coordinates: 63° 2' 21.73" N, 92° 13' 40.84"W). This follow-up report provides supplemental information based on the results of the incident assessment and is being provided in accordance with:

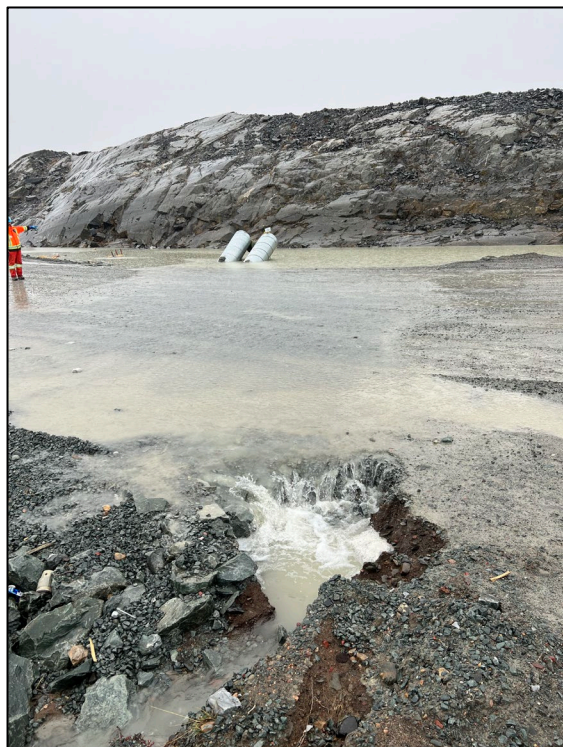
On June 7th, 2023, at approximately 4:00 am, the two culverts situated at Itivia sustained damage during a 1 in 50-year rainfall event. Due to substantial water accumulation within the catchment basin, the buoyancy force of air within the submerged culverts exceeded the weight of the culverts and cover resulting in uplift of the upstream portions of the culverts. Water could no longer be conveyed through the culverts and an unknown volume of water flowed over the roadway upstream of sample location MEL-SR-1. The MEL-SR-1 monitoring station is located at the southern end of Itivia and flows out to Melvin Bay approximately 75 meters to the south.

Photo 1 – Situation upon arrival.

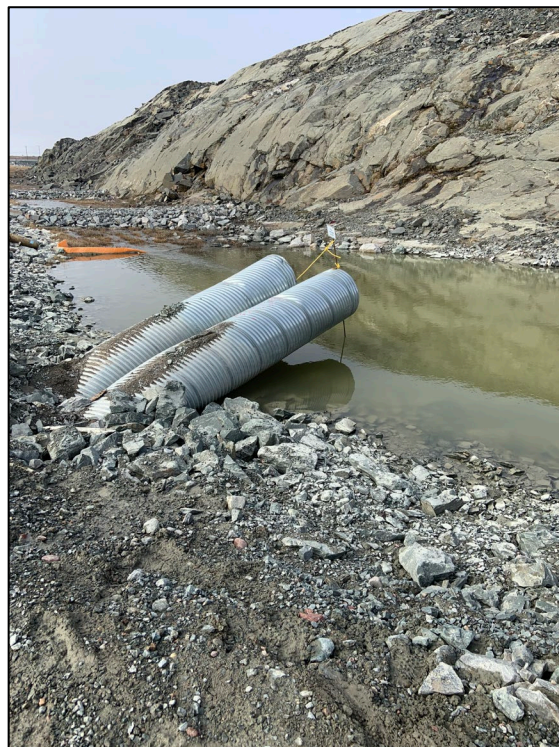
Photo 2 – 1h after response.

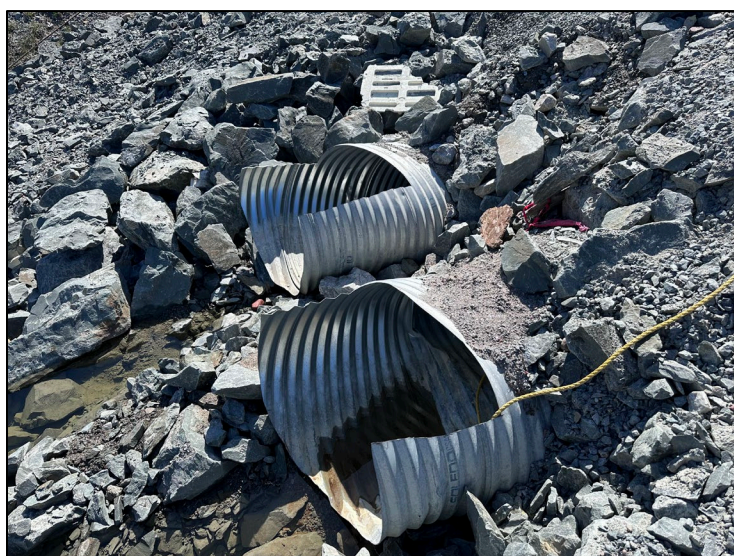
Photo 3 – Temporary repair to the culvert inlets.

- Cut off damaged inlets to allow water flow through culverts until permanent repairs or replacements can be made (completed);
- Until the culverts are repaired or replaced, ensure that a pump with sufficient pumping capacity will be left at the culvert and be ready to operate as soon as an extreme event is forecasted;
- Repair or replace culverts during dry season (fall/winter);
- Consider designing the repaired or replaced culverts to manage rainfall events of greater magnitude, relative to original design;
- Ensure that design and associated construction provide sufficient cover of upstream culvert portions to prevent damage if flooding within the upstream basin occurs again;
- Ensure there is no potential for culvert inlets to become obstructed by sediment and erosion controls during large runoff events;

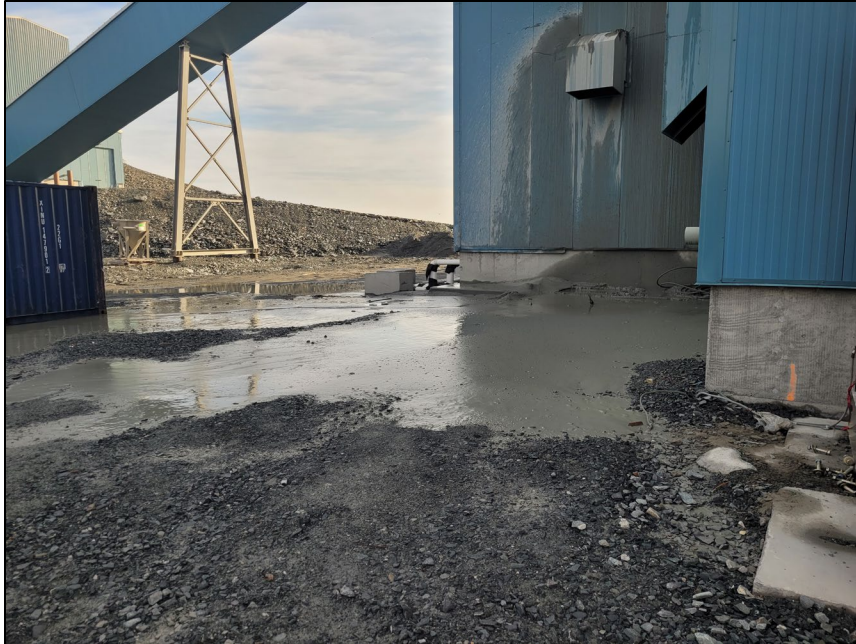
On August 12th, 2023, at approximately 2:30 a.m., there was an inadvertent release of approximately 1.5m³ of tailings and fresh water outside the paste plant facility. The incident resulted from an overflow within the solid tailings hopper due to a malfunctioning sensor. In response, the plant operator undertook remedial actions, which involved hosing down the affected area. This action inadvertently led the mixture of tailings and fresh water to migrate from a maintenance door outside the facility.

Photo 1: Spill location.

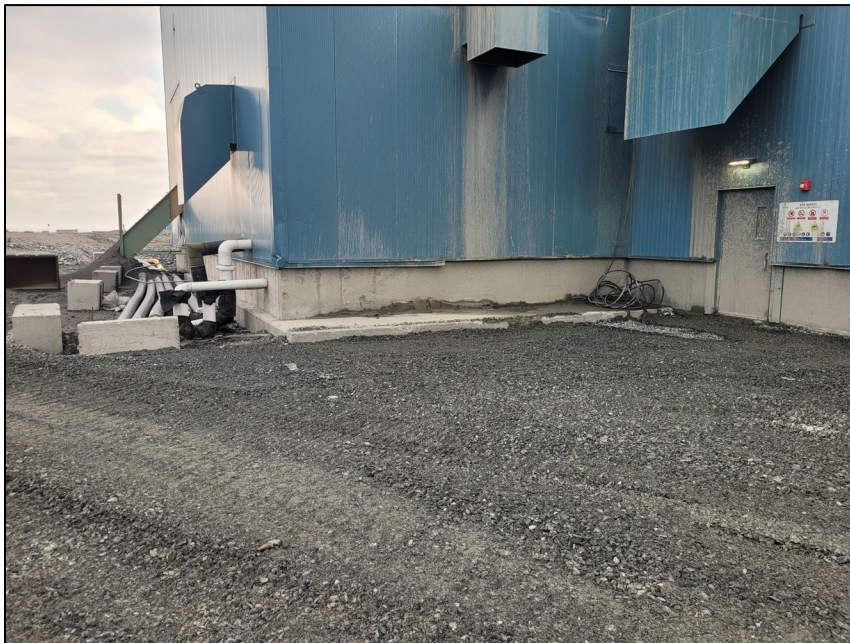
Photo 2: Post spill clean-up.

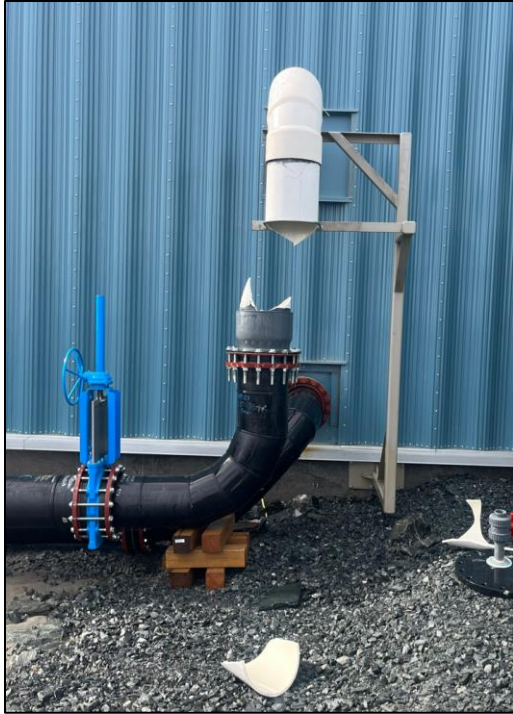
On August 25th, 2023, at approximately 10:00 am, there was an inadvertent release of approximately 20 m³ of contact water outside the Water Treatment Complex (WTC) during the Saline Effluent Treatment Plant (SETP) commissioning activities. A High-Density Polyethylene (HDPE) influent line that transitions to a Polyvinyl Chloride (PVC) coupler as it enters the WTC was conveying saline contact water from Tiriganiaq Open Pit 2 (Tiri 02) to the SETP. The contraction of the HDPE line caused the vertical portion of the coupling to shift, then break due to additional stress, resulting in a spill of contact water. Due to the location of the spill, contact water flowed into Collection Pond 1 (CP1), a part of the site's surface contact runoff management system.

Photo 1: Broken segment of PVC pipe, facing southwest.

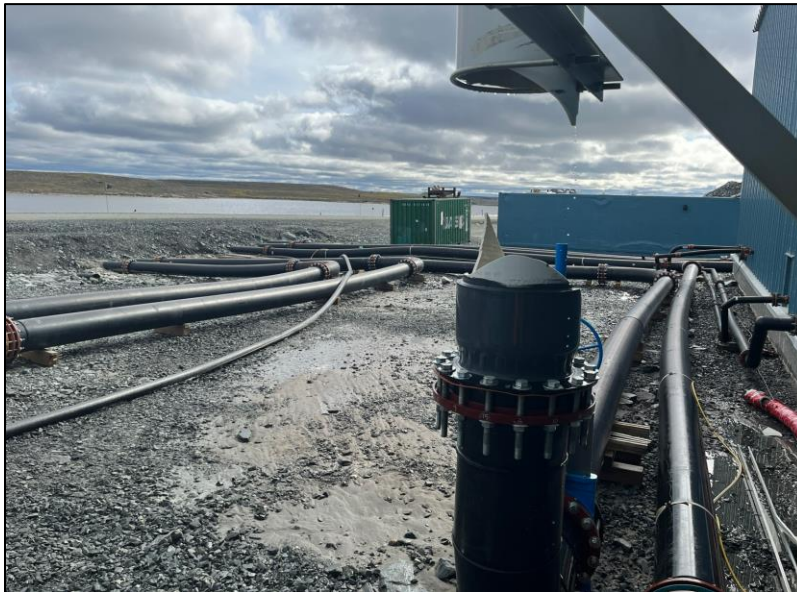
Photo 2: Broken segment of PVC pipe, facing southeast.

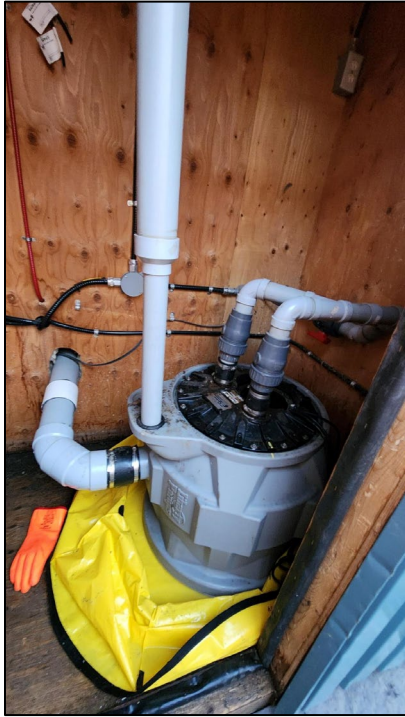
On August 30th, 2023, at approximately 05:00, an estimated 25 L of sewage was spilled onto the industrial pad by wing 4 lift station. A power failure at wing 4 de-energized the lift station and caused the spill. No water bodies were impacted by this spill. The closest water body (Lake G2) is approximately 225 meters northwest, as seen in Figure 1.

Photo 1: Sewage spill location.

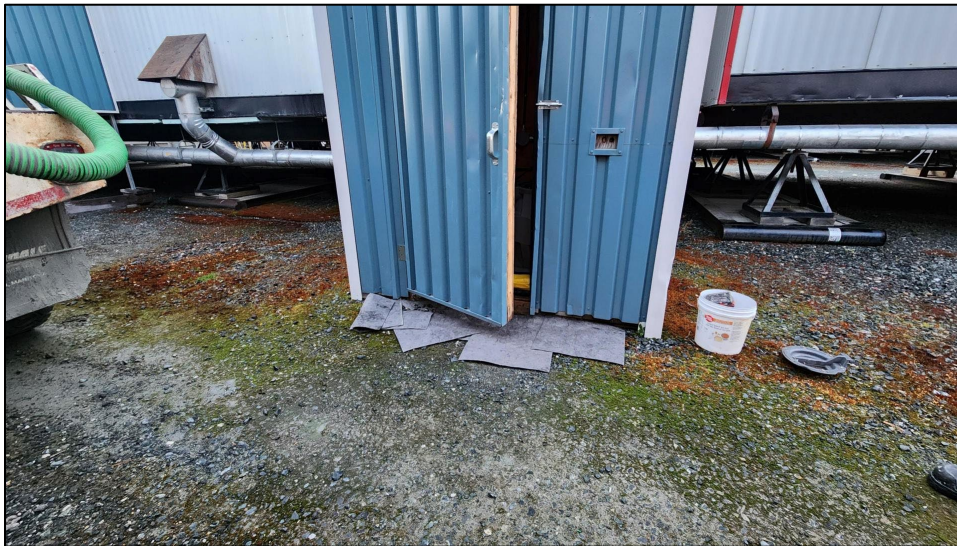
Photo 2: Sewage spill remediation.

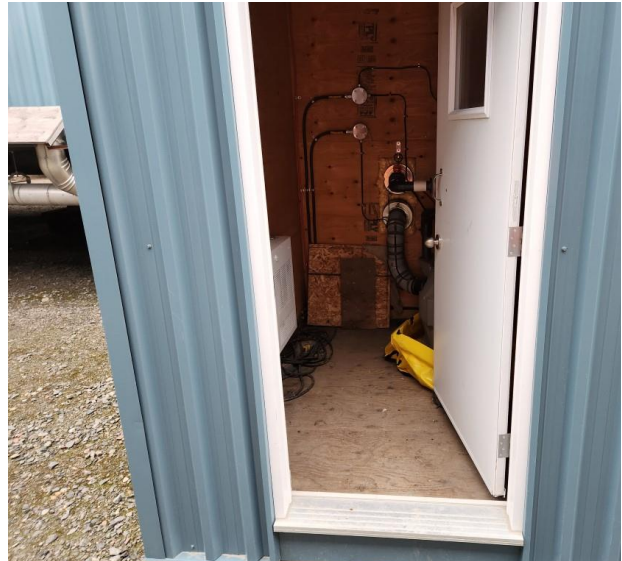
Photos 3 and 4: Spill location post remediation.

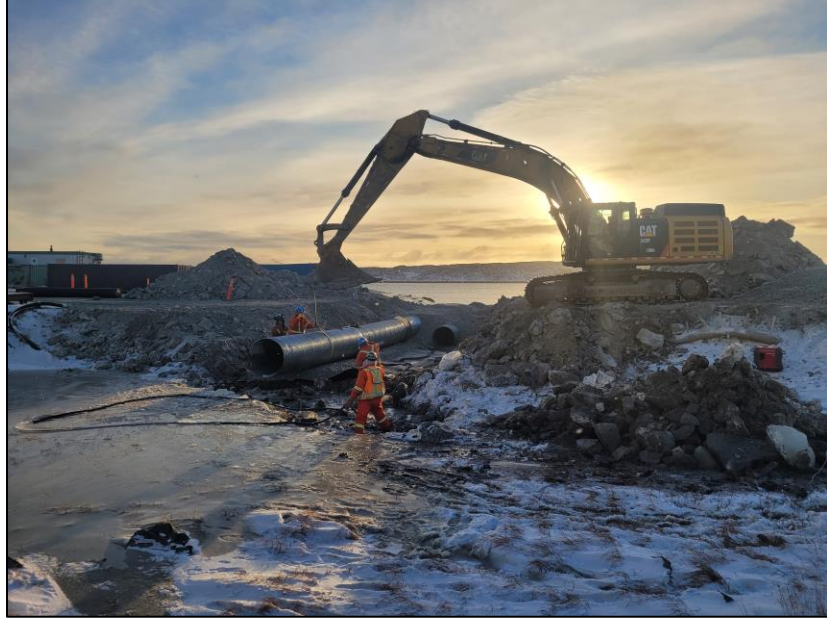
A submersible pump was installed in the excavation upstream of the culverts to dewater the area, and the discharge stream was directed into one of the partially installed culverts (Figure 2). Approximately 6 m³ of water was pumped from the excavation.

Figure 2: Dewatering of excavated area upstream of new Itivia culverts.

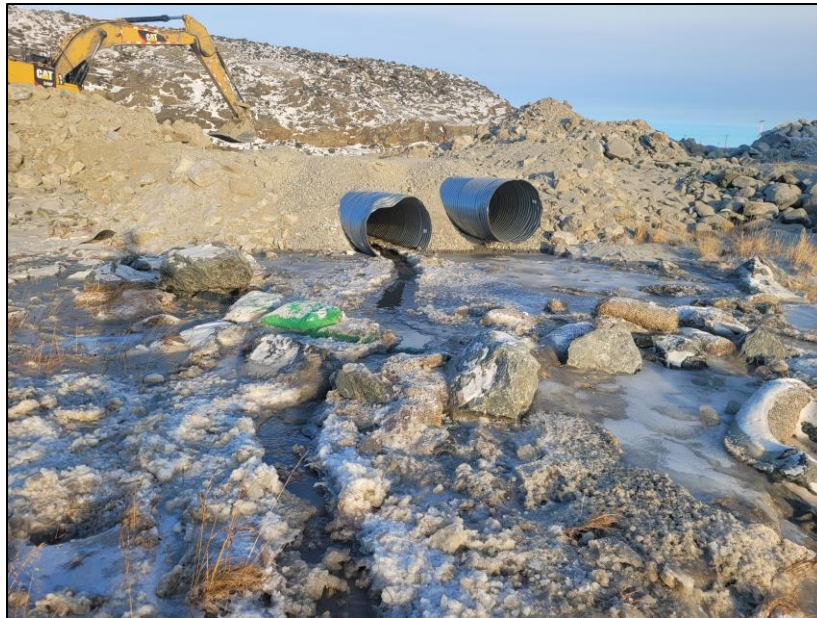
Figure 3: Discharge of pump dewatering downstream of Itivia culverts.

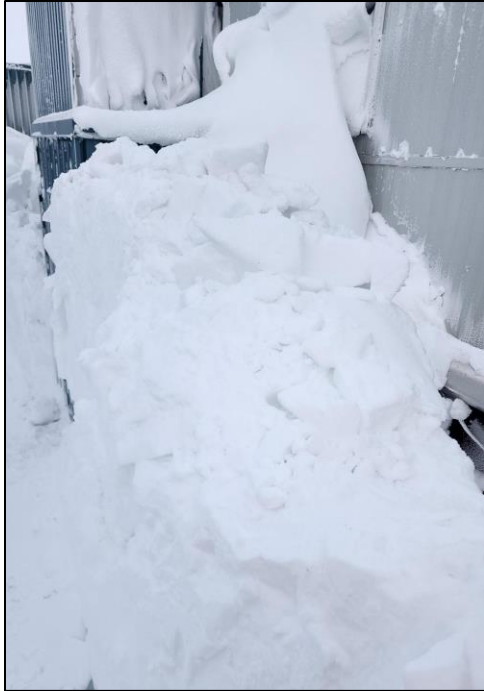
On November 29th, 2023, at 13:00, approximately 4m³ of sewage was inadvertently released to the camp pad due to a damaged sewage distribution line between the accommodations and the Wing 10 lift station. Snow accumulation caused a crack due to direct stress on the line. The nearest water body of water, Lake G2, is located about 250 m northwest as seen in Figure 1.

Photo 1: Sewage spill location.

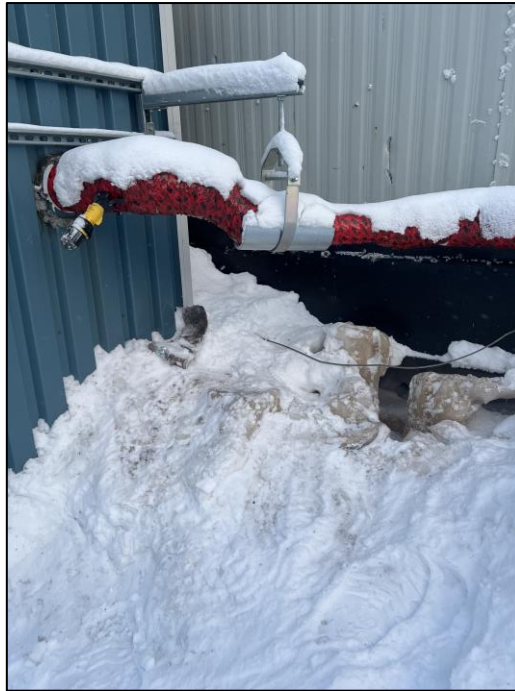
Photo 2: Spill location post snow removal.

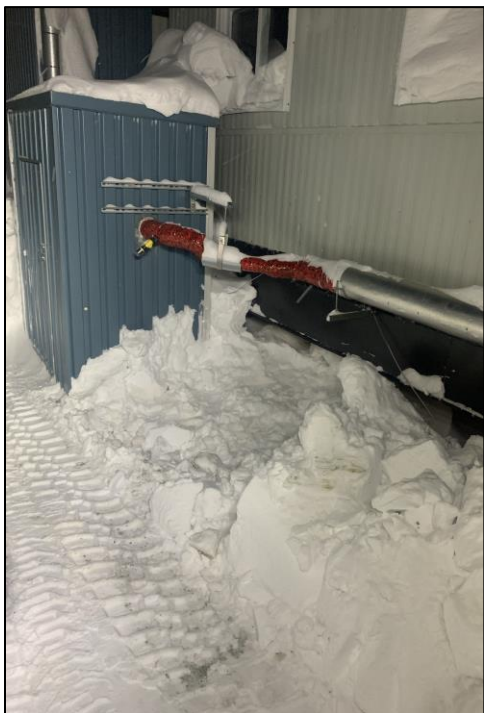
Photo 3: Spill location post remediation.

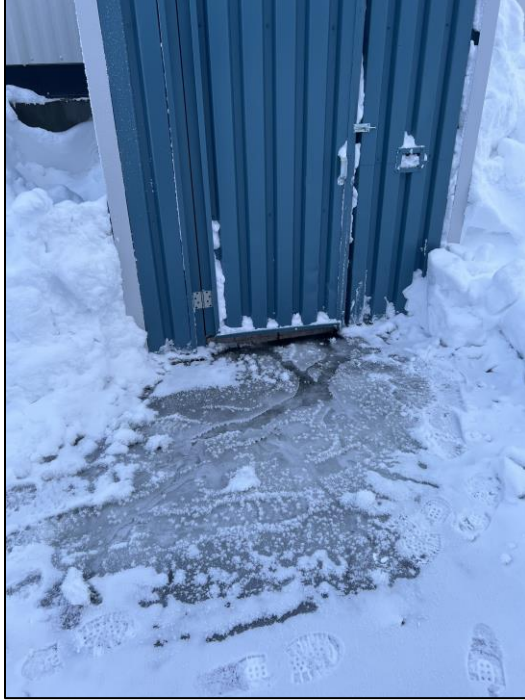
On December 11th, 2023, at approximately 11:30, an estimated 10 L of sewage was spilled onto the industrial pad at the wing 4 lift station. Due to a site power outage, the transfer pump did not engage allowing the lift station holding tank to overflow. No water bodies were impacted by the spill. The closest water body (Lake G2) is approximately 220 m northwest, as seen in Figure 1.

Photo 1: Sewage spill location.
